Root Cause Analysis of the Uncontrolled Hydrocarbon Release from Aliso Canyon SS-25

May 16, 2019

MAIN REPORT

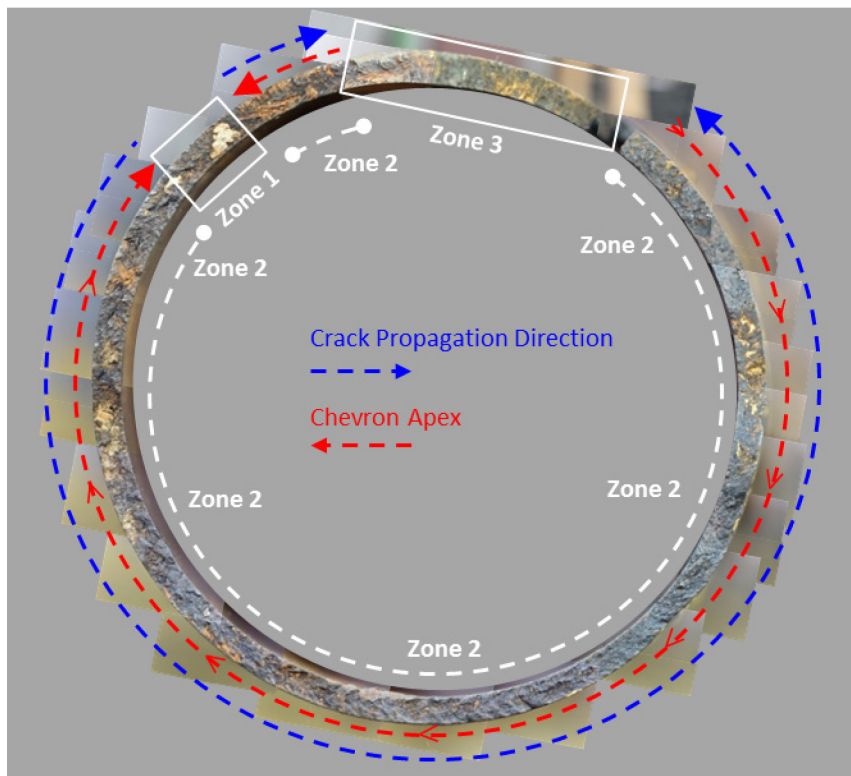
Figure 69: Zone 2 Chevron Marks and Crack Propagation Direction

Zone 2 was characterized by chevron marks with their apexes oriented towards Zone 1 (origin). Figure 69 shows the fracture surface in the non-cleaned condition. The chevron marks are clearly visible on a majority of the fracture surface in Zone 2. Zone 2 is identified by the dashed white circle in Figure 69. The dashed red and blue circles represent the chevron apexes and crack propagation, respectively. Zone 2 began at Zone 1 and arrested at the upper arrest point for the axial rupture. The beginning and end points for Zone 2 are indicated by the white dots at the end of the white circle.

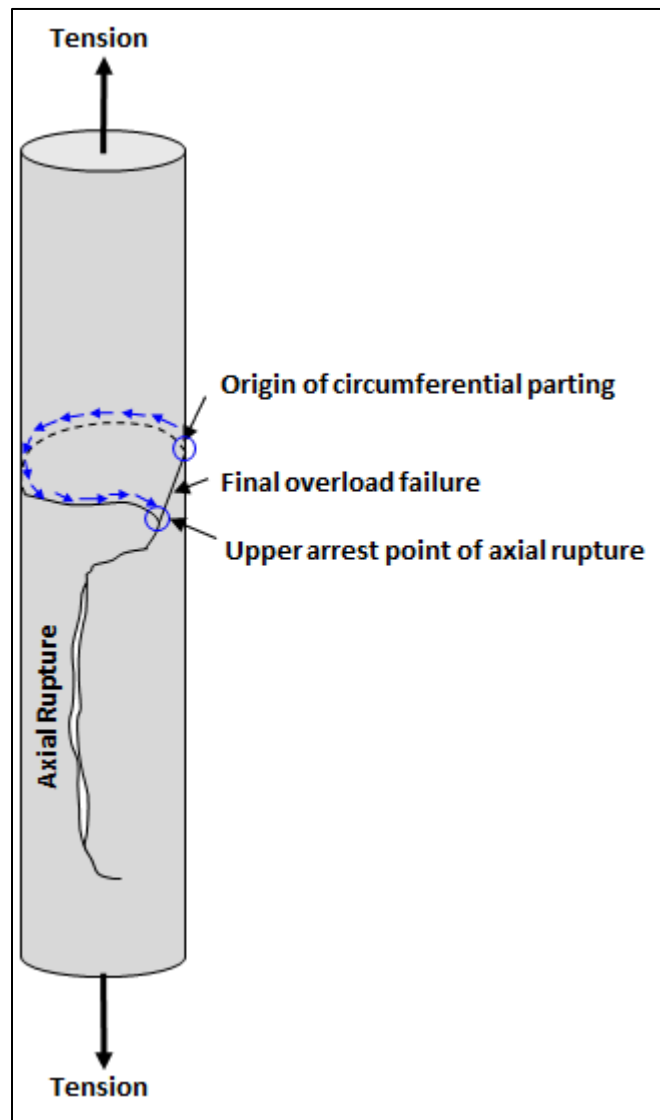
Figure 70: Schematic of the Axial Rupture and Circumferential Parting

the chevron marks produced by the axial rupture. The initiation site and chevron marks produced by the circumferential parting were located approximately 3.7 in. (94 mm) from the upper arrest point of the axial rupture. Figure 70 is a schematic of the crack path for the axial rupture and circumferential parting. The schematic shows how the circumferential parting initiated above the arrest point of the axial rupture. The crack propagated circumferentially until it reached the axial rupture arrest point. The final ligament failed due to the axial load generated by the weight and tension of the 7 in. casing string. The axial rupture and circumferential parting are thought to be two separate events because there was no evidence that the chevron marks from the axial rupture continued into the circumferential parting. The close proximity of the two failures suggests that they are related despite being two separate events.

Observations during the visual examination identified a significant difference between the axial rupture and circumferential parting. The circumferential parting was brittle, unlike the axial rupture, which was characterized by bulging and ductile tearing. The circumferential parting showed no evidence of plastic deformation or necking due to ductile overload. Measurements of the fracture surface were made to confirm this observation. Furthermore, Zone 1 of the circumferential parting was predominantly cleavage.

This is in contrast to Zone 1 of the axial rupture, which was characterized by micro-void-coalescence. These observations suggest that the axial rupture and circumferential parting occurred at different temperature regimes.

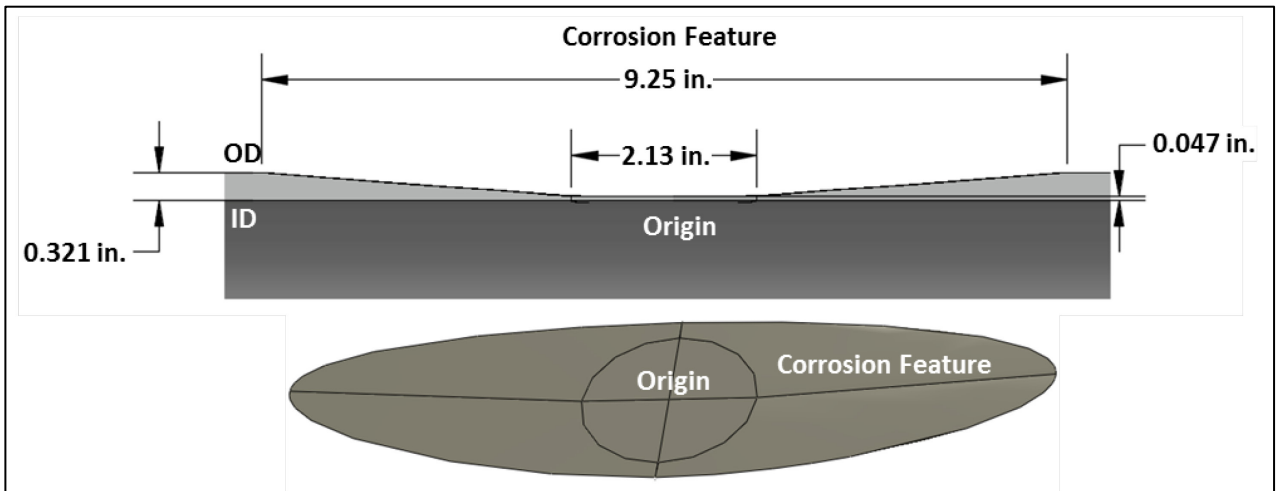
Figure 71: Corrosion Feature Geometry Model 1

Model 1 was a simplified model that focused only on the wall thinning effect (Figure 71). The wall loss of 85% (remaining wall of 0.047 in.) is depicted in the origin that was 2.13 in. The overall corrosion feature was 9.25 in. long.

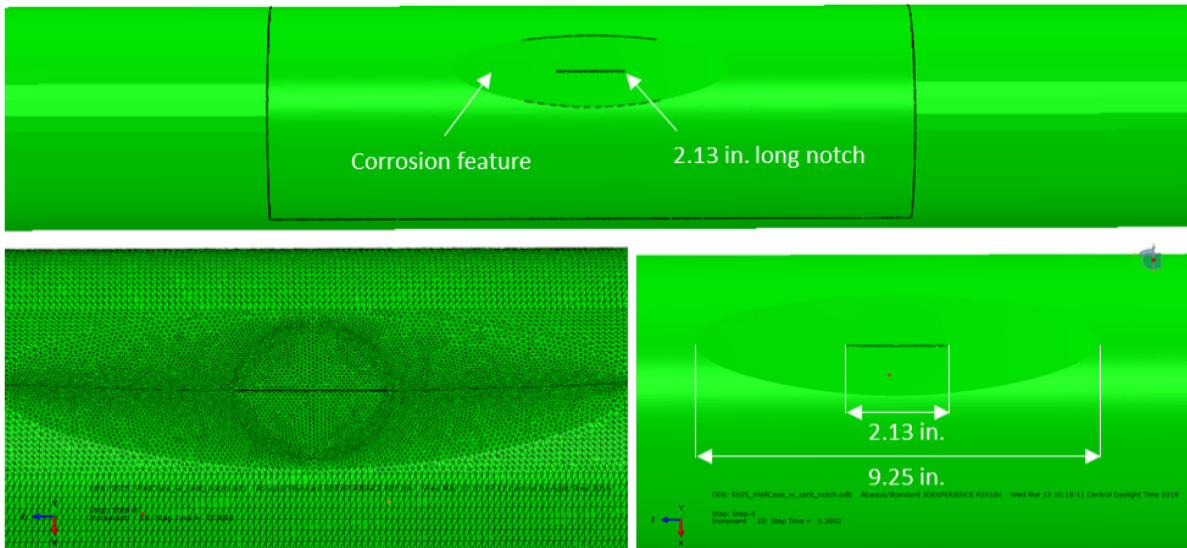
Figure 72: Model 2 Schematic and Mesh for Corrosion Feature and 2.13 in. Notch

Model 2 included a notch that depicted the striated grooves that were observed at the failure locations. The grooves’ dimensions were measured, and the diameter of the notch was noted to be 0.2 mm. However, the small dimensions were beyond the capability of the FE modeling tools; a notch radius of 1.0 mm was used to capture the notch effect of the corrosion grooves. The bottom of the notch was placed at a depth such that the remaining wall was equal to 1.26 mm, which is the same remaining wall as Model 1.

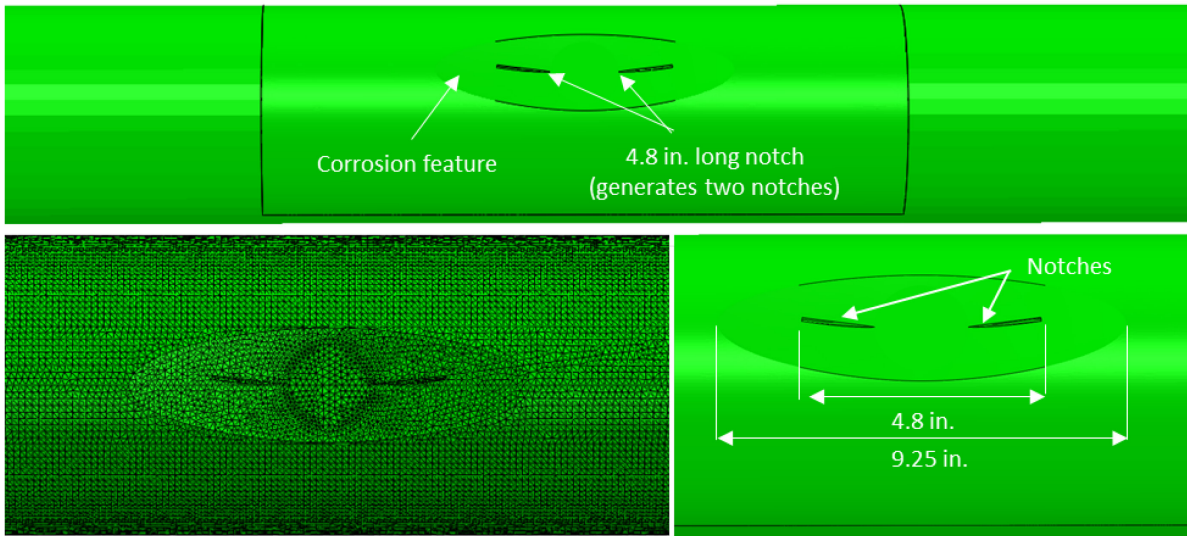
Figure 73: Model 3 Schematic and Mesh for Corrosion Feature and 4.8 in. Notch

Model 3 was designed to introduce the notch effect while maintaining the wall thinning within the ductile tearing region (2.13 in. circular region). The semi-elliptical bowl was modeled in the same way as Model 1. Unlike Model 2, the minimum wall thickness of 1.26 mm was maintained within the ductile tearing zone. A notch was introduced with a length increased to the macro definition of the origin (4.8 in.).

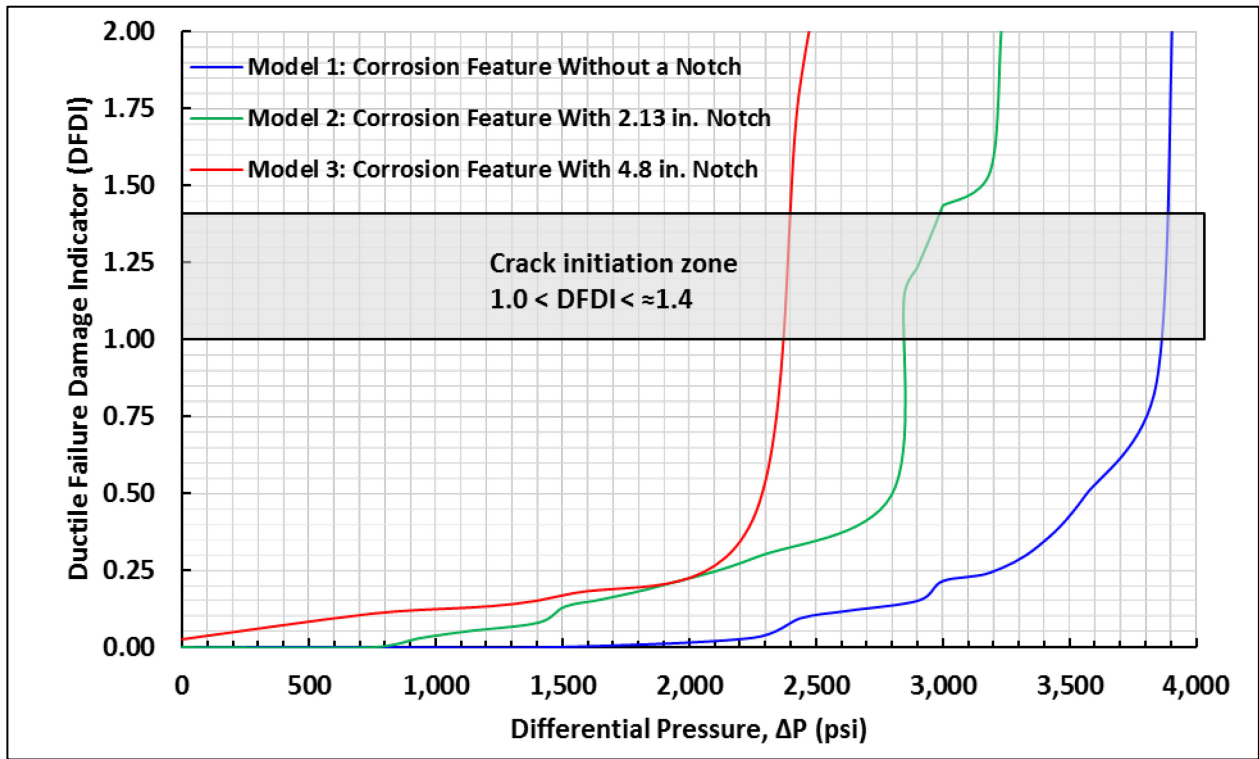
Figure 74: DFDI Evolution with Differential Pressure for Models 1, 2, and 3

A DFDI value of 1.0 was used to determine the differential pressure at which a crack would initiate within the corrosion feature. The DFDI is predicted for the three models as a function of pressure, and Figure 74 shows the results. The DFDI evolution is exponential, which implies the DFDI increases from 1.0 to 1.4 with a small increase in pressure. This implies that the crack initiates and grows by ductile tearing.

Table 5 shows the point of crack initiation in the plastic region when DFDI equals 1. The pure corrosion wall loss model predicts a pressure of 3,850 psi for a crack to initiate in this region. As shown previously in Table 4, the internal pressure on October 23, 2015, reached around 2,700 psi on surface and 2,791 psi at 892 ft. Model 1 schematic of the corrosion is not reflective of the failure scenario. Models 2 and 3 have differential pressures ranging from 2,327 to 2,836 psi, which is in the range of the pressures that existed at 892 ft. Since neither model completely captures the complexity of the failure region due to limitations of the FE modeling, the predicted range of failure pressures is from 2,327 to 2,836 psi. The key finding from the modeling is that the presence of the grooves was an essential element of the failure occurring at 2,791 psi internal pressure.

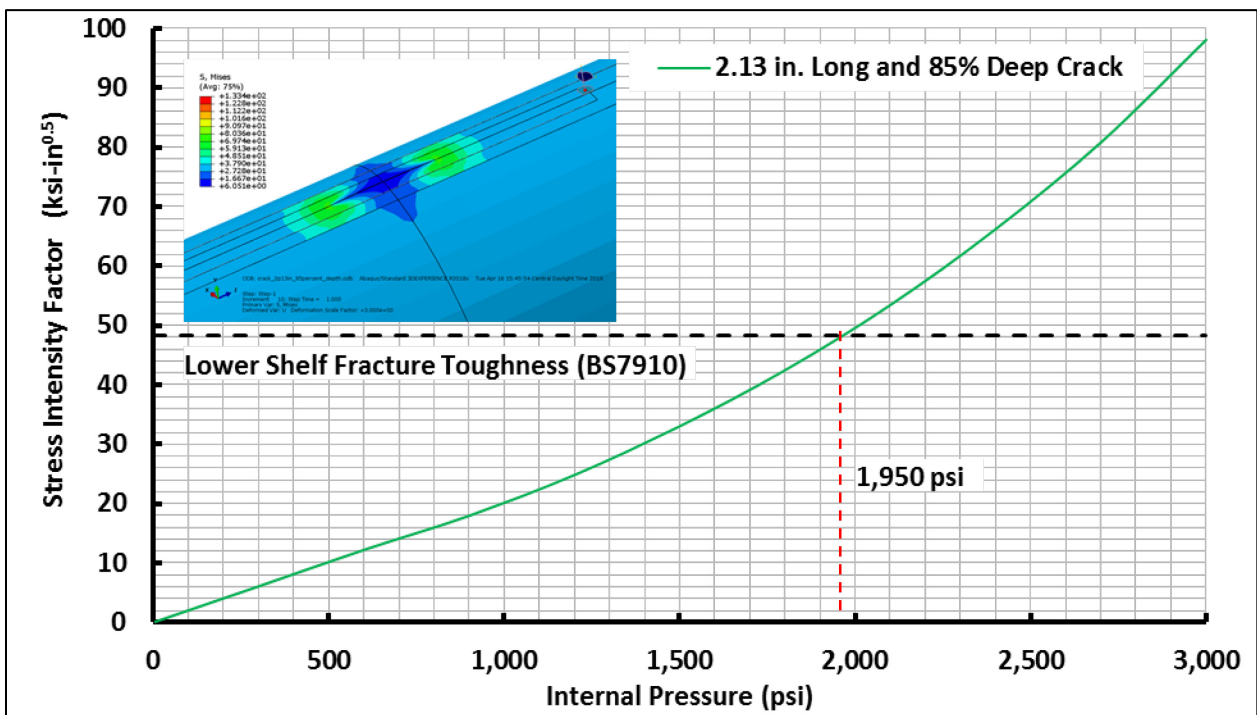
Figure 75: Stress Intensity Factor Evolution with Applied Internal Pressure

Charpy data were used to establish the fracture toughness of this material. The 7 in. casing J55 material exhibited lower shelf toughness properties at temperatures of 75°F (24°C). At room temperature, the average full size Charpy is around 14 J. This Charpy was converted to lower shelf fracture toughness (K_{Ic}) based on equations from BS7910 and equals 48.3 ksi-in^{1/2} shown with a dashed line in Figure 75.

In the FE model of the crack, the crack tip stress intensity factor reaches a value of 48.3 ksi-in^{1/2} equaling the fracture toughness when the internal pressure was approximately 1,950 psi. Figure 75 shows the results of the fracture mechanics analysis. The crack is unstable beyond 1,950 psi at room temperature. The results show that a 2.13 in. long and 85% deep crack would propagate at differential pressures ≥ 1,950 psi. The estimated strain-based failure pressure (2,327—2,836 psi) is above the fracture toughness-based instability pressure (1,950 psi). This shows that once the 2.13 in. crack formed by ductile tearing was unstable.

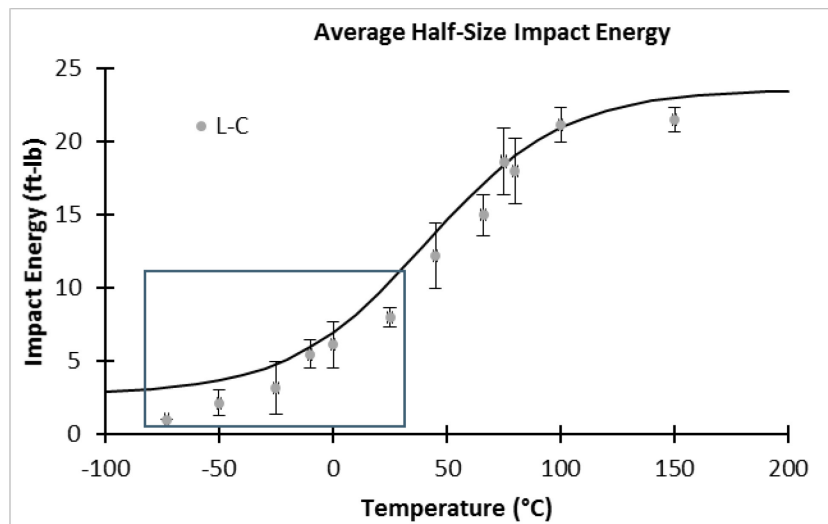
Figure 76: Average Half-Size Charpy Impact Energy vs Temperature for L-C Orientation

The average Charpy impact toughness data measured in the L-C (longitudinal-circumferential) direction as a function of temperature is shown in Figure 76.

The region of interest is the lower shelf that is marked by the box in Figure 76. Fracture toughness has been correlated to Charpy data for the lower shelf based on BS7910, which is shown by the equation below.

The fracture toughness that is estimated for the circumferential parting (Table 6) is correlated to Charpy. Then, from the Charpy data, the temperature is estimated and shown in the last column. The circumferential parting occurred at a temperature that would have ranged from -76°F to -38°F (-60°C to -39°C); the range is defined by the defect dimensions and the fracture mechanics model that is used.

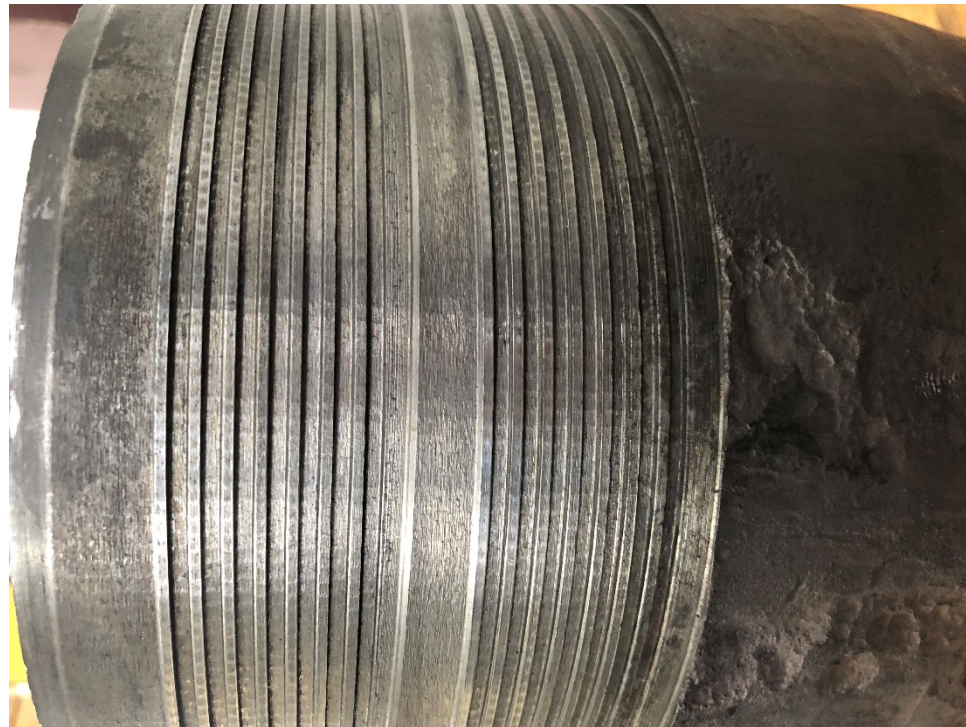
Figure 78: Pin and Box from Leaking Connection C023A1C

The highest leak rates came from C016B and C023A1C, which leaked at 1,120 SCCM (57 scf/D) and 196 SLM (9,967 scf/D) respectively. Connection C023A1C was located in the well 2.3 ft below where the 7 in. casing parted. The remaining seven leaking connections had very low flow rates.

None of the rates were high: there were no indications of any thread erosion as shown in Figure 78. The threads appeared to be in as-machined condition; however, the testing showed that for C021B at 1,000 psi the connection was leaking at more than 4 SCCM, whereas at 3,300 psi the leak rate was 128 SCCM. The leak rates were low and it could be stated that the gas seeped through the connections. The connection testing results were reproducible, implying that the nine connections leaked, albeit at low flow rates. Consequently, the conclusion based on the examination of the threads and the connection testing results was that hydrocarbon gas seeped through some of the connections at low flow rates.

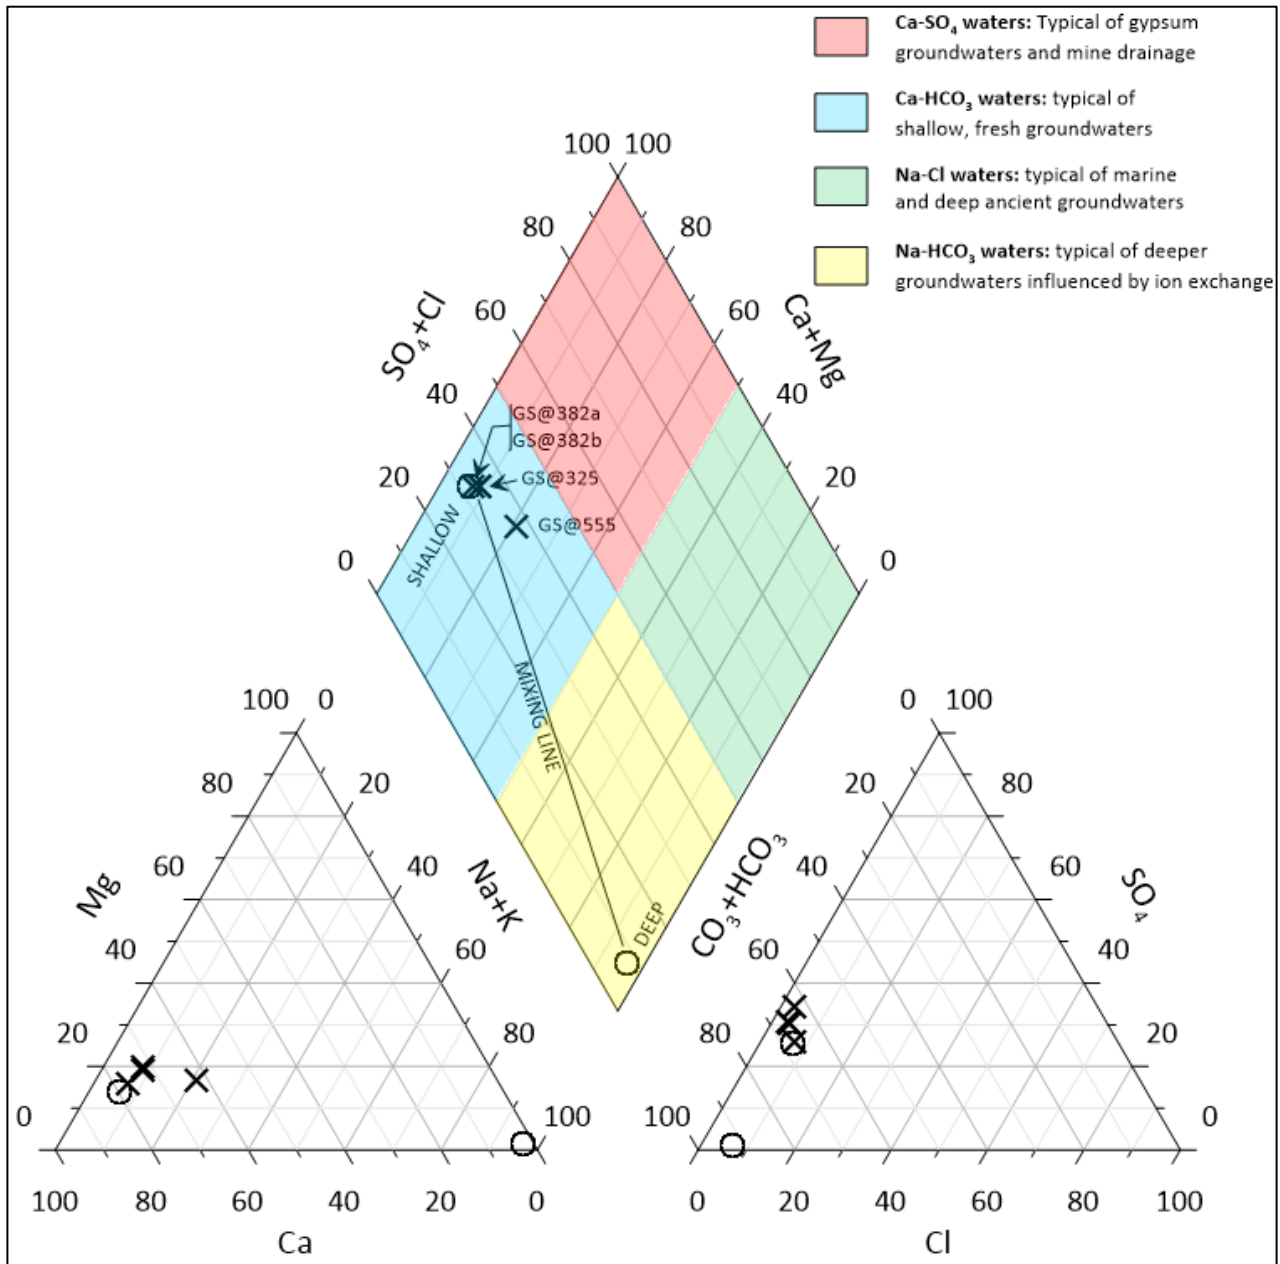
Figure 80: Piper Plots Showing all the Water Analyses

To interpret the water samples, the grab samples that were collected while drilling and the samples collected from the two monitoring wells are depicted on a Piper Plot in Figure 80 [27]. The grab samples compared to the monitoring well samples from shallow depth were identical, which was expected. These waters had calcium cations with bicarbonate. However, the deeper sample was richer in sodium with bicarbonate anions. The cations were different for the shallow versus the deeper water samples.

The difference in the water samples may be due to a mechanism that is discussed in hydrochemical literature known as ion-exchange [28]. The interaction of the water with the clay minerals has been known to result in an exchange of the ion from the water with that adsorbed on a solid. Clays are known to have high ion-exchange capacities when compared to other minerals. As the water permeated deeper into the formation, it would have encountered other clay formations, and the calcium ion would have been replaced by the sodium ion. This mechanism explains the difference in water chemistry between the shallow and deeper samples.

There were distinct shallow (340 to 440 ft) and deeper (900 to 1,000 ft) groundwater with slight differences in water chemistry. This water likely represented the environment in the production casing annulus and outside of the surface casing.

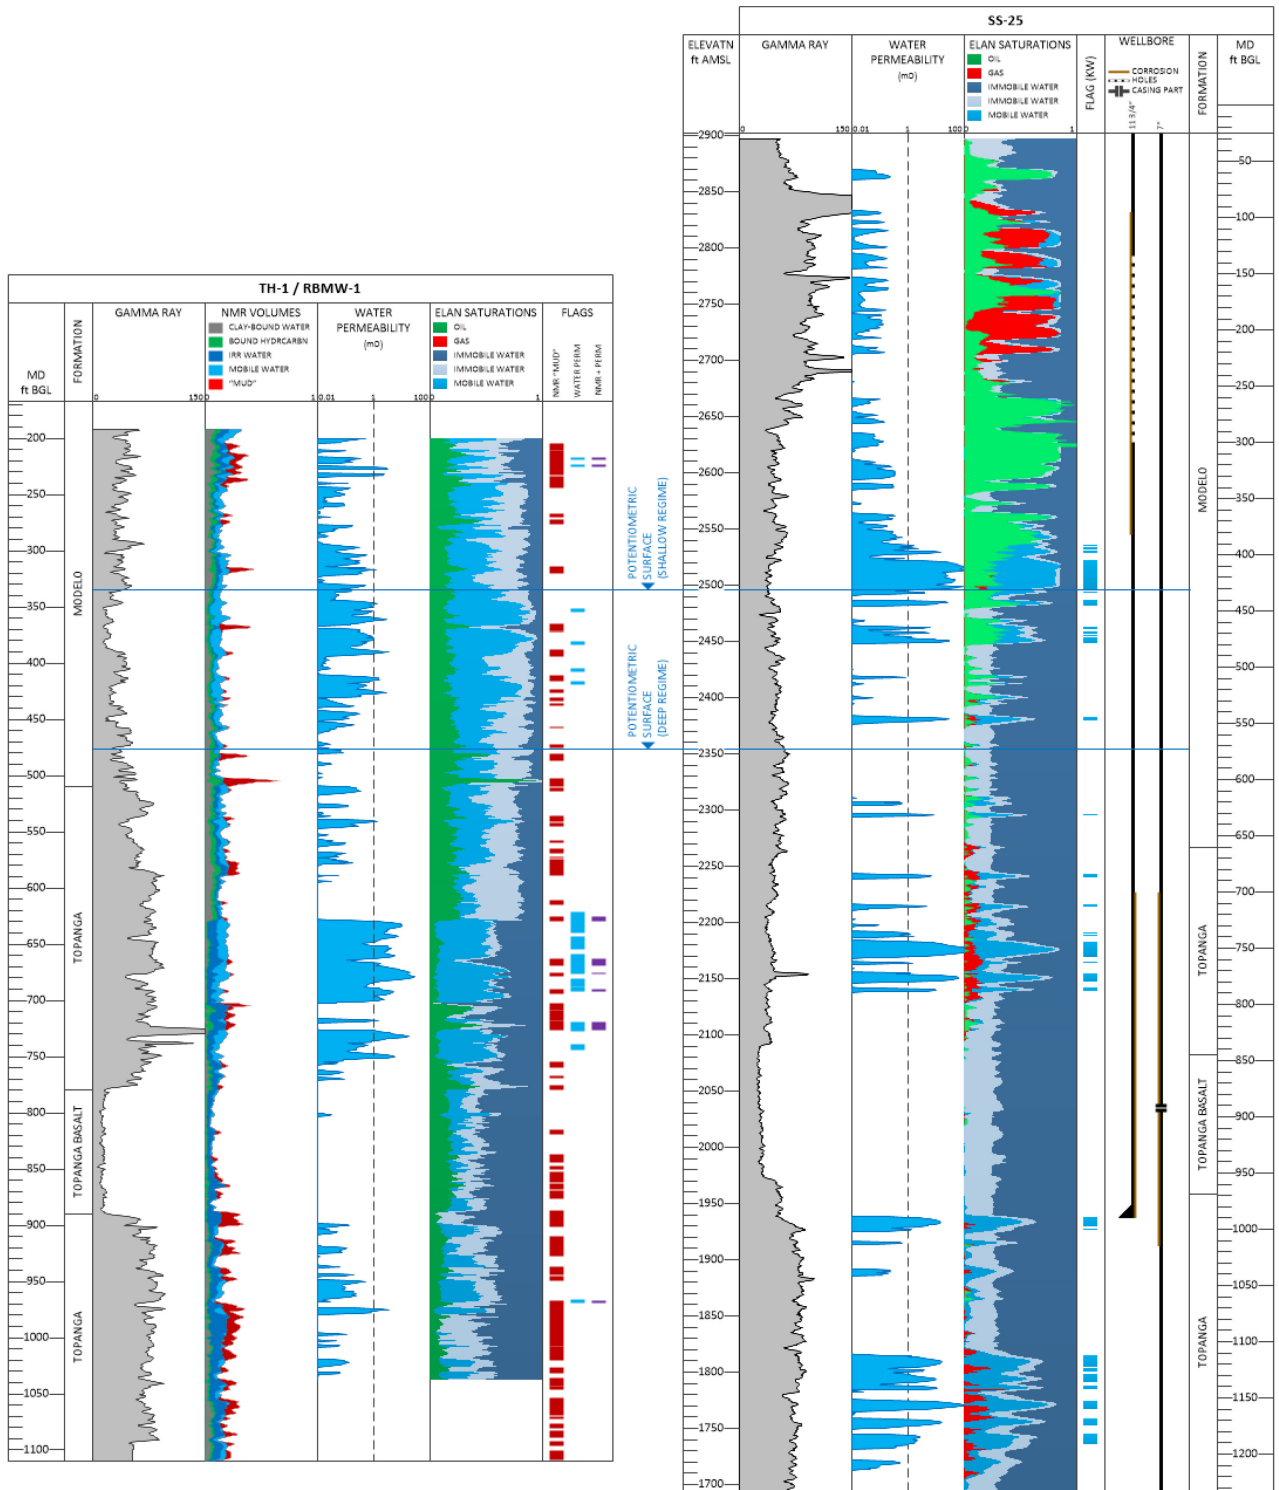
Figure 81: Correlated Geophysical Logs for RBMW-1 and SS-25 Wells

In the NMR track, the Mud column indicates high-permeability layers, which would be invaded by drilling fluids once the hole is filled to run the NMR logs. Since NMR logs can only be run in open holes, it was not possible to run an NMR log in the SS-25 well. The Modelo formation is above 510 ft in RMBW-1, whereas it is above 660 ft in the SS-25 well. Similarly, above the basalt, the Topanga formation ranges from 510 to 780 ft, whereas in the SS-25 well it ranges from 660 to 845 ft. After the basalt, the Topanga formation starts at 890 ft in RMBW-1 and starts at 970 ft in SS-25.

- Around six thin high-permeability water layers between approximately 310 and 420 ft are observed in the Modelo formation.
- One massive high-permeability water layer between approximately 620 and 690 ft is observed in the upper Topanga formation (above the basalt), and one thin and two thicker high-permeability layers are observed between approximately 710 and 740 ft.
- No high-permeability water layer is observed in the basalt.
- One moderately thick high-permeability water layer is observed just below the basalt at approximately 970 ft.

- One massive and several thinner high-permeability water layers are observed between approximately 400 and 450 ft in the Modelo formation.
- Several thin to moderately thick high-permeability water layers are observed between approximately 740 and 790 ft in the upper Topanga formation (above the basalt).

- Similarly to RMBW-1, no high-permeability water layer is observed in the basalt.
- A moderately thick high-permeability water layer between 990 and 1,000 ft is observed below the basalt, right at the 11 3/4 in. casing shoe, and several moderately thick high-permeability water layers between 1,110 and 1,190 ft are observed below the shoe.

In summary, Figure 81 suggests that the mobile water is encountered in distinct higher-permeability layers in both Modelo and Topanga formations, but not in the basalt layer. From both logs, the basalt contains no water in SS-25 and RBMW-1. Below the basalt, there is a distinct water zone ranging from 990 to 1,010 ft in SS-25 right at and below the 11 3/4 in. shoe. There is a water permeability streak and mobile water between 990 and 1,010 ft in SS-25. This was likely the source of water that entered the production casing annulus. Further, several shallow high-permeability water layers are observed in both

SS-25 and RBMW-1 in the Modelo formation. These were likely sources of water for the corrosion observed in the 11 3/4 in casing.

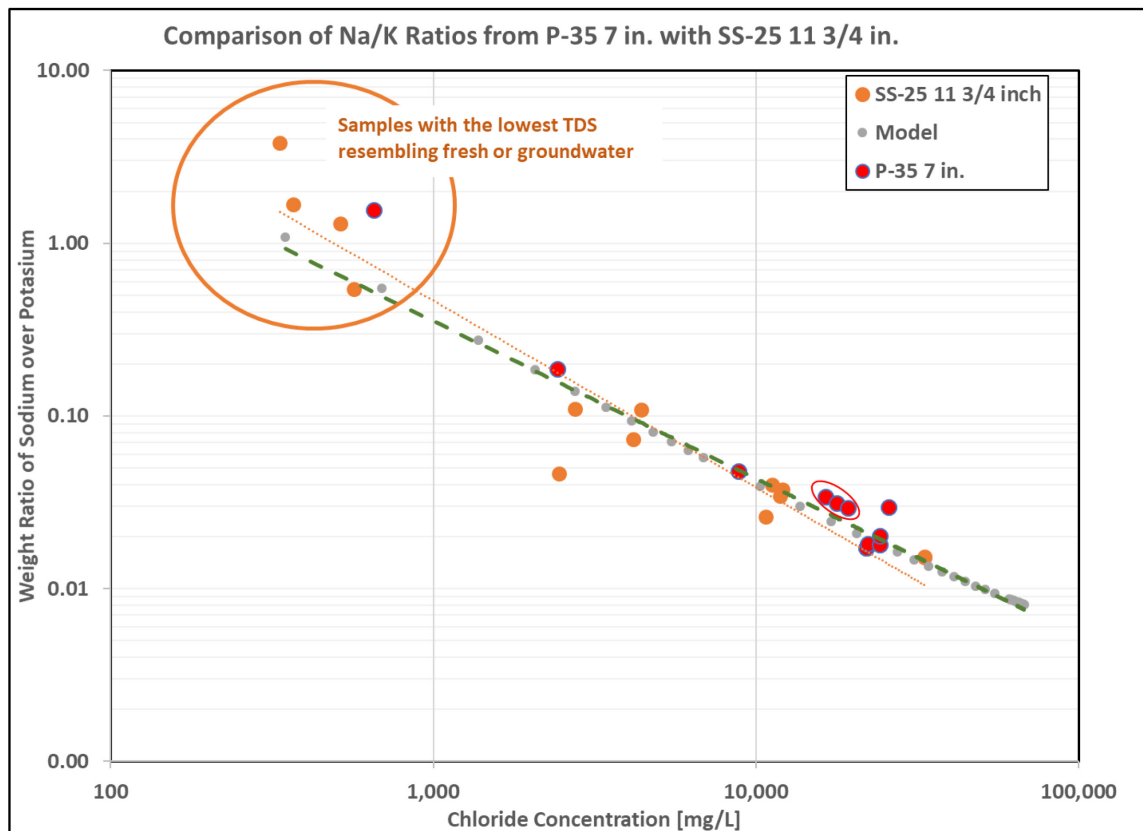
Figure 84: CHDT Results-Ratio of Sodium over Potassium versus Chloride

Through interpretation of the chemical analyses of these samples, it was established that their mineral content varied in wide limits, from about 400 mg/L to over 60,000 mg/L. More importantly, it was also found that the sodium to potassium weight ratio in the many samples that were collected from both wells increased exponentially with a decrease in the chloride concentration, as shown in Figure 84.

These results are interpreted by recognizing that during the drilling and completion of these wells, workover fluids, largely consisting of potassium chloride, got sequestered in areas of high permeability and porosity of the formations through which the wells were drilled. In certain locations around 900–1,000 ft (SS-25) and 400–500 ft (P-35), however, high Na/K ratios were found with very low chloride concentrations. This could only have occurred if low salinity groundwater rich in Na and low in K caused the residual, sequestered, workover fluid to be diluted. This dilution process was modeled and the model was found to result in identical relationships for both wells. These results conclusively establish the presence of low salinity groundwater at certain depths. Only if such low salinity groundwater were in fact flowing at these locations would the extreme dilution to less than 500 mg/L chloride in certain samples have been possible.

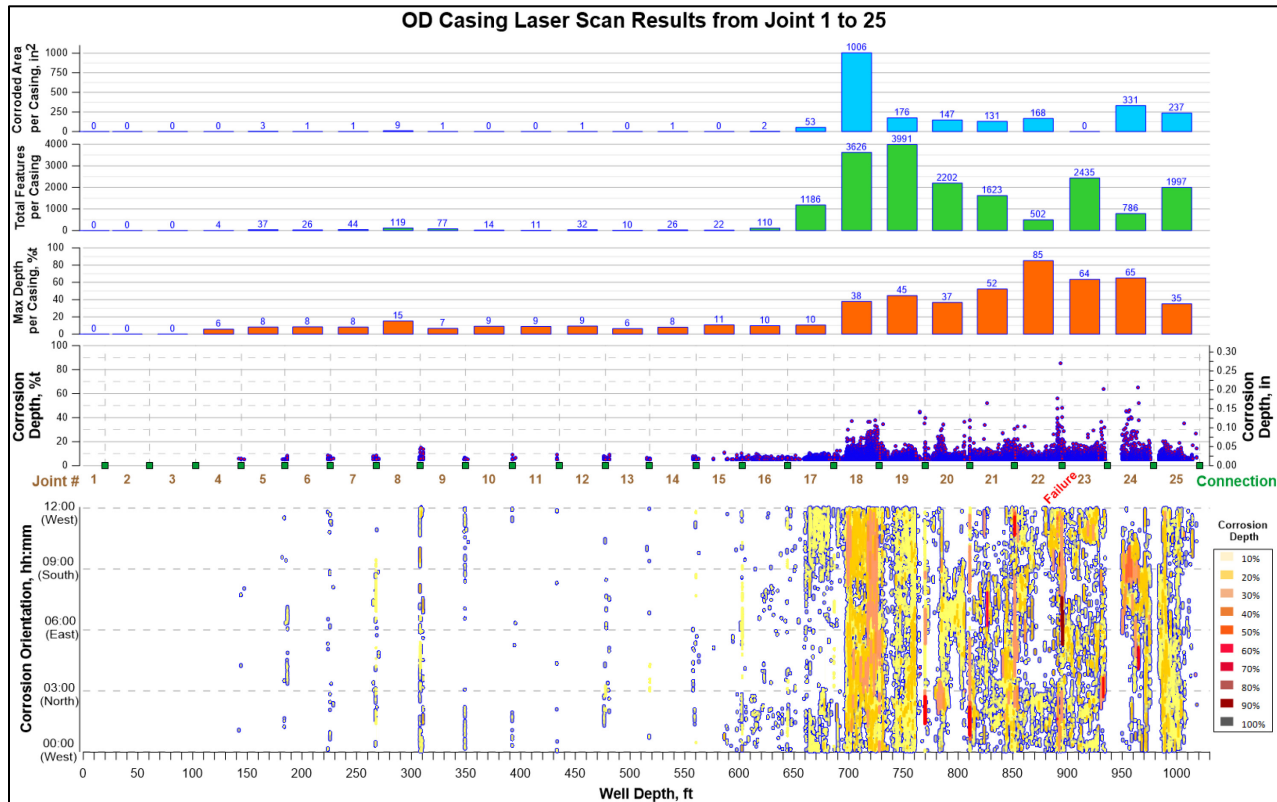
Figure 88: 7 in. Casing Outside Diameter Corrosion Distribution for Joints 1 through 25

All the data collected from the casing joints are summarized in Figure 88. The corroded area, number of features per casing joint, max corrosion depth per each joint, corrosion depth for all features, and finally depth distribution versus orientation are shown, demonstrating the distribution of the corrosion for all twenty-five 7 in. production casings extracted including connections. There is very little to no corrosion from joints 1 through 17 to a depth around 700 ft. In terms of maximum corrosion depth, the failure joint 22 had corrosion penetration at the failure location that was 85% wall loss. The majority of the corrosion features were 40% and lower in penetration. Joints 21, 22, 23, and 24 had the largest concentration of deep corrosion features. The key observation for all the joints with OD corrosion is that

the distribution is oriented all around the circumference of the production casing. No preferential orientation was noted for the OD corrosion in the 7 in. production casing.

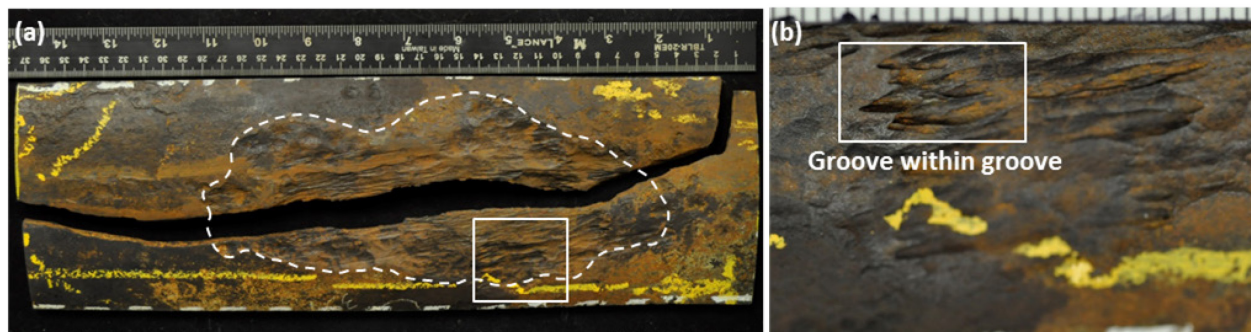
Figure 89: (a) Joint 22 Axial Rupture and (b) Type I Feature Showing V-shaped Tips

Type I was typical of the failure location and was characterized by striations as shown in Figure 89. These striation features have a groove with a sharp 'V' on each end of the groove. Type I corrosion could be visually identified, and the size of these features varied by location. The striated grooves were noted in all the joints starting from joint 18 onwards; however, none of the connections exhibited this type of corrosion.

Type I corrosion at the failure location, as shown in Figure 89, is distinct in nature. The possible cause for such corrosion was assessed and investigated by using morphology, scale, and microbial data.

The axial rupture occurred at the location where the Type I corrosion feature was present (Figure 89). Type I features can be described as a patch of metal loss with striated grooves that are oriented 10 to 15 degrees off longitudinal axes. The grooves contained pointed tips as seen in Figure 89. Some groove tips were present within another groove. The Type I metal loss features were observed as isolated patches along the length of the SS-25 7 in. casing. The maximum wall loss within the patch was 85% of wall. Adjacent to the feature was unaffected metal surface (no metal loss).

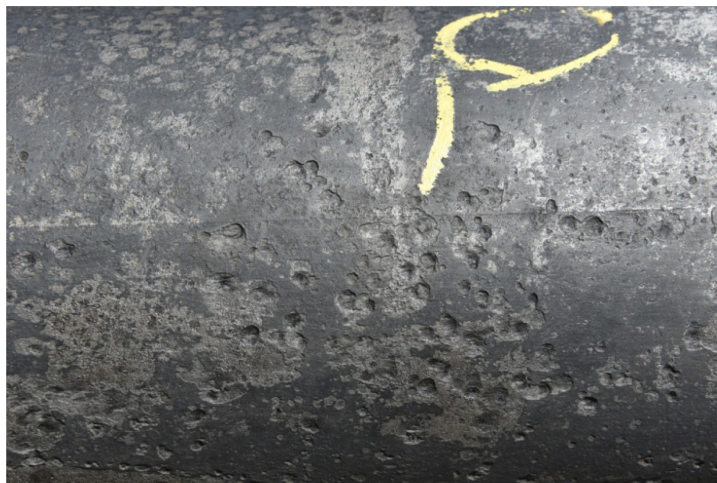
Figure 90: Type II Corrosion—Isolated Small Pits

Another type of corrosion that was observed in the joints is classified as a Type II feature as shown in Figure 90. These features were isolated smaller pits, and quite often shallow. These were observed across all of the joints and some connections.

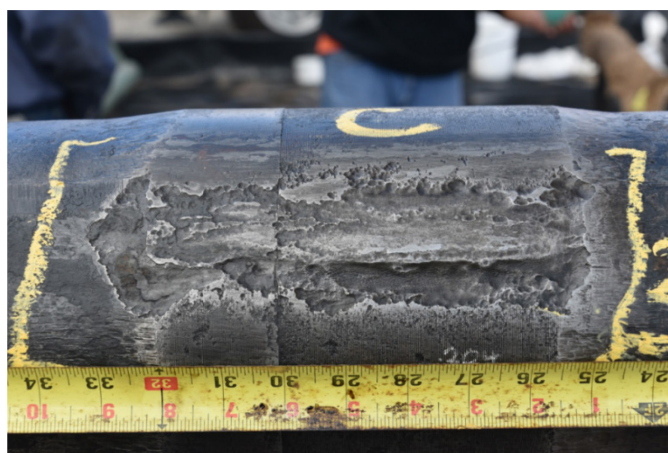
Figure 91: Type III Corrosion feature

Finally, Type III features appeared as very unusual elongated shapes. Several small scoop-shaped features adjacent to each other are seen within the elongated region as shown in Figure 91. The middle region of Type III feature is not severely attacked by corrosion. Nearly, every connection from connection 16 onwards exhibited Type III, and it was not noted on any of the joints, with one exception (joint 20).

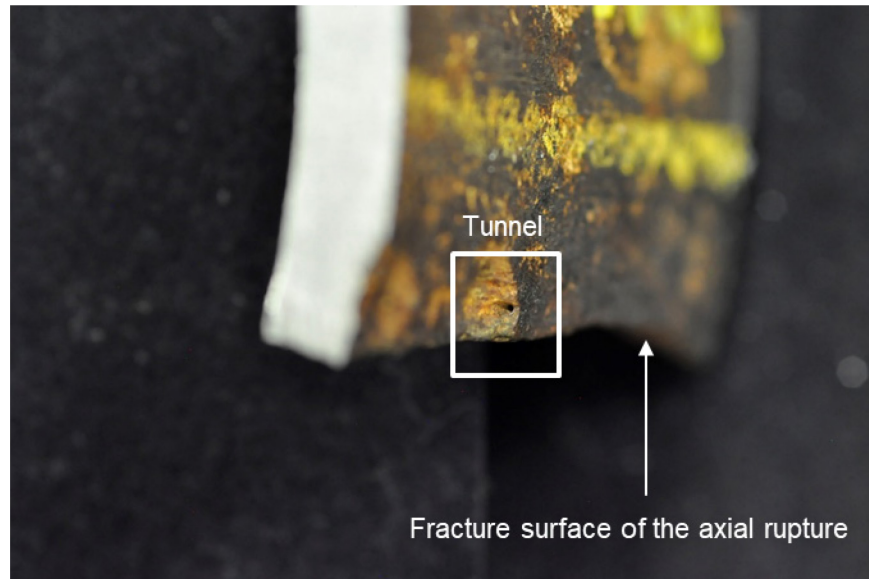
Figure 92: C023A1-B2A5 Groove Tunnel Adjacent to Axial Rupture Fracture Surface

The axial rupture specimen C023A1-B2 from joint 22 had a corrosion patch with striated grooves (Type I corrosion feature). The corrosion patch had a length of 9.5 in. along the longitudinal axis. The specimen was divided into smaller sections to facilitate the SEM investigation of the fracture surface and corrosion features. Specimen C023A1-B2A5 from the axial rupture had a visible tunnel in the groove that was visually identified (Figure 92). The tunnel orientation was parallel to the axial rupture fracture surface. The tunnel penetrated the base metal. Figure 93 shows the magnified image of the tunnel using the SEM image of the same tunnel in Figure 92. Within the tunnel there are scale deposits. Despite the samples being exposed to kill and other fluids since the leak event, the scales and other deposits within these tunnels should have been relatively unaffected.

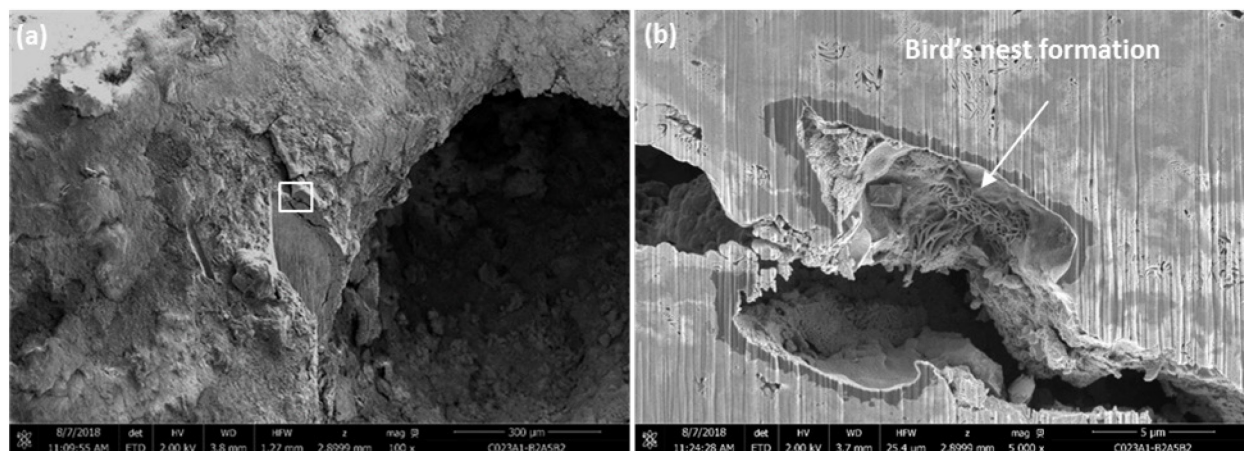
Figure 95: FIB Cross Section of the Tunnel Wall in C023A1-B2A5B2 at (a) 100× and (b) 5,000×

FIB cross-sectioning was done on the wall of the tunnel to look at the deposit morphology on sample C023A1-B2A5B2. Figure 95 shows the corrosion deposit morphology, which looks like the bird’s nest formation. This has been described by various authors who have studied atmospheric corrosion [30] [31] [32]. An EDS analysis revealed that the corrosion deposit contained ≈40 atomic percent (at%) Iron (Fe), 18 at% Carbon (C), 18 at% Oxygen (O), 9 at% Calcium (Ca), 0.2 at% Sulfur (S), and small amounts (<1 at%) of other elements. Another FIB cross section at the tip of the tunnel (Figure 96) reveals the corrosion products that form inside the tunnel. The main elements found with EDS were C (≈60 at%), Fe (≈19 at%), O (≈19 at%), and small amounts of S, K, Mn, Cl, Si, and Al. The corrosion product did not appear to be dense. Several layers of deposits were seen inside the tunnel.

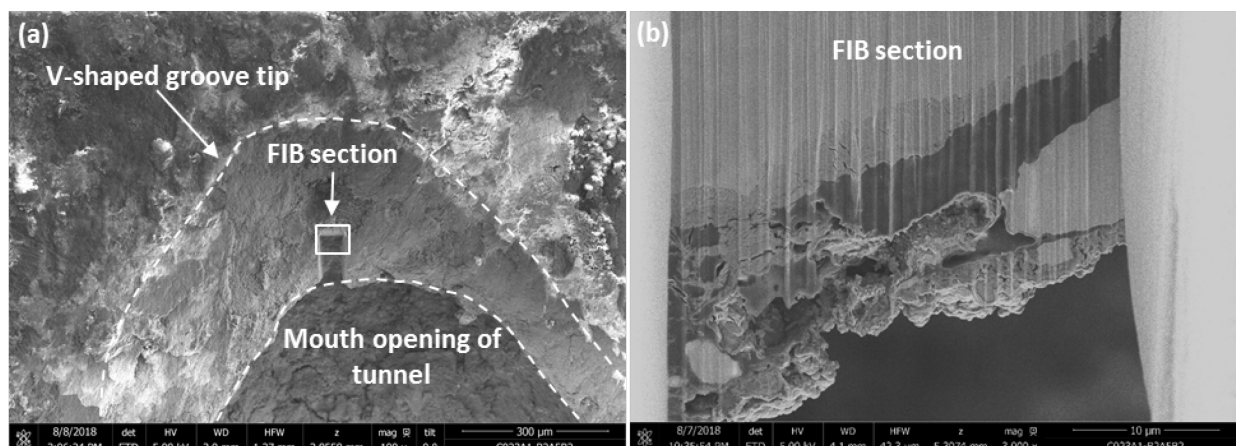
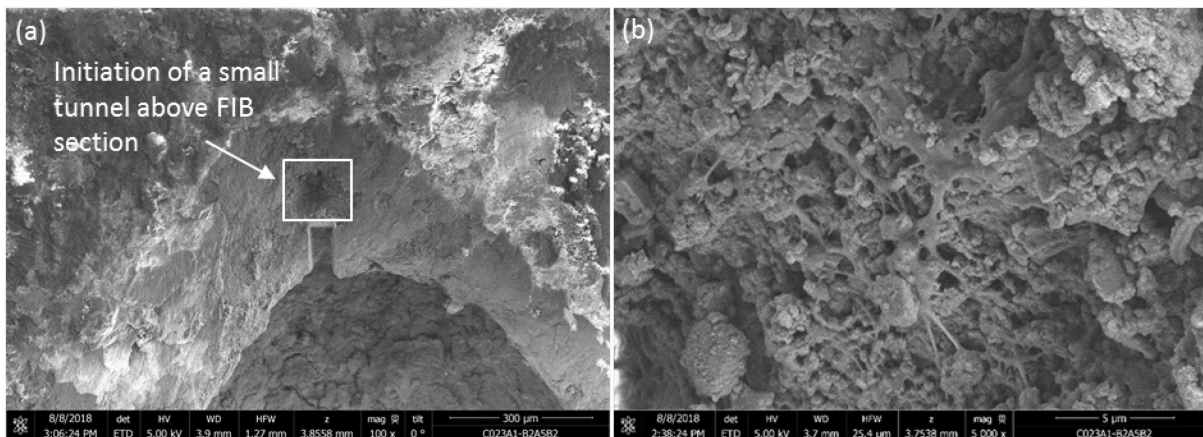
Figure 96: FIB Cross Section of the Tunnel Tip in C023A1-B2A5B2 Viewed at (a) 100× and (b) 3,000×

Further investigation of the area adjacent to the major tunnel identified a smaller tunnel at the initial formation stage. A closer look at the low magnification image in Figure 96 (a) shows a small, darker circular feature (white arrow) that appears to be another tunnel directly above the FIB cross section. Figure 97 shows a high magnification image of the circular feature. Material that appears to be extra-cellular was within the smaller tunnel. EDS analysis showed that the material surrounding the forming tunnel had a high amount of C (≈ 77 at%), with 10 at% Fe, 9 at% O, and 0.6 at% S. The high carbon on the extra-cellular looking material may indicate biological activity related to the formation of the tunnel.

Figure 97: C023A1-B2A5B2 (a) Small Tunnel and (b) Extra-Cellular Looking Material

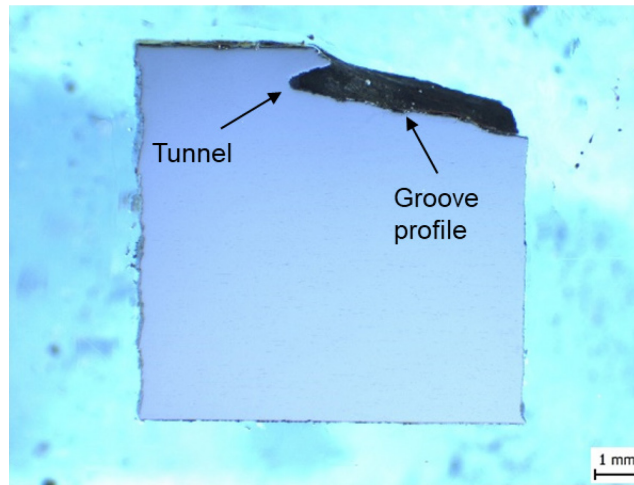
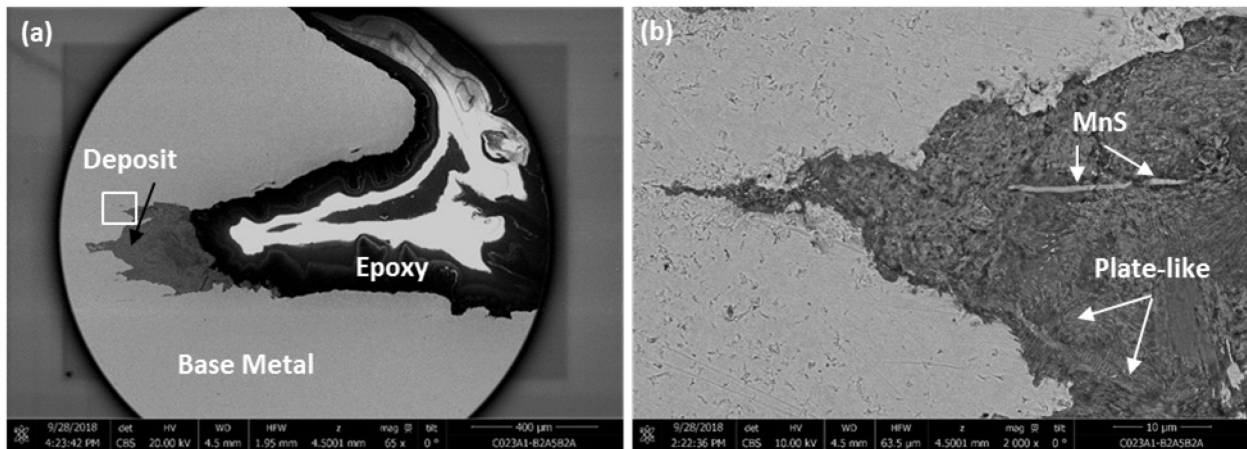
C023A1-B2A5B2A was subjected to a progressive-step wise metallographic sectioning across the major tunnel after the FIB investigation. The sample was mounted in epoxy. Figure 98 shows the groove profile of the depth of the tunnel along the longitudinal axis of the pipe after the second polish. The tunnel has a mouth opening of 0.0197 in. (0.5 mm) and extends 0.0393 in. (1 mm) into the metal. Figure 99 shows that the corrosion deposit at the tip of the tunnel is denser. Lamellar (plate-like) features are visible from SEM high magnification image in Figure 99. The presence of the lamellar cementite provides an anchor to the corrosion products [33]. EDS analysis showed that the corrosion product inside the tunnel was rich in O and C. The analysis also revealed that manganese sulfide (MnS) inclusion was present and surrounded by the corrosion product.

Figure 98: Stereo Microscope Image of C023A1-B2A5B2A

Figure 99: (a) Second Metallographic Cross Section of C023A1-B2A5B2A and (b) High Magnification Image of Corrosion Deposit

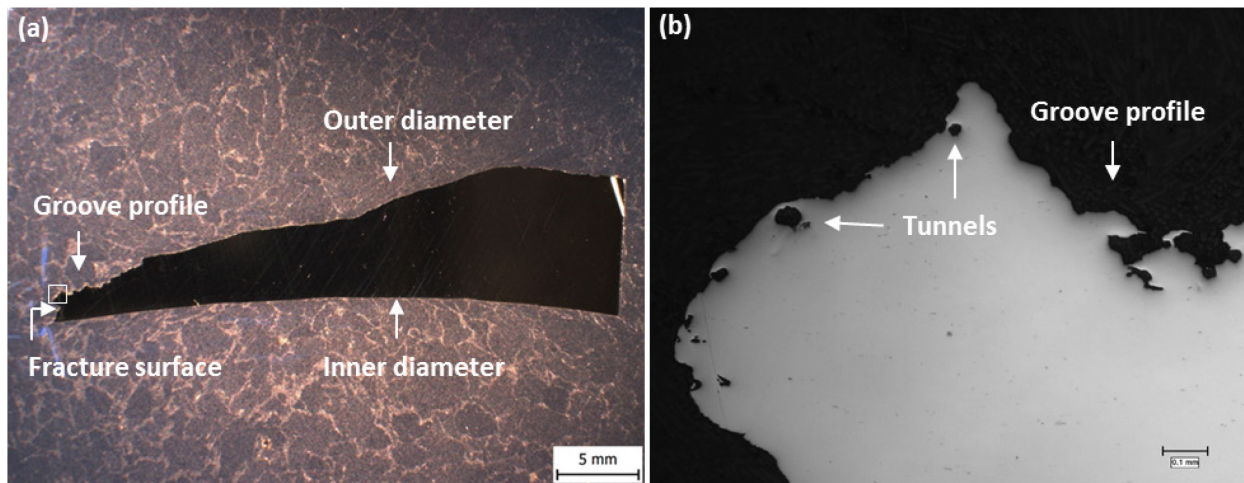
Figure 100: (a) C023A1-B2C2 Mounted and Polished and a (b) High Magnification Image Near Fracture Surface

C023A1-B2C2 was extracted from the initiation site of the axial rupture fracture surface. The specimen was mounted in epoxy and polished. Figure 100 shows a cross section of C023A1-B2C2 indicating the presence of tunnels directly below the groove inside of the Type I corrosion feature. The cross section also shows that MnS inclusions are present in the tunnel along with the acicular corrosion deposit. Figure 101 shows the SEM image of the cross section and the sulfur and manganese mapping obtained with EDS. The corrosion products inside the tunnel were not very dense. They were identified as hematite, modified hematite, magnetite, and organic matter using Raman spectroscopy.
