Root Cause Analysis of the Uncontrolled Hydrocarbon Release from Aliso Canyon SS-25

May 16, 2019

MAIN REPORT

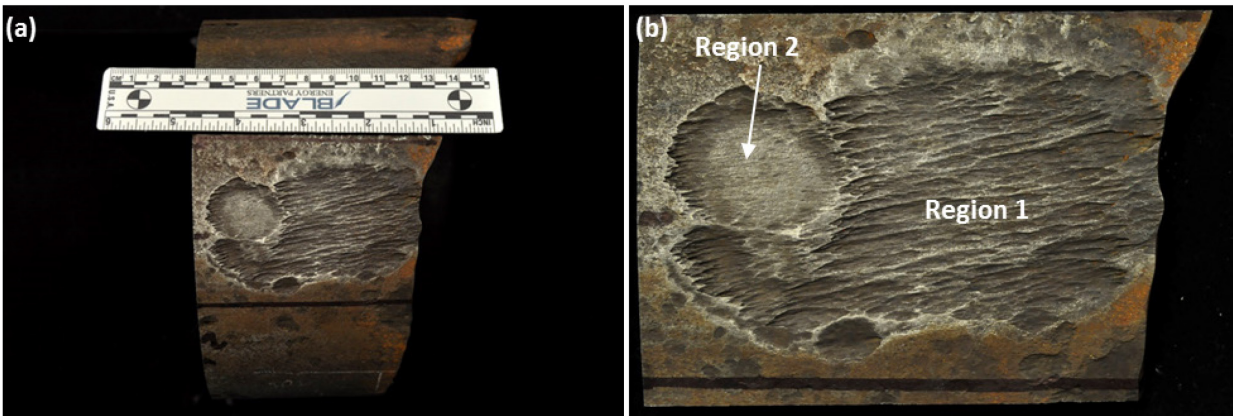
Figure 102: (a) C022B1 Specimen Extracted from the 7 in. Casing Adjacent to the Circumferential Fracture; (b) Macroscopic View of C022B1 Specimen After Cutting

Specimen C022B1 was extracted from the failed joint (joint 22). The specimen was located adjacent to the circumferential parting. The corrosion patch is approximately 3.5 in. long in the longitudinal direction and contained two regions. Region 1 of the corrosion patch has striated grooves that are visible within the entire region. Region 2 of the corrosion patch contains groove tips that are visible on the edge; however, striated grooves are not very visible on the mid region (Figure 102). The crystalline deposits were also observed on the striated grooves. Raman spectroscopy analysis of specimen C022B1 showed presence of carbonate, iron oxide combination, and organic matter. The number of grooves and groove density was quantified in a patch of corrosion, which was then compared to MnS density. There was no relationship between the two; the MnS density was much higher than the groove density. The

conclusion of this study was that there was no apparent correlation between MnS inclusions and the grooves.

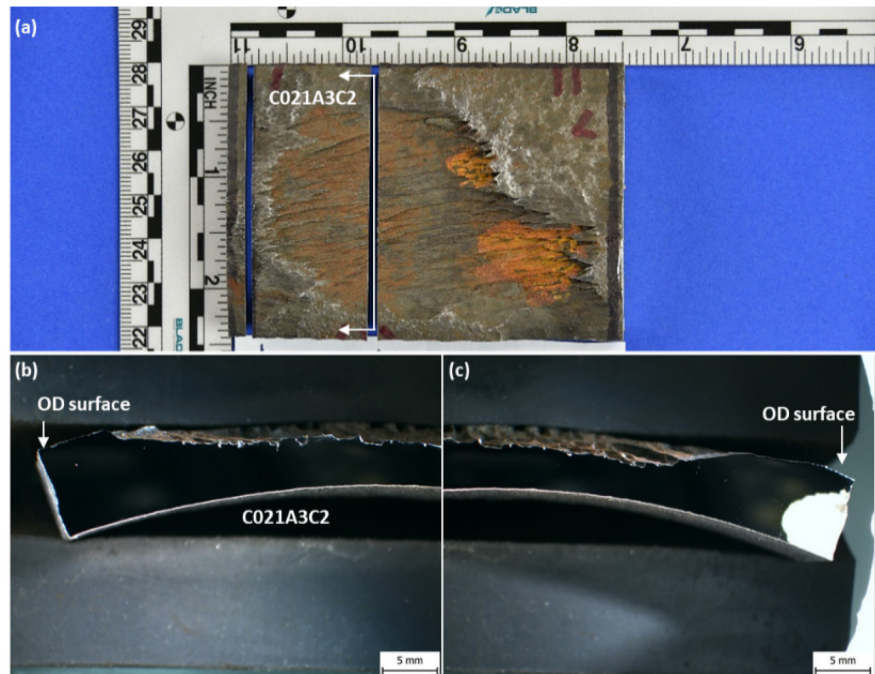
Figure 103: (a) C021A3C Pipe Section from 7 in. Casing; (b) and (c) Cross section near center

Specimen C021A3C was extracted from joint 21 of the SS-25 7 in. casing. This specimen exhibited a corrosion patch with striated grooves (Figure 103 [b]) approximately 3 in. long along the longitudinal axis. Groove tips were seen within larger groove tips and the striated grooves were visible over the entire corrosion patch. Raman analysis showed the presence of hematite (Fe_2O_3) and an iron oxide combination of hematite (Fe_2O_3), goethite ($\alpha-FeO(OH)$), and ferrihydrite ($Fe(OH)_3$).

Specimen C021A3C was sectioned across the striated grooves to investigate the groove profile and tips. Figure 103 (b) and (c) shows the profile of the grooves within the corrosion patch and unaffected OD

surface indicated by arrows. This image shows severe metal loss towards the center of the corrosion patch. Each individual groove contributed to the metal loss profile.

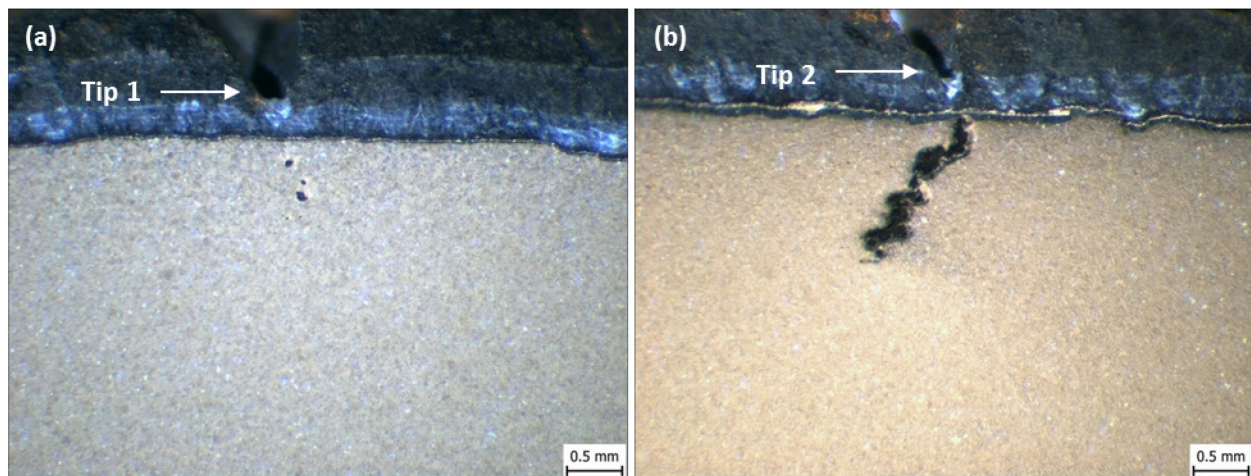
The cross section of specimen C021A3C2 near the groove tips revealed several tunnels underneath the groove tip. C021A3C2 groove tips were cross sectioned 1 mm ahead of the V-shaped groove tips. The dark circles in Figure 105 reveal the presence of several tunnels underneath Tips 1 and 2. Figure 106 are metallographs taken after the polished surfaces were etched of tunnels under Tips 1 and 2. Figure 106 (a) shows that even small tunnels can occur at 850 μm below the OD surface, and in Figure 106 (b) under Tip 2, the tunnels appeared to coalesce into a larger tunnel. A closer look at the tunnel under Tip 1 in Figure 106 (a) shows tunnels of various diameters that are isolated within the ferrite-pearlite microstructure. None of these tunnels appeared to be connected. In contrast to these, under Tip 2, the tunnels appeared to have coalesced into a large tunnel, as shown in Figure 106 (b).

Figure 105: Stereo Microscope Images of Tunnels beneath (a) Tip 1 and (b) Tip 2

Figure 106: Microstructure Adjacent to Tip 1 and Tip 2 Tunnels

All the tunnels were filled with corrosion product. SEM images taken at higher magnification show the presence of the lamellar feature and MnS inclusion in the corrosion products. EDS confirmed the presence of MnS and showed that the corrosion product was rich in O. The lamella structure was seen both on the etched pearlite (alternating layers of ferrite and cementite) and on the corrosion products). There seemed to be a preferential anodic dissolution of ferrite, leaving the cementite behind.

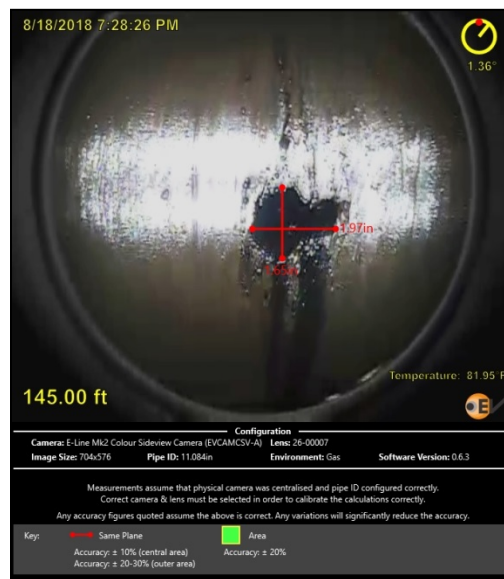
Figure 108: Picture of Hole in 11 3/4 in. Casing with Dimensions from Video Imaging at 145 ft

- At shallow depths in the casing, ranging from 90 to 385 ft, there were holes or metal loss indications. The various technologies, including caliper, UCI and HRVRT identified these through wall metal losses. The camera data were consistent with the logging data, and a typical photograph of the hole is shown in Figure 108. A total of 58 holes were identified, with 50 of them in joint 5 at depths ranging from 152.1 to 195.4 ft.

- Some of these approximately 58 holes could have existed prior to the 7 in. casing axial rupture. Many of the holes exhibited sharp corners that may have been more typical of a burst failure, implying that they occurred due to a pressure surge in the surface casing. These holes provided a pathway for the gas to the surface that further complicated the well-control operations. These holes provided a less resistant pathway to the surface, resulting in a higher gas leak rate.

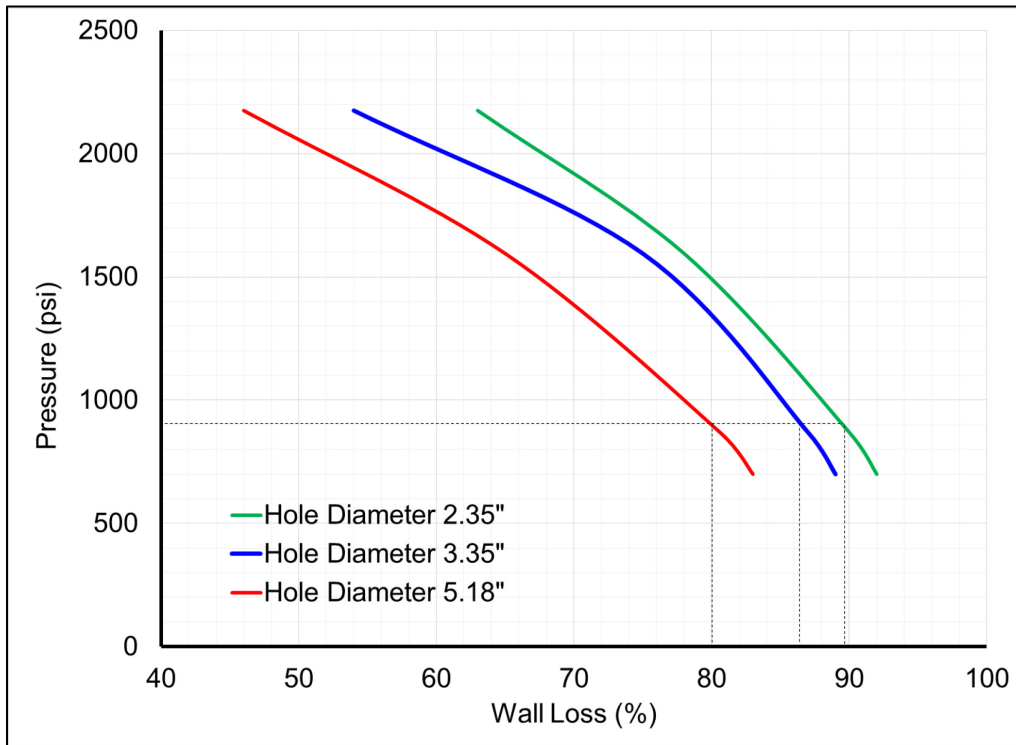
Figure 109: RSTRENG Safe Pressure Limit as a Function of Wall Loss

- Failure pressure was estimated using RSTRENG, assuming three different hole diameters and variable wall loss. The results are summarized in Figure 109, which shows that the external corrosion would have resulted in a hole at penetrations ranging from 80 to 90% of wall loss. The holes may have been a consequence of an internal pressure of 800 psi or higher. The pressure in the surface casing annulus surged to 800 psi at one point right after the axial rupture. The holes are likely a consequence of the axial rupture.

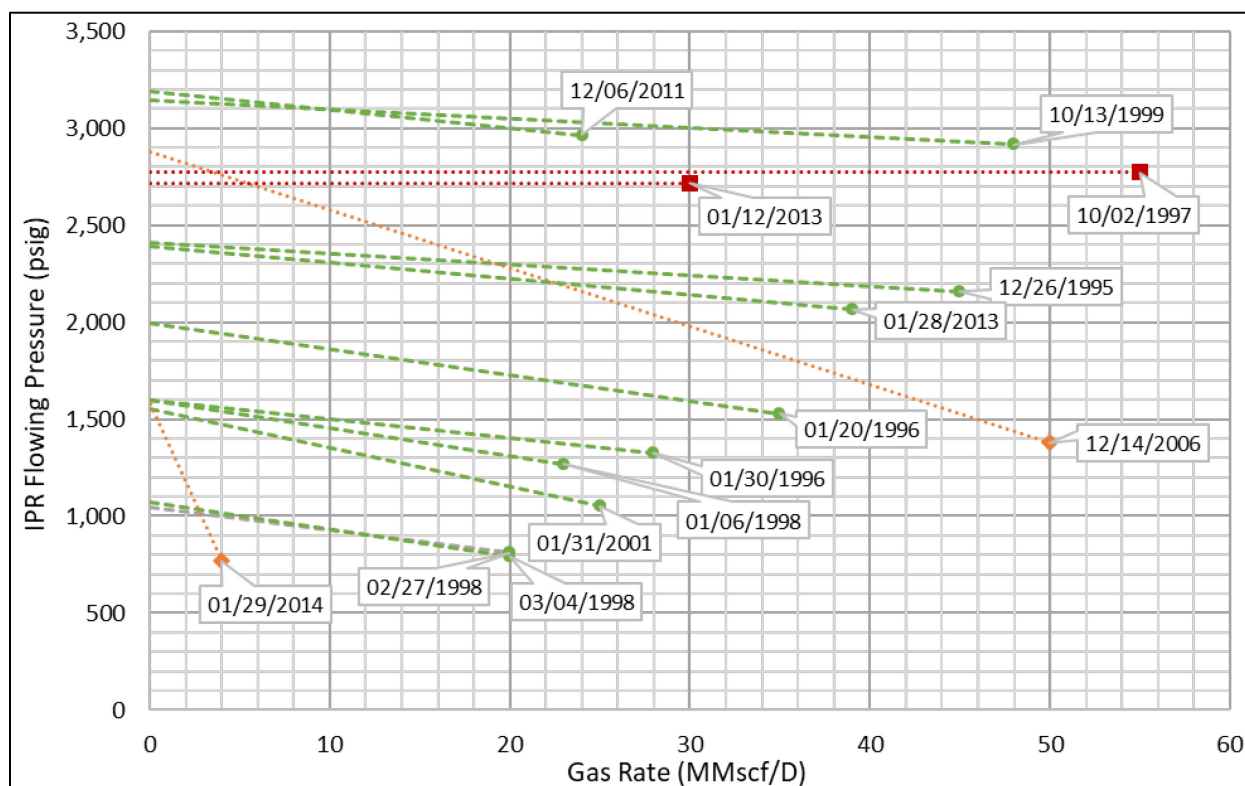
Figure 111: SS-25 Validation of Well Tests 1995–2015

Figure 111 shows the well tests for the previous 20 years on a performance chart. Wellhead pressures (WHP) were converted to bottomhole pressures by using the well model. In the figure, the well test itself is marked as a circle with a line connecting back to the reservoir pressure that was estimated from the provided static shut-in pressure. (As expected, the reservoir pressure varied by month of test according to the yearly cycle of demand.) The colors and symbols are as follows:

The questionable test of January 12, 2013 (in red), was re-run on January 28, 2013. The questionable test of January 29, 2014 (in orange), was not re-run; it was the test that was the most recent prior to the leak. Any adjustments based on the January 29 test that were made to any model would have under-predicted deliverability. This most recent test was inconsistent with the tests of the last 20 years.

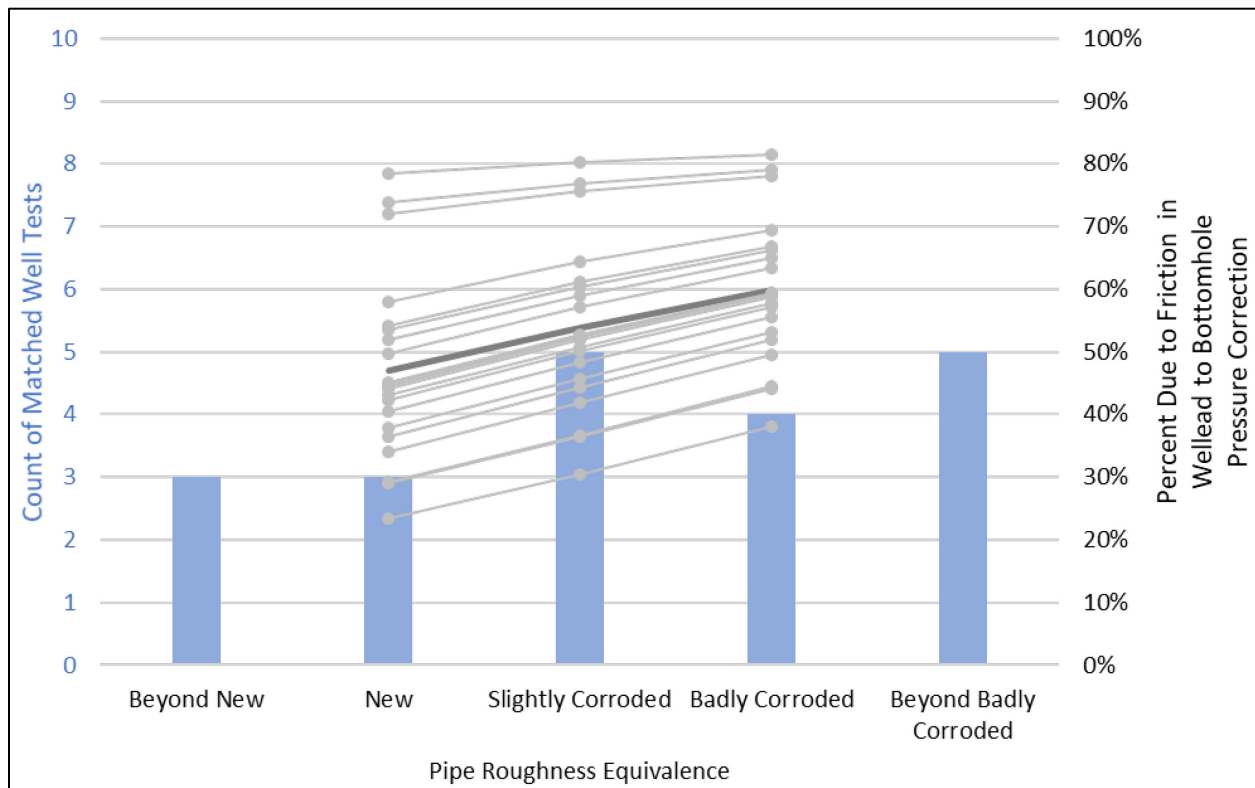
Figure 112: SS-25 Pipe Roughness Study for Well Tests 1980–2015

Figure 112 shows the best-estimate pipe roughness for well tests from the last 37 years. The roughness differed from test to test, and friction was significant (it averaged 45 to 60% of pressure loss in the outflow model).

Because there was sufficient random scatter in the well tests, a best-estimate approach was to assume the presence of pipe roughness in the slightly corroded category. (This was also supported by metal loss logs, which were run after the well was killed.) The scatter in the well tests resulted in uncertainty in the downhole flowing conditions and, consequently, uncertainty in the inflow properties. The best estimates would be statistically averaged estimates. A maximum leak rate could have been calculated by assuming new pipe roughness, for example, to engineer kill attempts.

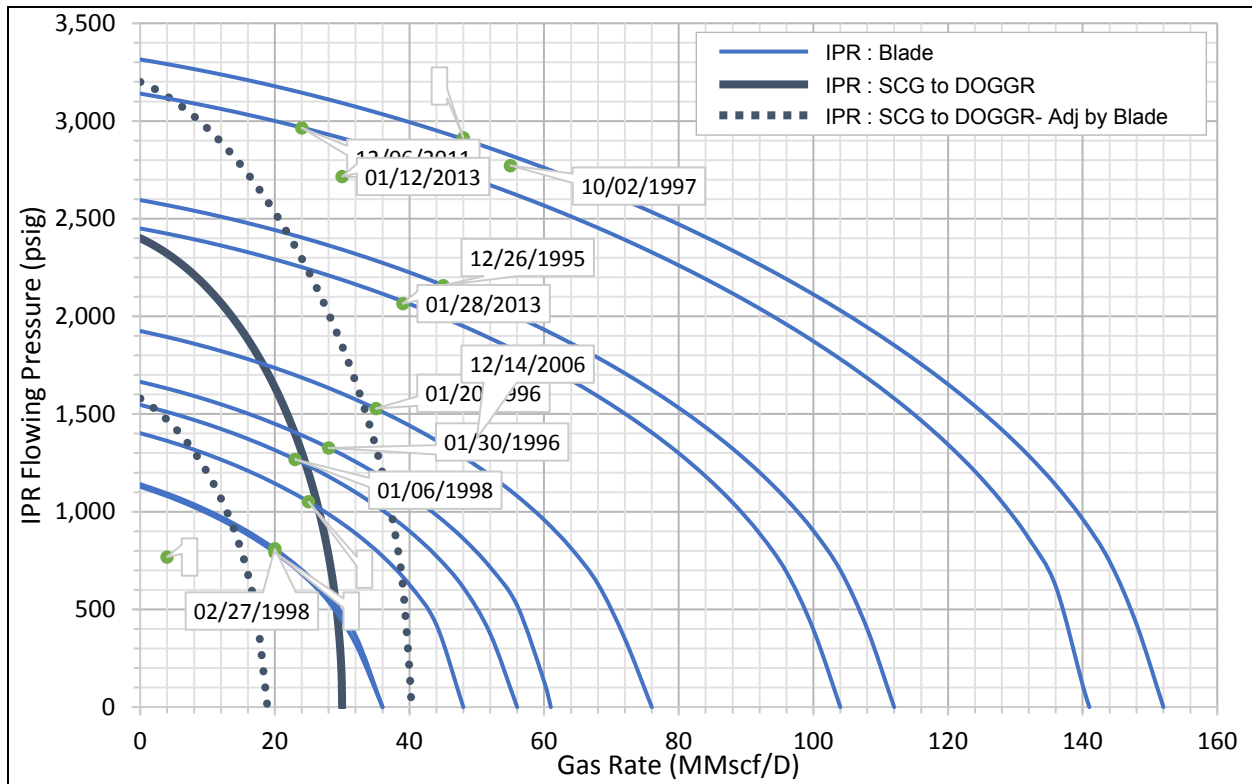
Figure 113: SS-25 Match of Well Tests 1995–2015

Figure 113 shows the best estimated match of the analyzable flow tests for the last 20 years using the best-estimate properties shown in Table 16. Blade’s inflow performance relationship (IPR) estimates for each well test are plotted as solid, thin blue lines. The model’s drainage area reservoir pressure varied, at the most, 100 psi from the static measured pressure at the time of the test.

Blade identified an IPR curve that first appeared in a SoCalGas response to a DOGGR request [40]. This request implied that a national laboratory was modeling the kill attempts on behalf of DOGGR, and DOGGR wanted the laboratory to use the same data that the well-control company was using. This SoCalGas-provided IPR curve is plotted in Figure 113 as a solid, thick navy line.

The SoCalGas IPR did not match Blade’s best-estimate IPR, which was derived from valid well tests. The Blade model could be used to match the SoCalGas IPR by changing the permeability from 80 to 30 md and increasing the gas turbulence to 0.5 (MMscf/D)⁻¹. Blade adjusted the reservoir pressure of the SoCalGas IPR, and this was still not representative of any well test. A more representative IPR obtained from proper modeling of the production well tests would have been a better basis for designing kill attempts.

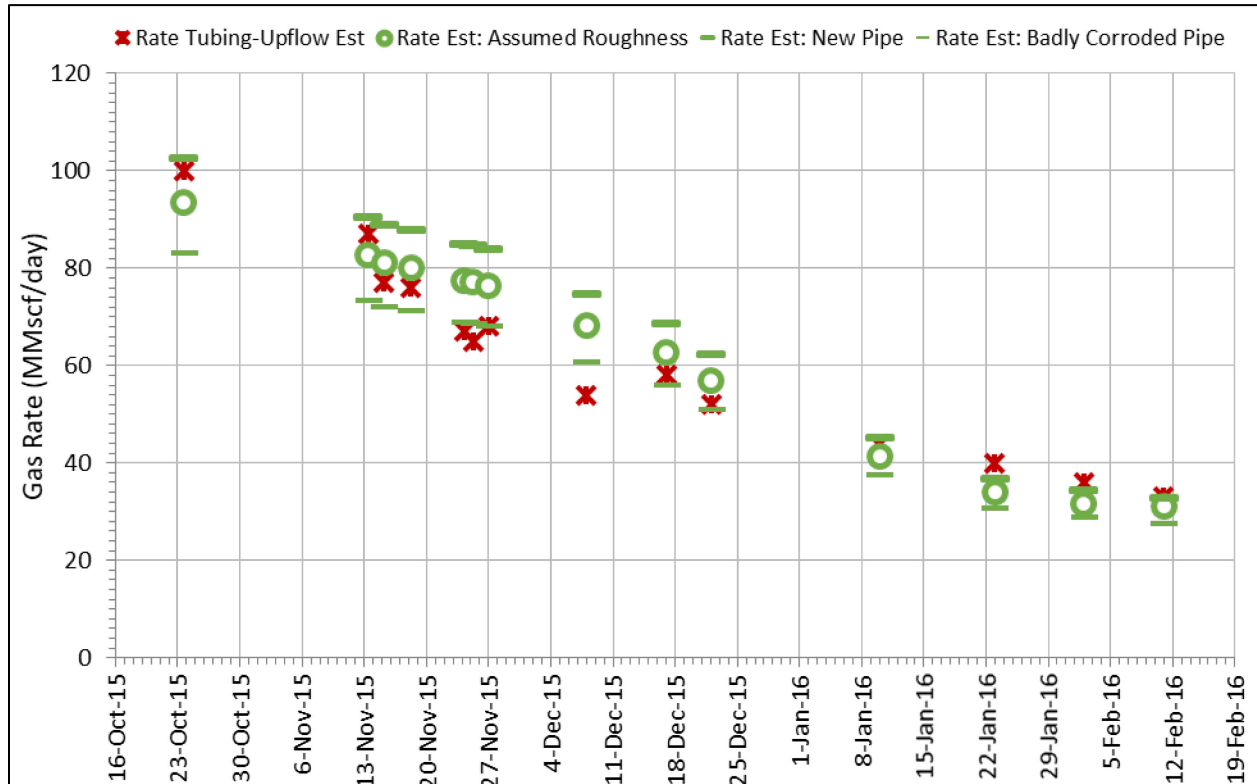
Figure 115: SS-25 Key Rate Estimates using Upflow-Only and Upflow-Inflow Models

Blade performed such *tubing-upflow only* calculations. Figure 115 compares the results of these calculations (in red) with the more accurate *upflow-inflow* (or IPR) models (in green). The tubing-upflow estimates prior to and after the kill attempts matched the upflow-inflow model for new pipe. This further validated Blade’s IPR model, which was used in reviewing the kill attempt designs. During the kill

attempts, the well flow was more unstable, and the estimates were more scattered. Both methodologies for rate estimates suggested that the first kill should have been designed for at least 93 MMscf/D.

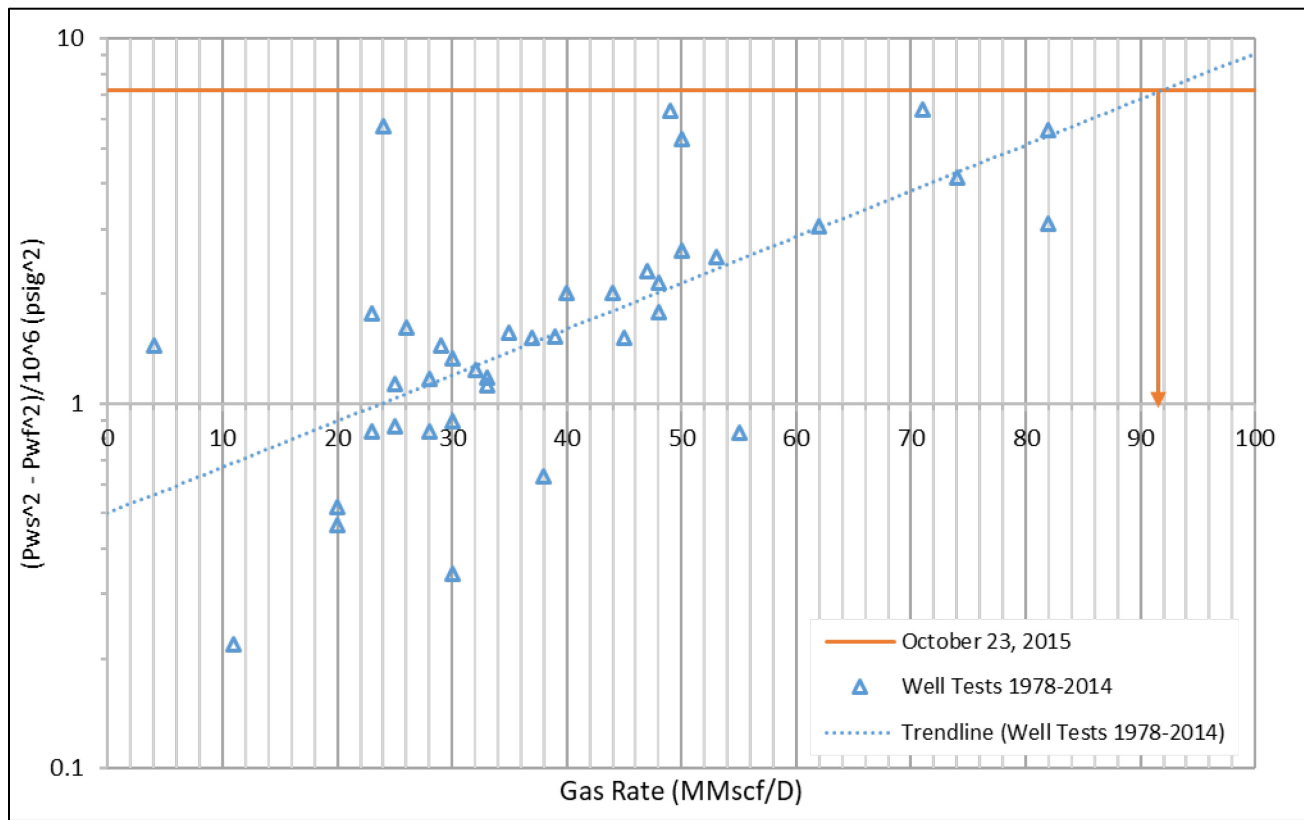
Figure 116: P-Squared Rate Estimate for October 23, 2015

There was a third method available to estimate the leak rate. This is shown in Figure 116, where P_{ws} is the static WHP (i.e., well shut-in or not flowing) and P_{wf} is the flowing WHP upstream of the choke. This process allows the calibration of the well deliverability and the estimation of the well flow rates at various pressure differences. The results are shown in Figure 114; the initial leak rate on October 23 matched the 91 MMscf/D estimated through the more accurate model. SoCalGas did use this method to estimate the leak rate; however, the leak rates were estimated to be ranging from 56 MMscf/D to 62 MMscf/D because the downstream choke pressure was used instead of upstream choke pressure.

The key observation from the PROSPER analysis discussed above is that the gas rates were significantly higher than those estimated during the incident. The higher gas rate could have been correctly estimated using industry-standard flow simulations or other methods using data available at the time of the incident. Additional details regarding the well deliverability modeling and analyses please refer to the supplementary report on SS-25 Nodal Analysis with Uncontrolled Leak Estimation [41].

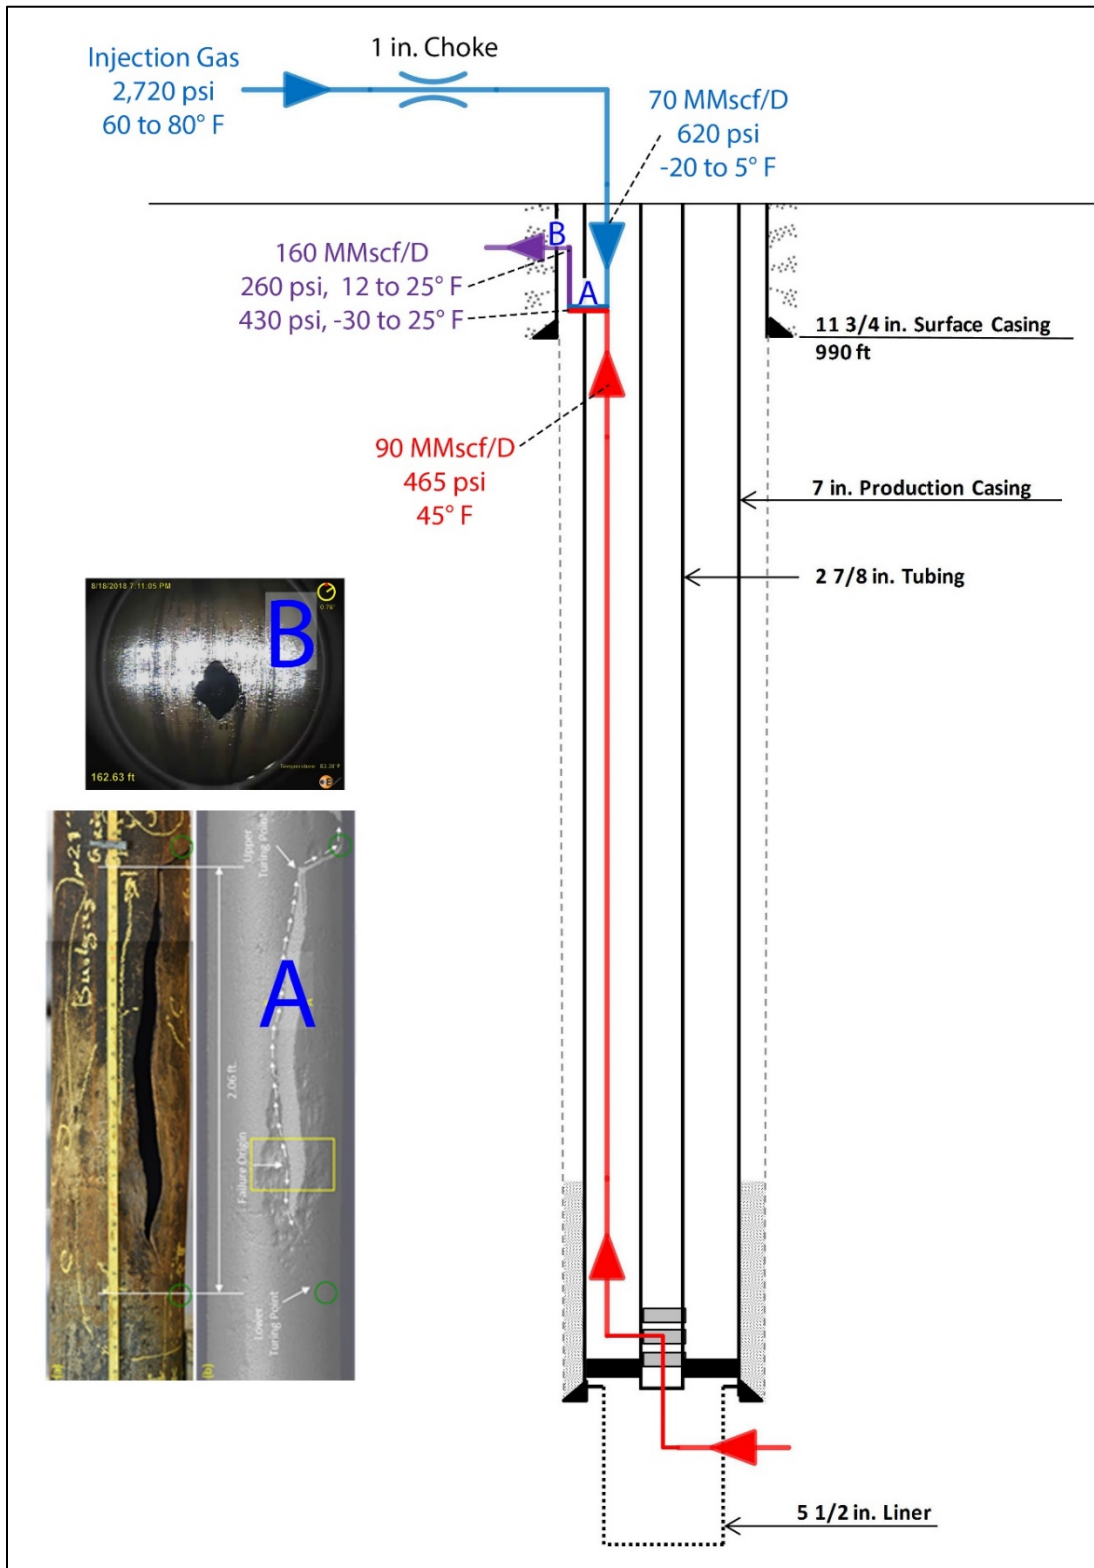
Figure 117: Summary of the PROSPER Results Prior to Shut-In of SS-25, A-Ruptured 7 in. Casing and B-Hole in the 11 3/4 in. Casing

To determine when the 7 in. casing failure occurred, Blade first modeled the flow in SS-25 prior to the shut-in. The problem was solved by using PROSPER. Figure 117 shows the SS-25 well flow problem posed to PROSPER and the pressure, rates, and temperatures that PROSPER calculated. First, focusing on the flow from the wellhead down the 7 in. × 2 7/8 in. production casing annulus to the leak point at 892 ft, the WHP required to drive 70 MMscf/D to 892 ft was 620 psi, and the arrival pressure at this depth was 465 psi. The WHP of 620 psi was too high to cause the SSV to close. In fact, even if the pressure at 892 ft were 260 psi (and it could not have been this low because 260 psi was the pressure at the holes in the surface casing as shown in Figure 117-B), the WHP would still have been about 500 psi. This means that when SS-25 was on injection, even if the 7 in. casing had already failed, the SSV would not have closed. The only time the SSV would have closed would have been when the well was shut in and the 7 in. casing had already failed. This is confirmed by the fact that the SSV closed immediately when SS-25 was shut in on the afternoon of October 23, 2015.

Figure 117 shows that prior to the shut-in of SS-25, the total estimated leak rate at 892 ft. through the production casing was 160 MMscf/D, of which 70 MMscf/D was from the injection system and 90 MMscf/D from the reservoir. This period, however, lasted less than half a day before the leak was detected and the well was shut in.

Metallurgical analysis showed that the 7 in. casing failed in two steps. The first was the instantaneous 2 ft long axial rupture that occurred at ambient temperature. The axial rupture (Figure 117-A) was followed by a low temperature brittle circumferential parting of the 7 in. casing. The parting was brittle and required extremely low temperature (−78°F to −38°F).

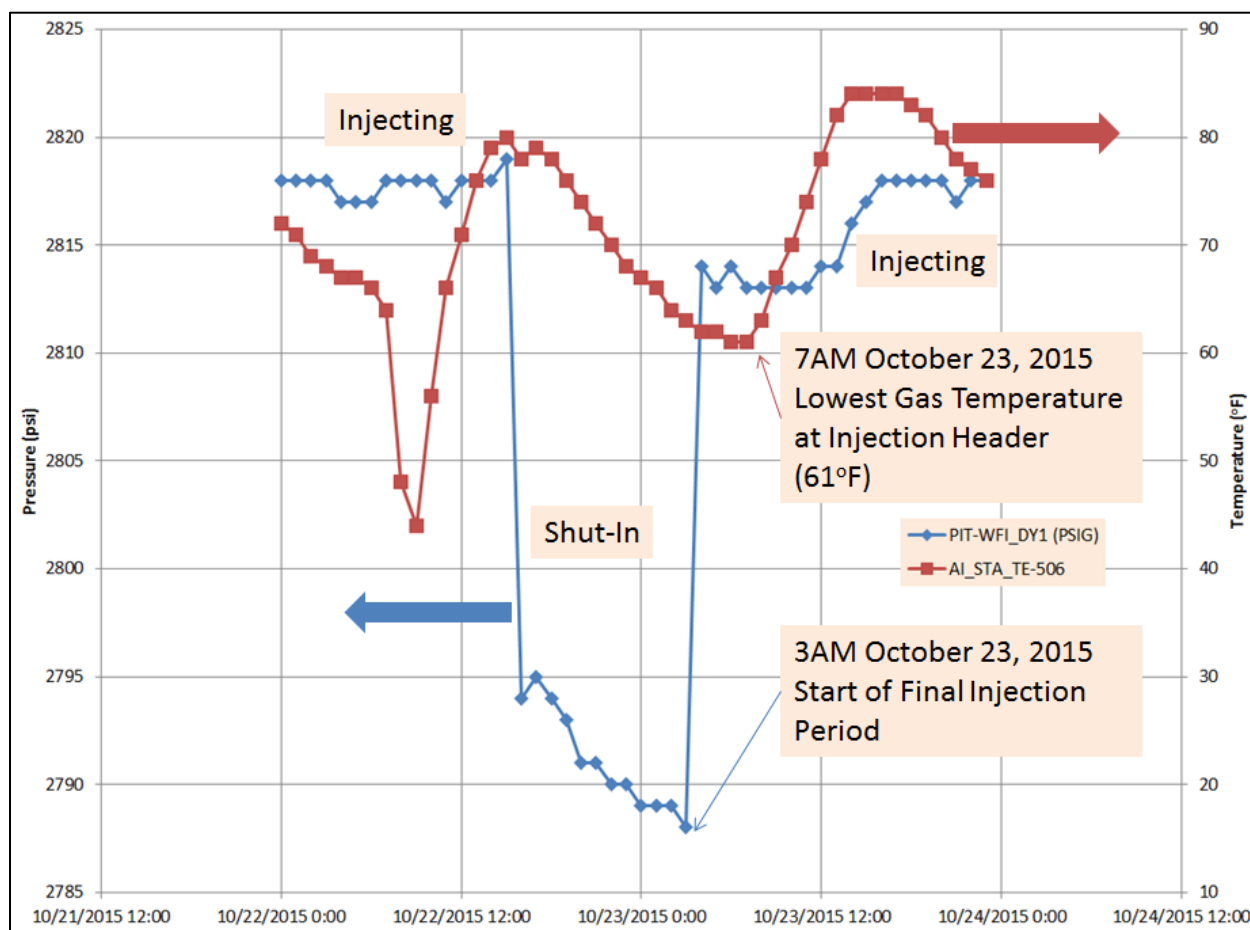
Figure 118: PIT-WFI_DY1 Hourly Pressure and AI_STA_TE-506 Hourly Temperature Measurements

Figure 118 shows the hourly pressure and temperature reading at the compressor station. The pressure gauge, PIT-WFI_DY1, measured the pressure in the trunk line to the western area of Aliso Canyon, which included SS-25. The pressure varied between about 2,815 psi and 2,790 psi. When the pressure was 2,815 psi, SS-25 was injecting. The system was shut in around 3 PM on October 22, 2015; injection was restarted between 3 and 4 AM on October 23, 2015.

Had the 7 in. casing failed during the shut-in period, the pressure reading of PIT-WFI_DY1 would have fallen to as low as 300 psi, the low pressure set point of the SSV. This is because the leak at SS-25 would have drained the gas in the trunk line leading to SS-25 until the SSV closed. Figure 118 shows that PIT-WFI_DY1 during the shut-in period prior to the final shut-in. No anomalously low-pressure reading was observed. The 7 in. casing did not fail during this shut-in period. The 7 in. casing, therefore, must have failed during the final injection period, which started after 3 AM on October 23, 2015.

Such low temperatures however could have occurred prior to final shut-in of SS-25. Figure 118 shows that the temperature at the compressor station was between 60°F and 85°F. SS-25 is about 1,000 ft higher in elevation relative to the compressor station. Therefore, the inlet gas temperatures to the SS-25 1 in. choke were likely several degrees lower. The pressure drop across the 1 in. choke was estimated to be 2,100 psi. Using the 0.56°F/14.7 psi J-T coefficient, this pressure drop corresponded to a decrease in temperature of about 80°F. The outlet temperature of this 1 in. choke therefore ranged from −20 to 5°F. PROSPER estimated that the flow down the 7 in. × 2 7/8 in. annulus led to an additional 8°F temperature

Figure 118 shows that during the final injection period, the lowest temperature measured at the compressor station occurred between 7 and 8 AM on October 23, 2015. Consequently, the gas temperature at the failure location would have been the coldest during this period. This suggests that the circumferential parting likely occurred between 7 and 8 AM. Therefore, the initial axial rupture must have happened sometime prior to the parting but after the start of injection on October 23, 2015.

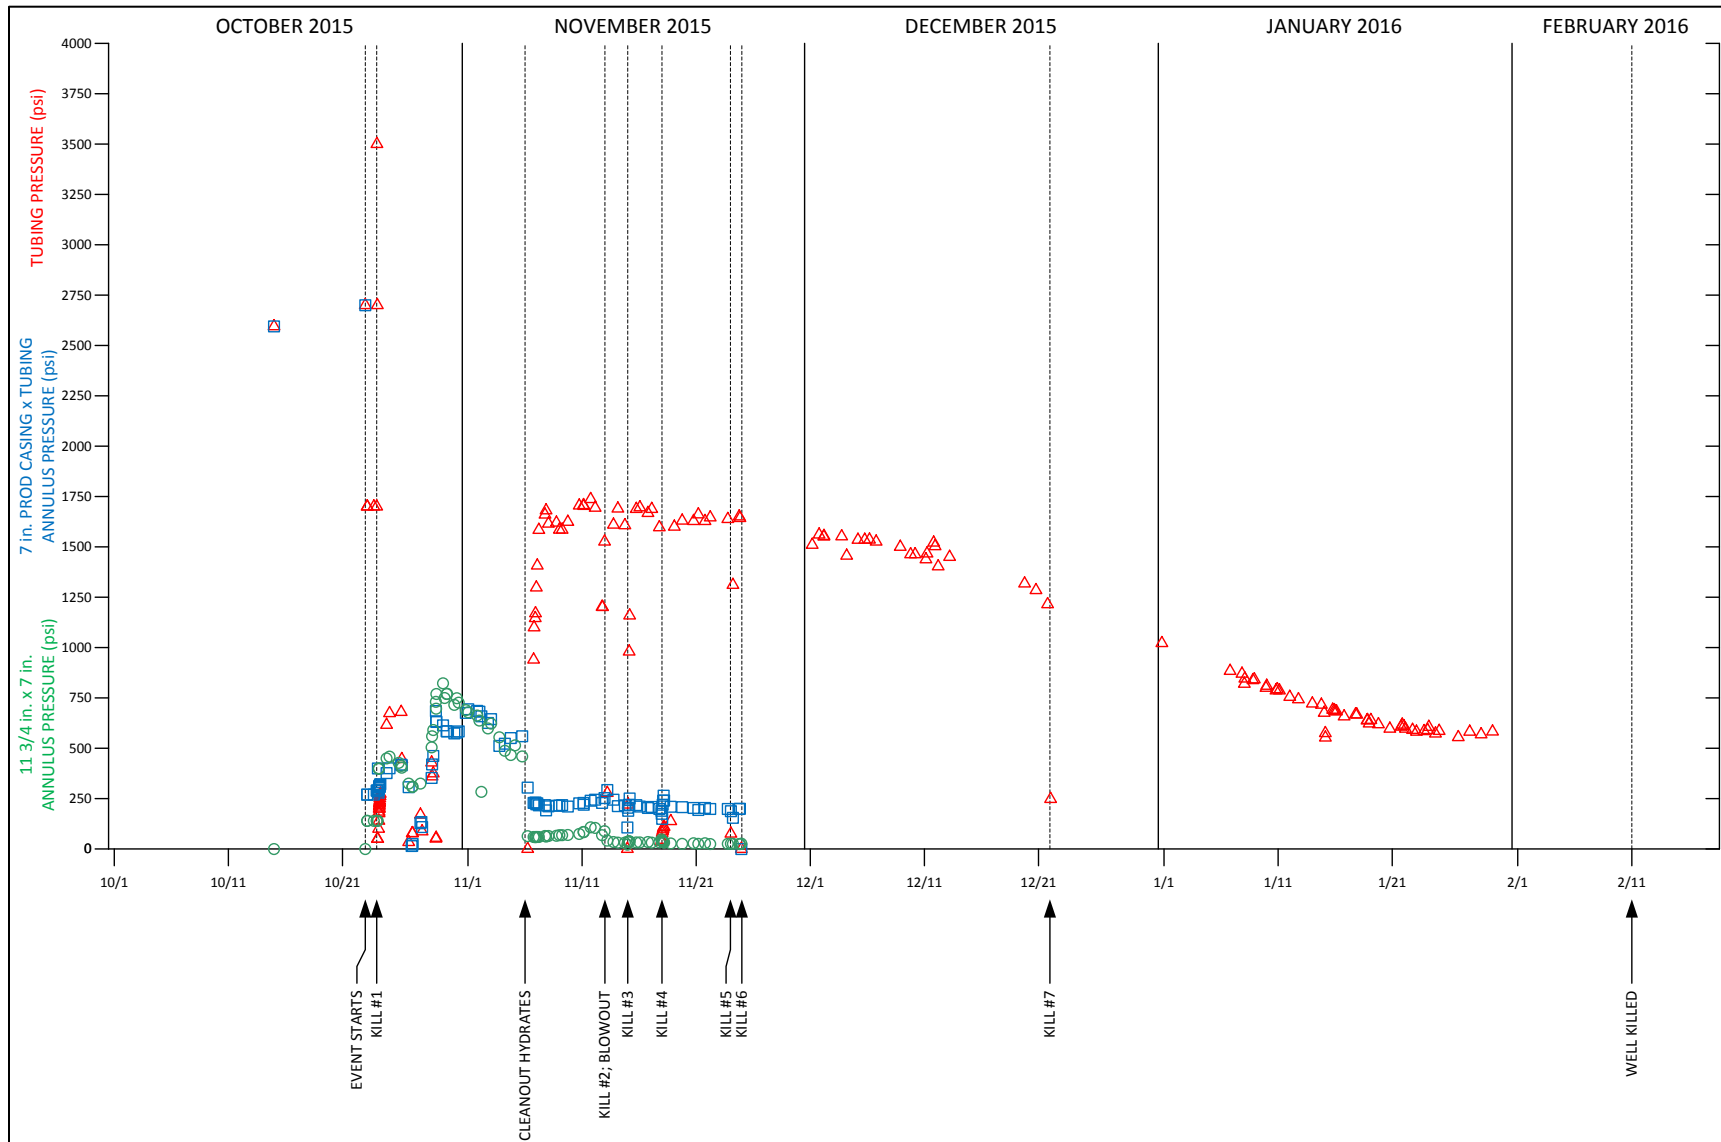
Figure 119: SS-25 Wellhead Pressure Measurements During the Incident

This redirection was important because the surface casing annulus pressure was as high as 800 psi between October 25 and November 6, 2015 (Figure 119). PROSPER estimated that, at these pressures, the temperature of the leaking gas could have reached 60°F . If the bulk of this warm gas had flowed up the 11 3/4 in. x 7 in. annulus, the upper section inside the well would have thawed out significantly, increasing the gas flow to the surface. However, because this did not occur, the upper section stayed cold.

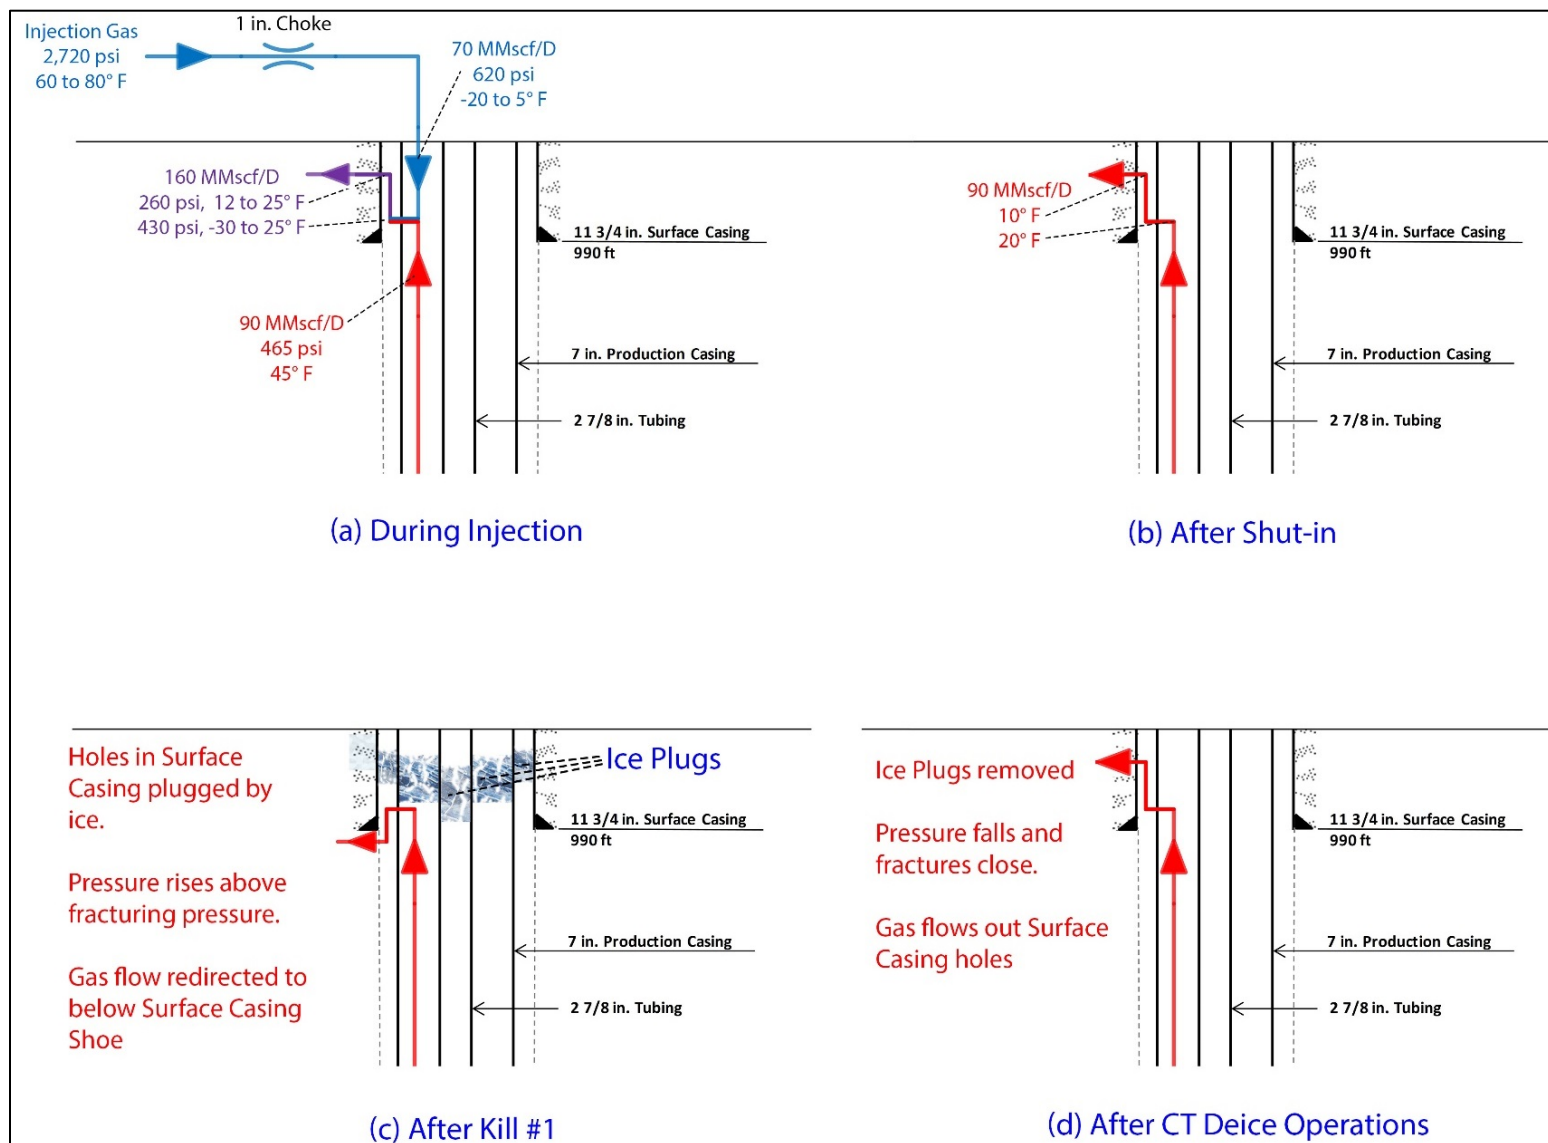
Figure 120: Summary of the Leak Paths Prior to SS-25 Shut-In to after Deicing Operation on November 6, 2015

On November 6, 2015, a solution of glycol and 10.8 ppg CaCl_2 was pumped down the tubing and unblocked the pathways, allowing the gas to flow out of the 11 3/4 in. holes again. The pressure in the 11 3/4 in. \times 7 in. annulus fell to 60 psi, which was lower than the initial 140 psi pressure. The kill attempt #1 might have opened up additional pathways for the gas, and the deicing operation might have unplugged them. The DOGGR representative reported that after the deicing operation, the gas leak rate increased substantially [6]. Figure 120 summarizes how the flow paths changed from prior to the shut-in to after the deicing operation.

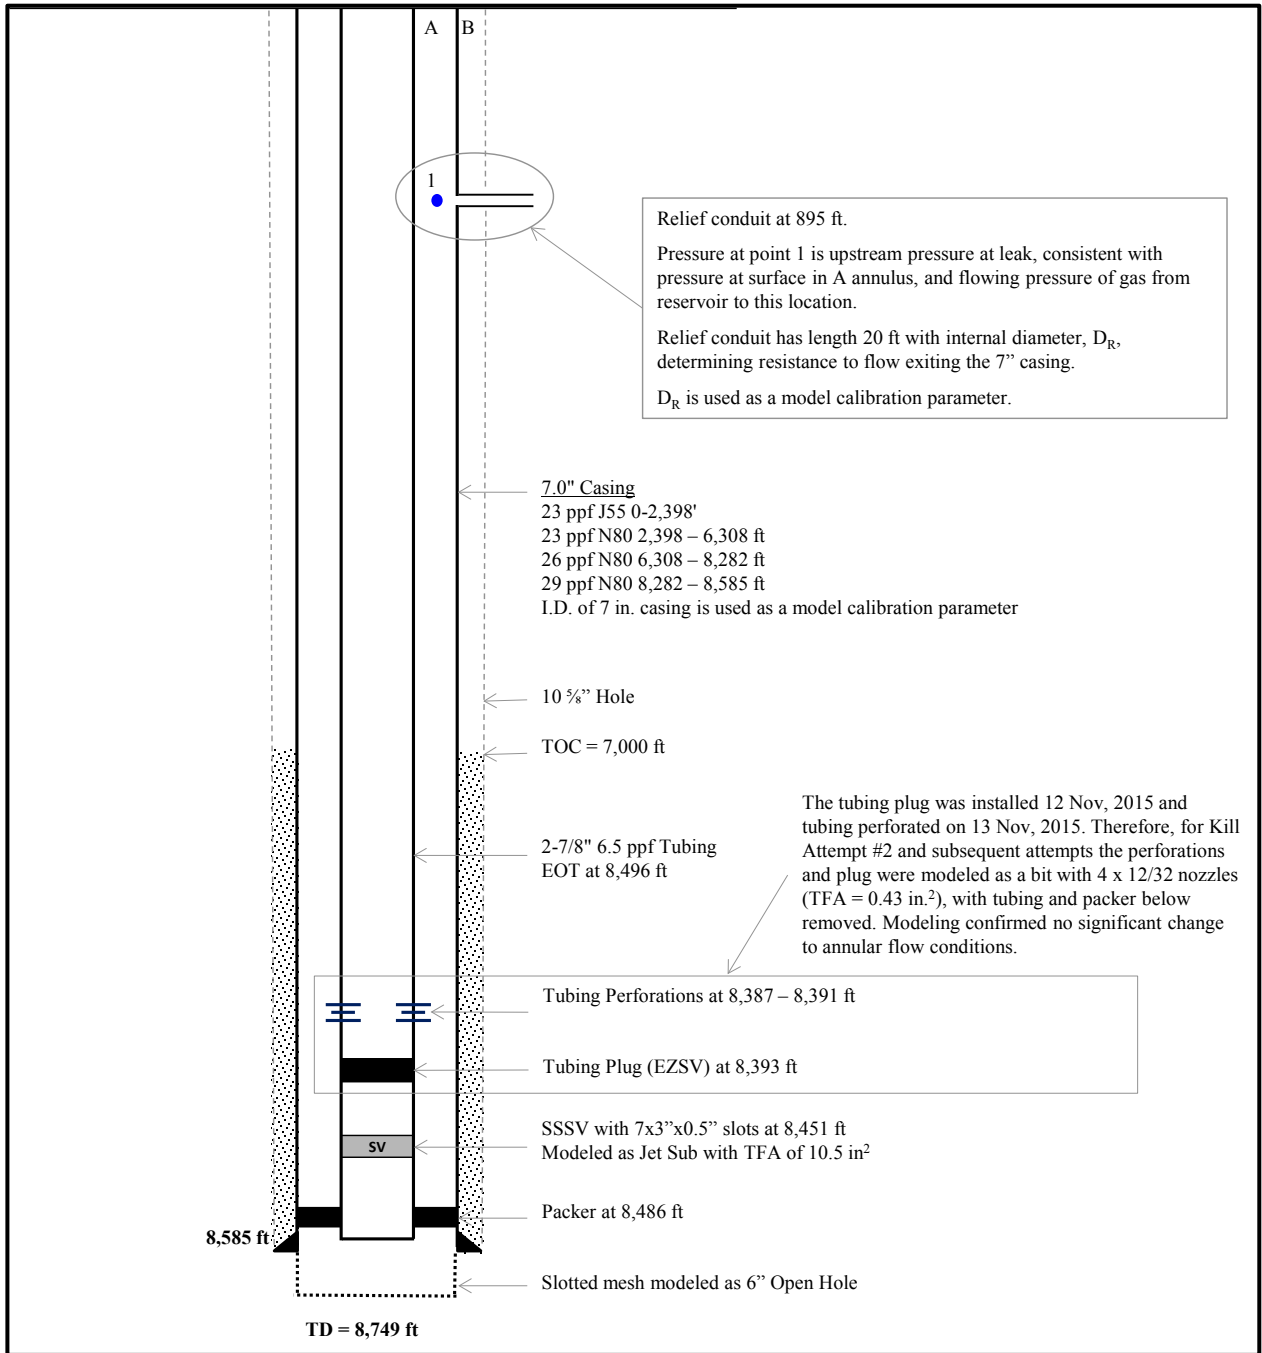
Figure 121: Physical Model as Set up in the Drillbench Blowout Control Model

This subsection analyzes why each one of the kill attempts failed and if any of them could have been successful. Blade set-up the SS-25 physical system within the Drillbench Blowout Control software (Figure 121). After shut-in and prior to kill attempt #1 on October 24, 2015, gas had flowed from the reservoir into the bottom of the tubing, entered the 7 in. x 2 7/8 in. annulus via ports near the packer, flowed up the 7 in. x 2 7/8 in. annulus, exited the 7 in. casing through a leak at 892 ft, and finally flowed to the surface through the formation. When the pumping of the kill fluid down the tubing of this physical system was initiated, the influx gas and kill fluid met in the tubing, and the combined flow entered the annulus through the ports.

Prior to kill attempt #2 on November 13, 2015, a plug had been set in the tubing at 8,393 ft, and the tubing had been perforated a few feet above the plug. Within the software, the plug and perforations were represented as a bit with nozzles, forming the equivalent flow area of the perforations. When the pumping of kill fluid down the tubing of this physical system was initiated, the kill fluid entered the annulus via the bit nozzles (perforations) while influx gas flowed up from below. The modeling details and approach are in the *SS-25 Transient Well Kill Analysis* supplementary report [46].

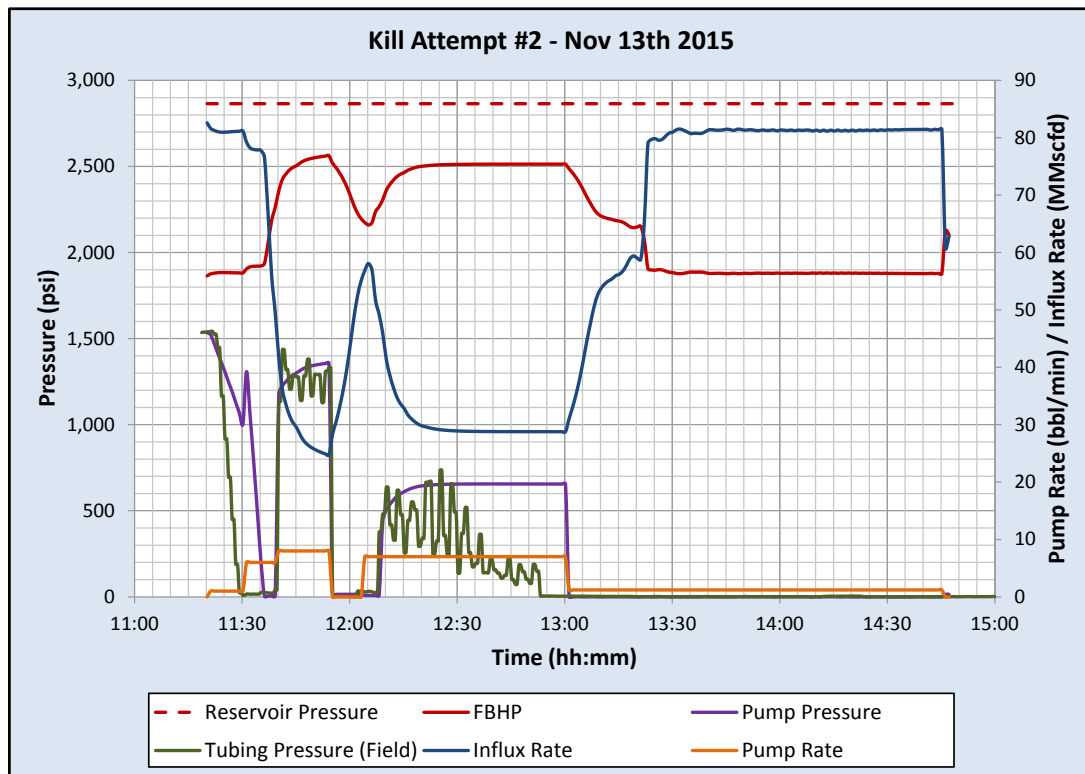
Figure 122: Simulation of Kill Attempt #2

Blade simulated kill attempt #2 in detail (Figure 122). When the FBHPⁱⁱ (flowing bottomhole pressure) (solid red line) is less than the reservoir pressure (dashed red line), the gas will flow from the reservoir into the wellbore as shown by the influx rate (solid navy line). The well is killed if the FBHP is higher than the reservoir pressure so that the influx rate is zero.

Figure 122 shows the results of the kill attempt as it was executed. As kill fluid was pumped into the well, the FBHP (solid red line) increased, and the influx rate (navy line) decreased (between 11:30 AM and 11:55 AM and between 12:05 PM and 1 PM). However, the FBHP did not rise above the reservoir pressure (dashed red line), and the influx rate did not go to zero; therefore, the well was not killed. When the pump was turned off (between 11:55 AM and 12:05 PM) or pump rate (orange line) was reduced (after 1 PM), the FBHP decreased, and the influx rate increased. In fact, between 12:05 PM and 1 PM, both the FBHP and the influx rate stabilized at 2,500 psi and 28–29 MMscf/D; this indicates that the kill attempt was not sufficient to kill the well even if the pumping had continued indefinitely.

At the time of kill attempt #2, the estimated leak rate was 83 MMscf/D. Blade’s analysis indicates that the 9.4 ppg fluid was not dense enough to kill the well at a realistic pumping rate. The well could have been killed by pumping a 12 ppg fluid at 9 bpm or a 15 ppg fluid at 6 bpm (Table 20). (Blade’s analyses assume that kill fluids would have been pumped down the tubing; it would have been impossible to kill SS-25 by pumping down the 7 in. casing.)
