Root Cause Analysis of the Uncontrolled Hydrocarbon Release from Aliso Canyon SS-25

May 16, 2019

MAIN REPORT

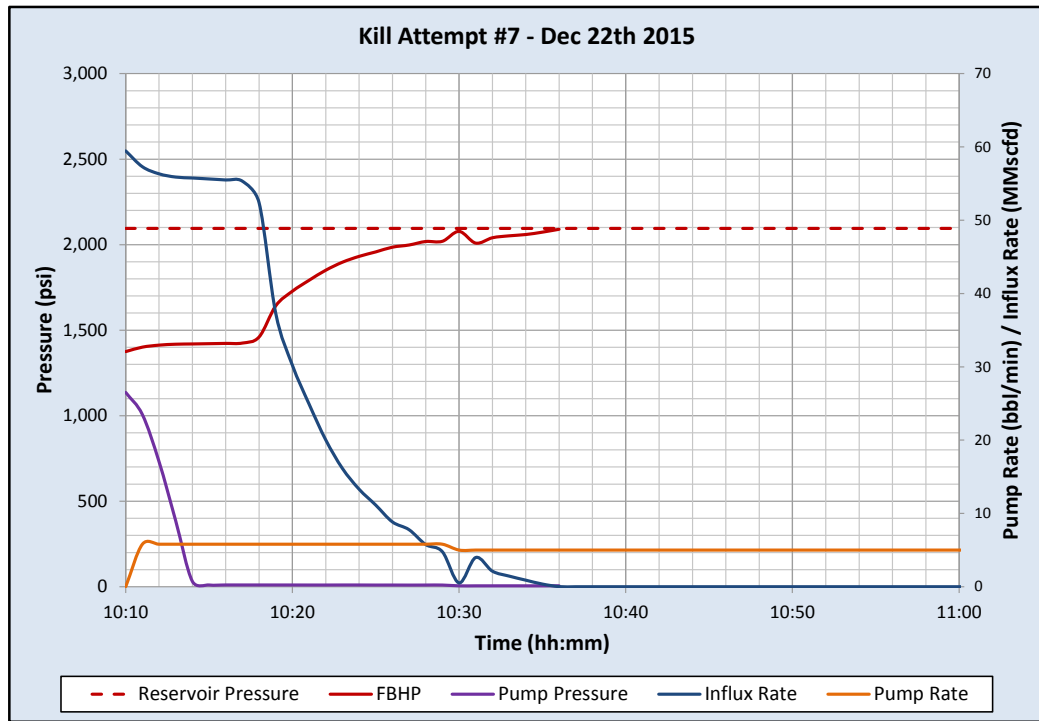
Figure 123: Simulation of Kill Attempt #7

The estimated leak rate was 60 MMscf/D. Results of Blade's simulations are shown in Figure 123. As pumping continued, the FBHP (solid red line) approached the reservoir pressure (dashed red line), and both influx rate (solid navy line) and pump pressure (solid purple line, also WHP) went to zero. This behavior was consistent with what was observed in the field during the kill attempt. At 10:30 AM, the well was just about to be killed, although premature shutdown of the pumps resulted in the FBHP decreasing and the influx rate increasing. Pumping needed to continue for some time after the well had seemed to have been killed to ensure that the well had been effectively killed. This did not happen in the field because the pumps were shut down early. Blade's analysis (Table 25) confirms that the well should have been killed with either 12 ppg fluid pumped at 6 bpm or 15 ppg fluid pumped at 5 bpm.

In conclusion, kill attempt #7 was a "near kill" that failed because the pumping was terminated early due to concern for potential wellhead damage. A contributing factor was the cumulative damage done by previous, unsuccessful kill attempts to the well site and wellhead, which caused this kill attempt to be terminated early.

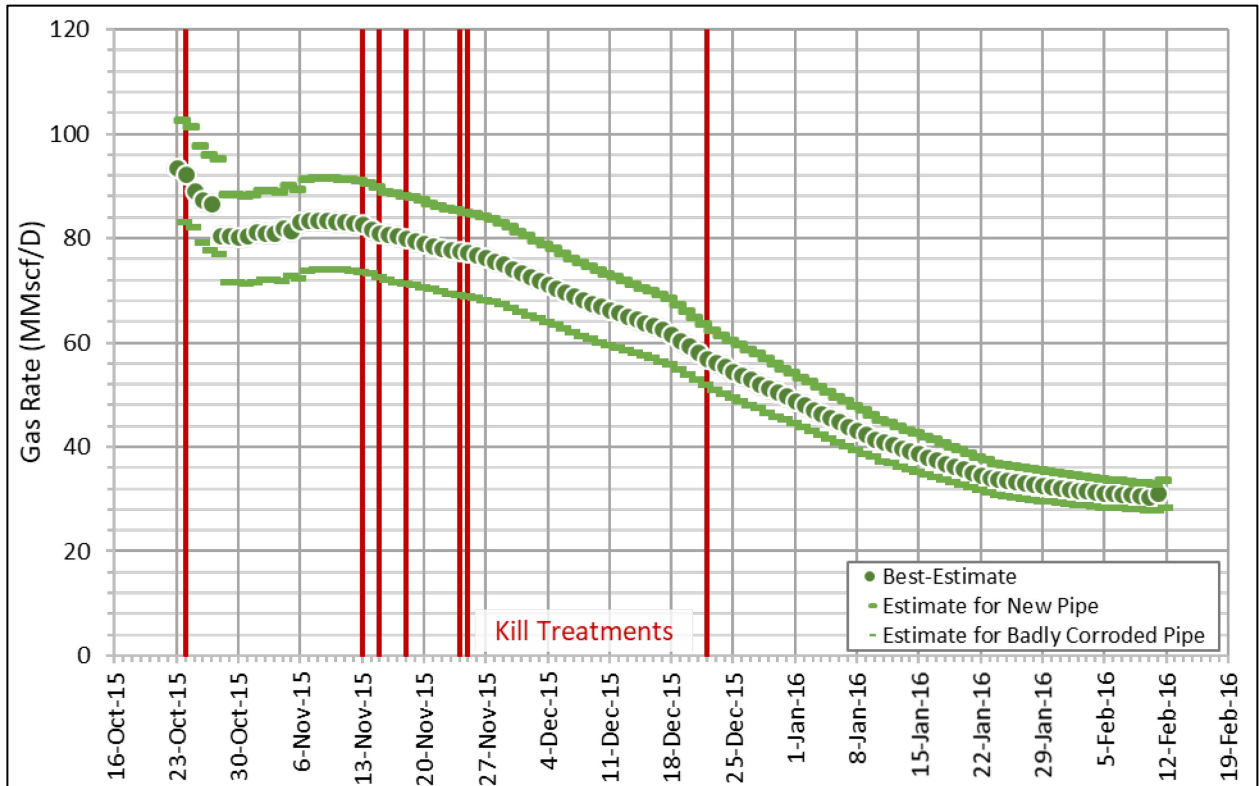
Figure 124: SS-25 Leak Rate Estimate (October 23, 2015–February 11, 2016)

The cumulative gas release volume was estimated using the modeling results. Figure 124 presents Blade’s SS-25 withdrawal rate estimate for the duration of the uncontrolled leak using the PROSPER model described in Section 3.2.1 The kill attempts are shown to highlight the rates that the kill attempts should have been designed to kill. Kill attempt #1 had a discharge rate of 93 MMscf/D, kill attempts #2 to #6 had discharge rates from 83 to 78 MMscf/d, and kill attempt #7 had a discharge rate of 60 MMscf/D. Blade derived the best-estimate rate from data available after the well was killed.

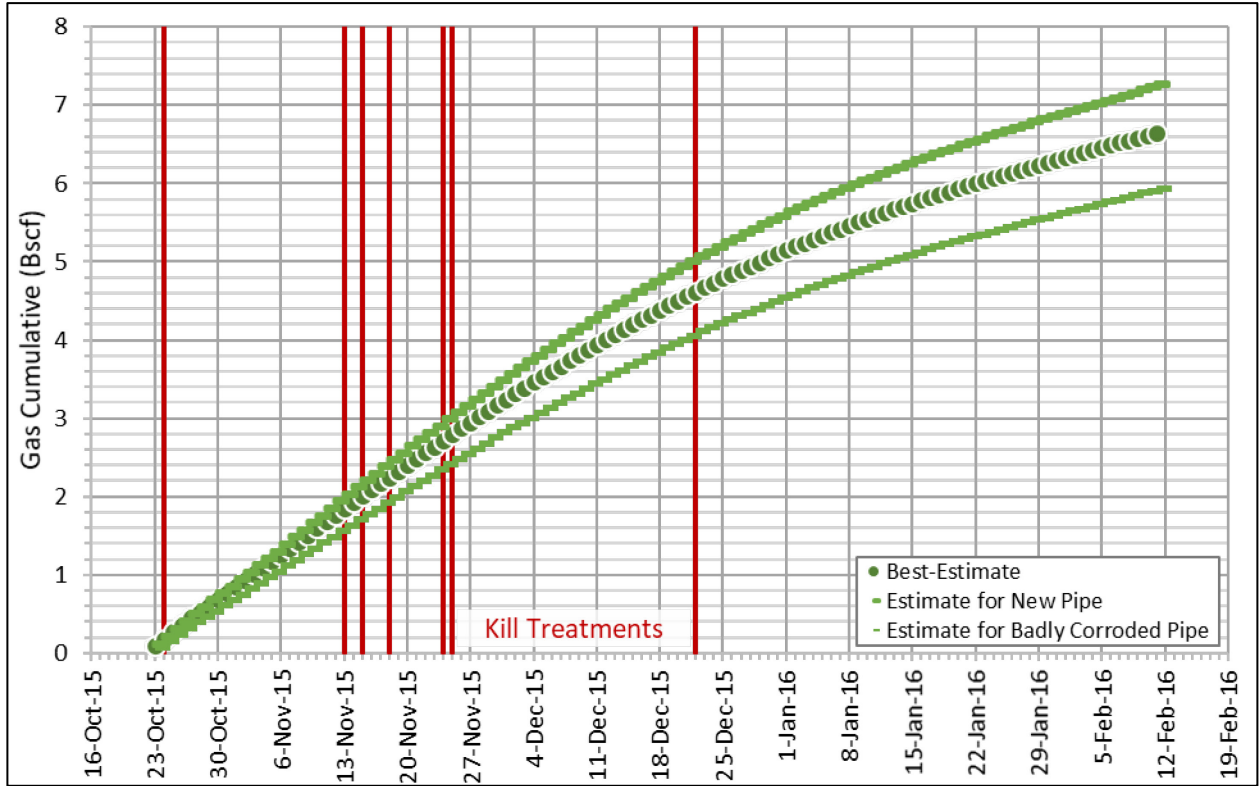
Figure 125: SS-25 Leak Cumulative Estimate (October 23 to February 11)

Figure 125 presents Blade’s SS-25 cumulative leak estimate for the duration of the incident. If the uncontrolled leak had ended by kill attempt #2, the methane discharge would have been less than one-third of the final amount.

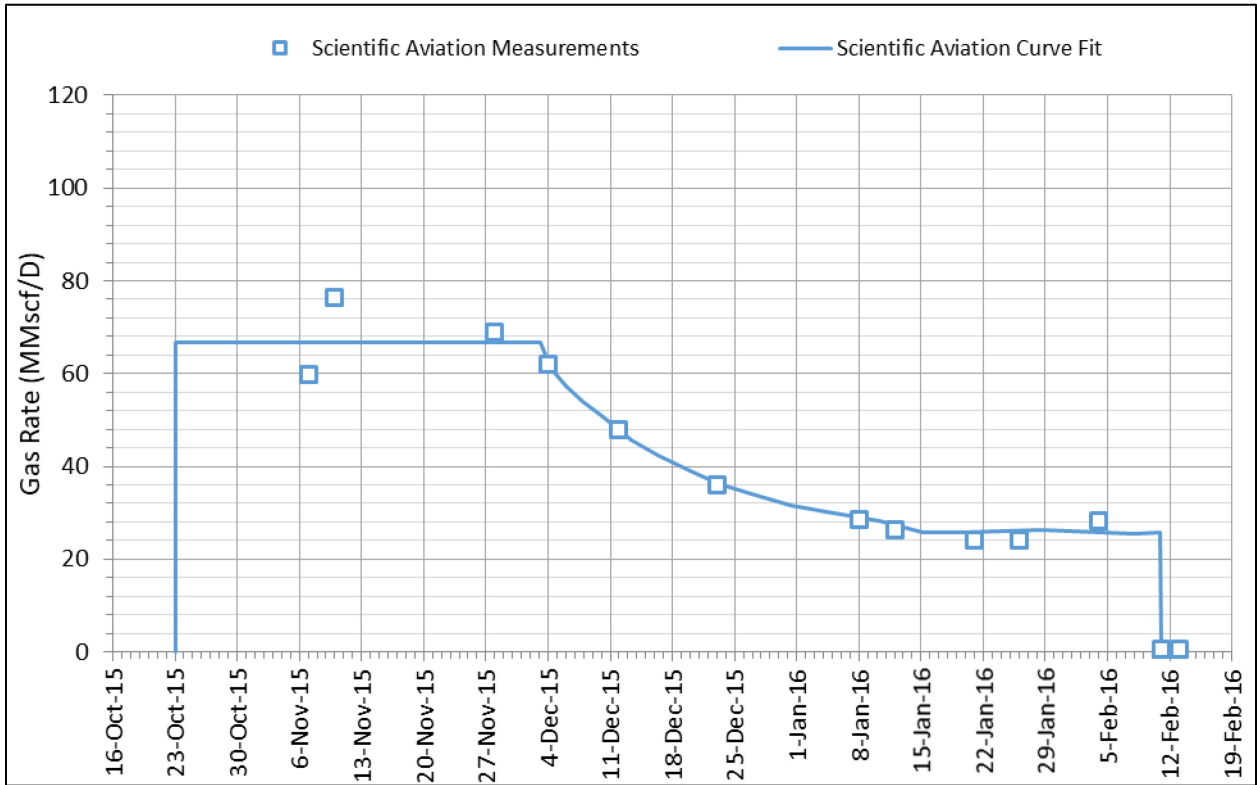
Figure 126: SS-25 Measured Leak-Rate History–Scientific Aviation

CARB derived their estimate following a review of the Scientific Aviation estimate. Scientific Aviation estimated the airborne emissions of the leak by analyzing data gathered by flying a specially equipped aircraft over the leak site [48]. Figure 126 shows the estimated airborne rates (converted from metric tons of methane to standard gas rates using the equation of state model from Blade’s SS-25 PROSPER well model).

Although Scientific Aviation’s plane was nearby for other measurements when the SS-25 leak occurred and mobilized quickly to measure the leak, the initial leak rates were not measured. Also, only airborne hydrocarbons were measured, and this did not necessarily represent the total leak. Hydrocarbons could have dispersed through the fracture matrix and taken an unknown path that delayed emissions to the air. This dispersion and delay were likely to affect the Scientific Aviation measurements.

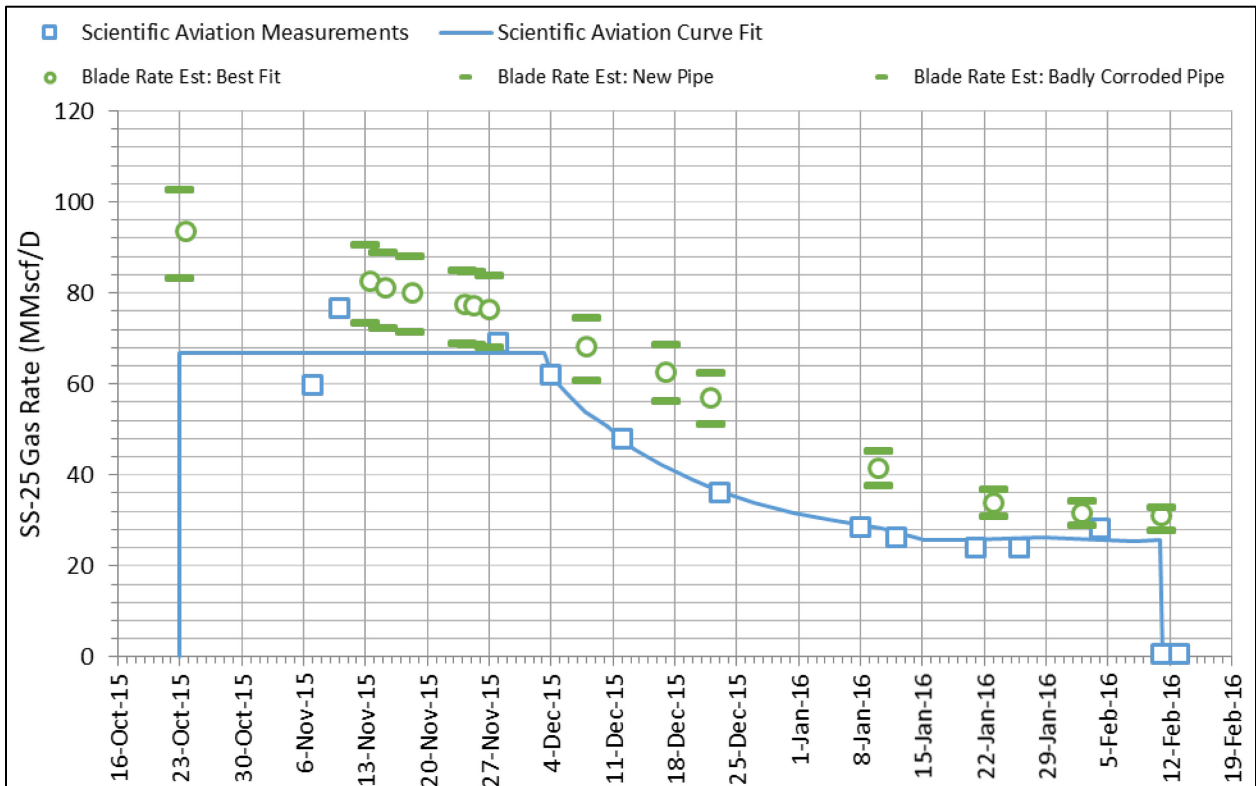
Figure 127: SS-25 Leak-Rate History Comparison—Blade and Scientific Aviation

Figure 127 compares the rates of Scientific Aviation with those of this report. The lower estimated rates, which assumed badly corroded tubing and casing, were the lower limit, and the higher estimated rates, which assumed new tubing, were the upper limit. Pulled production casing and logging after the leak showed evidence of metal loss, corrosion, and scaling. The best rates were from the assumed pipe roughness based on corrosion and scaling and were always just at or above the Scientific Aviation rates. Note that the plateau rate assumed by Scientific Aviation for the six weeks was a result of limited measurements.

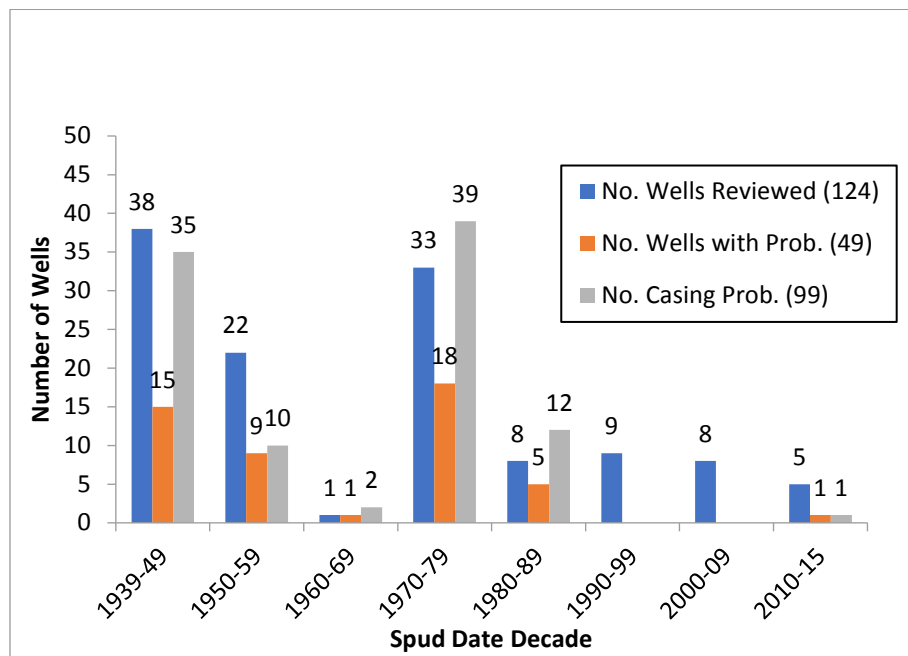
Figure 129: Number of Wells Reviewed, Wells with Failures, and Casing Failures

Figure 129 shows a breakdown of the number of wells reviewed, wells with casing problems, and casing failures by spud date (the start date of the well drilling process) at ten-year intervals. As the plot shows, most of the drilling activity happened in two groups: from 1939 to 1959, when the field was developed for oil and gas production, and from 1970 to 1979, when many of the gas storage wells were drilled.

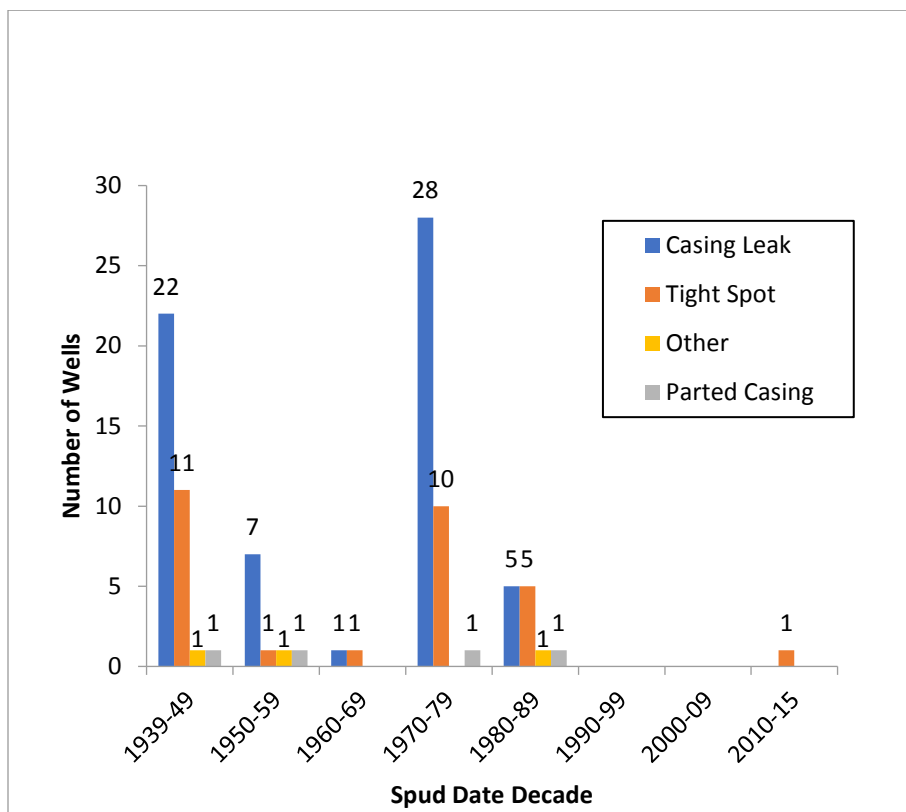
Figure 130: Number and Types of Casing Failures by Spud Date

Figure 130 shows that casing leaks represent the majority of the casing failures.

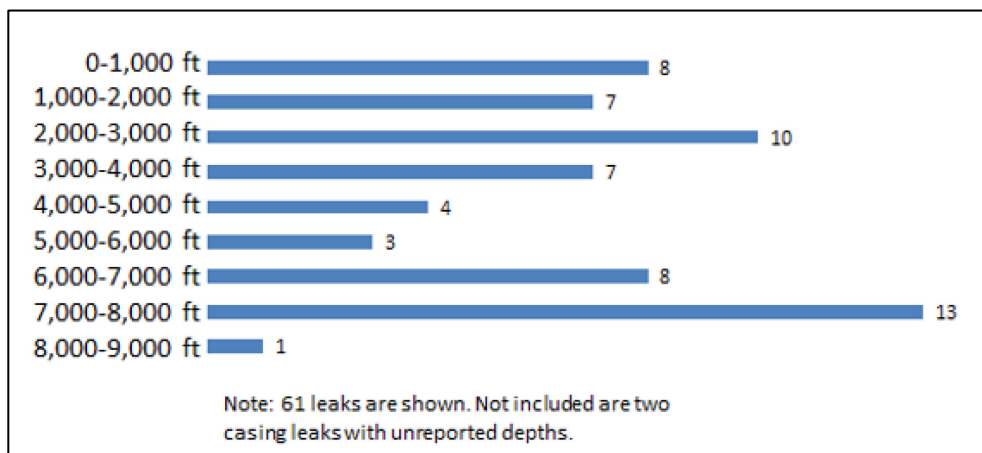
Figure 131: Casing Leak Count by Depth Range

Figure 131 shows the number of casing leaks by depth range. Our analysis shows that:

- 8 of 61 (13%) casing leaks occurred above 1,000 ft, including the one in SS-25.
- 52% of the leaks were between the surface and 4,000 ft with no trend of leak count vs. depth.
- Leaks in the lower part of the well were more numerous from 7,000 ft to 8,000 ft.
- 63 casing leaks occurred in 41 wells for an average of 1.5 leaks per well.

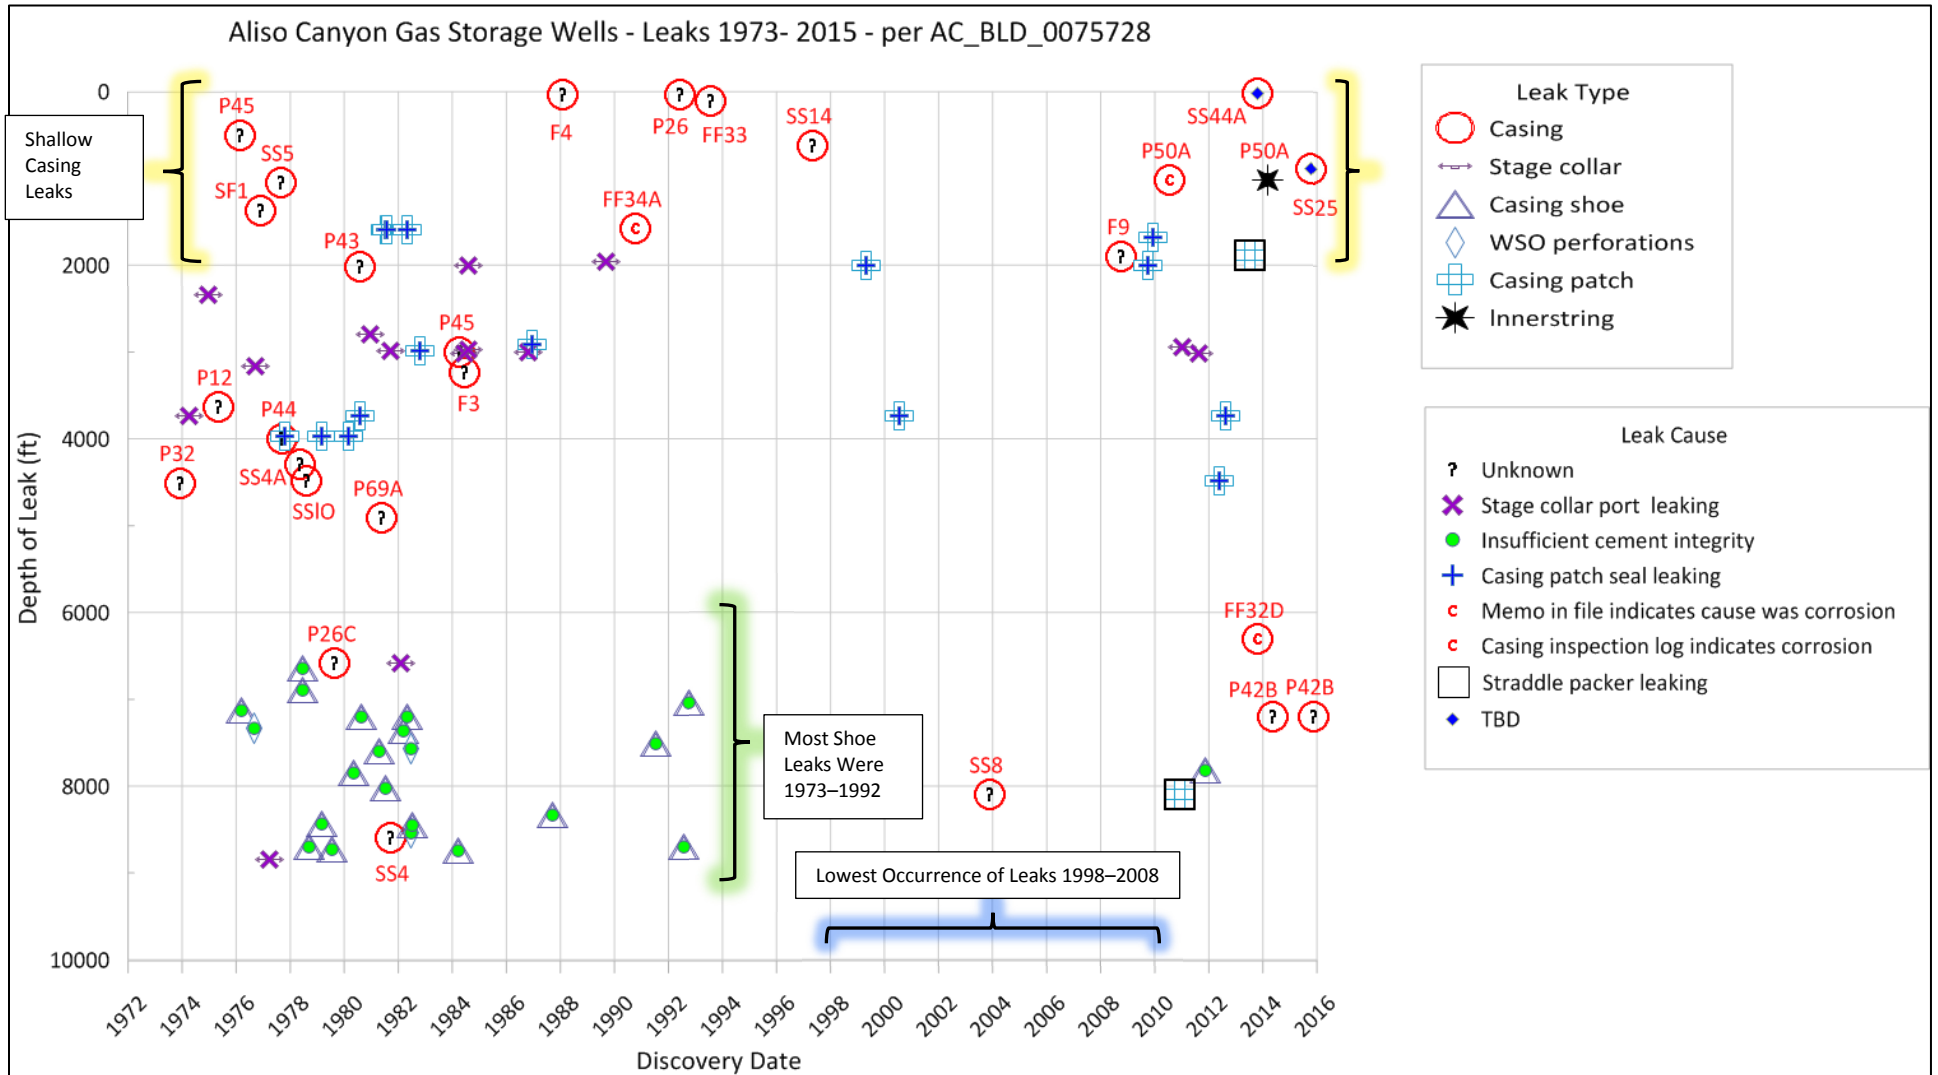
Figure 132: Leaks per SoCalGas Data [51]

Figure 132 shows the data from SoCalGas table graphically by leak discovery date on the x-axis and well depth on the y-axis. There are two legends: one for the leak type and a second one for the leak cause. A few trends are visible. What is apparent is that leaks of any type were most prevalent before the mid-1990s. For the casing shoe leak type, all but one leak occurred before 1992, denoted by a green brace. Although not of high importance to the RCA, numerous leaks in stage collars and casing patches (intended to cover the stage collars) are present. Most relevant to the RCA are the casing leaks denoted by red circles. Denoted within each circle are SoCalGas’s determinations of the leak cause. The ? symbol denotes unknown causes. About half of the casing leaks are shallower than 2,000 ft and denoted by yellow braces. Most of the shallow casing leaks have unknown causes. There does seem to be a reduction in the number of leaks identified from around 1998 to 2008—denoted by a blue brace. We are not entirely sure why this was the case. There were no changes in the SoCalGas Monitoring Program (Appendix A.1).

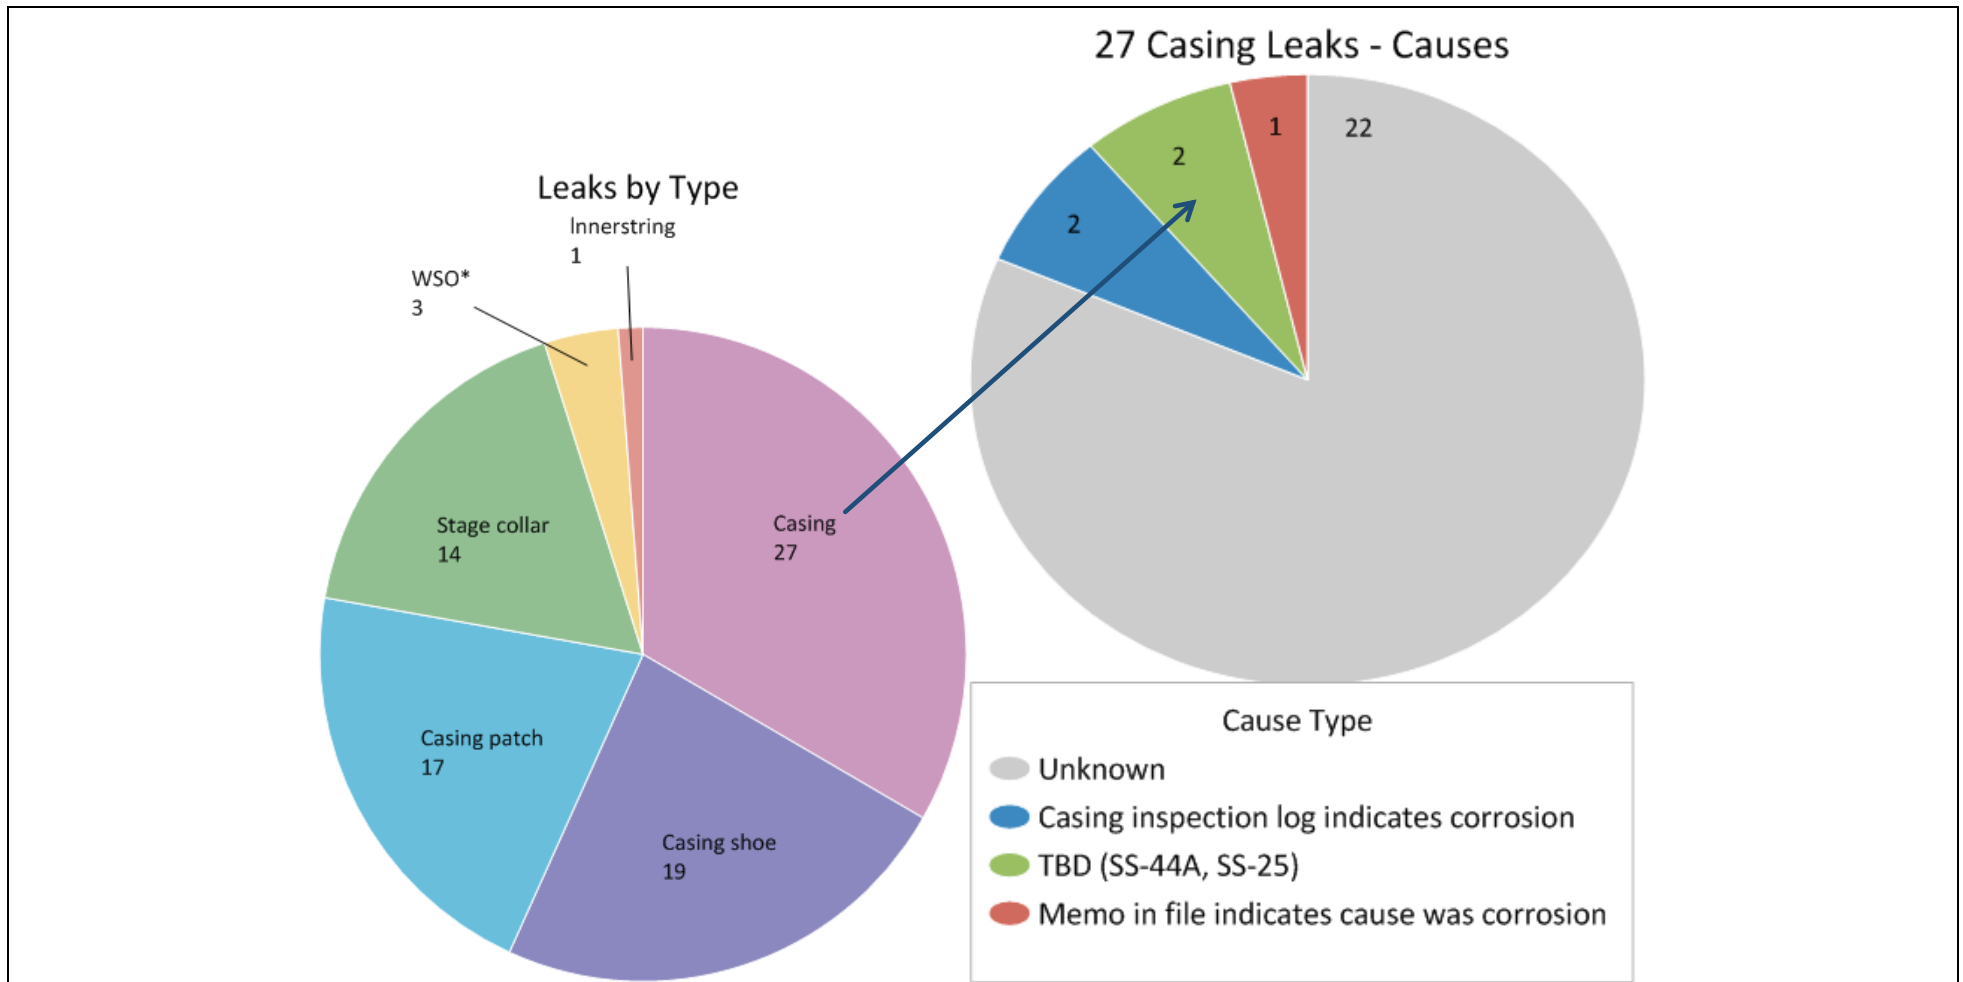
Figure 133: Leaks by Type per SoCalGas [51]

Figure 133 shows two pie charts: The left one shows the casing leak type and the right one shows the casing leak causes. Of the 81 leaks, 27 are casing leaks. The rest of the leak types are stage collar, casing shoe, water shut off (WSO) perforations, casing patch, and inner string, but these are not of interest to the RCA. The stage collar and casing patch leaks are related because casing patches were run to isolate leaks in the stage collars. Of the 27 casing leaks, 22 are of unknown reasons. Three casing leaks are stated to relate to corrosion, and two casing leaks are to be determined (TBD).

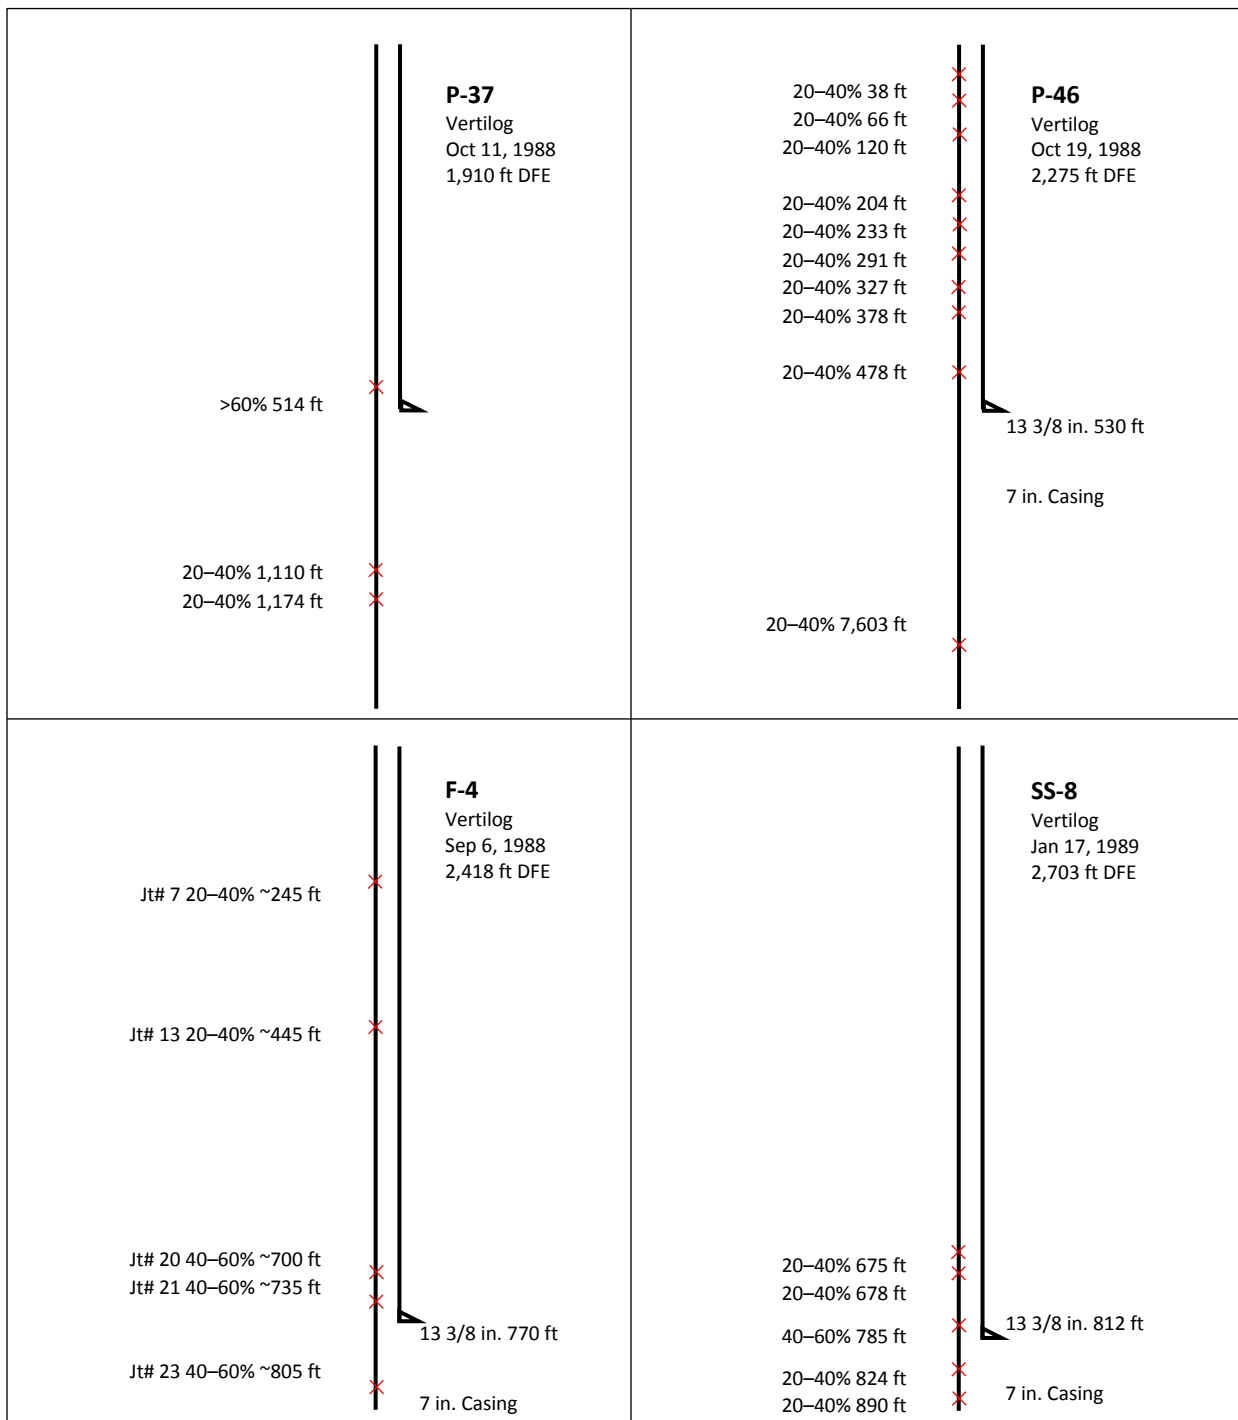
Figure 136: Wellbore Schematics Showing Vertilog Penetration Data

Figure 136 summarizes the percent penetration and depths from the Vertilog inspection results for wells P-37, P-46, F-4, and SS-8 production casings above and immediately below the surface casing shoe. The four wells were inspected in 1988 and 1989. The derrick floor elevation (DFE) above sea level is included and shows the significant variation in surface elevations among the wells. All of these wells had OD indications. P-46 had numerous metal loss indications above the shoe; and all of them had indications shallower than 1,000 ft. The behavior in these wells appears similar to SS-25.

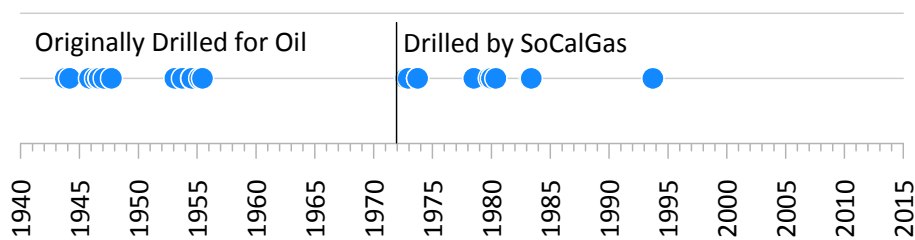
Figure 137: Range of Spud Dates for Wells with Shallow Corrosion on Production Casing

- Column 3 shows the spud dates of the wells ranging from October 19, 1943, to September 20, 1993, a span of nearly 50 years. Figure 137 shows the spud dates of these wells. The two major groups were: first, wells drilled in the 1940s and 1950s by Tidewater, et. al., and second, wells drilled by SoCalGas, about an equal number of wells were from each group; this suggests that the company that drilled the wells was not a factor for shallow corrosion. Although not investigated in detail, the drilling techniques would have been different from 1943 to 1993; this suggests that drilling techniques were not a factor for shallow corrosion either.

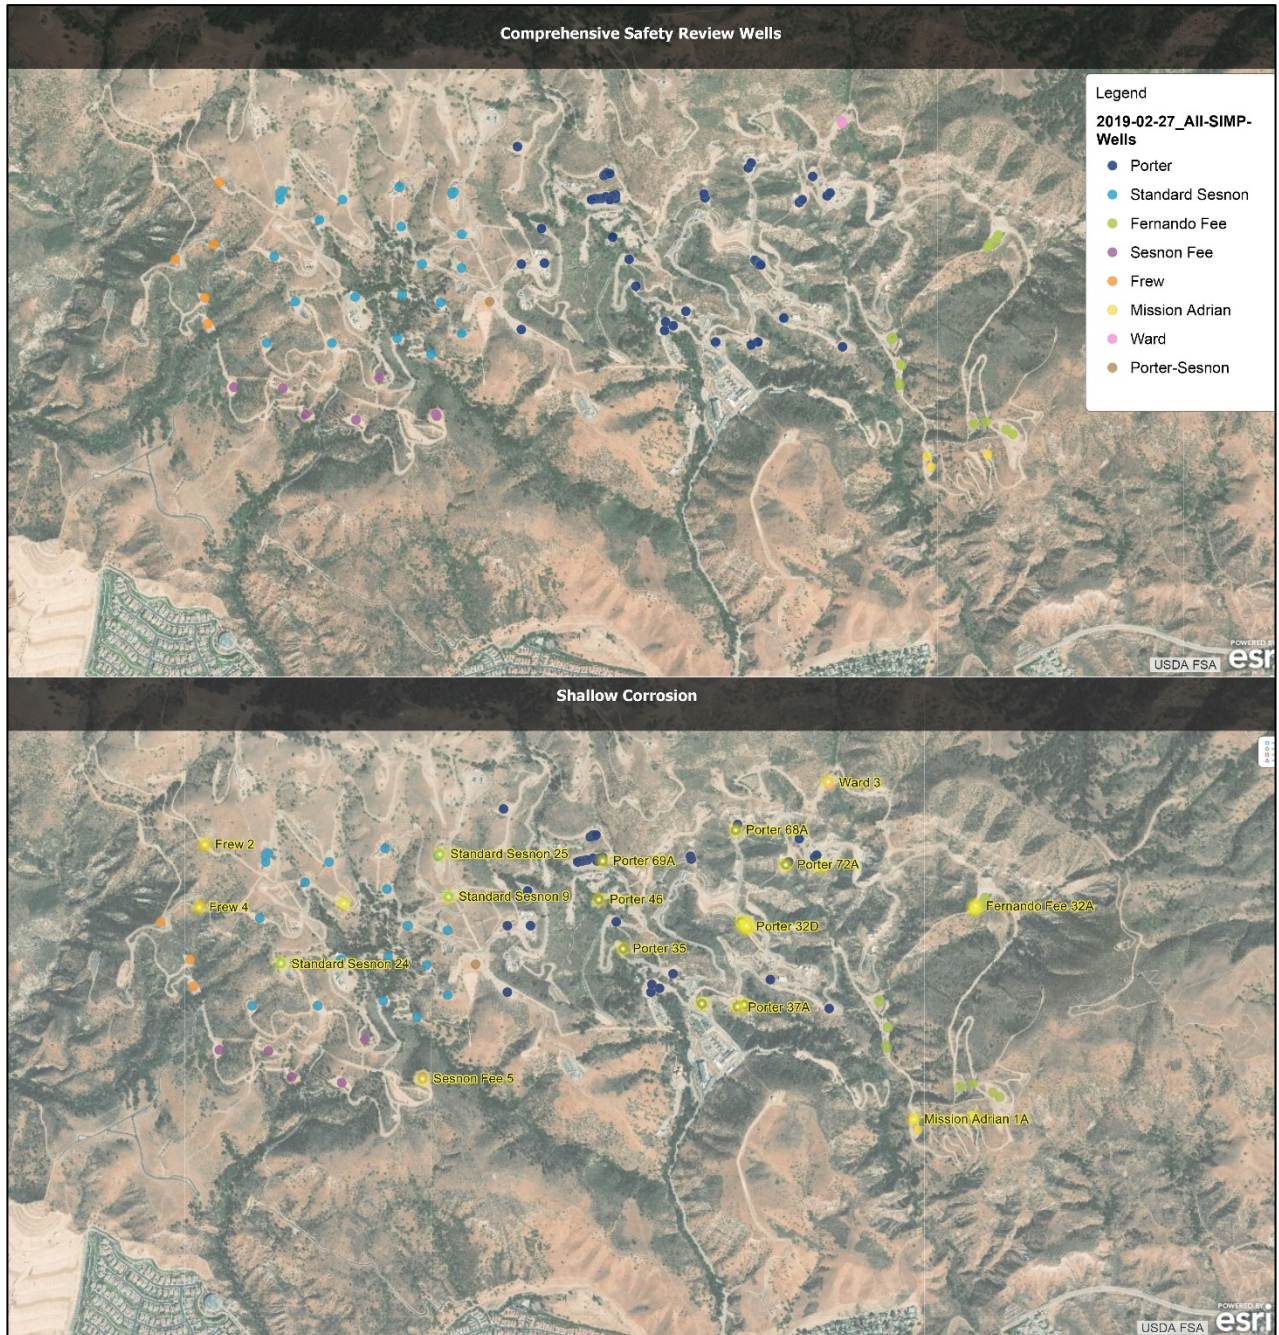
Figure 138: Well Locations with Shallow External Corrosion on Production Casing Excluding SS-25

Figure 138 shows the locations of the 114 comprehensive safety review wells, also known as the SIMP wells, (upper graphic), and the 27 wells with shallow external corrosion on the production casing (lower graphic). These 27 wells are spread throughout Aliso Canyon with no apparent trends.

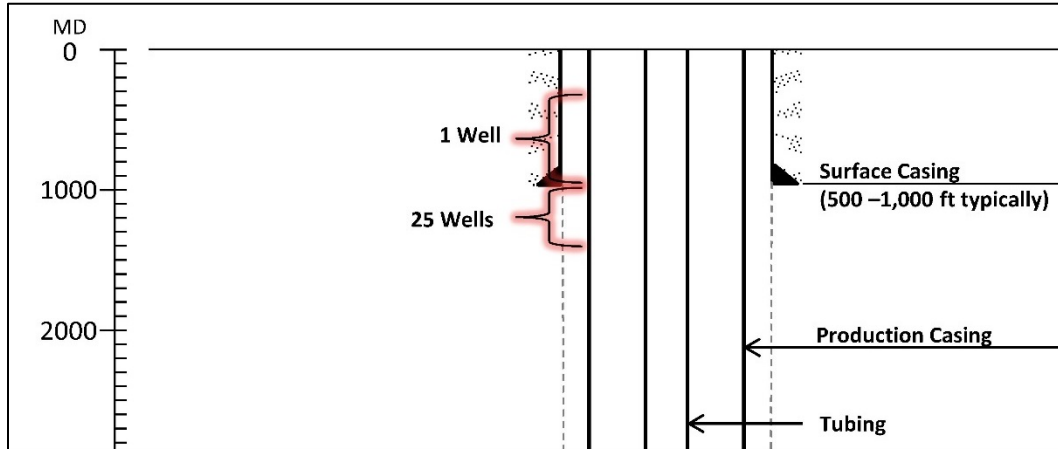
Figure 139: Location of Shallow External Corrosion on Production Casing Not Including SS-25

Figure 139 shows the location of the shallow external corrosion on the production casing for 26 wells. Almost all of the wells had production casing external corrosion present just below the surface casing shoe. One well, P-50A, had production casing external corrosion above the surface casing shoe. SS-25 was not included, but it was the only well that showed shallow corrosion above *and* below the surface casing shoe.

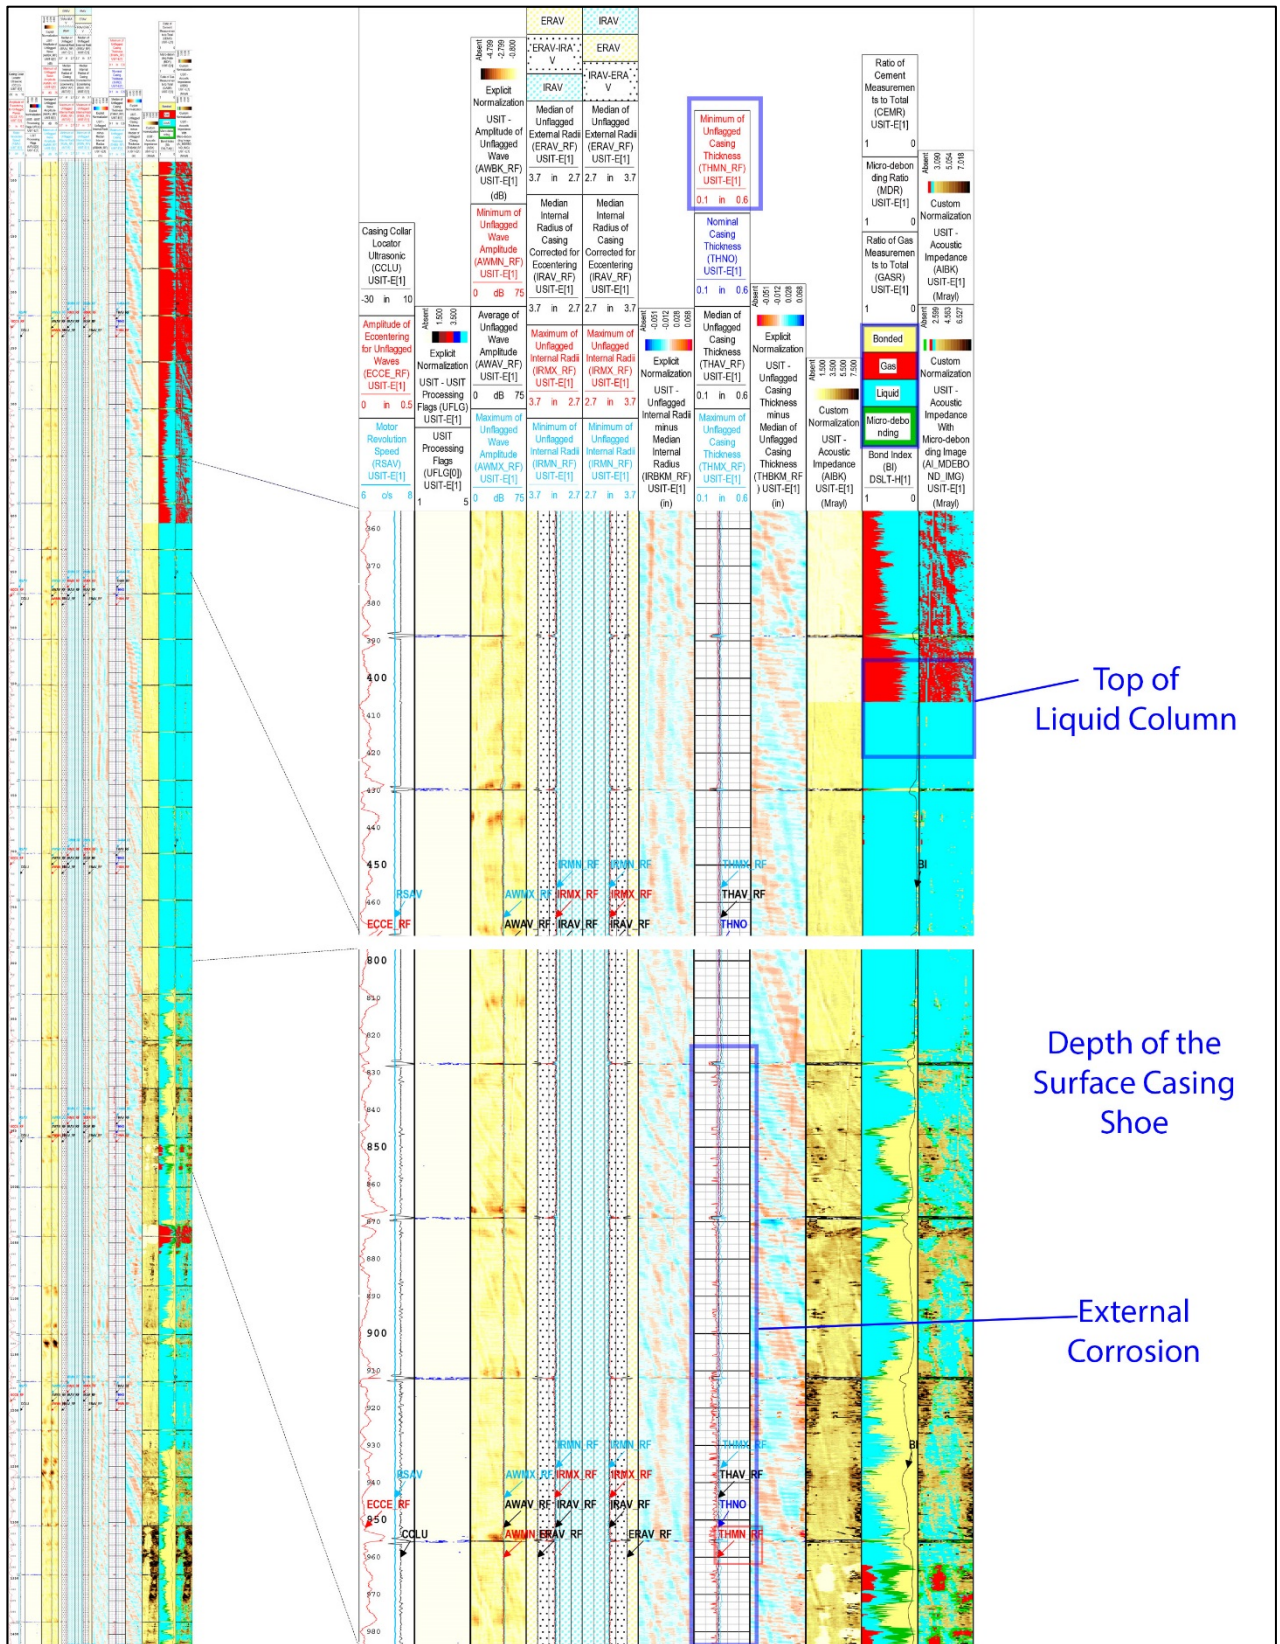
Figure 140: SF-5 Production Casing USIT Log Example of External Corrosion

Figure 140 shows a production casing UltraSonic Imager Tool (USIT) log from SF-5 which is a well in the West section of Aliso Canyon. The production casing is 7 in. 23 ppf (0.317 in. wall thickness) N80 LTC. The track titled Minimum of Unflagged Thickness (THMN_RF) is the minimum wall thickness of the production casing measured by the USIT. THMN_RF is denoted by a red line and labeled in red. Above the depth of the surface casing shoe, THMN_RF shows no variability; the production casing has no issues here. Below the depth of the surface casing shoe, THMN_RF drops erratically down to approximately 0.23 in. wall thickness or 27% penetration. Note each division on the THM_RF track is 0.1 in. Blade interprets this production casing metal loss as external corrosion. Some additional observations were evident. The 13 3/8 in. x 7 in. casing annulus is liquid filled to a depth of approximately 400 ft and is labeled “Top of Liquid Column”; this observation of a deep annulus liquid level with gas on top is common to most of the wells reviewed. At the depth of the shoe, the percentage of solids increases; this is also common to most of the wells reviewed. This is denoted by yellow shading in the second from the right track. In some of the wells reviewed, gas is present behind the 7 in. casing adjacent to the casing OD. This is denoted by red shading in the second from the right track.

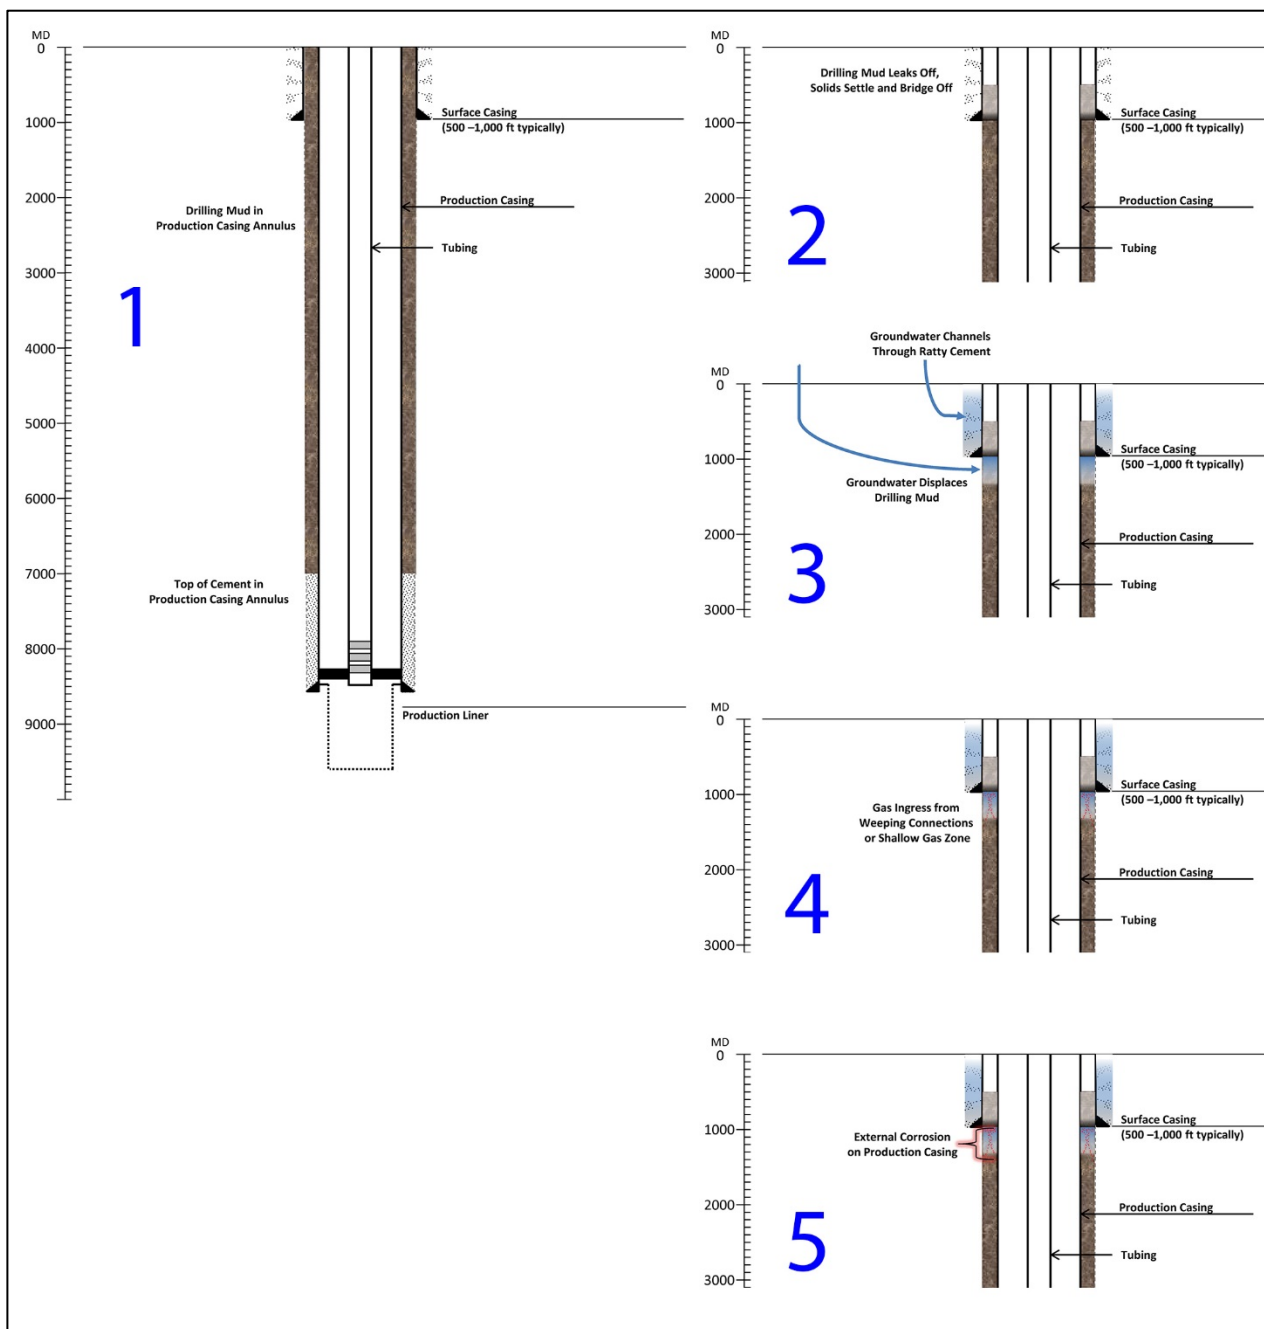
Figure 141: Hypothesis for the Shallow External Corrosion Mechanism

One area of investigation focuses on the location of corrosion near the surface casing shoe. This is common in a number of wells; this suggests a common corrosion mechanism. Figure 141 shows a possible corrosion mechanism supported by some of the observations discussed previously. Using the numbered inset images, the hypothesis is as follows:

5. Corrosion initiated and grew in the aqueous carbon dioxide environment. This process may have been assisted by microbes residing in the groundwater.

The hypothesis described above is consistent with the shallow corrosion observed across the 25 wells. Much of the shallow corrosion, unlike SS-25, was only observed below the surface casing shoe. Further analysis is necessary to develop this hypothesis and appropriately mitigate.
