Root Cause Analysis of the Uncontrolled Hydrocarbon Release from Aliso Canyon SS-25

May 16, 2019

MAIN REPORT

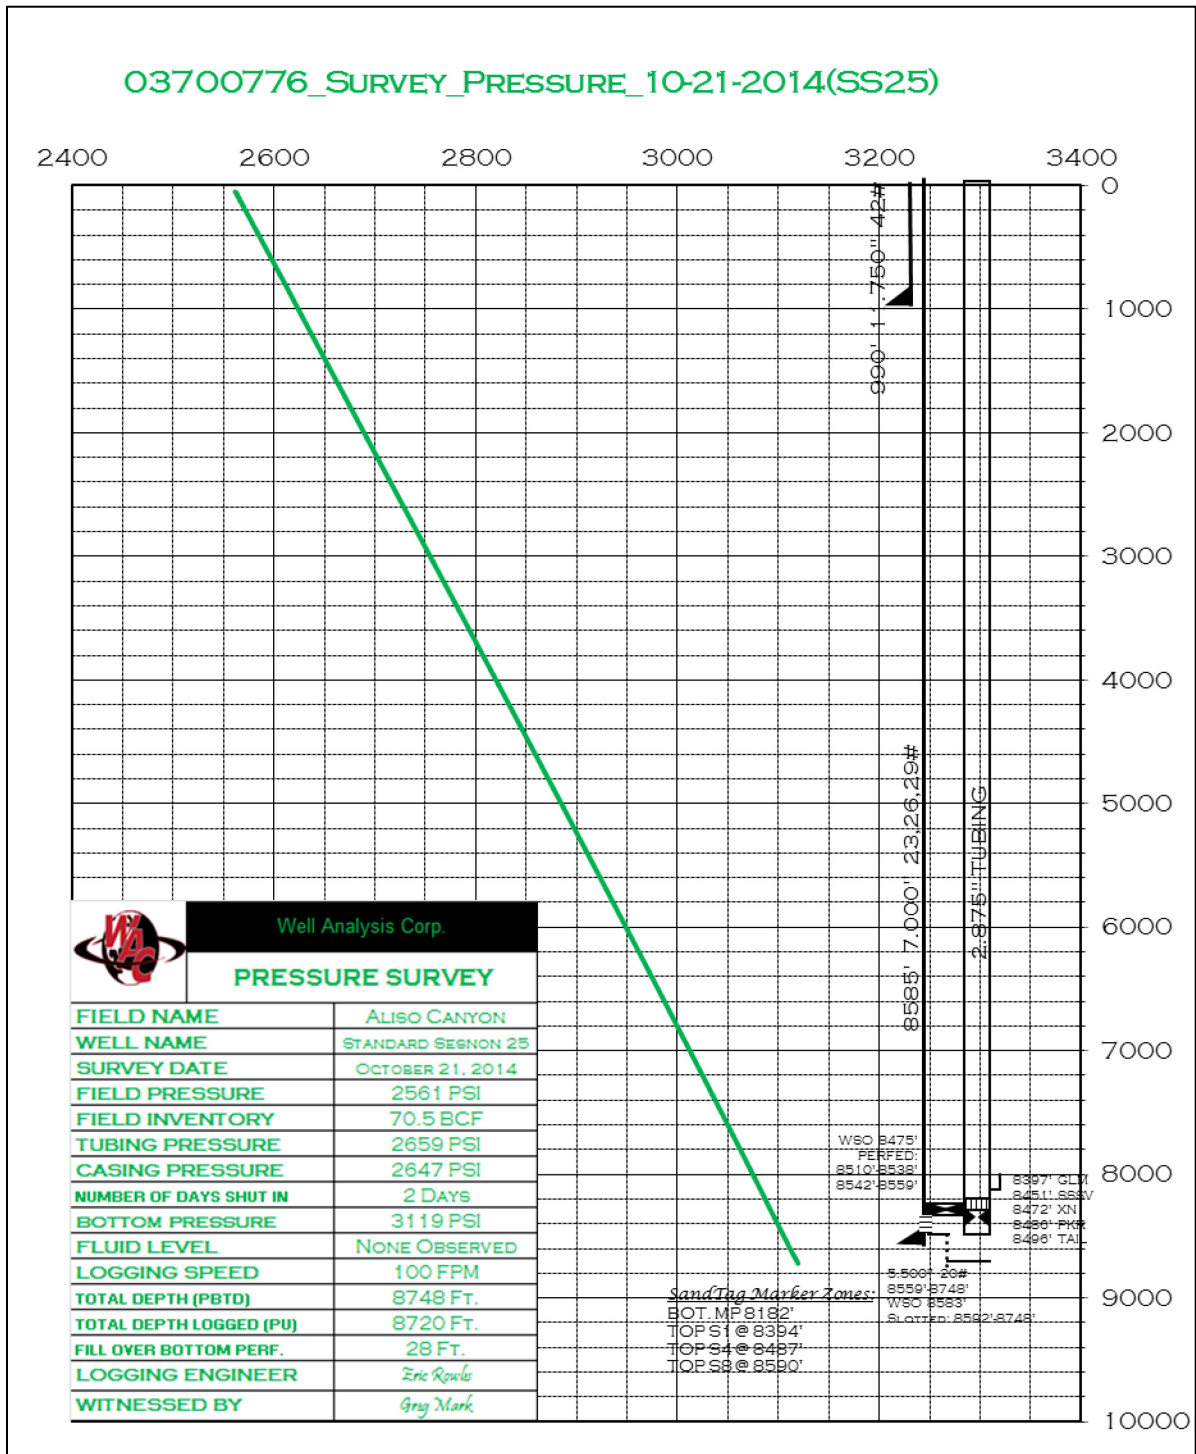
Figure 143: Most Recent SS-25 Pressure Survey, October 21, 2014

Although SoCalGas performed 41 pressure surveys in 41 years, neither the *DOGGR Project Approval Letter* [72] nor the *SoCalGas Gas Inventory-Monitoring, Verification, and Reporting Company Operations Standard Gas Operations* [73] required pressure surveys. Figure 143 shows the most recent pressure survey on October 21, 2014, to 8,720 ft, in which there seems to be a discrepancy; the title block entry for “Tubing Pressure” (2,659 psi) does not match the graphed data, which appears to be between 2,550–2,600 psi. Despite this discrepancy, no pressure anomalies are observed in the graphed data.

Blade’s interpretation of the pressures surveys is that they were not effective in determining the presence or location of a casing leak; small leaks would go undetected. From a casing integrity perspective, pressure surveys differ from pressure tests substantially. In pressure surveys, the well is open to the storage zone, and any gas that escapes into a casing leak is replenished by the storage zone. This is considerably different than a pressure test where all external sources of pressure are isolated. Additionally, the pressures observed during these pressure surveys are the shut-in pressures. The pressure profiles during shut-in are lower than during standard gas injection operations. In other words, pressure surveys are taken at times when the casing is under less pressure than during gas injection.

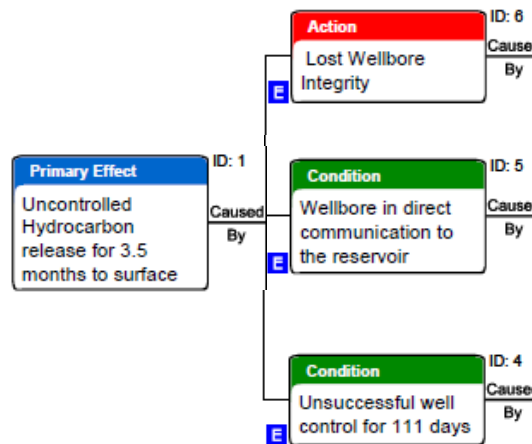
Figure 146: Causes of the SS-25 Incident

- The well-control efforts took 111 days to stop the reservoir gas from leaking to the surface. Seven attempts were made to stop the gas flowing up through the wellbore by pumping kill fluids down into the well from the surface. These top kill attempts were unsuccessful and, ultimately, a relief well had to be drilled to intersect the SS-25 wellbore at 8,534 ft and bring the gas flow to a stop by pumping kill fluid down the relief well to fill SS-25 with kill fluid from the bottom. If, for example, the first top-kill had been successful, the flow of gas to the surface would have been stopped within days. For example, had a successful well kill occurred by October 26, the cumulative volume leaked would have been 0.4 BCF instead of around 6 BCF.

Figure 146 shows the primary effect of the SS-25 incident and the three causes.

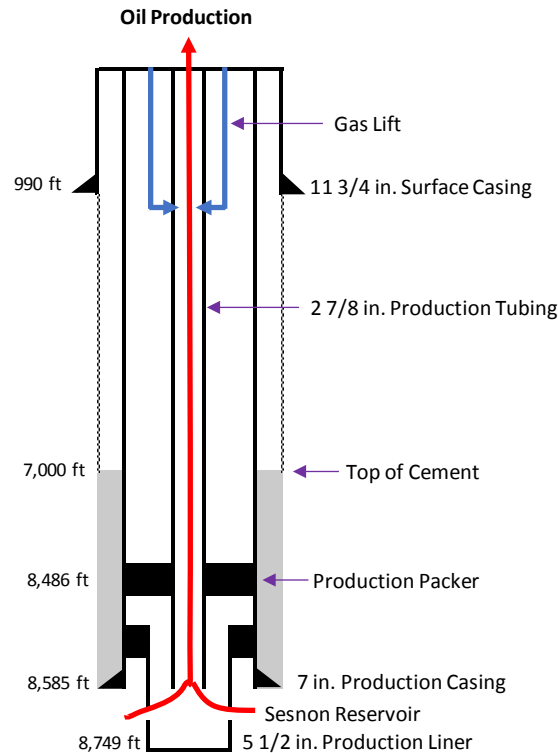
Figure 148: Well Schematic from When SS-25 Was an Oil Well

In 1954, SS-25 was drilled and then completed as an oil producing well. Figure 148 shows that a 7 in. production casing string was run from the surface to 8,585 ft, which was approximately 200 ft into the Sesnon oil reservoir. Below the 7 in. casing, a 200 ft 5 1/2 in. production liner was run across the Sesnon formation. This liner had slots cut along its length. A 2 7/8 in. production tubing string was run inside the 7 in. casing. At the bottom of the tubing string, a production packer isolated the annular space between the tubing and the 7 in. casing. During production the oil flowed from the Sesnon through the slots in the liner, up into the tubing, and up the tubing to the surface. The production packer prevented oil from flowing into the 7 in. x 2 7/8 in. annulus. Thus, the wellbore was in direct communication with the reservoir, allowing the oil to be recovered from the reservoir, which was the objective of the well. Note that the reservoir pressure was not high enough to force the oil all the way to surface. Several gas lift valves were therefore installed in the upper section of the tubing string. This allowed gas to be pumped down the 7 in. x 2-7/8 in. annulus, through the gas lift valves and into the tubing. The gas mixed with the oil making it lighter so that it would flow to the surface.

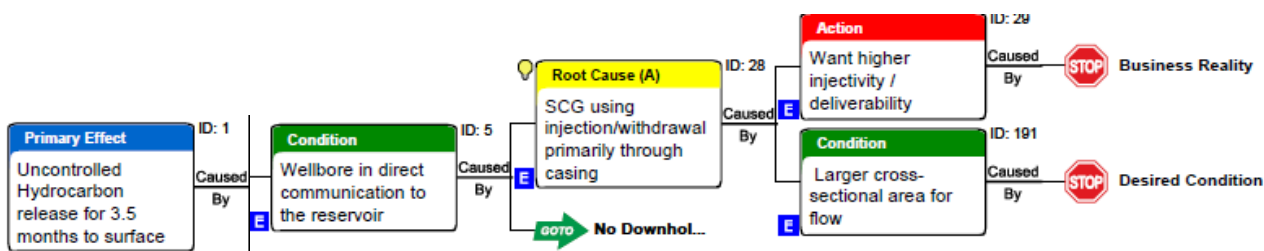
Figure 149: Causes—Wellbore in Direct Communication with the Wellbore

Having the wellbore in direct communication with the reservoir is a business reality. However, as Figure 149 shows, the effects of the incident were complicated by the fact that the well was configured for injection and withdrawal through the tubing and casing. In the 38 years SS-25 was used as a gas storage well, it was mostly used for injection, and most of that was done through the casing. Injecting gas through the casing allowed higher injection and withdrawal rates because it provided a larger flow area (than just the tubing), and a higher rate of gas could be injected through the casing. Maximizing the injection and withdrawal rates at lower pressures through each well is a business reality, reducing the need for additional storage wells. But this had an adverse impact on the wellbore integrity. Another impact of the well configuration was the absence of a functioning downhole annular flow safety system. Such a system had been initially installed but proved to be unreliable, and it was later removed. This is discussed in more detail in Section 5.2.3.

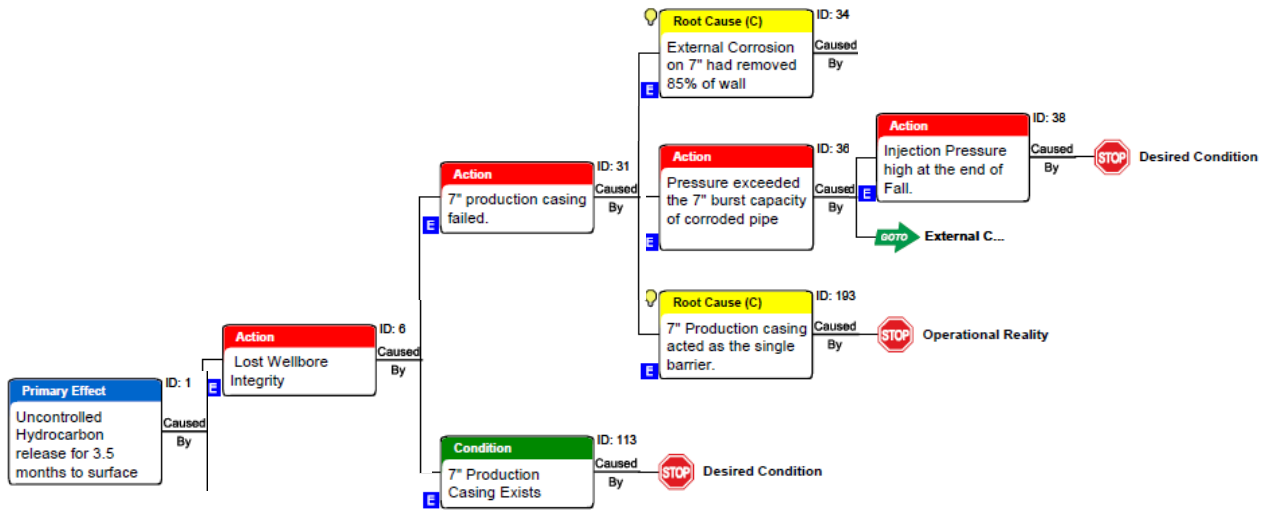
Figure 150: Causes—Lost Wellbore Integrity

At the time of the incident, gas was being injected into the reservoir. Wellbore integrity was lost when the 7 in. casing (which was being used to provide the conduit between the reservoir and the surface) ruptured and parted, allowing the pressurized gas to escape from the wellbore. Figure 150 shows that the following were the causes of the failure:

- The external corrosion on the 7 in. casing had removed 85% of the wall thickness.
- The pressure inside the 7 in. casing exceeded the burst capacity of the corroded casing.
- The 7 in. casing acted as a single barrier.

Rig operations during Phase 3 found that the 7 in. casing had parted at 892 ft. Blade examined the parted sections and found that external corrosion had removed 85% of the wall thickness, which consequently reduced the burst capacity of the 7 in. casing. At the time of the failure, the pressure of the gas being injected into the wellbore was 2,700 psi surface pressure. Blade developed a finite element model of the corroded region where the 7 in. casing failed by using the actual material properties and dimensions of the corroded section. The corroded region included sharp grooves causing a stress concentration that was approximated in the finite element model. The modeling predicted that the corrosion region would fail at a differential pressure between 2,327 and 2,836 psi. This is consistent with an internal pressure of 2,791 psi at the failure location. The surface injection pressure varies throughout the year and was at the highest level for the year. This was normal for the fall months, when more gas is stored for the upcoming winter demand.

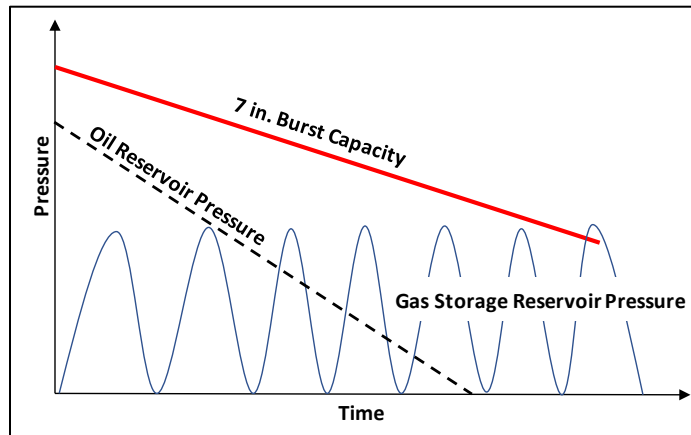
Figure 151: Oil and Gas Storage Reservoir Pressures Compared

Recall that SS-25 was originally designed to be an oil producer in 1954 and was converted to gas storage in 1973, 19 years later. Other wells in Aliso Canyon drilled after 1973 were designed specifically to be gas storage wells. A key difference between the two types of wells is that the reservoir pressure in an oil well decreases gradually over time, whereas the reservoir pressure in a gas storage well does not. An oil well experiences the highest pressures on the first day of production, and pressure then decreases over time. The pressures that gas storage wells are exposed to are cyclic as gas is injected and withdrawn normally on annual cycles (Figure 151). The cyclic pressure levels are approximately the same year after year; the 7 in. casing burst capacity decreased over time because of the effects of wall loss corrosion. A key tenet of ensuring wellbore integrity is that the casing be designed to withstand the pressures it will be exposed to over the complete life of the well.

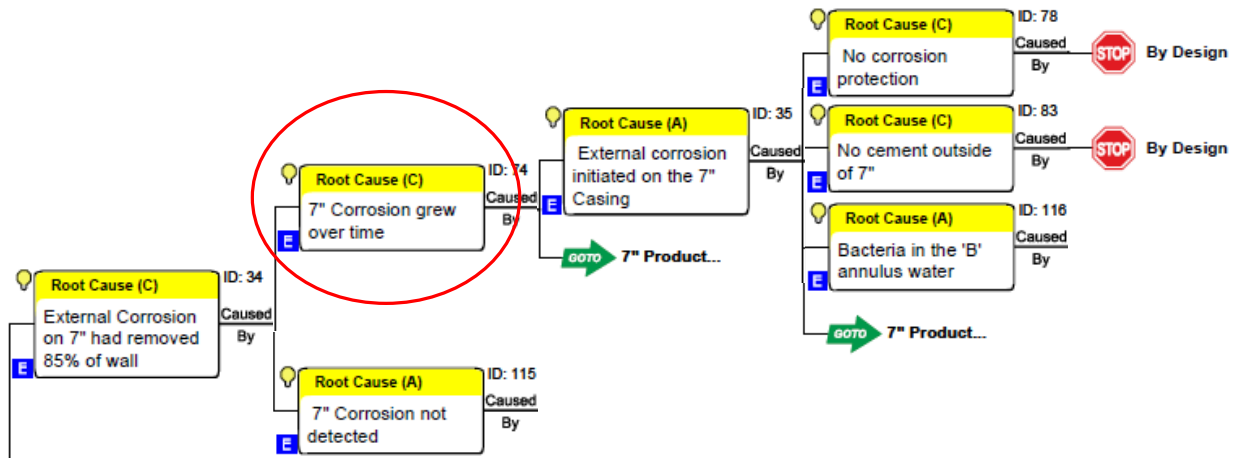
Figure 152: Causes—Corrosion Growing Over Time

Corrosion initiated on the OD of the 7 in. casing and continued to grow over time because there was neither corrosion protection for the OD nor cement outside the casing at 892 ft, and the environment in the 7 in. × 11 3/4 in. annulus was conducive to corrosion (Figure 152). Blade's laboratory analysis of the parted 7 in. casing showed that the wall thickness reduction was caused by microbiologically influenced corrosion (MIC).

For the 7 in. casing to have corroded, it must have been in direct contact with an environment that allowed the corrosion mechanism to exist, and a corrosion protection mechanism must have been absent. Cathodic protection systems, for example, are commonly used to protect pipelines from corrosion and are sometimes used on surface casing strings. While a cathodic protection system would have provided corrosion protection to the 11 3/4 in. casing, it would not have protected the 7 in. casing inside the 11 3/4 in. casing. Therefore, the most common method for providing corrosion protection for casing strings is to manage the environment or to modify the casing metallurgy. The presence of bonded cement outside of the 7 in. casing would have mitigated external corrosion. However, there was no cement around the 7 in. casing at 892 ft, because when the well was originally drilled, the cement around the 7 in. casing was intentionally brought up to 7,000 ft and not to surface. The environment outside of the 7 in. casing, above 7,000 ft, would therefore have originally consisted of the drilling fluid used while drilling the well.

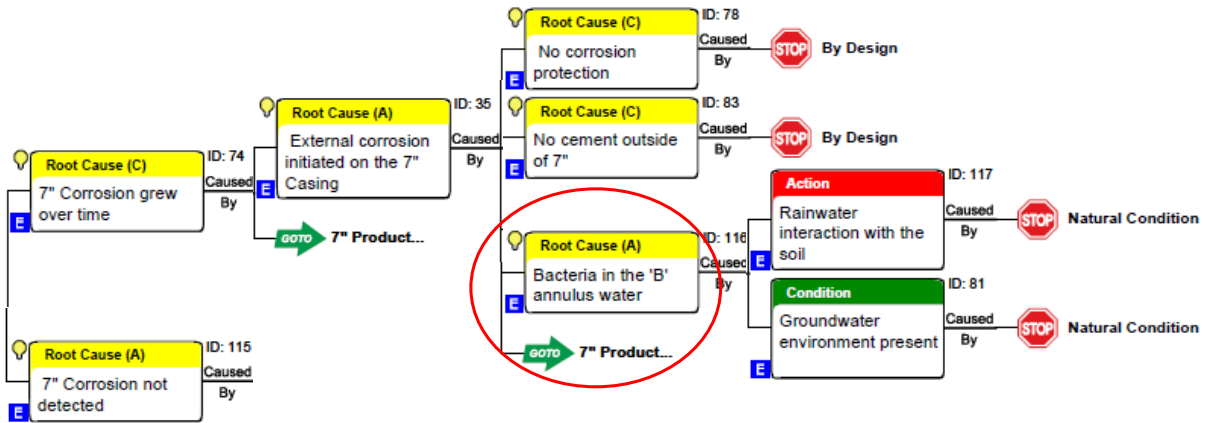
Figure 153: Causes—Annulus Fluid Corrosion Mechanism

The drilling fluid that was left behind the 7 in. casing had a pH ranging from 10 to 12 and would not have caused corrosion. Over time, the drilling fluid leaked off and was displaced by groundwater. The fluid level in the annulus rose and fell with the groundwater level. The groundwater had a microbial environment that resulted in slow corrosion of the OD of the 7 in. production casing (Figure 153).

The metallurgical analyses documented that the failure location had corroded due to MIC. The evidence supporting the interpretation of MIC included metallurgical, scale and corrosion product chemistry, and scale microbial analyses. The metallurgical assessment demonstrated the presence of tunnels, striations and the microbial nature of the corrosion scale. The Raman and XRD analyses demonstrated the predominance of magnetite and modified hematite. The microbial analyses of the scale demonstrated the consistent and predominant presence of methanogen strains that likely caused corrosion. Finally, many of

the 7 in. Speedtite connections exhibited slow leaks, and this seepage of gas likely introduced carbon dioxide, a nutrient for the methanogens.

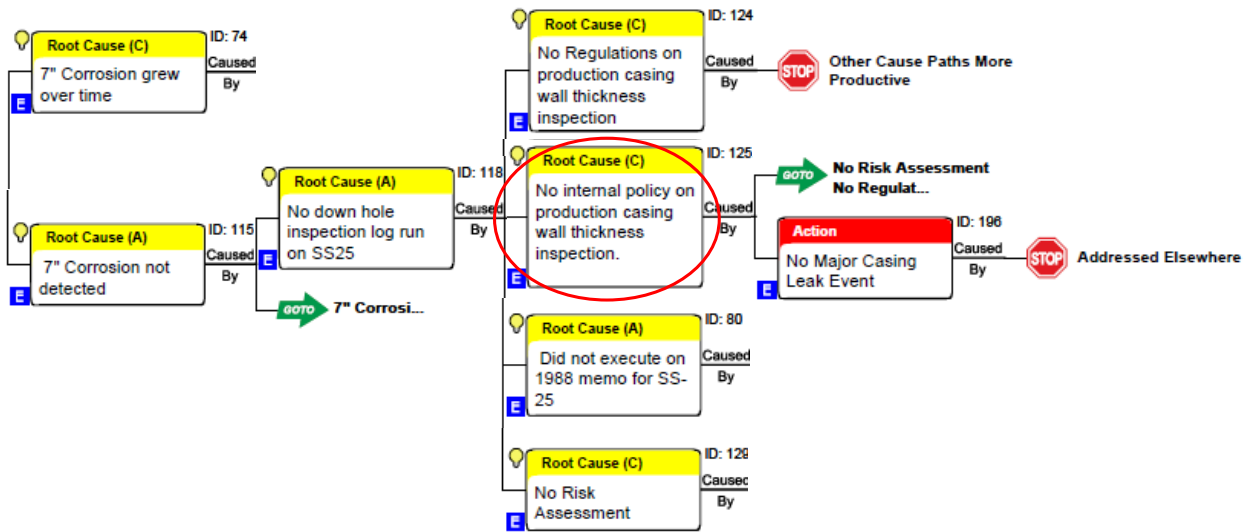
Figure 155: Causes—No Policy on Wall Thickness Inspections

Corrosion was not detected because the 7 in. casing wall thickness had never been inspected; therefore, the fact that the 7 in. casing was undergoing wall loss corrosion was unknown. Various acoustic and electromagnetic based tools can be run in a well with wireline to measure wall thickness along the entire length of a casing or tubing string. These logs were not run in the 7 in. casing because (Figure 154):

- No regulations were in place requiring them at the time.
- No internal SoCalGas policy addressed wall thickness inspections at the time.
- No action from SoCalGas was taken on a 1988 memo recommending that a wall thickness inspection be done at SS-25.
- No risk assessment was performed.

The 2015 DOGGR regulations required periodic MITs, and annual temperature surveys were approved to meet the MIT requirements. Annual temperature surveys and periodic noise logs were run in SS-25 from 1974 to 2014, and no anomalies were found. This type of monitoring program is not capable of detecting corrosion or the growth of corrosion over time (irrespective of whether it is on the ID or OD). The temperature and noise surveys do not measure wall thickness; they will only detect a leak and are consequently after-the-fact, reactive techniques.

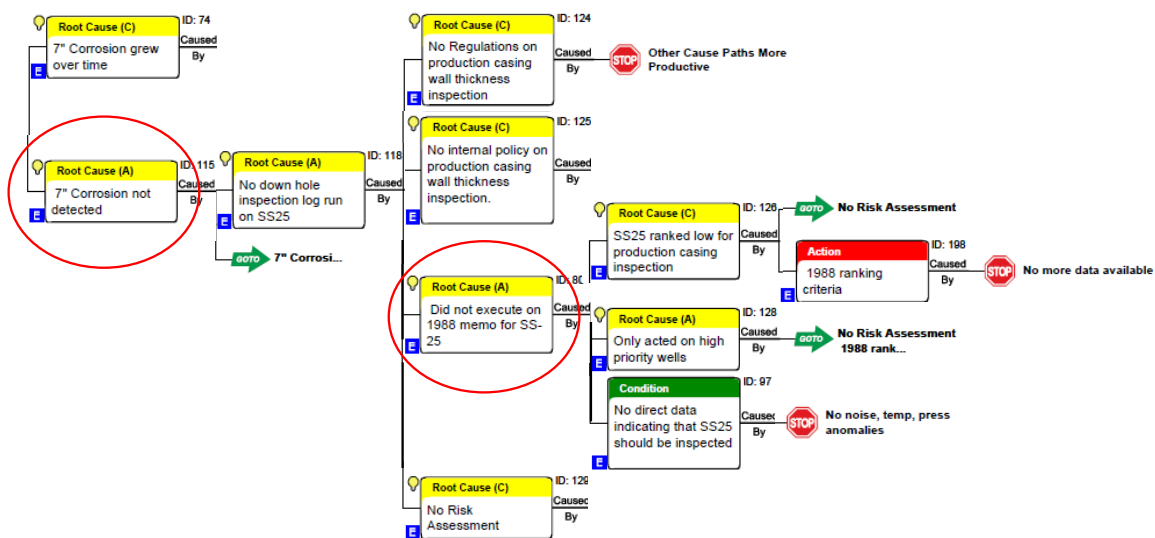
Figure 156: Causes—Not Executing on the 1988 Memo

The 20 wells recommended for a casing wall thickness inspection were originally oil wells completed between 1944 and 1956. The recommendation was to use a Vertilog inspection tool that used magnetic flux leakage measurements to measure casing wall thickness. The recommendation for conducting the survey was approved with the work to be done over the following two years. During that time, 7 of the 20 wells ended up being inspected (5 were high priority, 1 was medium, and 1 had already been scheduled for a workover). The inspection logs showed metal loss, and an inner casing string was run in some of the wells to mitigate the wall loss. However, 13 of the 20 wells were not inspected within the recommended 2-year window. SoCalGas stated that the remaining 13 wells were not inspected because the Vertilog technology available in 1988 “proved to be less effective at identifying casing leaks than the well diagnostic tests that SoCalGas routinely performed on its underground gas storage wells (e.g. annual temperature surveys, noise logs, etc.) [76].” At the time, there were no anomalies or direct evidence from the noise and temperature log monitoring program that SS-25 needed a wall thickness inspection (Figure 156).

A wall thickness inspection provides a leading indicator of possible casing integrity issues. The noise and temperature logs results are trailing indicators because the leak has to already have happened to be detected. Seven of the wells were inspected, and many of them had OD metal loss indications. There was no follow-up investigation of these anomalies. Further, there was no investigation of why these wells exhibited OD corrosion and why the remaining thirteen wells did not require further analyses (the remaining thirteen wells had been ranked as medium and low priority).

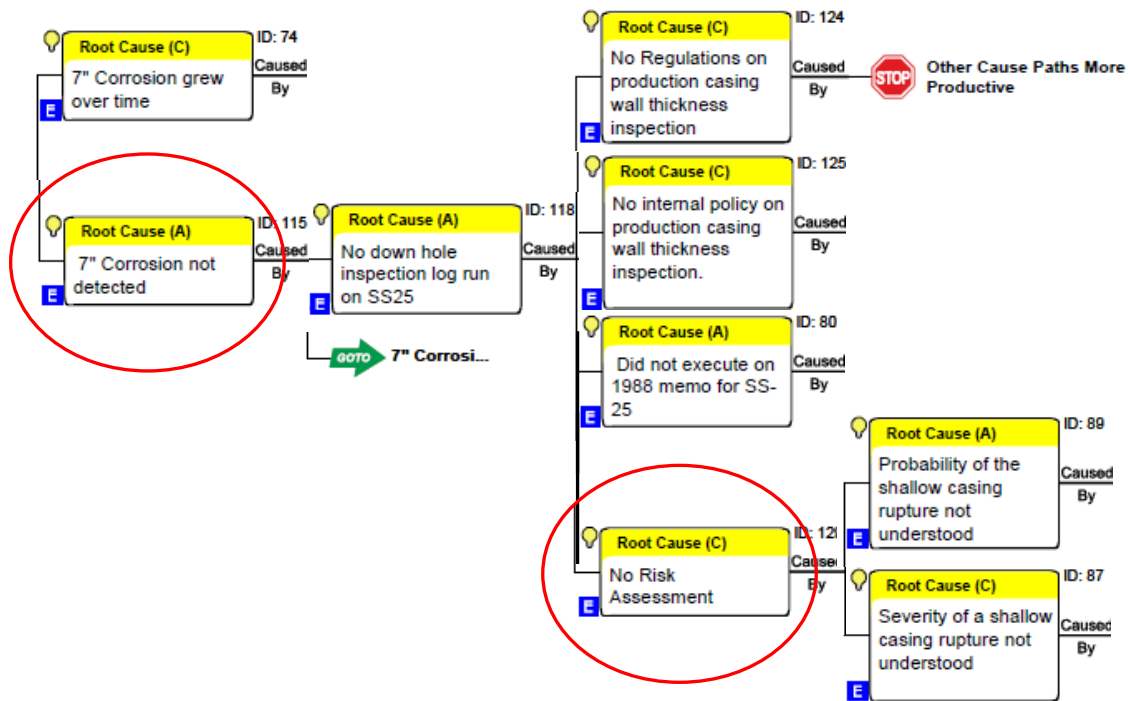
Figure 157: Causes—No Risk Assessment

One hundred and twenty-four wells were designated as gas storage by DOGGR in 2018. Blade's review of the Aliso Canyon well files shows that 40% of the wells had casing failures (leaks, tight spots, parted casing) with an average of 2 failures per well (99 failures in 49 wells). There had been underground blowouts in two wells, Frew-3 in 1984, and FF-34A in 1990. Five of the seven wells that were inspected with the Vertilog tool after the 1988 memo had wall thickness reduction ranging from greater than 20% to greater than 60%. A SoCalGas internal review of casing leaks prepared for CPUC in 2018 listed 81 leaks. Fifty-four of these were related to stage collars, casing shoes, water shut off perforations, casing patches, and inner strings. Of the remaining 27, 3 leaks were related to corrosion, 2 were still being evaluated, and 22 had unknown causes.

Despite this, there is no evidence that SoCalGas conducted a formal failure analysis or follow-up risk assessment on any of the casing failures to determine why they occurred. Nor was there an investigation of the reasons for, and the potential consequences of, the corrosion. It is deduced that the reasons for this are because (Figure 157):

- The probability of a shallow casing rupture was not understood
- The severity of a shallow casing rupture was not understood

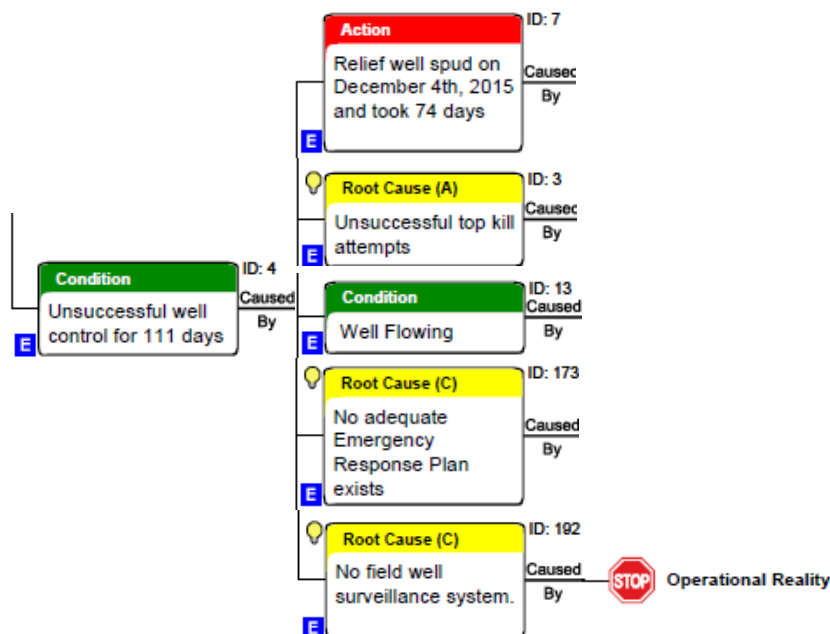
Figure 159: Causes of Unsuccessful Well Control

Seven attempts were made to top kill the well without success. A relief well had to be drilled to intersect SS-25 at 8,534 ft, and kill fluid was pumped down the relief well and into SS-25 from the bottom, which killed the well. It took 111 days to kill the well because (Figure 159):

- The top kill attempts were unsuccessful.
- The well was flowing.
- The emergency response plans were inadequate.
- There was no field well surveillance system.
- The relief well started on December 4, 2015, and took 69 days to complete (74 days including rig up time).

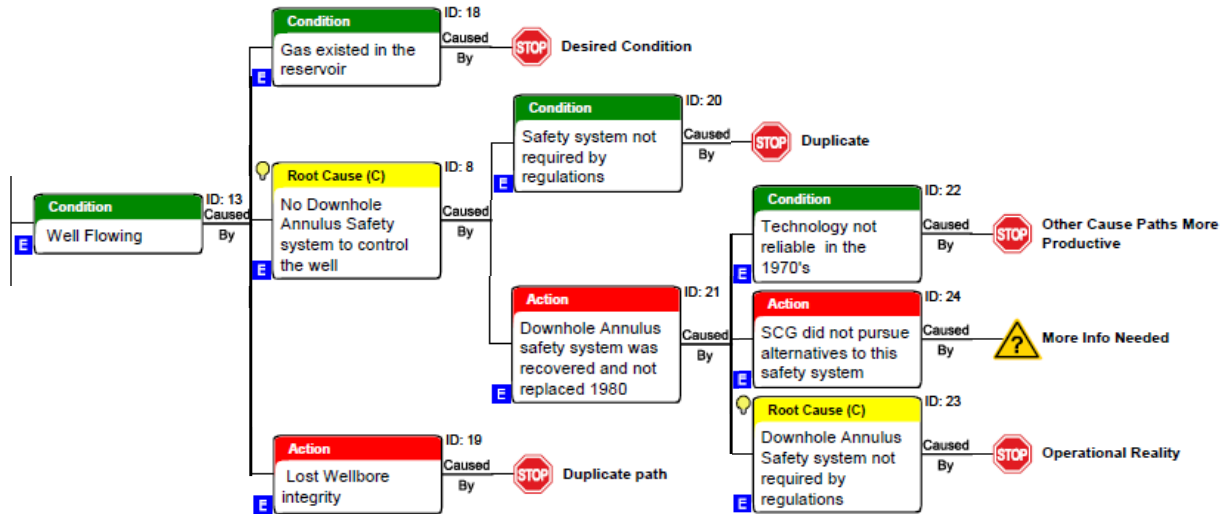
Figure 160: Causes—Well Flowing

The well was flowing because wellbore integrity was lost when the 7 in. casing failed at 892 ft and a downhole annular safety system was not in place to control the well (Figure 160). At the time of the failure, gas was being injected through the casing and into the reservoir. Just after the casing had failed, the injected gas started exiting the well, and gas from the reservoir began flowing up the well and out through the failed casing. Once the leak was discovered, the gas injection was stopped, and the well was shut in at the surface, but gas continued to flow from the reservoir and out the failed area.

A Camco annular flow safety system was installed in SS-25 in July 1976. This system was intended to shut off gas flow in the tubing-casing annulus in the event of a leak in the casing or uncontrolled flow at surface. It was run with the completion tubing and packer and placed deep in the well, above the packer, near the reservoir to provide deep isolation. The safety system was removed and replaced in February 1979. Another attempt was made to repair and test the system in January 1980, when it was concluded that the system did not function as designed. The internal components were then removed, rendering the annular flow safety system inoperable. There are numerous documents in the Aliso Canyon well files indicating problems with this type of safety system. Two systems were tried in various wells in the field; one provided by Camco and the other by Otis. Use of these devices was discontinued in the 1980s,

according to SoCalGas, because they did not work as designed and were unreliable. This is discussed in more detail in the *SS-25 Annular Flow Safety System Review* supplementary report [77].

SoCalGas did not pursue or implement alternatives to the safety system. However, viable deep-set downhole annular safety systems for gas or gas storage wells do not exist even today. Shallow-set systems run in the tubing string that shut off the gas flow in the event of a tubing failure are in common use today, but deep-set annular flow safety systems are not. A shallow-set system would have not prevented SS-25 from flowing either because what failed was the casing and not the tubing. The 2015 regulations did not require a subsurface safety device for non-critical wells.

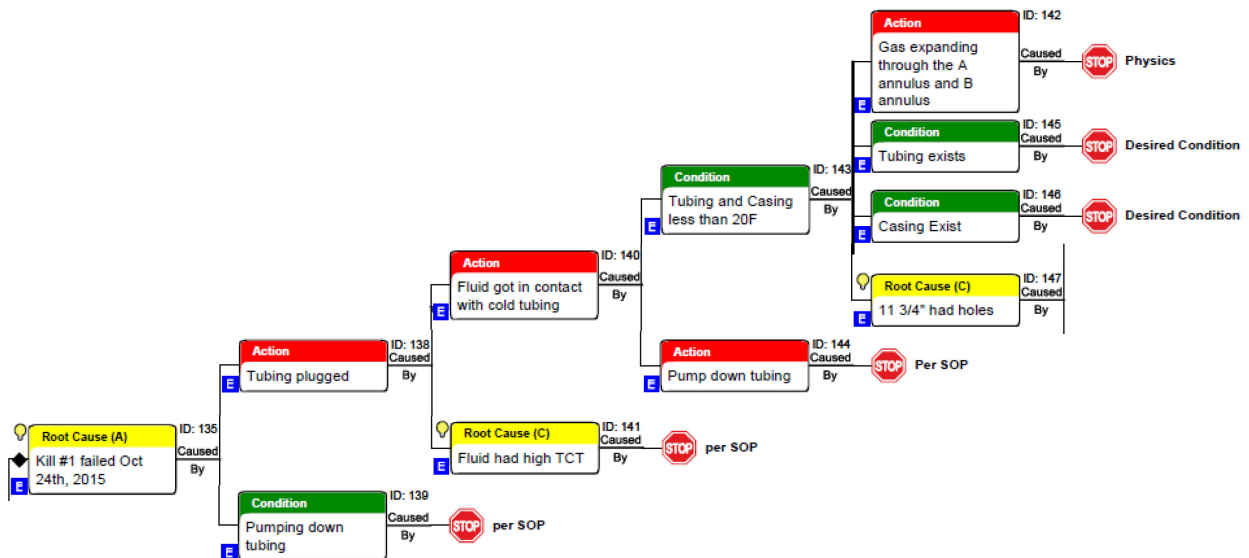
Figure 162: Causes—Unsuccessful Kill Attempt #1

Initially, the nature and depth of the leak were unknown. The plan for the first kill attempt was to pump 10 ppg polymer brine kill fluid down the tubing to stop the flow of gas and to displace the gas in the 7 in. x 2 7/8 in. annulus with kill fluid to finish killing the well. On October 24, after pumping 11.8 bbl of the polymer brine, the pump pressure jumped to 3,500 psi, and pumping was stopped. During this time the pressure in the 7 in. x 2 7/8 in. annulus remained constant at 290 psi, indicating that there was no communication between the tubing and the annulus, and the tubing was plugged. The pumping was then switched over to the 7 in. x 2 7/8 in. annulus. After pumping 89 bbl of brine, gas started to break through to the surface through cracks in the ground around the well and pumping was stopped. These results suggested a wellhead seal leak or a shallow leak in the 7 in. casing existed.

Because of the Joule-Thomson effect, the flowing gas cooled to approximately 20°F by the time it reached the area where the 7 in. casing parted. The cooling of the gas then cooled the tubing causing the brine being pumped down the tubing to freeze and form a plug in the tubing. The freezing happened because TCT of the brine was higher than the temperature of the tubing. TCT is the temperature at which salt begins to precipitate, causing the brine solution to solidify. The first top-kill attempt was therefore unsuccessful because the tubing became plugged, preventing the kill fluid from being pumped down the tubing (Figure 162).

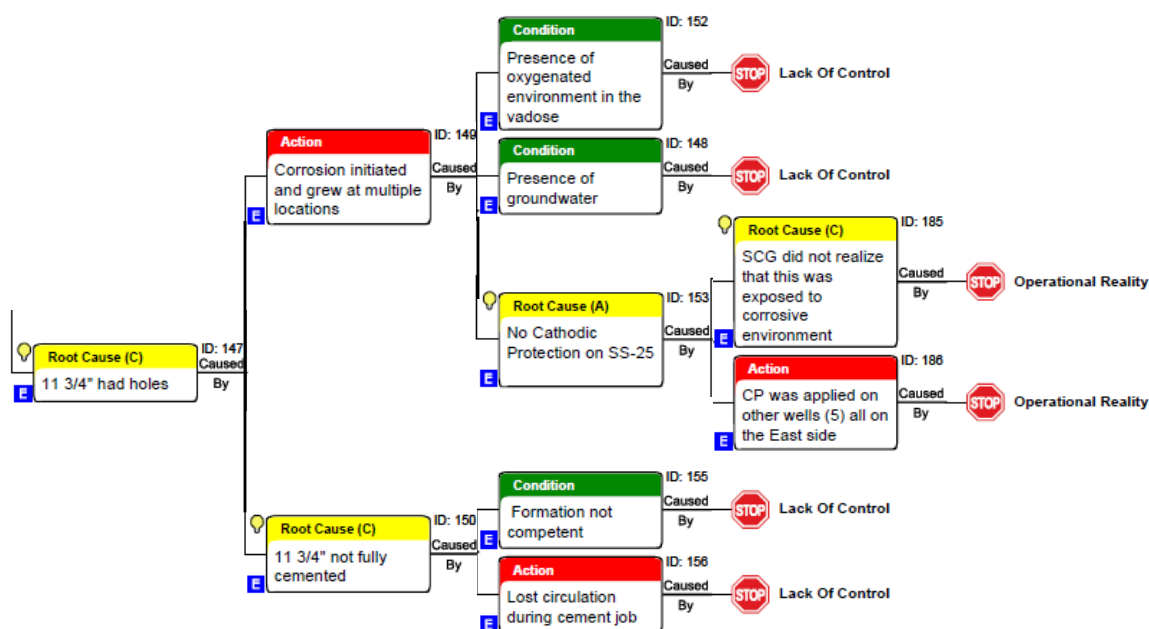
Figure 163: Causes—Holes in 11 3/4 in. Surface Casing

During the Phase 3 evaluation of the condition of the 11 3/4 in. surface casing, holes in the casing were found between 134 and 300 ft. These holes were caused by the escaping gas pressure following external corrosion because the casing was neither fully cemented nor cathodically protected leaving the casing exposed to an environment conducive to corrosion (Figure 163). This environment consisted of the undersaturated vadose zone containing air and some water, from surface to 300–400 ft, and then groundwater in the deeper formations.

Lost circulation occurred at 169 ft when the 11 3/4 in. hole section was originally drilled in 1953. This was because the strength of the formations being drilled is low, as is frequently the case in the first several hundred feet in a well. The hydrostatic pressure of the drilling fluid being used exceeded the formation strength, causing lost circulation. Lost circulation also occurred when the 11 3/4 in. was run and was being cemented so that cement was not circulated to surface. Cement was pumped from the surface, and it was assumed that the annulus around the casing had been filled with cement. However, when cement integrity logs were run in the 11 3/4 in. during the Phase 3 operations, fair cement was only found outside the casing from 606 to 660 ft and from 950 to 985 ft, leaving the majority of the casing exposed (Figure 163). Surface casing cathodic protection had been applied to five other wells at Aliso Canyon, but not to SS-25.

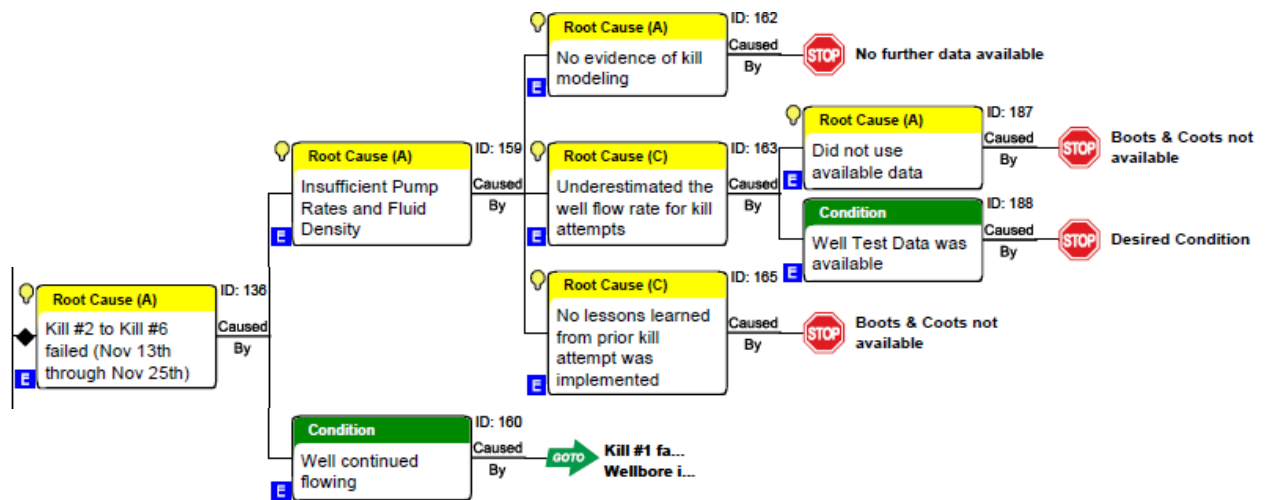
Figure 165: Causes—Unsuccessful Kill Attempts #2 Through #6

Kill attempts #2 through #6 occurred from November 13 through November 25 and were unsuccessful fundamentally because the pump rates and fluid densities used were insufficient to stop the well from flowing (Figure 165). Various combinations of kill fluid densities and volumes were pumped at various rates without success. Gas, oil, and kill fluid were observed flowing to surface through fissures in the ground, and a large crater began to form around the well. Each kill attempt was a variation of the previous one. It appears that lessons from previously unsuccessful attempts were not applied to refine the future attempts. Gas flow rate leaking from the well appeared to be underestimated, based on later kill modeling. There is no evidence that any kill modeling was done to predict the optimum kill fluid density, volume, and pump rates to design kill operations. Models are estimates and have errors,

depending on how much actual data is available and what assumptions need to be made. However, modeling a well kill is the only way to get a reasonable idea of what would be required to kill the well given the complexity of the fluid and gas flow paths, the high gas flow rate, and the shallow leak depth.

The flow rate data is critical to designing a well kill. For example, during kill attempt #2, the Blade estimated flow rate was 83 MMscf/D. The 9.4 ppg kill density fluid could not kill this well; however, 12 ppg at a flow rate of 9 to 10 bbl/min would have gotten the well under control. There is no documentation to indicate that any modeling or analyses were ever performed for kill attempts #2–6. The decisions appeared to be based on the static reservoir pressure and this would be inadequate and inappropriate for designing kills [3]. SoCalGas-provided information suggested that the well-control company was using 30 MMscf/D as the well flow rate [40]. It is unclear whether this information was ever used in any modeling. Flow rate and kill fluid density have to be designed by using established industry modeling tools before preparing an operational plan to ensure the well is killed.

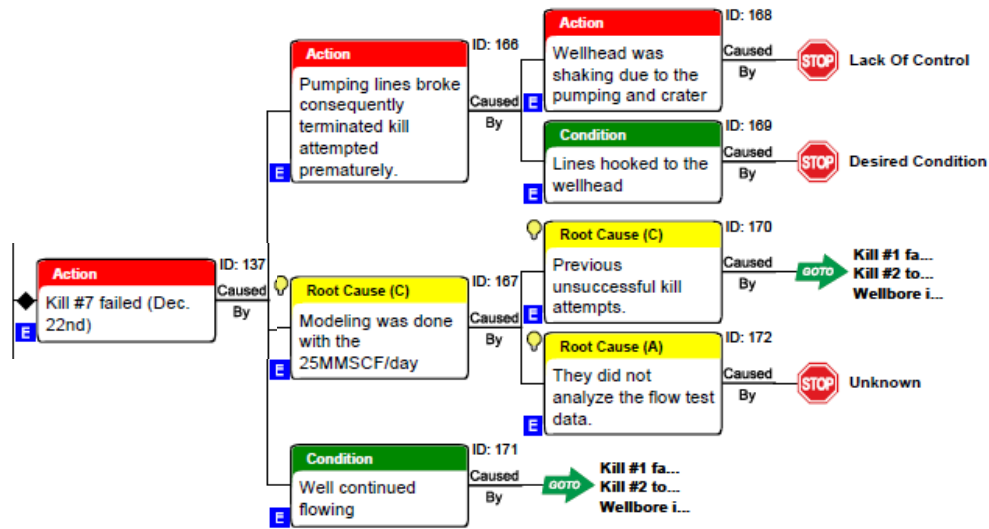
Figure 166: Causes—Unsuccessful Kill Attempt #7

There is data indicating that the design of kill attempt #7 was modeled ahead of time. The well-control company appeared to assume a gas flow rate of around 25–30 MMscf/D, whereas Blade-estimated flow rate was 60 MMscf/D. However, the annulus pressure dropped to 0 psi for a time indicating that the well had likely been killed, but pumping had to be stopped because of severe vibrations of the wellhead. The wellhead movement caused pumping lines to break off, and operations were stopped to prevent damage to the wellhead itself (Figure 166). The inability to continuously fill the well allowed the production zone to resume flowing. No further attempts were made to top kill the well.

The underestimation of the gas flow rate was a deficiency in planning the kill attempts. Flow rate modeling by Add Energy in February 2016 and later by Blade, using the data that were available at the time of the incident, has estimated the gas flow rate to be 80 and 93 MMscf/D, respectively. Records show that the flow rate used for modeling kill attempt #7 was 25 MMscf/D. However, Blade’s estimate for kill attempt #7 was a gas flow rate of 60 MMscf/D.

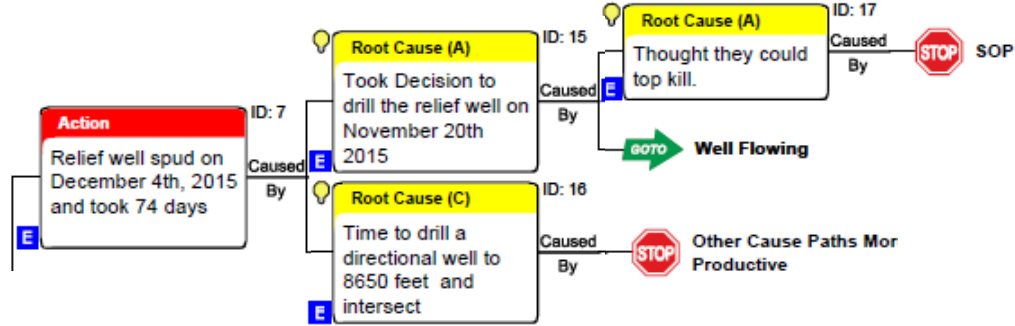
Figure 167: Causes—Relief Well Drilling

The decision to start drilling the relief well was made on November 20, 2015, after four unsuccessful top-kill attempts (Figure 167). The objective of the relief well was to drill down and intersect (i.e., drill into) the SS-25 well at 8,534 ft just below the packer and the top of the 5 1/2 in liner. This would allow kill fluid to be pumped down the P-39A well and into SS-25 near the bottom of the wellbore. The drilling of the P-39A relief well began on December 4, 2015. It took 69 days (74 days including rig up time) to drill down and intersect SS-25. The gas flow was stopped on February 11, 2016, and the well was declared secure on February 18, 2016.

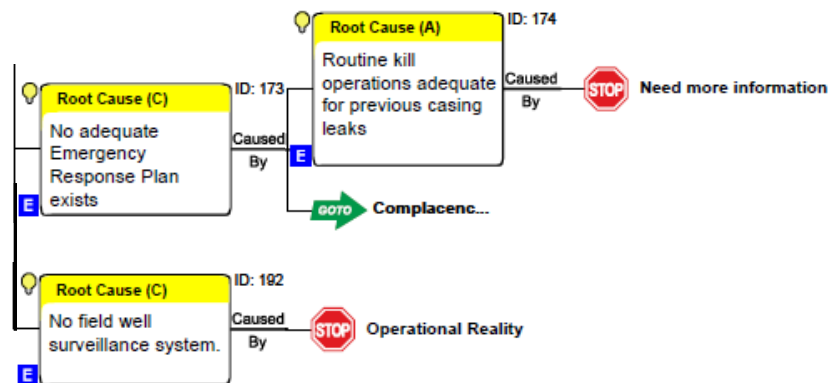
Figure 168: Causes—Emergency Response Plan and Field Surveillance

This suggests that the emergency response plan for this kind of incident was inadequate, and that it was assumed that the routine kill operations were adequate for any scenario (Figure 168). The tubing and casing pressures were measured manually on a weekly basis for all the Aliso Canyon wells. If these pressures had been monitored in real-time with a field surveillance system, then the initial leak in SS-25 would have been detected immediately and injection stopped. This could have prevented the brittle circumferential parting from occurring.

The lack of real-time pressure measurements prevented the immediate identification of the 7 in. casing failure. The constant monitoring of the tubing, production casing and surface casing pressures will provide better insight into operational deviations in all wells. If this type of system had been installed on SS-25, it would have provided insight into the time of the leak, the opportunity to shut in the well immediately, size of the leak, and the extent of the problem. Furthermore, the information could have been used during well-control effort improving the chances of an early success.
