UNITED STATES DISTRICT COURT
NORTHERN DISTRICT OF CALIFORNIA

PACIFIC GAS AND ELECTRIC
COMPANY,

**PG&E Independent
Monitor Report of
November 19, 2021**

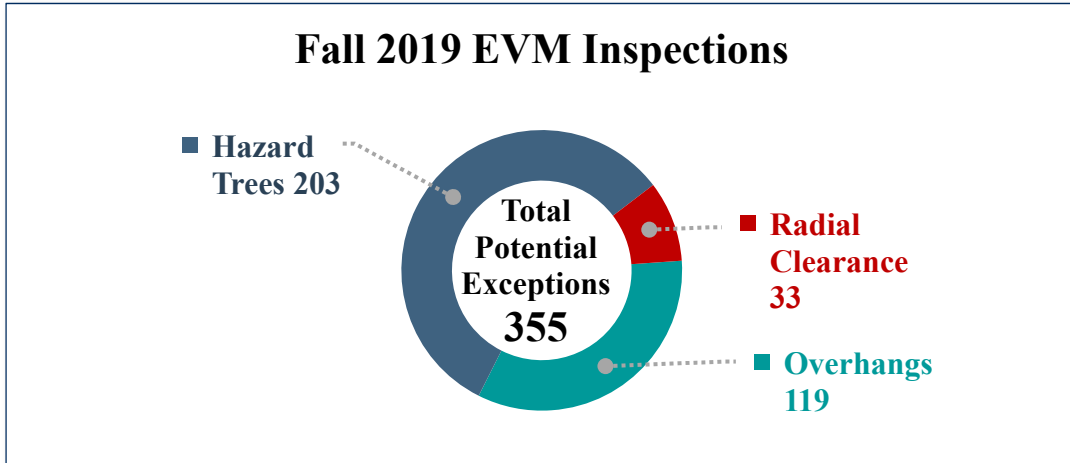
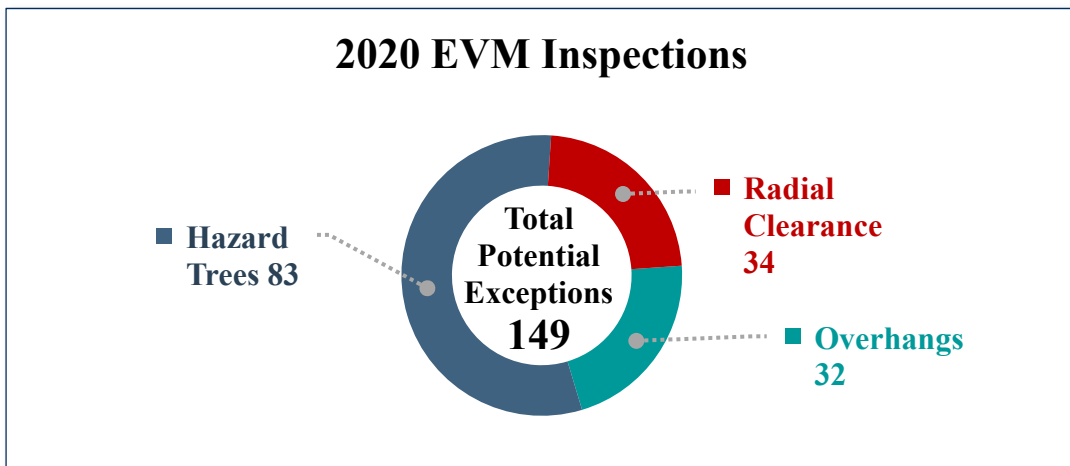
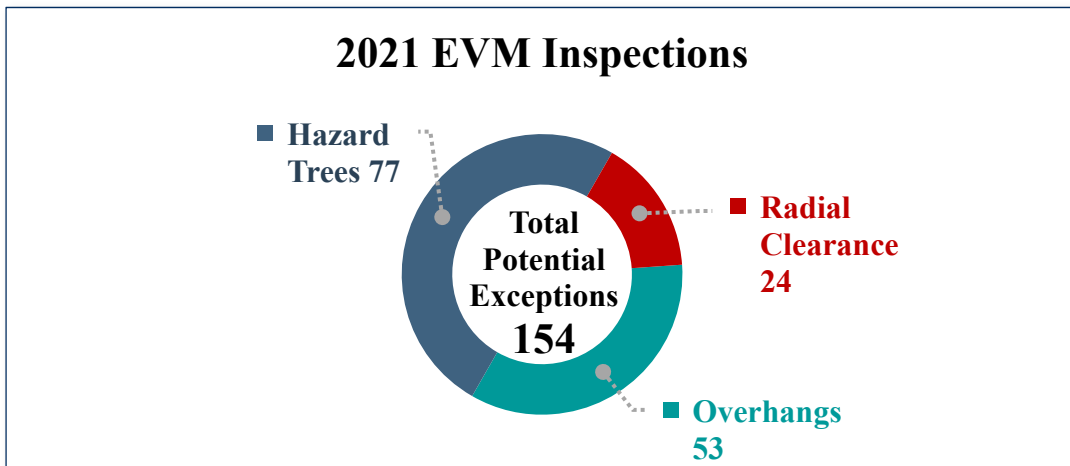
EXHIBIT 4: EVM INSPECTION STATISTICS

For Monitor team inspections of EVM areas from 2019-2021, the three graphs below show the number of potential exceptions observed.

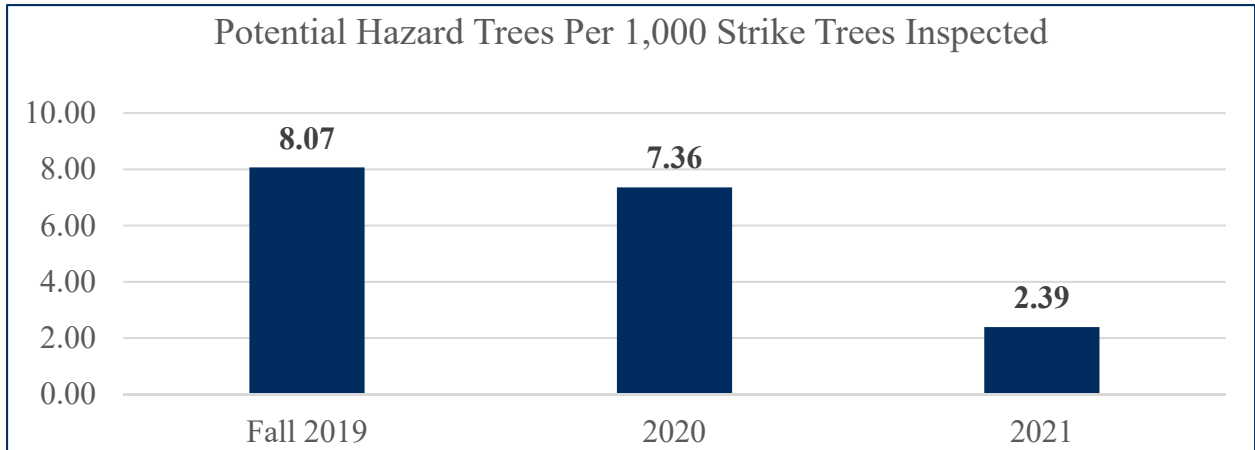
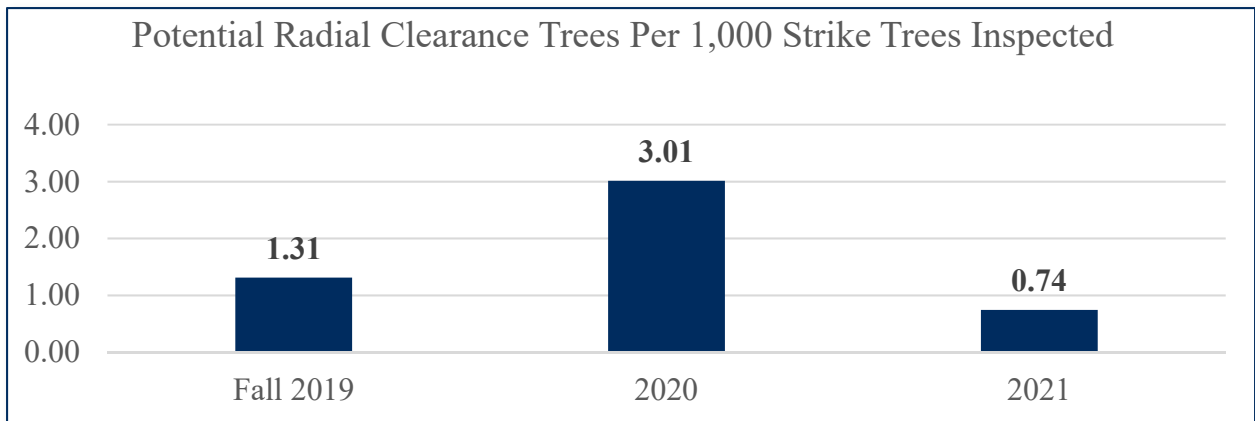
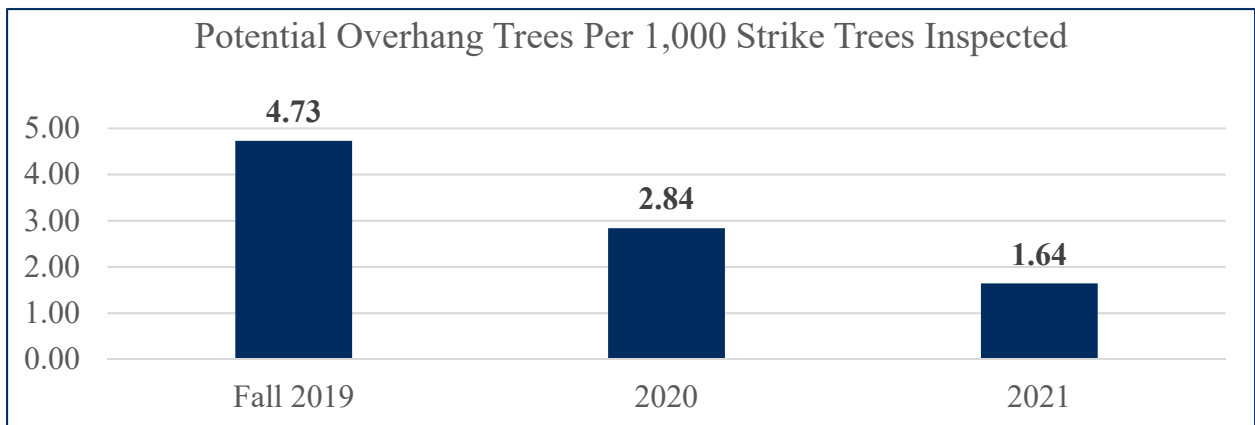
For Monitor team inspections of EVM areas from 2019-2021, the first graph shows the number of potential hazard trees observed per 1,000 strike trees inspected, the second graph shows the number of potential radial clearance issues observed per 1,000 strike trees inspected, and the third graph shows the number of potential overhang trees observed per 1,000 strike trees inspected.

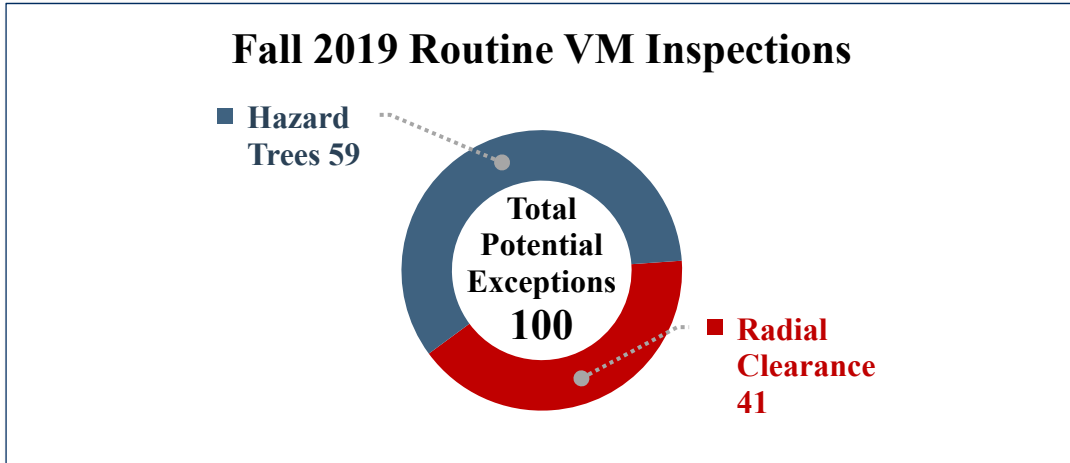
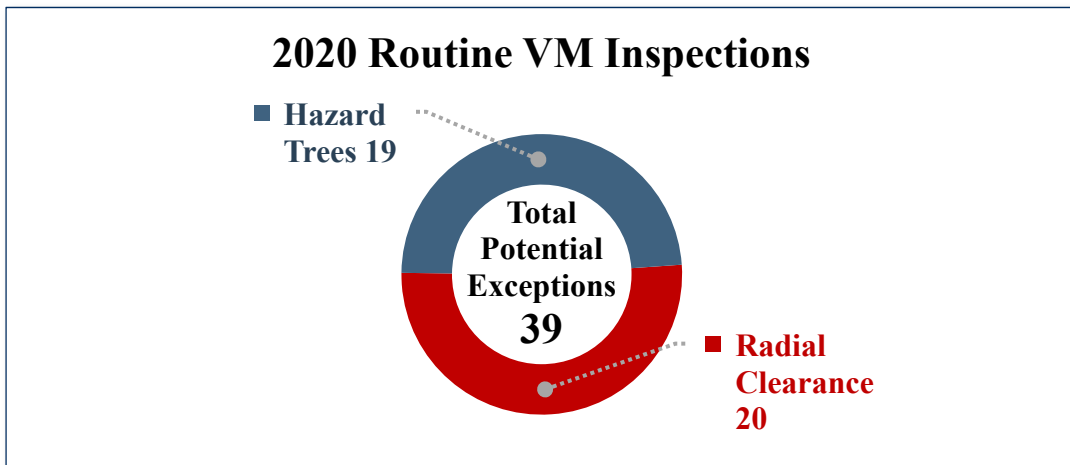
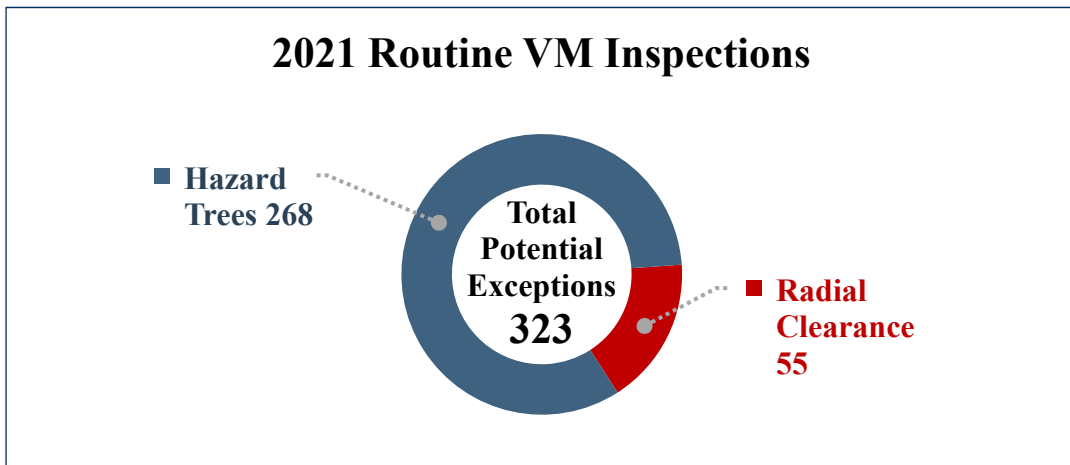
EXHIBIT 5: ROUTINE VM INSPECTION STATISTICS

For Monitor team inspections of Routine VM areas from 2019-2021, the three graphs below show the number of potential exceptions observed.

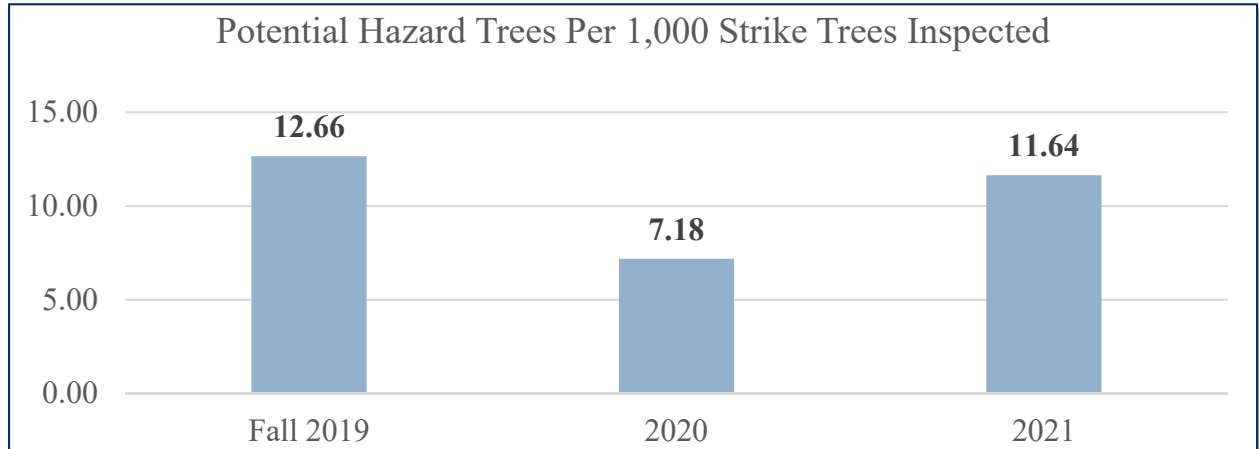
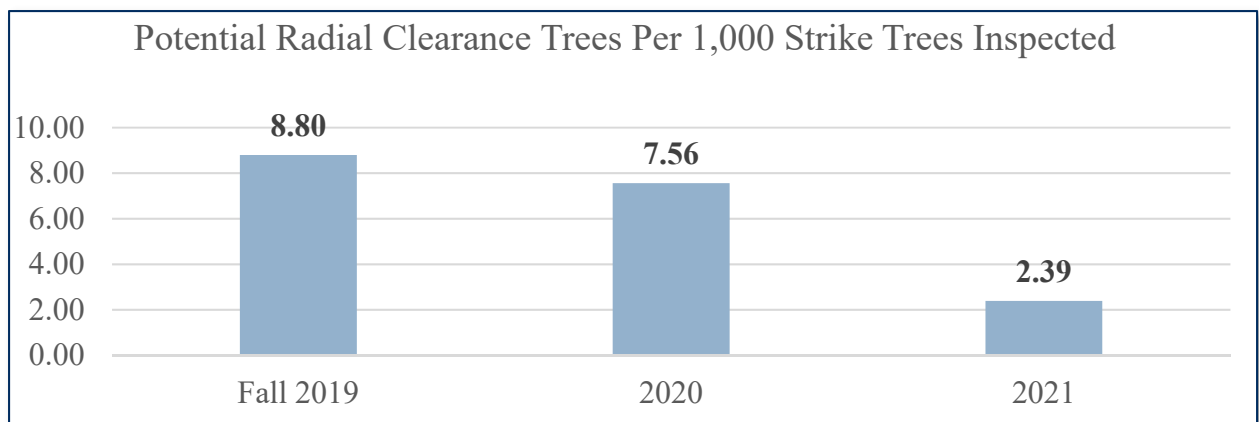
For Monitor team inspections of Routine VM areas from 2019-2021, the first graph shows the number of potential hazard trees observed per 1,000 strike trees inspected, and the second graph shows the number of potential radial clearance issues observed per 1,000 strike trees inspected.

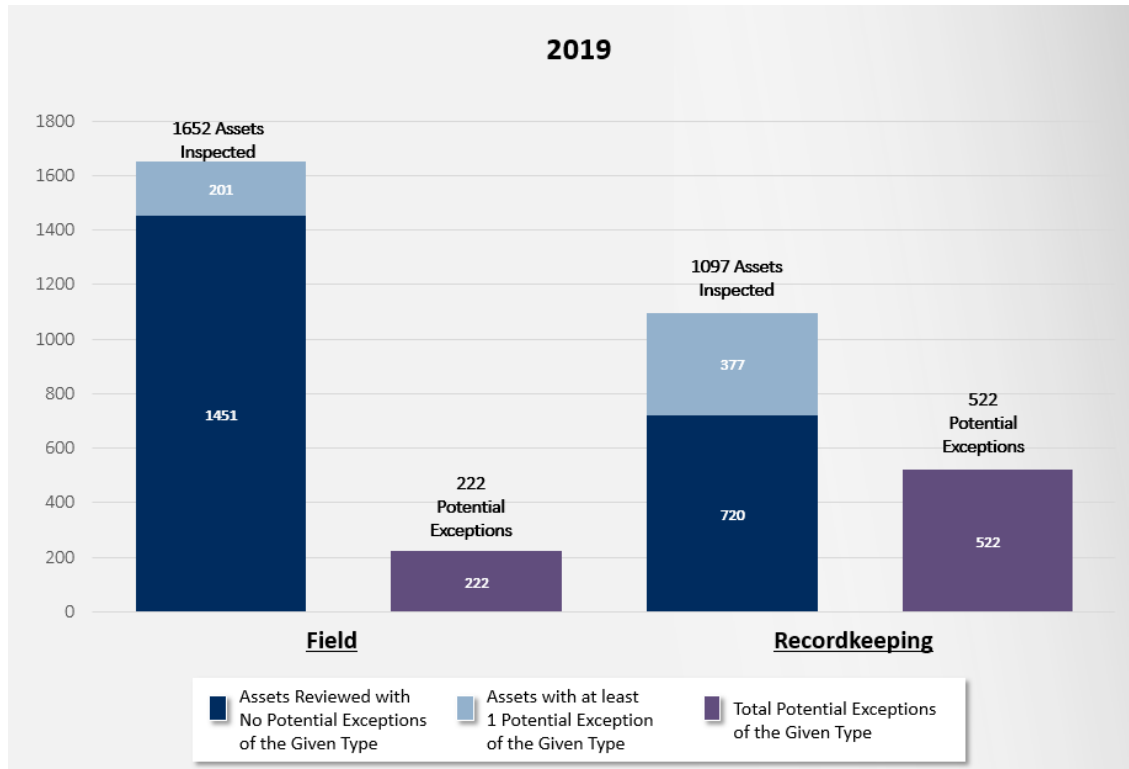
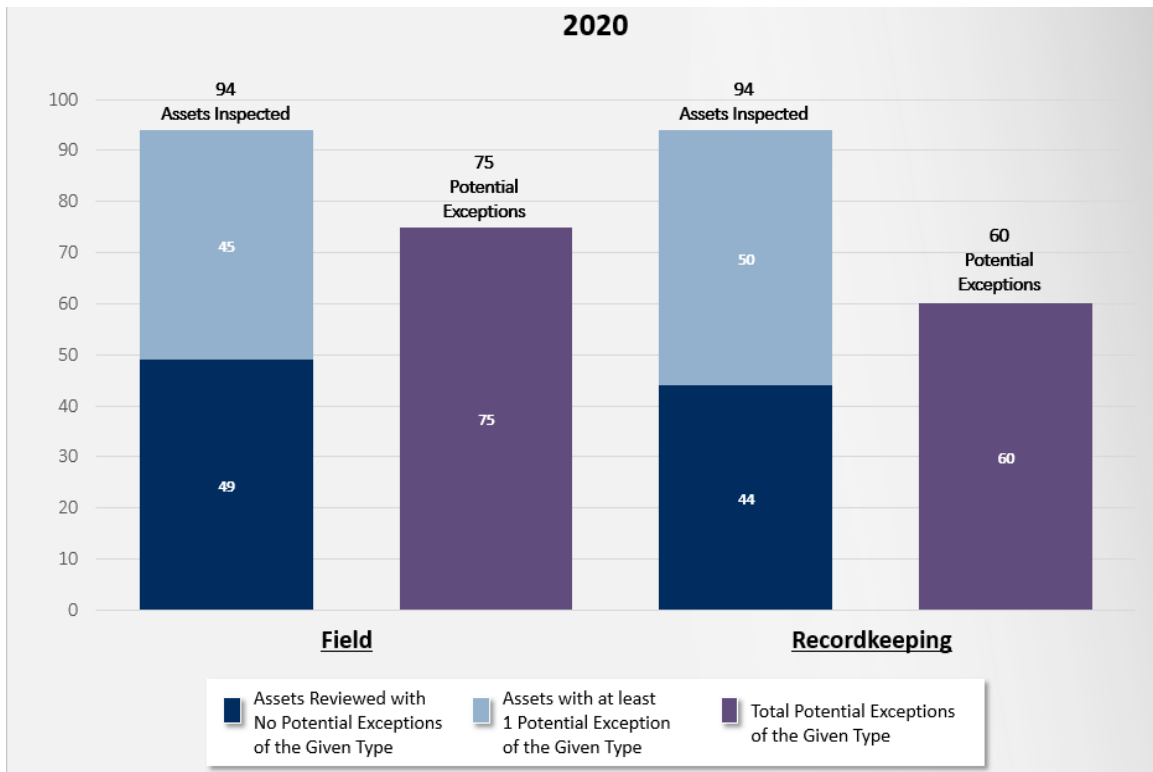
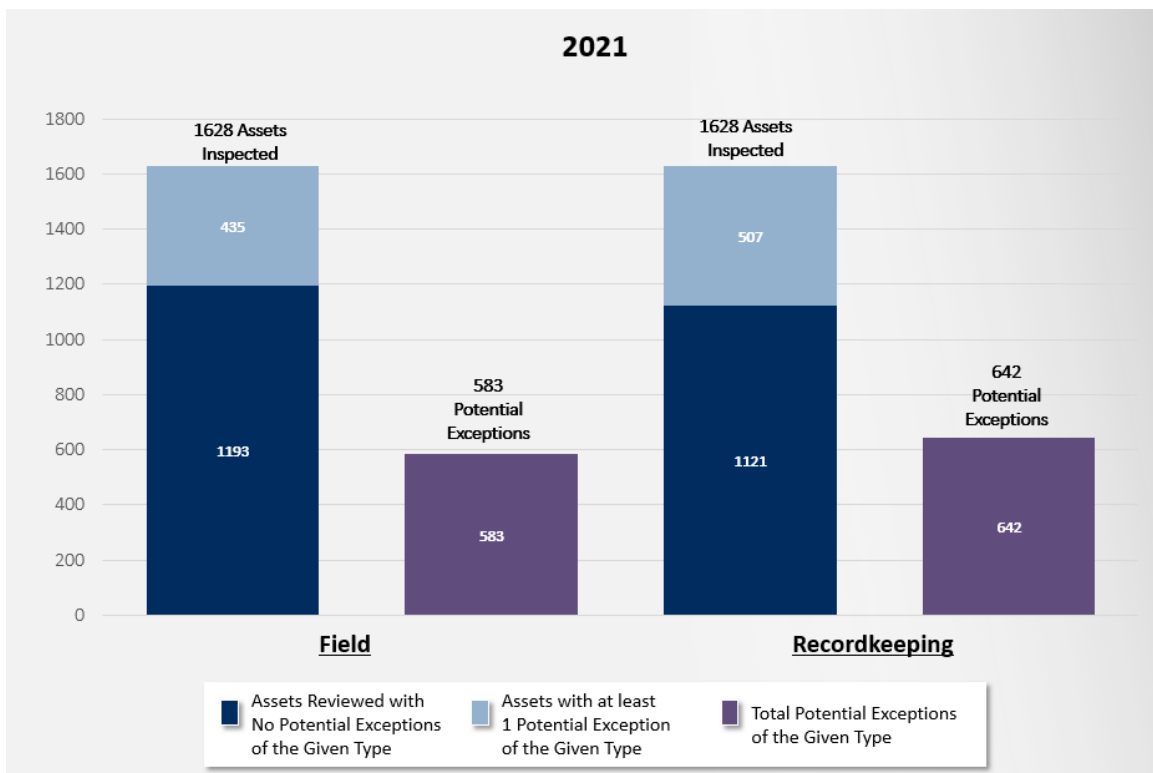
EXHIBIT 10: REVIEW OF DISTRIBUTION INSPECTION FINDINGS (2019 - 2021)

The graphics below show the number of distribution inspections reviewed by the Monitor team each year, as well as the number of potential exceptions recorded.

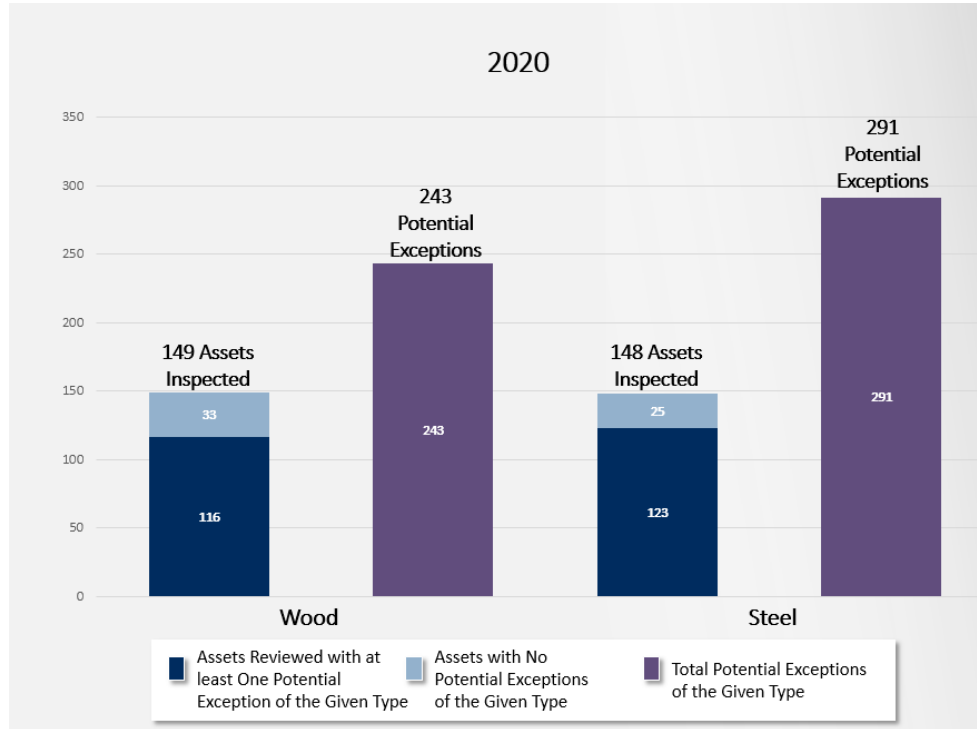
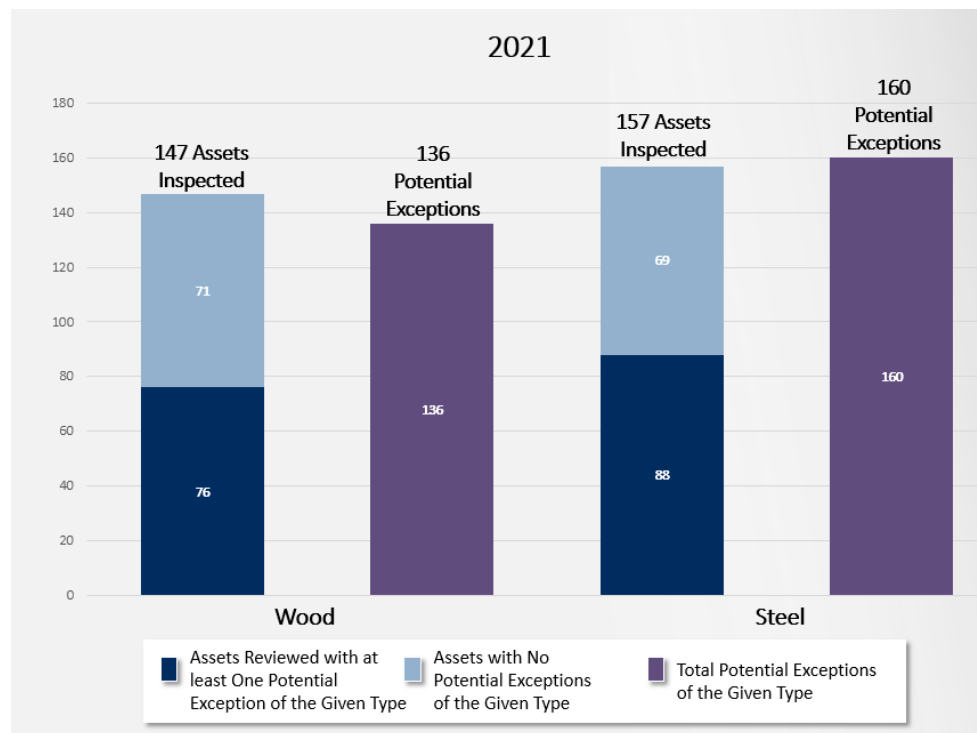
EXHIBIT 11: REVIEW OF TRANSMISSION INSPECTION FINDINGS (2020 - 2021)

The graphic below shows the number of transmission inspections reviewed by the Monitor team each year, as well as the number of potential exceptions recorded.

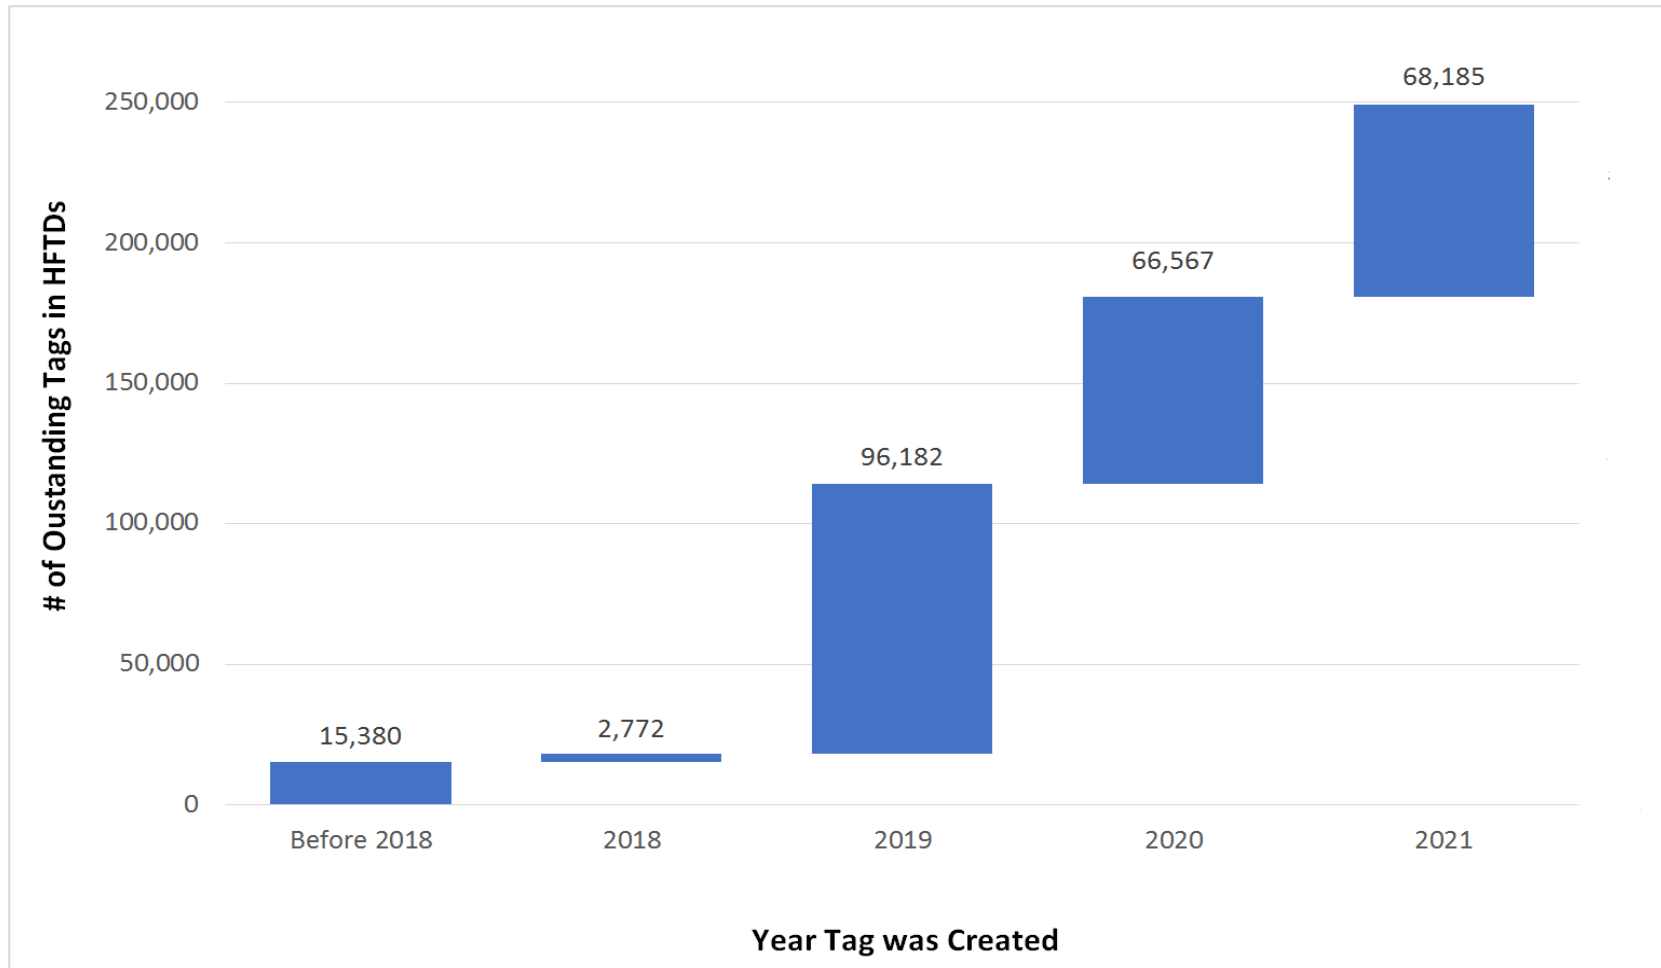
EXHIBIT 12: INCREASING BACKLOG OF INFRASTRUCTURE-RELATED REMEDIATION WORK

This graphic shows the increasing backlog of outstanding transmission and distribution tags through June 2021.
