STAFF REPORT

PROCEEDING NO. 20I-0437E

IN THE MATTER OF THE INVESTIGATION INTO THE HISTORY AND CONTINUING OPERATIONS OF THE PUBLIC SERVICE COMPANY OF COLORADO COMANCHE UNIT 3 GENERATING STATION PURSUANT TO DECISION NO. C20-0505.

March 1, 2021

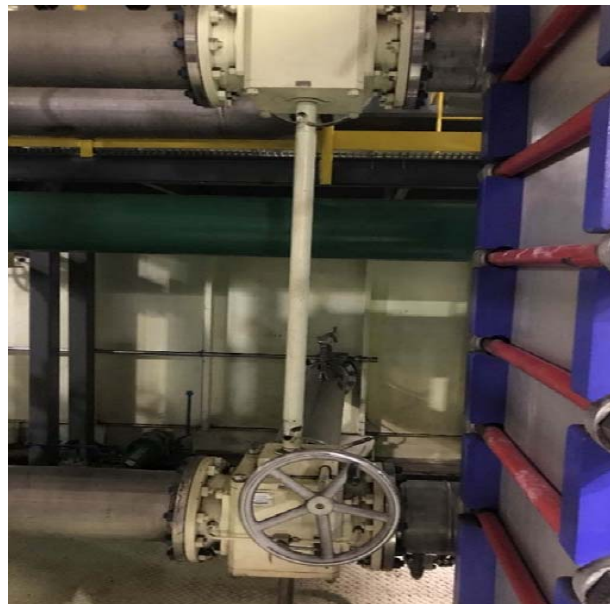
*Figure 10. TLO cooler 6-way transfer valve.*³⁷

Consistent with best design practices, most large turbines having TLO systems have two heat exchangers and two lube oil strainers. The piping and valve configurations required to provide this redundancy is complex to design and costly to install. On the Comanche 3 turbine, the original piping designers chose to employ a singular unique valve assembly called a TLO Cooler 6-Way Transfer Valve which is shown below:

The Comanche 3 TLO Cooler 6-Way Transfer Valve was manufactured by Indufil and enables continuous operation of one train (A or B) while allowing

the other train to undergo maintenance such as filter changes. Indufil has since been absorbed by John Crane, which no longer supports this particular valve and has classified it as obsolete. Thus, the Company knows it cannot get replacement parts for the TLO Cooler 6-Way Transfer Valve. The Company has no policy with regard to the use of obsolete equipment in the power plant. Instead the Company explains that each piece of equipment is evaluated on its condition and maintainability. If parts are not available, or if repair costs are substantial, then Company will consider replacement of the equipment with an updated design.³⁸

The Technical Improvement Team evaluated the TLO Cooler 6-way Transfer Valve and identified equipment damage based on design flaws in the valve's actuator. Specifically, the design for the valve master actuator worm gear stop pin (dowel pin) was determined inadequate (i.e., the original carbon steel material and 10mm pin size was undersized) and, as a result, sheared off at some unknown point in time during prior operation.³⁹
