# MaxiTrans, Refrigerated Rear Trailer - Body Separation

## Report

# Engineering Report

## Maxi-CUBE Body Separation January 2020

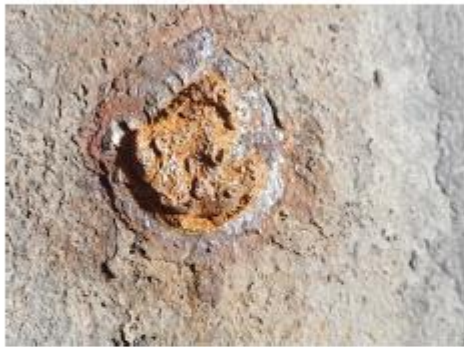
This was the best of the welds, but it still has about half of its area that is not fused.

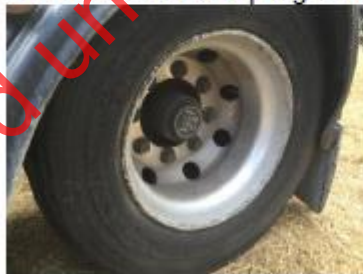
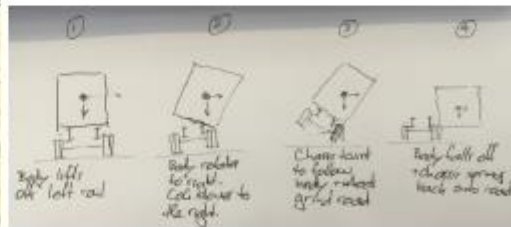
The chassis is twisted and the outside wall of the right side forward tyre and its rim have been in hard contact with the road. It is believed that after the body started to roll off, the chassis was then forced to roll after it, but finally the chassis was able to spring back once the body was clear.

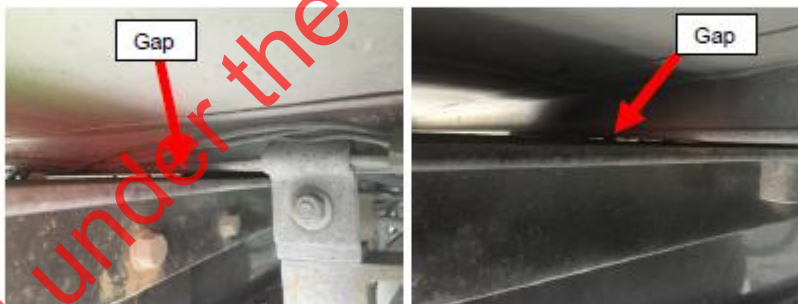
On some failed joints it is possible to see light through the gap (on an unloaded empty trailer), and sometimes cross members with failed welds show some degree of rust bleed. A pry bar proved to be ineffective, or the locations inaccessible, and the force required was too great to safely apply. In practice a man with a jack is the way to check these parts.
