Race Rock Lighthouse
Long Island Sound, New York
Report of Investigation
30 August 2019

**REPORT OF INVESTIGATION
Race Rock Lighthouse**

Race Rock Reef, Long Island Sound, SW of Fishers Island, Suffolk County, New York
WSA Ref No 1909.01

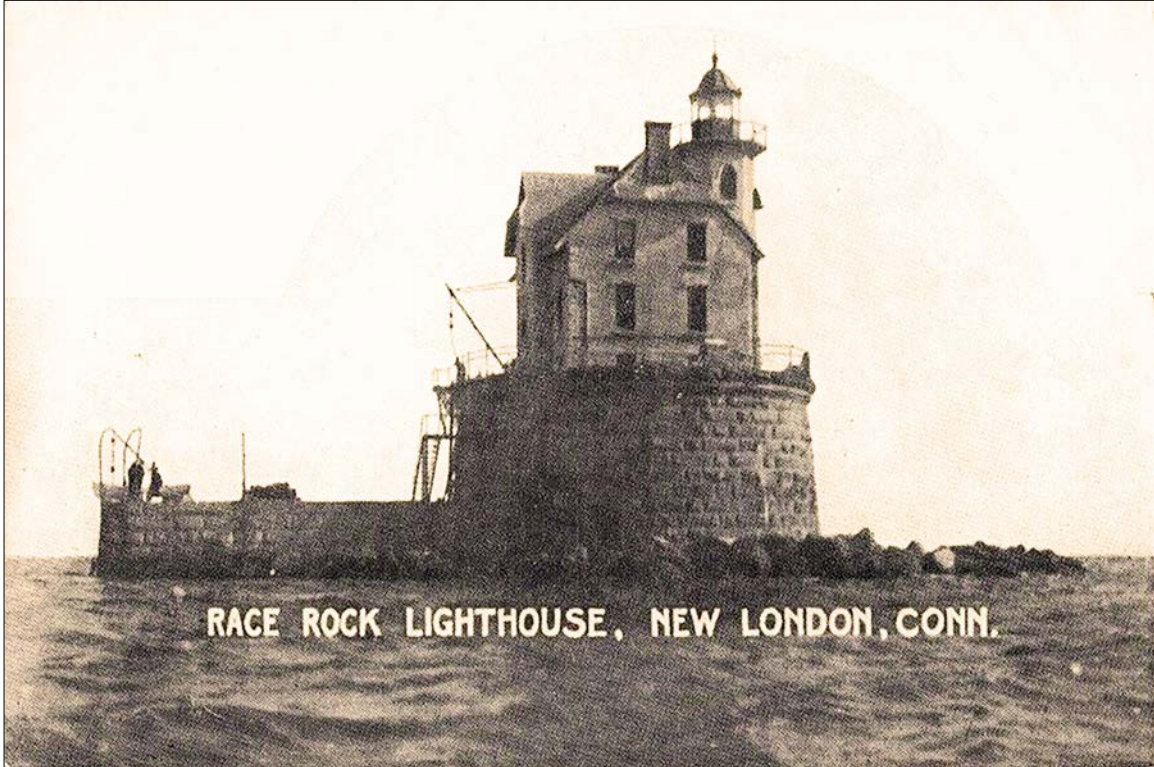
Photo 1. Race Rock Lighthouse is oriented roughly on ordinal points: its tower entrance faces generally southwest (SW). Note the original jetty/breakwater configuration in this pre-1915 image.

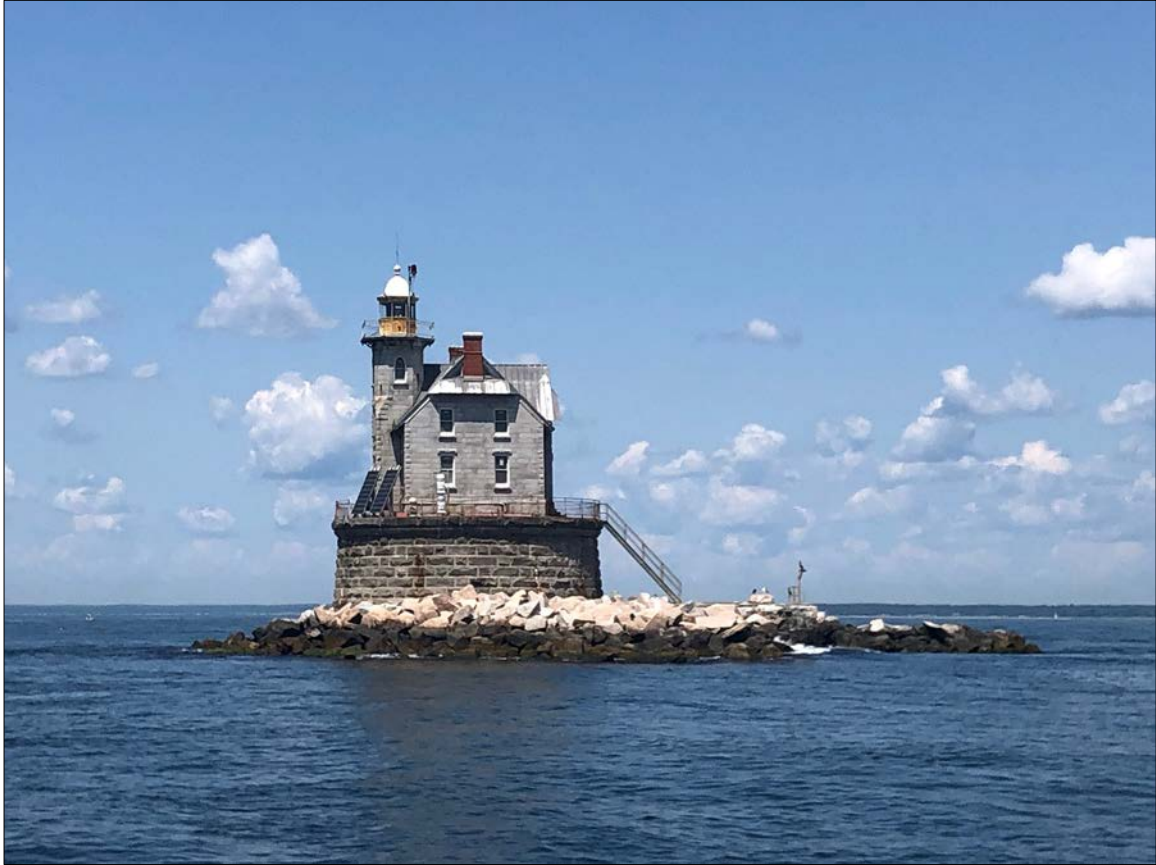
Photo 4. View of Lighthouse looking west.

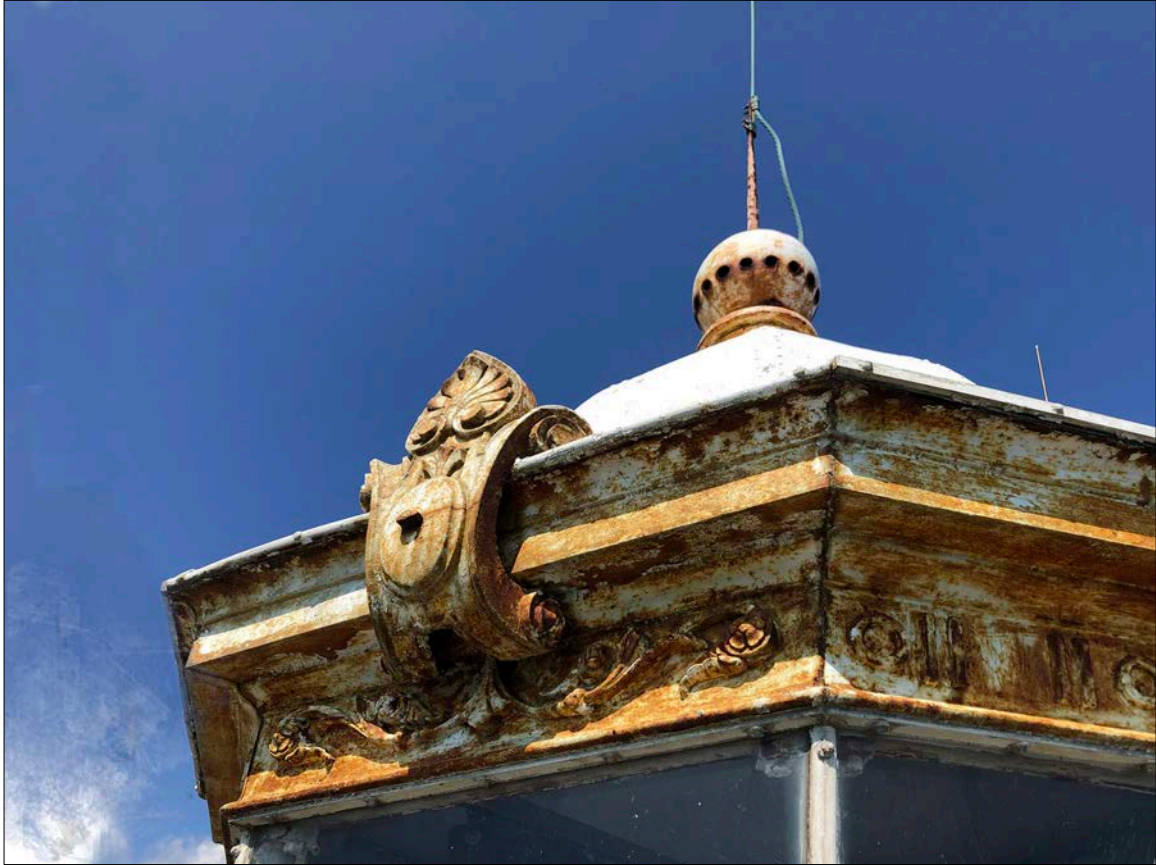
Photo 14. A cast iron cartouche, as well as embellishments of the lower fasciae, demonstrate the celebratory nature of Lighthouse design; these were the technological marvels of their time, expressed in architectural details such as these, as well as in literature and visual arts. Their allure is undiminished.
