# NUCLEAR SAFETY, SECURITY AND SAFEGUARDS IN UKRAINE

## 2<sup>nd</sup> Summary Report by the Director General

28 April – 5 September 2022

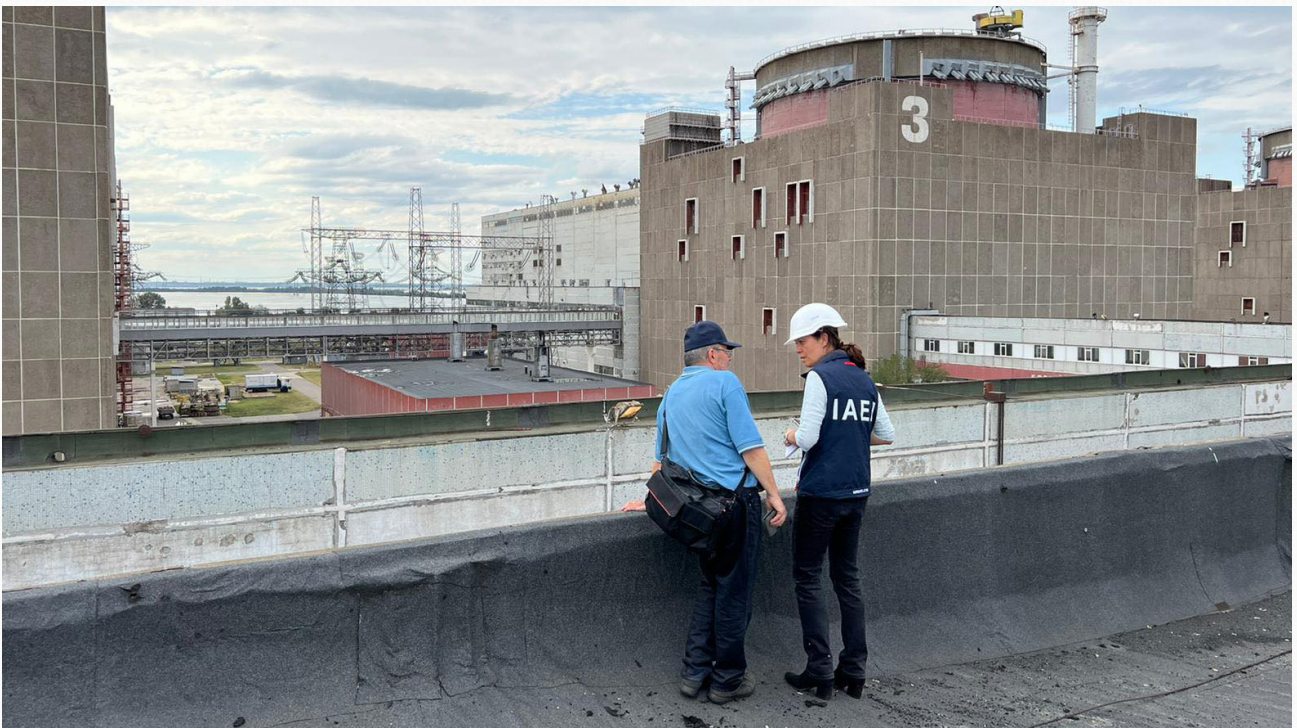
The IAEA team observes the damage caused by shelling on the roof of the special building at the ZNPP that houses, among other items, the fresh nuclear fuel and the solid radioactive waste storage facility. (Photo: IAEA)

IAEA Deputy Director General, Head of Department of Nuclear Safety and Security, Lydie Evrard, with IAEA staff visiting roof top of the special building at the ZNPP that houses, among other items, the fresh nuclear fuel and the solid radioactive waste storage facility. (Photo: IAEA)

**Recommendation 1:** The IAEA recommends that shelling on site and in its vicinity should be stopped immediately to avoid any further damages to the plant and associated facilities, for the safety of the operating staff and to maintain the physical integrity to support safe and secure operation. This requires agreement by all relevant parties to the establishment of a nuclear safety and security protection zone around the ZNPP.
