City of Kodiak
Kodiak Historical Society

RUSSIAN-AMERICAN COMPANY MAGAZIN
KODIAK, ALASKA
Historic Structure Report

MARCH 22, 2022

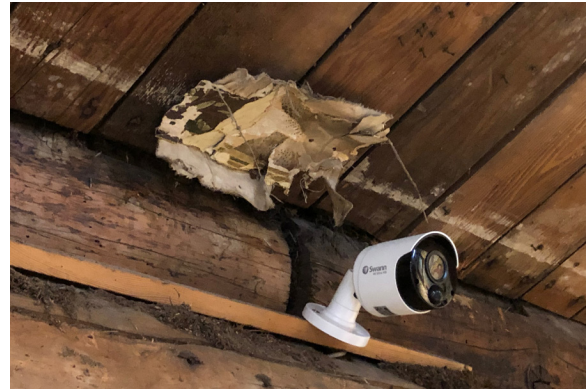
The ceiling in this room consists of unpainted wood boards, and there are remnants of wallpaper or canvas cladding in places (Figure 1-61). The ceiling boards are original or from an early period of the building's evolution.

Figure 1-61. Remnants of wallpaper at ceiling. (BM, 08/24/2021)

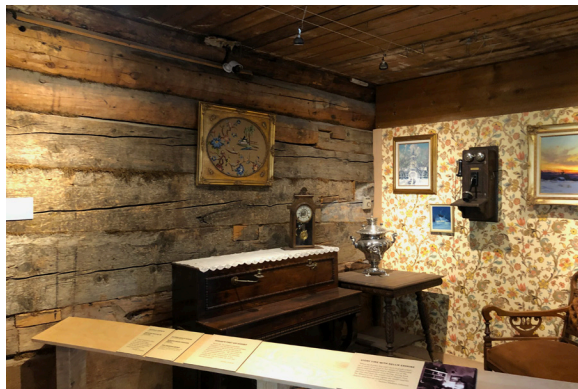
There is a modern partition-wall that extends from mid-point of the original log dividing wall, westward, terminating halfway to the west wall of the room. This partial enclosure separates the museum space into two exhibit areas and provides exhibit wall space (Figure 1-60).

Figure 1-60. New partition wall in Museum I 102 abuts the historic log wall. (BM, 08/24/2021)

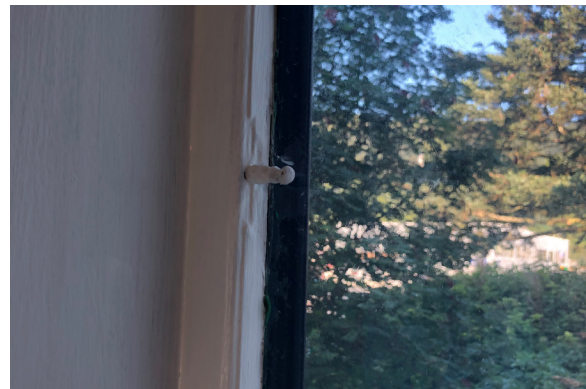
Figure 1-63. Windows are painted shut. (BM, 08/24/2021)

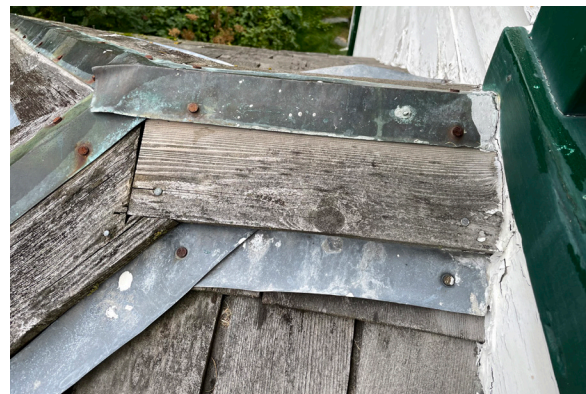
Figure 1-137. Alcove roof and connection to the west facade. (KAC, 08/24/2021)

The alcove roof is in poor condition. The Kodiak History Museum has reported leaks during heavy rain at the alcove. This is likely due to insufficient and improperly installed flashing. Sealant where the alcove roof meets the building is cracked but mostly intact.

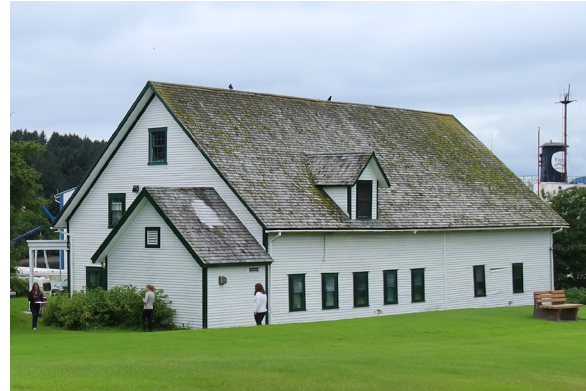
Figure 1-138. Magazin viewed from northeast. Note the small dormer, center, and the patch of replaced shingles at the addition roof, image left. (EAV, 08/24/2021)

The roof of the mechanical addition is in similarly poor condition to the main roof. Approximately 50% of zinc strips are missing at the ridge.

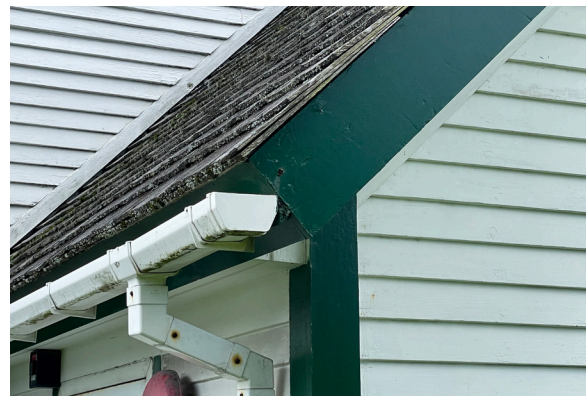
Figure 1-139. Eave condition at the addition showing fascia, gutter, and downspout. (KAC, 08/24/2021)

The gutters are undersized for the cedar shingle assembly. Shingles overhang the gutters, leaving only 1-inch of the gutter exposed to above. As a result, they fail to catch much of the run-off water and are not sufficiently protecting the building elements below.

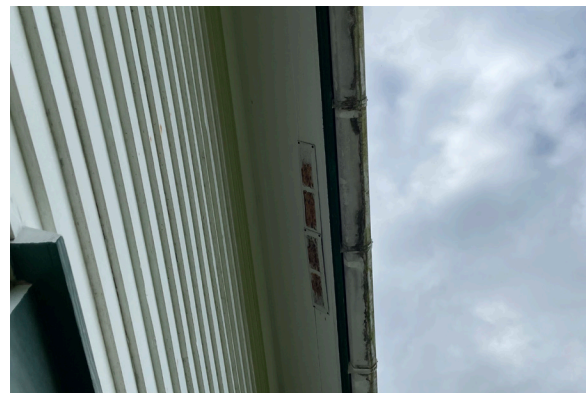
Figure 1-140. Enclosed eave with fixed louver vent. (KAC, 08/24/2021)

Soffit boards are in fair condition. Some loss of paint and deterioration is typical at the lowest board and at board ends. The soffit vents are intended to work in conjunction with the ridge vent to provide passive ventilation in the attic. They are currently inoperable due to interior coverings and so do not provide any venting.

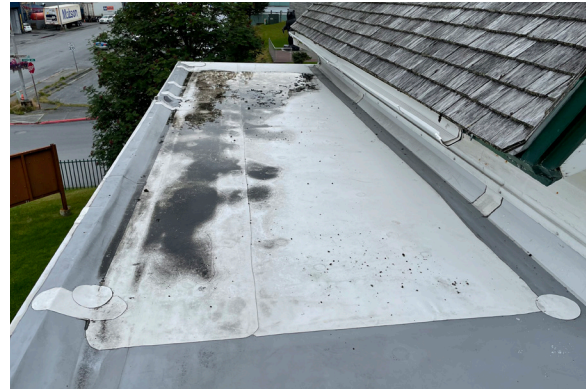
The flat roof above the porch is in poor condition. The roof does not slope towards drains, but towards the northwest where ponding is observed. The Kodiak History Museum has reported significant seasonal leaks in the west end of the Sun Porch just below this. Recent patches have been made in the roof, in an effort to halt the leaks, which were not effective. Without an opportunity to observe an active leak, cause is assumed to be related to improperly directed drainage and/or areas at the flashing and counterflashing, which are not correctly sealed.

Figure 1-144. Ponding water at the west end of the porch roof. Recent patches visible in white. (KAC, 08/24/2021)

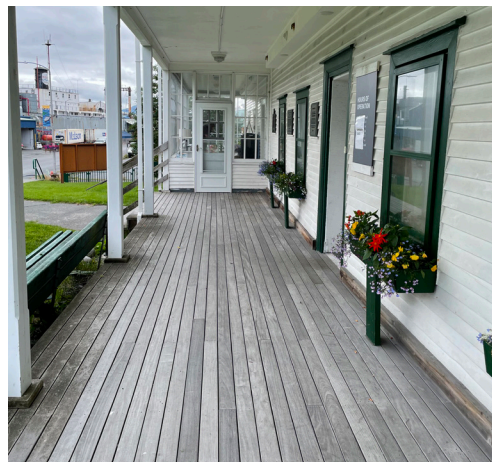
Figure 1-145. Porch viewed from east. (KAC, 08/24/2021)

The porch is in good condition. Four of the wood columns are in good condition, however, some checked and missing paint was observed at column bases and corners. The column immediately west of the steps is in fair to poor condition. Rotted wood and missing paint was observed at the base of this column.

Some bio-growth was observed along south and east decking boards, where they are most exposed to weathering. The bottom riser of the step is dark with water damage and bio-growth where it meets the ground.

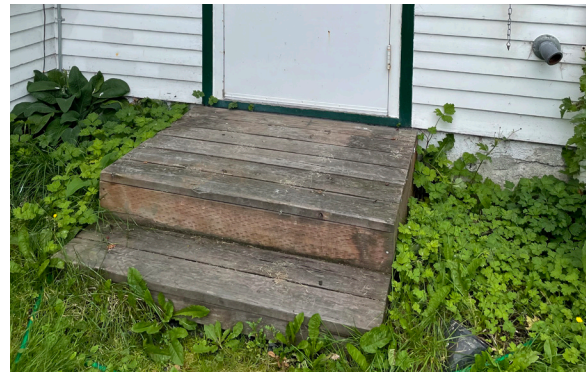
Figure 1-148. Stoop at the mechanical addition. (KAC, 08/24/2021)

The stoop at the mechanical addition is in fair condition. Vegetation directly against the wood is contributing to deterioration. Bio-growth was observed on the decking. Debris has collected between decking boards and is hosting additional growth.

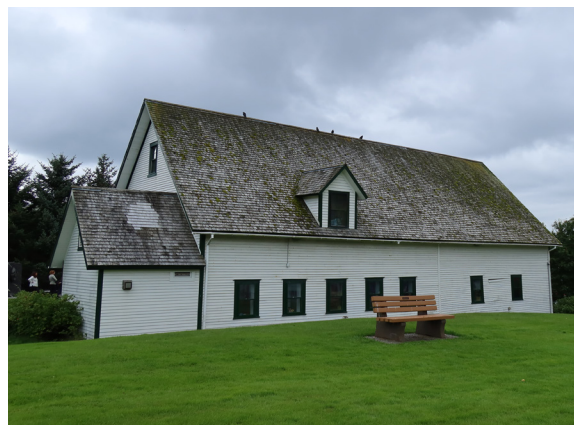
Figure 1-153. North facade. (EAV, 08/24/2021)

wood siding are concealed with paint but rust stains from moisture penetration are visible. Some siding boards are splitting. One board on the north facade has become loose and is hanging down, exposing unpainted vertical boards beneath.

A downspout centrally-located on the north facade fell off during the 2020-2021 winter. Water is no longer diverted away from the building in this location, but falls directly against the siding. Bio-growth and deterioration of paint and siding was observed here. Siding below the missing downspout is in poor condition.

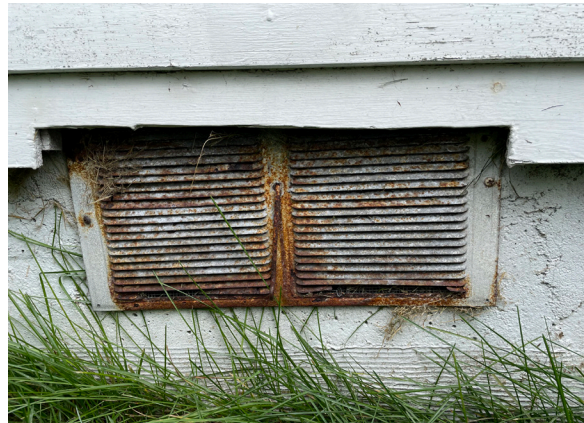
Below the wood siding, the concrete foundation, painted white, is visible at the base of the exterior walls. Metal vents with fixed louvers are intended to provide ventilation to the crawlspace through the foundation. These are painted white on the exterior and covered with sheet metal on the interior, blocking the flow of air through the vent. Along the north facade, the wood siding is notched to accommodate the vents. The vents are not historic elements.

Figure 1-160. Foundation vent and notched siding at the north facade. (KAC, 08/24/2021)

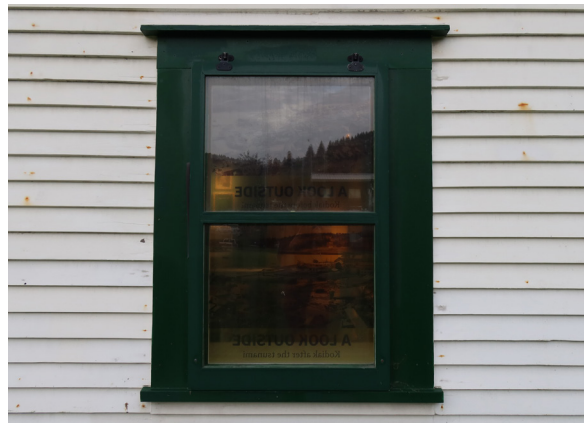
Figure 1-161. Window 22 with typical window trim. (EAV, 08/24/2021)

typically project approximately 2-inches beyond the face and sides of the trim. Window 30 does not have a head casing. There is typically no apron trim below sills, consistent with the historic conditions. Exterior window trim is typically painted dark green. Trim at Windows 20 through 24 and 26A and B was recently reconstructed in kind.

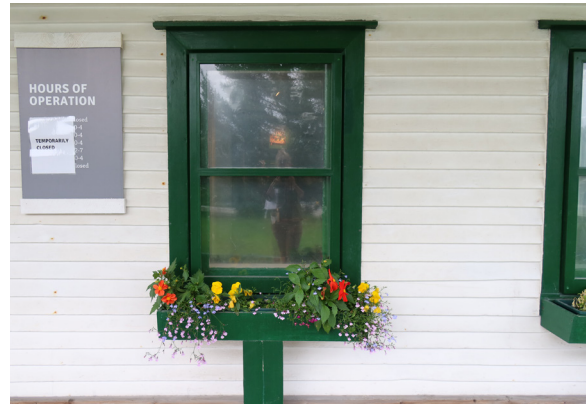
Figure 1-162. Trim with mitered corners and window box at Window 02, Type A. (EAV, 08/24/2021)

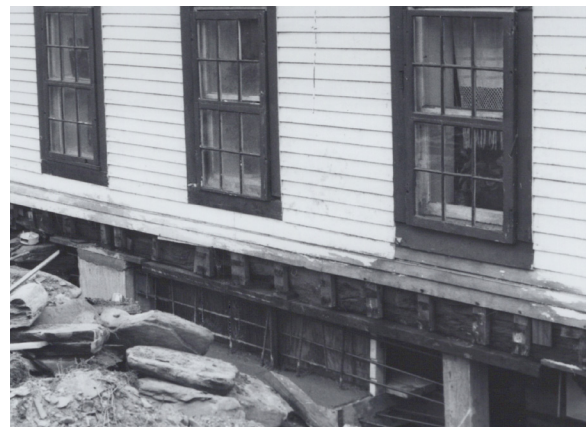
Figure 1-164. Historic storm windows along north facade. (Kodiak History Museum, ca. 1970s)

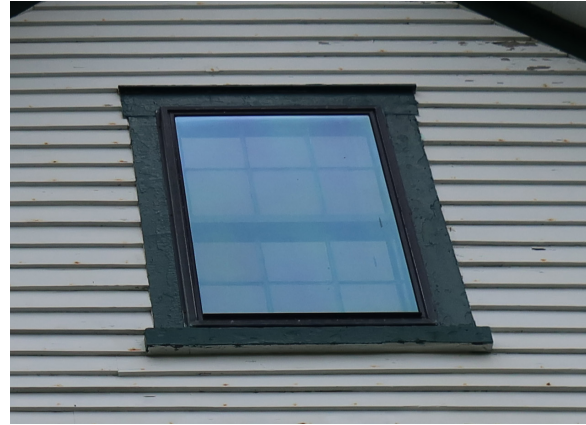
Figure 1-190. Window 33, Type D. (EAV, 08/24/2021)

This Type D window has an incompatible aluminum storm frame that is missing glazing and so does not protect the window.

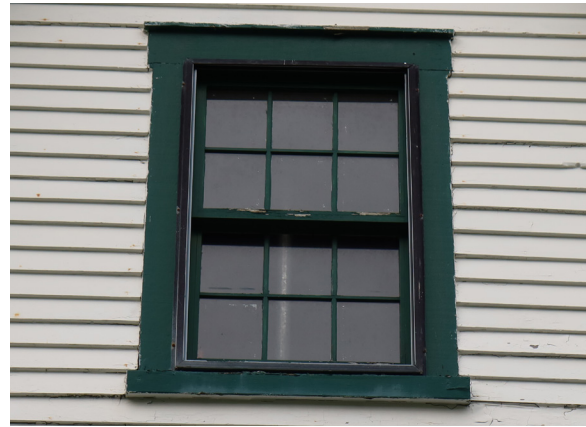
Figure 1-189. Window 34, Type D. (EAV, 08/24/2021)

Windows are overall in fair condition. All glazing is intact, with the exception of the storm at Window 34.

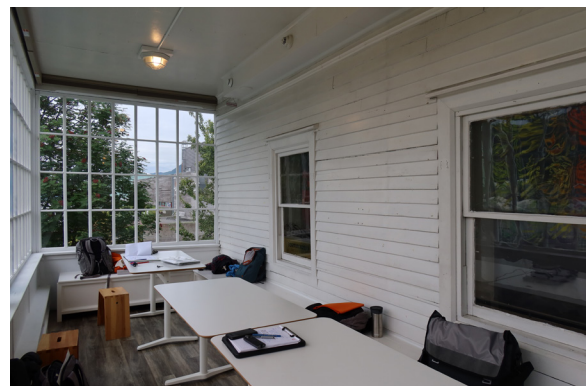
Figure 1-191. Built-in bench in front of Windows 05 and 06. (EAV, 08/24/2021)

in front of Windows 05 and 06 such that a person sitting down may lean back against the single-pane untempered glass of the bottom sash. This is a concern both for the safety of building occupants and for the condition of the windows.

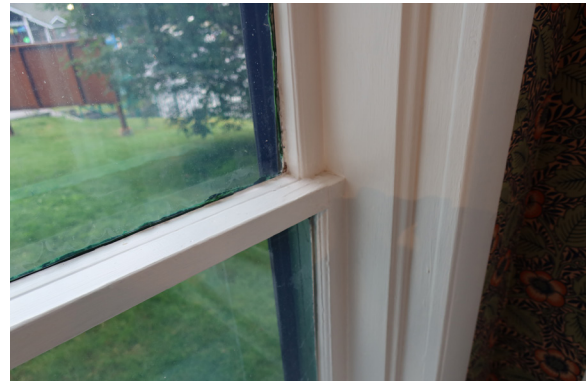
Figure 1-193. Window 15, interior. Note visible paint on glazing and sashes painted shut. (EAV, 08/24/2021)

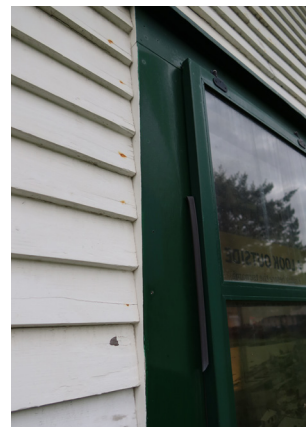
Good to fair condition. The rubberized sealant strip between the storm and sash is loose and hanging down. Without a strong seal between storm and sash, water infiltration and damage will occur.

Figure 1-194. Loose sealant strip at storm of Window 22. (EAV, 08/24/2021)

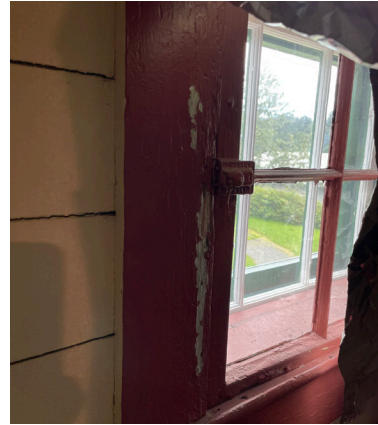
Figure 1-195. Window 31, interior. (KAC, 08/24/2021)

Fair to poor condition. Glazing is intact. Glazing putty and paint are not cleanly applied and are visible from the interior. Wood elements are not painted on the interior. Water staining was observed on both sash and the interior sill. A paper towel has been stuffed between the bottom sash and sill, possibly intended to stop a leak. Debris has gathered on interior surfaces.

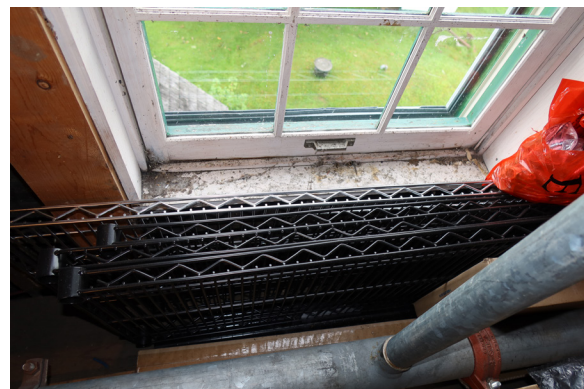
Fair condition. Glazing is intact. Glazing putty and paint are not cleanly applied and are visible from the interior. Paint is in poor condition on the exterior, estimated 20% missing or cracked. Wood elements are painted on the interior. Approximately 15% of paint on the interior sill is missing. Water

Figure 1-197. Debris and water damage at sill of Window 34. (EAV, 08/24/2021)

staining was observed at the interior sill. Debris has gathered on interior surfaces.

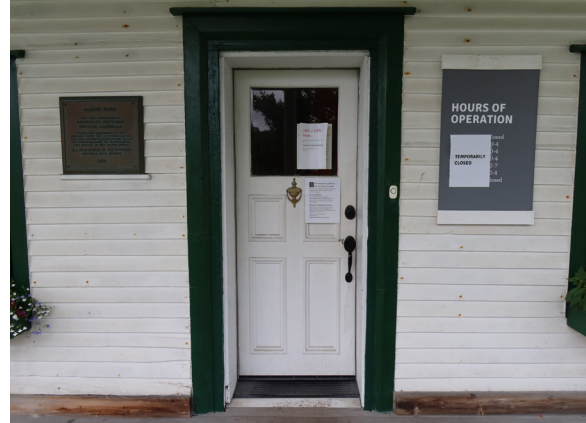
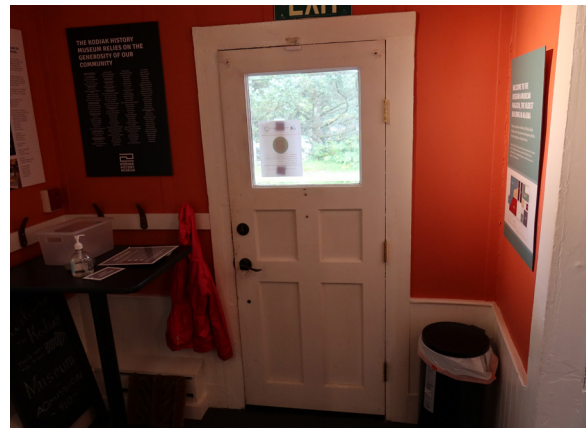
Good to fair condition. Multiple layers of paint are thickly applied. Scratches and wear in the paint were observed near the latch and lock on both interior and exterior faces. Some missing paint was observed on the exterior near the latch and handle. Shallow gouges in the wood of the bottom rail were observed at both exterior and interior. These gouges have been painted over.

On the interior, plastic brackets are screwed into each stile near the door head. These appear to have been used for a window covering that has since been abandoned. A security door sensor is mounted to the top rail. This has been abandoned and the paired trim-mounted element is missing.

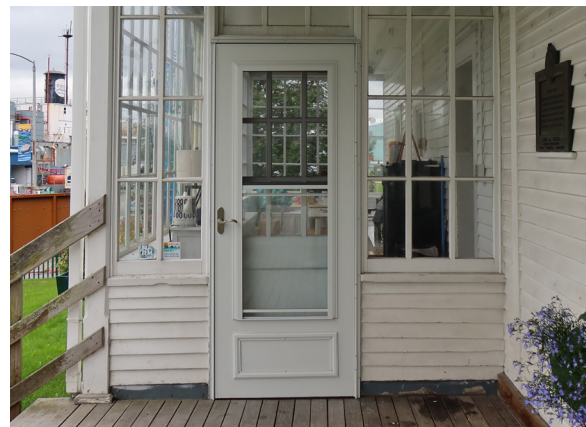
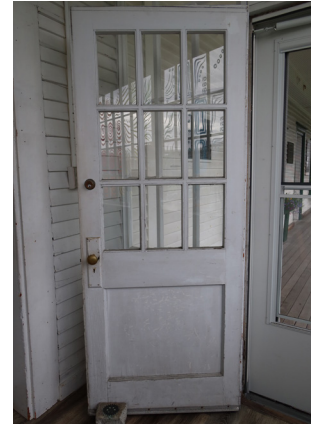
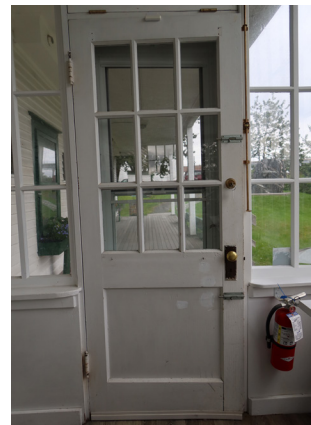
Fair condition. Paint is worn and missing where the door meets the casing. Paint on the exterior hardware is worn and missing. Paint on the exterior face of the door is darkened from dirt, scratched, and selectively repainted in areas.

On the interior, paint is worn and scratched. Paint is selectively repainted in a brighter white. Approximately 95% of paint on the door knob back plate is missing. Some rust and missing paint was observed at the hinges.

Glazing in the door is intact. Glazing putty is cracked. Paint is mostly intact at mullions.

Estimated 70% of paint is missing on the wood threshold.

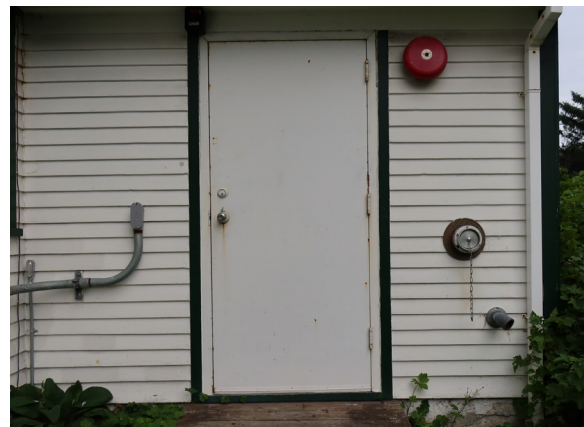
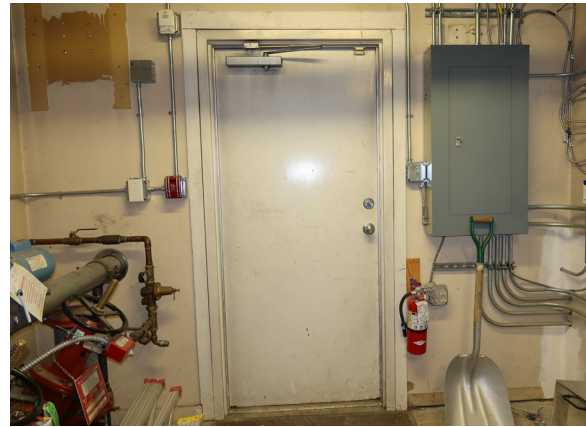
Fair condition. Paint is scratched and worn on both sides. Rust was observed on the exterior near the door knob and hinges and on the frame. Operation is smooth.

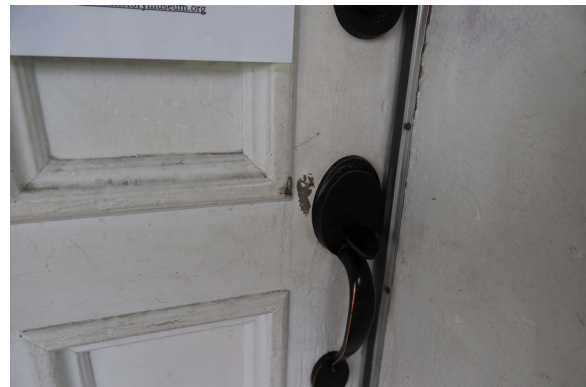
Figure 1-205. Worn and missing paint near hardware of Door 100, exterior. (EAV, 08/24/2021)

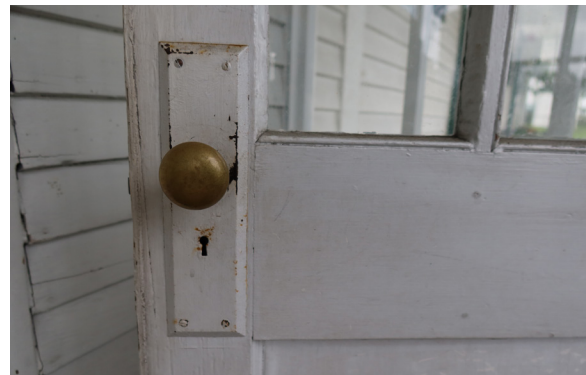
Figure 1-206. Missing and worn paint on and near hardware of Door 103B, exterior. (EAV, 08/24/2021)

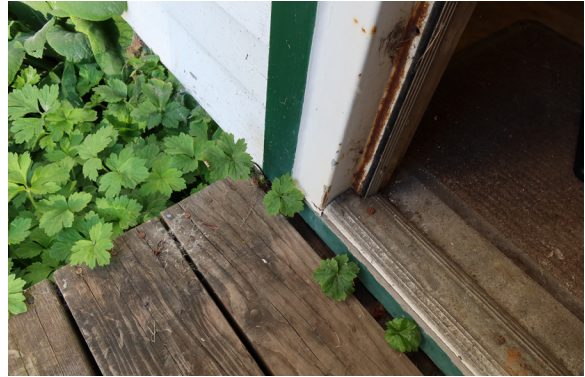
Figure 1-207. Rust at frame of Door 110. (EAV, 08/24/2021)

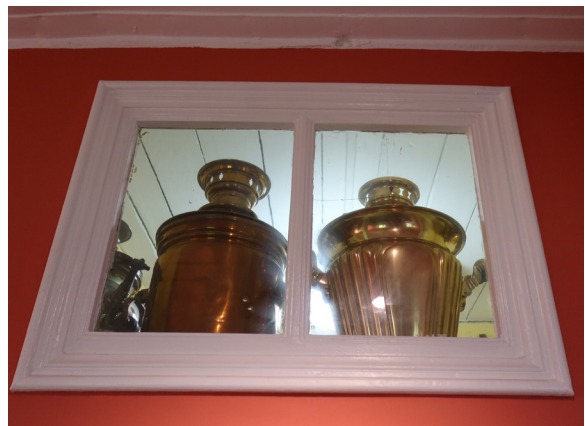
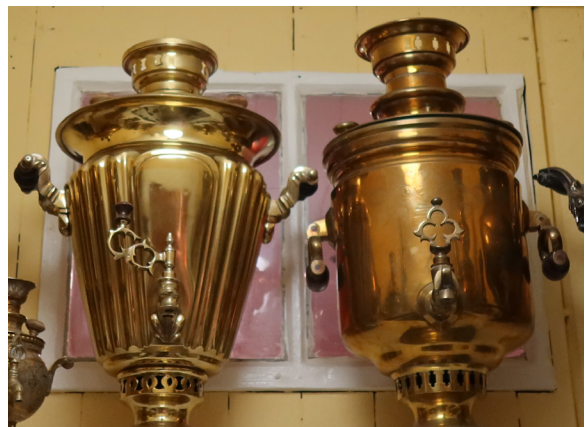
The glazing in the east lite is cracked, but remains within the sash. Paint is intact.

Figure 1-208. Fixed interior window, Entry 100 side. (EAV, 08/24/2021)

Figure 1-209. Fixed interior window, Pantry 106 side. (EAV, 08/24/2021)

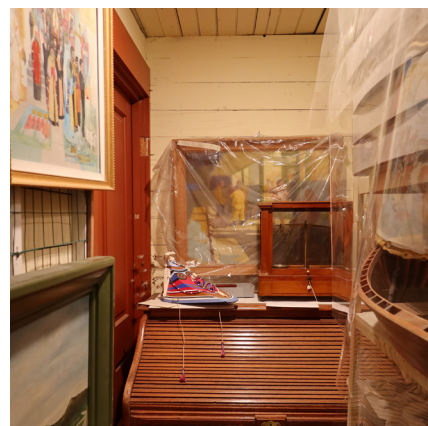
Figure 1-233. Door 203B is blocked by collections in Collections III 203. (EAV, 08/24/2021)

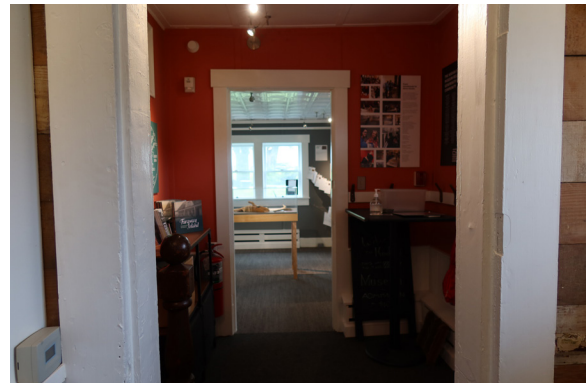
Fair condition. The trim is gouged and deeply scratched from wear. Paint has since been applied and is intact.

Figure 1-241. Gouged and painted trim at CO 101. Note also mark at right from previous door hinge, painted over. (EAV, 08/24/2021)

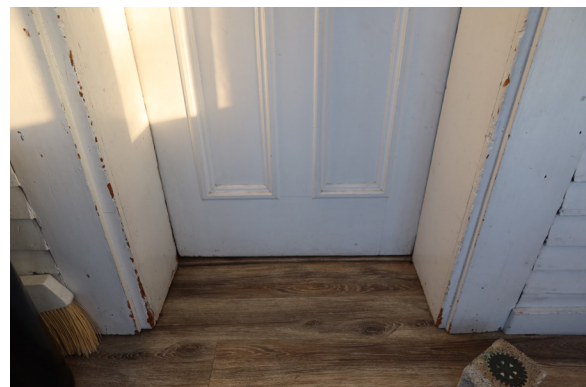
Fair condition. Glazing is intact. The door and hardware operate smoothly.

On the Museum I (102) side, wood trim is heavily gouged near the floor. The door is also scratched and gouged from wear. A roll-down UV-filter is mounted over the glazing.

Similar scratches and indications of wear are present on the Sun Porch (103) side. Some paint is missing, particularly at the corners of the door panel and trim.

Figure 1-242. Missing paint at trim on Sun Porch 103 side of Door 103A. (EAV, 08/24/2021)

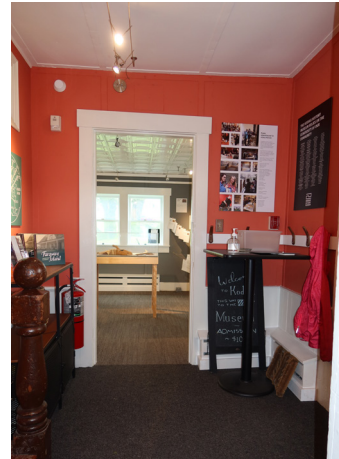
Figure 1-245. East wall of Entry 100. (EAV, 08/24/2021)

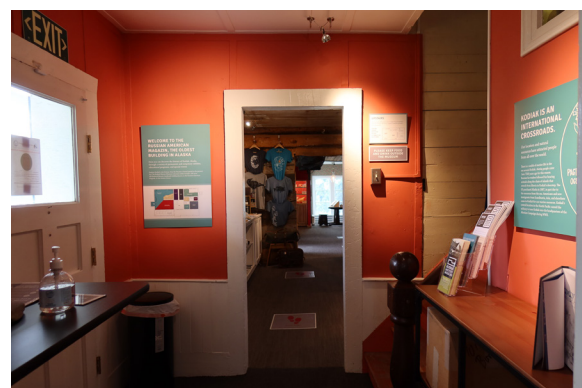
Figure 1-247. West wall of Entry 100. (EAV, 08/24/2021)

Good condition. Paint at walls and ceiling is intact. Paint at trim is thickly layered, but intact. Warped gypsum wallboard and battens were observed at the west wall above Cased Opening 101. Cause of the warping is assumed to be structural and not moisture-

related. Paint is intact here, indicating no active movement. Floor is in good condition.

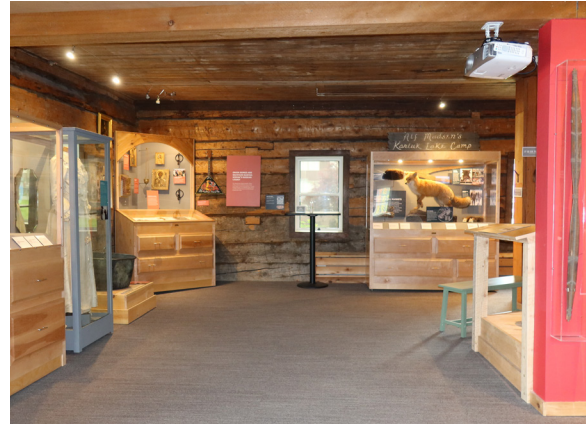
On the north side of the room, near Window 19, a vertical plumbing chase is enclosed by unpainted wood boards. The resultant column is approximately 11-inches wide in each direction. Two ceiling boards running from the column to the west wall are not historic. These boards are not tongue and groove and building wrap is visible through the gaps between them.

Figure 1-255. North wall of Museum I 102. (EAV, 08/24/2021)

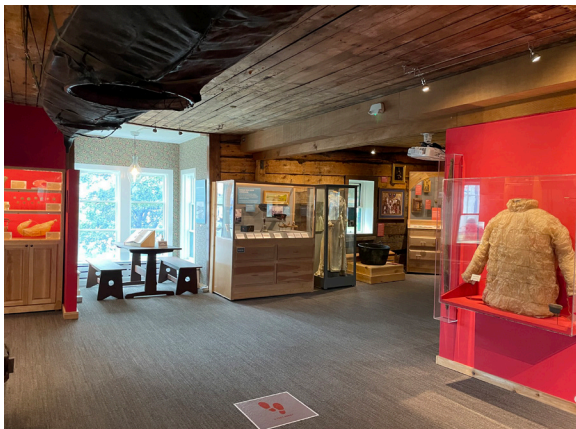
Figure 1-254. West wall of Museum I 102. (KAC, 08/24/2021)

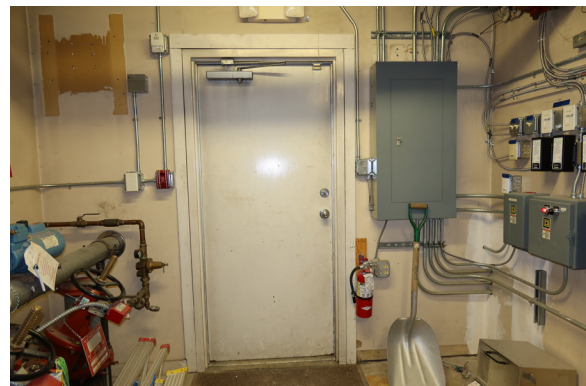
Figure 1-275. South wall of Mechanical Room 110. (EAV, 08/24/2021)

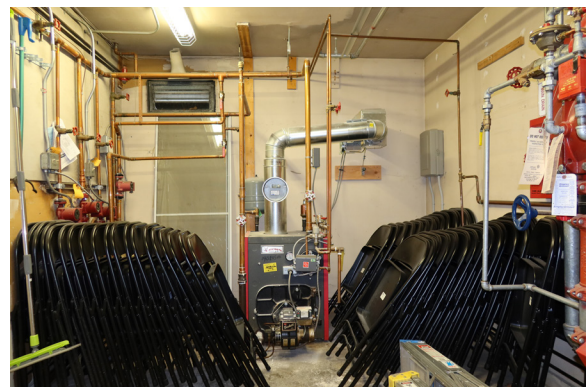
Figure 1-276. North wall of Mechanical Room 110. (EAV, 08/24/2021)

The mechanical room is in fair to poor condition. Gypsum board at the north wall is in fair condition. Some staining, gouges and water damage is observed.

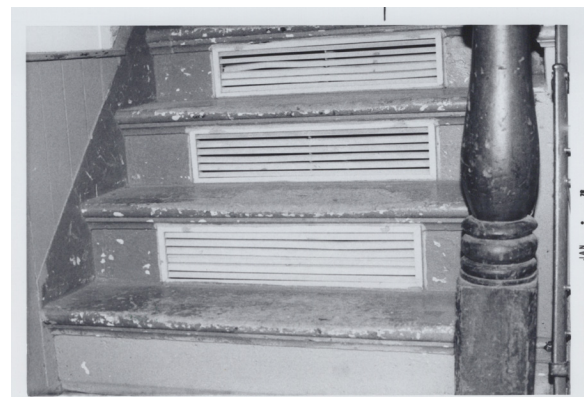
Figure 1-283. Ventilation grilles in risers of three steps, since removed. (Kodiak History Museum, photograph developed January, 1978).

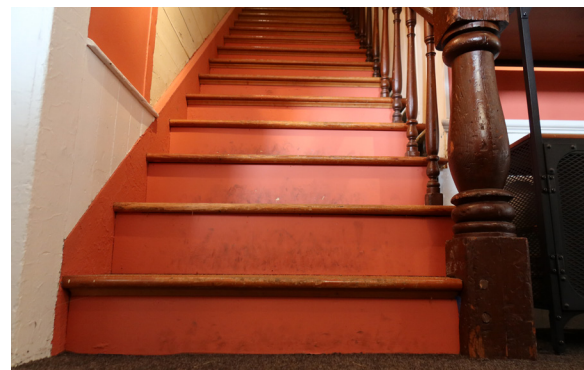
Three steps near the bottom are missing the ogee trim. These risers were replaced when ventilation grilles were removed from the risers.

Figure 1-284. Facing north at the bottom of the stairs to the second floor. Note missing trim at replaced risers. (EAV, 08/24/2021)

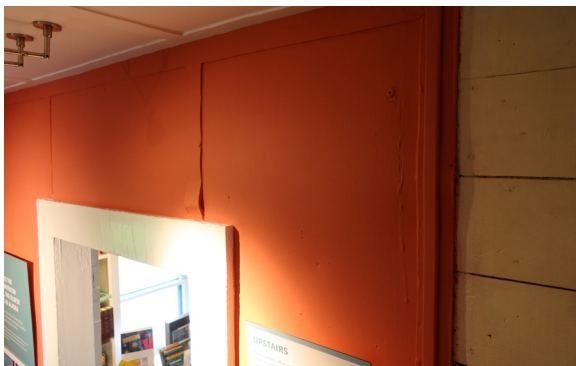
Figure 1-285. Warped gypsum wall board and battens in Entry 100. (EAV, 08/24/2021)

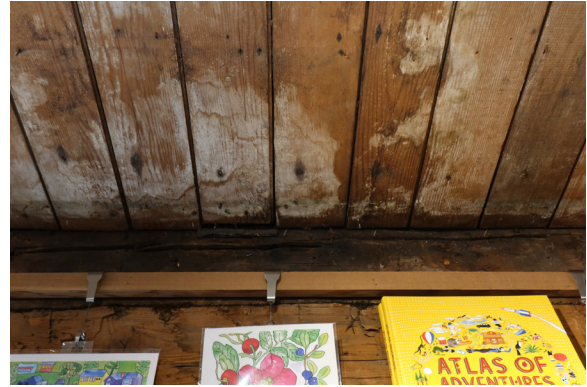
Good condition. Where not covered by casework, historic walls are in good condition. Portions of the south and east walls were not visible and thus could not be assessed. Some staining was observed at the ceiling above Window 04. Floors are in good condition.

Figure 1-288. Stained ceiling boards in Gift Shop 101. (EAV, 08/24/2021)

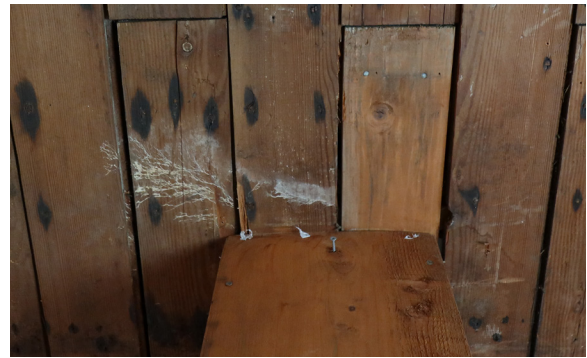
Good to fair condition. Floor finish is in good condition, however, the floor slopes strongly to the southwest. See Structural Section for additional information on floor slope. Ceiling finishes are in good to fair condition. Mycelium growth was observed on ceiling boards adjacent to the plumbing chase, indicating a leak. Water staining was observed on the alcove ceiling, indicative of a roof leak.

Figure 1-286. Growth on ceiling boards near the plumbing chase in Museum I 102. (EAV, 08/24/2021)

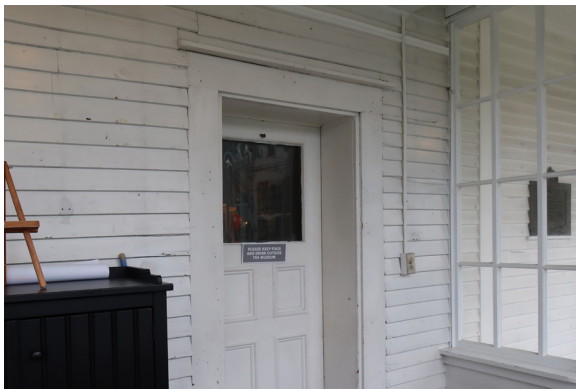
Good condition. The floor and ceiling are in good condition. The north wall is in good to fair condition. Paint is mostly intact, with some scratches. Other walls appear to be in good condition. The west and north walls could not be assessed where obstructed by the built-in benches.

Figure 1-291. Scratched paint at north wall of Sun Porch 103. (EAV, 08/24/2021)

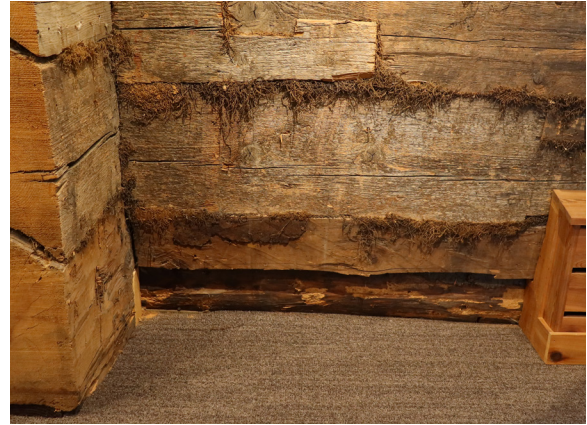
The north wall is in good to fair condition. The bottom log is not original. The face of this log sits shy of the interior face of the wall and is not hewn flat like the other logs. Evidence of past insect infestation was observed. Gaps in the wall around this log are filled with wood plugs and cotton rags.

Figure 1-289. Previously replaced log at north wall of Museum II 104. (EAV, 08/24/2021)

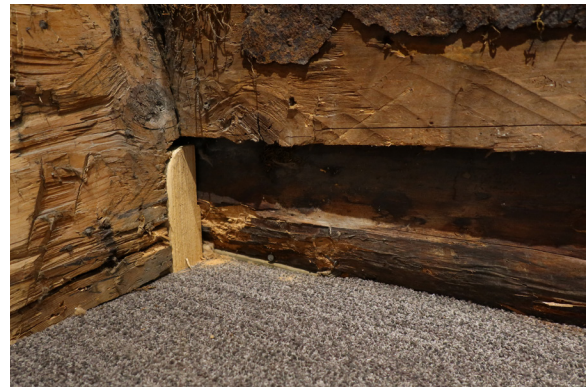
Figure 1-292. Previously replaced log at north wall of Museum II 104. (EAV, 08/24/2021)

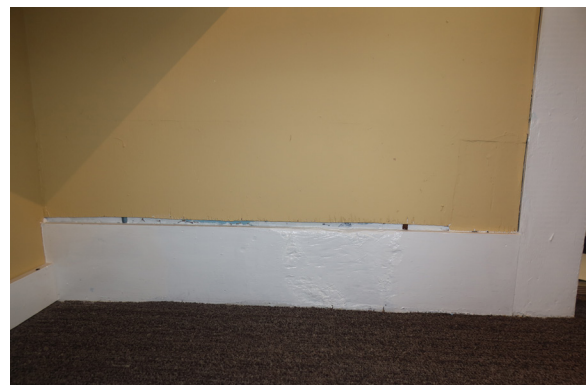
Museum III is in good to fair condition. Plywood and trim on the north wall are heavily gouged and show signs of wear. Paint is intact. All other finishes are in good condition.

Figure 1-295. Worn plywood and wall base at north wall of Museum III 111. (EAV, 08/24/2021)

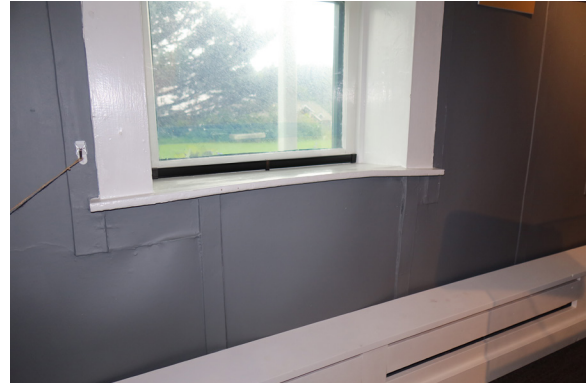
At the south side of the room, gypsum wallboard and battens below Window 01 is warped. The window sill is cracked, indicating movement within the wall. Paint is intact

and surfaces are dry. Observed warping is assumed to be from past settlement and/or water damage that is not currently active.

Figure 1-296. Warped sill and finishes at Window 01 in Museum IV 112. (EAV, 08/24/2021)

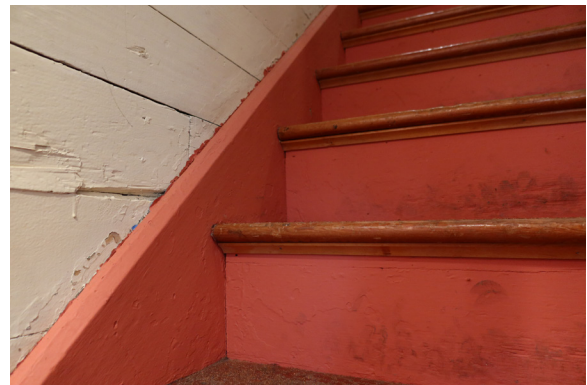
Good to fair condition. Paint on risers is scuffed and marked from wear. Wood elements are slightly worn but mostly intact.

Figure 1-297. Scuffed risers and thick paint at the stairs. (EAV, 08/24/2021)

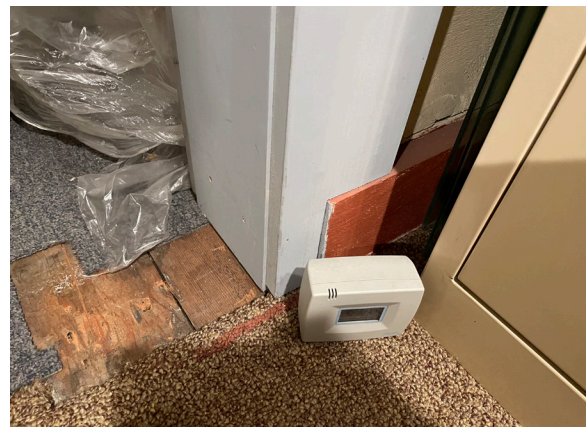
A patch of missing carpet at Cased Opening 201A reveals unpainted wood floor boards, running north-south.

Figure 1-305. Missing carpet reveals wood floor boards at CO 201A. (KAC, 08/24/2021)

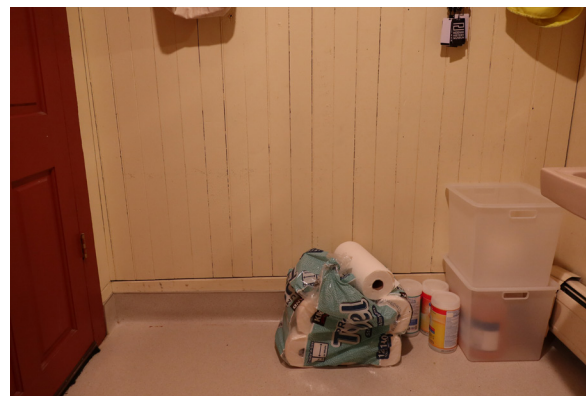
Figure 1-322. Lapped wall base at west wall of Staff Restroom 207. (EAV, 08/24/2021)

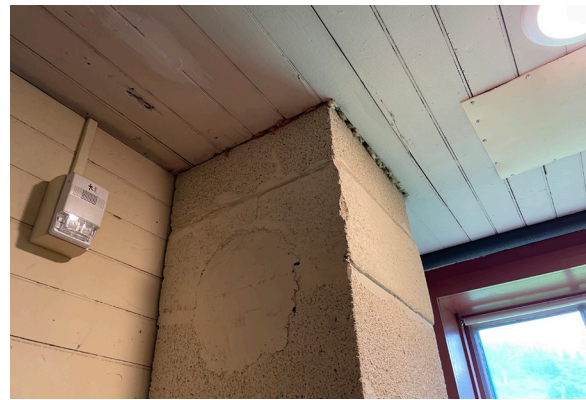
Figure 1-328. Patched ceiling and abandoned chimney in Stair Hall 200. (KAC, 08/24/2021)

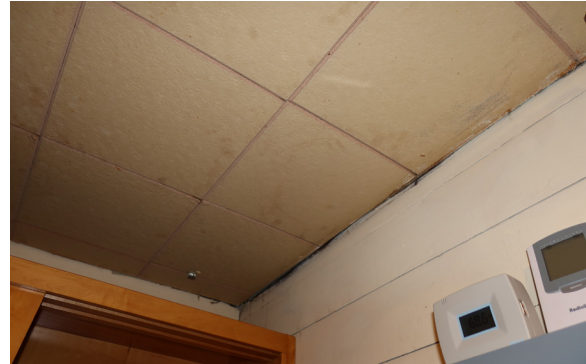
Figure 1-330. Ceiling tiles and wall boards at northeast corner of Collections II 202. (EAV, 08/24/2021)

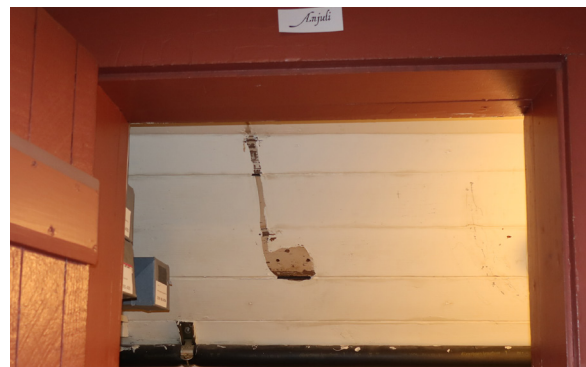
Figure 1-331. Missing paint from previous attachments in Anjuli 202A. (EAV, 08/24/2021)

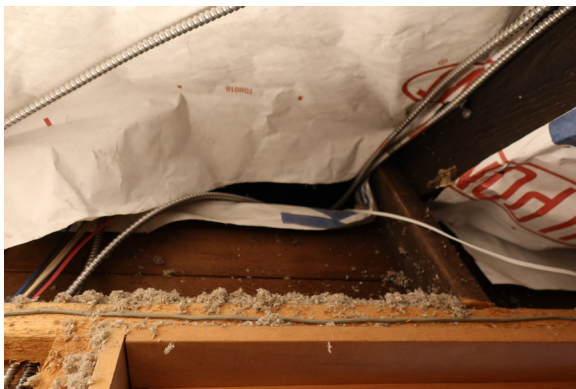
Fair condition. Blown-in insulation from the attic is falling into the room at gaps where the ceiling meets the wall. The board sheathing on the west wall has some water staining.

Figure 1-333. Insulation from above falling into Storage 205B. (EAV, 08/24/2021)

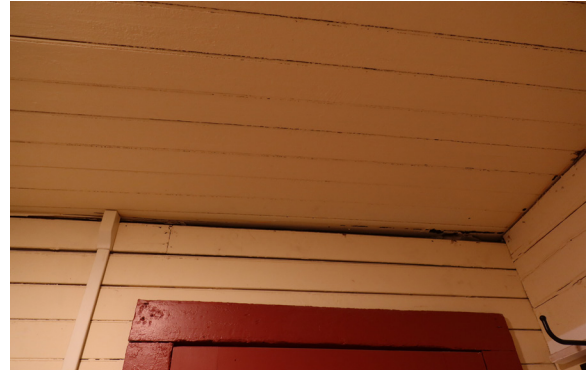
Fair condition. Floors are in good condition. Walls and ceiling are in good to fair condition. All wood finishes at the walls and ceiling are thickly painted with multiple coats. Missing paint and nail holes indicate previous crown trim. There is a large gap between the south wall and the ceiling - up to 1-inch at the west.

Figure 1-335. Gap at the top of the south wall of Staff Restroom 207. (EAV, 08/24/2021)

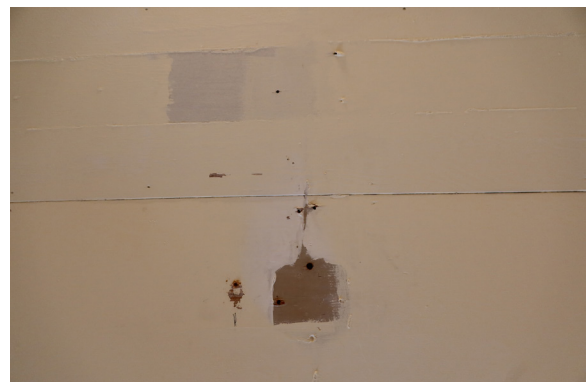
Fair condition. Carpet flooring is in good condition. Walls have been patched and are marked from previous attachments. Paint is missing on the ceiling from previous attachments. Walls and ceiling are in good to fair condition.

Figure 1-334. Missing paint at ceiling of Office II 206. (EAV, 08/24/2021)

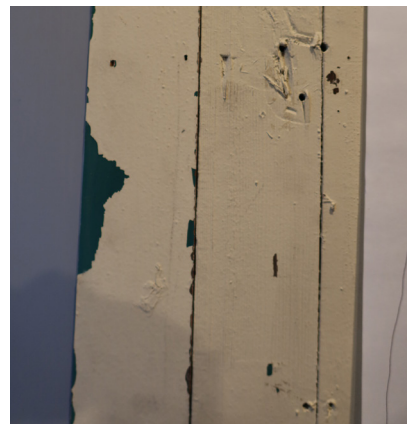
Figure 1-336. Thickly applied and missing paint at wall boards in Director's Office 208. (EAV, 08/24/2021)

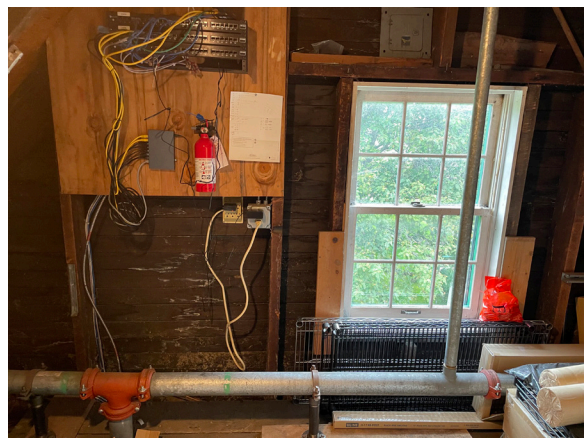
Figure 1-338. East wall of Attic I 300. (KAC, 08/24/2021)

Exposed sheathing at the east end is stained dark from smoke. Efflorescence and water staining is visible on most of the east wall.

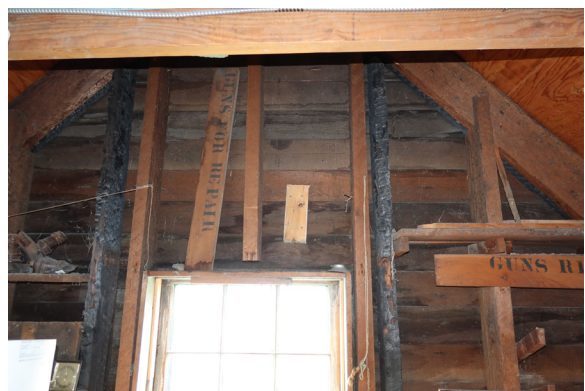
Figure 1-339. West wall of Attic I 300. (EAV, 08/24/2021)

Some of the roof framing members are dark with smoke stains and charred from fire. This is particularly significant at the west end. The sheathing at the west end is dark with moisture staining, but not charred, indicating that the sheathing was replaced sometime after the fire occurred. As noted in the Exterior Windows section, differing muntin profiles in Window 34 (east) and Window 33 (west) indicate that Window 34 is original. Based on conditions of Window 33, it is assumed that this was also installed after the fire occurred.

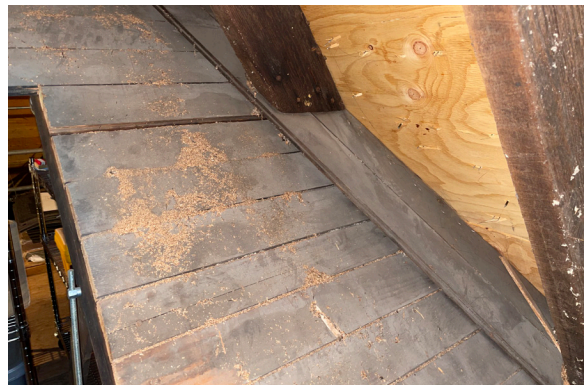
This is an unfinished and unoccupied space below the south gable dormer. It was previously inaccessible from the interior, divided from the rest of the attic by tongue and groove roof sheathing. An access hole is cut into the sheathing. Smoke staining on the face of the sheathing is not present at cut edges, indicating that the cut was made post-fire.

Figure 1-342. Sheathing with cut access hole, Attic II 301 side. (KAC, 08/24/2021)

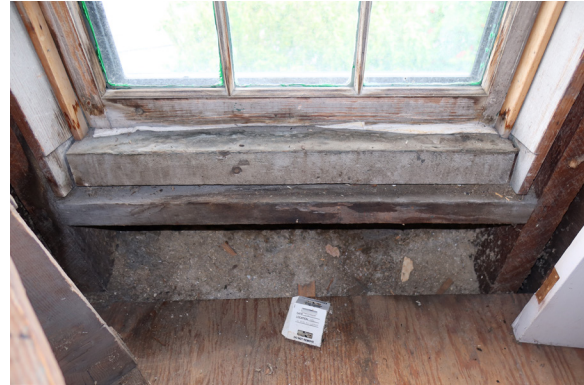
Wood framing members on the west wall are water-stained near the sill of Window 33.

Figure 1-344. Water-stained wood around the sill of Window 33. (EAV, 08/24/2021)

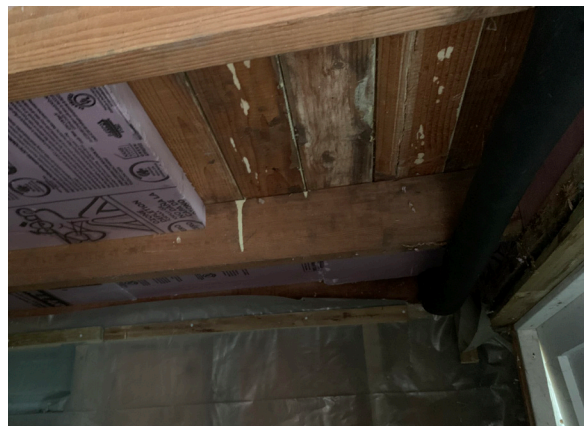
The Sun Porch is founded on 2x6 stud walls on concrete footings.

Figure 1-347. Interior face of the south wood stud foundation wall of the Sun Porch as seen through the plastic sheeting (CBB, 08/24/2021)

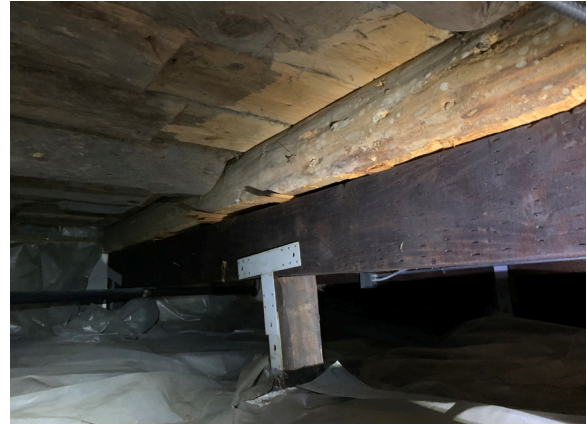
Figure 1-349. First floor framing of the Magazin west of the interior log wall. Note the deck boards framing to a dropped log beam that is now supported by a continuous dropped creosote treated member (CBB, 08/25/2021)

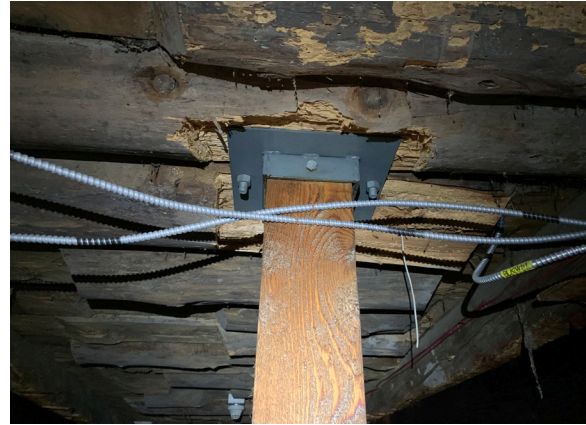
Figure 1-351. Timber post supporting dropped second floor glulam beam added in the 1980s as seen from the crawlspace (CBB, 08/24/2021)

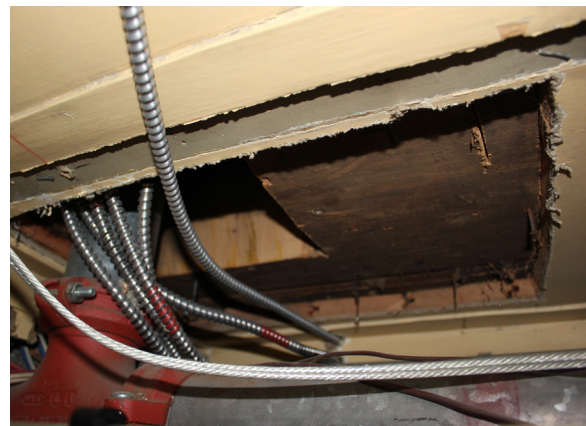
Figure 1-352. Second floor beam of the Magazin on the east half of the structure. Note the large hole cut in the beam to allow the piping to pass up to the second floor (CBB, 08/26/2021)

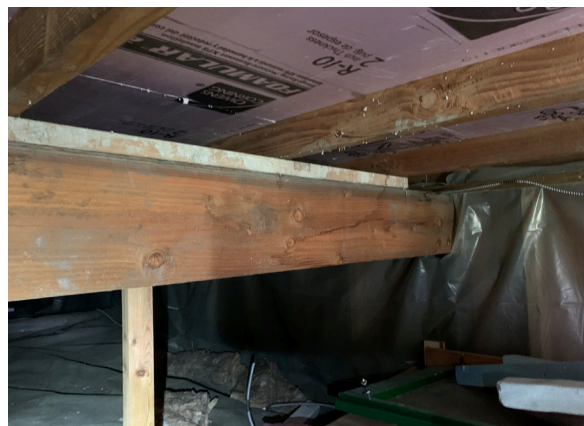
Figure 1-354. Joists and dropped beams of the first floor of the Sun Porch (CBB, 08/24/2021)

The Sun Porch floor framing is in fair condition. Although there are no signs of deterioration, the framing does not have adequate live load capacity for its function as a deck accessible to the public.

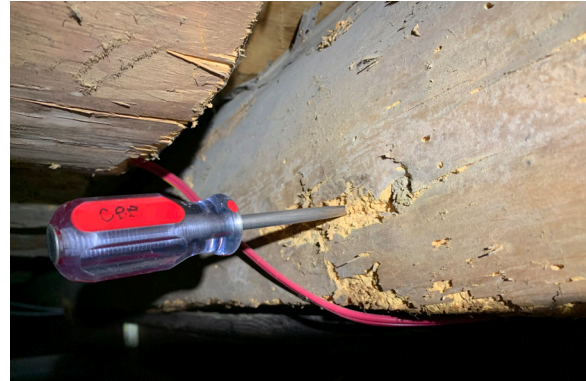
Figure 1-358. Insect damage visible on a first floor dropped log beam as exhibited by the penetration of the awl into the member (CBB, 08/26/2021)

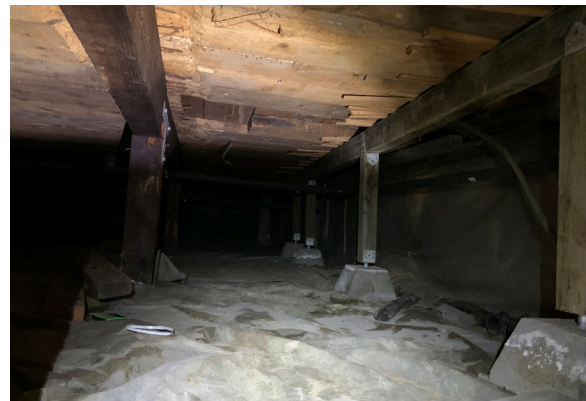
Figure 1-359. Added dropped beam, posts, and footings to support the previously unsupported floor framing at the south elevation of the structure near the front door (CBB, 08/24/2021)

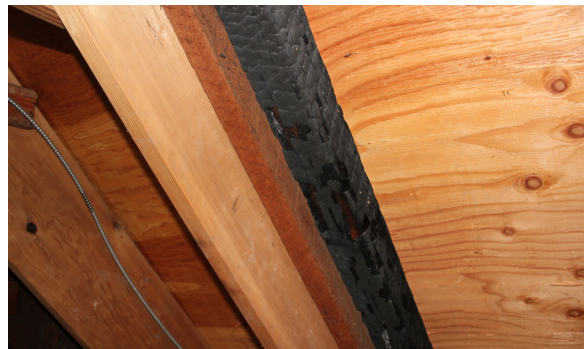
Figure 1-363. Charred 4x4 rafter with sisters (CBB, 08/26/2021)

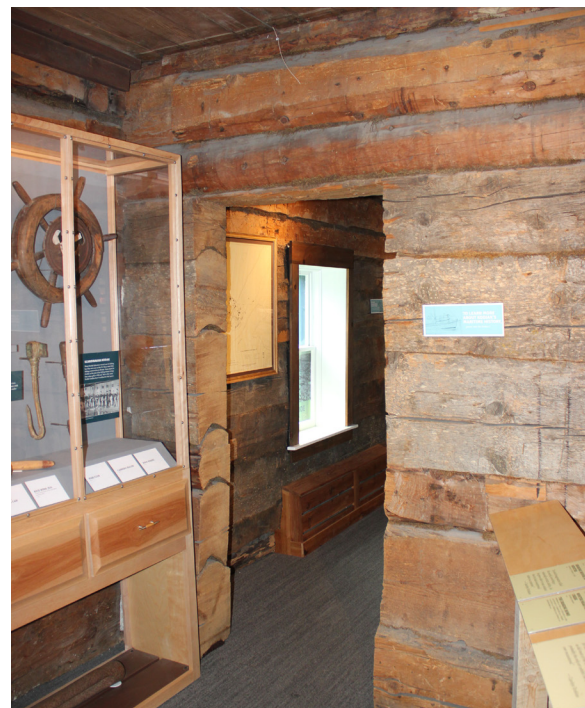
Two door openings were cut into the interior log wall after the original date of construction and there are no dedicated structural elements or connections to keep the portion of the wall between the openings in place (Figure 1-369). Similarly, an opening was

Figure 1-369. Opening created in the interior log wall after the original construction (CBB, 08/25/2021)
