City of Kodiak
Kodiak Historical Society

RUSSIAN-AMERICAN COMPANY MAGAZIN
KODIAK, ALASKA
Historic Structure Report

MARCH 22, 2022

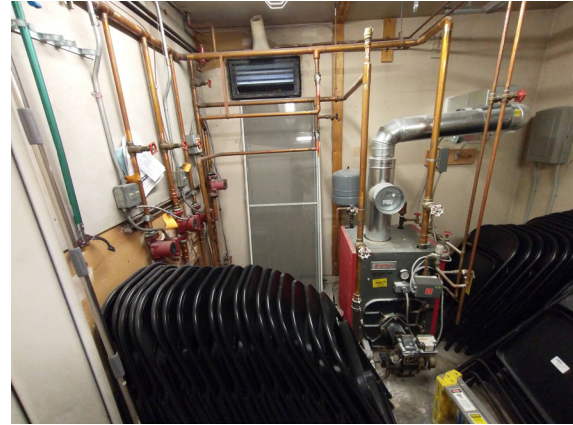
The existing mechanical system consists of a heating water boiler system with baseboard radiators throughout the building and (1) unit heater located in the crawlspace. The boiler is #2 fuel oil fired (served by fuel tank buried outside of the building) and has a draft inducer fan (Figure 1-370). The boiler was manufactured in 2011. There is currently no cooling system and no mechanical ventilation to the main occupied spaces. There is currently no mechanical ventilation serving the crawlspace.

Figure 1-370. Hydronic System (JSW 8/24/2021)

Condition: Poor
Needs full new mechanical system.

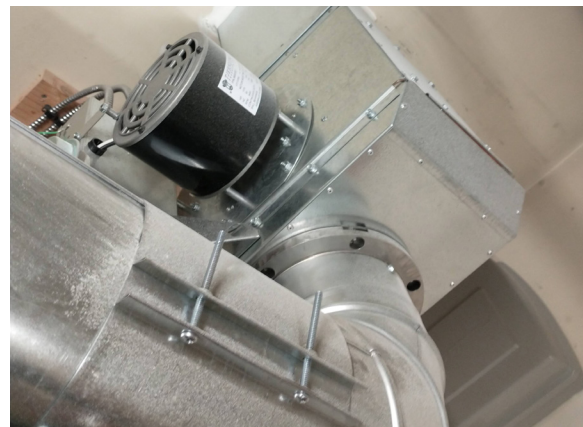
Figure 1-372. Boiler Flue Draft Inducer (JSW 8/24/2021)

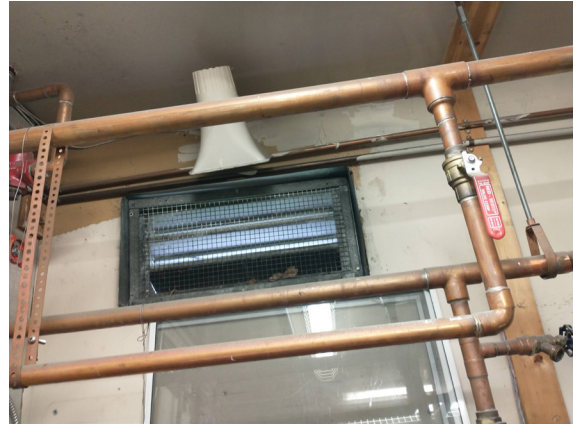
The boiler system combustion air enters via an exterior mounted louver on the North wall of the mechanical room. Figure 1-374

Figure 1-374. Combustion Air Louver (JSW 8/24/2021)

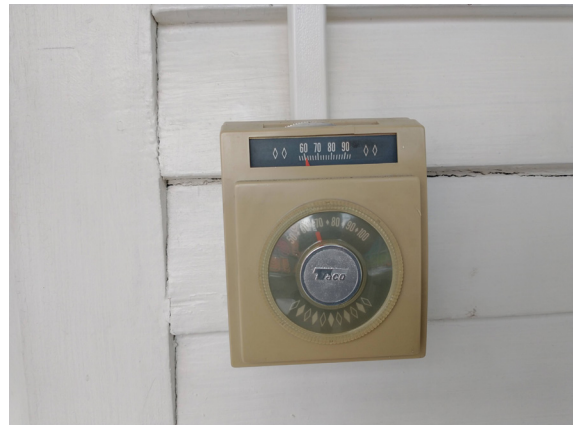
The boiler system has (5) temperature of control zones, each of which has a dedicated pump that operates on a call for heating. It was noted that the zone serving the East side of the first level has no thermostat located in the space. There is no building-level controls system. Figure 1-375

Figure 1-375. Hydronic Thermostat (JSW 8/24/2021)

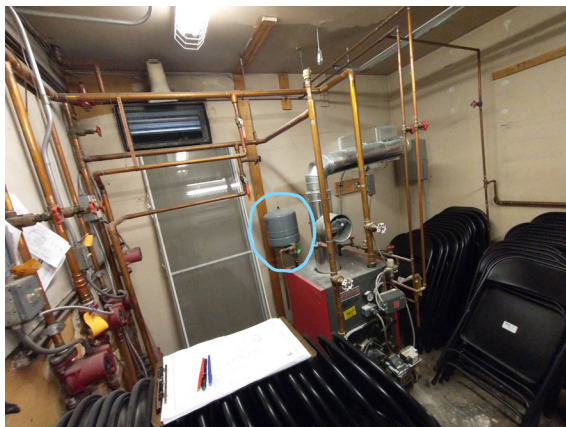
The boiler expansion tank is supported by pipe fittings only and is not supported via any structure. Figure 1-373

Figure 1-373. Poorly Supported Expansion Tank (JSW 8/24/2021)

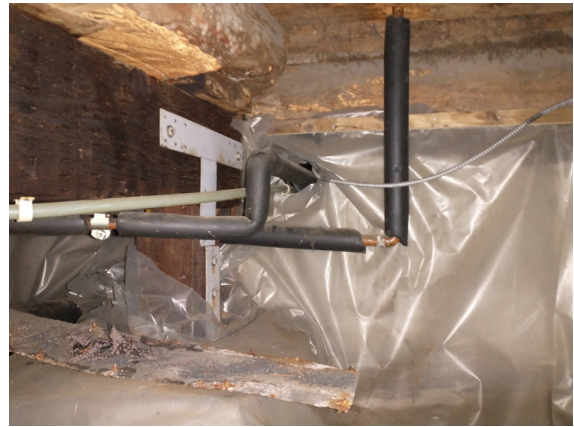
The hydronic piping throughout the building is copper excepting a few areas in the crawlspace where the piping was noted to have been replaced with PEX. The piping is poorly supported in many places throughout the building. The copper piping's exact age is unknown but is assumed to have been installed as part of the 1980 Heating Replacement scope. Figure 1-376

Figure 1-376. Hydronic Piping In The Crawlspace (JSW 8/24/2021)

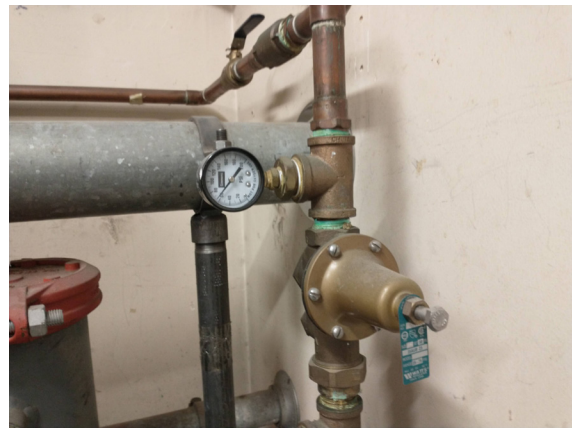
Figure 1-384. Domestic Water PRV (JSW 8/24/2021)

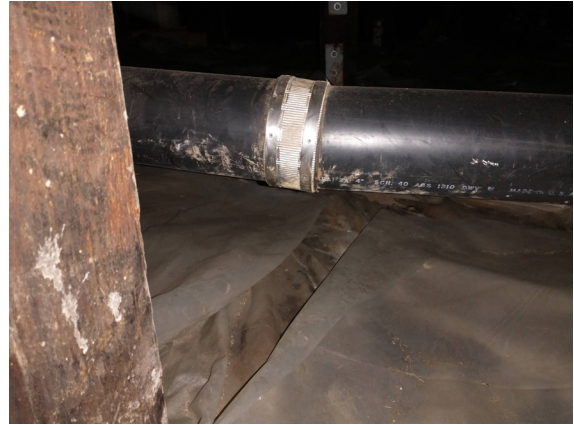
Waste piping in the crawlspace is ABS and appears to be in fair condition. The waste piping in the crawlspace is poorly supported and fittings were noted to be poorly joined in some locations. Figure 1-386

Figure 1-386. ABS Piping in Crawlspace (JSW 8/24/2021)

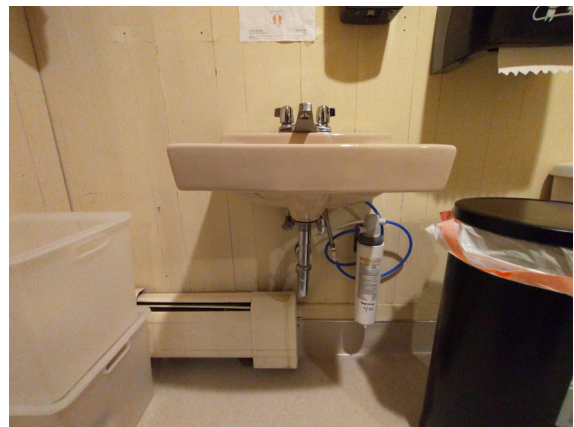
Water filters are installed under the break room sink and the second level restroom lavatory. Figure 1-388

Figure 1-388. Second Level Lavatory Filter (JSW 8/24/2021)

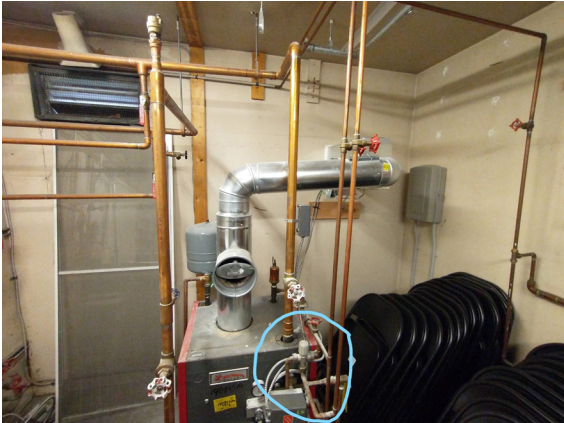
Domestic hot water is generated via a side-arm off of the hydronic boiler system. There is no domestic hot water recirculation in the building. Figure 1-389

Figure 1-389. Domestic Hot Water Mixing Valve (JSW 8/24/2021)

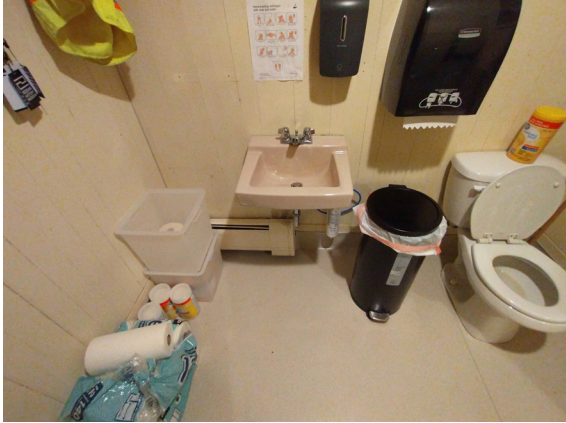
Figure 1-392. Second Level Restroom Fixtures (JSW 8/24/2021)

Needs a majority of the plumbing replaced. None of the current fixtures are ADA-complaint. Refer to the Architectural - Accessibility section for additional accessibility-related information.

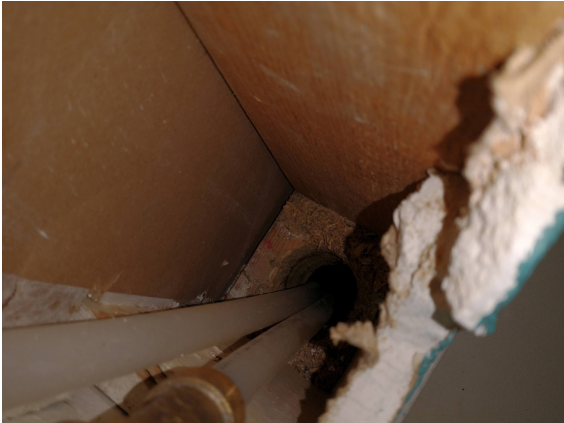
with a breakroom sink and one exterior mounted hose bibb. Domestic supply piping is routed within the crawlspace to serve the break room sink. There is a floor drain in the mechanical room the piping for which could not be located in the crawlspace. The exact routing of this piping is unknown. Figure 1-390

Figure 1-390. PEX Piping Down in Restroom Wall to Crawlspace (JSW 8/24/2021)

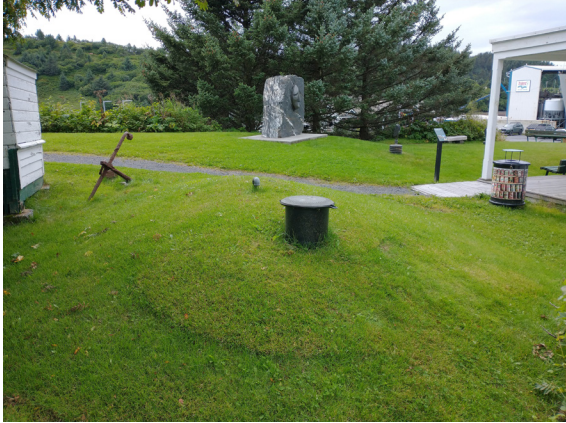
The building is supplied with #2 fuel oil (diesel) via a 500-gallon tank buried outside of the building that was installed in 1989. The diesel tank only serves the boiler in the mechanical room as there are no other fuel-fired pieces of equipment. Based on the 2004 RSA report, this tank is not believed to be a double-walled vessel. Figure 1-393

Figure 1-393. Fuel Tank Location (JSW 8/24/2021)

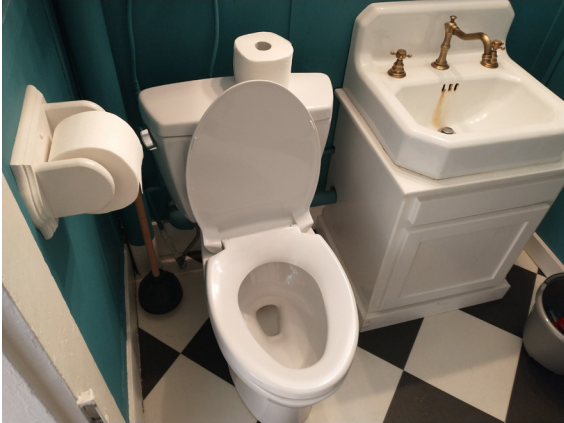
Figure 1-391. First Level Restroom Fixtures (JSW 8/24/2021)

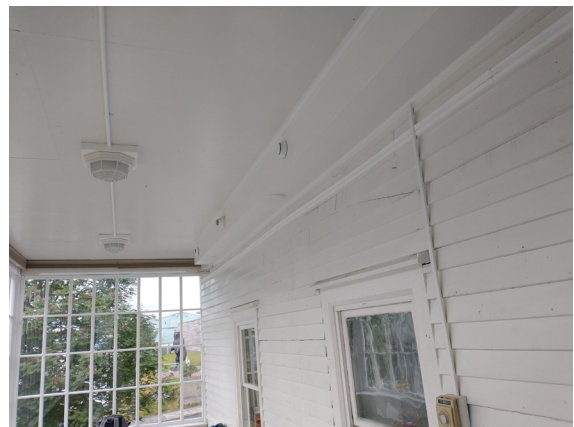
Fire sprinkler heads in the enclosed porch are fully recessed with white cover plate. Fire sprinkler heads in the exhibit area of First level are fully recessed with brown cover plates. Fire sprinkler heads in the tin ceiling are fully recessed with white cover plates. Fire sprinkler heads on the Second Level are pendant type and either exposed or installed in ceilings with white escutcheon rings. Fire sprinkler heads in the attic are exposed pendant-type heads. Figure 1-396

Figure 1-396. Fire Sprinkler Heads in Porch (JSW 8/24/2021)

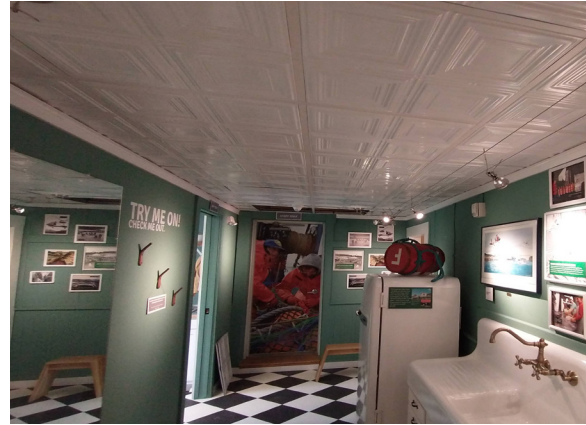
Throughout the building, there is a cable track lighting system (installed around the 1990's) utilized in the Museum spaces. Track heads contain MR16 lamps. The heads are supported by two live power cables, which can cause a shock if both sides are touched simultaneously. The system is suspended

Figure 1-405. Track Lighting (JSW, 8/25/2021)

from a historic ceiling. A fire was reported to occur because of a malfunction with a portion of this track lighting system. This portion was later replaced with the same system.

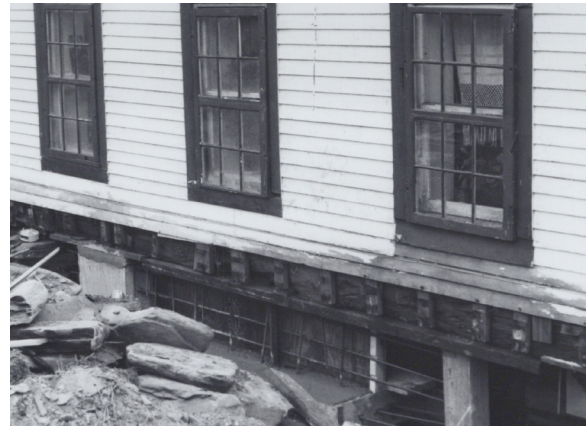
Where storm windows are missing (Windows 28 and 34), some weathering of paint and

Figure 5-1. Historic twelve-lite storm windows along north facade. (Kodiak History Museum, ca. 1970s)

glazing putty has begun to occur and will continue without a storm. Gently sand and repaint wood elements at these two windows. Replace any loose or cracked glazing putty. Construct historically compatible wood-frame storms with twelve lites, arranged in a six-over-six pattern for these two windows.
