Targeted Asbestos Refurbishment Survey

Address:
Central Fire Station
40 Pitt Street
Auckland
1010

Project Reference: M-00235.003

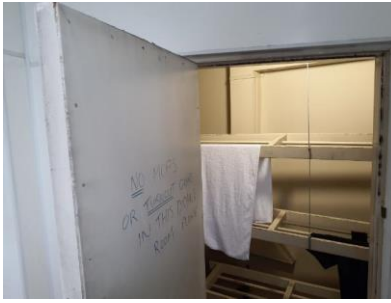
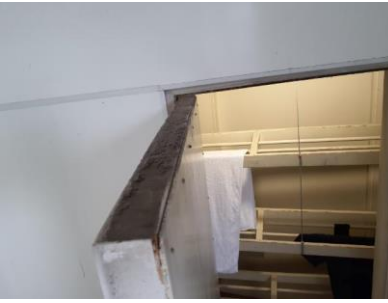
1st Floor 002 - Laundry and Cupboard Door Panel	Cement Product	S001	Sampled Chrysotile	2m sq	Easy	1	1	0	1	3	Non-Friable	Very Low	Remove material using an appropriately licenced asbestos removal contractor if area is part of refurbishment scope. Label and manage product if to remain in situ. Review and update Asbestos Management Plan accordingly.

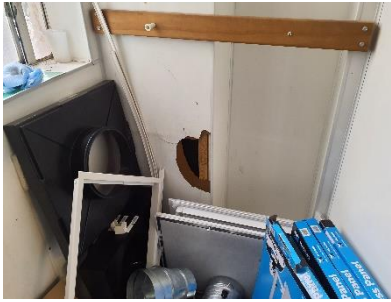
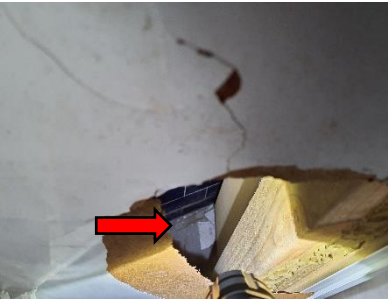
1st Floor 002 - Laundry and Cupboard Boxing	Cement Product	P001	Presumed Chrysotile	<1m sq	Hard	1	2	0	1	4	Non-Friable	Very Low	Remove material using an appropriately licenced asbestos removal contractor if area is part of refurbishment scope. Label and manage product if to remain in situ. Review and update Asbestos Management Plan accordingly.

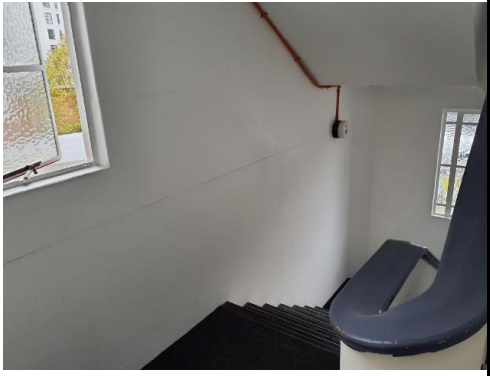
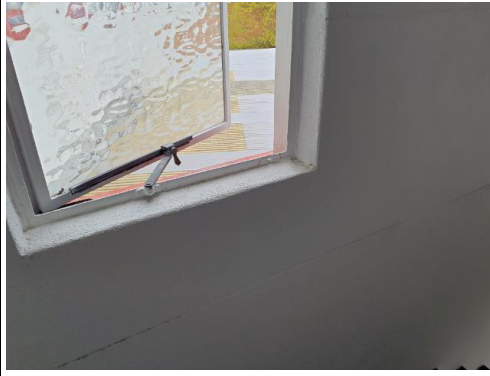
Location / Location Number – Room / Item Description	Material and Sample Details				Additional		
	Material	Sample Status	Sample ID	Result	Comment	Photo (Location)	Photo (Detailed)
1st Floor 001 - Stairwell Textured coating to wall	Textured Coating	Sampled	S003	NAD	No asbestos was detected, no further action is required.

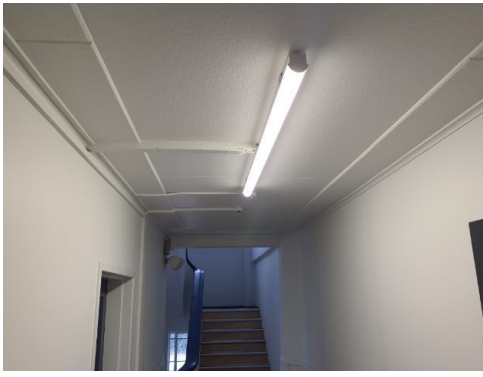
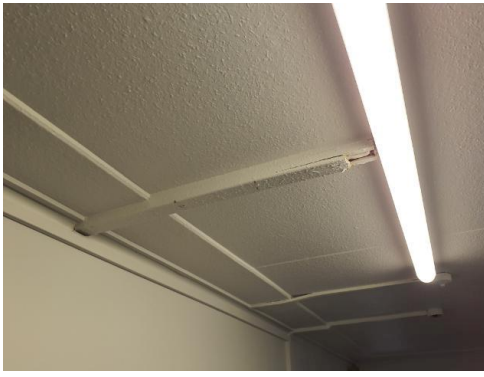
Location / Location Number – Room / Item Description	Material and Sample Details				Comment	Additional	
	Material	Sample Status	Sample ID	Result		Photo (Location)	Photo (Detailed)
1st Floor 003 - Corridor and Hall Textured coating to ceiling	Textured Coating	Sampled	S004	NAD	Composite sample taken. No asbestos was detected, no further action is required.

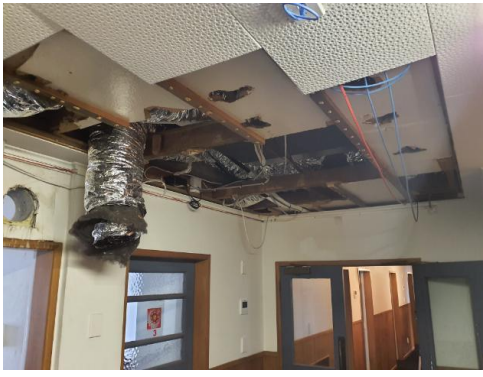
1st Floor 004 - Main Corridor Textured coating to ceiling	Textured Coating	Sampled	S007	NAD	Composite sample taken. No asbestos was detected, no further action is required.

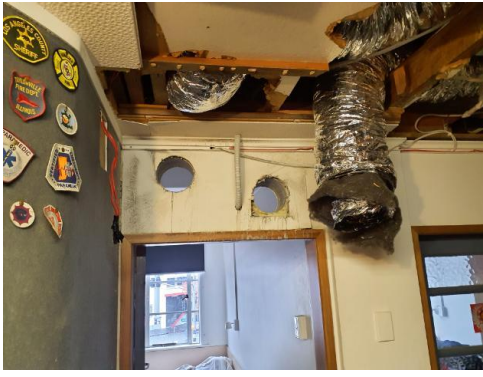
1st Floor 004 - Main Corridor Textured coating to wall	Textured Coating	Sampled	S002	NAD	Composite sample taken. No asbestos was detected, no further action is required.

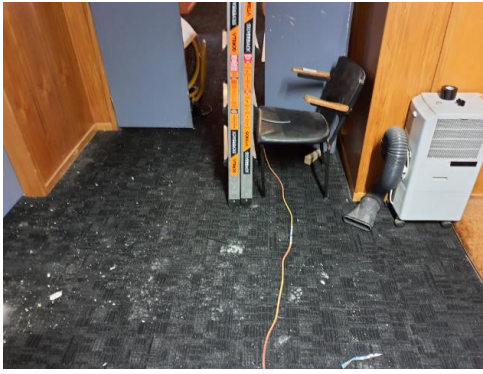
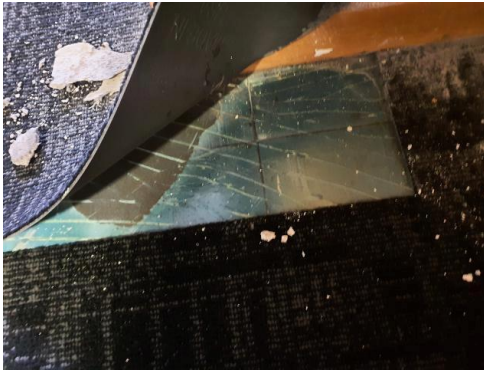
1st Floor 004 - Main Corridor Floor Tiles	Vinyl Products	Sampled	S006	NAD	No asbestos was detected, no further action is required.

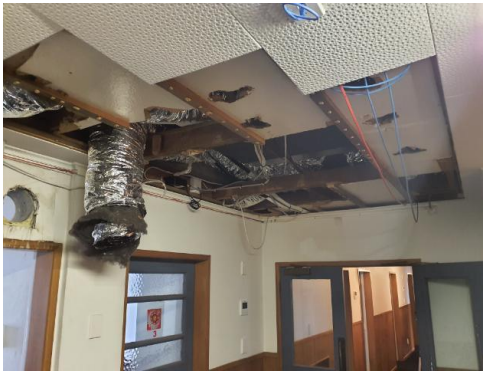
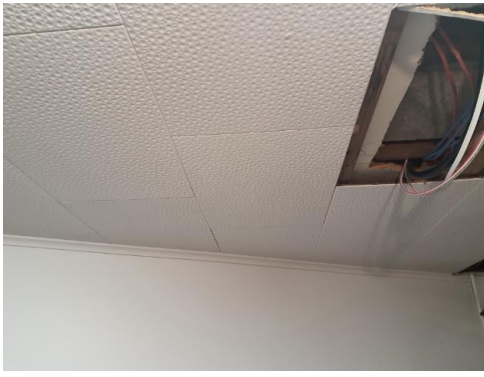
Location / Location Number – Room / Item Description	Material and Sample Details				Additional		
	Material	Sample Status	Sample ID	Result	Comment	Photo (Location)	Photo (Detailed)
1st Floor 004 - Main Corridor Textured coating to ceiling	Textured Coating	Sampled	S008	NAD	Composite sample taken. No asbestos was detected, no further action is required.

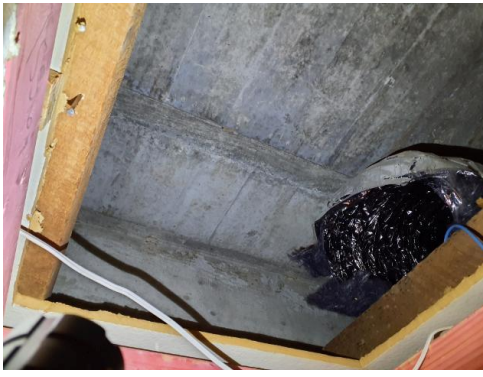
1st Floor 004 - Main Corridor Concrete filling compound to ceiling voids	Composite Product	Sampled	S013	NAD	No asbestos was detected, no further action is required.

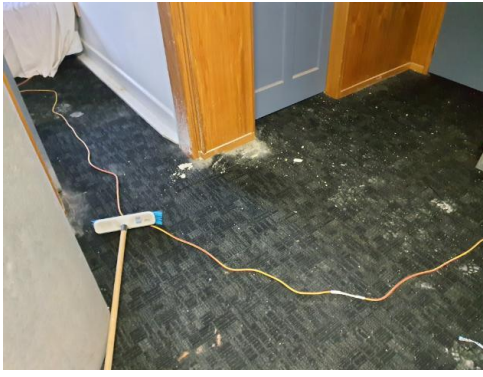
1st Floor 004 - Main Corridor Dust to floor	Debris / Dust Deposits	Sampled	S024	NAD	Composite sample taken. No asbestos was detected, no further action is required.

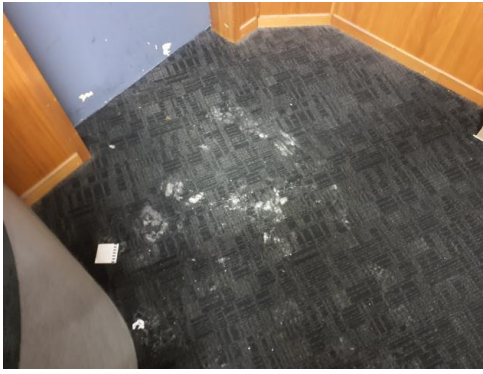
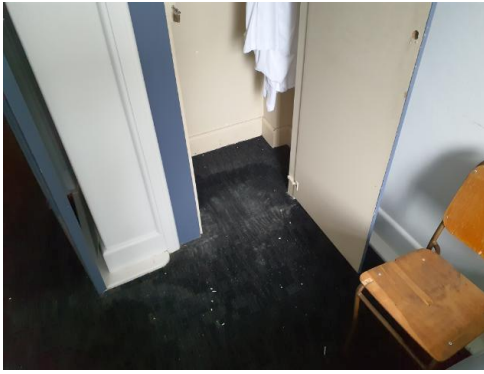
1st Floor 004 - Main Corridor Dust to floor	Debris / Dust Deposits	Sampled	S025	NAD	Composite sample taken. No asbestos was detected, no further action is required.

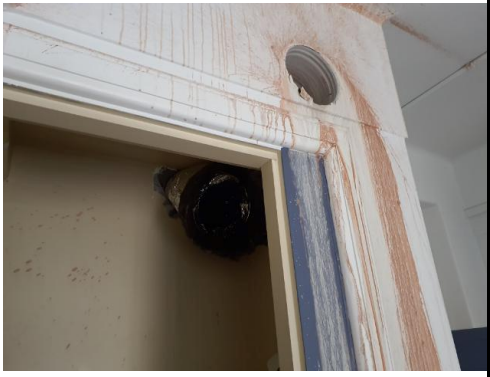
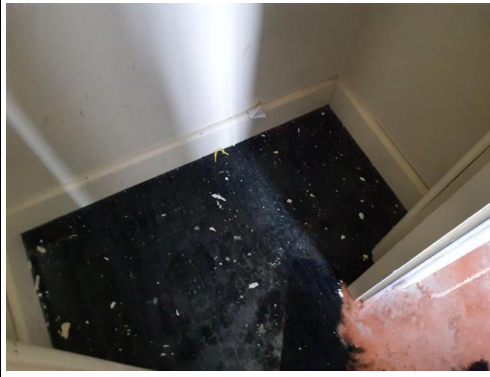
Location / Location Number – Room / Item Description	Material and Sample Details				Additional		
	Material	Sample Status	Sample ID	Result	Comment	Photo (Location)	Photo (Detailed)
1st Floor 007 - Bedroom 3 Cupboard debris	Debris / Dust Deposits	Sampled	S019	NAD	Composite sample taken. No asbestos was detected, no further action is required.

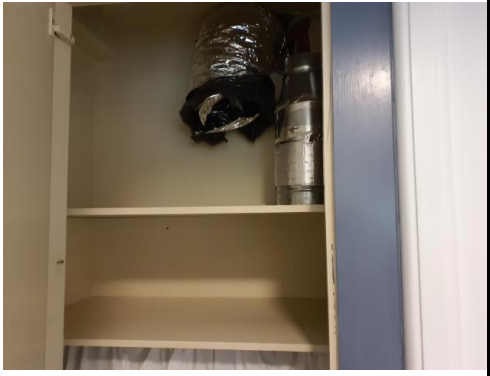
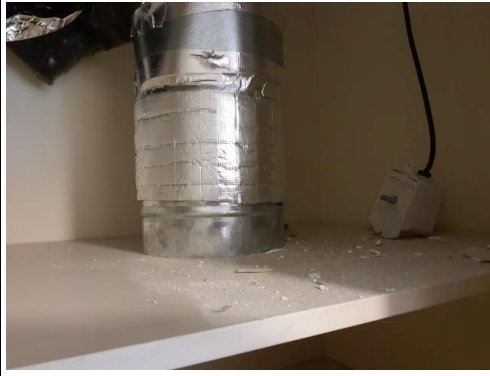
Location / Location Number – Room / Item Description	Material and Sample Details				Additional		
	Material	Sample Status	Sample ID	Result	Comment	Photo (Location)	Photo (Detailed)
1st Floor 011 - Bedroom 7 Debris in Cupboard	Debris / Dust Deposits	Sampled	S015	NAD	Composite sample taken. No asbestos was detected, no further action is required.

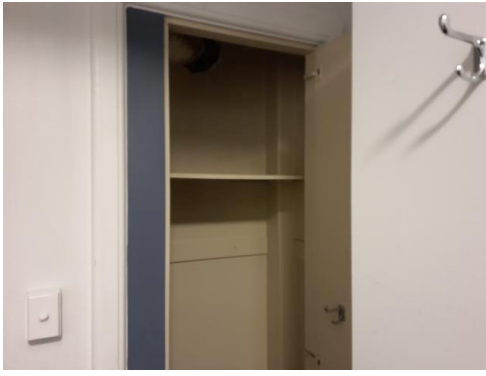
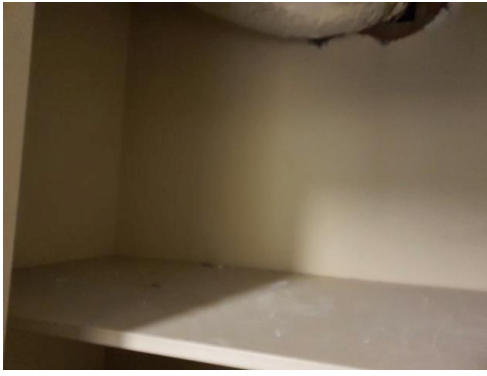
Location / Location Number – Room / Item Description	Material and Sample Details				Additional		
	Material	Sample Status	Sample ID	Result	Comment	Photo (Location)	Photo (Detailed)
1st Floor 014 - Bedroom 10 Debris in Cupboard	Debris / Dust Deposits	Sampled	S020	NAD	Composite sample taken. No asbestos was detected, no further action is required.

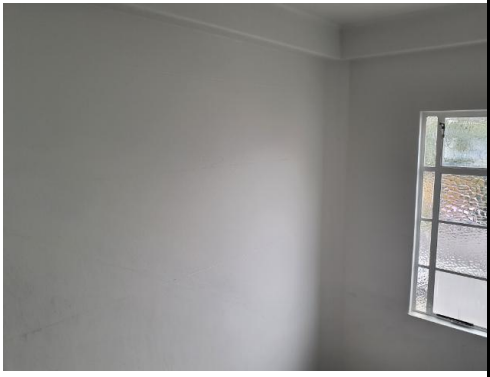
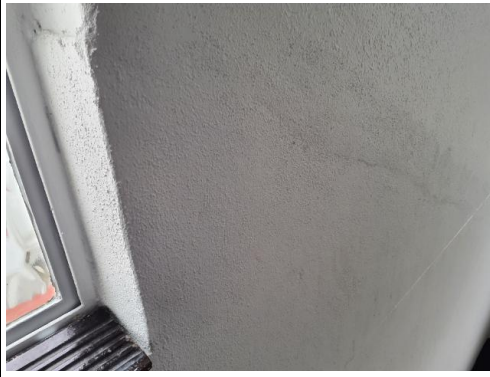
Location / Location Number – Room / Item Description	Material and Sample Details				Additional		
	Material	Sample Status	Sample ID	Result	Comment	Photo (Location)	Photo (Detailed)
2nd Floor 018 - Stairwell Textured coating to wall	Textured Coating	Cross Reference	As-X003	NAD	No asbestos was detected, no further action is required.

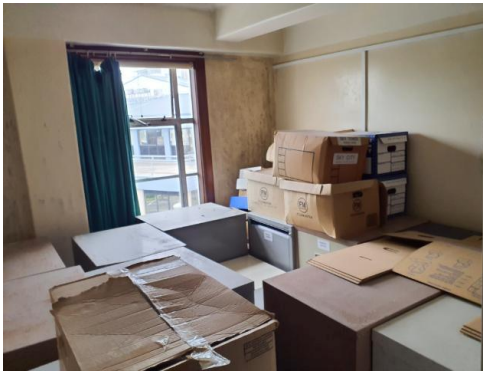
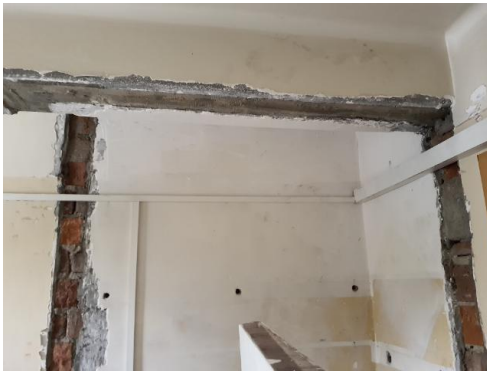
Location / Location Number – Room / Item Description	Material and Sample Details				Additional		
	Material	Sample Status	Sample ID	Result	Comment	Photo (Location)	Photo (Detailed)
2nd Floor 021 - Store Textured coating to wall	Textured Coating	Sampled	S031	NAD	Composite sample taken. No asbestos was detected, no further action is required.

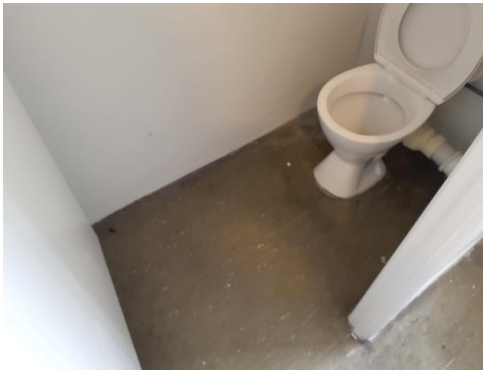
2nd Floor 024 - Female Toilet Floor Vinyl	Vinyl Products	Sampled	S033	NAD	No asbestos was detected, no further action is required.

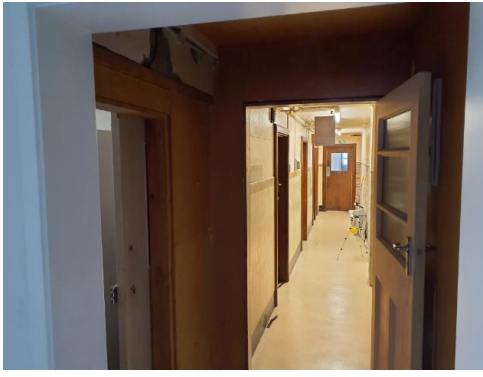
2nd Floor 026 - Corridor Textured coating to wall	Textured Coating	Sampled	S027	NAD	Composite sample taken. No asbestos was detected, no further action is required.

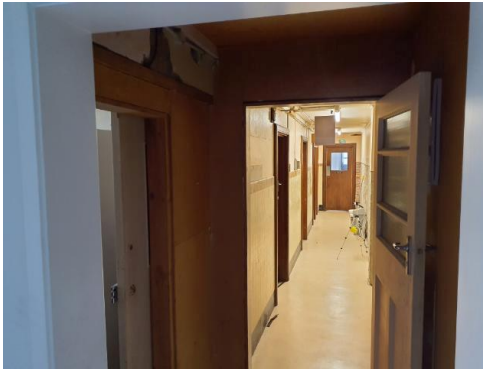
2nd Floor 026 - Corridor Textured coating to wall	Textured Coating	Sampled	S028	NAD	Composite sample taken. No asbestos was detected, no further action is required.

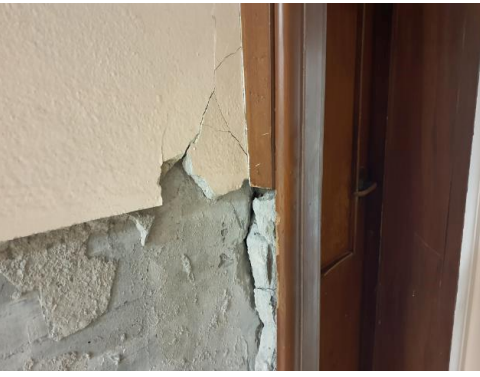
Location / Location Number – Room / Item Description	Material and Sample Details				Comment	Additional	
	Material	Sample Status	Sample ID	Result		Photo (Location)	Photo (Detailed)
2nd Floor 026 - Corridor Textured coating to wall	Textured Coating	Sampled	S029	NAD	Composite sample taken. No asbestos was detected, no further action is required.

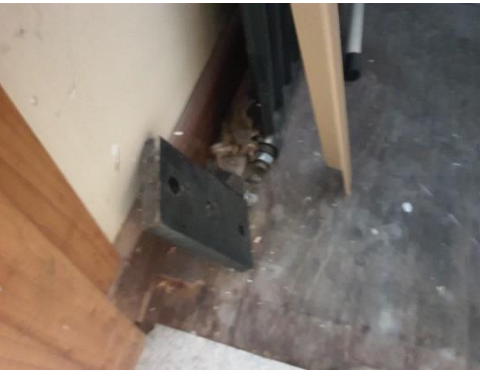
2nd Floor 026 - Corridor under construction Settled Dust to Surfaces	Debris / Dust Deposits	Sampled	S034	NAD	Composite sample taken. No asbestos was detected, no further action is required.

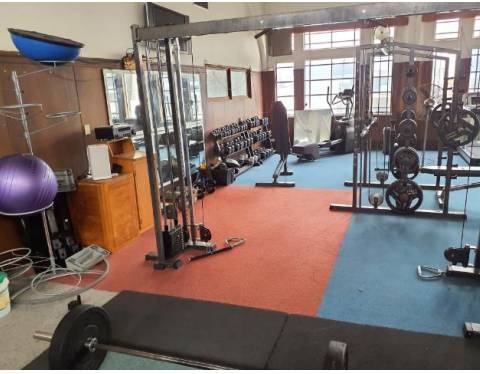
2nd Floor 027 - Gym Settled Dust and Debris to Surfaces	Debris / Dust Deposits	Sampled	S036	NAD	Composite sample taken. No asbestos was detected, no further action is required.

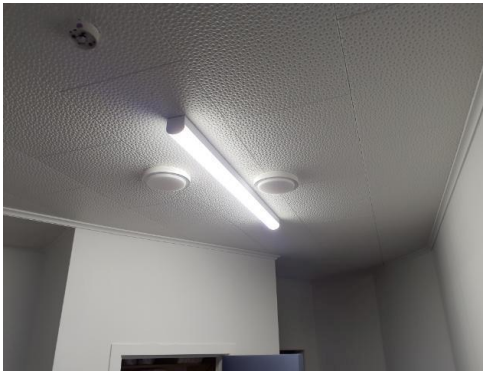
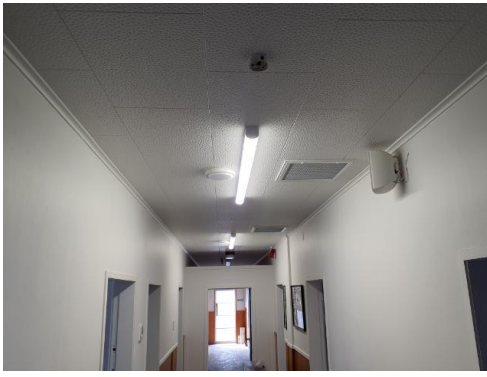
Location / Location Number – Room / Item Description	Material and Sample Details				Comment	Additional	
	Material	Sample Status	Sample ID	Result		Photo (Location)	Photo (Detailed)
2nd Floor 028 - Corridor and closet Ceiling Panels	Textured Coating	Cross Reference	As-X008	NAD	No asbestos was detected, no further action is required.

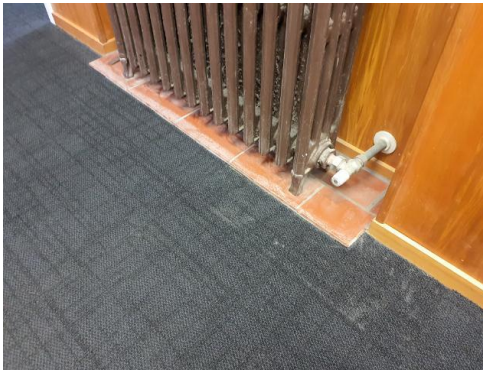
2nd Floor 032 - Bedroom 03 Settled Dust to Surfaces	Debris / Dust Deposits	Sampled	S042	NAD	Composite sample taken. No asbestos was detected, no further action is required.

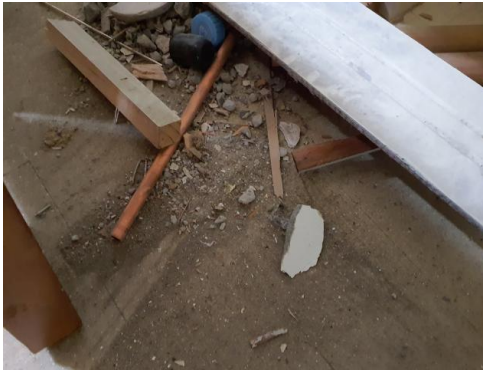
2nd Floor 035 - Bedroom 06 Settled Dust and Debris to Surfaces	Debris / Dust Deposits	Sampled	S041	NAD	No asbestos was detected, no further action is required.

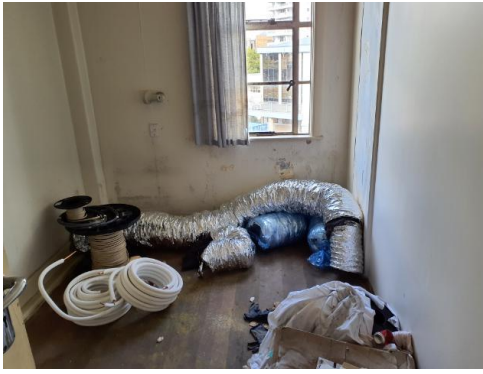
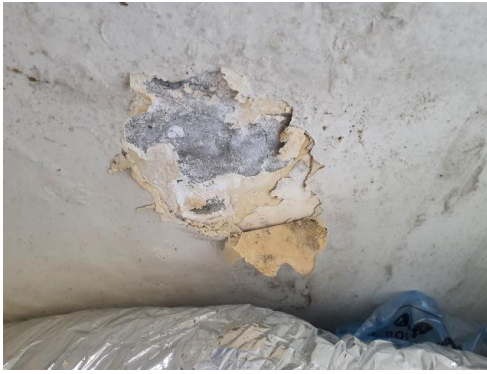
2nd Floor 037 - Bedroom 12 Textured coating to wall	Textured Coating	Sampled	S038	NAD	Composite sample taken. No asbestos was detected, no further action is required.

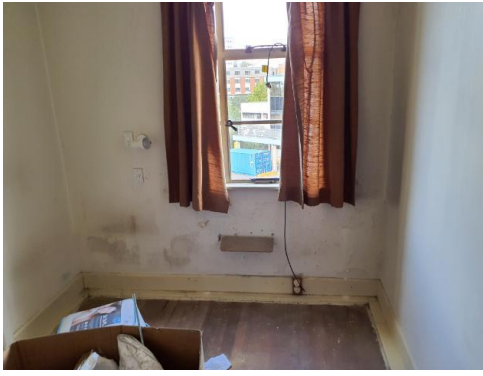
Location / Location Number – Room / Item Description	Material and Sample Details				Additional		
	Material	Sample Status	Sample ID	Result	Comment	Photo (Location)	Photo (Detailed)
2nd Floor 038 - Bedroom 11 Textured coating to wall	Textured Coating	Sampled	S039	NAD	Composite sample taken. No asbestos was detected, no further action is required.

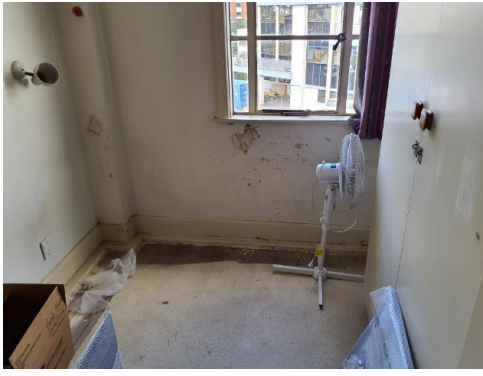
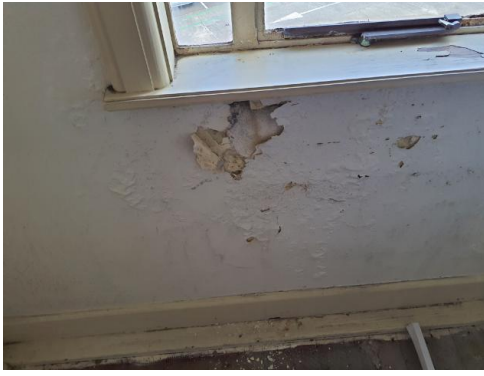
2nd Floor 039 - Bedroom 10 Textured coating to wall	Textured Coating	Sampled	S040	NAD	Composite sample taken. No asbestos was detected, no further action is required.

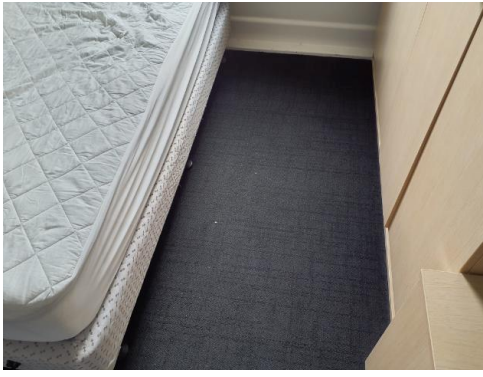
2nd Floor 041 - Bedroom 08 Settled Dust and Debris to Surfaces	Debris / Dust Deposits	Sampled	S043	NAD	Composite sample taken. No asbestos was detected, no further action is required.

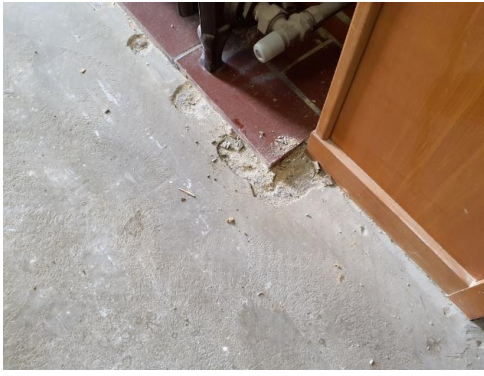
2nd Floor 043 - Corridor under construction Floor Screed	Composite Product	Sampled	S037	NAD	No asbestos was detected, no further action is required.

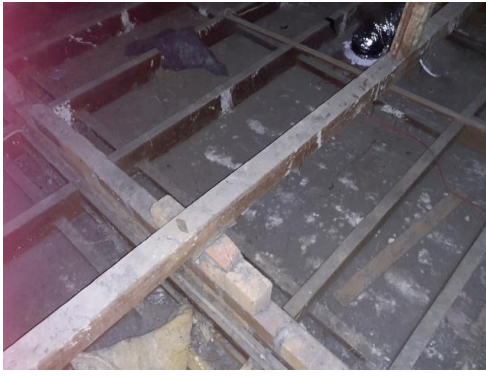
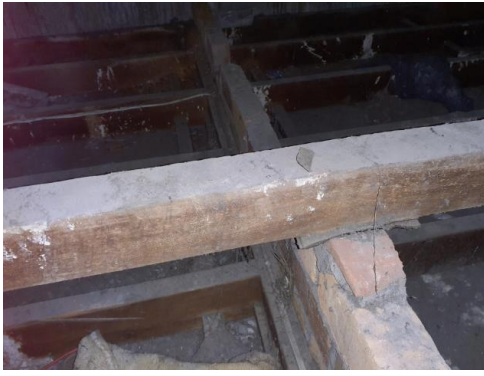
Location / Location Number – Room / Item Description	Material and Sample Details				Additional		
	Material	Sample Status	Sample ID	Result	Comment	Photo (Location)	Photo (Detailed)
044 - Roof Void DPC	Bituminous Product	Sampled	S047	NAD	No asbestos was detected, no further action is required.

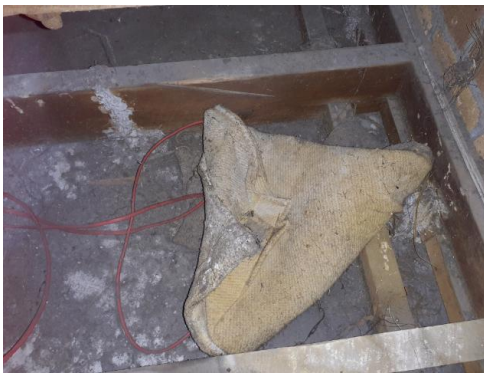
044 - Roof Void Fire blanket	Woven Product	Sampled	S048	NAD	No asbestos was detected, no further action is required.
