14 October 2021

Report

Ngauranga Gorge Fatal Incident Investigation

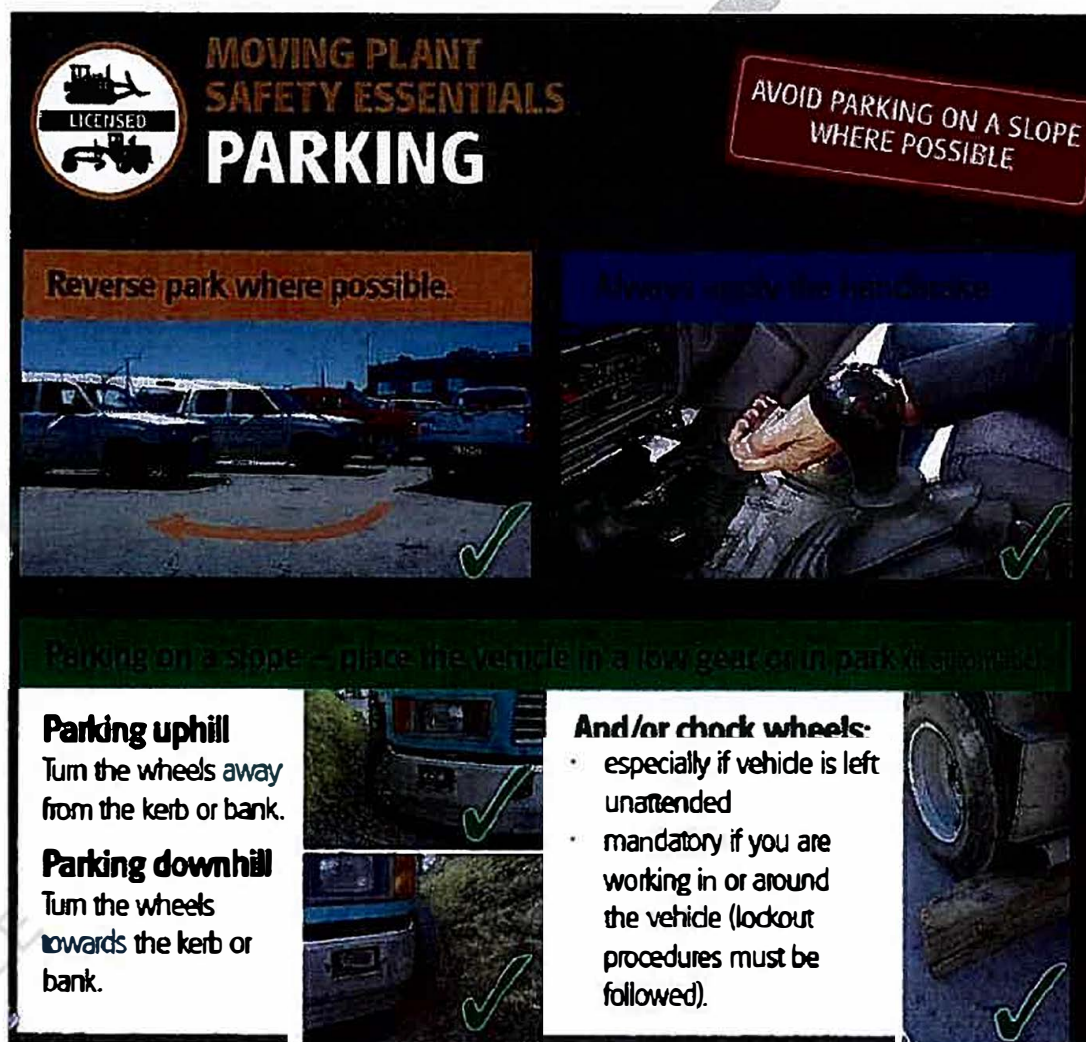
Figure 15 – FHL Moving Plant Safety Essentials – Parking flyer/poster [40027]

The FHL Moving Plant Safety Essentials – Parking flyer/poster [40027] (**Figure 15**) dated 16 May 2013, provides specific guidance to avoid parking on a slope where possible, and if parking on a slope:

And/or chock wheels:

- especially if vehicle is left unattended
- mandatory if you are working in or around the vehicle (lockout procedure must be followed).

It is the author's opinion that this is useful information that could have assisted in preventing the incident. However, there appears to have been no opportunity for Mr Jenkins (SEL) to have been exposed to this information by FHL.

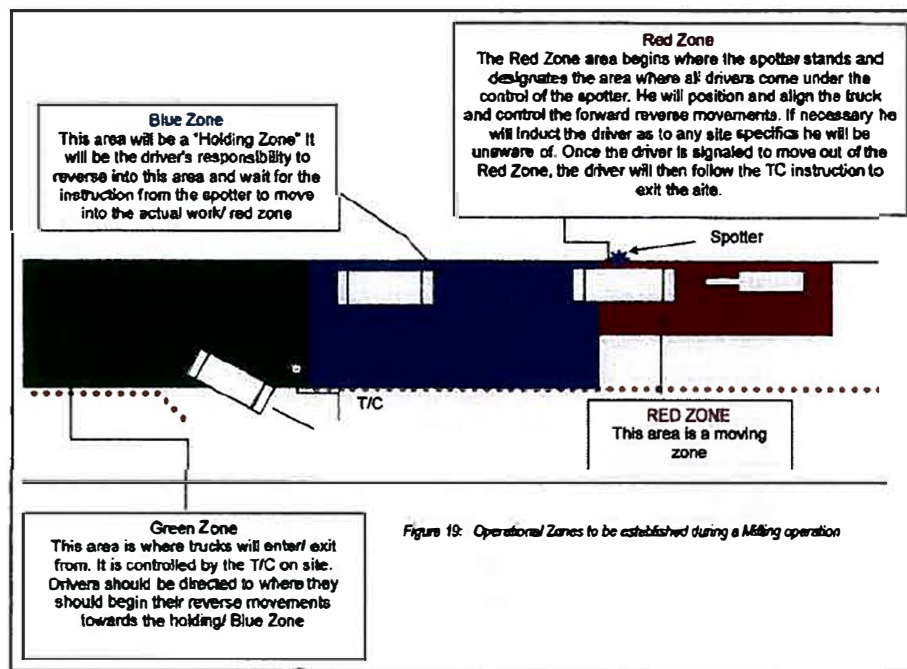
Figure 16 – Operational Zones for Milling [40023]

The Milling Department Emergency Procedures and Guidelines dated 17 June 2016 [40023] outlines department specific procedures and includes operational zones (**Figure 16**) that are to be established during pre-start tailgates and adhered to at all times when reversing to a milling machine.

35 Based on the description of the incident (**Section 4.6**), no operational zones had been specifically defined in the work area or advised at the tailgate and Mr Jenkins (SEL) had pulled into the work area without the assistance of a traffic controller (T/C) and moved through the “Blue Zone” to find the “Green Zone” (**Figure 16**). Admittedly, the milling machine was in the process of being set up and was not operational at the time.

40 It is the author’s opinion that there were very few relevant aspects of this procedure followed on the night of the incident.

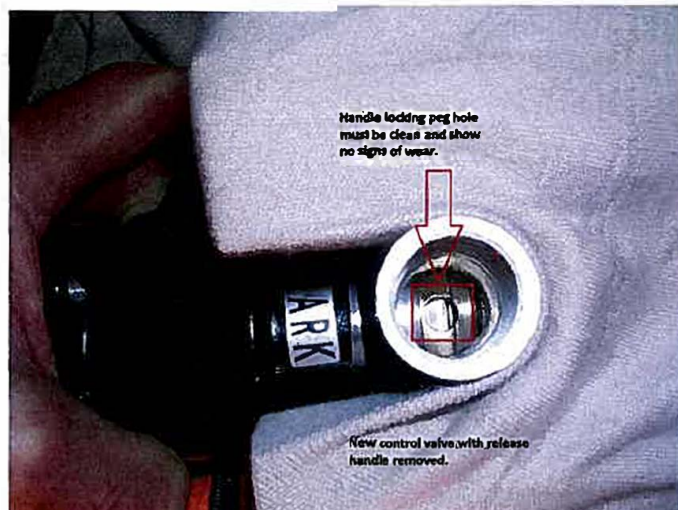
Locking peg hole

- When rotating the hand control handle it should move freely and should be spring loaded to the OFF position (Figure 1, item 3: rotational spring)
- The release handle lock must move freely up and be spring loaded down to the lock position
- With the hand brake applied and in locked position it should not be able to be released (rotated) without lifting the release handle.
