INDEPENDENT OPERATIONAL REVIEW

**New Zealand International Convention
Centre fire**

Prepared for Fire and Emergency New Zealand

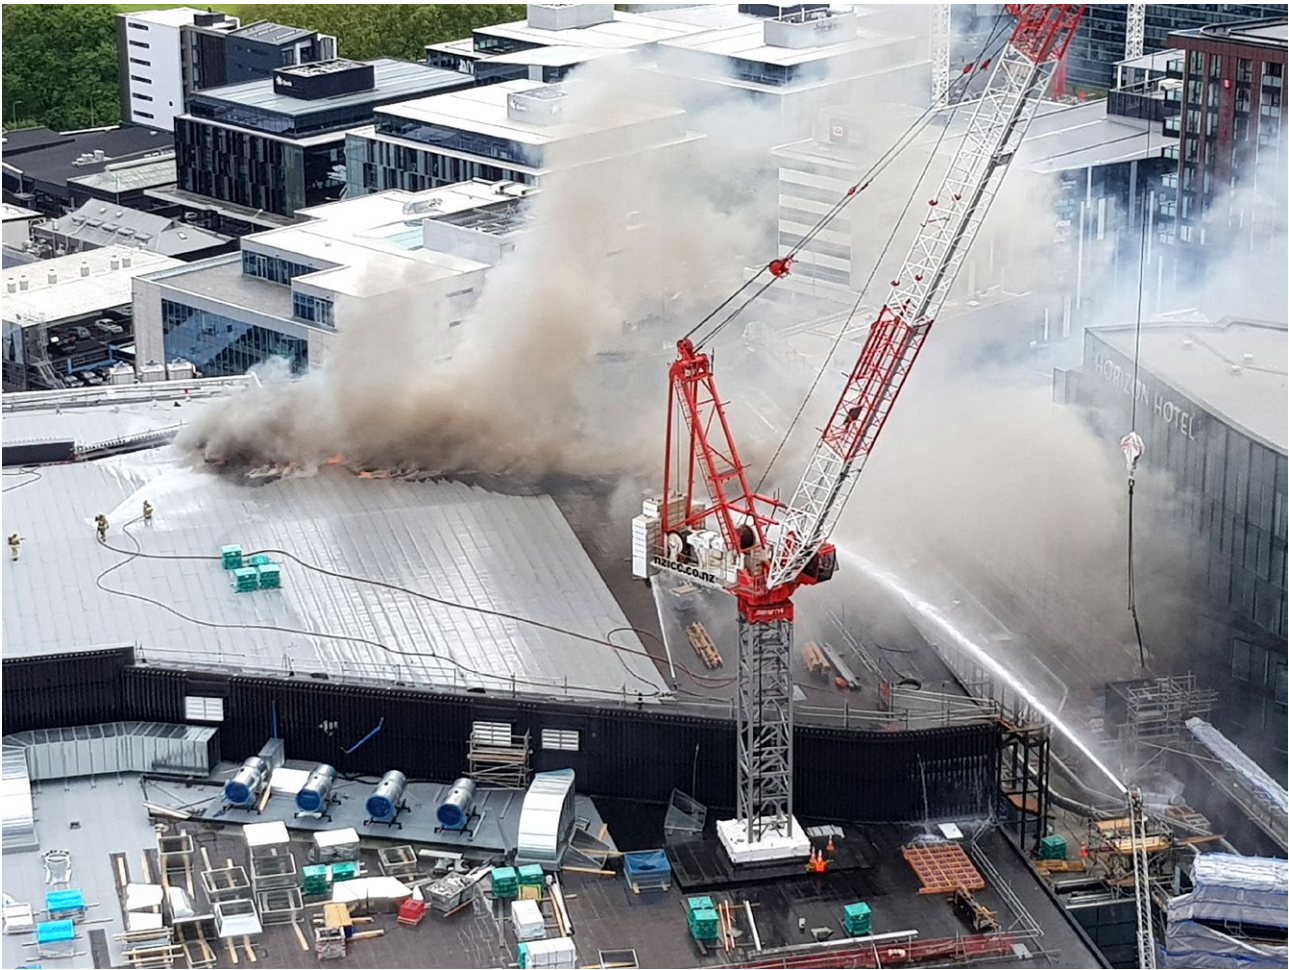
Early stages of firefighting operations – two low pressure deliveries and aerial monitor at work. Credit: Fire and Emergency New Zealand.

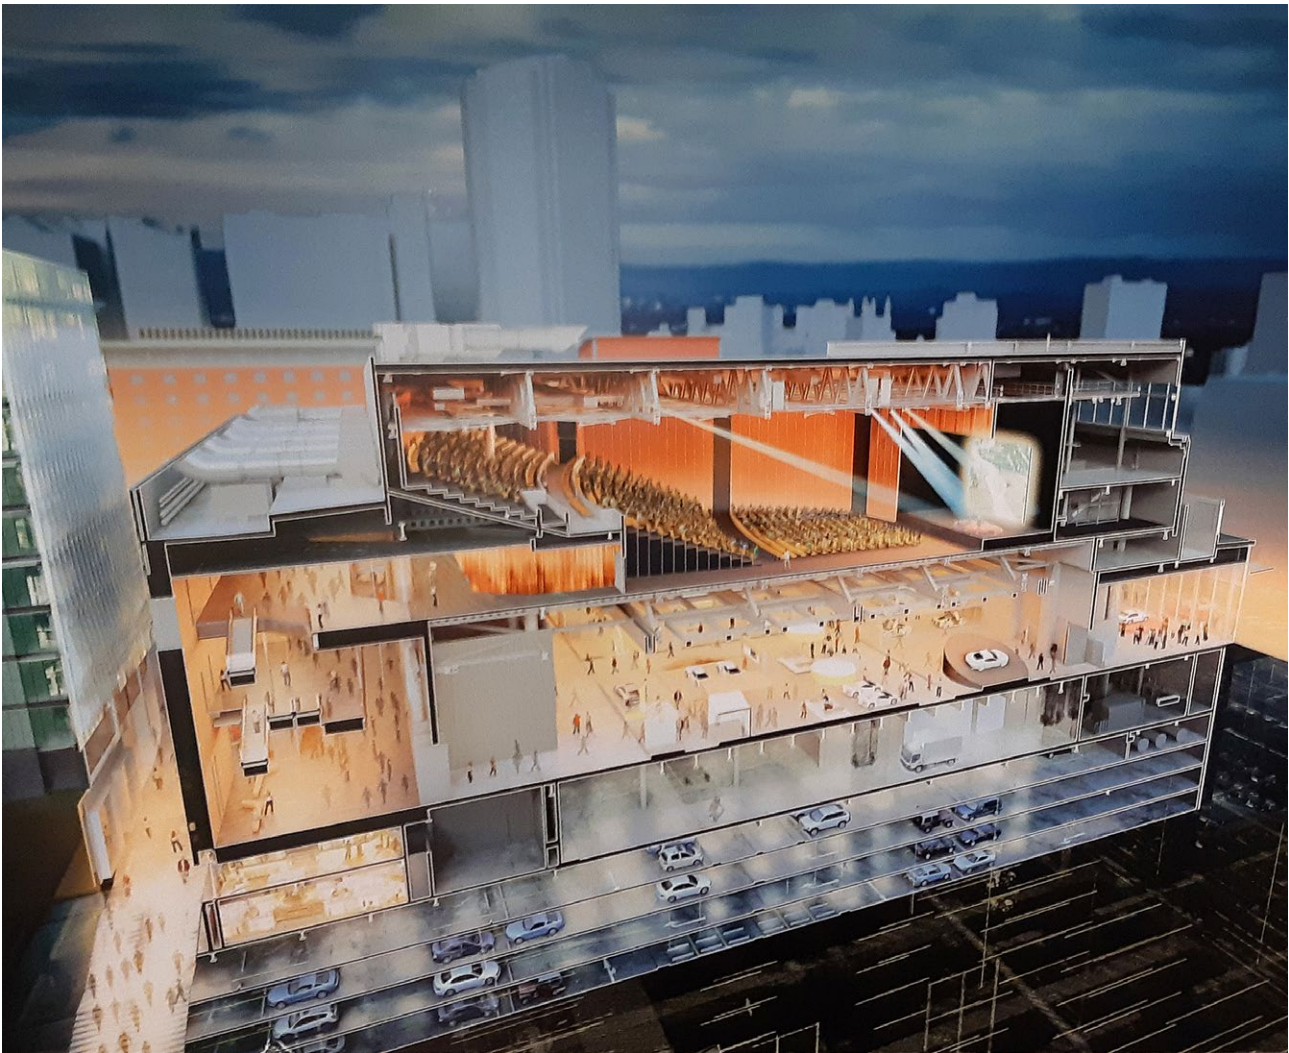
Figure 1: Architectural schematic of Convention Centre. Credit: Fletcher Construction.

- 3.38** The fuels burning in the fire were all products used in the construction of the roof. The skeleton of the roof had thousands of metres of high-grade timber to support the top layer of the roof. The roof was termed a 'non-walk on roof' that was engineered to carry a load not exceeding 75 kilograms per square metre.

- 3.39** The weather seal was a two-layer rubber membrane on plywood substrate. The plywood had a 50mm by 50mm stainless steel mesh stapled to it that the membrane lay on. Under this lay 100mm of thermal insulation supported on wire netting. This lay on hundreds of large joists packed with a compressed straw-like product to add further insulation properties. Below this again were acoustic panels on top of an absorption blanket.
