## FIRE CASE STUDY

An example of the challenges of emergency response in Tāmaki Makaurau

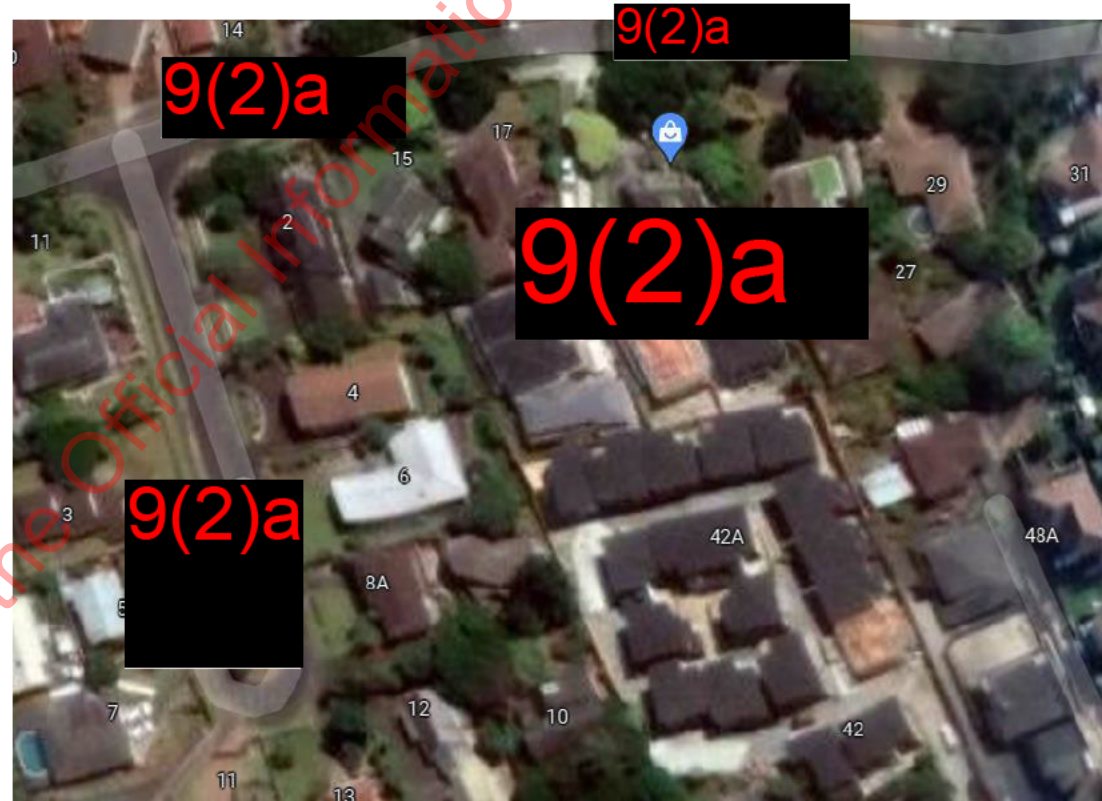
- On 7 April 2022 a fire occurred  
9(2)a
- Comcen received the report of the incident at 05:10hrs
- The first crew arrived at the incident at 05:17hrs
- The fire was brought under control at 06:31hrs
- The last fire appliance left the scene at 13:16hrs

- 9(2)a is a residential area zoned Residential Mixed Housing Suburban.
- The fire was located at a building site for residential infill housing
- The cause of the fire is suspected arson
- There were no residents in the property, and no injuries to the public
- A firefighter received minor burns
- It was a 3rd Alarm fire, 15 appliances attended from 10 stations across 2 fire districts
- The property (a stand alone house) was completely destroyed, 3 other properties were severely damaged due to the heat of the fire.

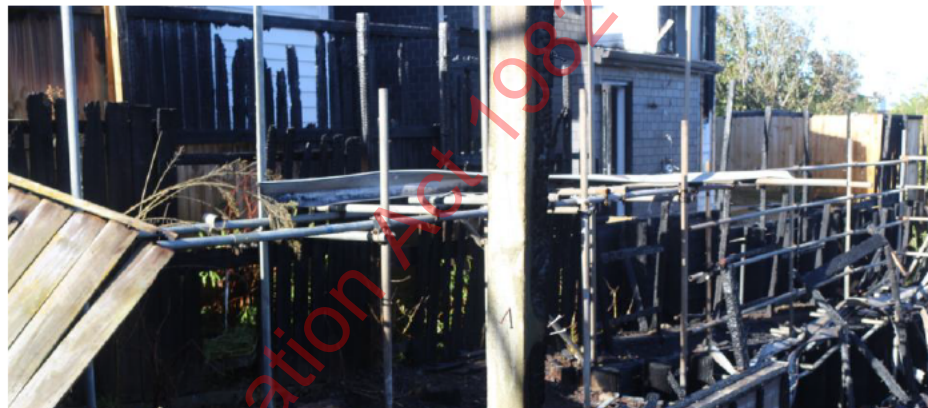
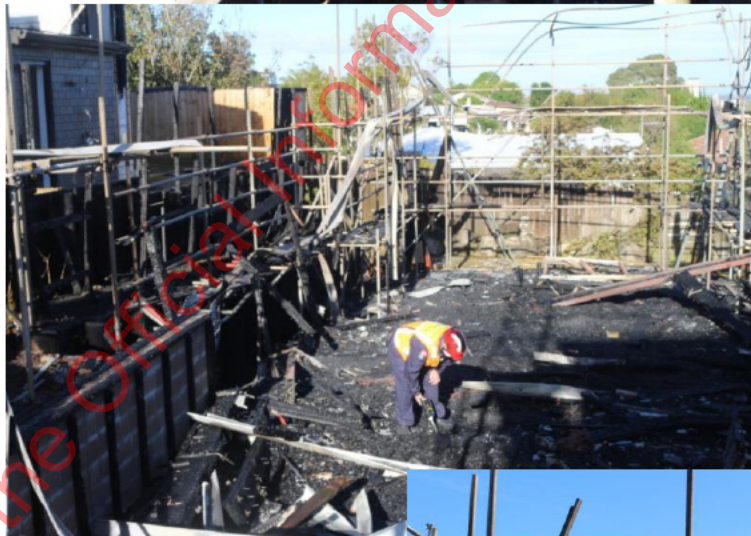
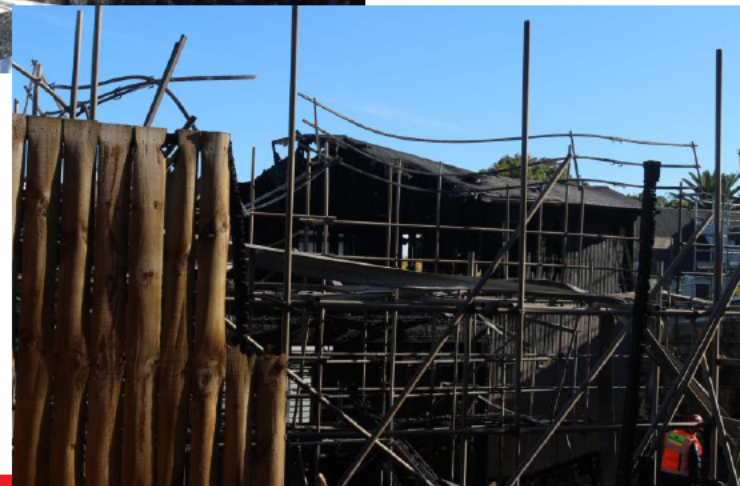
- **50 firefighters** put their personal safety at risk to extinguish the fire
- At least **4 family units** will not be ready for people to move into them (incurring stress and monetary costs)
- **Insurance administration** time and loss of business for developers

- **4 properties** damaged. Average cost of a property in Auckland is over **1.2m**
- Over **20- 30 tonnes** of debris per full house. Costing **\$1,260 - \$3,780**

- It is estimated that over **180,000L** of reticulated water was used in extinguishing the fire. Costing **\$307,080**

- Emissions for a complete fire loss of exemplar house is **27-38 tonnes** of Co2 Equivalent.
- GHG value estimate **\$1,702-\$2,395**
- **Does not include GHG emissions** from FENZ fire response activities

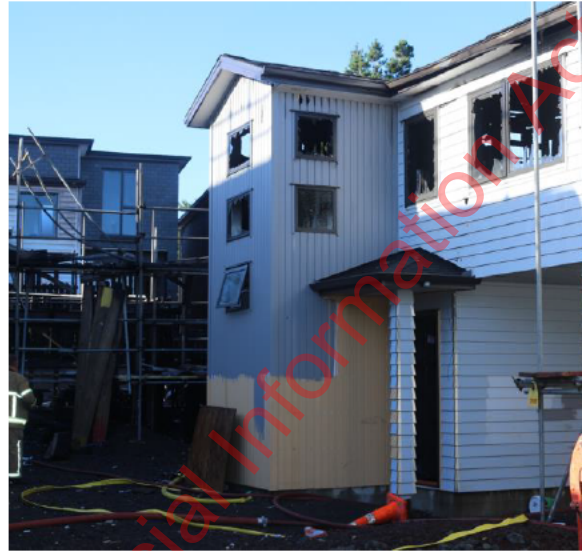
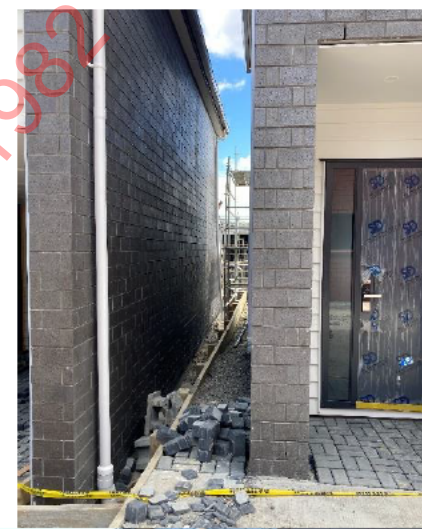
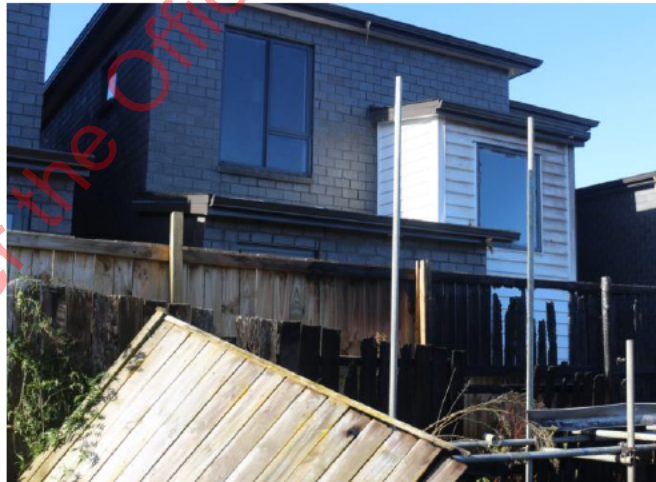
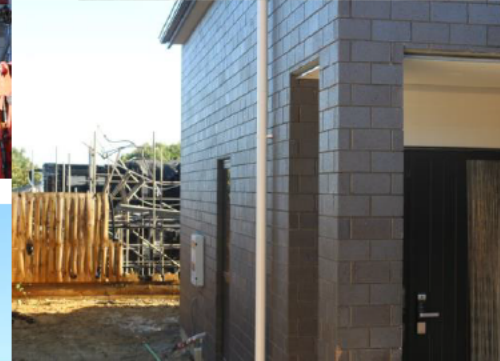
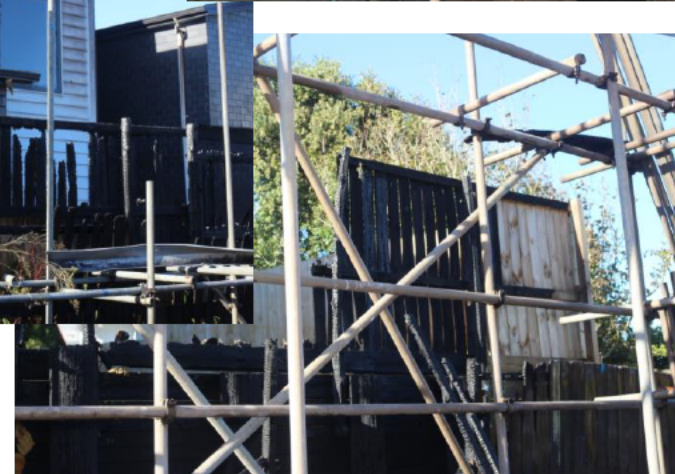
- C5.3 however exempts standalone dwellings, to developments such as 19 Derrimore Heights so excess requirements do not apply.
- The Building Act allows for single family homes, such as 19 Derrimore Heights to only require a smoke alarm and be 1m from the property boundary.

- In this instance the 1m boundary resulted in:
  - destruction of the other properties at 19 and 21 Derrimore Heights
  - destruction of the retaining wall between 19 Derrimore Heights and 42 Redoubt road

- There are also limited access requirements for town houses and multi-story development. This is resulting in development that is inaccessible or takes significantly longer to access in the event of emergency.

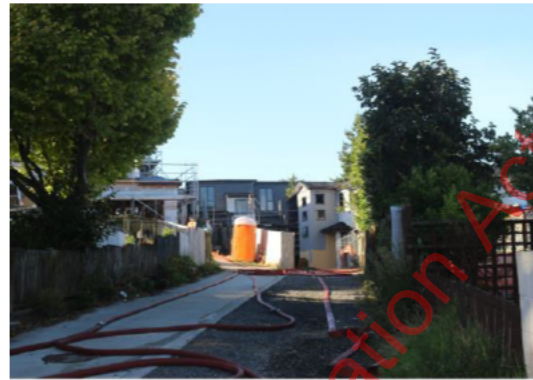
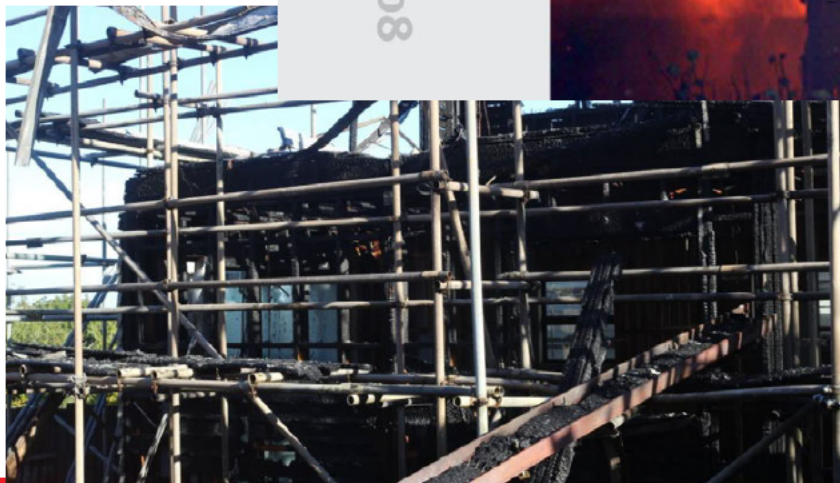
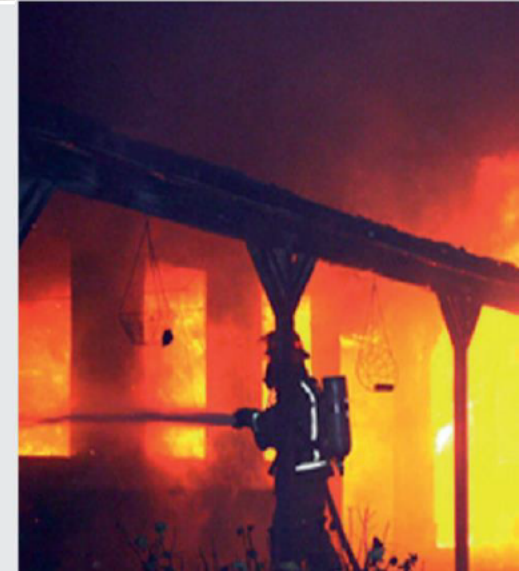
- It is critical for Fire and Emergency that water supply infrastructure is in place prior to any development commencing and that this water supply has adequate capacity and pressures available to service future growth.
- Adequate capacity and pressure for each development can be determined through the New Zealand Fire Service Firefighting Water Supplies Code of Practice SNZ PAS 4509:2008
- The Code of Practice, however is non-mandatory.

- Resource consents process, building consents process and bylaw enforcement, creates gaps in ensuring adequate water supply to new developments.

- Reduction of water flow to reduce waste/leaking has the potential to reduce water flow for firefighting
- Even after fixing the hydrant at 9(2)a, flow is only 960L/m
- Connections that seek the inclusion of fire safety systems (sprinklers) have the greatest potential to prevent the spread of fire in closely located dwelling, townhouses or apartments. Their installation however have the potential to exceed network capacity.
