Aviation Investigation Report AIR-23-01

Abrupt Loss of Pitch Control and Water Impact

West Isle Air dba Friday Harbor Seaplanes de Havilland DHC-3, N725TH

Mutiny Bay, Washington
September 4, 2022

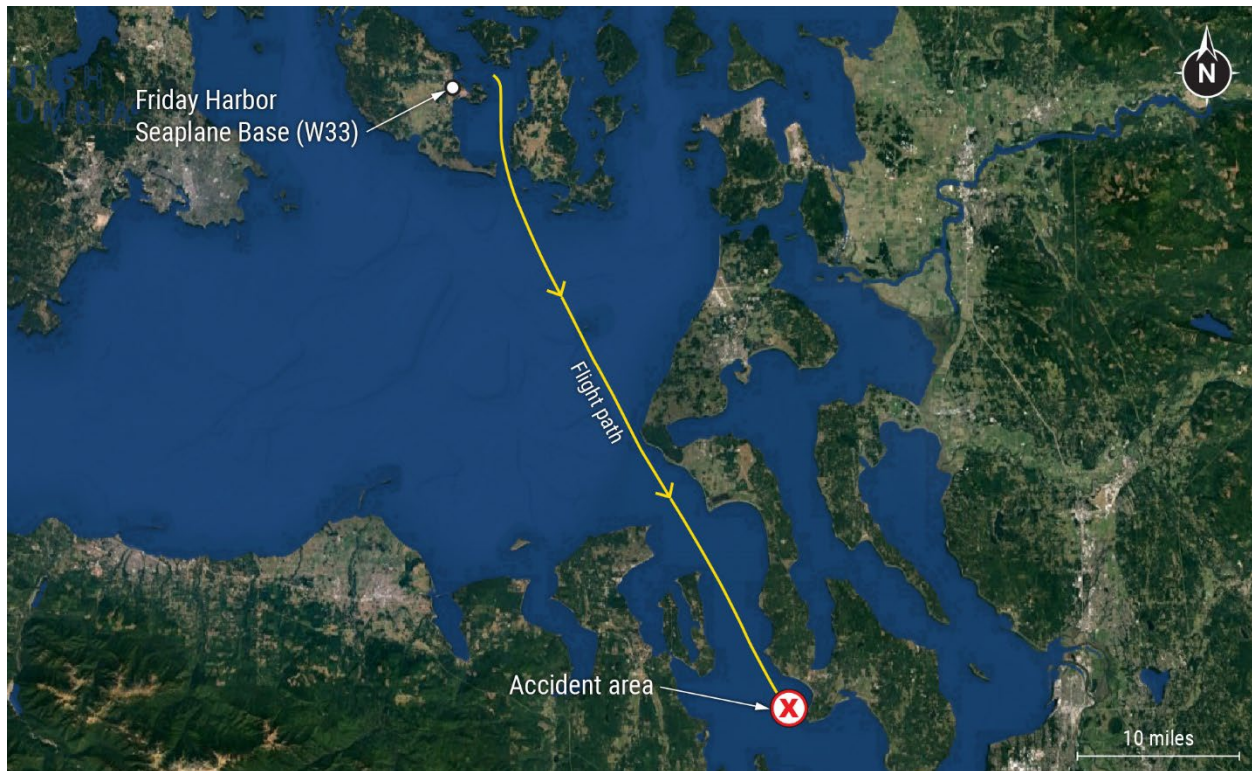
Figure 1. Flightpath of the accident airplane based on ADS-B data.

Witnesses near the accident site reported, and security camera video confirmed, the airplane was in level flight before it entered a slight climb and then pitched down. One witness described the descent as “near vertical” and estimated the airplane was in an 85° nose-down attitude before impact with the water. Several witnesses described the airplane as “spinning,” “rotating,” or “spiraling” during portions of the steep descent. One witness reported hearing the engine/propeller and noted that he did not hear any “pitch change” in the sounds. The airplane continued in a nose-low, near-vertical descent until it impacted water in Mutiny Bay.

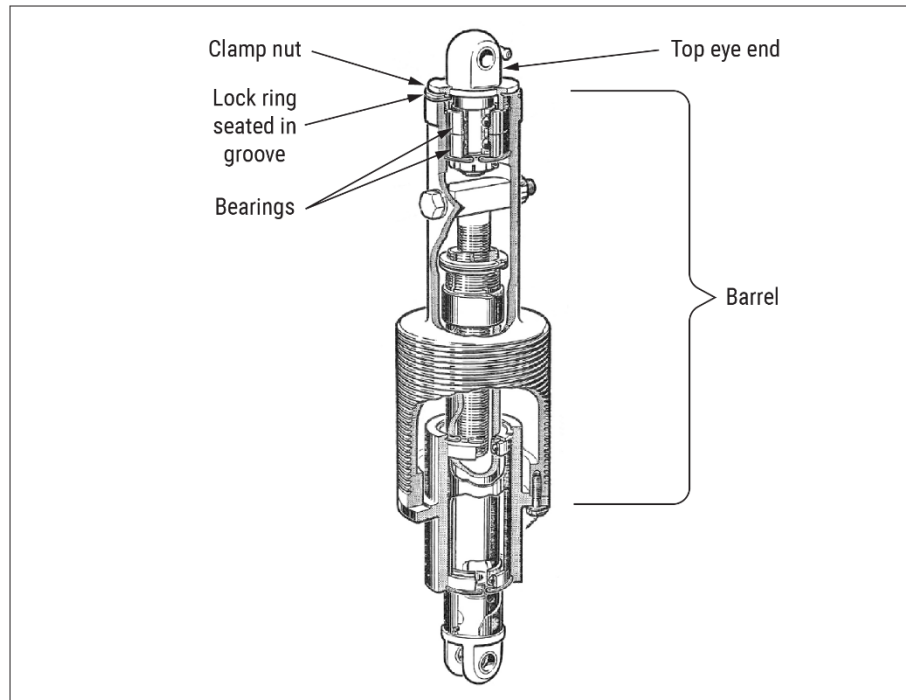
The horizontal stabilizer trim actuator is attached to the horizontal stabilizer with a bolt that connects the top eye end of the actuator to the rear mounting structure on the stabilizer. According to the DHC-3 aircraft maintenance manual (AMM), a clamp nut attaches the top eye end and bearing assembly to the barrel of

the actuator (see figure 4). Both the clamp nut and the barrel end of the horizontal stabilizer trim actuator are threaded so that the clamp nut can be securely screwed into the actuator barrel. The bearing assembly is designed to allow the barrel of the actuator to freely turn around the top eye end.

Figure 4. Horizontal stabilizer trim actuator (Source: Viking Air).

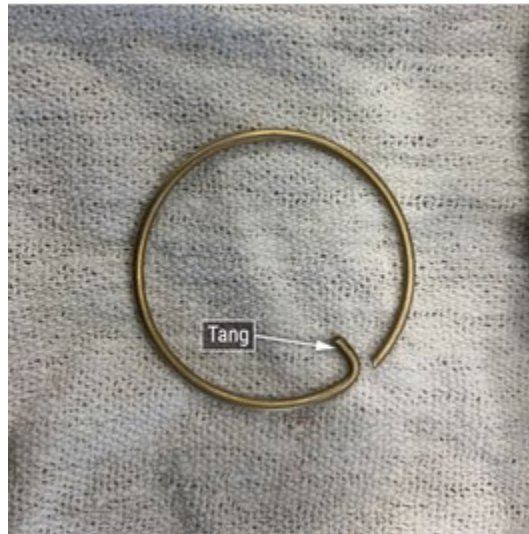
During normal assembly (at the time of manufacture), once the clamp nut is properly screwed into the horizontal stabilizer trim actuator barrel, a hole is drilled through the clamp nut (utilizing the existing hole in the lock ring groove of the barrel as a guide) that aligns with another hole in the lock ring groove on the actuator barrel.⁹ When the lock ring is installed on the barrel, the tang portion of the lock ring (the portion that is bent inward, as shown in figure 5) must pass through the hole in the actuator barrel and into the hole in the clamp nut, engaging both components and preventing the clamp nut from unscrewing from the actuator barrel.

⁹ For subsequent maintenance activities in which the clamp nut is removed, maintenance personnel would typically align the hole in the clamp nut with the existing hole in the lock ring groove on the actuator barrel upon reinstallation of the clamp nut. However, there is no guidance restricting the drilling of subsequent holes in the clamp nut.

Figure 5. Exemplar lock ring.

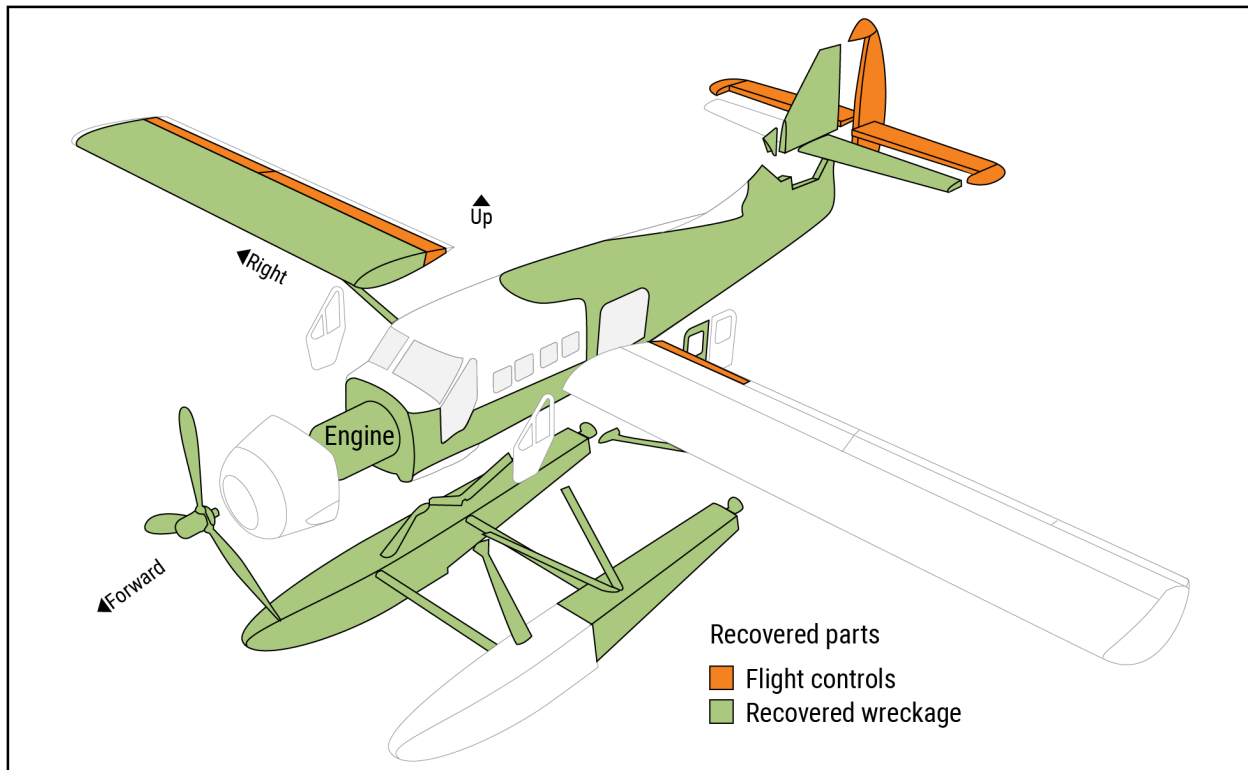
The airplane impacted Mutiny Bay and sank to a depth of about 200 ft. Wreckage was recovered between September 6 and September 30, 2022. After recovery from Mutiny Bay, the wreckage was transported to a secure facility for examination. The main items recovered included the nose fuel tank, engine mount and engine, propeller hub and blades, forward fuselage, center fuselage, tail section (empennage), right wing, most of the floats, some sections of flaps, and the left and right elevators (see figure 6).

Figure 6. A diagram of the recovered wreckage and flight controls (Source: Viking Air, recreated by NTSB).

The aft fuselage and empennage were separated from the rest of the airplane during recovery. The left side of the horizontal stabilizer, vertical stabilizer, and the lower portion of the rudder remained attached to the empennage. The left and right elevators were separated from the horizontal stabilizer.

An indentation in the shape of the horizontal stabilizer leading edge was observed on the left side fuselage skin just forward of the stabilizer cutout. The horizontal rib assembly installed in the aft fuselage below the horizontal stabilizer (shelf) and the fuselage side skins were crushed downward near the location of the stabilizer rear spar. Linear (fore-aft) scrapes were observed on the horizontal stabilizer lower skin rivet lines coincident with the edges of the shelf.

Most of the right side of the horizontal stabilizer was fractured off and not recovered. About 2 feet of the forward spar and leading edge of the right horizontal stabilizer remained attached. The forward end of this section was pulled outboard away from the fuselage and had a downward bend located about 6 inches from the root. The remaining part of the stabilizer fractured from this section on a 45° angle downward and aft. A downward indentation on the leading edge started at the stabilizer root and extended outboard about 2 feet.

The center and left side of the horizontal stabilizer remained attached to the forward hinge points in the aft fuselage and was twisted clockwise (as viewed looking down) about 15° around the center of the stabilizer. The entire left side of the stabilizer was mostly intact but was damaged and bent.

The right elevator was mostly intact but damaged and was separated from the stabilizer at the hinge points. The elevator was buckled with the outboard section bent upward and the forward and aft spars were broken at the upward bend. The right elevator counterweights and the servo tab were intact and in place.

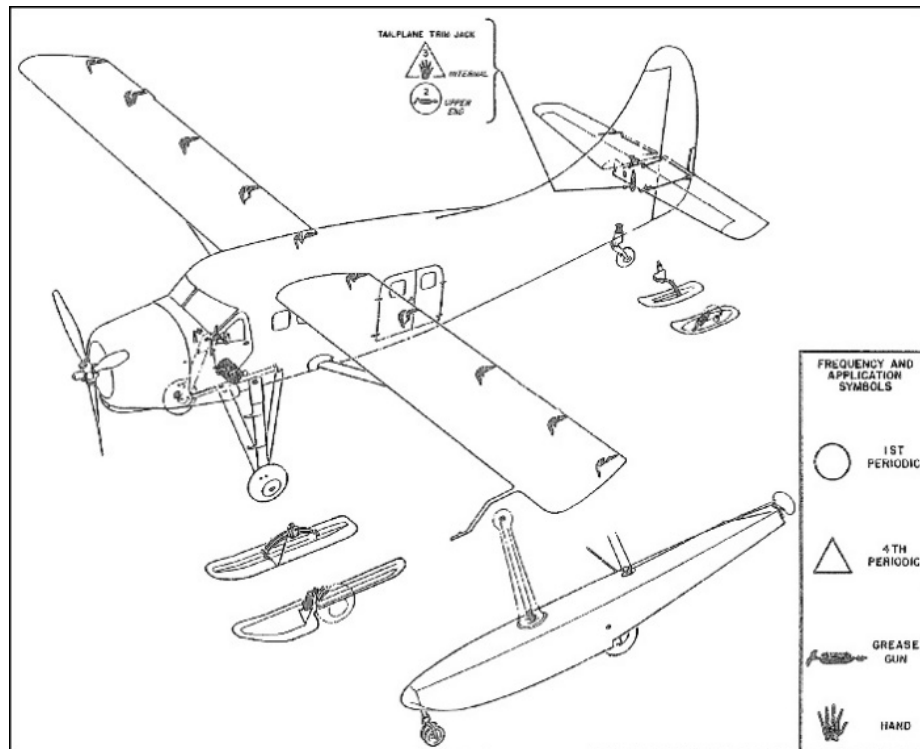
Regarding a lubrication schedule for the horizontal stabilizer trim actuator, a review of the DHC-3 AMM revealed a lubrication diagram that included symbols to specify the frequency and type of application; no written instructions were included regarding the lubrication requirements (see figure 13).⁴⁵ Based on the diagram, maintenance personnel should apply one type of grease to the upper end of the horizontal actuator using a grease gun at each 100-hour inspection and internally apply another type of grease, by hand, every 400 hours.⁴⁶

Figure 13. Lubrication diagram for the airplane (Source: Viking Air, edited by NTSB).
