Transport Accident  
Investigation  
Commission

# Final report

**Report of the Transport Accident Investigation Commission into  
two stevedoring accidents in April 2022**

***Maritime inquiry MO-2022-203  
Container vessel, Capitaine Tasman  
Stevedore fatality during container loading operations  
Port of Auckland  
19 April 2022***

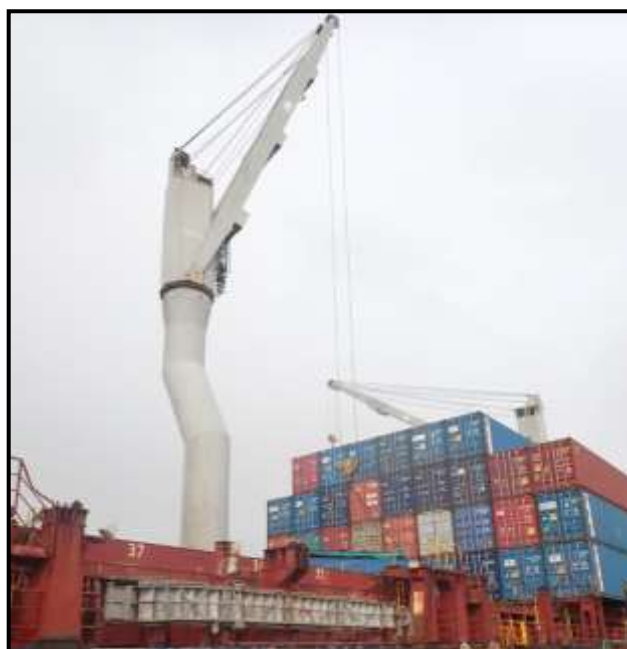
**Figure 13: Crane number three**

- A1.32. The vessel's cargo-handling equipment consisted of three onboard cranes. Each crane was operated from a cab that was accessed via internal ladders within the crane pedestals.
- A1.33. Each crane had the ability to slew<sup>59</sup> 360 degrees and had a safe lifting weight of 45 tonnes. Crane number three (see Figure 13) had a work radius<sup>60</sup> of 3.5 metres to 29.0 metres and the maximum hoist speed with a load was 19 metres per minute.

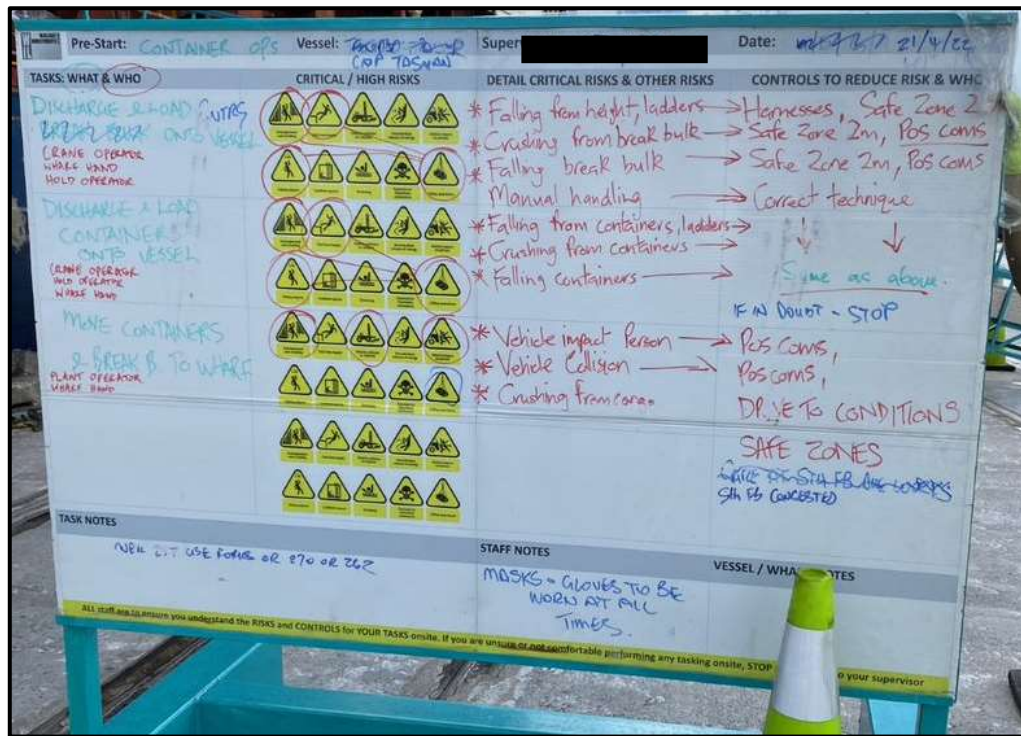
**Figure 14: Pre-start meeting board**  
(Credit: Wallace Investments Limited)

- A1.61. The supervisors overseeing the gangs conducted pre-start meetings at the beginning of every shift on an operational worksite. Critical risks associated with each role within the gang were identified along with the applicable lifesaver controls. The briefings were recorded on a whiteboard and were photographed and uploaded to Mango for safety assurance purposes. The pre-start board for 19 April 2022<sup>73</sup> is shown in Figure 14.

<sup>73</sup> The date on the board has been changed to reflect the pre-start briefing which took place when operations resumed following the accident, however, the content remains the same as it was on the morning of the event.

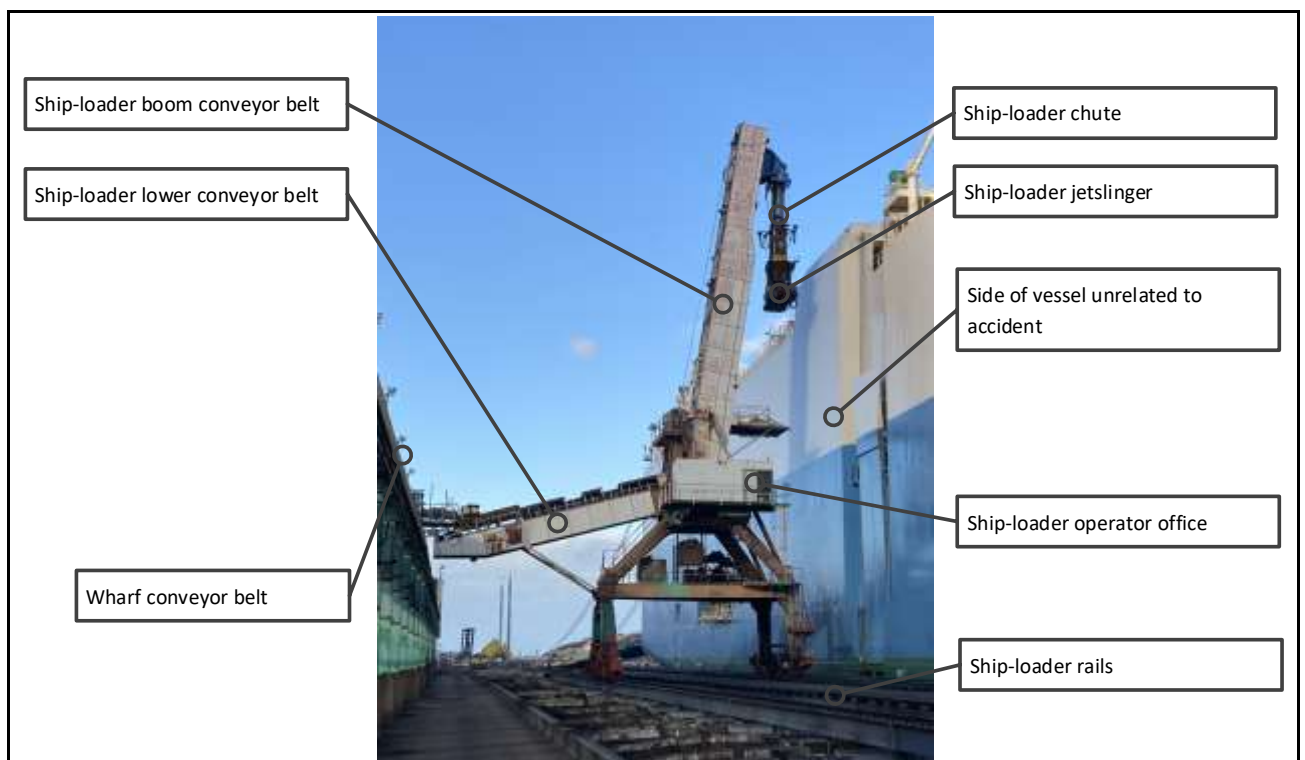
**Figure 16: LPC ship-loader in its stowed position next to a car carrier vessel**

- B1.4. Lyttelton Port has a coal stockpile facility and coal loading operation. The coal was moved from the stockpile to the vessel via conveyor belts. The final stage of the process, loading coal into the vessel's hold, used specialist equipment known as a ship-loader.
- B1.5. The ship-loader travelled on rails parallel to the edge of the wharf. The wharf conveyor belt fed coal onto the ship-loader lower conveyor belt, which then fed the coal onto the boom conveyor belt, which in turn fed it into the loader chute, from which it passed out through the jetslinger and into the ship's hold (see Figure 16 and Figure 17).
- B1.6. The jetslinger incorporated a short conveyor belt moving at high speed to direct the coal in the direction and elevation required.

- B1.12. The ship-loader operator made their way to the ship-loader operator office within the ship-loader (see Figure 16) and at about 0700, after a limited handover from the ship-loader operator going off-shift, they assumed control of the ship-loader. The signalman had made his way onboard the vessel and began their shift at about 0700.

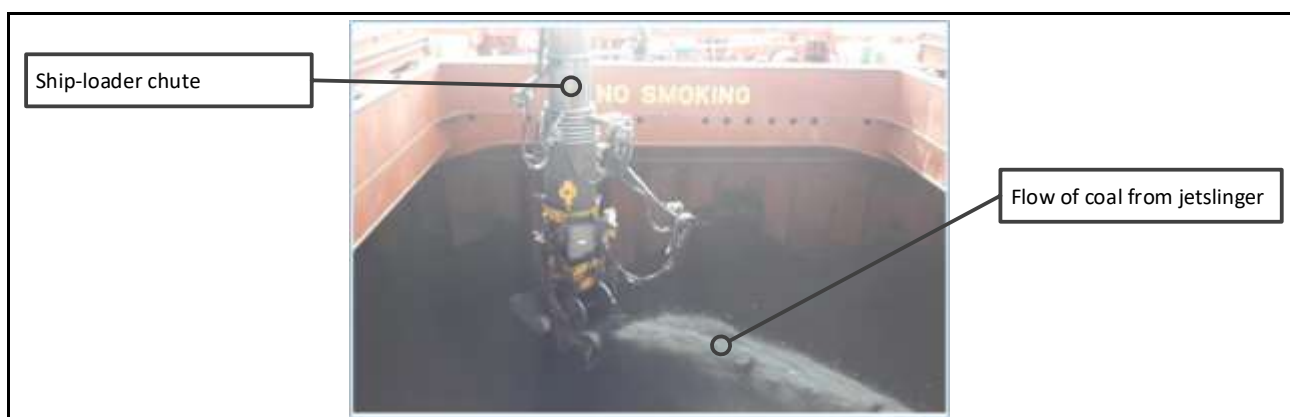
**Figure 17: Jetslinger in operation, loading coal onto a different vessel**

- B1.16. Throughout the loading process, coal was flowing from the jetslinger (see Figure 17) continuously. Usually, the flow of coal was only stopped by the ship-loader operator when it was necessary to move the ship-loader between cargo holds.
