Aviation Investigation Preliminary Report

Location:	Portland, OR	Accident Number:	DCA24MA063
Date & Time:	January 5, 2024, 17:14 Local	Registration:	N704AL
Aircraft:	Boeing 737-9	Injuries:	177 None
Flight Conducted Under:	Part 121: Air carrier - Scheduled

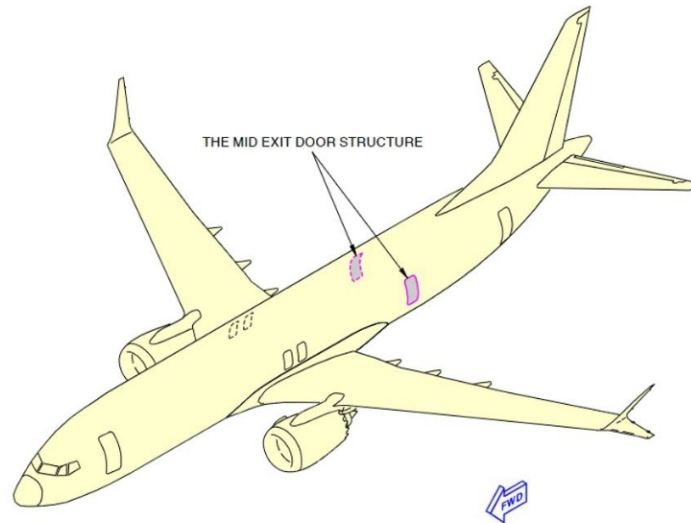
The airplane was equipped with a MED plug option (see figure 2 and third image in figure 3 below), which Alaska Airlines had selected based on its desired seating configuration. Benefits afforded by the plug option include:

Figure 2. Diagram showing the mid exit door locations. (Source: Boeing. Image Copyright © Boeing. Reproduced with permission.)

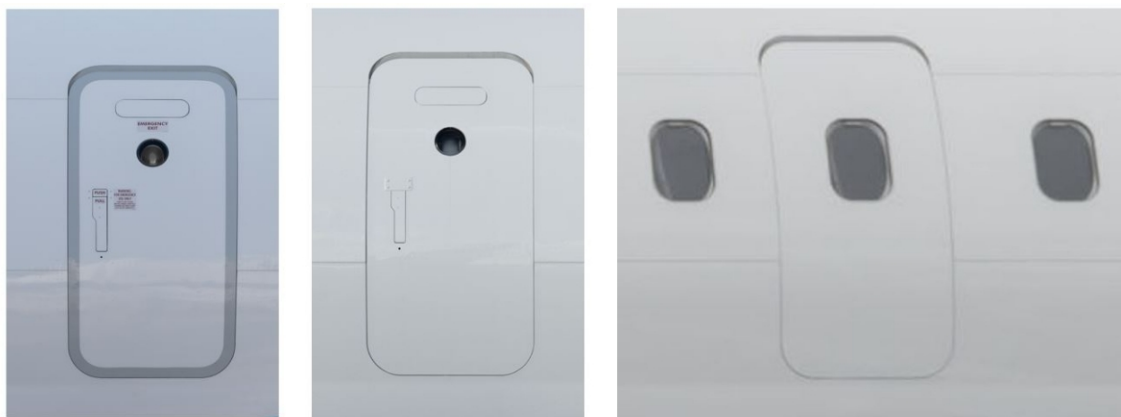
Figure 3. Three types of mid exit doors. (Source: Boeing. Image Copyright © Boeing. Reproduced with permission.)
