Shorebird nest fates at Boca Chica after rocket test launch

Prepared by Justin LeClaire, David Newstead
Coastal Bend Bays & Estuaries Program
June 6, 2024

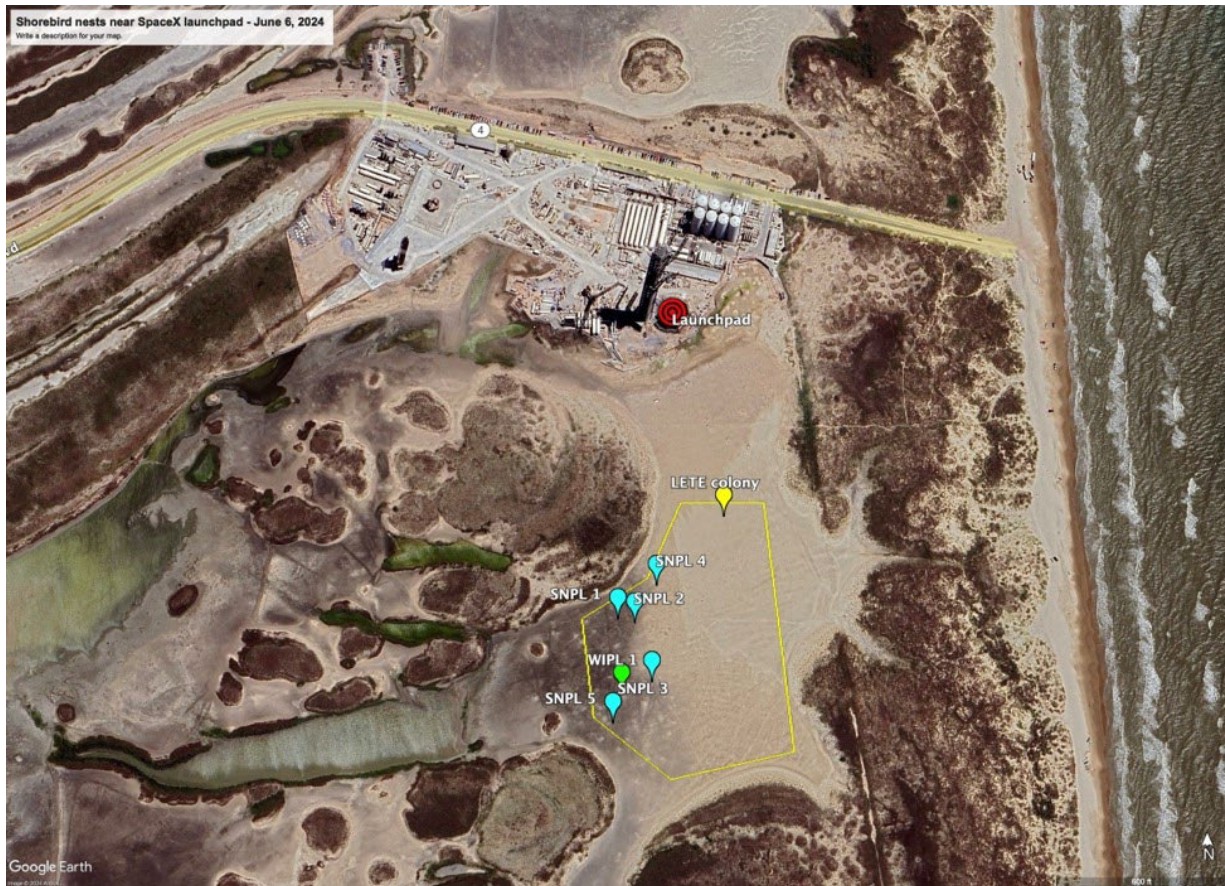
Figure 1. Map of the South Launch subsite at Boca Chica showing the locations of active plover nests and a dispersed Least Tern colony on June 5, 2024 in relation to the rocket launchpad.

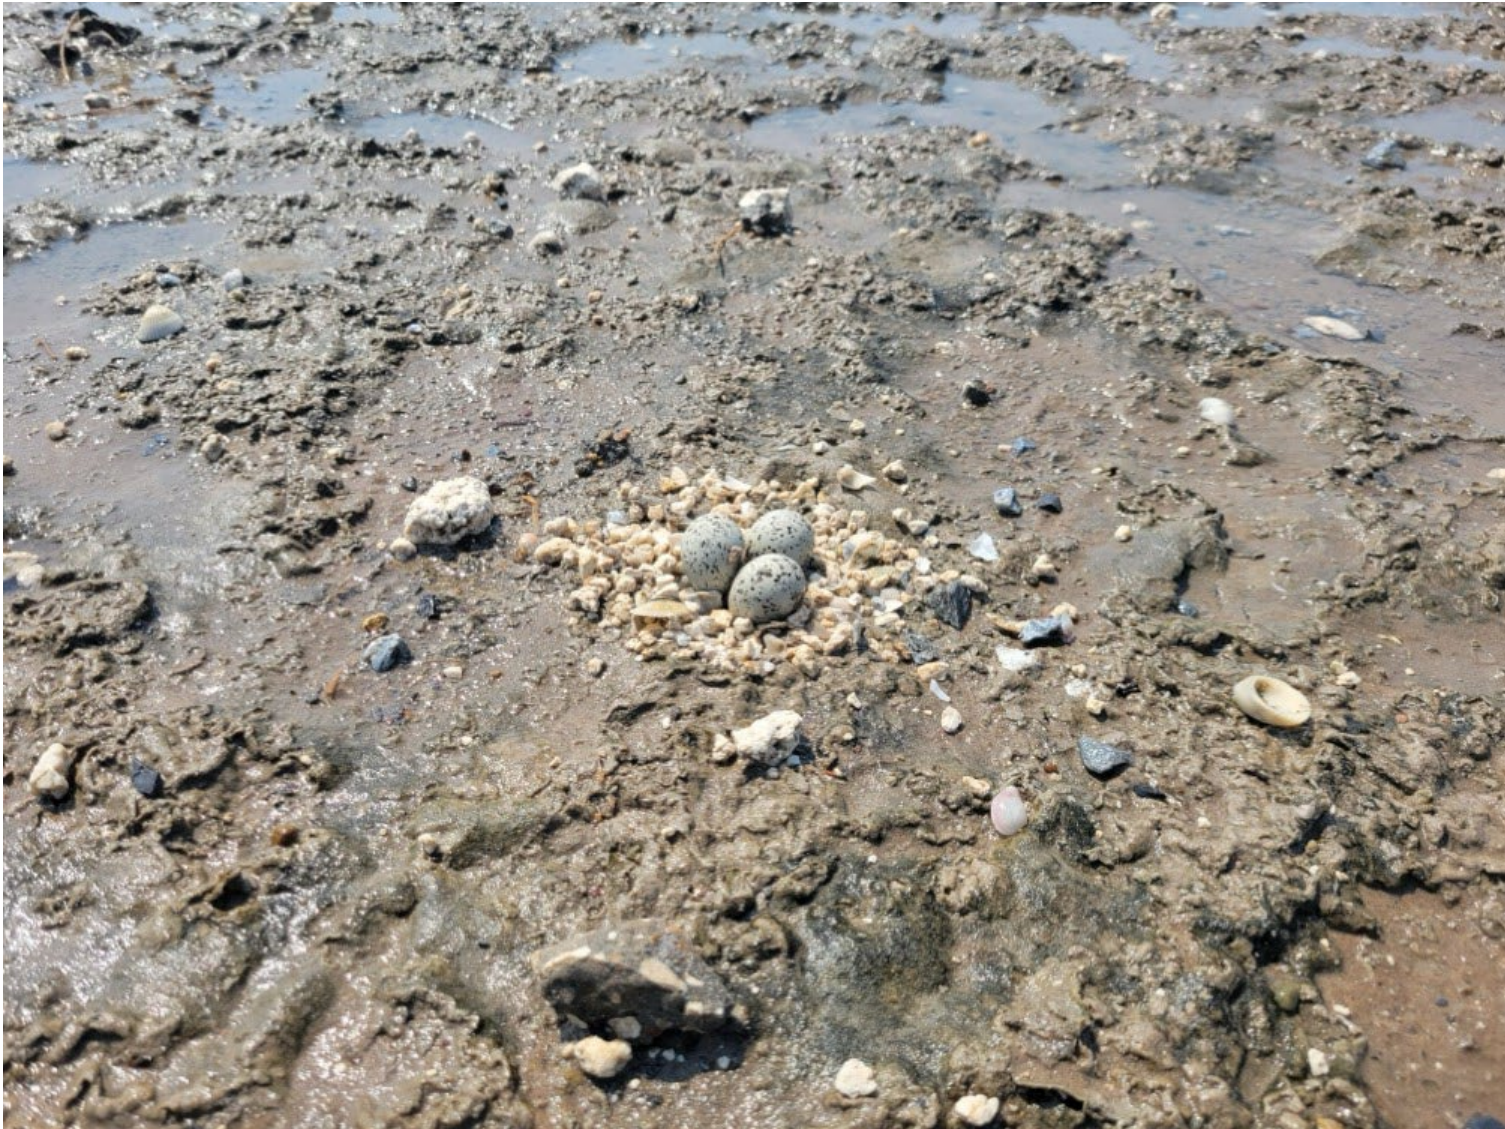
Figure 2. SNPL 1 nest intact and with 3 eggs on June 5, the day before the rocket test launch.

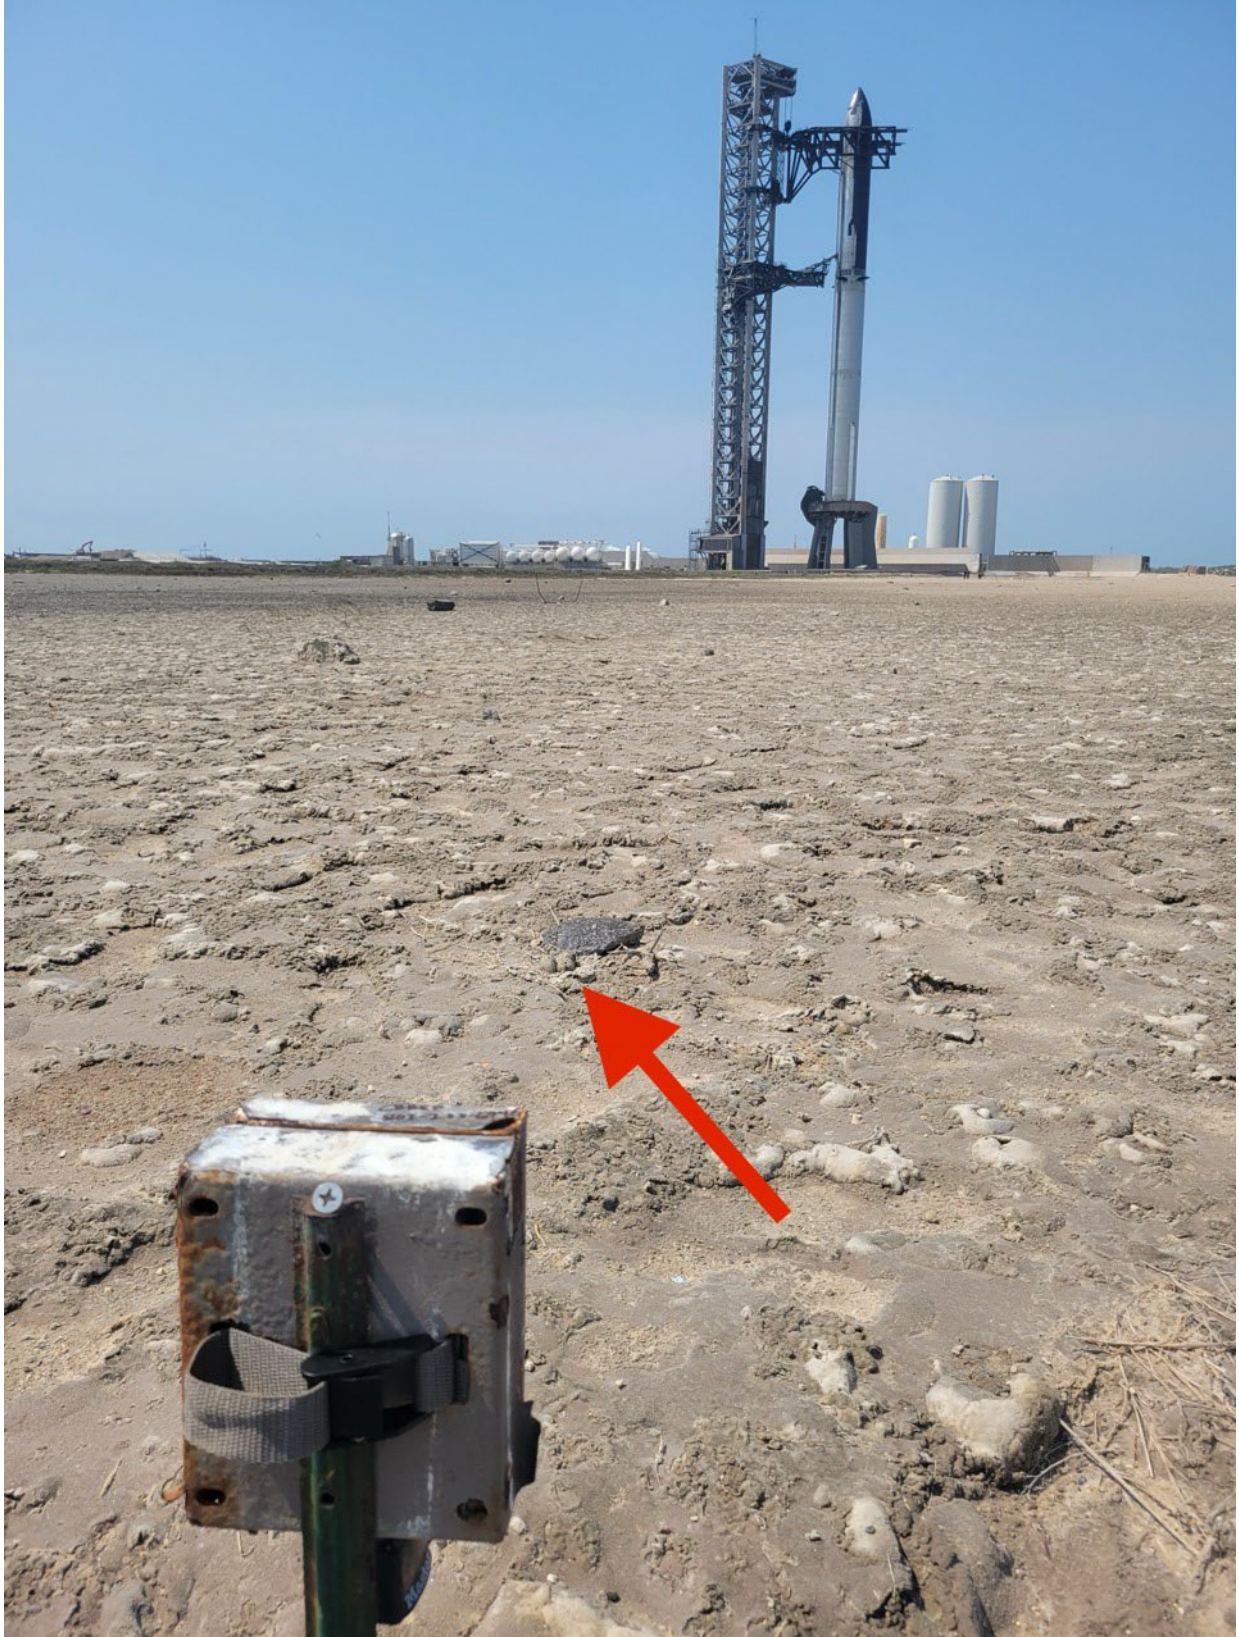
Figure 13. WIPL 1 as referenced by red arrow with game camera installed nearby facing north pre-launch on June 5, 2024.

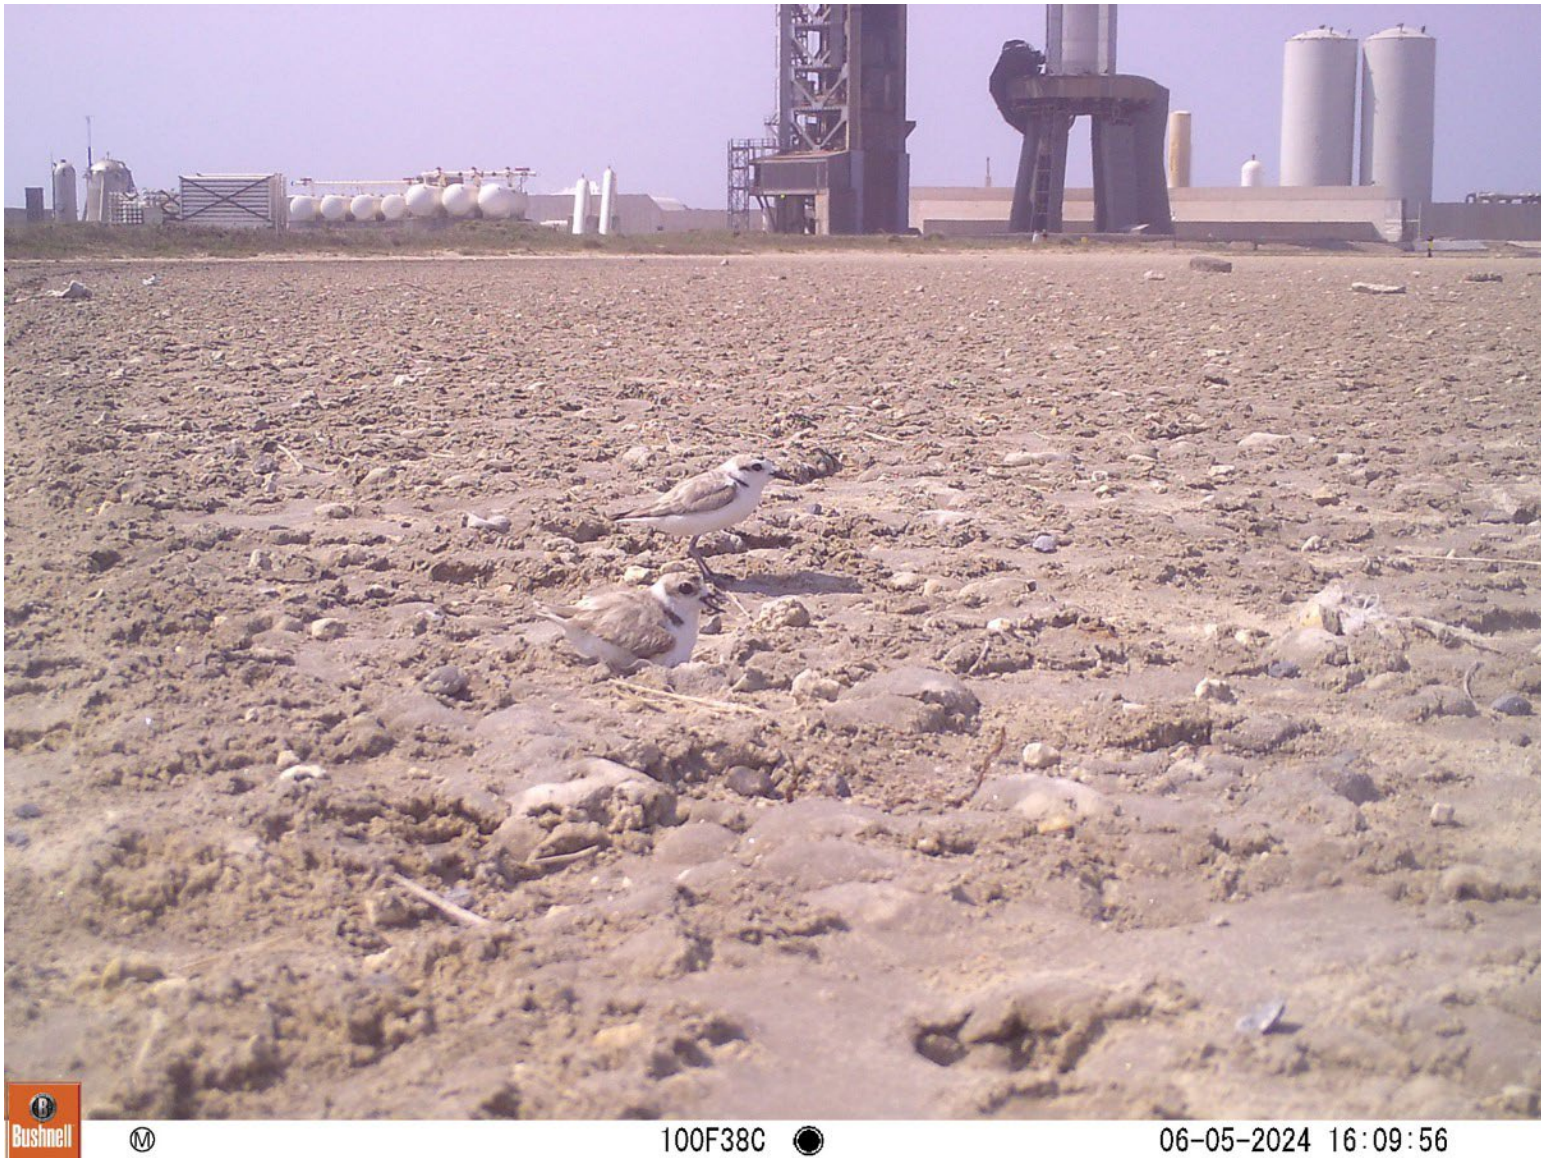
- SNPL 2 camera: camera angle did not allow for clear viewing of nest contents, but the SNPL pair did return to incubate the 3-egg nest after camera installation for a few photos. No other photographs were taken until 7:50am on June 6, just after the rocket launch when the dust cloud and debris can again be seen rapidly moving towards the camera. Nest contents are not perfectly clear in the images but the edge of at least two eggs appear to be visible in the nest cup. The images turn a yellowish hue after the dust settles and no more photographs were taken until CBBEP staff checked the nest at 12:28pm. The nest was then observed with just a single egg in it that was cracked and no longer viable, though the attending SNPLs were still incubating the nest.

Figure 21. SNPL pair incubating SNPL 2 shortly after the game camera was set up pre-launch on June 5, 2024.

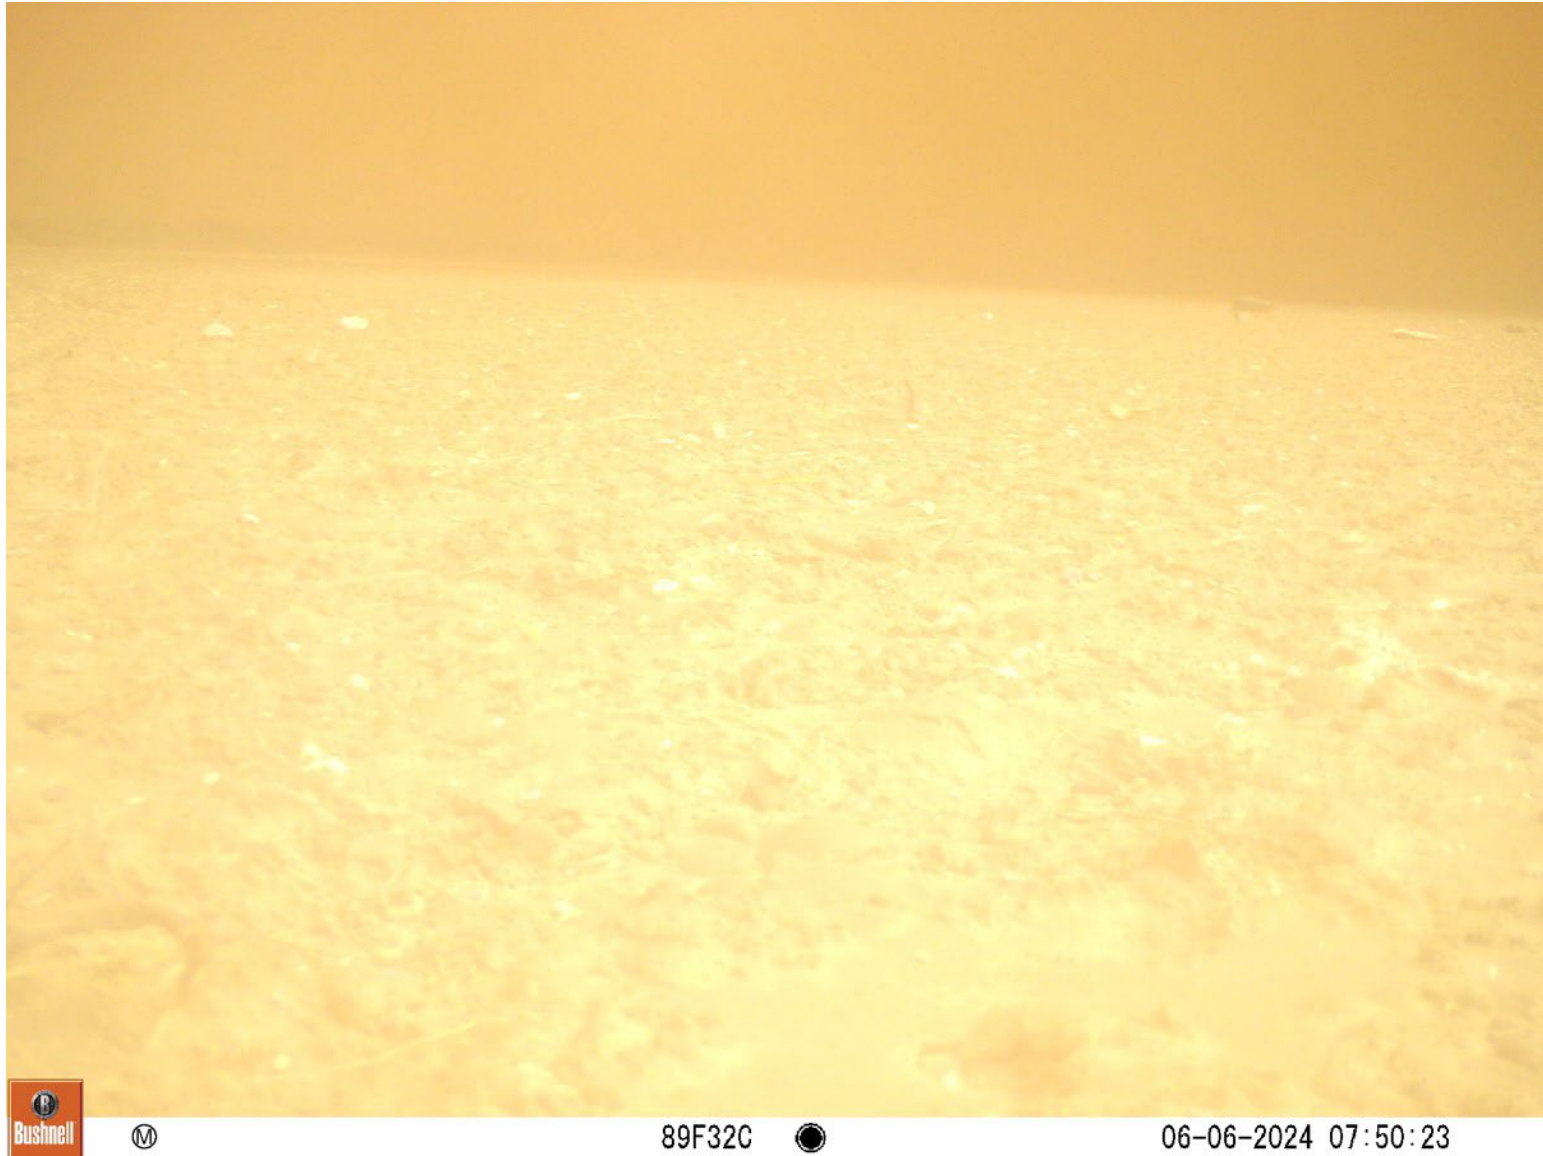
Figure 23. The last SNPL 2 game camera photograph taken post-launch until CBBEP staff checked the nest 4.5 hours later on June 6, 2024.

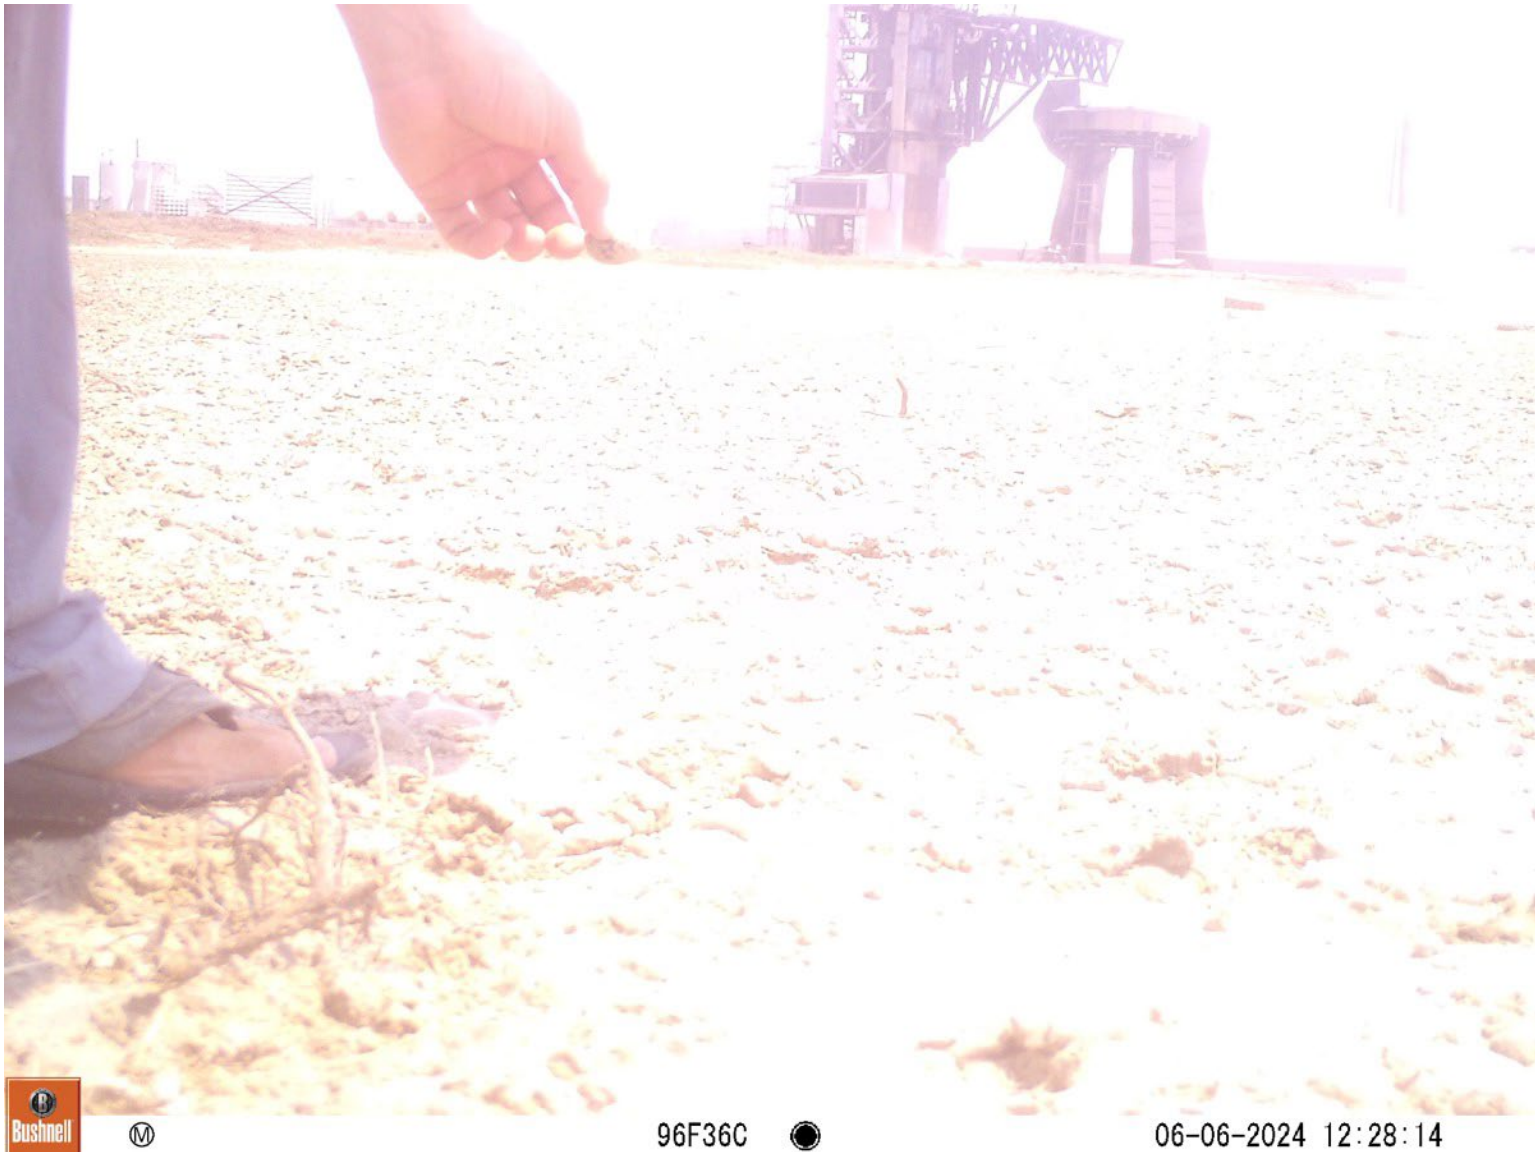
Figure 24. SNPL 2 game camera with CBBEP staff checking SNPL 2 nest post-launch on June 6, 2024, proving camera is still operational despite limited clarity.
