REINFORCED AUTOCLAVED AERATED CONCRETE (RAAC) ROOF PANEL ASSESSMENT

Ontario Science Centre Building A – B14175
770 Don Mills Road, North York, ON

Infrastructure Ontario and Ministry of Infrastructure
June 18, 2024

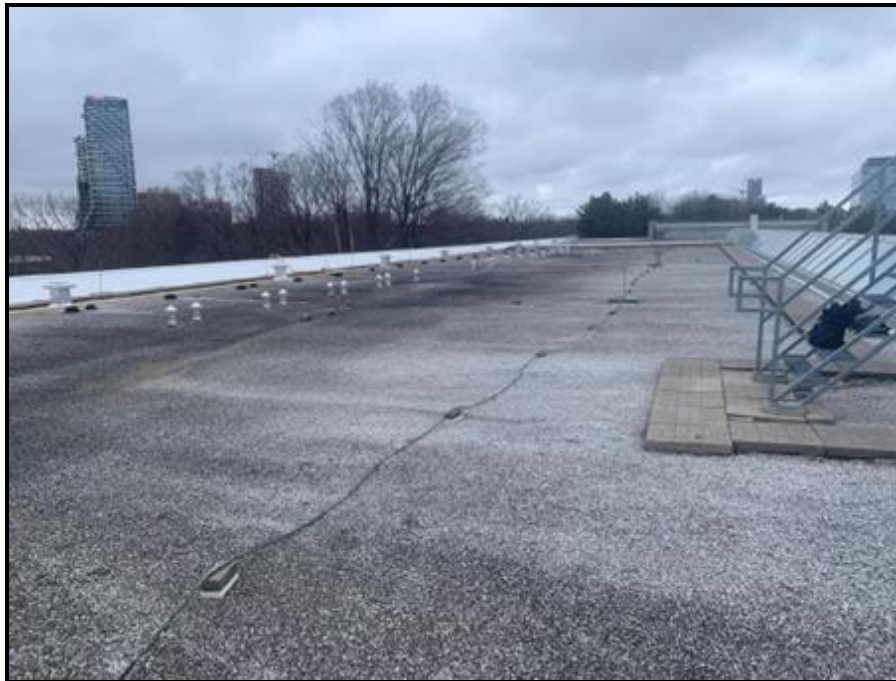
Photograph 22
Repair Area A2 - Repair broken gas line support

Roof Area	Observations
A2	<p>Repair Location A2</p> <ul style="list-style-type: none"> - Repair broken gas line support on the north end of Roof area A2 (Photograph 22) - Remove excessive algae growth on the north end of roof area. (Photograph 23) - Remove organic debris from roof drain at the north end of roof area A2. (Photograph 24) - Remove organic debris from expansion joint between roof areas A2 and A3. (Photograph 25)
A3	<p>General</p> <ul style="list-style-type: none"> - The existing roofing assembly is considered to be in fair condition. With an expected serviceable life of 5 to 10 years (Photograph 26) - Very low termination at the louvered grate located on the north end of Roof area A3, possibility for water migration into the existing roof system - Organic debris observed at the north end of roof area A3 - Minor algae accumulation at the north end of Roof area A3 - Area of deteriorated sealant, possibility of water migration into the existing roof system at the north end of roof area A3

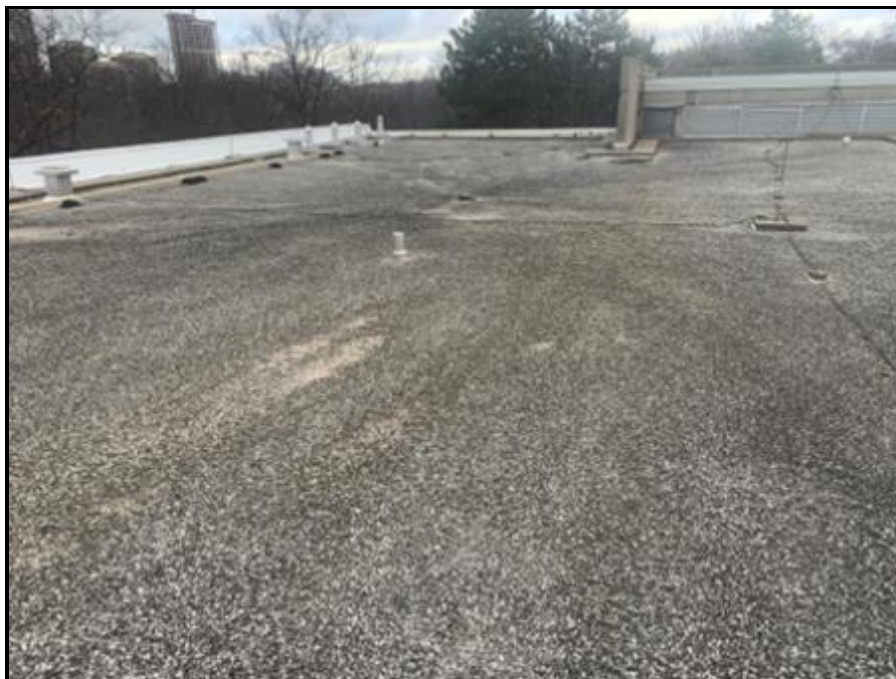
Photograph 27

Repair Area A3 - Remove organic debris observed at the north end of roof area A3

A3	<p>Repair Location A3</p> <ul style="list-style-type: none"> - Remove organic debris observed at the north end of roof area A3. (Photograph 27) - Remove minor algae accumulation at the north end of Roof area A3 (Photograph 28) - Remove and replace area of deteriorated sealant at the north end of roof area A3 (Photograph 29)
A4	<p>General</p> <ul style="list-style-type: none"> - The existing roofing assembly is considered to be in fair condition. With an expected serviceable life of 5 to 10 years. (Photograph 30) - Sealant deficiency at reglet possible source of water migration into roof system - Minor organic debris accumulated at the existing roof drain
A4	<p>Repair Location A4</p> <ul style="list-style-type: none"> - Remove and replace Sealant deficiency at reglet (Photograph 31) - Remove minor organic debris accumulated at the existing roof drain (Photograph 32)

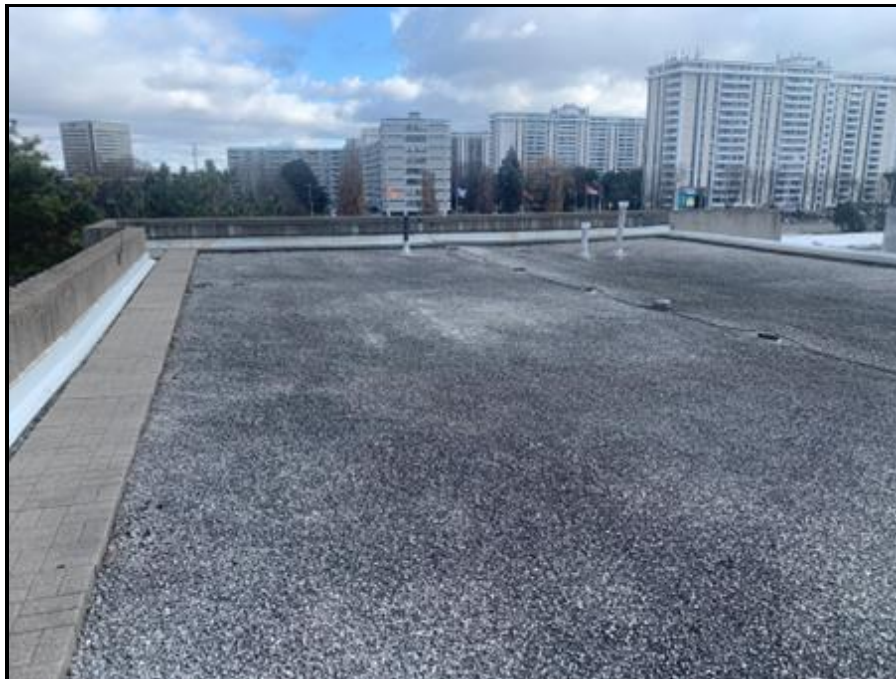
Photograph 31

Repair Area A4 - Remove and replace Sealant deficiency at reglet

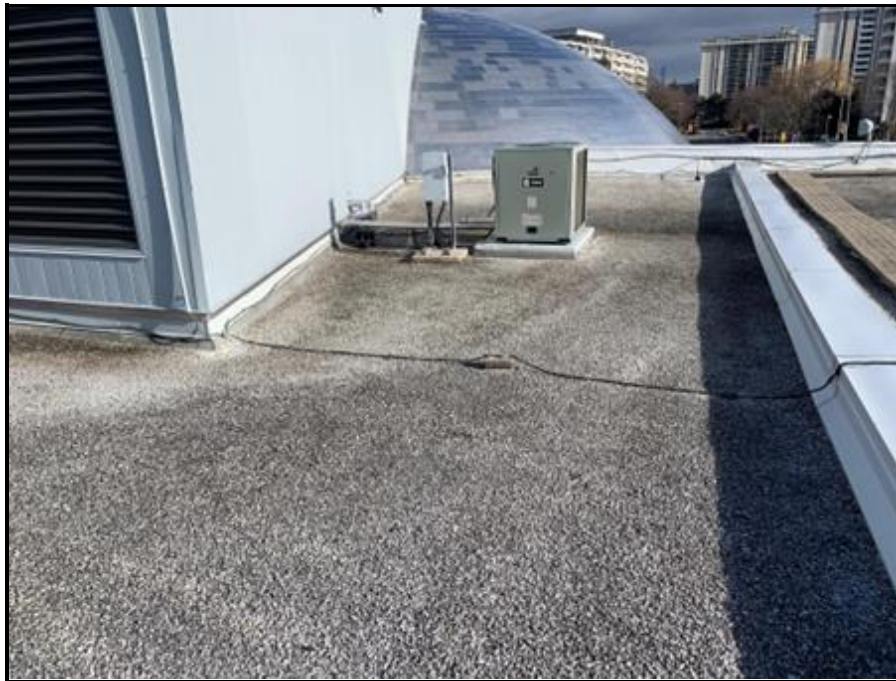
Photograph 39

Repair Area A6a - Repair minor depression in the existing membrane at the entrance to the mechanical room. Install membrane protection under the existing patio stone

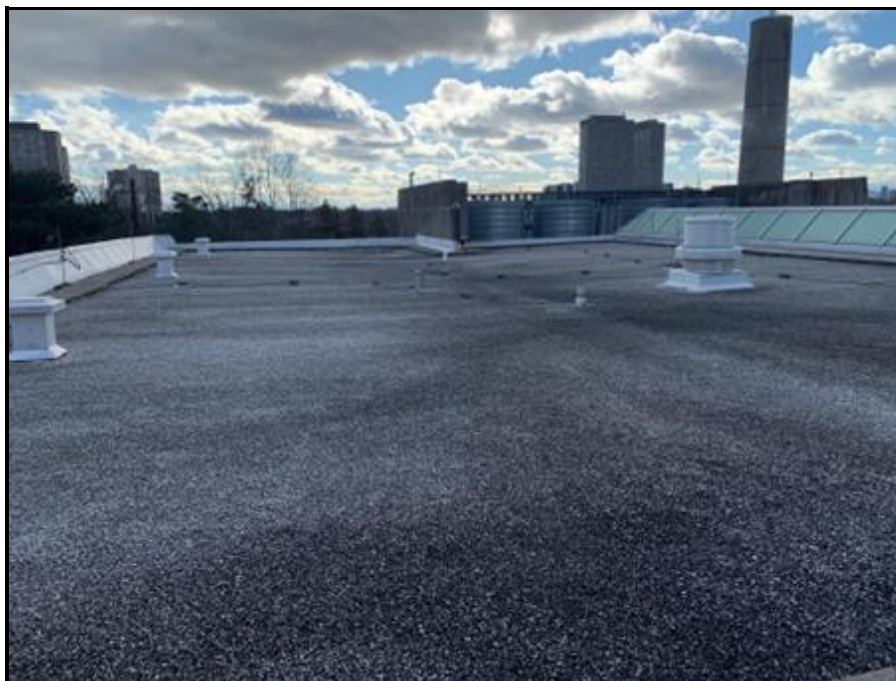
Photograph 43

Repair Area A7 - Remove minor algae accumulation located at the south drain
