**UNITED STATES AIR FORCE**  
**AIRCRAFT ACCIDENT INVESTIGATION**  
**BOARD REPORT**

**CV-22B, T/N 10-0054**

**LOCATION: YAKUSHIMA ISLAND, JAPAN**

**DATE OF ACCIDENT: 29 NOVEMBER 2023**

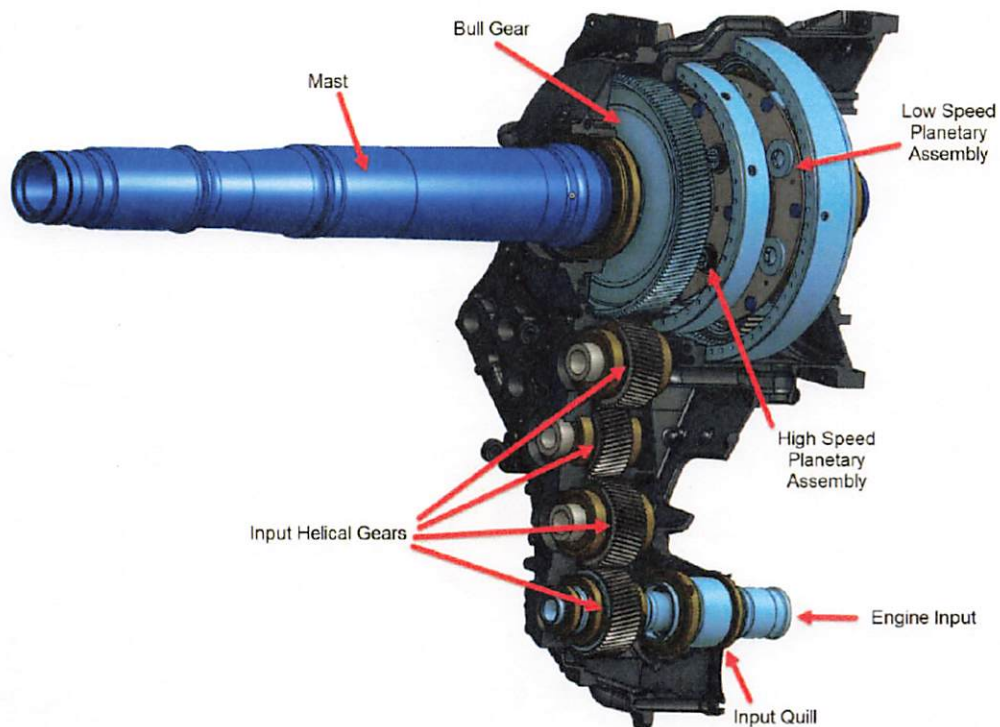
Figure 3. PRGB Schematic (Tab J-356)

The CV-22B has two proprotor gearboxes (PRGB), one mounted in each nacelle (Tab DD-7). The PRGB transmits power and provides speed reduction from the engine to the proprotors (Tab DD-7).

While all engines are operating, torque is supplied to each PRGB directly from their respective side's engine (Tab DD-7). The left-hand and right-hand PRGBs are essentially mirror images of each other, except that the left-hand PRGB has an extra idler gear to provide counterclockwise rotation of the left-hand propotor, while the right-hand PRGB turns clockwise (Tab DD-7). The PRGB has two independent and separate lubrication systems (Tab DD-7). A primary lubrication system is integral to the PRGB, and a secondary emergency lubrication system provides 30 minutes of operation if the primary drops below 30 pounds per square inch oil pressure (Tab DD-7). Each PRGB has chip detectors, used to detect ferrous particles (Tab DD-7).

The PRGB is designed to receive power from the same side engine via the input quill, which is where the clutch assembly is housed (Tab J-355). The clutch assembly transmits the power into the PRGB through the input helical gears (four in left-hand PRGB and three in right-hand PRGB) to the helical gear set on the bull gear (Tab J-355). The bull gear helical gear set also meshes with the interconnect helical idler gear, which meshes with the interconnect helical gear to power the pylon driveshaft (part of the interconnecting drive system (ICDS)) (Tab J-355). In the event of a same side engine failure, this design allows the opposite side's engine to power the PRGB by transferring power through the ICDS/pylon driveshaft to the interconnect gears and then the bull gear helical gear set (Tab J-355). When both engines are operating, it is possible for the bull gear to be driven simultaneously by both the input helical idler gear (from the same side engine) and interconnect helical idler gear (from the opposite side engine) to receive additional power from the opposite side engine (Tab J-355).

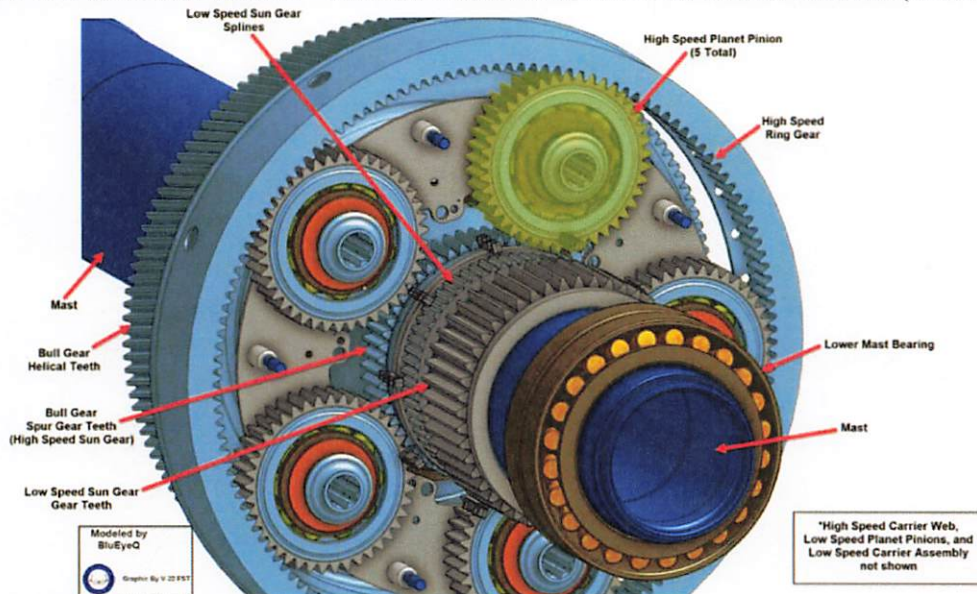
**Figure 4. PRGB Schematic – HS Sun Gear Mesh with HS Planet Pinions (Tab J-359)**

Power is then transferred through a set of splines on the high-speed carrier in mesh with the low-speed sun gear's forward splines (Tab J-355). The low-speed sun gear aft gear set then drives the low-speed planet pinions (Tab J-355). The low-speed planet pinions are also meshed with the low-speed ring gear (which is fixed to the PRGB housing), and thus, drive the low-speed carrier assembly (Tab J-355). The low-speed carrier has splines which mesh with splines on the PRGB mast (Tab J-355). Note that the mast is positioned through the centers of the bull gear, high-speed carrier assembly, and low speed carrier assembly, but is driven only by the low-speed carrier assembly (Tab J-355). As the low-speed carrier drives the mast, the mast drives the respective propotor (Tab J-355). This PRGB gear train provides an increase in torque and reduction in speed from the engine to the mast (speed ratio of 37.798 to 1) (Tab J-355).

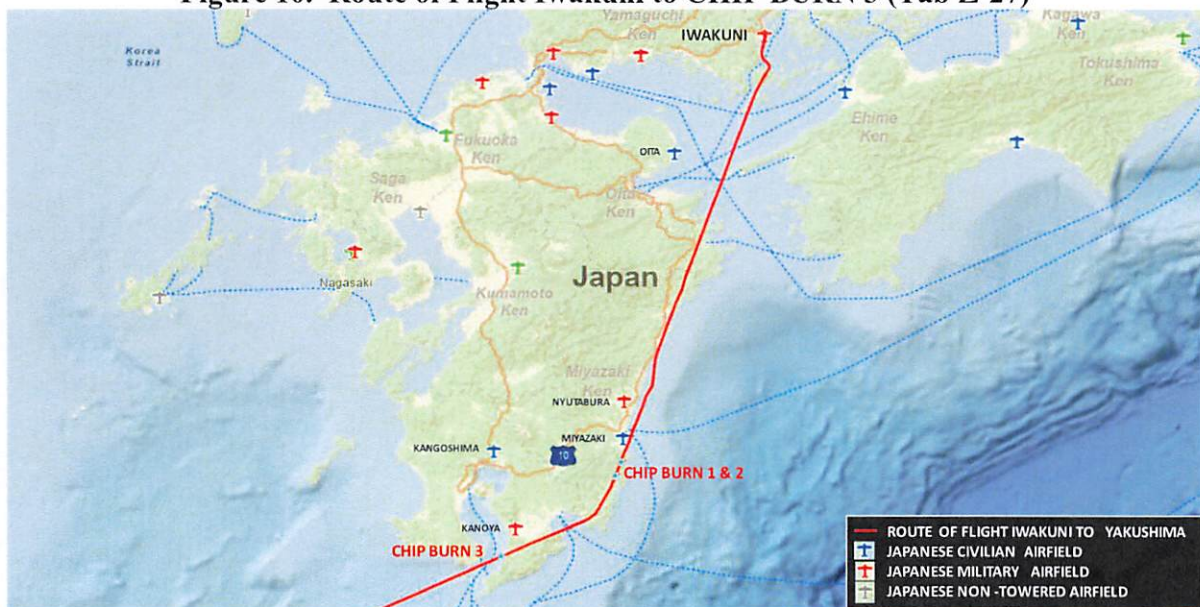
**Figure 10. Route of Flight Iwakuni to CHIP BURN 3 (Tab Z-27)**

As the formation approached the southern tip of mainland Japan, 12 minutes after the second chip burn advisory, the MSMAFE announced a third left-hand PRGB CHIP BURN advisory and the MP verbally acknowledged (Tabs DD-48, and II-51). MSMAFE notified the MC that per NFM guidance, they were now in “Land as Soon as Practical” criteria and confirmed there were no secondary indications (Tab II-51). The MP marked the time for the third chip burn advisory and told the MC to monitor the times to see if their frequency increased and to continue monitoring for secondary indications (Tab II-52). The MC discussed that eventually the nearest airfield would be on Okinawa, but at that moment, the MA was still approximately 300 NM from Okinawa, all over open water (Tabs DD-48 and II-48). The MC did not discuss the actual nearest airfield, Kanoya AB, which was approximately 10 miles behind their current position (Tabs Z-27 and DD-48). The MP called G21 on the formation interplane frequency to communicate they had three PRGB CHIP BURN advisories but planned to continue the mission (Tab II-52). During that radio transmission, five minutes after the third left-hand PRGB CHIP BURN advisory, a fourth left-hand PRGB CHIP BURN advisory posted (Tab II-52). The IBR was receiving information, but aircraft mission systems were still not operational, so the MSMAFE left his seat to assist the MSMATS in troubleshooting the IBR connection (Tabs DD-48, and II-54).

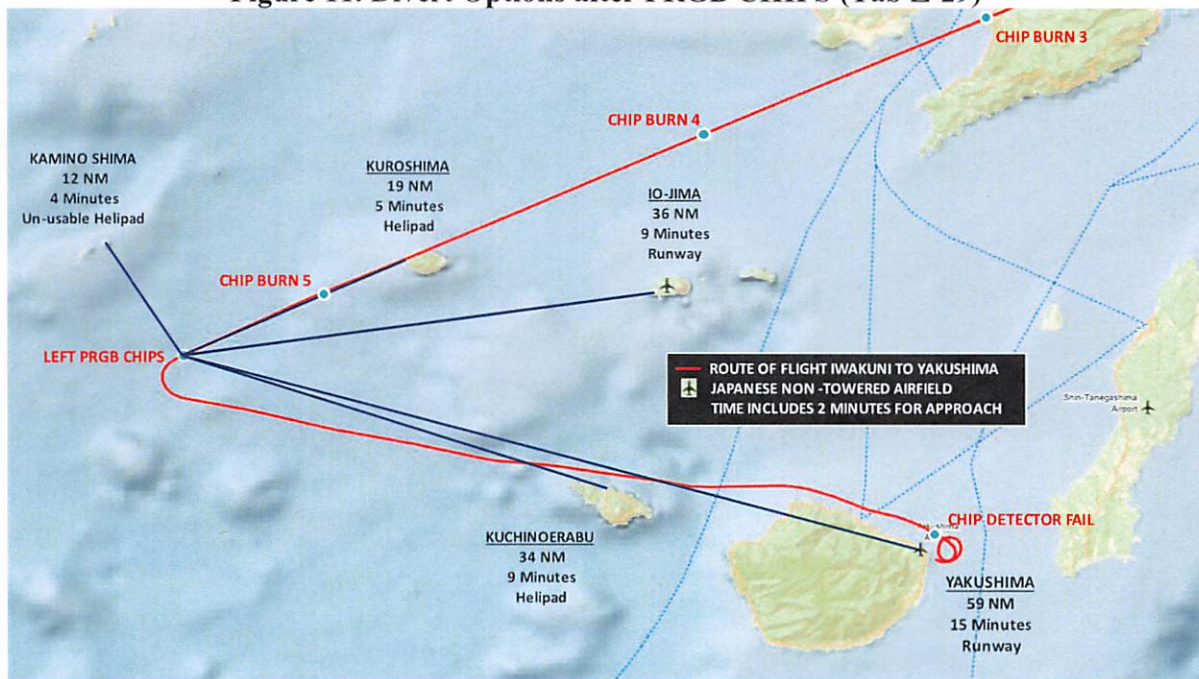
**Figure 11. Divert Options after PRGB CHIPS (Tab Z-29)**

At this time, closer divert possibilities existed, including a vertical landing option at Kuroshima, and a roll-on landing option at Satsuma-IoJima Airport, which is represented in Figure 11 (Tab Z-29). Four minutes after the PRGB CHIPS caution post, without further discussion of divert options, the MC began a gradual descent to 1,000 feet MSL to setup the MA for entry into the aircraft traffic pattern at Yakushima airport (Tabs DD-49, and II-58).

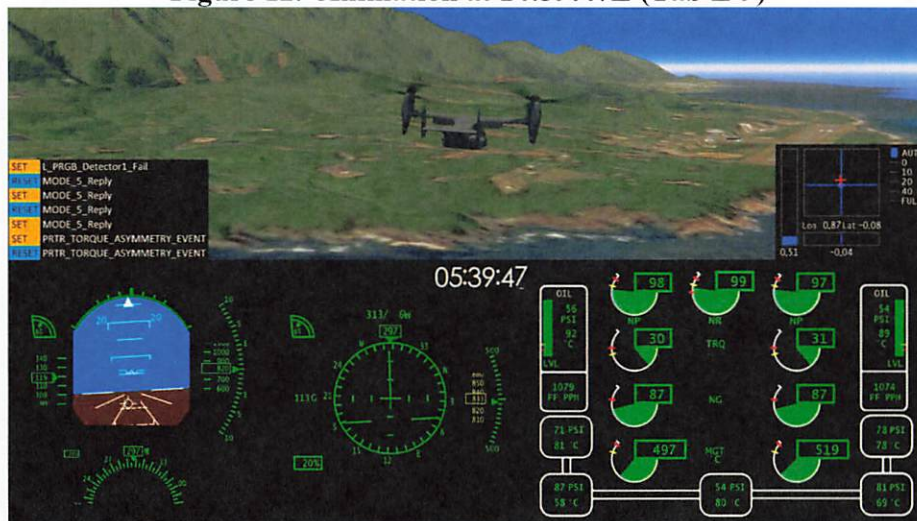
**Figure 12. Animation at 14:39:47L (Tab Z-9)**

Within the last six seconds of data, cascading failures in short succession were recorded by the KVADR (Tab DD-49). Audible engine surges could be heard in the ambient recording from the cockpit microphone, followed by an auditory master caution tone (Tab DD-49). Left-hand PRGB oil pressure rapidly dropped with an associated, “L PRGB OIL PRESS LOW” caution, followed by a voice warning, “DRIVESHAFT FAILURE, DRIVESHAFT” (Tabs DD-49, and II-64).
