UNITED STATES AIR FORCE
AIRCRAFT ACCIDENT INVESTIGATION
BOARD REPORT

CV-22B, T/N 10-0054

21st SPECIAL OPERATIONS SQUADRON
353rd SPECIAL OPERATIONS WING
YOKOTA AIR BASE, JAPAN

DATE OF ACCIDENT: 29 NOVEMBER 2023

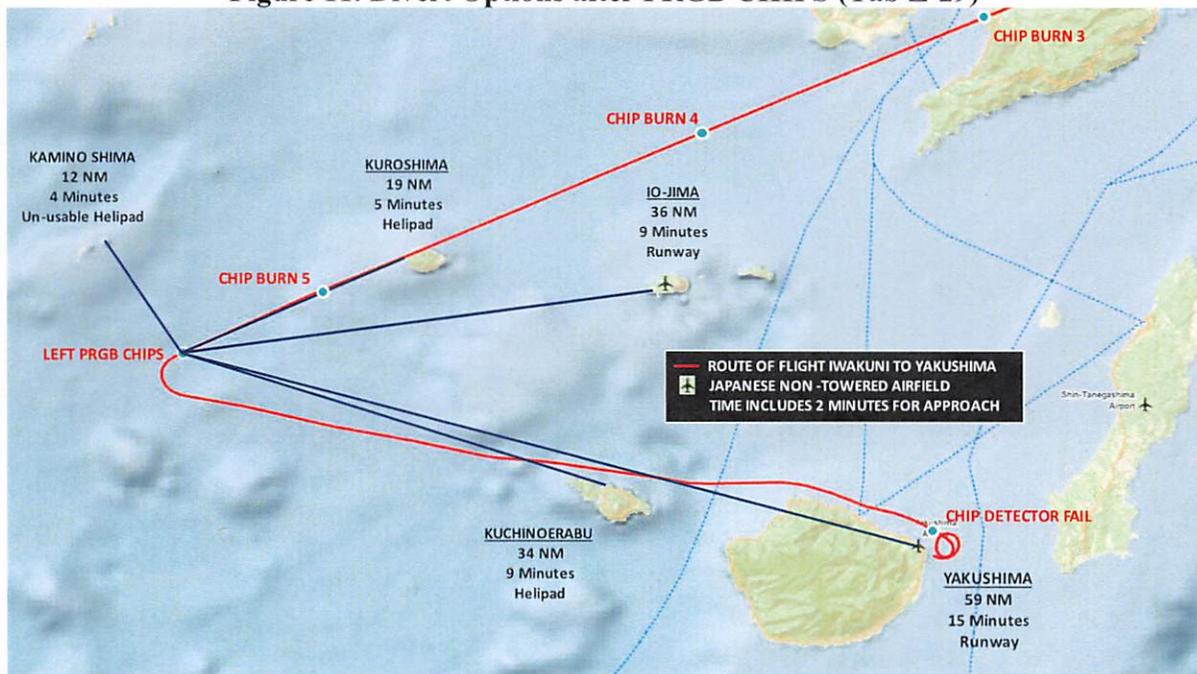
Figure 11. Divert Options after PRGB CHIPS (Tab Z-29)

At this time, closer divert possibilities existed, including a vertical landing option at Kuroshima, and a roll-on landing option at Satsuma-IoJima Airport, which is represented in Figure 11 (Tab Z-29). Four minutes after the PRGB CHIPS caution post, without further discussion of divert options, the MC began a gradual descent to 1,000 feet MSL to setup the MA for entry into the aircraft traffic pattern at Yakushima airport (Tabs DD-49, and II-58).

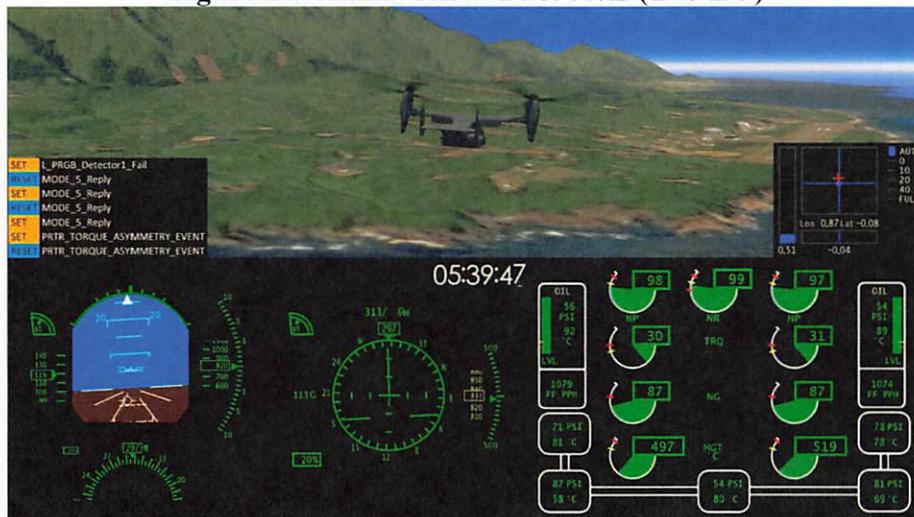
Figure 12. Animation at 14:39:47L (Tab Z-9)

During the Before Landing Checklist, MCP briefed an “airland” approach to the ground (i.e., land vertically like a helicopter) (Tabs DD-49, and II-62). Two minutes prior to landing, the MCP slowed the aircraft and brought the nacelles up in preparation for landing (Tab DD-49).

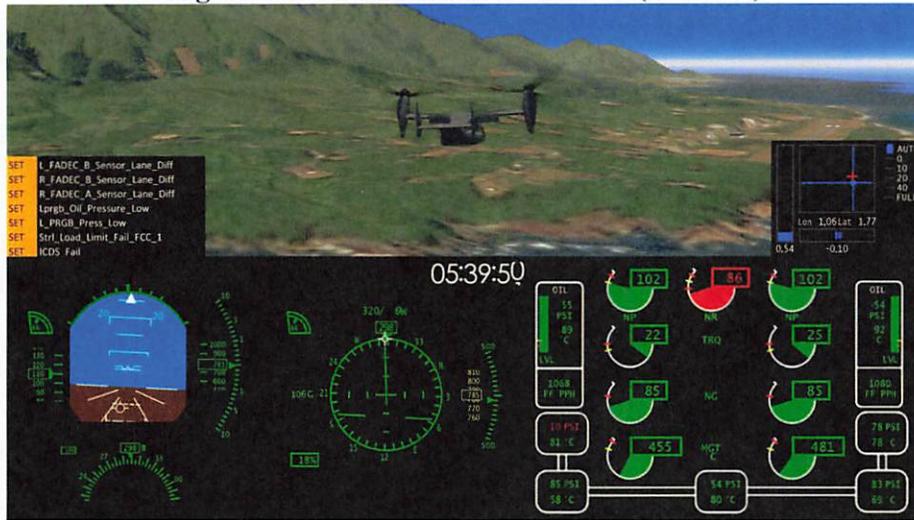
Figure 13. Animation at 14:39:50L (Tab Z-9)

Within the last six seconds of data, cascading failures in short succession were recorded by the KVADR (Tab DD-49). Audible engine surges could be heard in the ambient recording from the cockpit microphone, followed by an auditory master caution tone (Tab DD-49). Left-hand PRGB oil pressure rapidly dropped with an associated, “L PRGB OIL PRESS LOW” caution, followed by a voice warning, “DRIVESHAFT FAILURE, DRIVESHAFT” (Tabs DD-49, and II-64).

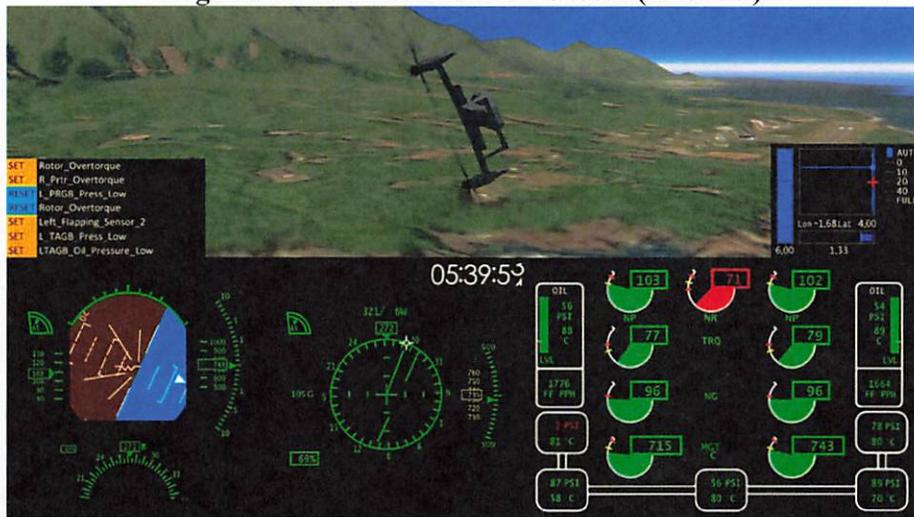
Figure 14. Animation at 14:39:53L (Tab Z-9)

Approximately one-half mile from the approach end of runway 32, the MA was at 785 feet, 106 knots ground speed, with nacelles at 66 degrees, flaps set to auto, and the landing gear retracted, as shown in Figure 15 (Tab DD-49 to DD-50). Every step of the Before Landing Checklist was completed except the extension of the landing gear (Tab II-58). At 14:39:53L (5:39:53Z), 49 minutes after the first left-hand PRGB CHIP BURN advisory posted, the MA abruptly rolled left and rapidly exceeded 90 degrees angle of bank (Tab DD-50). The KVADR's last record was at 5:39:53Z (14:39:53L) depicted in Figure 16 below (Tab Z-9). The thrust control lever was all the way forward at full power (Tab DD-50). The cyclic was 1.6 inches forward of center and full right, the rudder was 1.3 inches right (Tab DD-50). The MA rolled inverted and continued to roll to the left, the left nacelle caught on fire, and an object separated from the MA and fell to the water to the right of the aircraft flight path (Tab DD-50). The MA disappeared from radar at 14:40L (5:40Z) (Tab EE-9). The MA impacted the water upright, nose down, and rolling left (Tab DD-50).
