Lahaina Fire Incident Analysis Report

Steve Kerber
Derek Alkonis

September 13, 2024
Columbia, MD

This document is the second in a series of three (3) reports commissioned by the Hawai'i Department of the Attorney General (DOAG) to provide an independent review of the tragic fire that destroyed much of Lahaina, Hawai'i, on August 8-9, 2023.

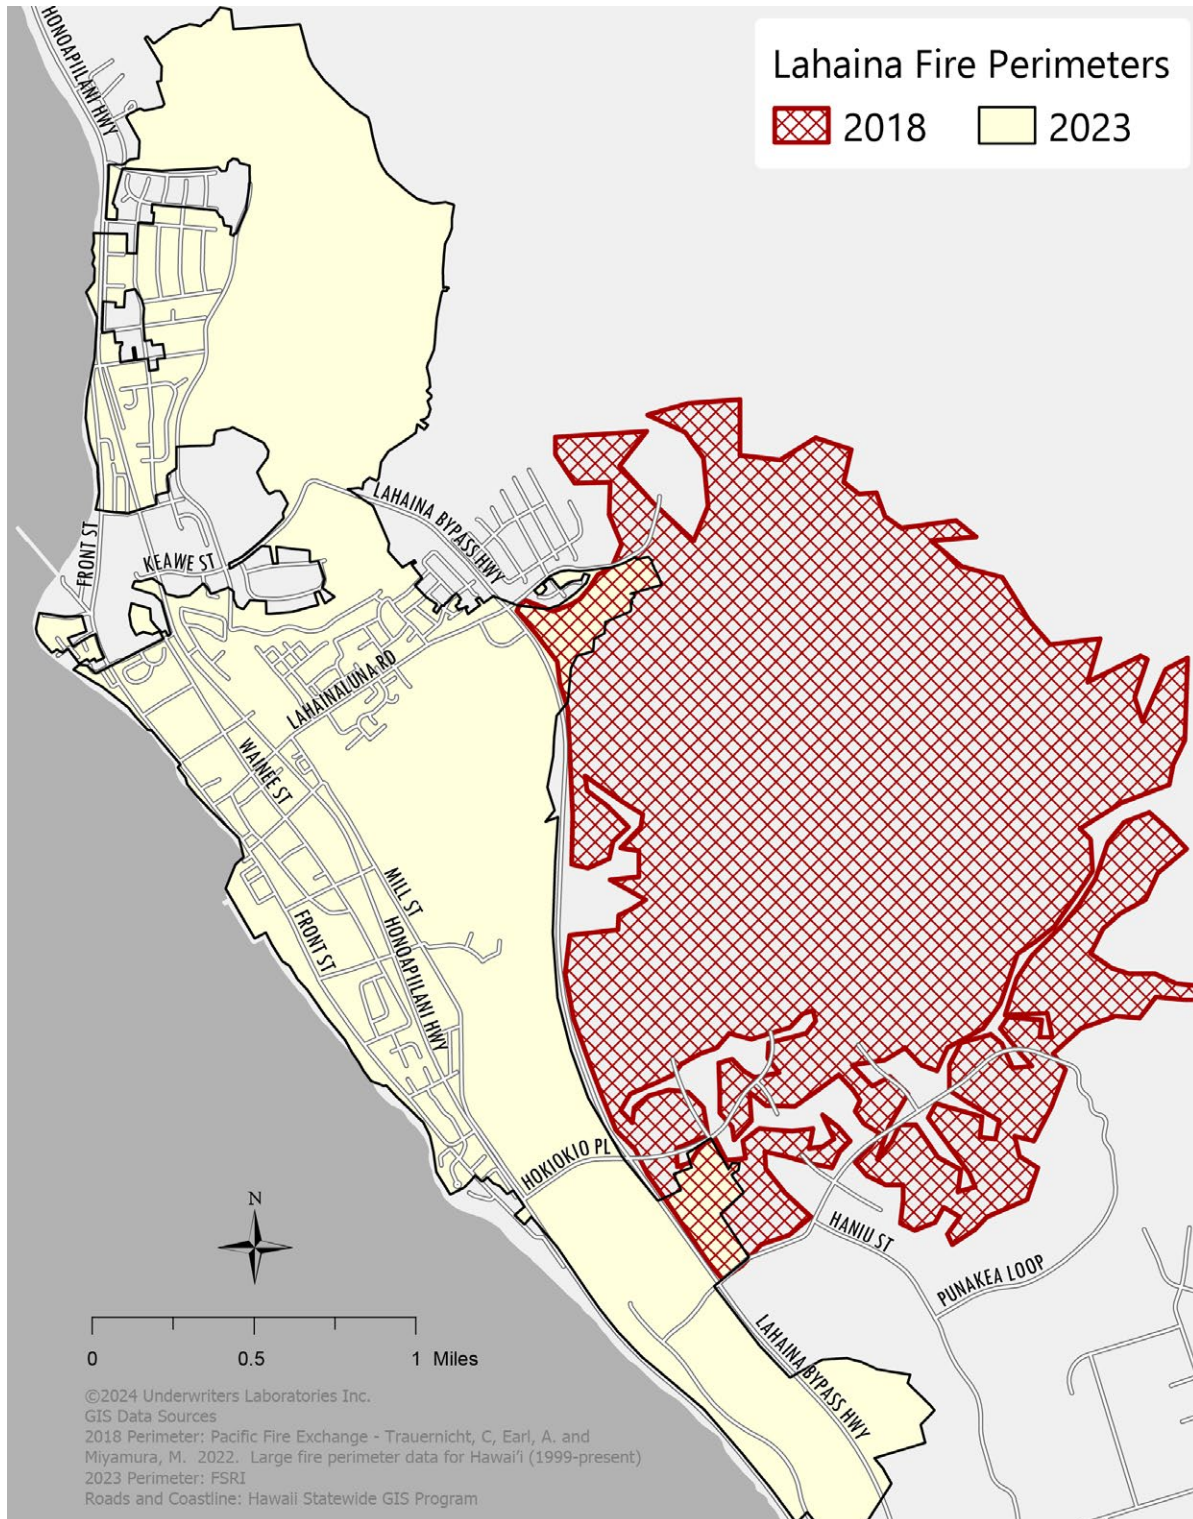
The Lahaina Fires of 2018 and 2023 shared similarities, but also had important differences. Both occurred in August and were fanned by high winds generated by a pressure gradient caused by an approaching tropical cyclone. They also shared a burn perimeter off the Highway 3000 Bypass (Lahaina Bypass) north of Punakea Loop and approximately 65 acres of shared burned area (Figure 2.2.4.1).

Figure 2.2.4.1 Overlay of 2018 and 2023 fire perimeters.

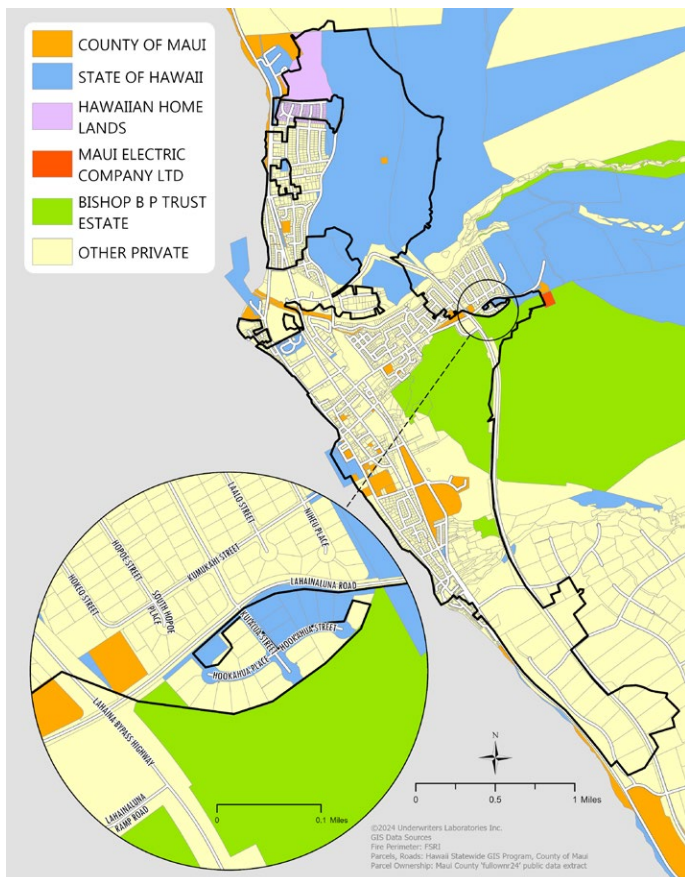
For example, two (2) of the four (4) August 2023 fires impacted state lands. In Lahaina, one (1) parcel of the impacted wildland area is under management of DLNR-Land Division, with no record of vegetation management. Several smaller parcels within the impacted developed area are owned and managed by the State Department of Education (within the blue State of Hawai'i area), also with no clear accountability for wildfire risk reduction or vegetative fuels management (Figure 3.3.2.2).

Figure 3.3.2.2 Map of Lahaina showing burn perimeter and land ownership. Detail shows Lahaina fire origin just northeast of Ho'okahua Street where the County of Maui, State of Hawai'i, and private lands converge. Source: Hawai'i Statewide GIS Program, Office of Planning and Sustainable Development, State of Hawai'i.⁸⁵

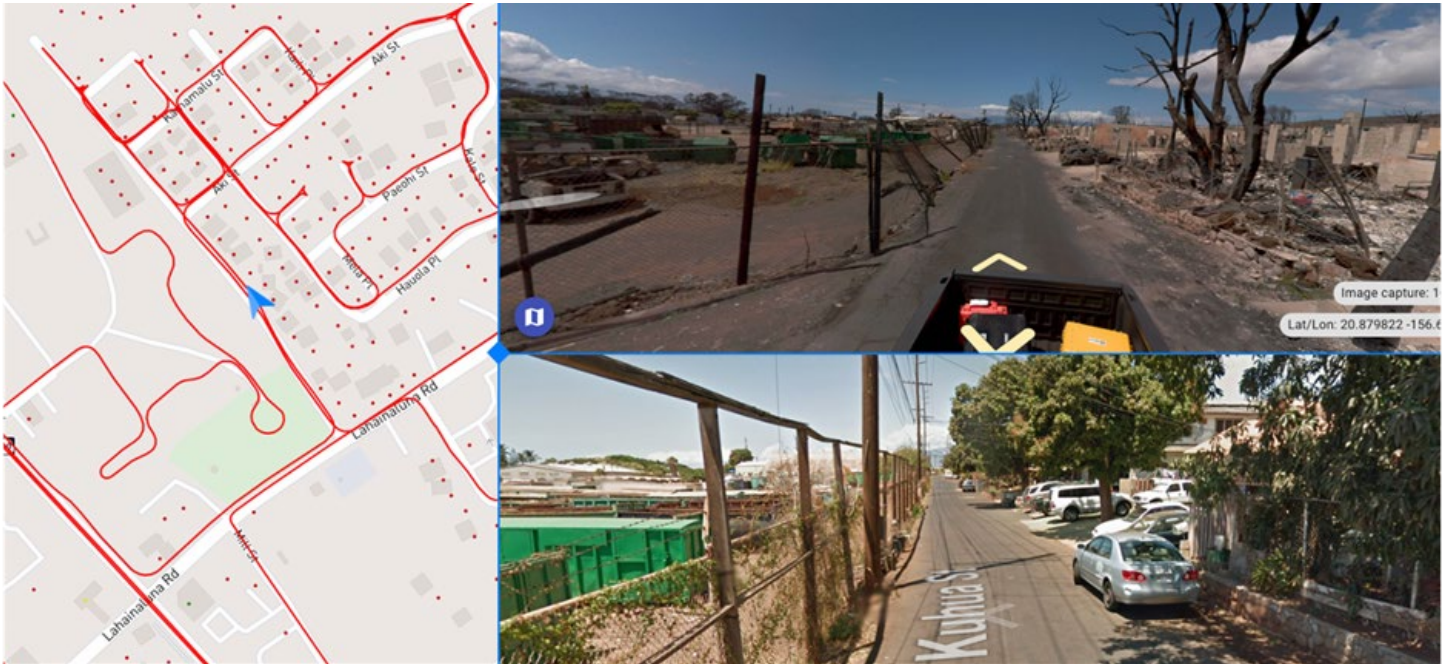
Figure 3.4.2.2.1 Kuhua Street Northbound: Map showing Kuhua Street looking north toward Aki Street. Pre-fire image taken September 2011 (bottom, right) and post-fire image taken October 6, 2023 (top, right).¹²⁶

According to police maps, 29 of the fire victims were located on Kuhua Street (Figure 3.4.2.2.1 and Figure 3.4.2.2.2). Other narrow roadways and alleys throughout Lahaina posed similar challenges during the evacuation process.

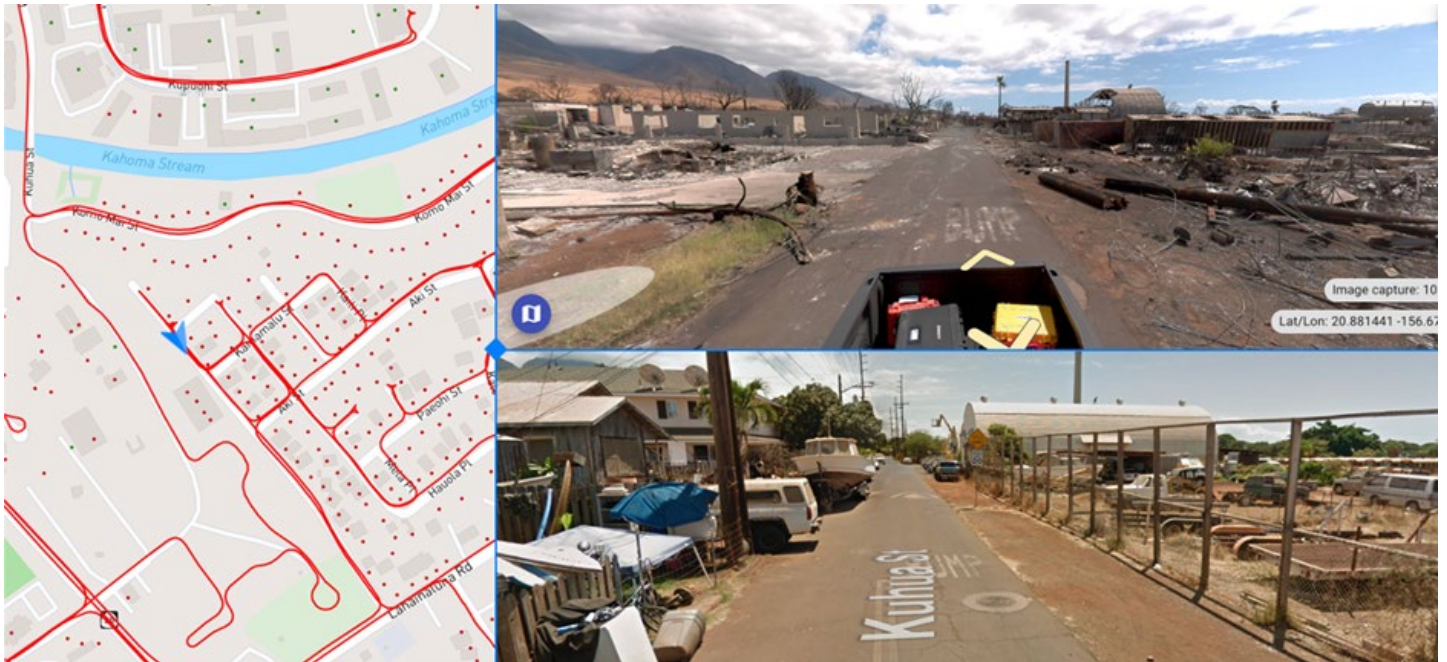
Figure 3.4.2.2.2 Kuhua Street Southbound: Map showing Kuhua Street looking south toward Kamamalu Street. Pre-fire image taken September 2011 (bottom, right) and post-fire image taken October 6, 2023 (top, right).¹²⁷

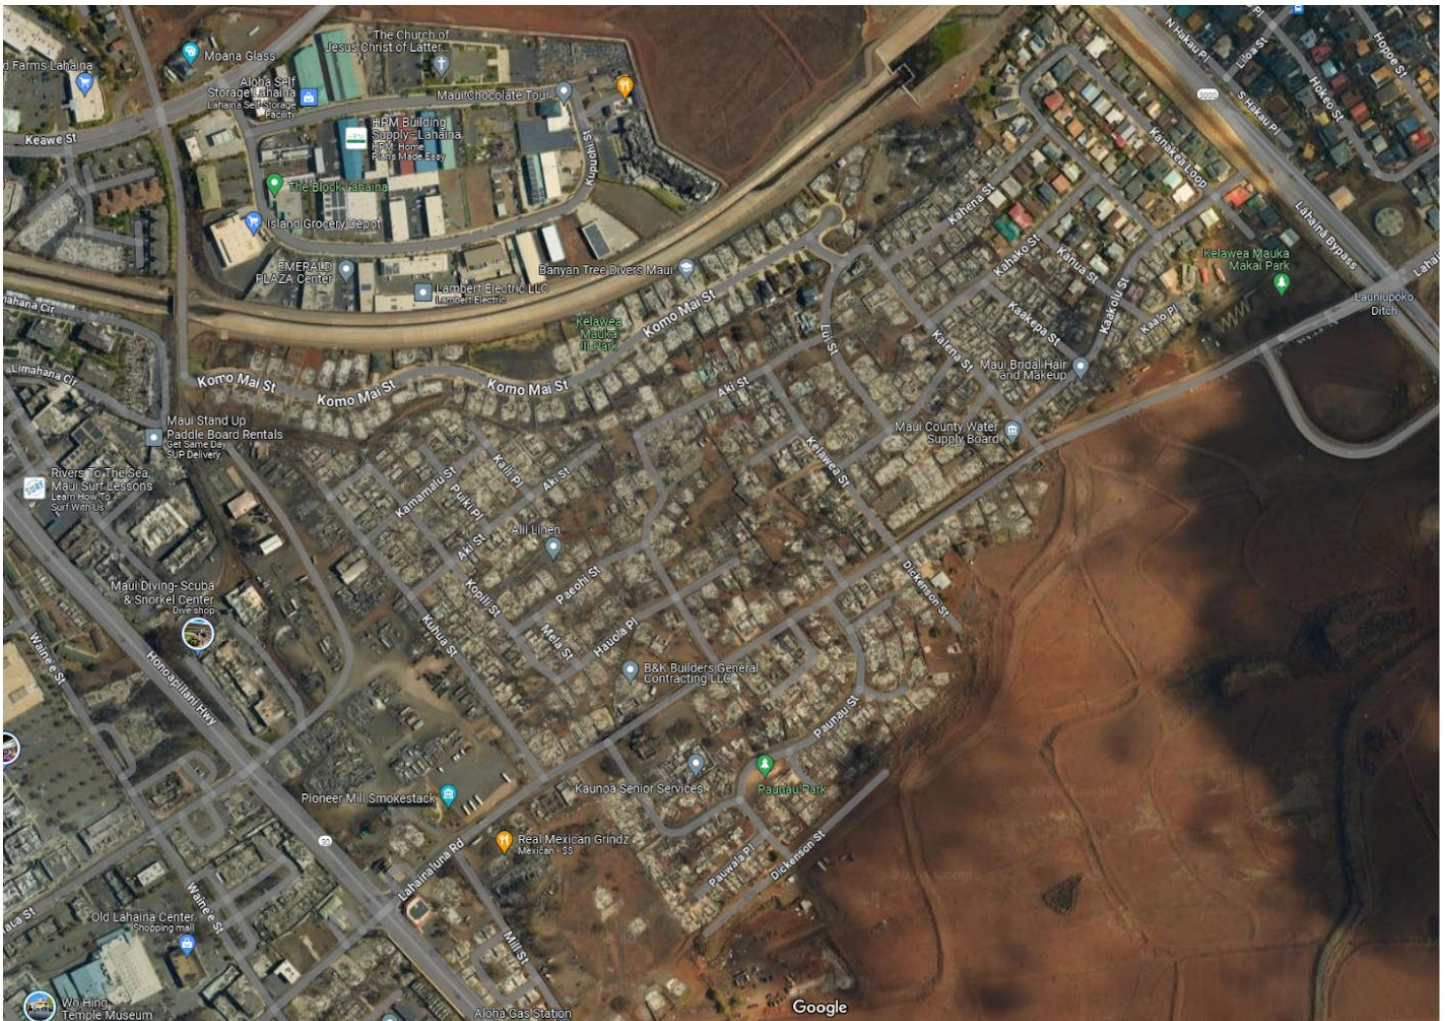
(Figure 3.4.2.2.3). Street signs existed for most streets, however, signage informing drivers of dead ends, or indicating egress route direction were mostly not present.

Figure 3.4.2.2.3 Map of the Lahainaluna neighborhood displaying a labyrinth of roads, multiple dead ends, and limited egress routes. KUHUA Street is where many of the 102 decedents were found.

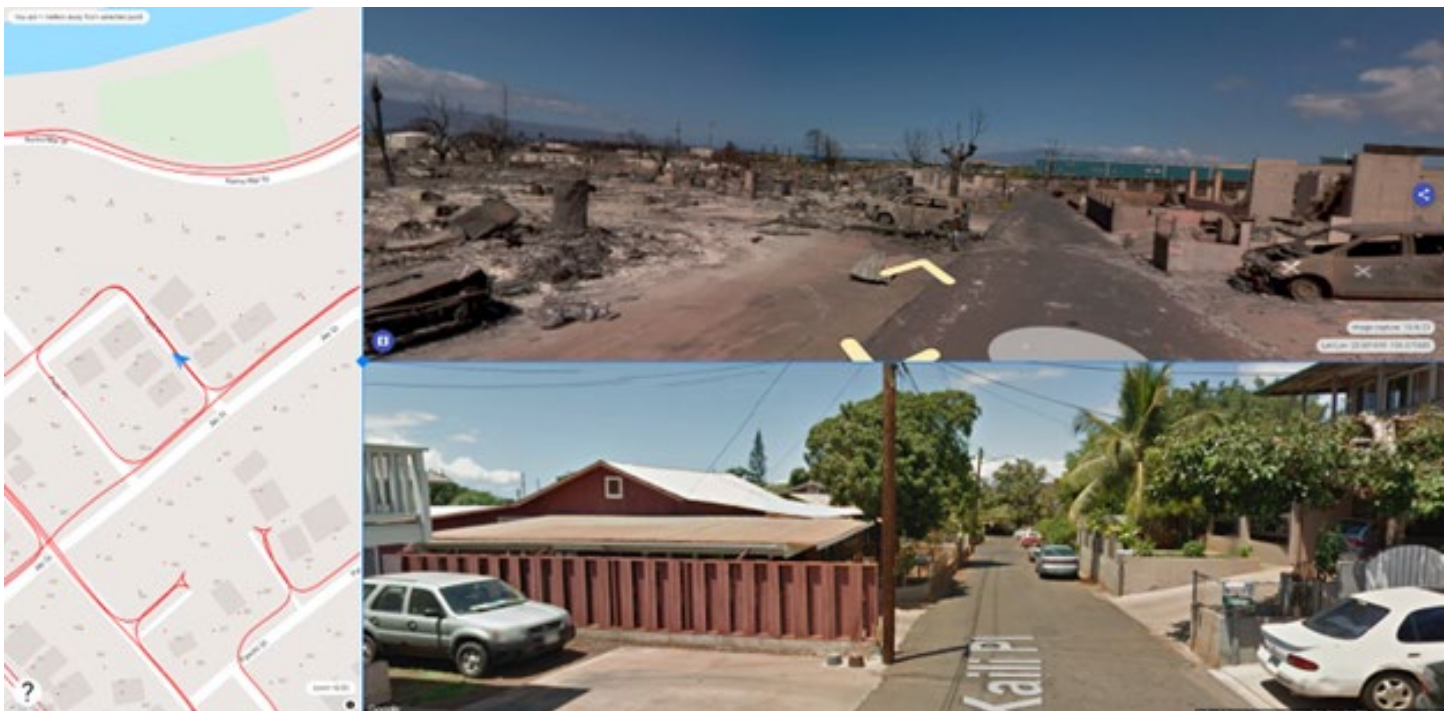
requirements generally seen in other municipalities. However, in many of the older Lahaina neighborhoods with small lot sizes and narrow streets, it is not possible to legally park where parking is restricted within four (4) feet of either side of a public or private driveway. On and before August 8, 2023, there were too many vehicles and not enough parking spaces to accommodate them.

Figure 3.4.2.3.1 Kaili Place showing narrow street and vehicle parking. Pre-fire image taken September 2011 and post-fire image taken October 6, 2023.¹³²

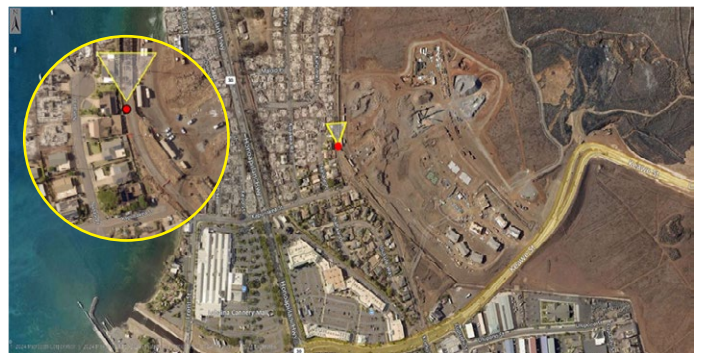
Figure 3.4.2.4.1 Photo of Old Cane Haul Road, often referred to by police officers and firefighters as Oil Road, just north of Kapunakea Street. This road is accessed through a gate located on the north side of Keawe Street at Kuhua Street. Oil Road was used extensively during evacuations due to utility poles blocking Hwy-30 just north of Keawe Street. Inset: Old Cane Haul Viewpoint. Image showing the area depicted in the photograph above.

The unplanned use of these roads during the emergency highlighted several issues. The lack of maintenance of these roads over the years has led to deterioration, making them difficult to navigate quickly and safely. Overgrown vegetation, erosion, and debris further complicate their use. The emergency nature of opening gates to connect paved roads to these dirt roads pointed to an important gap in pre-planned alternate routes for emergency evacuations and access.

RECOMMENDATION: Identify, name, map, and provide signage on dirt roads that serve as alternate egress/evacuation routes so residents and emergency responders refer to them by the same name.

RECOMMENDATION: Inspect and maintain dirt roads annually. Modernize, standardize, and maintain barriers on dirt roads to help ensure they can be used during emergencies.

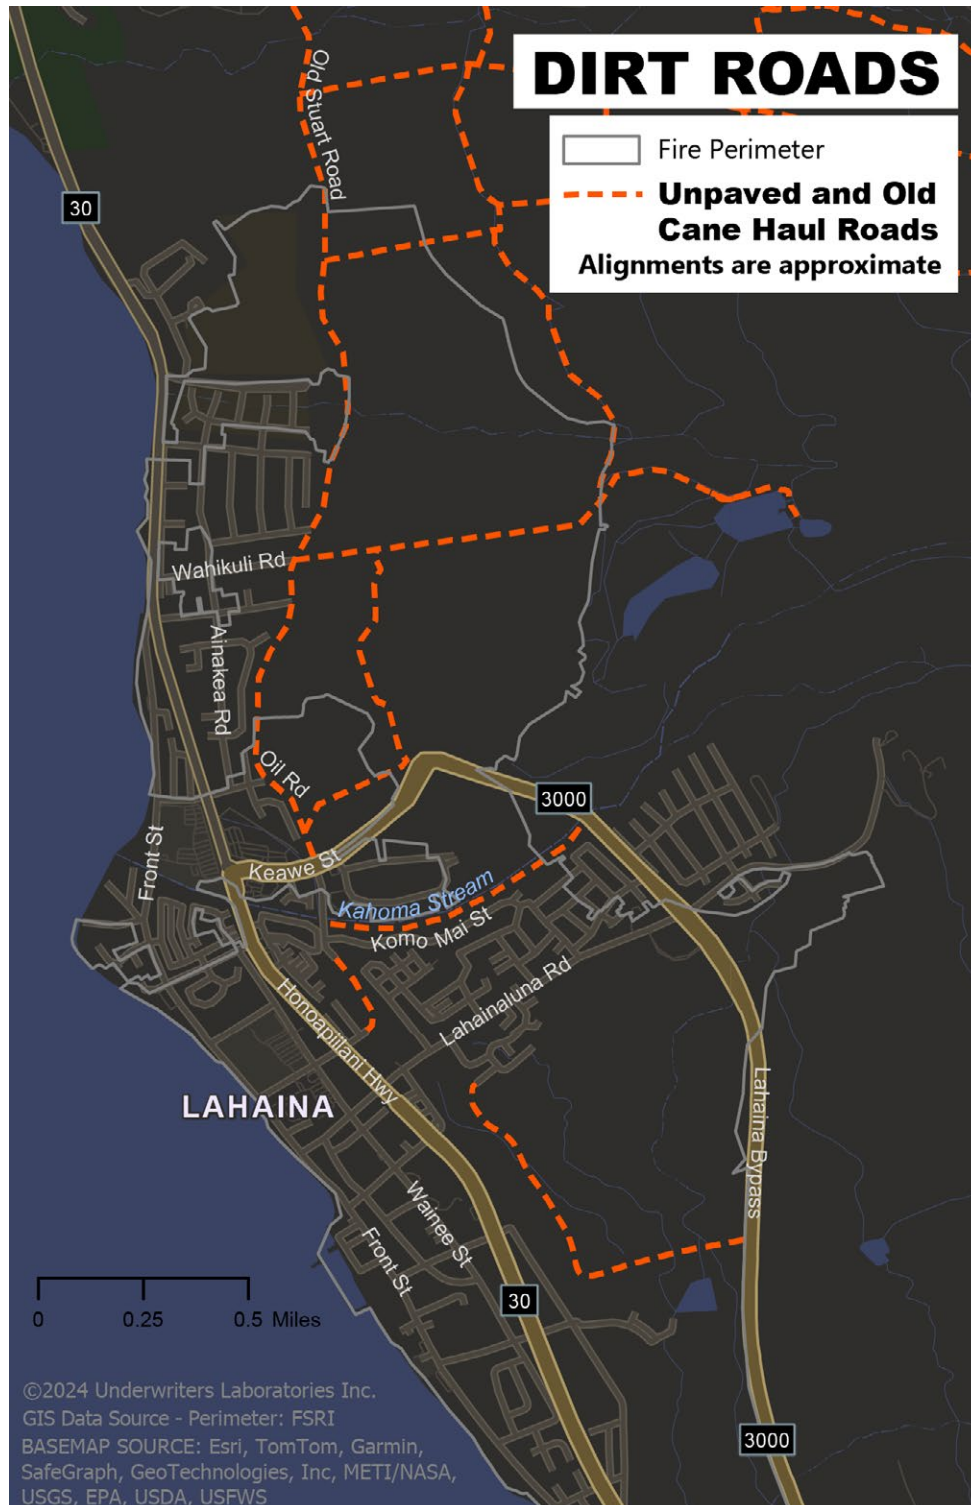
Dirt roads in central and south Lahaina also served as evacuation routes. The dirt road extending along the south bank of Kahoma Stream, parallel to Komo Mai Street, and the dirt road cutting through the vegetation on the south end were both critical egress options. These dirt roads also lacked signage and are not consistently identified on maps.

Figure 3.4.2.4.2 Unpaved Roads. Cane Haul Roads. Map of Lahaina's dirt road network, including fire perimeter. Road names are included with source. These roads were used by residents to evacuate as fire and smoke was bearing down.

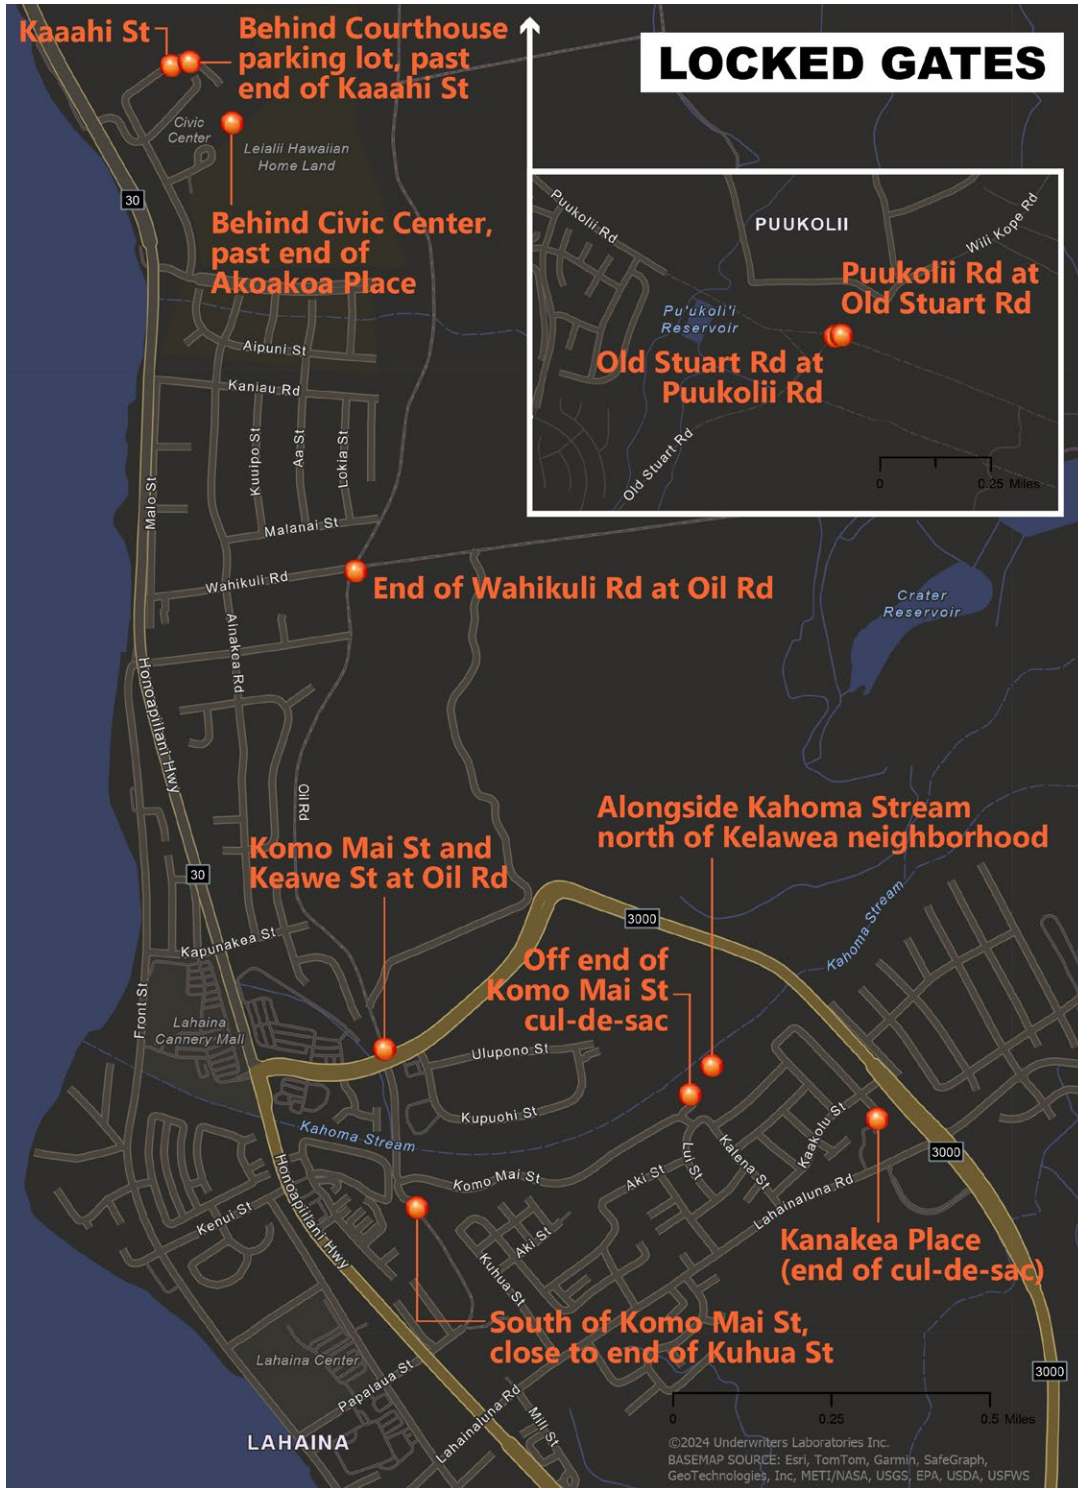
Figure 3.4.2.4.3 Locked Gates Map. Map showing location of locked gates preventing access to dirt roads used during August 8-9, 2023. MPD officers shared how they had to cut the locks to open the gates to allow vehicles to escape the fire and smoke.

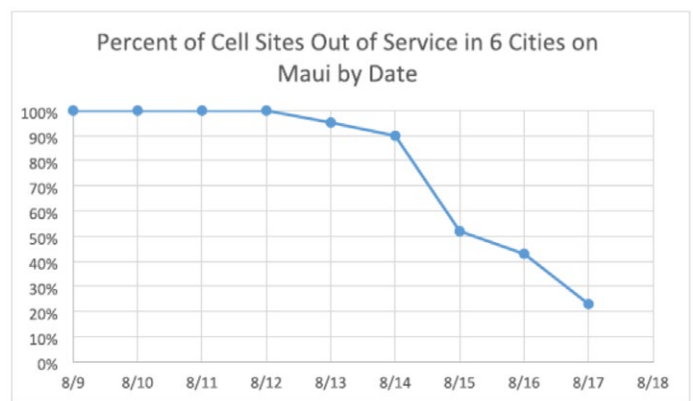
For August 9-12, 2023, the Federal Communications Commission report indicates that 100% of the cell sites were out of service (Figure 3.5.1).

Figure 3.5.1 FCC-registered cell sites out of service in the County of Maui, HI. Source: Federal Communications Commission, Communications Status Report for Areas Impacted by Hawai'i Wildfires August 9-17, 2023.

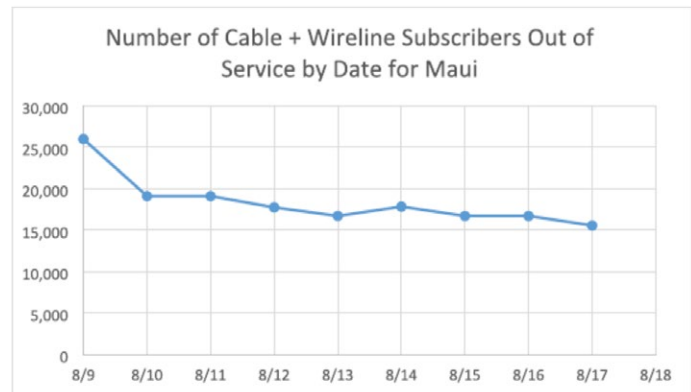
Wireline and cable telecommunications services were also rendered inoperable for many subscribers from the impacts of the August 8-9, 2023, fires, including electrical failures, fire impingement, etc. (Figure 3.5.1.1)

Figure 3.5.1.1 Number of cable and wireline subscribers out of service by date for Maui.¹⁴⁹

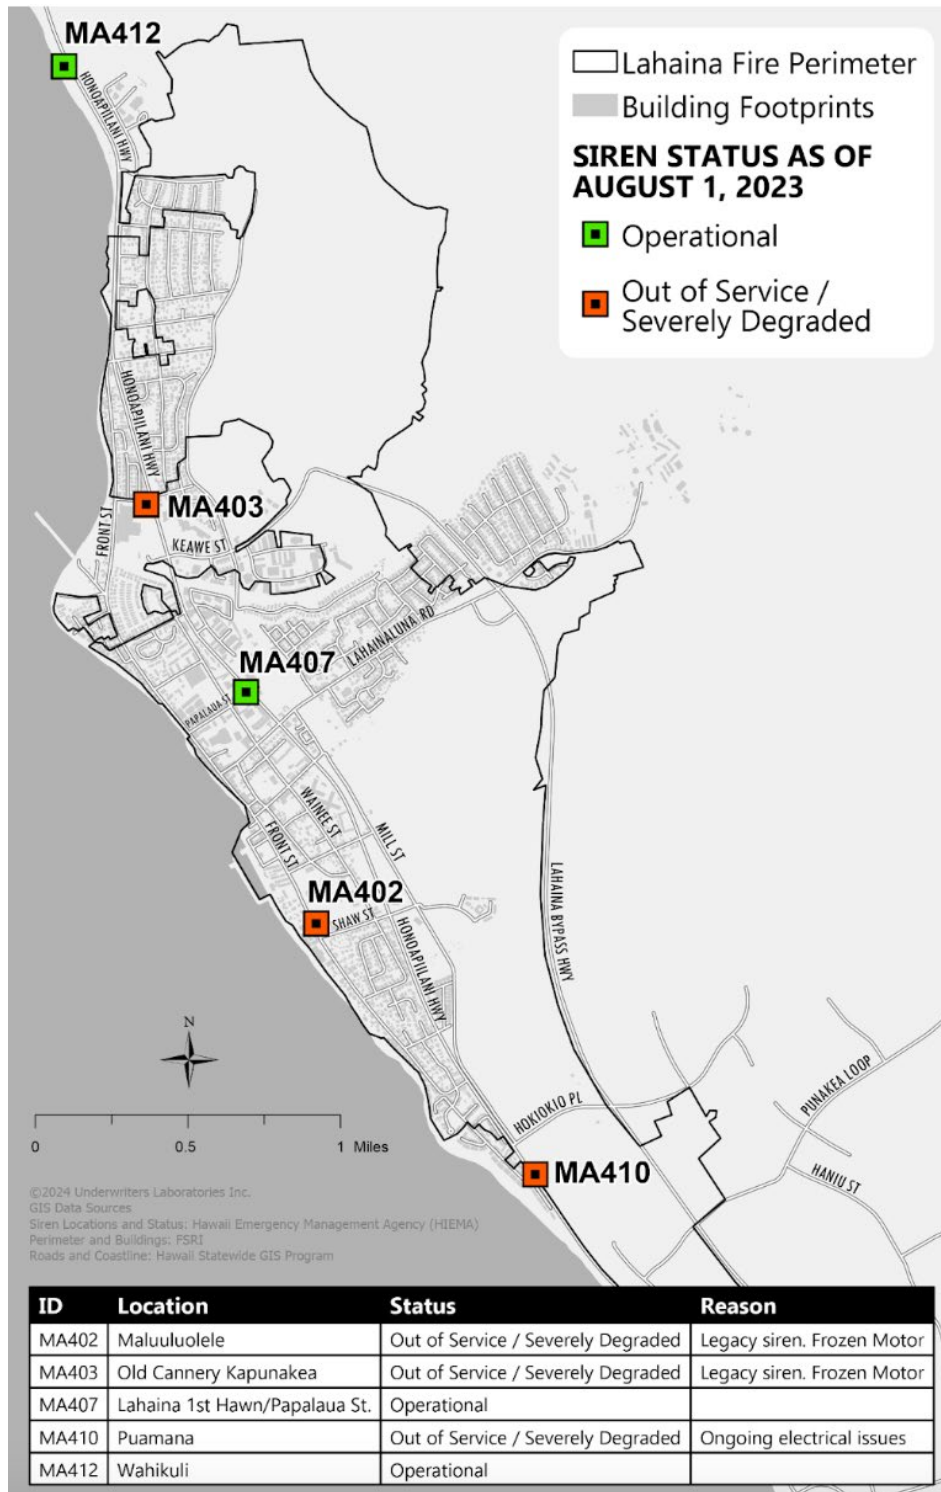
On August 8, 2023, there were five (5) sirens located off of Hwy-30 and near the coastline in the area of the Lahaina PM fire¹⁵² (Figure 3.5.1.2.1). According to siren test records (Appendix Section 6.11) provided by both MEMA and HI-EMA, siren MA407, located near Papalaua Street and Hwy-30, and siren MA412, located off Hwy-30 just north of the Lahaina Civic Center, were the only two sirens operable at the time of the fire.

The records provided are exception-type reports, where only inoperable sirens are listed for each county. Although siren's MA407 and MA412 may have been operable on or before August 8, 2023, they were also very likely inoperable throughout August 8, 2023, due to the area experiencing intermittent cell service. Without a reliable cell signal, it would have been difficult to activate them.

Figure 3.5.1.2.1 Map displaying locations and functional status of Lahaina outdoor warning sirens as of August 1, 2023 (first business day of the month = siren monthly test day). Base map provided by <https://hiema.maps.arcgis.com/apps/dashboards/226e62cd78f340c29e52d4f38c46ac21>. Siren status and maintenance records provided by MEMA and HI-EMA.

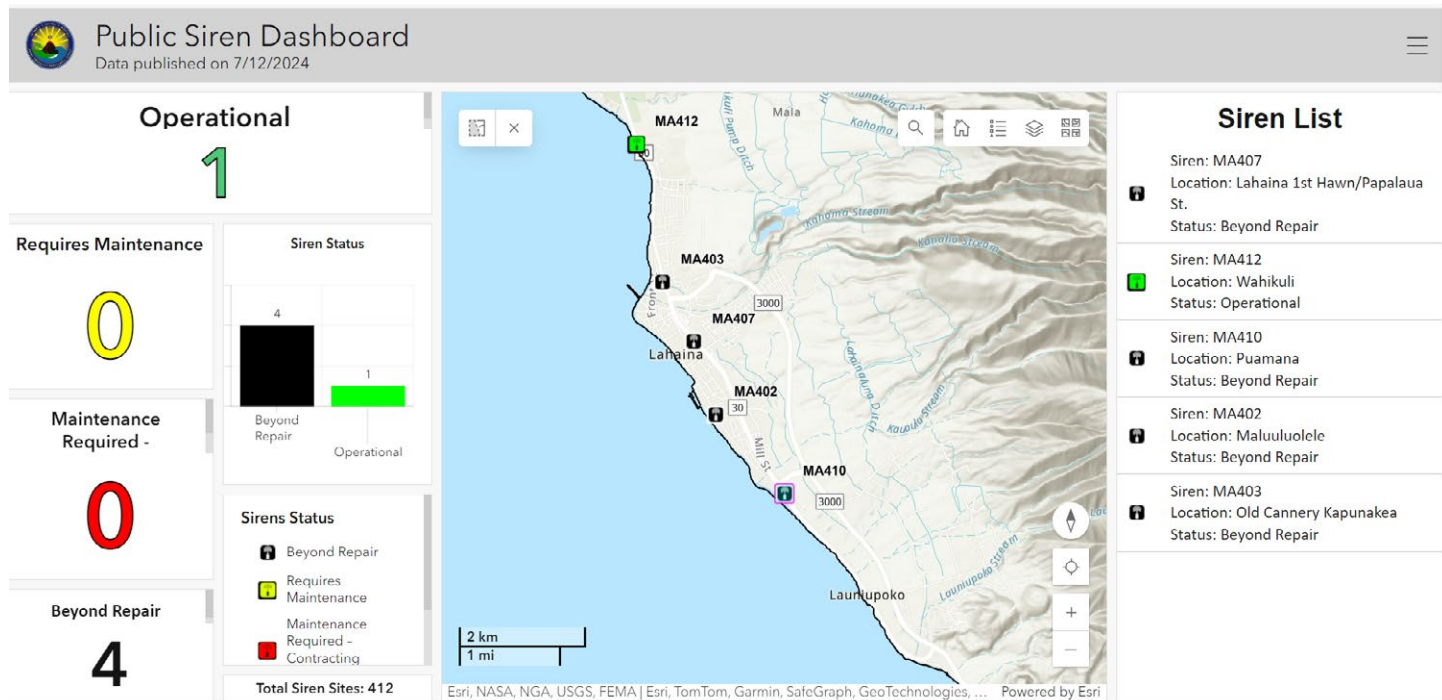
Figure 3.5.1.2.2 The public sirens in Lahaina on August 8, 2023, and their operational status as of July 12, 2024. Source: ARCIS.

The status of the State of Hawai'i Outdoor Warning Siren System is shared via the [Public Siren Dashboard](#).¹⁵³ The July 12, 2024, dashboard for the Lahaina area in Figure 3.5.1.2.2 indicates that MA412, just north of the Lahaina Civic Center, is currently (as of July 2024) the only operable siren.

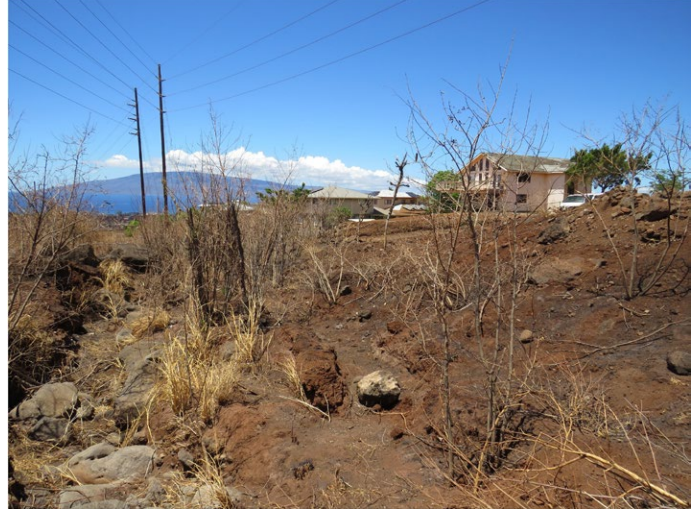
The mid-slope burn area includes a ravine with angled sides made from randomly stacked boulders of various sizes (Figure 3.7.7.3). Small tufts of dry vegetation and combustible human trash filled the voids created between the boulders. The ravine provides natural drainage, running east (mauka-higher elevation) to west (makai-lower elevation) toward the coast.

Figure 3.7.7.3 Post-fire image taken September 3, 2023, from near the top of the ravine southeast of the two-story home in the image at 8 Ho'okahua Street. Image shows unburned vegetation in rocky terrain. Inset: Viewpoint of the image in the photograph above.

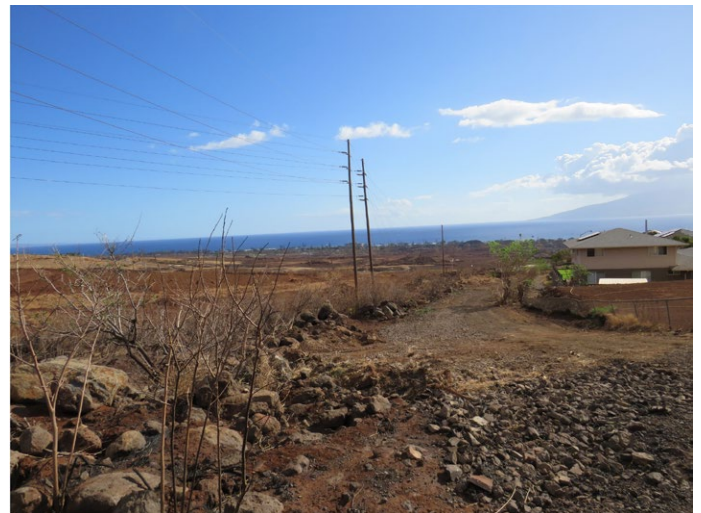
Many overhead electrical transmission lines extended over the area where the Lahaina AM fire burned, and several were directly over the ravine (Figure 3.7.7.4).

Figure 3.7.7.4 Post-fire image taken September 3, 2023, from near the east end (mauka) of the ravine southeast of the two-story home in the image at 7 ■ Ku'ialua Street. Image shows unburned vegetation in rocky terrain. Inset: Viewpoint of the image above.

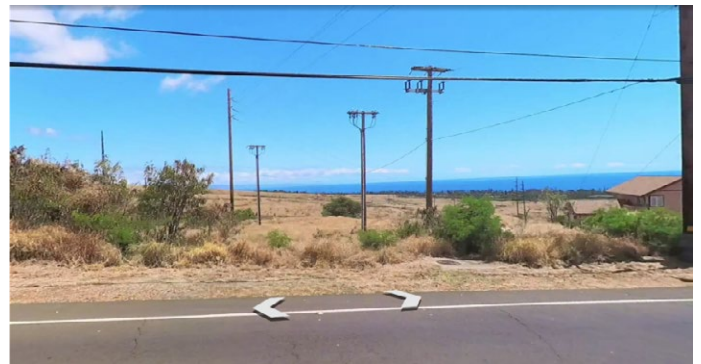
Images from before the August 8, 2023, fire show the highly invasive non-native buffelgrass and haole koa dominating the area just behind the homes off of Ho'okahua Street and on the southside of Lahainaluna Road, across from the intermediate school (Figure 3.7.7.5).

Figure 3.7.7.5 Google Street View image (pre-fire, date unknown) looking south from Lahainaluna Road. Home in the image is addressed at 8 Ho'okahua Street and was the structure nearest the Lahaina AM fire point of origin. Image shows buffelgrass and haole koa at the base of several utility poles supporting overhead electrical lines. Inset: Viewpoint of the image above.

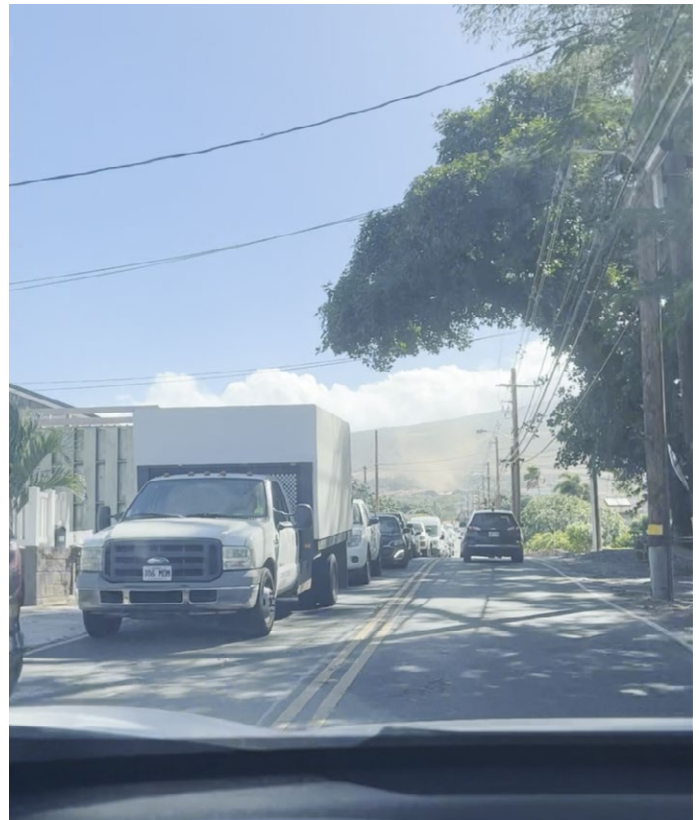
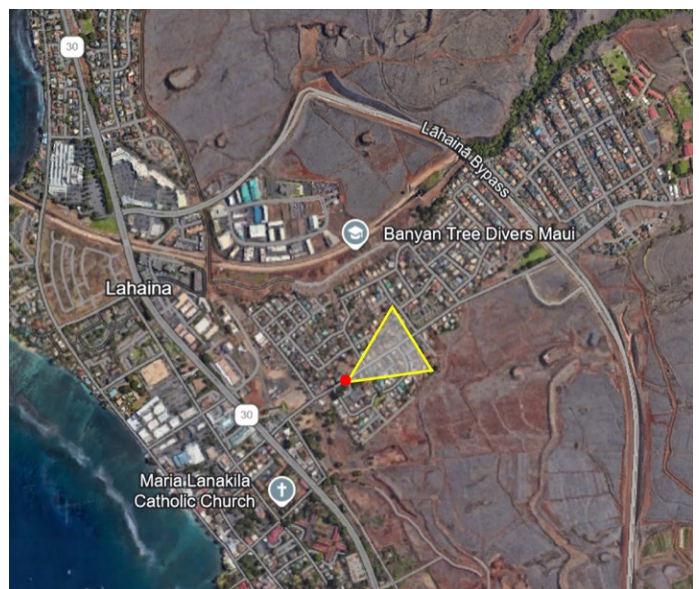
However, the fire was in challenging terrain with void spaces created by rocks in the ravine, which was difficult to access due to the danger of unstable utility poles and steep slopes described above (Figure 3.7.7.2). Additionally, the presence of dust in the area could have obstructed their view. The extreme downslope winds stirred up dust clouds, making it difficult to see any remaining smoke (Figure 3.7.7.3.1).

Figure 3.7.7.3.1 Video image captured on August 8, 2023, at 09:07, taken from a vehicle traveling eastbound (mauka) on Lahainaluna Road. At the far east end (mauka), a dust cloud can be seen near the location where the Lahaina AM fire burned. Insert: Viewpoint looking east (mauka) on Lahainaluna Road.

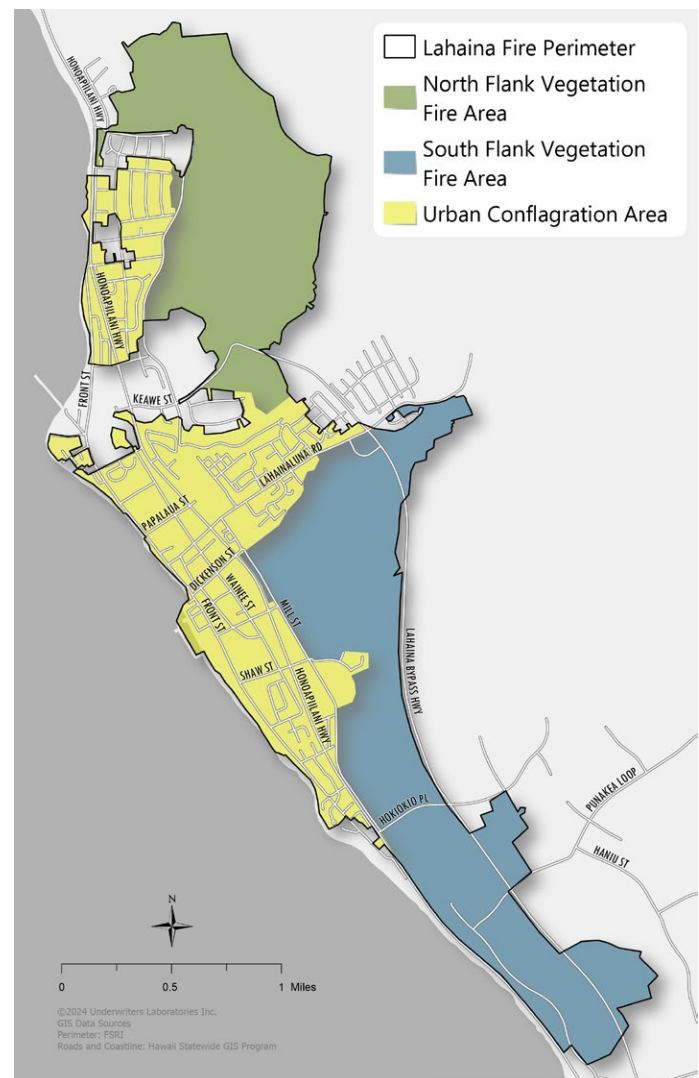
The Lahaina PM fire consisted of a wildfire-initiated urban conflagration flanked by fast-moving vegetation fires on the north and south (Figure 3.7.7.5.1).

Figure 3.7.7.5.1 Map of Lahaina PM fire perimeter showing area of urban conflagration and vegetation fires on north and south flanks.

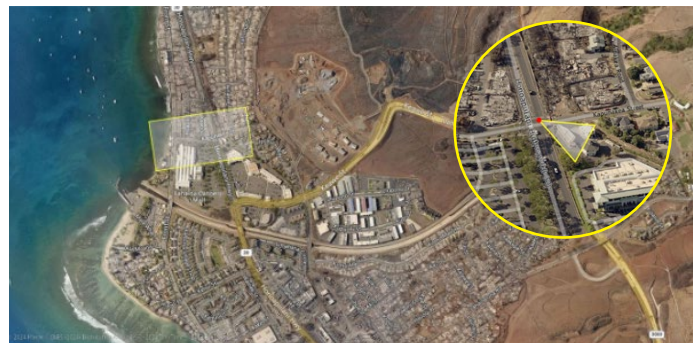
Several factors caused extensive congestion and traffic issues before the start of the fire on August 8, 2023. High winds downed utility poles and utility lines and toppled trees, while debris from vegetation and building materials blocked major traffic routes, creating numerous hazards for vehicles (Figure 3.8.2.1). This obstruction severely limited traffic flow in and out of Lahaina.

Figure 3.8.2.1 Several downed utility poles and powerlines in the northbound lane of Hwy-30 and Kapunakea Street. Photo taken August 8, 2023, at 16:52. Inset: Viewpoint of photo of downed utility poles and electrical lines at Hwy-30 and Kapunakea Street.

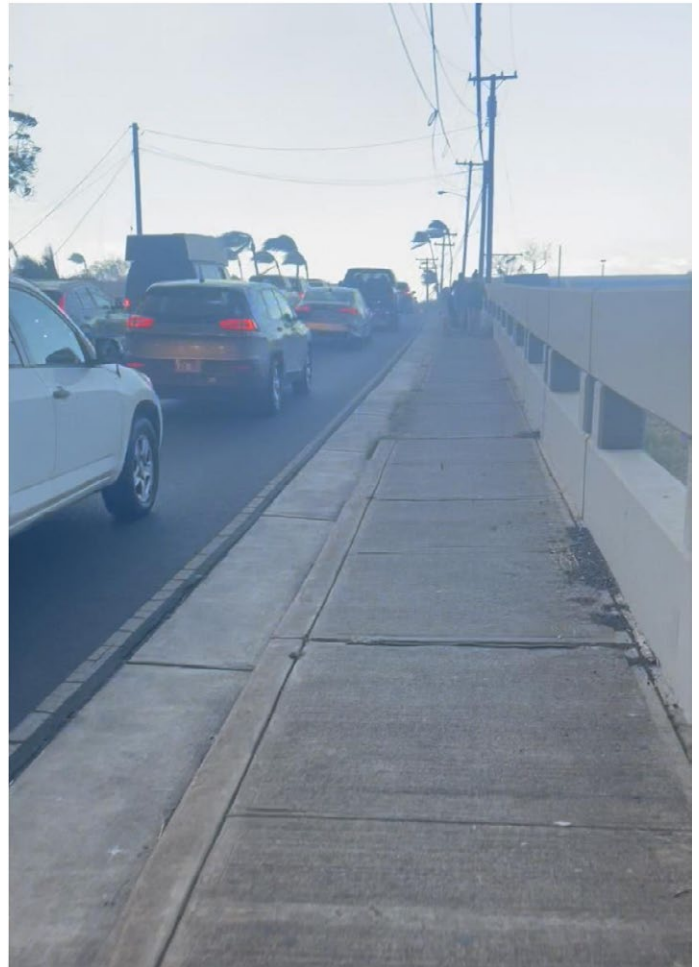
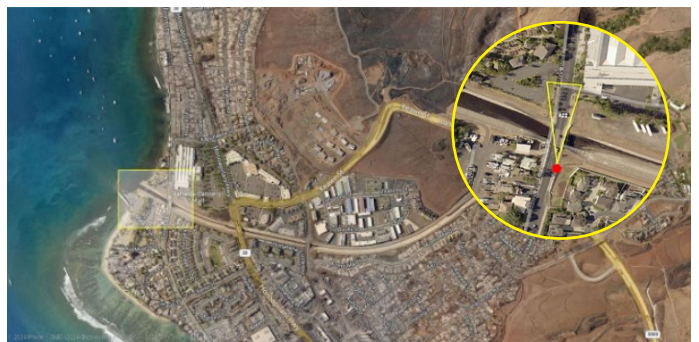
Figure 3.8.2.2 Northbound Front Street traffic over Kahoma Stream on August 8, 2023, at 17:05. Inset: Viewpoint of northbound Front Street traffic over Kahoma Stream on August 8, 2023, at 17:05.

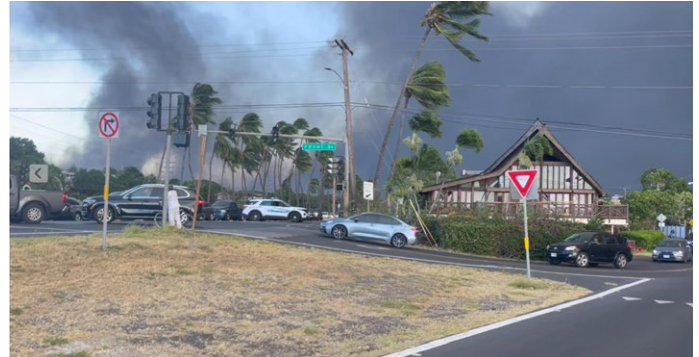
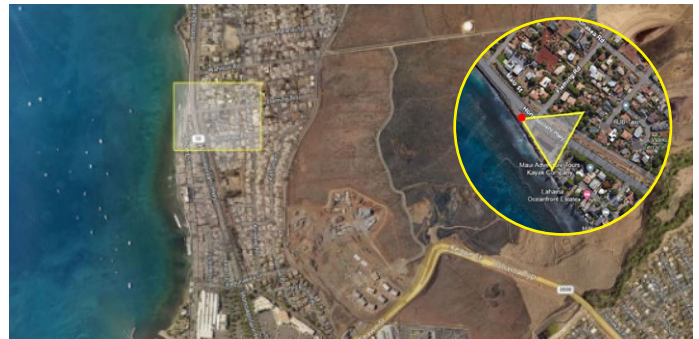
Figure 3.8.2.3 Front Street at Hwy-30 on August 8, 2023, at 17:28 shows MPD vehicles redirecting southbound Hwy-30 traffic away from the fire, and vehicles on northbound Front Street merging onto northbound Hwy-30. Inset: Viewpoint looking south toward Front Street and Hwy-30 intersection.

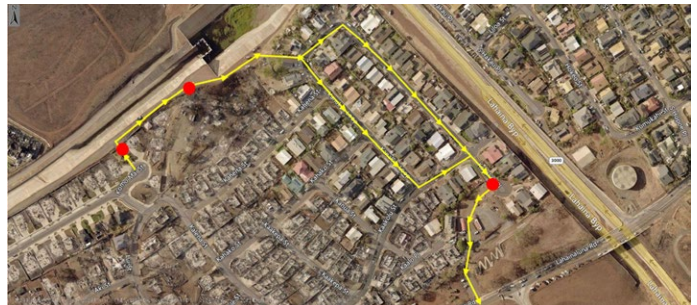
As the fire grew in intensity and consumed structure after structure down Lahainaluna Road, by 16:30 on August 8, 2023, the main westbound egress routes down Komo Mai Street and Lahainaluna Road were cut off by fire. Due to the quick actions of MPD officers and residents, alternative egress routes through locked gates and dirt roads enabled many residents to evacuate safely (Figure 3.8.2.4).

Figure 3.8.2.4 Evacuation route used by residents exiting the Lahainaluna neighborhood as the fire burned through the Lahainaluna neighborhood. Route required breaking open three (3) locked gates (red circles), and driving on dirt roads to make access to Lahainaluna Road, and ultimately, the Lahaina Bypass.

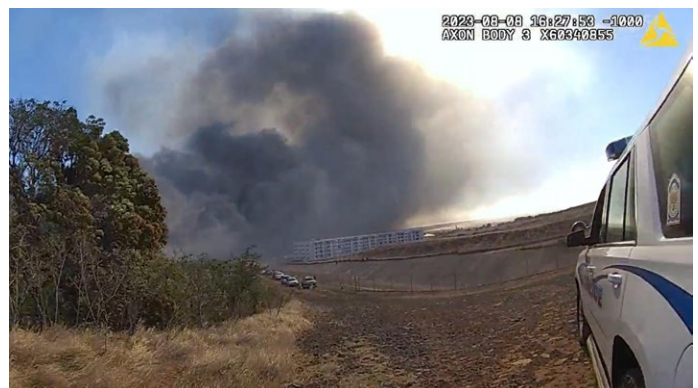
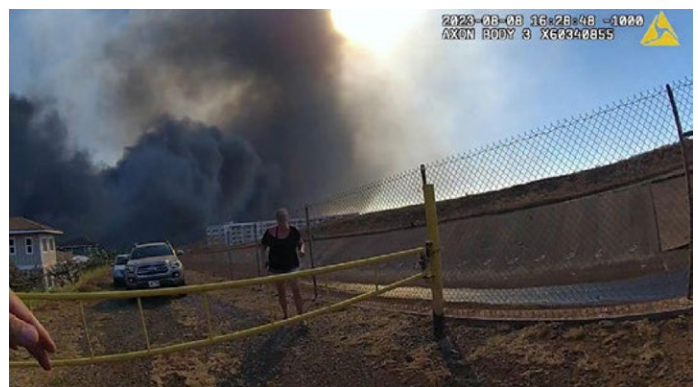
The route was accessed via the east end of Komo Mai Street using a small dirt road between 3█ and 4█ Komo Mai Street. This led to a path along the south bank of Kahoma Stream, which allowed traffic to flow eastbound onto Kanakea Loop (Figure 3.8.2.5).

Figure 3.8.2.5 Body-worn camera (BWC) images of a MPD officer captured August 8, 2023, at 16:27 and 16:28 on a private vacant lot north of 4█ Komo Mai Street and south of Kahoma Stream. MPD officers and residents broke through the gate to travel on the dirt road to Kanakea Loop, and ultimately, out to the Lahaina Bypass via Lahainaluna Road. Inset: Viewpoint of BWC image of MPD officer assisting residents evacuating dirt road on a private lot on south side of Kahoma Stream.

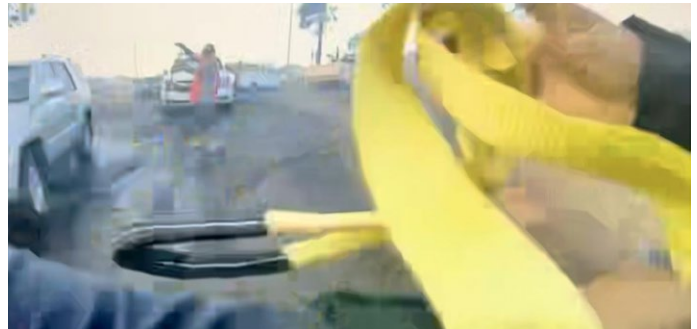
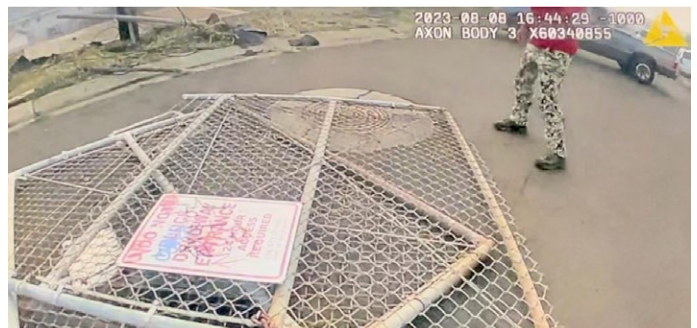
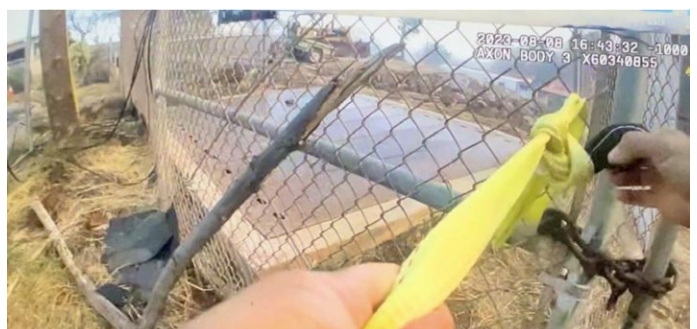
Egressing the neighborhood along Kanakea Loop proved challenging due to the westbound streets of Kahena, Kahako, and Ka'akolu being cut off by fire. The only way out was through the County of Maui Department of Water Supply lot across from 1005 Kanakea Loop. MPD officers used their vehicles equipped with tow straps, and in some cases their own bodies, to open gates that were blocking the critical egress route (Figure 3.8.2.6).

Figure 3.8.2.6 BWC image capture of a MPD officer August 8, 2023, at 16:43, 16:44, and 16:46 breaking through a locked gate securing the County of Maui Department of Water Supply Lot (Parcel No. 450310010000) on Kanakea Loop, directly across from 1005 Kanakea Loop. Gate restricted access to the county lot, leading to a second gate that provided access to the Kelaweā Mauka Makai Park parking lot, and ultimately, Lahainaluna Road. Inset: Viewpoint of MPD officers making access through the locked gate, securing the county lot in the west side (makai) of Kanakea Loop, across from 1005 Kanakea Loop.
