Lahaina Fire Incident Analysis Report

Steve Kerber
Derek Alkonis

September 13, 2024
Columbia, MD

This document is the second in a series of three (3) reports commissioned by the Hawai'i Department of the Attorney General (DOAG) to provide an independent review of the tragic fire that destroyed much of Lahaina, Hawai'i, on August 8-9, 2023.

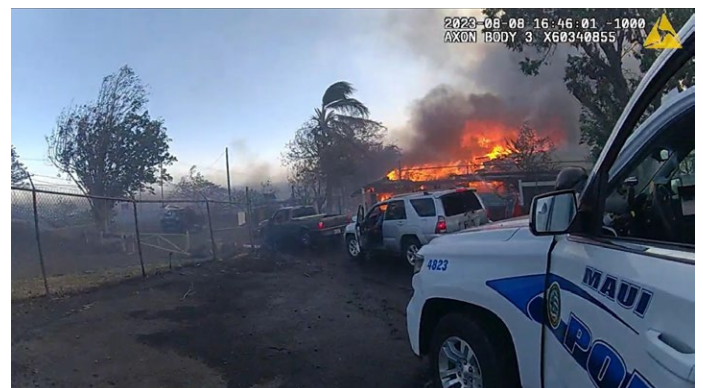
Numerous vehicles followed one another from the Komo Mai Street dirt road to Kanakea Loop, through the County of Maui Department of Water Supply lot (Figure 3.8.2.7) and the Kelawea Mauka Makai Park parking lot, to eastbound Lahainaluna Road, and ultimately, to the safety of the Lahaina Bypass.

Figure 3.8.2.7 BWC image captured on August 8, 2023, at 16:46 of a MPD officer within the County of Maui Department of Water Supply lot (Parcel No. 450310010000) just north of Kelawea Mauka Makai Park. MPD officers and residents broke through locked gates to exit the lot into the Kelawea Mauka Makai Park parking lot, then to Lahainaluna Road, and ultimately, to the Lahaina Bypass to escape the fire. Inset: Viewpoint of BWC image of MPD officer inside county lot residents used to travel through to escape the fire.

The direct intervention of MPD officers allowed for quicker evacuations and access to safer areas. The necessity of rapid access measures to open these gates highlighted a significant gap in the preparedness and planning for such emergencies. Ensuring these routes are maintained and accessible by emergency crews could vastly improve evacuation operations in future incidents.

Ensuring multiple, well-maintained evacuation routes are available and first responders have the necessary access to these routes is crucial. Pre-planned and regularly updated evacuation routes can mitigate delays and ensure smoother evacuations during emergencies.

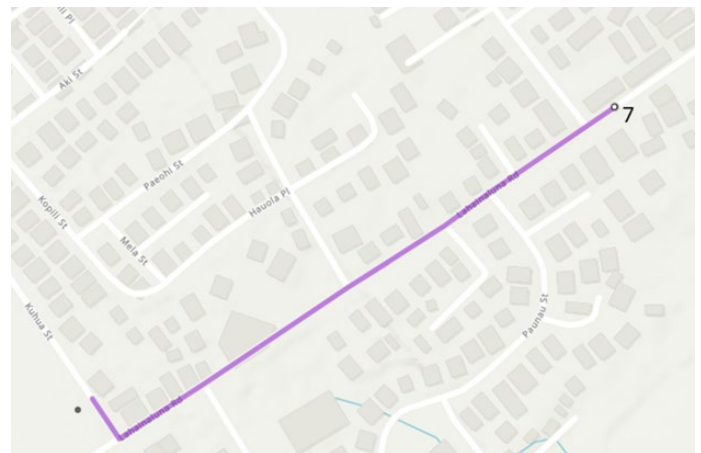
There were three (3) clusters of fatalities located in the Lahainaluna neighborhood. The first was at the Hale Mahaolu Eono independent-living apartment complex at 8███ Kelaweā Street. Seven (7) residents were among the fatalities. Six (6) were recovered on the facility property and one (1) evacuated to the area of Lahainaluna Road and Kuhua Street and was recovered there (Figure 3.8.10.4).

The average age of those who did not evacuate this complex was 86. This complex was very close (approximately 200 feet to the closest point) to the first structures that ignited after the fire jumped the Lahaina Bypass. The MFD initially positioned several units to try to stop the fire's progression near the intersection of Kalena Street and Lahainaluna Road, but were unsuccessful. MPD officers worked to evacuate the complex, but were forced to fall back

Figure 3.8.10.4 Evacuation path of the resident of the Hale Mahaolu Eono independent-living apartment complex at 8███ Kelaweā Street who was recovered on Kuhua Street.

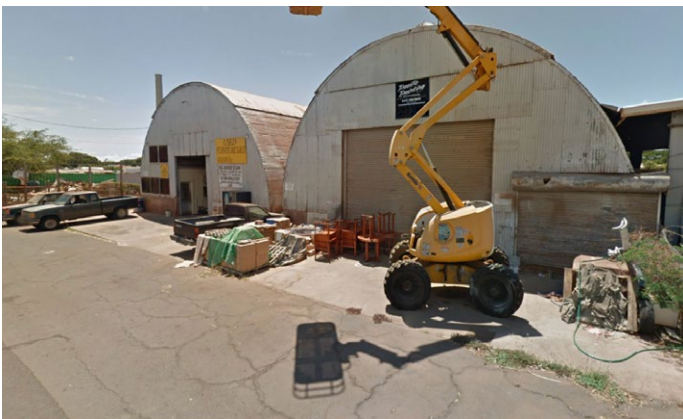
The second cluster of fatalities was located inside 8█ Kuhua Street. Six (6) people sought refuge inside a structure described in MPD documents as a “quonset hut.” This lightweight prefabricated structure of corrugated, galvanized steel with a semi-circular cross-section faced Kuhua Street. The remainder of Kuhua Street was lined with a security fence that residents described as well-reinforced due to previous vandalizations of the mill property that ran along most of the western side (makai) of Kuhua Street (Figure 3.8.10.5).

Figure 3.8.10.5 Front of 8█ Kuhua Road from Google Street View (Sept 2011).

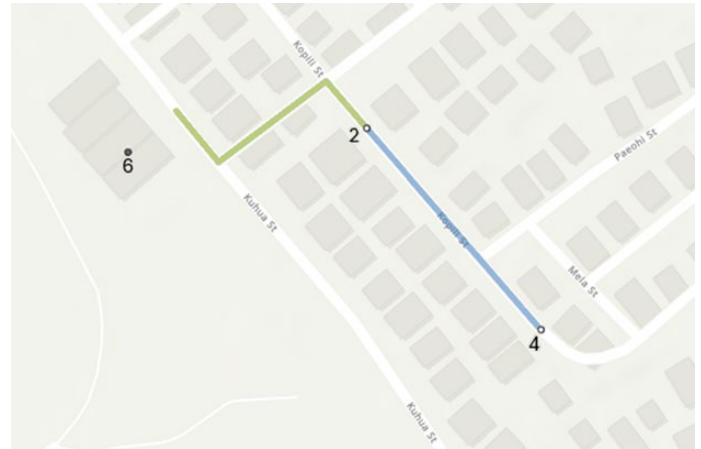
Figure 3.8.10.6 Potential egress routes for fatalities recovered from 8█ Kuhua Street.

Based on resident reports and media stories, a large tree came down blocking Kuhua Street just south of Aki Street, and a utility pole came down across Kuhua Street just north of Aki Street. All six (6) victims lived on Kopili Street and likely traveled north on Kopili Street, then west on Aki Street to Kuhua Street, where they became trapped, unable to go north or south without hitting an obstruction (Figure 3.8.10.6).

Once the fire spread to the Kuhua Street and Aki Street area at approximately 16:42, when a 911 caller advised the fire was getting closer to Kuhua

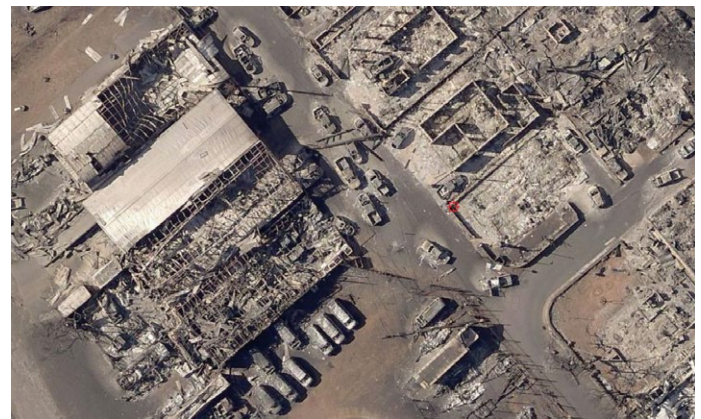
Figure 3.8.10.7 August 11, 2023, satellite image of 8█ Kuhua Street and surrounding area.

Street and Aki Street, they were left with no evacuation route. Unfortunately, the structure did not resist the fire and was burned out, along with the six (6) victims (Figure 3.8.10.7).

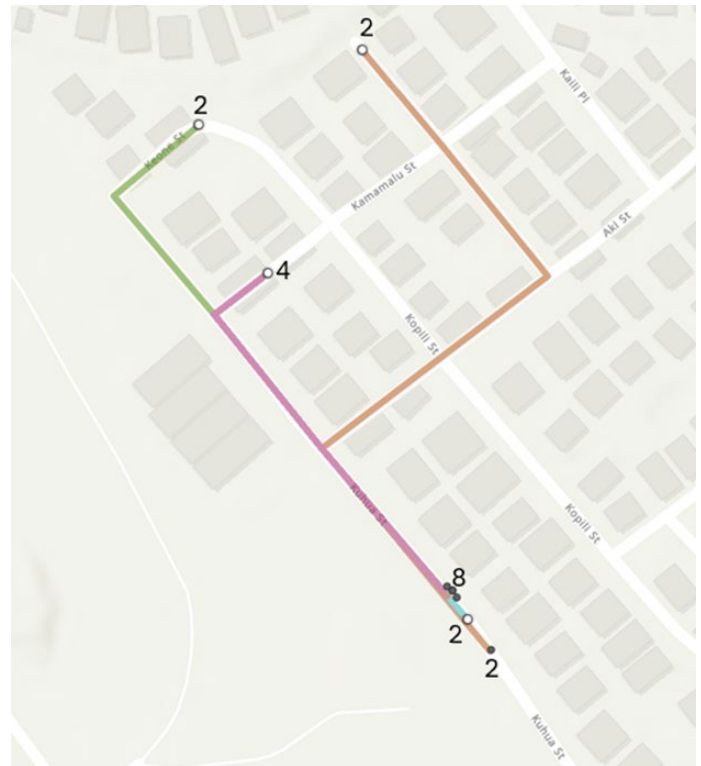
Figure 3.8.10.8 Potential egress routes for those recovered in vehicles in front of 8█-8█ Kuhua Street.

This address is where two (2) of the victims (Terri Thomas and Dale Richter) were reported to have lived. Tony Takafua, Salote Tone, Fa'aoso Tone, and Malui'fonua Tone were presumably evacuating from 9█ Kuhua Street in their car headed south on Kuhua Street toward Lahainaluna Road. Juan Deleon and Ediomede Castillo were presumably evacuating from their home at 3█ Keone Street in their car, headed south on Kuhua Street toward Lahainaluna Road (Figure 3.8.10.8).

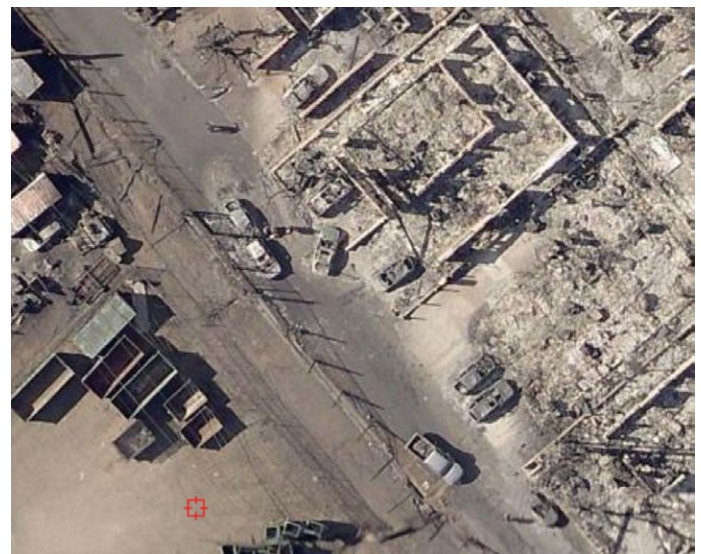
Figure 3.8.10.9 August 11, 2023, satellite image of 8█-8█ Kuhua Street and surrounding area.

It is not known what time they all reached this area. However, they were able to get past the area on the corner of Aki Street and Kuhua Street. The fire first reached the area of Kuhua Street and Lahainaluna Road at 15:57. At 16:25, homes were reported to be on fire in this area. The vehicles in front of 8█ Kuhua Street were consumed by fire, while the vehicle in front of 8█ does not appear to have been consumed by the fire (Figure 3.8.10.9).

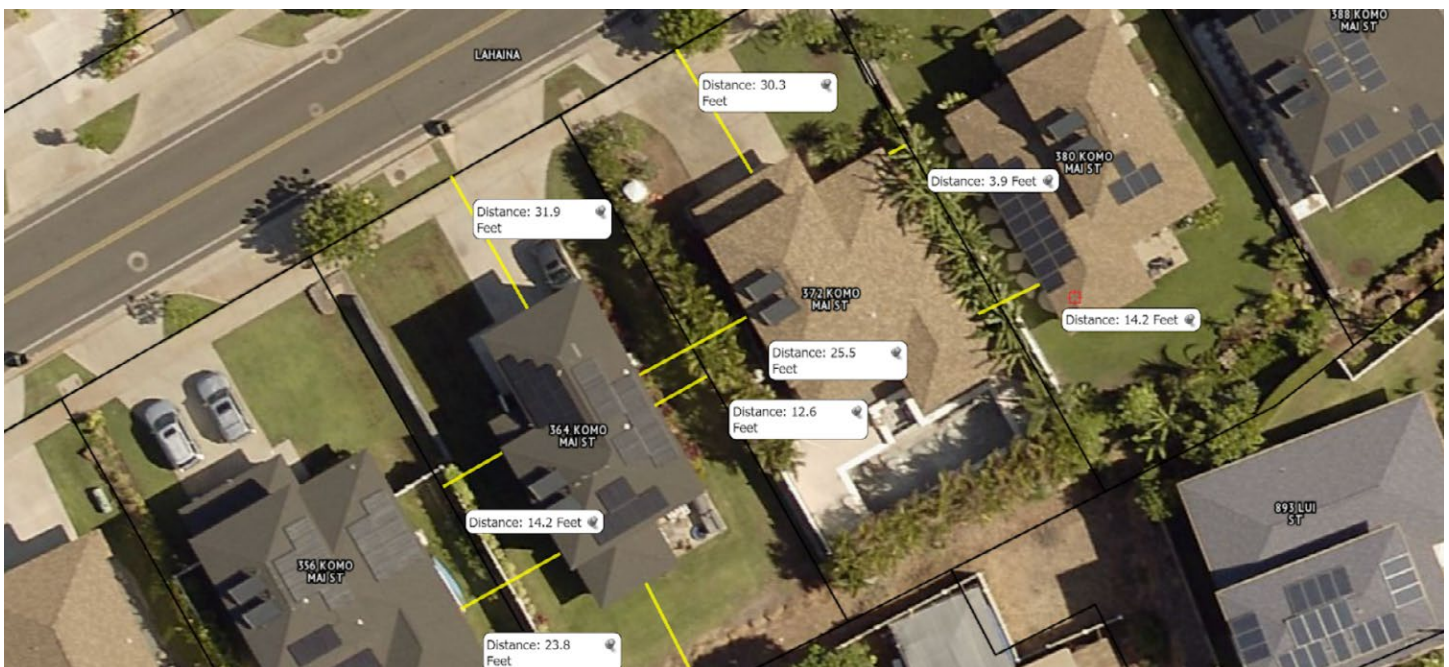
Structure separation distance is the distance between two structures, either on the same parcel or between parcels. Setbacks are the distances between structures and property lines. Aerial imagery can be used to measure the distance between roof lines of structures (Figure 4.1.3.1).

Figure 4.1.3.1 Example of distance measurement capabilities with aerial imagery and potential reference point for set back and separation distances.

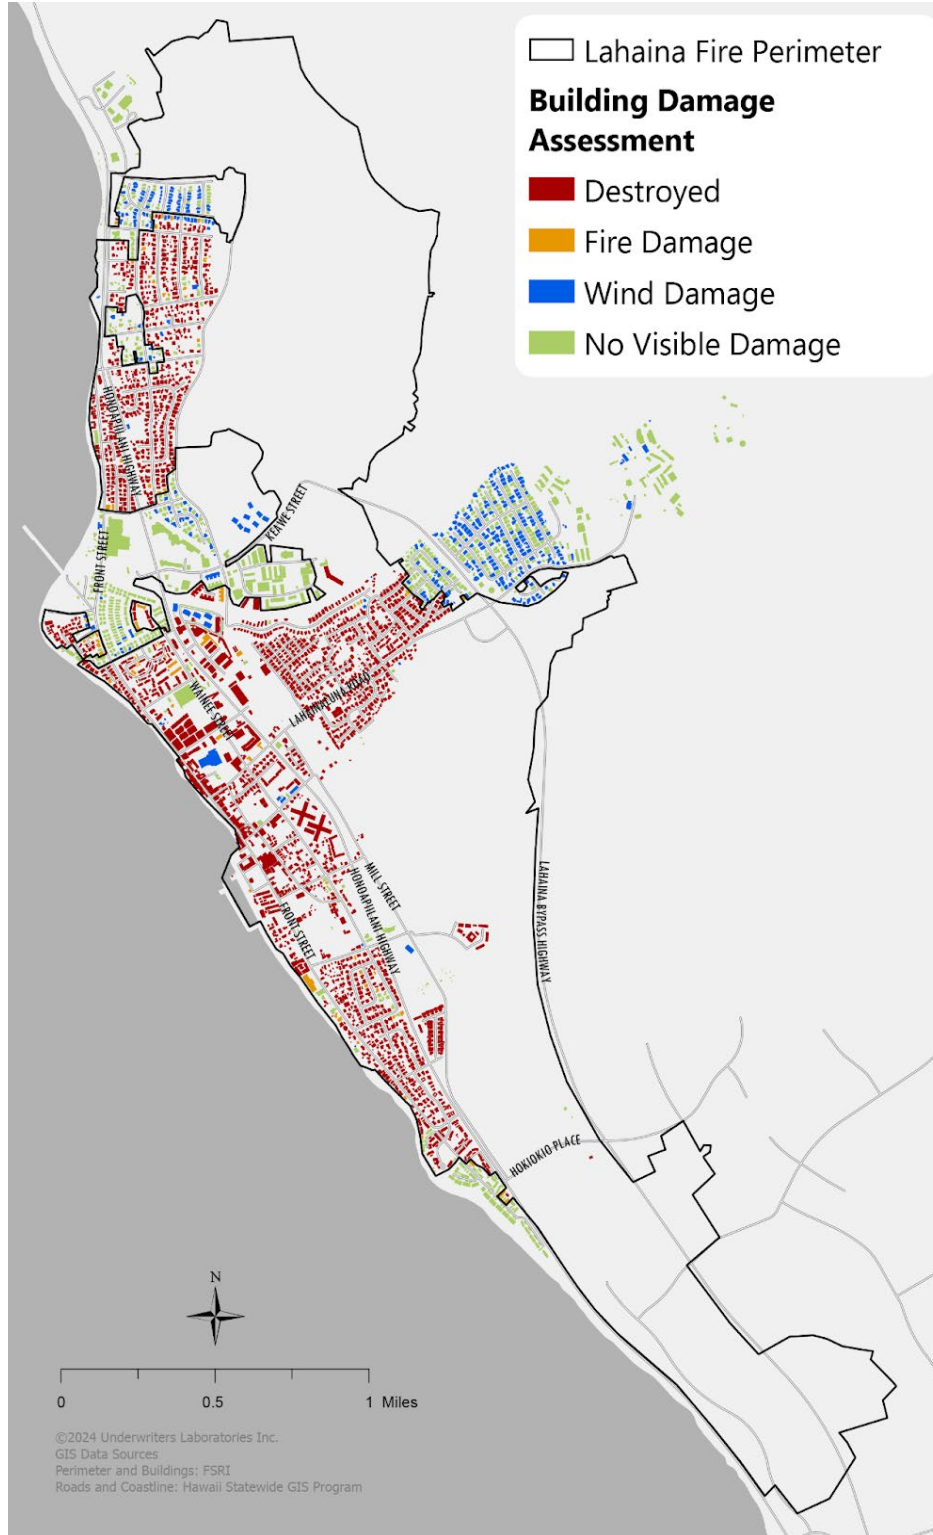
Figure 4.2.1.1 is the structure damage assessment based on data available and current understanding that combines information gleaned from previously published datasets with ground truth from Phase One evidence.

FEMA GSDA	FSRI
Total # Structures	2807	3335
Destroyed	1791	2117
Damaged	283	431
No Visible Damage	733	787

Figure 4.2.1.1 Structure damage assessment map of Lahaina as a result of the August 8-9, 2023 fire.

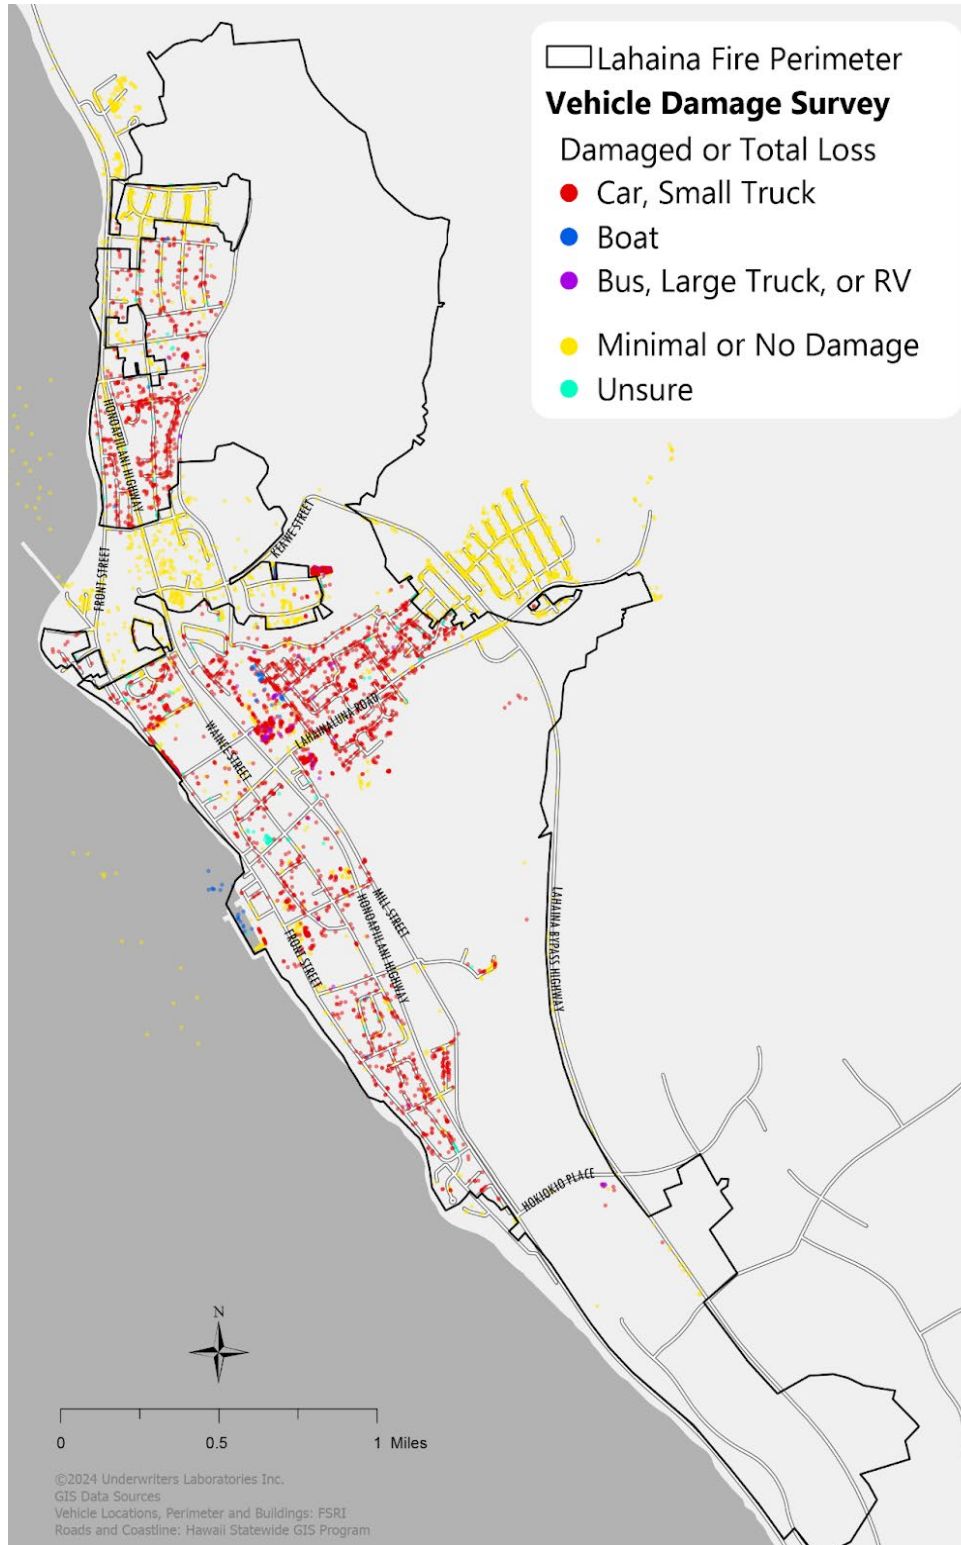
FSRI conducted a visual survey using post-fire aerial imagery captured August 11-13, 2023, to create a dataset of vehicle locations and damage classification (Figure 4.2.2.1). It is evident from the imagery (and as reported) that vehicles, both destroyed and undestroyed, were moved at some point during or after the incident.

Figure 4.2.2.1 Overview of incident area with location of vehicles identified in aerial imagery captured August 11-13, 2023.

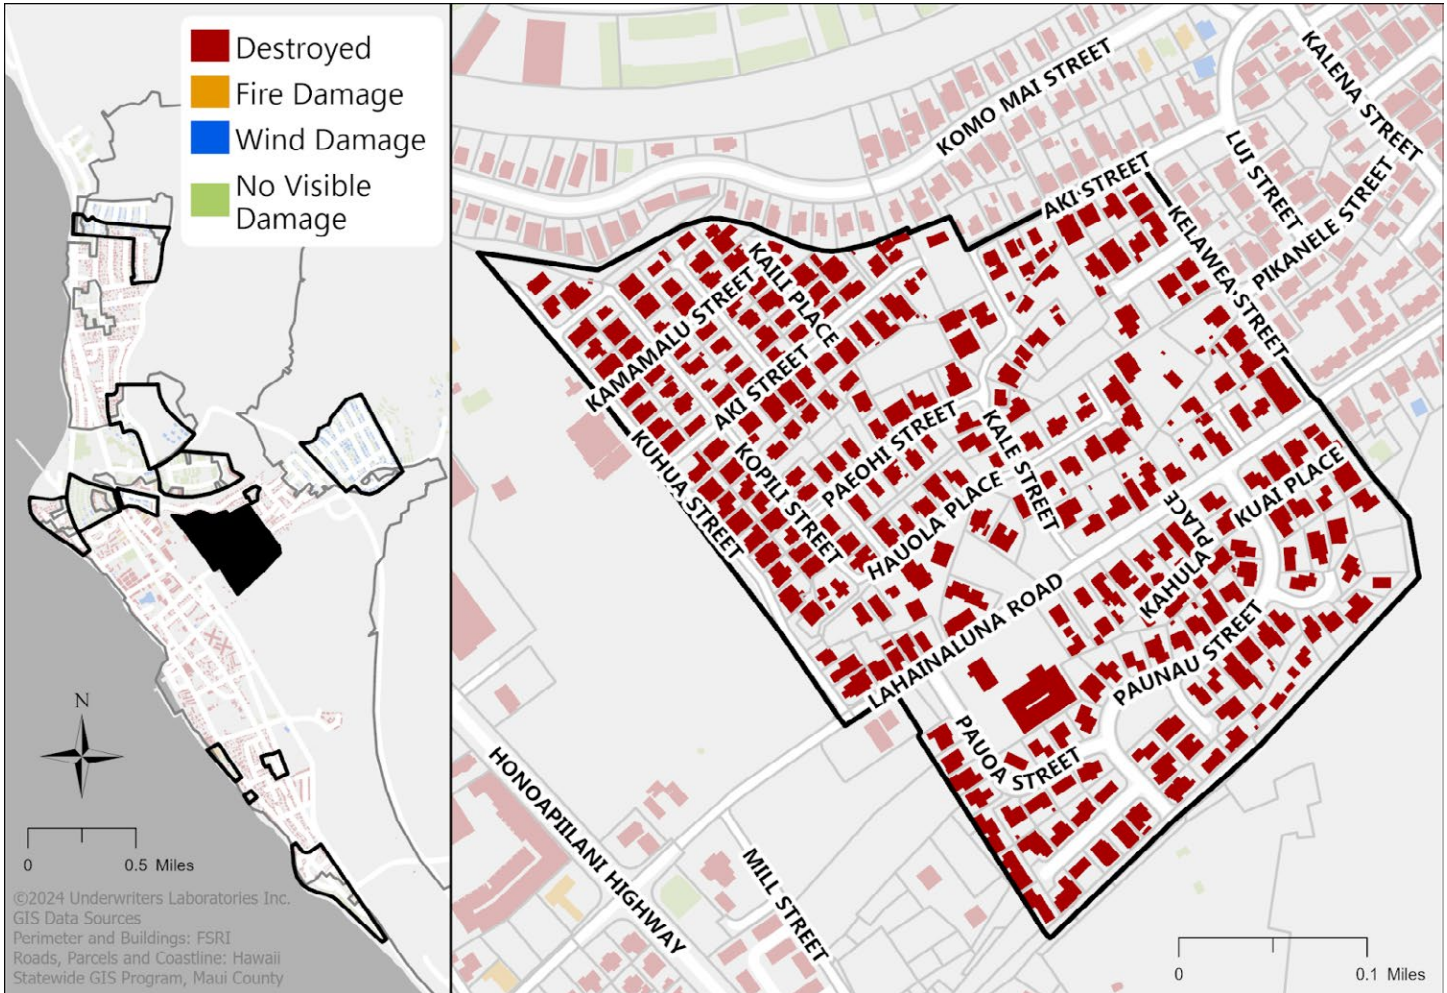
Figure 4.3.3.1.2 Damage classification assessment map of Kelawe Community analysis area.

The neighborhood is bound on the west (makai) by a large industrial area that had once been the Pioneer Sugar Mill, and was originally constructed as employee housing for the mill. All of the structures in this area were destroyed (Figure 4.3.3.1.2).

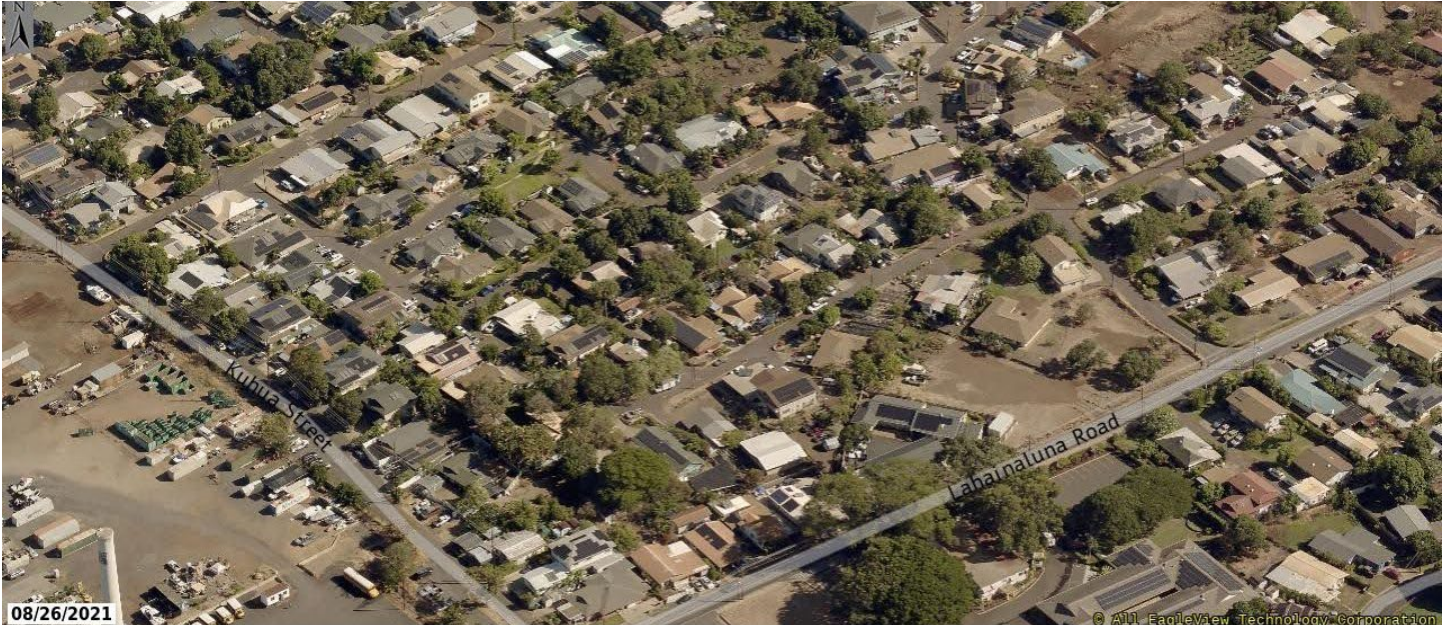
Figure 4.3.3.1.3 EagleView image taken August 26, 2021 showing the high community density.

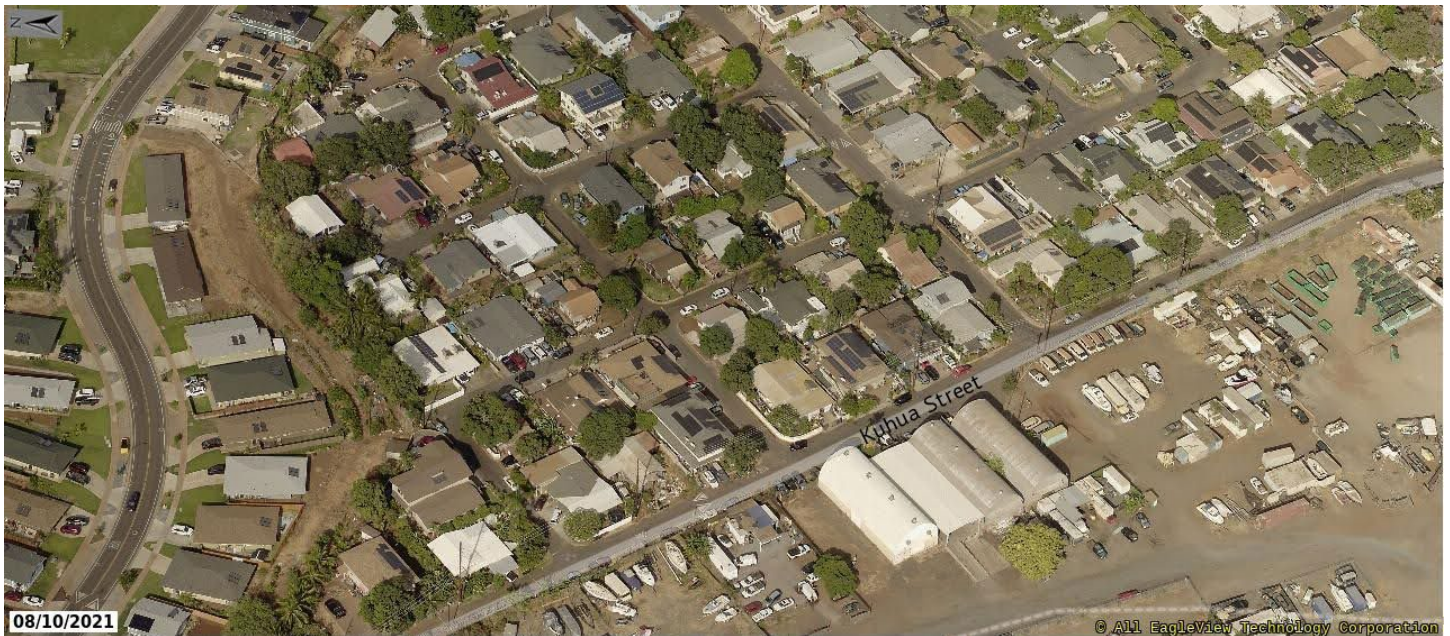
Plans for the original homes in this community (Figure 4.3.3.1.4) show they were designed to be less than 1,000 feet². Figure 4.3.3.1.5 shows that by 2022, additional structures had filled the empty spaces between these original structures, causing very little separation distance between buildings.

Figure 4.3.3.1.5 Pre-fire aerial imagery captured August 2021 of the area along Kuhua Street depicted in Figure 4.3.3.1.4.

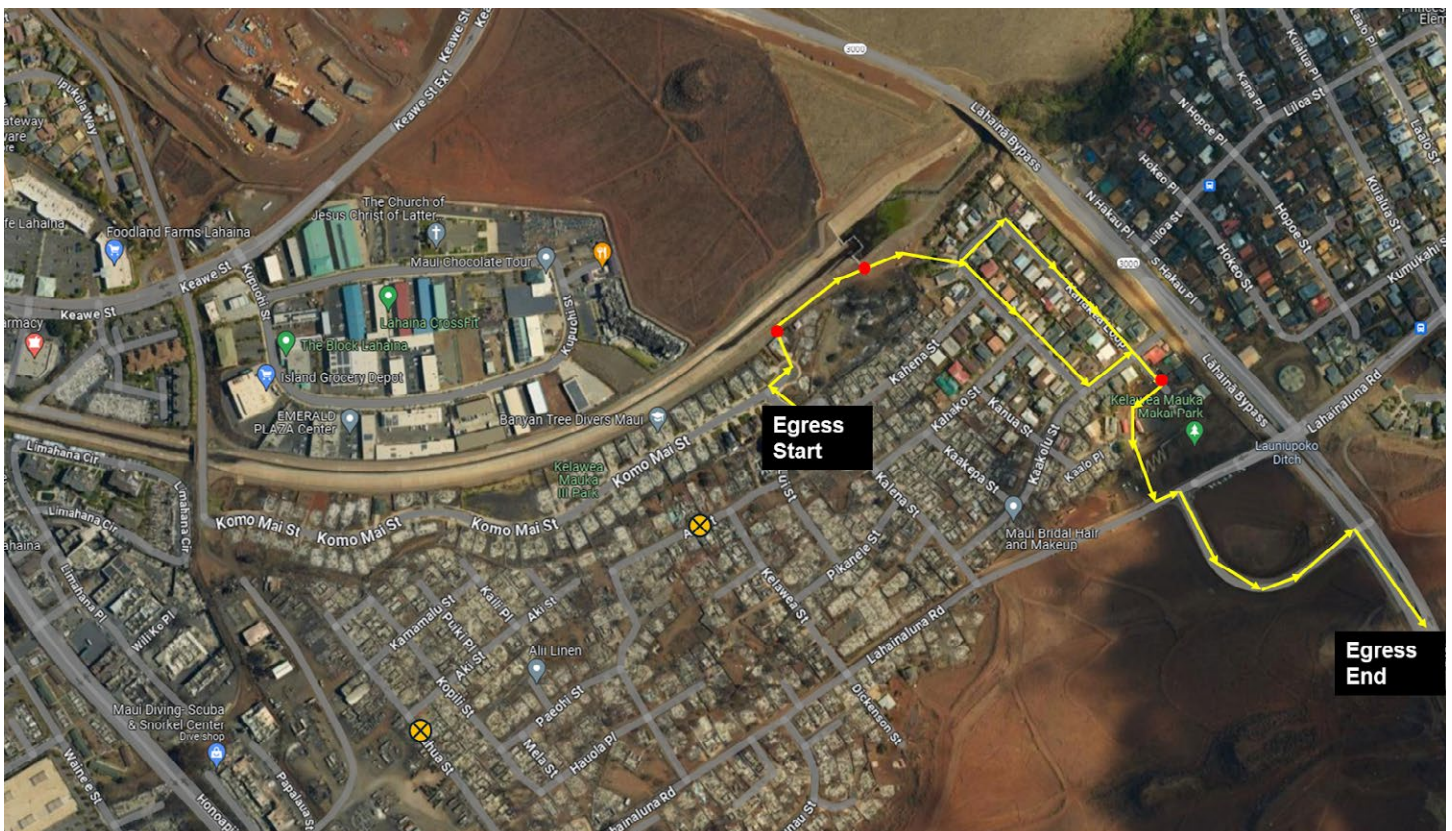
Figure 4.3.3.1.7 Map showing egress route at 16:41 after the fire cut off the westbound exits via Komo Mai Street and Lahainaluna Road. Orange dots represent the location of the fallen trees and debris blocking Kuhua and Aki Streets. Red dots represent locked gates that police officers and residents forcibly opened to gain access to alternative egress routes depicted by the yellow lines.

RECOMMENDATION: Ensuring gates blocking potential evacuation routes are equipped with standardized locks and that emergency responders have the necessary keys or access codes is also vital.

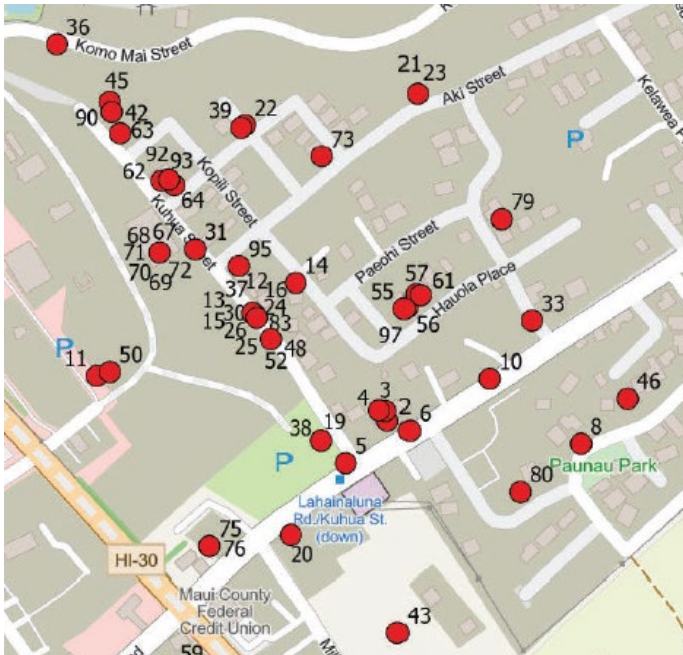
Fifty citizens perished in this area or after exposure to conditions in this area (Figure 4.3.3.1.8). Fifty-five of those killed in the fire had addresses in the neighborhood. Many people narrowly escaped and there are many stories of neighbors helping neighbors to escape the fast spreading urban conflagration. For more information on the circumstances surrounding the fatalities, see Section 3.8.10.

Figure 4.3.3.1.8 Fatality locations in this area as provided by the MPD.

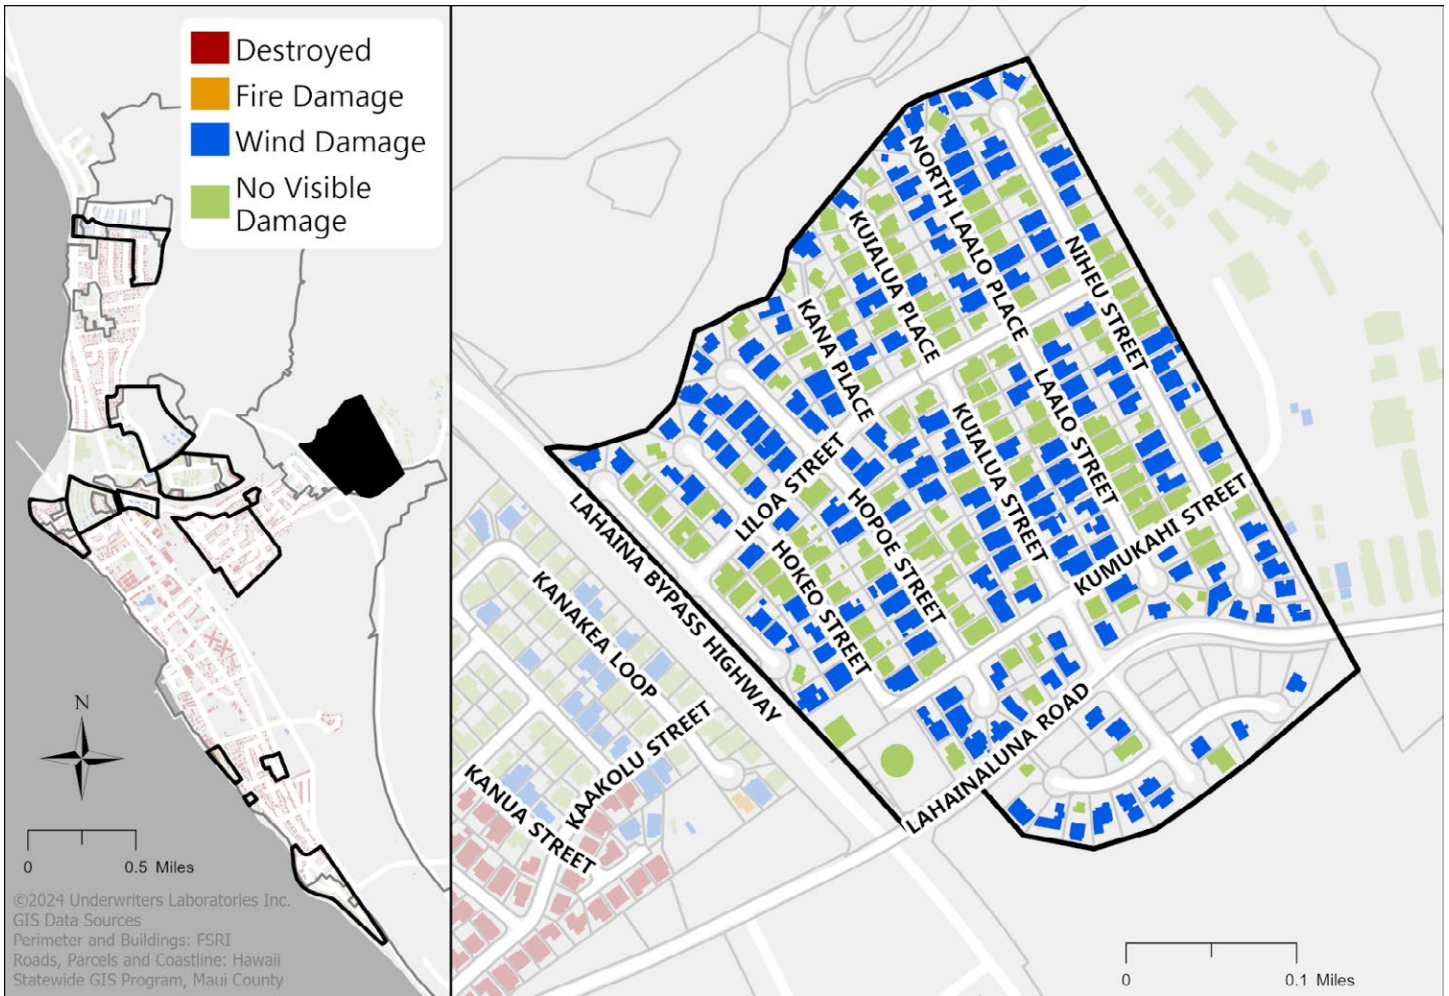
The area of origin is just behind the homes on Ho'okahua Street, but does not appear to have damaged any of the structures. Several residents indicated they engaged in firefighting activities, including fighting spot fires and defending structures. Without these actions it is likely structures would have ignited and resulted in similar destruction that occurred west (makai) of the bypass. Most of these structures were outside of the fire perimeter, but many sustained damage due to high winds before and during the fire. Of the 276 properties, 162 (59%) have visible damage due to wind (Figure 4.3.3.2.2).

Figure 4.3.3.2.2 Damage classification assessment map of Kelaweā Mauka III subdivision analysis area.

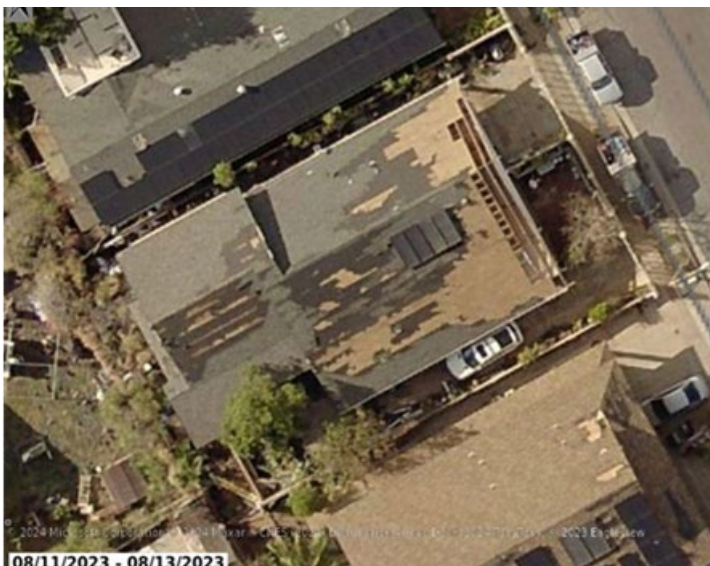
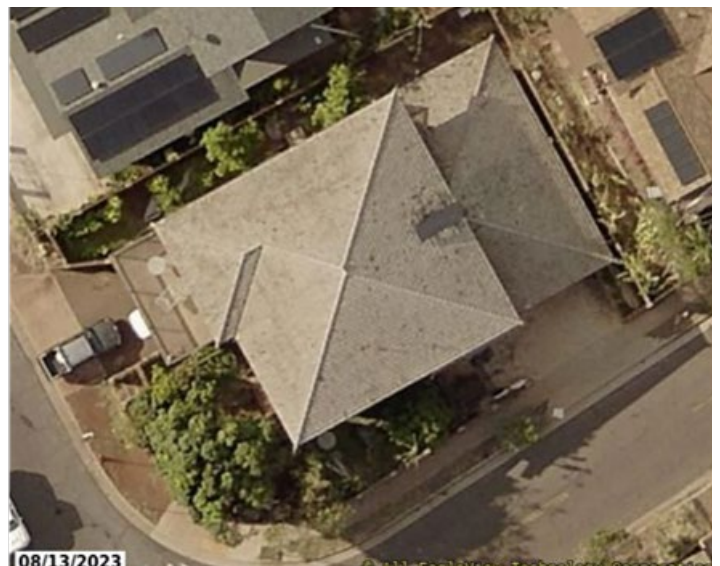
Given these caveats, this sample of wind damaged structures provides insight into the plausible damage to other structures before and during the fire, which would subsequently impact their vulnerability to fire damage, particularly for entry of airborne embers.

Figure 4.3.3.2.3 Example of wind damage in the Kelaweā Mauka III subdivision—(bottom left) damaged roof sheathing and (bottom right) loss of roof covering.

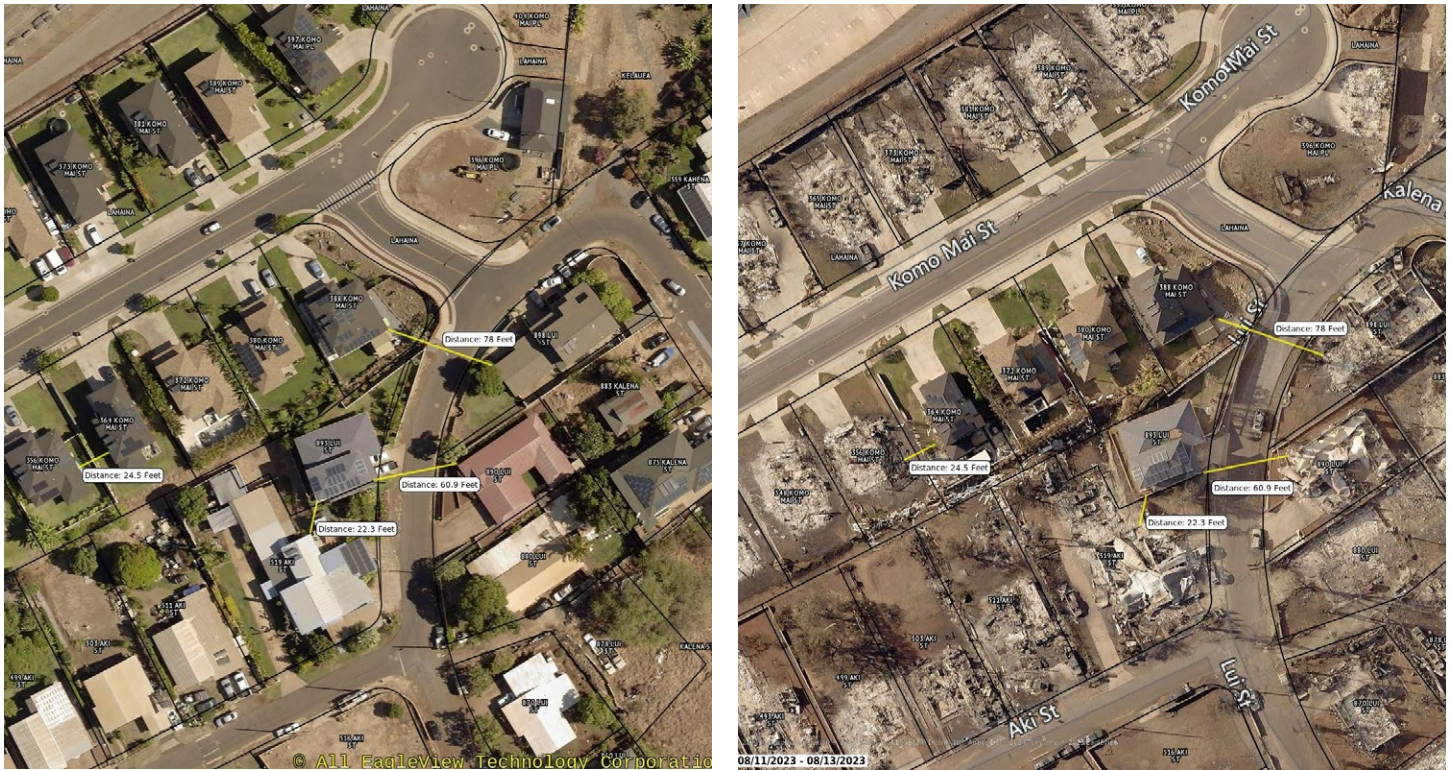
Figure 4.3.3.3.1 Pre- and post-fire aerial imagery of homes that survived the fire on Komo Mai Street and Lu'i Street. Annotations depict separation distances between perimeter structures and nearest destroyed structure.

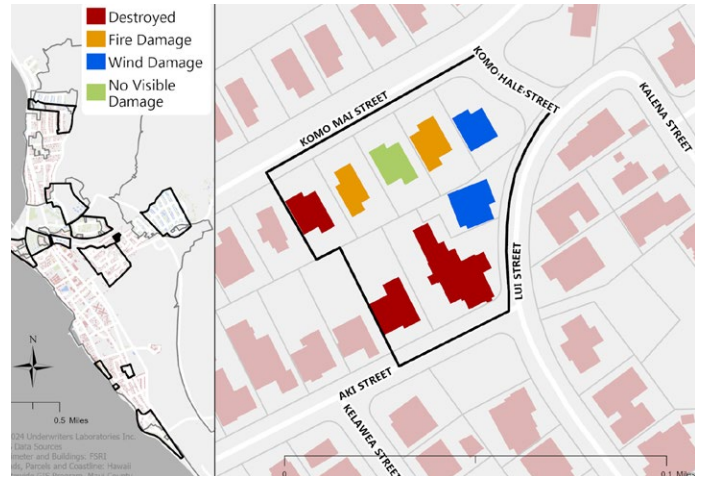
Five (5) structures at the corner of Komo Mai Street and Lu'i Street were not destroyed, while all adjacent ones were destroyed (Figure 4.3.3.3.2). The western-most (makai) home that was not destroyed—3█ Komo Mai Street—was impacted by the adjacent (downwind) structure, including what appears to be discoloration of the fiber cement siding and damage to windows on the fire-exposed side of the structure (Figure 4.3.3.3.3).

Figure 4.3.3.3.2 Damage classification assessment map of Kahoma subdivision analysis area.

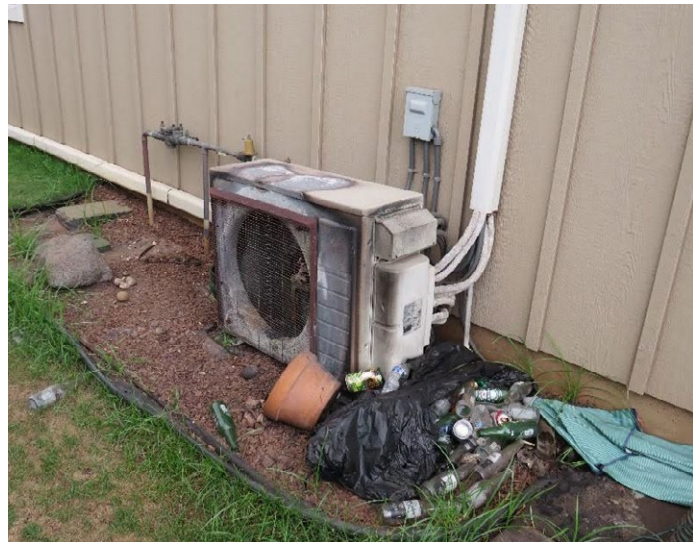
Based on the incident timelines (see Phase One report), MFD units E3, L3, and other personnel were in the area of Lu'i Street and Komo Mai Street from approximately 16:00 to 19:00 on August 8, 2023. During this time, firefighting units implemented structure defense tactics, including fire suppression and exposure protection (Figure 4.3.3.3.4). These defensive actions were likely the primary reason that these structures were not destroyed.

Figure 4.3.3.3.4 Isolated fire damage to 311 Komo Mai Street. Spot fire (ember ignition) caused localized damage, but did not spread to the structure, likely due to defensive actions.

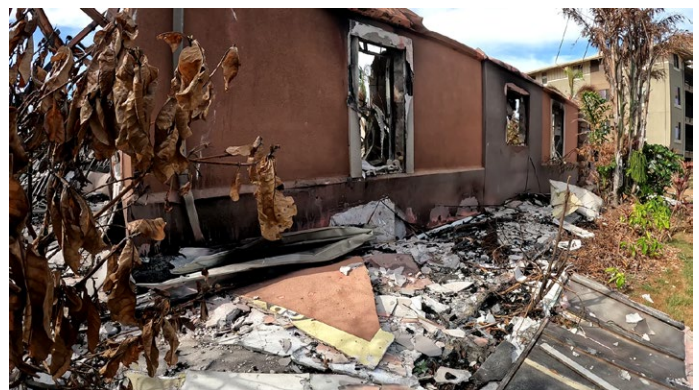
The first floor exterior walls are concrete masonry block (CMU) blocked with stucco cladding, while upper floors were constructed with gypsum sheathing and similar stucco cladding.

Figure 4.3.3.4.4 Destroyed apartment building showing CMU block exterior wall construction (first floor) and noncombustible sheathing with stucco finish coat and fiber cement siding.

These noncombustible exterior wall materials likely contained the fire within the burning structures and reduced exposure to adjacent buildings. Additionally, the 40- to 50-foot separation distance between the burning buildings, and nearby structures, could also have been a contributing factor in why fire did not spread to the adjacent apartment buildings.

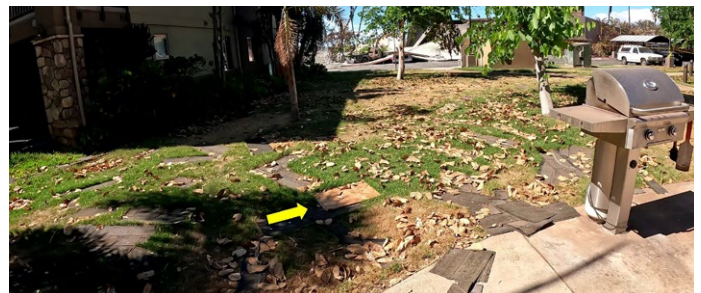
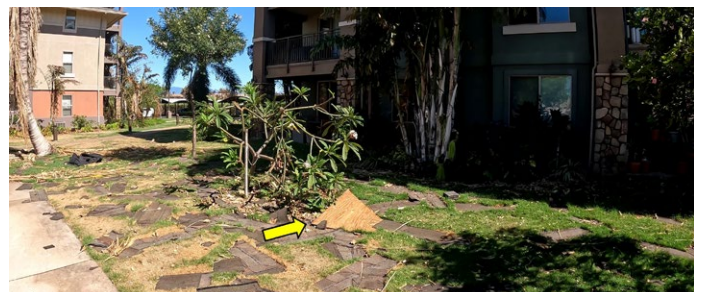
However, these surviving structures sustained substantial wind damage, including detachment of roof coverings, as well as the removal of roof sheathing (Figure 4.3.3.4.5) and broken windows (Figure 4.3.3.4.6), which could create potential pathways for embers into the structures.

Figure 4.3.3.4.5 Wind damage to undestroyed apartment buildings, including significant roof covering (composition shingle) loss and roof sheathing.

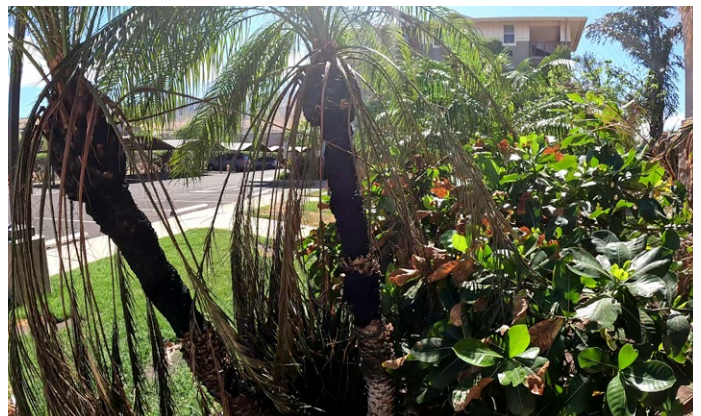
There is evidence of some firebrand/ember ignitions of ornamental vegetation (Figure 4.3.3.4.7), but a notable lack of spot fires in grasses in the community, compared to spot fires in the grasses adjacent to Kahoma Stream.

This evidence suggests the ember exposure was sufficient, but most fuels in the apartment complex, including vegetation, were not receptive to ignition. The lack of ignition in the vegetation may be attributed to the apparent lushness caused by irrigation.

Figure 4.3.3.4.7 Ornamental vegetation (palm bracts) ignited by embers and burned without igniting adjacent vegetation.

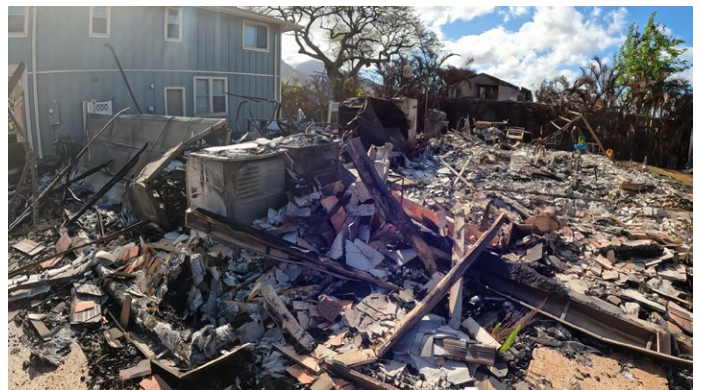
There was one (1) single family home (2█ Kahoma Village Loop) that was ignited by embers on the southeast corner of the village (Figure 4.3.3.5.4). The house fire was recorded by Central at 16:44:56. MPD BWC footage shows the house's roof on fire at 17:41 and water being applied from the Kenui Street side (Figure 4.3.3.5.5).

The MFD, with support from private tankers, kept the fire from extending to adjacent structures. There was no thermal damage to the home to the east (mauka), even though this house was only approximately 14 feet away from the neighboring home.

Figure 4.3.3.5.4 Destroyed single family home at 2█ Kahoma Village Loop from the front (north).

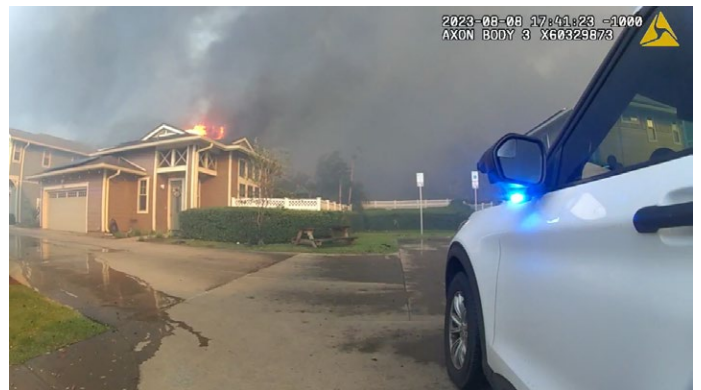
Figure 4.3.3.5.5 Body worn camera image captured by an MPD officer on August 8, 2023, at 17:41:23, showing the house fire in Kahoma Village.

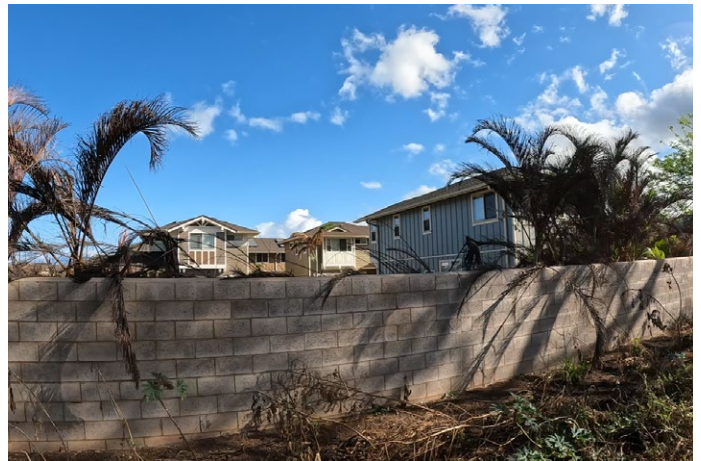
Figure 4.3.3.5.6 Destroyed single family home from the rear on the other side of the concrete wall.

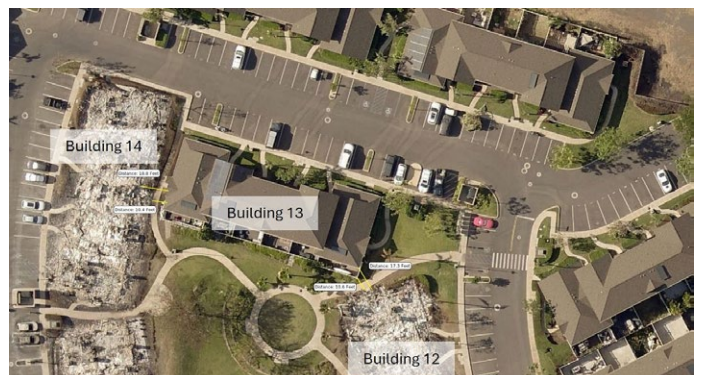
Building 13 was damaged (melted window trim, cracked windows, dried out shrubs, and melted vinyl fence) by adjacent Buildings 12 and 14, but did not ignite (Figure 4.3.3.5.7). Building 14 (destroyed) caused damage to windows and a vinyl fence (Figure 4.3.3.5.8 and Figure 4.3.3.5.9).

Figure 4.3.3.5.7 Aerial imagery of distances between Building 13 (damaged), Building 12 (destroyed), and Building 14 (destroyed).

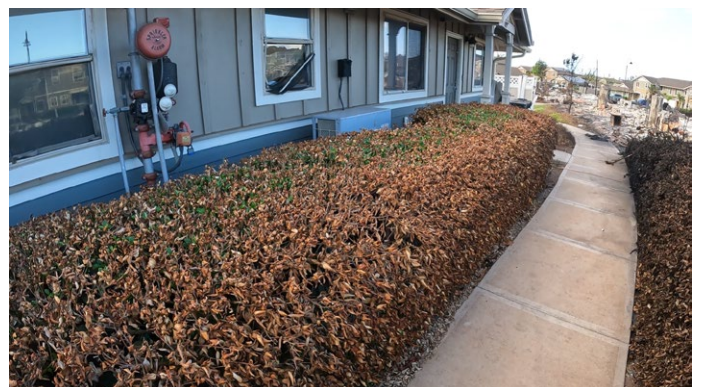
Figure 4.3.3.5.8 Ground-based photograph of space between Building 13 (shown on the left of the image) and Building 14 (shown on the right), showing damaged windows and heat damaged/dried (but not ignited) vegetation.

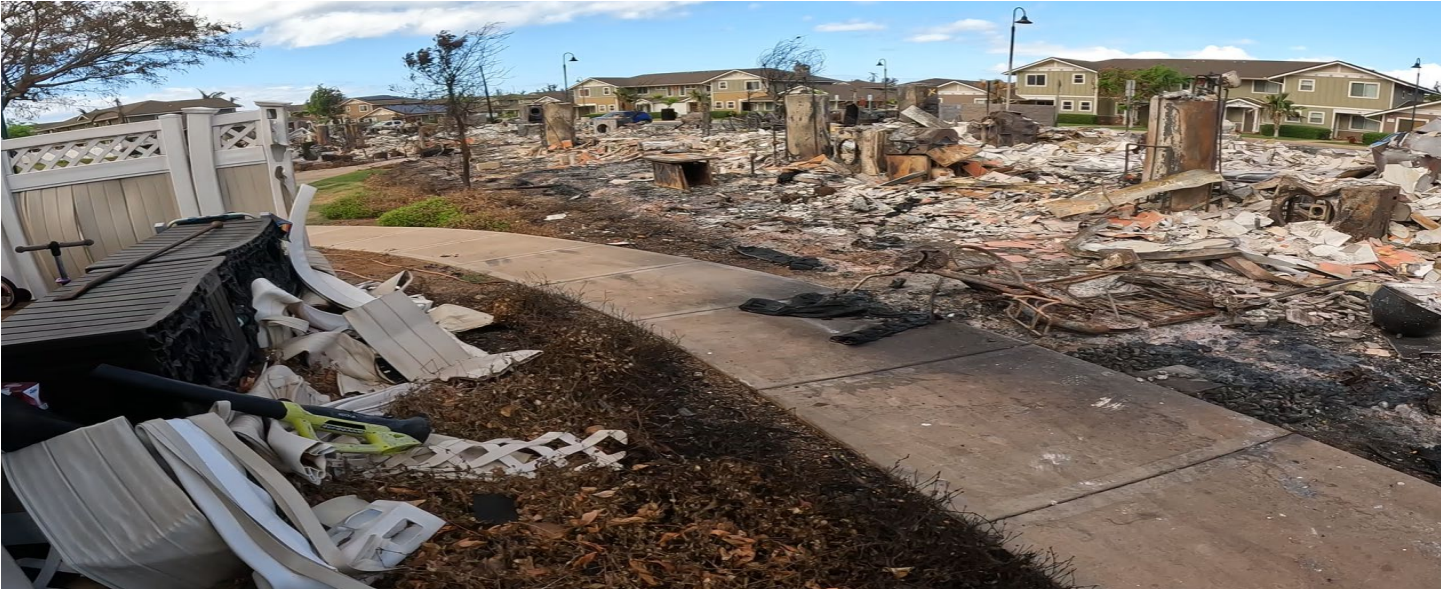
Figure 4.3.3.5.9 Ground-based photograph of space between Building 13 (shown on the left of the image) and Building 14 (shown on the right).

Building 13 was approximately 20 feet away from Building 12, which was also a total loss. Each townhouse building had vinyl fenced-in backyards, which could be as close as 10 feet from one another (Figure 4.3.3.5.9). The combustible materials (e.g., outdoor furniture) between the buildings measured 12 feet between their vinyl fences (Figure 4.3.3.5.9).
