Lahaina Fire Incident Analysis Report

Steve Kerber
Derek Alkonis

September 13, 2024
Columbia, MD

This document is the second in a series of three (3) reports commissioned by the Hawai'i Department of the Attorney General (DOAG) to provide an independent review of the tragic fire that destroyed much of Lahaina, Hawai'i, on August 8-9, 2023.

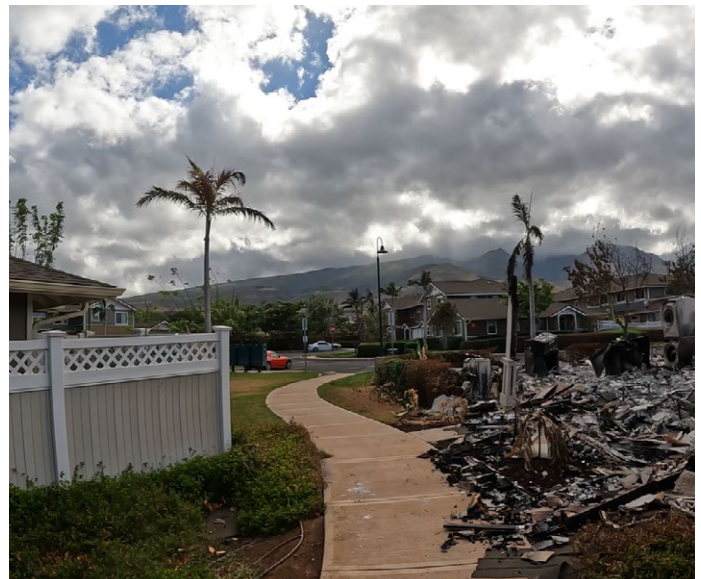
Figure 4.3.3.5.10 Photograph of space between Building 12 (shown on the right of the image) and Building 13 (shown on the left), showing minimal damage to the vinyl fence.

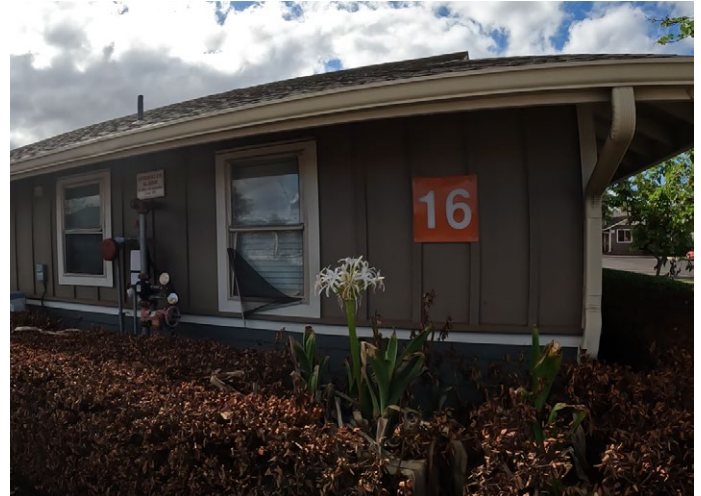
Building 16 was damaged (melted window trim, cracked windows, bubbled paint, dried out shrubs, melted vinyl fence) but did not ignite (Figure 4.3.3.5.11). Building 16 was located approximately 16 feet from Building 15, which was destroyed (Figure 4.3.3.5.12). Several vehicles were also destroyed. Those vehicles were approximately 22 to 30 feet from the nearest window opening in the building.

Figure 4.3.3.4.11 Thermal damage (window) to the front of Building 16, across from Building 15 (destroyed).

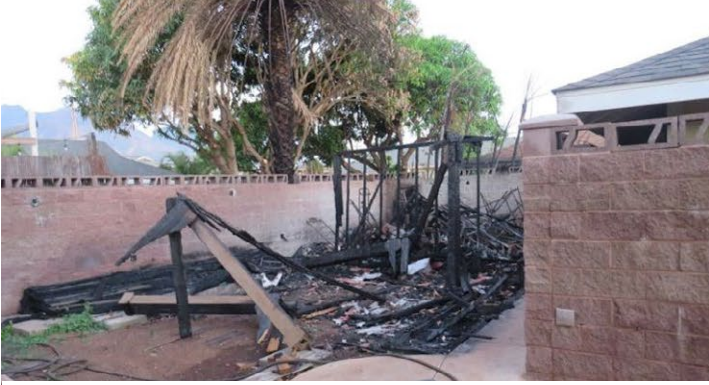
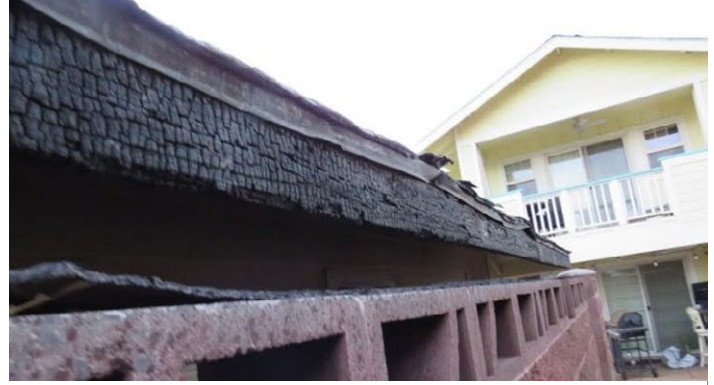
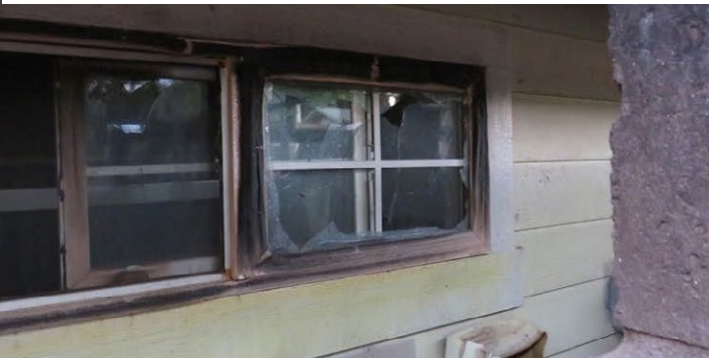
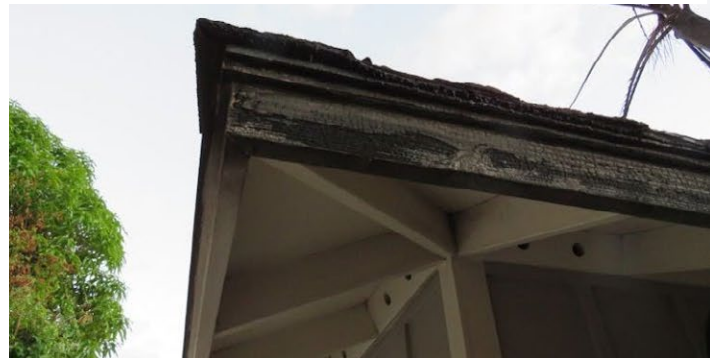
Two buildings, 4 Ala Moana Street and 5 Ala Moana Street, were damaged by a destroyed accessory structure in the backyard of 4 Ala Moana Street. The accessory structure was most likely ignited by embers, due to the lack of continuous fire spread. The destroyed burning accessory structure

caused damage to both 4█ Ala Moana Street (burned fascia and broken windows) and 5█ Ala Moana Street (burned fascia and a damaged storage container) (Figure 4.3.3.6.4).

There is evidence that defensive actions (connected residential hoses flaked out in the area) to suppress the burning structure and/or protect adjacent structures, which could have been a contributing factor to why the fire did not spread further on the parcel.

Figure 4.3.3.6.4 Destroyed accessory structure at 4 Ala Moana Street (top left). The burning structure caused damage to 4 Ala Moana Street (top right and bottom left) and 5 Ala Moana Street (bottom right).

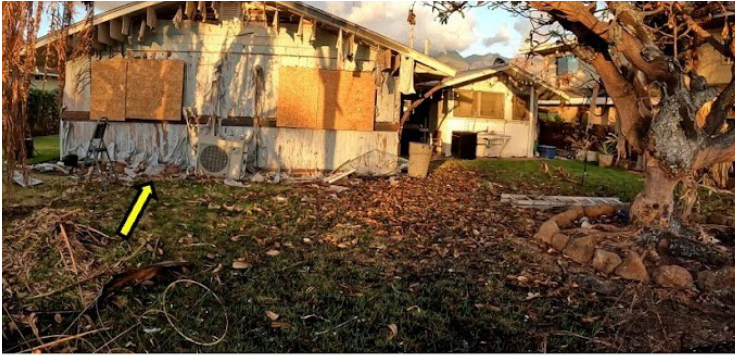
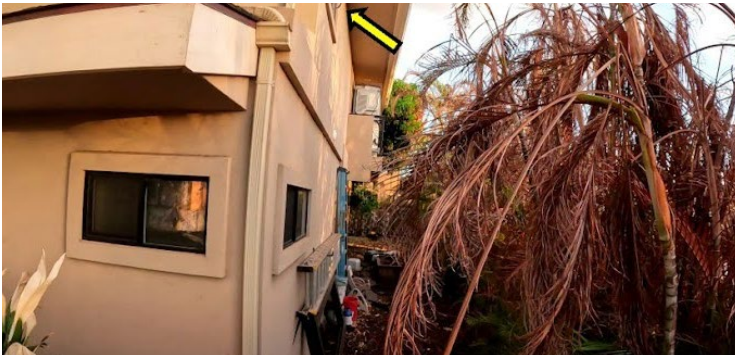
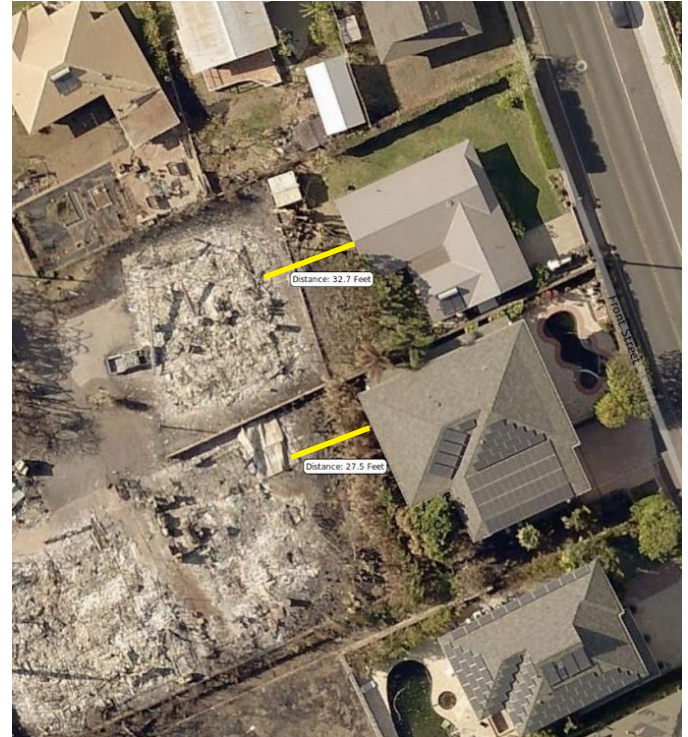
Slightly further south, the burning structures on Lahilahi Place caused damage to the rear side exposures at 11 and 11 Front Street, 20 to 40 feet away. The vinyl siding and window frames were damaged by the radiant heat, but did not ignite (Figure 4.3.3.6.6). A garden hose found behind 11 Front Street may have been used by the residents described above to protect these structures from ignition.

Figure 4.3.3.6.6 Destroyed structure on Lahilahi Place caused damage to the rear side of 11 (top) and 11 (bottom) Front Street structures.

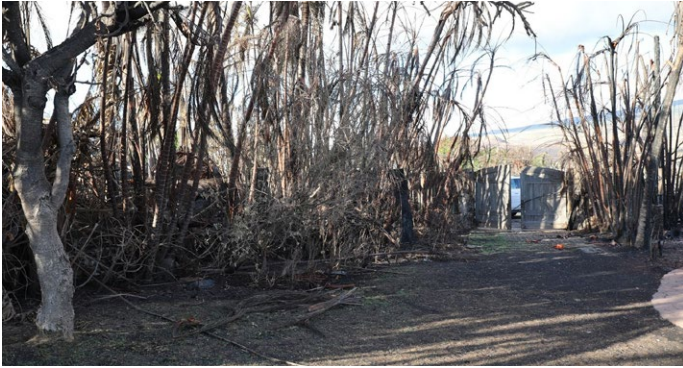
There is evidence of ground fire in the vegetation, potentially from embers, but limited fire spread. The dense, lush (apparently well-watered) foliage and fence may have provided some shielding of the radiant heat from the burning adjacent structure, a contributing factor for the reduced thermal exposure (Figure 4.3.3.6.8).

Figure 4.3.3.6.8 Vegetation and fence on “B” side exposure of 1■ Kamaka Circle.

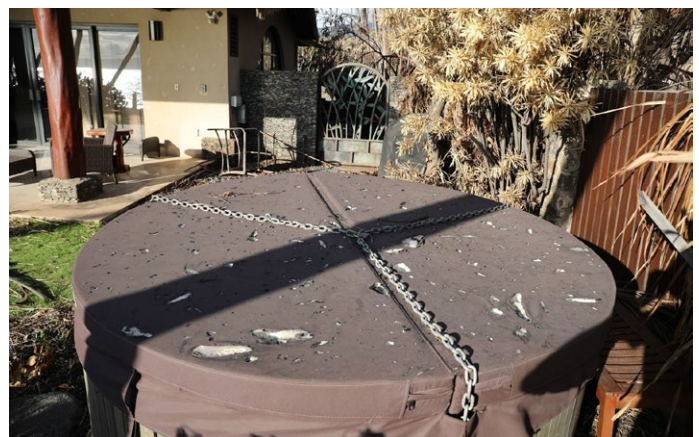
In addition to the thermal exposure from adjacent burning structures, there was considerable ember exposure evident at this location. The hot tub cover and sun shade had numerous burn marks from embers that were energetic enough to pyrolyze these materials after they landed. Ember size characteristics, such as size and shape, can be measured based on the burn marks they leave,²⁵⁸ such as those shown in Figure 4.3.3.6.10.

Figure 4.3.3.6.10 Ember damage of a hot tub cover reveals the noticeable size variation of embers encountered during the fire.

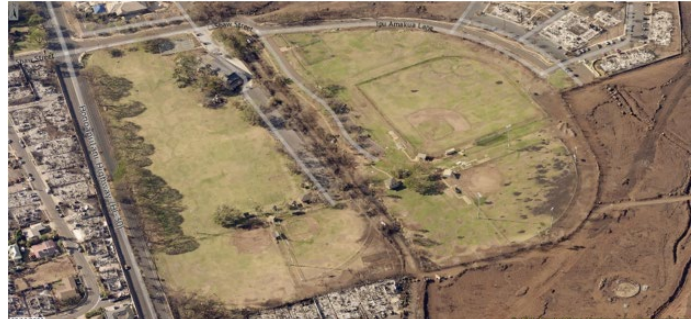
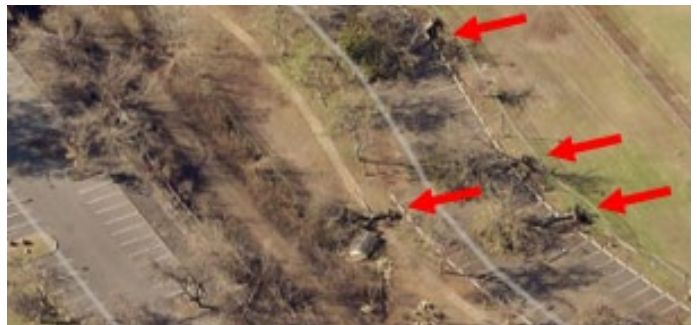
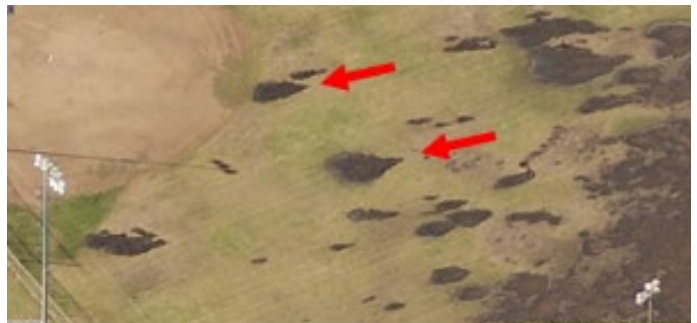
These visual signs of damage suggest winds impacting this area were predominantly from the east (mauka), laying trees and poles to the west (makai) and driving spot fires in the same direction (Figure 4.3.4.1.3).

Figure 4.3.4.1.3 The orientation of wind impacting the 400 block of Front Street in Lahaina can be visualized in the grass fields on either side of Mill Street, around the Lahaina Aquatic Center and Boys & Girls Clubs of Maui (middle). Representative damage to trees oriented towards the west (makai) (bottom). Spot fire damage in the softball field, where the heel of the fire can be identified towards the east (mauka), indicating spread to the west (makai)—assuming flat terrain on the grass field (top).

The vegetation fire spreading from north to south near the Boys & Girls Clubs likely caused fire spotting on the west (makai) softball field (Figure 4.3.4.1.3, bottom) later in the day.

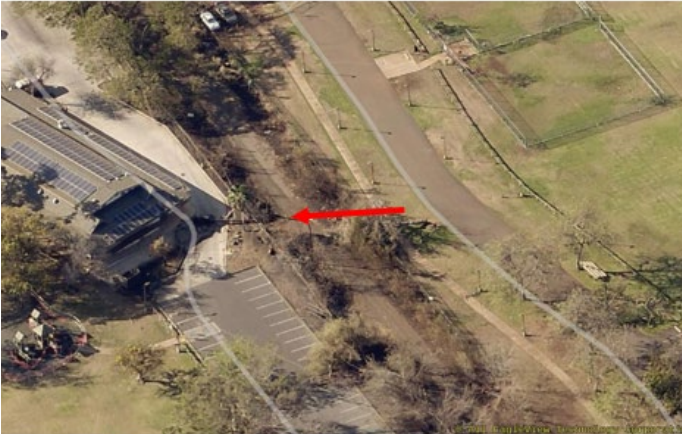
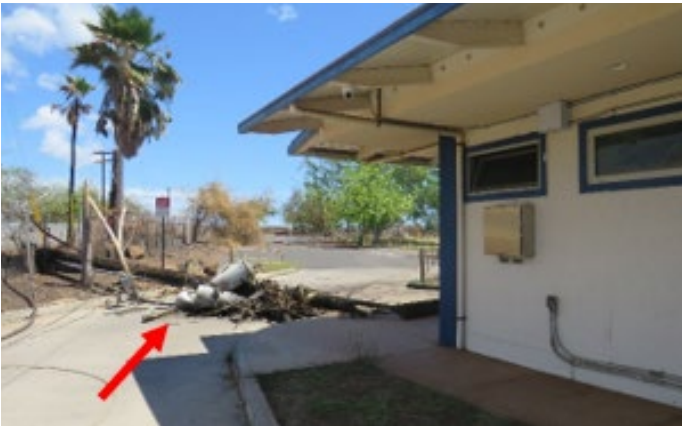
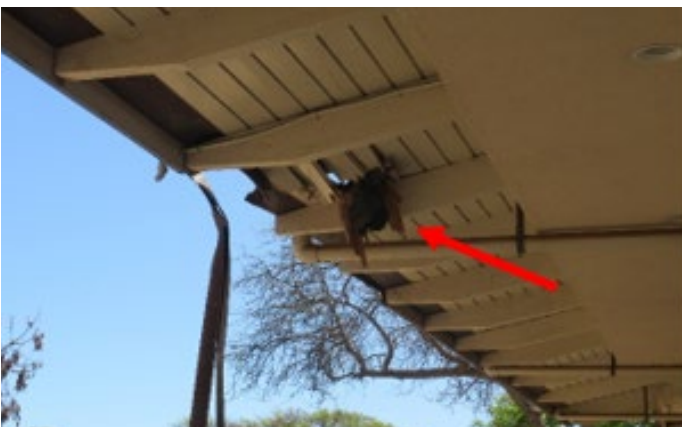
Downed utility poles can be seen along Mill Street to the east (mauka) of the Lahaina Aquatic Center and Boys & Girls Clubs of Maui (Figure 4.3.4.1.4). One (1) of these poles hit and damaged the roof of the Boys & Girls Clubs of Maui (Figure 4.3.4.1.4).

Figure 4.3.4.1.4 Utility pole south of Mill Street that hit and damaged the roof of the Boys & Girls Clubs of Maui.

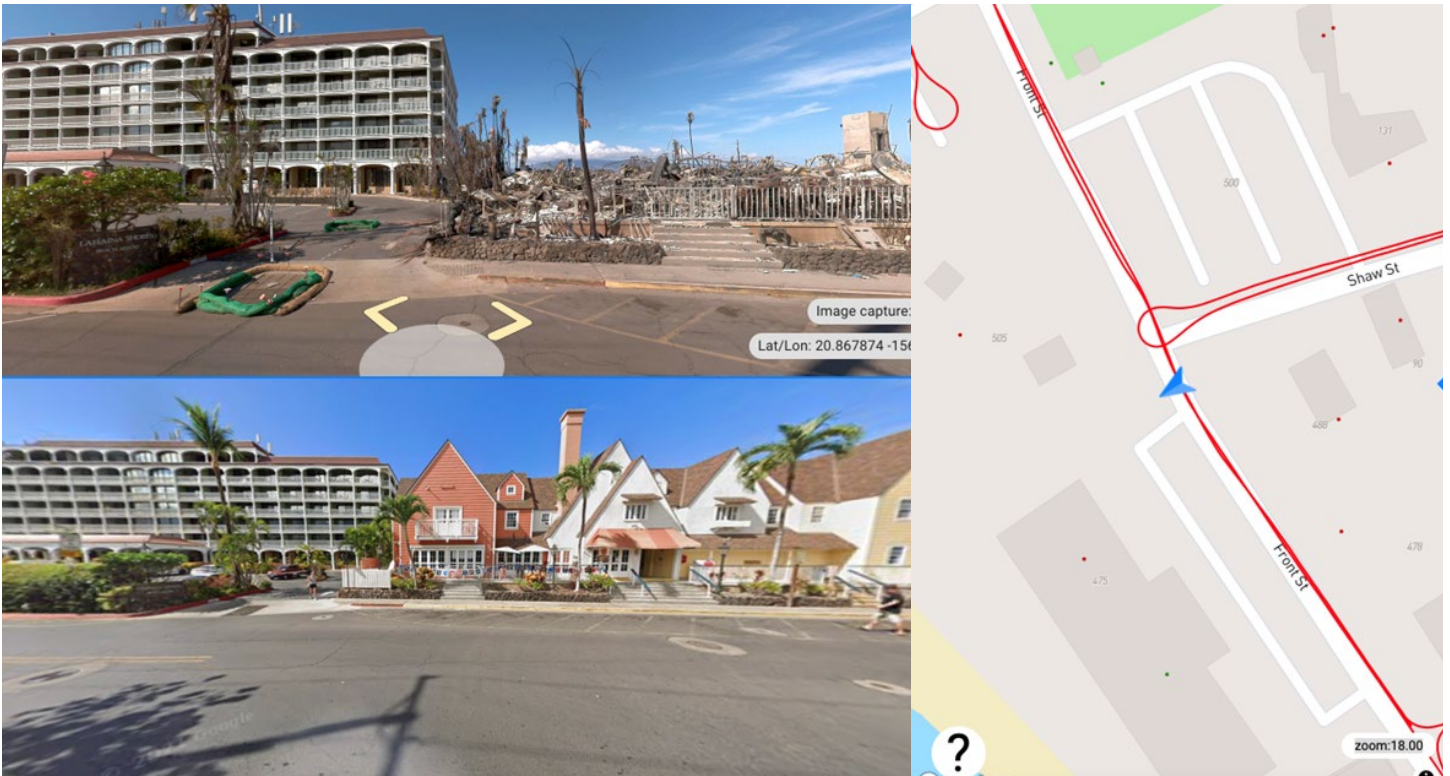
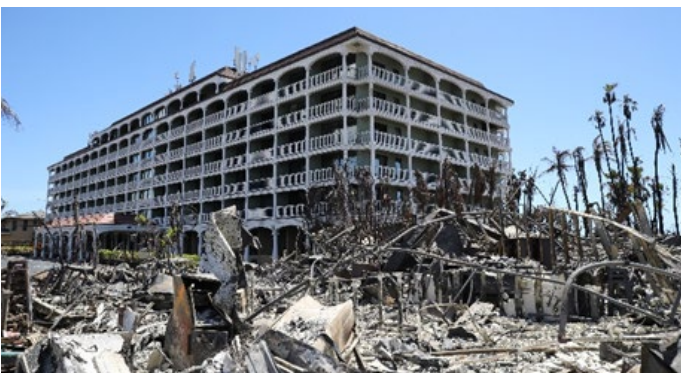
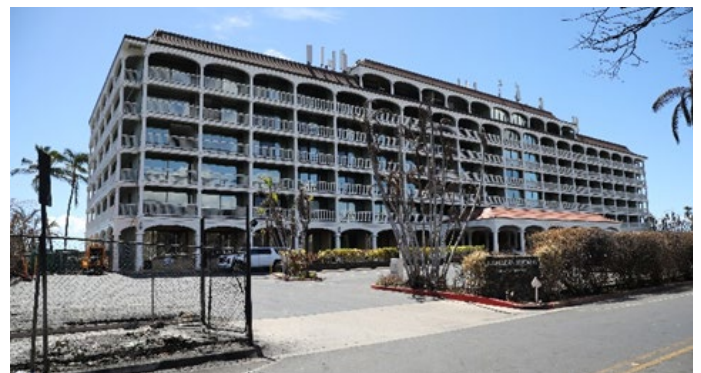
Structure-to-structure fire spread from the north was interrupted at the Lahaina Shores Beach Resort (Figure 4.3.4.1.5). The Shops at 505, immediately north of this structure, were completely destroyed, resulting in notable radiant heat damage to the balconies and windows of the condominium on the north side (Figures 4.3.4.1.7 and 4.3.4.1.8).

Tall, lush vegetation was present between the condominium and shopping mall, particularly at the eastern (mauka) and central portions. This vegetation potentially provided some protection from radiant heating and possible ember attack and did not ignite, protecting the condominium from significant damage.

Figure 4.3.4.1.5 Lahaina Shores Beach Resort (4 Front Street) in southern Lahaina. Top panel depicts the street location and robotic street imagery before and after the fire. (bottom left) Overall view of structure from southeast (note fenced area in bottom left where trash bins and materials are typically stored) (bottom right). View from northeast beyond the destroyed Shops at 5 Front Street.

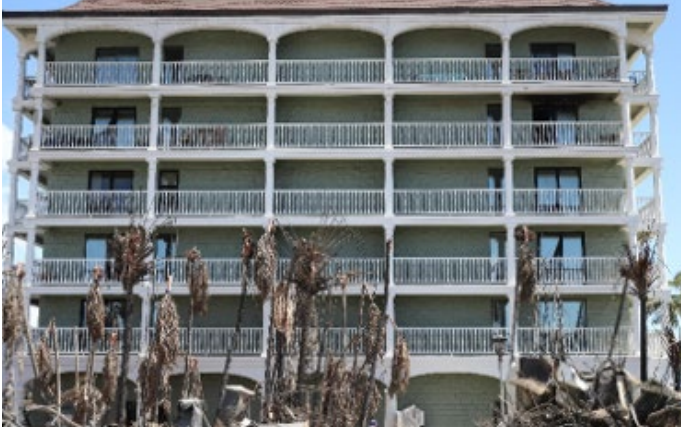
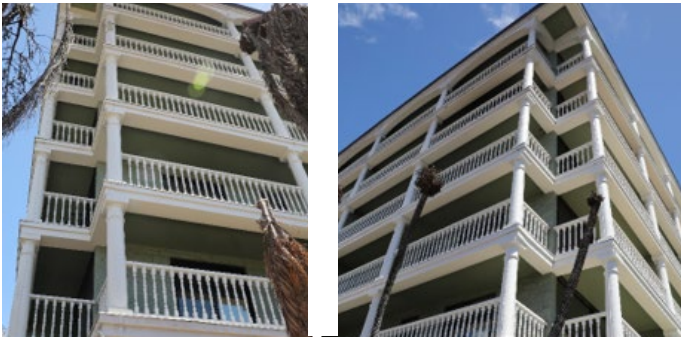
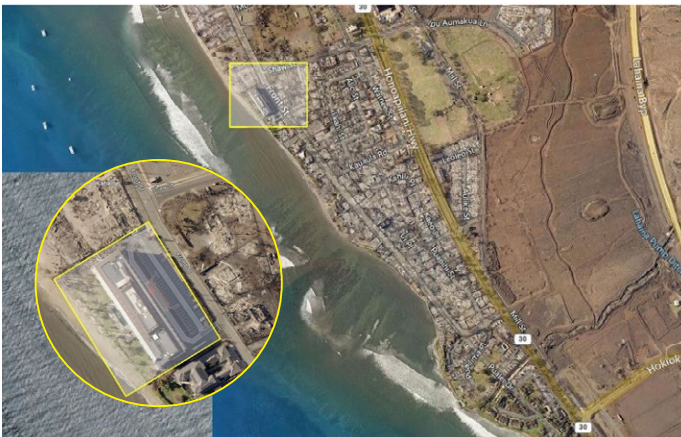
The bulk of the damage to the condominium includes bubbling and flaking of paint on its balconies, which is more severe along the upper two (2) floors. Windows, screens, and patio furnishings were also damaged on the second through sixth floors on the western (makai)-side rooms. Screen and window damage is only noted on the fifth floor in the eastern (mauka)-side rooms (Figures 4.3.4.1.7-4.3.4.1.8).

Figure 4.3.4.1.6 Radiant heat damage to the north end of the Lahaina Shores Beach Resort (4█ Front Street). More severe bubbling to the paint is noted on the western (makai) portion of the structure (middle right) compared to that on the east-mauka (middle left) for the bottom four (4) floors, though more bubbling is noted on the fifth and sixth floors on the west (makai). Larger amounts of lush vegetation between the eastern (mauka) portions of the building compared to the western-side (makai) may have aided in locally reducing radiant heat impacting the north face of this structure. Inset: Viewpoint showing the area depicted in the photographs above.

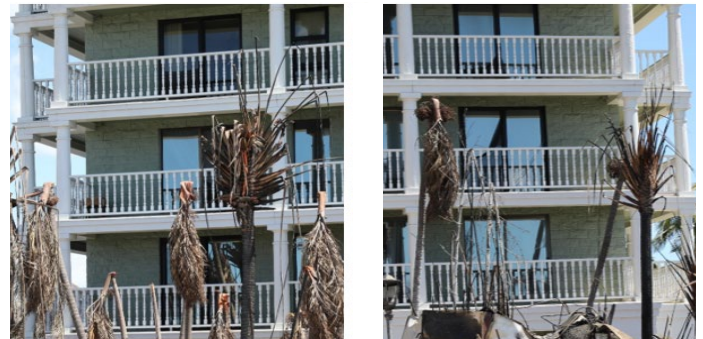
Several screens on the sliding doors dropped from their frame. Cracked glass in windows and doors was noted, but did not appear to cause large pieces of glass to fall out. There was also some radiant damage to furnishings on the sixth-floor balcony, though these items did not appear to ignite.

Figure 4.3.4.1.7 Increased window damage on the lower floor windows on the west-makai (right) compared to the east-mauka (left). Cracking is noted on the second and fourth floor windows with screens partially dropped on the third and fourth floors for the rooms on the west (makai).

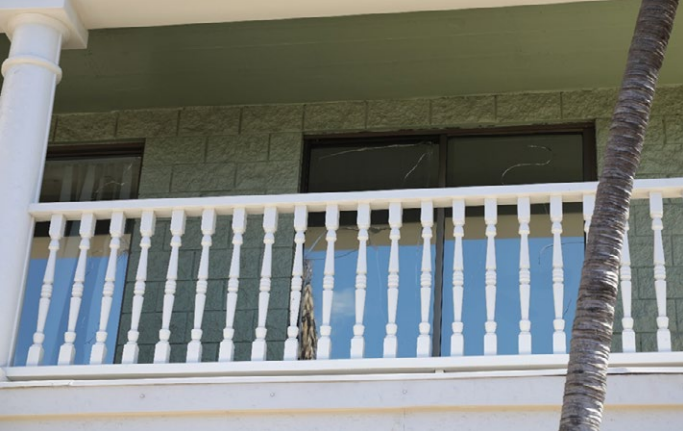
Figure 4.3.4.1.8 Close up of window damage on the second floor windows on the west (makai) room of 4 Front Street.

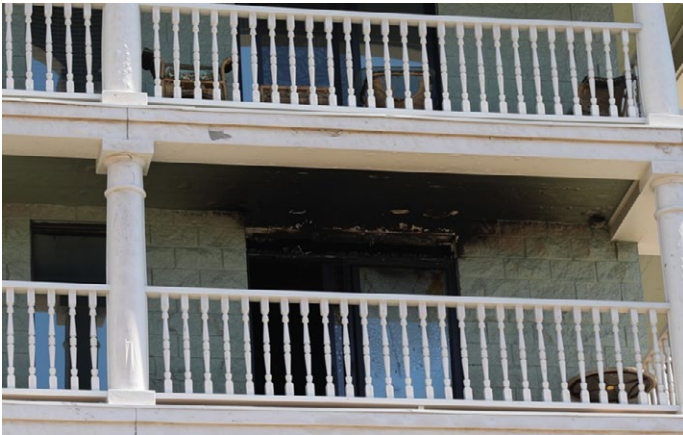
Also on the fifth floor, the door to an western (makai)-side room appears to have been opened with smoke/fire damage above the sliding glass door indicating smoke emanated from this compartment (Figure 4.3.4.1.9). The sliding glass door is more heavily damaged than the others on floors above and below. This damage does not appear to have spread on the exterior of the structure, except as noted, indicating the fire likely came from within the interior.

Figure 4.3.4.1.9 Close up of the open compartment on the fifth floor and thermal damage to furnishings on the sixth floor of 4 Front Street.

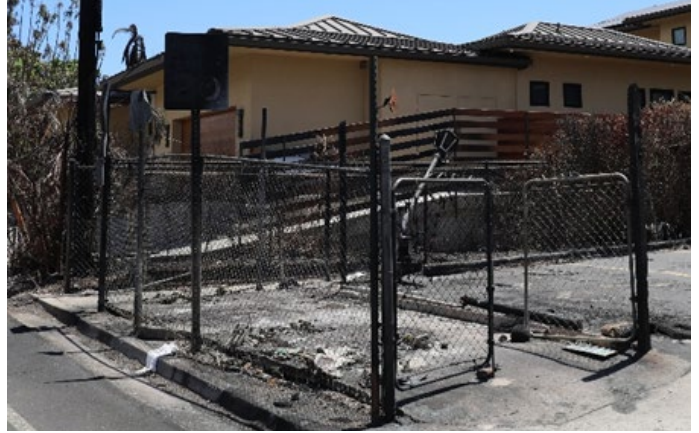
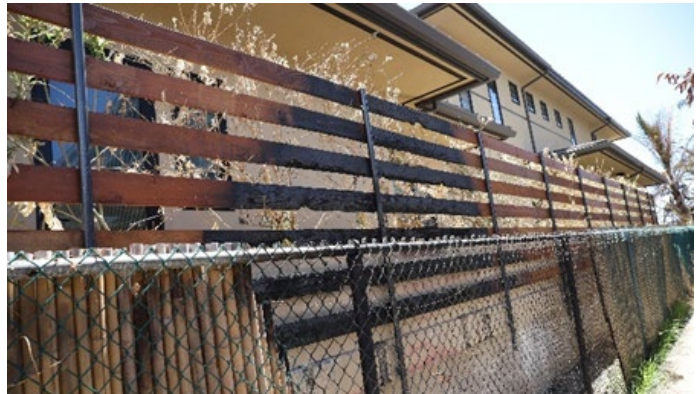
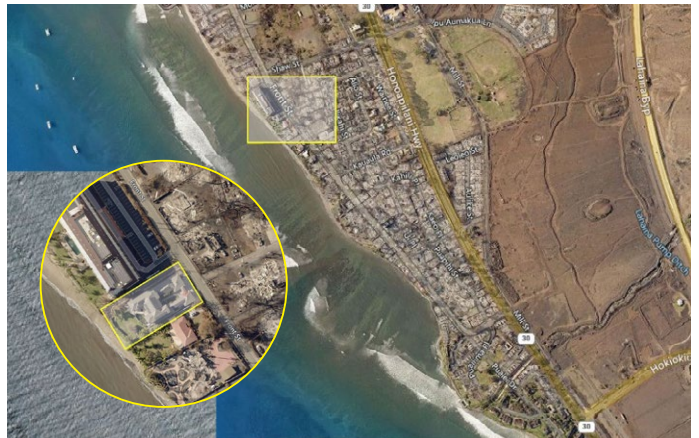
A garbage can/disposal area in the southeast parking lot of 4█ Front Street was ignited and destroyed everything inside the fence (Figure 4.3.4.1.5, Figure 4.3.4.1.10).

Figure 4.3.4.1.10 Ember and/or radiant heat ignited and destroyed the 475 Front Street garbage can/disposal area, which subsequently damaged a light post and the wood railing/fence on the northwest corner of 4 Front Street. Inset: Viewpoint showing the area depicted in the photograph above.

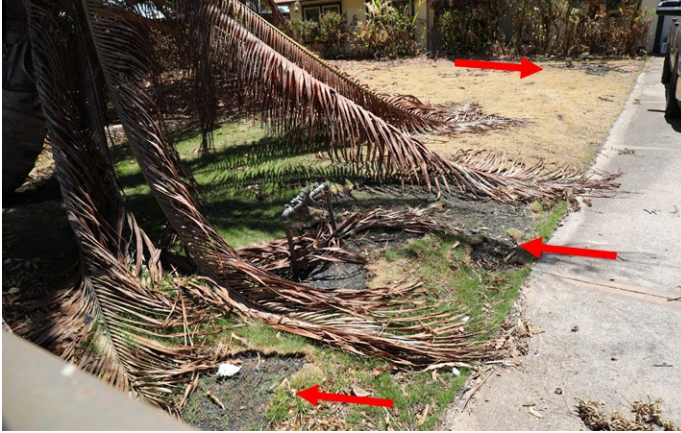
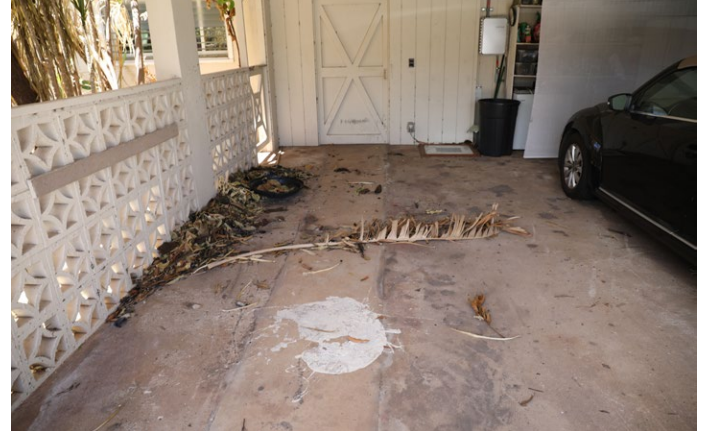
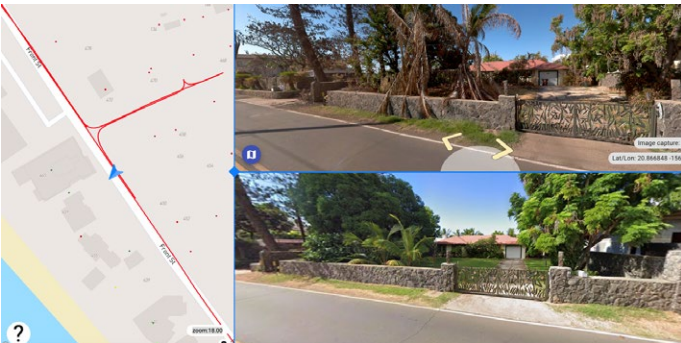
Spot fires were noted in the front lawn of 4█ Front Street, but these also did not spread further to the structure or vehicles (Figure 4.3.4.1.11).

Figure 4.3.4.1.11 Ember-created spot fires in the front lawn of 4 Front Street (top). Bottom panel shows the map location and street image before and after the fire at 4 Front Street.

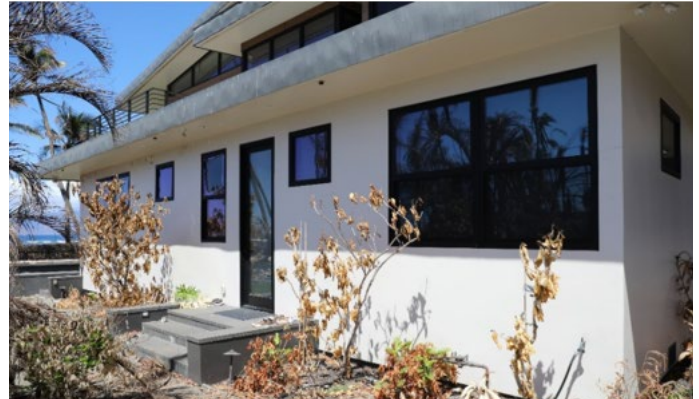
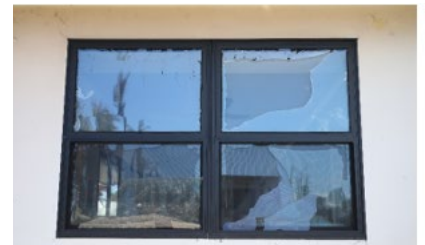
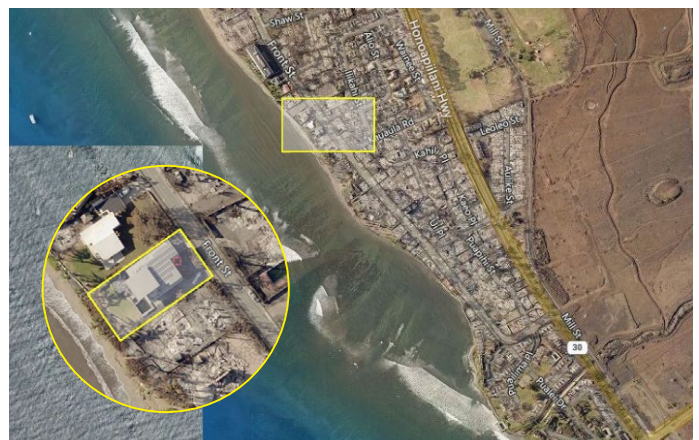
The furthest south surviving structure on this block was 4 Front Street, which shared an entry from Front Street with the 4 Front Street structures that were destroyed. The south/southeast facing portions of 4 Front Street were substantially impacted by radiant heat from the fire in the 4 Front Street structures.

While some bubbling and flaking of the paint on the first floor and slight warping of the metal fascia trim was noted, the most substantial damage was observed on the south-facing windows, particularly on the first floor (Figure 4.3.4.1.13).

The five (5) double-pane windows on the first floor of the structure (closer to the larger 4█ Front Street structure) had the outer pane cracked and with several large pieces of glass that dropped out.

The windows in this structure were in aluminum frames, which are less likely to warp than vinyl frame windows that were commonly found in other structures, which may have been important in the survival of the glass panes in these windows.

Figure 4.3.4.1.13 Window damage on the south side of 4█ Front Street. Ember damage to shoes on doorstep indicates energetic embers were present in the area, which could have increased risk for ignition of interior combustibles had windows completely failed. Inset: Viewpoint showing the area depicted in the photographs above.

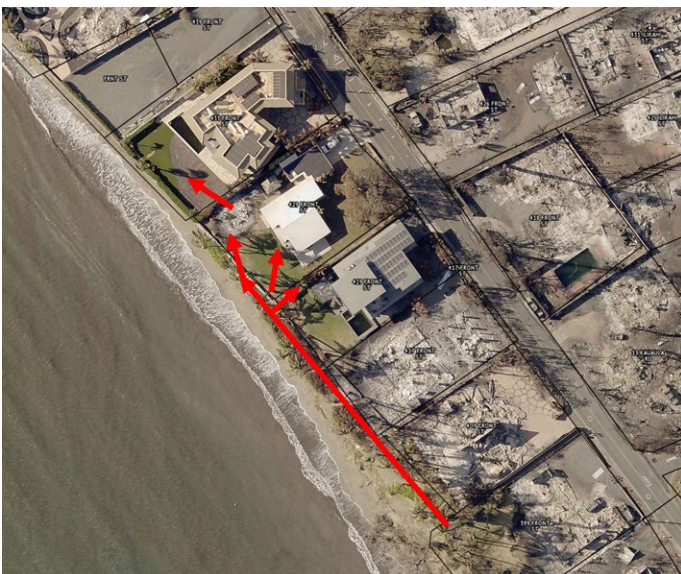
Even though the structures on the west (makai) side of the 400 block of Front Street were adjacent to the coast with no addressed structures to the west (makai), post-fire damage assessment suggests fire spread through vegetation to the west (makai) of several of these structures, which was likely responsible for some thermal damage to these properties (Figure 4.3.4.1.14).

The prevailing easterly (mauka) winds may aid fire propagation along the northwest orientation of these property lines. But intermittent shifts in wind direction, or obstructions caused by local vegetation and breaks in the fence, could have supported embers moving back to the east (mauka) as seen by the wood fence damage to the east (mauka) of this wall at the 4█-4█ Front Street property line (Figure 4.3.4.1.16), the ignition of the accessory structure in the northwest corner of the 4█ Front Street property, and the ignition of an outdoor chair near the rear patio door/window assembly of this structure.

Figure 4.3.4.1.14 Overhead view of 4█-4█ Front Street showing potential path of fire progression along a low stone wall west (makai) of the property lines and then east (mauka) along 4█-4█ property line wood fence, into an accessory structure and a chair by on the patio of 4█ Front Street (see Figures 4.3.4.1.15, 4.3.4.1.16, 4.3.4.1.17, 4.3.4.1.18).

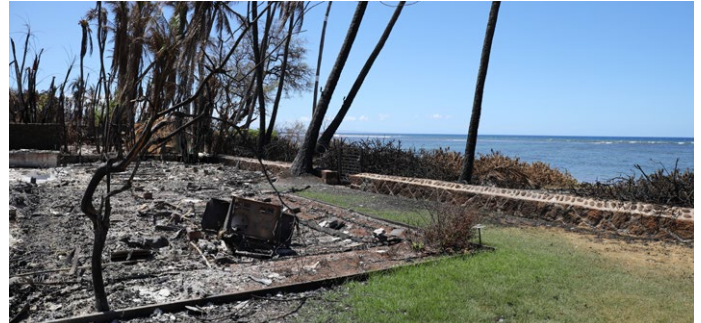
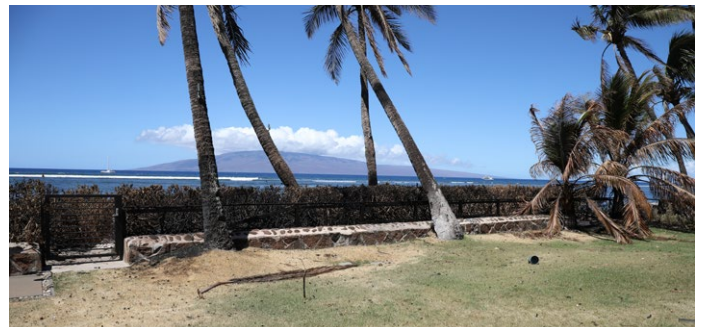
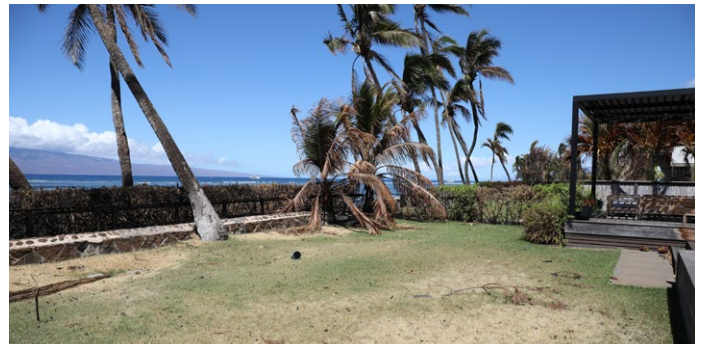
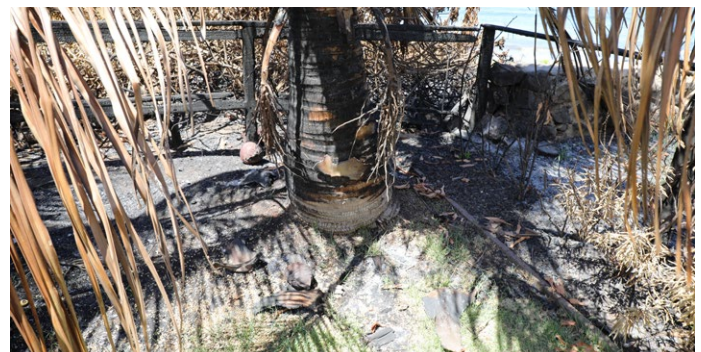
A vegetation fire propagated along the west (makai) side of the low stone wall border to the west (makai) side of several properties in this area, with indications of crossing into the backyard of 4█ and 4█ Front Street at a gap in the wall (between these two (2) property lines) and when palm trees crossover low to the wall toward the ocean (Figure 4.3.4.1.15-4.3.4.1.16).

Figure 4.3.4.1.15 Vegetation and fence fire west (makai) of the low stone walls along 4█ and 4█ Front Street. The vegetation fire remained west (makai) of the stone wall other than at the 4█-4█ property line, where a gap is present.

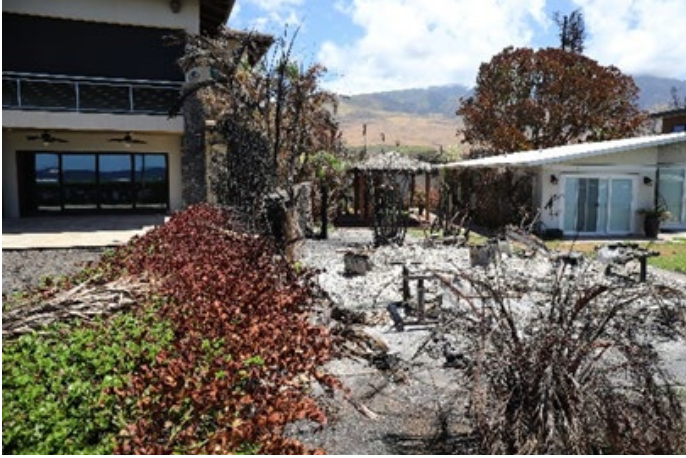
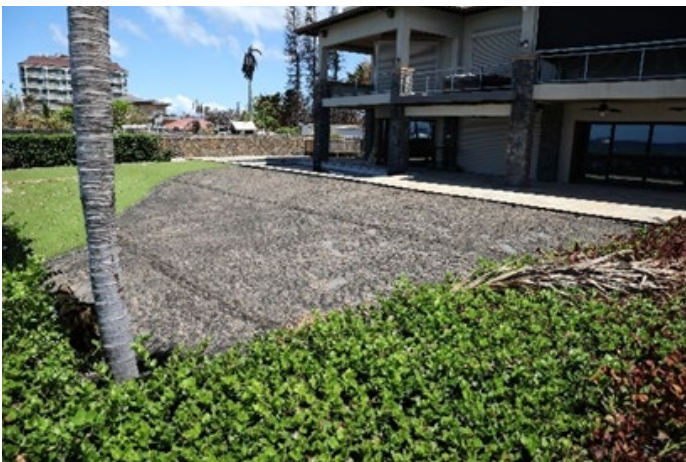
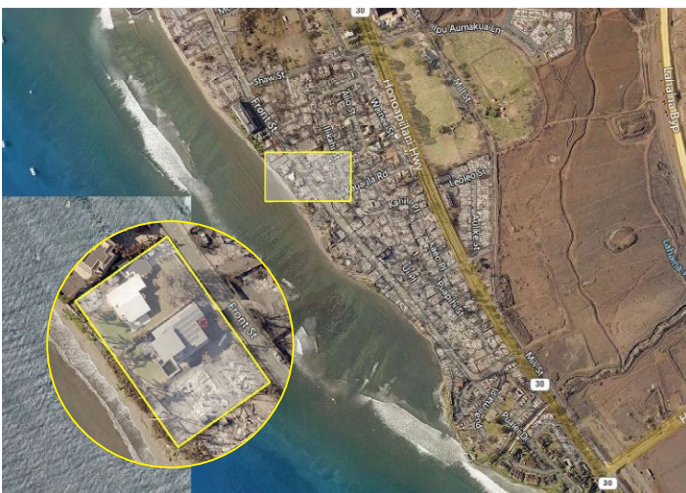
The fire in the accessory structure resulted in the burning of synthetic turf in the backyard of the property to the north (4█ Front Street), which spread toward the west (makai) and northwest with limited spread to the east by the noncombustible patio around the pool (Figure 4.3.4.1.17).

Figure 4.3.4.1.17 Destroyed accessory structure in northwest corner of 4 Front Street (top) and spread into backyard turf in 4 Front Street due to embers and/or radiant heating (middle). Inset: Viewpoint showing the area depicted in the photographs above.

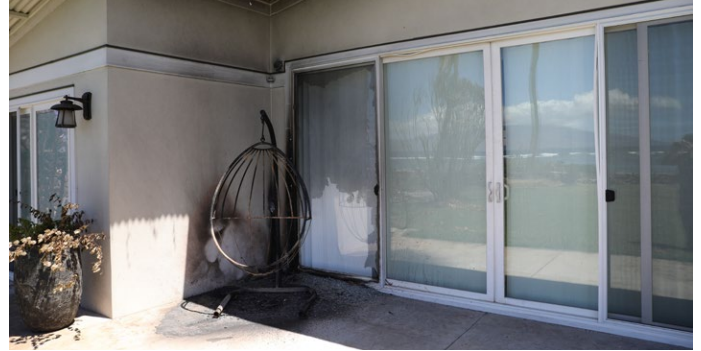
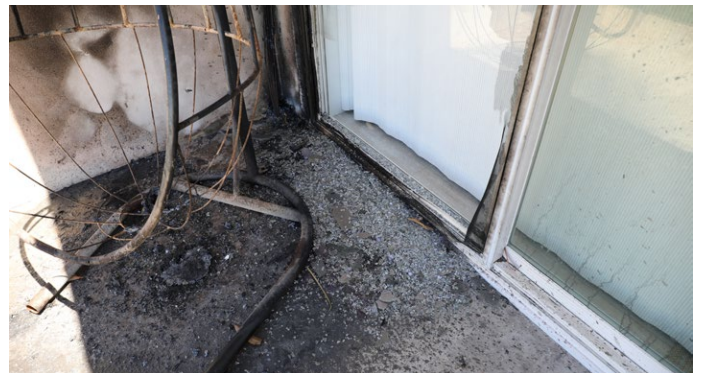
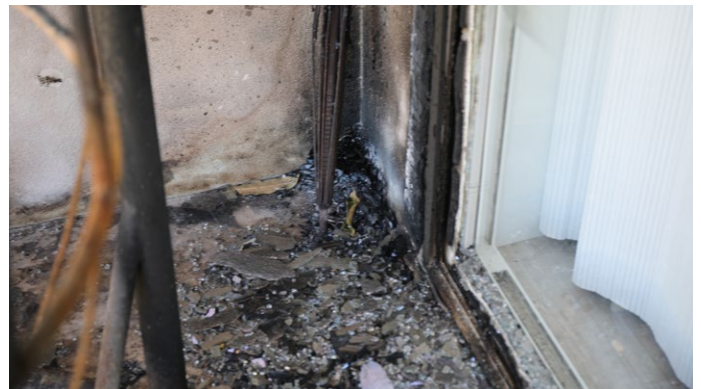
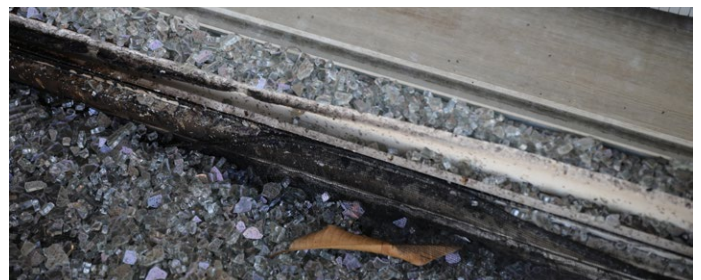
An outdoor chair fire in close proximity to the patio door/window assembly glass resulted in failure of the outer pane of a full-length, fixed window, while the inner pane remained intact (Figure 4.3.4.1.18).

In this specific instance, the glass near this fire was tempered (as can be seen by the many small pieces of glass after failure). This type of glass can withstand more intense fire exposure prior to failure compared to plain (annealed) glass,²⁵⁹ which is common in other window failures noted in this section.

Figure 4.3.4.1.18 Destroyed chair proximate to rear patio door/window assembly on 4 Front Street, where the outer pane failed and inner pane remained intact. Note the indications of tempered glass in this assembly.

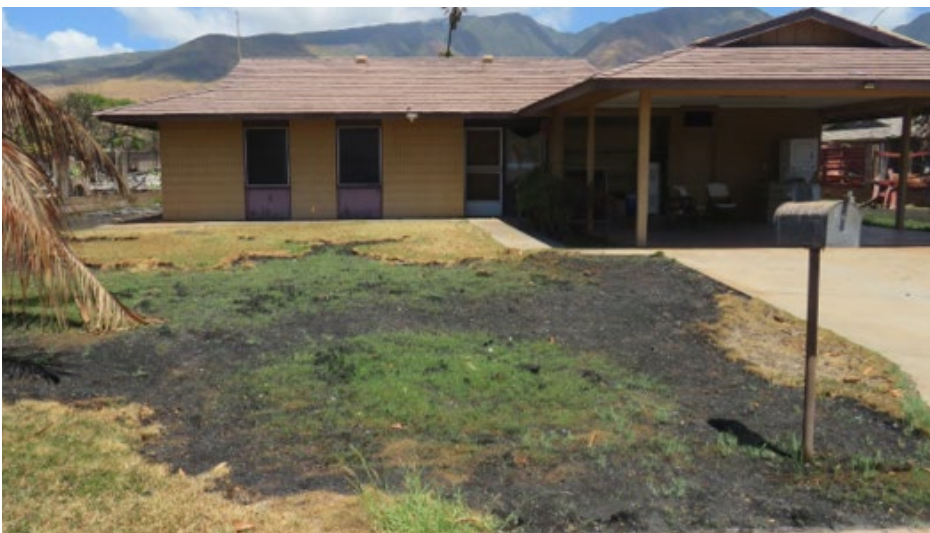
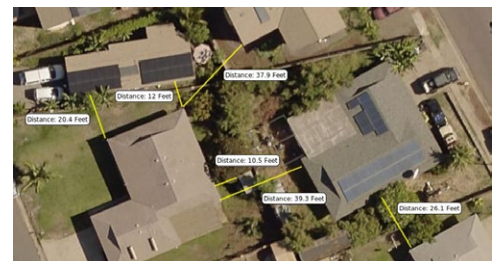
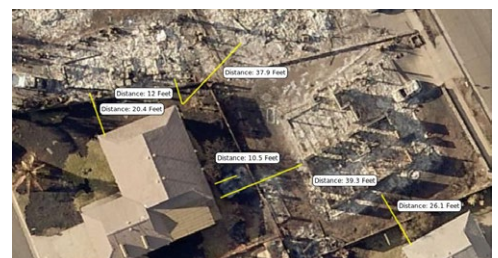
The northmost structure that did not burn in this group of surviving structures is 4█ 'Ālī'ō Street (Figure 4.3.4.2.4), which sustained structural damage to the roof and eaves along the northside and northwest corner. The property to the north of this lot, 4█ 'Ālī'ō Street, is approximately 12 feet from the corner of this roof. Heavy charring at the northwest end gradually decreased by about two-thirds toward the northeast end where paint remains on the soffit (Figure 4.3.4.2.5).

The soffit and roof deck above the eaves burned completely through, but the fire did not continue to propagate.

This structure is one of the few that noted more extensive damage to the eaves/roof than to the windows, which showed no indications of damage, possibly due to the relatively large eaves extending the roofline well past the windows, the presence of a heavy screen between the exposure and the windows, and/or the design of the louvered windows that allowed glass more flexibility to expand when heated without creating enough stress to fracture.

Figure 4.3.4.2.4 Northernmost surviving structure in the cluster of homes along the 400 block of 'Ālī'ō Street and Waine'e Street was located at 4█ 'Ālī'ō Street.

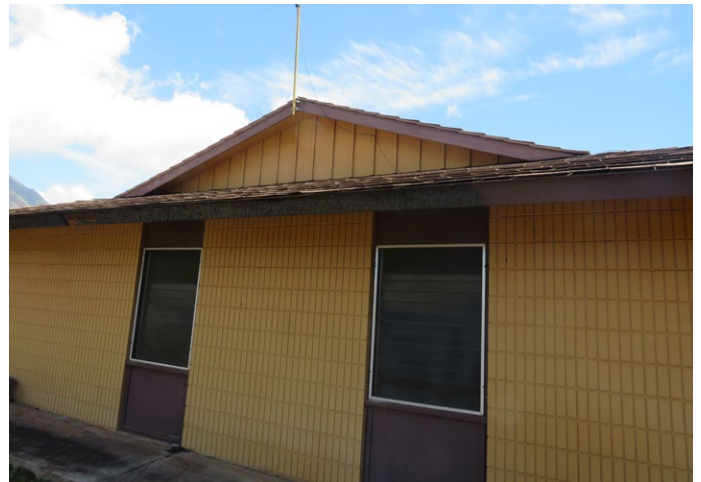
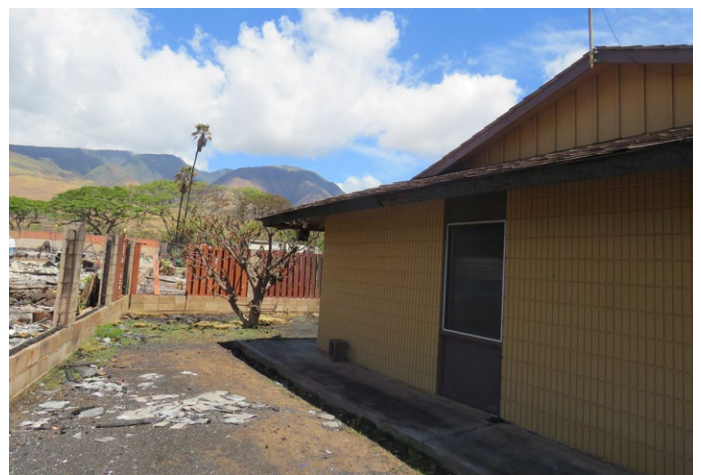
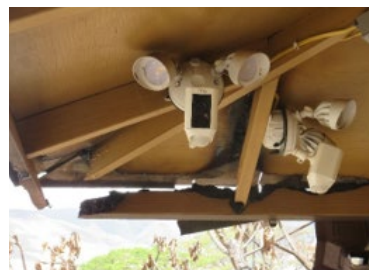
Figure 4.3.4.2.5 Eave and roof damage to the structure at 4█ ‘Ālī’ō Street.

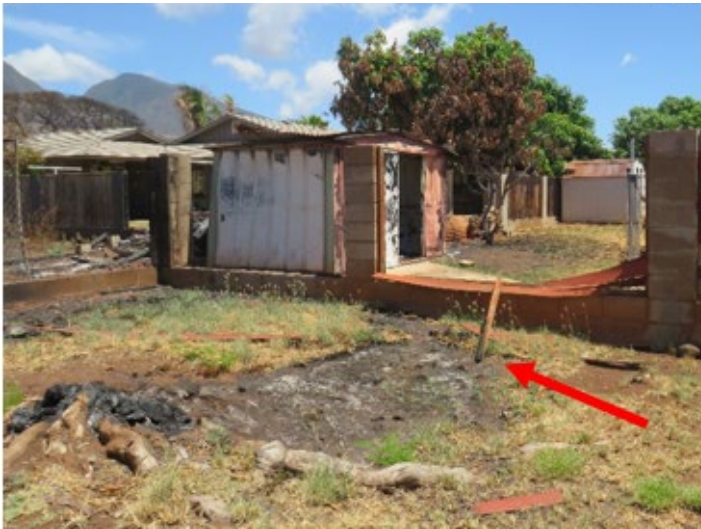
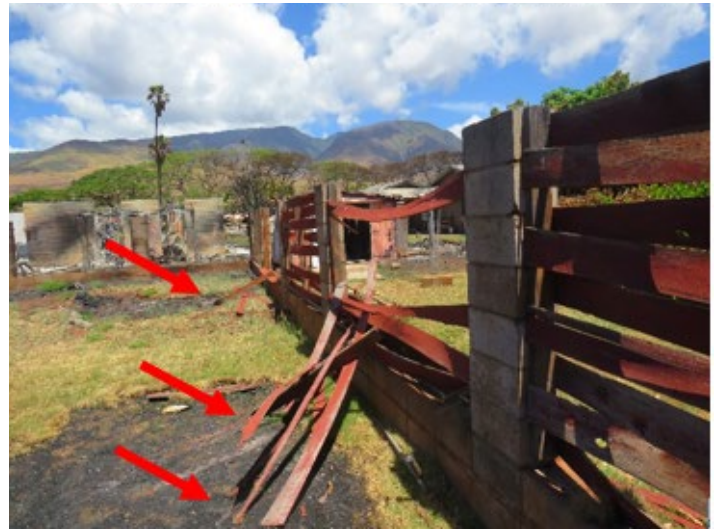
These grass fires may have been ignited either by fire brands blown to the west (makai) from destroyed properties to the east (mauka), which could have found a receptive fuel bed in the dry grasses or through failure of the wooden fence along the property lines.

To the south, the grass was very near the wooden portion of the walls and louvered windows, but the fire did not propagate to the structure. Shifts in wind and/or water from a nearby hose may have aided reducing this spread to the structure. In the west (makai) yard of 4█ ‘Ālī’ō Street, dried grasses ignited, yet islands of unburned grass remained where sprinklers had been set out.

Figure 4.3.4.2.6 Grass fire to the south of 4th 'Ālī'ō Street appears to have ignited in multiple locations where charred sections of the fence from the 4th-4th 'Ālī'ō Street property line landed in dry grass. While it propagated near the wooden structure on the southside of 4th 'Ālī'ō Street, it did not transition to the structure.

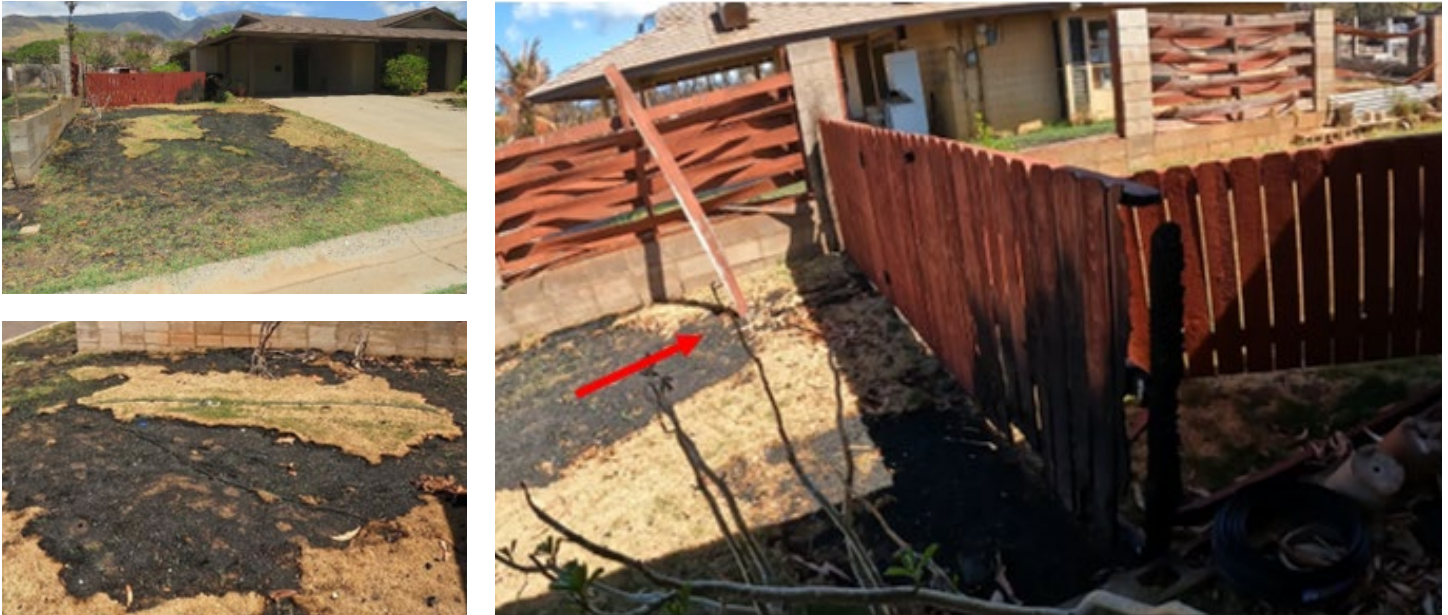
Figure 4.3.4.2.7 Grass fire in the northwest yard of 4█ 'Āli'ō Street appears to have been ignited where charred sections of the fence from the 4█-4█ 'Āli'ō Street property line landed in dry grass, which then backed up to the fence and gate connected to the structure. Sprinklers were distributed throughout the yard, including in the center of this section of undamaged grass.

The grassfire appeared to back up toward the gate and spread along the gate toward the house. However, the fence broke off the post because it was weakened through mass loss due to the fire. The fire did not continue to propagate along the fence after this point.

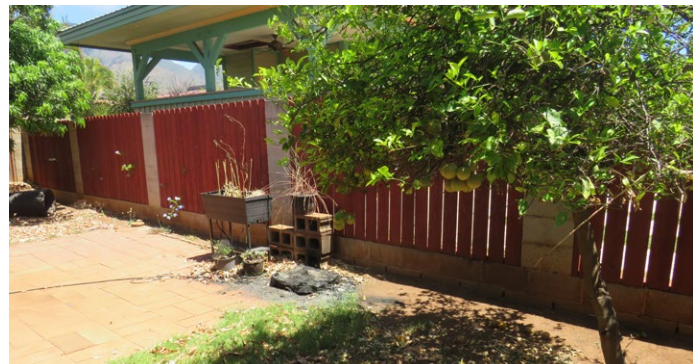
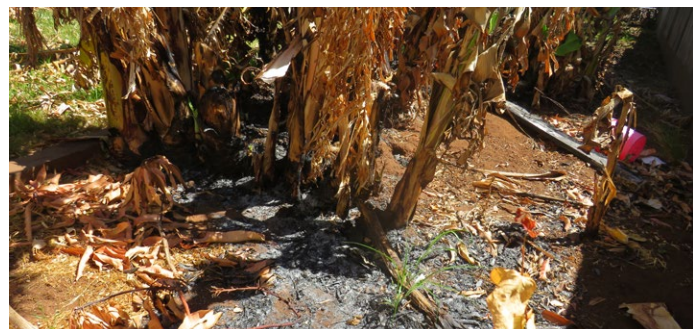
In several of the properties in this cluster, there was some localized ignition of landscaping materials that did not propagate to the structure (Figure 4.3.4.2.8).

Figure 4.3.4.2.8 Localized ignition of landscaping materials in the backyards of (top) 4█ 'Āli'ō Street and (bottom) 4█ Waine'e Street, including a section of deeply charred dimensional lumber that does not appear connected to any other structures in the immediate vicinity.
