Lahaina Fire Incident Analysis Report

Steve Kerber
Derek Alkonis

September 13, 2024
Columbia, MD

This document is the second in a series of three (3) reports commissioned by the Hawai'i Department of the Attorney General (DOAG) to provide an independent review of the tragic fire that destroyed much of Lahaina, Hawai'i, on August 8-9, 2023.

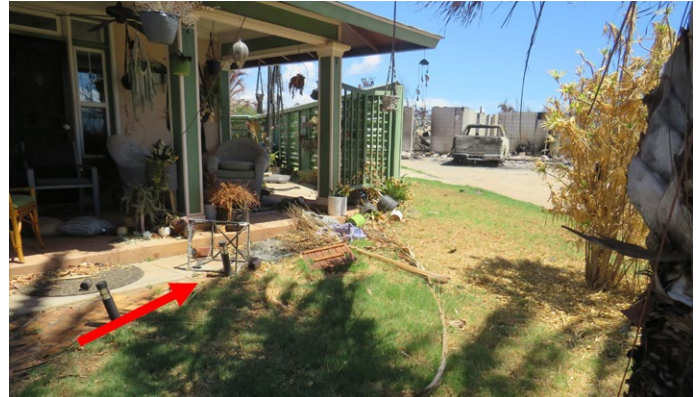
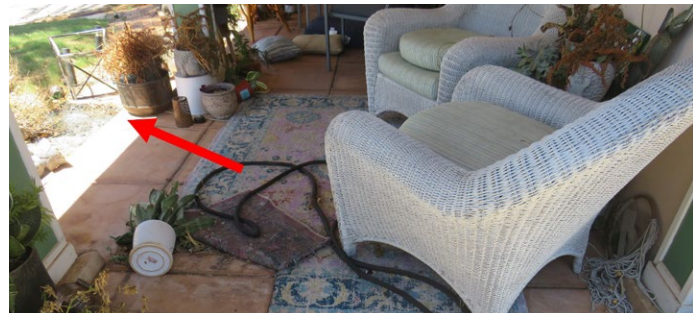
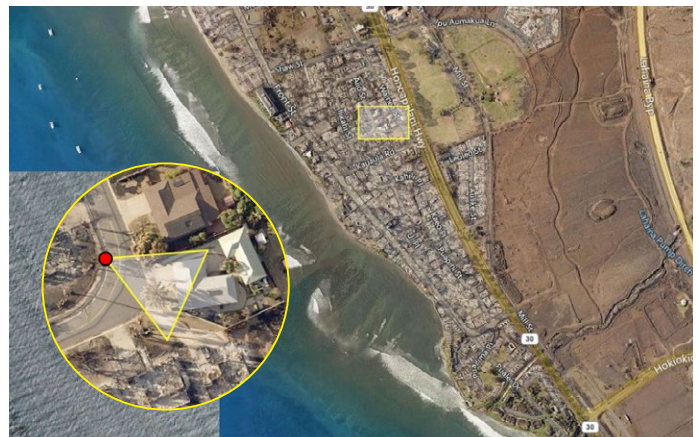
A small fire appears to have started at the southwest corner of the front porch on 4█ 'Āli'ō Street. This fire did not propagate from what appears to be a single item ignited despite a number of other combustible materials in the area, possibly aided by a garden hose in the area (Figure 4.3.4.2.10).

Figure 4.3.4.2.10 A spot fire near the southwest corner of the 4█ ‘Ālī‘ō Street porch was confined to a small area, possibly through water application from the garden hose on the porch. Insert: Viewpoint of 4█ ‘Ālī‘ō Street.

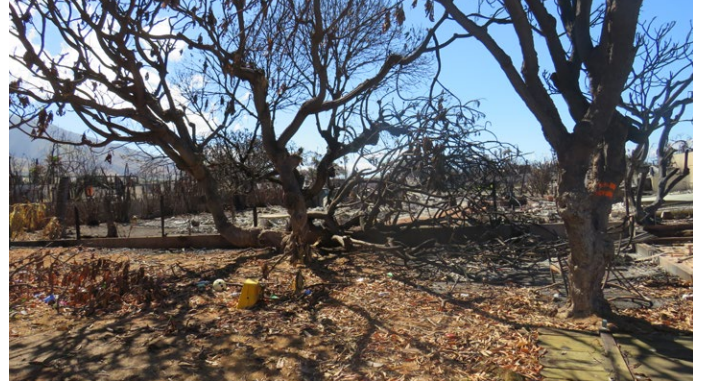
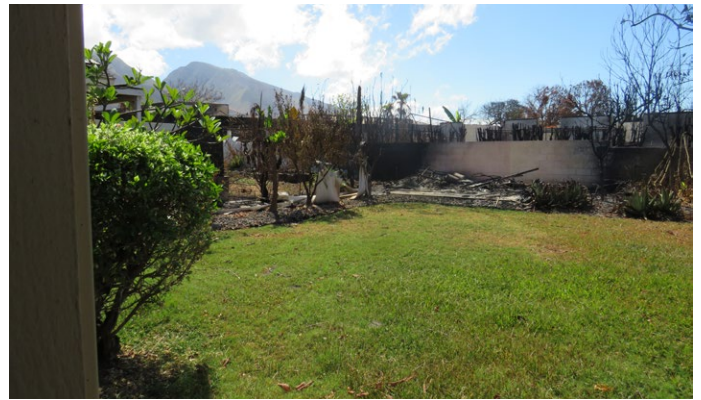
To the south of this cluster of surviving structures, 6█, 6█ and 6█ Kāhili Place were all destroyed by the fire. While the structures along Kāhili Place were located close to the northwest property lines, the surviving structures along Kaua‘ula Road had relatively deep backyards, separating the structures from the south property lines (Figure 4.3.4.2.3 and 4.3.4.2.12).

Figure 4.3.4.2.12 Deep yards to the south of (top) 6 and (bottom) 7 Kāua'ula Road separated these surviving structures from destroyed structures to the south. A shed in the southeast corner of 7 Kāua'ula Road was destroyed, yet this fire did not appear to create thermal damage on the main structure.

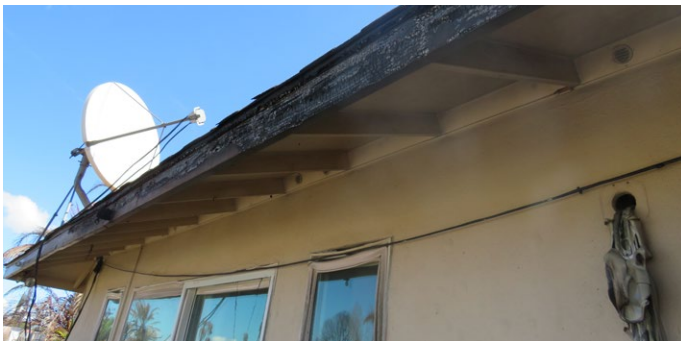
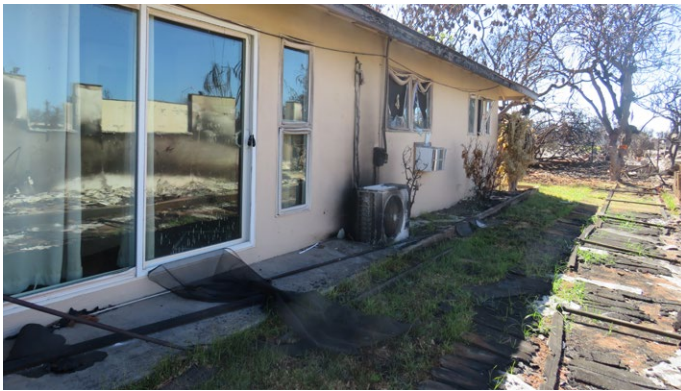
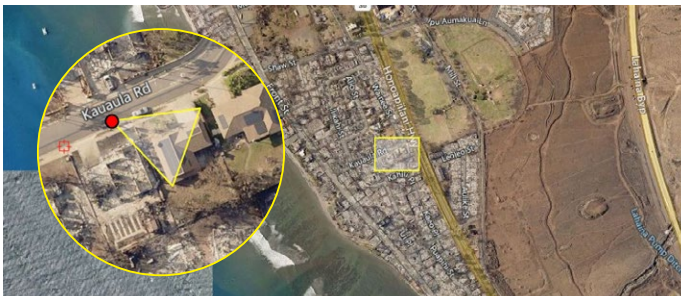
The west side (makai) of 6■ Kaua'ula Road is approximately 12 feet from the destroyed structure on 5■ Kaua'ula Road (Figure 4.3.4.2.16), and suffered heavy thermal damage from radiated heat. The fascia was heavily charred on the outer layer, though did not appear to propagate through its thickness or into the roof (Figure 4.3.4.2.14).

Figure 4.3.4.2.14 West (makai) side of 6■ Kaua'ula Road was severely impacted by radiant heat from the destroyed structure at 5■ Kaua'ula Road, located 12 feet to the west (makai). Heavy charring was noted in the fascia board at the end of the eave and plastic conduit melted, exposing a penetration through the exterior wall for AC access. Windows and screens on the sliding glass patio door were also damaged. Inset: Viewpoint showing the area depicted in the photographs above.

An air conditioning unit was heavily damaged along with the conduit around refrigerant lines along and through the structure. This melted plastic component uncovered a penetration through the exterior wall that could provide a pathway for embers that might reach this area. The windows on the west (makai) facing side of 6■ Kaua'ula Road experienced extensive damage (Figure 4.3.4.2.15).

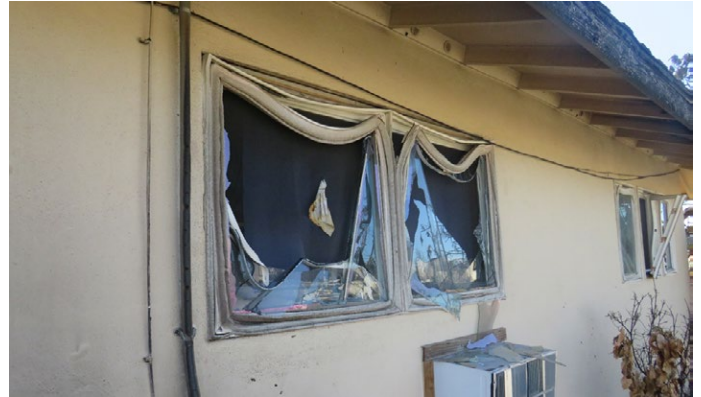
Figure 4.3.4.2.15 West (makai) side of 6■ Kaua'ula Road withstood extensive damage to windows, including three (3) casement style windows where frames were severely warped and both panes of glass failed and dropped out of the frame. The interior screen remained in place for all three (3) windows, and appears to have blocked some materials from entering the structure.

Two (2) windows in the middle of the structure had both panes of plain glass fail and fall out of the deformed frame. In both cases, the window screens remained intact and appear to have limited the ingress of some debris including some material that appeared hot enough to stick to the screen. These windows and screens were oriented opposite the prevailing wind direction, which may have also provided some level of protection for this opening.

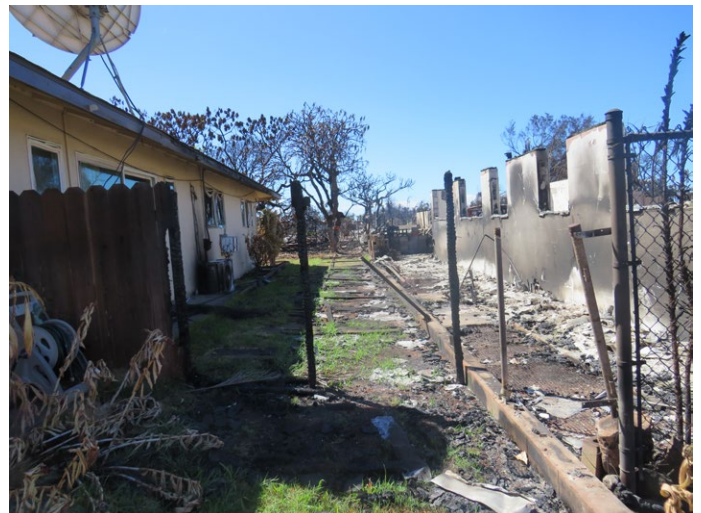
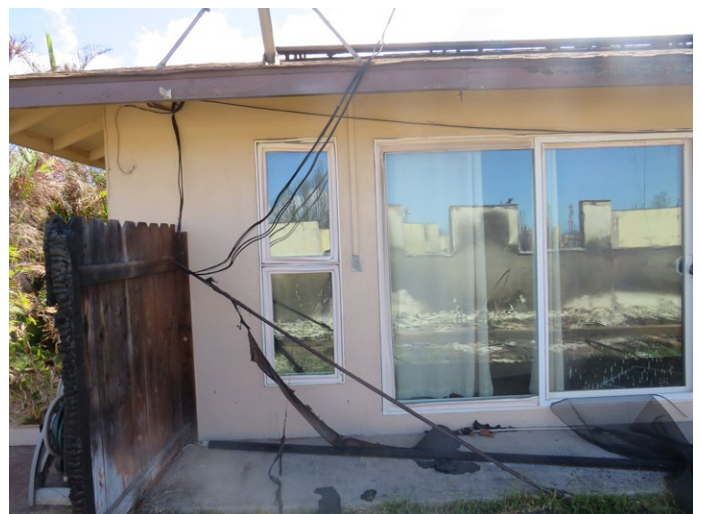
A wood fence between the two (2) structures was also severely damaged and eventually fell toward 6█ Kaua'ula Road (Figure 4.3.4.2.16).

Figure 4.3.4.2.16 A wood fence connecting the west (makai) side of 6█ Kaua'ula to the wood fence on the 6█-5█ property line was destroyed up to the easternmost (mauka) panel that was connected to the structure. Had fire continued along this fence, it could have directly exposed wood eave structure and increased heat flux to the already damaged window immediately south of the fence.

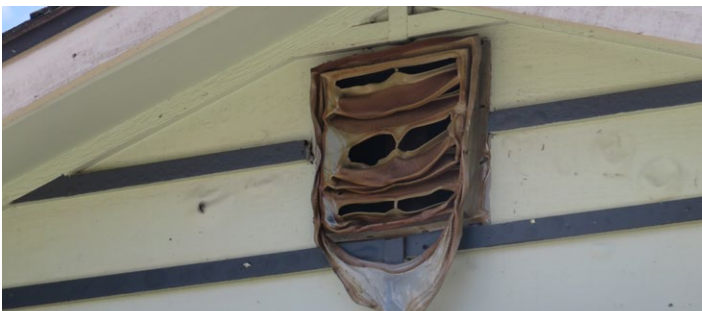
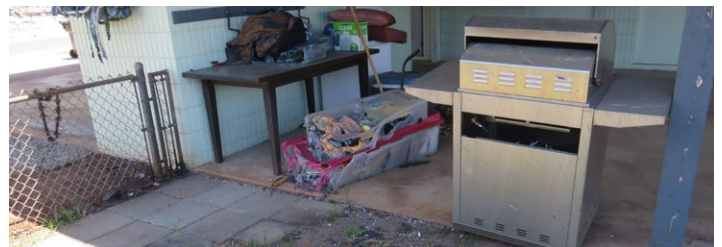
4█ 'Āli'ō Street sustained radiant heat damage on the north side to the structure eaves and gable vent, along with furnishings, belongings, garbage cans, and a large support beam in the covered parking area (Figure 4.3.4.2.18).

The parking area created a large distance from the destroyed structure at 4█ 'Āli'ō Street to the windows in this structure, which showed no visual signs of thermal damage. Much less damage was observed on the south side of the structure, where only softening and deformation of plastic trim around the windows was noted.

The distance between 4█ 'Āli'ō Street and the structures to the north and south were similar (approximately 17 feet). However, the structure to the north was two (2) stories, which likely provided more fuel and increased flux to 4█ 'Āli'ō Street compared to the single story structure to the south.

Figure 4.3.4.2.18 Radiant heat damage to the structure and household belongings at 447 'Āli'ō Street was noted primarily on the north side.

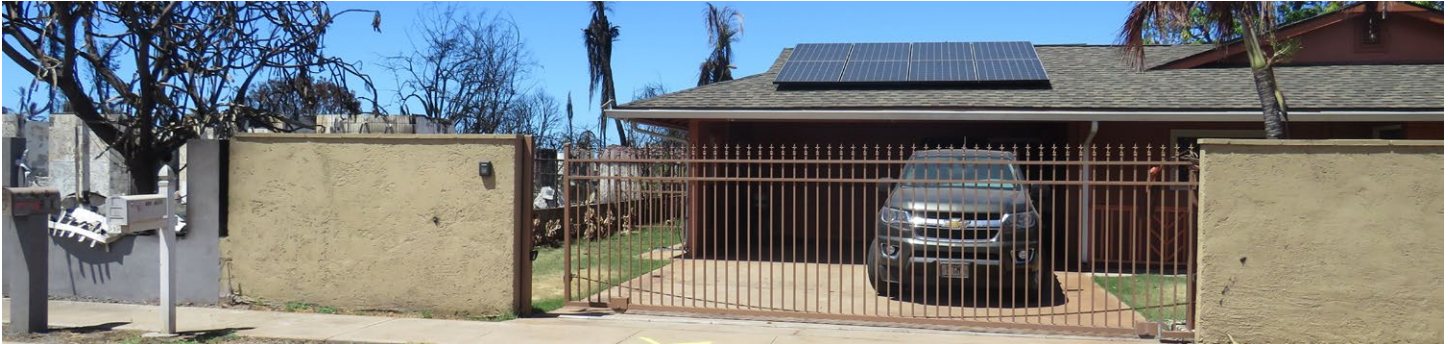
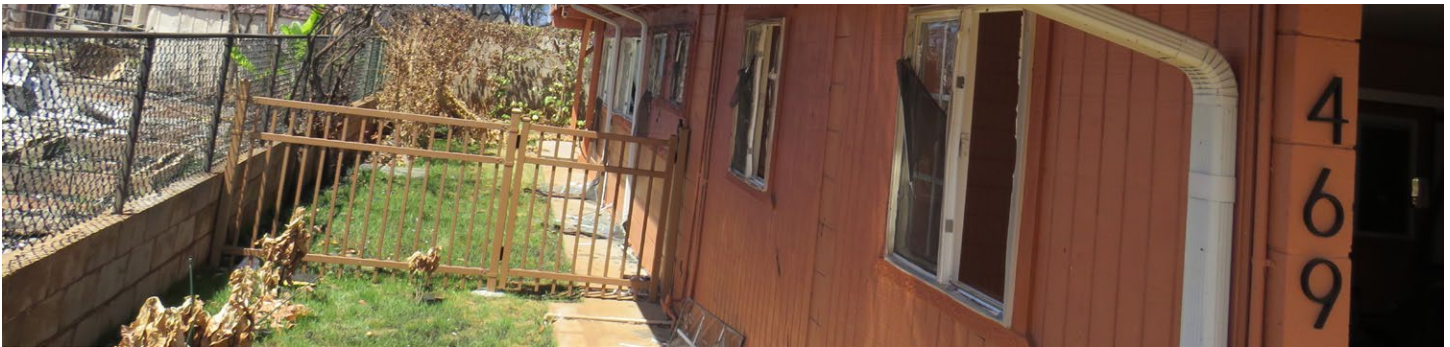
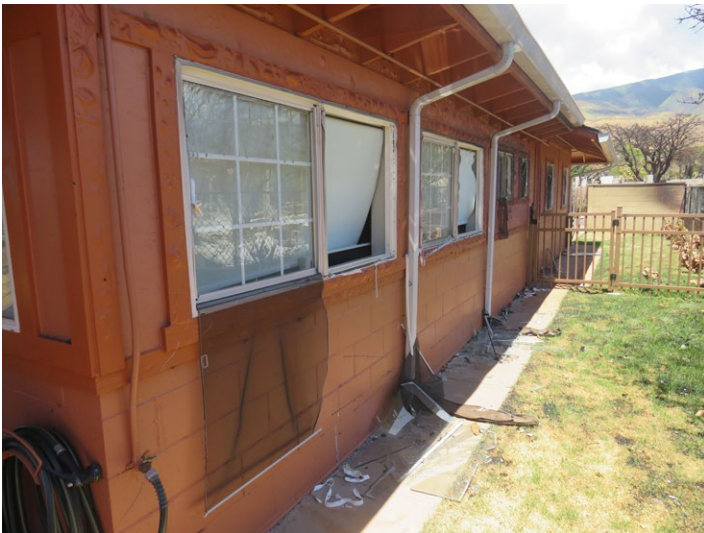
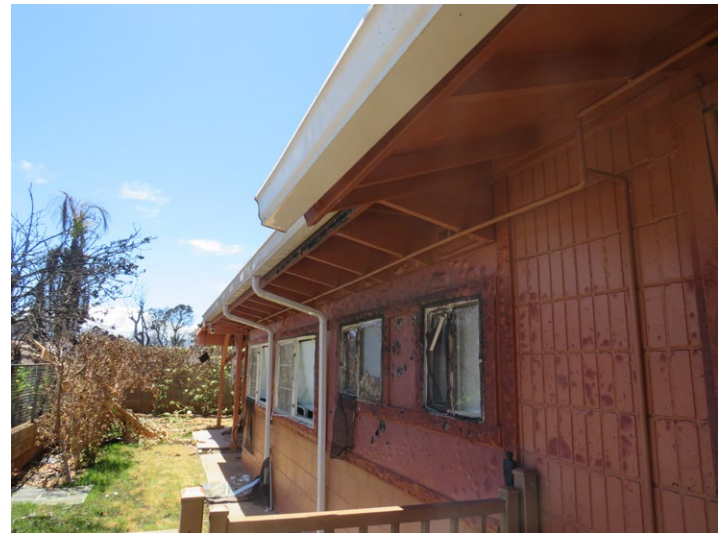
There were no visual indications of thermal damage to the west (makai), north, or east sides (mauka) of 4█ 'Ālī'ō Street, which is situated on a corner lot at the intersection of 'Ilikahi Street and 'Ālī'ō Street. However, the south exterior wall, proximate to the destroyed structure at 4█ 'Ālī'ō Street, was severely damaged. Deep charring of wood eaves and siding are noted, along with considerable paint bubbling (Figure 4.3.4.2.19).

Windows were deeply charred and glass was broken in at least one (1) pane. Four (4) of the sliding glass window assemblies had glass from the fixed sash fall completely out of the frame (moving sash may have been partially protected by a screen that was present between the destroyed structure and the window).

A window treatment in a bedroom and outdoor lamp in the garage showed signs of deformation due to heating, but no interior materials appeared to have ignited. The timing of these window failures relative to other structure fires in the area and shifting winds all impacted the relative risk created by these openings.

These large openings in the building envelope would have provided relatively easy access for embers to enter and accumulate inside this structure if enough energetic materials were transported to this area after the windows failed.

Figure 4.3.4.2.19 Radiant heat damage to the structure at 469 'Ālīō Street was noted only on the south side. Windows were severely damaged across the entire exterior wall, including four (4) windows where both panes failed and/or sashes fell out. Window screens over the sliding sash were less damaged than the fixed sashed with no screens.

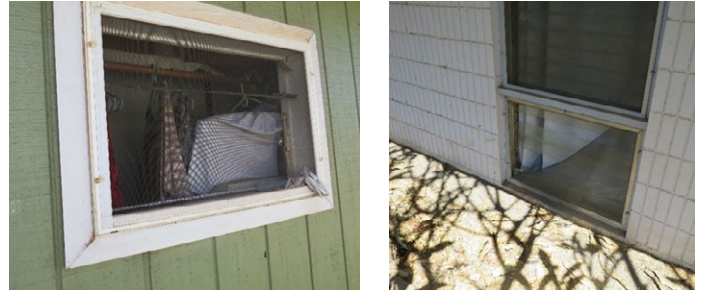
However, in the post-fire analysis, the condition of some window openings in surviving structures that could provide a route for entry through open/broken glass and/or screens were noted. For the examples shown in Figure 4.3.4.2.20, these openings were facing structures that also survived, which would likely result in a lower radiant heat and ember exposure than if oriented upwind from destroyed structures.

Figure 4.3.4.2.20 Examples of open/broken windows and/or screens in this cluster of surviving homes.

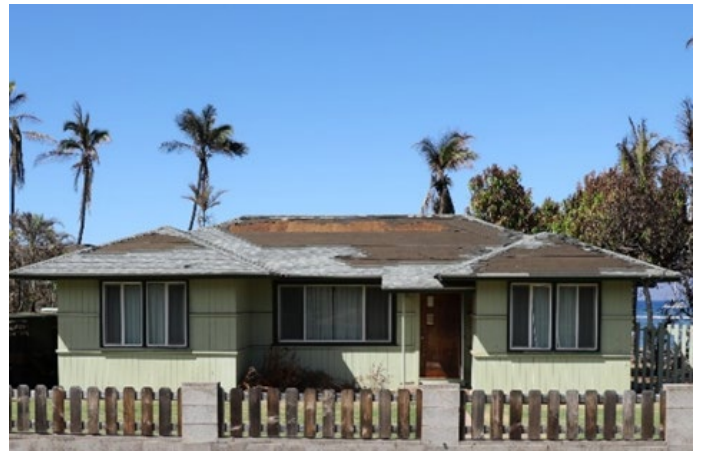
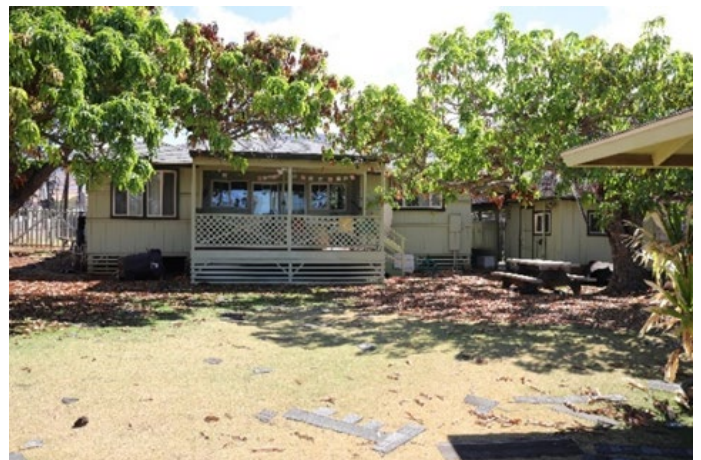
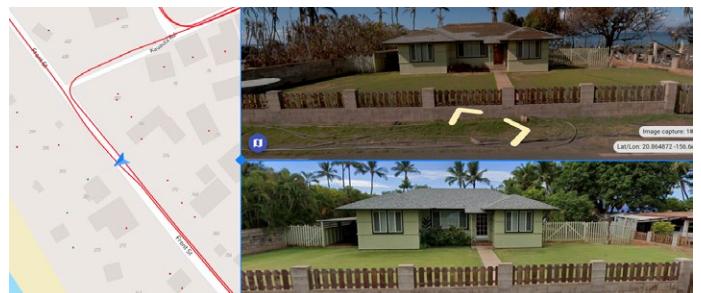
The post-fire damage assessment documented the impact of winds that resulted in damage to the roof of the main and secondary structure on 3█ Front Street (Figures 4.3.4.3.3 and 4.3.4.3.4).

The heaviest wind damage was noted on the east (mauka)-northeast facing aspects of the roof on the primary structure and southeast facing aspects of the roof on the secondary structure. Much of the displaced roofing material was located in the west (makai) yard of this property. This damage is consistent with strong winds from the east (mauka).

Figure 4.3.4.3.3 Strong winds removed shingles and tar paper from the roof of 3█ Front Street (top) and deposited much of this material in the west (makai) rear yard (middle).

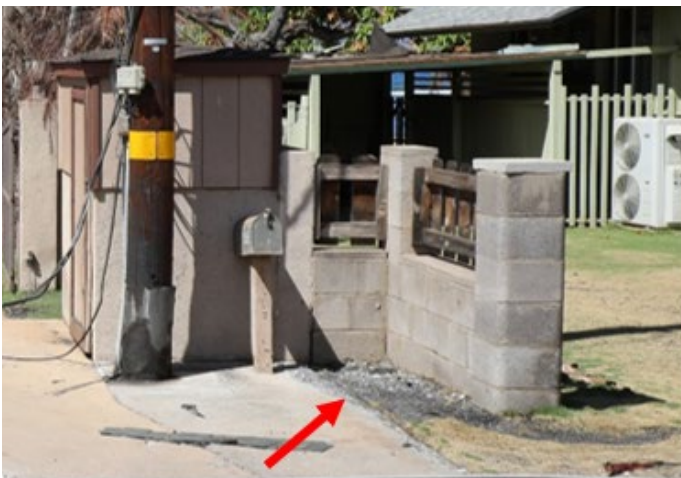
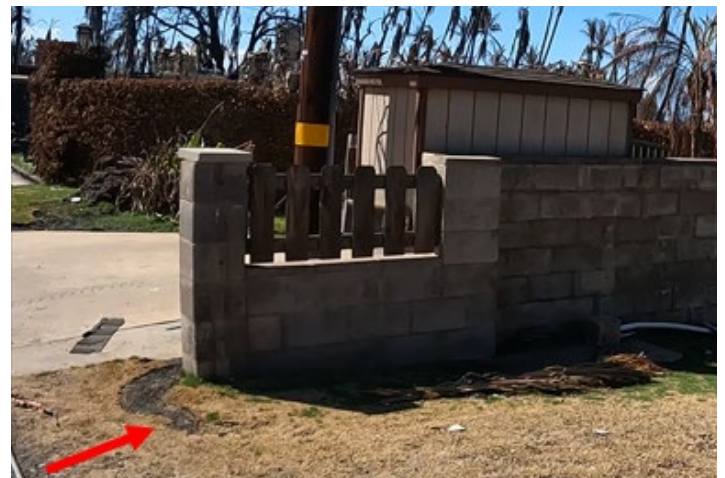
Dense, tall, and lush vegetation was planted between these structures along a block half wall (Figure 4.3.4.3.4 - 4.3.4.3.5). The vegetation likely aided in shielding 3█ Front Street from some of the radiant energy from the fire at 3█ Front Street, while also blocking some of the airborne embers. The block half wall would have also reduced these mechanisms of fire spread, particularly for embers moving along the ground under the force of wind.

Figure 4.3.4.3.4 Tall, lush vegetation was planted along block walls on either side of the driveway to 3█ Front Street, which may have provided protection to the 3█ and 3█ Front Street lots. The block wall south of 385 Front Street also influenced the ember movement. Note pile up in corner of wall (bottom left) and wind driven burn scar in grass around the wall toward the front of the structure showing the likely path of ground based embers deflected towards the north and away from the open garage (bottom right).

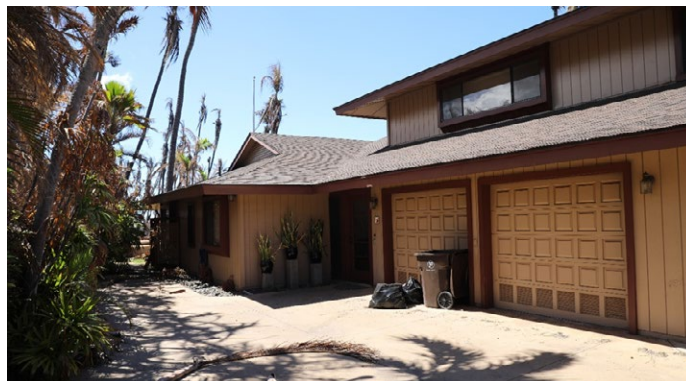
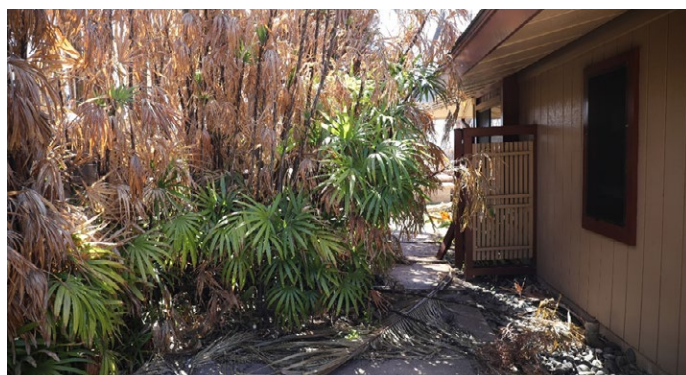
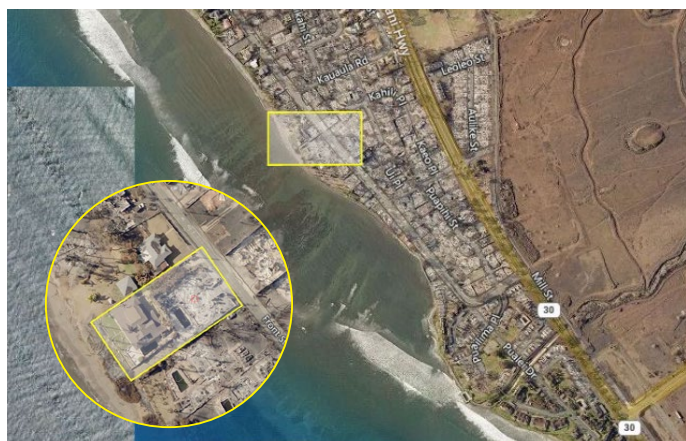
Figure 4.3.4.3.5 The east (mauka) facing exterior wall of 3█ Front Street did not have any indication of radiant heat damage and there were relatively limited signs of embers along the ground. Tall, lush vegetation plated along a block half-wall between 3█ and 3█ Front Street was still standing, including some plants that remained green at the time of the post-fire analysis. Inset: Viewpoint showing the area depicted in the photographs above.

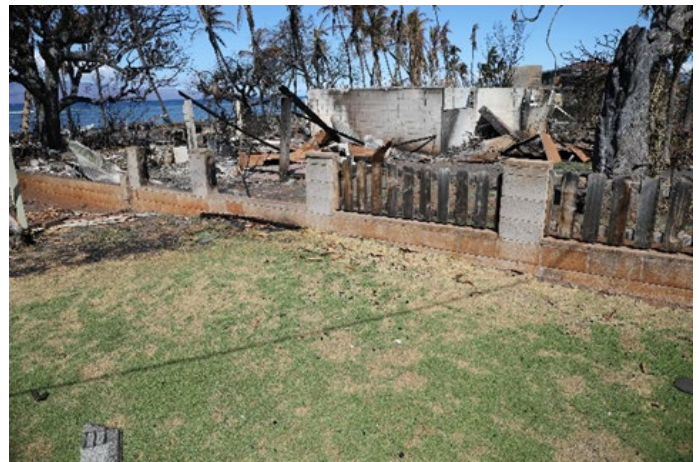
A wooden fence running perpendicular from the property line wall/fence to 3█ Front Street was heavily damaged in the fire (Figure 4.3.4.3.7). A portion of the northmost panel was consumed and could have provided a pathway for fire propagation between structures. However, the fence became dislodged and came off the next support post.

There were no obvious signs that this fence panel was forcibly removed by human intervention. However, this possibility cannot be ruled out at this time. In previously published wildfire investigations, it has been shown that combustible fences can act as a “wick,” allowing fire to travel between different structures or between structures and nearby vegetation.²⁶⁰

This displaced fence panel may have interrupted the fire spreading from the north to 3█ Front Street.

Figure 4.3.4.3.7 Burnt, charred, and broken wooden fence from the 3-3 Front Street property line directly connected to the structure at 3 Front Street. Wooden fences can act as a “wick,” carrying fire from one structure to the next. The northernmost panel was disconnected from the rest of the fence, removing this mechanism of fire spread.

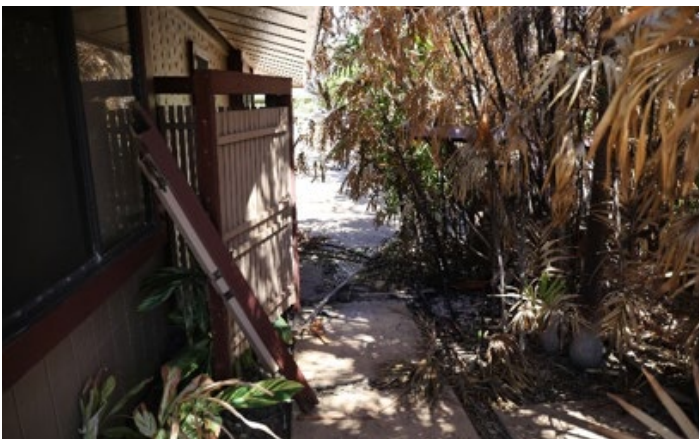
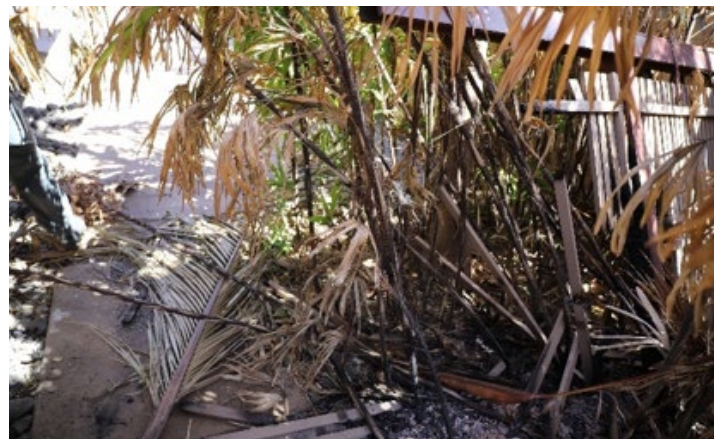
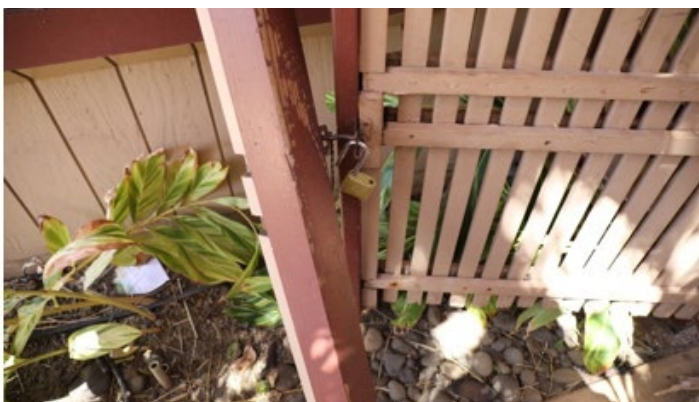
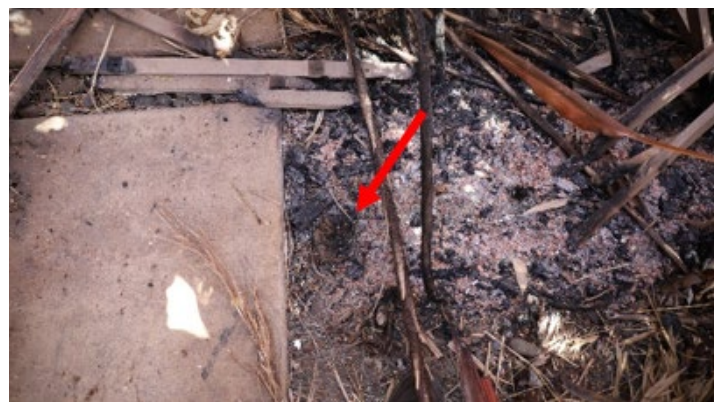
A wooden fence that physically connected the 3 Front Street property line and the exterior wall of the 3 Front Street structure also appeared to have been ignited by embers that landed in the dead leaves near the block half-wall base. While several pickets and rails were consumed in this spot fire, the support post for the gate appears to have been broken off and leaned against the structure.

Based on inspection of the physical damage to the post, the orientation of the gate and fence, and the char marks on the portion of the post remaining in the ground, it is likely the broken support post was caused by the gate being forced open while burning or smoldering was occurring in the area.

Figure 4.3.4.3.8 Gate and post moved away from burning fence pickets that interrupted the continuous wooden fuel from the 3█-3█ property line to the east (mauka) wall of 3█ Front Street. The charred end of the post remaining in the ground is indicated by the red arrow in the bottom right image.

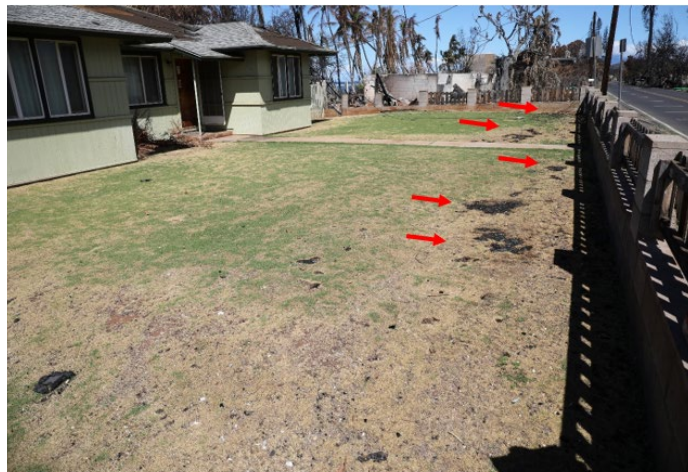
Burned areas appeared to be typically located closer to the east (mauka) and north wall and northeast corner, though there was one (1) spot very near the southeast corner of the structure that did not spread to the residence.

Figure 4.3.4.3.9 Multiple burn scars on grass in the east (mauka) yard of 3█ Front Street, particularly along the east (mauka) and north block half wall. One (1) spot formed near the southeast corner of the residence (bottom right), but did not extend to the structure.

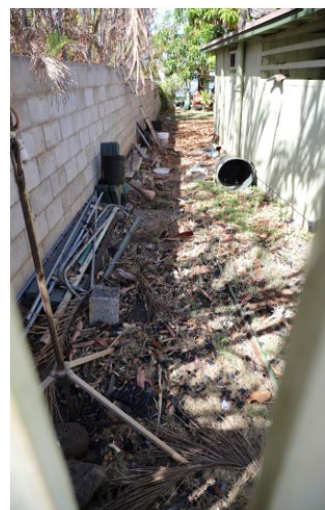
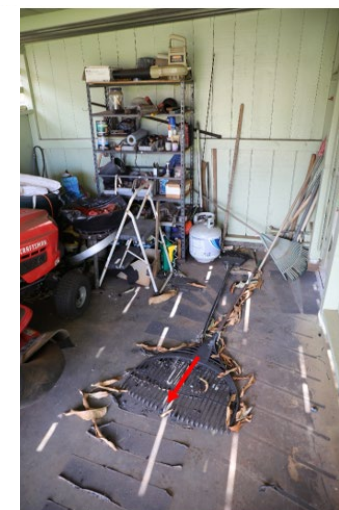
Accumulation of embers was also found in the open garage and side yard between the garage and block wall between this property and the driveway to 3█ Front Street (Figure 4.3.4.3.10). Embers collected in these areas did not have enough energy to ignite the combustibles present and eventually cooled down or burnt out.

Figure 4.3.4.3.10 Embers accumulated in both the side yard and open garage area but did not have enough energy (individually or accumulated) to create sustained ignition of combustibles. There are some indications of localized burning/melting, such as a tine on the plastic rake, but these did not spread.

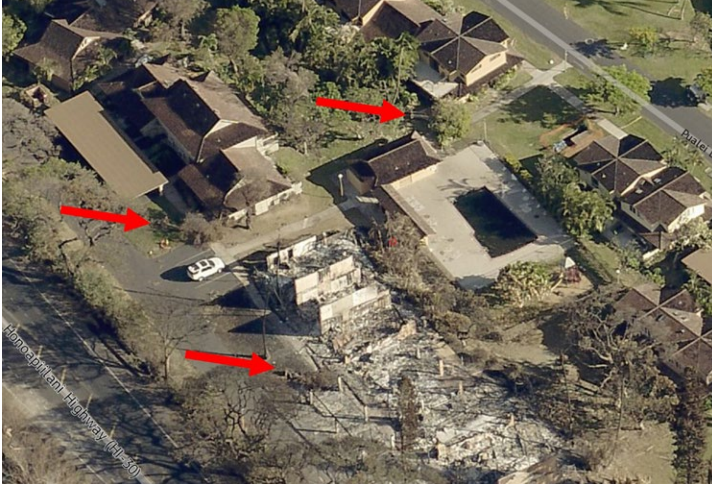
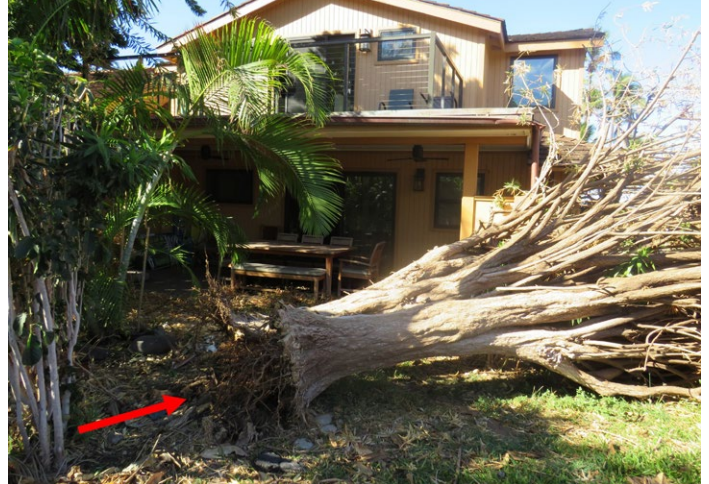
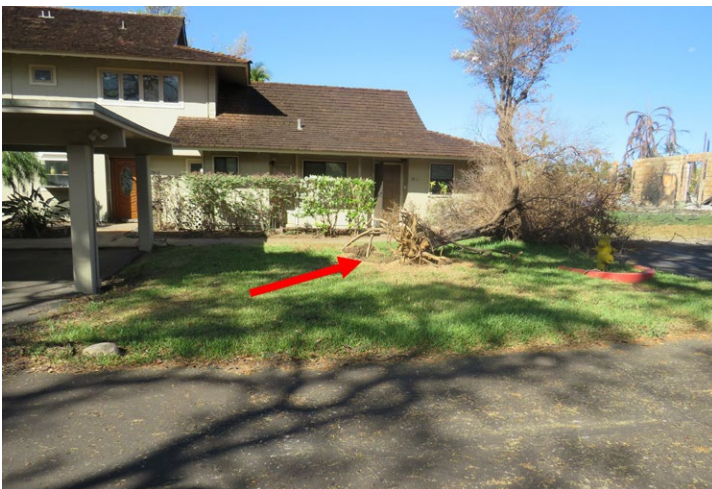
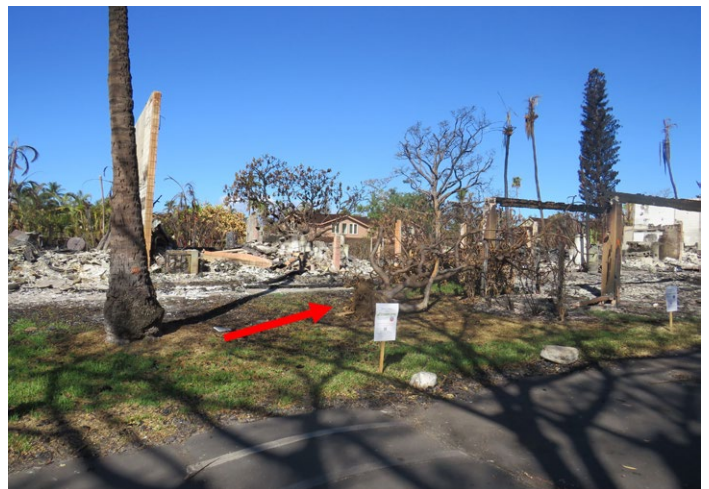
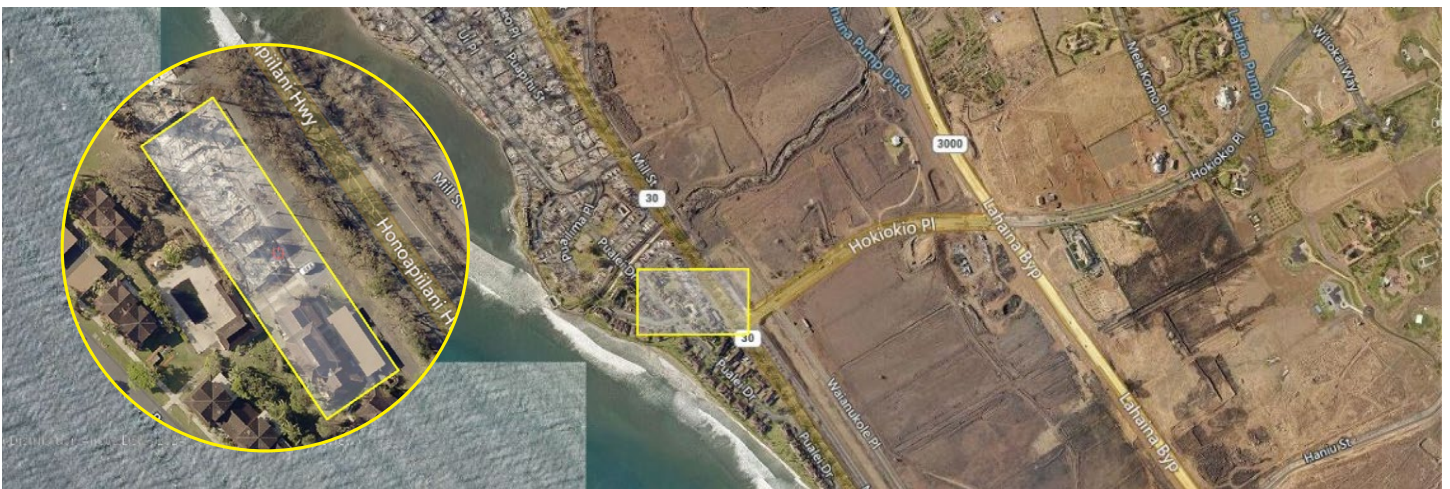
The post-fire damage assessment in Puamana documented the impact of winds that resulted in uprooting of several trees in this area, with the fallen trees most often oriented westward (makai) or northwestward (Figure 4.3.4.4.4).

Figure 4.3.4.4.4 Trees downed by wind facing west (makai)-northwest in the vicinity of 6 and 7 Puakukui Place. Red arrows identify the approximate location and orientation of fallen trees. The overview image (top left) is oriented with north facing towards the bottom. Inset: Viewpoint showing the area depicted in the photographs above.

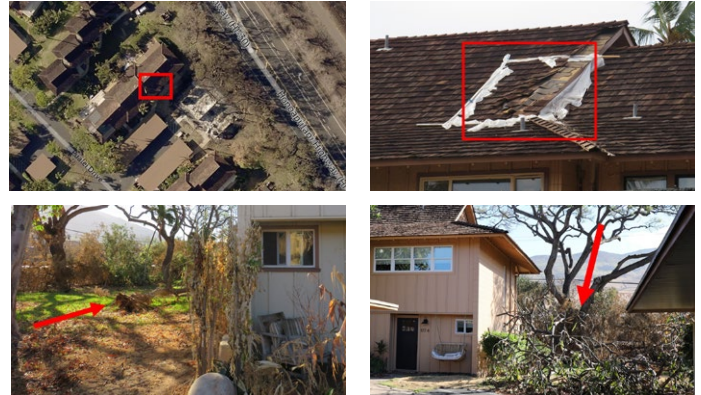
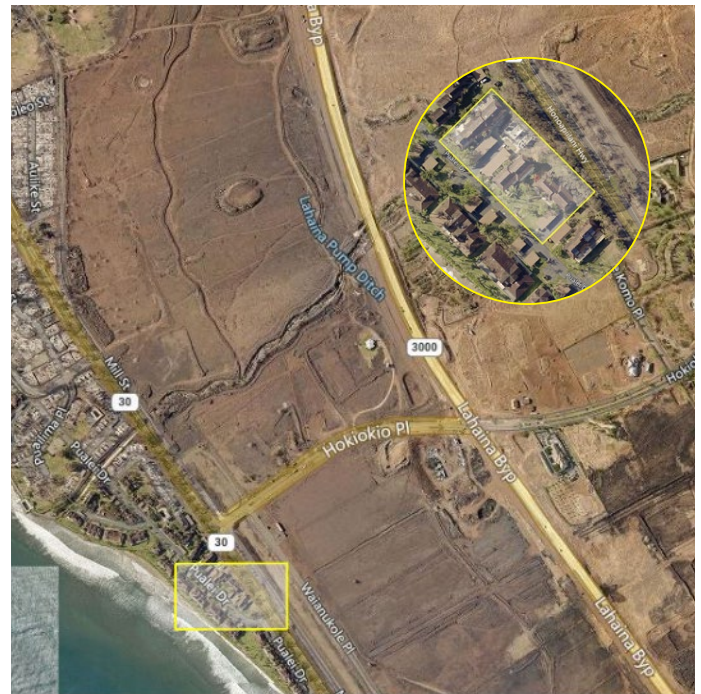
Additionally, roof damage to 1█ Pualei Drive appears on a southeasterly facing (mauka) ridge that would have been impacted by easterly (mauka) winds (Figure 4.3.4.4.5). However, at least one (1) tree near 1█ Pualei Drive fell oriented toward the southeast, possibly impacted by varying wind direction and velocity. The relative timing of the tree damage and the fire reaching Puamana has not been established.

Figure 4.3.4.4.5 Wind damage in the vicinity of 1█ Pualei Drive, including east-facing (mauka) corner of roof on to 1█ Pualei Drive, a tree downed by wind facing south-southeast (middle left), and a tree facing west (makai)-southwest located to the south of 1█ Pualei Drive (middle, right). Red arrows identify the approximate location and orientation of fallen trees. Inset: Viewpoint showing the area depicted in the photographs above.

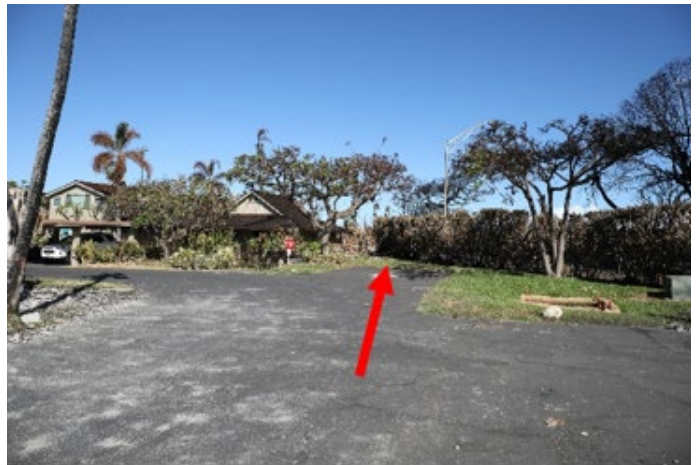
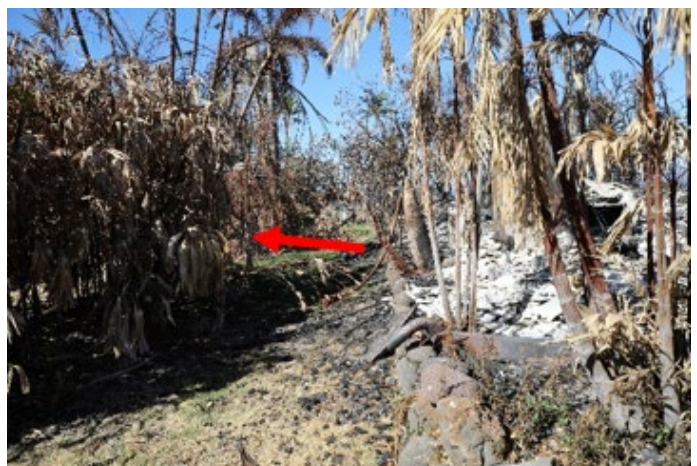
This surviving structure is also immediately adjacent to the destroyed structure at 2■ Front Street. There was no apparent damage from radiation heat to 3■ Pualoke Place, most likely due in some part to the tall, leafy vegetation standing between the two (2) structures (Figure 4.3.4.4.7).

Figure 4.3.4.4.7 Vegetation surrounding 3■ Pualoke Place, including address-side view showing vegetation along Front Street (to the right of the structure) and rear view showing standing leafy vegetation immediately behind the rear porches of the surviving structure.

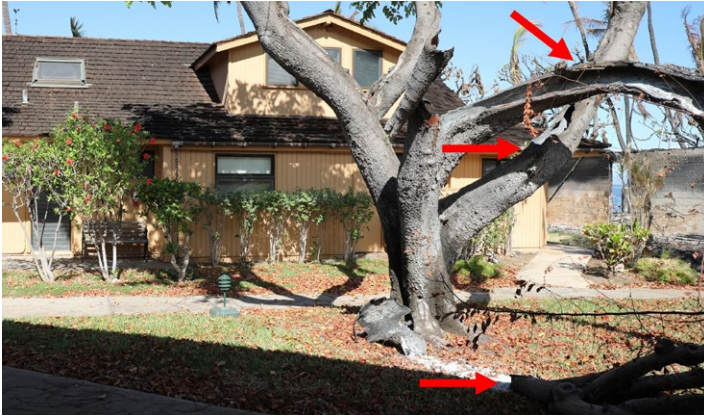
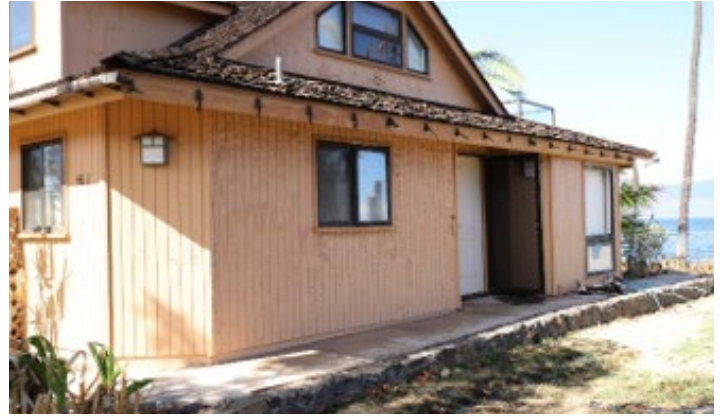
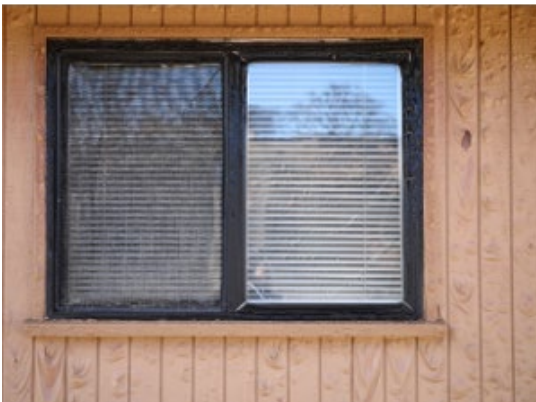
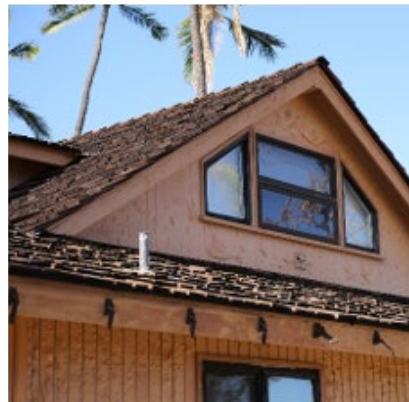
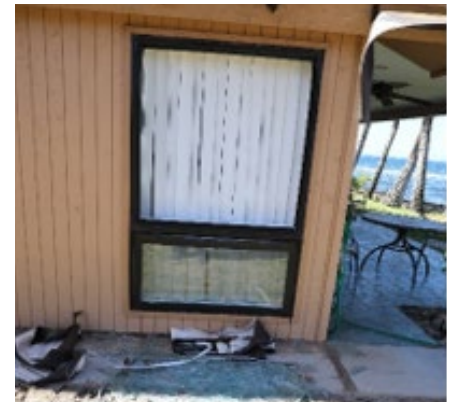
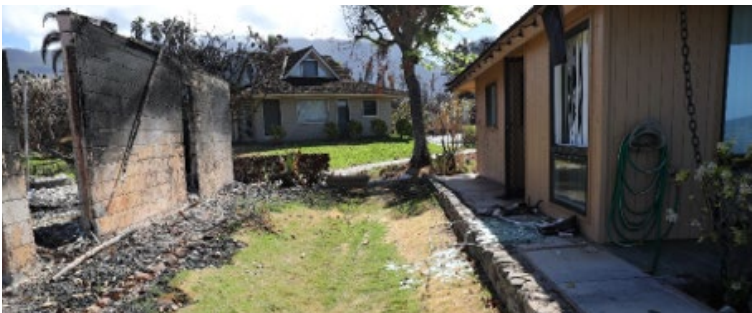
However, the north end of 4■ Pualoke Place (unit 4■) was heavily damaged by radiant heat from the destroyed 3■ Pualoke Place, including bubbling of paint on the first and second floor and melted gutters and plastic vent covers on the second floor (Figure 4.3.4.4.8).

There was also extensive damage to windows (glass cracking, frame warping) on the north side of the structure, including a large double pane (plain glass) window on the northwest corner that fell out from the frame. The vertical blinds inside this window appeared to have some warping possibly due to radiant heat, but they remained intact without charring.

The tree standing to the east (mauka) of unit 4■ is deeply charred on several west (makai) and southwest aspects of large branches (Figure 4.3.4.4.8, top left), which is likely from embers blown

into fissures, openings, or scars. This damage suggests embers with enough energy to create a smoldering fire in wood were present in this area.

Figure 4.3.4.4.8 Damage to the north end of 4 Pualoke Place immediately adjacent to the destroyed structure at 3 Pualoke Place. A tree to the east (mauka) of the structure sustained deep charring, likely from embers gathering in cracks, fissures, or scars in the tree bark (top left). Window damage on the north structure wall (top right) ranges from single pane cracking to vinyl frame warping (middle left) to complete pane fallout (middle center). Plastic vent cover and gutters melted and fell. Paint bubbled and peeled across most of the surface. No apparent indication of charring or damage to wood shake roofing materials or wood wall substrate (top right and middle right). Grass remained green between the destroyed and damaged structure. Garden hose noted at the corner of the structure (bottom left). Inset: Viewpoint showing area shown in the photographs above.

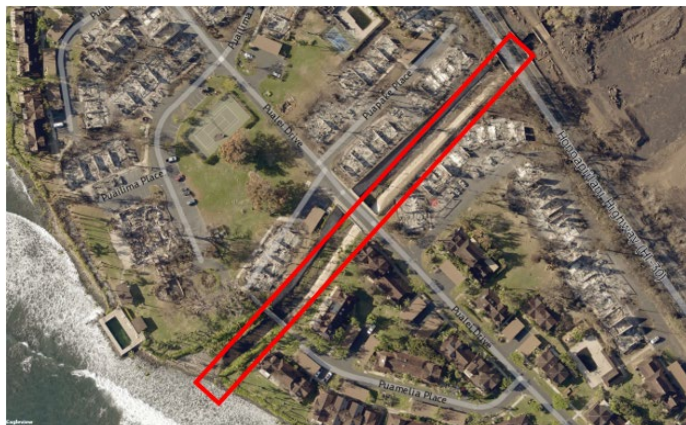
Figure 4.3.4.4.9 Kaua'ula Stream running through Puamana provided a physical separation between the northern section (where structures were destroyed between Hwy-30 and the coast) and the rest of the community (where destroyed structures were limited to the area between Hwy-30 and Pualei Drive).

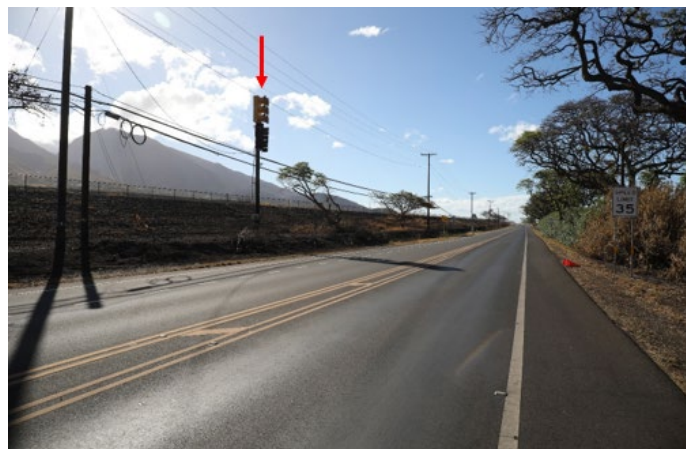
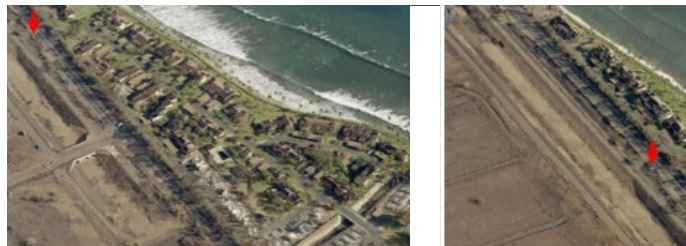
Extensive burning and charring is noted in the vegetation between Puakukui Place and Hwy-30 all the way to the location where Pualei Drive shifts east (mauka) and then runs adjacent to Hwy-30. At this location east (mauka) of Mill Street, the charred grass also appears to terminate, possibly due to either water application from the E11 with the private tanker and/or shifting winds.

Figure 4.3.4.4.10 Images along Hwy-30 and Mill Street indicating the southern termination of the grass fire on the bank east (mauka) of Mill Street coincides with the southern end of damaged vegetation along fence line west (makai) of Hwy-30. Approximate location of E11 radio transmission at 22:41 roughly coincides with this area (See Phase One report, Figure 4.3.1.40). Yellow siren provides a common orientation in each picture. Vegetation appears more heavily consumed around the drainage but remains more dense (yet damaged) further south until this transition to green foliage.

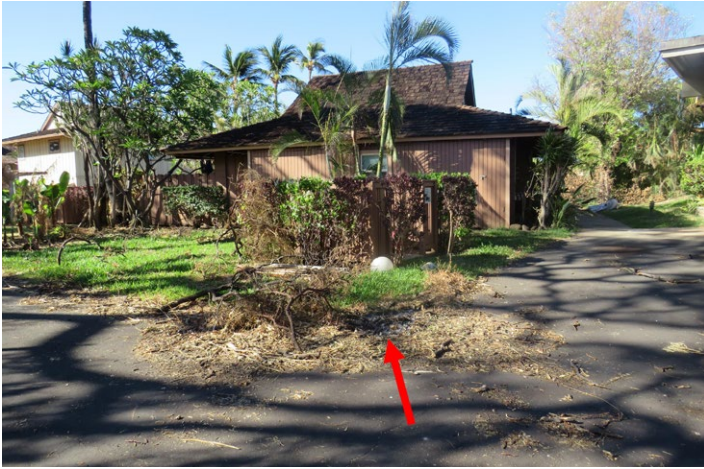
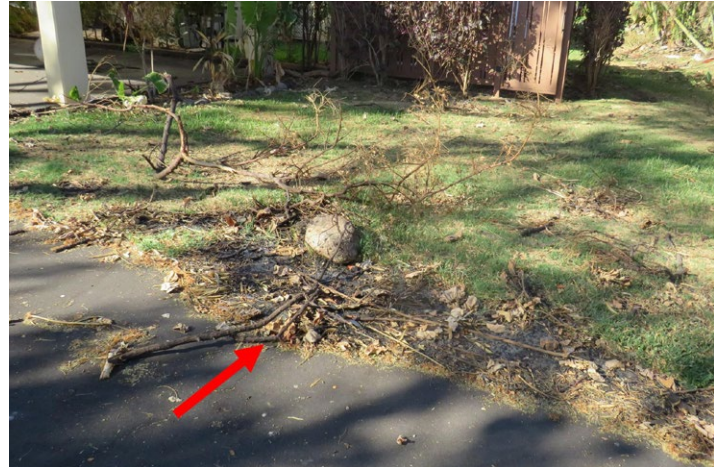
The underbrush appears more completely consumed farther north (closer to Kaua'ula Stream), likely due to a combination of longer burn times as the fire moved south, as well as radiant heat from consumed structures across Puakukui Place. Structure numbers 2■, 4■, 5■, and 6■, all of which were immediately adjacent to the fenceline or across Puakukui Place from the fenceline, were destroyed. 7■ Puakukui Place, along with 1■ and 1■ Pualei Drive, were also separated from the fenceline by Puakukui Place, but did not ignite. Spot fires in light fuels on the west (makai) side of the road and parking structures did ignite in a few locations, but did not continue to these structures (Figure 4.3.4.4.11).

Figure 4.3.4.4.11 Spotting across Puakukui Place in front of structures (top left) 1 and (top right) 1. Embers found a receptive fuel bed to ignite, but not sustain burning through the green grass. Inset: Viewpoint showing above images.

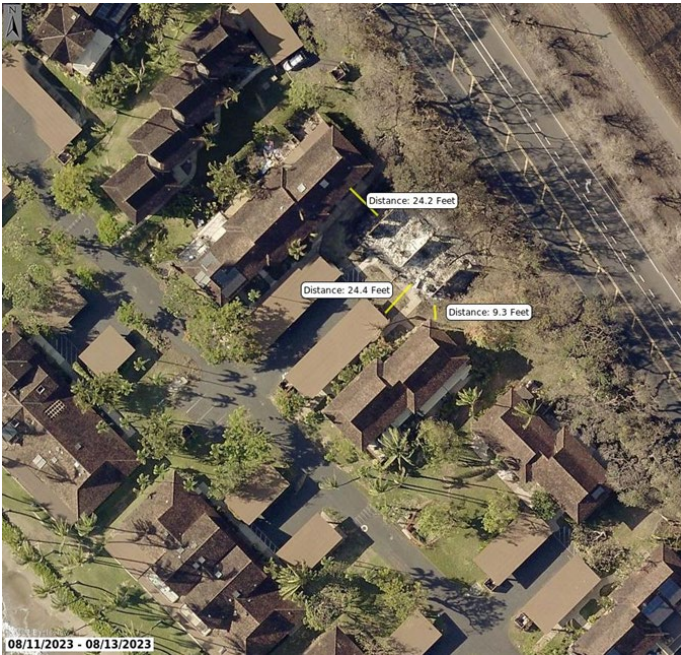
1 Pualei Drive is the southernmost structure destroyed in Puamana (Figure 4.3.4.4.12). While, structures immediately adjacent to the north, west (makai), and south were not destroyed, 1 Pualei Drive (northwest) received extensive thermal radiation damage, including bubbled paint, melted plastic conduit and vent covers (some vent covers fell off), and broken windows (Figure 4.3.4.4.13).

Figure 4.3.4.4.12 1 ■ Pualei Drive is the farthest south structure destroyed in Puamana. It is bounded by 1 ■ Pualei Drive to the northwest and 1 ■ Pualei Drive to the south and parking structures to the west (makai). Inset: Viewpoint shows the area appearing in the photograph above.
