Lahaina Fire Incident Analysis Report

Steve Kerber
Derek Alkonis

September 13, 2024
Columbia, MD

This document is the second in a series of three (3) reports commissioned by the Hawai'i Department of the Attorney General (DOAG) to provide an independent review of the tragic fire that destroyed much of Lahaina, Hawai'i, on August 8-9, 2023.

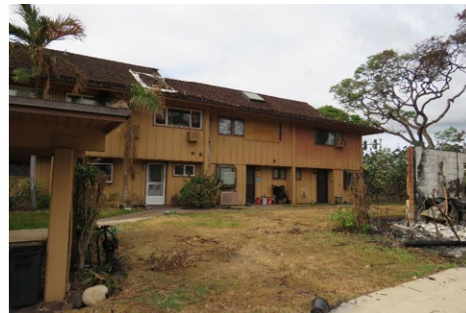
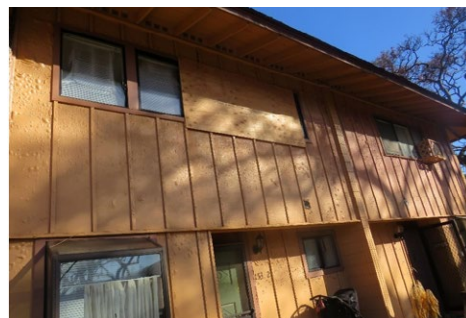
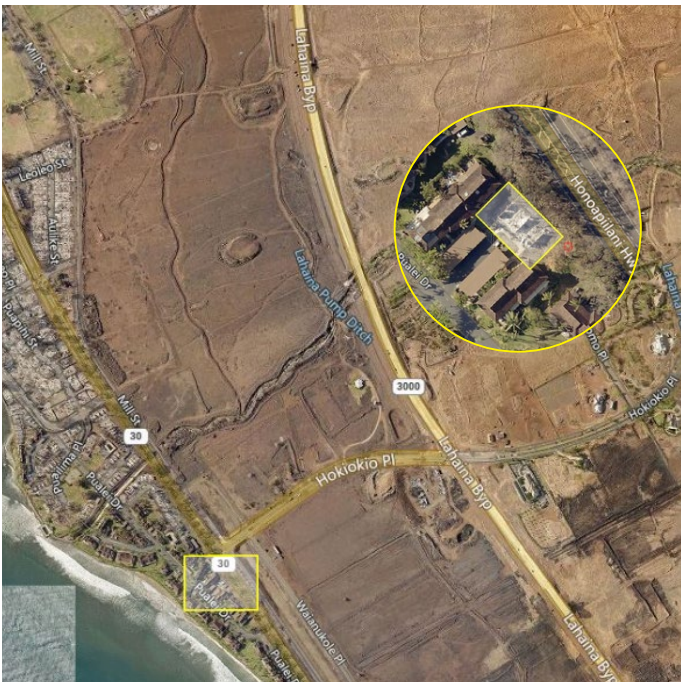
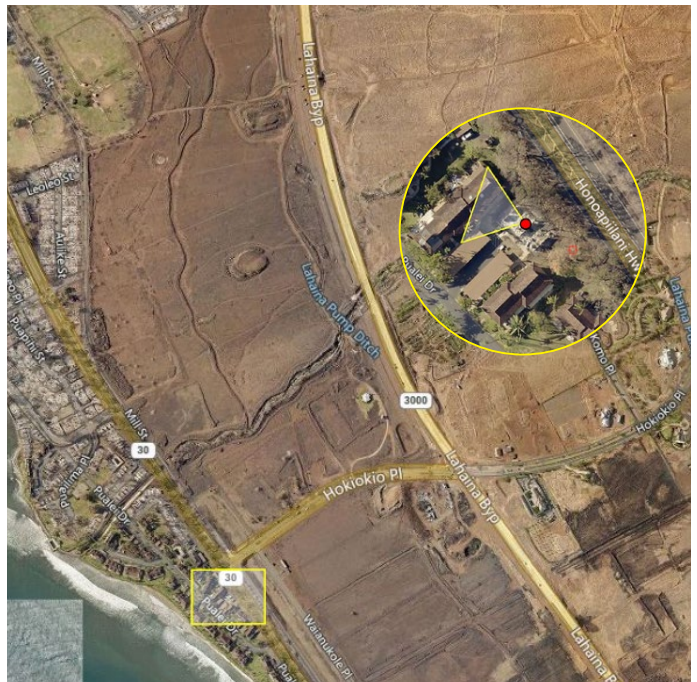
One (1) broken window was boarded up prior to documentation, so someone had accessed the area prior to the analysis. For the windows that were visible, at least one pane of the double pane windows remained intact. Horizontal blinds behind some of these windows appear warped, possibly

due to radiant heating, though no charring/melting was noted behind the window.

1 Pualei Drive is situated closer to the destroyed structure than 1 Pualei Drive, but radiant heat damage on this structure was limited to paint bubbling with no visible damage to windows or other components. This difference in damage between the two (2) nearby structures may suggest the wind at the time that 1 Pualei Drive was burning may have directed flames more toward the northwest than south or that more fuel was present in the northern part of the structure than the south.

Figure 4.3.4.4.13 Radiant heating damage on the southeast side of 1 ■ Pualei Drive. Window damage includes cracking and drop out of some panes, melting and deformation of frames and screens, and potentially deformation of blinds behind windows due to transmitted radiant heating. Damage was noted to plastic vent covers and charring of fascia board on the end of the roof line. Inset: Viewpoint showing the area depicted in the photographs above.

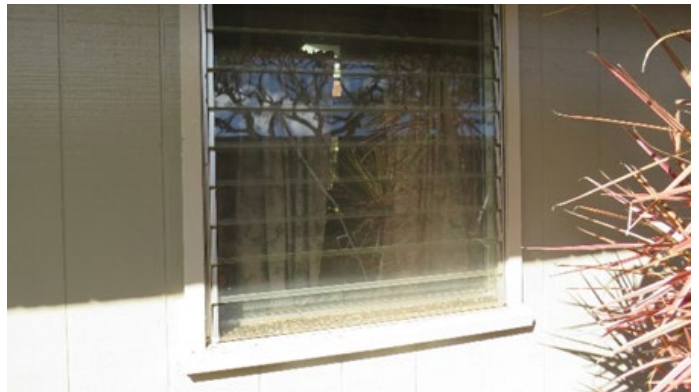
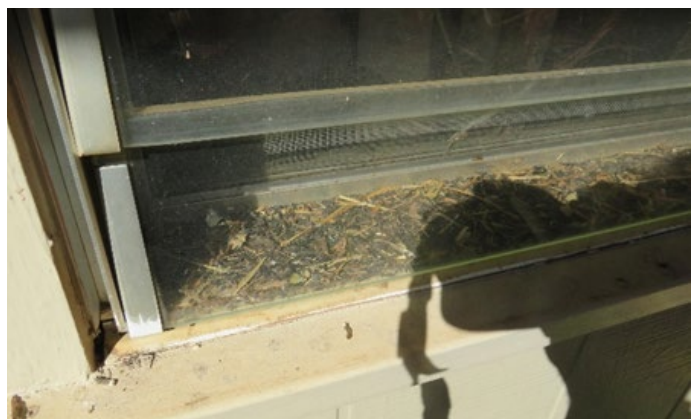
As described earlier, the orientation of windows and doors or roof/attic venting for the destroyed structures in Puamana cannot be definitively determined in the post-fire analysis. However, images collected from the surviving structure shows some windows may have been left partially open. For example, a louvered window was found partially open with debris and ash build up, but a screen was in place that appeared to keep the material from entering the structure (Figure 4.3.4.4.14).

Figure 4.3.4.4.14 Louvered windows left partially ajar where debris collected, including charred remains of possible embers. An intact screen behind this window kept these materials from entering the structure and possibly igniting interior contents.

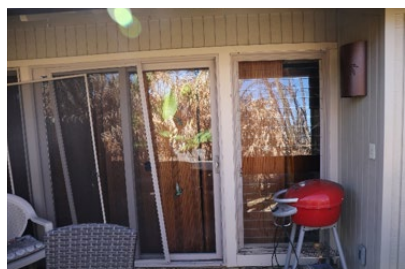
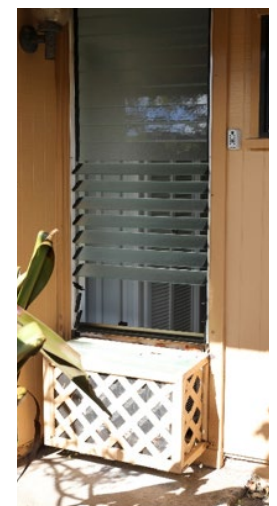
Other windows through this community were found open or potentially broken, though it is possible these were opened after the fire but prior to images being collected (Figure 4.3.4.4.15). Several of these windows did not have screens behind them, which if left open, would have allowed direct entry of embers that may impact the structures if they were present at this orientation.

Figure 4.3.4.4.15 Examples of open/broken windows on surviving structures in Puamana.

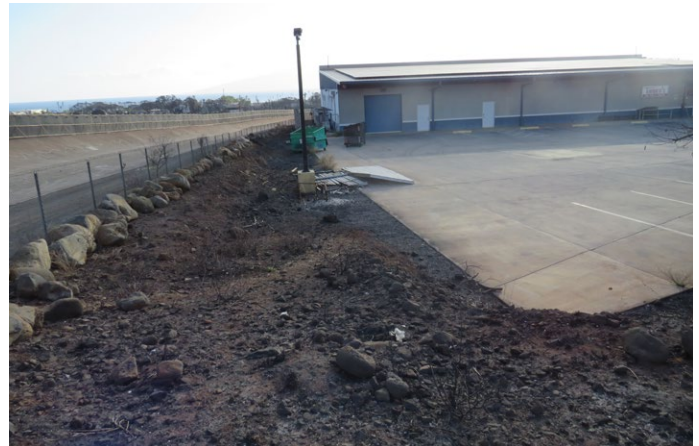
They relocated into the business park and began to extinguish the grass fires adjacent to 2█ Kupuohi Street (Figure 4.3.5.1.5 and 4.3.1.6).

Figure 4.3.5.1.5 Grasses burned along Kahoma Stream and behind 2█ Kupuohi Street (Tamara's Fine Wine & Liquors).

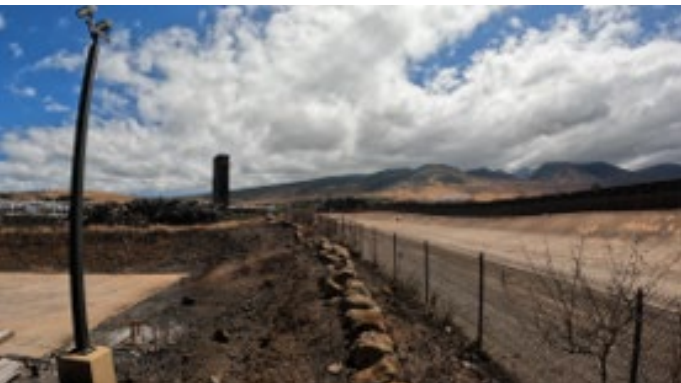
Figure 4.3.5.1.4 Grasses burned looking east (mauka) toward the Kaiāulu o Kupuohi Apartment complex.

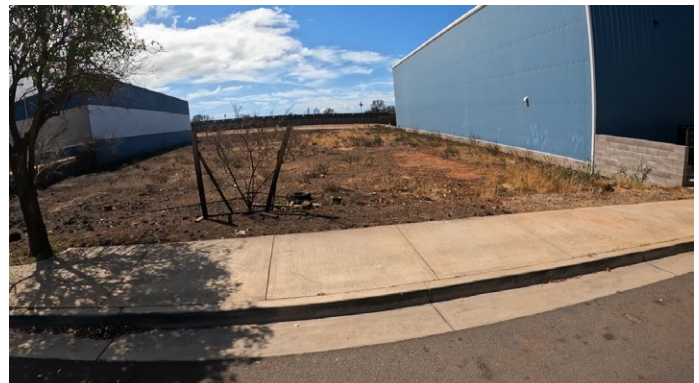
Figure 4.3.5.1.6 Grass lot burned at 2█ Kupuohi Street, one of the first fires reported on the north side of Kahoma Stream.

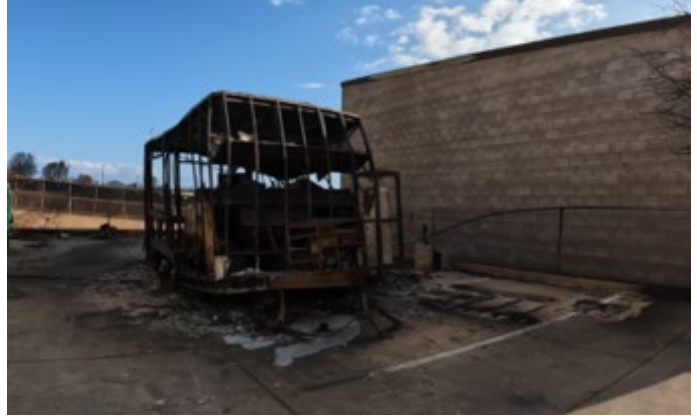
At 17:41:56, MPD officer 4SA2 notified Central of a vehicle engulfed in fire in the parking lot of 1█ Kupuohi Street (Figure 4.3.5.1.8 and Figure 4.3.5.1.9).

Figure 4.3.5.1.8 Trailer and building materials ignited by embers (1█ Kupuohi Street).

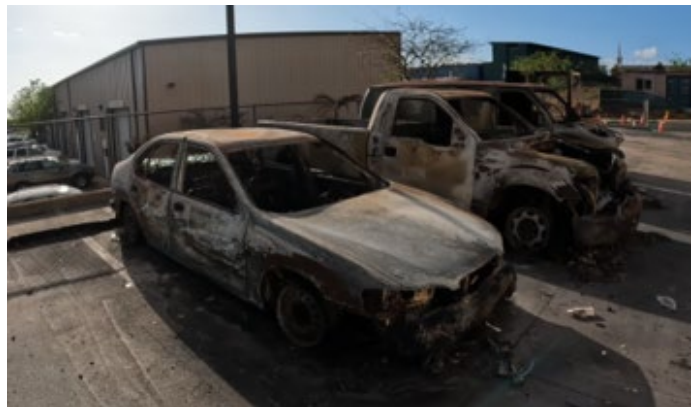
Figure 4.3.5.1.9 Vehicles consumed by fire in the parking lot of 1█ Kupuohi Street.

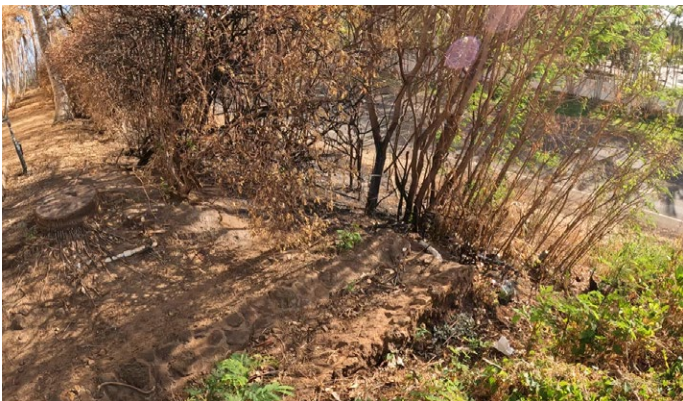
Figure 4.3.5.1.7 Location where the brush fire spread stopped behind 4█ Kupuohi Street.

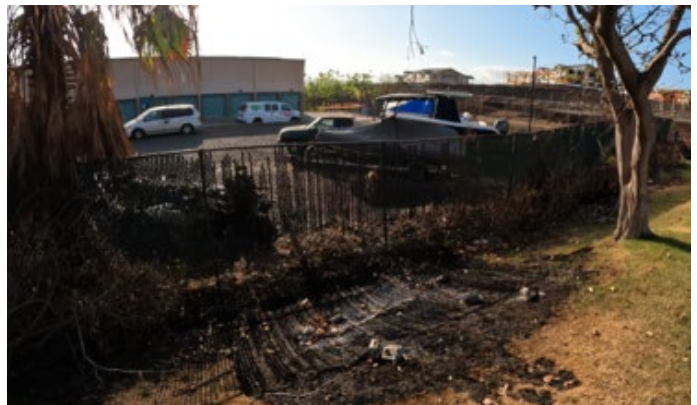
Between 19:13:30 and 20:00:09, RE1 advised Command there was an “ember wash” (airborne and ground traveling embers) exposing the Island Grocery Depot and a warehouse in the area. Unit E11 was fighting a truck fire next to the warehouses on Kupuohi Street. E3 attempted to engage the fire near the Church of Jesus Christ of Latter-day Saints building at 8█ Ulupono Street (Figures 4.3.5.1.10, 4.3.5.1.11, and 4.3.5.1.12).

Figure 4.3.5.1.10 Large spot fire west (makai) of the church (8█ Ulupono Street).

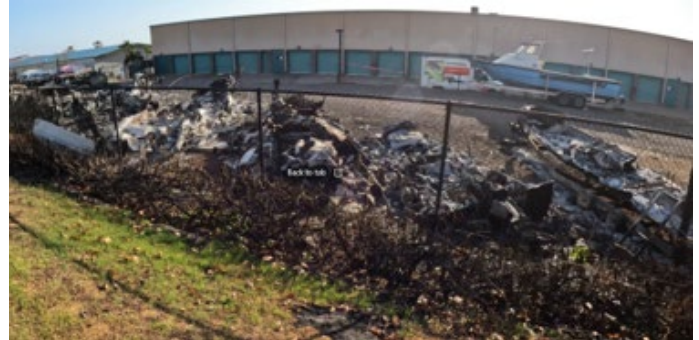
Figure 4.3.5.1.11 Vehicles consumed by fire west (makai) of the church (8█ Ulupono Street).

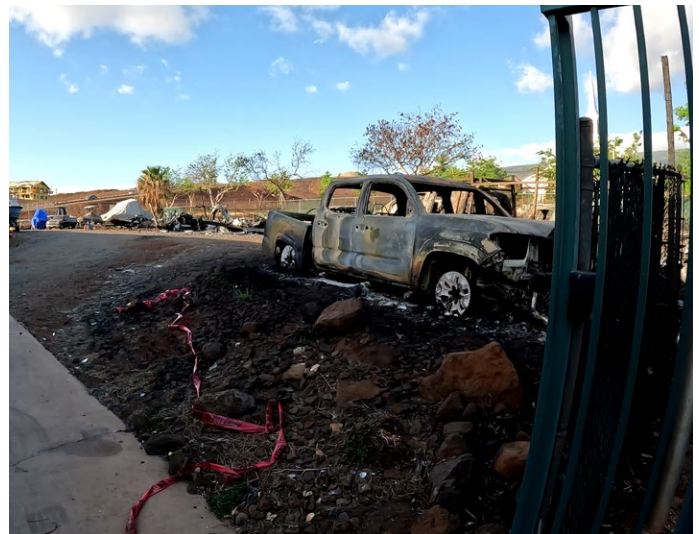
Figure 4.3.5.1.12 Additional vehicles consumed by fire west (makai) of the church (8█ Ulupono Street).

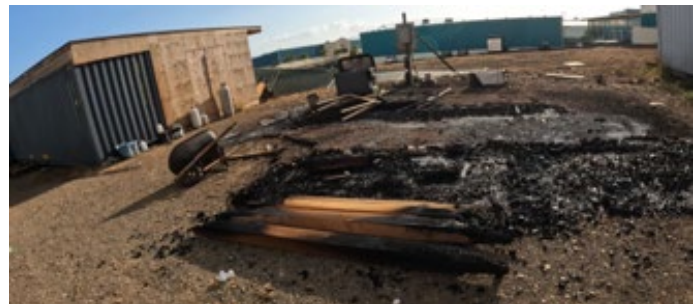
This activity allowed MFD units to suppress numerous spot, vehicle, building material, and structure fires before they spread (Figures 4.3.5.1.13, 4.3.5.1.14, 4.3.5.1.15, 4.3.5.1.16, 4.3.5.1.17, 4.3.5.1.18, and 4.3.5.1.19).

Figure 4.3.5.1.13 Materials storage area burned by embers (1█ Kupuohi Street).

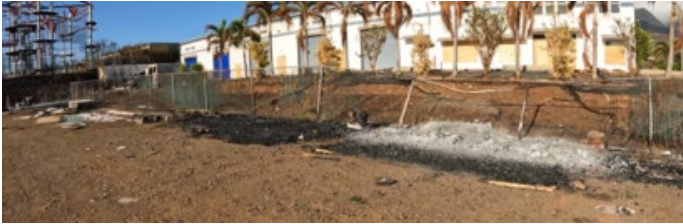
Figure 4.3.5.1.14 Materials storage area burned by embers (1 █ Kupuohi Street).

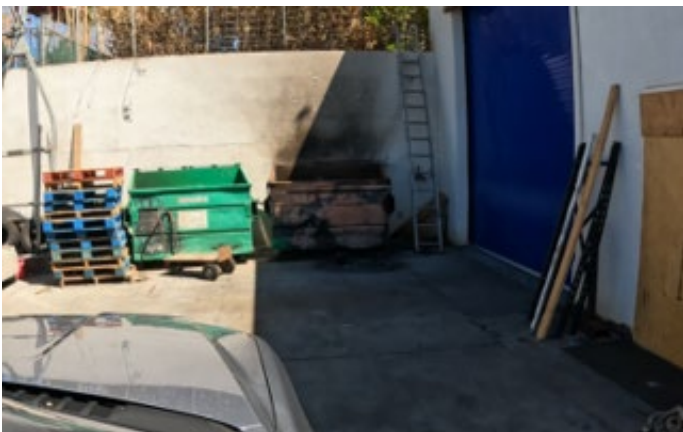
Figure 4.3.5.1.15 Dumpster fire to the west (makai) of 2 █ Kupuohi Street.

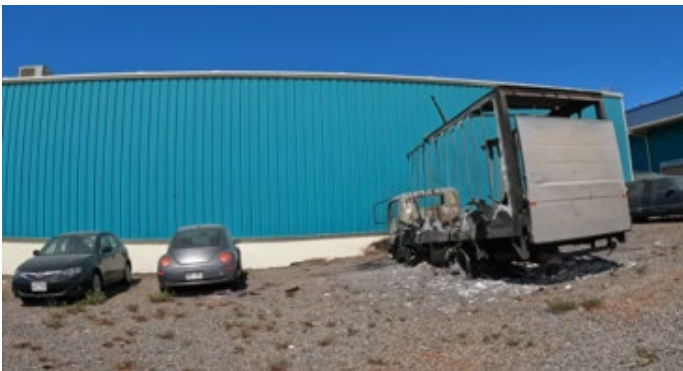
Figure 4.3.5.1.16 Box truck consumed by fire behind 1 █ Kupuohi Street.

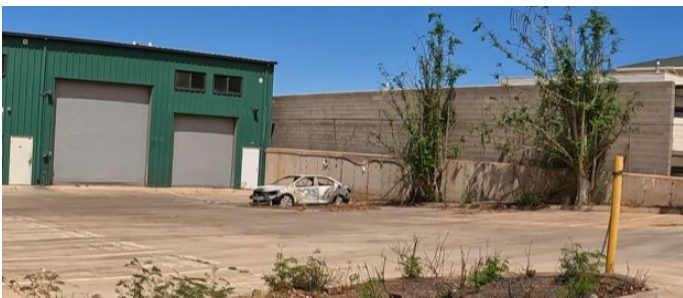
Figure 4.3.5.1.17 Car consumed by fire next to 2 █ Kupuohi Street.

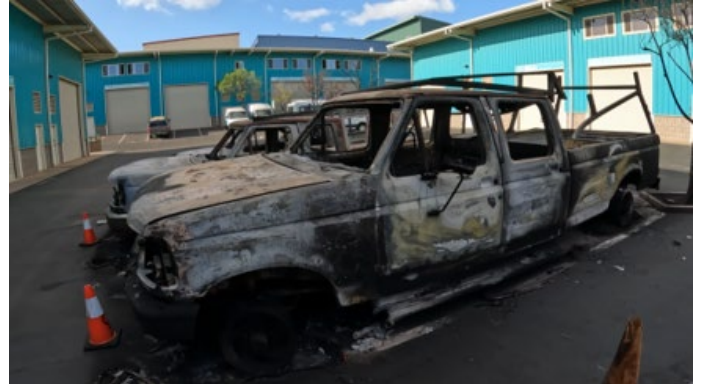
Figure 4.3.5.1.18 Vehicles consumed by fire in the middle of Emerald Plaza Place (near 1 █ Kupuohi Street).

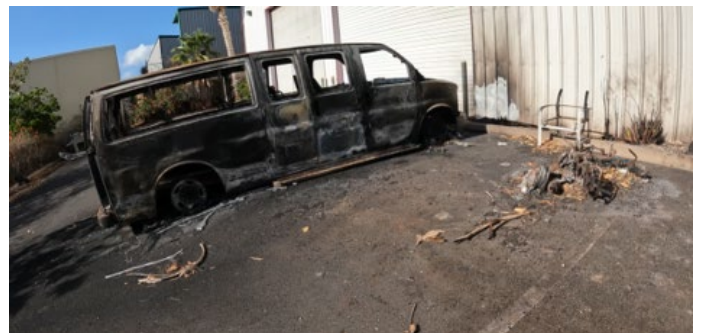
Figure 4.3.5.1.19 Van consumed by fire with thermal damage to 1 █ Kupuohi Street.

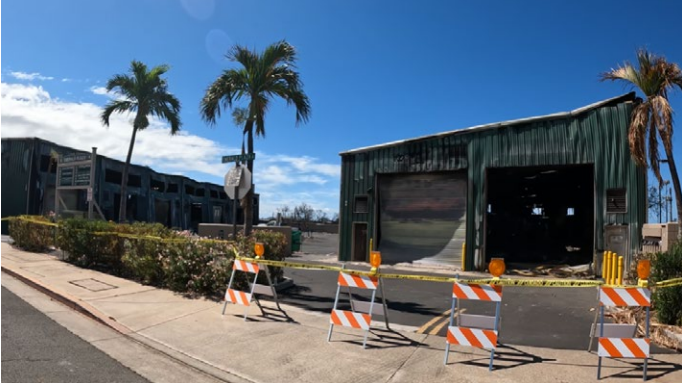
The two (2) warehouse buildings that burned (Figure 4.3.5.1.20 and Figure 4.3.5.1.21) had several open vents that may have allowed embers to enter the structure and ignite combustible materials. These buildings were also on the southwestern edge of the business park where large wind-borne plumes of embers likely traveled from nearby engulfed homes on the other side of the Kahoma Stream.

Figure 4.3.5.1.20 Emerald Plaza Building A consumed by fire.

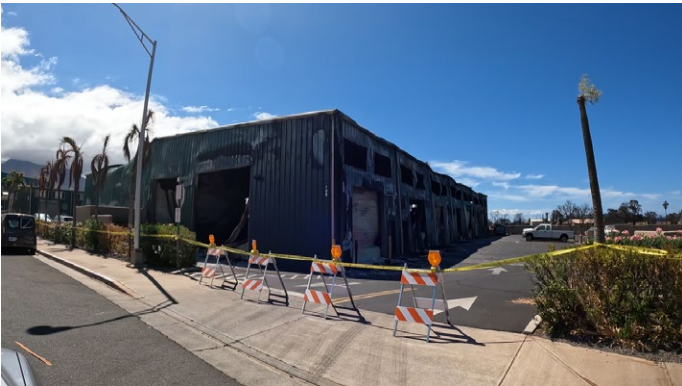
Figure 4.3.5.1.21 Emerald Plaza Building B and C consumed by fire.

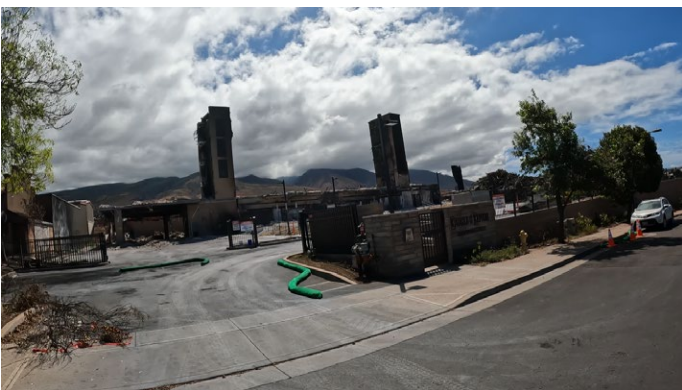
The ignition of the Kaiāulu o Kupuohi apartment complex (Figure 4.3.5.1.22) and the vehicle lot on the northeast corner of the business park (Figure 4.3.5.1.23) began later in the incident. There were no reports of the building or vehicle fires on MPD or MFD radio, so they likely ignited between the time units evacuated north of the Lahaina Civic Center and the following morning.

Figure 4.3.5.1.22 Kaiāulu o Kupuohi Apartment complex consumed by fire.

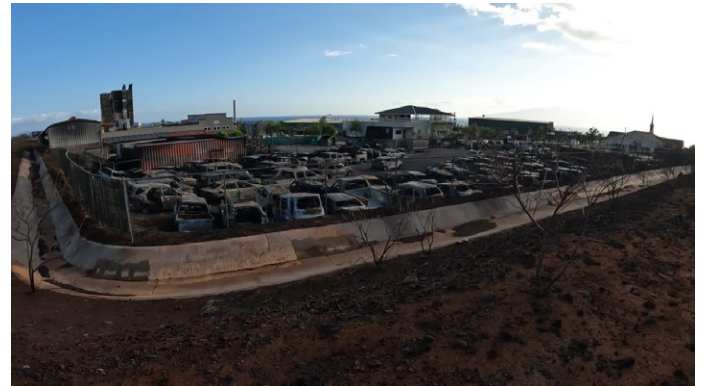
Figure 4.3.5.1.23 Lot of vehicles consumed by fire in the northeast corner of the business park.

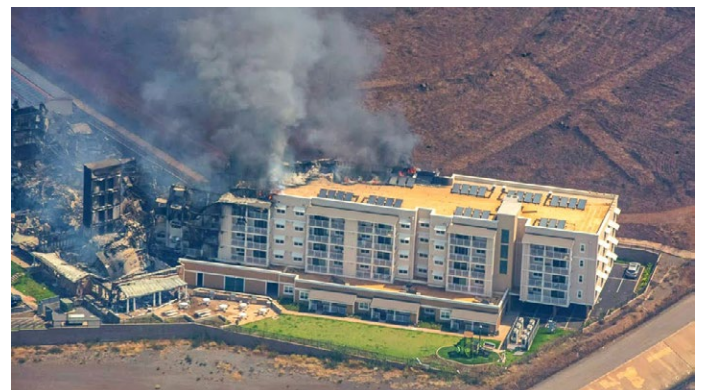
The first known resident video of the apartment complex on fire was recorded at 05:35 on August 9, 2023. At this time, the north wing of the building was on fire. The fire spread to the south and completely destroyed the structure within two (2) days, according to news reports (Figure 4.3.5.1.24).

Figure 4.3.5.1.24 Kaiāulu o Kupuohi Apartment complex continuing to burn following the August 8, 2023, fire.²⁶¹

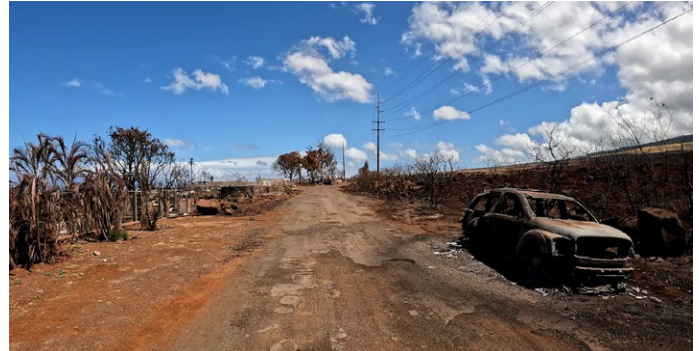
Figure 4.3.5.2.6 Car located at edge of construction site that supported the fire jumping Oil Road from the east-mauka (right to left).

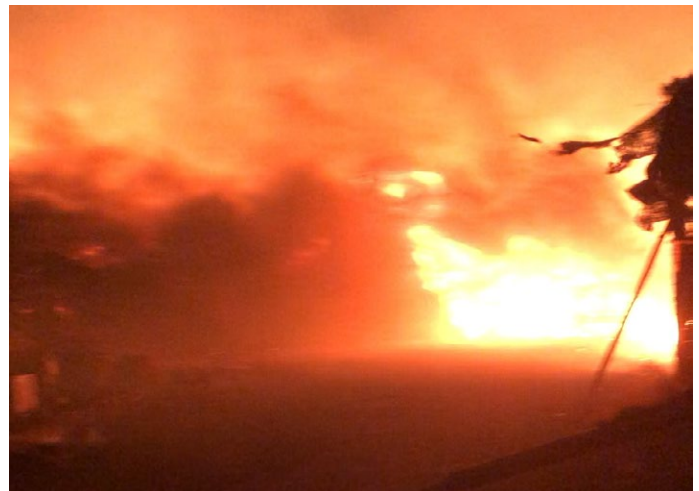
Figure 4.3.5.2.7 Resident video of car on fire at the northeast end of the construction site with heavy winds driving the fire toward 13█ Kahoma Street.

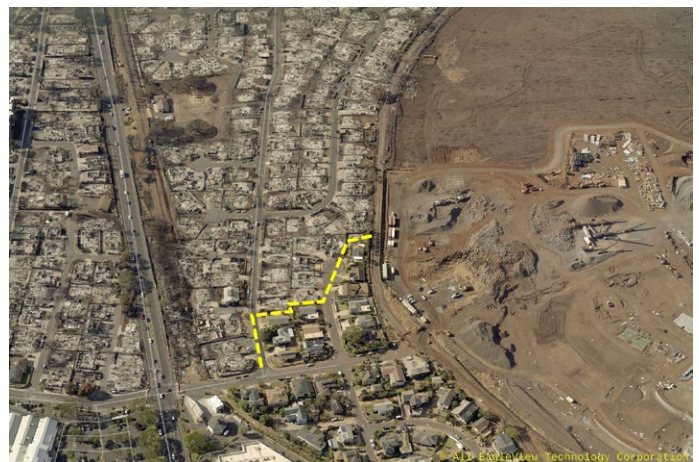
Figure 4.3.5.2.8 provides an overhead view of the northwest corner of the construction site, highlighting the interface where the fire stopped. Structure-to-structure fire spread that started from this location spread south until it reached the top of Nahale Street.

Figure 4.3.5.2.8 Overhead view of the area at the northwest corner of the construction site, highlighting the interface where the fire stopped. To the north, the fire stopped at the top of Nahale Street (Source: EagleView).

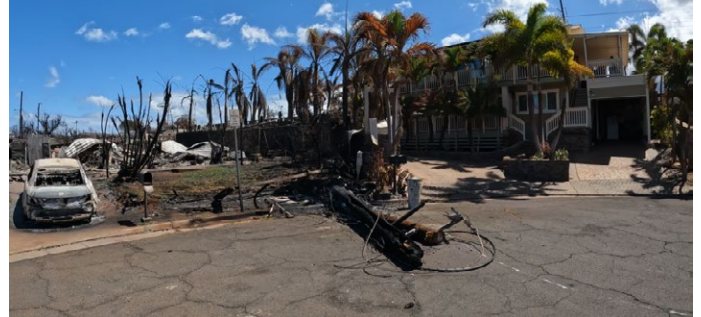
Figure 4.3.5.2.9 shows 12█ Nahale Street on left (destroyed) and 12█ Nahale Street on right (survived). An ancillary structure on the property was destroyed by fire, but the fire did not extend to the house. The fire did not propagate further south on the east side of Nahale Street, in part, due to the distance between structures, defensive actions taken by a neighbor to stop the fire, and a shift in wind direction.

Figure 4.3.5.2.9 12█ Nahale Street on the left and 12█ Nahale Street on the right.

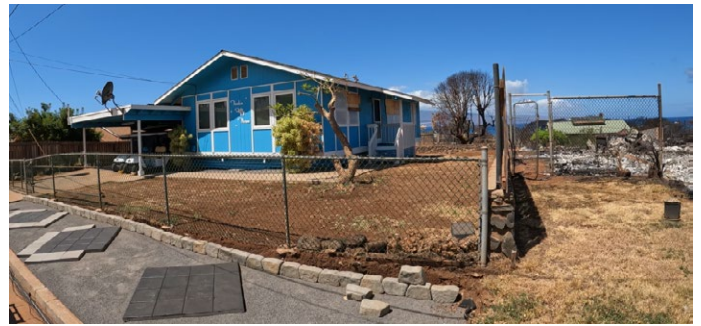
On the west side (makai) of Nahale Street, the fire propagated further south and destroyed 12█ Nahale Street, but 12█ Nahale Street survived (Figure 4.3.5.2.10). The fence separating the structures was burned, and 12█ Nahale Street was damaged (windows cracked and paint bubbled) due to radiant heat. However, the fire did not extend through the main structure.

Figure 4.3.5.2.10 12█ Nahale Street on the left and 12█ Nahale Street (destroyed) on the right.

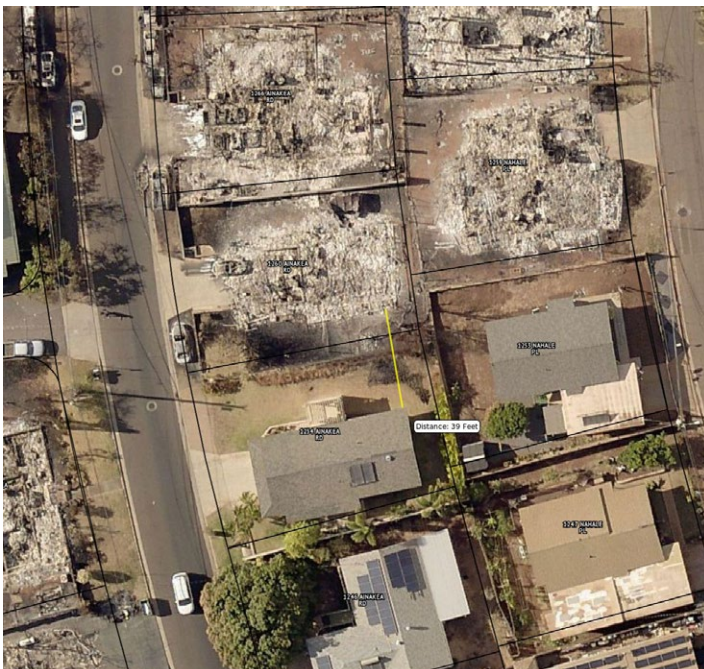
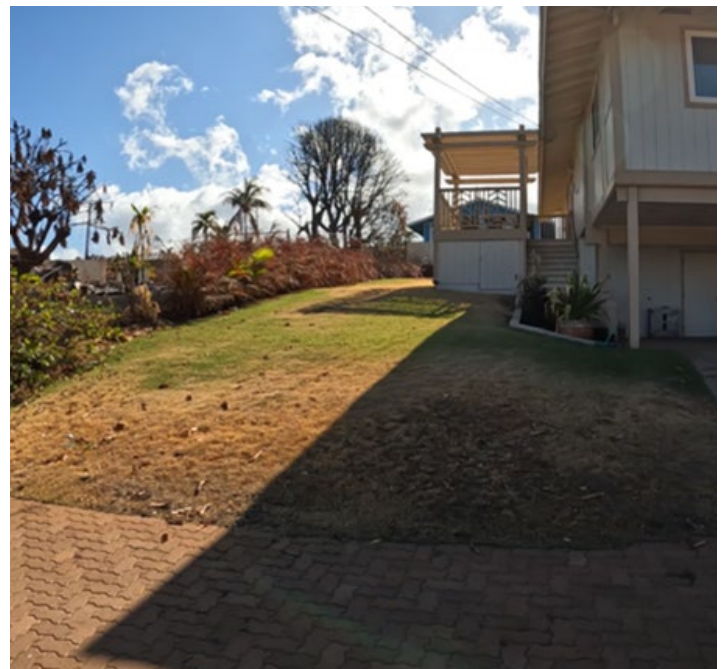
The structure to the rear of 12█ Nahale Street (12█ 'Ainakea Road) also survived the fire (Figure 4.3.5.2.11), though it also sustained radiant heat damage from the structure next door at 12█ 'Ainakea Road, including blistered paint and cracked windows (Figure 4.3.5.2.12).

Figure 4.3.5.2.11 (Left) Post-fire aerial image with annotated distance, 39 feet, between (destroyed) 12█ 'Ainakea Road and (damaged) 12█ 'Ainakea Road. (Right) Ground-based image of separation between destroyed and damaged structures.

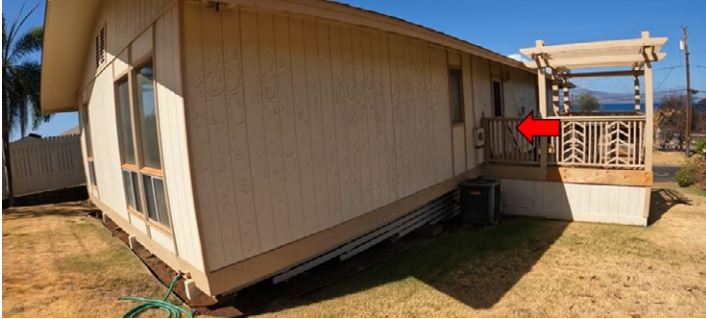
Figure 4.3.5.2.12 Northeast corner of 12█ 'Ainakea Road with blistering paint from radiant heat exposure (indicated by red arrow).

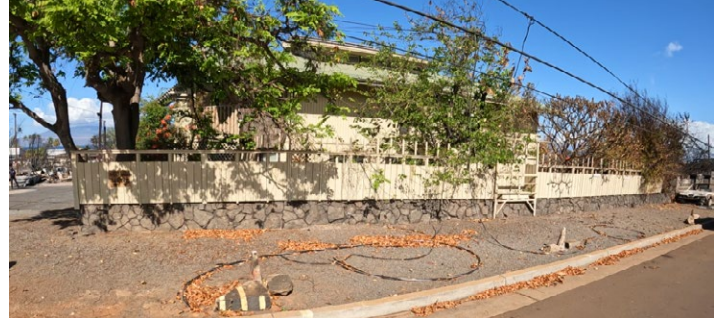
Figure 4.3.5.2.14 12█ 'Ainakea Road (Front view, oriented west).

Diagonally across 'Ainakea Road is 12█ 'Ainakea Road. This house survived even though structures on all four (4) sides of it were destroyed (Figure 4.3.5.2.13-4.3.5.2.16). The side of the house facing north toward 12█ 'Ainakea Road had blistered paint and cracked windows, but it showed no signs of ignition.

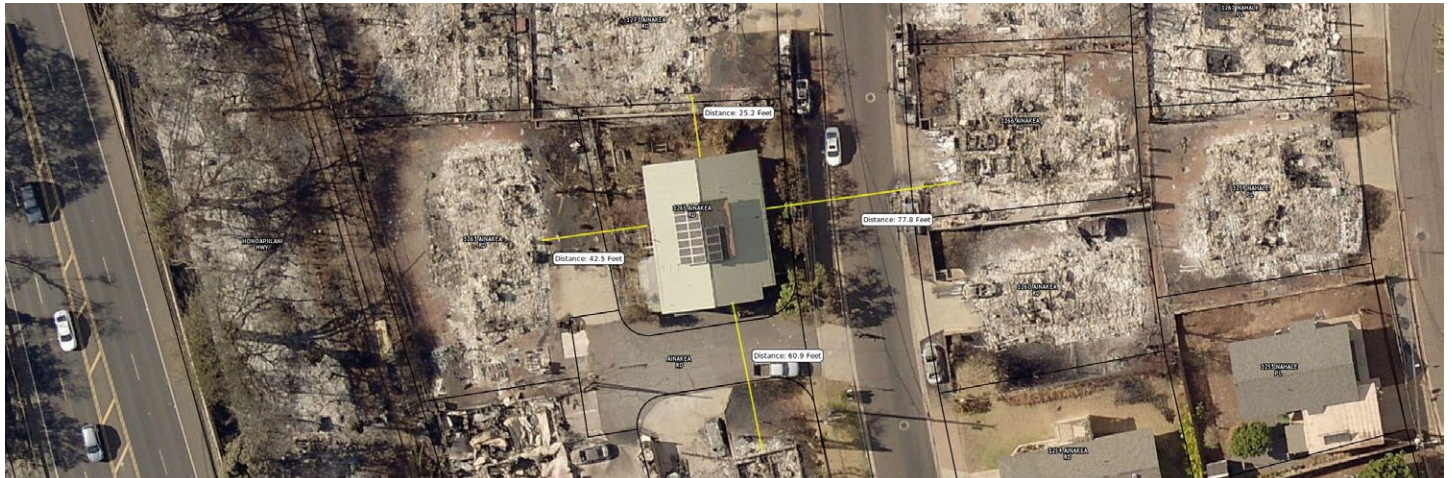
Figure 4.3.5.2.13 Post-fire aerial imagery of 12█ 'Ainakea Road with distances to adjacent (destroyed) buildings.

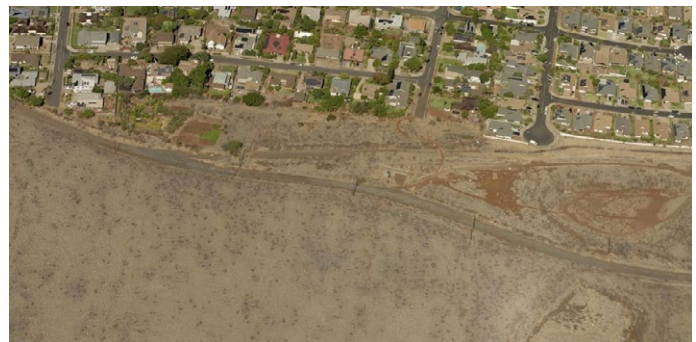
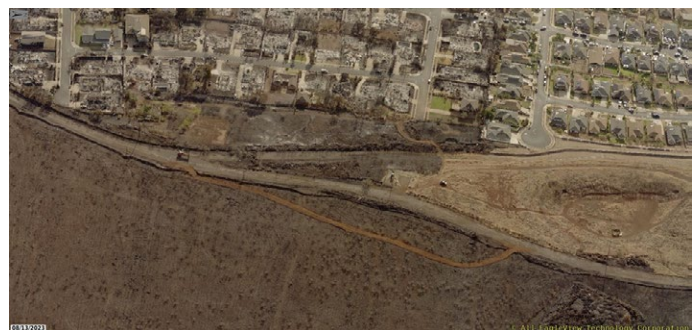
When the vegetation fire crossed over Oil Road, it continued to spread west (makai) to the eastern (mauka) property lines of these lots (Figure 4.3.5.3.3). Some of the structures on these properties were buffered by gardens, maintained (e.g., mowed and/or watered) lawns, and fences. Four (4) structures on the eastern (mauka) border of this area survived the fire with varying levels of damage.

Figure 4.3.5.3.3 Fire in the grassland along the eastern edge (mauka) of the northern zone crossed over Oil Road to the eastern edge (mauka) of properties on Lokia Street and Kaniau Road. The north flank vegetation fire remained east (mauka) of Oil Road between 'Aipuni Street and Leialii Parkway, after which the fire moved back west (makai). Note: North is to the right on these images.

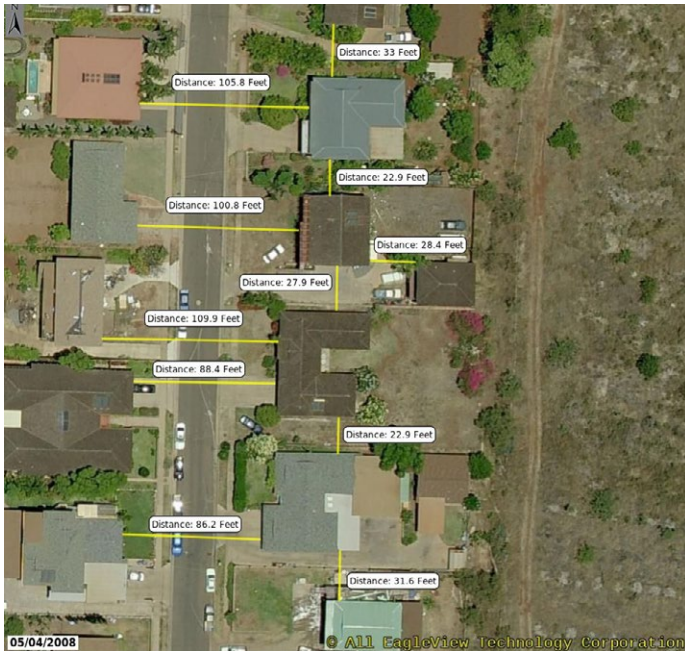
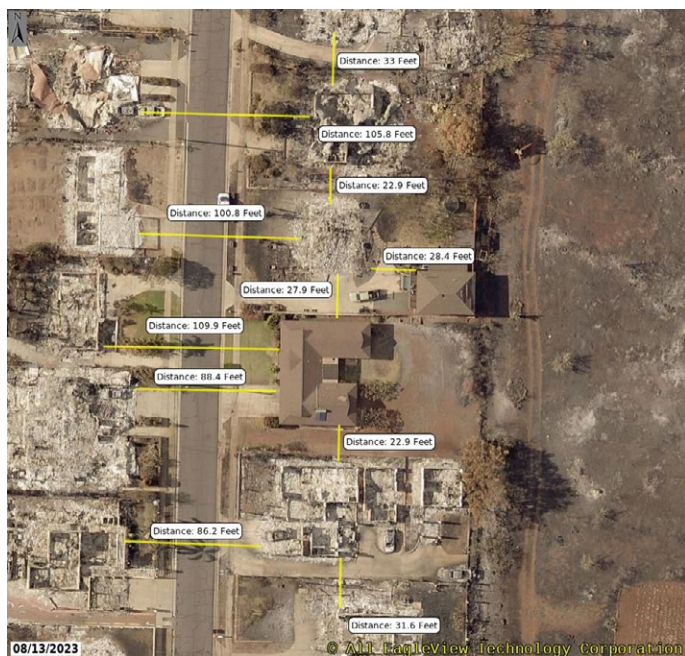
Two (2) structures on the east side (mauka) of Lokia Street were damaged by the fires, but survived

(Figure 4.3.5.3.4), including an accessory structure on 16█ Lokia Street located to the far east (mauka) of the property (Figure 4.3.5.3.5) and the structure at 16█ Lokia Street (Figure 4.3.5.3.6). Both had notable damage to the windows, some of which were boarded up from the inside.

Figure 4.3.5.3.4 Structure spacing along Lokia Street in the vicinity of the surviving structures on the east side (mauka) of the street, abutting the grassland fire.

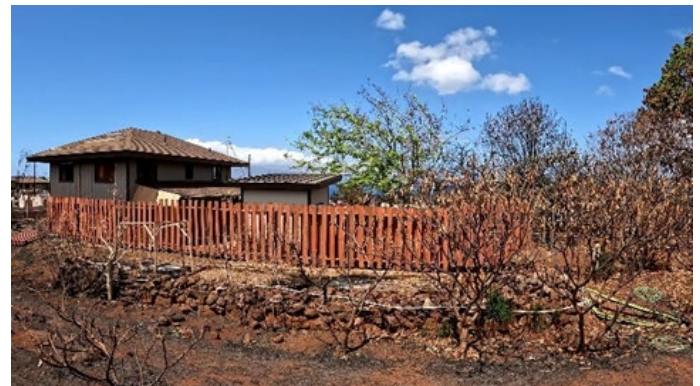
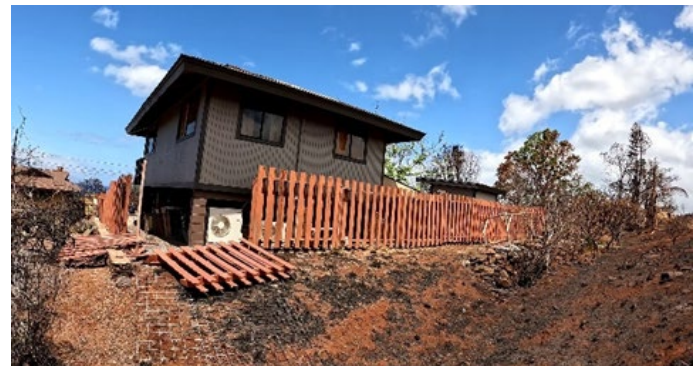
The structure at 16█ Lokia Street was elevated from the ground and was buffered by a garden to the east (mauka) of the property line fence. The southwest corner of the fence appeared to have caught fire at some point, but was broken out and burning was stopped.

Hoses were noted near the garden, which may have been used during the fire or may have been used to water and maintain the garden, providing a buffer of fuels with increased moisture and reduced burning potential.

Figure 4.3.5.3.5 The surviving accessory structure at 16███ Lokia Street was near the eastern (mauka) property line, but was buffered from the grassland by a garden (note intact hoses and stone landscaping separating from the grass) and a fence. The structure was elevated such that the damaged windows were a longer distance from the burning vegetation than a single-story structure. Charred sections of fence were broken away from the posts and burning was stopped. Broken windows were boarded up from the inside by the time images were collected.

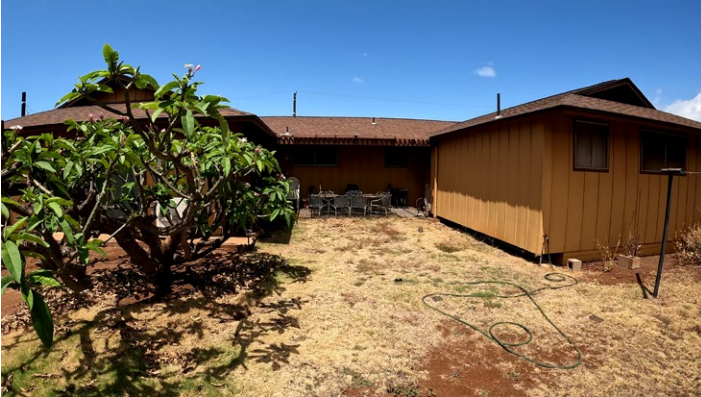
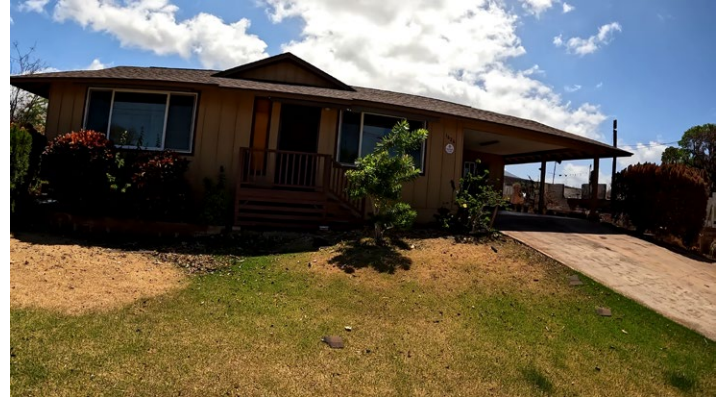
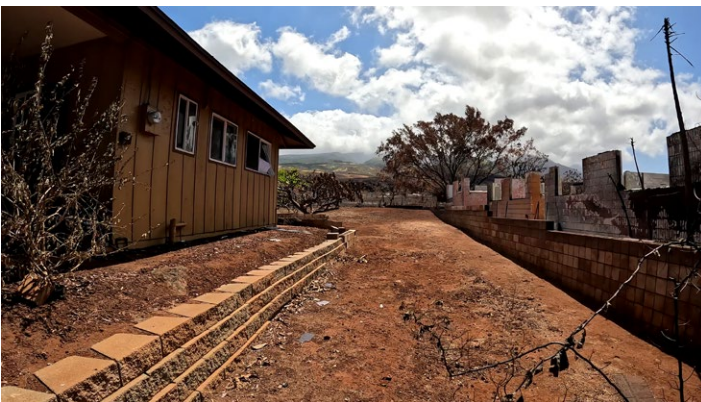
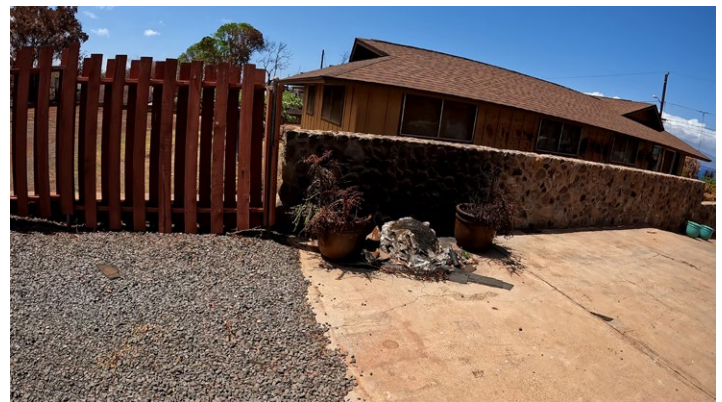
Figure 4.3.5.3.6 The 16 Lokia Street structure did not appear damaged by the grass fire to the east (mauka) sides (top left) or destroyed structure west (makai) of Lokia Street (top right). The structure was heavily damaged from radiant heating from the destroyed structure to the south (bottom left) and north (bottom, right).

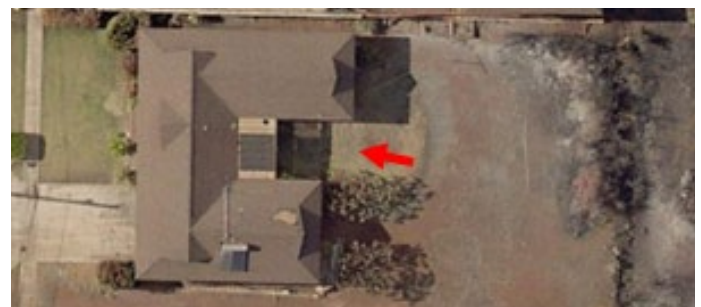
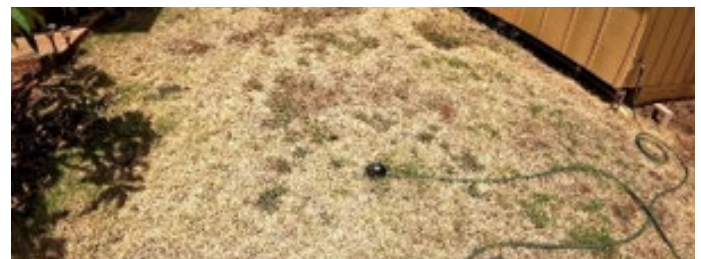
The vegetation fire in the grassland propagated into the east (mauka) yard of 16███ Lokia Street, but had limited impact on the structure itself. A sprinkler was noted in the east (mauka) yard in the vicinity of where the vegetation fire ended.

This sprinkler may have applied water during the fire either in preparing the property for the oncoming fire or prior to the fire to maintain the grass in this area (Figure 4.3.5.3.7). Regardless of when water was applied, fire-spread toward the structure was halted.

Figure 4.3.5.3.7 (top) Overhead view of 16 Lokia Street lot with approximate location of sprinkler that may have been used to prepare the property for the fire and/or defend the property during the fire.

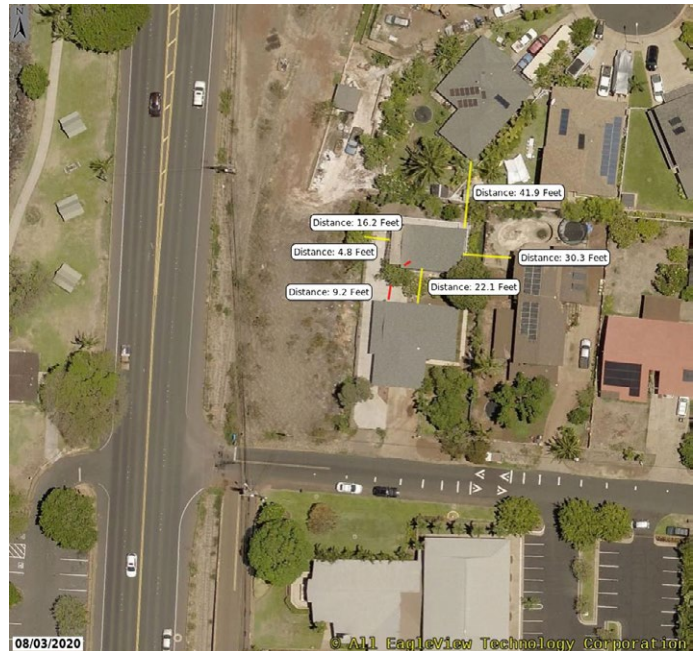
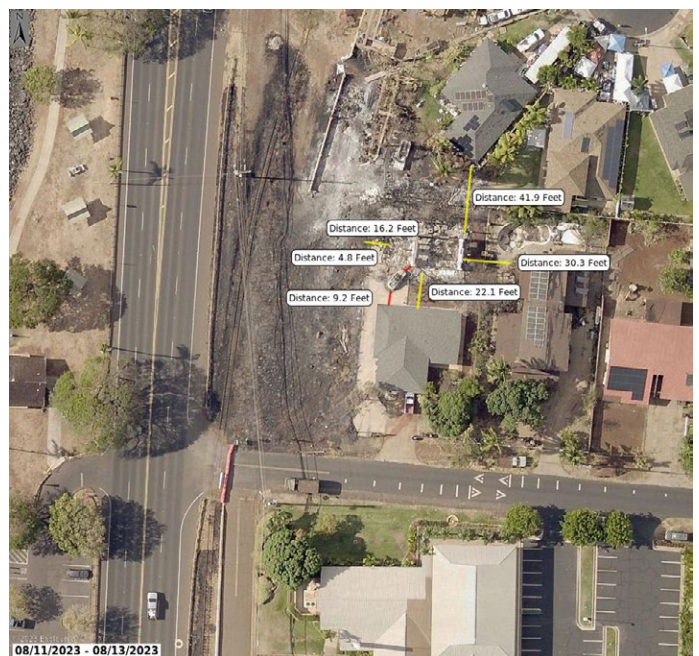
A vegetation fire also impacted structures on the west (makai) end of Kaniau Road. A single residential structure (accessory structure at 1█ Kaniau Road) was destroyed by this fire, despite being surrounded by at least two (2) surviving structures to the north, east (mauka), and south with no fire damage noted to the west (makai) of Hwy-30 (Figure 4.3.5.3.8).

Figure 4.3.5.3.8 Structure spacing near destroyed accessory structure at 1█ Kaniau Street.

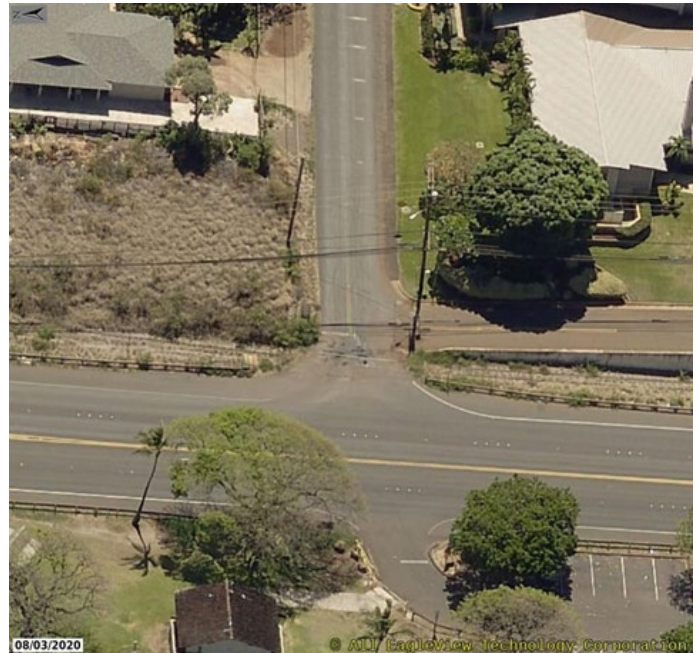
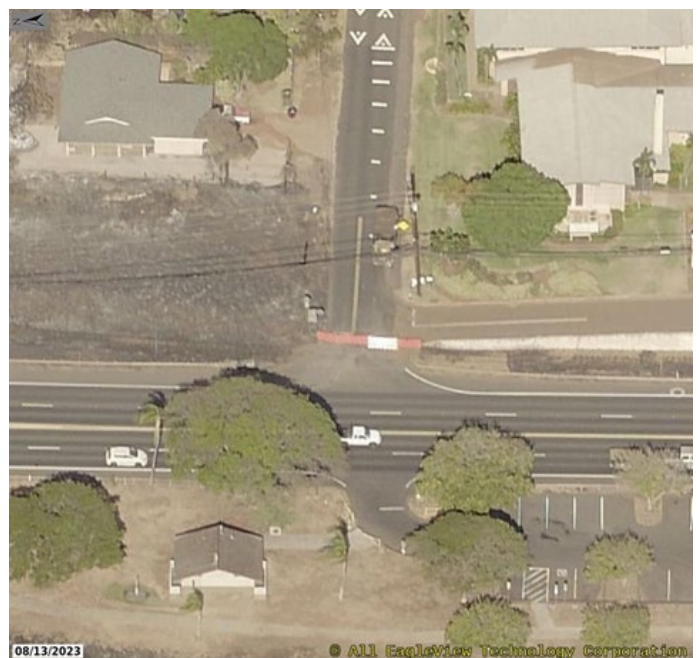
Tall grasses on the northeast corner of Kaniau Road and Hwy-30 would likely have provided a receptive fuel bed for embers that may have gathered there. If these grasses had dried out to the state shown in Figure 4.3.5.3.9, they would have more easily ignited the green, mowed lawns in the surrounding properties west (makai) of this location.

Fire traveling along the railroad tracks that parallel Hwy-30 between Kapunakea Street and Leiali'i Parkway could have carried embers or flames to this location and ignited dry grasses. Embers may also have reached these grasses if they were carried by wind down Kaniau Road.

Figure 4.3.5.3.9 Tall dry grasses are noted on the northeast corner of Kaniau Road and Hwy-30 in August 2020 (top), which could have provided a receptive fuel bed for fires along the railroad tracks or embers moving down (makai) Kaniau Road to ignite these grasses in August 2023 and travel to structures in the immediate vicinity (bottom). Note: North is to the left of these images.

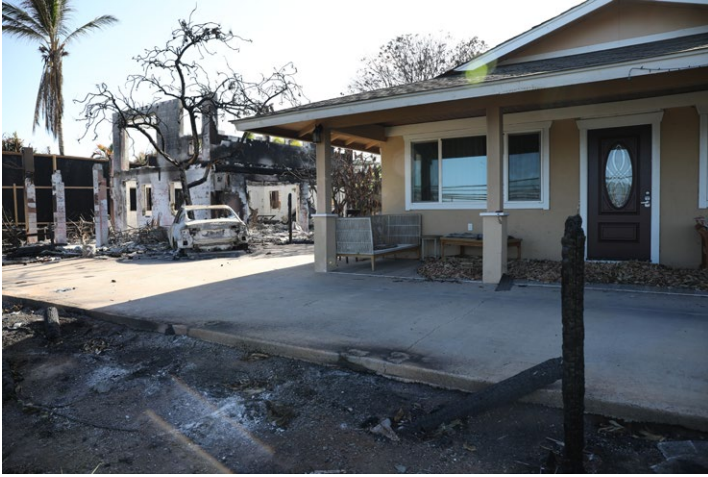
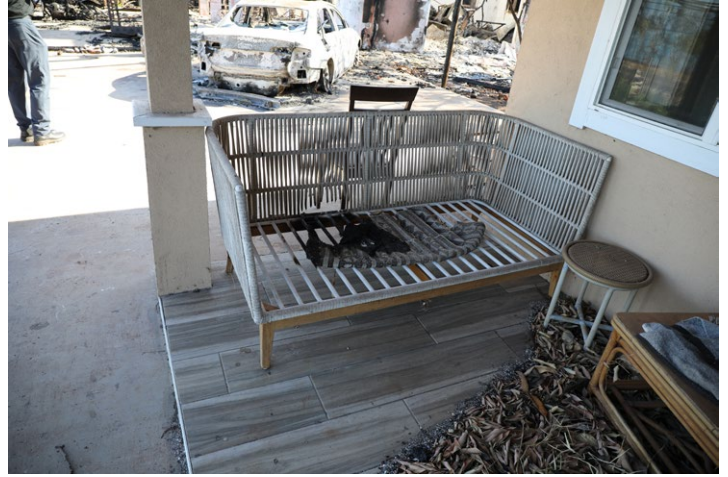
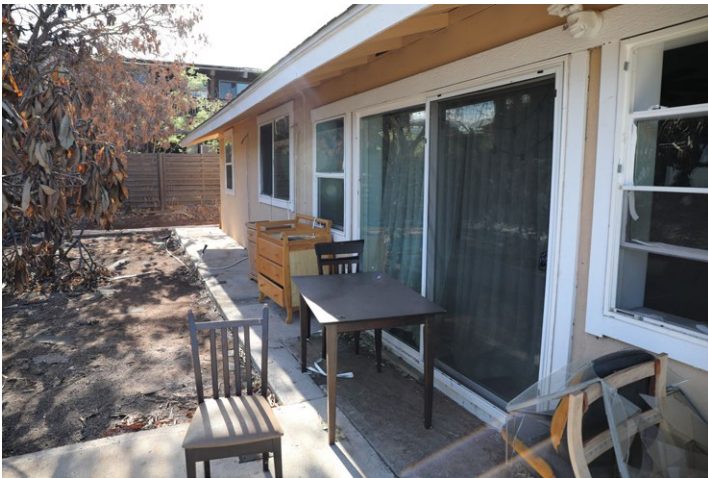
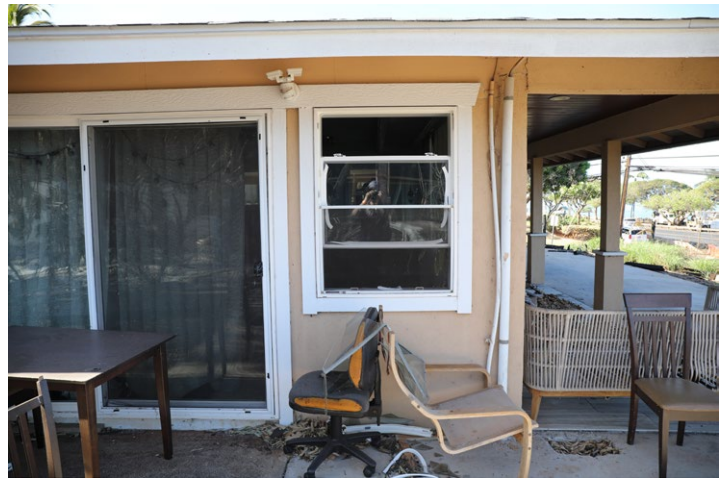
While the accessory structure on the 1■ Kaniau Road was destroyed by the fire, windows in the north side of the primary structure that was 20 to 25 feet to the south were damaged and spot fires were noted in outdoor furnishings to the west (makai) of this structure (Figure 4.3.5.3.10).

A vehicle between these two (2) structures was destroyed by the fire and may have played an important role in heat transfer to/from the vegetation and/or structure fire. The most extensive window damage was noted on the northwest corner, which was closest to the destroyed vehicle. However, damage to plastic molding on the windows was also noted on the west side (makai), proximate to the vegetation fire.

Figure 4.3.5.3.10 The primary structure at 1 Kaniau Road, in close proximity to the destroyed secondary structure and vehicle, had damaged windows, particularly close to the vehicle fire and ember damage to outdoor furnishings that did not extend to the structure.
