Lahaina Fire Incident Analysis Report

Steve Kerber
Derek Alkonis

September 13, 2024
Columbia, MD

This document is the second in a series of three (3) reports commissioned by the Hawai'i Department of the Attorney General (DOAG) to provide an independent review of the tragic fire that destroyed much of Lahaina, Hawai'i, on August 8-9, 2023.

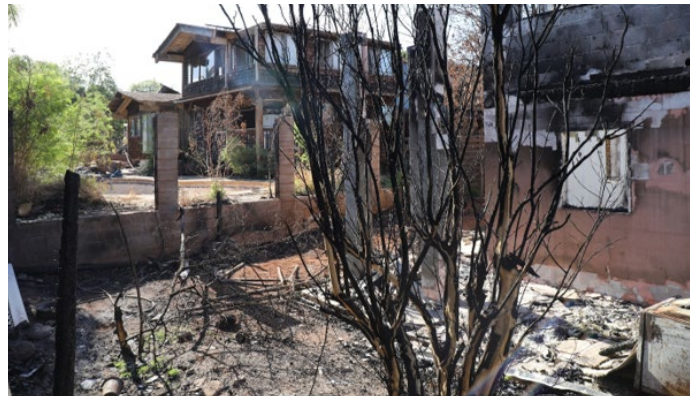
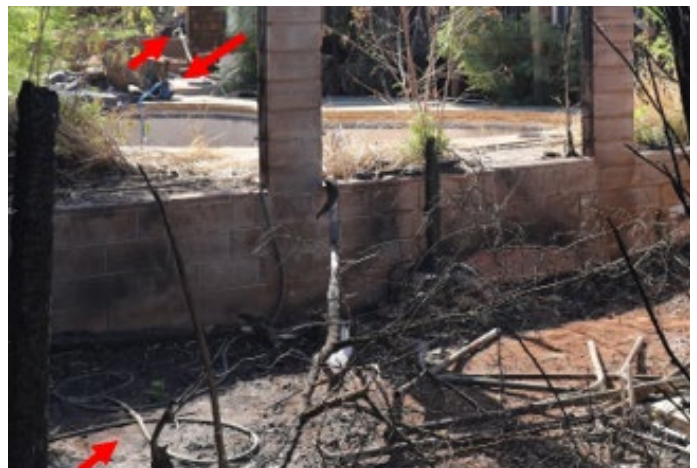
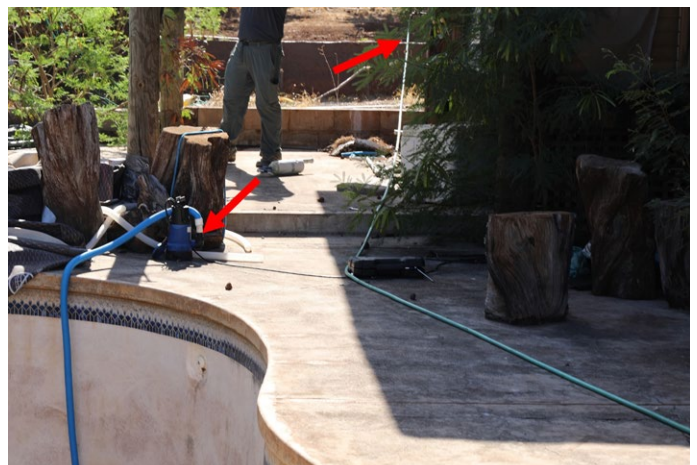
A garden hose was stretched from a hose bib on a structure in 1 Kaniau Road and remained deployed near 1 Kaniau Street. Conversations with local residents revealed neighbors used a pump to control the fire that was progressing along a plastic fence on the north property line. A pump was located next to a swimming pool in the south yard of 1 Kaniau Road (Figure 4.3.5.3.11).

Figure 4.3.5.3.11 Water resources from 1█ Kaniau Road were utilized to help control the fire from propagating farther east (mauka) from 1█ Kaniau Road. Garden hose was deployed from a hose bib with the terminal end remaining at the next lot. Neighbors reportedly used the pump to control a fire along the plastic fence at the north property line of this lot.

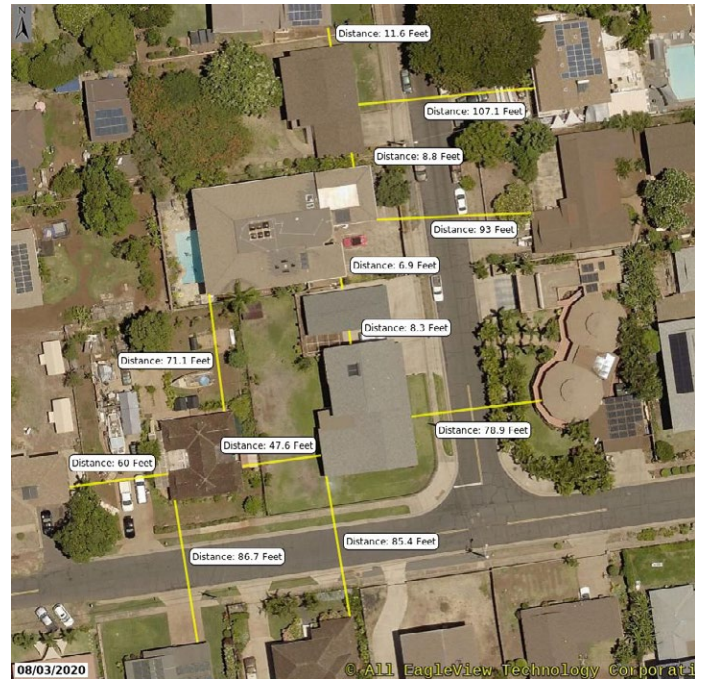
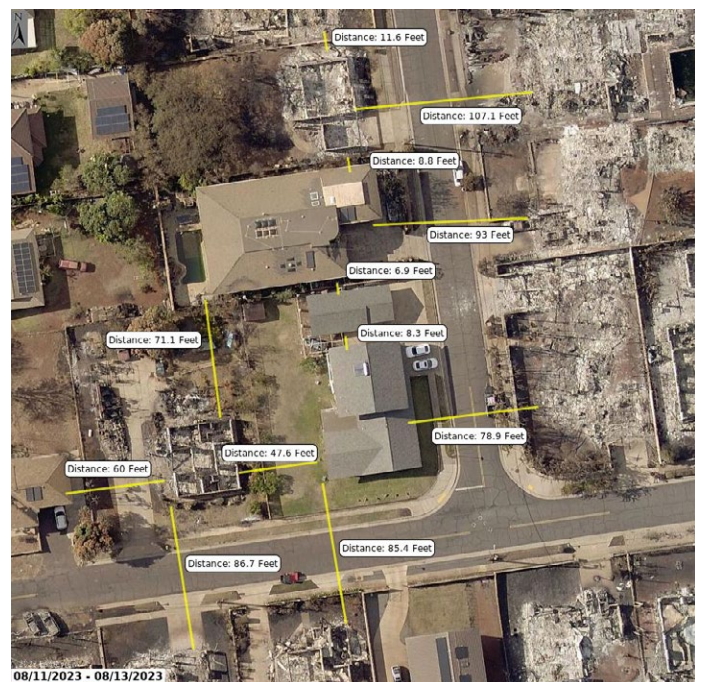
Figure 4.3.5.3.12 Structure spacing near surviving structures on the west side (makai) of the south end of Lokia Street.

The radiant heat impacting this structure may also have been reduced if the prevailing west (makai)/northwest winds had pushed flames and smoke plumes away from this structure.

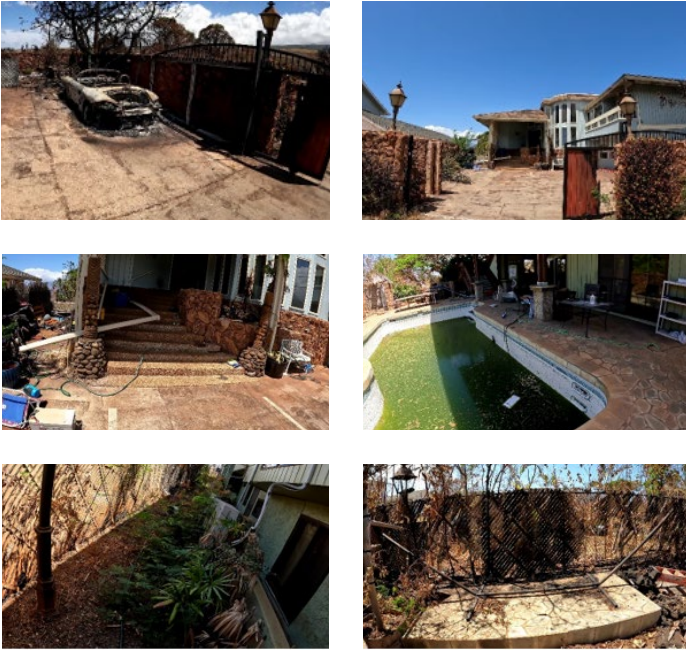
Figure 4.3.5.3.13 The 15███ Lokia Street lot experienced fire damage to the front entrance gate and destroyed a vehicle, but did not extend to the structure (top). The structure appears to have been defended, in part, by pumping water from the pool in the rear of the structure, powered by a battery system (middle). Damage to fences on the north and south sides of the properties (bottom), showing the end of the hose from the pump in the pool and along with a bucket (bottom left).

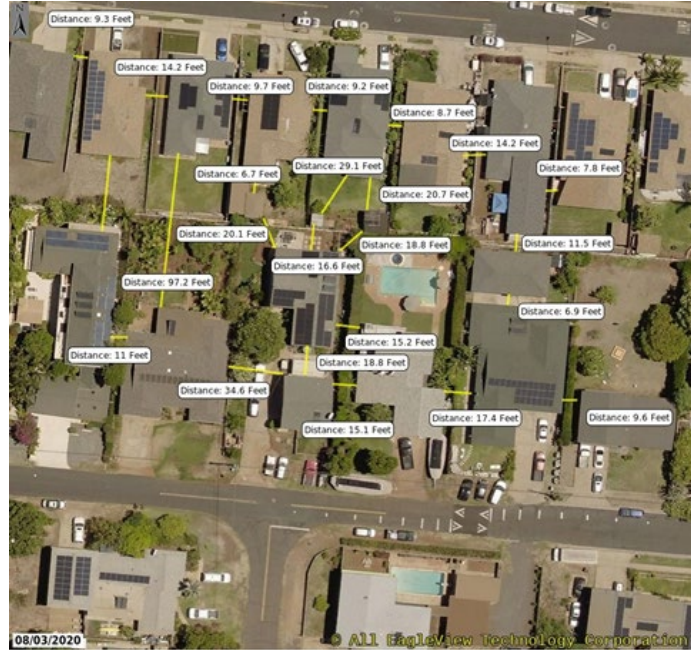
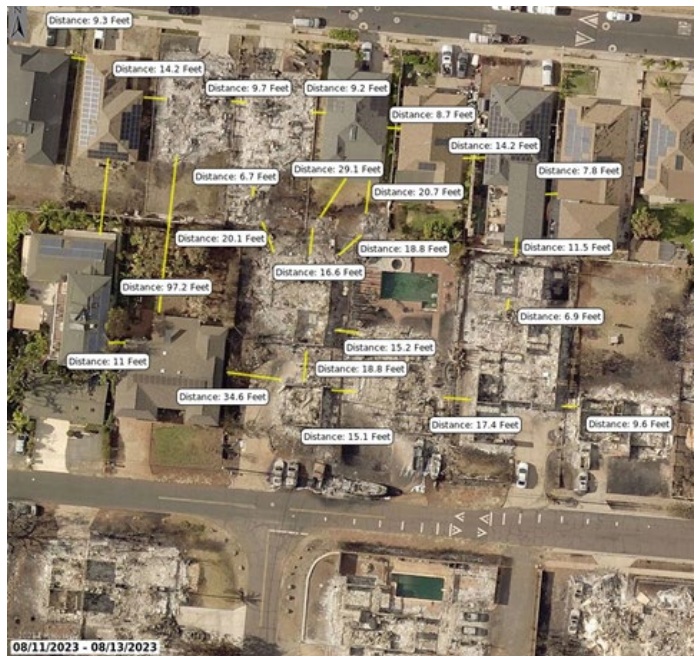
Figure 4.3.5.3.14 Structure spacing near surviving structures on the north side of Kaniau Street and south side of Aipuni Street.

The west side (makai) of the structure was more heavily damaged, particularly deformed window frames and broken window glass along with the deformation of window blinds on the interior of the structure (Figure 4.3.5.3.15). Considering the roofline of the destroyed structure at 9█ 'Aipuni was approximately 10 feet from the roofline of 1█ 'Aipuni, the amount of damage noted to the west side (makai) of this structure could have been more severe if it were not for defensive actions undertaken by firefighters and citizens.

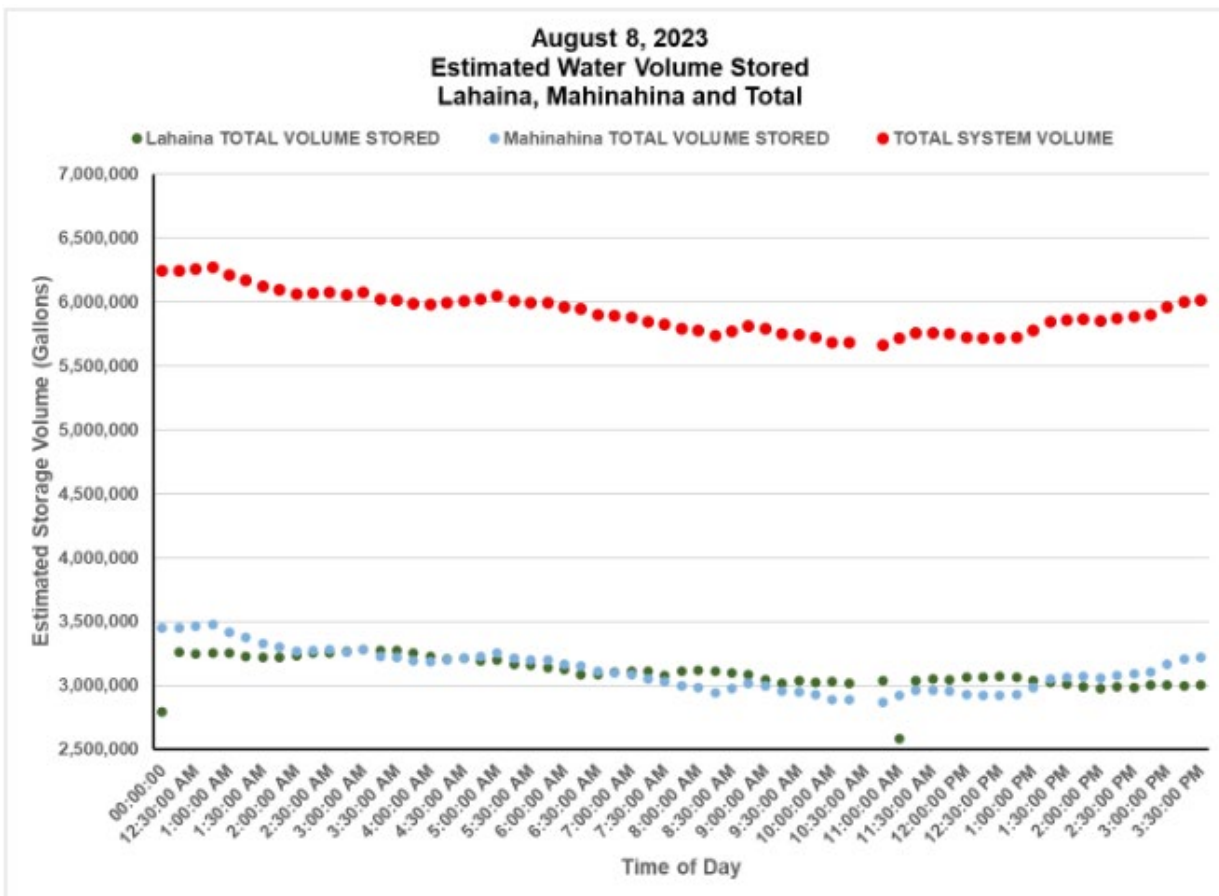
Figure 6.8.3 Estimated water volume stored in Lahaina and Māhinahina on August 8, 2023.

As per Figure 6.8.3, total system volume on August 8, 2023, ranged from just less than 7 MG to less than 6 MG until 15:30 when data was no longer available. Therefore, the amount of water stored in the two (2) systems met the state requirements for the required average daily demand until data was no longer available as described above.

A data recording system for the County of Maui Department of Water Supply routinely records the water level in each of the water storage tanks in both the Lahaina and Māhinahina storage and distribution systems. The graph below shows the time variation of water volume stored versus time for the Lahaina, Māhinahina and the two (2) systems combined. The recording of water level data by the county ceases at 3:30 p.m. on August 8, 2023, for all storage tanks in both the Lahaina and Māhinahina systems. The reason given by the county for the simultaneous loss of all tank level data was a power outage.

Note: The volumes calculated in the graph above are preliminary estimates based upon the tank capacity and the tank level recorded by the system. The recording system stopped recording data at 15:30 on August 8, 2023.
