## Flight Safety Investigation Report

**CANADIAN ARMED FORCES  
FLIGHT SAFETY INVESTIGATION REPORT (FSIR)**

**FILE NUMBER:** 1010-CH147F-197571 (DFS 2-5-3)  
**FSIMS IDENTIFICATION NUMBER:** 197571  
**DATE OF REPORT:** 7 October 2024  
**OCCURRENCE CATEGORY:** "A"  
**AIRCRAFT TYPE:** CH147F Chinook  
**AIRCRAFT REGISTRATION NUMBER:** CH147310  
**DATE OF OCCURRENCE:** 20 June 2023  
**TIME OF OCCURRENCE (L):** 0008 (L)  
**LOCATION:** CFB Petawawa, ON  
**OPERATOR:** 450 THS, CFB Petawawa

## SYNOPSIS

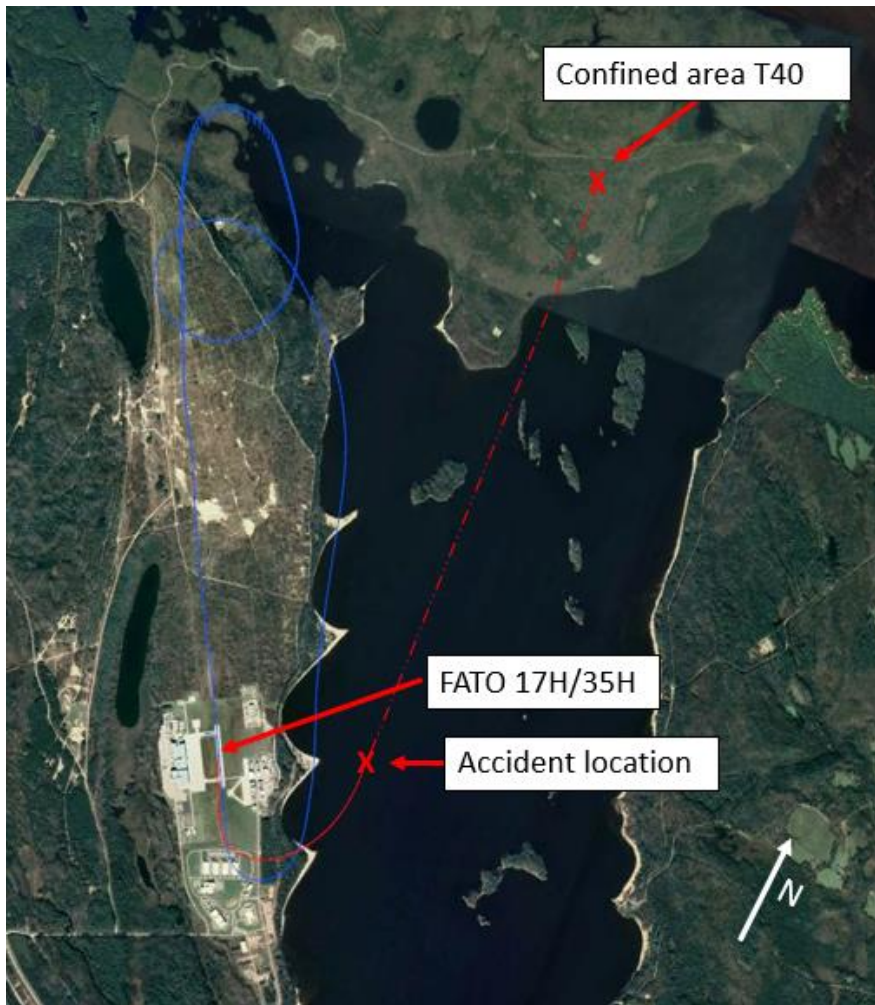
Figure 1 - Map showing the first leg (Blue) and the second leg (Red) for accident flight

1.1.2 When the SP took position in the right seat after the hot turn, the IP started to quiz the SP and then proceeded with the “*Before Taxi Check*”<sup>3</sup>. During this check the setting of the Radar Altimeter (RADALT) low altitude warning index, or RADALT bug, was omitted. While taxiing to the Final Approach and Take Off Area (FATO<sup>4</sup>) 17 for departure, the crew set up their Night Vision Goggles (NVG), commonly referred to as the “Goggle Up” procedure. The crew briefed a departure for a tactical navigation leg direct to the T40 confined area in training area “E”, at a planned groundspeed of 90 knots. They departed FATO 17 to the south with a left-hand turn northbound towards T40. Shortly after departure the IP simulated a #1 Engine Chip<sup>5</sup> emergency, which led to a landing back to FATO 17. In preparation for the landing, the RADALT bug was set to 125 ft Above Ground Level (AGL). During the approach the low altitude audio caution from the RADALT sounded. It was verbally acknowledged and cancelled by the SP. The landing was completed successfully. This first leg of the mission is shown in blue in [Figure 1](#).

1.1.3 The crew briefed another departure “as previously briefed” direct to T40, the second leg of the flight is depicted by the red line in [Figure 1](#). After completing a vertical departure southbound, the IP simulated an NVG failure<sup>6</sup> for the SP, at which time controls were passed to the IP. The IP announced and initiated a left-hand turn

northbound. Upon regaining NVG, controls were transferred back to the SP while still in the left-hand turn; at approximately a third of the planned 150 degrees turn. The IP then advised the SP of a Trim Roll Right advisory which the SP attempted to rectify once without success (1.6.15). The crew then conducted the *Before Landing Check*<sup>7</sup>, and the IP briefed navigation instructions to T40. Speed and altitude were briefed to be at the SP's discretion, and as the navigation details were being discussed between the pilots, the low altitude audio caution from the RADALT sounded and was promptly cancelled by one of the pilots with no acknowledgement or corrective actions. The aircraft decelerated slightly, and the Cabin Door FE called "*Height, 20 ft above water*". The aircraft impacted the Ottawa River at 00:08 L on 20 Jun 23, approximately 1.5 km from their departure point.

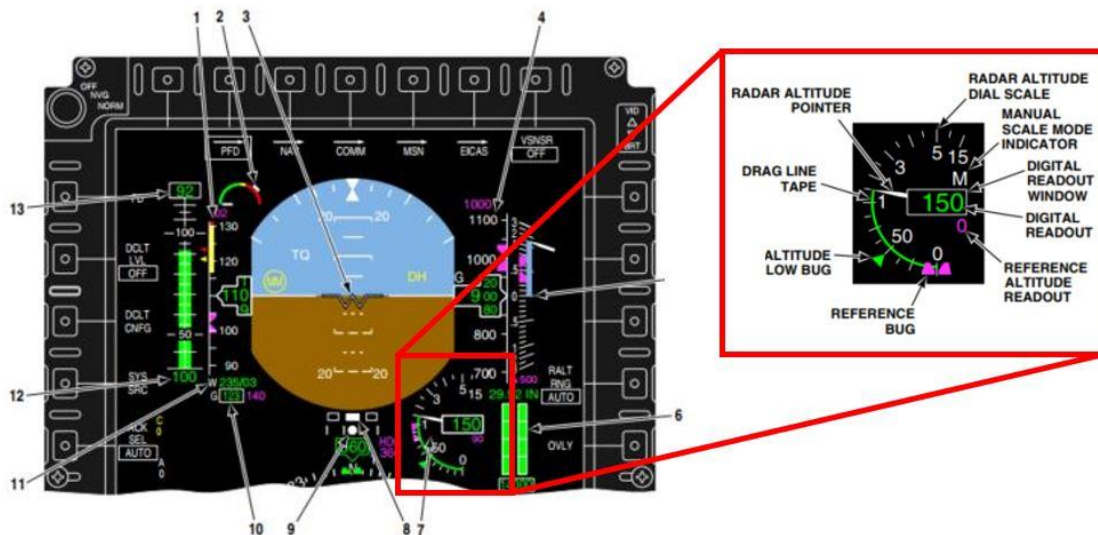
Figure 6 - CH147F RADALT Display on the PFD<sup>18</sup>

1.6.14 The RADALT bug is verified as part of the aircraft “Systems Check”, which is detailed in the Aircraft Procedural and Emergency Checklist<sup>17</sup>; this portion of the checklist does not have to be verbalized. The following checks include an aircraft “Systems Check”; hence the crew is required to verify the RADALT and set the bug at the desired altitude:

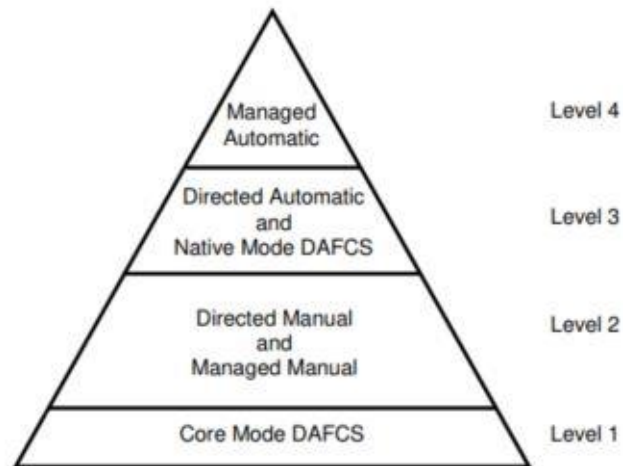
Figure 8 - CH147F Levels of Automation

1.6.18 The aircraft is equipped with four levels of automation. [Figure 8](#)<sup>22</sup> shows these four levels as well as their hierarchy. The first level is the Core Mode Digital Automatic Flight Control System (DAFCS). This level of automation is the most basic and least automated mode. It allows for the aircraft to be hand-flown while still benefiting from the stability provided through the DAFCS. At the time of the accident the aircraft was flown using the Core Mode DAFCS.

The investigation made numerous recommendations to amend the CH147F publications, including a recommendation to mandate the use of automation Level-3 (Native mode Digital Automatic Flight Control System) when operating below 200 ft above water at night. Additional recommendations were made to improve emergency response preparedness.

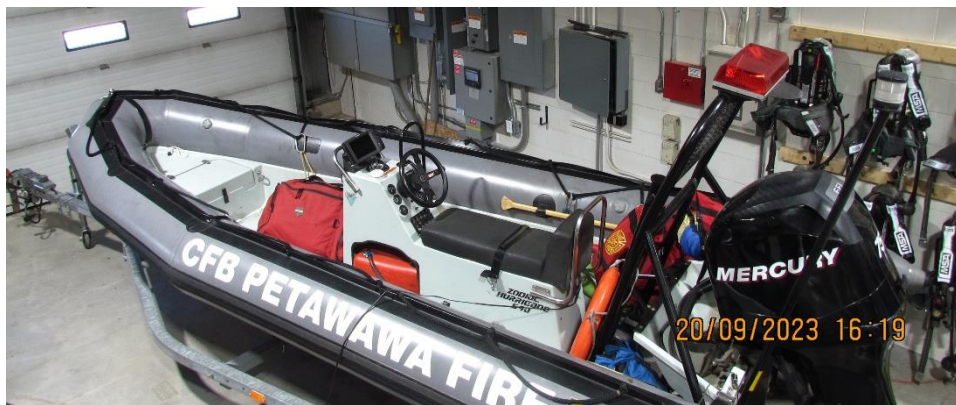
Photo 3 - Zodiac watercraft used by the first responders

1.15.8 The SAR operation was divided into two distinct efforts: one from the beach at Wegner Point nearest to the accident site and the other from a Zodiac watercraft ([Photo 3](#) and [Table 4](#)). The Zodiac boat had to be launched from the Jubilee Marina ([Figure 11](#)), which is located approximately five kilometres away from its storage location close to the Garrison Fire Hall.

1.15.11 Knowing that time was of the essence, and still waiting for the Zodiac to arrive, the first responders at Wegner Point entered the water on foot to make their way closer to the survivors. They were forced to turn around as the water was getting too deep too quickly and they were still too far from the survivors. One first responder remembered noticing four canoes that were lying on the ground as they were driving to Wegner Point. The canoes were located approximately 100 m away from the shore. A few first responders went back and brought two canoes to the shore and immediately boarded them to make their way to the survivors. The first survivor to be rescued by a canoe was the Cabin Door FE. The Ramp FE was rescued shortly after by the Zodiac crew who had, by then, made it to the accident site.

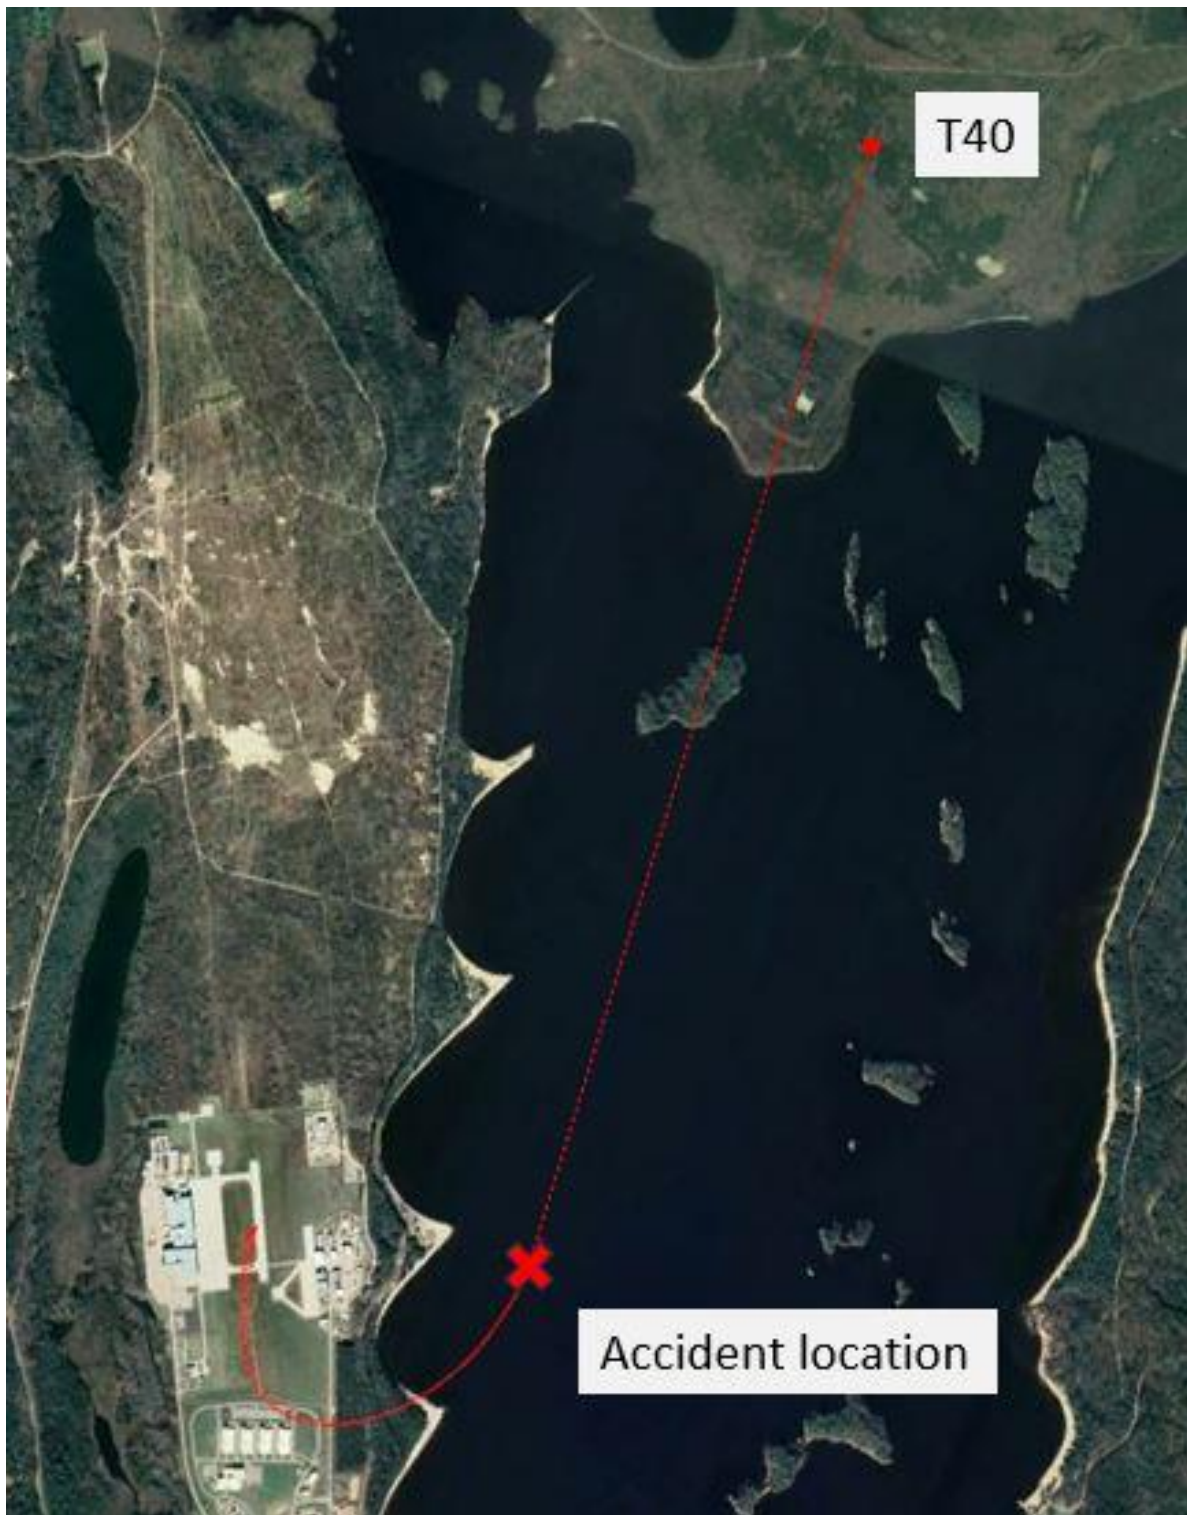
Figure G-2: Flight Path for the occurrence leg, indicating the accident location

The investigation determined that when the crew initiated the turn towards area T40, the aircraft entered a constant descent. None of the crew members realized the height and/or rate of descent of the aircraft before impact, resulting in a Controlled Flight into Terrain (CFIT) accident. It was concluded that the unperceived acceleration and the environmental conditions that night were key factors that played a role in this accident, contributing to the spatial disorientation experienced by the crew.
