# Lahaina Fire Incident Analysis Report

**September 13, 2024**  
**Columbia, MD**

This document is the second in a series of three (3) reports commissioned by the Hawai'i Department of the Attorney General (DOAG) to provide an independent review of the tragic fire that destroyed much of Lahaina, Hawai'i, on August 8-9, 2023.

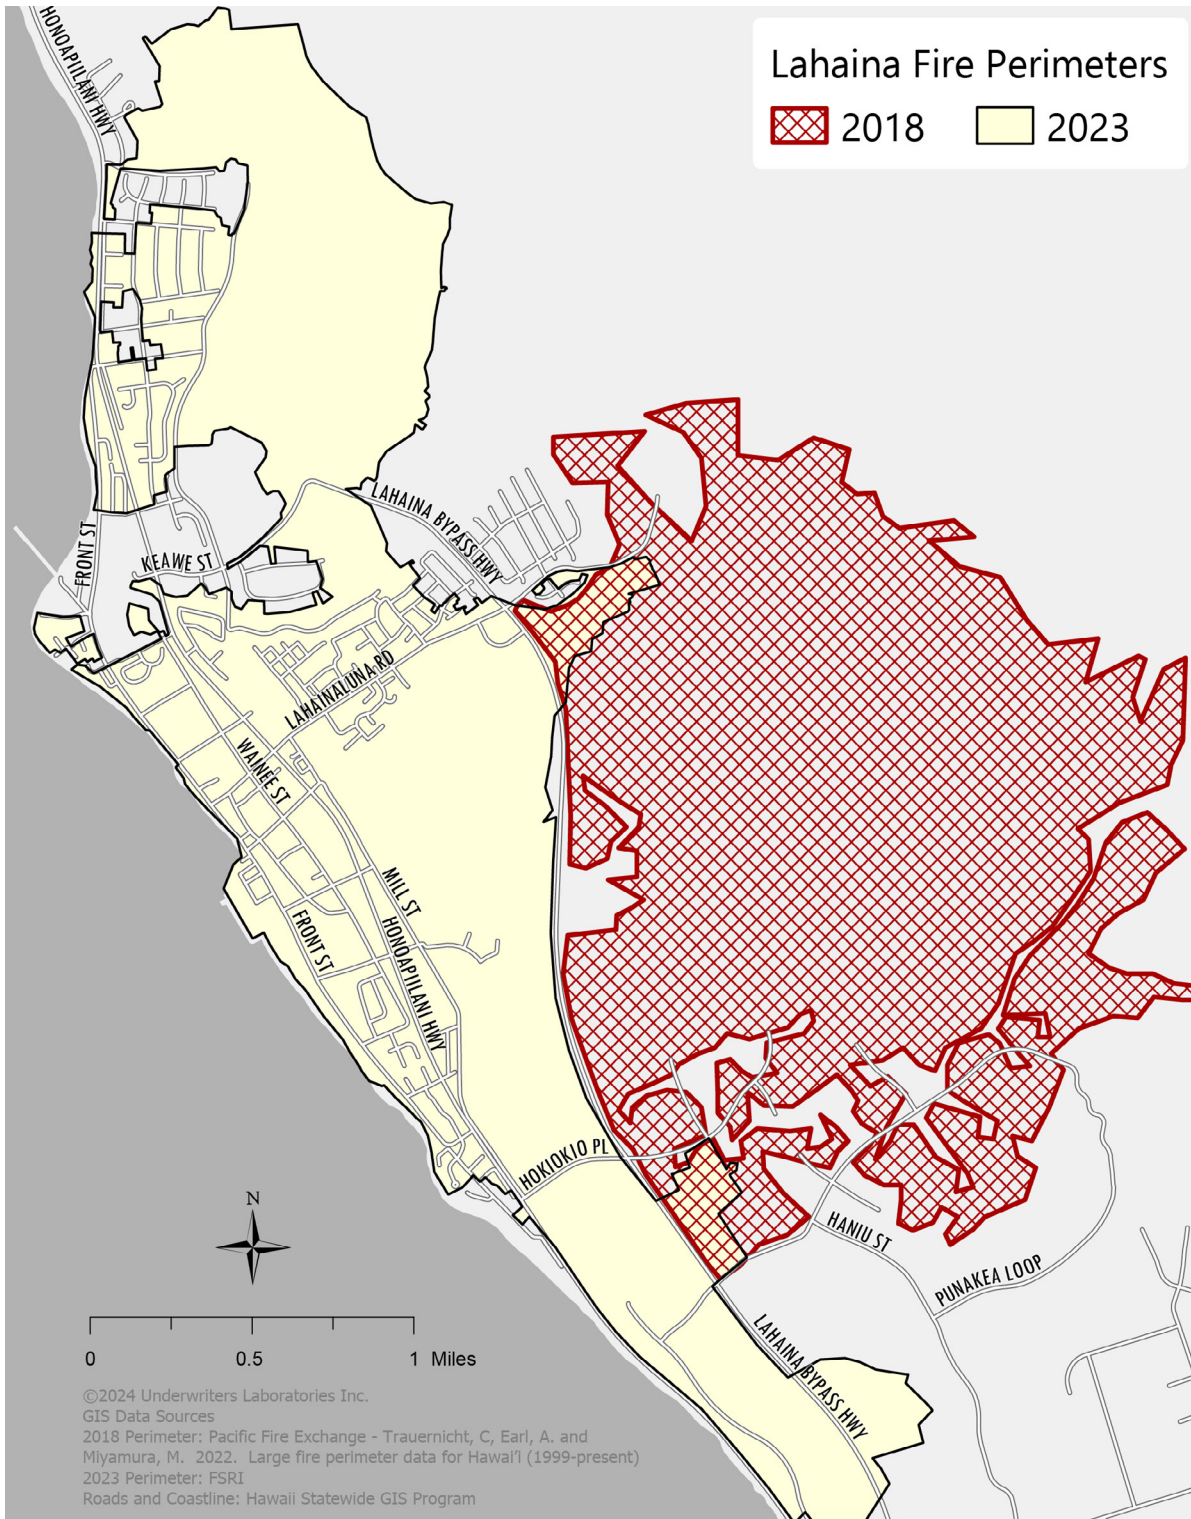
The Lahaina Fires of 2018 and 2023 shared similarities, but also had important differences. Both occurred in August and were fanned by high winds generated by a pressure gradient caused by an approaching tropical cyclone. They also shared a burn perimeter off the Highway 3000 Bypass (Lahaina Bypass) north of Punakea Loop and approximately 65 acres of shared burned area (Figure 2.2.4.1).

Figure 2.2.4.1 Overlay of 2018 and 2023 fire perimeters.

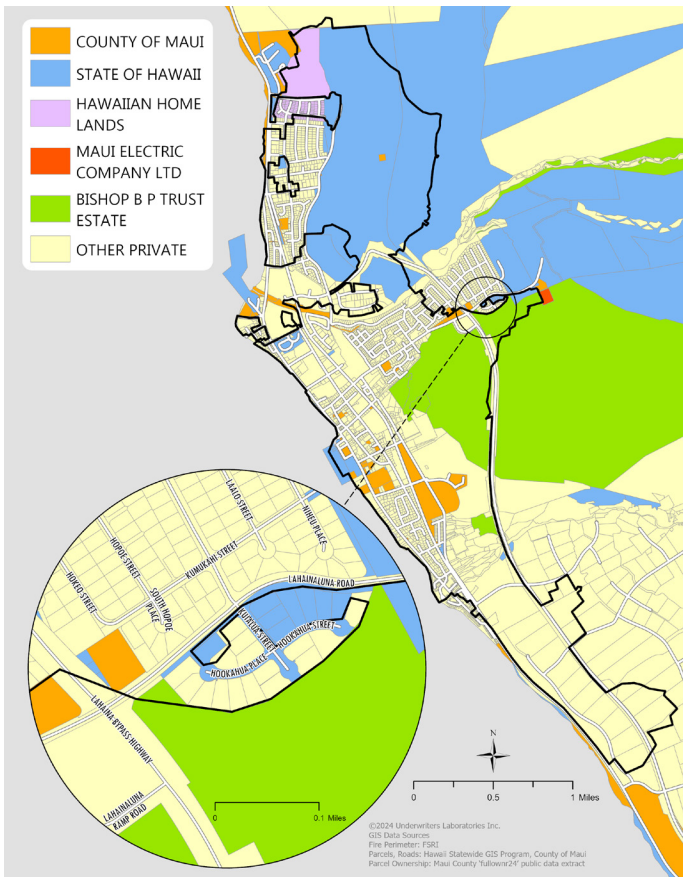
For example, two (2) of the four (4) August 2023 fires impacted state lands. In Lahaina, one (1) parcel of the impacted wildland area is under management of DLNR-Land Division, with no record of vegetation management. Several smaller parcels within the impacted developed area are owned and managed by the State Department of Education (within the blue State of Hawai'i area), also with no clear accountability for wildfire risk reduction or vegetative fuels management (Figure 3.3.2.2).

Figure 3.3.2.2 Map of Lahaina showing burn perimeter and land ownership. Detail shows Lahaina fire origin just northeast of Ho'okahua Street where the County of Maui, State of Hawai'i, and private lands converge. Source: Hawai'i Statewide GIS Program, Office of Planning and Sustainable Development, State of Hawai'i.<sup>85</sup>

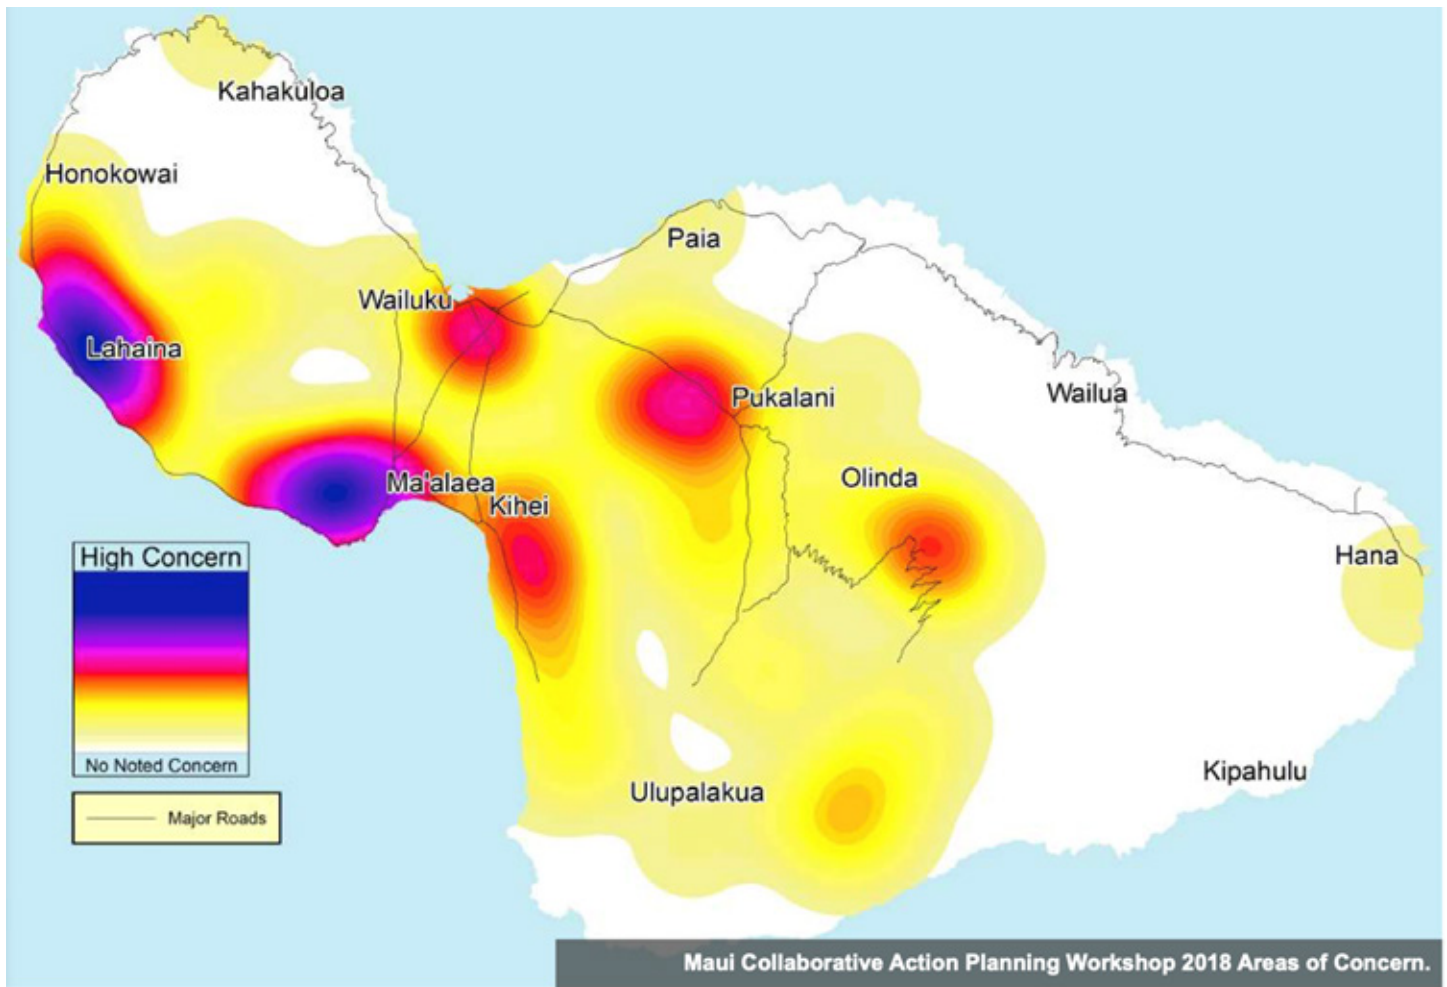
Despite Lahaina being identified as one of the highest priority areas for vegetative fuels management (Figure 3.3.8.1), it appears that relatively little work was actually done, due to the continued combination of funding challenges and lack of incentives, penalties, or financial support for private landowners to participate.<sup>107</sup>

Figure 3.3.8.1 Fire Risk Heat Map: In 2018, 41 individuals from Maui representing government organizations, businesses, private landowners, and residents participated in a workshop to identify and prioritize county areas by their values at risk, hazardous vegetation, and where to start the hazard mitigation effort. The areas of highest concern represent where the participants selected as high priority for each of the three (3) categories.<sup>108</sup>

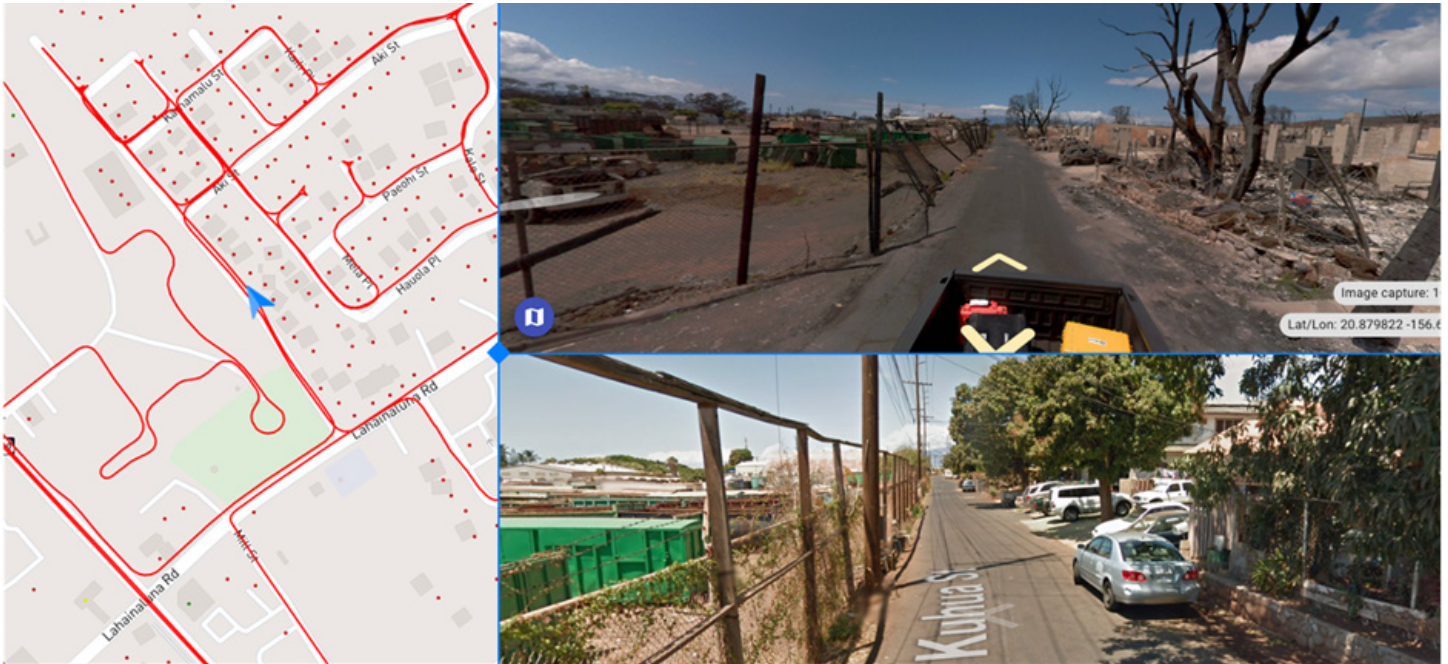
Figure 3.4.2.2.1 Kuhua Street Northbound: Map showing Kuhua Street looking north toward Aki Street. Pre-fire image taken September 2011 (bottom, right) and post-fire image taken October 6, 2023 (top, right).<sup>126</sup>

According to police maps, 29 of the fire victims were located on Kuhua Street (Figure 3.4.2.2.1 and Figure 3.4.2.2.2). Other narrow roadways and alleys throughout Lahaina posed similar challenges during the evacuation process.

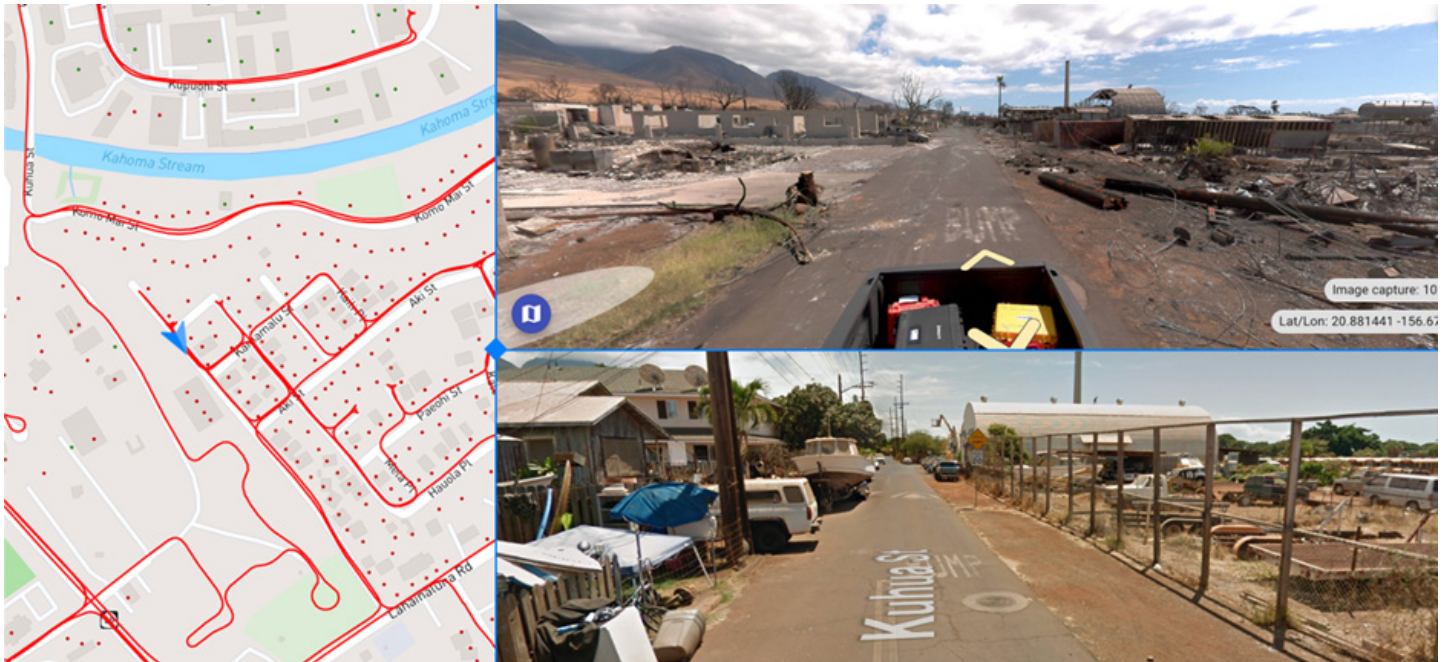
Figure 3.4.2.2.2 Kuhua Street Southbound: Map showing Kuhua Street looking south toward Kamamalu Street. Pre-fire image taken September 2011 (bottom, right) and post-fire image taken October 6, 2023 (top, right).<sup>127</sup>

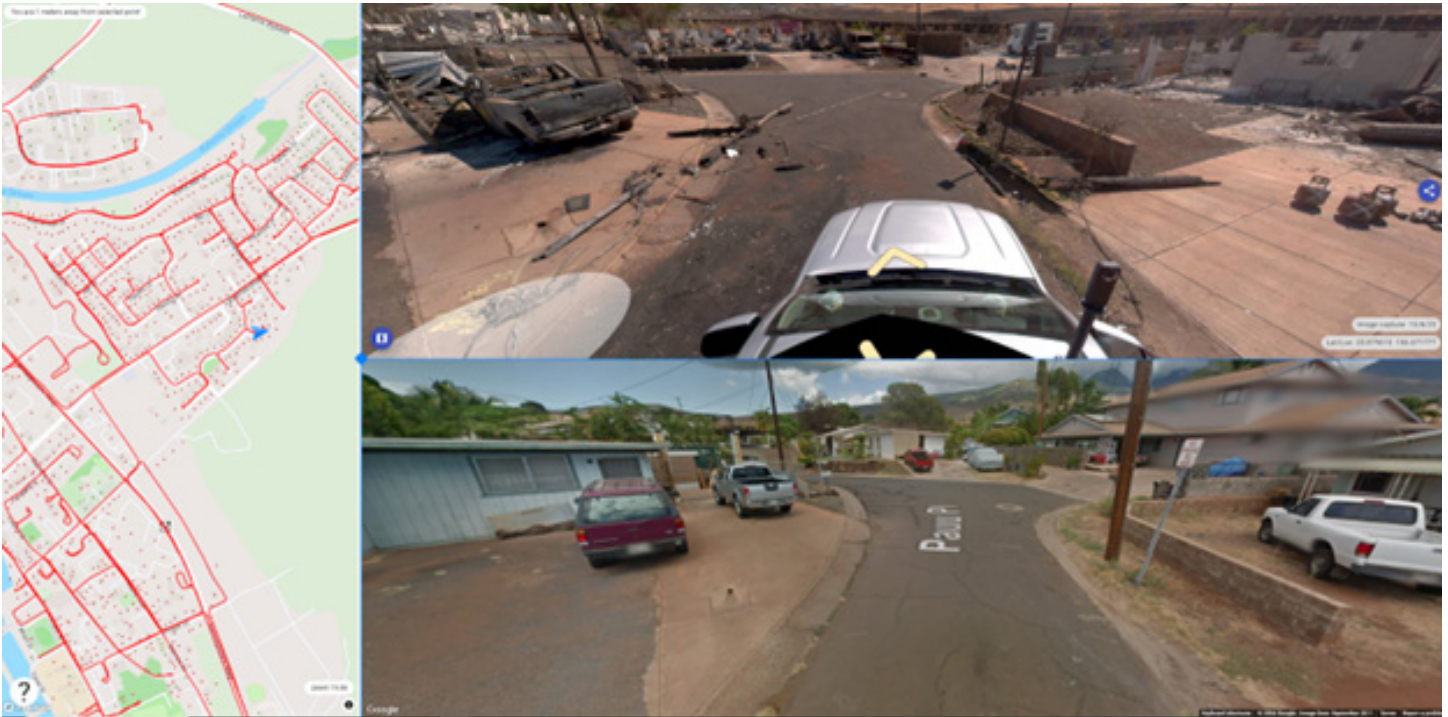
Figure 3.4.2.3.2 Pā'ū'ū Place. Image showing multiple no parking signs at the dead end of Pā'ū'ū Place in the Lahainaluna neighborhood. Pre-fire image taken September 2011 and post-fire image taken October 6, 2023.<sup>134</sup>

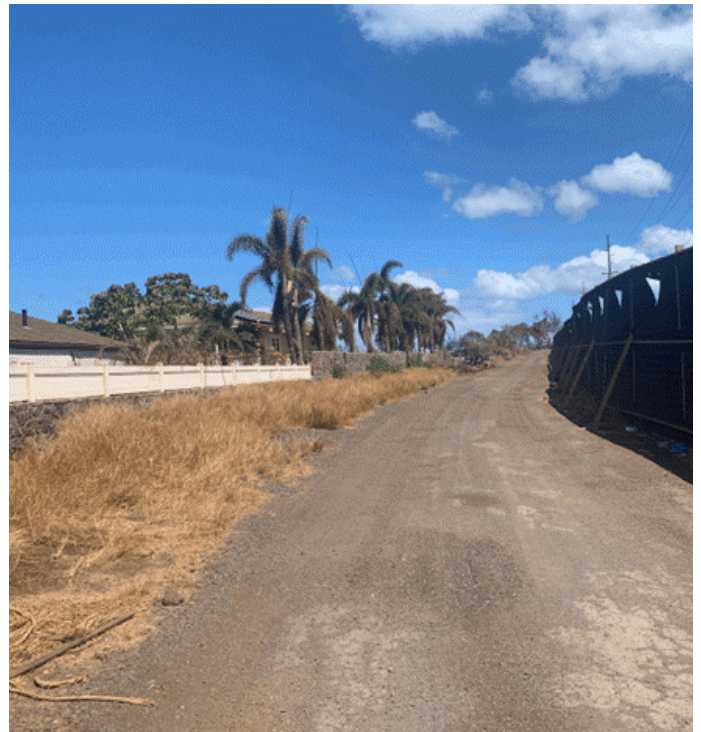
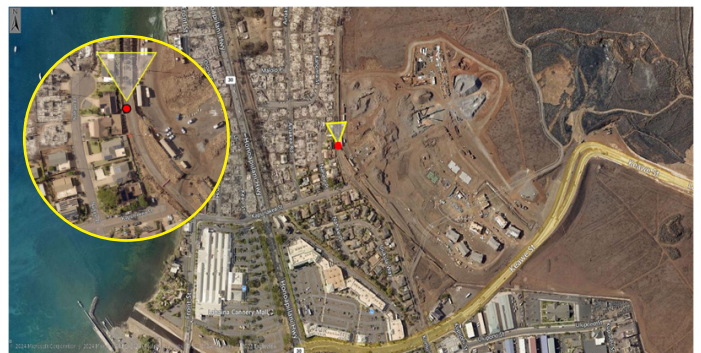
*Figure 3.4.2.4.1 Photo of Old Cane Haul Road, often referred to by police officers and firefighters as Oil Road, just north of Kapunakea Street. This road is accessed through a gate located on the north side of Keawe Street at Kuhua Street. Oil Road was used extensively during evacuations due to utility poles blocking Hwy-30 just north of Keawe Street. Inset: Old Cane Haul Viewpoint. Image showing the area depicted in the photograph above.*

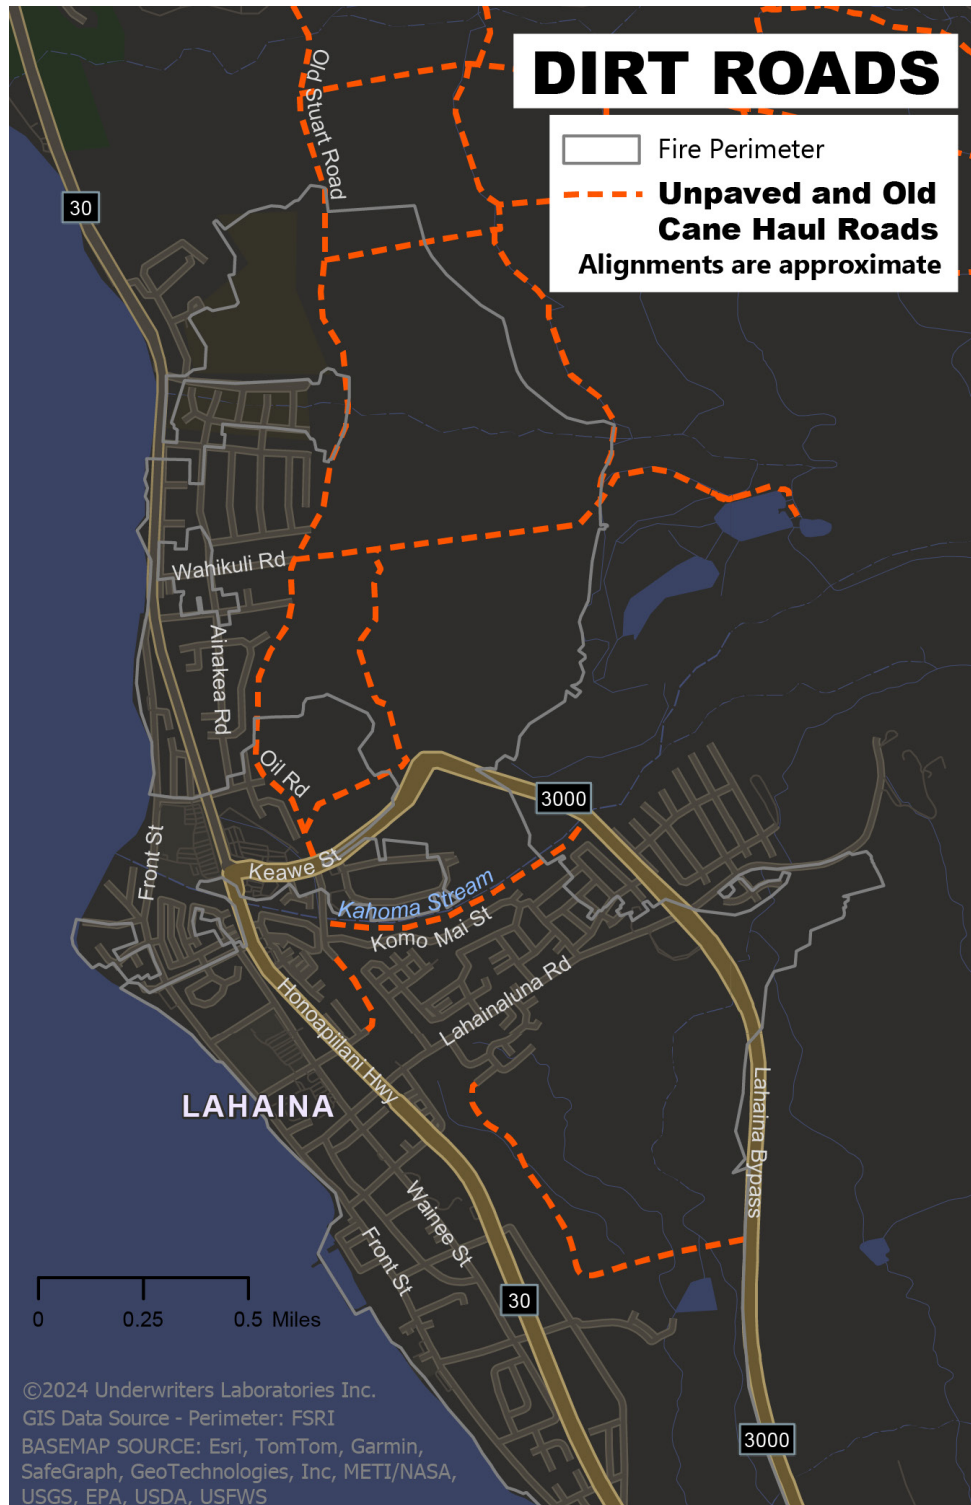
Figure 3.4.2.4.2 Unpaved Roads. Cane Haul Roads. Map of Lahaina's dirt road network, including fire perimeter. Road names are included with source. These roads were used by residents to evacuate as fire and smoke was bearing down.

The unplanned use of these roads during the emergency highlighted several issues. The lack of maintenance of these roads over the years has led to deterioration, making them difficult to navigate quickly and safely. Overgrown vegetation, erosion, and debris further complicate their use. The emergency nature of opening gates to connect paved roads to these dirt roads pointed to an important gap in pre-planned alternate routes for emergency evacuations and access.

**RECOMMENDATION:** Identify, name, map, and provide signage on dirt roads that serve as alternate egress/evacuation routes so residents and emergency responders refer to them by the same name.

**RECOMMENDATION:** Inspect and maintain dirt roads annually. Modernize, standardize, and maintain barriers on dirt roads to help ensure they can be used during emergencies.

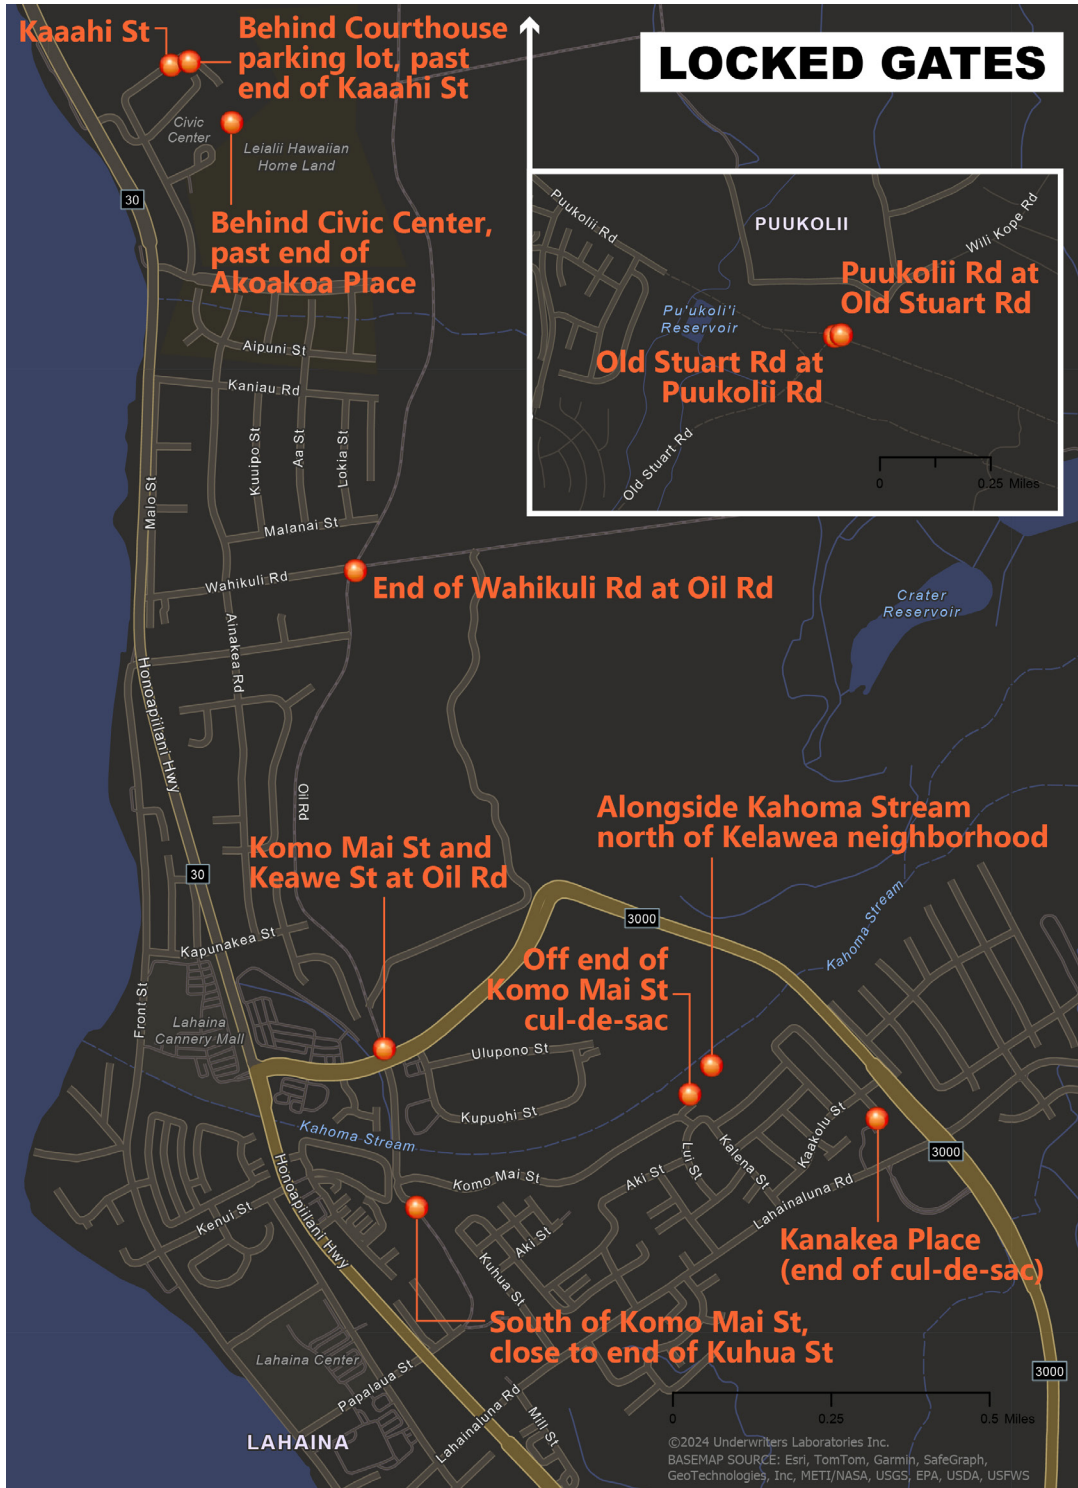
Figure 3.4.2.4.3 Locked Gates Map. Map showing location of locked gates preventing access to dirt roads used during August 8-9, 2023. MPD officers shared how they had to cut the locks to open the gates to allow vehicles to escape the fire and smoke.

<p><b>16. FINDING:</b> Emergency responders did not have ready capability to unlock emergency gates at various locations, including schools, to facilitate evacuations. They were often forced to rely on a third-party response for such access.</p>	<p><b>RECOMMENDATION:</b> The MPD and MFD should develop an assessment of its ability to access local utilities (Hawaiian Electric), flood control, waterworks, farms, resorts and public facilities (ex. private and public schools), flood control roads and gates, agricultural roads and gates, harbor areas, etc.) for emergencies. Create a system of universal lock security access that is available to all emergency responders and landowners.</p>
<p><b>17. FINDING:</b> Severe congestion due to parked cars along neighborhood streets hindered evacuation and response efforts.</p>	<p><b>RECOMMENDATION:</b> The MPD and county authorities should assess the parking needs and challenges within neighborhoods. This may include evaluating factors, such as population density, housing types, availability of off-street parking, street width, proximity to commercial areas or public transportation, and existing parking issues.</p>

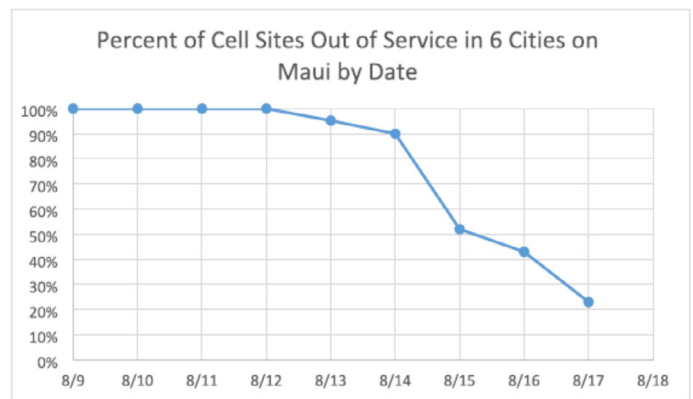
For August 9-12, 2023, the Federal Communications Commission report indicates that 100% of the cell sites were out of service (Figure 3.5.1).

Figure 3.5.1 FCC-registered cell sites out of service in the County of Maui, HI. Source: Federal Communications Commission, Communications Status Report for Areas Impacted by Hawai'i Wildfires August 9-17, 2023.

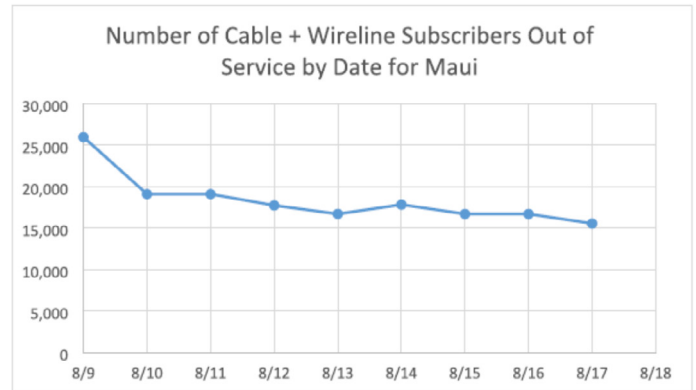
Wireline and cable telecommunications services were also rendered inoperable for many subscribers from the impacts of the August 8-9, 2023, fires, including electrical failures, fire impingement, etc. (Figure 3.5.1.1)

Figure 3.5.1.1 Number of cable and wireline subscribers out of service by date for Maui.<sup>149</sup>

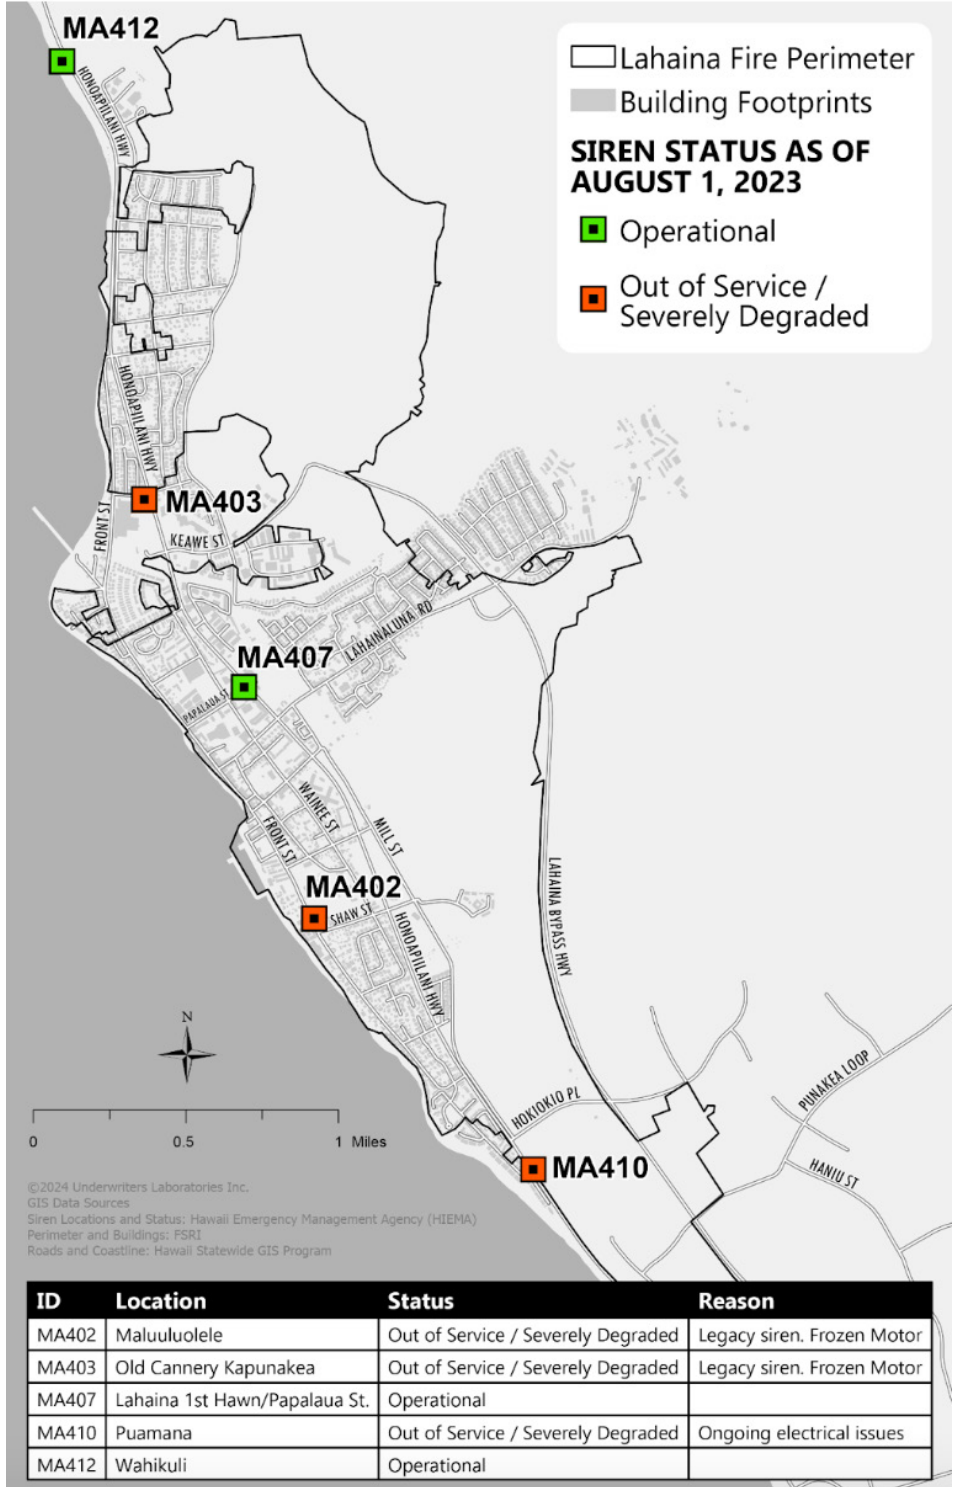
On August 8, 2023, there were five (5) sirens located off of Hwy-30 and near the coastline in the area of the Lahaina PM fire<sup>152</sup> (Figure 3.5.1.2.1). According to siren test records (Appendix Section 6.11) provided by both MEMA and HI-EMA, siren MA407, located near Papalaua Street and Hwy-30, and siren MA412, located off Hwy-30 just north of the Lahaina Civic Center, were the only two sirens operable at the time of the fire.

The records provided are exception-type reports, where only inoperable sirens are listed for each county. Although siren's MA407 and MA412 may have been operable on or before August 8, 2023, they were also very likely inoperable throughout August 8, 2023, due to the area experiencing intermittent cell service. Without a reliable cell signal, it would have been difficult to activate them.

Figure 3.5.1.2.1 Map displaying locations and functional status of Lahaina outdoor warning sirens as of August 1, 2023 (first business day of the month = siren monthly test day). Base map provided by <https://hiema.maps.arcgis.com/apps/dashboards/226e62cd78f340c29e52d4f38c46ac21>. Siren status and maintenance records provided by MEMA and HI-EMA.

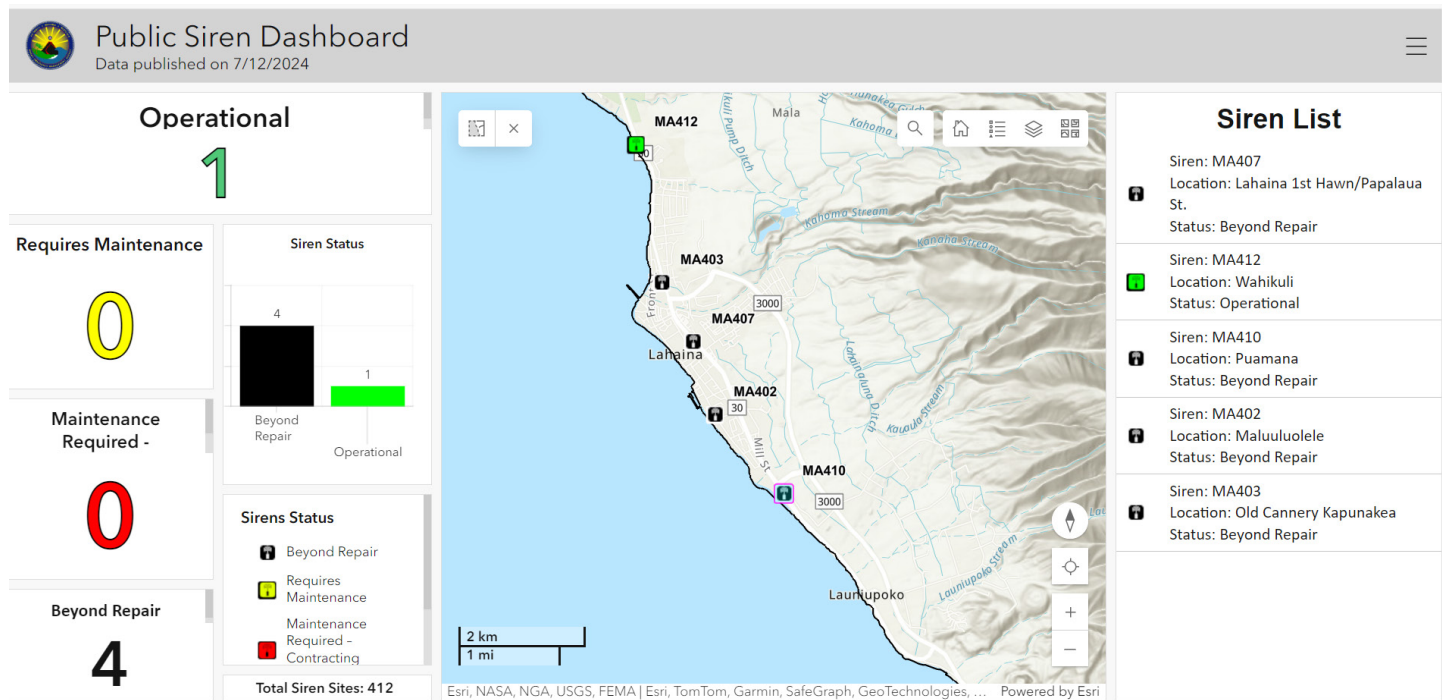
Figure 3.5.1.2.2 The public sirens in Lahaina on August 8, 2023, and their operational status as of July 12, 2024. Source: ARCIS.

The status of the State of Hawai'i Outdoor Warning Siren System is shared via the [Public Siren Dashboard](#).<sup>153</sup> The July 12, 2024, dashboard for the Lahaina area in Figure 3.5.1.2.2 indicates that MA412, just north of the Lahaina Civic Center, is currently (as of July 2024) the only operable siren.

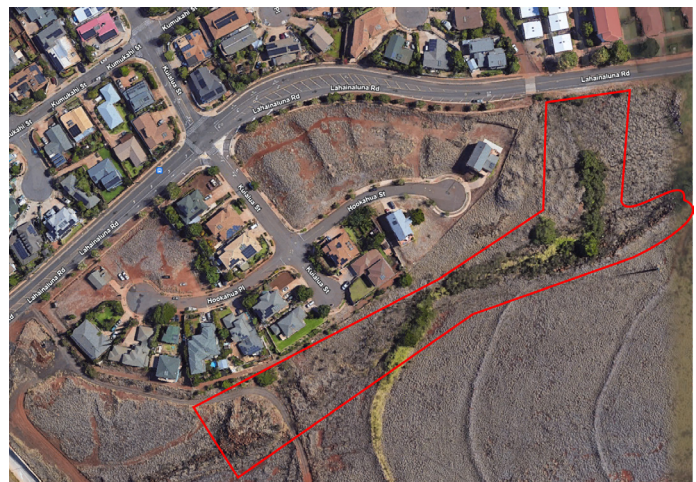
Figure 3.7.7.2 Google Earth pre-fire image (July 9, 2016) of the area where the Lahaina AM fire burned. Red outline marks the ravine with walls made of large boulders that contained voids where tufts of dry vegetation and combustible trash were concealed. The area outlined is approximately five (5) acres.

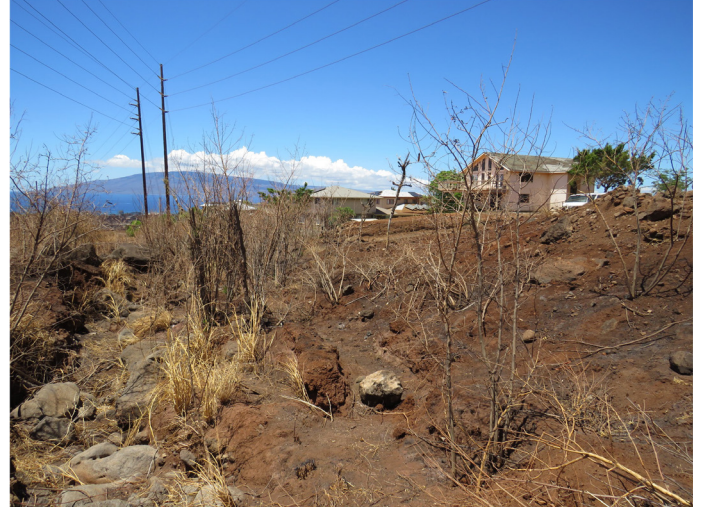
The mid-slope burn area includes a ravine with angled sides made from randomly stacked boulders of various sizes (Figure 3.7.7.3). Small tufts of dry vegetation and combustible human trash filled the voids created between the boulders. The ravine provides natural drainage, running east (mauka-higher elevation) to west (makai-lower elevation) toward the coast.

Figure 3.7.7.3 Post-fire image taken September 3, 2023, from near the top of the ravine southeast of the two-story home in the image at 8 Ho'okahua Street. Image shows unburned vegetation in rocky terrain. Inset: Viewpoint of the image in the photograph above.

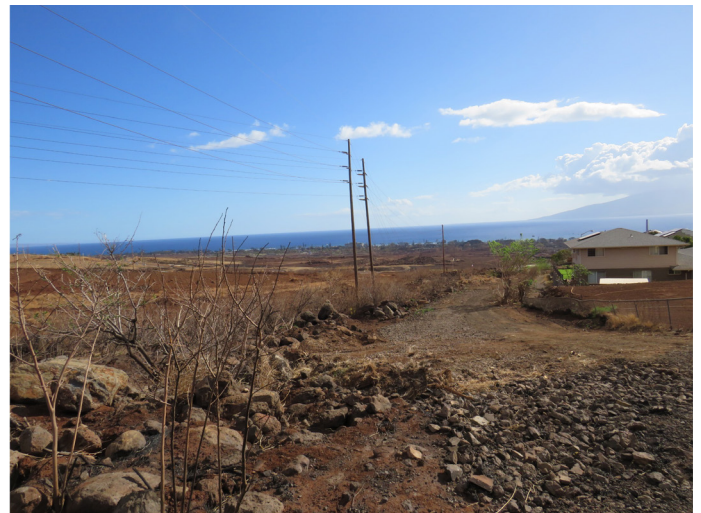
Many overhead electrical transmission lines extended over the area where the Lahaina AM fire burned, and several were directly over the ravine (Figure 3.7.7.4).

Figure 3.7.7.4 Post-fire image taken September 3, 2023, from near the east end (mauka) of the ravine southeast of the two-story home in the image at 7 █ Ku'ialua Street. Image shows unburned vegetation in rocky terrain. Inset: Viewpoint of the image above.

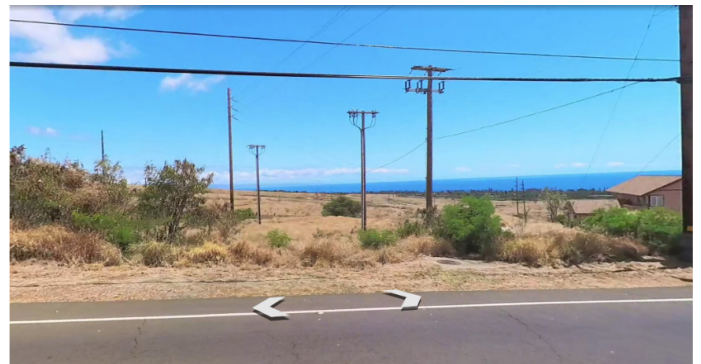
Images from before the August 8, 2023, fire show the highly invasive non-native buffelgrass and haole koa dominating the area just behind the homes off of Ho'okahua Street and on the southside of Lahainaluna Road, across from the intermediate school (Figure 3.7.7.5).

Live and dead fuel moistures are unknown as these measurements were not recorded, however, the vegetation was in a well-cured state with golden brown color, common for August. As indicated in Section 3.2, the leeward side of Maui was in Red Flag Weather (KBDI > 600, >20 mph winds, RH <45%).

Figure 3.7.7.5 Google Street View image (pre-fire, date unknown) looking south from Lahainaluna Road. Home in the image is addressed at 8█ Ho'okahua Street and was the structure nearest the Lahaina AM fire point of origin. Image shows buffelgrass and haole koa at the base of several utility poles supporting overhead electrical lines. Inset: Viewpoint of the image above.

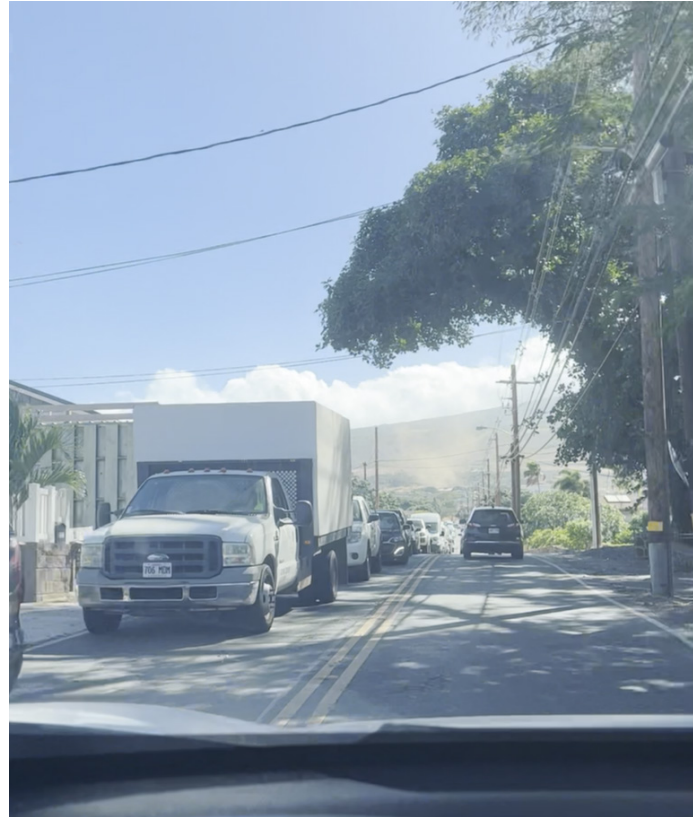
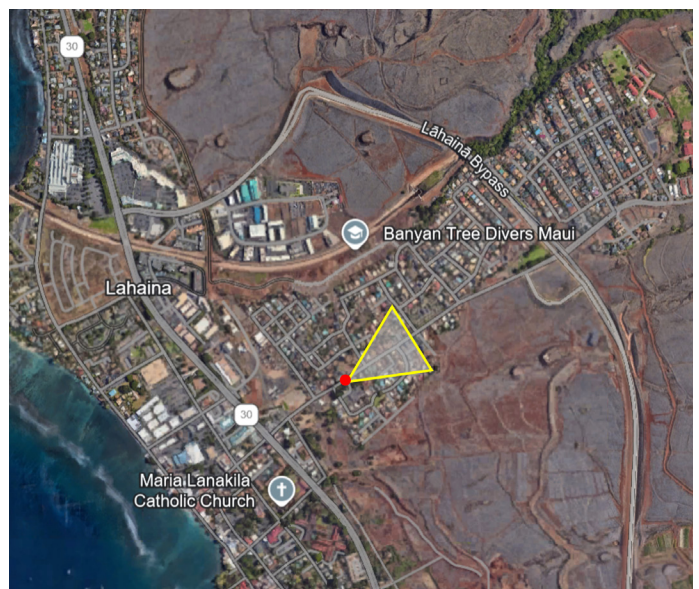
However, the fire was in challenging terrain with void spaces created by rocks in the ravine, which was difficult to access due to the danger of unstable utility poles and steep slopes described above (Figure 3.7.7.2). Additionally, the presence of dust in the area could have obstructed their view. The extreme downslope winds stirred up dust clouds, making it difficult to see any remaining smoke (Figure 3.7.7.3.1).

Figure 3.7.7.3.1 Video image captured on August 8, 2023, at 09:07, taken from a vehicle traveling eastbound (mauka) on Lahainaluna Road. At the far east end (mauka), a dust cloud can be seen near the location where the Lahaina AM fire burned. Insert: Viewpoint looking east (mauka) on Lahainaluna Road.

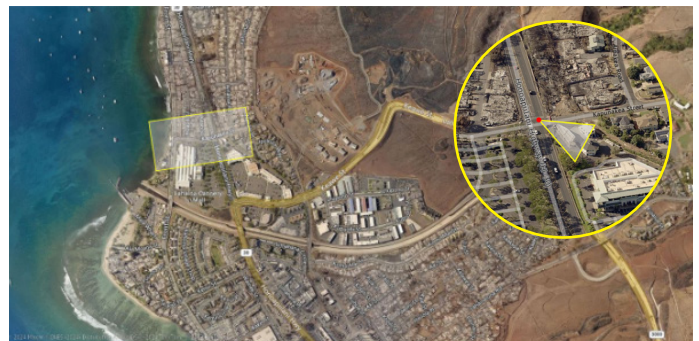
Several factors caused extensive congestion and traffic issues before the start of the fire on August 8, 2023. High winds downed utility poles and utility lines and toppled trees, while debris from vegetation and building materials blocked major traffic routes, creating numerous hazards for vehicles (Figure 3.8.2.1). This obstruction severely limited traffic flow in and out of Lahaina.

Figure 3.8.2.1 Several downed utility poles and powerlines in the northbound lane of Hwy-30 and Kapunakea Street. Photo taken August 8, 2023, at 16:52. Inset: Viewpoint of photo of downed utility poles and electrical lines at Hwy-30 and Kapunakea Street.

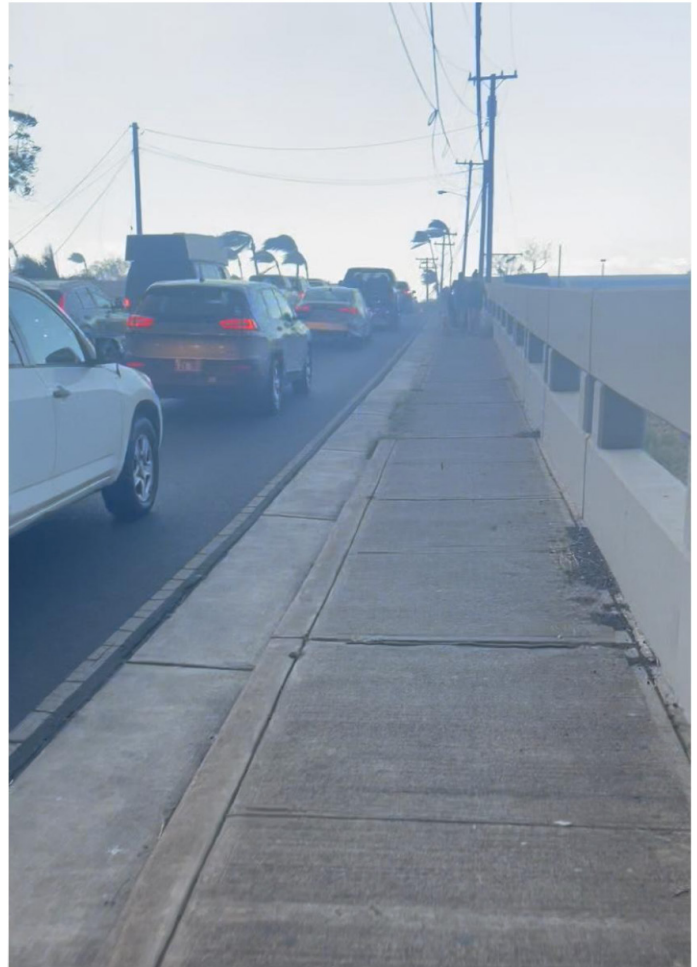
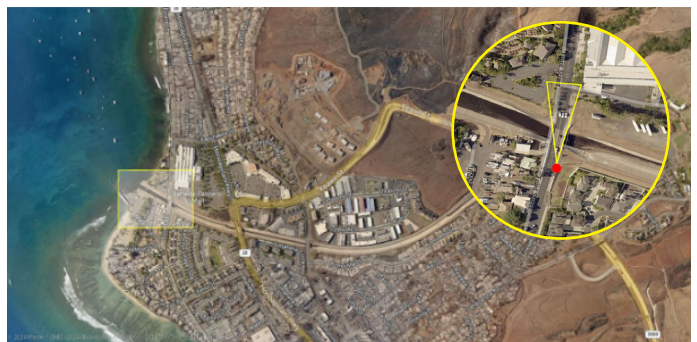
Figure 3.8.2.2 Northbound Front Street traffic over Kahoma Stream on August 8, 2023, at 17:05. Inset: Viewpoint of northbound Front Street traffic over Kahoma Stream on August 8, 2023, at 17:05.

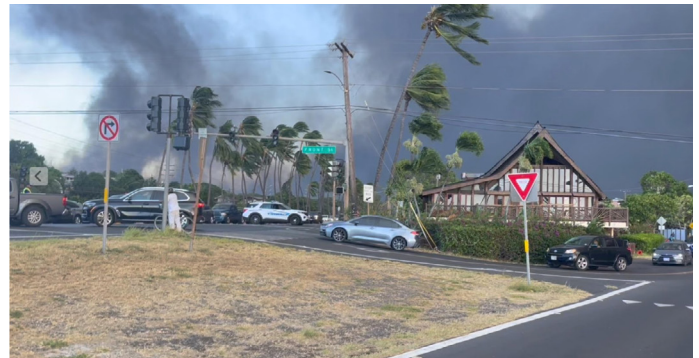
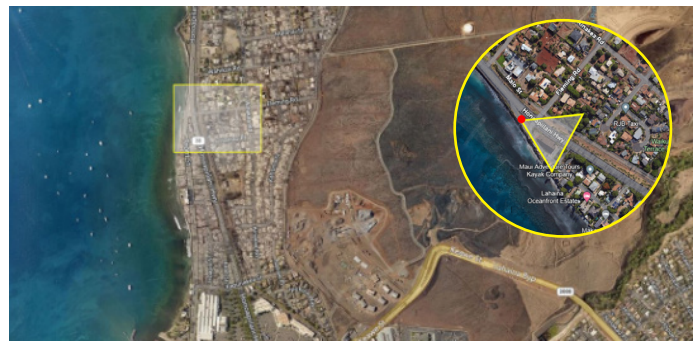
Figure 3.8.2.3 Front Street at Hwy-30 on August 8, 2023, at 17:28 shows MPD vehicles redirecting southbound Hwy-30 traffic away from the fire, and vehicles on northbound Front Street merging onto northbound Hwy-30. Inset: Viewpoint looking south toward Front Street and Hwy-30 intersection.

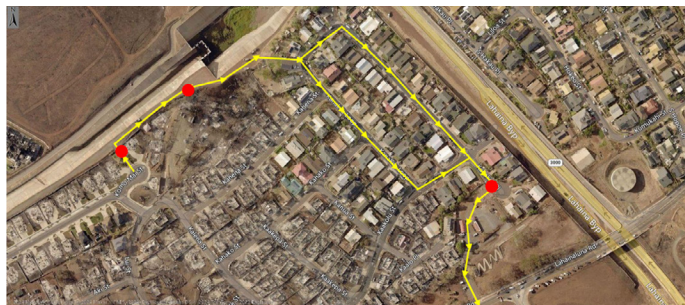
As the fire grew in intensity and consumed structure after structure down Lahainaluna Road, by 16:30 on August 8, 2023, the main westbound egress routes down Komo Mai Street and Lahainaluna Road were cut off by fire. Due to the quick actions of MPD officers and residents, alternative egress routes through locked gates and dirt roads enabled many residents to evacuate safely (Figure 3.8.2.4).

Figure 3.8.2.4 Evacuation route used by residents exiting the Lahainaluna neighborhood as the fire burned through the Lahainaluna neighborhood. Route required breaking open three (3) locked gates (red circles), and driving on dirt roads to make access to Lahainaluna Road, and ultimately, the Lahaina Bypass.

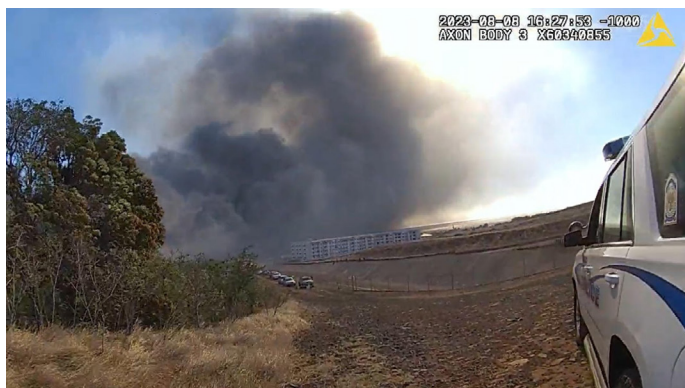
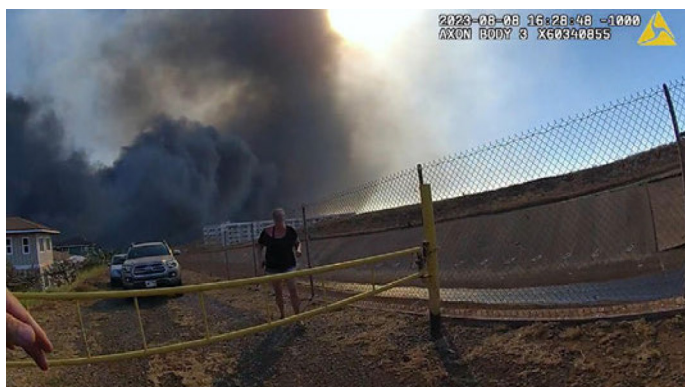
The route was accessed via the east end of Komo Mai Street using a small dirt road between 3█ and 4█ Komo Mai Street. This led to a path along the south bank of Kahoma Stream, which allowed traffic to flow eastbound onto Kanakea Loop (Figure 3.8.2.5).

Figure 3.8.2.5 Body-worn camera (BWC) images of a MPD officer captured August 8, 2023, at 16:27 and 16:28 on a private vacant lot north of 4█ Komo Mai Street and south of Kahoma Stream. MPD officers and residents broke through the gate to travel on the dirt road to Kanakea Loop, and ultimately, out to the Lahaina Bypass via Lahainaluna Road. Inset: Viewpoint of BWC image of MPD officer assisting residents evacuating dirt road on a private lot on south side of Kahoma Stream.
