# Lahaina Fire Incident Analysis Report

**September 13, 2024**  
**Columbia, MD**

This document is the second in a series of three (3) reports commissioned by the Hawai'i Department of the Attorney General (DOAG) to provide an independent review of the tragic fire that destroyed much of Lahaina, Hawai'i, on August 8-9, 2023.

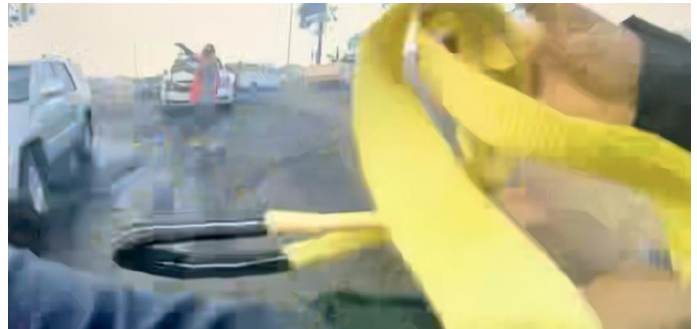
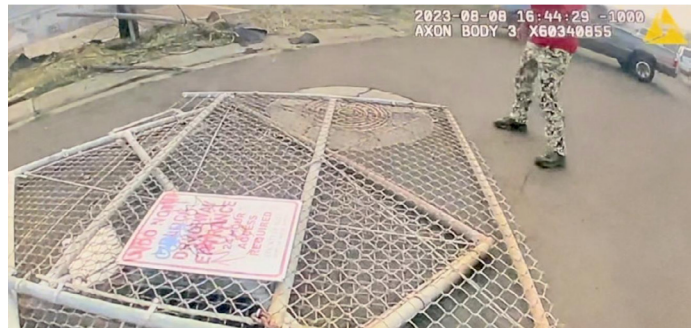
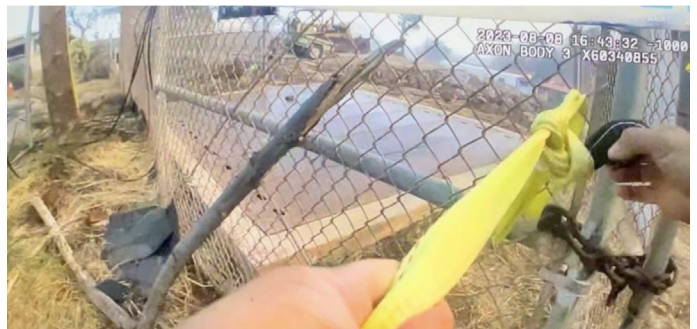
Egressing the neighborhood along Kanakea Loop proved challenging due to the westbound streets of Kahena, Kahako, and Ka'akolu being cut off by fire. The only way out was through the County of Maui Department of Water Supply lot across from 1005 Kanakea Loop. MPD officers used their vehicles equipped with tow straps, and in some cases their own bodies, to open gates that were blocking the critical egress route (Figure 3.8.2.6).

Figure 3.8.2.6 BWC image capture of a MPD officer August 8, 2023, at 16:43, 16:44, and 16:46 breaking through a locked gate securing the County of Maui Department of Water Supply Lot (Parcel No. 450310010000) on Kanakea Loop, directly across from 1005 Kanakea Loop. Gate restricted access to the county lot, leading to a second gate that provided access to the Kelaweā Mauka Makai Park parking lot, and ultimately, Lahainaluna Road. Inset: Viewpoint of MPD officers making access through the locked gate, securing the county lot in the west side (makai) of Kanakea Loop, across from 1005 Kanakea Loop.

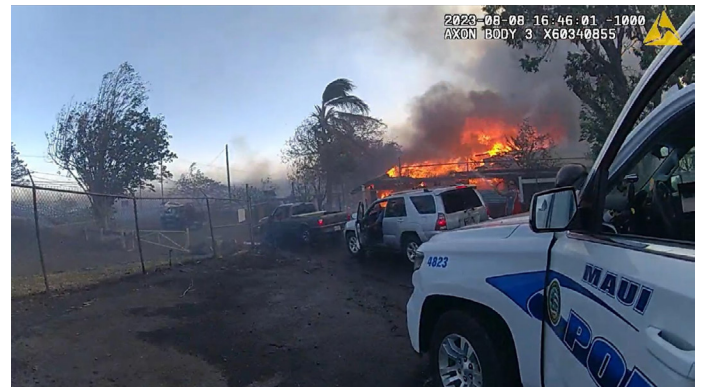
Numerous vehicles followed one another from the Komo Mai Street dirt road to Kanakea Loop, through the County of Maui Department of Water Supply lot (Figure 3.8.2.7) and the Kelawea Mauka Makai Park parking lot, to eastbound Lahainaluna Road, and ultimately, to the safety of the Lahaina Bypass.

The direct intervention of MPD officers allowed for quicker evacuations and access to safer areas. The necessity of rapid access measures to open these gates highlighted a significant gap in the preparedness and planning for such emergencies. Ensuring these routes are maintained and accessible by emergency crews could vastly improve evacuation operations in future incidents.

Figure 3.8.2.7 BWC image captured on August 8, 2023, at 16:46 of a MPD officer within the County of Maui Department of Water Supply lot (Parcel No. 450310010000) just north of Kelawea Mauka Makai Park. MPD officers and residents broke through locked gates to exit the lot into the Kelawea Mauka Makai Park parking lot, then to Lahainaluna Road, and ultimately, to the Lahaina Bypass to escape the fire. Inset: Viewpoint of BWC image of MPD officer inside county lot residents used to travel through to escape the fire.

Ensuring multiple, well-maintained evacuation routes are available and first responders have the necessary access to these routes is crucial. Pre-planned and regularly updated evacuation routes can mitigate delays and ensure smoother evacuations during emergencies.

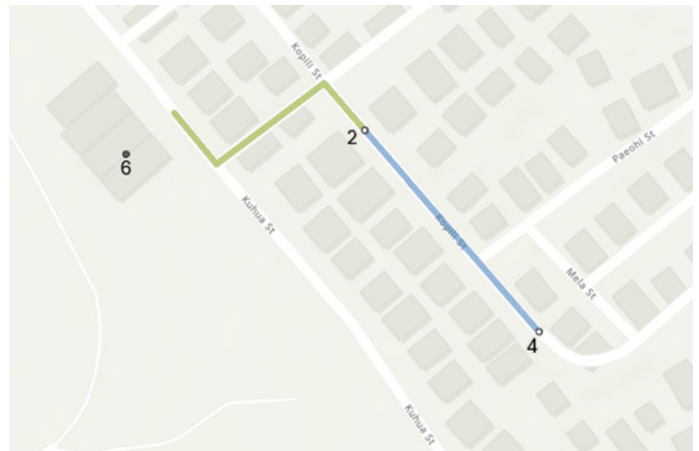
Based on resident reports and media stories, a large tree came down blocking Kuhua Street just south of Aki Street, and a utility pole came down across Kuhua Street just north of Aki Street. All six (6) victims lived on Kopili Street and likely traveled north on Kopili Street, then west on Aki Street to Kuhua Street, where they became trapped, unable to go north or south without hitting an obstruction (Figure 3.8.10.6).

Figure 3.8.10.6 Potential egress routes for fatalities recovered from 8█ Kuhua Street.

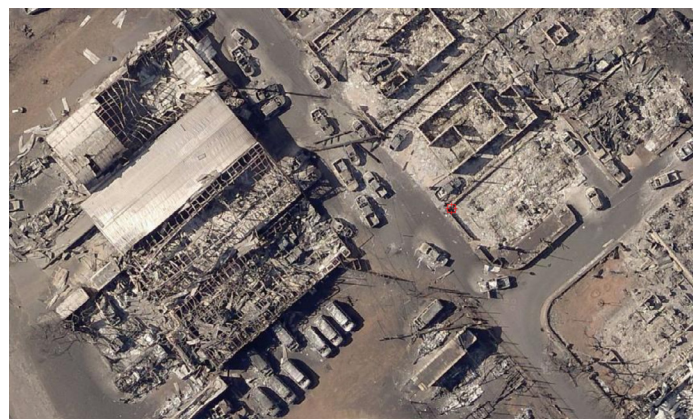
Figure 3.8.10.7 August 11, 2023, satellite image of 8█ Kuhua Street and surrounding area.

Street and Aki Street, they were left with no evacuation route. Unfortunately, the structure did not resist the fire and was burned out, along with the six (6) victims (Figure 3.8.10.7).

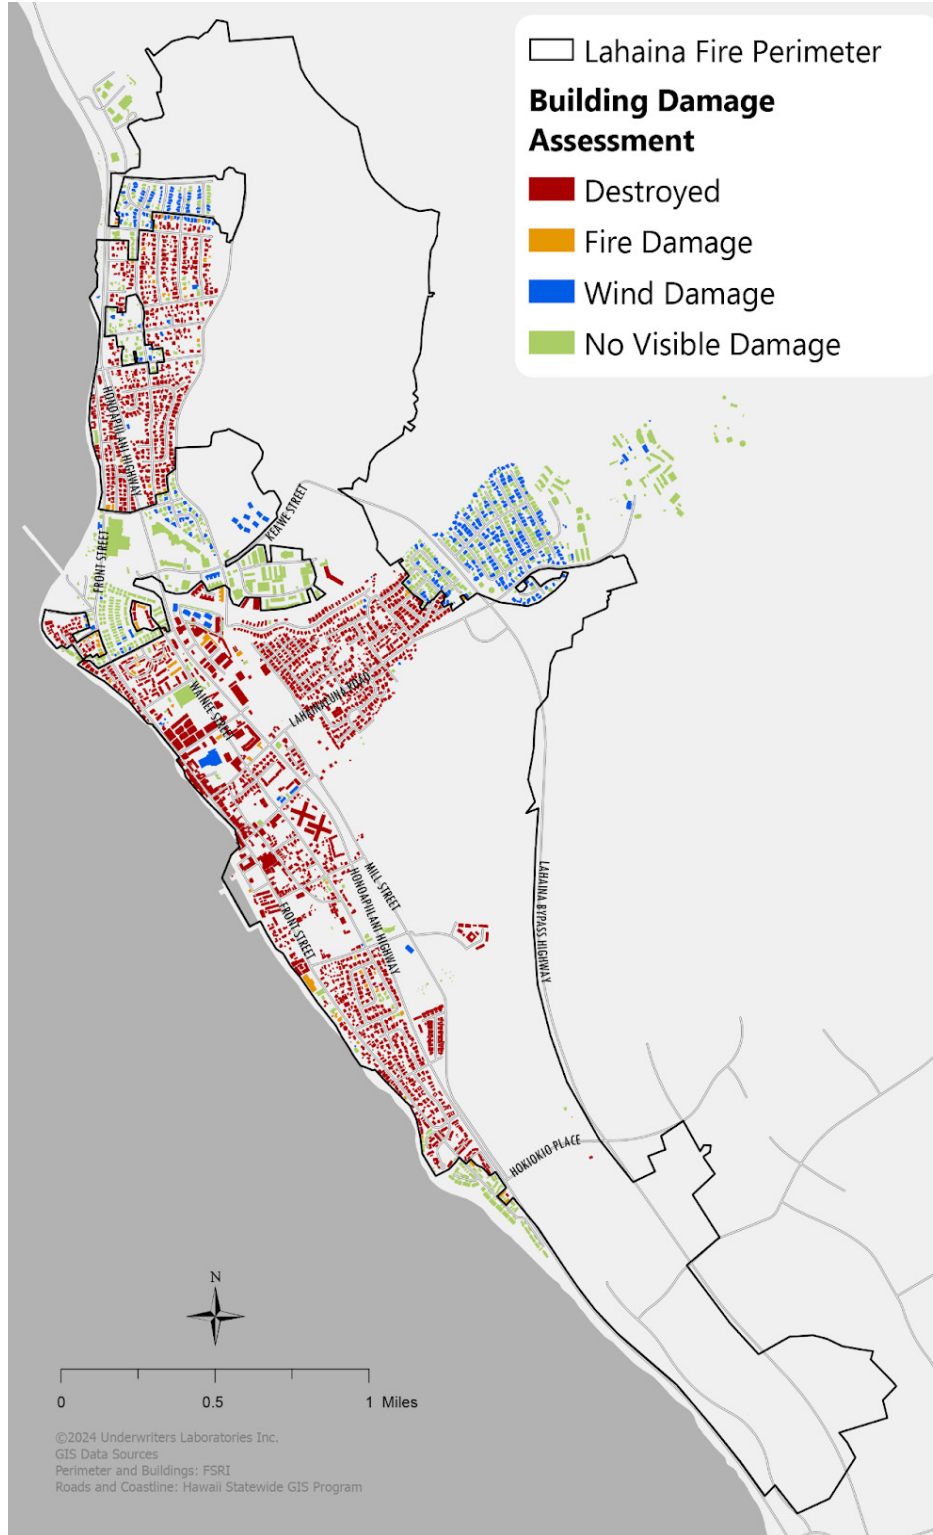
Figure 4.2.1.1 is the structure damage assessment based on data available and current understanding that combines information gleaned from previously published datasets with ground truth from Phase One evidence.

Figure 4.2.1.1 Structure damage assessment map of Lahaina as a result of the August 8-9, 2023 fire.

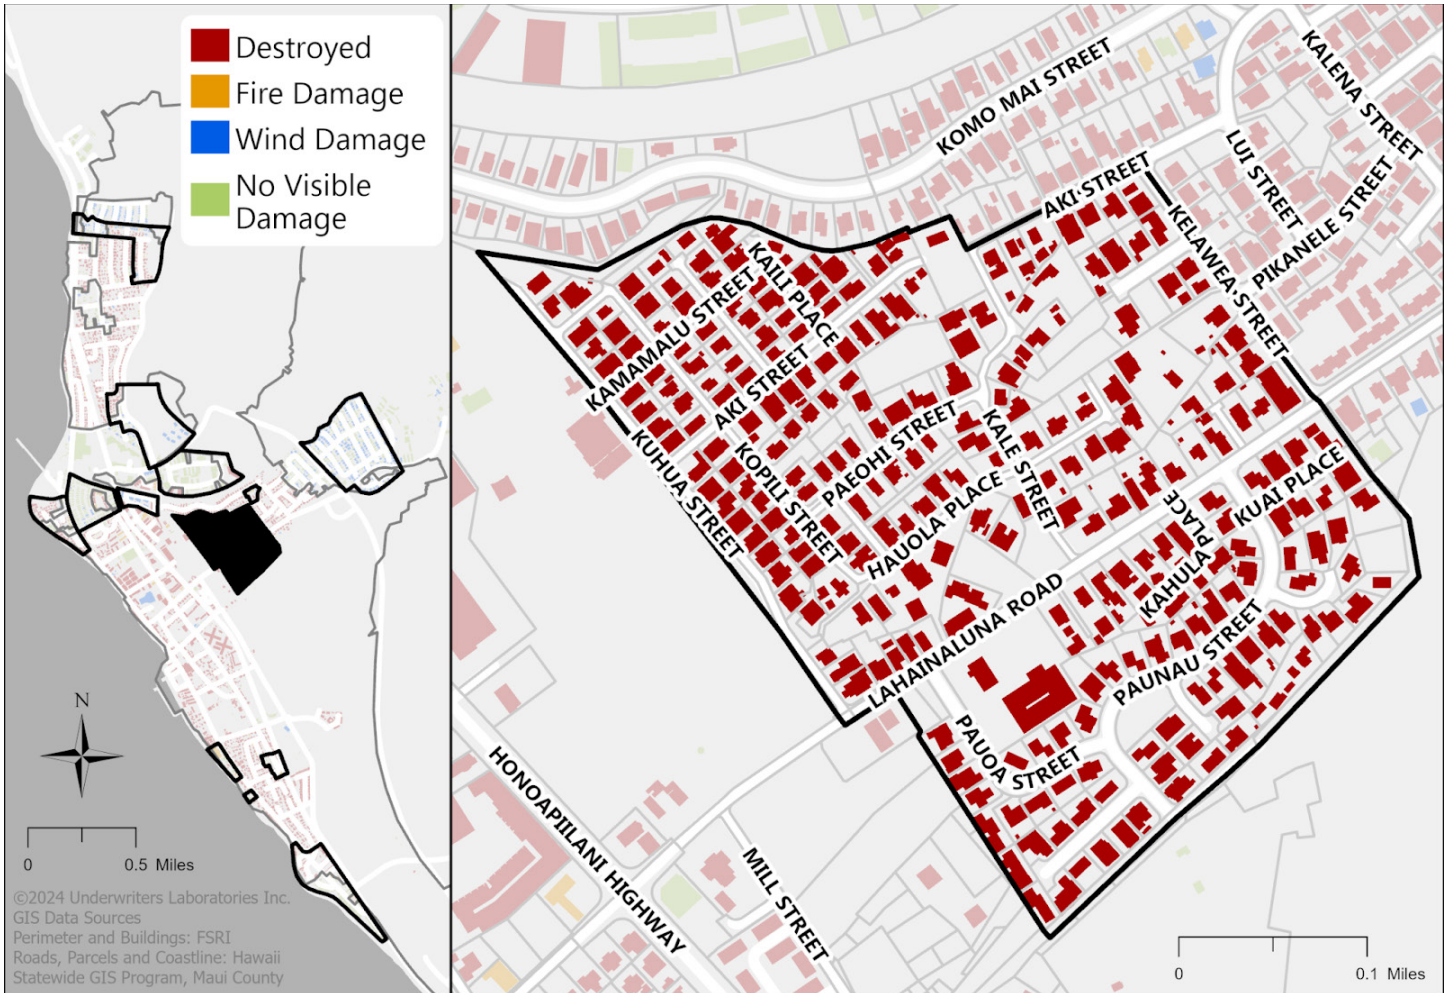
Figure 4.3.3.1.2 Damage classification assessment map of Kelawe Community analysis area.

The neighborhood is bound on the west (makai) by a large industrial area that had once been the Pioneer Sugar Mill, and was originally constructed as employee housing for the mill. All of the structures in this area were destroyed (Figure 4.3.3.1.2).

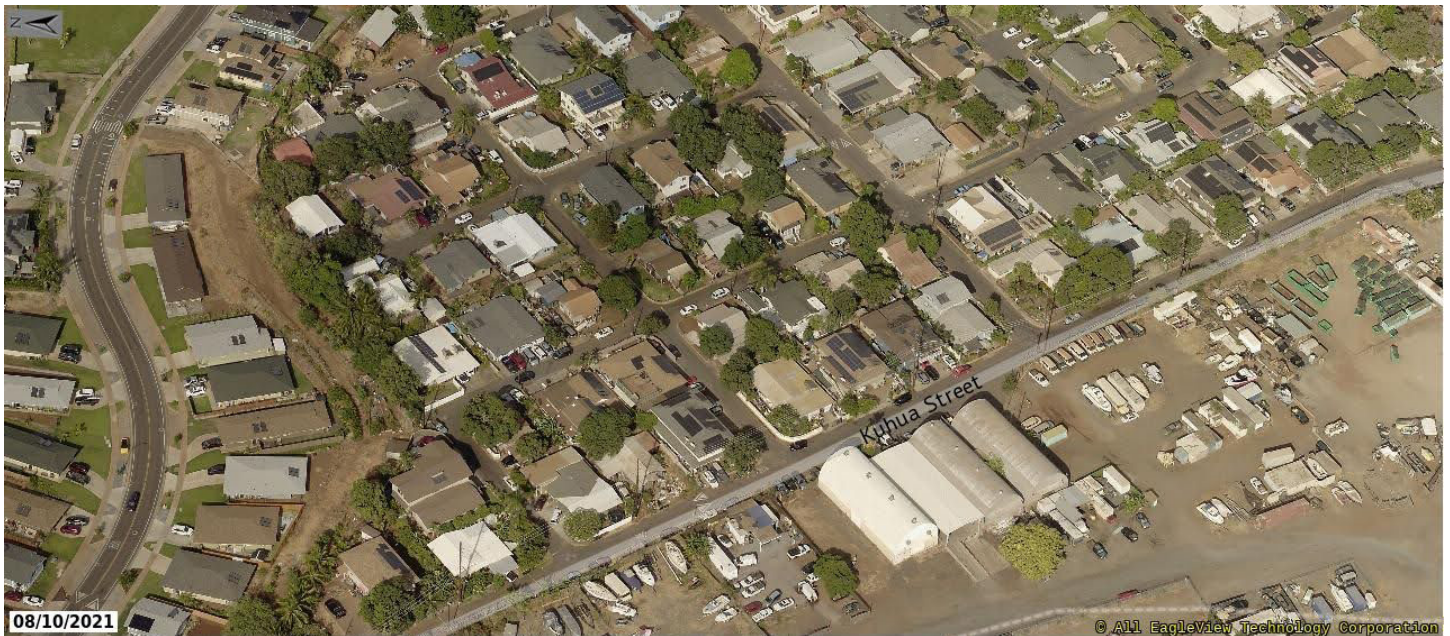
Plans for the original homes in this community (Figure 4.3.3.1.4) show they were designed to be less than 1,000 feet<sup>2</sup>. Figure 4.3.3.1.5 shows that by 2022, additional structures had filled the empty spaces between these original structures, causing very little separation distance between buildings.

Figure 4.3.3.1.5 Pre-fire aerial imagery captured August 2021 of the area along Kuhua Street depicted in Figure 4.3.3.1.4.

Many factors have influenced this trend over the years, including increased housing costs, multigenerational living, and lack of zoning and/or enforcement.

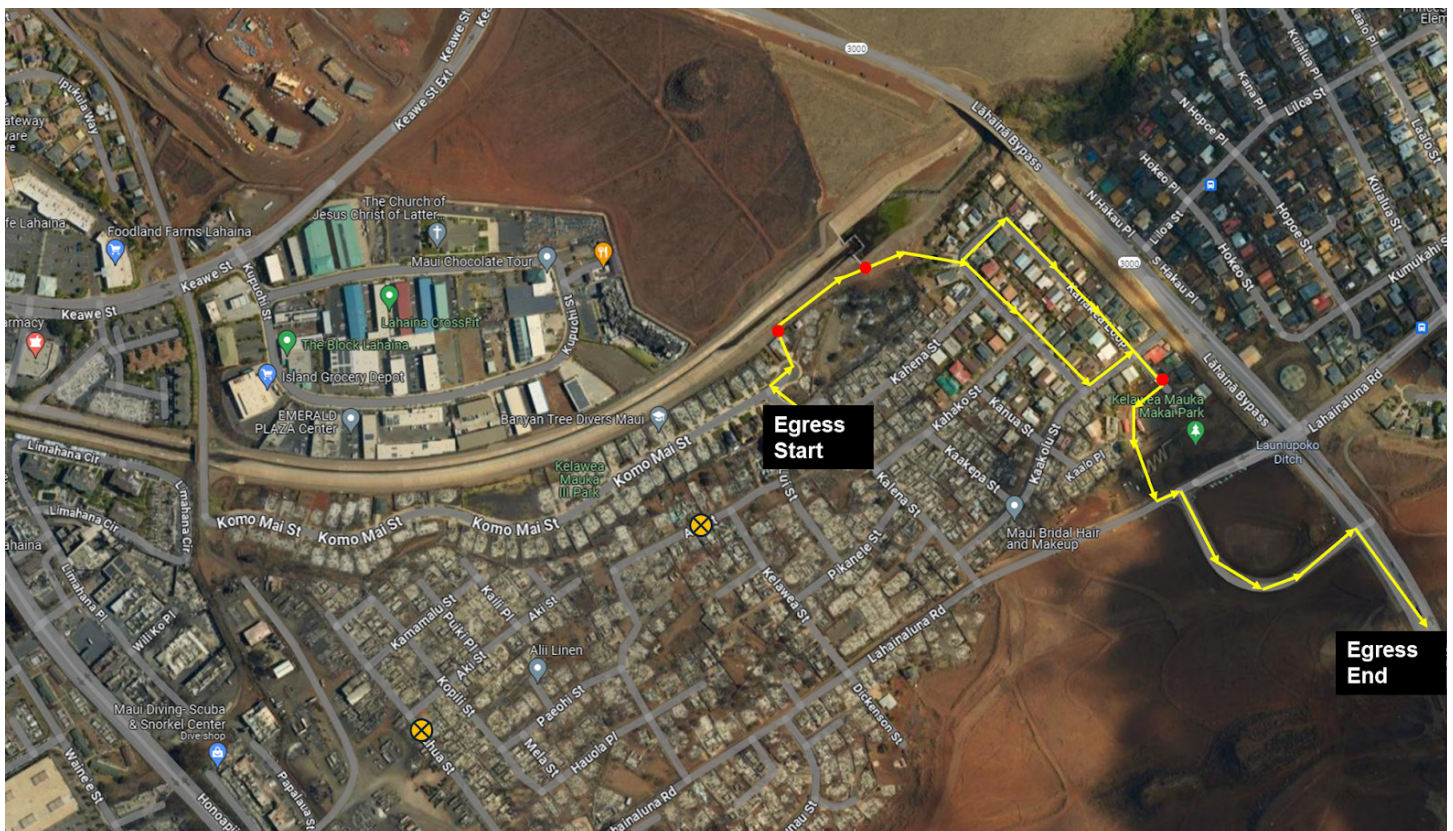
Figure 4.3.3.1.7 Map showing egress route at 16:41 after the fire cut off the westbound exits via Komo Mai Street and Lahainaluna Road. Orange dots represent the location of the fallen trees and debris blocking Kuhua and Aki Streets. Red dots represent locked gates that police officers and residents forcibly opened to gain access to alternative egress routes depicted by the yellow lines.

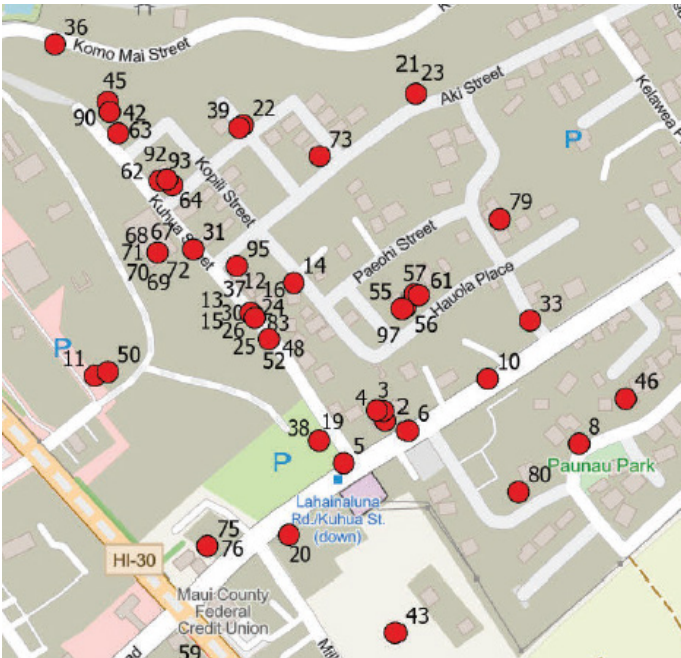
Fifty citizens perished in this area or after exposure to conditions in this area (Figure 4.3.3.1.8). Fifty-five of those killed in the fire had addresses in the neighborhood. Many people narrowly escaped and there are many stories of neighbors helping neighbors to escape the fast spreading urban conflagration. For more information on the circumstances surrounding the fatalities, see Section 3.8.10.

Figure 4.3.3.1.8 Fatality locations in this area as provided by the MPD.

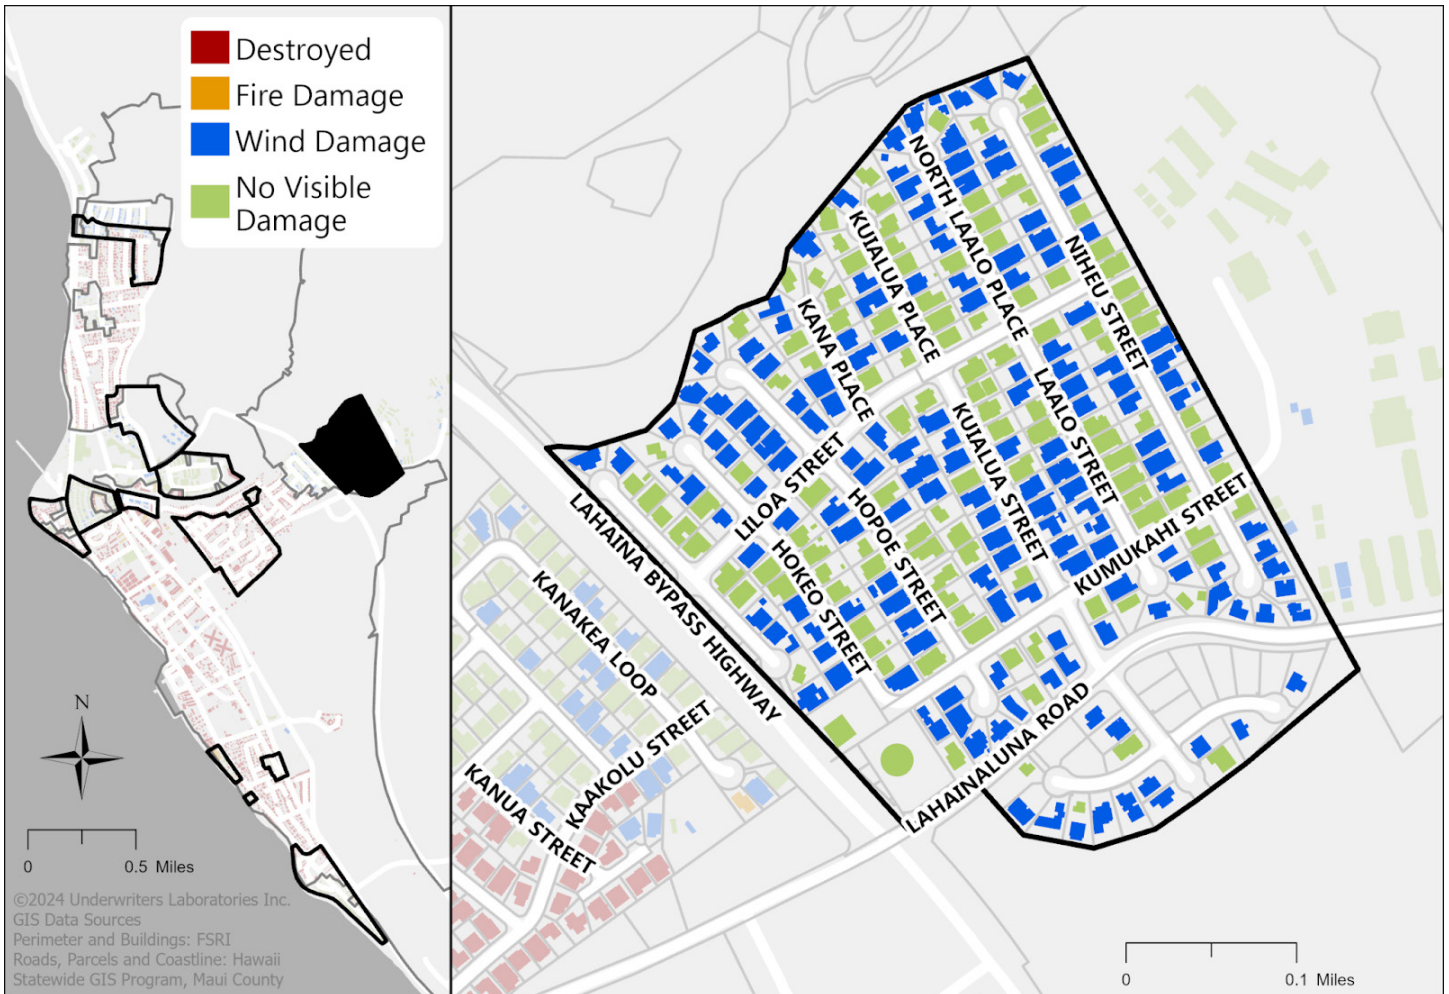
The area of origin is just behind the homes on Ho'okahua Street, but does not appear to have damaged any of the structures. Several residents indicated they engaged in firefighting activities, including fighting spot fires and defending structures. Without these actions it is likely structures would have ignited and resulted in similar destruction that occurred west (makai) of the bypass. Most of these structures were outside of the fire perimeter, but many sustained damage due to high winds before and during the fire. Of the 276 properties, 162 (59%) have visible damage due to wind (Figure 4.3.3.2.2).

Figure 4.3.3.2.2 Damage classification assessment map of Kelaweau Mauka III subdivision analysis area.

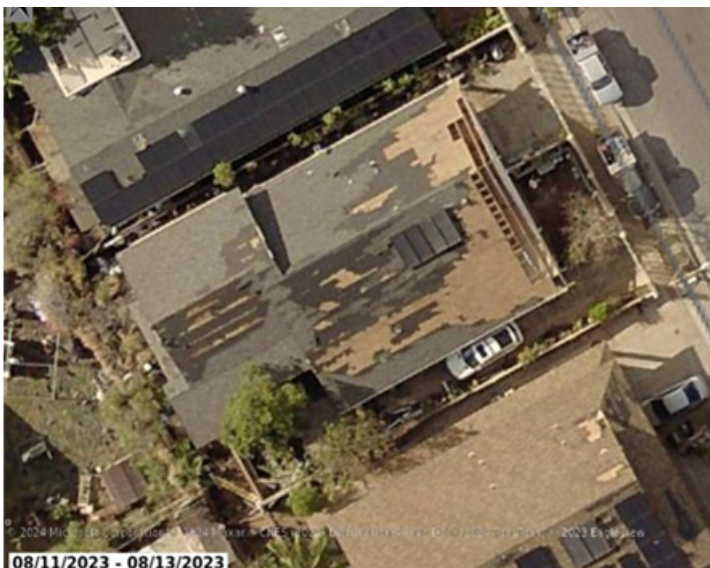
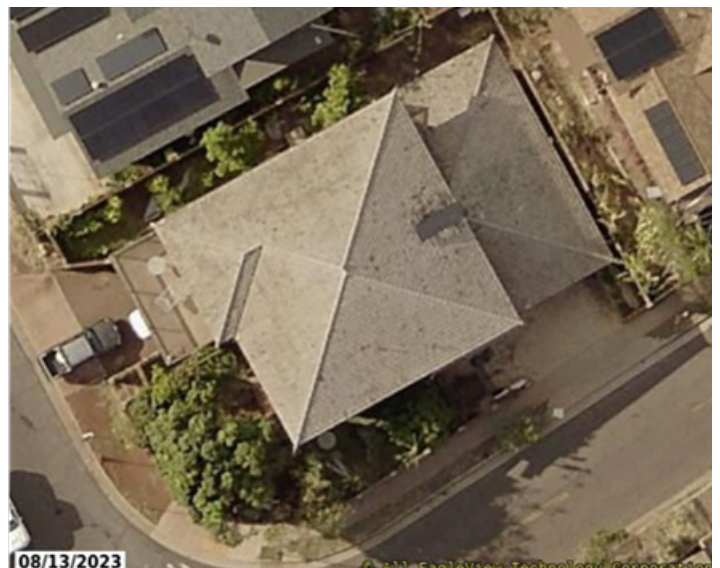
Figure 4.3.3.2.3 Example of wind damage in the Kelaweia Mauka III subdivision—(bottom left) damaged roof sheathing and (bottom right) loss of roof covering.

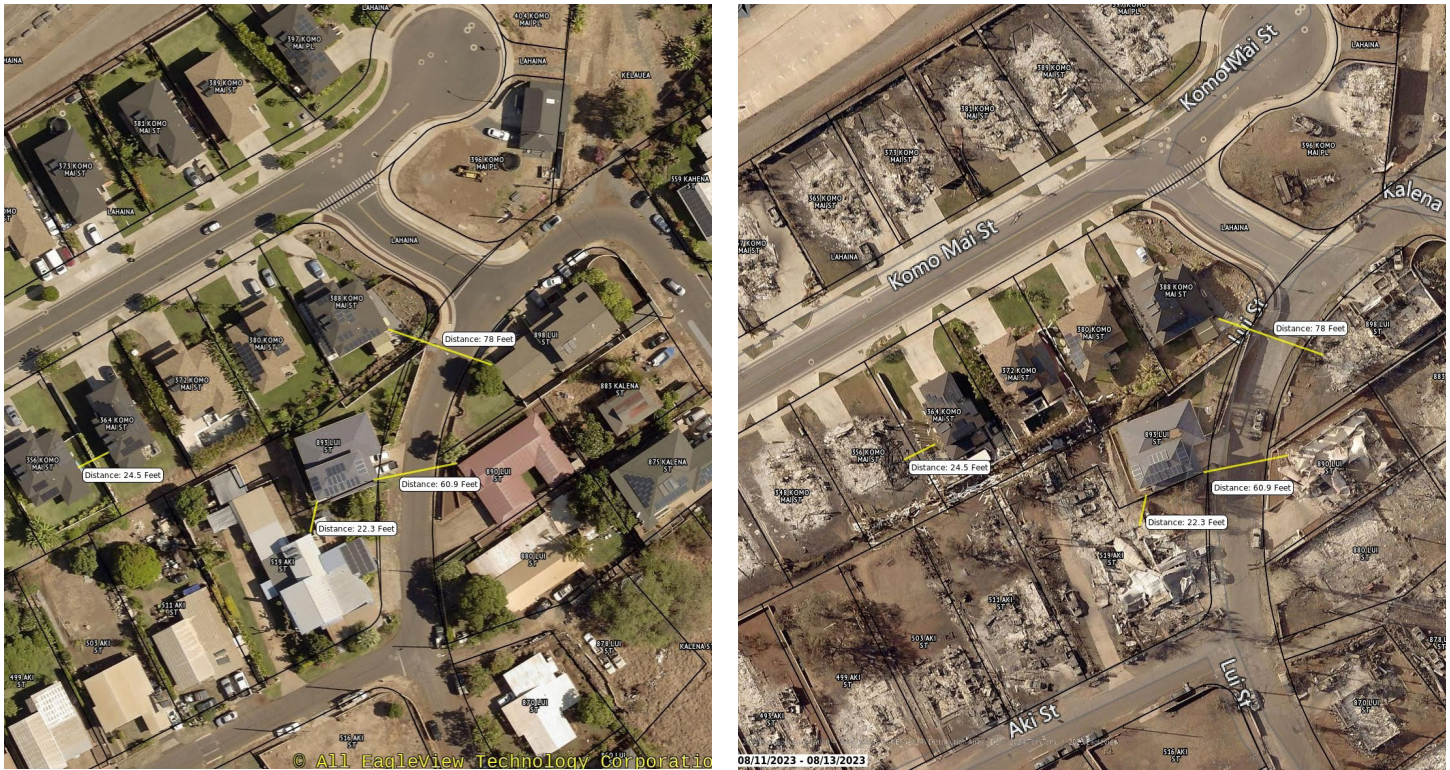
Figure 4.3.3.3.1 Pre- and post-fire aerial imagery of homes that survived the fire on Komo Mai Street and Lu'i Street. Annotations depict separation distances between perimeter structures and nearest destroyed structure.

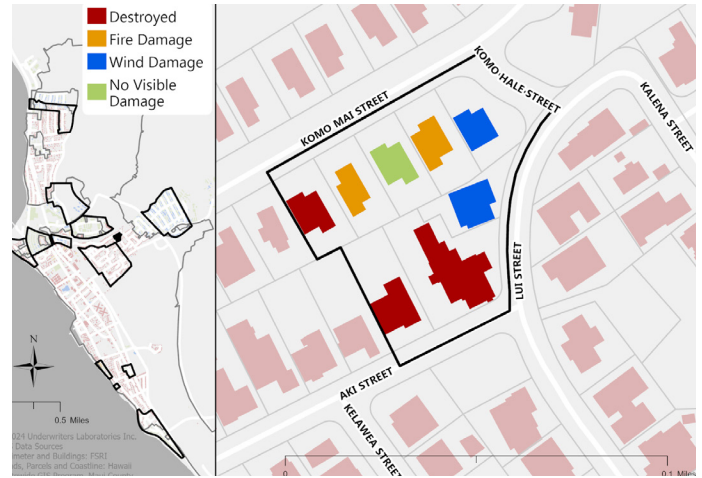
Five (5) structures at the corner of Komo Mai Street and Lu'i Street were not destroyed, while all adjacent ones were destroyed (Figure 4.3.3.3.2). The western-most (makai) home that was not destroyed—3█ Komo Mai Street—was impacted by the adjacent (downwind) structure, including what appears to be discoloration of the fiber cement siding and damage to windows on the fire-exposed side of the structure (Figure 4.3.3.3.3).

Figure 4.3.3.2 Damage classification assessment map of Kahoma subdivision analysis area.

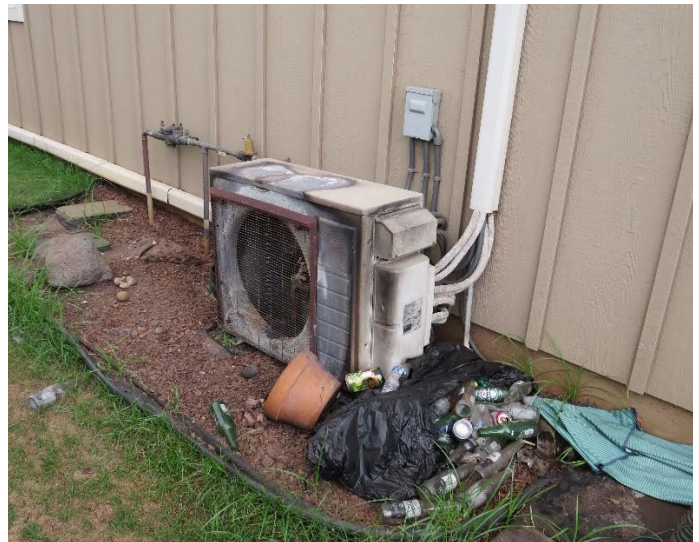
Based on the incident timelines (see Phase One report), MFD units E3, L3, and other personnel were in the area of Lu'i Street and Komo Mai Street from approximately 16:00 to 19:00 on August 8, 2023. During this time, firefighting units implemented structure defense tactics, including fire suppression and exposure protection (Figure 4.3.3.3.4). These defensive actions were likely the primary reason that these structures were not destroyed.

Figure 4.3.3.3.4 Isolated fire damage to 311 Komo Mai Street. Spot fire (ember ignition) caused localized damage, but did not spread to the structure, likely due to defensive actions.

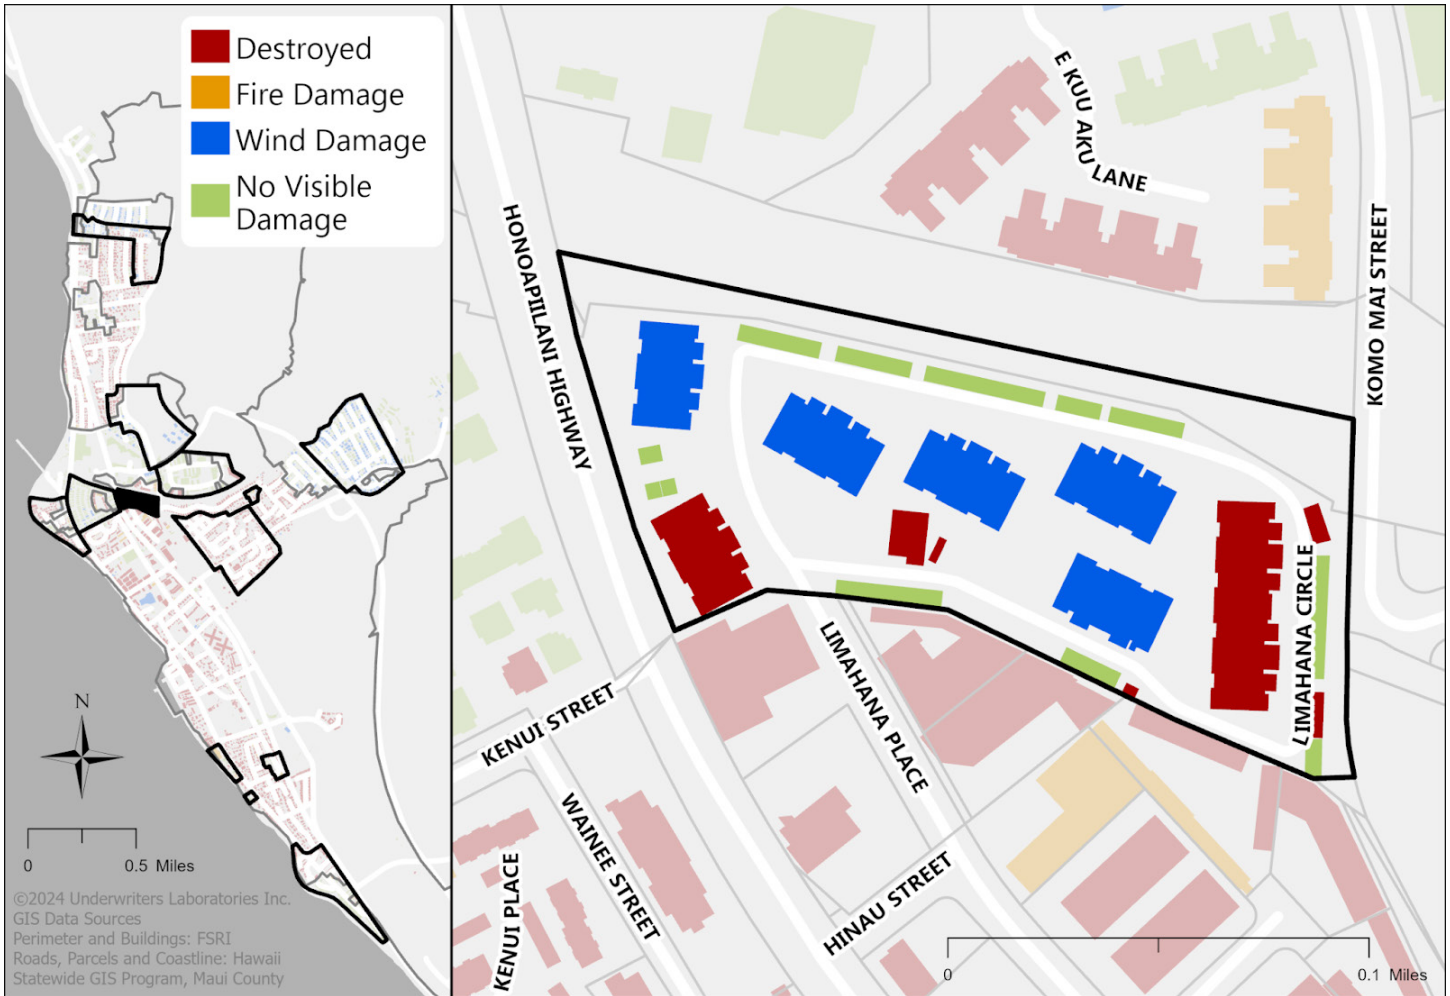
Within the complex, several structures were destroyed, including two (2) apartment buildings and the office/amenity building, while the remaining five (5) apartment buildings sustained wind damage, but were not destroyed (Figure 4.3.3.4.2).

Figure 4.3.3.4.2 Damage classification assessment map of Opukea apartment complex analysis area.

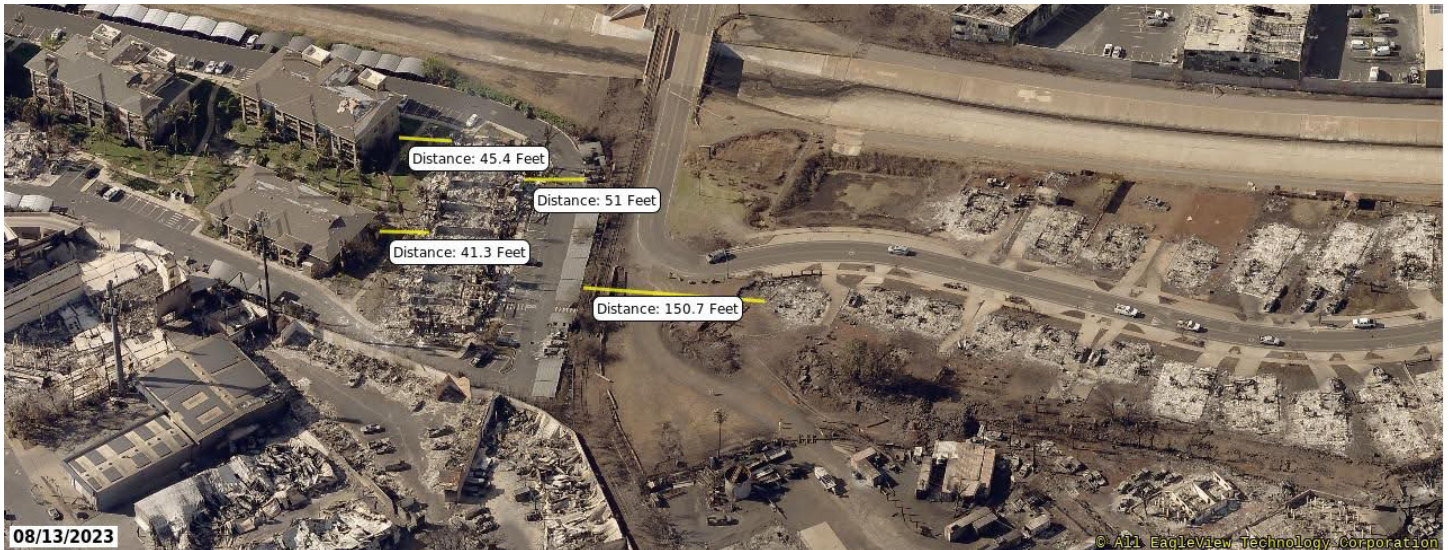
At this point in the incident, most of the structures on Komo Mai Street (other than those described in Section 4.3.3.3) were burning and generating embers that were likely capable of spreading fire over the 150-foot distance to resident vehicles and 40 to 50 feet further from the vehicles to the east (mauka)-most apartment building (Figure 4.3.3.4.3).

Figure 4.3.3.4.3 Distance between nearest destroyed structure on Komo Mai Street, destroyed vehicles, destroyed apartment building, and undestroyed apartment building.

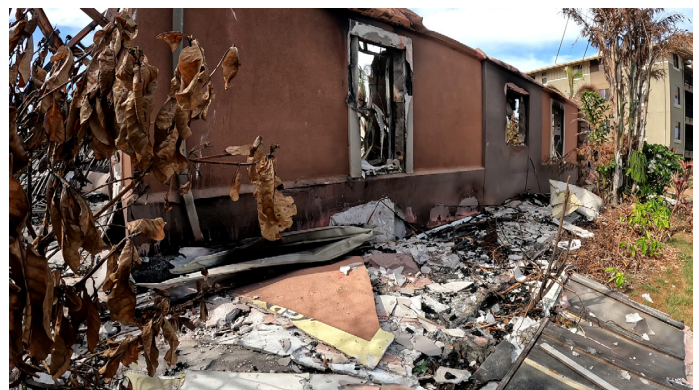
The first floor exterior walls are concrete masonry block (CMU) blocked with stucco cladding, while upper floors were constructed with gypsum sheathing and similar stucco cladding.

Figure 4.3.3.4.4 Destroyed apartment building showing CMU block exterior wall construction (first floor) and noncombustible sheathing with stucco finish coat and fiber cement siding.

These noncombustible exterior wall materials likely contained the fire within the burning structures and reduced exposure to adjacent buildings. Additionally, the 40- to 50-foot separation distance between the burning buildings, and nearby structures, could also have been a contributing factor in why fire did not spread to the adjacent apartment buildings.

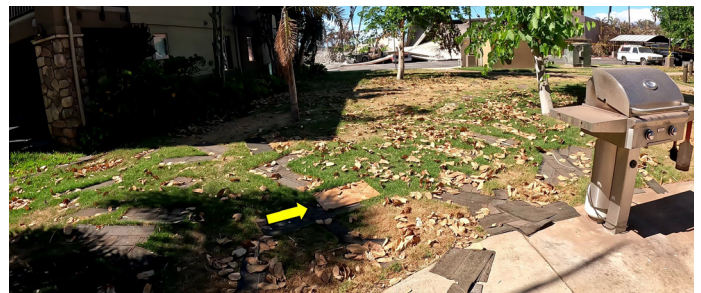
However, these surviving structures sustained substantial wind damage, including detachment of roof coverings, as well as the removal of roof sheathing (Figure 4.3.3.4.5) and broken windows (Figure 4.3.3.4.6), which could create potential pathways for embers into the structures.

Figure 4.3.3.4.5 Wind damage to undestroyed apartment buildings, including significant roof covering (composition shingle) loss and roof sheathing.

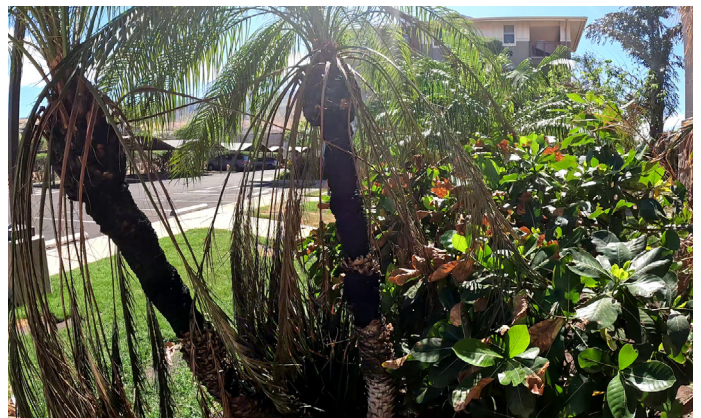
There is evidence of some firebrand/ember ignitions of ornamental vegetation (Figure 4.3.3.4.7), but a notable lack of spot fires in grasses in the community, compared to spot fires in the grasses adjacent to Kahoma Stream.

This evidence suggests the ember exposure was sufficient, but most fuels in the apartment complex, including vegetation, were not receptive to ignition. The lack of ignition in the vegetation may be attributed to the apparent lushness caused by irrigation.

Figure 4.3.3.4.7 Ornamental vegetation (palm bracts) ignited by embers and burned without igniting adjacent vegetation.

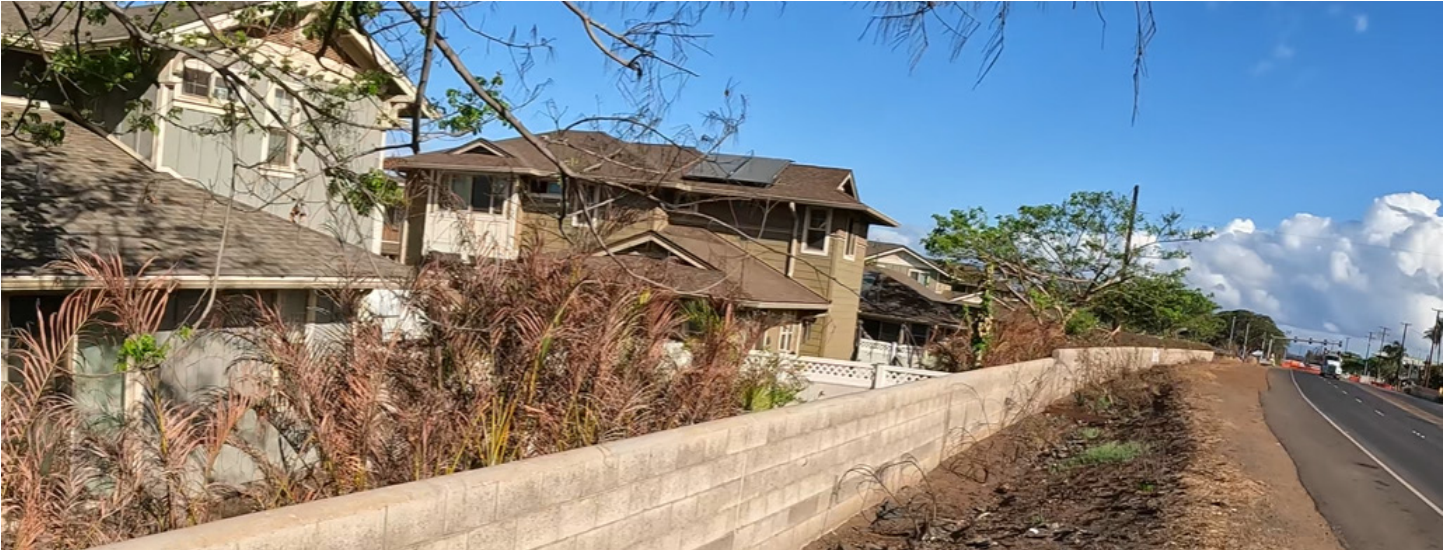
Figure 4.3.3.5.3 Concrete barrier wall along Hwy-30.

Notably, this was the side of the village that received the bulk of the ember exposure from the fire to the east (mauka), driven by westerly (makai) winds. Although all of the grasses along the concrete barrier wall had burned, the homes behind the wall did not appear to have any thermal damage.

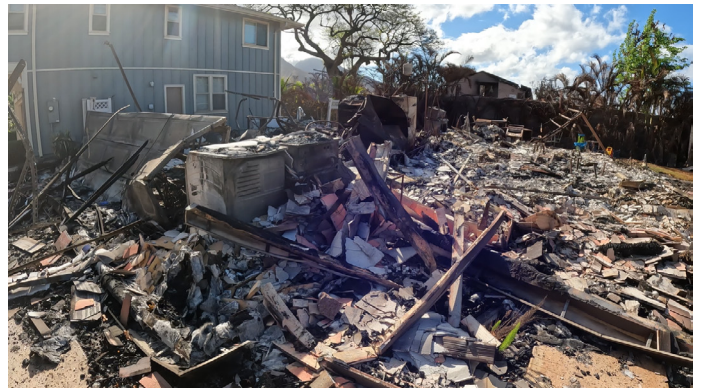
There was one (1) single family home (2█ Kahoma Village Loop) that was ignited by embers on the southeast corner of the village (Figure 4.3.3.5.4). The house fire was recorded by Central at 16:44:56. MPD BWC footage shows the house's roof on fire at 17:41 and water being applied from the Kenui Street side (Figure 4.3.3.5.5).

The MFD, with support from private tankers, kept the fire from extending to adjacent structures. There was no thermal damage to the home to the east (mauka), even though this house was only approximately 14 feet away from the neighboring home.

Figure 4.3.3.5.4 Destroyed single family home at 2█ Kahoma Village Loop from the front (north).

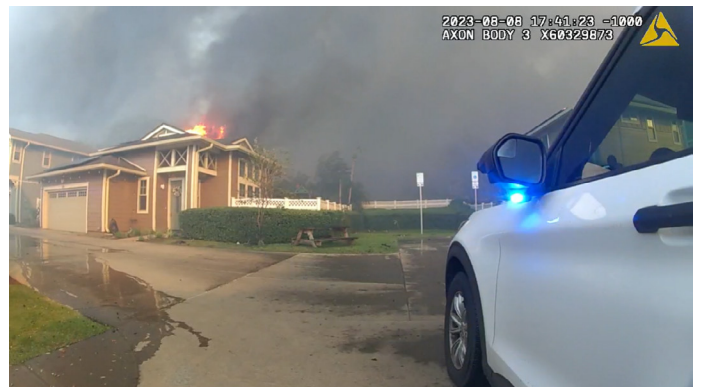
Figure 4.3.3.5.5 Body worn camera image captured by an MPD officer on August 8, 2023, at 17:41:23, showing the house fire in Kahoma Village.

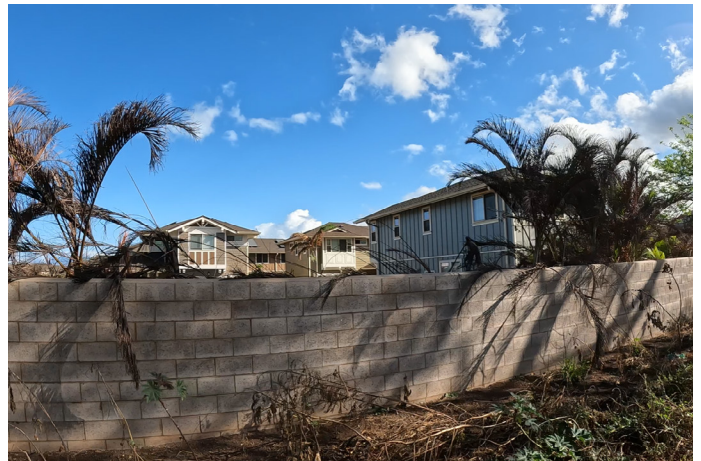
Figure 4.3.3.5.6 Destroyed single family home from the rear on the other side of the concrete wall.

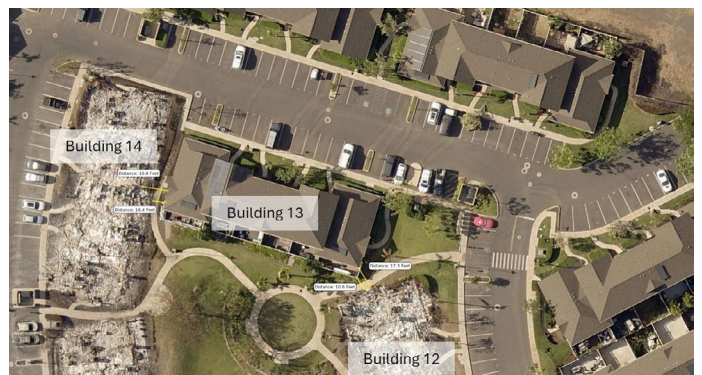
Building 13 was damaged (melted window trim, cracked windows, dried out shrubs, and melted vinyl fence) by adjacent Buildings 12 and 14, but did not ignite (Figure 4.3.3.5.7). Building 14 (destroyed) caused damage to windows and a vinyl fence (Figure 4.3.3.5.8 and Figure 4.3.3.5.9).

Figure 4.3.3.5.7 Aerial imagery of distances between Building 13 (damaged), Building 12 (destroyed), and Building 14 (destroyed).

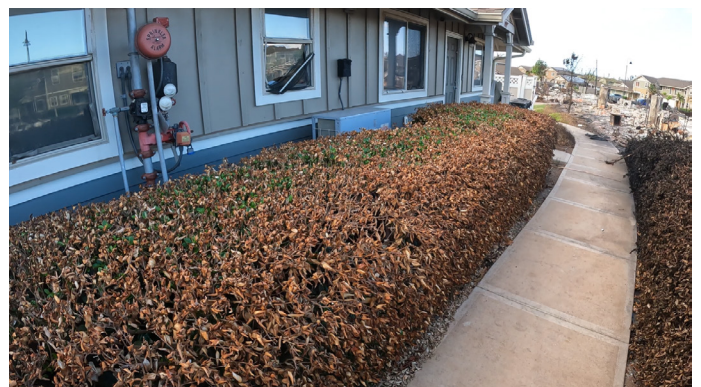
Figure 4.3.3.5.8 Ground-based photograph of space between Building 13 (shown on the left of the image) and Building 14 (shown on the right), showing damaged windows and heat damaged/dried (but not ignited) vegetation.

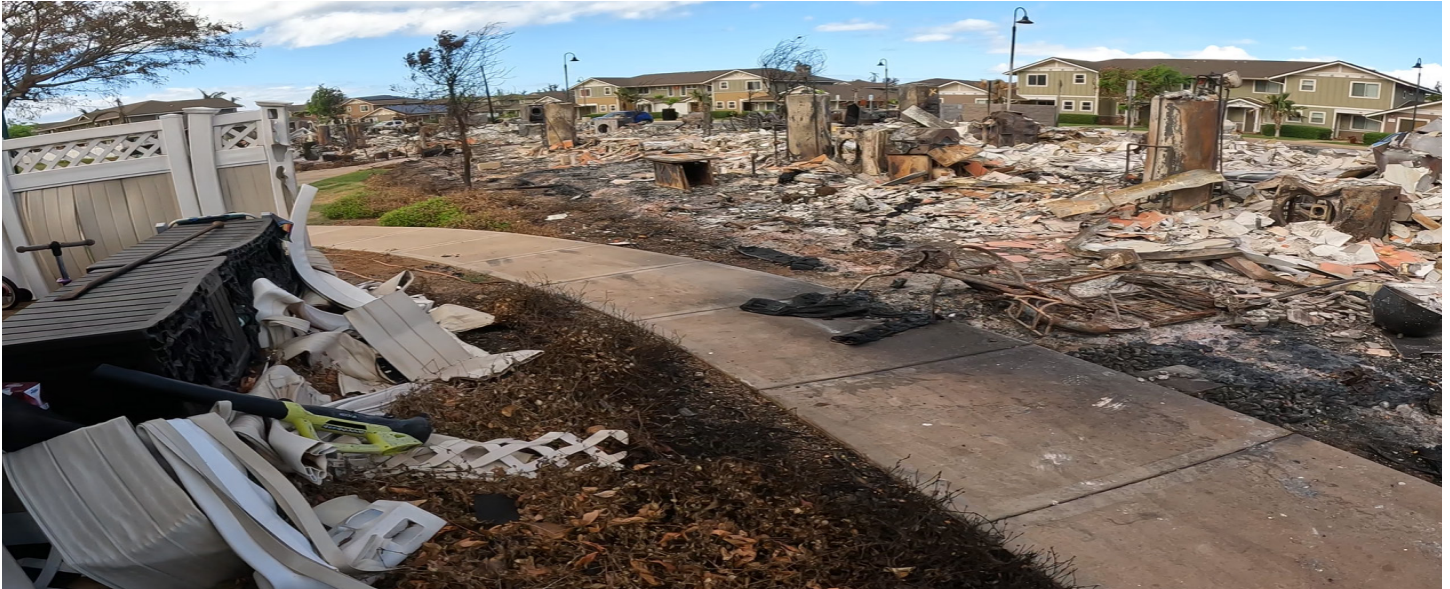
Figure 4.3.3.5.9 Ground-based photograph of space between Building 13 (shown on the left of the image) and Building 14 (shown on the right).

Building 13 was approximately 20 feet away from Building 12, which was also a total loss. Each townhouse building had vinyl fenced-in backyards, which could be as close as 10 feet from one another (Figure 4.3.3.5.9). The combustible materials (e.g., outdoor furniture) between the buildings measured 12 feet between their vinyl fences (Figure 4.3.3.5.9).

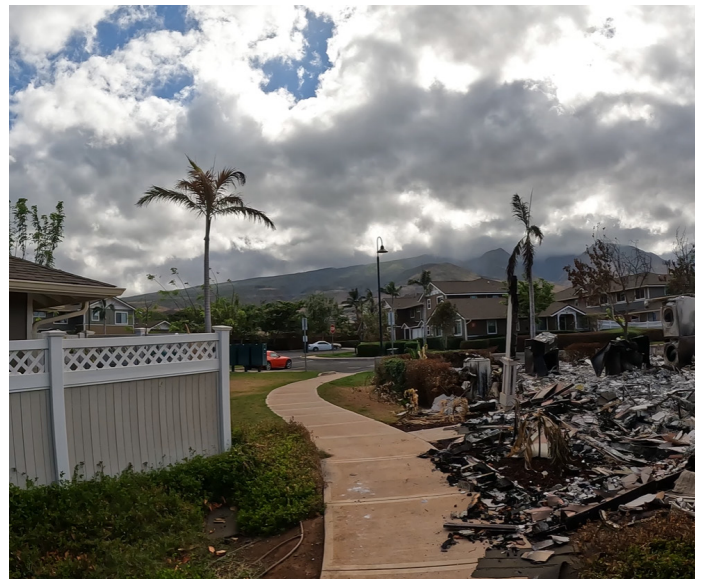
Figure 4.3.3.5.10 Photograph of space between Building 12 (shown on the right of the image) and Building 13 (shown on the left), showing minimal damage to the vinyl fence.

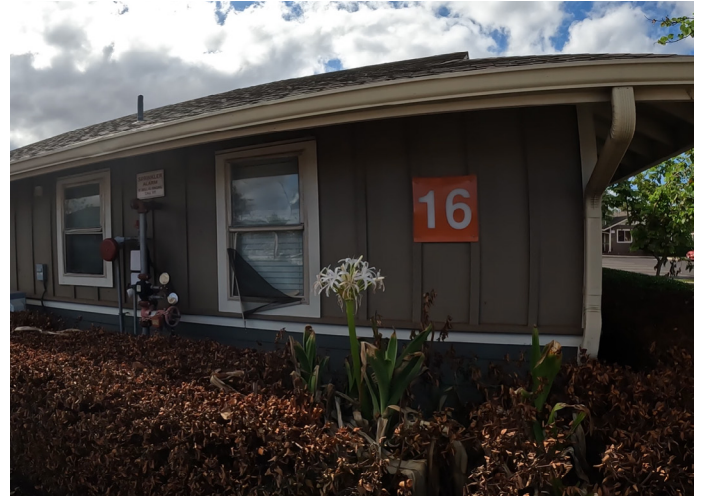
Building 16 was damaged (melted window trim, cracked windows, bubbled paint, dried out shrubs, melted vinyl fence) but did not ignite (Figure 4.3.3.5.11). Building 16 was located approximately 16 feet from Building 15, which was destroyed (Figure 4.3.3.5.12). Several vehicles were also destroyed. Those vehicles were approximately 22 to 30 feet from the nearest window opening in the building.

Figure 4.3.3.4.11 Thermal damage (window) to the front of Building 16, across from Building 15 (destroyed).

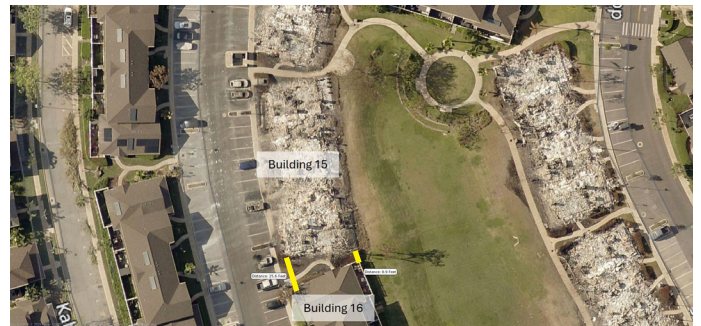
Figure 4.3.3.5.12 Distance between Building 15 (undestroyed) and Building 16 (destroyed) and several vehicles lost during the fire.
