# Lahaina Fire Incident Analysis Report

**September 13, 2024**  
**Columbia, MD**

This document is the second in a series of three (3) reports commissioned by the Hawai'i Department of the Attorney General (DOAG) to provide an independent review of the tragic fire that destroyed much of Lahaina, Hawai'i, on August 8-9, 2023.

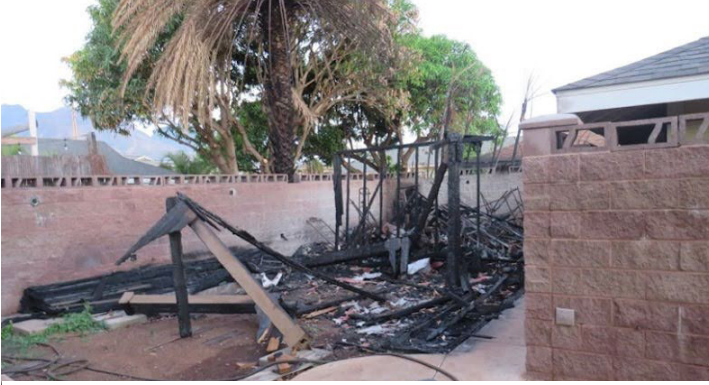
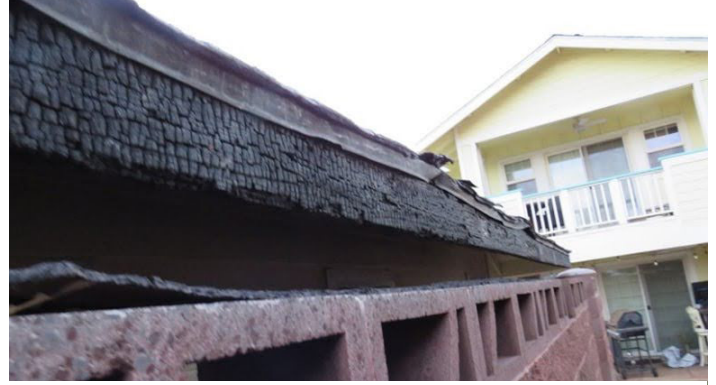
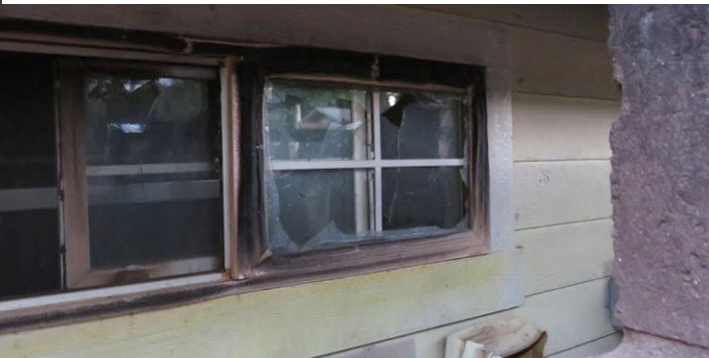
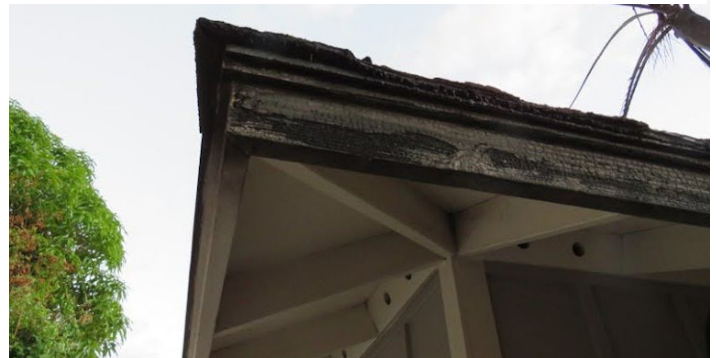
Two buildings, 4 Ala Moana Street and 5 Ala Moana Street, were damaged by a destroyed accessory structure in the backyard of 4 Ala Moana Street. The accessory structure was most likely ignited by embers, due to the lack of continuous fire spread. The destroyed burning accessory structure

caused damage to both 4█ Ala Moana Street (burned fascia and broken windows) and 5█ Ala Moana Street (burned fascia and a damaged storage container) (Figure 4.3.3.6.4).

There is evidence that defensive actions (connected residential hoses flaked out in the area) to suppress the burning structure and/or protect adjacent structures, which could have been a contributing factor to why the fire did not spread further on the parcel.

Figure 4.3.3.6.4 Destroyed accessory structure at 4 Ala Moana Street (top left). The burning structure caused damage to 4 Ala Moana Street (top right and bottom left) and 5 Ala Moana Street (bottom right).

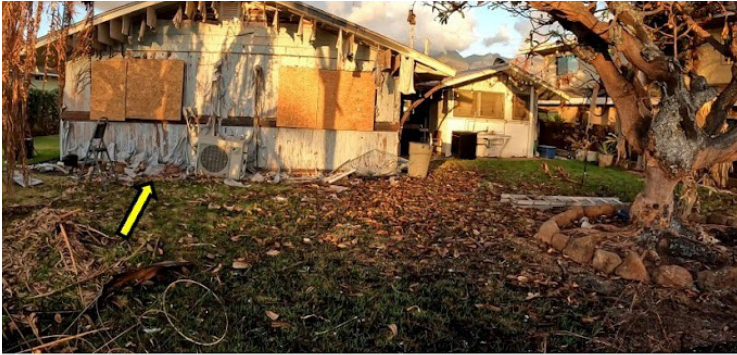
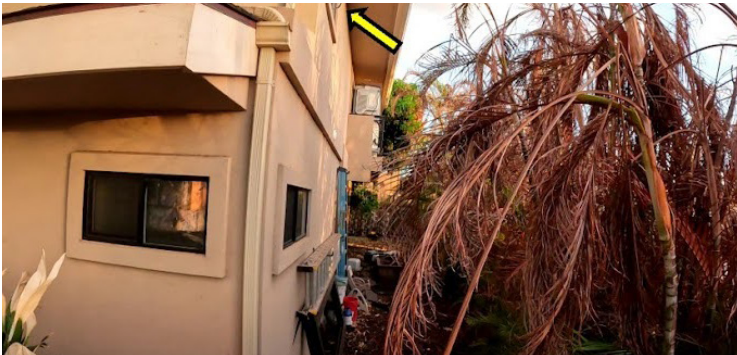
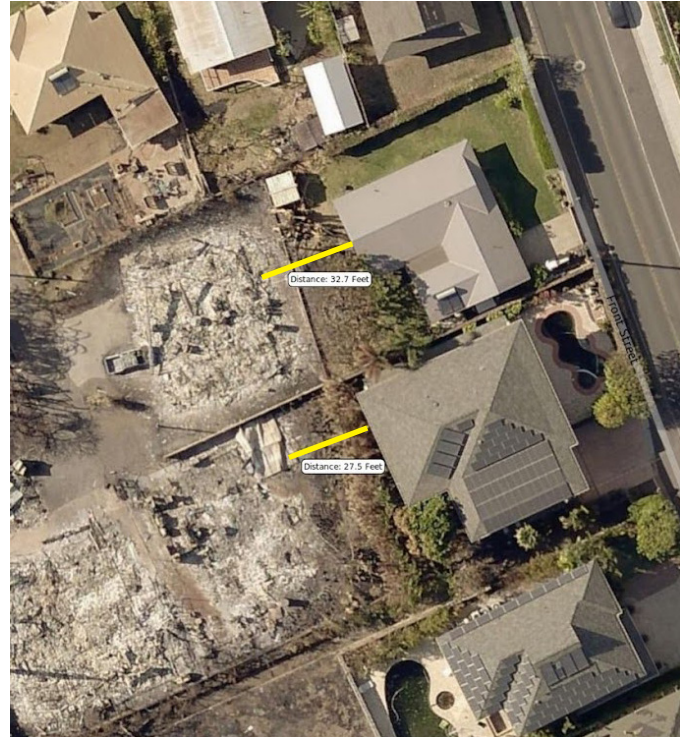
Slightly further south, the burning structures on Lahilahi Place caused damage to the rear side exposures at 11 and 11 Front Street, 20 to 40 feet away. The vinyl siding and window frames were damaged by the radiant heat, but did not ignite (Figure 4.3.3.6.6). A garden hose found behind 11 Front Street may have been used by the residents described above to protect these structures from ignition.

Figure 4.3.3.6.6 Destroyed structure on Lahilahi Place caused damage to the rear side of 11█ (top) and 11█ (bottom) Front Street structures.

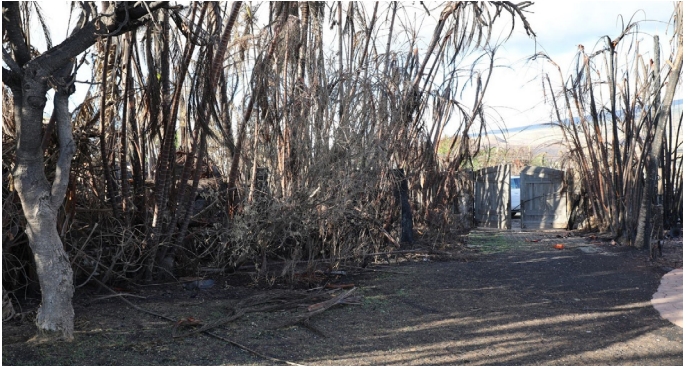
There is evidence of ground fire in the vegetation, potentially from embers, but limited fire spread. The dense, lush (apparently well-watered) foliage and fence may have provided some shielding of the radiant heat from the burning adjacent structure, a contributing factor for the reduced thermal exposure (Figure 4.3.3.6.8).

Figure 4.3.3.6.8 Vegetation and fence on “B” side exposure of 1■ Kamaka Circle.

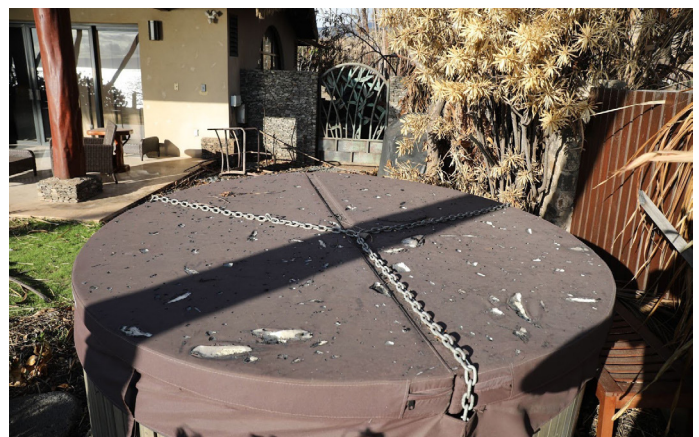
In addition to the thermal exposure from adjacent burning structures, there was considerable ember exposure evident at this location. The hot tub cover and sun shade had numerous burn marks from embers that were energetic enough to pyrolyze these materials after they landed. Ember size characteristics, such as size and shape, can be measured based on the burn marks they leave,<sup>258</sup> such as those shown in Figure 4.3.3.6.10.

Figure 4.3.3.6.10 Ember damage of a hot tub cover reveals the noticeable size variation of embers encountered during the fire.

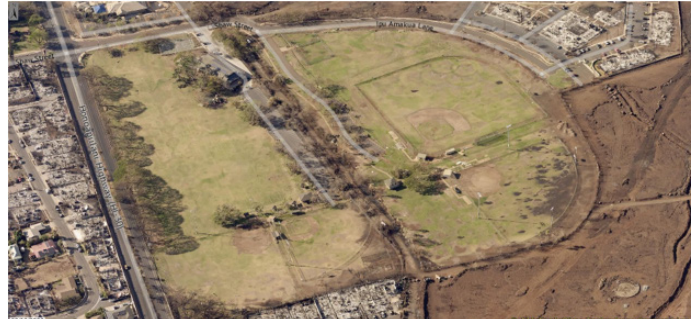
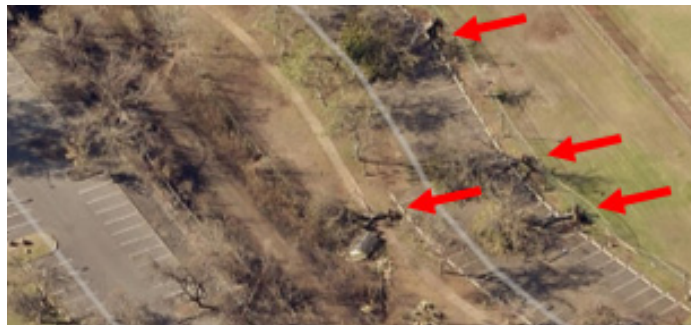
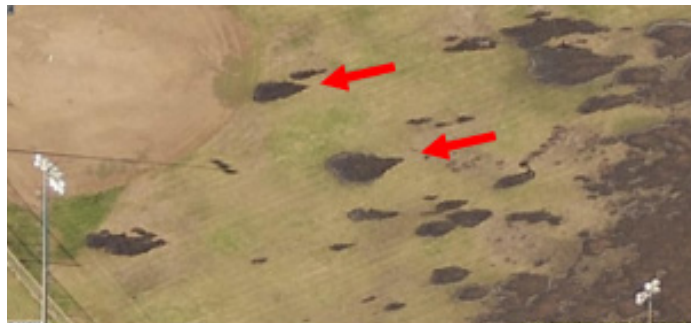
These visual signs of damage suggest winds impacting this area were predominantly from the east (mauka), laying trees and poles to the west (makai) and driving spot fires in the same direction (Figure 4.3.4.1.3).

Figure 4.3.4.1.3 The orientation of wind impacting the 400 block of Front Street in Lahaina can be visualized in the grass fields on either side of Mill Street, around the Lahaina Aquatic Center and Boys & Girls Clubs of Maui (middle). Representative damage to trees oriented towards the west (makai) (bottom). Spot fire damage in the softball field, where the heel of the fire can be identified towards the east (mauka), indicating spread to the west (makai)—assuming flat terrain on the grass field (top).

The vegetation fire spreading from north to south near the Boys & Girls Clubs likely caused fire spotting on the west (makai) softball field (Figure 4.3.4.1.3, bottom) later in the day.

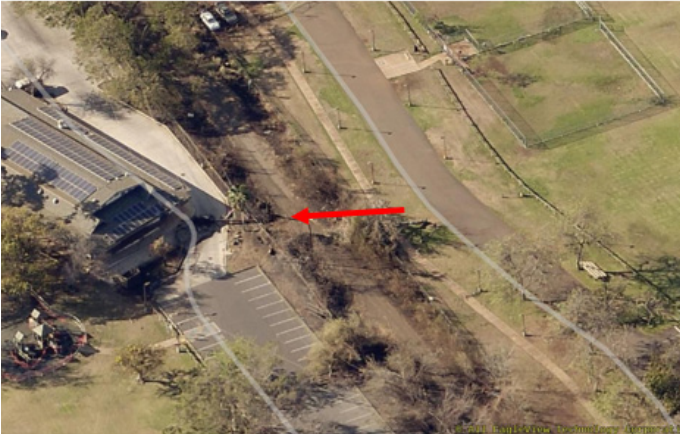
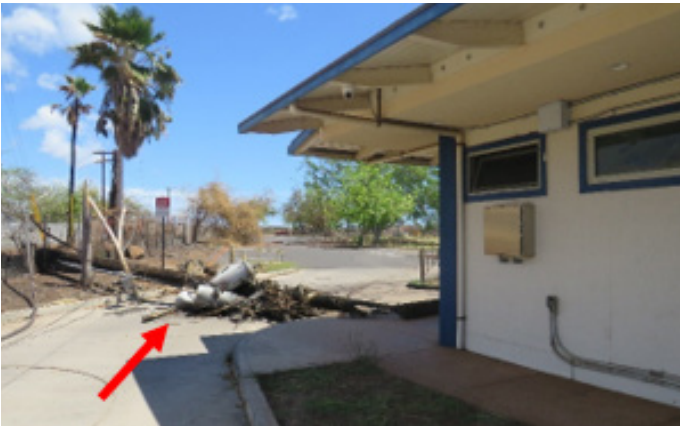
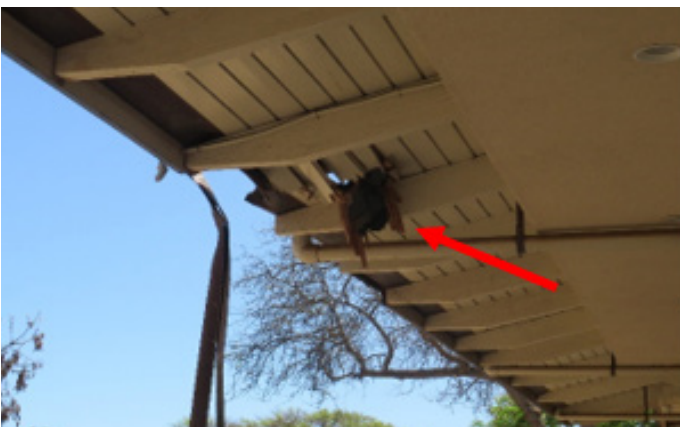
Downed utility poles can be seen along Mill Street to the east (mauka) of the Lahaina Aquatic Center and Boys & Girls Clubs of Maui (Figure 4.3.4.1.4). One (1) of these poles hit and damaged the roof of the Boys & Girls Clubs of Maui (Figure 4.3.4.1.4).

Figure 4.3.4.1.4 Utility pole south of Mill Street that hit and damaged the roof of the Boys & Girls Clubs of Maui.

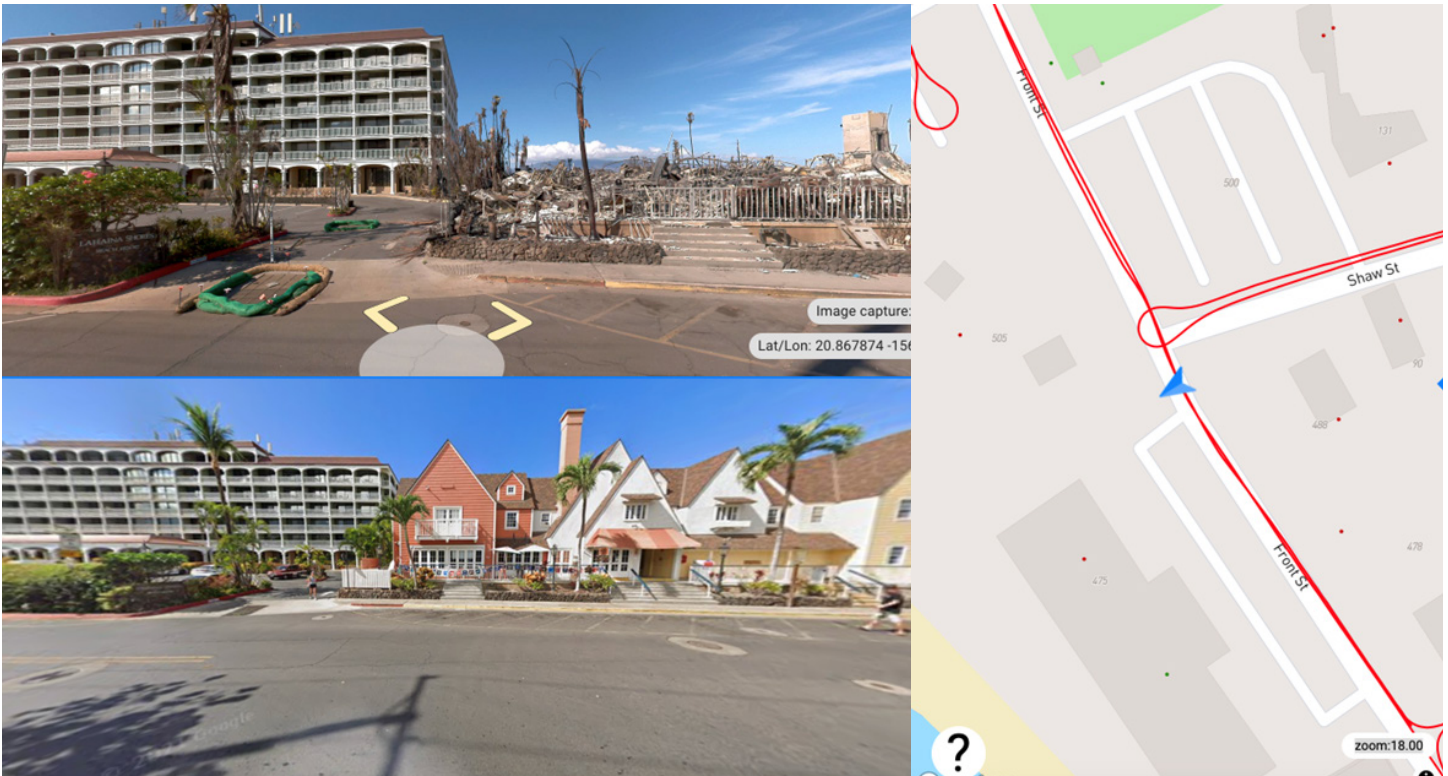
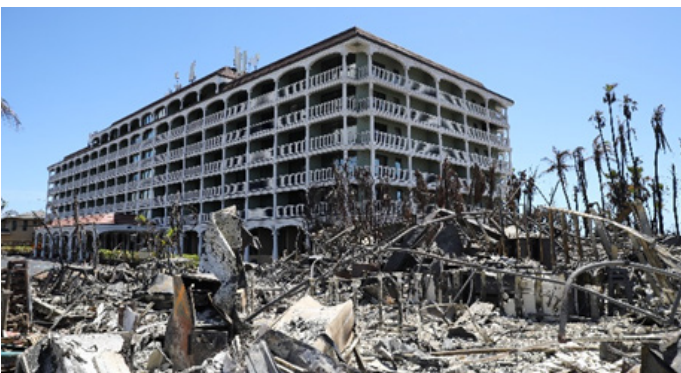
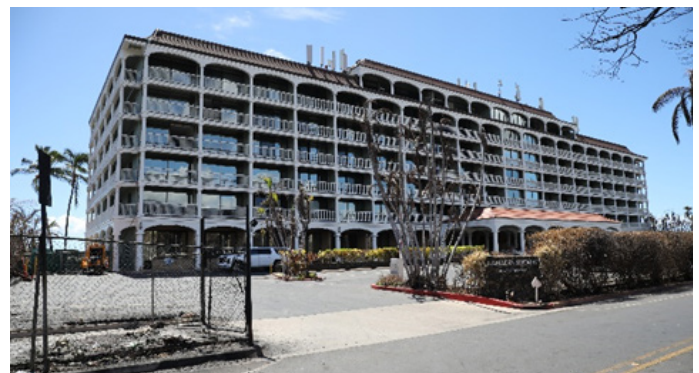
Structure-to-structure fire spread from the north was interrupted at the Lahaina Shores Beach Resort (Figure 4.3.4.1.5). The Shops at 505, immediately north of this structure, were completely destroyed, resulting in notable radiant heat damage to the balconies and windows of the condominium on the north side (Figures 4.3.4.1.7 and 4.3.4.1.8).

Figure 4.3.4.1.5 Lahaina Shores Beach Resort (4 ■ Front Street) in southern Lahaina. Top panel depicts the street location and robotic street imagery before and after the fire. (bottom left) Overall view of structure from southeast (note fenced area in bottom left where trash bins and materials are typically stored) (bottom right). View from northeast beyond the destroyed Shops at 5 ■ Front Street.

A garbage can/disposal area in the southeast parking lot of 4█ Front Street was ignited and destroyed everything inside the fence (Figure 4.3.4.1.5, Figure 4.3.4.1.10).

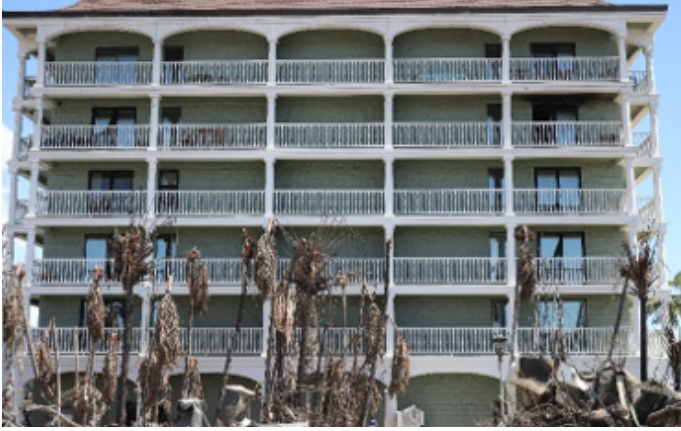
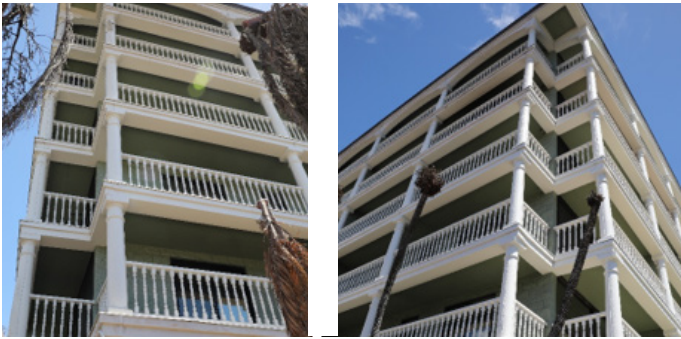
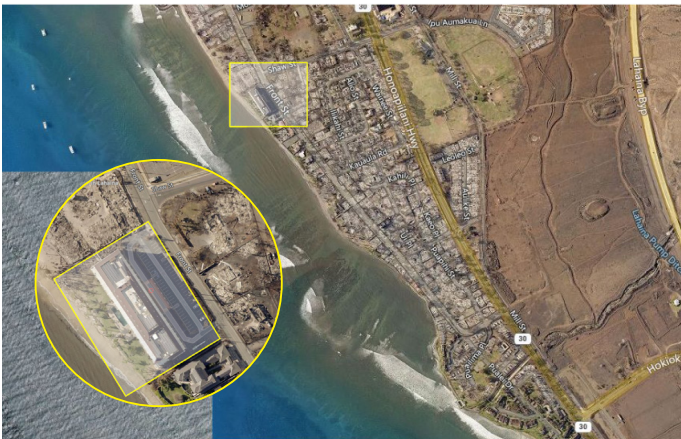
The bulk of the damage to the condominium includes bubbling and flaking of paint on its balconies, which is more severe along the upper two (2) floors. Windows, screens, and patio furnishings were also damaged on the second through sixth floors on the western (makai)-side rooms. Screen and window damage is only noted on the fifth floor in the eastern (mauka)-side rooms (Figures 4.3.4.1.7-4.3.4.1.8).

Figure 4.3.4.1.6 Radiant heat damage to the north end of the Lahaina Shores Beach Resort (4█ Front Street). More severe bubbling to the paint is noted on the western (makai) portion of the structure (middle right) compared to that on the east-mauka (middle left) for the bottom four (4) floors, though more bubbling is noted on the fifth and sixth floors on the west (makai). Larger amounts of lush vegetation between the eastern (mauka) portions of the building compared to the western-side (makai) may have aided in locally reducing radiant heat impacting the north face of this structure. Inset: Viewpoint showing the area depicted in the photographs above.

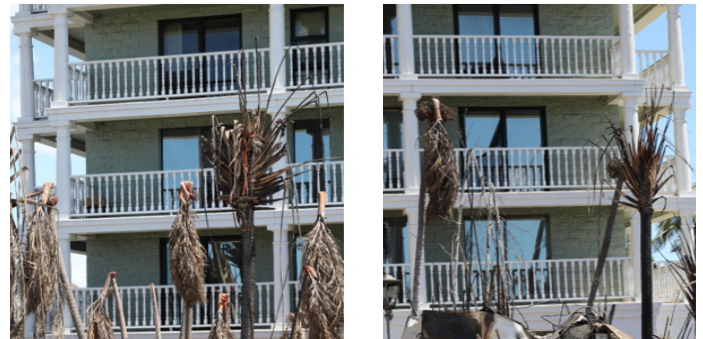
Several screens on the sliding doors dropped from their frame. Cracked glass in windows and doors was noted, but did not appear to cause large pieces of glass to fall out. There was also some radiant damage to furnishings on the sixth-floor balcony, though these items did not appear to ignite.

Figure 4.3.4.1.7 Increased window damage on the lower floor windows on the west-makai (right) compared to the east-mauka (left). Cracking is noted on the second and fourth floor windows with screens partially dropped on the third and fourth floors for the rooms on the west (makai).

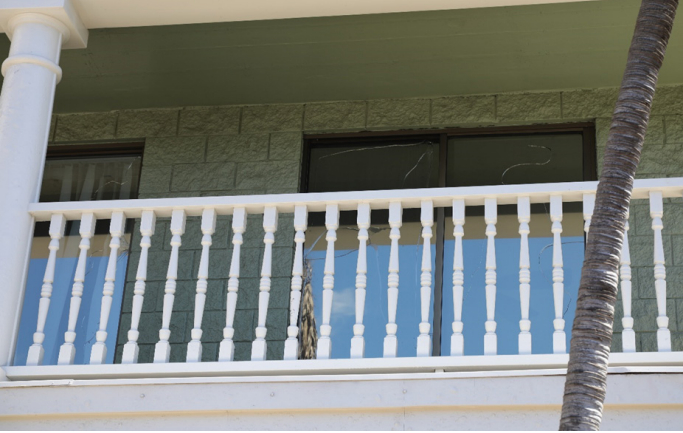
Figure 4.3.4.1.8 Close up of window damage on the second floor windows on the west (makai) room of 4 Front Street.

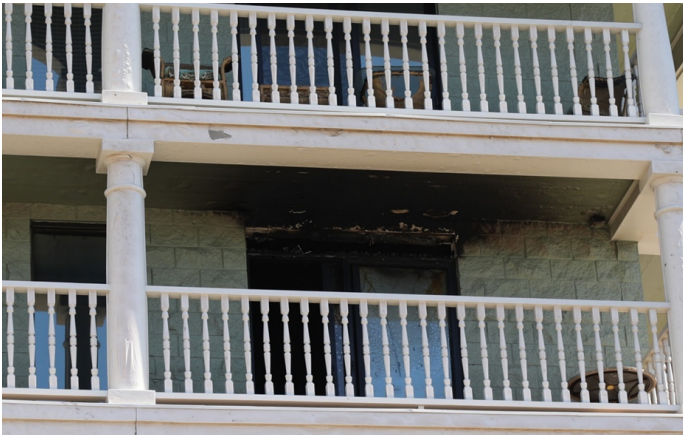
Also on the fifth floor, the door to an western (makai)-side room appears to have been opened with smoke/fire damage above the sliding glass door indicating smoke emanated from this compartment (Figure 4.3.4.1.9). The sliding glass door is more heavily damaged than the others on floors above and below. This damage does not appear to have spread on the exterior of the structure, except as noted, indicating the fire likely came from within the interior.

Figure 4.3.4.1.9 Close up of the open compartment on the fifth floor and thermal damage to furnishings on the sixth floor of 4 Front Street.

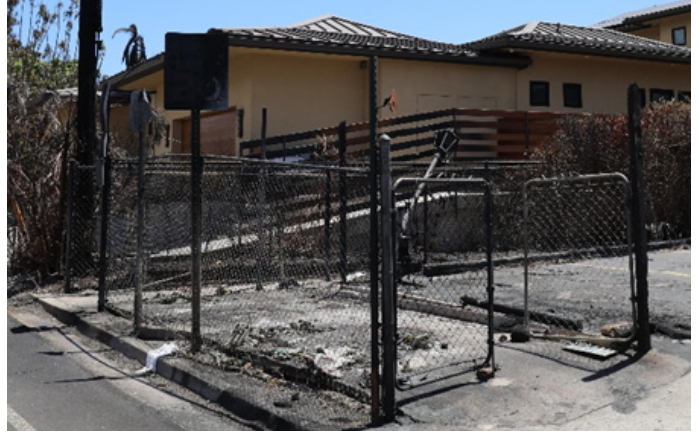
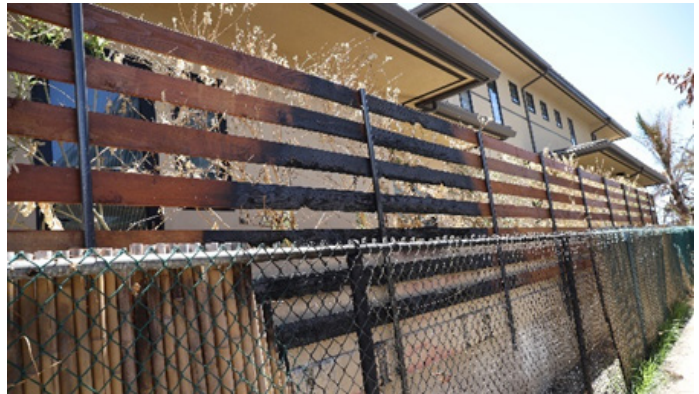
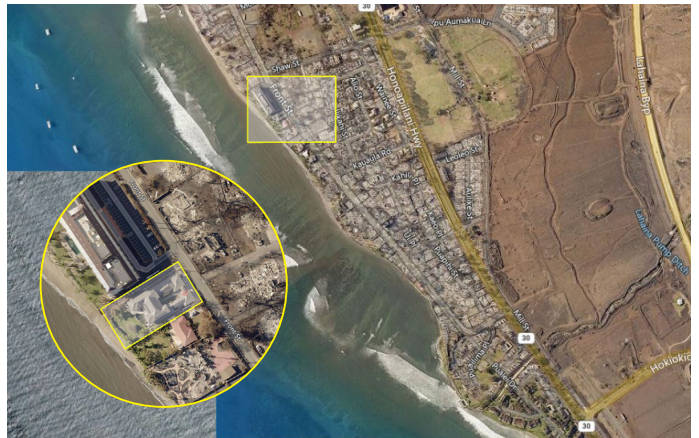
Figure 4.3.4.1.10 Ember and/or radiant heat ignited and destroyed the 475 Front Street garbage can/disposal area, which subsequently damaged a light post and the wood railing/fence on the northwest corner of 4 Front Street. Inset: Viewpoint showing the area depicted in the photograph above.

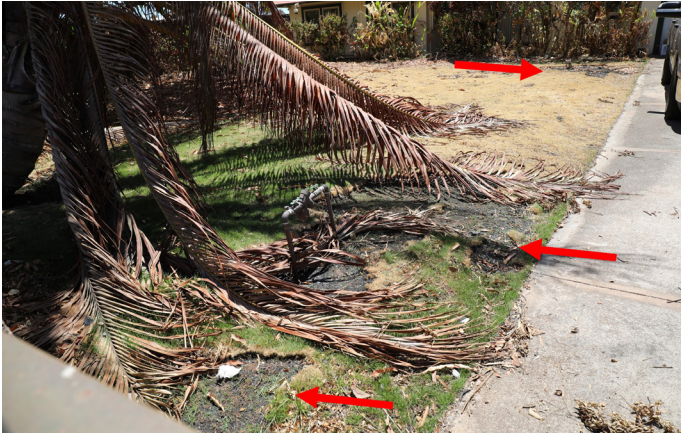
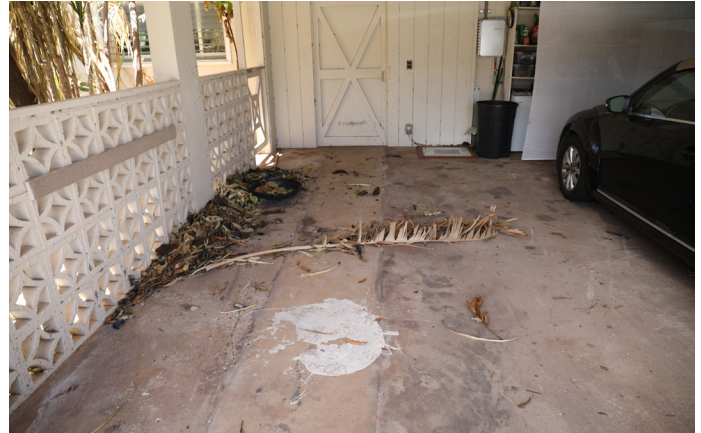
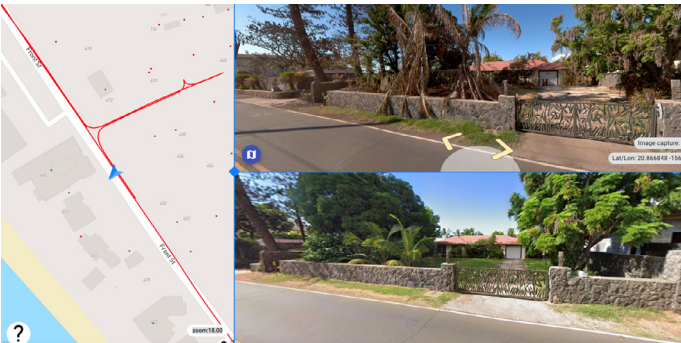
Spot fires were noted in the front lawn of 4█ Front Street, but these also did not spread further to the structure or vehicles (Figure 4.3.4.1.11).

Figure 4.3.4.1.11 Ember-created spot fires in the front lawn of 4 Front Street (top). Bottom panel shows the map location and street image before and after the fire at 4 Front Street.

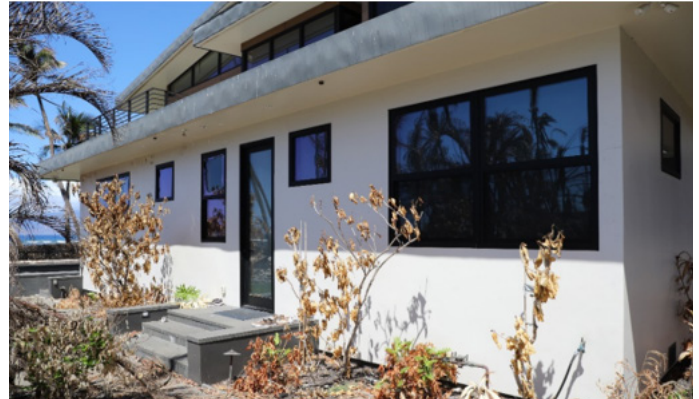
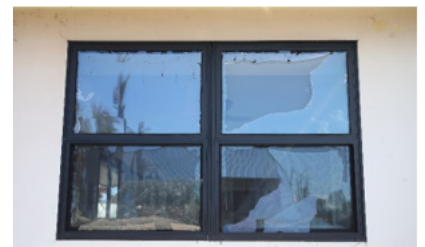
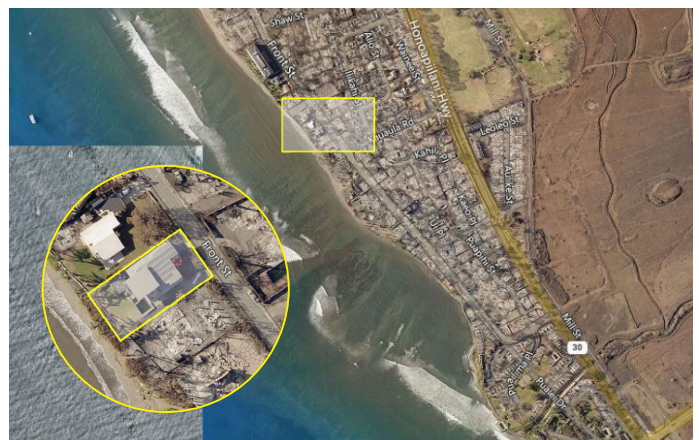
While some bubbling and flaking of the paint on the first floor and slight warping of the metal fascia trim was noted, the most substantial damage was observed on the south-facing windows, particularly on the first floor (Figure 4.3.4.1.13).

The five (5) double-pane windows on the first floor of the structure (closer to the larger 4█ Front Street structure) had the outer pane cracked and with several large pieces of glass that dropped out.

The windows in this structure were in aluminum frames, which are less likely to warp than vinyl frame windows that were commonly found in other structures, which may have been important in the survival of the glass panes in these windows.

Figure 4.3.4.1.13 Window damage on the south side of 4█ Front Street. Ember damage to shoes on doorstep indicates energetic embers were present in the area, which could have increased risk for ignition of interior combustibles had windows completely failed. Inset: Viewpoint showing the area depicted in the photographs above.

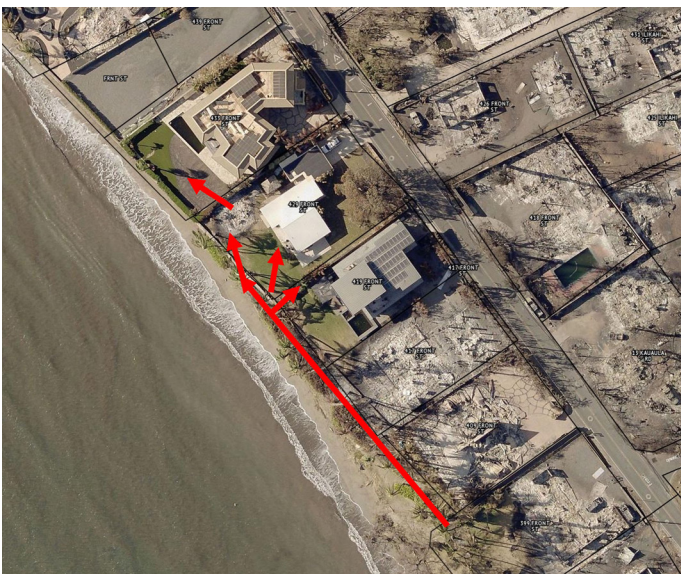
Even though the structures on the west (makai) side of the 400 block of Front Street were adjacent to the coast with no addressed structures to the west (makai), post-fire damage assessment suggests fire spread through vegetation to the west (makai) of several of these structures, which was likely responsible for some thermal damage to these properties (Figure 4.3.4.1.14).

Figure 4.3.4.1.14 Overhead view of 4█-4█ Front Street showing potential path of fire progression along a low stone wall west (makai) of the property lines and then east (mauka) along 4█-4█ property line wood fence, into an accessory structure and a chair by on the patio of 4█ Front Street (see Figures 4.3.4.1.15, 4.3.4.1.16, 4.3.4.1.17, 4.3.4.1.18).

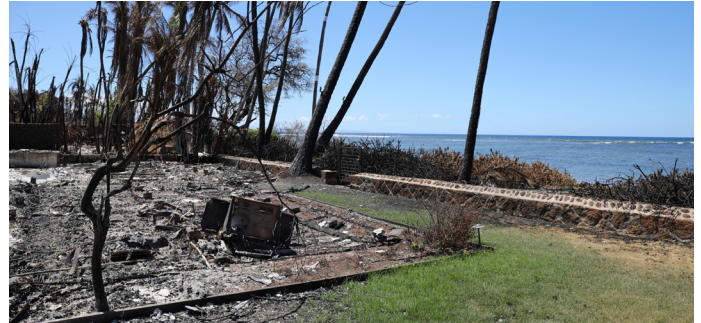
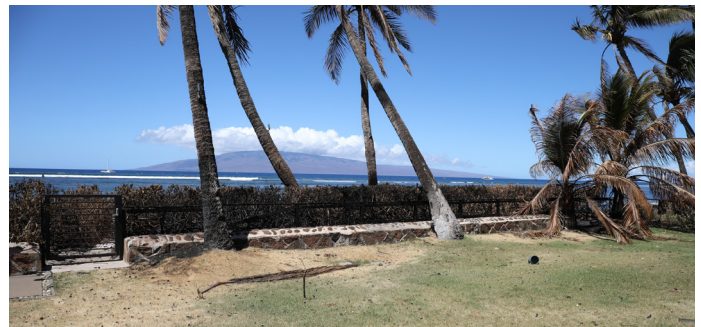
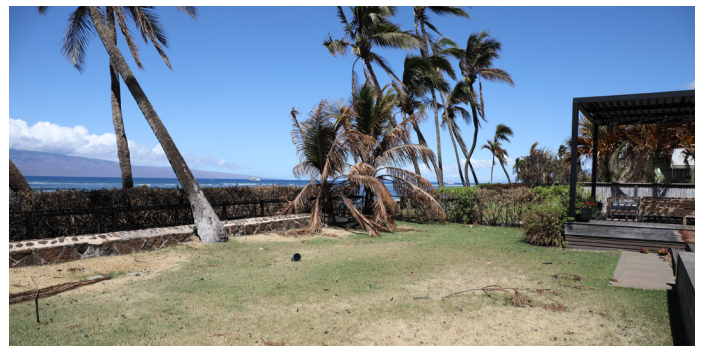
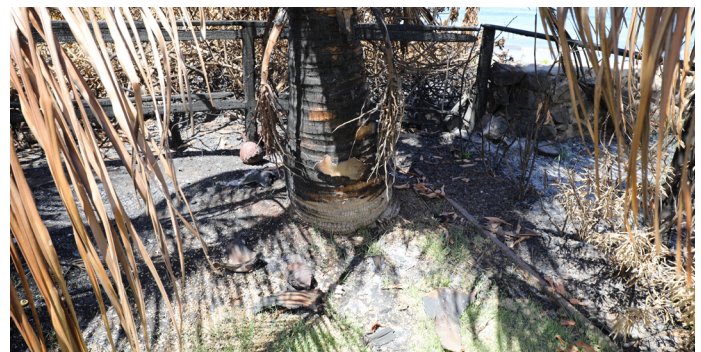
A vegetation fire propagated along the west (makai) side of the low stone wall border to the west (makai) side of several properties in this area, with indications of crossing into the backyard of 4█ and 4█ Front Street at a gap in the wall (between these two (2) property lines) and when palm trees crossover low to the wall toward the ocean (Figure 4.3.4.1.15-4.3.4.1.16).

Figure 4.3.4.1.15 Vegetation and fence fire west (makai) of the low stone walls along 4█ and 4█ Front Street. The vegetation fire remained west (makai) of the stone wall other than at the 4█-4█ property line, where a gap is present.

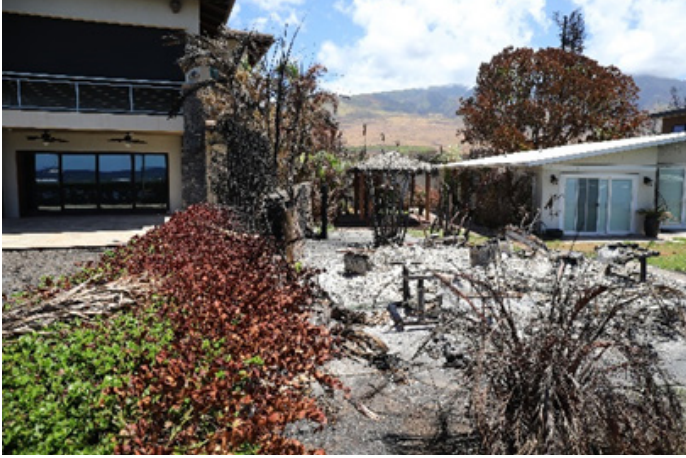
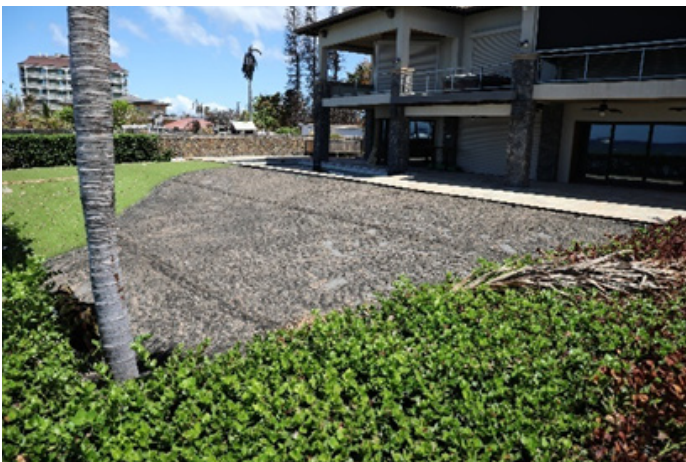
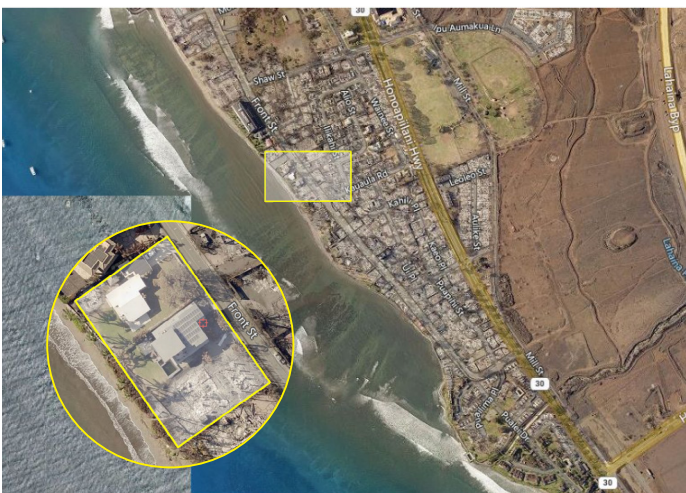
The fire in the accessory structure resulted in the burning of synthetic turf in the backyard of the property to the north (4█ Front Street), which spread toward the west (makai) and northwest with limited spread to the east by the noncombustible patio around the pool (Figure 4.3.4.1.17).

Figure 4.3.4.1.17 Destroyed accessory structure in northwest corner of 4 Front Street (top) and spread into backyard turf in 4 Front Street due to embers and/or radiant heating (middle). Inset: Viewpoint showing the area depicted in the photographs above.

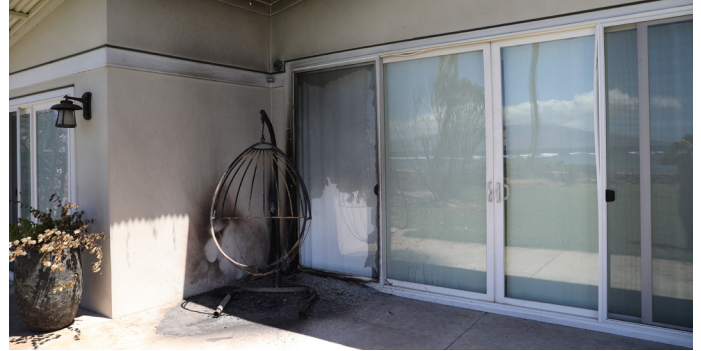
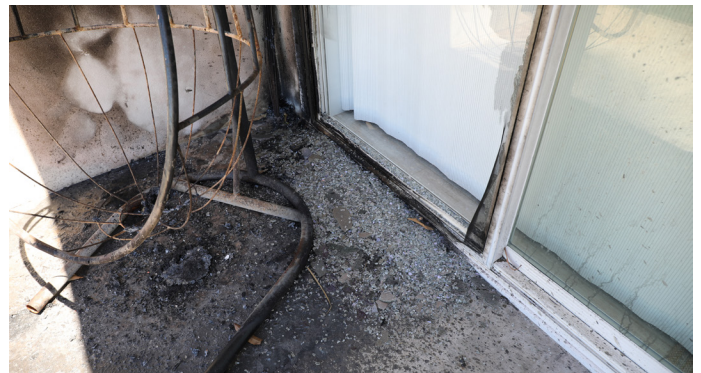
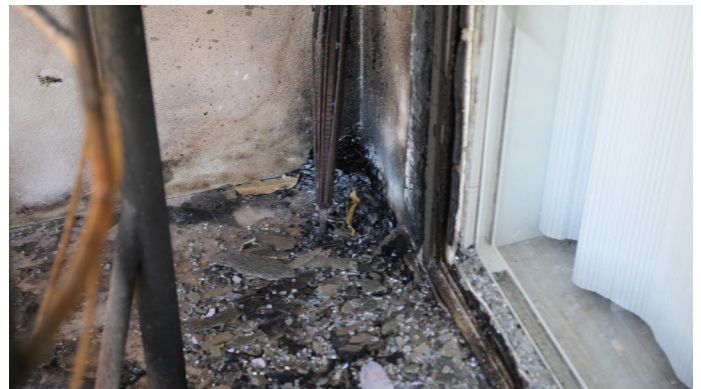
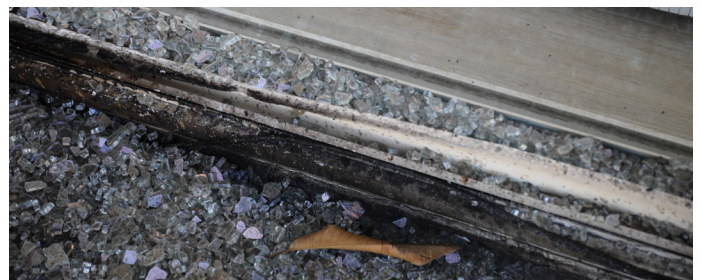
An outdoor chair fire in close proximity to the patio door/window assembly glass resulted in failure of the outer pane of a full-length, fixed window, while the inner pane remained intact (Figure 4.3.4.1.18).

In this specific instance, the glass near this fire was tempered (as can be seen by the many small pieces of glass after failure). This type of glass can withstand more intense fire exposure prior to failure compared to plain (annealed) glass,<sup>259</sup> which is common in other window failures noted in this section.

Figure 4.3.4.1.18 Destroyed chair proximate to rear patio door/window assembly on 4 Front Street, where the outer pane failed and inner pane remained intact. Note the indications of tempered glass in this assembly.

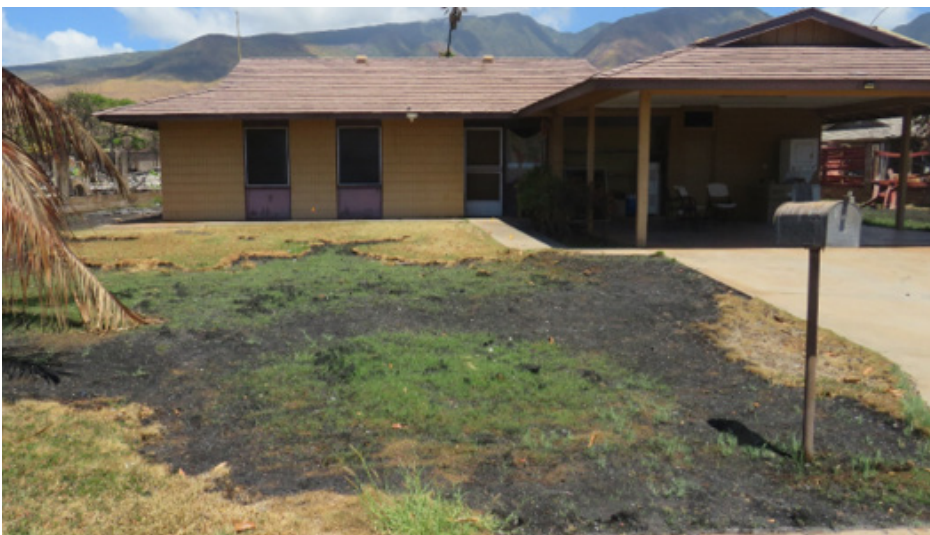
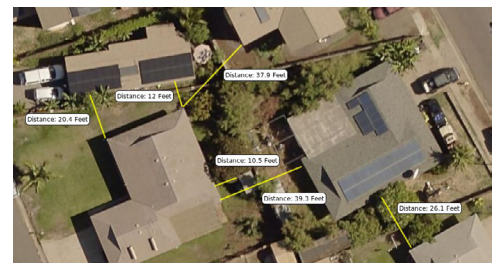
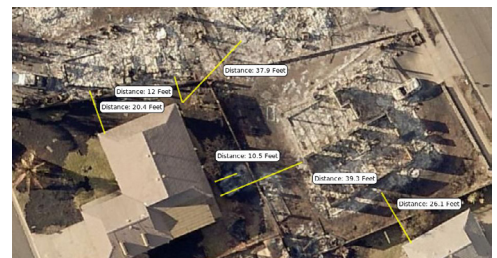
The northmost structure that did not burn in this group of surviving structures is 4█ 'Ālī'ō Street (Figure 4.3.4.2.4), which sustained structural damage to the roof and eaves along the northside and northwest corner. The property to the north of this lot, 4█ 'Ālī'ō Street, is approximately 12 feet from the corner of this roof. Heavy charring at the northwest end gradually decreased by about two-thirds toward the northeast end where paint remains on the soffit (Figure 4.3.4.2.5).

The soffit and roof deck above the eaves burned completely through, but the fire did not continue to propagate.

This structure is one of the few that noted more extensive damage to the eaves/roof than to the windows, which showed no indications of damage, possibly due to the relatively large eaves extending the roofline well past the windows, the presence of a heavy screen between the exposure and the windows, and/or the design of the louvered windows that allowed glass more flexibility to expand when heated without creating enough stress to fracture.

Figure 4.3.4.2.4 Northernmost surviving structure in the cluster of homes along the 400 block of 'Ālī'ō Street and Waine'e Street was located at 4█ 'Ālī'ō Street.

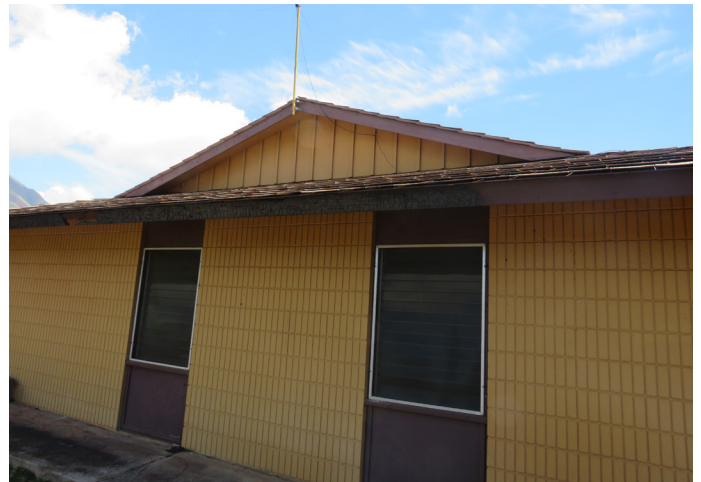
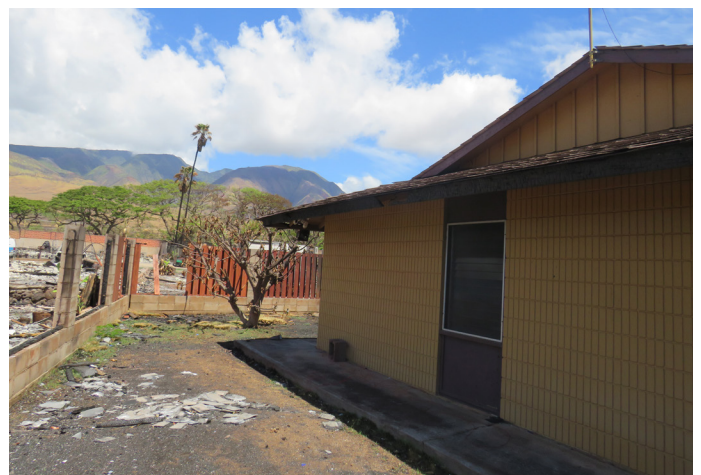
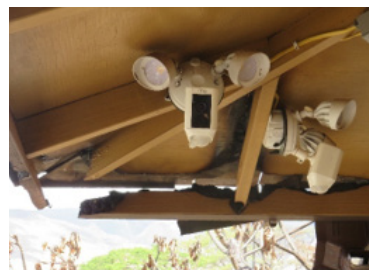
Figure 4.3.4.2.5 Eave and roof damage to the structure at 4█ ‘Ālī’ō Street.

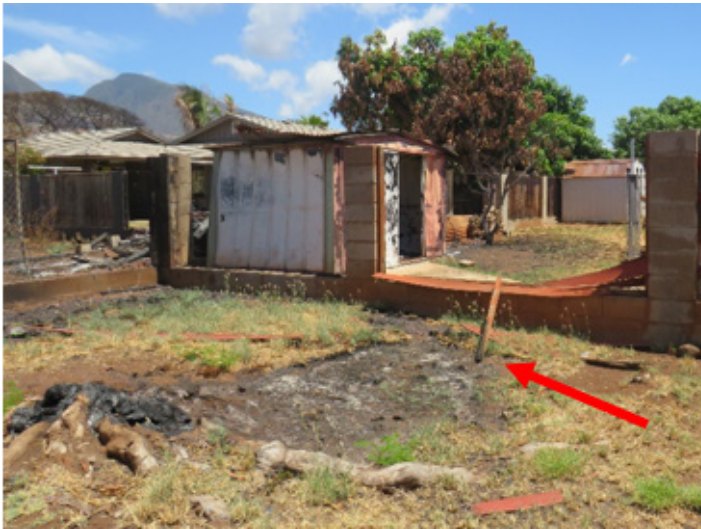
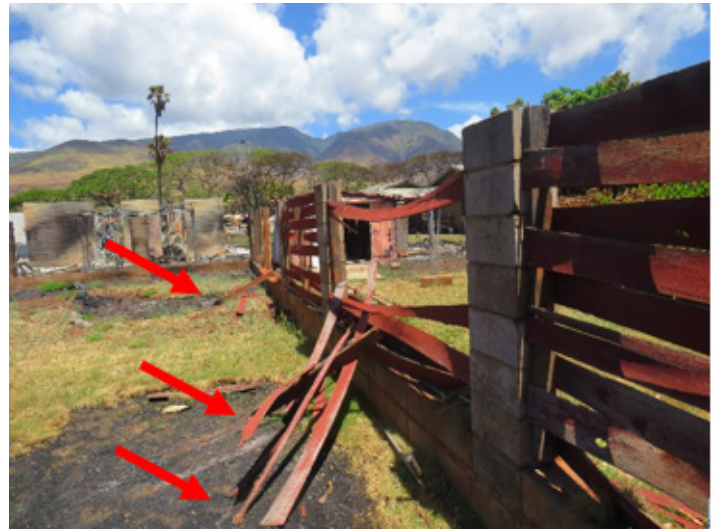
Under the eaves on the west (makai), north, and east (mauka) of the 4█ ‘Ālī’ō Street structure, a wide concrete pathway separated the structure from the grass, which provides an ample buffer to keep the grass fire from reaching the structure.

To the south, the grass was very near the wooden portion of the walls and louvered windows, but the fire did not propagate to the structure. Shifts in wind and/or water from a nearby hose may have aided reducing this spread to the structure. In the west (makai) yard of 4█ ‘Ālī’ō Street, dried grasses ignited, yet islands of unburned grass remained where sprinklers had been set out.

Figure 4.3.4.2.6 Grass fire to the south of 4<sup>th</sup> 'Ālī'ō Street appears to have ignited in multiple locations where charred sections of the fence from the 4<sup>th</sup>-4<sup>th</sup> 'Ālī'ō Street property line landed in dry grass. While it propagated near the wooden structure on the southside of 4<sup>th</sup> 'Ālī'ō Street, it did not transition to the structure.

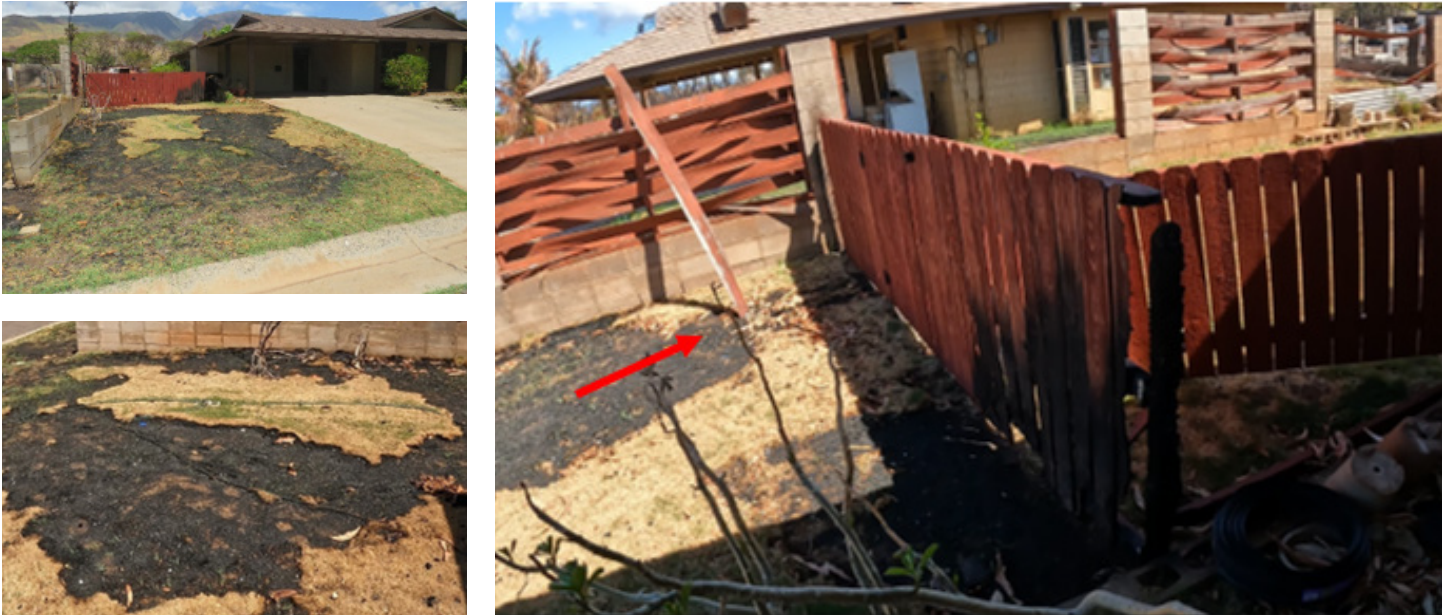
Figure 4.3.4.2.7 Grass fire in the northwest yard of 4█ 'Āli'ō Street appears to have been ignited where charred sections of the fence from the 4█-4█ 'Āli'ō Street property line landed in dry grass, which then backed up to the fence and gate connected to the structure. Sprinklers were distributed throughout the yard, including in the center of this section of undamaged grass.

The grassfire appeared to back up toward the gate and spread along the gate toward the house. However, the fence broke off the post because it was weakened through mass loss due to the fire. The fire did not continue to propagate along the fence after this point.

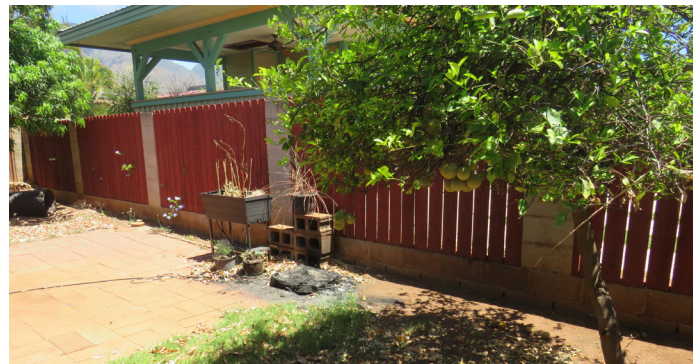
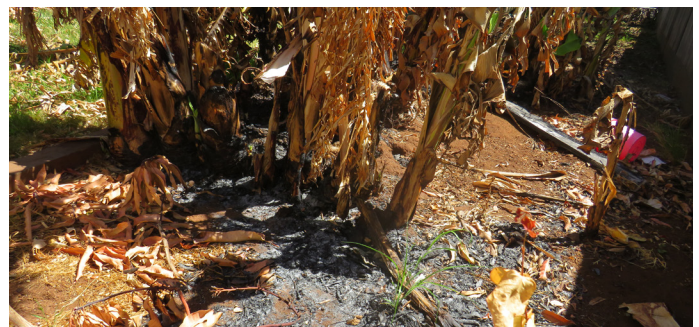
In several of the properties in this cluster, there was some localized ignition of landscaping materials that did not propagate to the structure (Figure 4.3.4.2.8).

Figure 4.3.4.2.8 Localized ignition of landscaping materials in the backyards of (top) 4█ 'Āli'ō Street and (bottom) 4█ Waine'e Street, including a section of deeply charred dimensional lumber that does not appear connected to any other structures in the immediate vicinity.

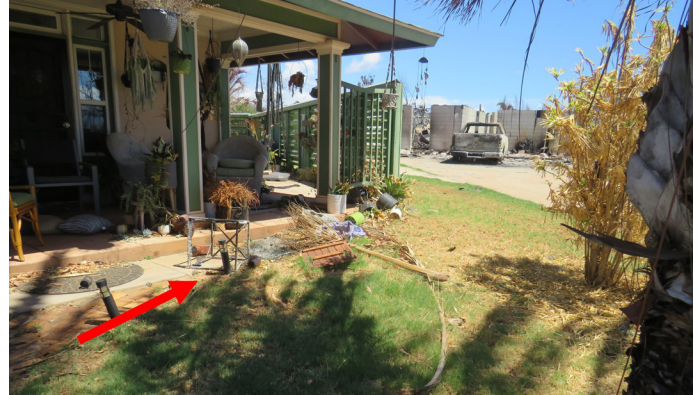
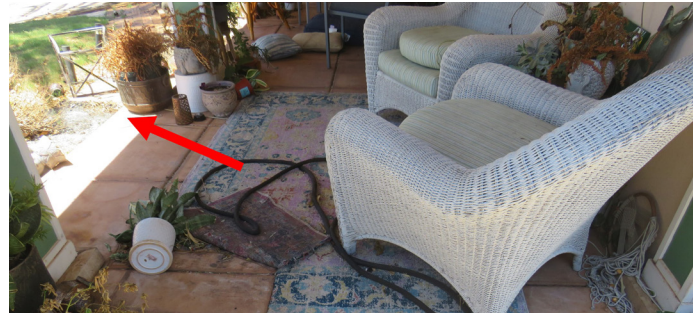
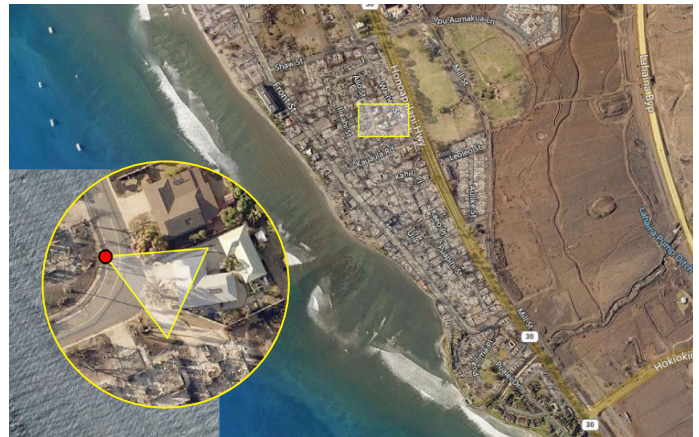
A small fire appears to have started at the southwest corner of the front porch on 4█ 'Āli'ō Street. This fire did not propagate from what appears to be a single item ignited despite a number of other combustible materials in the area, possibly aided by a garden hose in the area (Figure 4.3.4.2.10).

Figure 4.3.4.2.10 A spot fire near the southwest corner of the 4█ ‘Ālī‘ō Street porch was confined to a small area, possibly through water application from the garden hose on the porch. Insert: Viewpoint of 4█ ‘Ālī‘ō Street.

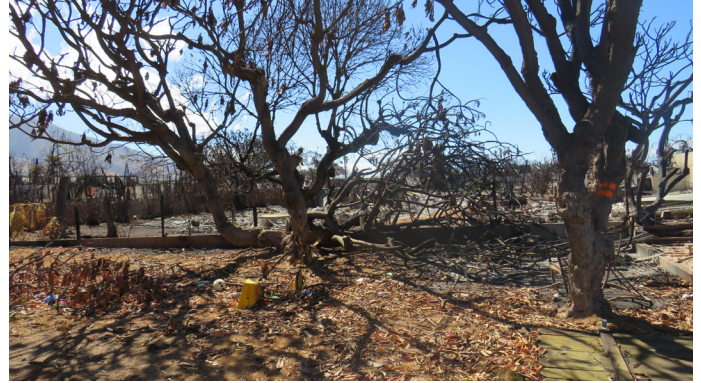
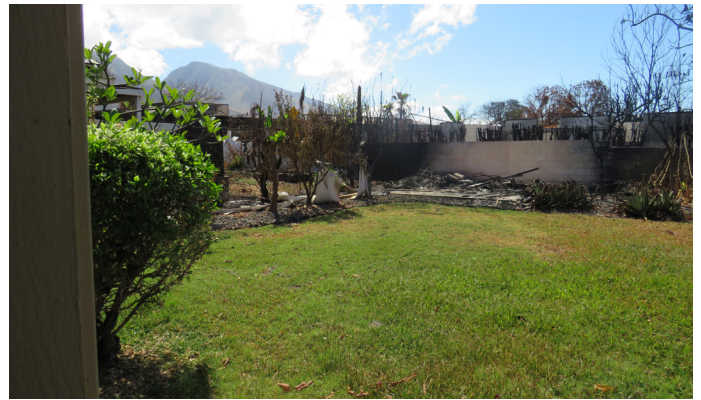
To the south of this cluster of surviving structures, 6█, 6█ and 6█ Kāhili Place were all destroyed by the fire. While the structures along Kāhili Place were located close to the northwest property lines, the surviving structures along Kaua‘ula Road had relatively deep backyards, separating the structures from the south property lines (Figure 4.3.4.2.3 and 4.3.4.2.12).

Figure 4.3.4.2.12 Deep yards to the south of (top) 6 and (bottom) 7 Kāua'ula Road separated these surviving structures from destroyed structures to the south. A shed in the southeast corner of 7 Kāua'ula Road was destroyed, yet this fire did not appear to create thermal damage on the main structure.
