# Lahaina Fire Incident Analysis Report

**September 13, 2024**  
**Columbia, MD**

This document is the second in a series of three (3) reports commissioned by the Hawai'i Department of the Attorney General (DOAG) to provide an independent review of the tragic fire that destroyed much of Lahaina, Hawai'i, on August 8-9, 2023.

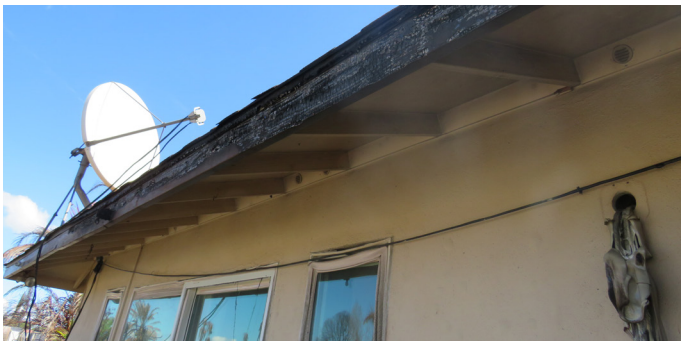
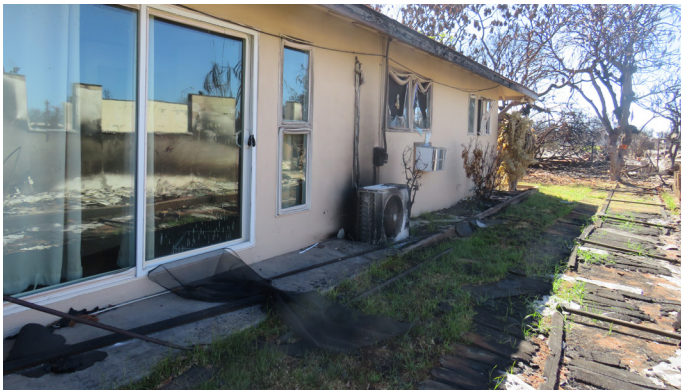
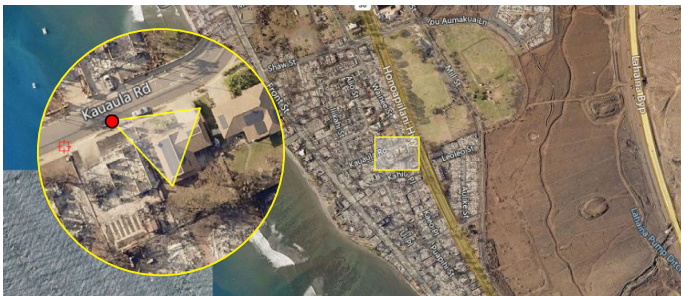
The west side (makai) of 6█ Kaua'ula Road is approximately 12 feet from the destroyed structure on 5█ Kaua'ula Road (Figure 4.3.4.2.16), and suffered heavy thermal damage from radiated heat. The fascia was heavily charred on the outer layer, though did not appear to propagate through its thickness or into the roof (Figure 4.3.4.2.14).

Figure 4.3.4.2.14 West (makai) side of 6█ Kaua'ula Road was severely impacted by radiant heat from the destroyed structure at 5█ Kaua'ula Road, located 12 feet to the west (makai). Heavy charring was noted in the fascia board at the end of the eave and plastic conduit melted, exposing a penetration through the exterior wall for AC access. Windows and screens on the sliding glass patio door were also damaged. Inset: Viewpoint showing the area depicted in the photographs above.

An air conditioning unit was heavily damaged along with the conduit around refrigerant lines along and through the structure. This melted plastic component uncovered a penetration through the exterior wall that could provide a pathway for embers that might reach this area. The windows on the west (makai) facing side of 6█ Kaua'ula Road experienced extensive damage (Figure 4.3.4.2.15).

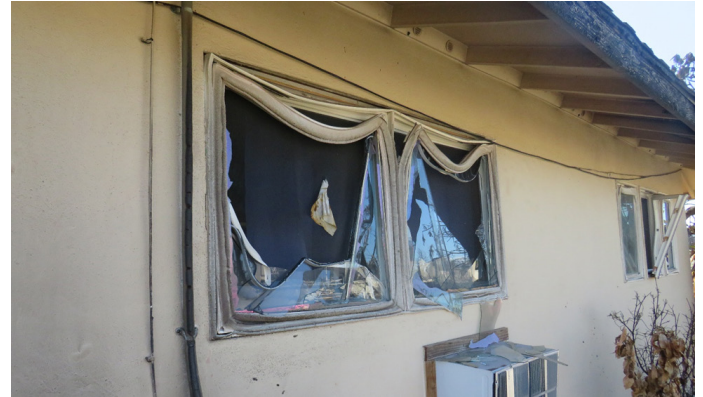
Figure 4.3.4.2.15 West (makai) side of 6█ Kaua'ula Road withstood extensive damage to windows, including three (3) casement style windows where frames were severely warped and both panes of glass failed and dropped out of the frame. The interior screen remained in place for all three (3) windows, and appears to have blocked some materials from entering the structure.

Two (2) windows in the middle of the structure had both panes of plain glass fail and fall out of the deformed frame. In both cases, the window screens remained intact and appear to have limited the ingress of some debris including some material that appeared hot enough to stick to the screen. These windows and screens were oriented opposite the prevailing wind direction, which may have also provided some level of protection for this opening.

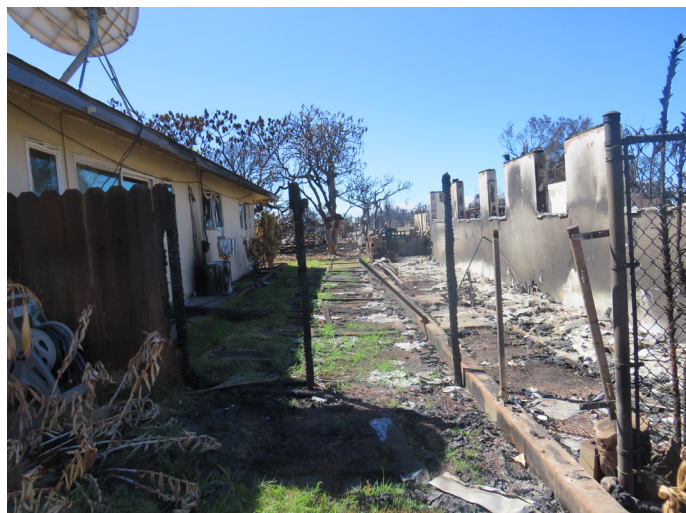
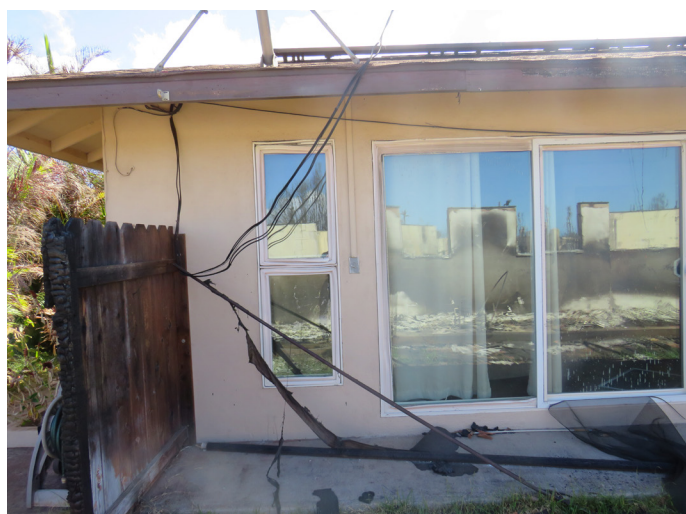
A wood fence between the two (2) structures was also severely damaged and eventually fell toward 6█ Kaua'ula Road (Figure 4.3.4.2.16).

Figure 4.3.4.2.16 A wood fence connecting the west (makai) side of 6█ Kaua'ula to the wood fence on the 6█-5█ property line was destroyed up to the easternmost (mauka) panel that was connected to the structure. Had fire continued along this fence, it could have directly exposed wood eave structure and increased heat flux to the already damaged window immediately south of the fence.

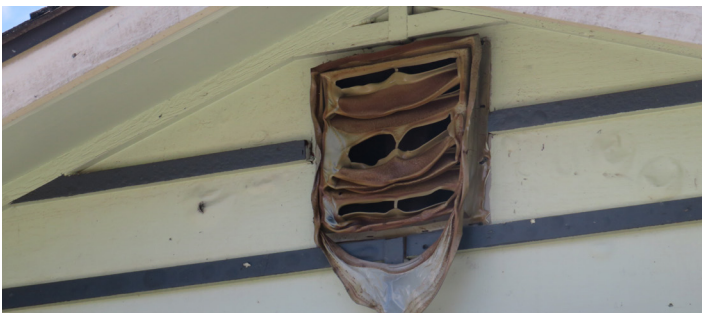
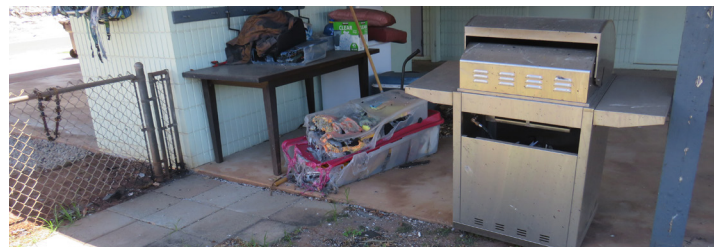
4█ 'Āli'ō Street sustained radiant heat damage on the north side to the structure eaves and gable vent, along with furnishings, belongings, garbage cans, and a large support beam in the covered parking area (Figure 4.3.4.2.18).

The parking area created a large distance from the destroyed structure at 4█ 'Āli'ō Street to the windows in this structure, which showed no visual signs of thermal damage. Much less damage was observed on the south side of the structure, where only softening and deformation of plastic trim around the windows was noted.

The distance between 4█ 'Āli'ō Street and the structures to the north and south were similar (approximately 17 feet). However, the structure to the north was two (2) stories, which likely provided more fuel and increased flux to 4█ 'Āli'ō Street compared to the single story structure to the south.

Figure 4.3.4.2.18 Radiant heat damage to the structure and household belongings at 447 Ālīō Street was noted primarily on the north side.

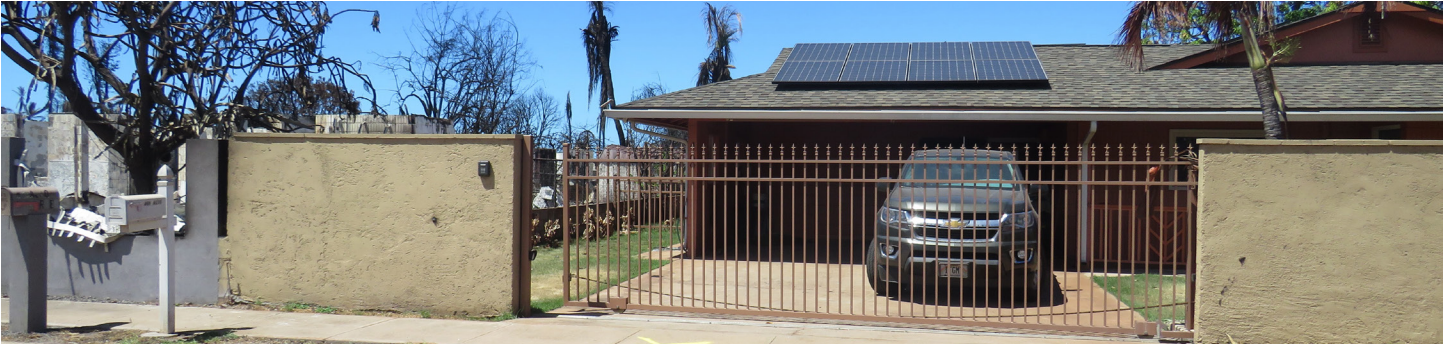
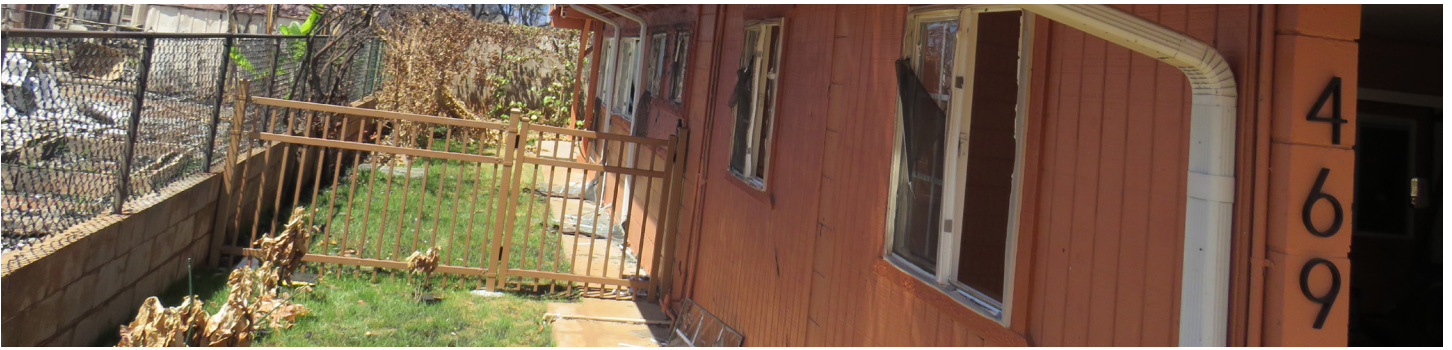
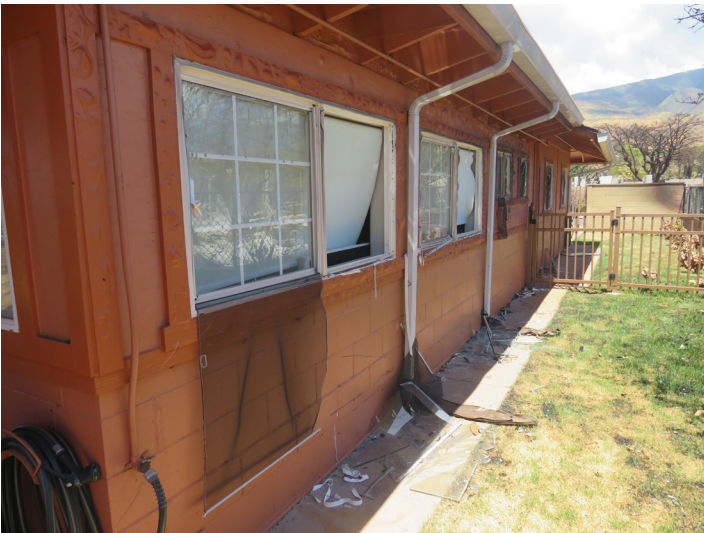
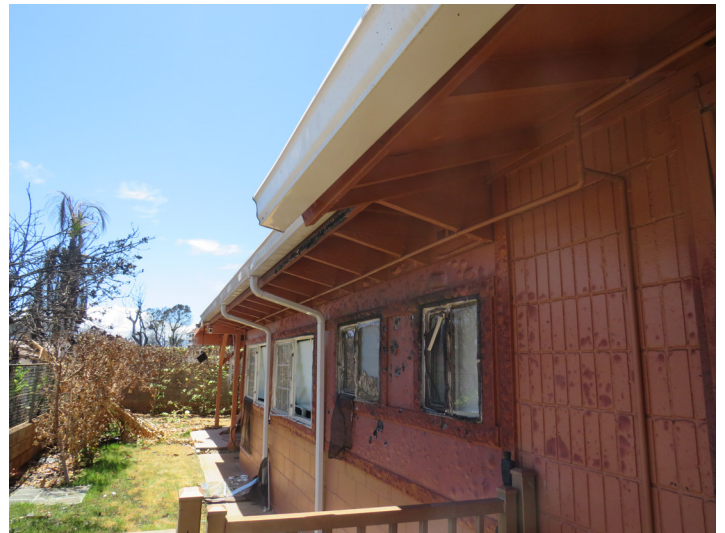
There were no visual indications of thermal damage to the west (makai), north, or east sides (mauka) of 4█ 'Ālī'ō Street, which is situated on a corner lot at the intersection of 'Ilikahi Street and 'Ālī'ō Street. However, the south exterior wall, proximate to the destroyed structure at 4█ 'Ālī'ō Street, was severely damaged. Deep charring of wood eaves and siding are noted, along with considerable paint bubbling (Figure 4.3.4.2.19).

Windows were deeply charred and glass was broken in at least one (1) pane. Four (4) of the sliding glass window assemblies had glass from the fixed sash fall completely out of the frame (moving sash may have been partially protected by a screen that was present between the destroyed structure and the window).

A window treatment in a bedroom and outdoor lamp in the garage showed signs of deformation due to heating, but no interior materials appeared to have ignited. The timing of these window failures relative to other structure fires in the area and shifting winds all impacted the relative risk created by these openings.

These large openings in the building envelope would have provided relatively easy access for embers to enter and accumulate inside this structure if enough energetic materials were transported to this area after the windows failed.

*Figure 4.3.4.2.19 Radiant heat damage to the structure at 469 'Ālīō Street was noted only on the south side. Windows were severely damaged across the entire exterior wall, including four (4) windows where both panes failed and/or sashes fell out. Window screens over the sliding sash were less damaged than the fixed sashed with no screens.*

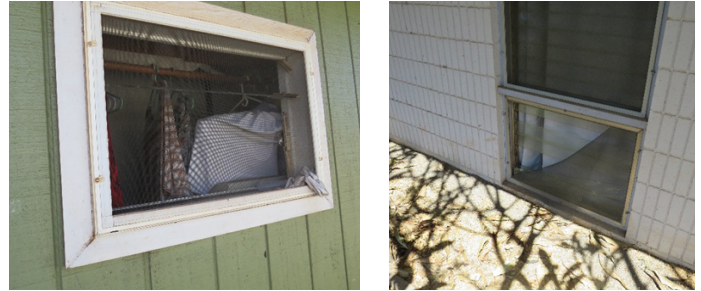
However, in the post-fire analysis, the condition of some window openings in surviving structures that could provide a route for entry through open/broken glass and/or screens were noted. For the examples shown in Figure 4.3.4.2.20, these openings were facing structures that also survived, which would likely result in a lower radiant heat and ember exposure than if oriented upwind from destroyed structures.

Figure 4.3.4.2.20 Examples of open/broken windows and/or screens in this cluster of surviving homes.

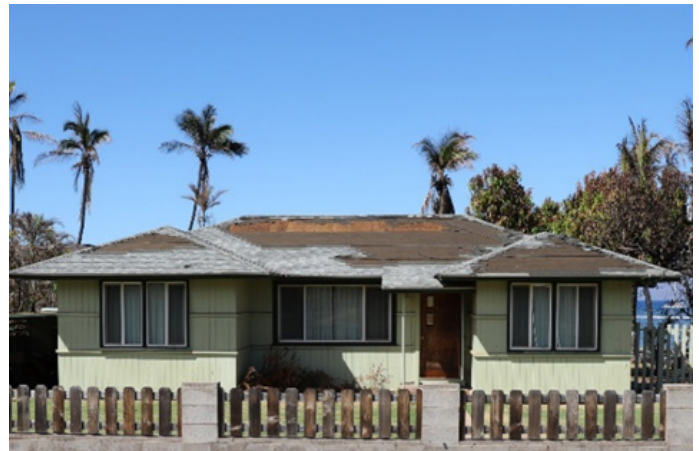
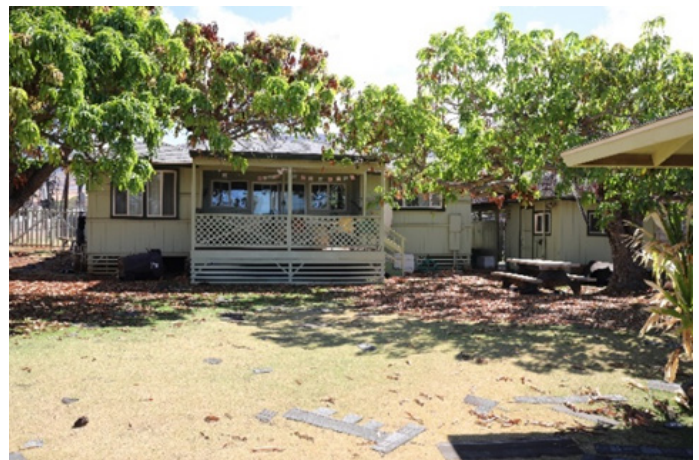
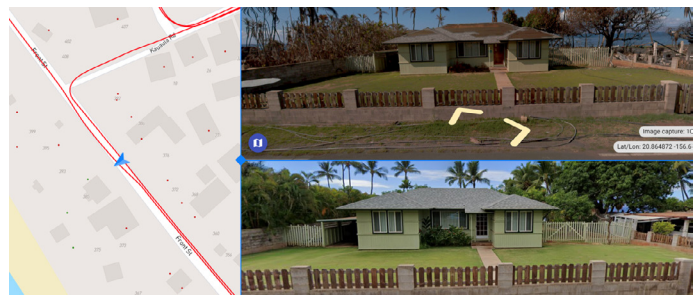
The post-fire damage assessment documented the impact of winds that resulted in damage to the roof of the main and secondary structure on 3█ Front Street (Figures 4.3.4.3.3 and 4.3.4.3.4).

The heaviest wind damage was noted on the east (mauka)-northeast facing aspects of the roof on the primary structure and southeast facing aspects of the roof on the secondary structure. Much of the displaced roofing material was located in the west (makai) yard of this property. This damage is consistent with strong winds from the east (mauka).

Figure 4.3.4.3.3 Strong winds removed shingles and tar paper from the roof of 3█ Front Street (top) and deposited much of this material in the west (makai) rear yard (middle).

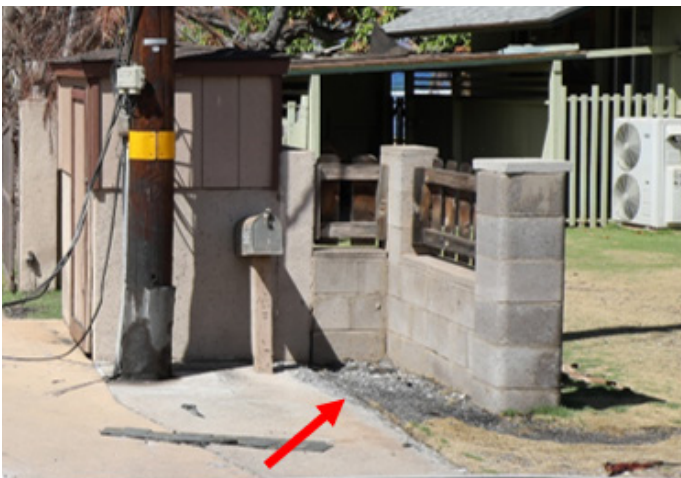
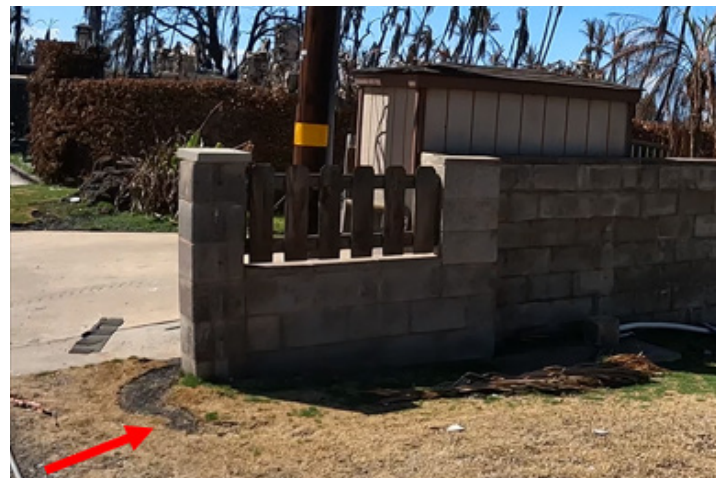
Dense, tall, and lush vegetation was planted between these structures along a block half wall (Figure 4.3.4.3.4 - 4.3.4.3.5). The vegetation likely aided in shielding 3█ Front Street from some of the radiant energy from the fire at 3█ Front Street, while also blocking some of the airborne embers. The block half wall would have also reduced these mechanisms of fire spread, particularly for embers moving along the ground under the force of wind.

Figure 4.3.4.3.4 Tall, lush vegetation was planted along block walls on either side of the driveway to 3█ Front Street, which may have provided protection to the 3█ and 3█ Front Street lots. The block wall south of 3█ Front Street also influenced the ember movement. Note pile up in corner of wall (bottom left) and wind driven burn scar in grass around the wall toward the front of the structure showing the likely path of ground based embers deflected towards the north and away from the open garage (bottom right).

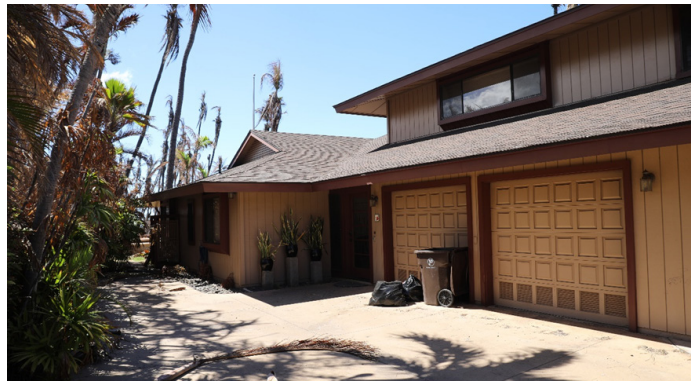
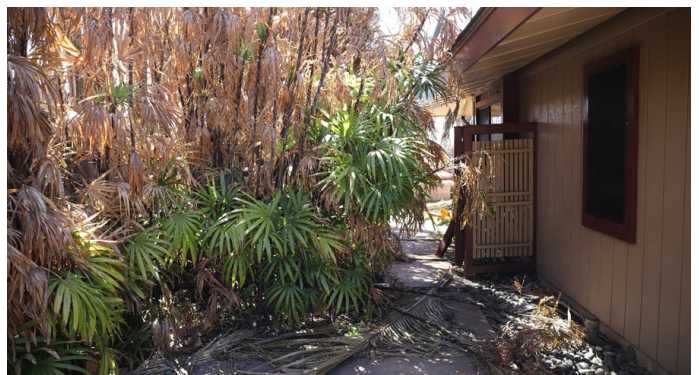
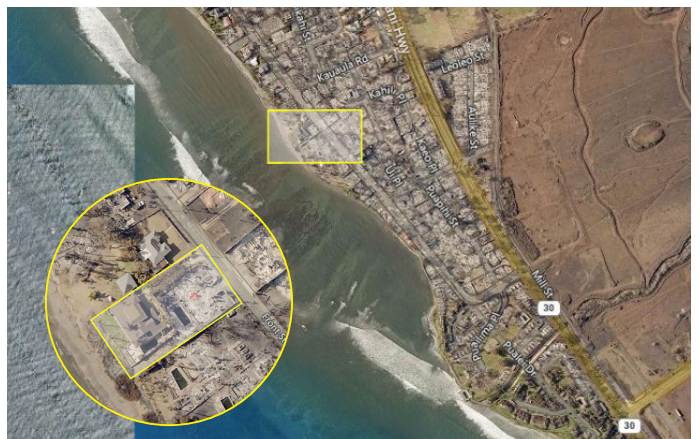
Figure 4.3.4.3.5 The east (mauka) facing exterior wall of 3█ Front Street did not have any indication of radiant heat damage and there were relatively limited signs of embers along the ground. Tall, lush vegetation plated along a block half-wall between 3█ and 3█ Front Street was still standing, including some plants that remained green at the time of the post-fire analysis. Inset: Viewpoint showing the area depicted in the photographs above.

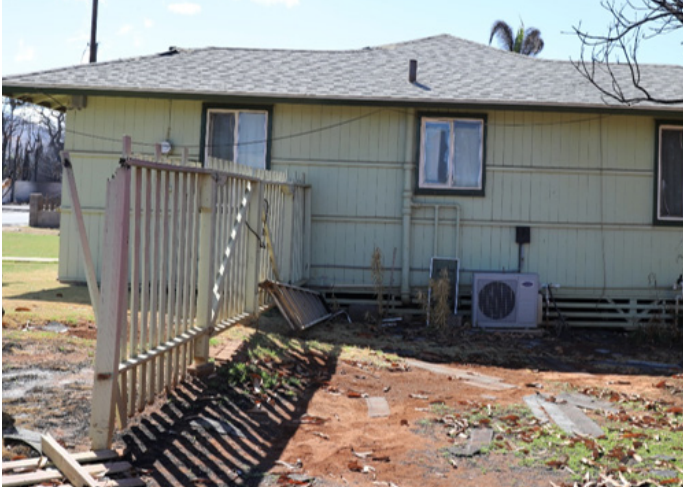
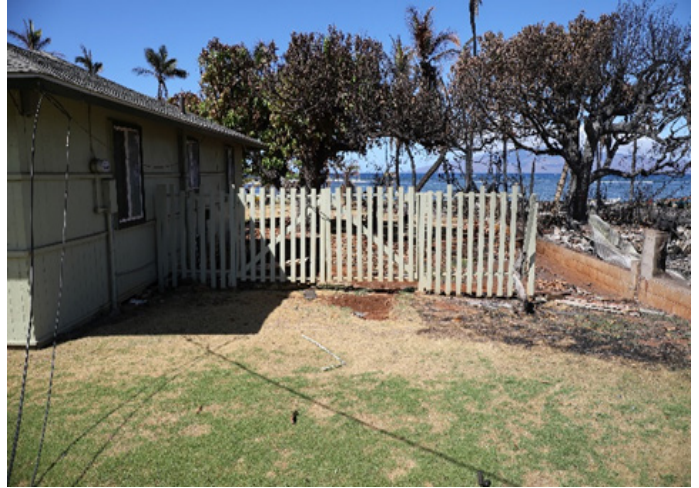
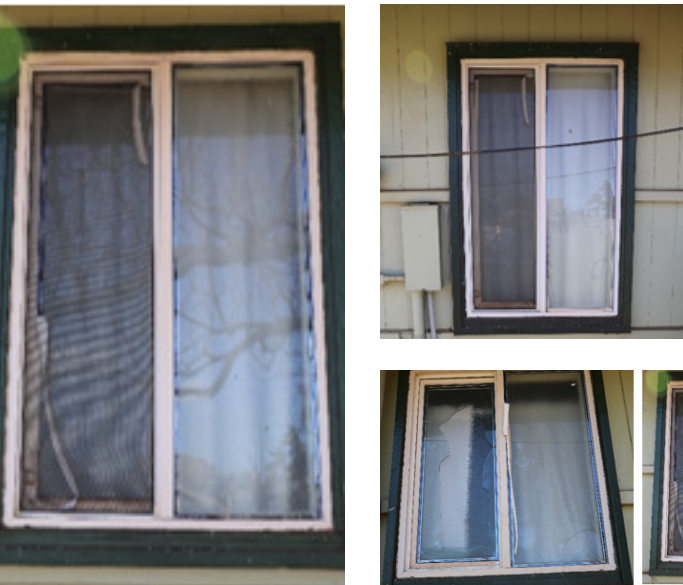
Immediately to the north of 3█ Front Street, the structures at 3█ Front Street were completely destroyed. The main portion of the structure on 3█ Front Street was more than 55 feet from the 3█ Front Street. Despite being a longer distance than the destroyed structure to the south, the radiant heat exposure on the north side of 3█ Front Street was sufficient to crack the glass in several windows and deform portions of the vinyl window frame material.

In all cases, it appears that only the outer pane of the windows were cracked and the inner pane remained intact (Figure 4.3.4.3.6). Paint on the wood siding was bubbled in a few locations, but no thermal damage was visible on the roof.

Figure 4.3.4.3.6 Window damage along the north wall of 3 Front Street.

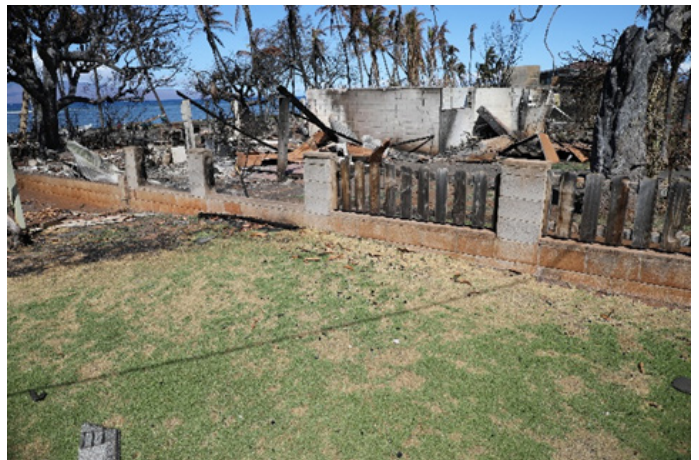
A wooden fence running perpendicular from the property line wall/fence to 3█ Front Street was heavily damaged in the fire (Figure 4.3.4.3.7). A portion of the northmost panel was consumed and could have provided a pathway for fire propagation between structures. However, the fence became dislodged and came off the next support post.

There were no obvious signs that this fence panel was forcibly removed by human intervention. However, this possibility cannot be ruled out at this time. In previously published wildfire investigations, it has been shown that combustible fences can act as a “wick,” allowing fire to travel between different structures or between structures and nearby vegetation.<sup>260</sup>

This displaced fence panel may have interrupted the fire spreading from the north to 3█ Front Street.

Figure 4.3.4.3.7 Burnt, charred, and broken wooden fence from the 3-3 Front Street property line directly connected to the structure at 3 Front Street. Wooden fences can act as a “wick,” carrying fire from one structure to the next. The northernmost panel was disconnected from the rest of the fence, removing this mechanism of fire spread.

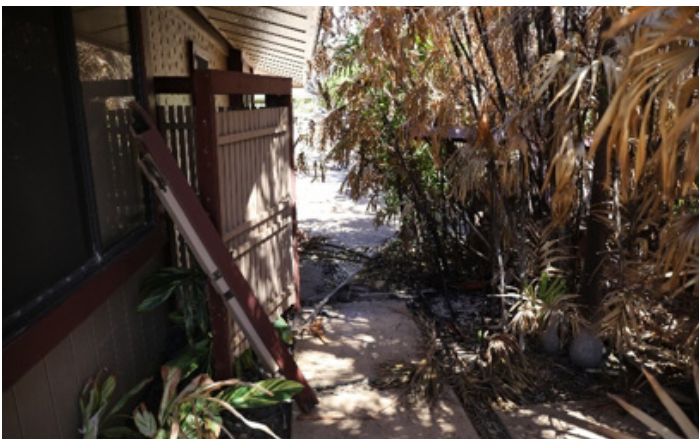
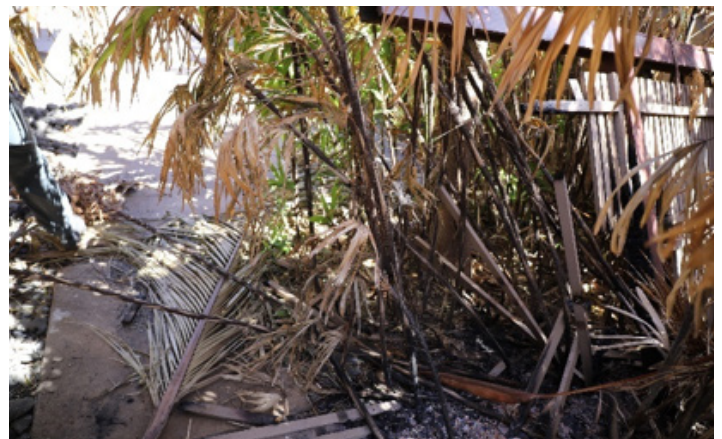
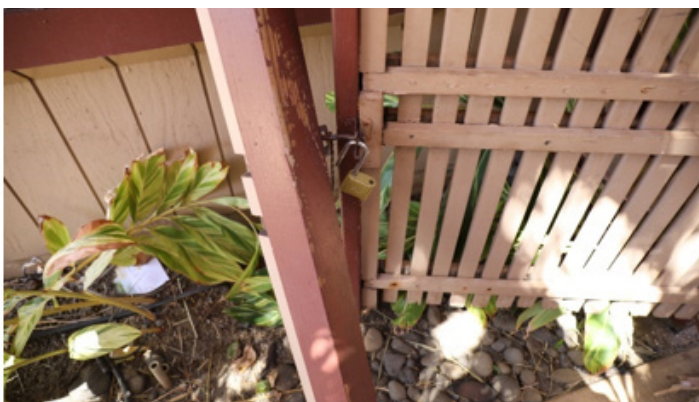
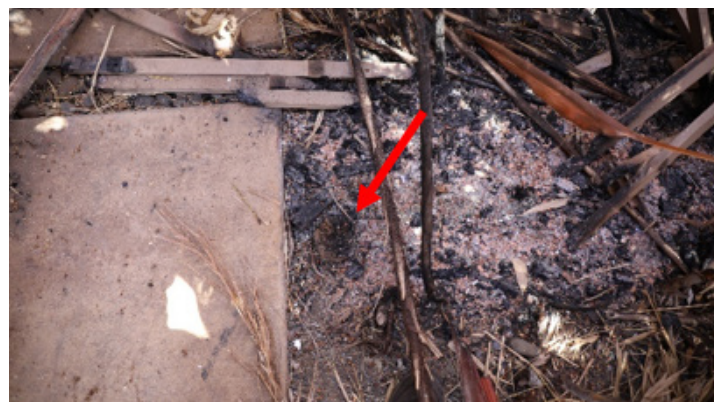
A wooden fence that physically connected the 3 Front Street property line and the exterior wall of the 3 Front Street structure also appeared to have been ignited by embers that landed in the dead leaves near the block half-wall base. While several pickets and rails were consumed in this spot fire, the support post for the gate appears to have been broken off and leaned against the structure.

Based on inspection of the physical damage to the post, the orientation of the gate and fence, and the char marks on the portion of the post remaining in the ground, it is likely the broken support post was caused by the gate being forced open while burning or smoldering was occurring in the area.

Figure 4.3.4.3.8 Gate and post moved away from burning fence pickets that interrupted the continuous wooden fuel from the 3█-3█ property line to the east (mauka) wall of 3█ Front Street. The charred end of the post remaining in the ground is indicated by the red arrow in the bottom right image.

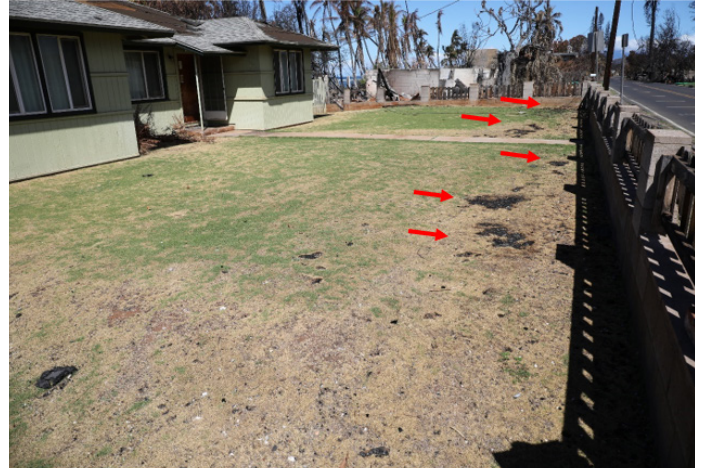
were noted in the yard to the east (mauka) of the structure, inside the front block half wall (Figure 4.3.4.3.9).

Burned areas appeared to be typically located closer to the east (mauka) and north wall and northeast corner, though there was one (1) spot very near the southeast corner of the structure that did not spread to the residence.

Figure 4.3.4.3.9 Multiple burn scars on grass in the east (mauka) yard of 3█ Front Street, particularly along the east (mauka) and north block half wall. One (1) spot formed near the southeast corner of the residence (bottom right), but did not extend to the structure.

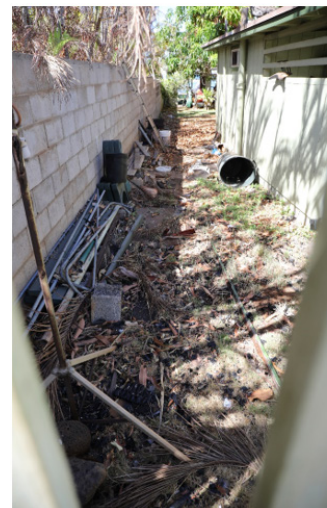
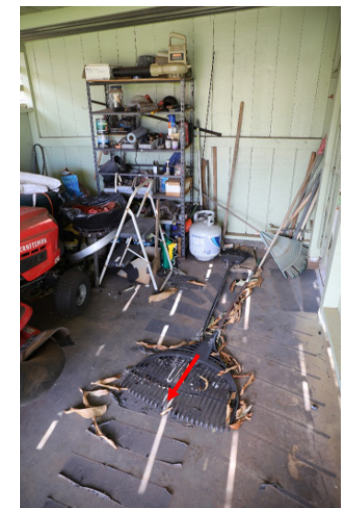
Accumulation of embers was also found in the open garage and side yard between the garage and block wall between this property and the driveway to 3█ Front Street (Figure 4.3.4.3.10). Embers collected in these areas did not have enough energy to ignite the combustibles present and eventually cooled down or burnt out.

Figure 4.3.4.3.10 Embers accumulated in both the side yard and open garage area but did not have enough energy (individually or accumulated) to create sustained ignition of combustibles. There are some indications of localized burning/melting, such as a tine on the plastic rake, but these did not spread.

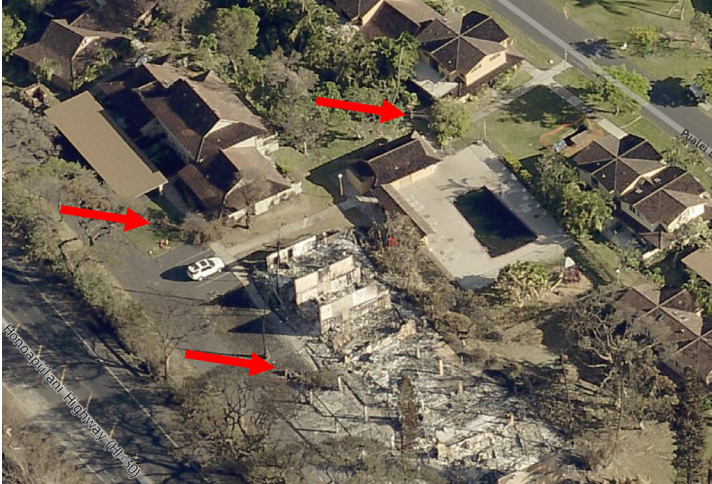
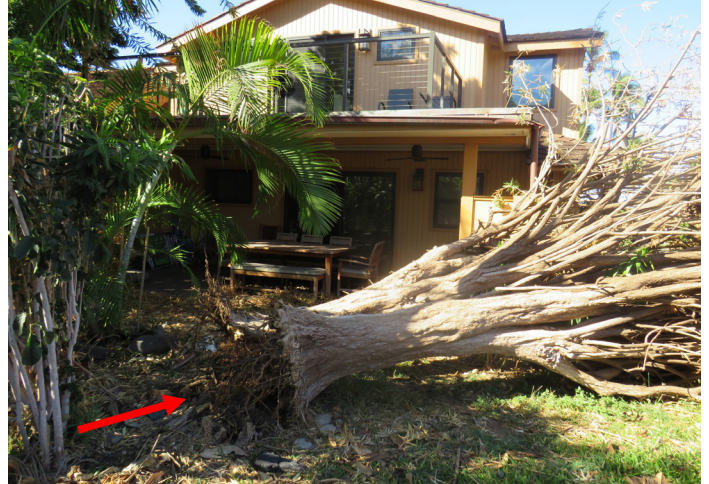
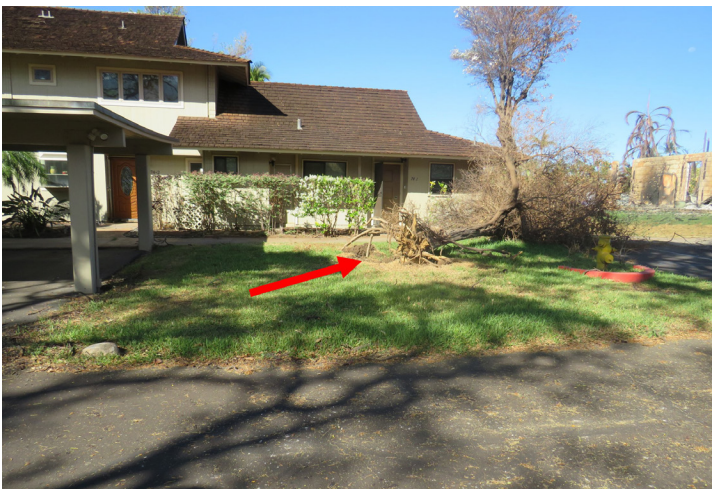
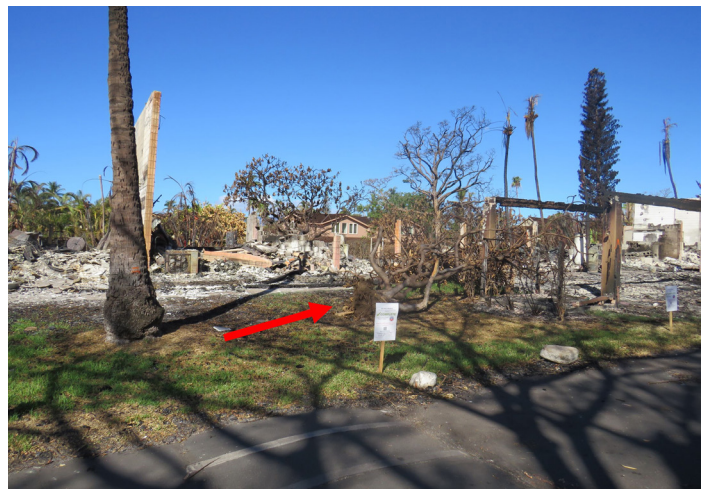
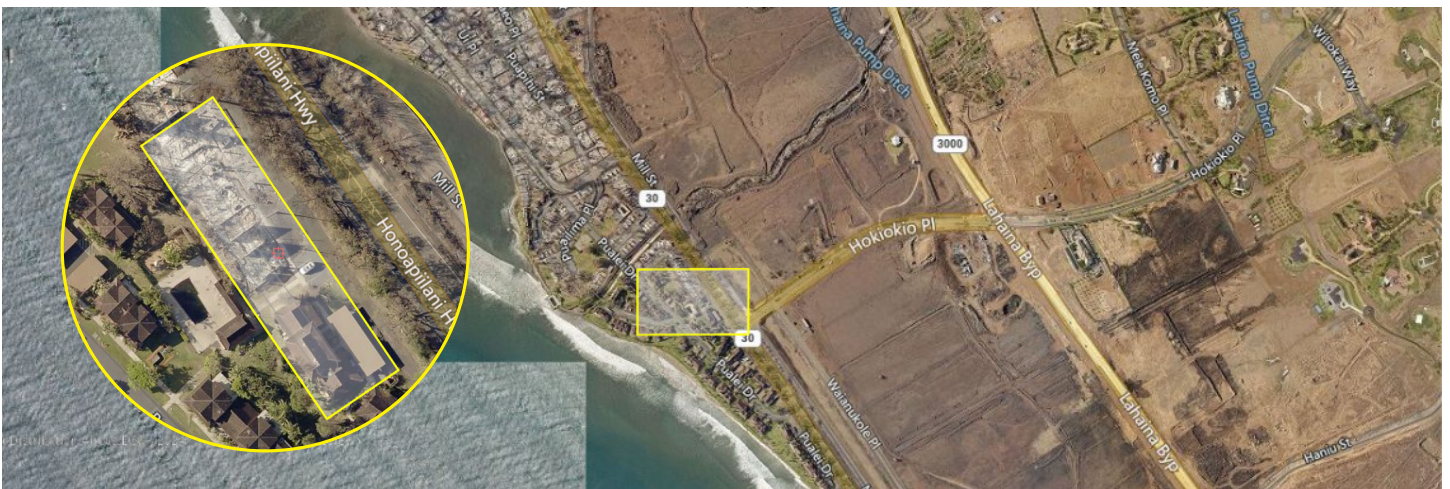
The post-fire damage assessment in Puamana documented the impact of winds that resulted in uprooting of several trees in this area, with the fallen trees most often oriented westward (makai) or northwestward (Figure 4.3.4.4.4).

Figure 4.3.4.4.4 Trees downed by wind facing west (makai)-northwest in the vicinity of 6 and 7 Puakukui Place. Red arrows identify the approximate location and orientation of fallen trees. The overview image (top left) is oriented with north facing towards the bottom. Inset: Viewpoint showing the area depicted in the photographs above.

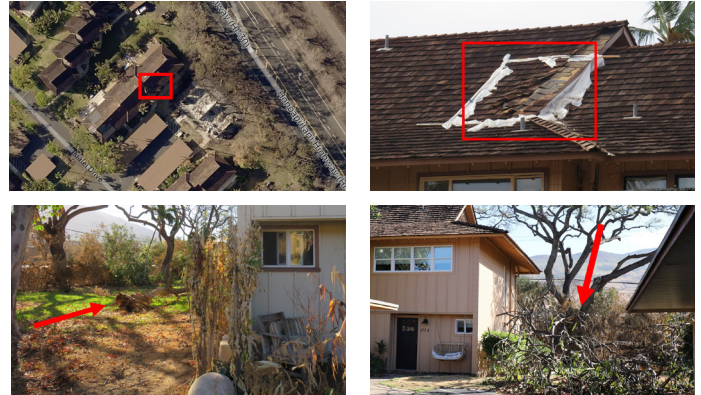
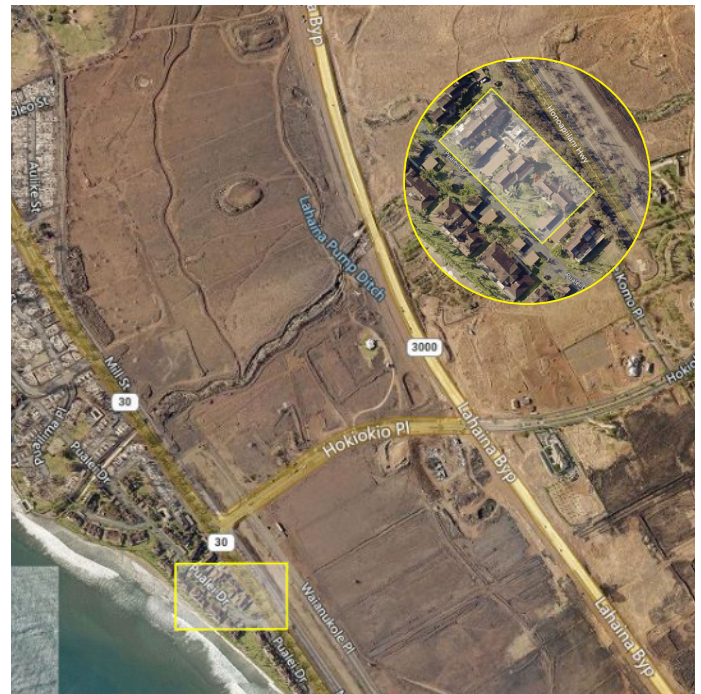
Additionally, roof damage to 1█ Pualei Drive appears on a southeasterly facing (mauka) ridge that would have been impacted by easterly (mauka) winds (Figure 4.3.4.4.5). However, at least one (1) tree near 1█ Pualei Drive fell oriented toward the southeast, possibly impacted by varying wind direction and velocity. The relative timing of the tree damage and the fire reaching Puamana has not been established.

Figure 4.3.4.4.5 Wind damage in the vicinity of 1█ Pualei Drive, including east-facing (mauka) corner of roof on to 1█ Pualei Drive, a tree downed by wind facing south-southeast (middle left), and a tree facing west (makai)-southwest located to the south of 1█ Pualei Drive (middle, right). Red arrows identify the approximate location and orientation of fallen trees. Inset: Viewpoint showing the area depicted in the photographs above.

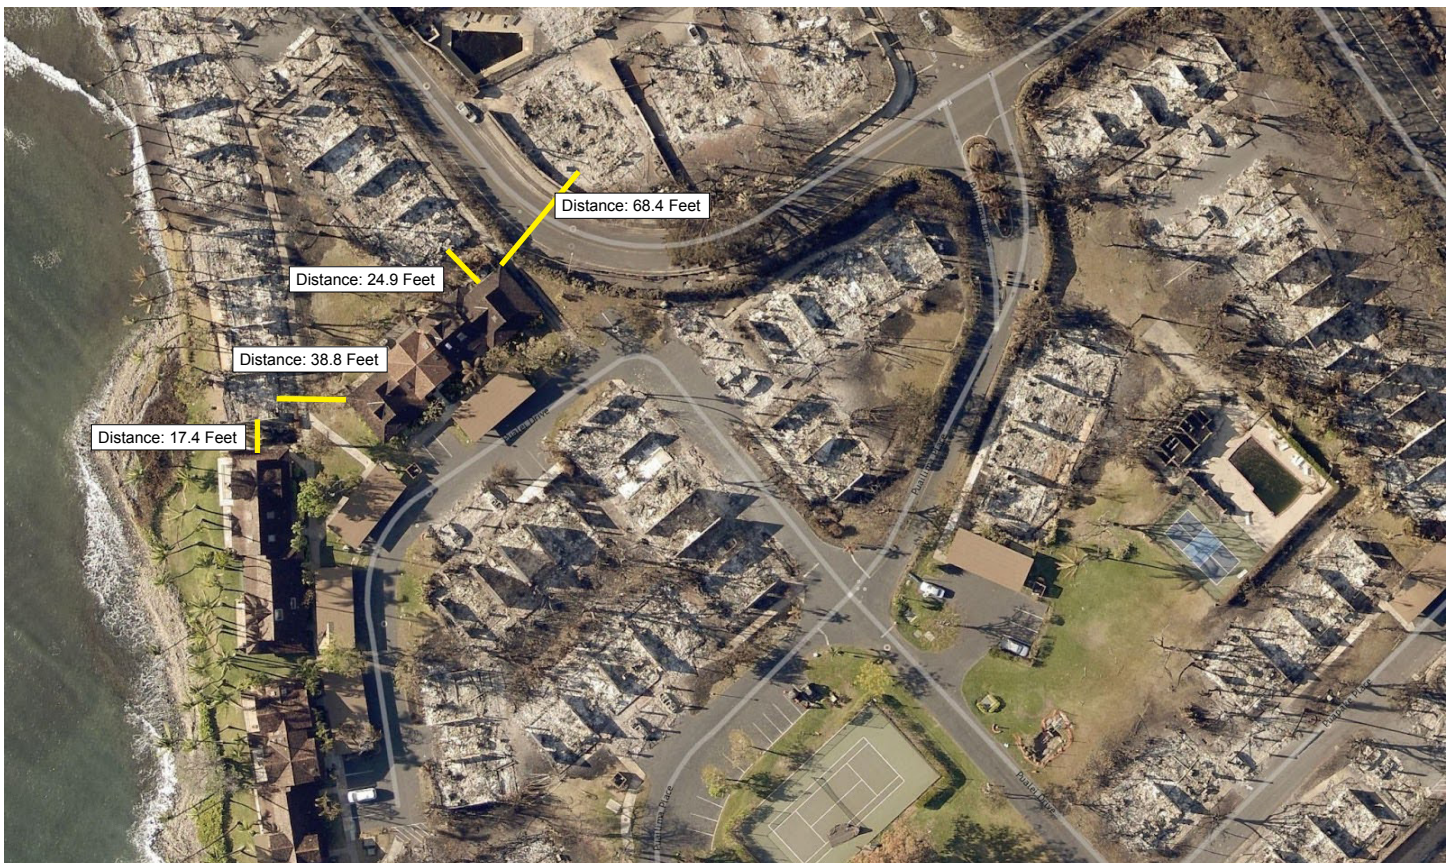
Figure 4.3.4.4.6 Three (3) surviving structures in the north part of Puamana (3■, 4■, and 5■ Pualoke Place).

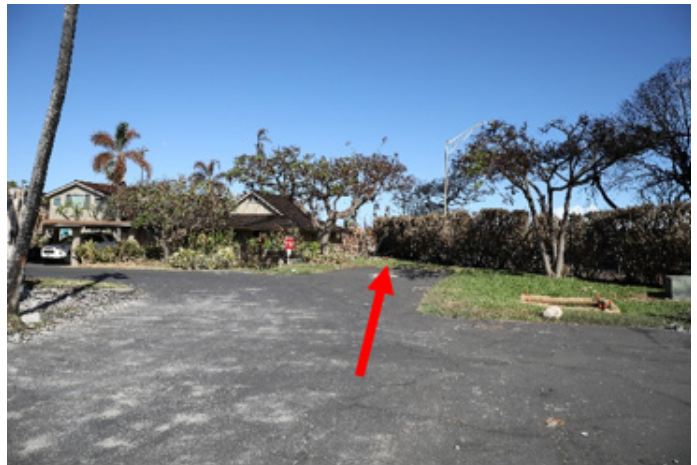
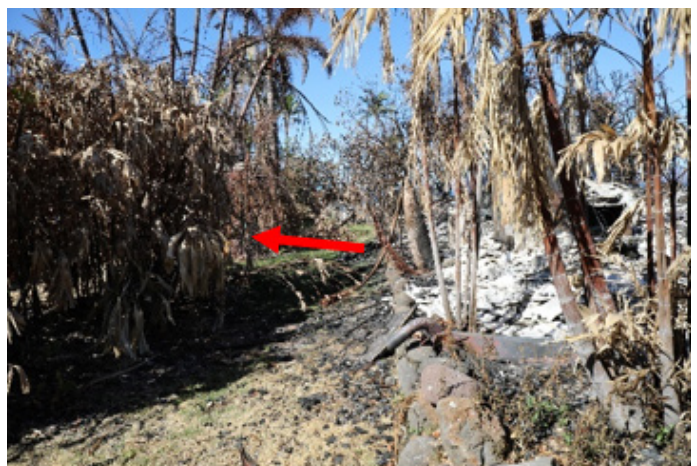
This surviving structure is also immediately adjacent to the destroyed structure at 2■ Front Street. There was no apparent damage from radiation heat to 3■ Pualoke Place, most likely due in some part to the tall, leafy vegetation standing between the two (2) structures (Figure 4.3.4.4.7).

The grass surrounding 3■ Pualoke Place was also green and healthy, preventing the fire from spreading along the ground. The westernmost (makai) corner of this structure does not have any apparent radiant heat damage from the other adjacent destroyed structure at 3■ Pualoke Place.

Figure 4.3.4.4.7 Vegetation surrounding 3■ Pualoke Place, including address-side view showing vegetation along Front Street (to the right of the structure) and rear view showing standing leafy vegetation immediately behind the rear porches of the surviving structure.

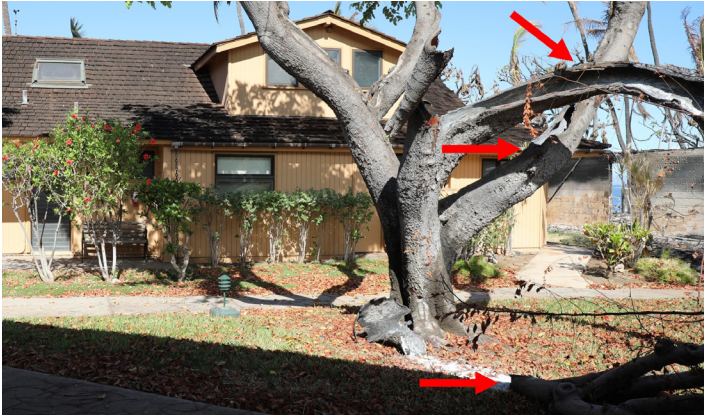
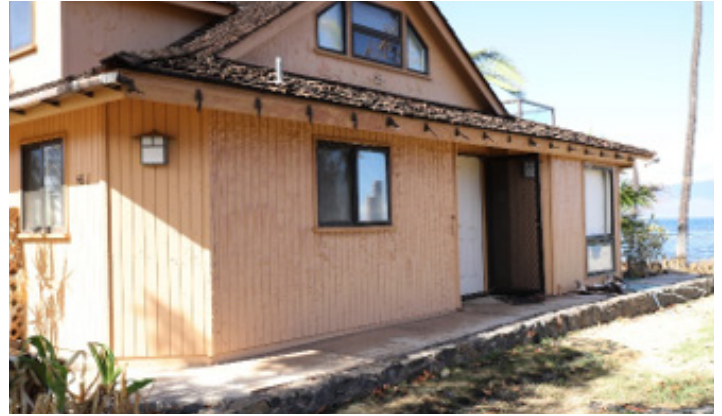
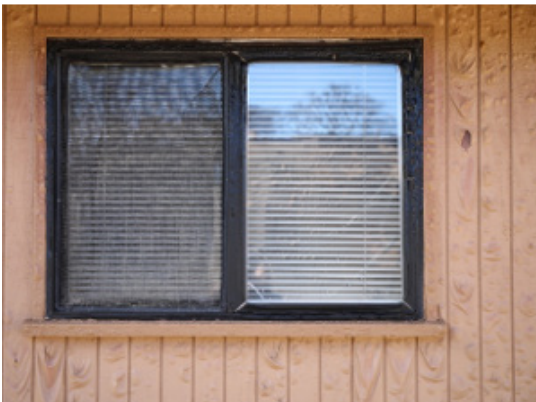
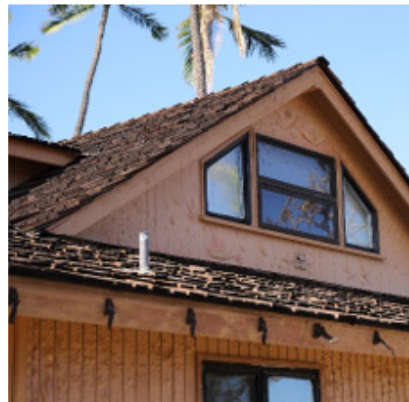
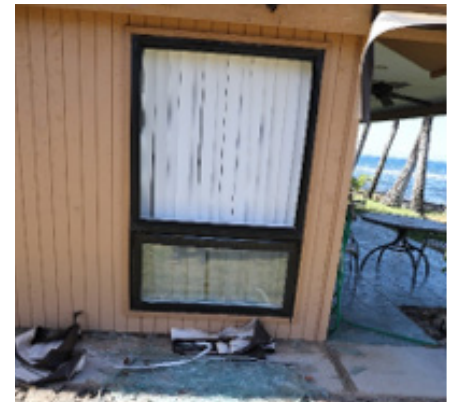
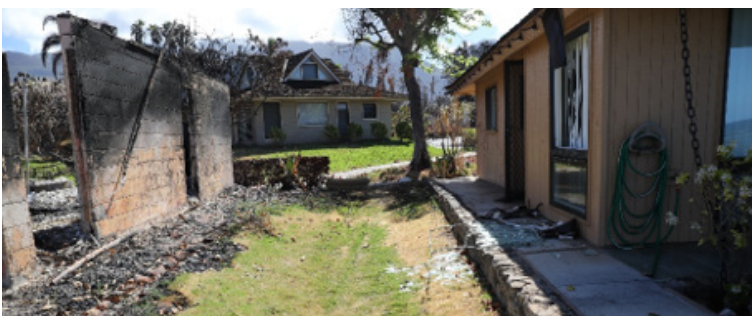
However, the north end of 4■ Pualoke Place (unit 4■) was heavily damaged by radiant heat from the destroyed 3■ Pualoke Place, including bubbling of paint on the first and second floor and melted gutters and plastic vent covers on the second floor (Figure 4.3.4.4.8).

There was also extensive damage to windows (glass cracking, frame warping) on the north side of the structure, including a large double pane (plain glass) window on the northwest corner that fell out from the frame. The vertical blinds inside this window appeared to have some warping possibly due to radiant heat, but they remained intact without charring.

Very little soot was noted inside this window. Prevailing winds were typically easterly (off-shore), so this opening may not have been in the path to receive embers from 3■ Pualoke Place or other structures/vegetation fires further east (mauka).

The tree standing to the east (mauka) of unit 4■ is deeply charred on several west (makai) and southwest aspects of large branches (Figure 4.3.4.4.8, top left), which is likely from embers blown

into fissures, openings, or scars. This damage suggests embers with enough energy to create a smoldering fire in wood were present in this area.

Figure 4.3.4.4.8 Damage to the north end of 4 Pualoke Place immediately adjacent to the destroyed structure at 3 Pualoke Place. A tree to the east (mauka) of the structure sustained deep charring, likely from embers gathering in cracks, fissures, or scars in the tree bark (top left). Window damage on the north structure wall (top right) ranges from single pane cracking to vinyl frame warping (middle left) to complete pane fallout (middle center). Plastic vent cover and gutters melted and fell. Paint bubbled and peeled across most of the surface. No apparent indication of charring or damage to wood shake roofing materials or wood wall substrate (top right and middle right). Grass remained green between the destroyed and damaged structure. Garden hose noted at the corner of the structure (bottom left). Inset: Viewpoint showing area shown in the photographs above.

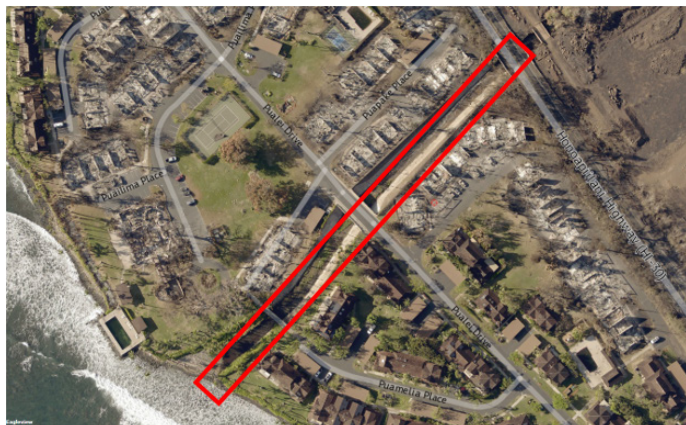
All residential structures between Pualoke Place and Kaua‘ula Stream and west (makai) of Hwy-30 were destroyed. The concrete drainage may have helped limit additional spread from the north, particularly for structures southwest (makai) of Pualei Drive (Figure 4.3.4.4.9).

Figure 4.3.4.4.9 Kaua'ula Stream running through Puamana provided a physical separation between the northern section (where structures were destroyed between Hwy-30 and the coast) and the rest of the community (where destroyed structures were limited to the area between Hwy-30 and Pualei Drive).

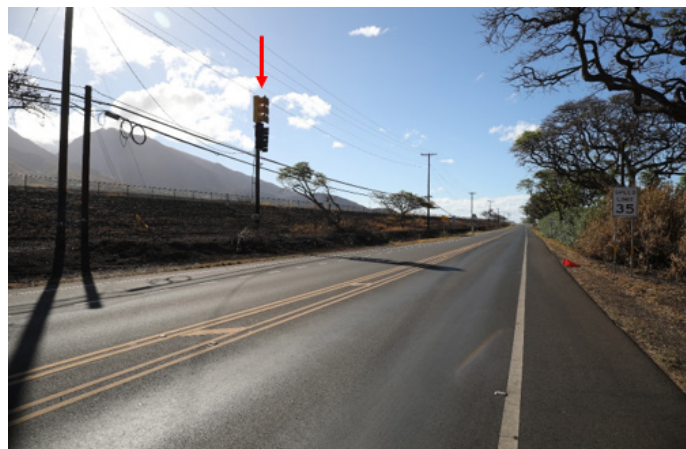
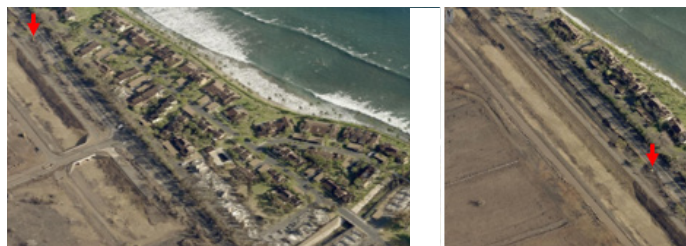
Extensive burning and charring is noted in the vegetation between Puakukui Place and Hwy-30 all the way to the location where Pualei Drive shifts east (mauka) and then runs adjacent to Hwy-30. At this location east (mauka) of Mill Street, the charred grass also appears to terminate, possibly due to either water application from the E11 with the private tanker and/or shifting winds.

Figure 4.3.4.4.10 Images along Hwy-30 and Mill Street indicating the southern termination of the grass fire on the bank east (mauka) of Mill Street coincides with the southern end of damaged vegetation along fence line west (makai) of Hwy-30. Approximate location of E11 radio transmission at 22:41 roughly coincides with this area (See Phase One report, Figure 4.3.1.40). Yellow siren provides a common orientation in each picture. Vegetation appears more heavily consumed around the drainage but remains more dense (yet damaged) further south until this transition to green foliage.

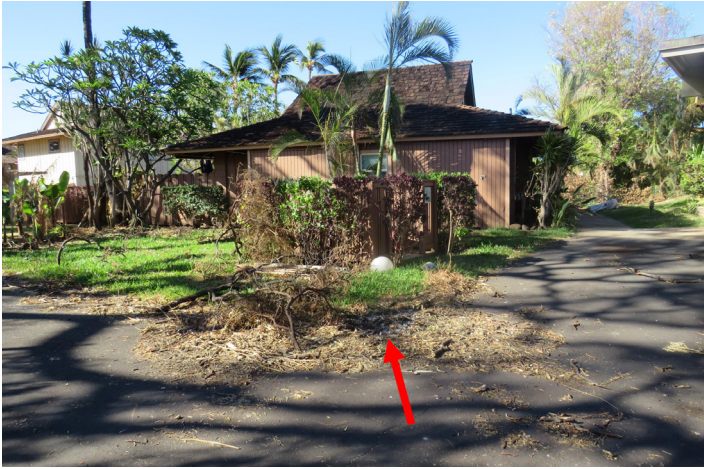
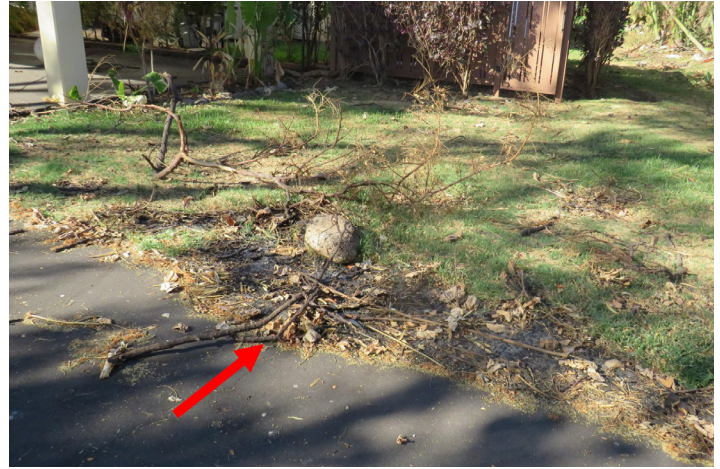
The underbrush appears more completely consumed farther north (closer to Kaua'ula Stream), likely due to a combination of longer burn times as the fire moved south, as well as radiant heat from consumed structures across Puakukui Place. Structure numbers 2■, 4■, 5■, and 6■, all of which were immediately adjacent to the fenceline or across Puakukui Place from the fenceline, were destroyed. 7■ Puakukui Place, along with 1■ and 1■ Pualei Drive, were also separated from the fenceline by Puakukui Place, but did not ignite. Spot fires in light fuels on the west (makai) side of the road and parking structures did ignite in a few locations, but did not continue to these structures (Figure 4.3.4.4.11).

Figure 4.3.4.4.11 Spotting across Puakukui Place in front of structures (top left) 1 and (top right) 1. Embers found a receptive fuel bed to ignite, but not sustain burning through the green grass. Inset: Viewpoint showing above images.
