# Lahaina Fire Incident Analysis Report

**September 13, 2024**  
**Columbia, MD**

This document is the second in a series of three (3) reports commissioned by the Hawai'i Department of the Attorney General (DOAG) to provide an independent review of the tragic fire that destroyed much of Lahaina, Hawai'i, on August 8-9, 2023.

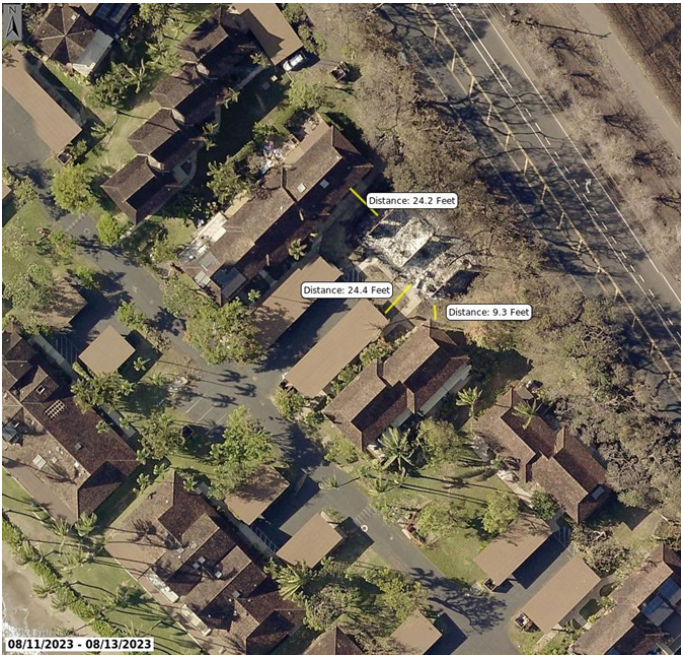
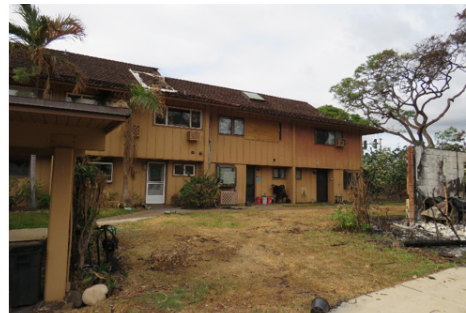
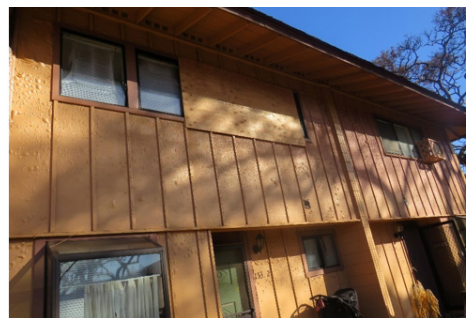
1 Pualei Drive is the southernmost structure destroyed in Puamana (Figure 4.3.4.4.12). While, structures immediately adjacent to the north, west (makai), and south were not destroyed, 1 Pualei Drive (northwest) received extensive thermal radiation damage, including bubbled paint, melted plastic conduit and vent covers (some vent covers fell off), and broken windows (Figure 4.3.4.4.13).

Figure 4.3.4.4.12 1 Pualei Drive is the farthest south structure destroyed in Puamana. It is bounded by 1 Pualei Drive to the northwest and 1 Pualei Drive to the south and parking structures to the west (makai). Inset: Viewpoint shows the area appearing in the photograph above.

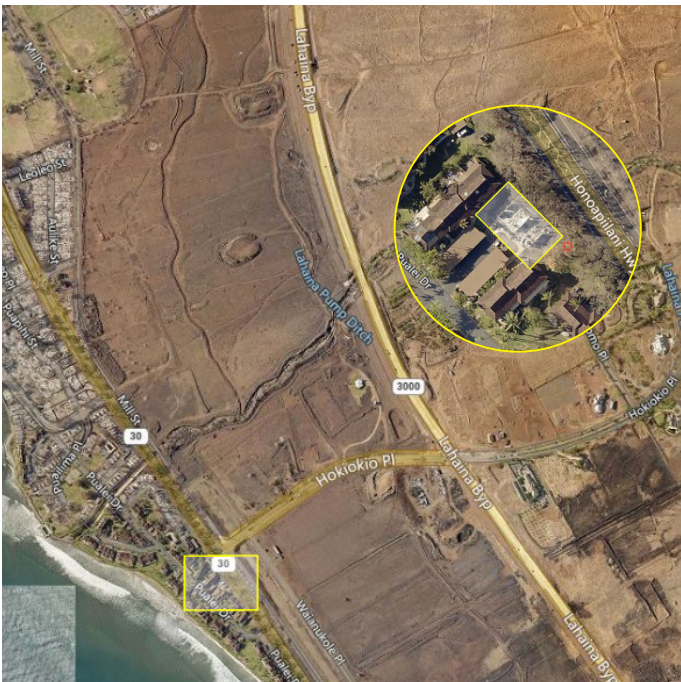
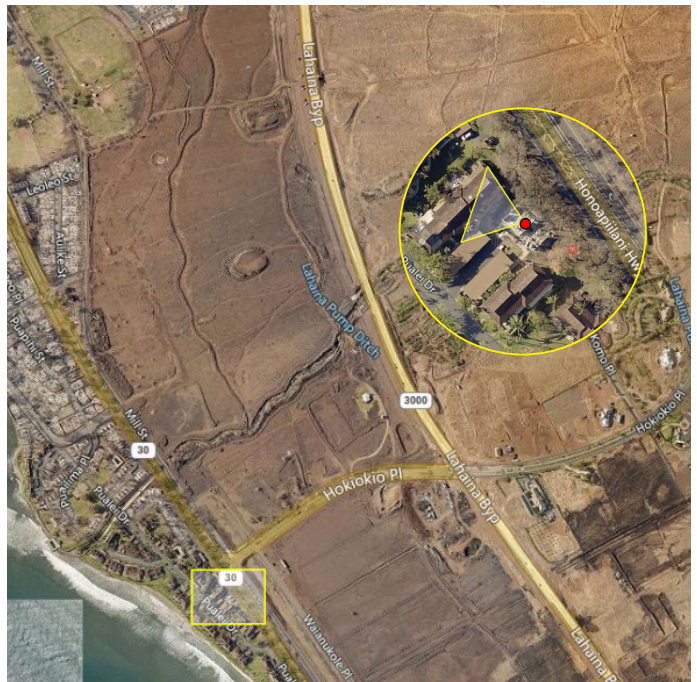
One (1) broken window was boarded up prior to documentation, so someone had accessed the area prior to the analysis. For the windows that were visible, at least one pane of the double pane windows remained intact. Horizontal blinds behind some of these windows appear warped, possibly

due to radiant heating, though no charring/melting was noted behind the window.

Figure 4.3.4.4.13 Radiant heating damage on the southeast side of 1 Pualei Drive. Window damage includes cracking and drop out of some panes, melting and deformation of frames and screens, and potentially deformation of blinds behind windows due to transmitted radiant heating. Damage was noted to plastic vent covers and charring of fascia board on the end of the roof line. Inset: Viewpoint showing the area depicted in the photographs above.

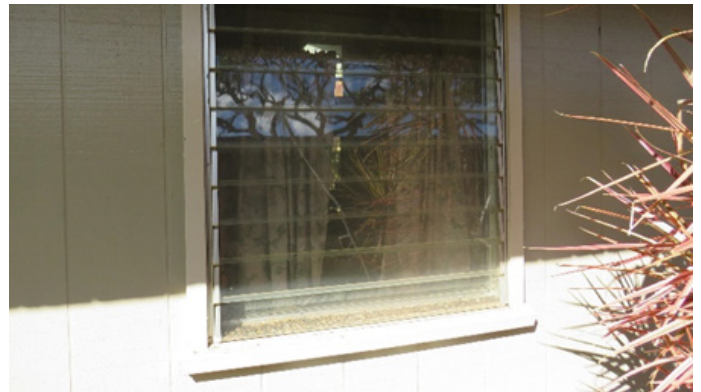
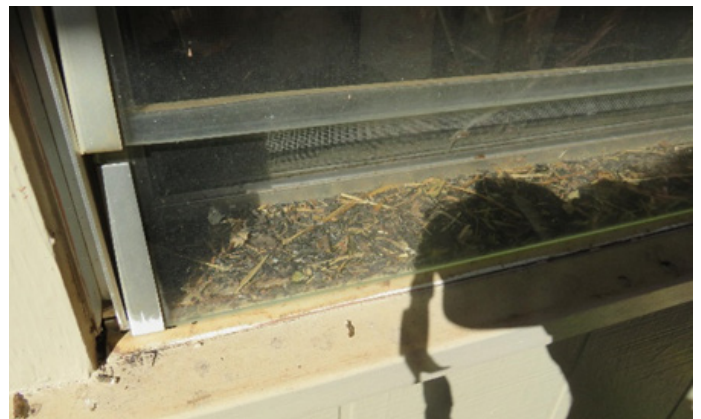
As described earlier, the orientation of windows and doors or roof/attic venting for the destroyed structures in Puamana cannot be definitively determined in the post-fire analysis. However, images collected from the surviving structure shows some windows may have been left partially open. For example, a louvered window was found partially open with debris and ash build up, but a screen was in place that appeared to keep the material from entering the structure (Figure 4.3.4.4.14).

Figure 4.3.4.4.14 Louvered windows left partially ajar where debris collected, including charred remains of possible embers. An intact screen behind this window kept these materials from entering the structure and possibly igniting interior contents.

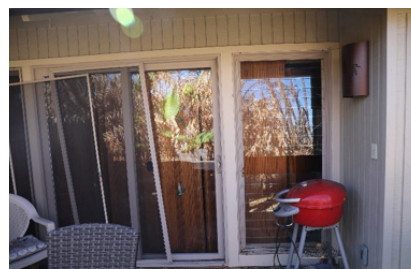
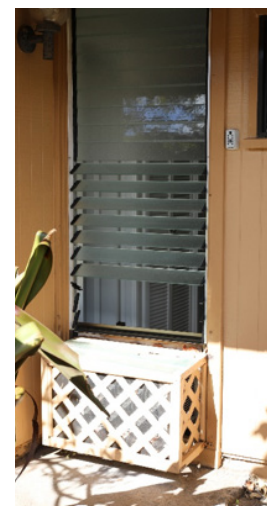
Other windows through this community were found open or potentially broken, though it is possible these were opened after the fire but prior to images being collected (Figure 4.3.4.4.15). Several of these windows did not have screens behind them, which if left open, would have allowed direct entry of embers that may impact the structures if they were present at this orientation.

Figure 4.3.4.4.15 Examples of open/broken windows on surviving structures in Puamana.

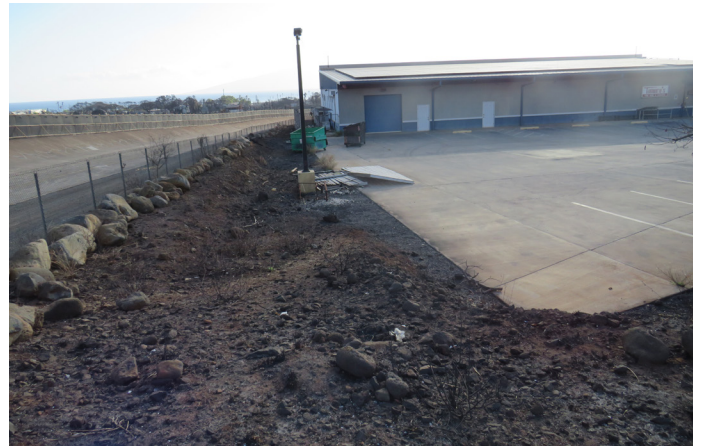
They relocated into the business park and began to extinguish the grass fires adjacent to 2█ Kupuohi Street (Figure 4.3.5.1.5 and 4.3.1.6).

Figure 4.3.5.1.5 Grasses burned along Kahoma Stream and behind 2█ Kupuohi Street (Tamura's Fine Wine & Liquors).

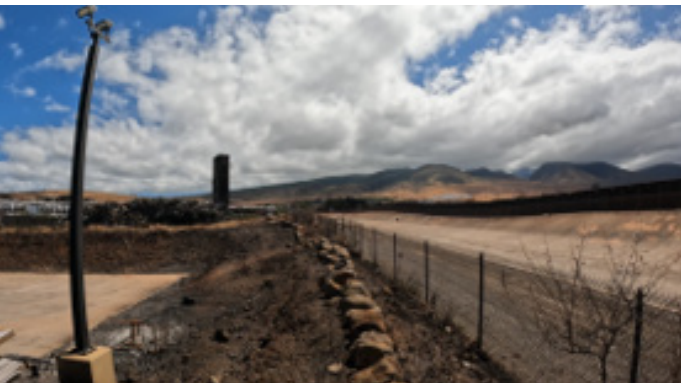
Figure 4.3.5.1.4 Grasses burned looking east (mauka) toward the Kaiāulu o Kupuohi Apartment complex.

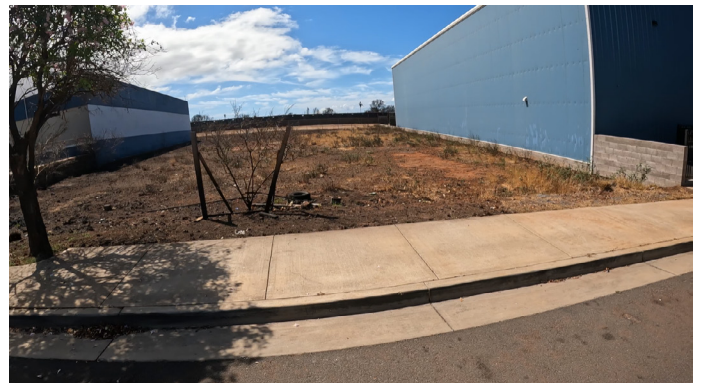
Figure 4.3.5.1.6 Grass lot burned at 2█ Kupuohi Street, one of the first fires reported on the north side of Kahoma Stream.

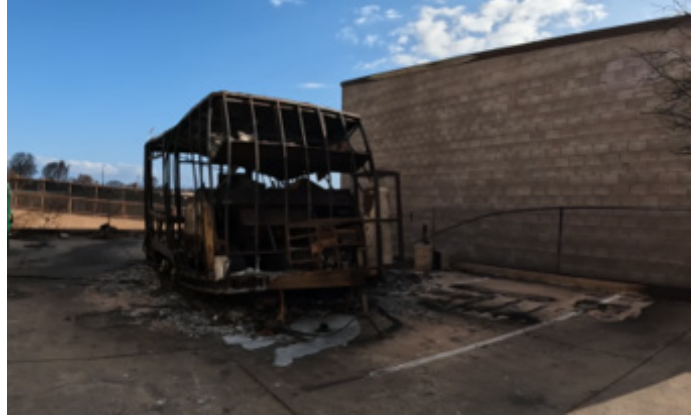
At 17:41:56, MPD officer 4SA2 notified Central of a vehicle engulfed in fire in the parking lot of 1█ Kupuohi Street (Figure 4.3.5.1.8 and Figure 4.3.5.1.9).

Figure 4.3.5.1.8 Trailer and building materials ignited by embers (1█ Kupuohi Street).

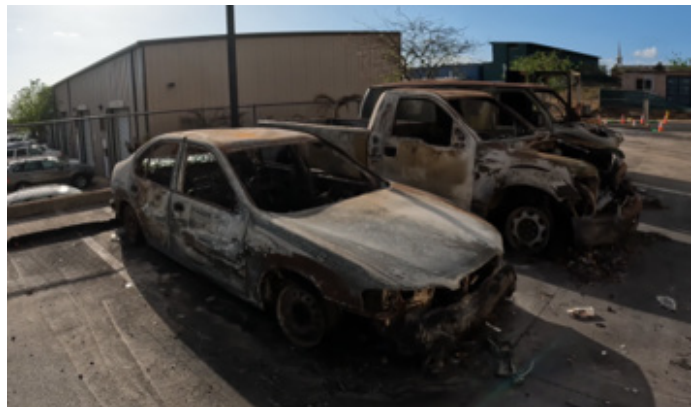
Figure 4.3.5.1.9 Vehicles consumed by fire in the parking lot of 1█ Kupuohi Street.

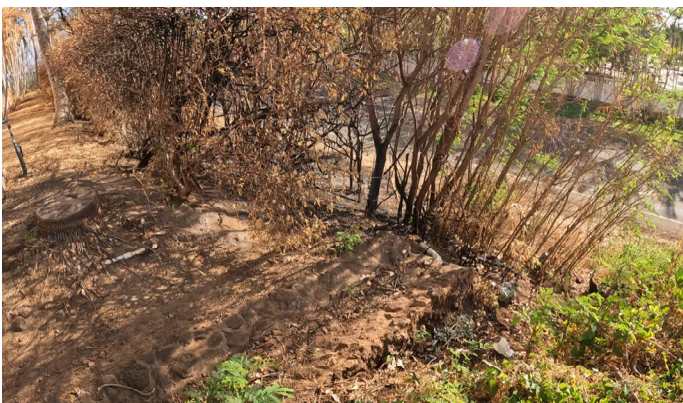
Figure 4.3.5.1.7 Location where the brush fire spread stopped behind 4█ Kupuohi Street.

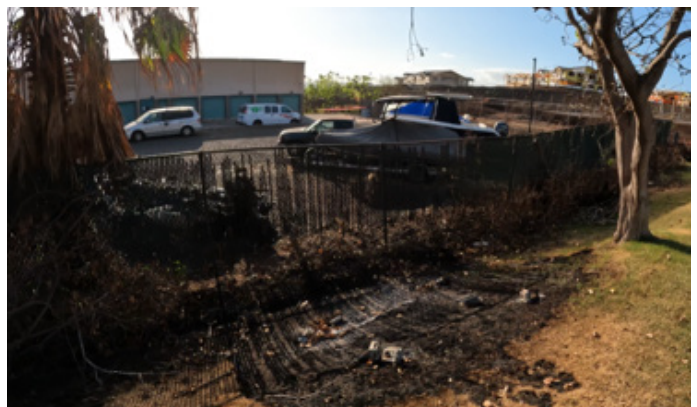
Between 19:13:30 and 20:00:09, RE1 advised Command there was an “ember wash” (airborne and ground traveling embers) exposing the Island Grocery Depot and a warehouse in the area. Unit E11 was fighting a truck fire next to the warehouses on Kupuohi Street. E3 attempted to engage the fire near the Church of Jesus Christ of Latter-day Saints building at 8█ Ulupono Street (Figures 4.3.5.1.10, 4.3.5.1.11, and 4.3.5.1.12).

Figure 4.3.5.1.10 Large spot fire west (makai) of the church (8█ Ulupono Street).

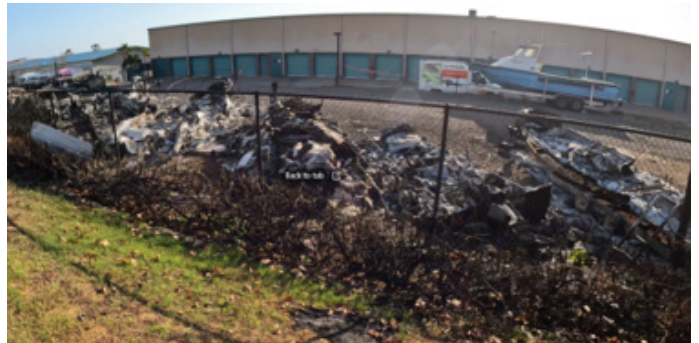
Figure 4.3.5.1.11 Vehicles consumed by fire west (makai) of the church (8█ Ulupono Street).

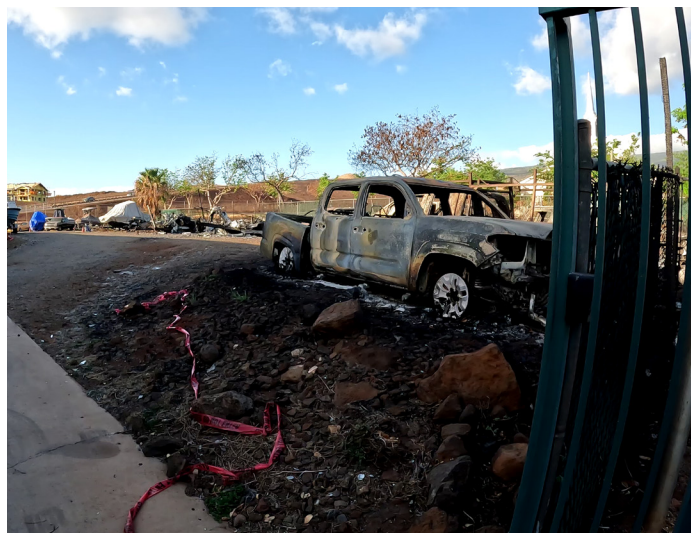
Figure 4.3.5.1.12 Additional vehicles consumed by fire west (makai) of the church (8█ Ulupono Street).

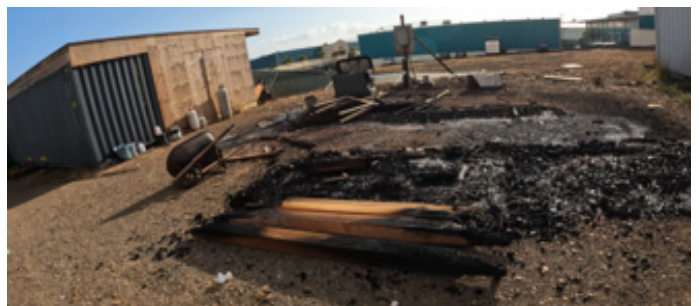
This activity allowed MFD units to suppress numerous spot, vehicle, building material, and structure fires before they spread (Figures 4.3.5.1.13, 4.3.5.1.14, 4.3.5.1.15, 4.3.5.1.16, 4.3.5.1.17, 4.3.5.1.18, and 4.3.5.1.19).

Figure 4.3.5.1.13 Materials storage area burned by embers (1█ Kupuohi Street).

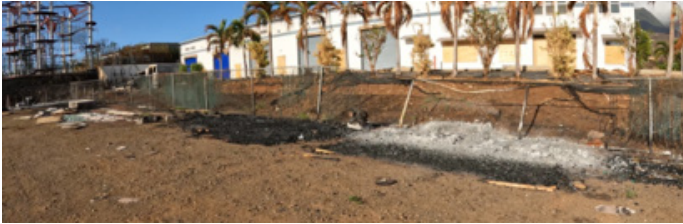
Figure 4.3.5.1.14 Materials storage area burned by embers (1 █ Kupuohi Street).

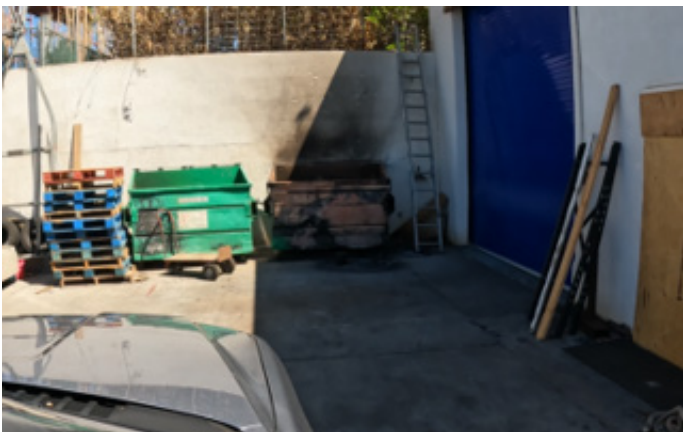
Figure 4.3.5.1.15 Dumpster fire to the west (makai) of 2 █ Kupuohi Street.

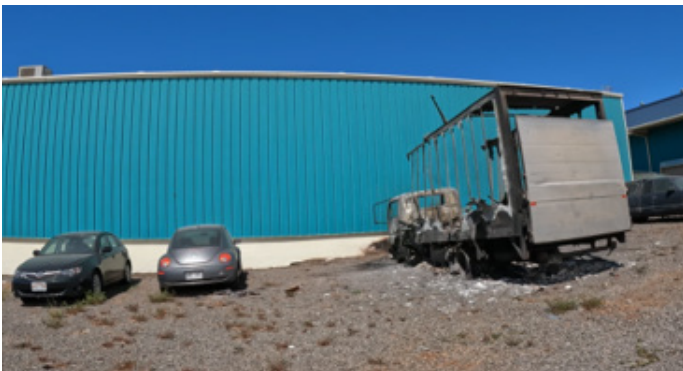
Figure 4.3.5.1.16 Box truck consumed by fire behind 1 █ Kupuohi Street.

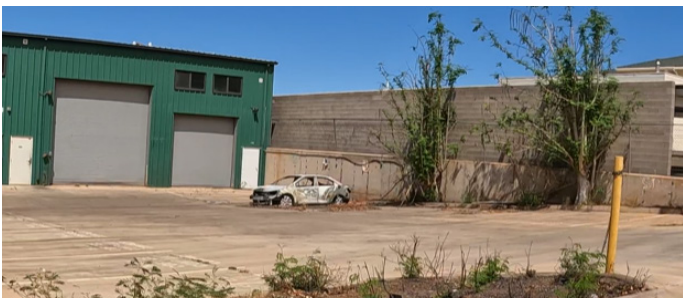
Figure 4.3.5.1.17 Car consumed by fire next to 2 █ Kupuohi Street.

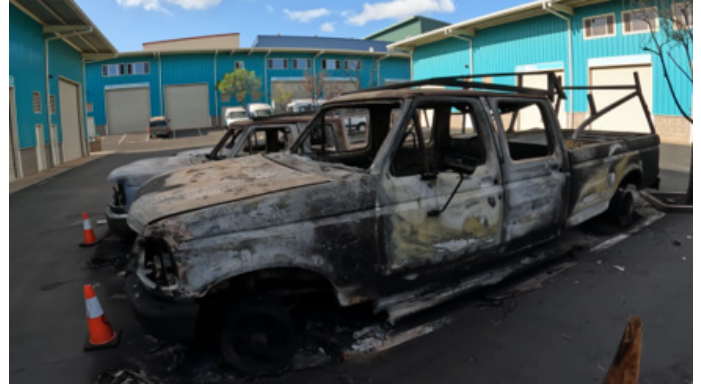
Figure 4.3.5.1.18 Vehicles consumed by fire in the middle of Emerald Plaza Place (near 1 █ Kupuohi Street).

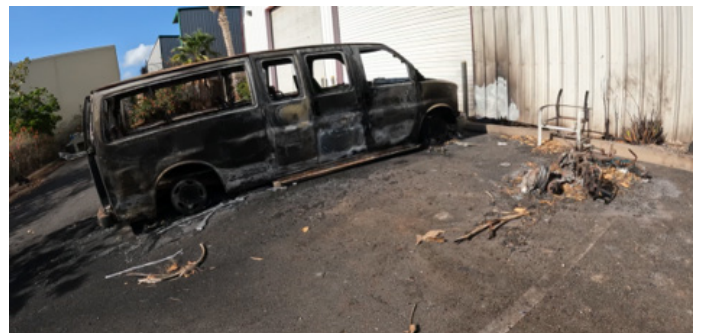
Figure 4.3.5.1.19 Van consumed by fire with thermal damage to 1 █ Kupuohi Street.

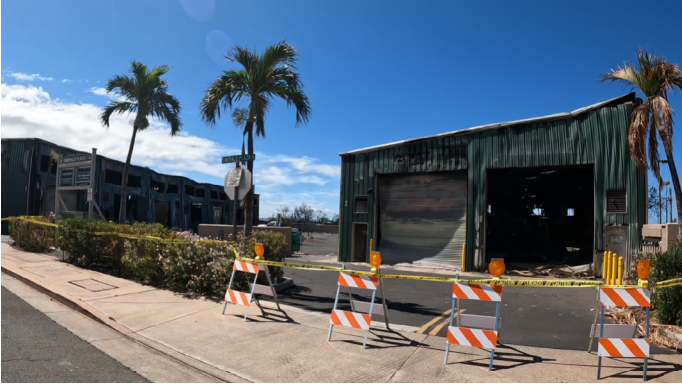
The two (2) warehouse buildings that burned (Figure 4.3.5.1.20 and Figure 4.3.5.1.21) had several open vents that may have allowed embers to enter the structure and ignite combustible materials. These buildings were also on the southwestern edge of the business park where large wind-borne plumes of embers likely traveled from nearby engulfed homes on the other side of the Kahoma Stream.

Figure 4.3.5.1.20 Emerald Plaza Building A consumed by fire.

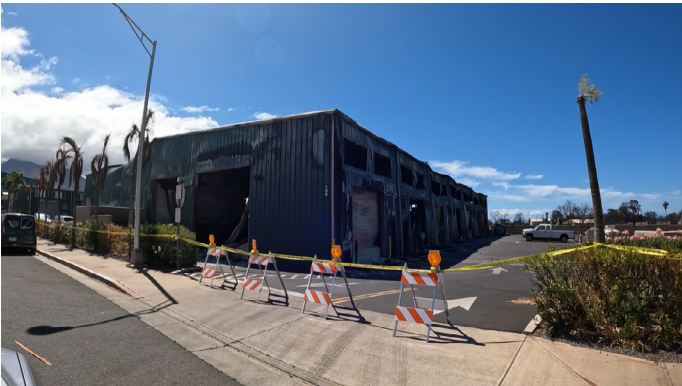
Figure 4.3.5.1.21 Emerald Plaza Building B and C consumed by fire.

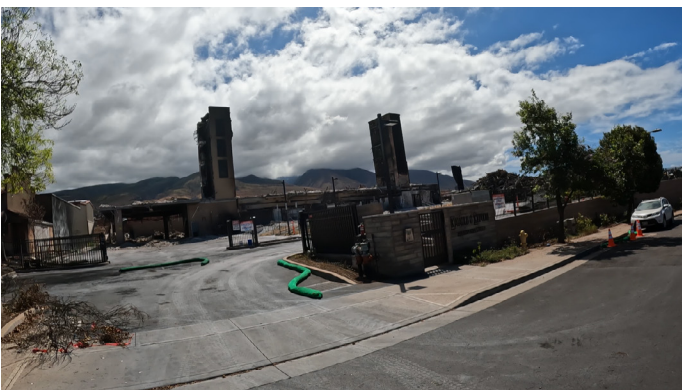
The ignition of the Kaiāulu o Kupuohi apartment complex (Figure 4.3.5.1.22) and the vehicle lot on the northeast corner of the business park (Figure 4.3.5.1.23) began later in the incident. There were no reports of the building or vehicle fires on MPD or MFD radio, so they likely ignited between the time units evacuated north of the Lahaina Civic Center and the following morning.

Figure 4.3.5.1.22 Kaiāulu o Kupuohi Apartment complex consumed by fire.

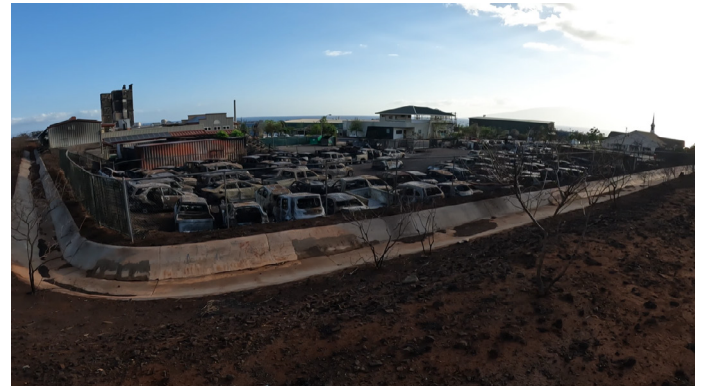
Figure 4.3.5.1.23 Lot of vehicles consumed by fire in the northeast corner of the business park.

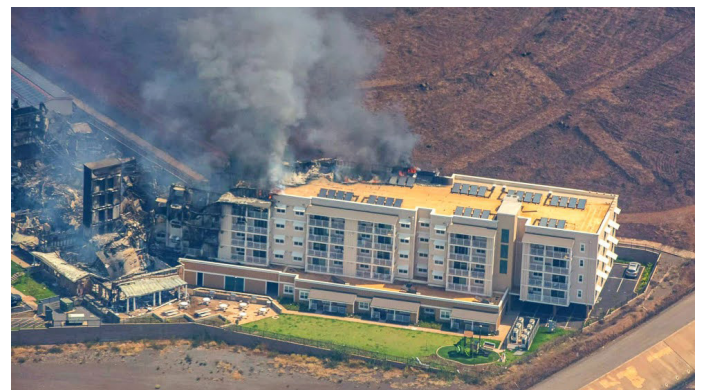
The first known resident video of the apartment complex on fire was recorded at 05:35 on August 9, 2023. At this time, the north wing of the building was on fire. The fire spread to the south and completely destroyed the structure within two (2) days, according to news reports (Figure 4.3.5.1.24).

Figure 4.3.5.1.24 Kaiāulu o Kupuohi Apartment complex continuing to burn following the August 8, 2023, fire.<sup>261</sup>

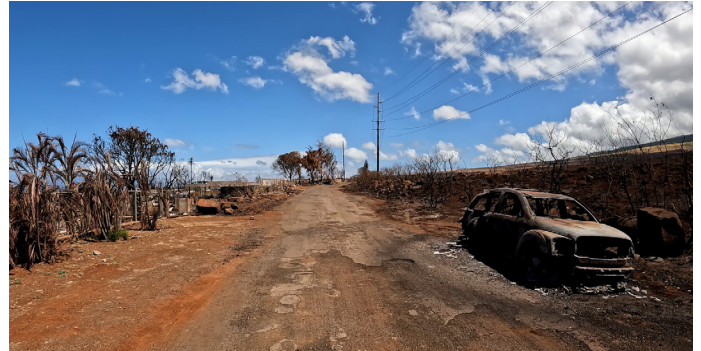
Figure 4.3.5.2.6 Car located at edge of construction site that supported the fire jumping Oil Road from the east-mauka (right to left).

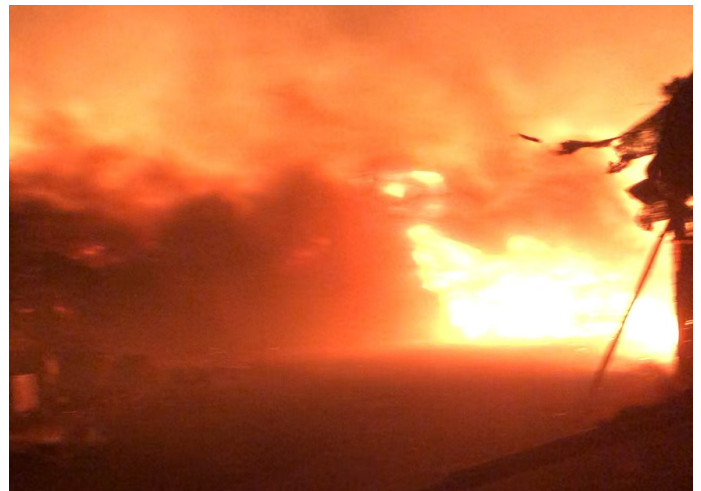
Figure 4.3.5.2.7 Resident video of car on fire at the northeast end of the construction site with heavy winds driving the fire toward 13█ Kahoma Street.

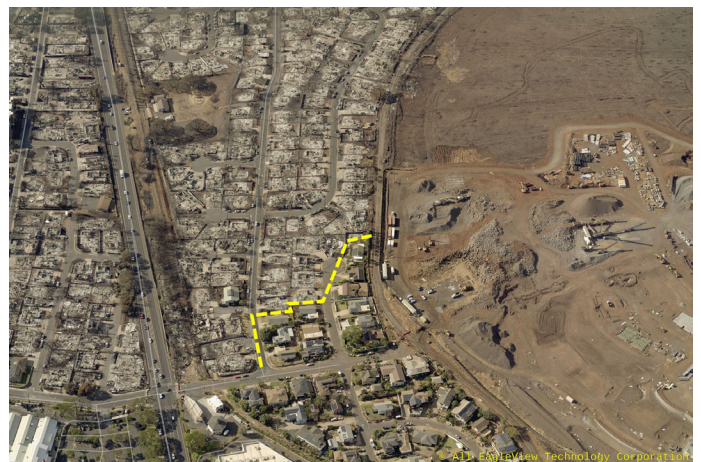
Figure 4.3.5.2.8 provides an overhead view of the northwest corner of the construction site, highlighting the interface where the fire stopped. Structure-to-structure fire spread that started from this location spread south until it reached the top of Nahale Street.

Figure 4.3.5.2.8 Overhead view of the area at the northwest corner of the construction site, highlighting the interface where the fire stopped. To the north, the fire stopped at the top of Nahale Street (Source: EagleView).

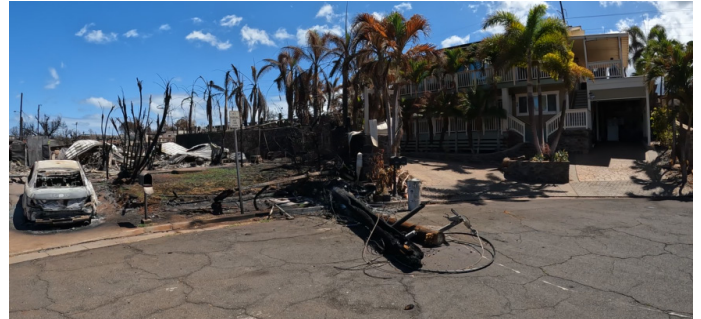
Figure 4.3.5.2.9 12█ Nahale Street on the left and 12█ Nahale Street on the right.

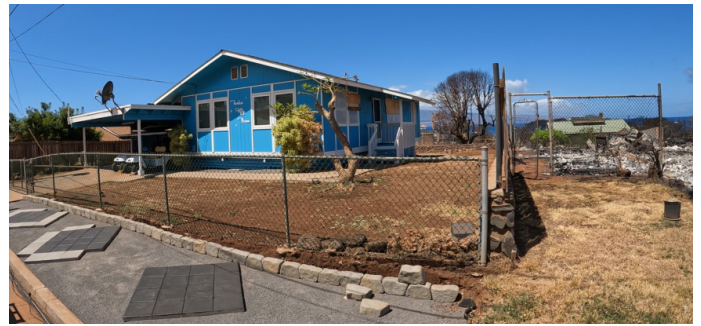
On the west side (makai) of Nahale Street, the fire propagated further south and destroyed 12█ Nahale Street, but 12█ Nahale Street survived (Figure 4.3.5.2.10). The fence separating the structures was burned, and 12█ Nahale Street was damaged (windows cracked and paint bubbled) due to radiant heat. However, the fire did not extend through the main structure.

Figure 4.3.5.2.10 12█ Nahale Street on the left and 12█ Nahale Street (destroyed) on the right.

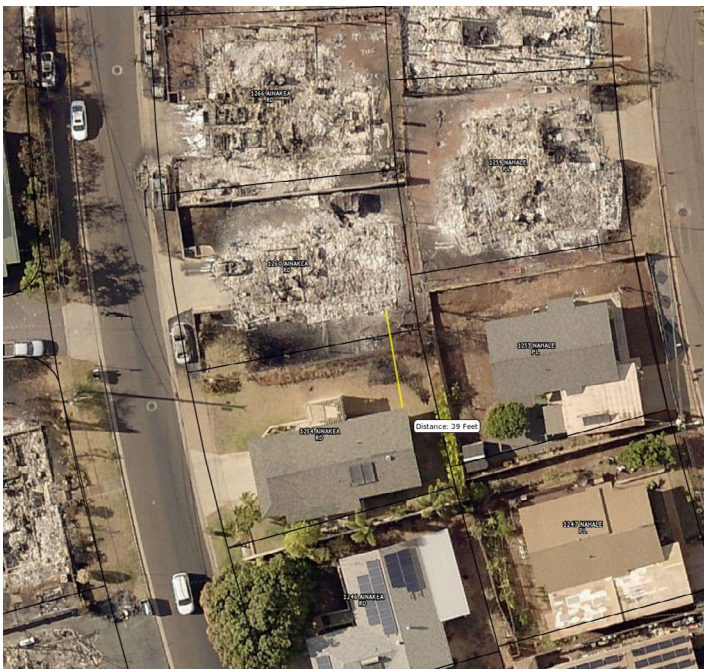
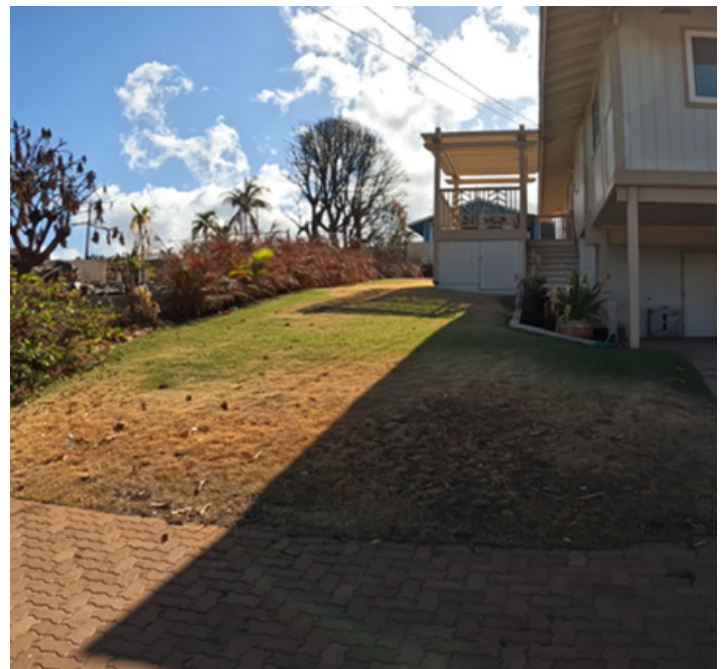
The structure to the rear of 12█ Nahale Street (12█ 'Ainakea Road) also survived the fire (Figure 4.3.5.2.11), though it also sustained radiant heat damage from the structure next door at 12█ 'Ainakea Road, including blistered paint and cracked windows (Figure 4.3.5.2.12).

Figure 4.3.5.2.11 (Left) Post-fire aerial image with annotated distance, 39 feet, between (destroyed) 12█ 'Ainakea Road and (damaged) 12█ 'Ainakea Road. (Right) Ground-based image of separation between destroyed and damaged structures.

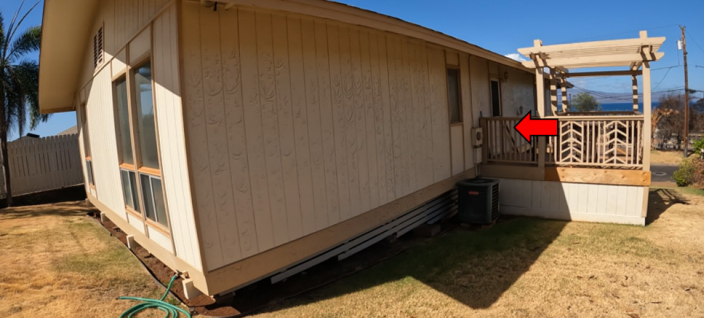
Figure 4.3.5.2.12 Northeast corner of 12█ 'Ainakea Road with blistering paint from radiant heat exposure (indicated by red arrow).

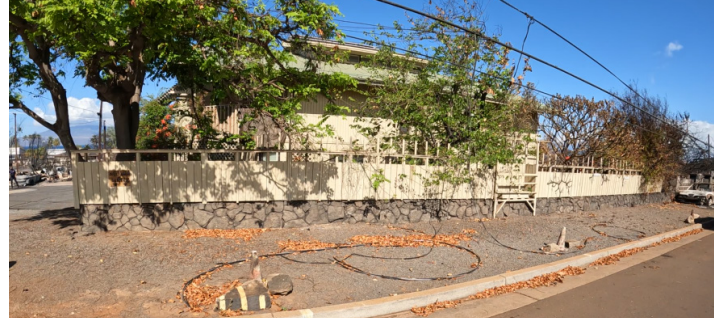
Figure 4.3.5.2.14 12█ 'Ainakea Road (Front view, oriented west).

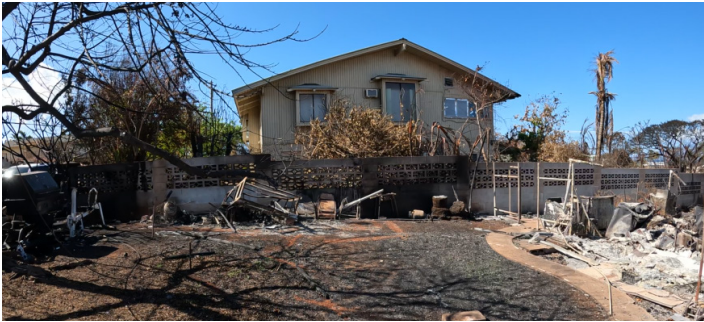
Figure 4.3.5.2.15 12█ 'Ainakea Road (side view, oriented north).

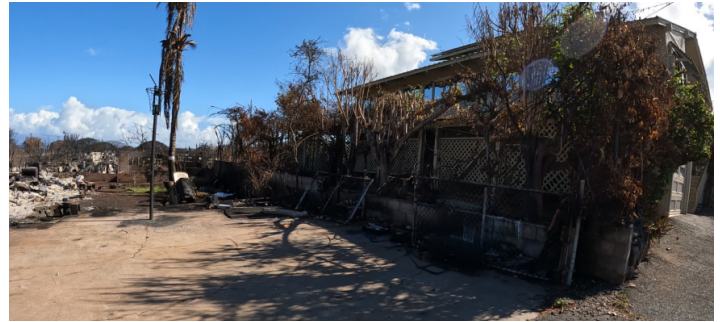
Figure 4.3.5.2.16 12█ 'Ainakea Road (rear view, oriented northeast).

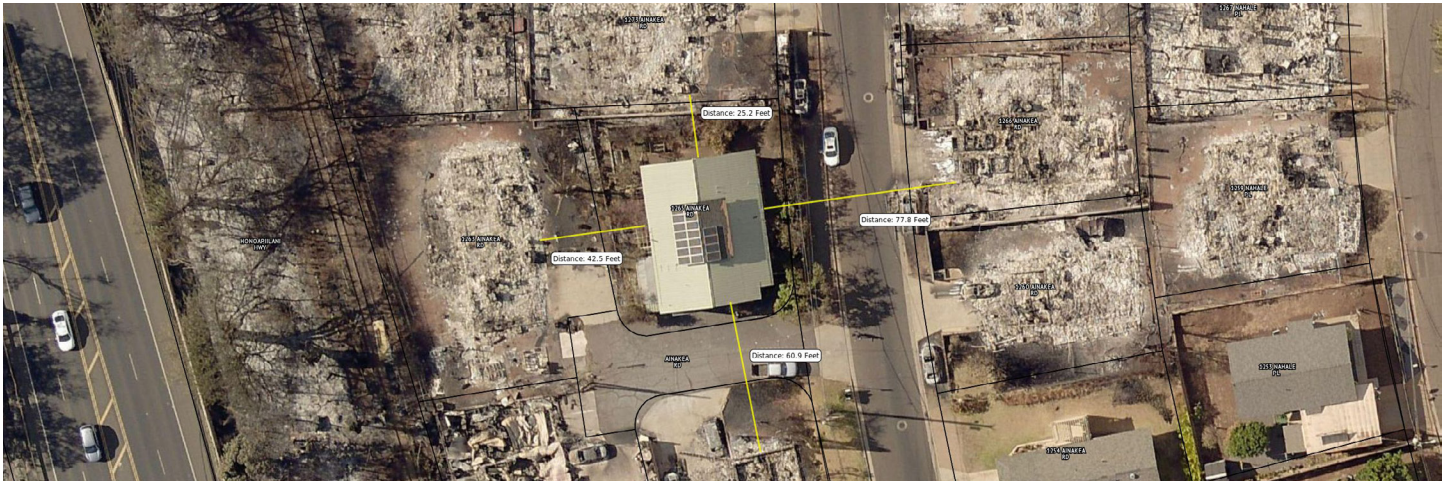
Figure 4.3.5.2.13 Post-fire aerial imagery of 12█ 'Ainakea Road with distances to adjacent (destroyed) buildings.

Diagonally across 'Ainakea Road is 12█ 'Ainakea Road. This house survived even though structures on all four (4) sides of it were destroyed (Figure 4.3.5.2.13-4.3.5.2.16). The side of the house facing north toward 12█ 'Ainakea Road had blistered paint and cracked windows, but it showed no signs of ignition.

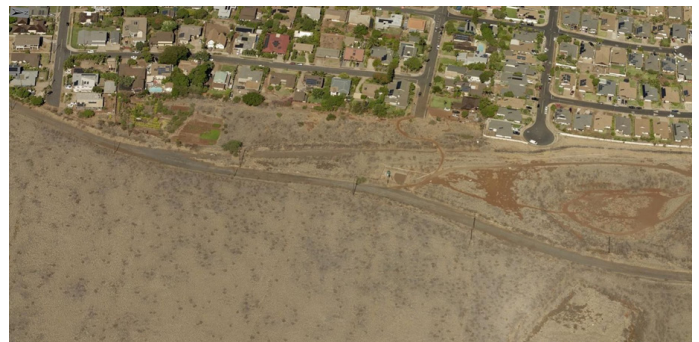
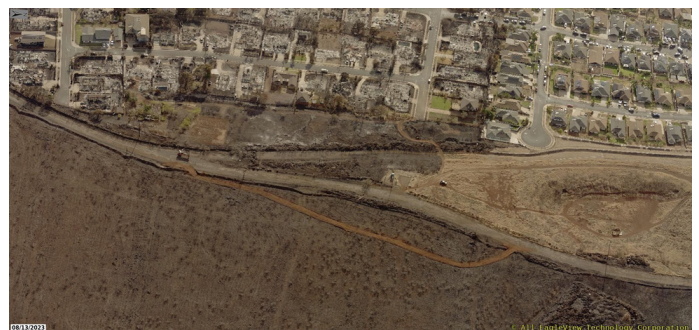
When the vegetation fire crossed over Oil Road, it continued to spread west (makai) to the eastern (mauka) property lines of these lots (Figure 4.3.5.3.3). Some of the structures on these properties were buffered by gardens, maintained (e.g., mowed and/or watered) lawns, and fences. Four (4) structures on the eastern (mauka) border of this area survived the fire with varying levels of damage.

Figure 4.3.5.3.3 Fire in the grassland along the eastern edge (mauka) of the northern zone crossed over Oil Road to the eastern edge (mauka) of properties on Lokia Street and Kaniau Road. The north flank vegetation fire remained east (mauka) of Oil Road between 'Aipuni Street and Leialii Parkway, after which the fire moved back west (makai). Note: North is to the right on these images.

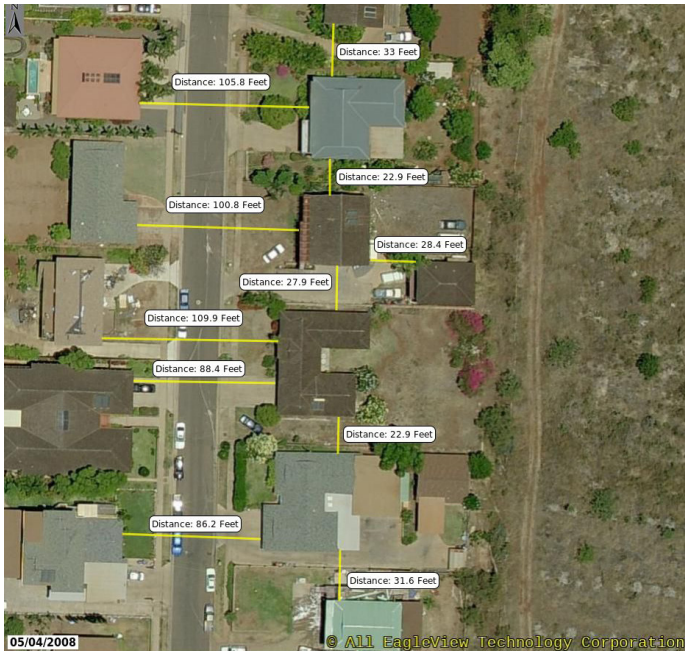
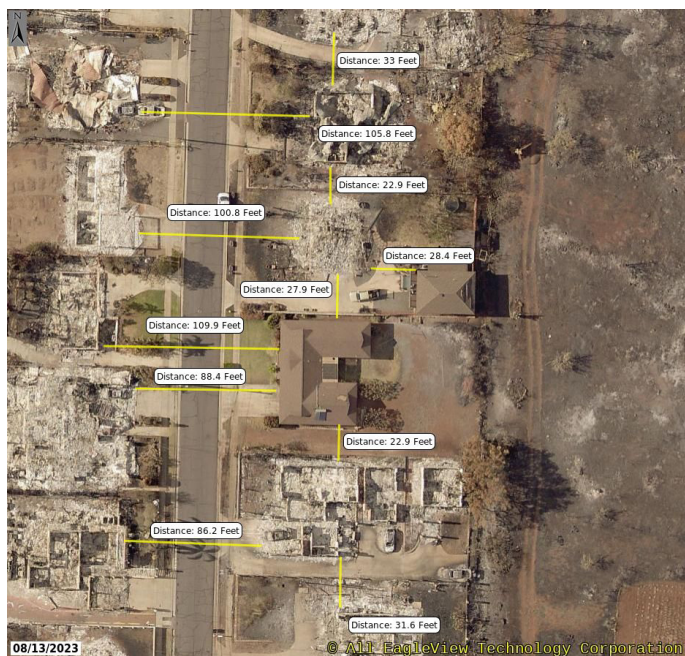
Two (2) structures on the east side (mauka) of Lokia Street were damaged by the fires, but survived

Figure 4.3.5.3.4 Structure spacing along Lokia Street in the vicinity of the surviving structures on the east side (mauka) of the street, abutting the grassland fire.

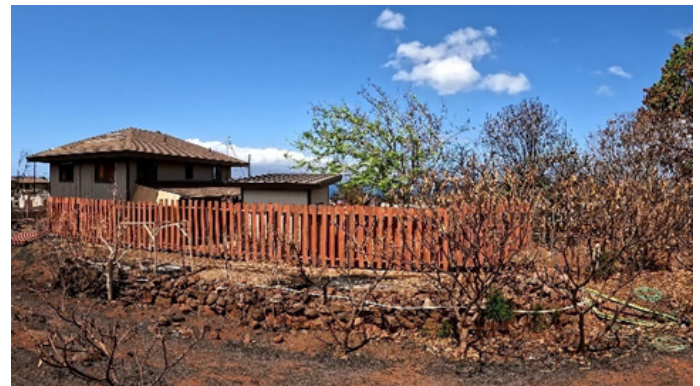
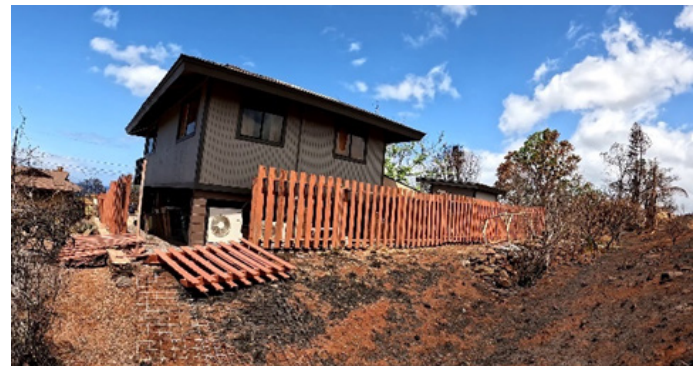
The structure at 16█ Lokia Street was elevated from the ground and was buffered by a garden to the east (mauka) of the property line fence. The southwest corner of the fence appeared to have caught fire at some point, but was broken out and burning was stopped.

Hoses were noted near the garden, which may have been used during the fire or may have been used to water and maintain the garden, providing a buffer of fuels with increased moisture and reduced burning potential.

Figure 4.3.5.3.5 The surviving accessory structure at 16███ Lokia Street was near the eastern (mauka) property line, but was buffered from the grassland by a garden (note intact hoses and stone landscaping separating from the grass) and a fence. The structure was elevated such that the damaged windows were a longer distance from the burning vegetation than a single-story structure. Charred sections of fence were broken away from the posts and burning was stopped. Broken windows were boarded up from the inside by the time images were collected.

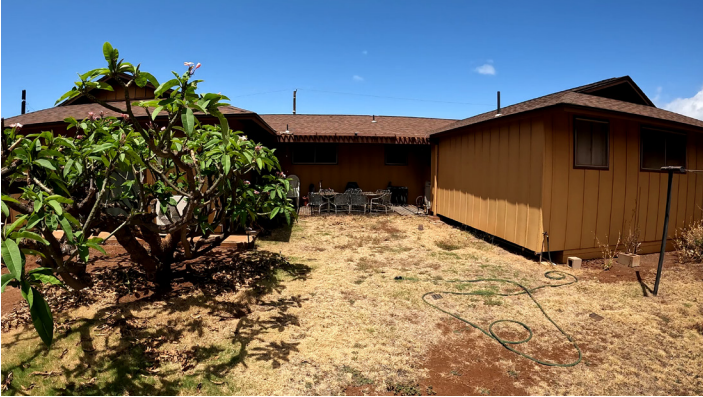
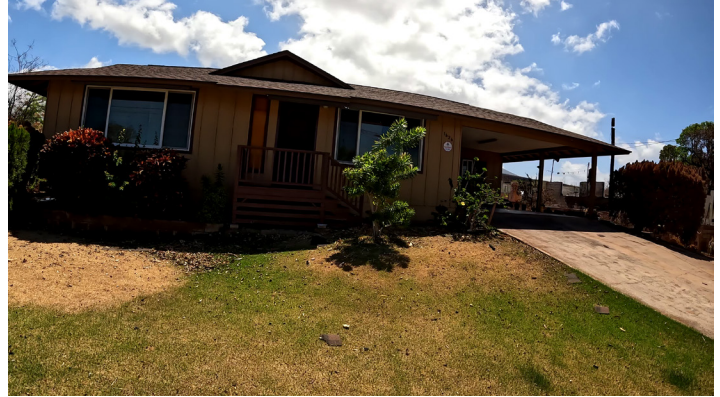
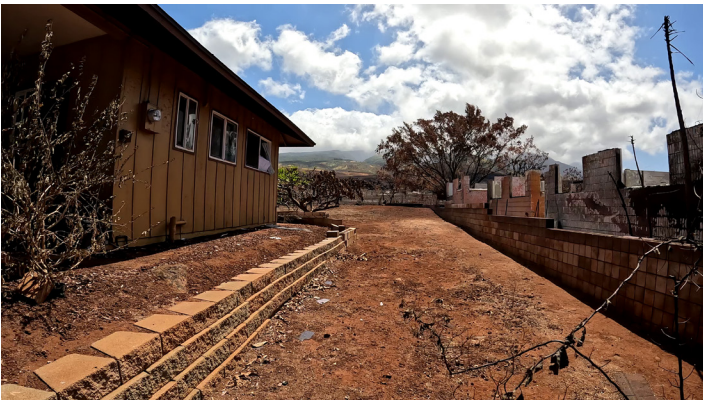
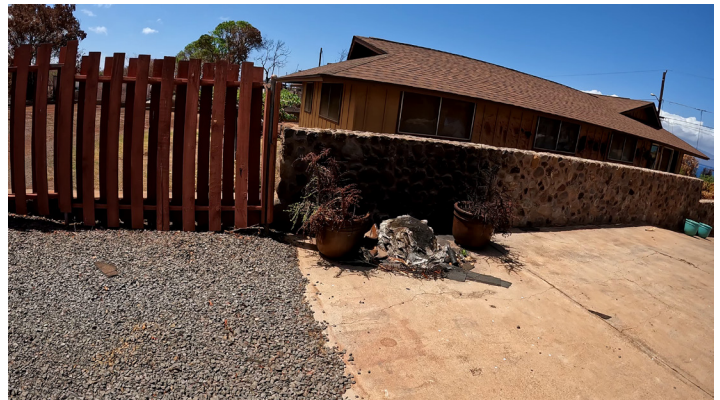
Figure 4.3.5.3.6 The 16██ Lokia Street structure did not appear damaged by the grass fire to the east (mauka) sides (top left) or destroyed structure west (makai) of Lokia Street (top right). The structure was heavily damaged from radiant heating from the destroyed structure to the south (bottom left) and north (bottom, right).

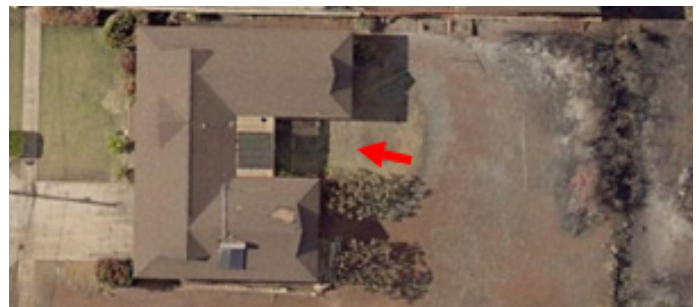
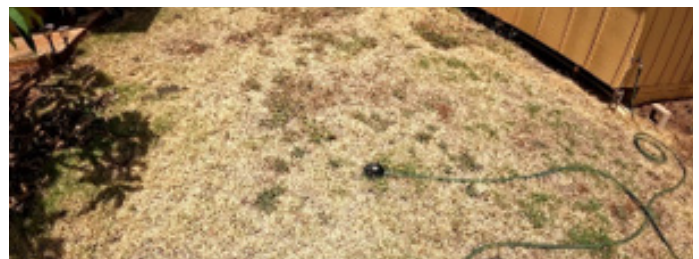
The vegetation fire in the grassland propagated into the east (mauka) yard of 16███ Lokia Street, but had limited impact on the structure itself. A sprinkler was noted in the east (mauka) yard in the vicinity of where the vegetation fire ended.

This sprinkler may have applied water during the fire either in preparing the property for the oncoming fire or prior to the fire to maintain the grass in this area (Figure 4.3.5.3.7). Regardless of when water was applied, fire-spread toward the structure was halted.

Figure 4.3.5.3.7 (top) Overhead view of 16██ Lokia Street lot with approximate location of sprinkler that may have been used to prepare the property for the fire and/or defend the property during the fire.

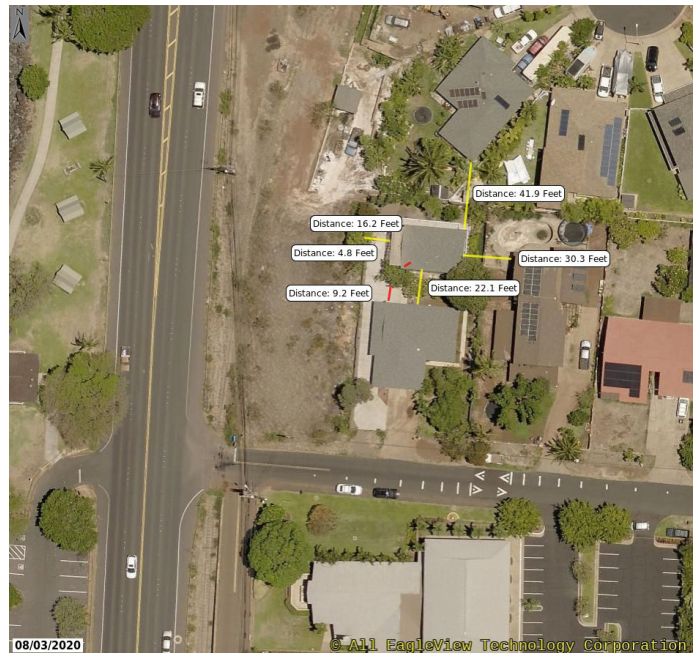
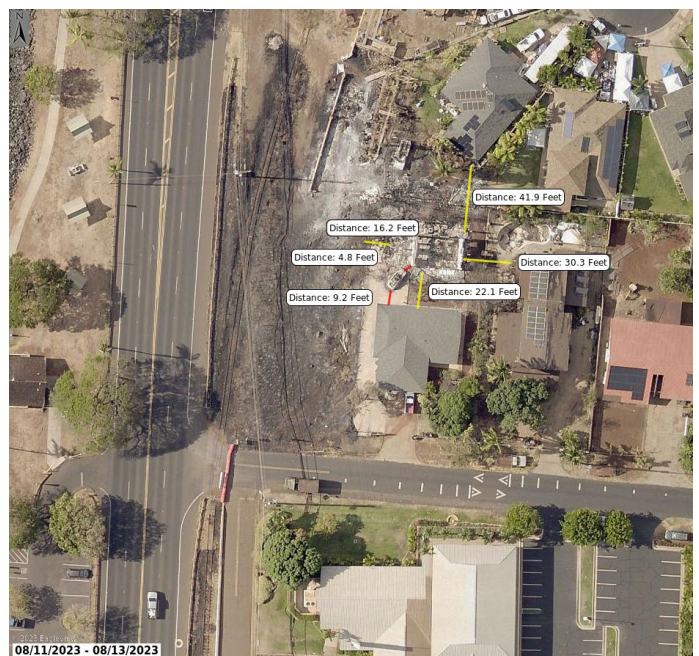
A vegetation fire also impacted structures on the west (makai) end of Kaniau Road. A single residential structure (accessory structure at 1█ Kaniau Road) was destroyed by this fire, despite being surrounded by at least two (2) surviving structures to the north, east (mauka), and south with no fire damage noted to the west (makai) of Hwy-30 (Figure 4.3.5.3.8).

Figure 4.3.5.3.8 Structure spacing near destroyed accessory structure at 1█ Kaniau Street.

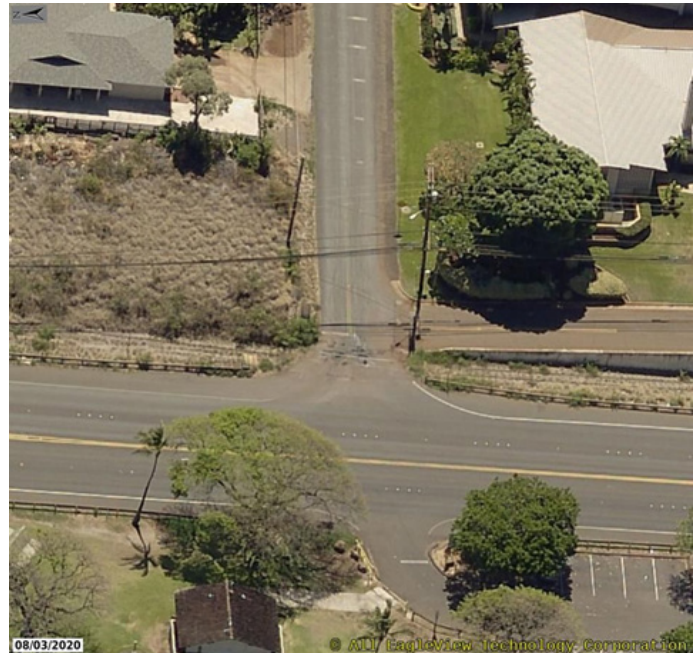
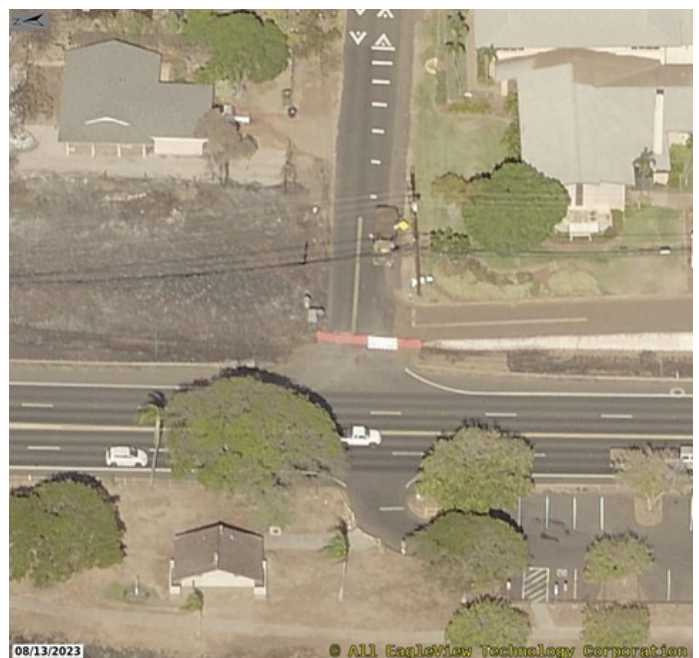
Tall grasses on the northeast corner of Kaniau Road and Hwy-30 would likely have provided a receptive fuel bed for embers that may have gathered there. If these grasses had dried out to the state shown in Figure 4.3.5.3.9, they would have more easily ignited the green, mowed lawns in the surrounding properties west (makai) of this location.

Figure 4.3.5.3.9 Tall dry grasses are noted on the northeast corner of Kaniau Road and Hwy-30 in August 2020 (top), which could have provided a receptive fuel bed for fires along the railroad tracks or embers moving down (makai) Kaniau Road to ignite these grasses in August 2023 and travel to structures in the immediate vicinity (bottom). Note: North is to the left of these images.

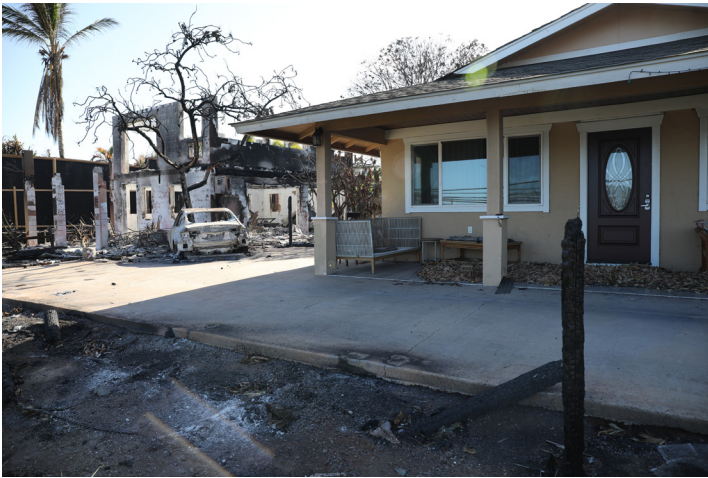
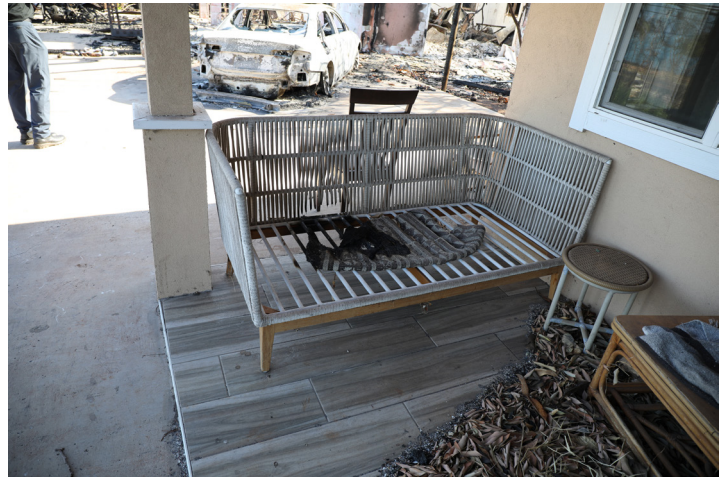
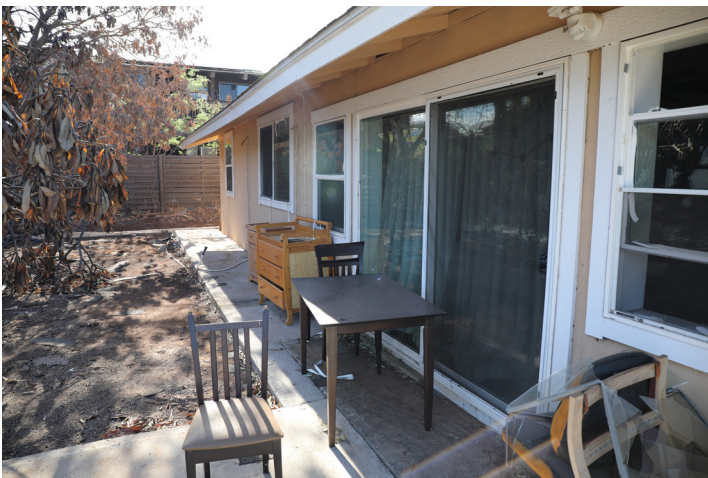
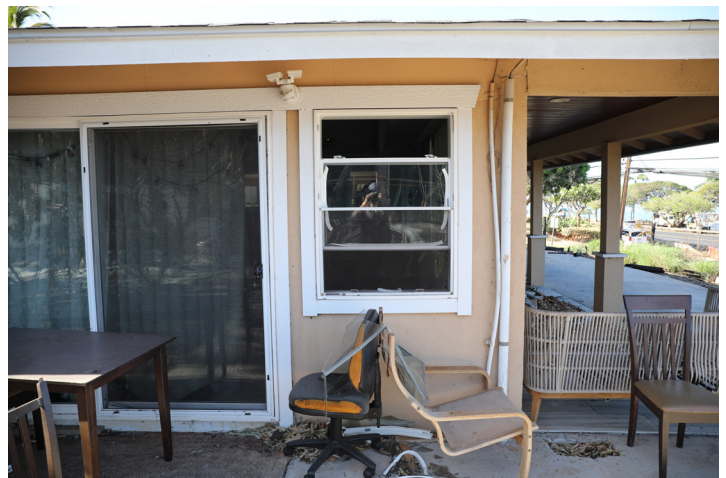
While the accessory structure on the 1■ Kaniau Road was destroyed by the fire, windows in the north side of the primary structure that was 20 to 25 feet to the south were damaged and spot fires were noted in outdoor furnishings to the west (makai) of this structure (Figure 4.3.5.3.10).

A vehicle between these two (2) structures was destroyed by the fire and may have played an important role in heat transfer to/from the vegetation and/or structure fire. The most extensive window damage was noted on the northwest corner, which was closest to the destroyed vehicle. However, damage to plastic molding on the windows was also noted on the west side (makai), proximate to the vegetation fire.

Figure 4.3.5.3.10 The primary structure at 1 Kaniau Road, in close proximity to the destroyed secondary structure and vehicle, had damaged windows, particularly close to the vehicle fire and ember damage to outdoor furnishings that did not extend to the structure.
