# Lahaina Fire Incident Analysis Report

**September 13, 2024**  
**Columbia, MD**

This document is the second in a series of three (3) reports commissioned by the Hawai'i Department of the Attorney General (DOAG) to provide an independent review of the tragic fire that destroyed much of Lahaina, Hawai'i, on August 8-9, 2023.

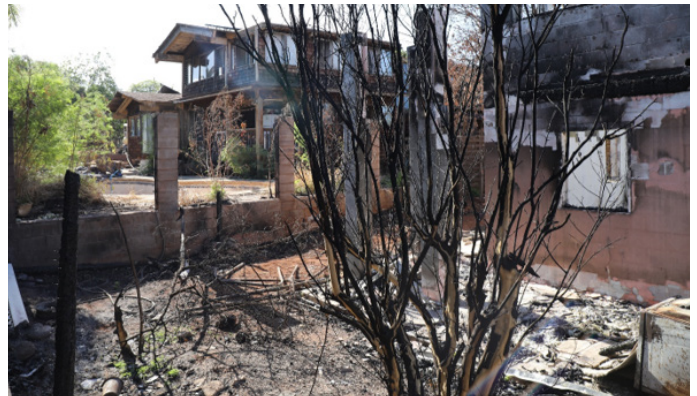
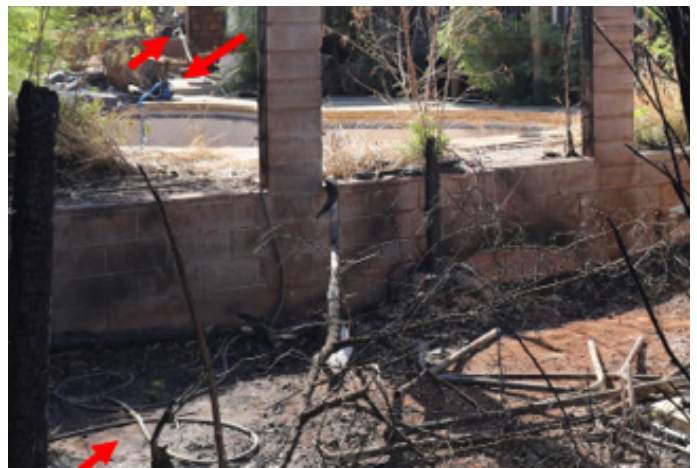
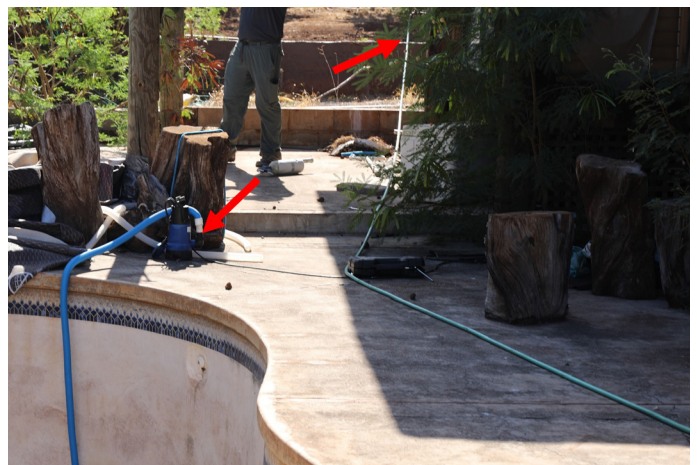
A garden hose was stretched from a hose bib on a structure in 1 Kaniau Road and remained deployed near 1 Kaniau Street. Conversations with local residents revealed neighbors used a pump to control the fire that was progressing along a plastic fence on the north property line. A pump was located next to a swimming pool in the south yard of 1 Kaniau Road (Figure 4.3.5.3.11).

Figure 4.3.5.3.11 Water resources from 1█ Kaniau Road were utilized to help control the fire from propagating farther east (mauka) from 1█ Kaniau Road. Garden hose was deployed from a hose bib with the terminal end remaining at the next lot. Neighbors reportedly used the pump to control a fire along the plastic fence at the north property line of this lot.

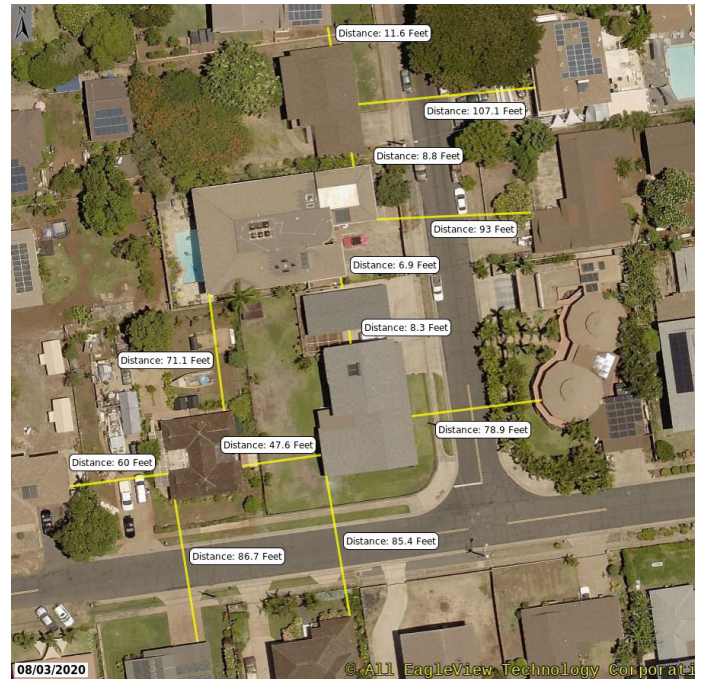
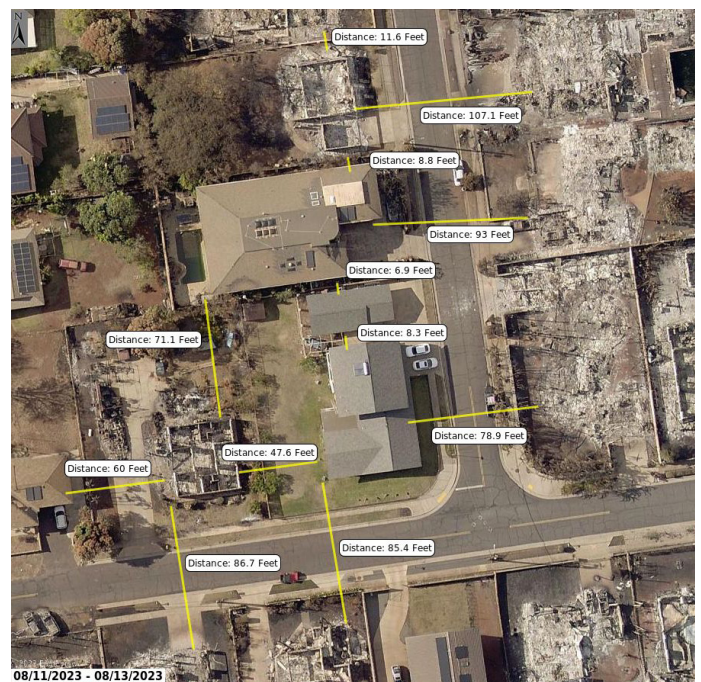
Defensive actions that appeared to utilize a residential swimming pool were also noted on the west side (makai) of Lokia Street, near the south end of the road where it intersects Malanai Street (Figure 4.3.5.3.12).

Figure 4.3.5.3.12 Structure spacing near surviving structures on the west side (makai) of the south end of Lokia Street.

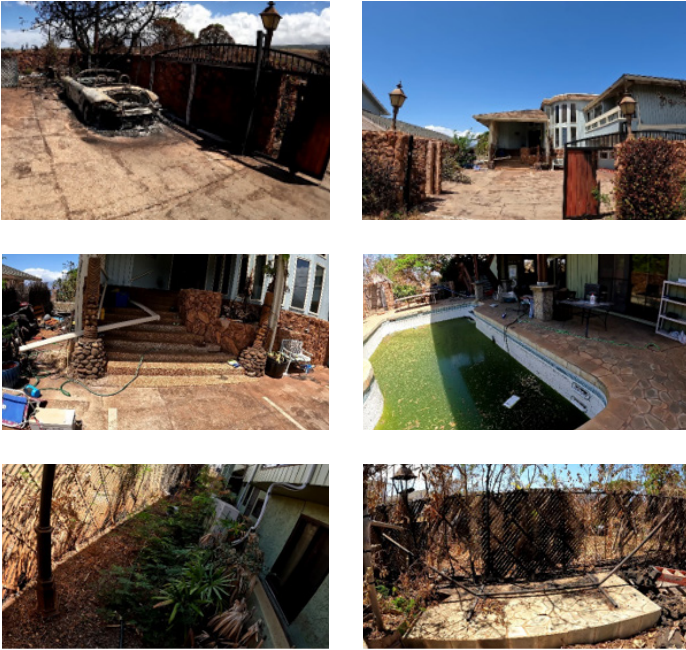
Figure 4.3.5.3.13 The 15███ Lokia Street lot experienced fire damage to the front entrance gate and destroyed a vehicle, but did not extend to the structure (top). The structure appears to have been defended, in part, by pumping water from the pool in the rear of the structure, powered by a battery system (middle). Damage to fences on the north and south sides of the properties (bottom), showing the end of the hose from the pump in the pool and along with a bucket (bottom left).

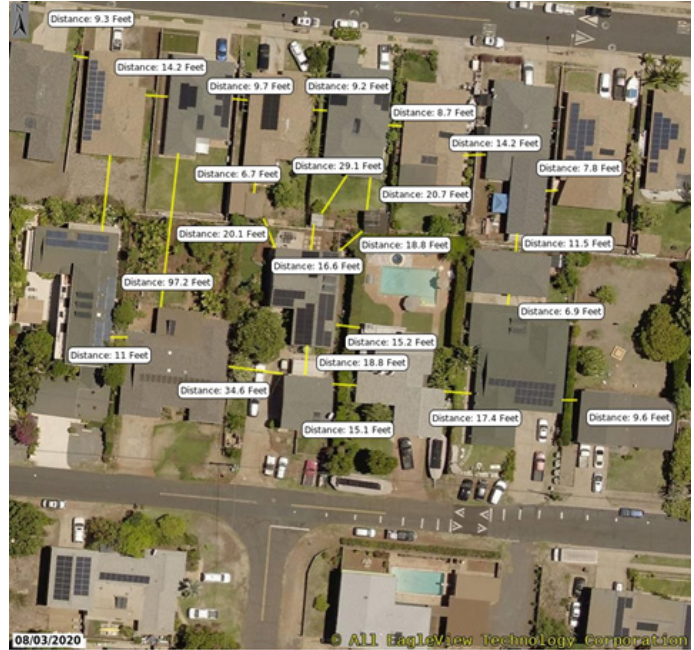
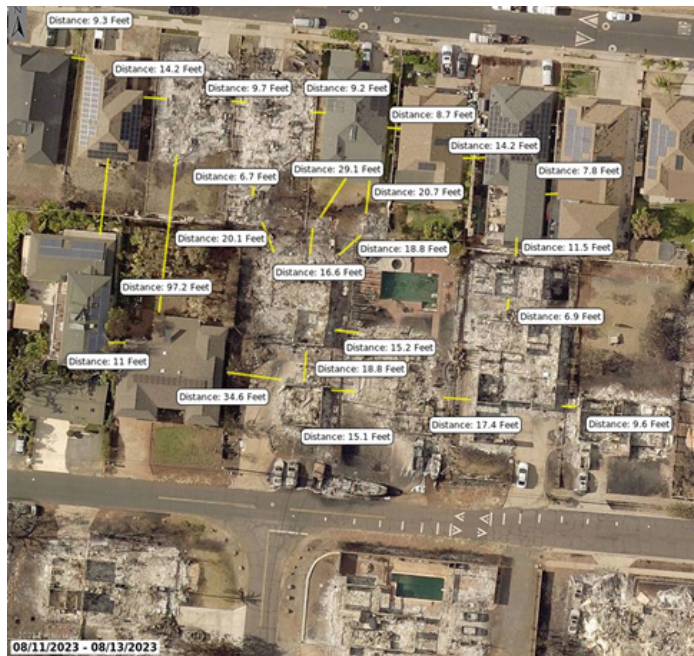
Structures to the east (mauka) and west (makai)—1█ and 7█ 'Aipuni Street—of these destroyed structures were damaged by the fire through radiant heat transfer, but survived, due, in part, to defensive actions conducted by firefighters and citizens.

Figure 4.3.5.3.14 Structure spacing near surviving structures on the north side of Kaniau Street and south side of Aipuni Street.

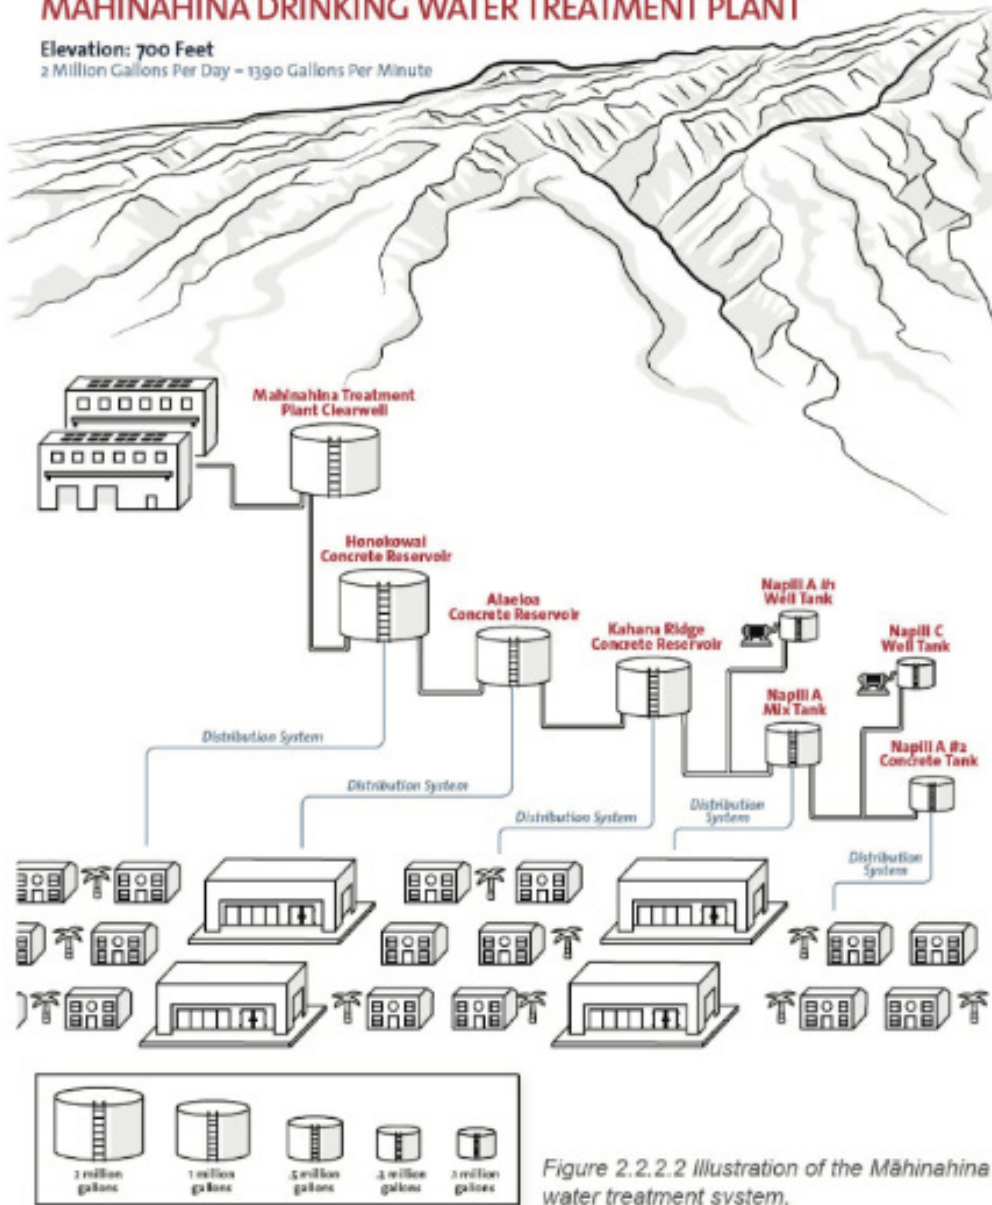
Figure 6.8.2 Māhinahina drinking water treatment system

Elevation: 700 Feet  
2 Million Gallons Per Day – 1390 Gallons Per Minute

Figure 2.2.2.2 Illustration of the Māhinahina drinking water treatment system.

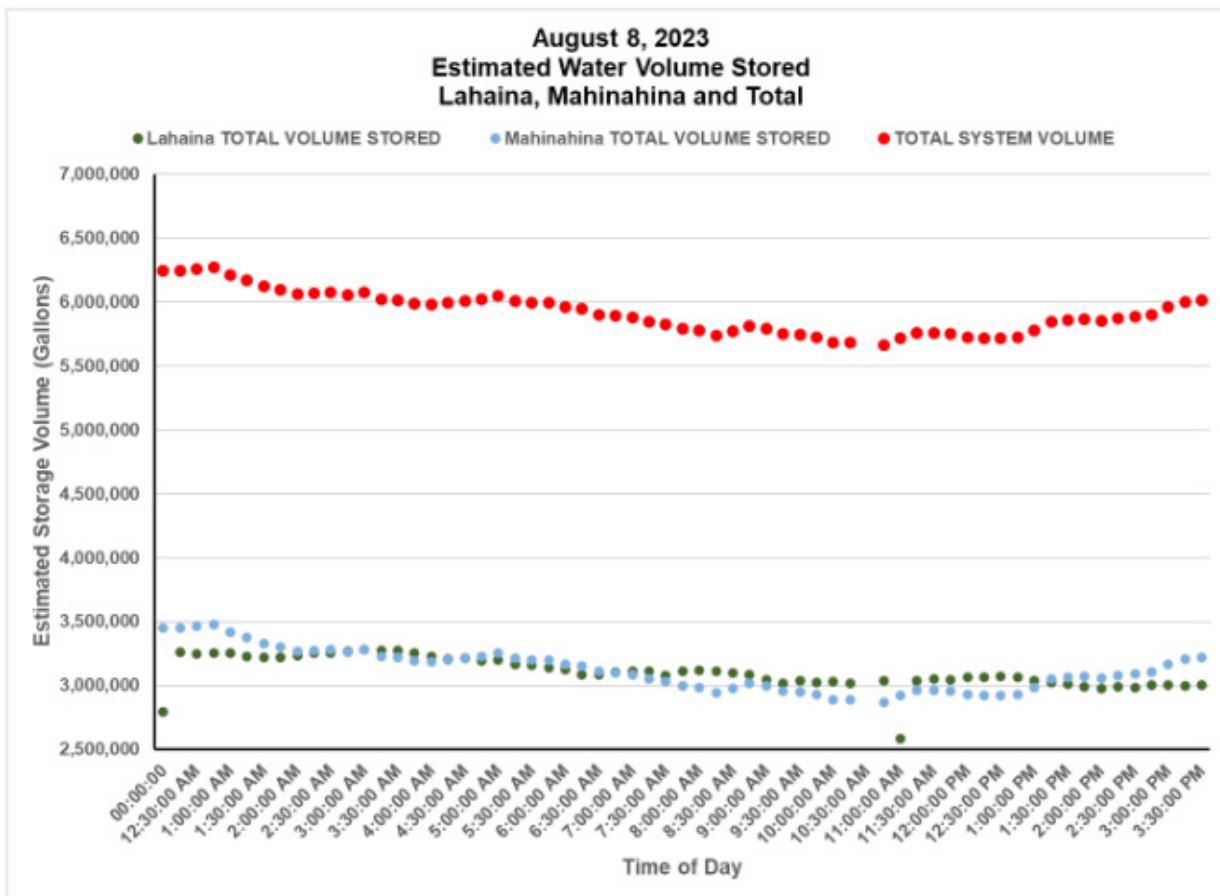
Figure 6.8.3 Estimated water volume stored in Lahaina and Māhinahina on August 8, 2023.

As per Figure 6.8.3, total system volume on August 8, 2023, ranged from just less than 7 MG to less than 6 MG until 15:30 when data was no longer available. Therefore, the amount of water stored in the two (2) systems met the state requirements for the required average daily demand until data was no longer available as described above.

A data recording system for the County of Maui Department of Water Supply routinely records the water level in each of the water storage tanks in both the Lahaina and Māhinahina storage and distribution systems. The graph below shows the time variation of water volume stored versus time for the Lahaina, Māhinahina and the two (2) systems combined. The recording of water level data by the county ceases at 3:30 p.m. on August 8, 2023, for all storage tanks in both the Lahaina and Māhinahina systems. The reason given by the county for the simultaneous loss of all tank level data was a power outage.

**Note:** The volumes calculated in the graph above are preliminary estimates based upon the tank capacity and the tank level recorded by the system. The recording system stopped recording data at 15:30 on August 8, 2023.
