**CALIFORNIA PUBLIC UTILITIES COMMISSION
Safety and Enforcement Division
Utilities Safety and Reliability Branch**

Incident Investigation Report

Incident Number: E20170505-01

Location of the Incident: Bahia Substation
Benicia, CA
County: Solano

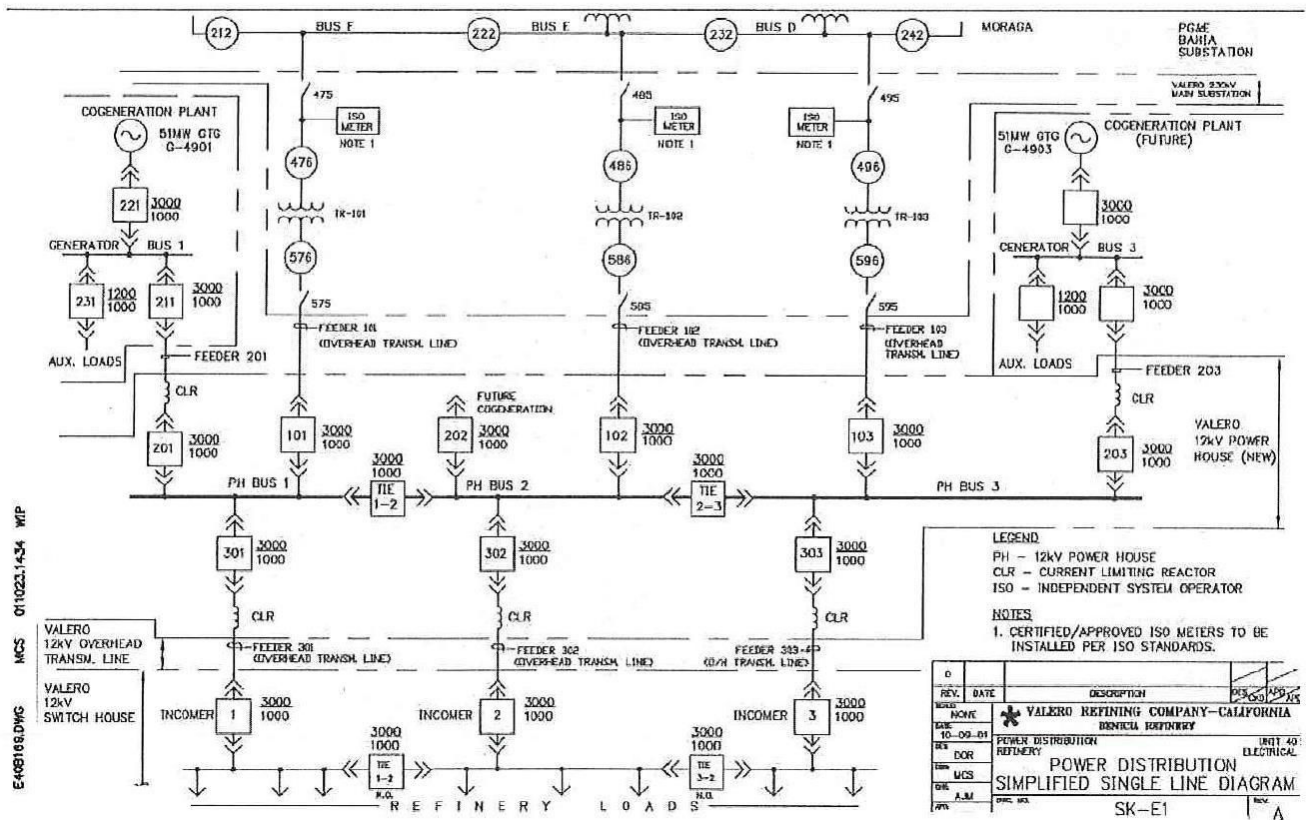
VALERO/BAHIA SINGLE LINE DIAGRAM

Figure 2: Valero/Bahia Single-line Diagram including Valero's Cogeneration plant

When the CCVT on circuit breaker 242 failed, it created an undervoltage condition on the Bahia-Moraga line. On the day of the incident, PG&E crew opened circuit breaker 212 to clear the Vaca Dixon-Bahia line. With this, both conditions were satisfied for condition 3, which activated the anti-islanding protection scheme. Additionally, it shows why Valero circuit breakers 476, 486, and 496 opened as soon as Bahia circuit breaker 212 opened.
