VISUAL INSPECTION AND EVALUATION REPORT

Rockwall-Forney Dam
Dallas Water Utilities
Dallas/Kaufman Counties, Texas

Schnabel Reference #20C22001.00
July 30, 2021

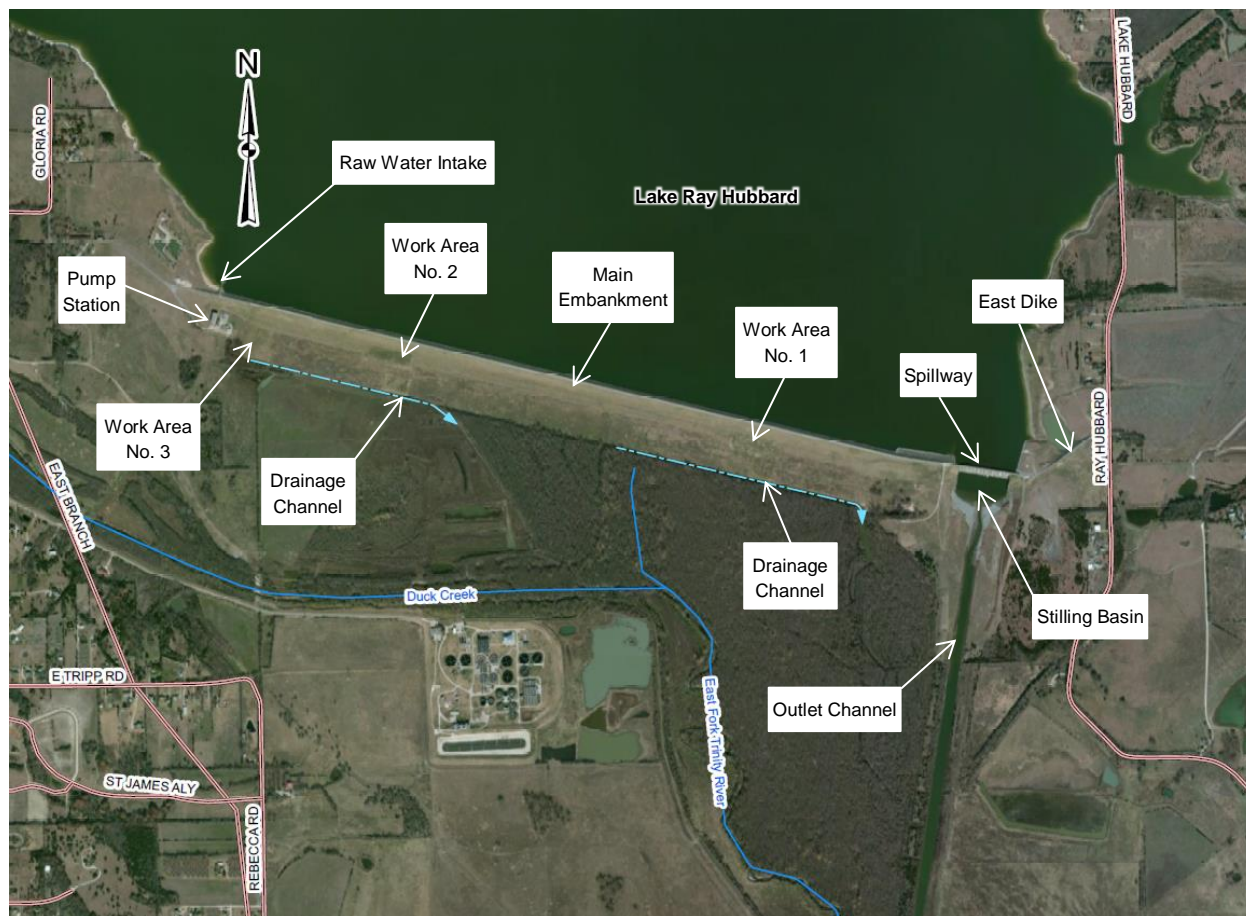
Figure 2-1: General Site Layout

A general layout of Forney Dam and appurtenant structures is presented in Figure 2-1.

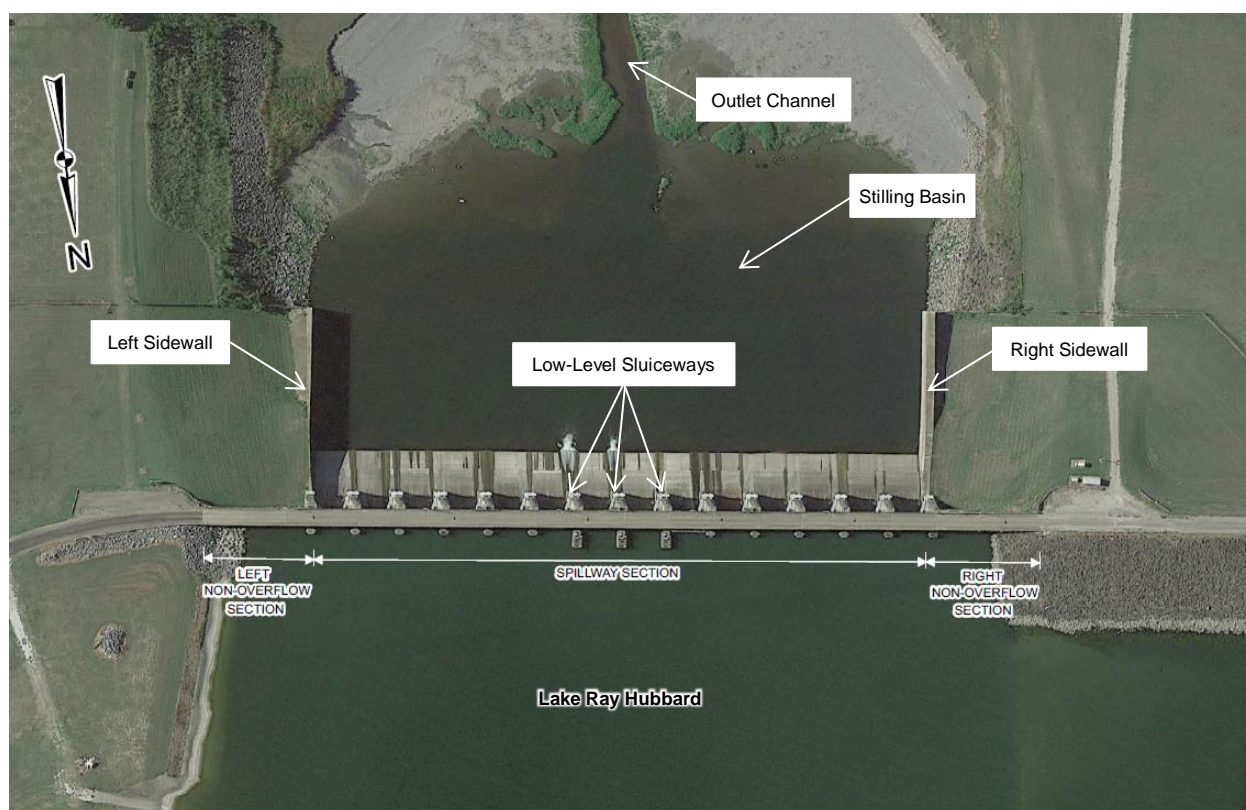
Figure 2-2: Spillway Layout

The concrete dam consists of a 904-foot wide gravity section that is founded on shale. From right to left the concrete gravity structure consists of the right non-overflow, 664-foot wide spillway consisting of 14 radial gates seating on ogee crests, and left non-overflow. The crest elevation of the ogee weir is labeled on the “as-built” documents to be 409.5 feet. The 14 radial gates each have horizontal and vertical dimensions of 40-feet and 28-feet, respectively. Within this report, radial gate and Tainter gate may be used interchangeably. The gate bays are separated by thirteen (13) 8-foot wide piers resulting in an effective spillway width of 560 feet. A reinforced-concrete chute conveys spillway discharges at a grade of 3H:1V to the stilling basin with a top of concrete elevation of 367.0 feet. The stilling basin is 125 feet in length, and contains staggered baffle blocks and an end sill. Three low-level sluiceways, each 4.5-feet by 6.75-feet, are located in the central spillway piers. A vertical intake tower is located on the upstream end of each central pier, with sluice gates provided at varying elevations to release water. A general layout of the spillway is presented in Figure 2-2.

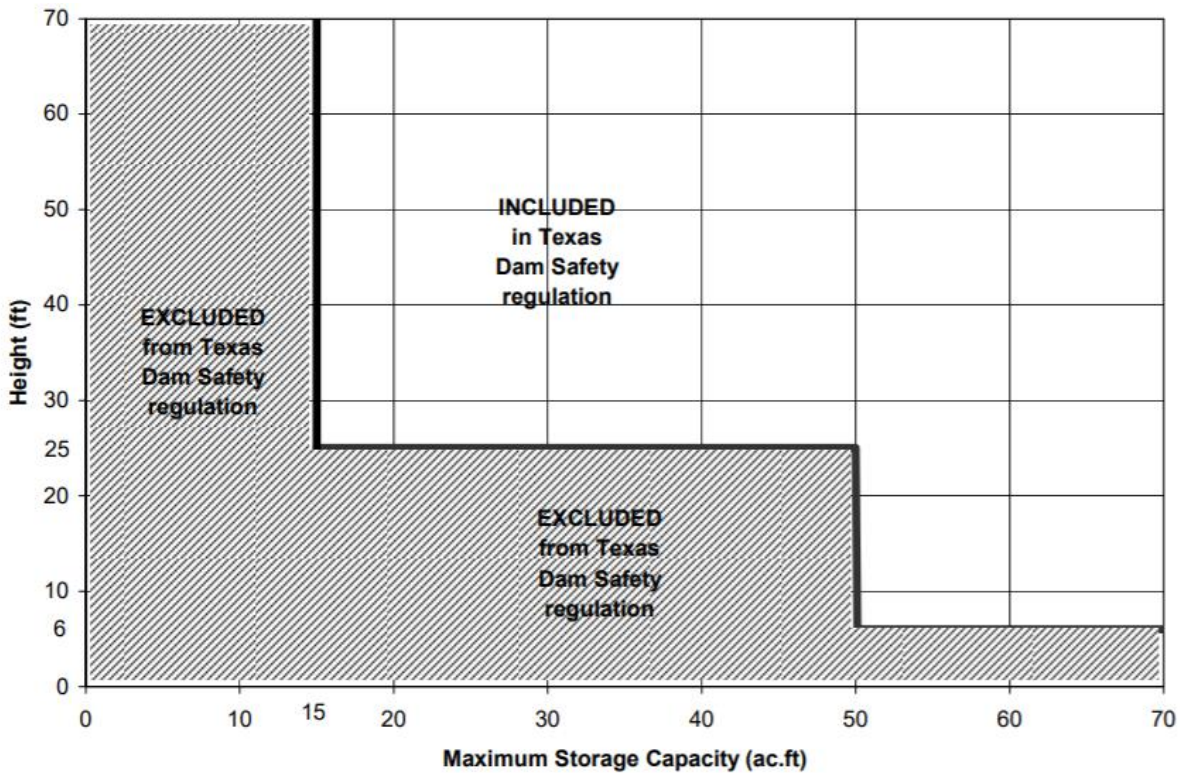
Figure 3-1: Texas Dam Safety Regulation

TCEQ regulates both public and private dams within the state via the Dam Safety Program. Texas Administrative Code Title 30, Part 1, Chapter 299, titled 'Dams and Reservoirs', provides the framework and requirements for structures regulated by the Dam Safety Program. TCEQ regulates dams that have a height equal to, or greater than, 25 feet and a maximum storage capacity of not less than 15 acre-feet. In addition, TCEQ provides for the regulation of smaller dams (6 feet in height or greater) impounding large storage volumes (50 acre-feet and greater). Figure 3-1 below summarizes the structures that are regulated by TCEQ based upon height and/or volume.

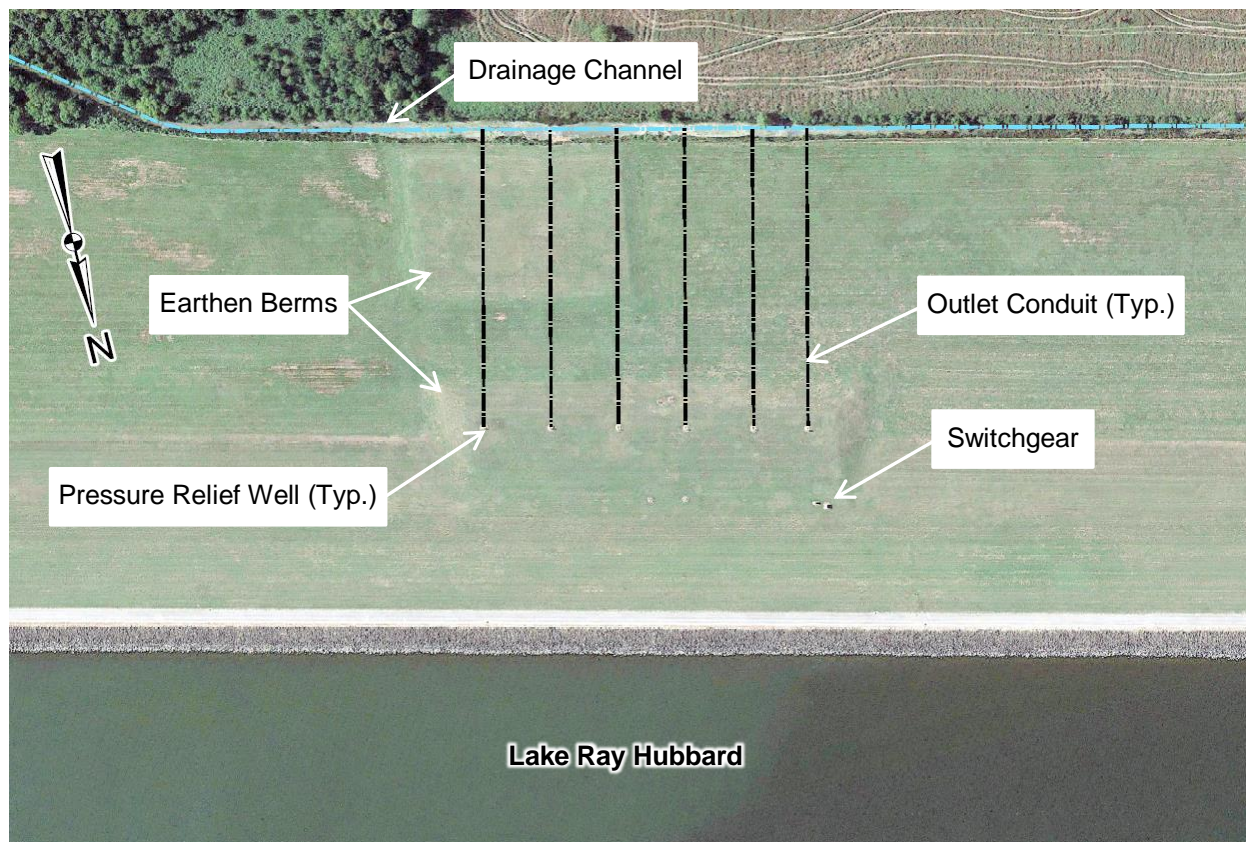
Figure 6-2: Work Area 2 Layout

The three Work Areas constructed to address excessive hydrostatic pressures at the toe of the embankment were observed during the visual inspection of the downstream slope. Work Areas 1 and 2, located at approximate stations 78+50 and 29+00, respectively, consist of earthen berms approximately 15 feet in height with pressure relief wells and sand blankets to collect and discharge seepage and alleviate excess pore pressures. Work Area 2 has an additional earthen berm approximately 5 feet in height with a sand blanket located downstream of the toe near the drainage channel. The pressure relief wells operate automatically and discharges are conveyed to the drainage channels downstream from the dam. The downstream ends of the discharge conduits are situated on concrete outlet supports along the edge of the channel. Schnabel notes that substantial erosion capable of undermining or destabilizing the concrete outlets was noted adjacent to several of the outlets. The pressure relief wells did not operate at the time of the inspection; however, DWU personnel indicated that the pressure relief wells are operational. A general layout of Work Area 2 is presented in Figure 6-2. Work Area 1 is similar.

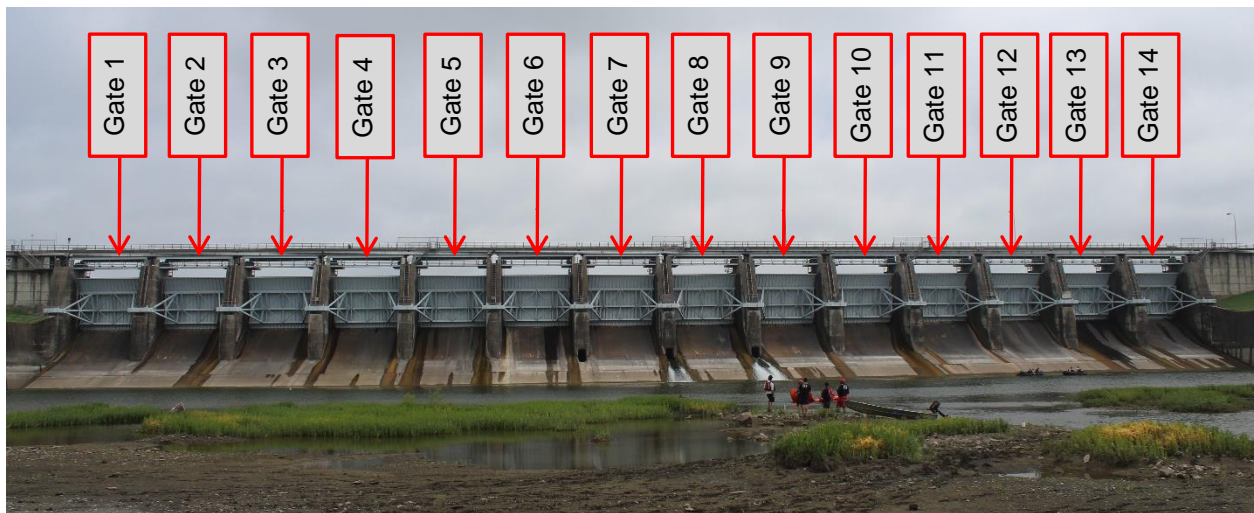
Figure 6-4: Tainter Gate Numbering

In addition, the Tainter gate numbering system shown in Figure 6-4 is referenced throughout the report.

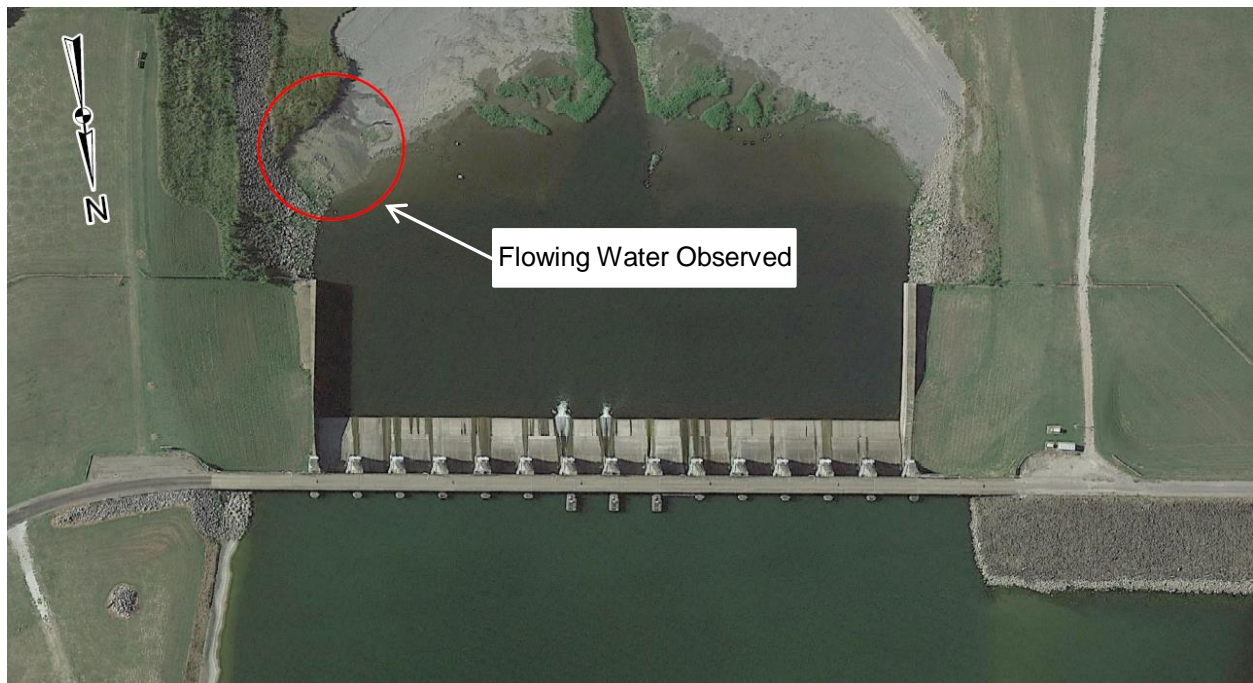
Figure 6-5: Potential Seepage Area near Stilling Basin

A significant amount of flowing water was observed discharging from the left side slope immediately downstream from the riprap at the end of the left stilling basin sidewall. This area is indicated in Figure 6-5. The water was observed to be clear, and discharging from between the shale and soil at the bottom of the left side slope. No water was observed flowing from the slope at higher elevations; however, riprap coverage in this area hindered observations. A determination could not be made as to whether the origin of the flowing water is seepage or groundwater. Previous inspection reports have identified perennial flowing water in in this area. Given the presence of the void upstream of the gravity structure, the potential for drainage material to not be compatible with soil materials, and the presence of historic seepage, Schnabel recommends that this seepage be evaluated and, if needed, appropriate remedial measures be designed and implemented to address the source and impact of the seepage.

- A significant amount of flowing water was observed discharging from the left side slope immediately downstream from the riprap at the end of the left stilling basin sidewall. The source of this flowing water should be evaluated, particularly considering the "void" or eroded area observed near the spillway entrance channel. (See Section 6.7 and Appendix B).

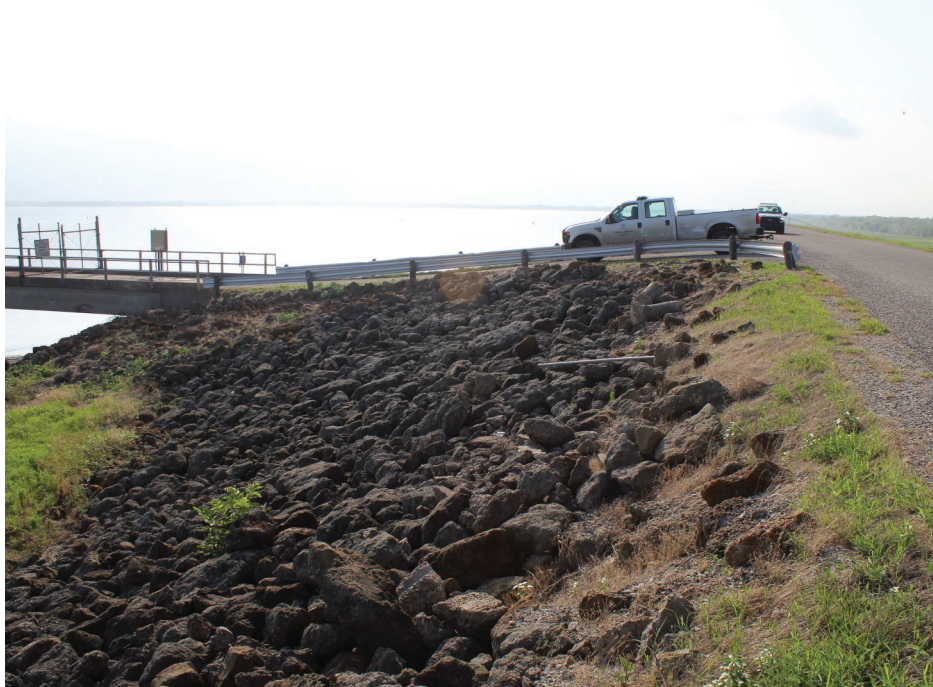
PHOTOGRAPH No.: 1

LOCATION: Sta 4+00, upstream slope of main embankment, looking left

COMMENTS: Riprap is adequate. No visual indication of instability.

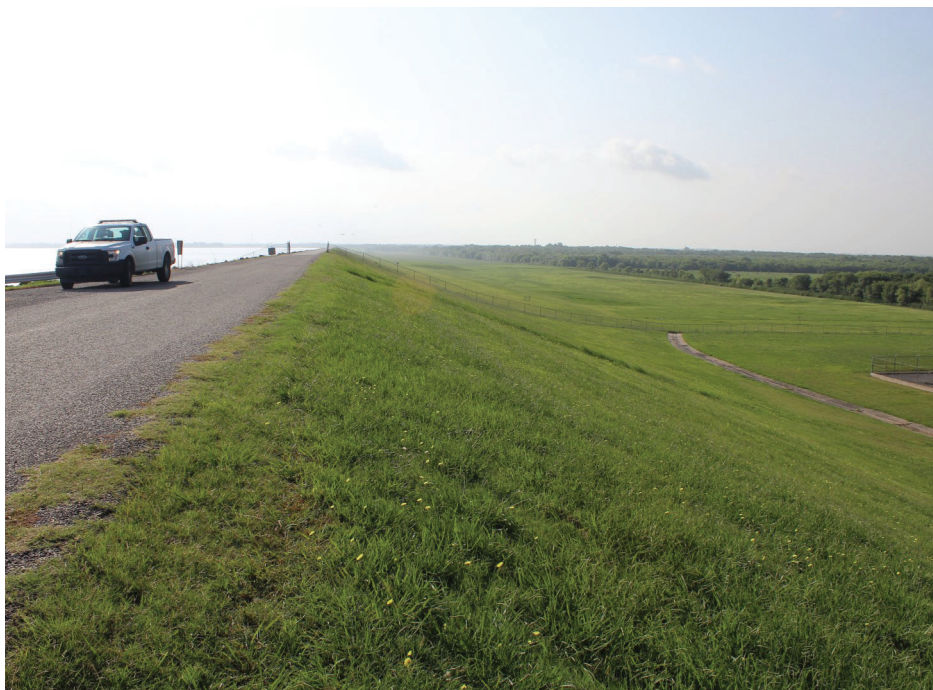
PHOTOGRAPH No.: 2

LOCATION: Sta 4+00, downstream slope of main embankment, looking left

COMMENTS: Slope is uniform and well-maintained.

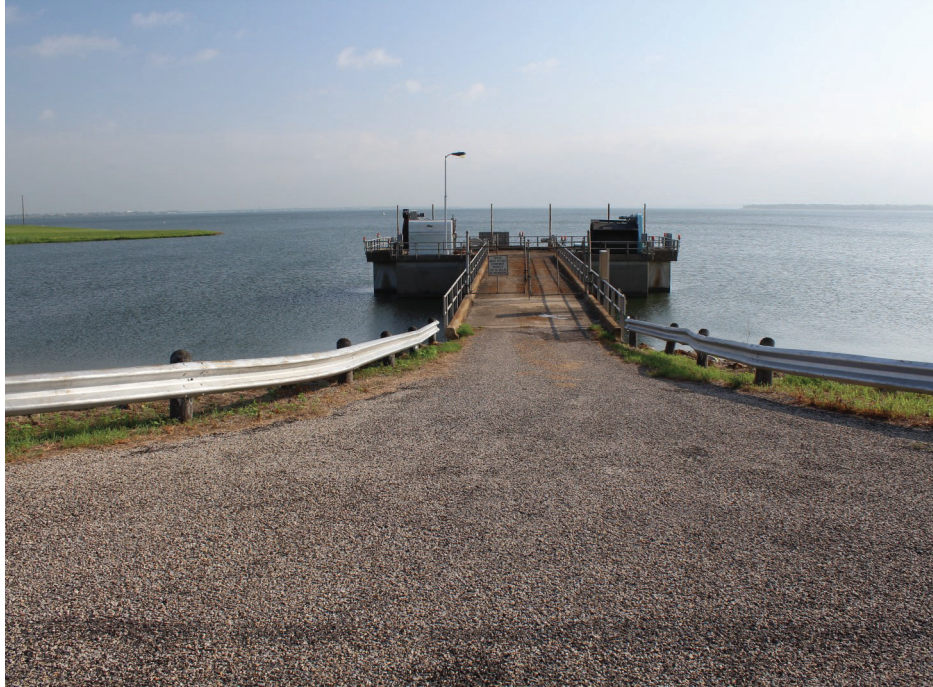
PHOTOGRAPH No.: 3

LOCATION: Sta 5+00, crest of main embankment, looking upstream

COMMENTS: Raw water intake structure is shown.

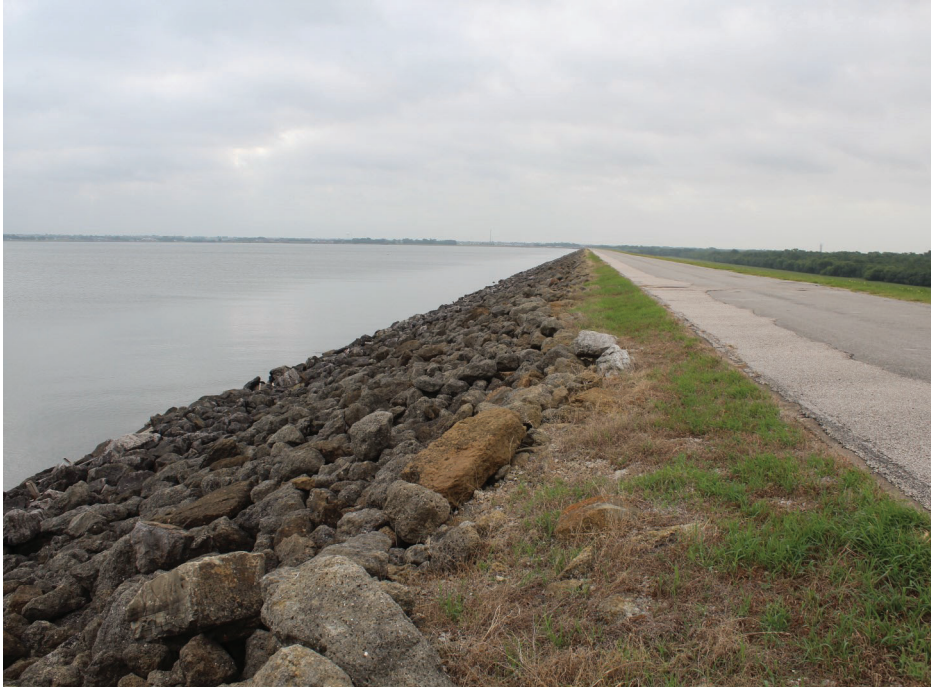
PHOTOGRAPH No.: 5

LOCATION: Sta 24+00, upstream slope of main embankment, looking left

COMMENTS: Riprap is adequate. No visual indication of instability.

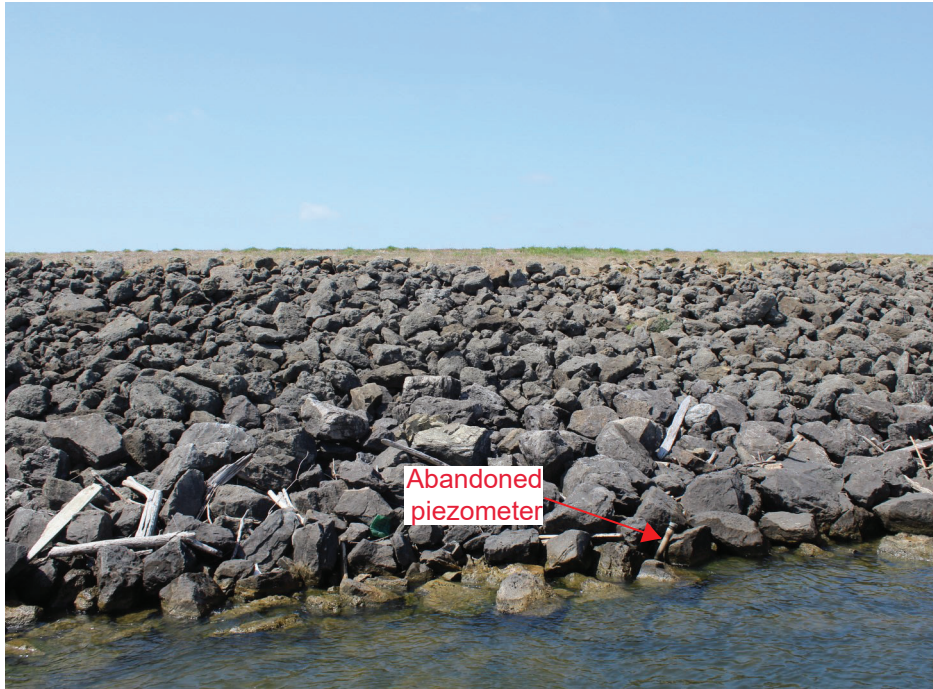
PHOTOGRAPH No.: 7

LOCATION: Sta 36+00, upstream slope of main embankment, looking downstream

COMMENTS: Abandoned piezometer is shown.

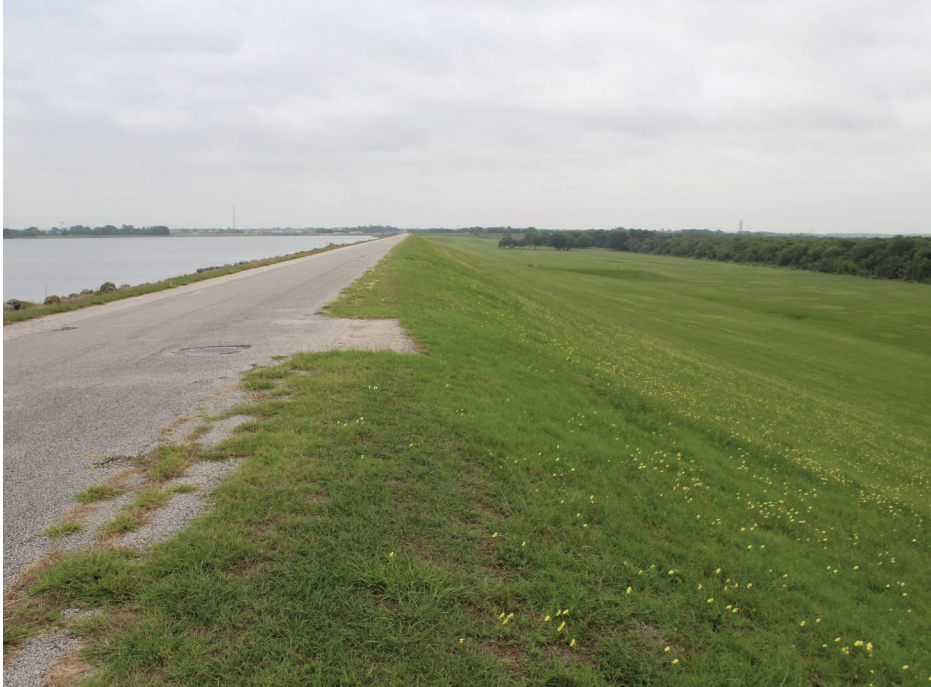
PHOTOGRAPH No.: 11

LOCATION: Sta 64+00, downstream slope of main embankment, looking left

COMMENTS: Slope is uniform and well-maintained.

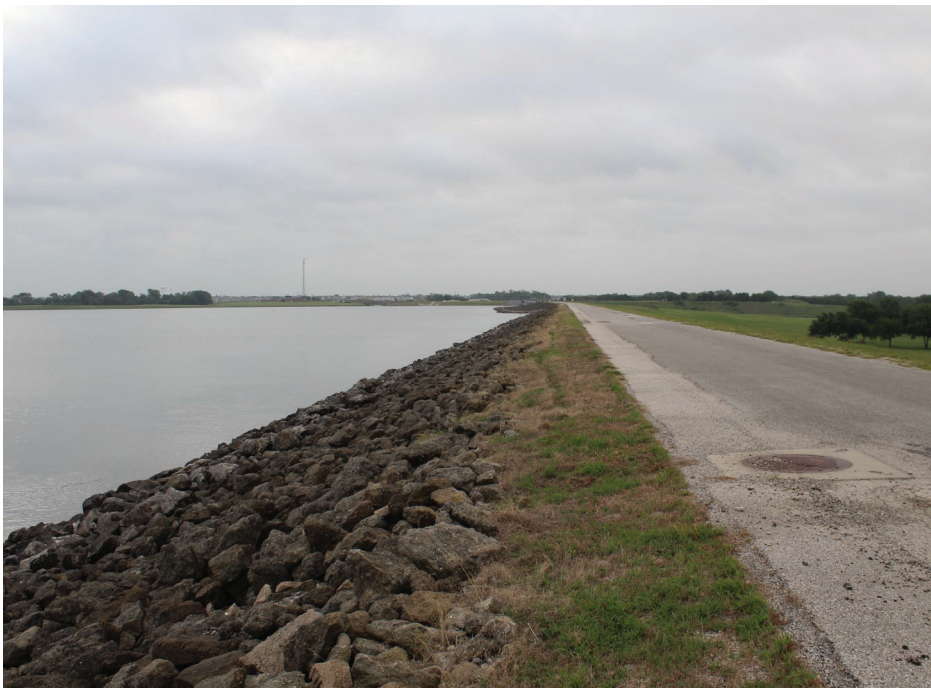
PHOTOGRAPH No.: 12

LOCATION: Sta 84+00, upstream slope of main embankment, looking right

COMMENTS: Riprap is adequate. No visual indication of instability.

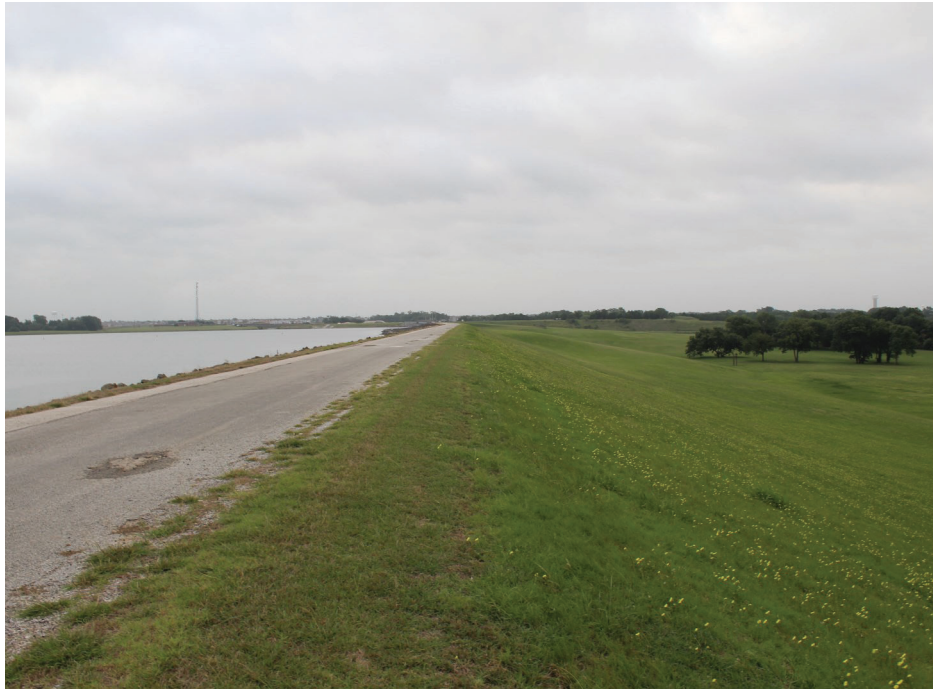
PHOTOGRAPH No.: 13

LOCATION: Sta 84+00, downstream slope of main embankment, looking left

COMMENTS: Slope is uniform and well-maintained.

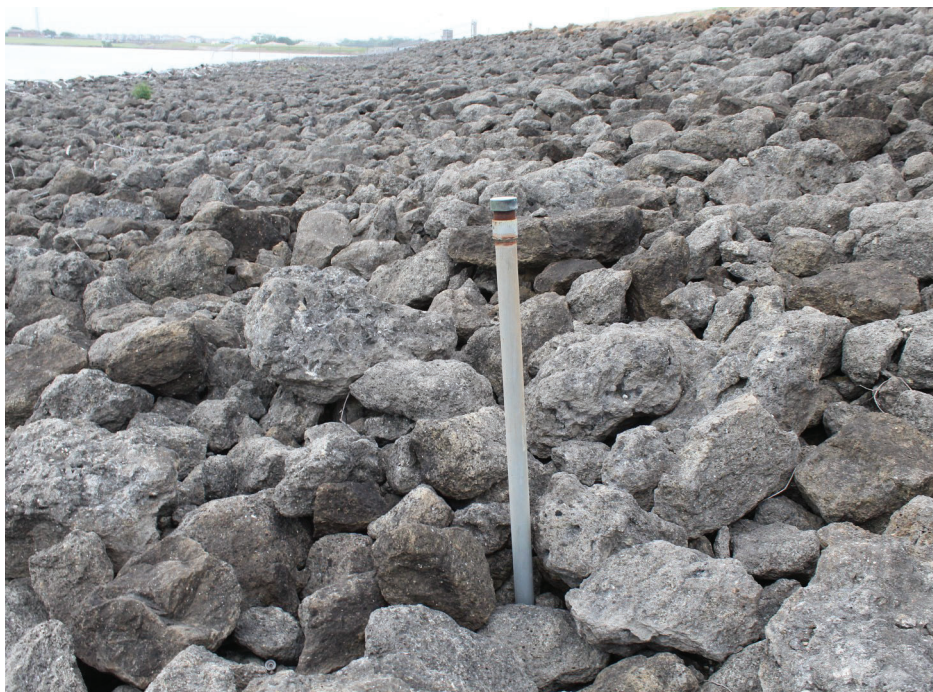
PHOTOGRAPH No.: 14

LOCATION: Sta 97+50, upstream slope of main embankment, looking left

COMMENTS: Abandoned piezometer is shown.

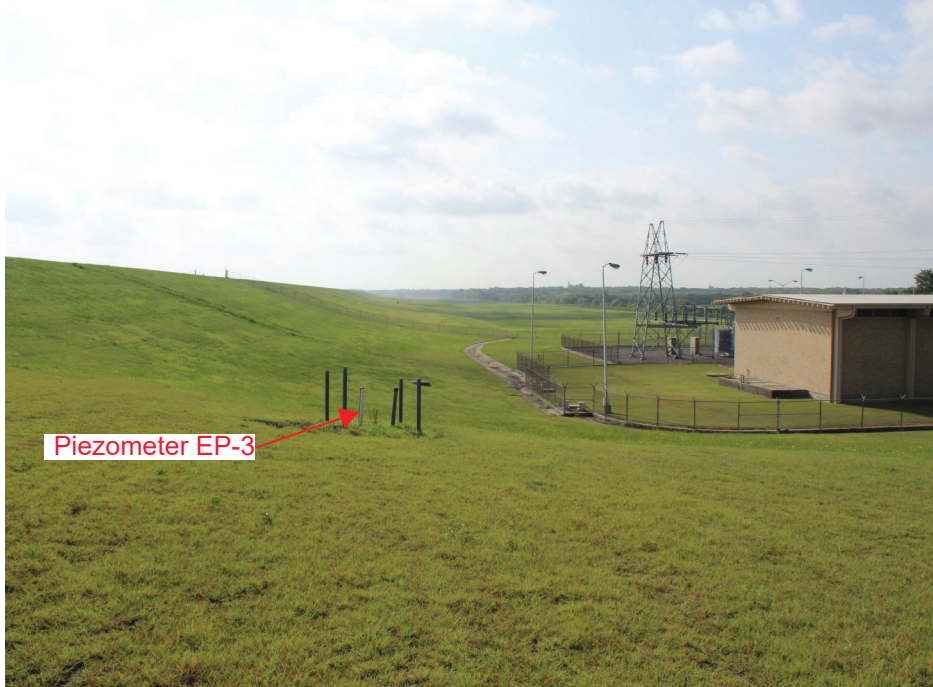
PHOTOGRAPH No.: 15

LOCATION: Sta 4+00, right abutment of main embankment, looking left

COMMENTS: Piezometer EP-3 is shown.

- Evaluate elevated piezometric levels near the ground surface in several piezometers within the embankment and downstream area. In addition, evaluate the cause of the upward trend in recorded water levels of some piezometers.

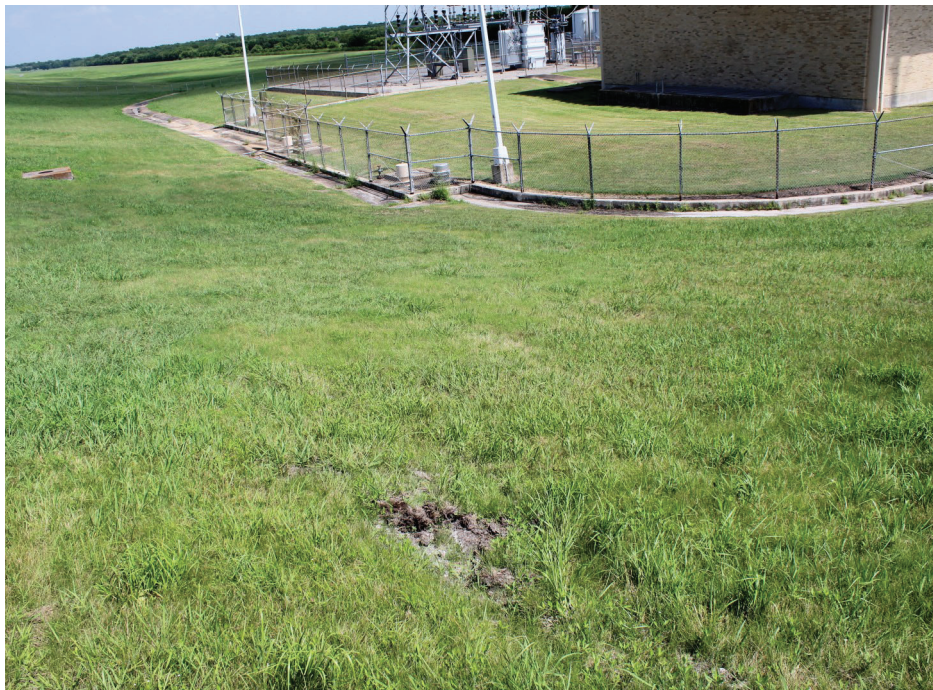
PHOTOGRAPH No.: 16

LOCATION: Sta 4+00, right abutment of main embankment

COMMENTS: Historic wet area indicated by DWU personnel. No wetness was present at time of inspection.

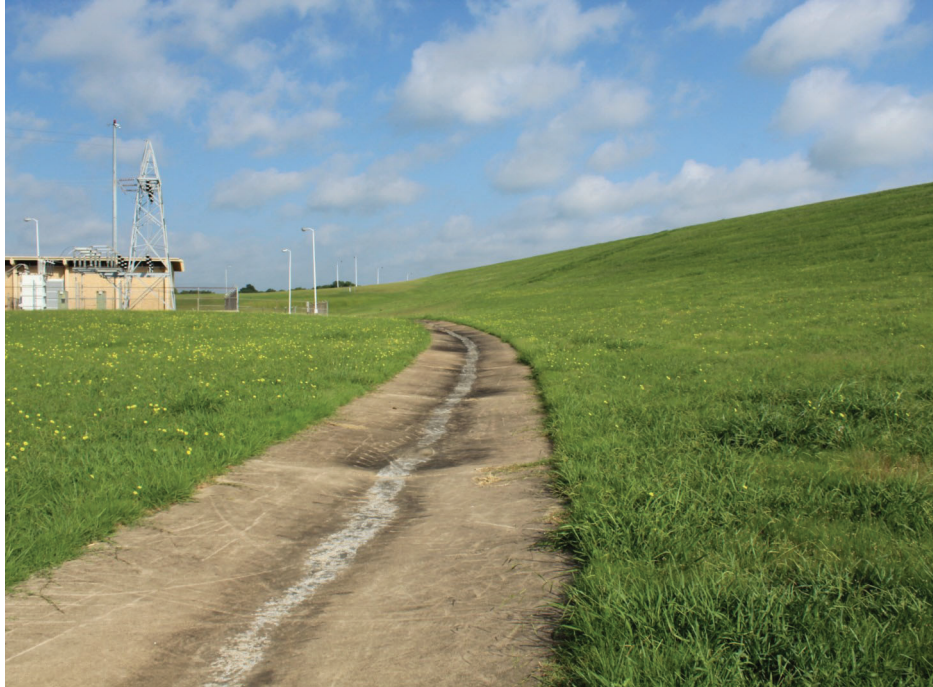
PHOTOGRAPH No.: 17

LOCATION: Sta 10+00, downstream toe of main embankment, looking right

COMMENTS: Concrete channel collecting surface water was dry at the time of inspection.

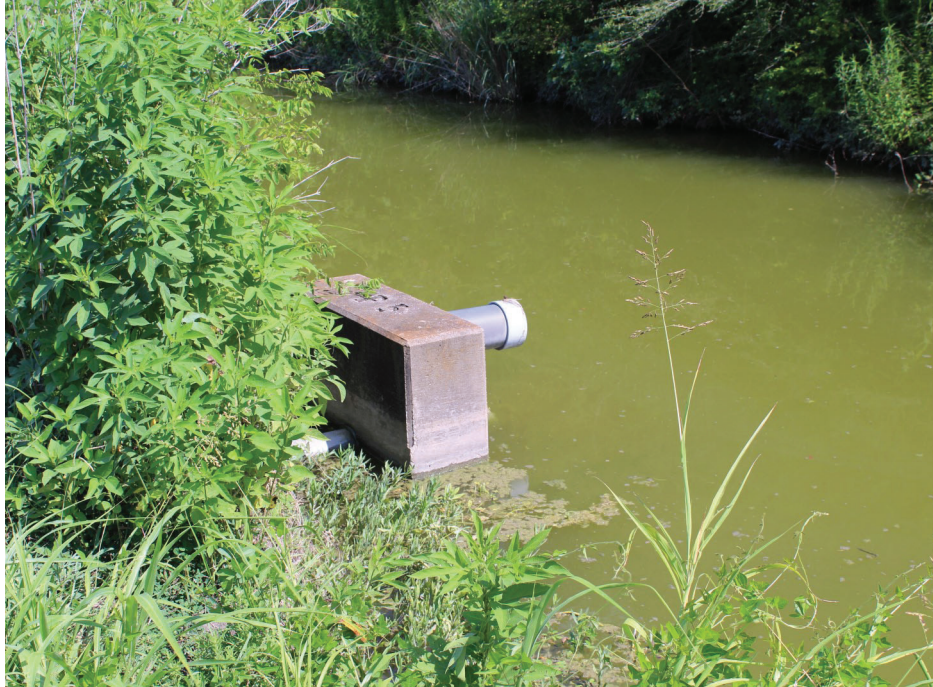
PHOTOGRAPH No.: 19

LOCATION: Sta 78+50,
drainage channel down-
stream of Work Area 1

COMMENTS: Pressure relief
well outlet is shown.

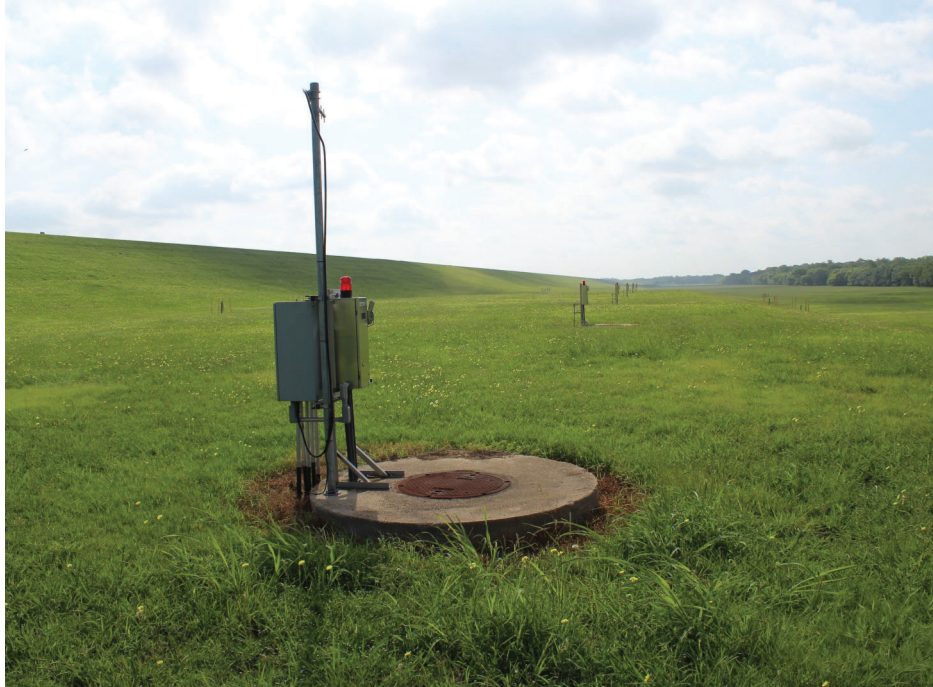
PHOTOGRAPH No.: 21

LOCATION: Sta 29+00, downstream slope main embankment, looking left

COMMENTS: Relief well for Work Area 2 is shown.

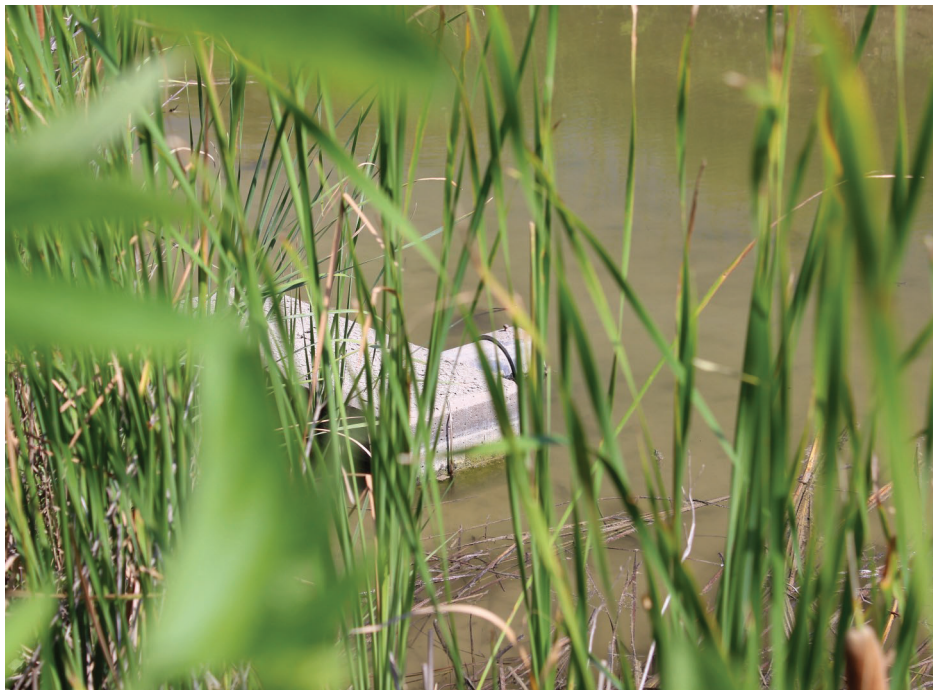
PHOTOGRAPH No.: 22

LOCATION: Sta 29+00, drainage channel downstream of Work Area 2

COMMENTS: Pressure relief well outlet is shown. Note elevated water surface has inundated the outlet.

- Maintain an operational log for the pressure relief wells, to include runtimes and discharges.
- Evaluate the cause for the elevated water in the drainage channels downstream of the dam. The channel blockage should be removed such that the pressure relief well outlets are not inundated.

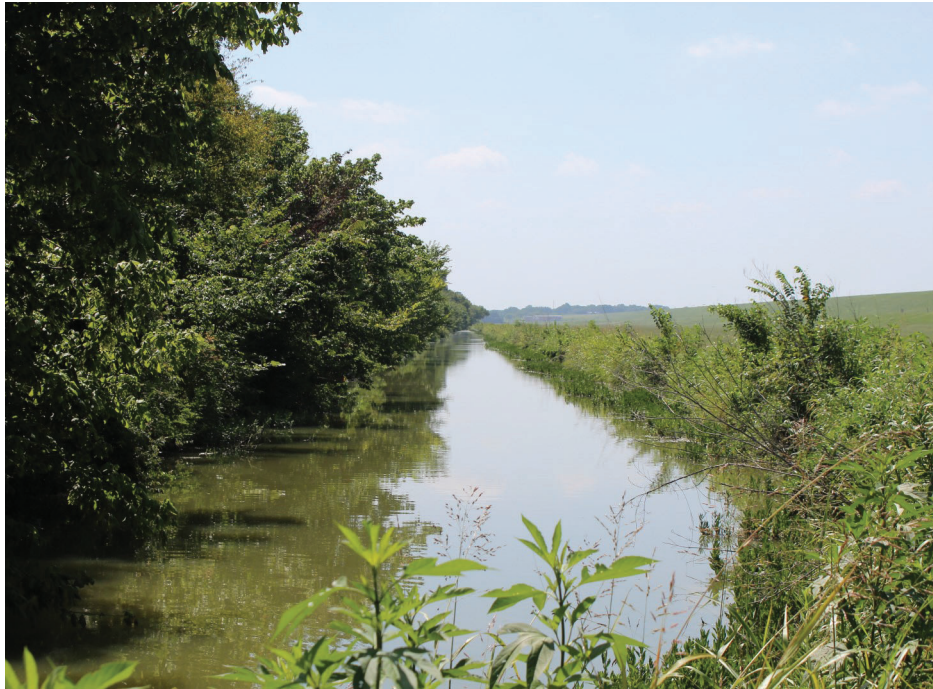
PHOTOGRAPH No.: 23

LOCATION: Sta 83+00, drainage channel downstream of main embankment

COMMENTS: Note elevated water surface.

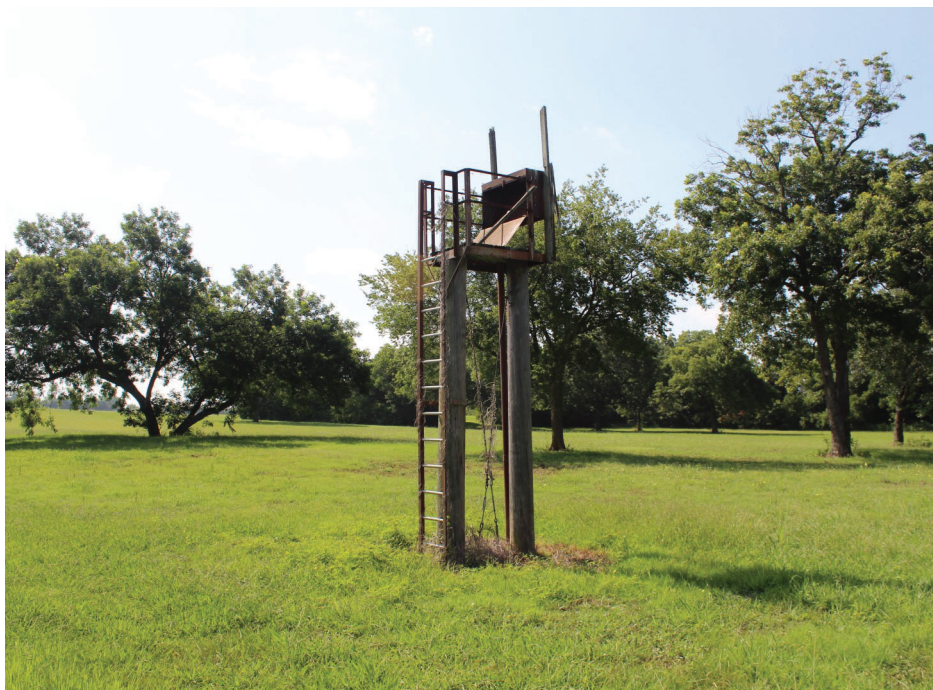
PHOTOGRAPH No.: 24

LOCATION: Sta. 84+00, downstream toe of main embankment

COMMENTS: Abandoned pore pressure cell recording tower is shown.

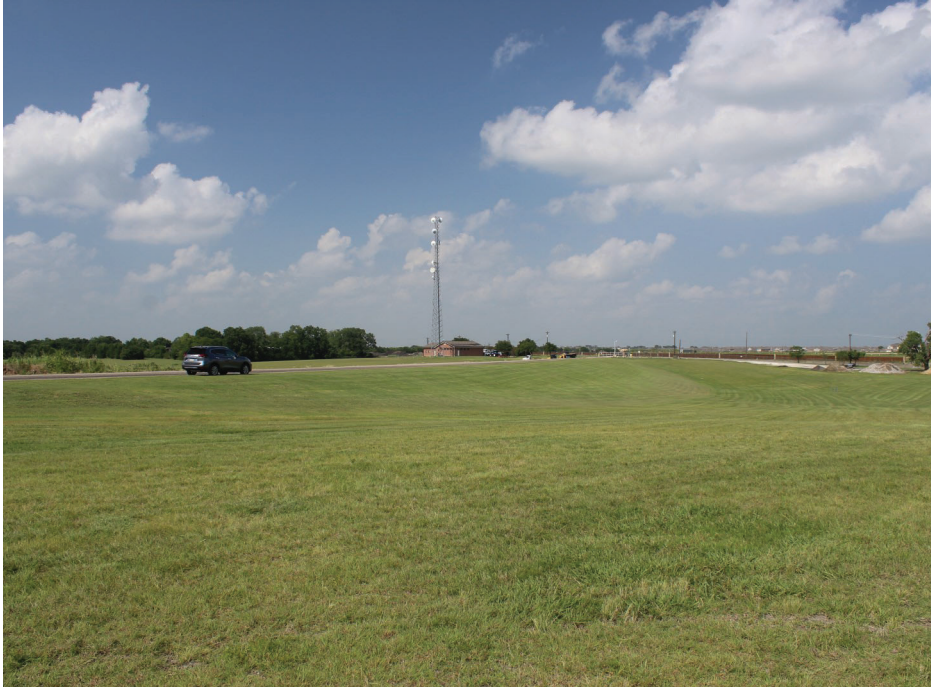
PHOTOGRAPH No.: 25

LOCATION: Sta. 115+00, downstream slope of saddle embankment, looking left

COMMENTS: Slope is uniform and well-maintained.

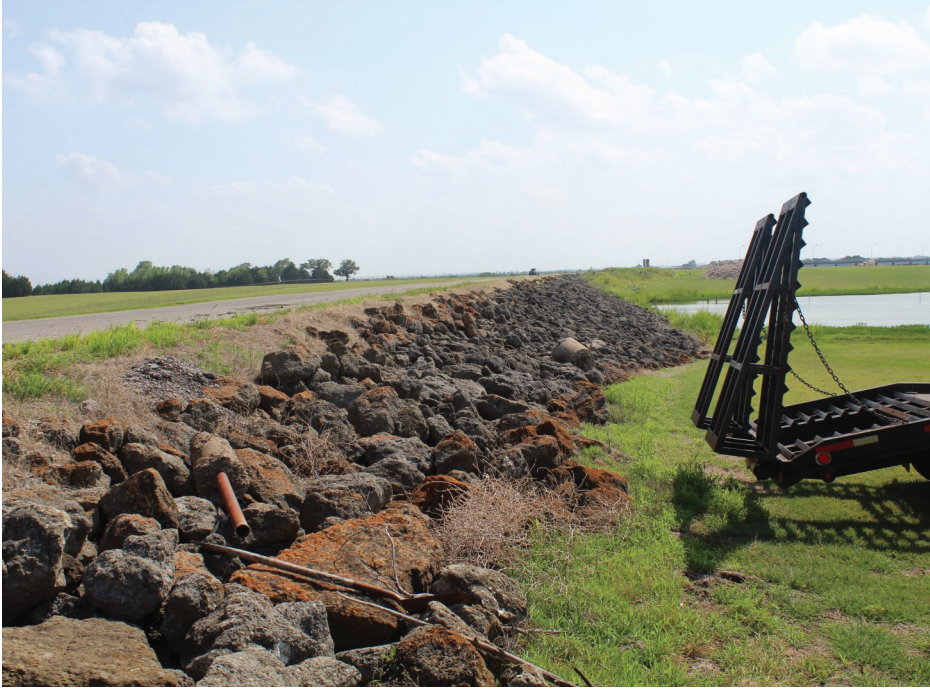
PHOTOGRAPH No.: 27

LOCATION: Sta. 125+50, upstream slope of saddle embankment, looking right

COMMENTS: Riprap is adequate. No visual indication of instability.

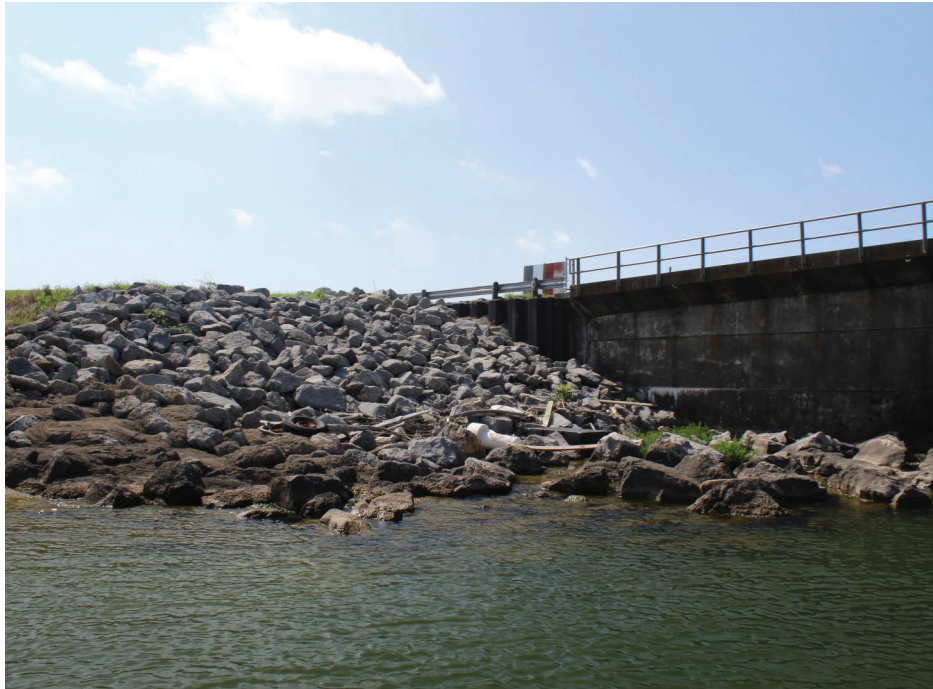
PHOTOGRAPH No.: 29

LOCATION: Upstream side of left non-overflow section, looking left

COMMENTS: Area of void below grouted riprap indicated by DWU personnel.

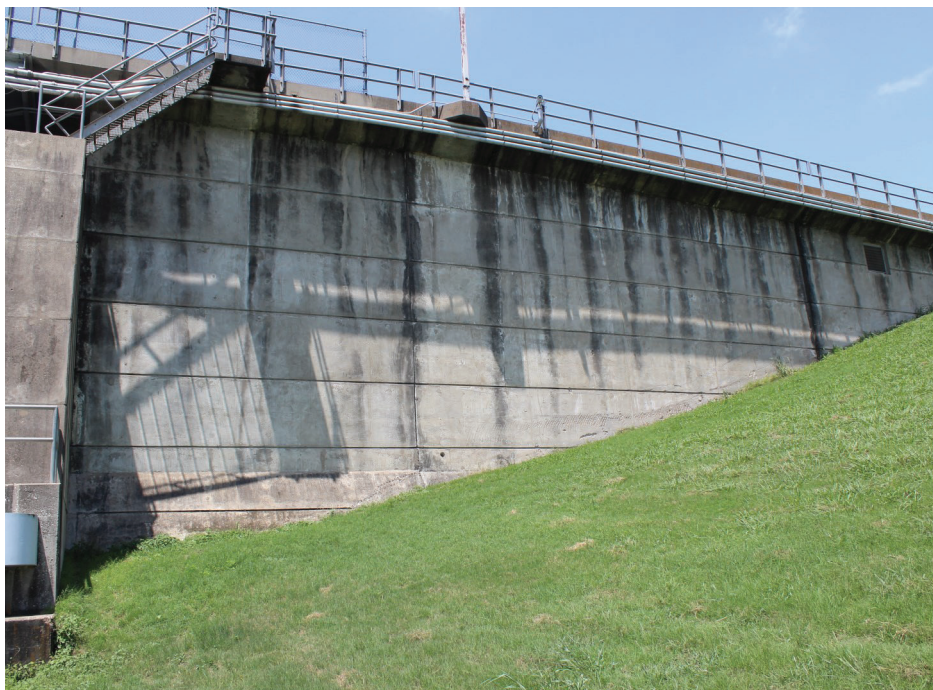
PHOTOGRAPH No.: 30

LOCATION: Downstream side of left non-overflow section

COMMENTS: No visual and obvious signs of structural instability.

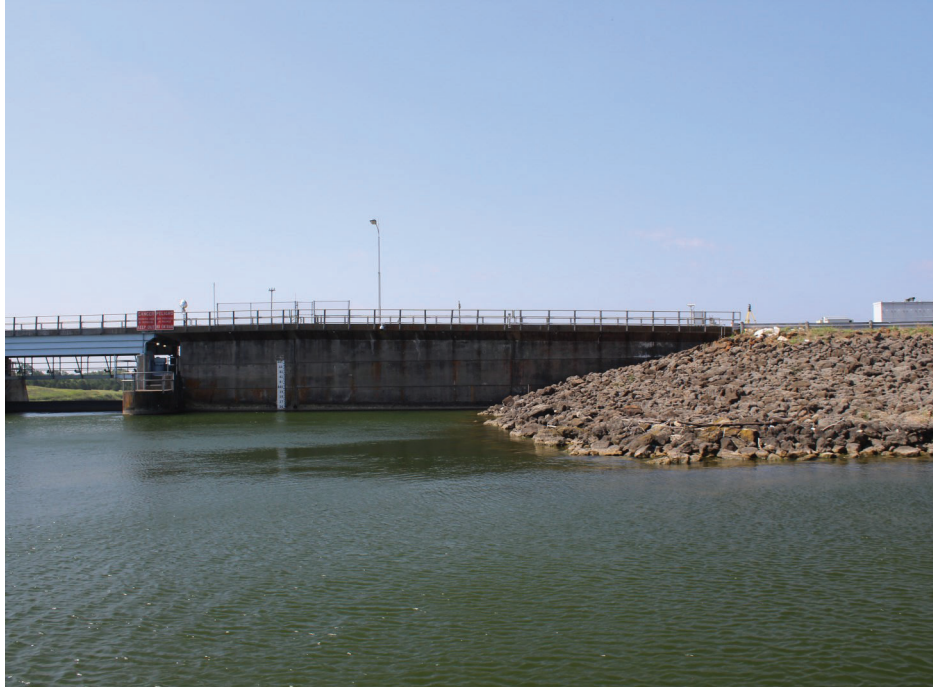
PHOTOGRAPH No.: 31

LOCATION: Upstream side of right non-overflow section

COMMENTS: No visual and obvious signs of structural instability.

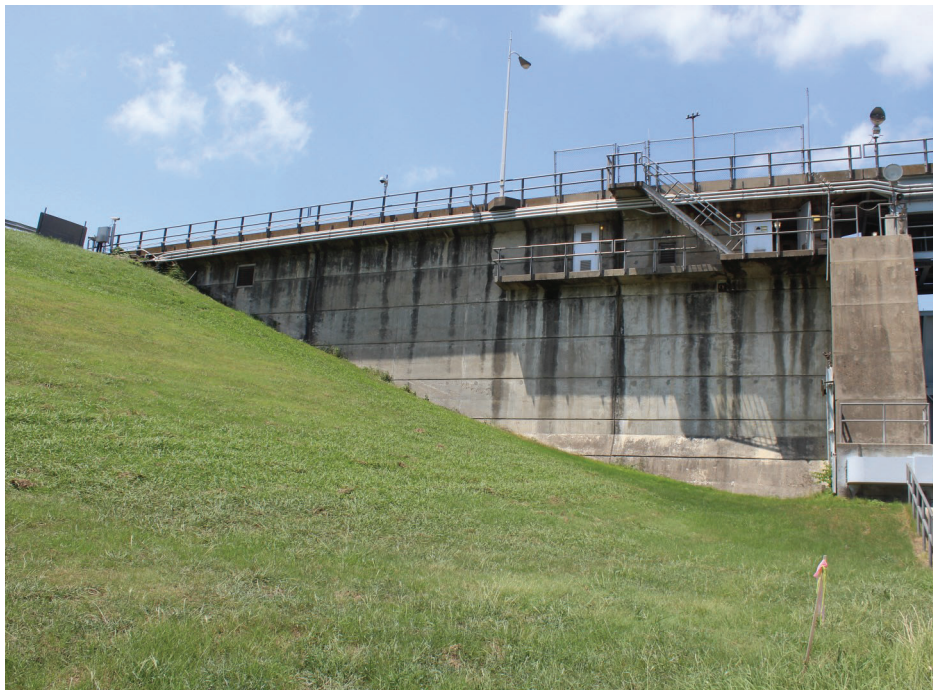
PHOTOGRAPH No.: 32

LOCATION: Downstream side of right non-overflow section

COMMENTS: No visual and obvious signs of structural instability.
