VISUAL INSPECTION AND EVALUATION REPORT

Rockwall-Forney Dam
Dallas Water Utilities
Dallas/Kaufman Counties, Texas

Schnabel Reference #20C22001.00
July 30, 2021

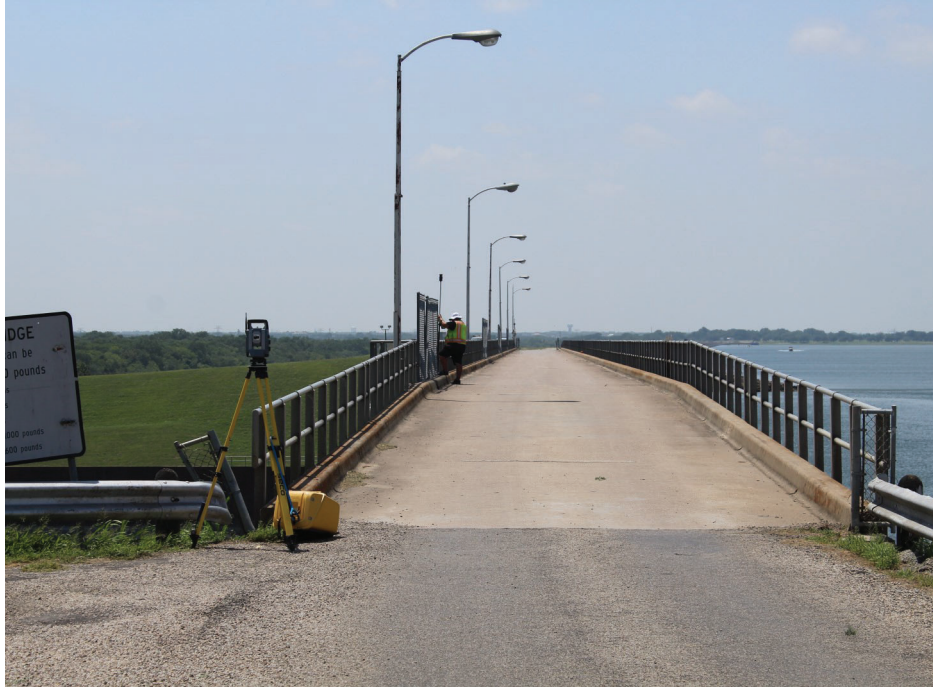
PHOTOGRAPH No.: 33

LOCATION: Bridge over spillway, viewed from left side

COMMENTS: Bridge is straight and level.

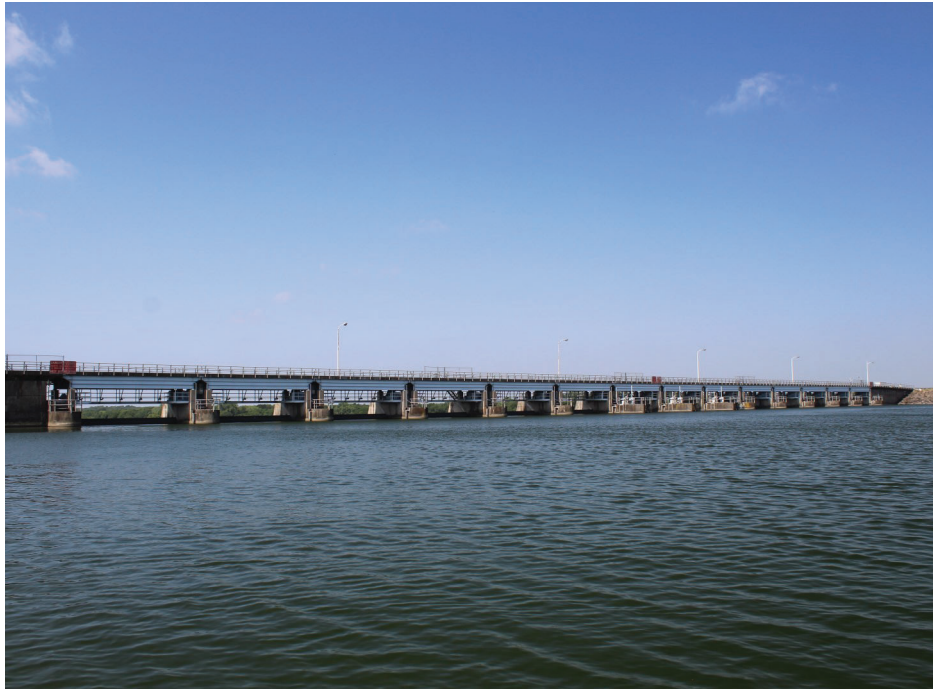
PHOTOGRAPH No.: 35

LOCATION: Upstream side of spillway

COMMENTS: Gates 1 through 14 shown from right to left.

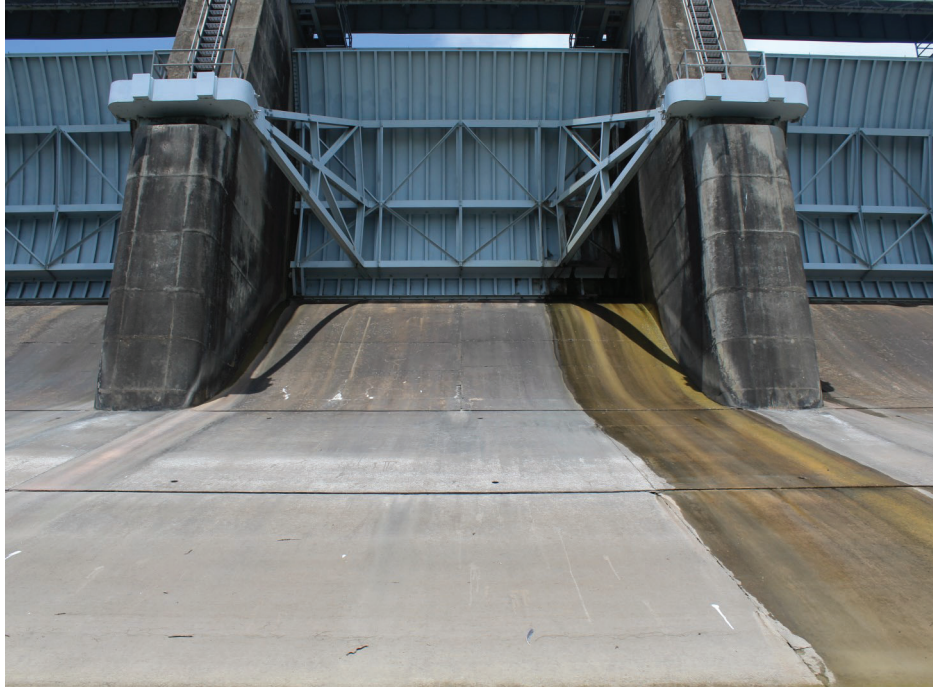
PHOTOGRAPH No.: 37

LOCATION: Downstream side of Gate 2

COMMENTS: Some surficial cracking and spalls observed.

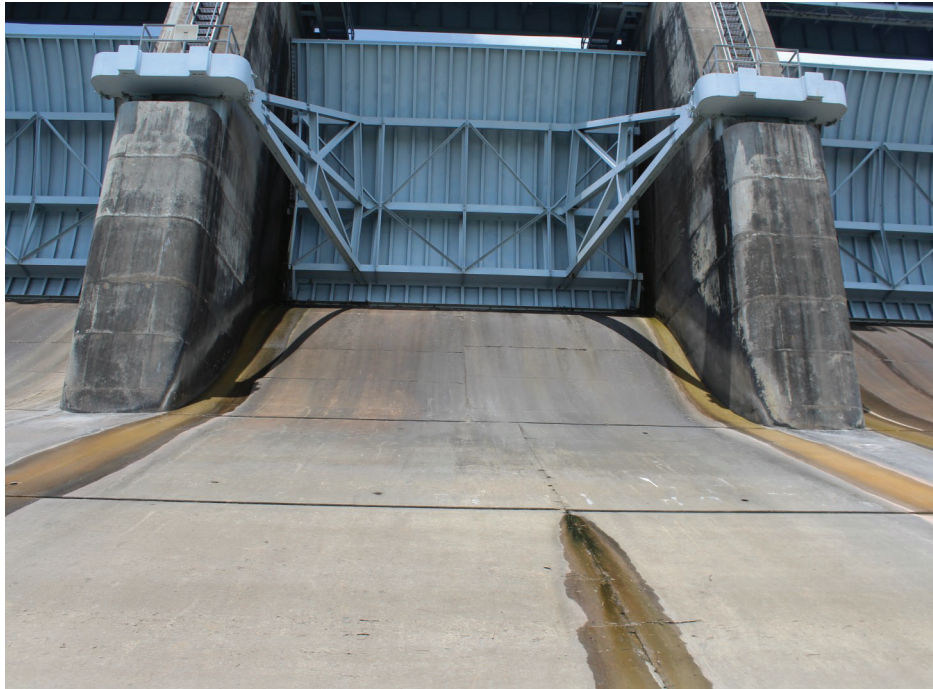
PHOTOGRAPH No.: 39

LOCATION: Downstream side of Gate 4

COMMENTS: Some surficial cracking and spalls observed.

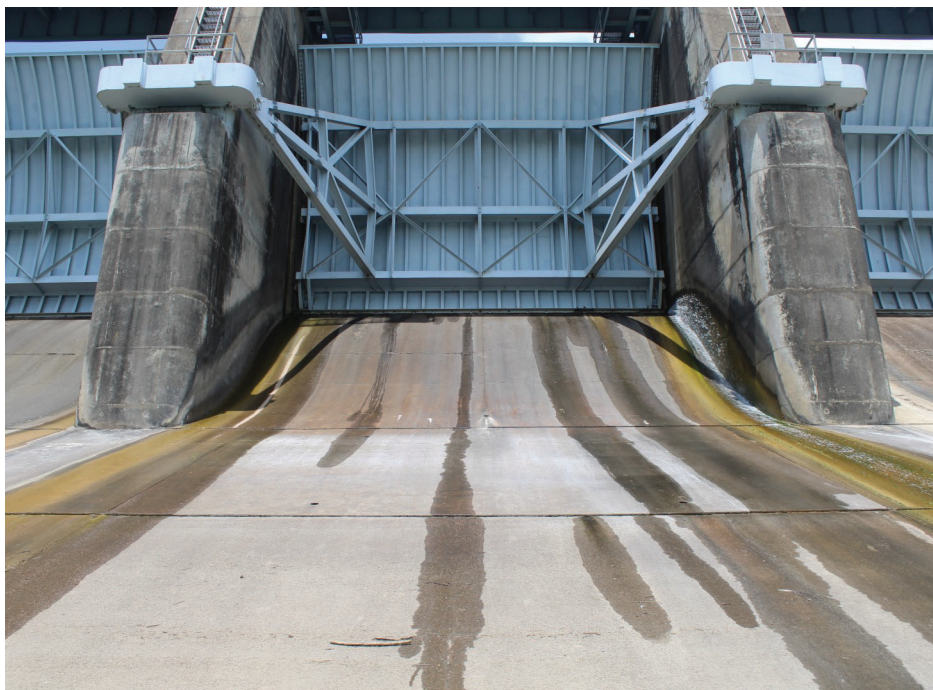
PHOTOGRAPH No.: 40

LOCATION: Downstream side of Gate 5

COMMENTS: Some surficial cracking and spalls observed.

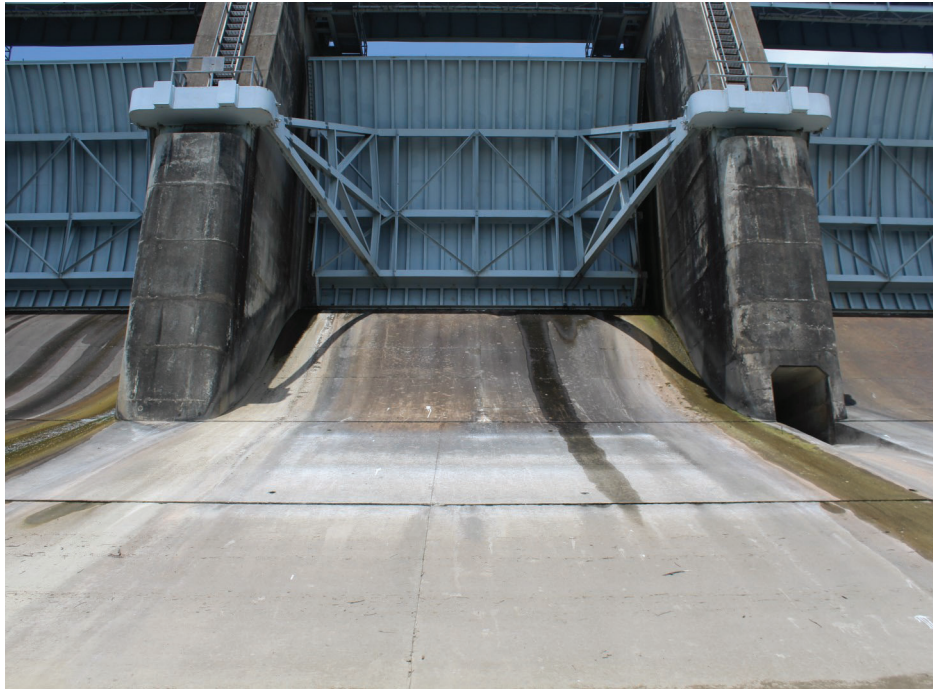
PHOTOGRAPH No.: 41

LOCATION: Downstream side of Gate 6

COMMENTS: Some surficial cracking and spalls observed.

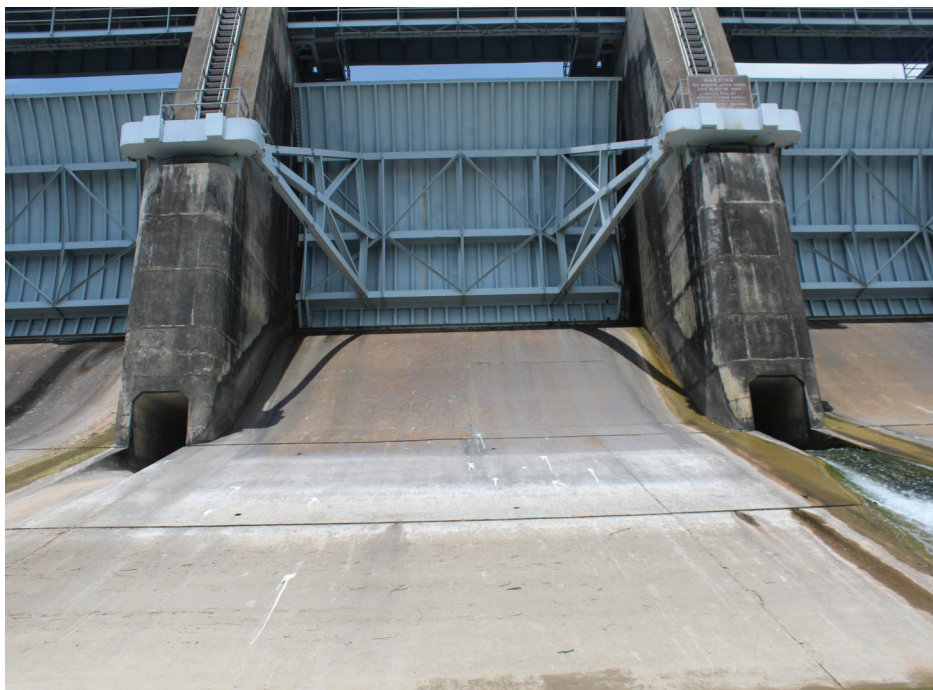
PHOTOGRAPH No.: 42

LOCATION: Downstream side of Gate 7

COMMENTS: Some surficial cracking and spalls observed.

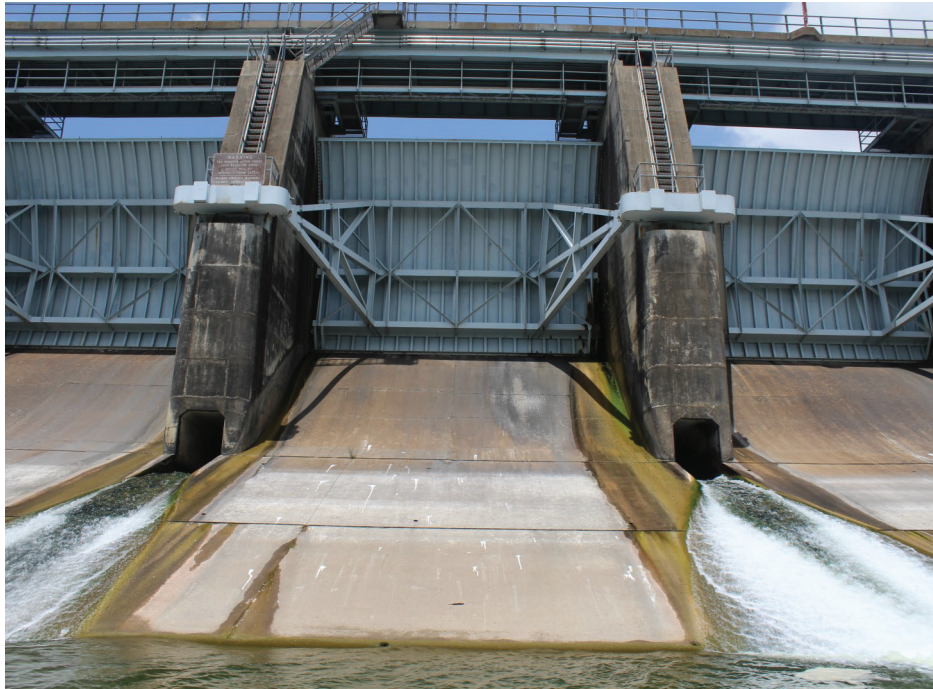
PHOTOGRAPH No.: 43

LOCATION: Downstream side of Gate 8

COMMENTS: Some surficial cracking and spalls observed.

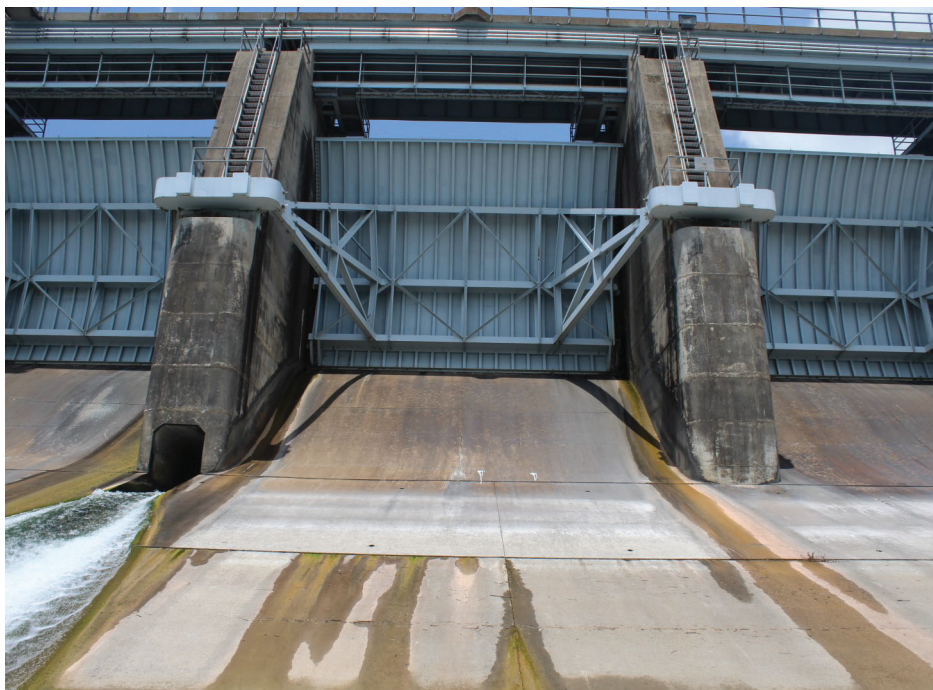
PHOTOGRAPH No.: 44

LOCATION: Downstream side of Gate 9

COMMENTS: Some surficial cracking and spalls observed.

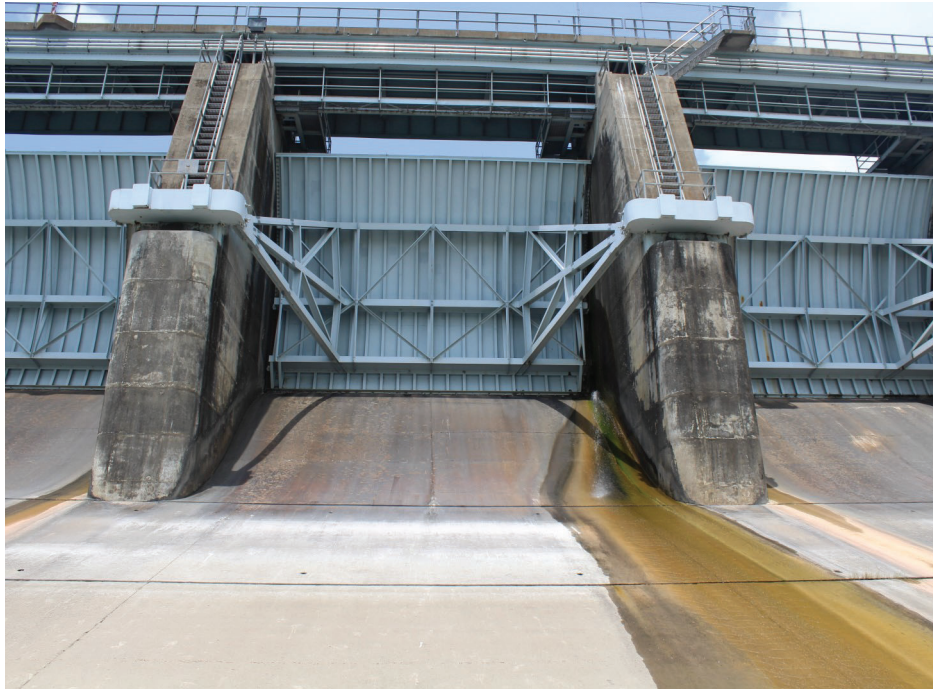
PHOTOGRAPH No.: 45

LOCATION: Downstream side of Gate 10

COMMENTS: Some surficial cracking and spalls observed.

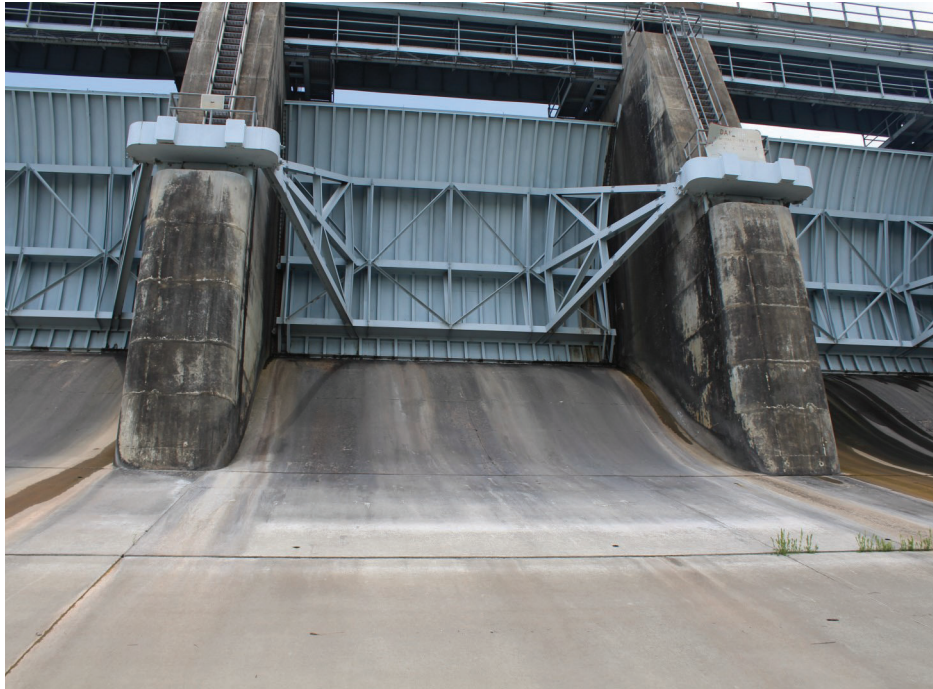
PHOTOGRAPH No.: 47

LOCATION: Downstream side of Gate 12

COMMENTS: Some surficial cracking and spalls observed.

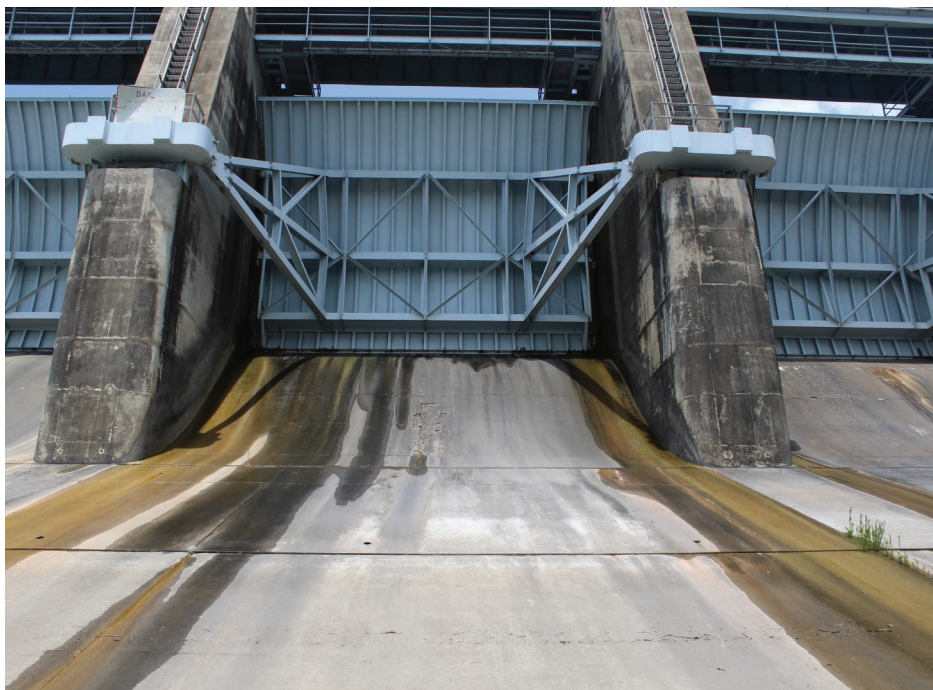
PHOTOGRAPH No.: 48

LOCATION: Downstream side of Gate 13

COMMENTS: Some surficial cracking and spalls observed.

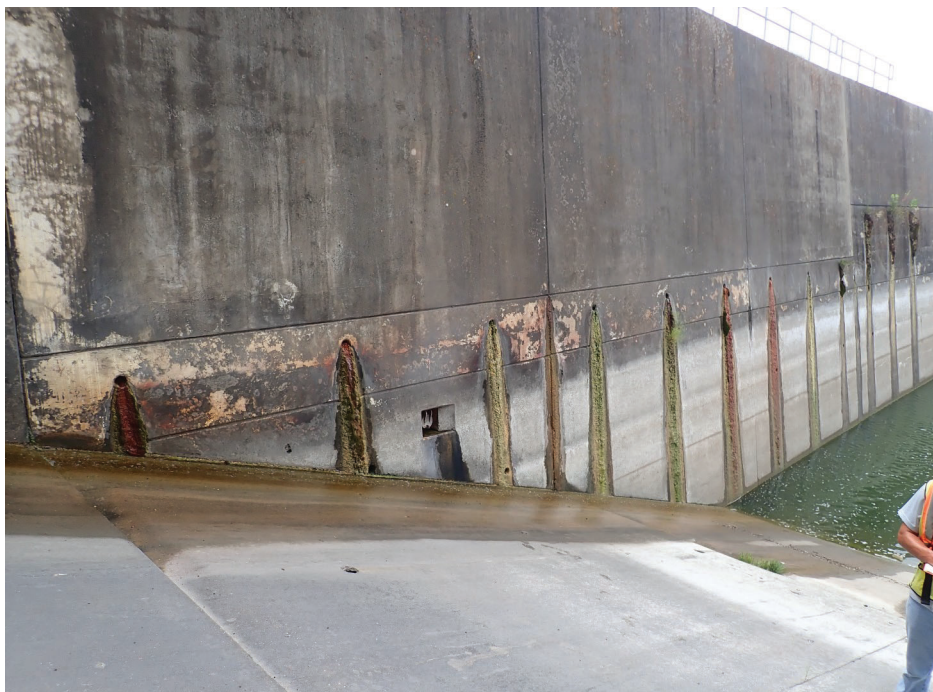
PHOTOGRAPH No.: 50

LOCATION: Left spillway sidewall

COMMENTS: Significant vegetative growth was observed in the upper wall drain outlets.

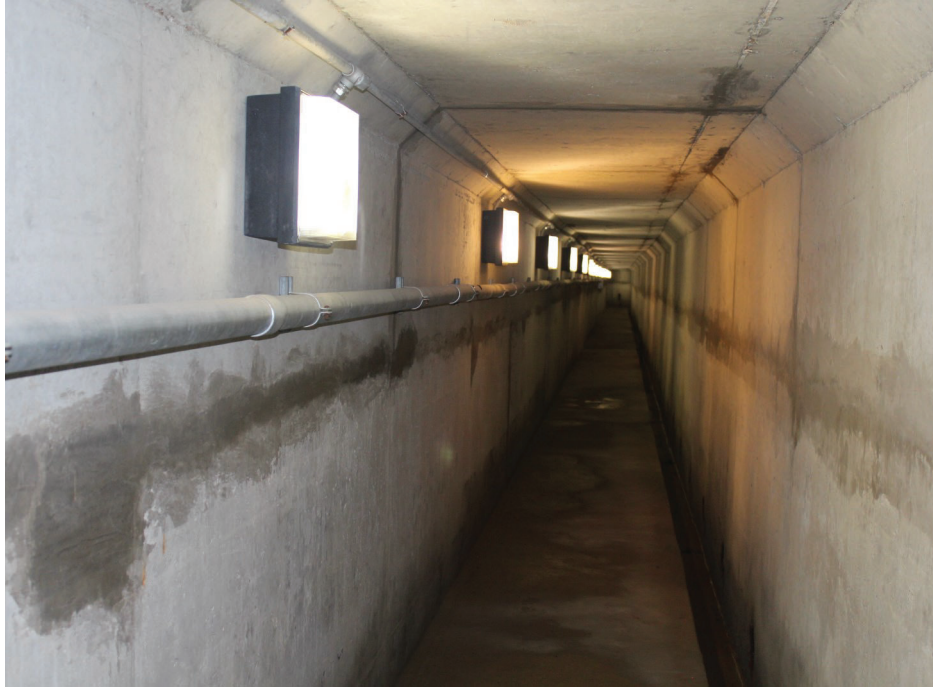
PHOTOGRAPH No.: 51

LOCATION: Drainage gallery,
looking left

COMMENTS: Gallery is in adequate condition with little seepage observed.

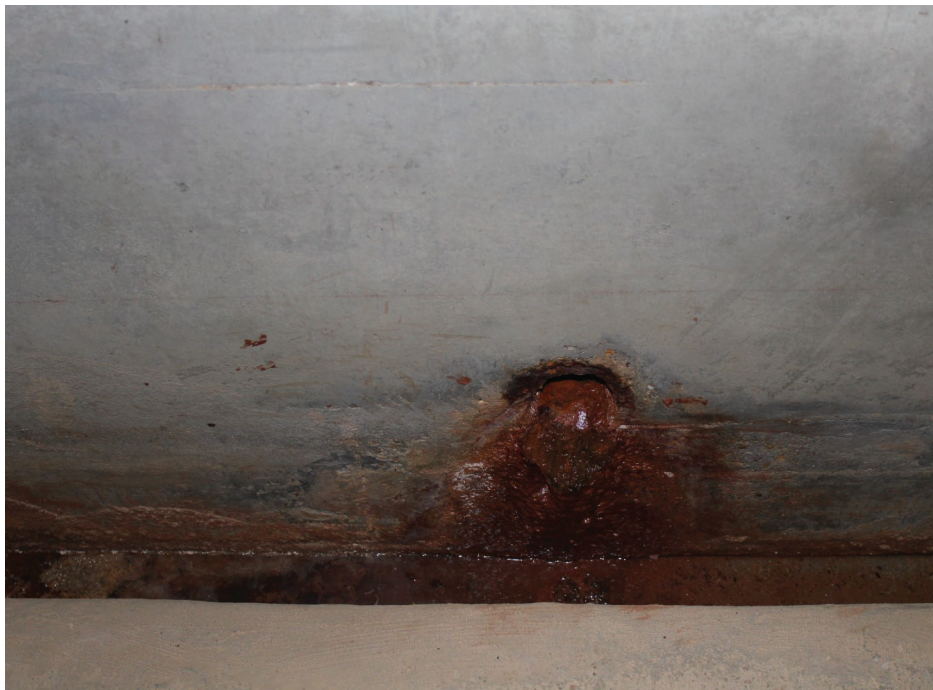
PHOTOGRAPH No.: 52

LOCATION: Drainage gallery,
upstream side

COMMENTS: Typical foundation drain is shown. Some corrosion of the steel conduits within the drain holes was observed.

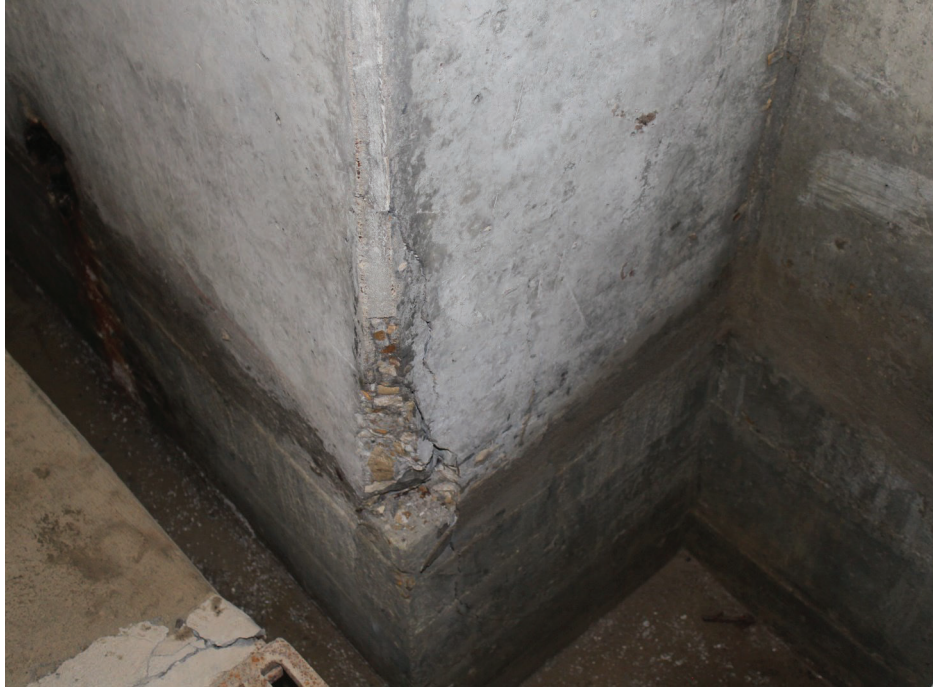
PHOTOGRAPH No.: 53

LOCATION: Left drainage gallery sump, upstream side

COMMENTS: Note concrete spalling at corner.

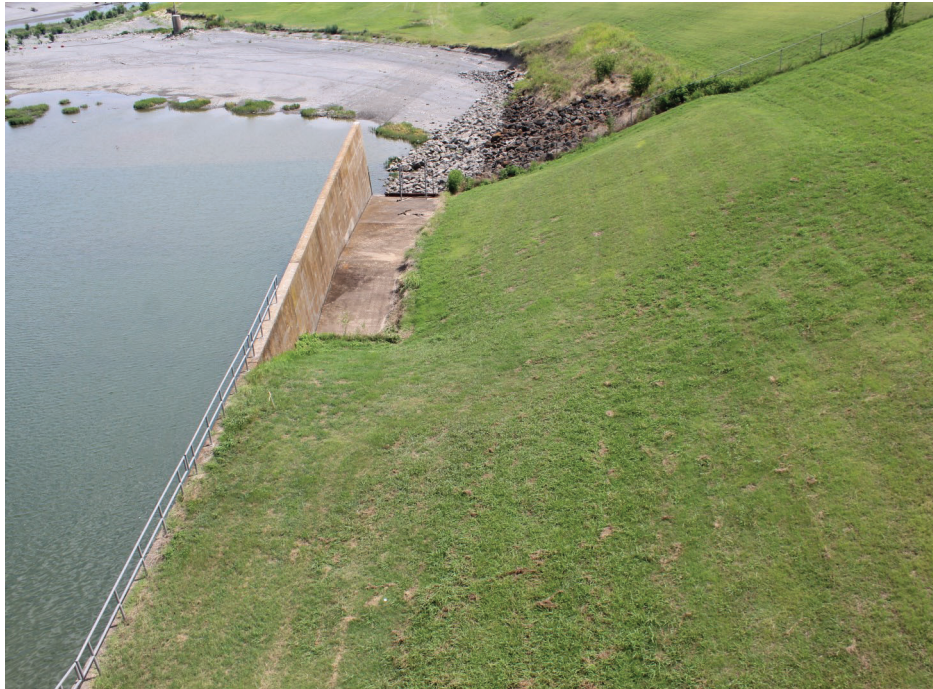
PHOTOGRAPH No.: 55

LOCATION: Right spillway
sidewall, looking downstream

COMMENTS: Wall is level and
straight. Wall drain outlets were
dry at time of inspection.

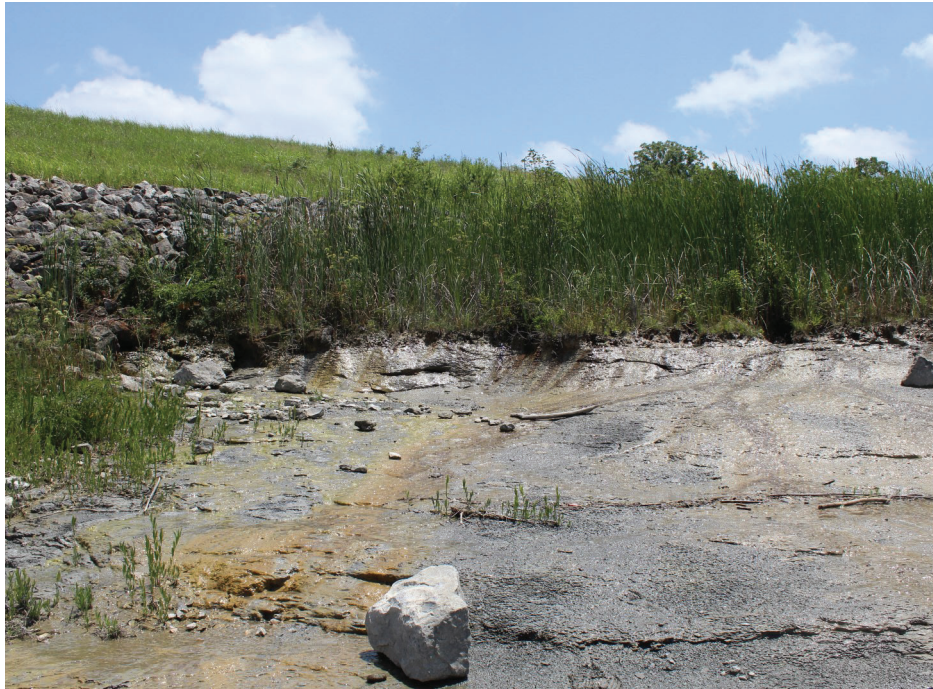
PHOTOGRAPH No.: 57

LOCATION: Left side of stilling basin, downstream of sidewall

COMMENTS: Flowing water was observed.

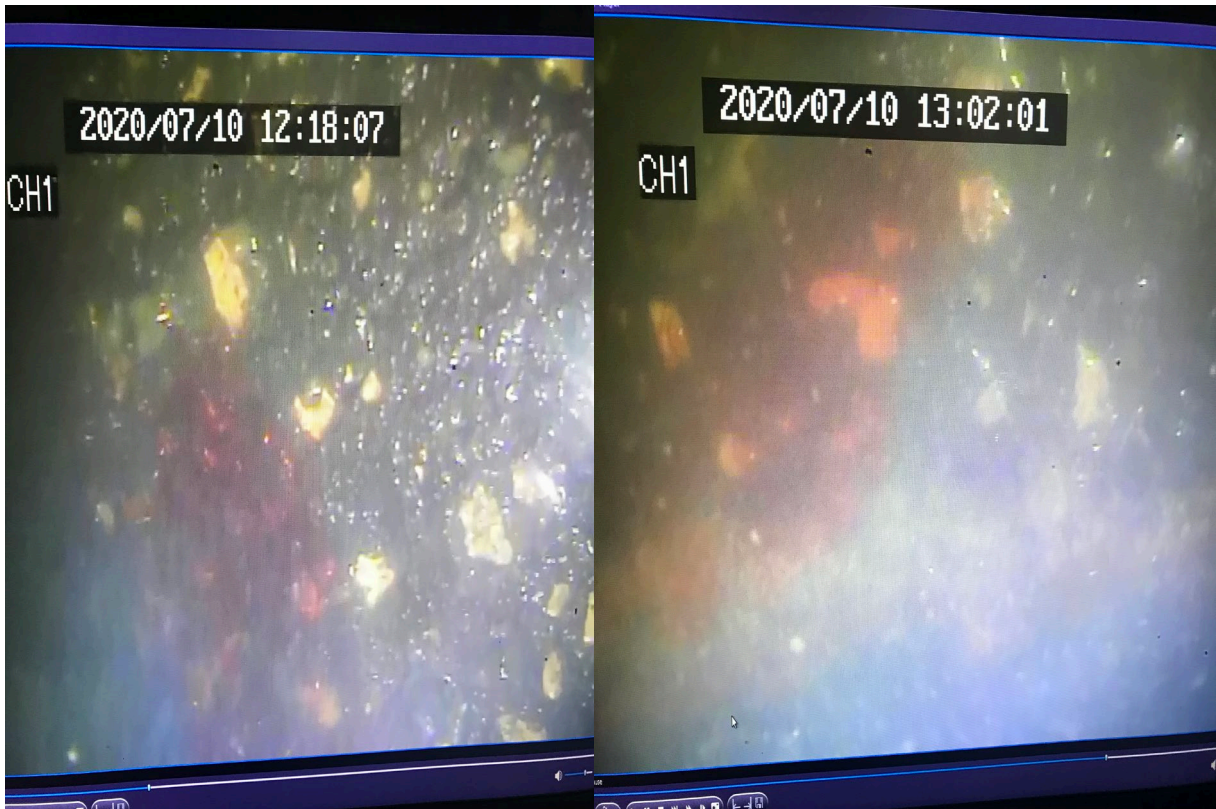
The divers noted a leak at the 12 o'clock position at 65'. They used a red dye to detect the leak. It seems to be a small leak that is exiting through the porous concrete.

The second leak was located at the 1 o'clock position at 103'. It is a quarter sized hole that the divers located using red dye.

The two pictures below are still shots of the video when they diver discovered the leaks. They are time stamped so that they can be located in the videos that have been provided.

Both leaks where marked with a grease pencil inside the pipe. We recommend cleaning the concrete around the leaks and repairing the leaks with underwater epoxy.

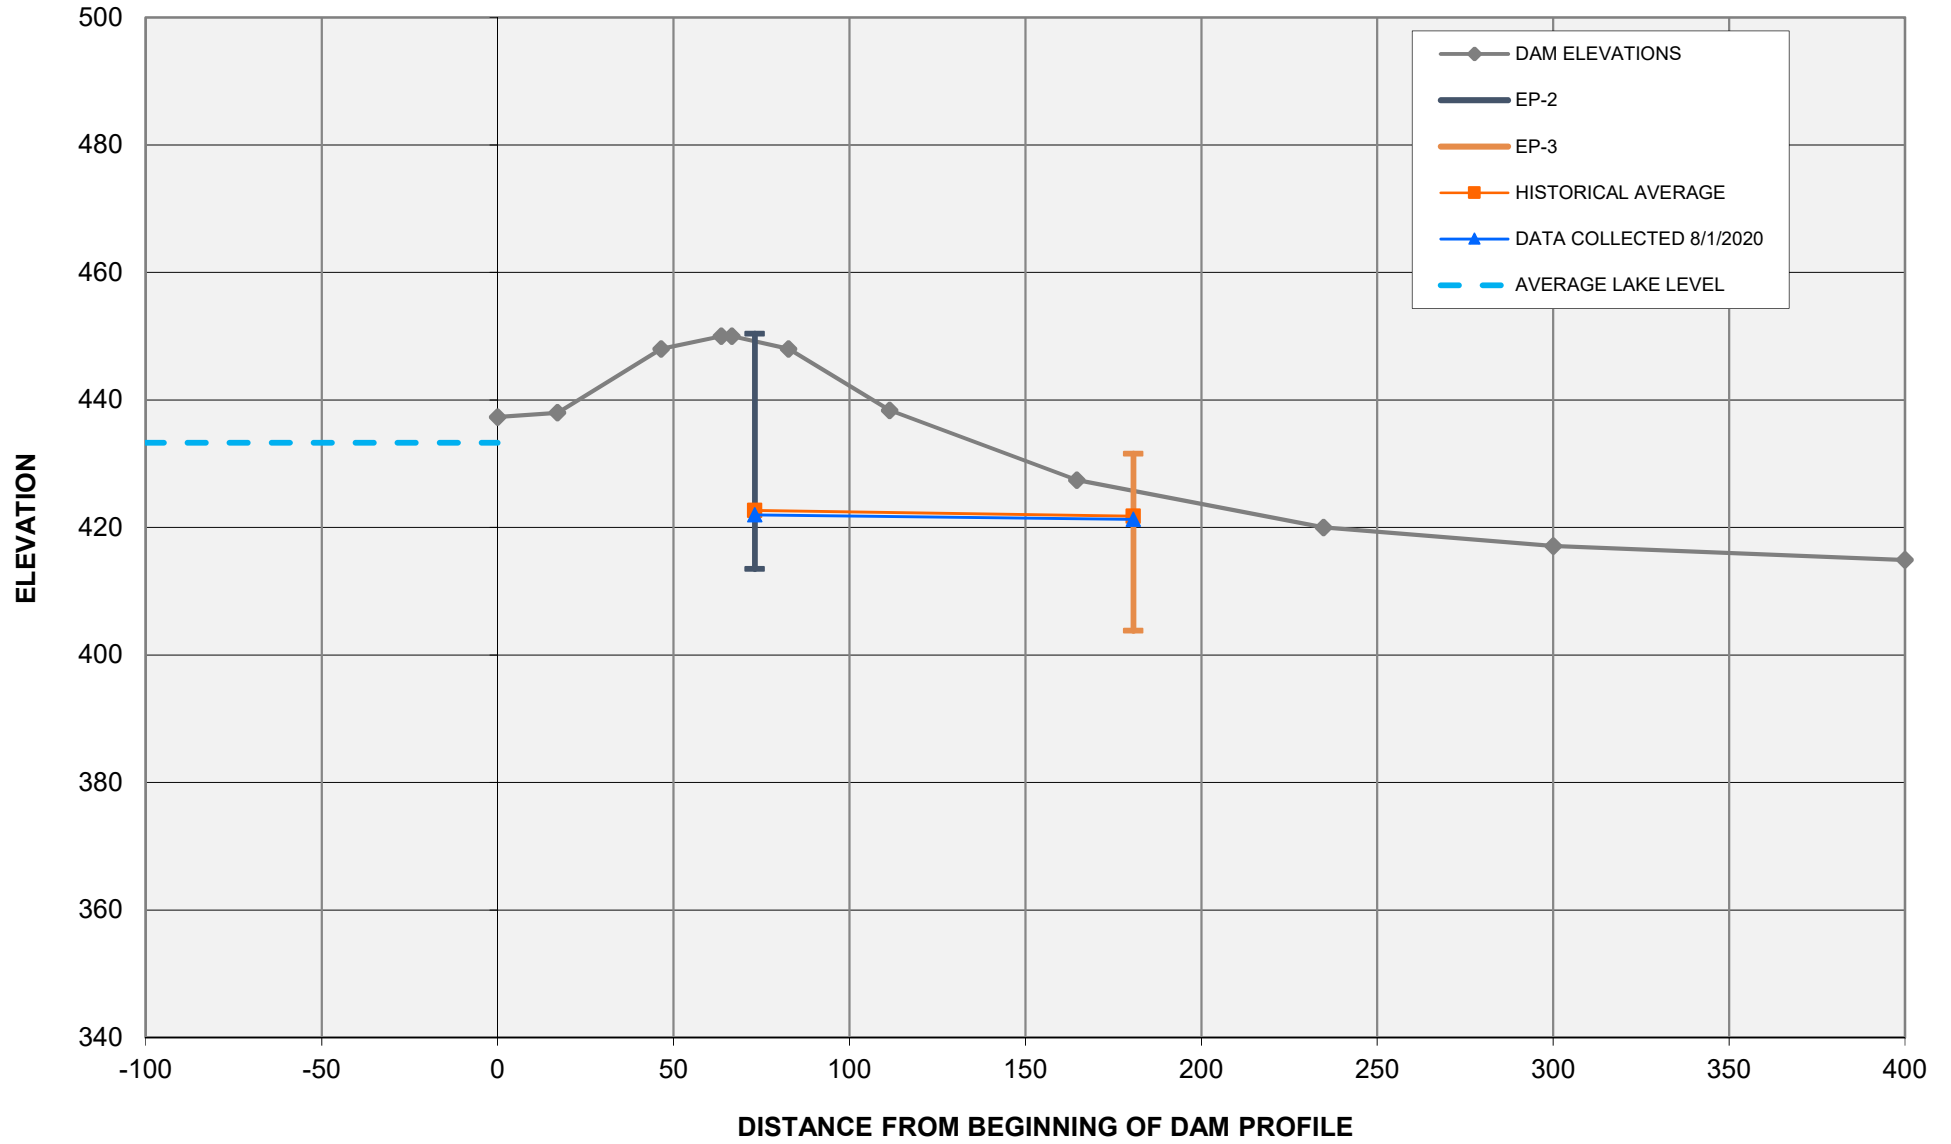
FORNEY LAKE DAM PHREATIC SURFACE - PIEZOMETERS EP-2, EP-3

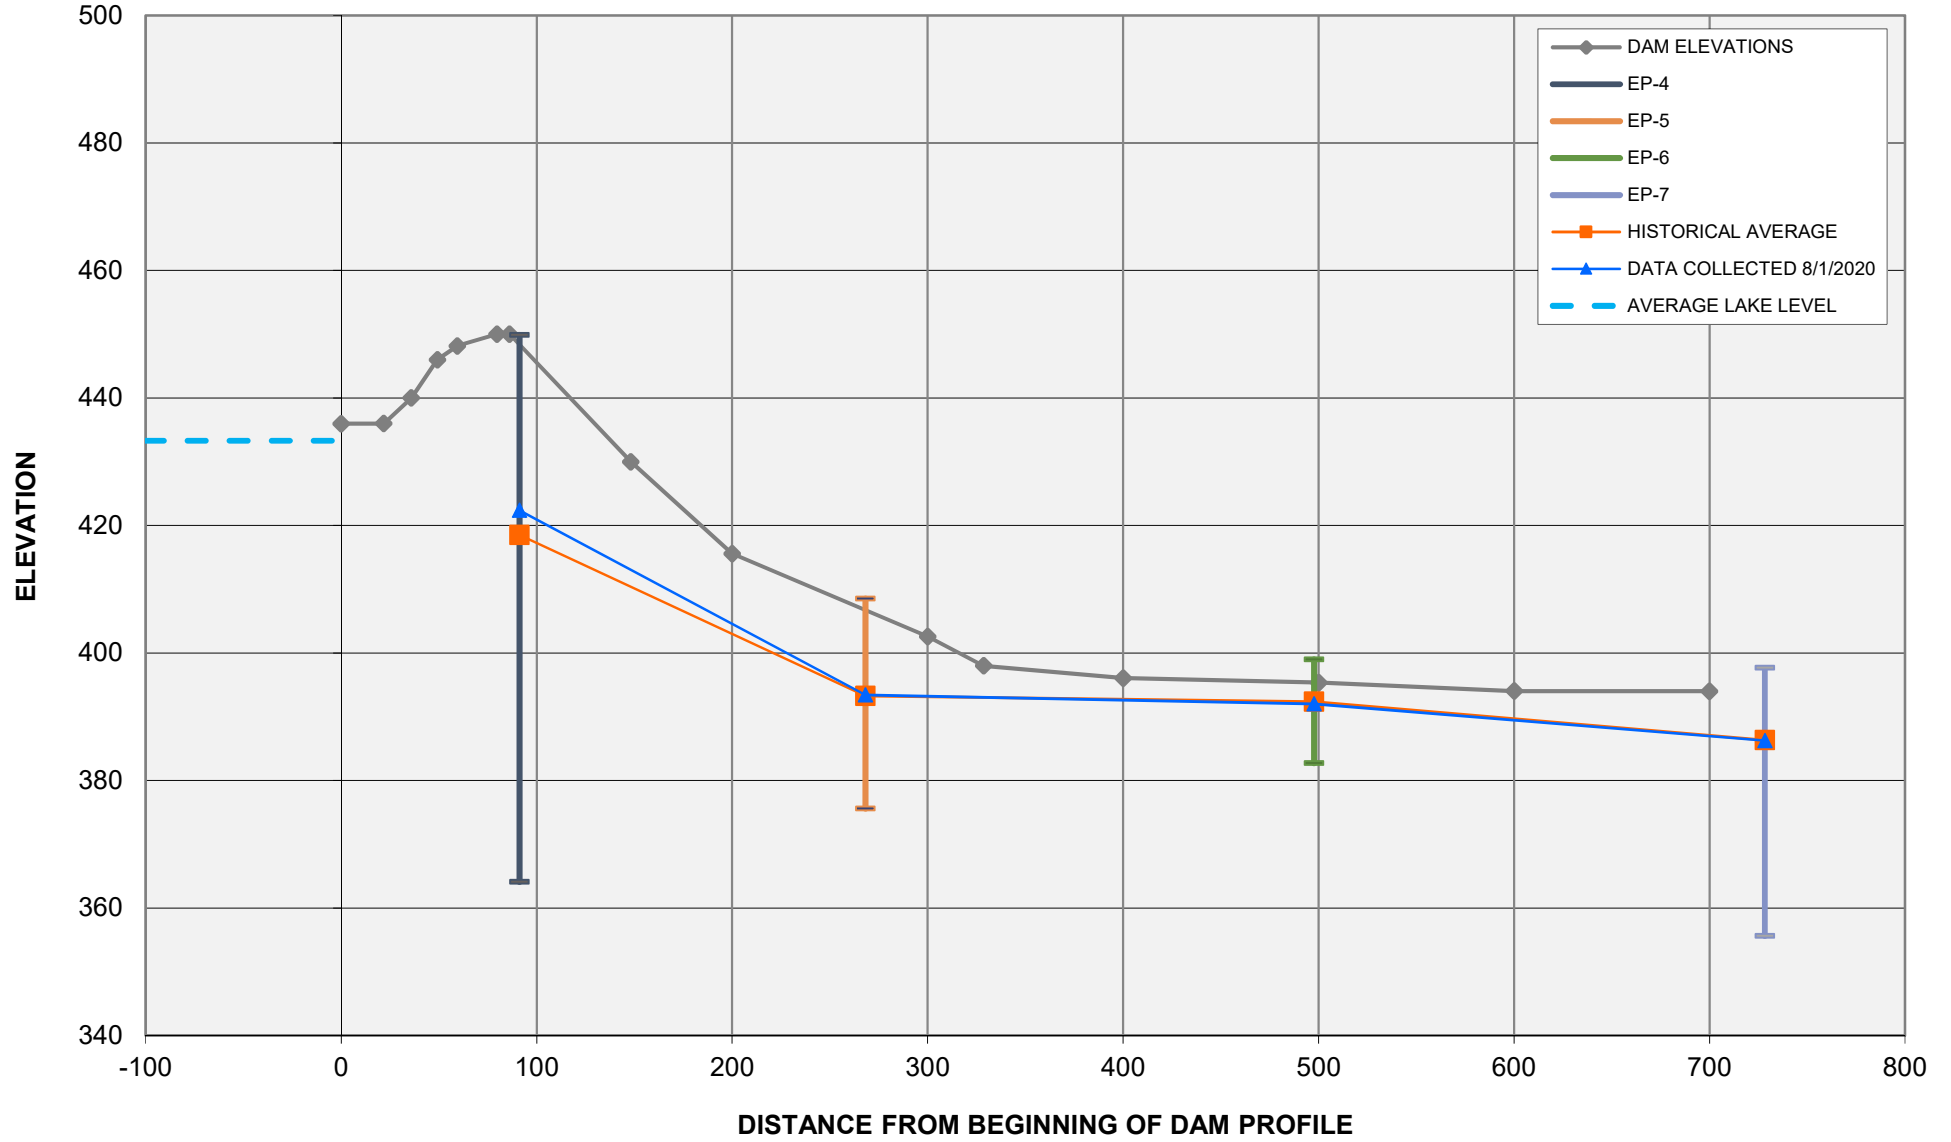
FORNEY LAKE DAM PHREATIC SURFACE - PIEZOMETERS EP-4, EP-5, EP-6, EP-7

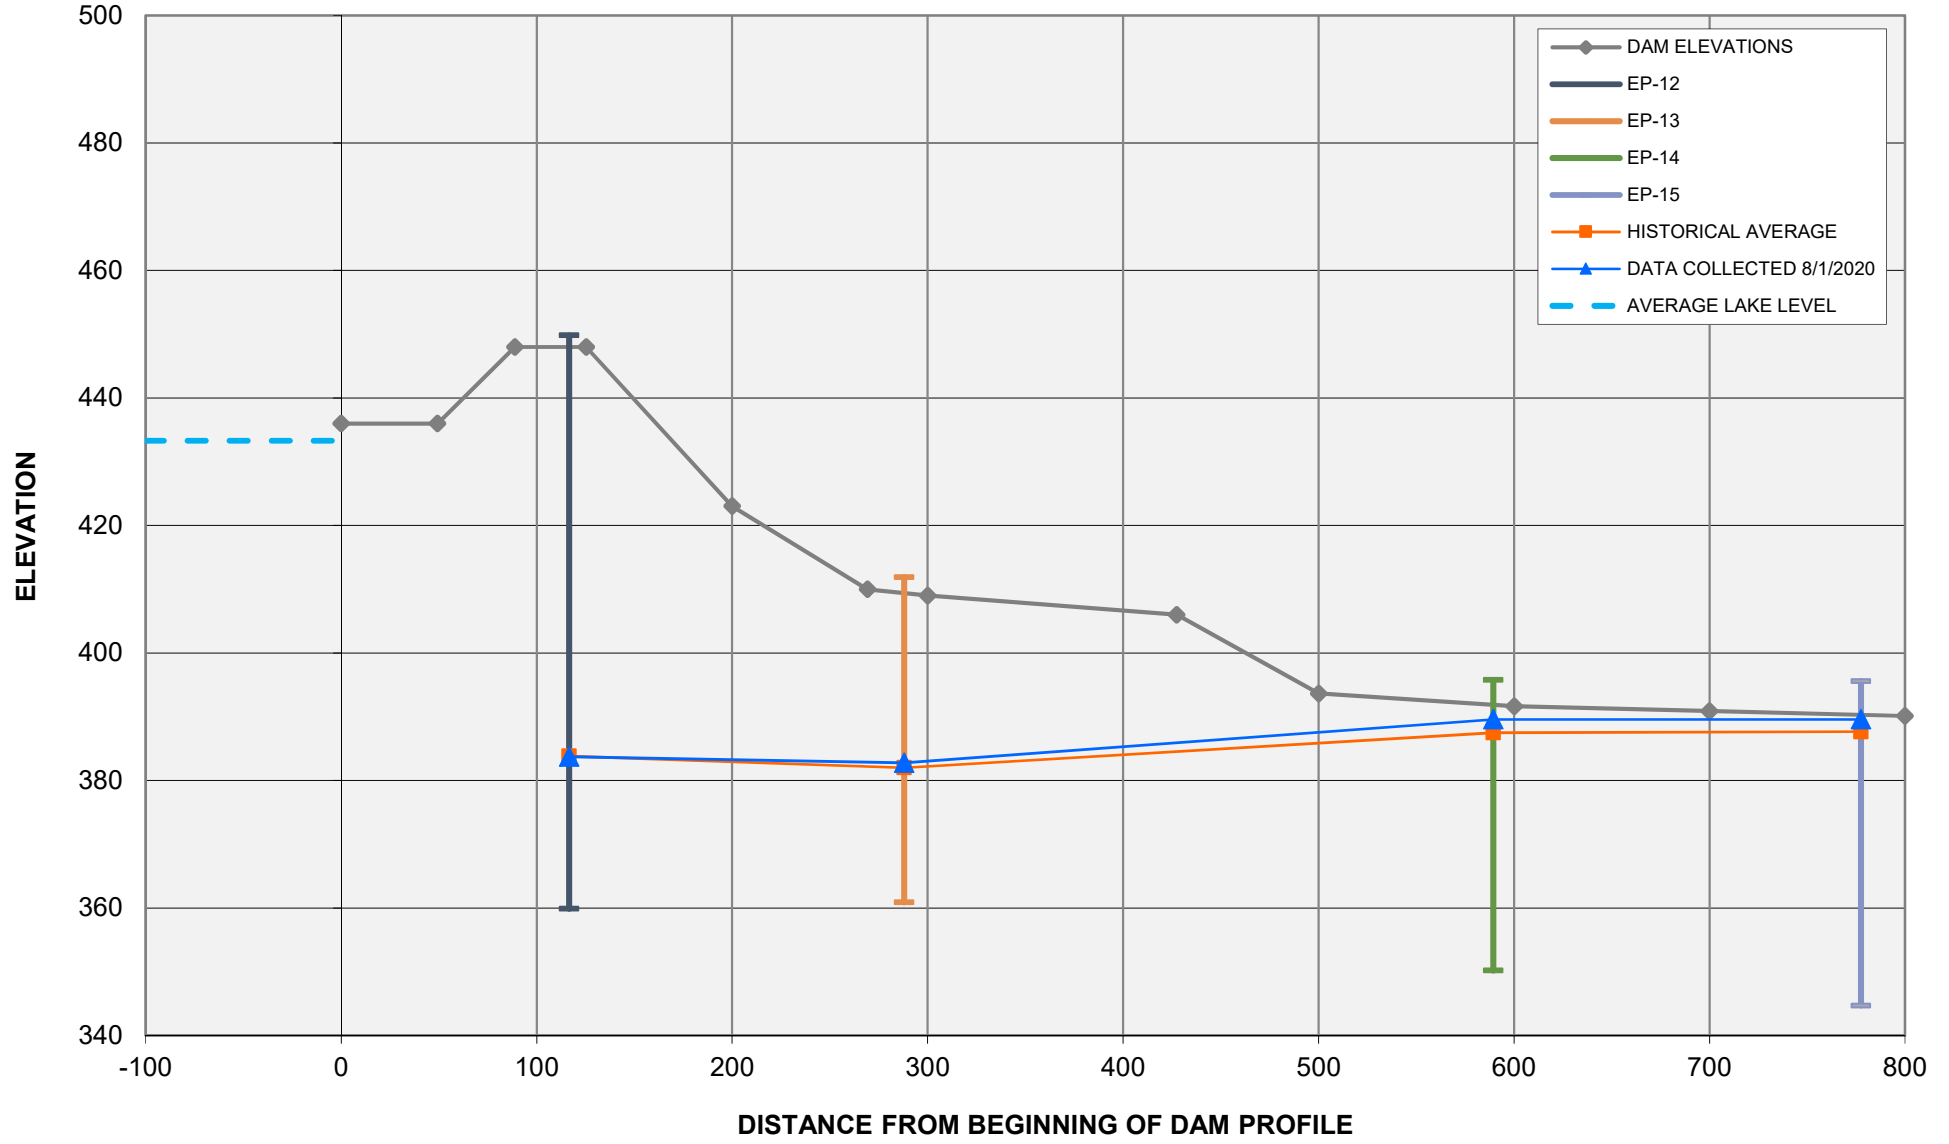
FORNEY LAKE DAM PHREATIC SURFACE - PIEZOMETERS EP-12, EP-13, EP-14, EP-15

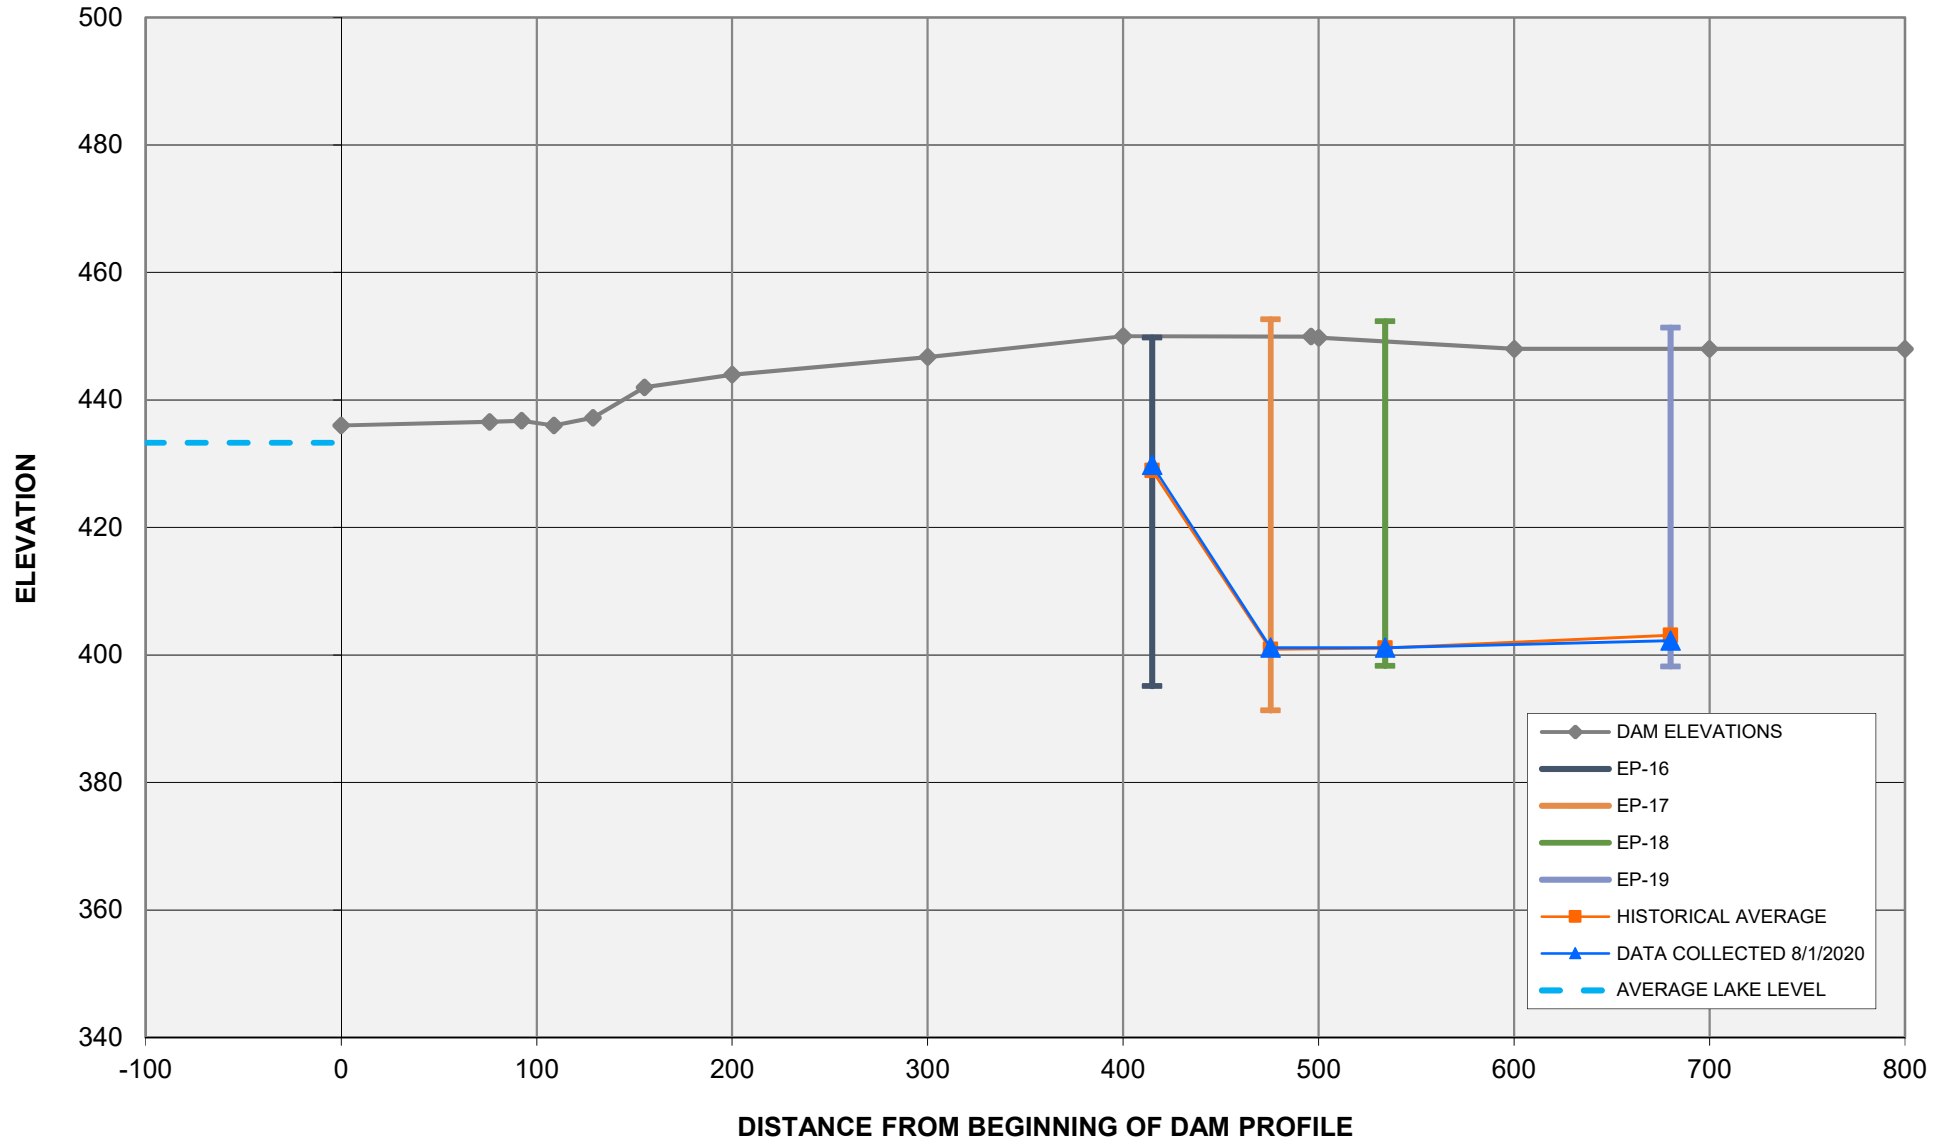
FORNEY LAKE DAM PHREATIC SURFACE - PIEZOMETERS EP-16, EP-17, EP-18, EP-19
