VISUAL INSPECTION AND EVALUATION REPORT

Rockwall-Forney Dam
Dallas Water Utilities
Dallas/Kaufman Counties, Texas

Schnabel Reference #20C22001.00
July 30, 2021

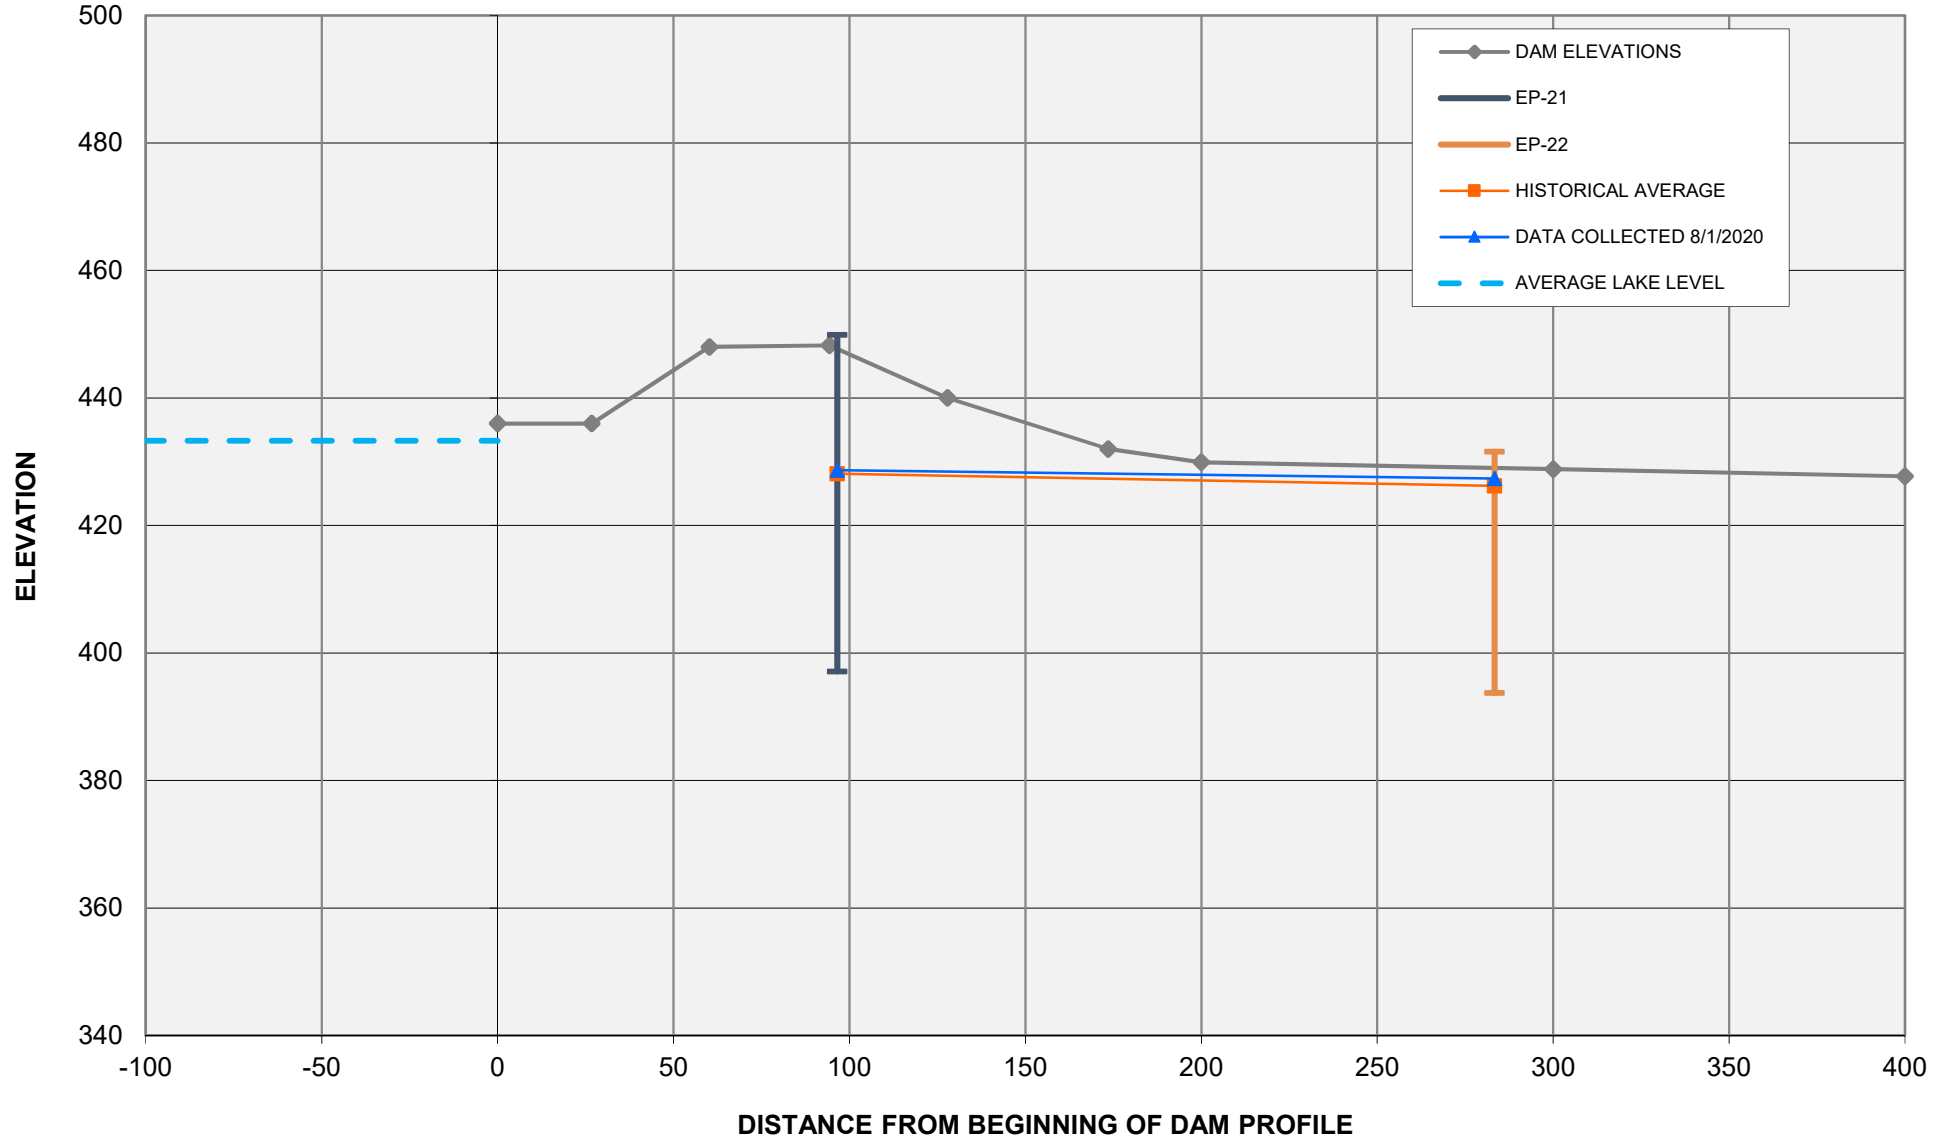
FORNEY LAKE DAM PHREATIC SURFACE - PIEZOMETERS EP-21, EP-22

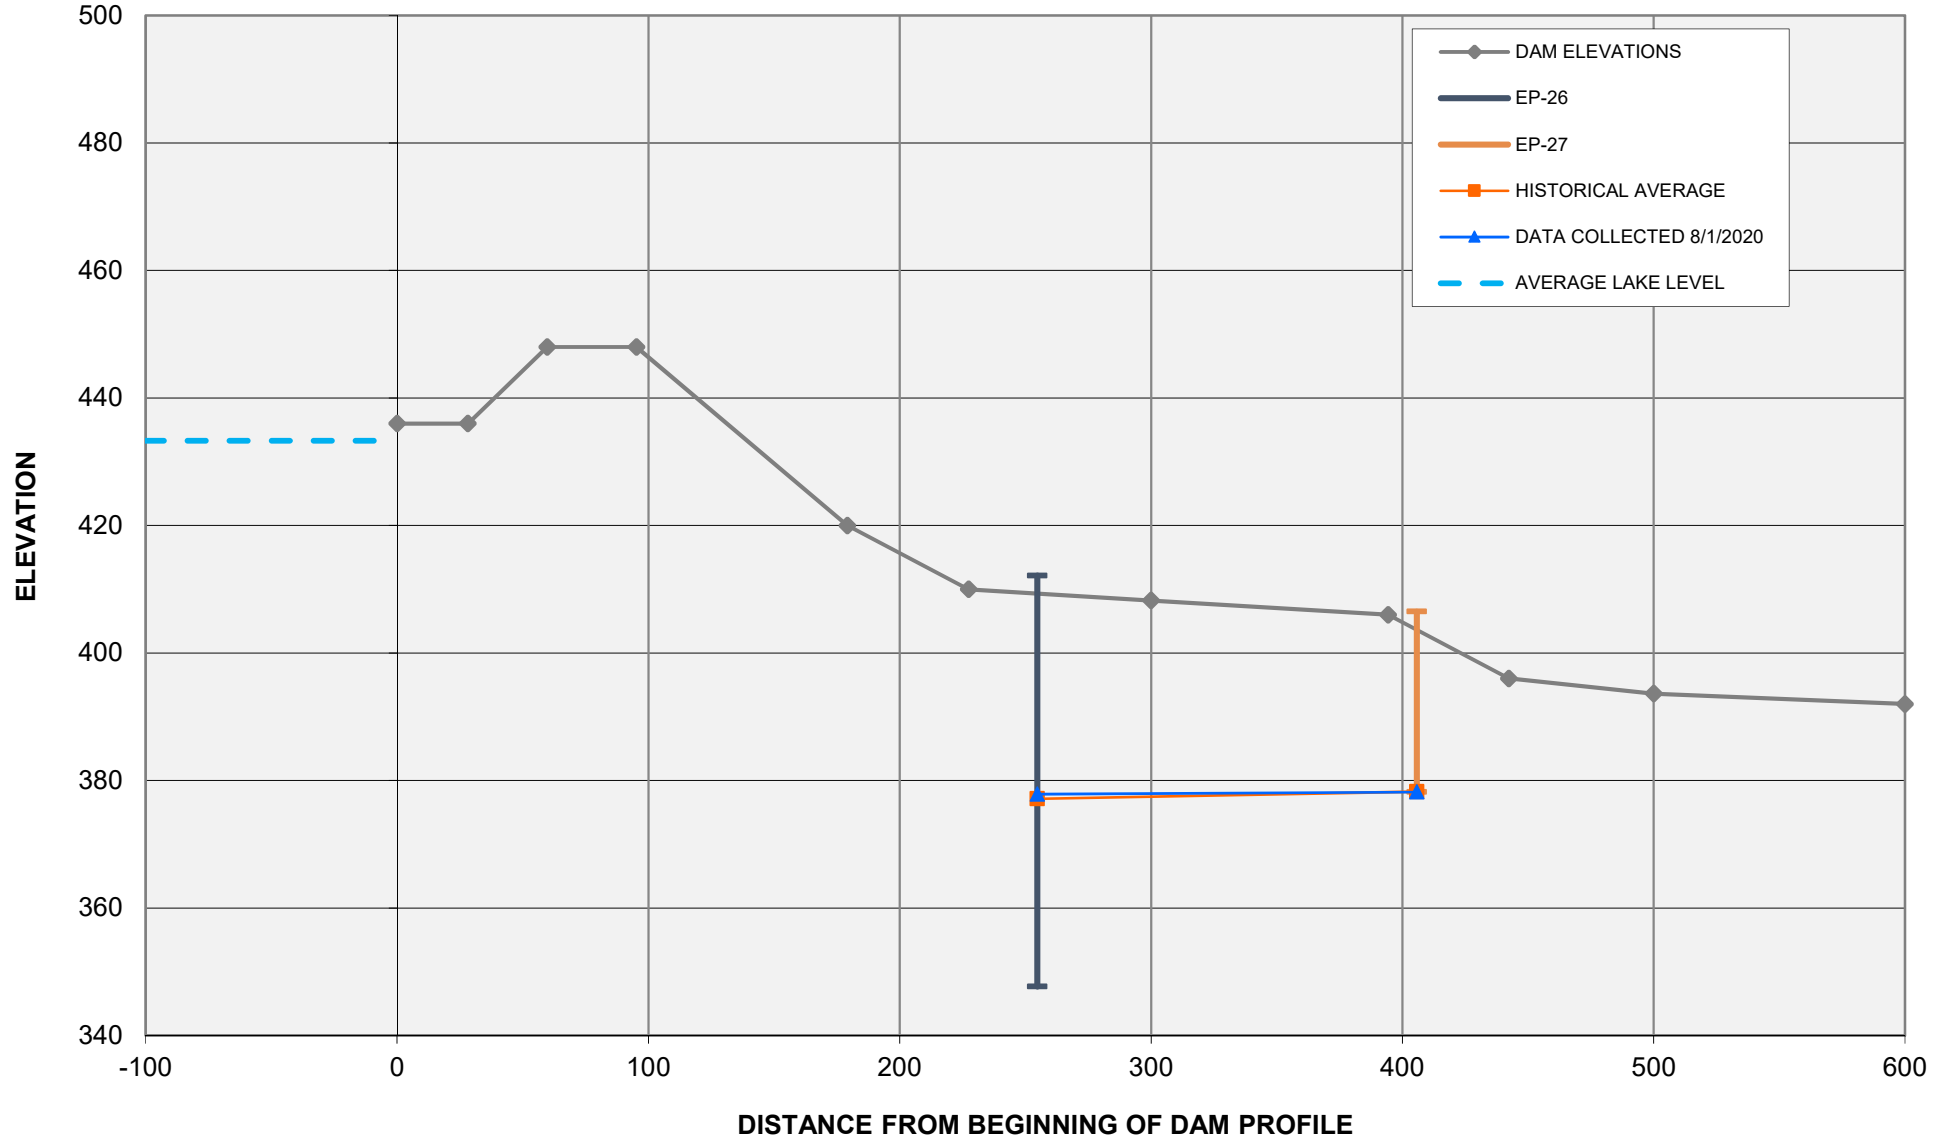
FORNEY LAKE DAM PHREATIC SURFACE - PIEZOMETERS EP-26, EP-27

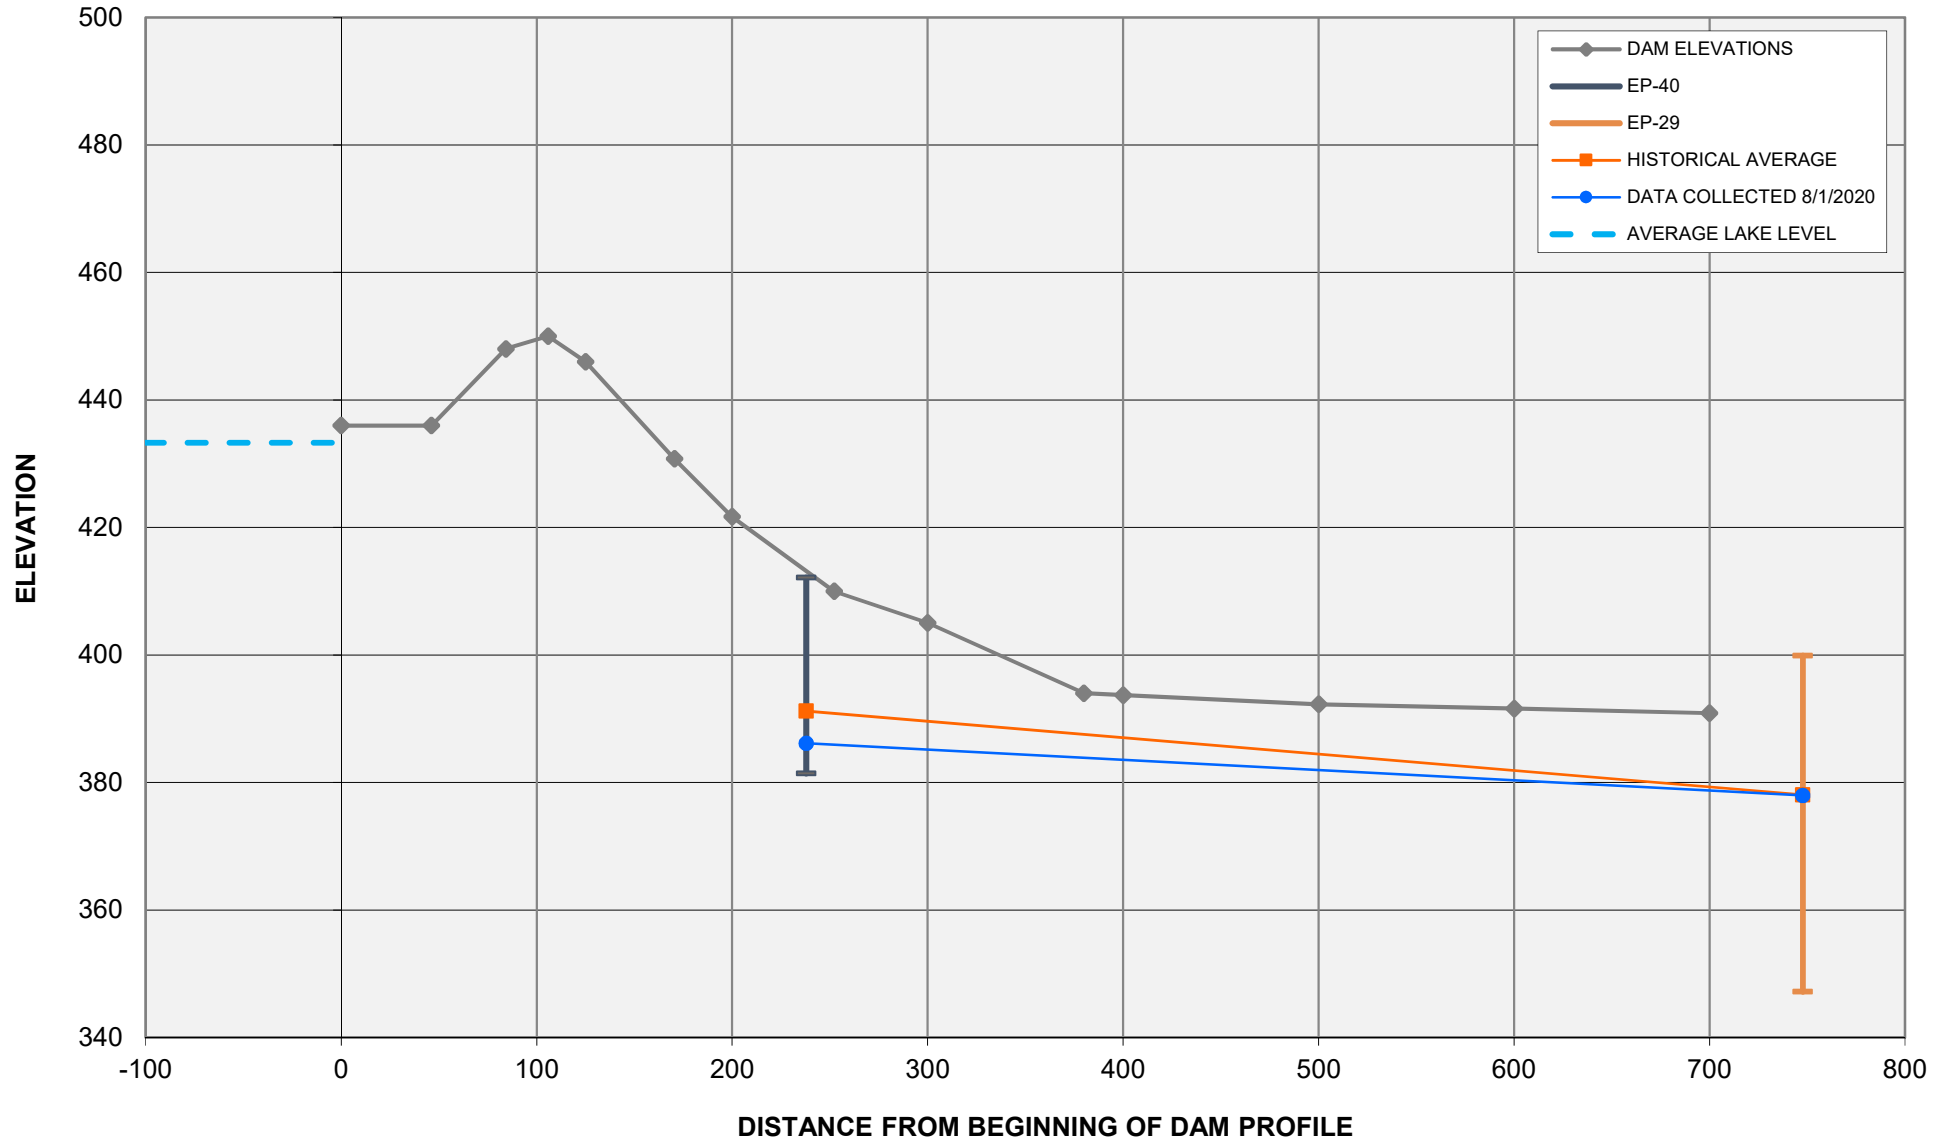
FORNEY LAKE DAM PHREATIC SURFACE - PIEZOMETERS EP-29, EP-40

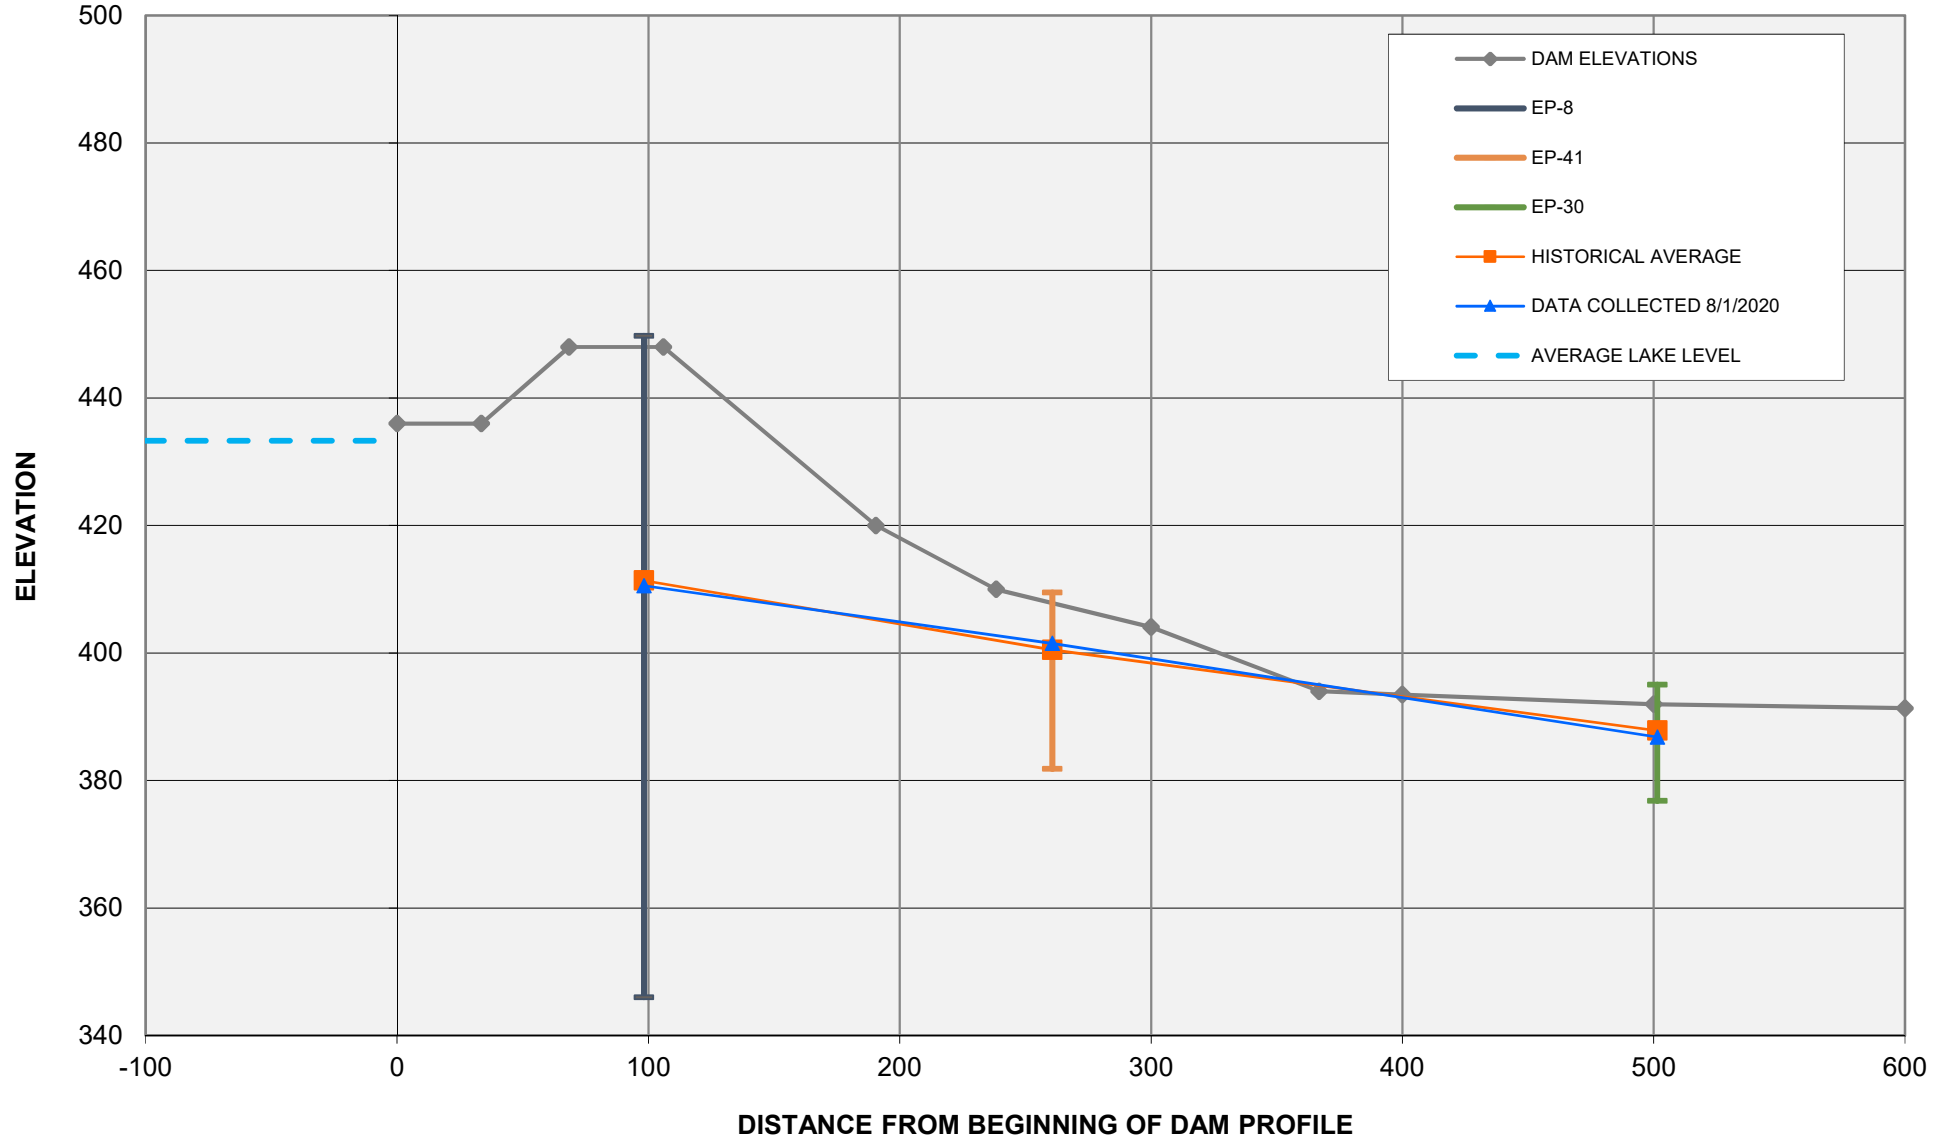
FORNEY LAKE DAM PHREATIC SURFACE - PIEZOMETERS EP-8, EP-30, EP-41

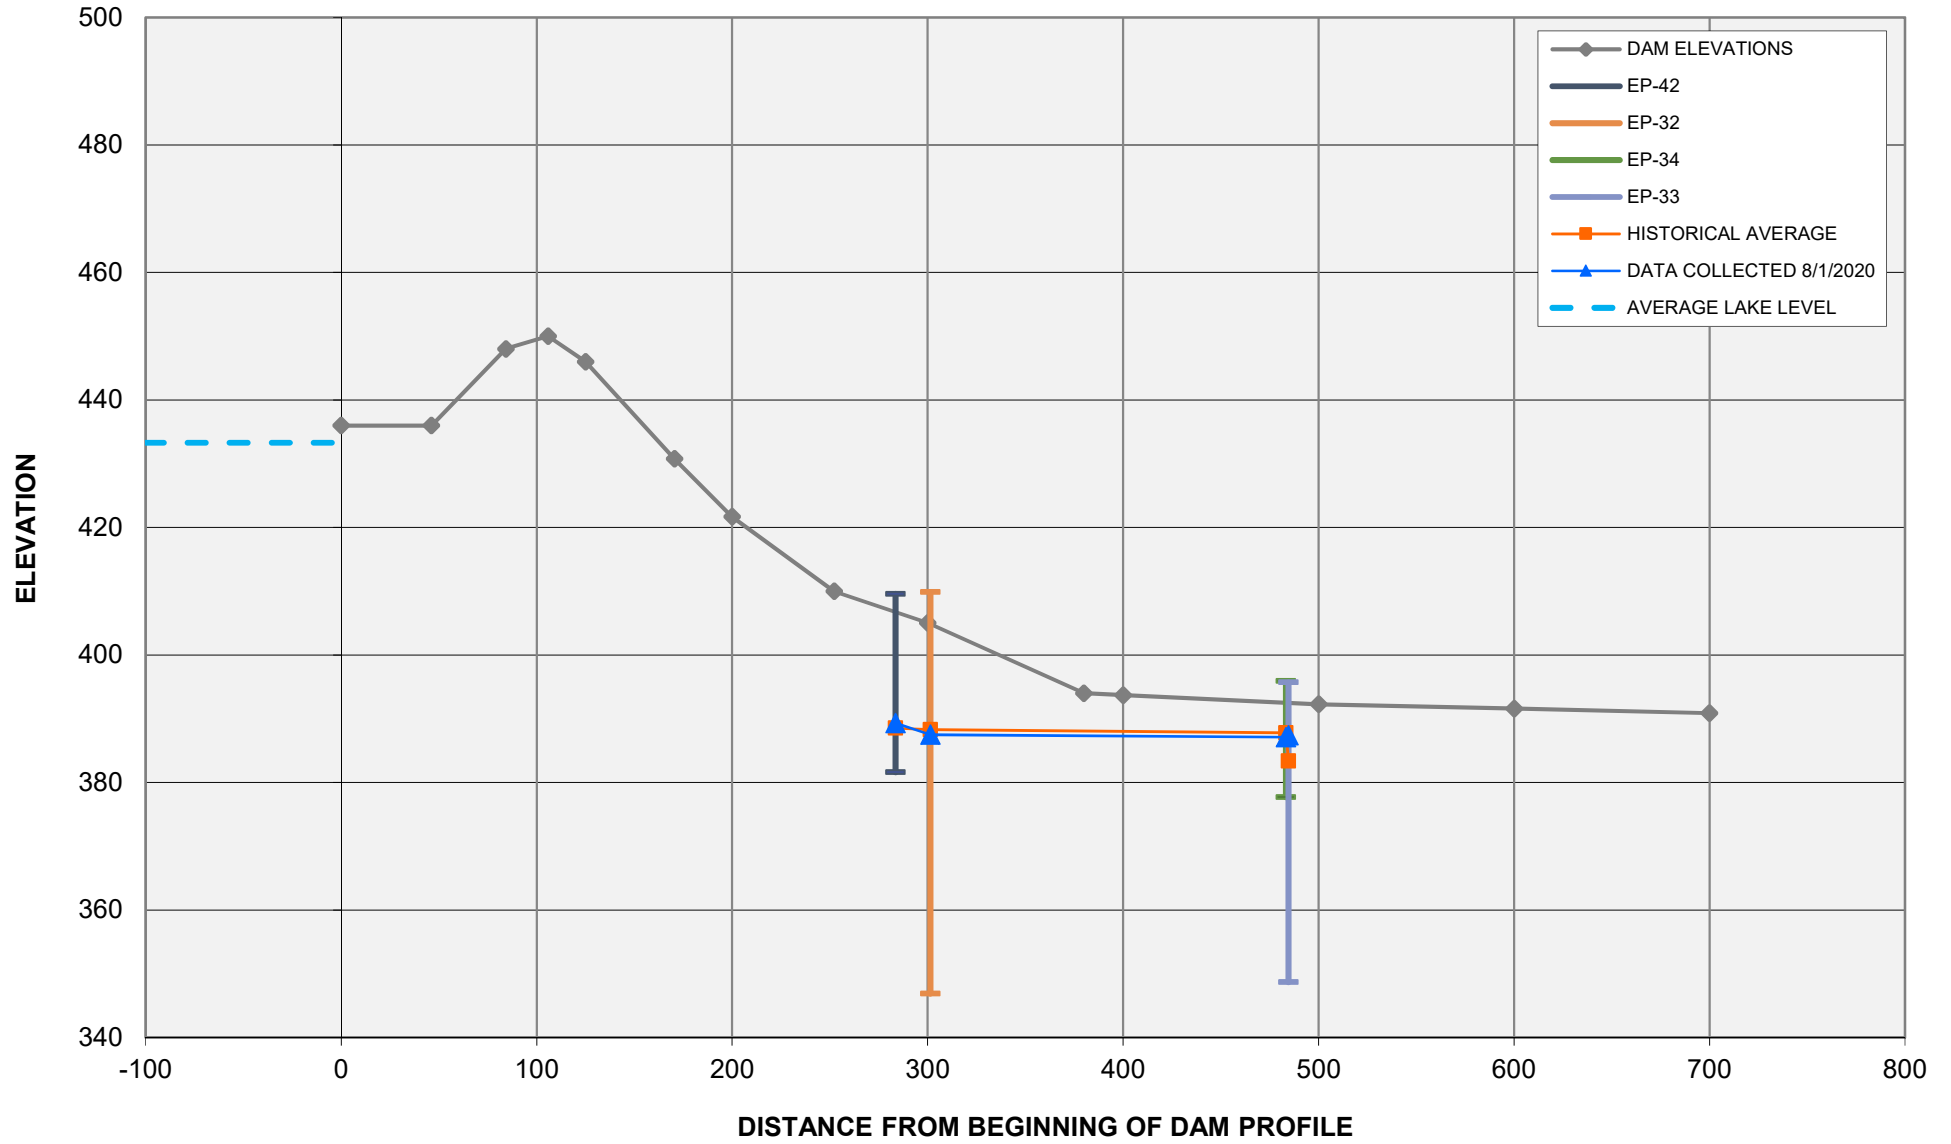
FORNEY LAKE DAM PHREATIC SURFACE - PIEZOMETERS EP-32, EP-33, EP-34, EP-42

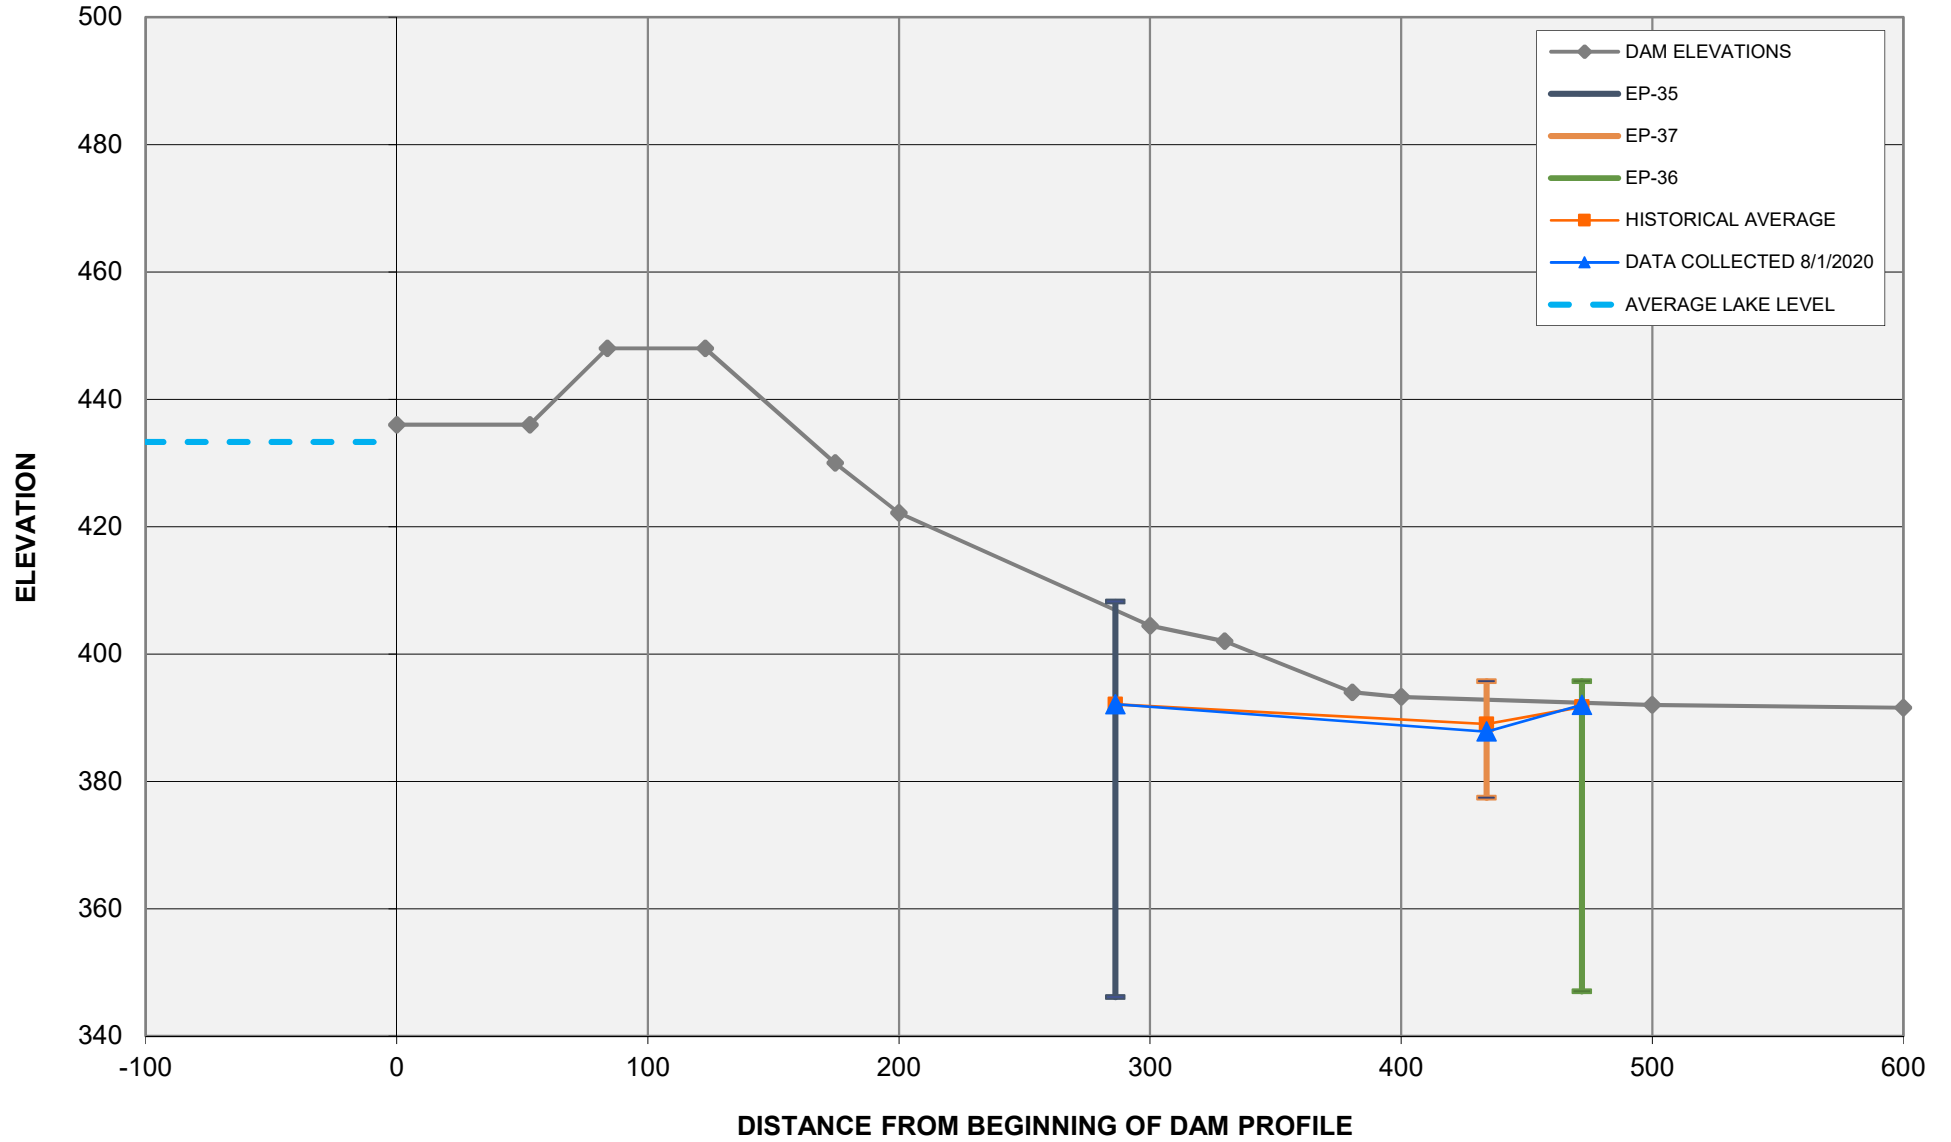
FORNEY LAKE DAM PHREATIC SURFACE - PIEZOMETERS EP-35, EP-36, EP-37

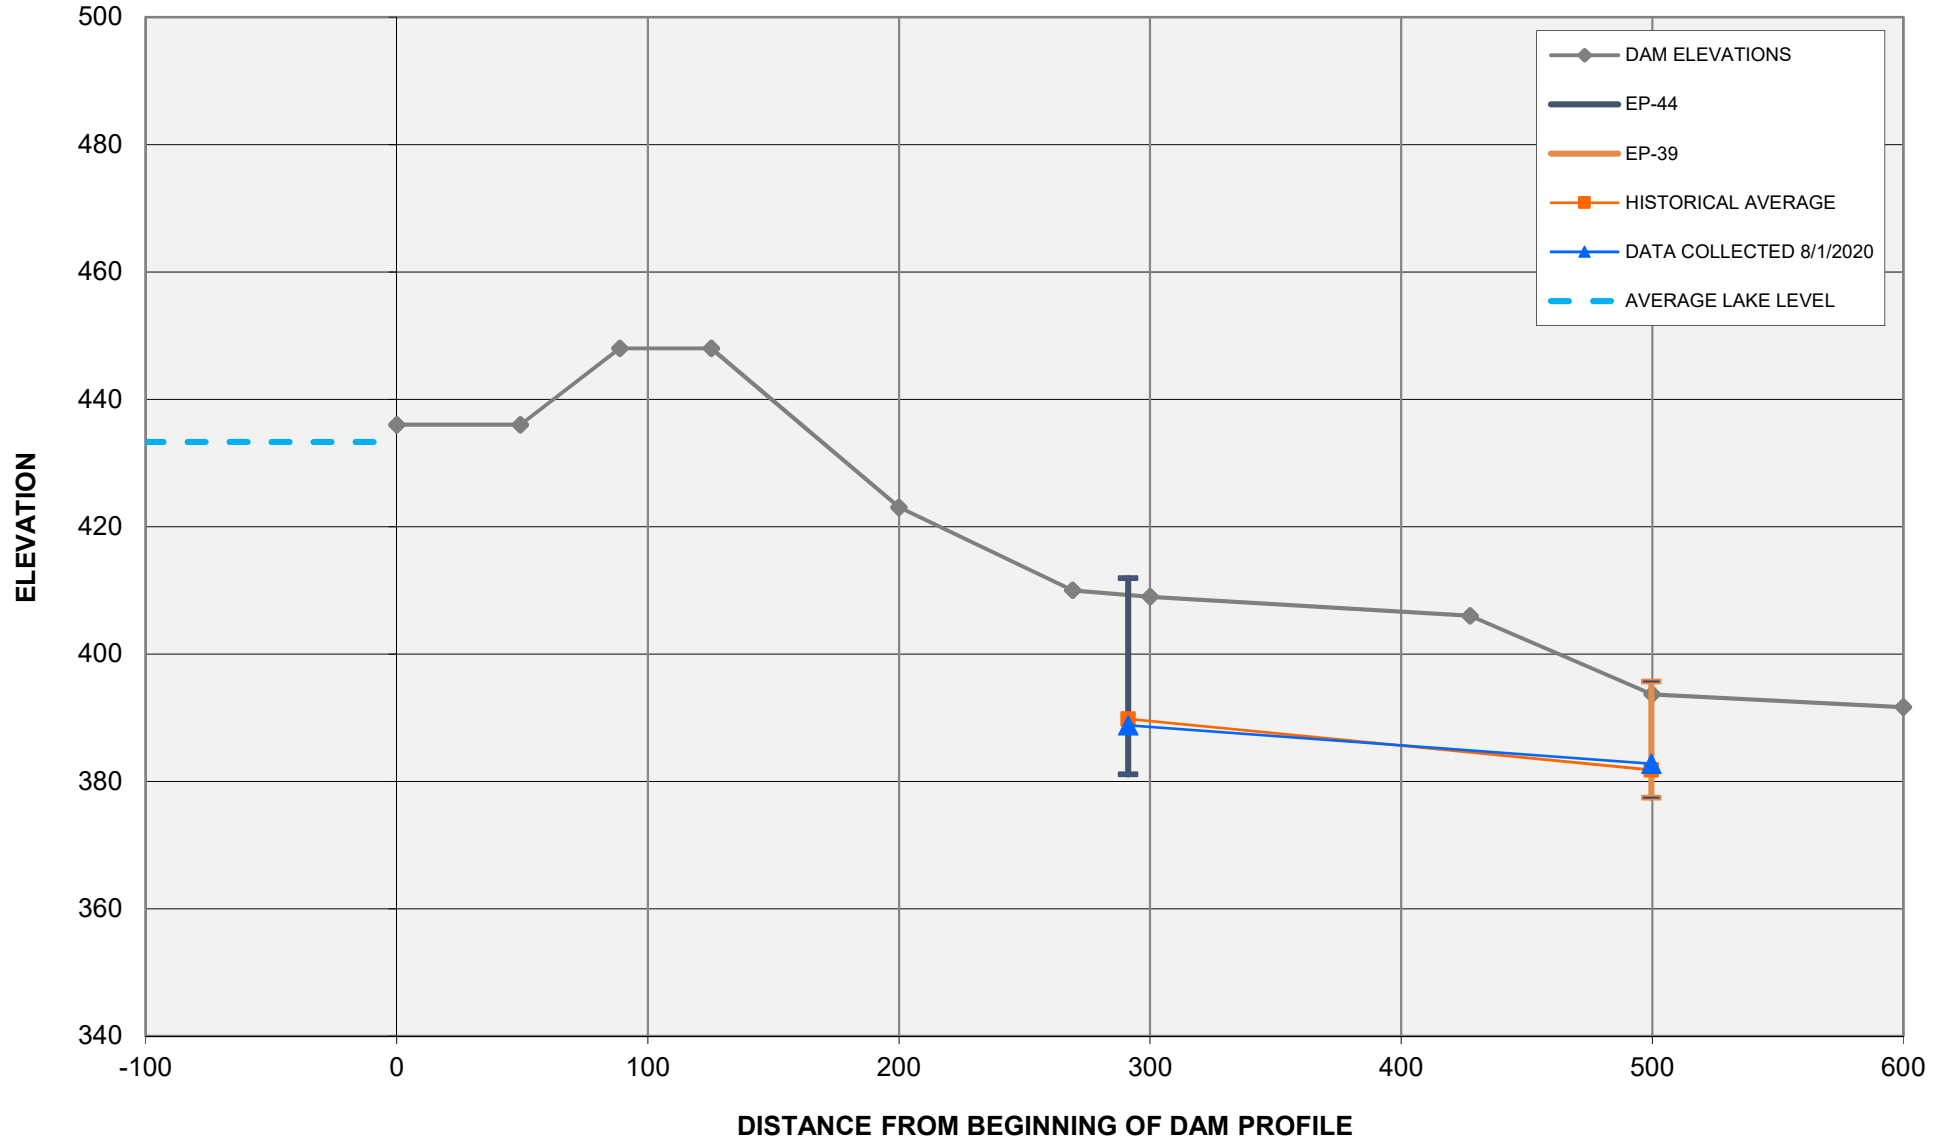
FORNEY LAKE DAM PHREATIC SURFACE - PIEZOMETERS EP-39, EP-44

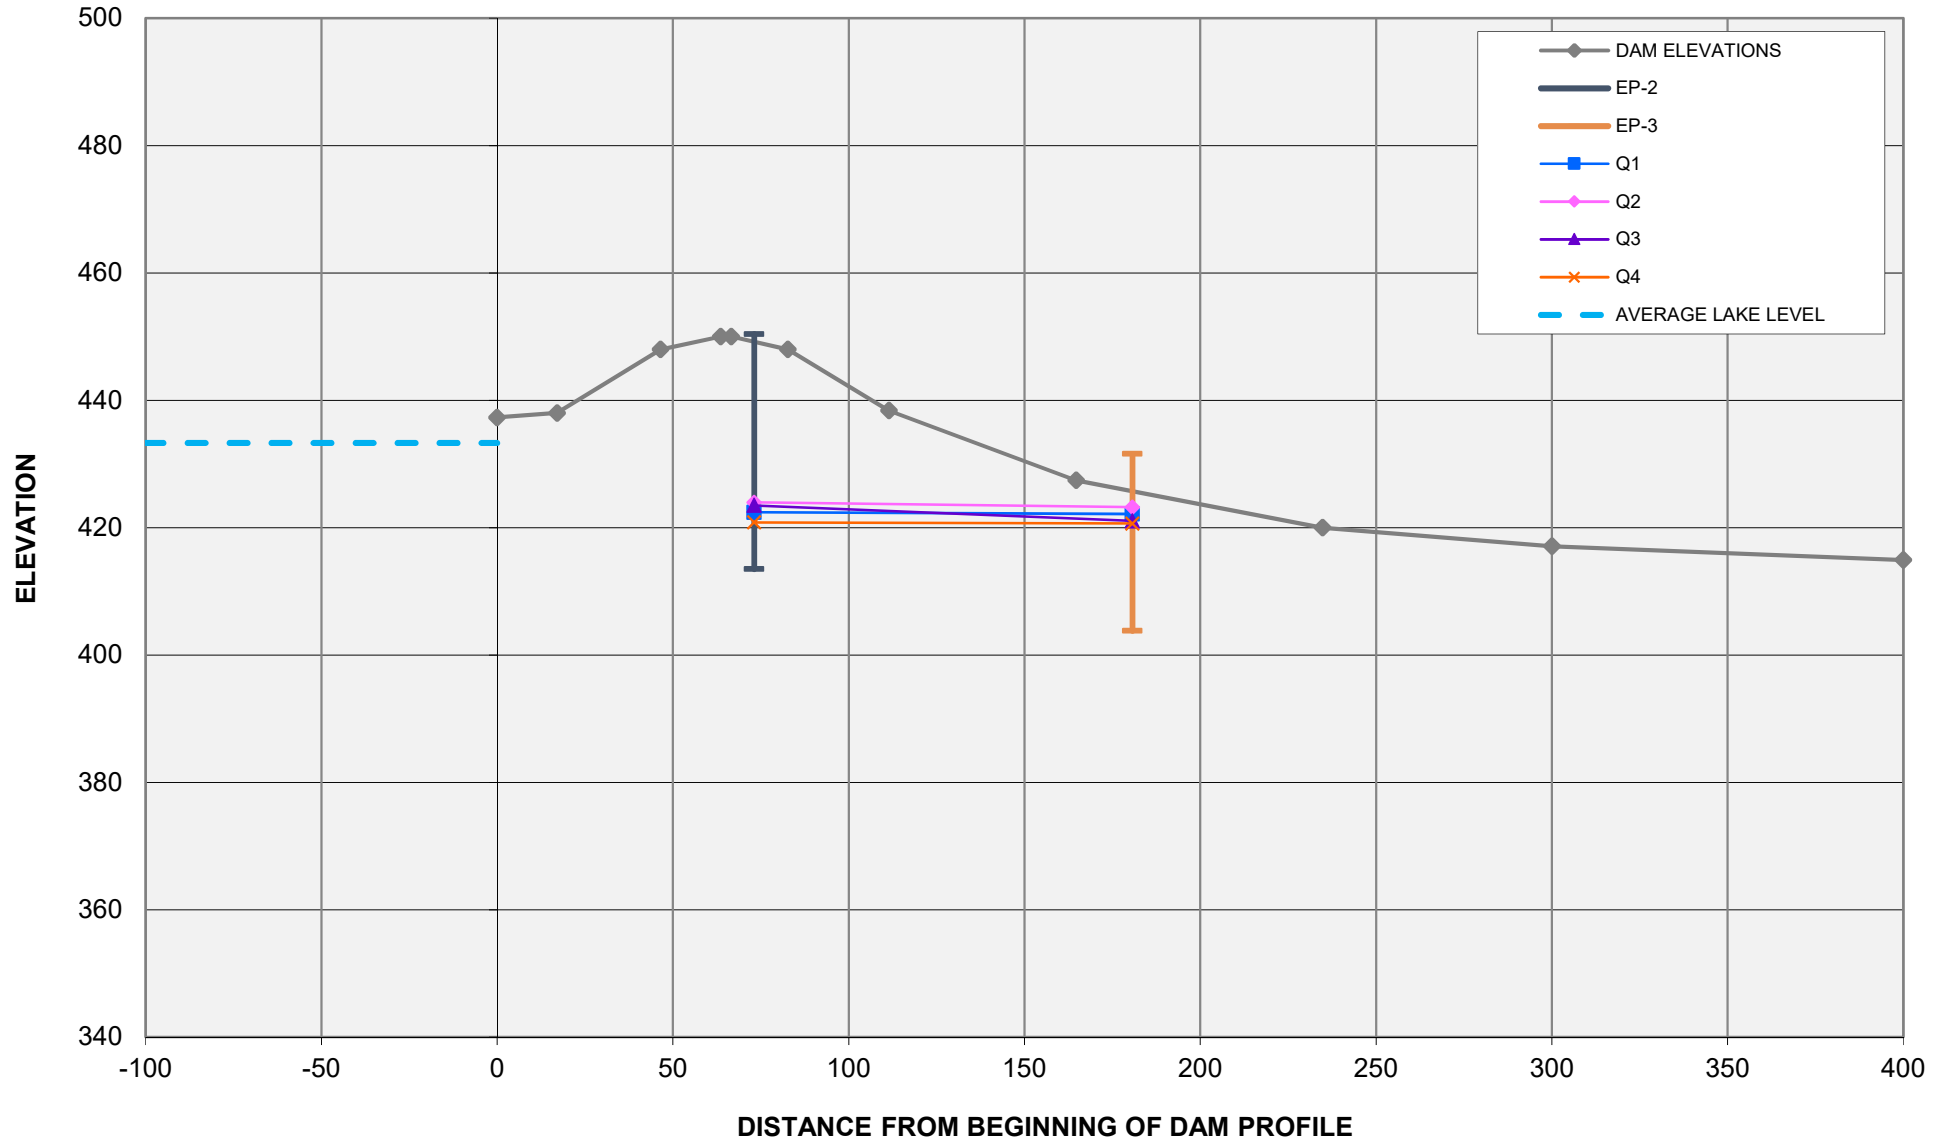
FORNEY LAKE DAM PHREATIC SURFACE - PIEZOMETERS EP-2, EP-3

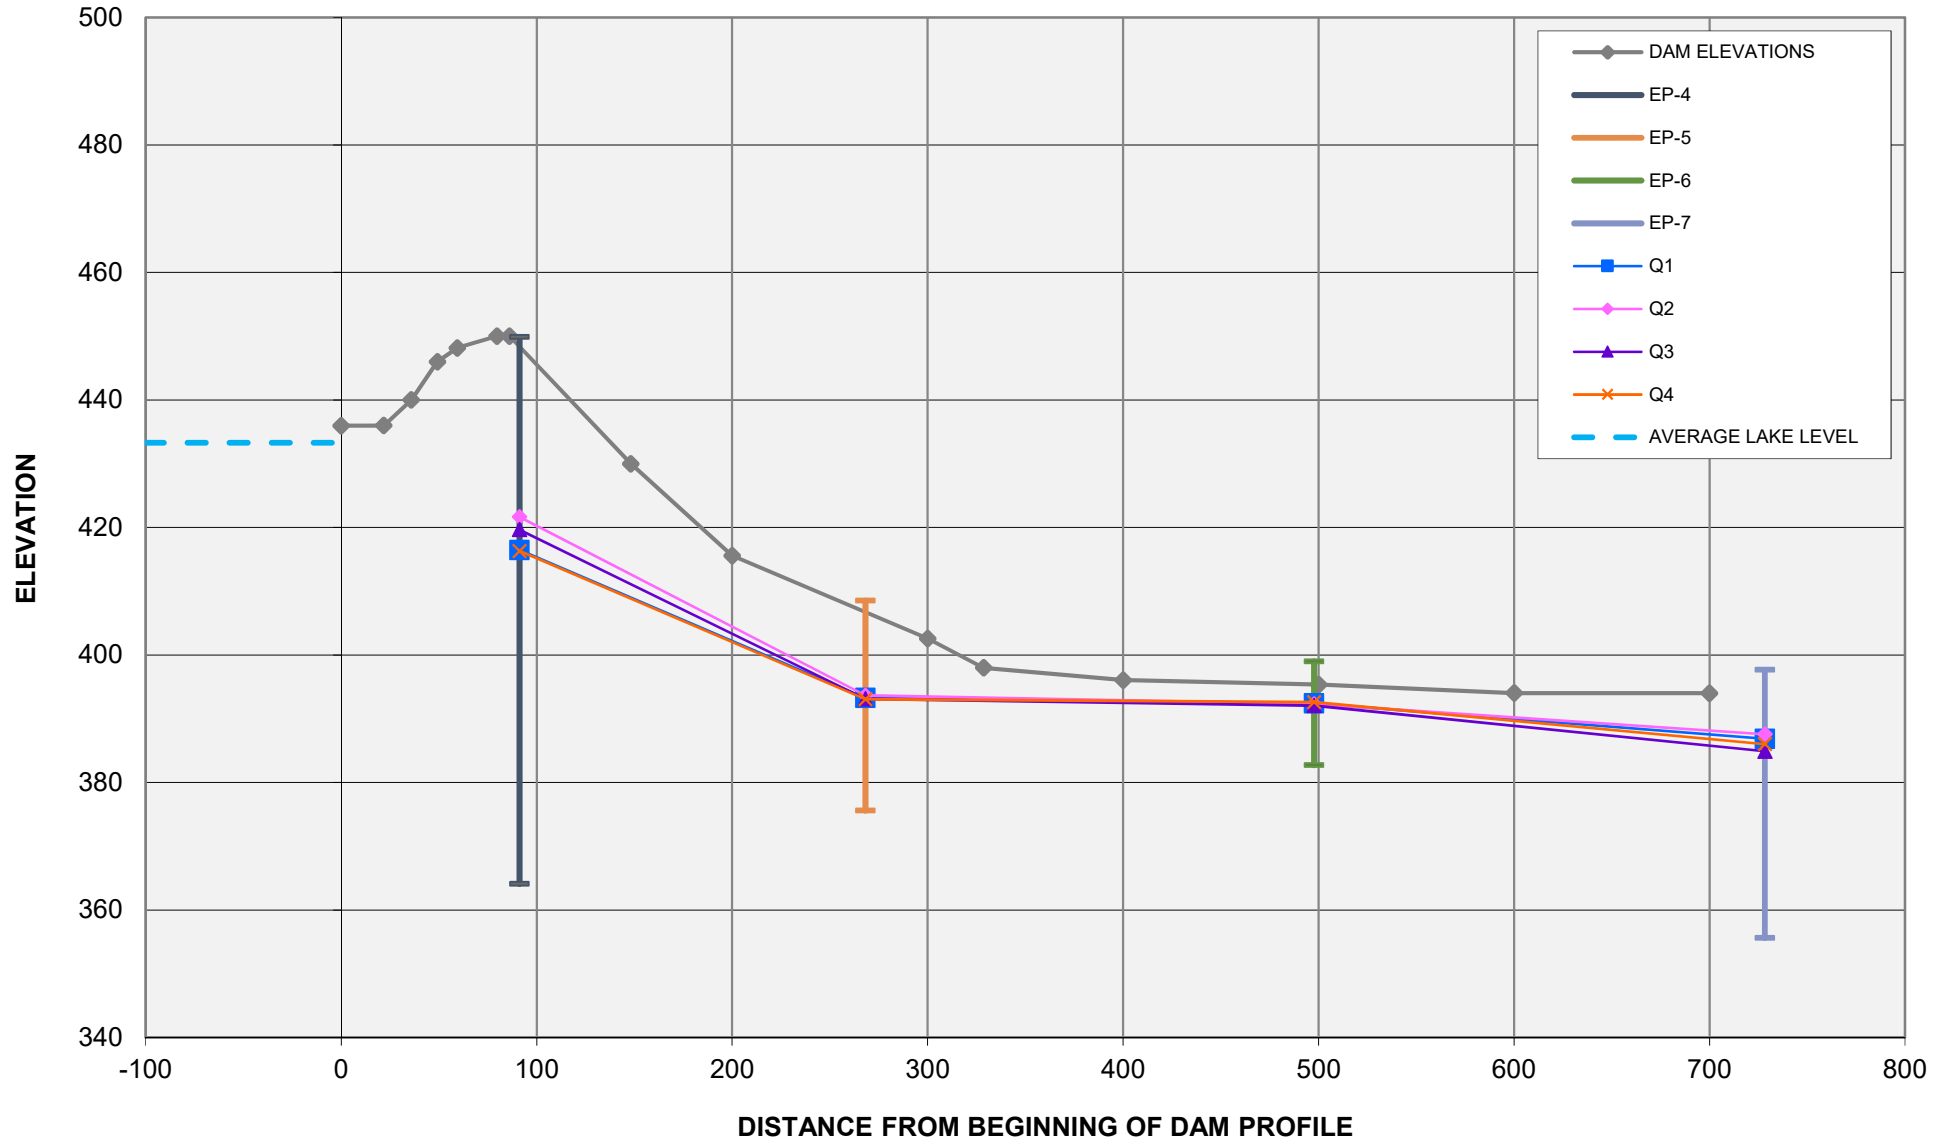
FORNEY LAKE DAM PHREATIC SURFACE - PIEZOMETERS EP-4, EP-5, EP-6, EP-7

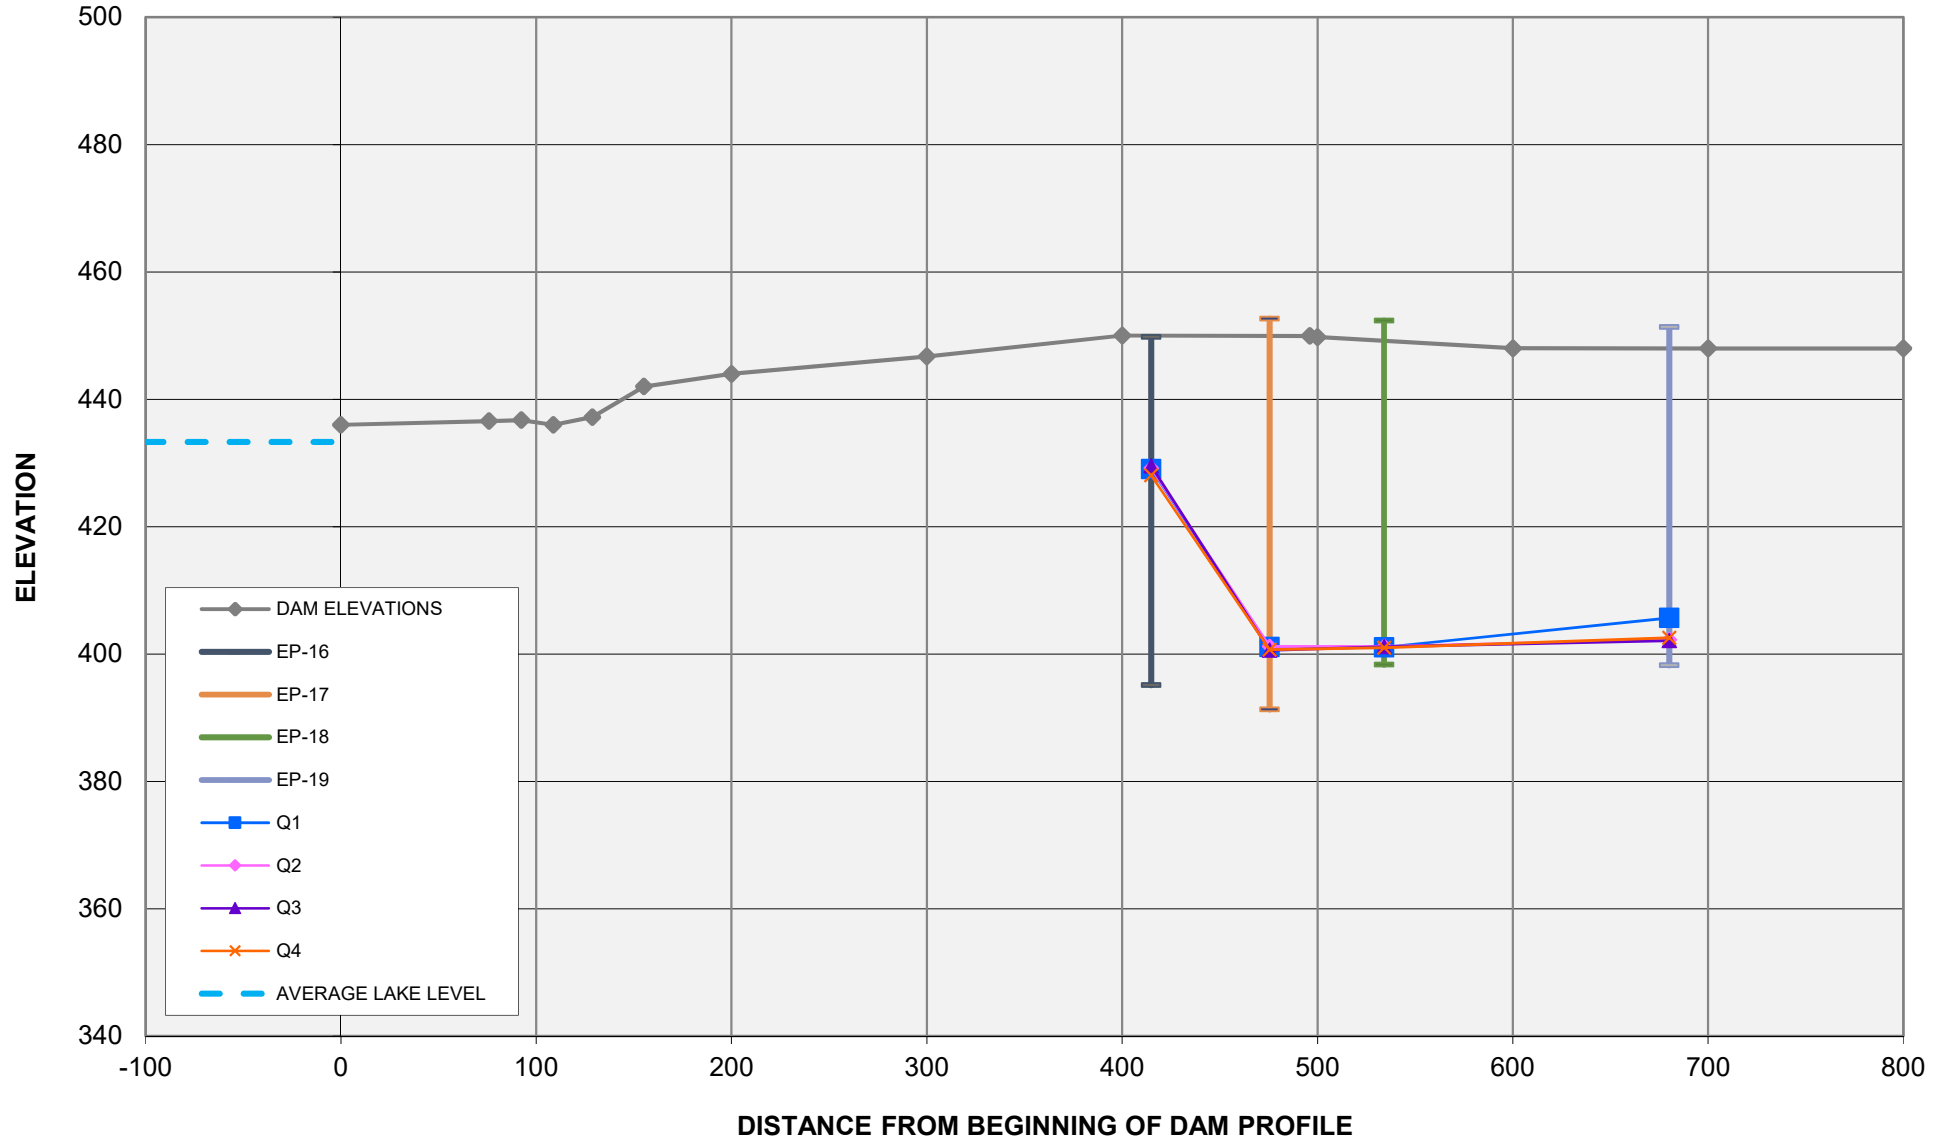
FORNEY LAKE DAM PHREATIC SURFACE - PIEZOMETERS EP-16, EP-17, EP-18, EP-19
