VISUAL INSPECTION AND EVALUATION REPORT

Rockwall-Forney Dam
Dallas Water Utilities
Dallas/Kaufman Counties, Texas

Schnabel Reference #20C22001.00
July 30, 2021

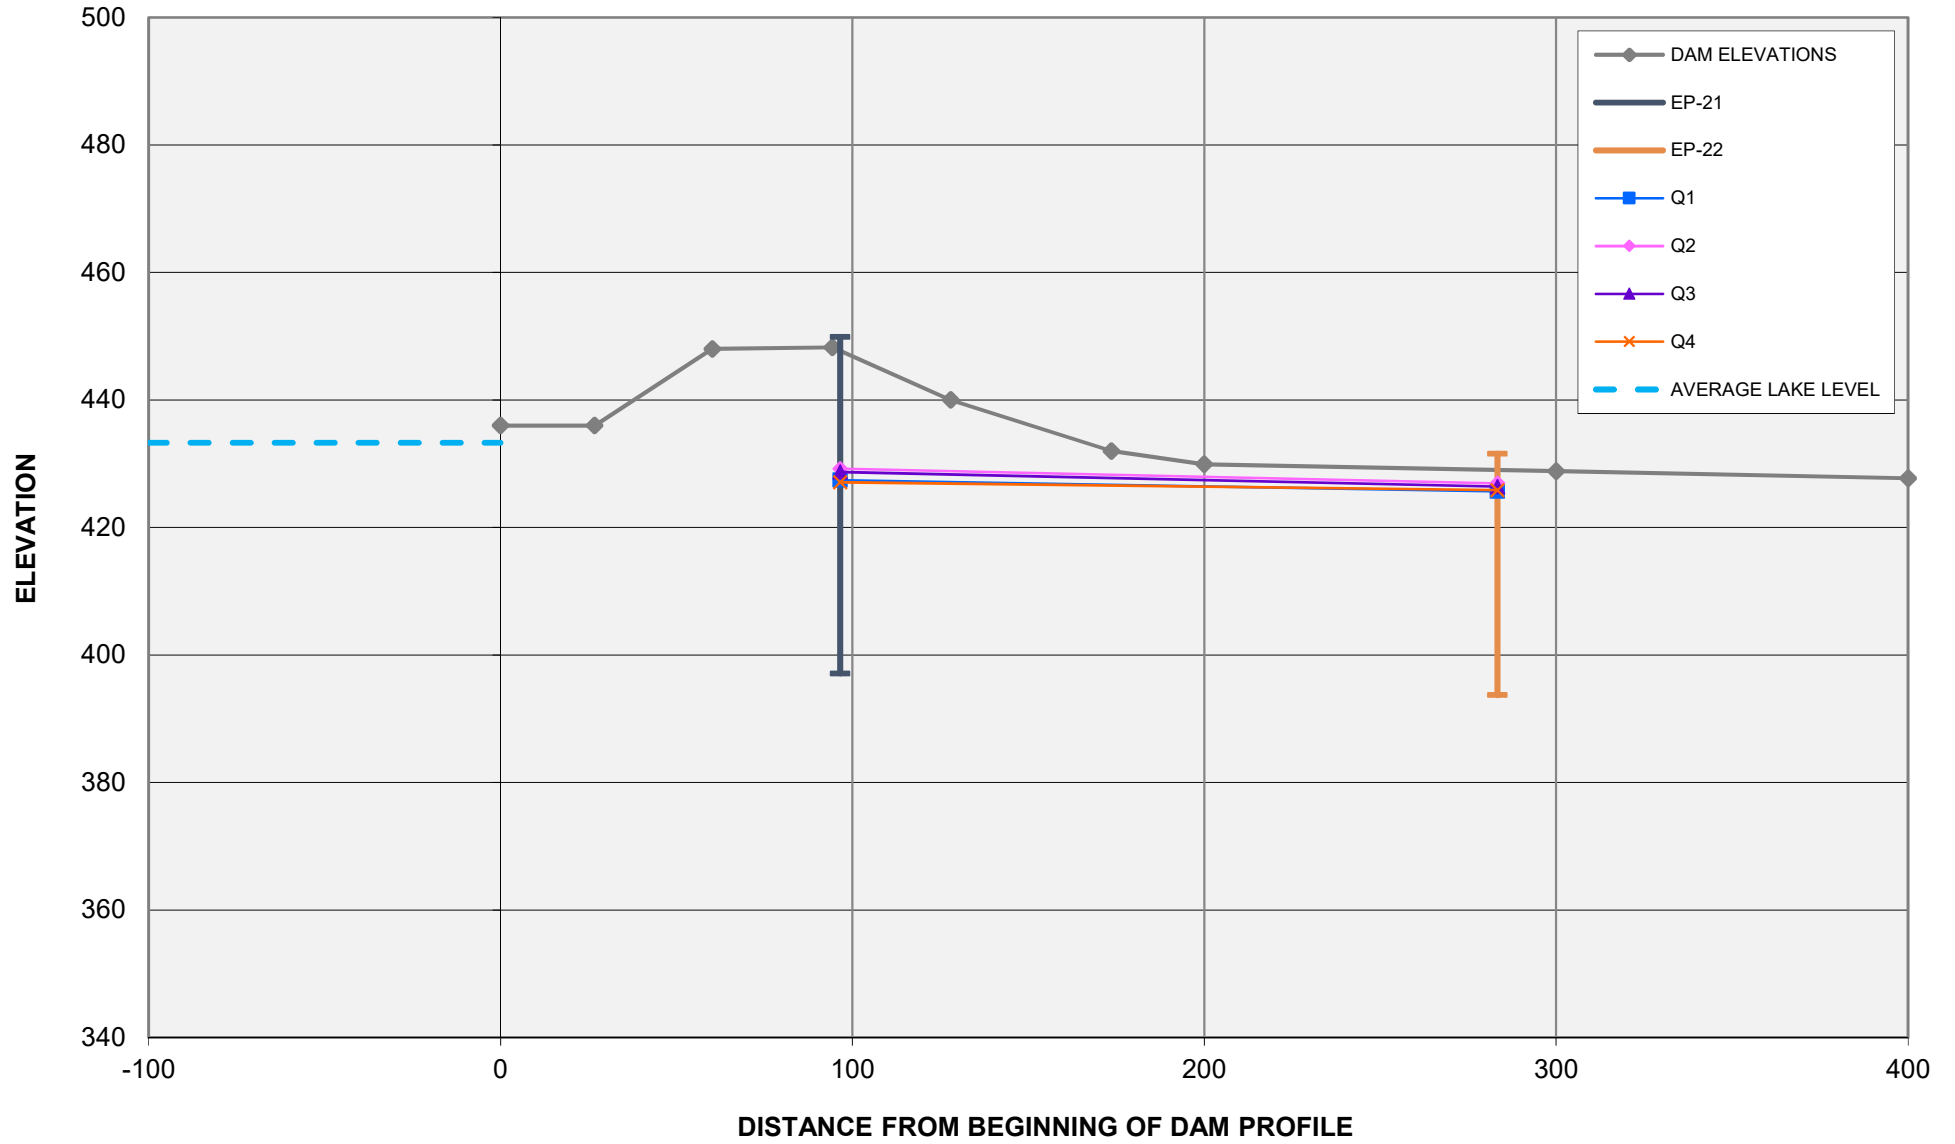
FORNEY LAKE DAM PHREATIC SURFACE - PIEZOMETERS EP-21, EP-22

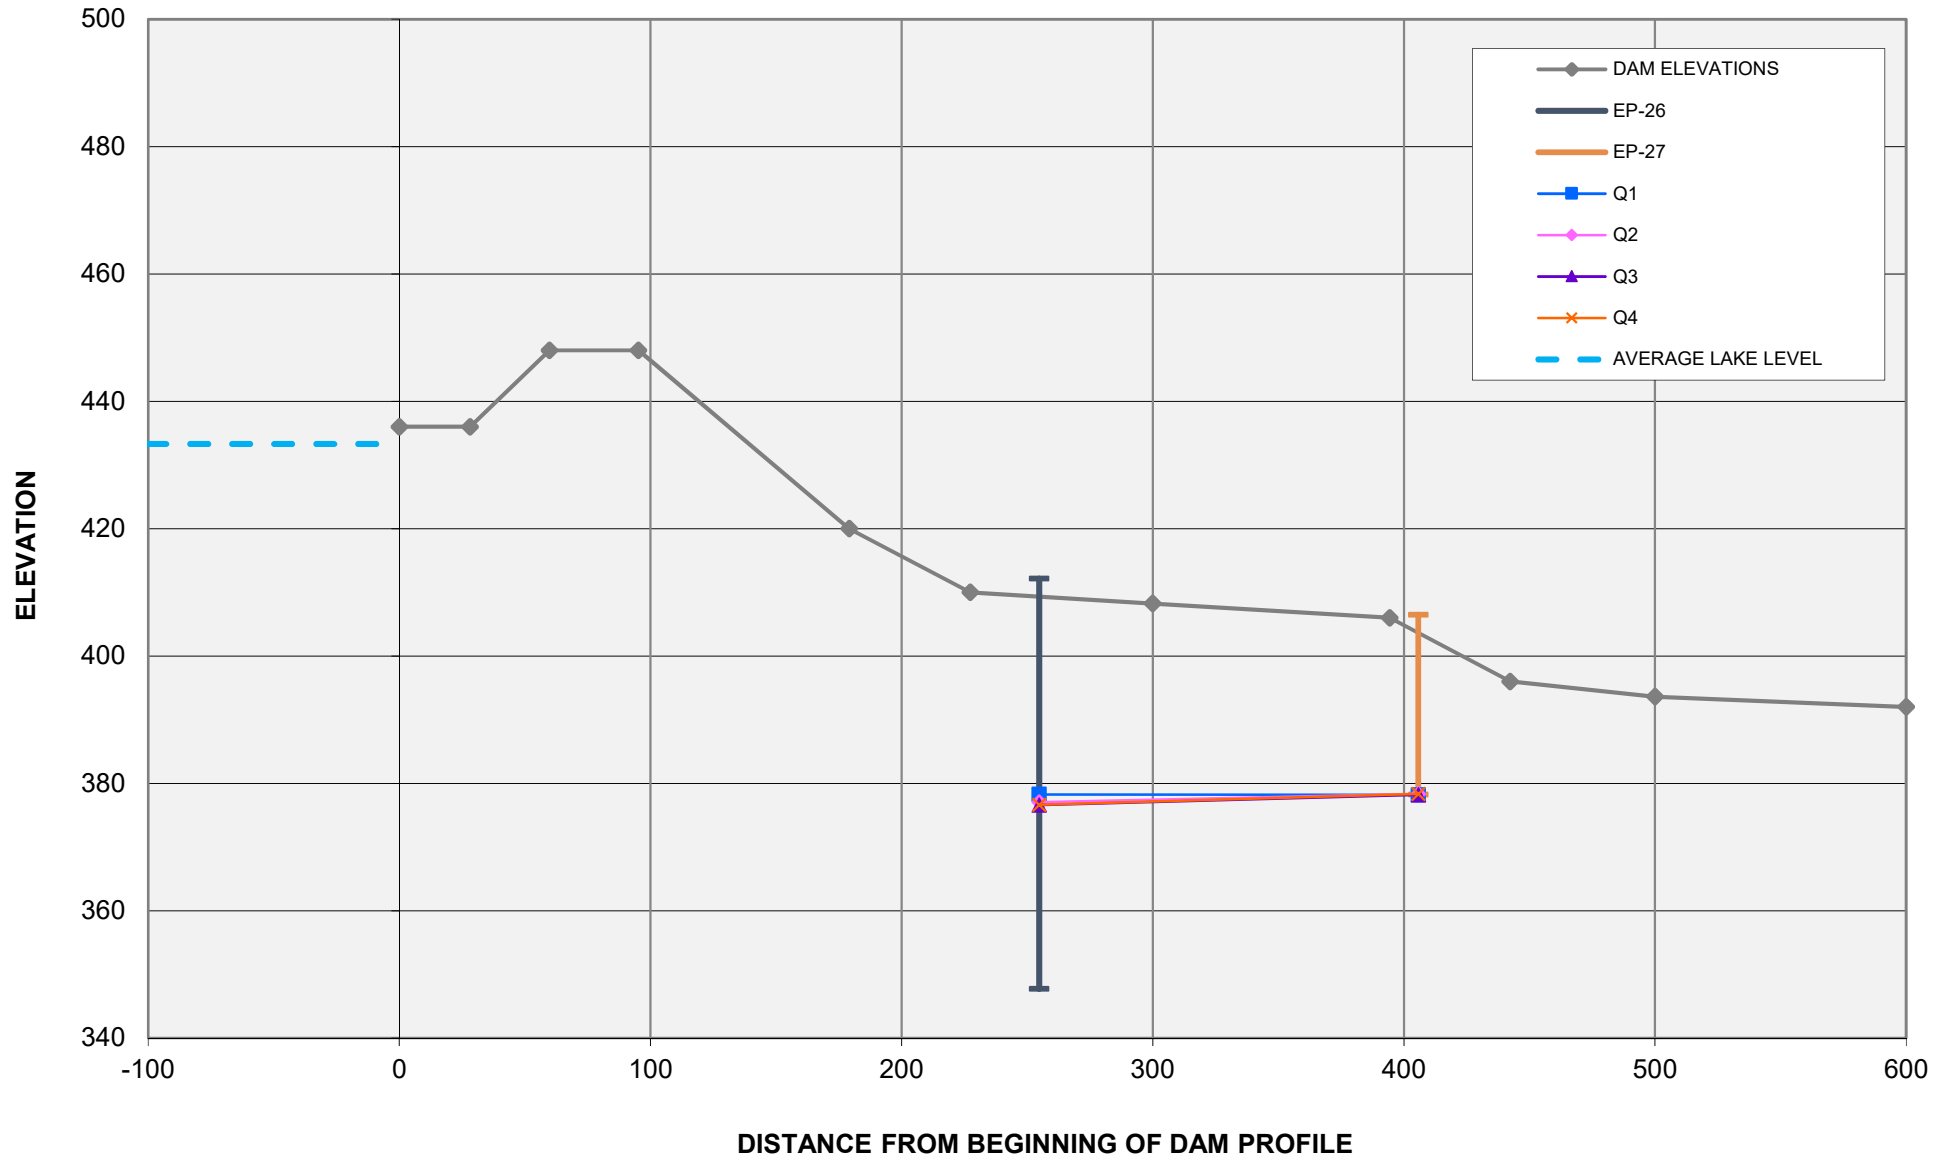
FORNEY LAKE DAM PHREATIC SURFACE - PIEZOMETERS EP-26, EP-27

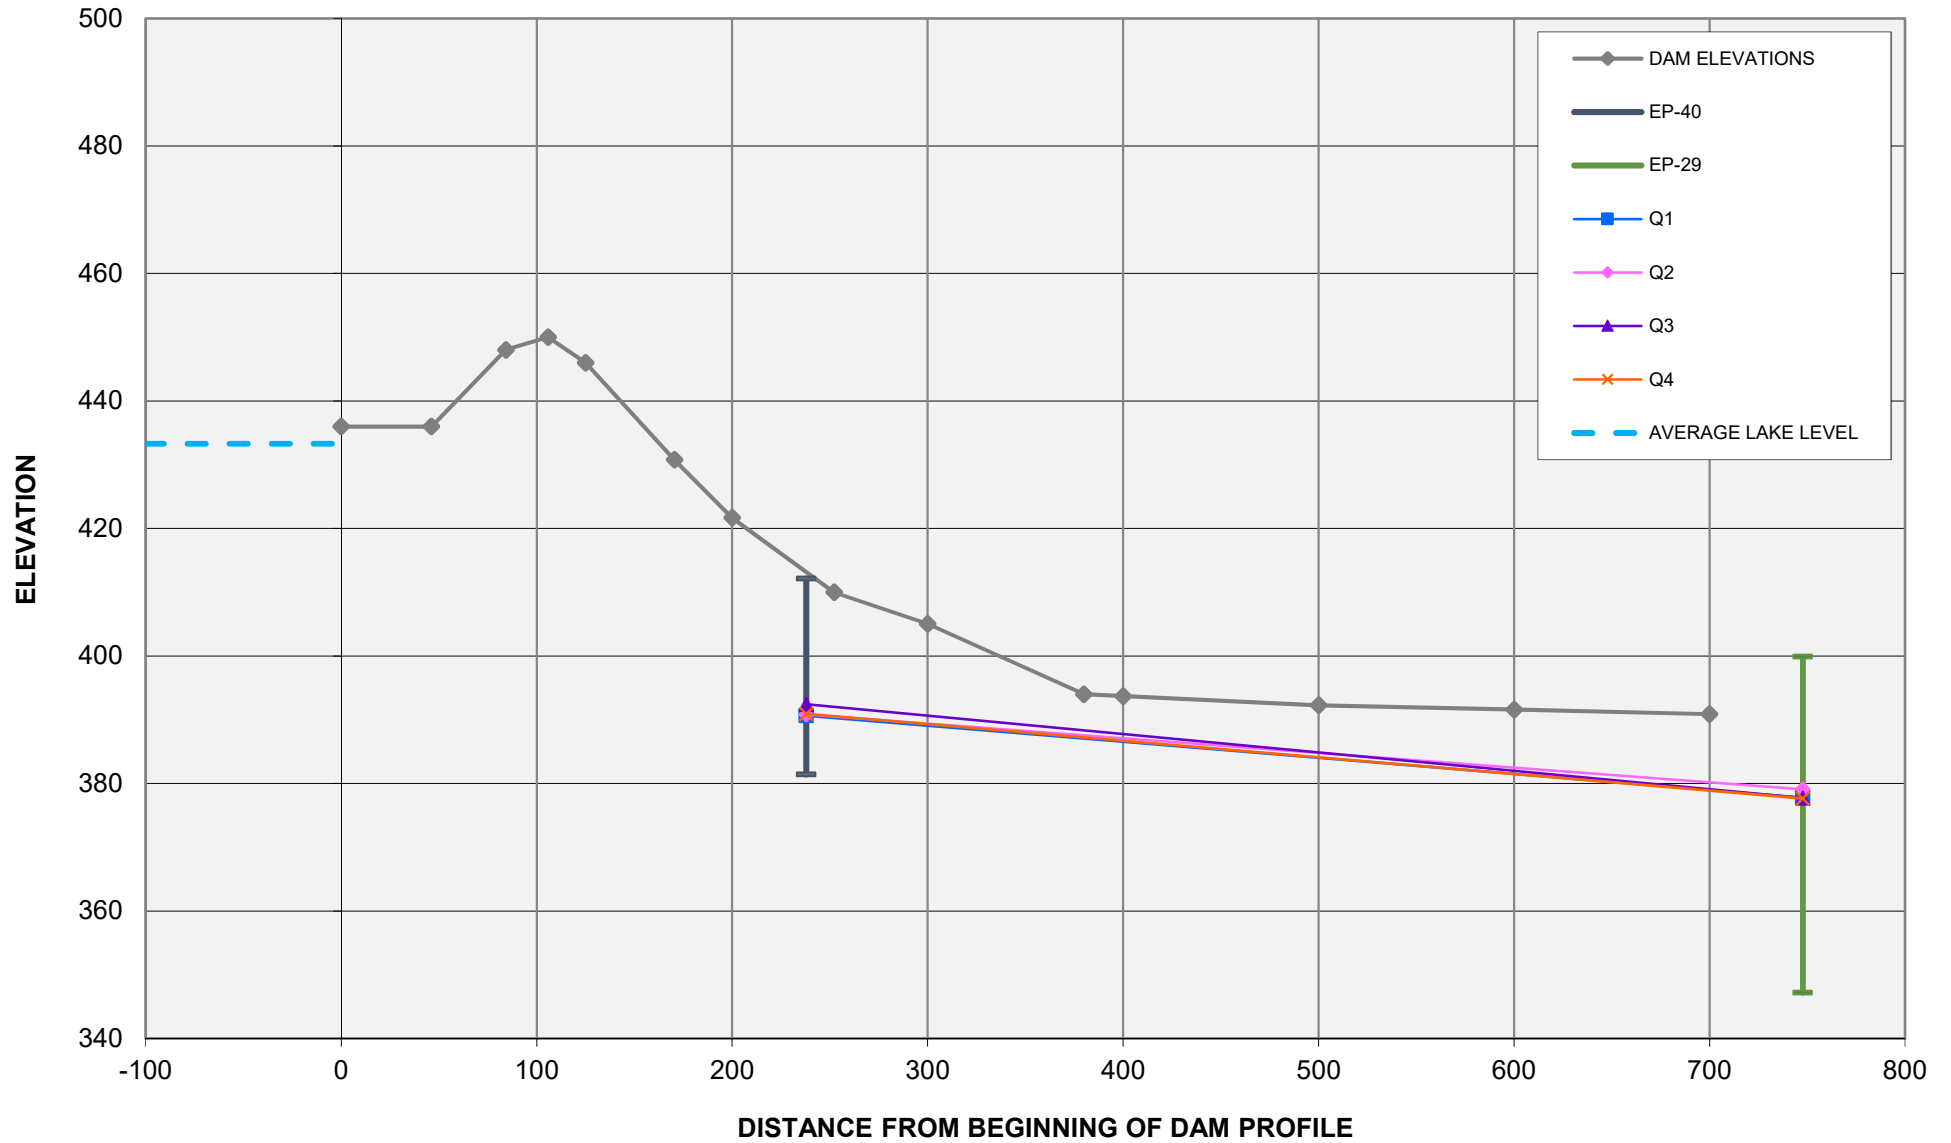
FORNEY LAKE DAM PHREATIC SURFACE - PIEZOMETERS EP-29, EP-40

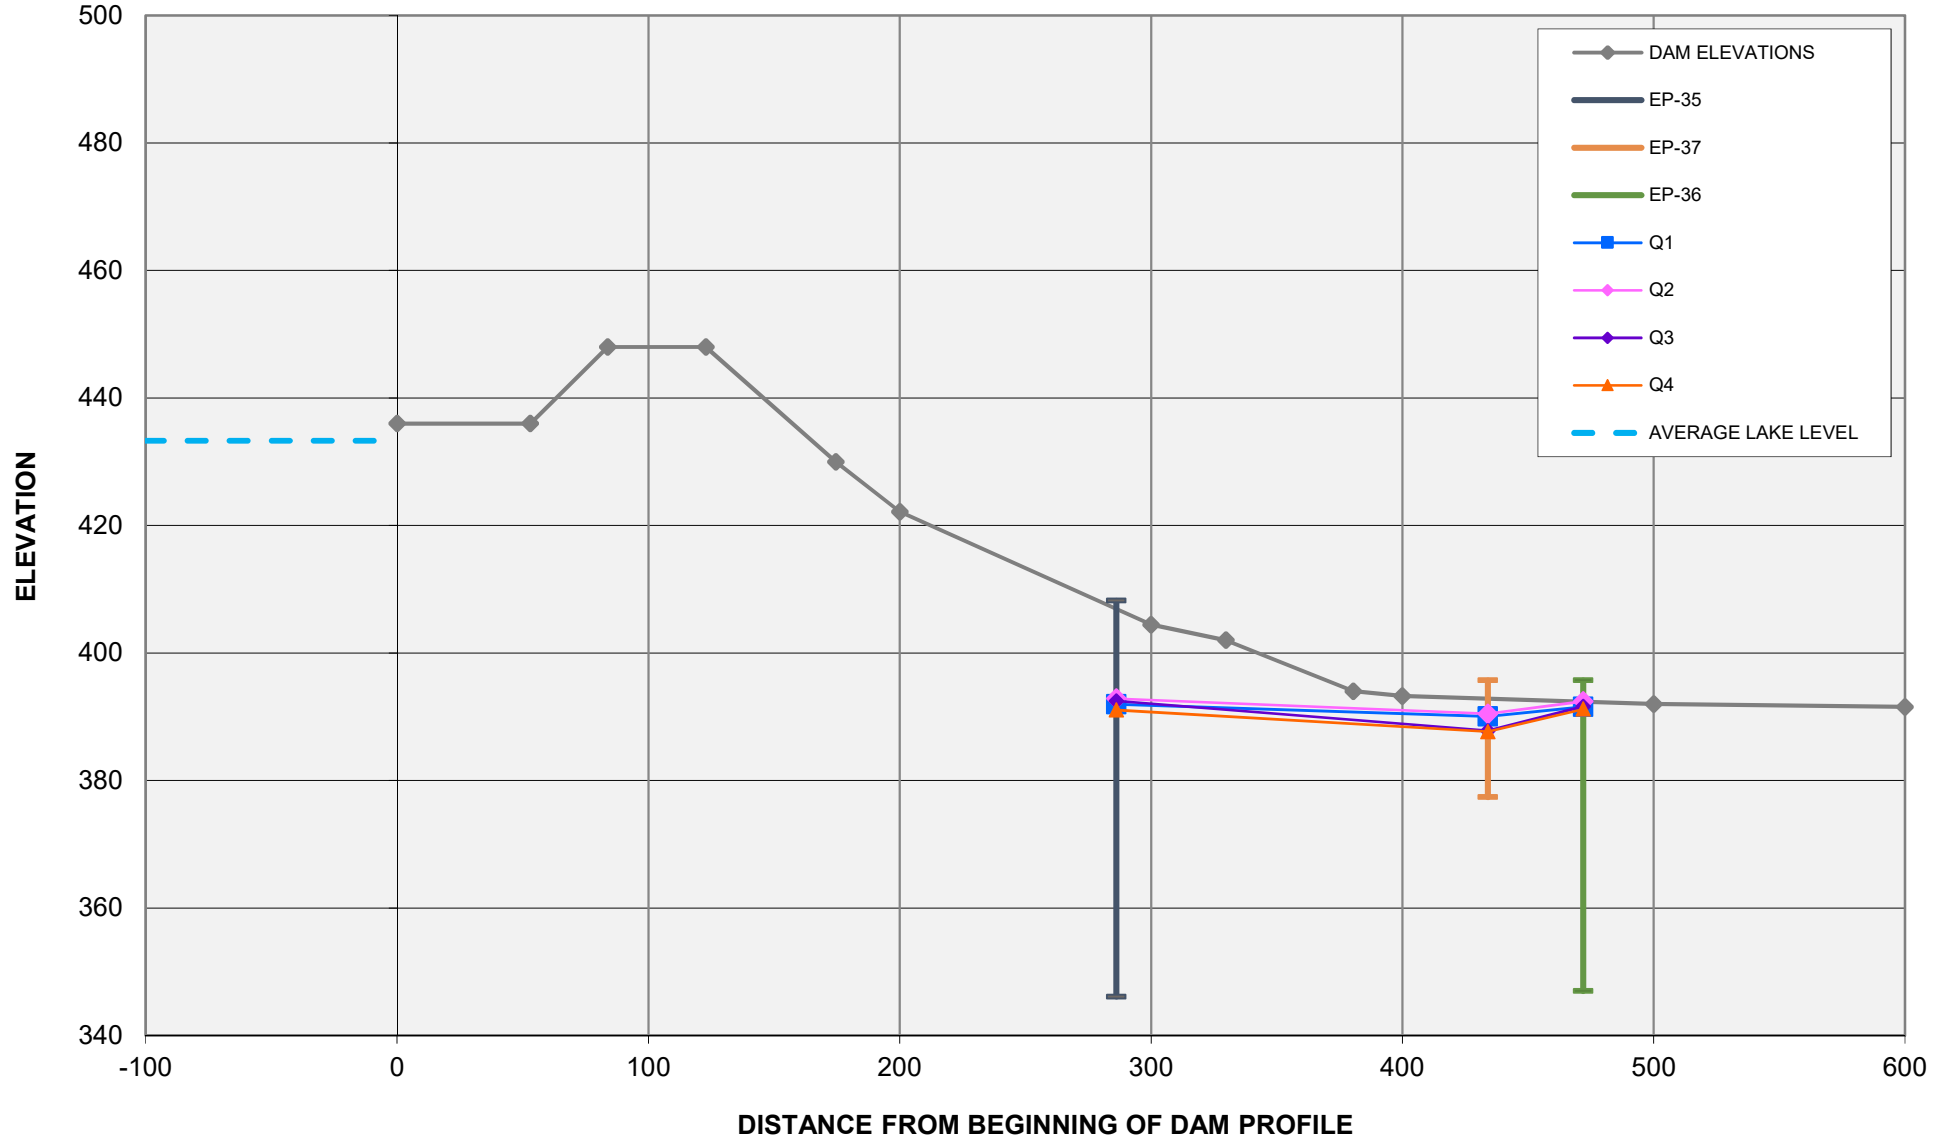
FORNEY LAKE DAM PHREATIC SURFACE - PIEZOMETERS EP-35, EP-36, EP-37

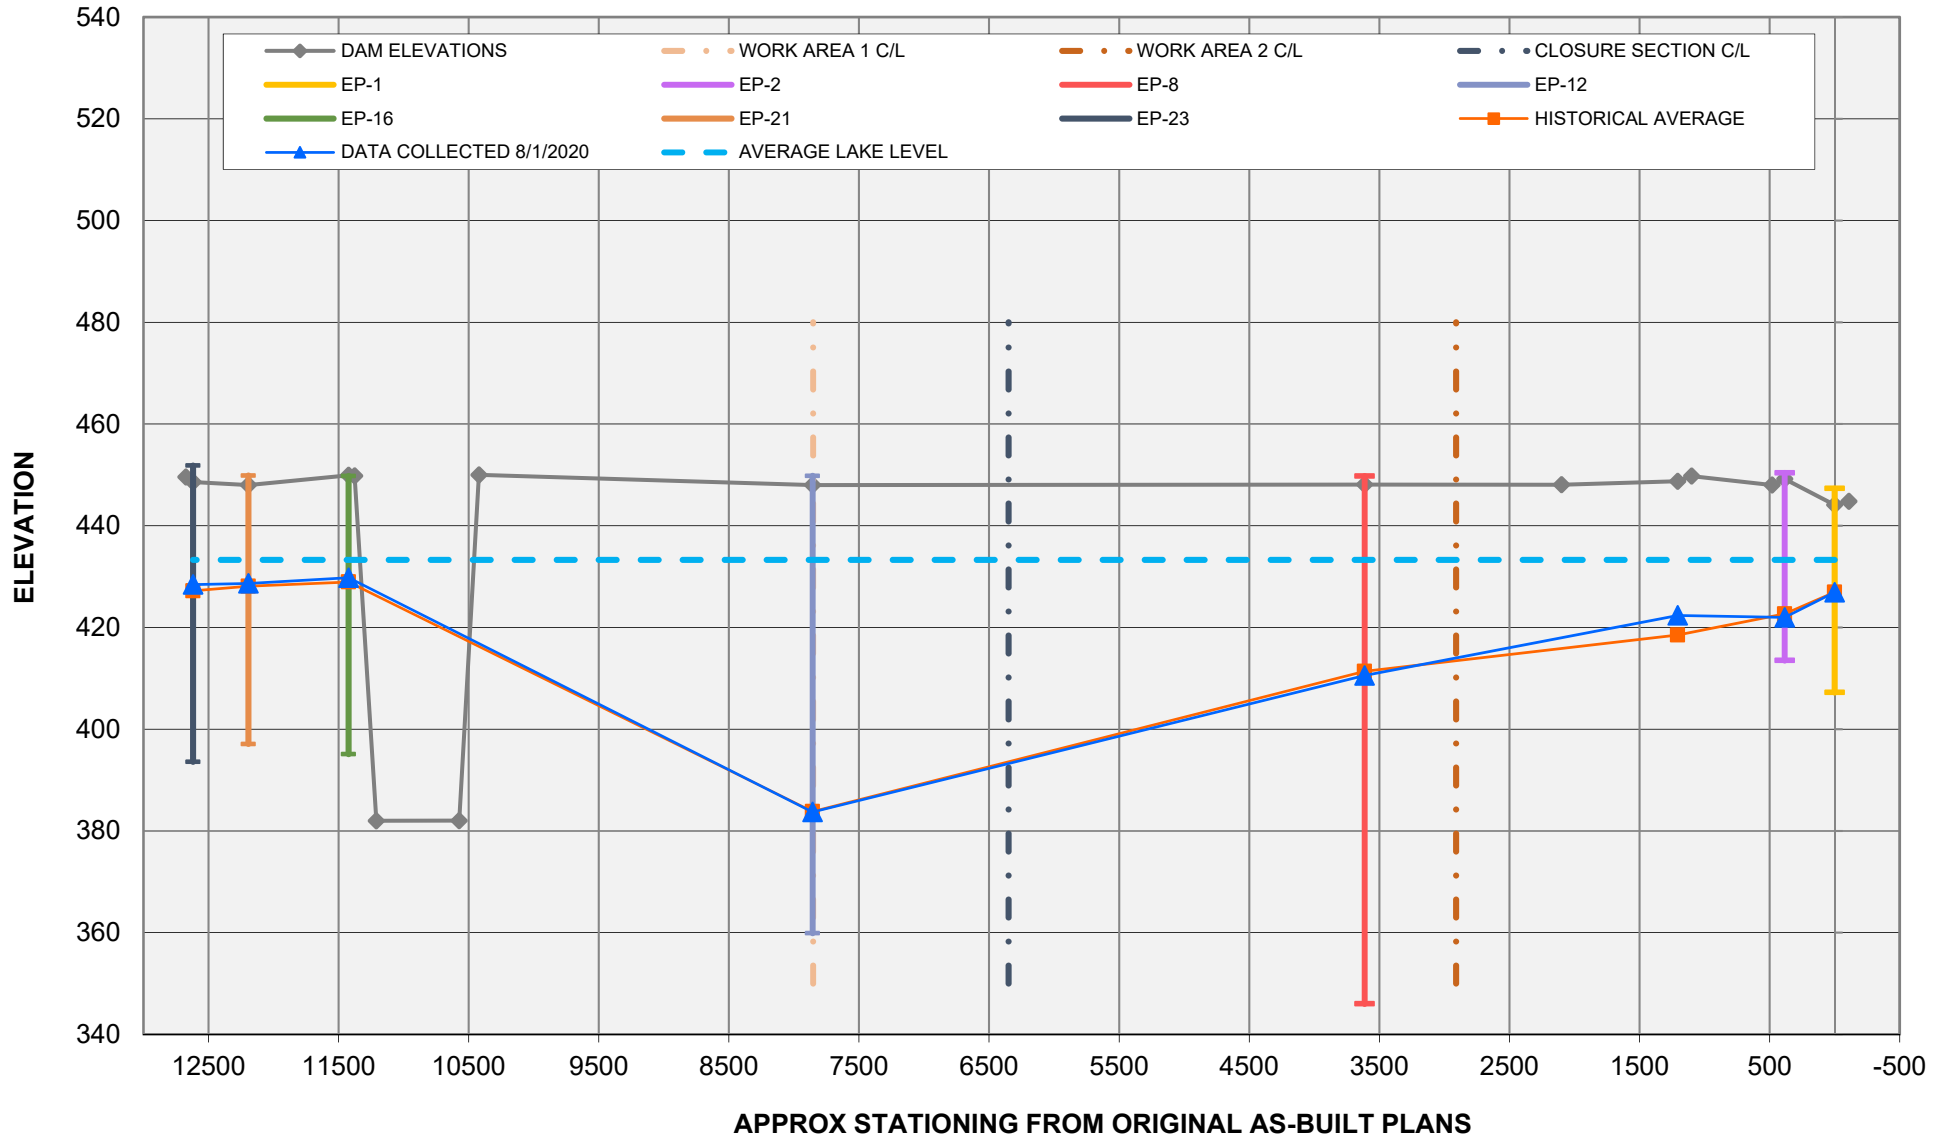
FORNEY LAKE DAM PHREATIC SURFACE - CREST PROFILE

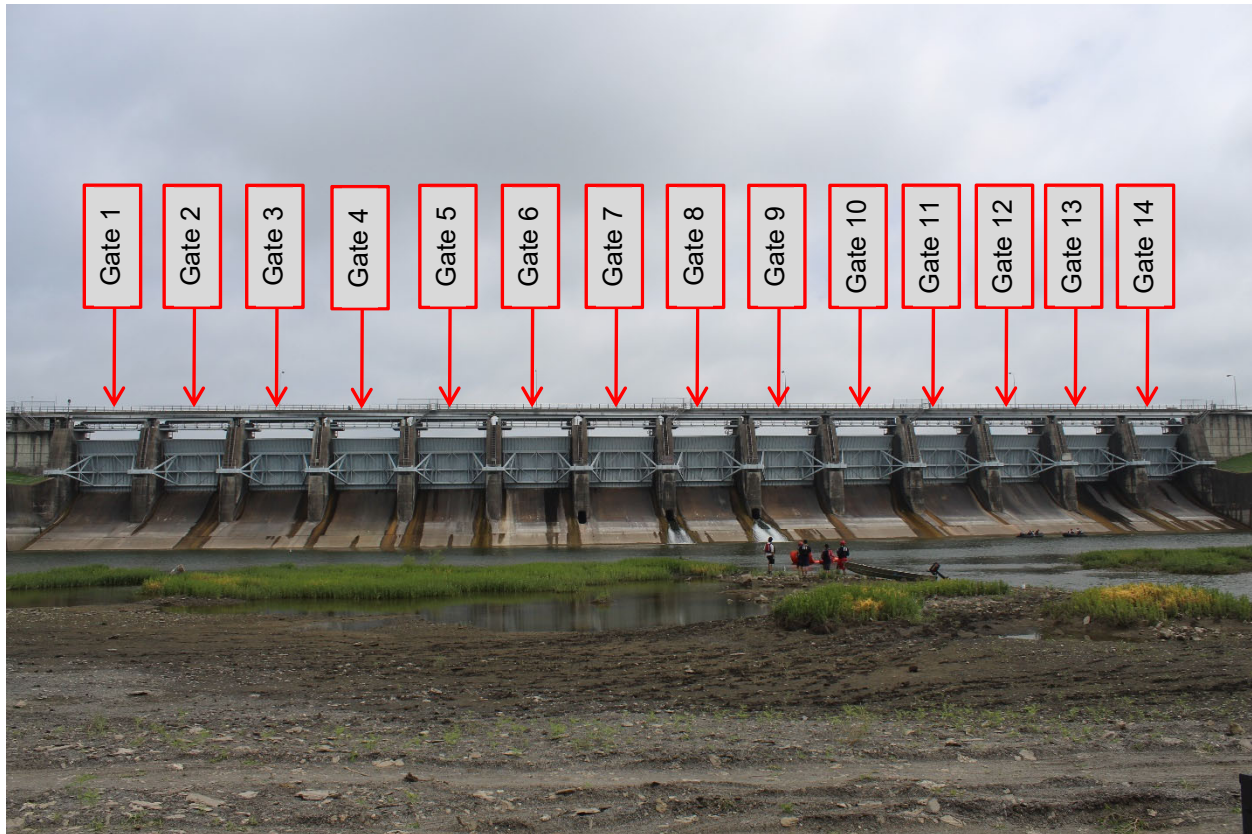
Figure 3-1: Principal spillway and gate numbering nomenclature. Photo is taken looking upstream.

The gate numbering system as shown above in Figure 3-1 is used consistently in this report to identify individual gates and is consistent with the project gate numbering system. Left and right as used in this report are referenced to looking in the downstream direction unless otherwise noted.

Gate numbering is based on the numbering system as shown in Figure 3-1. The terms left and right as used in this report are based on looking downstream unless otherwise noted.

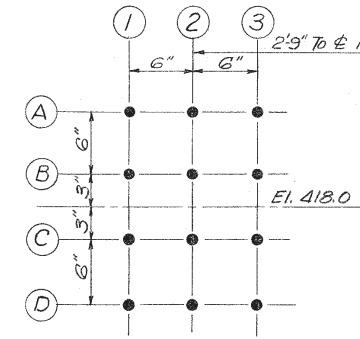
ROD PATTERN

STAGE	RODS
1	B-3 ϕ D-3
2	A-3 ϕ C-3
3	B-2 ϕ D-2
4	A-2 ϕ C-2
5	B-1 ϕ D-1
6	A-1 ϕ C-1

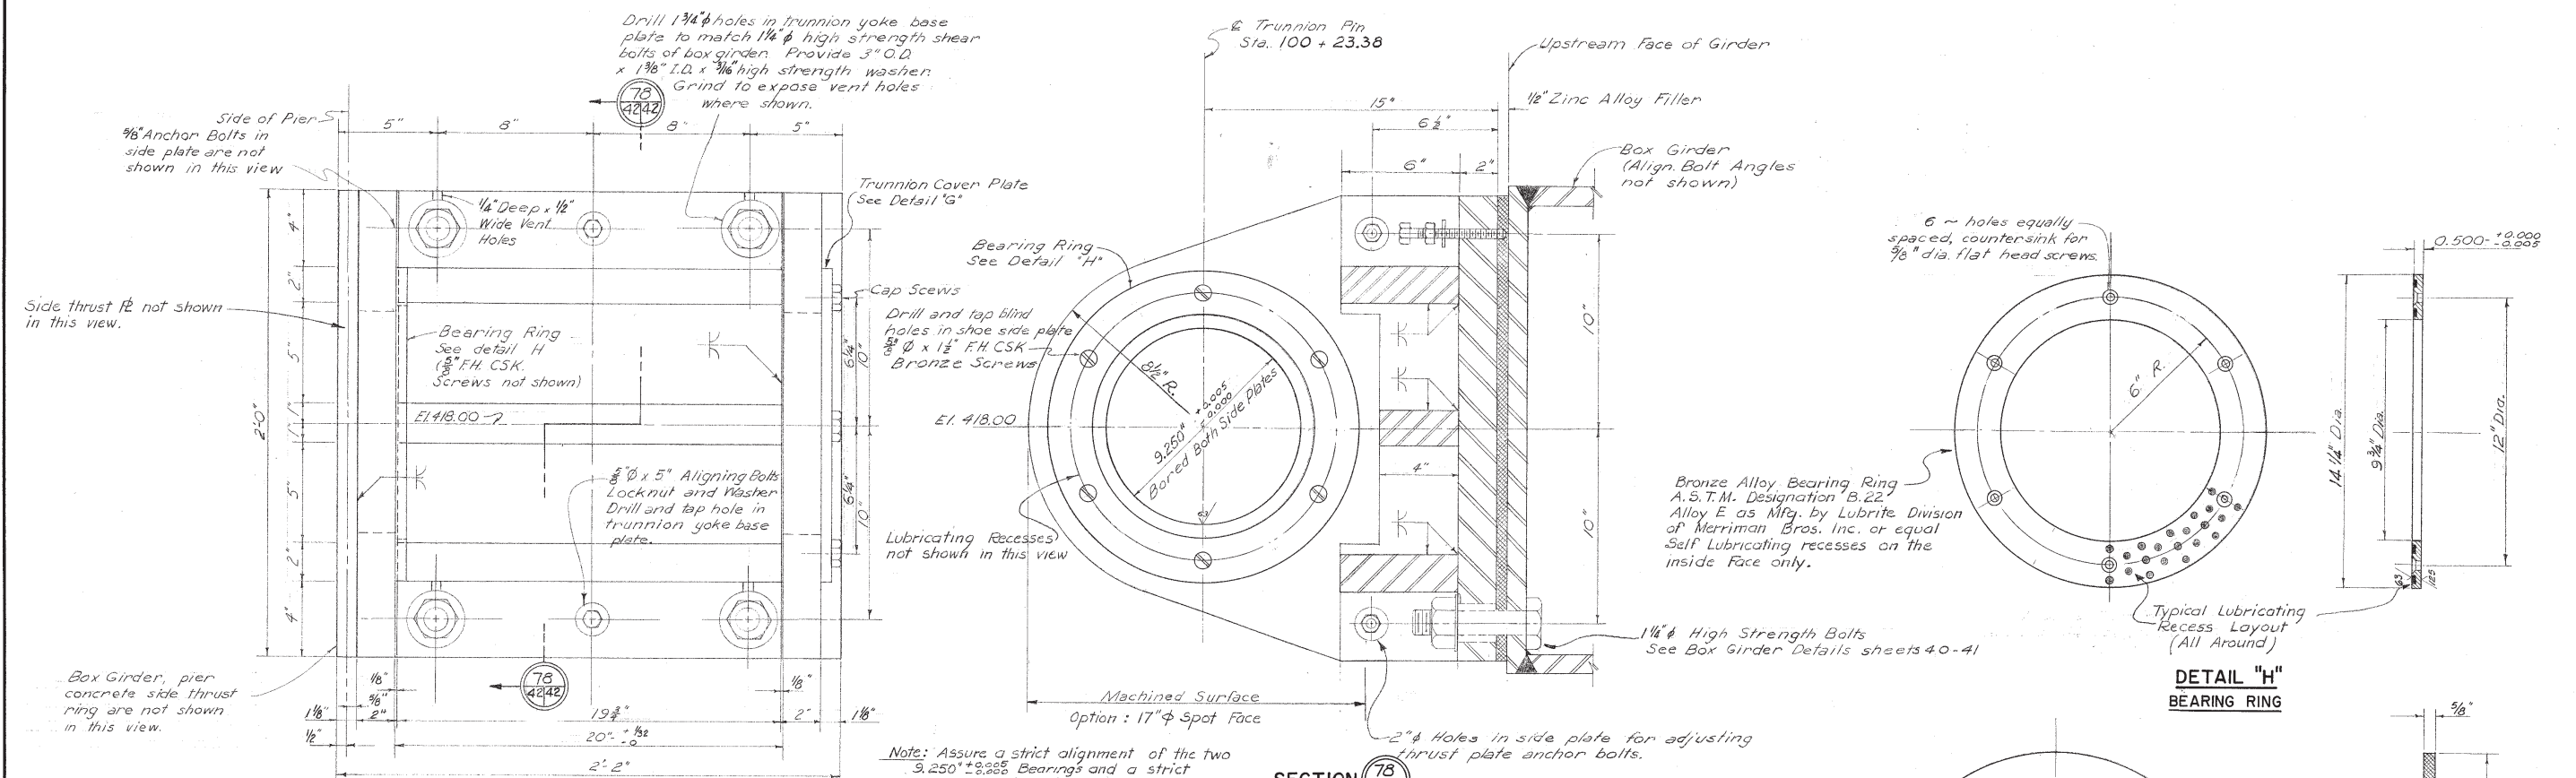
UPSTREAM ELEVATION
TRUNNION YOKE

Note: Assure a strict alignment of the two 9.250\"/>

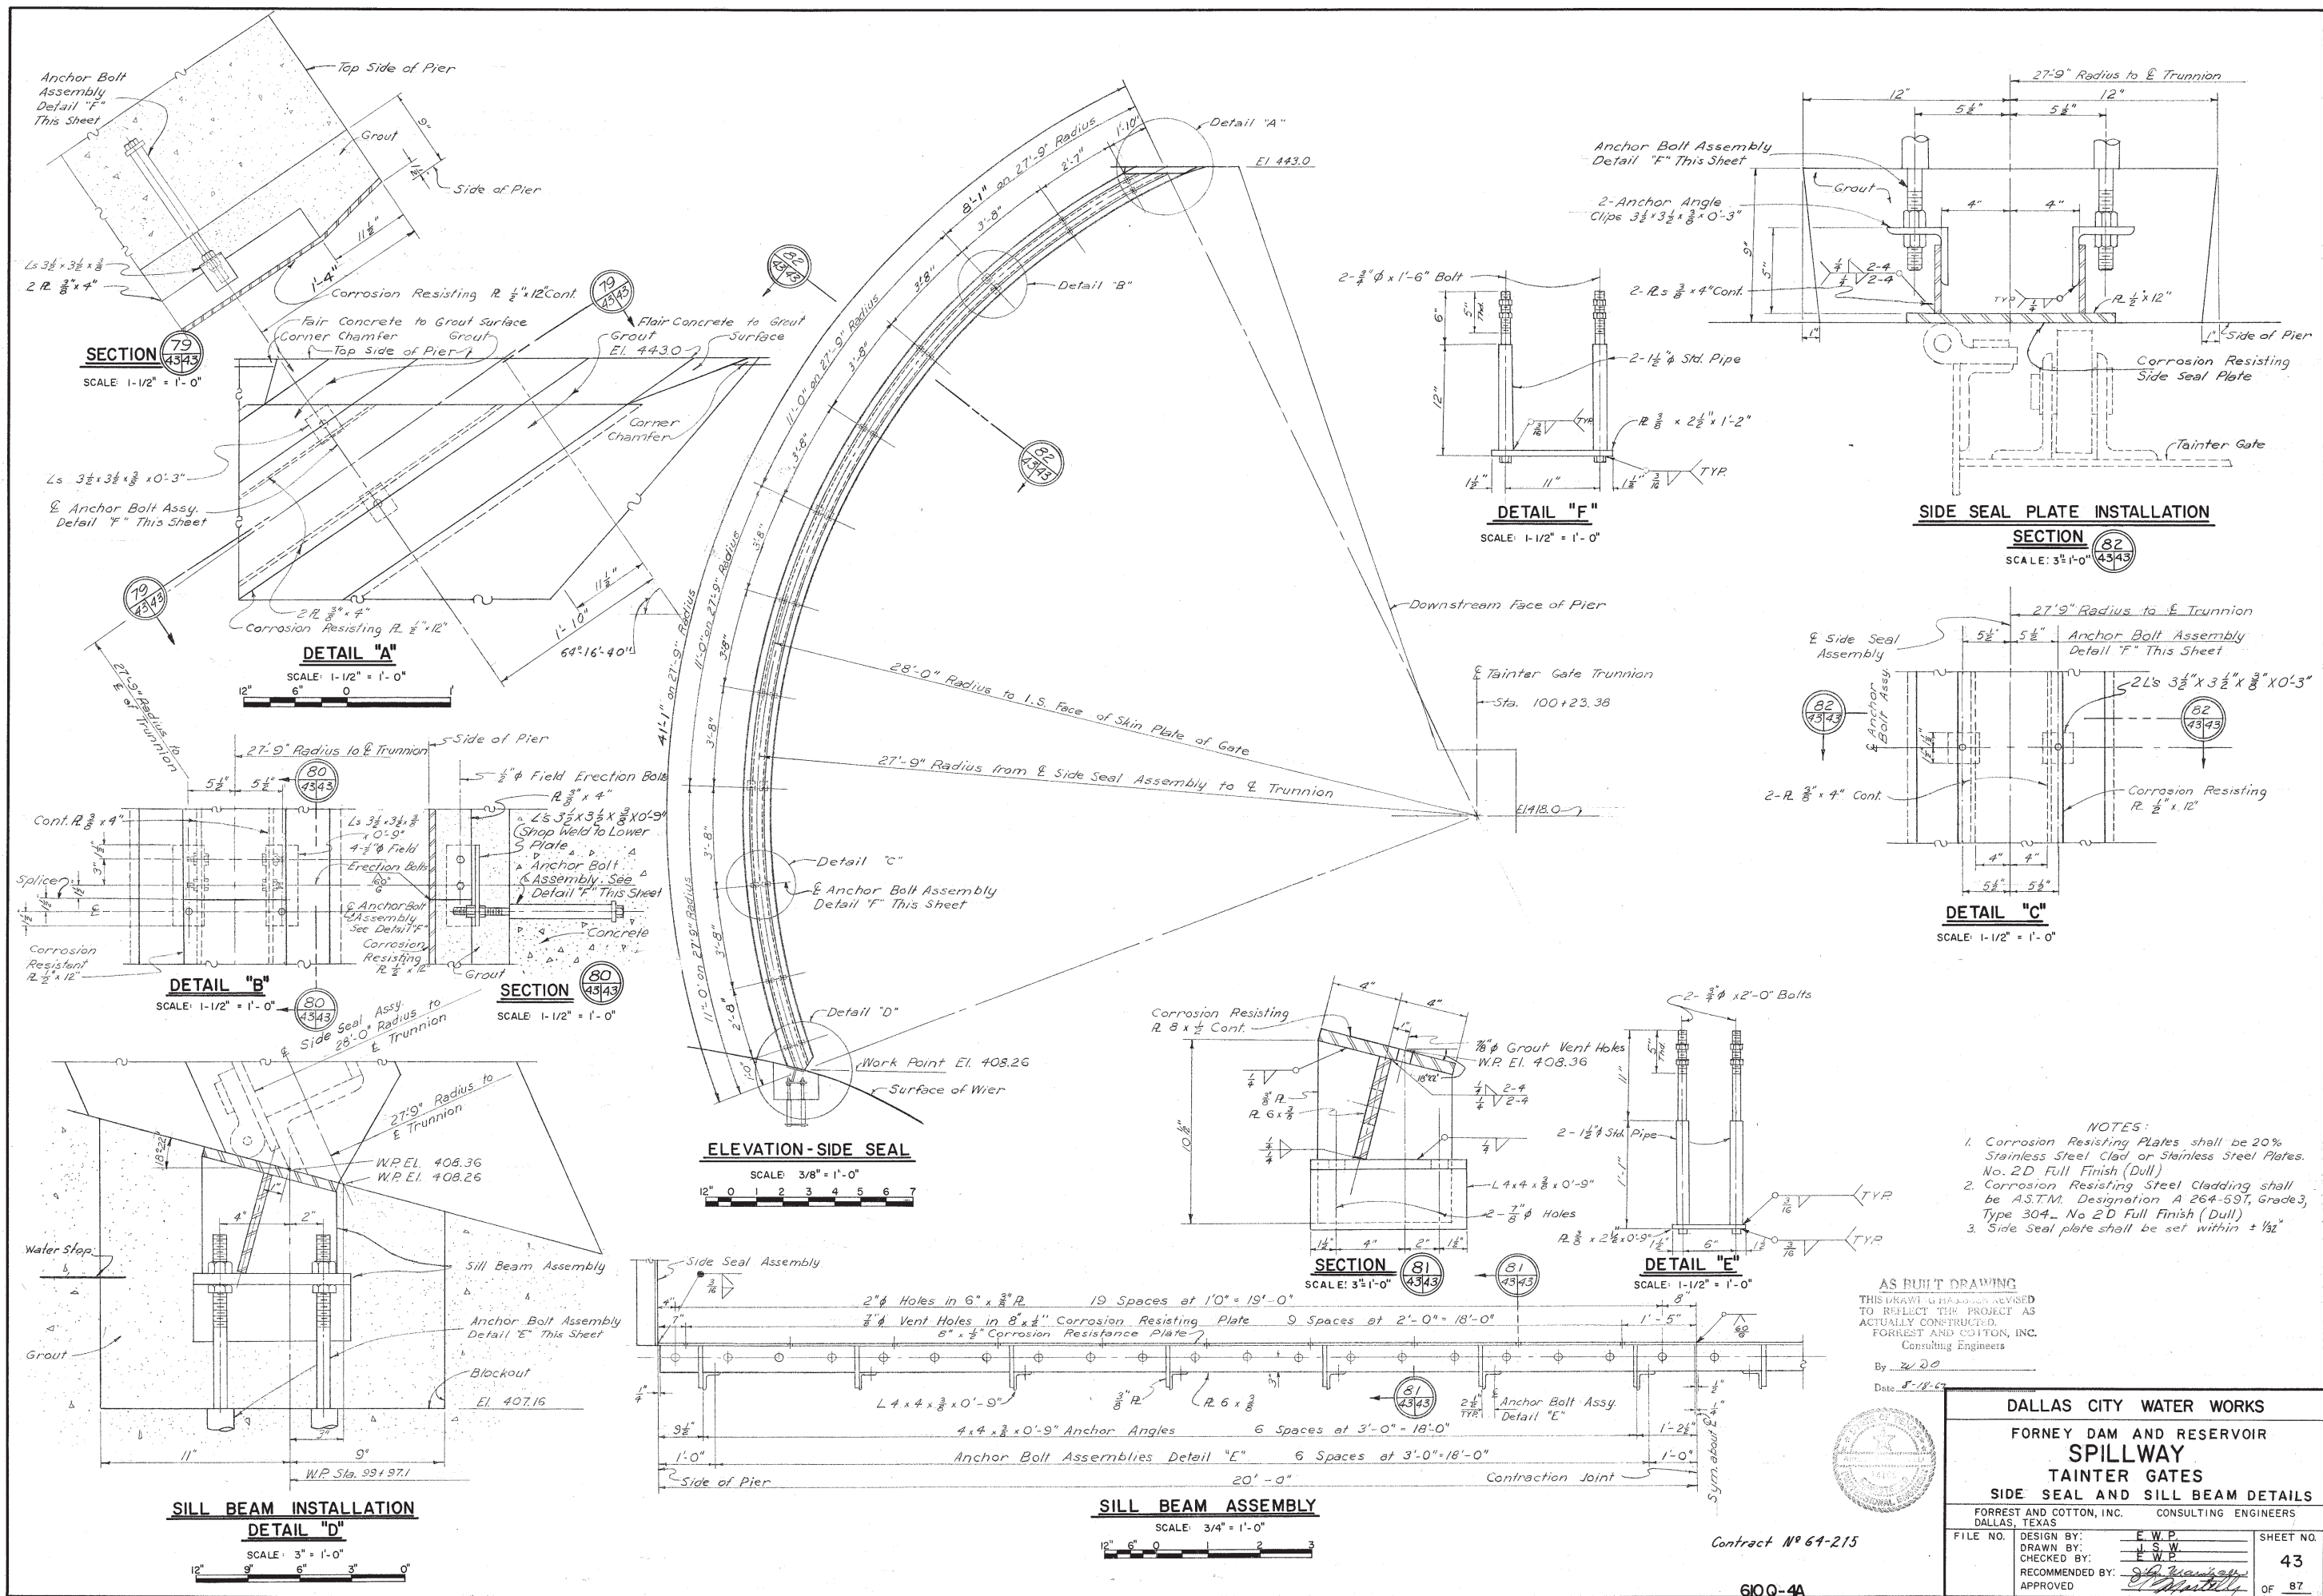
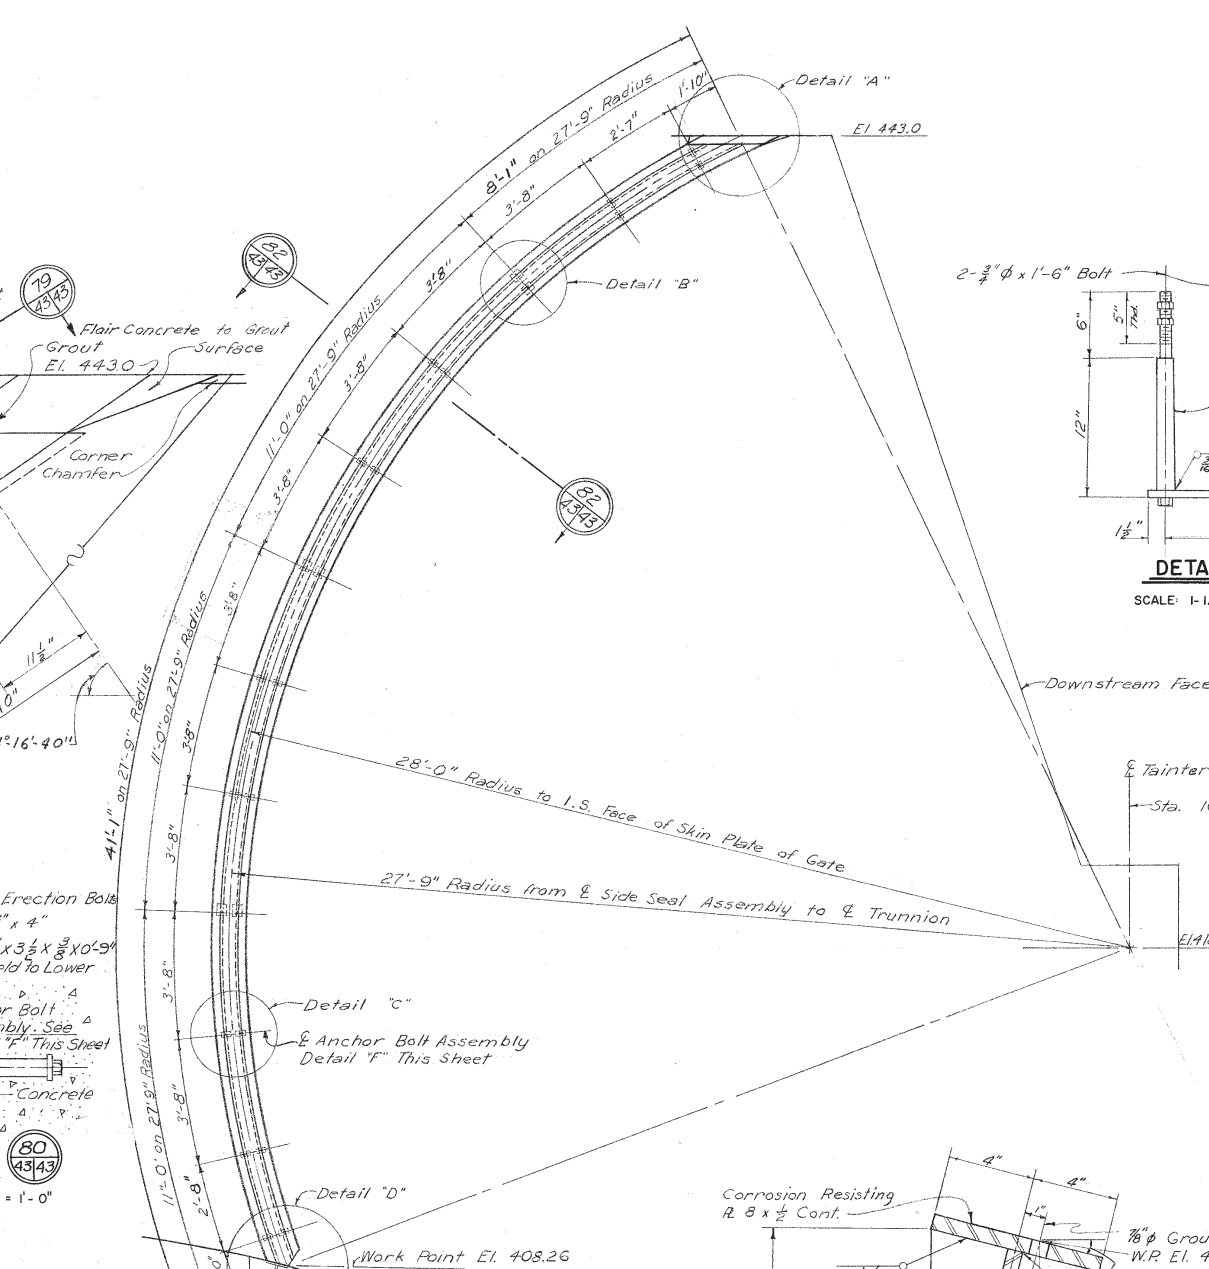
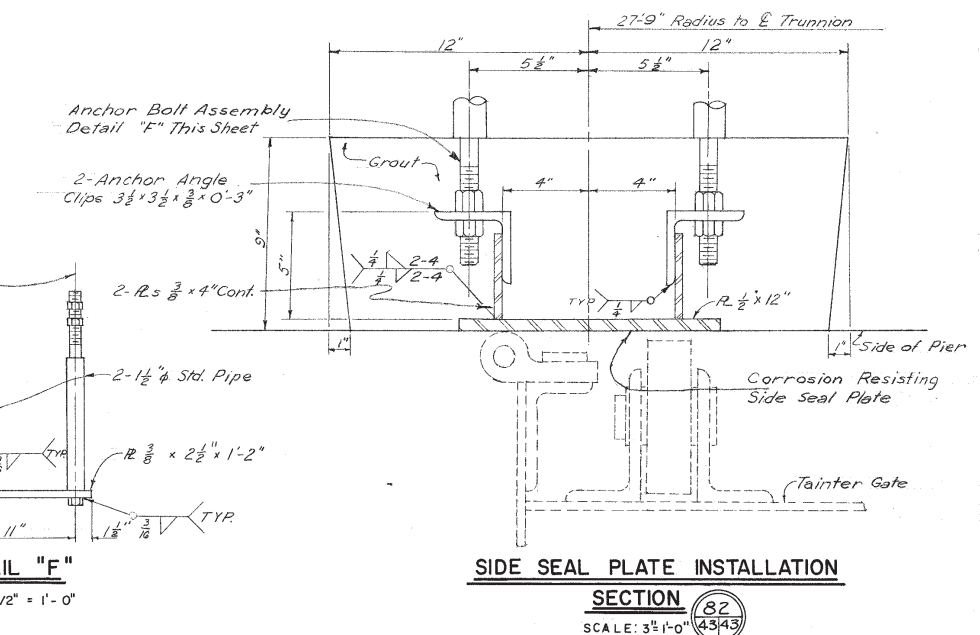
- Corrosion Resisting Plates shall be 20% Stainless Steel Clad or Stainless Steel Plates. No. 2D Full Finish (Dull)
- Corrosion Resisting Steel Cladding shall be ASTM Designation A 264-59T, Grade 3, Type 304, No 2D Full Finish (Dull)
- Side Seal plate shall be set within ± 1/2"

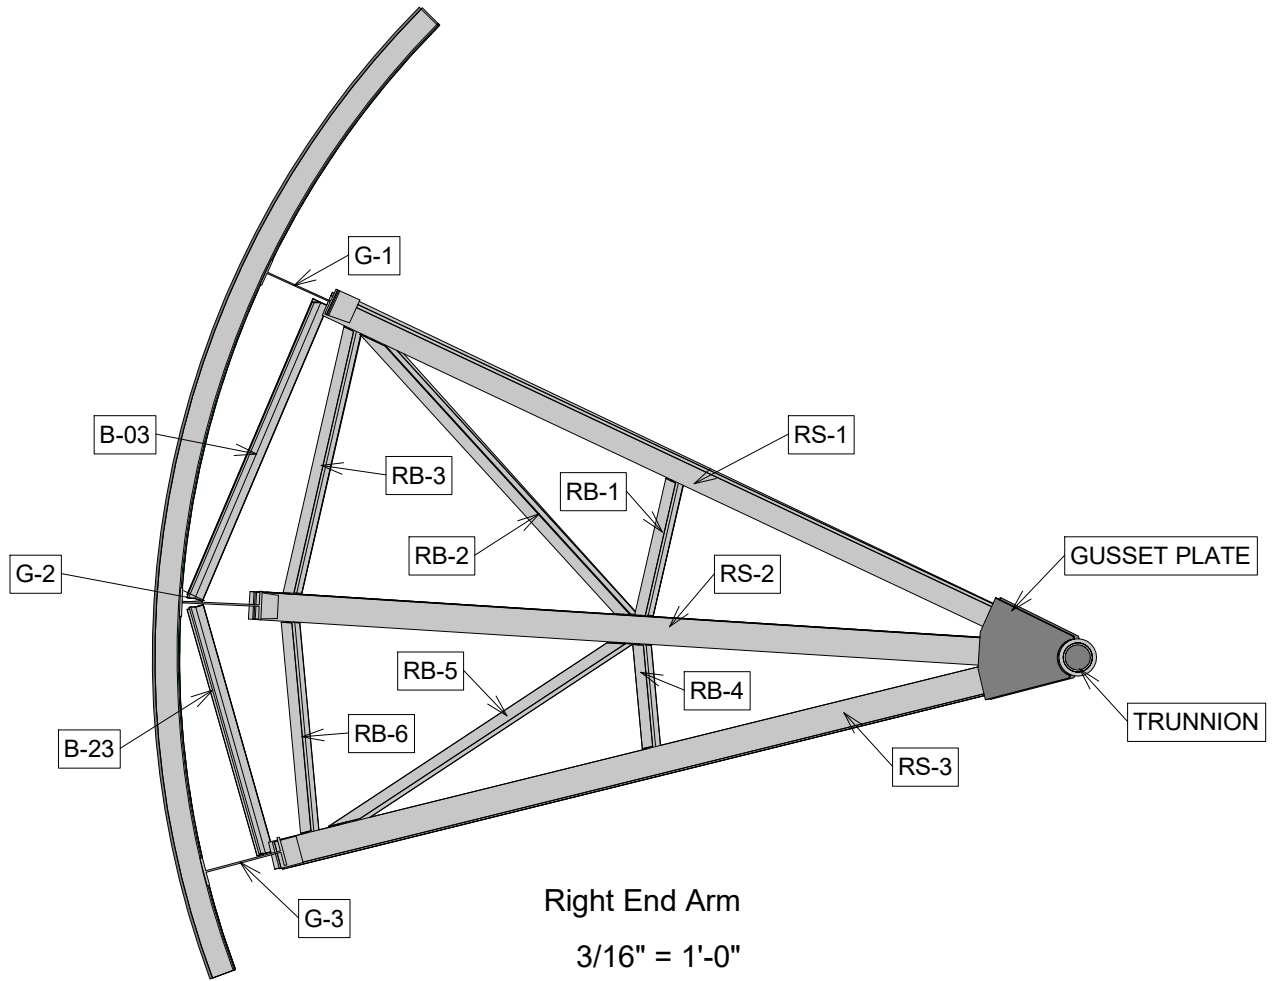
SHEET 02 OF 04	DRAWING #: S.2	PROJECT: 20C22001.00	FORNEY DAM TAINTER GATE GATE INSPECTION GARVER, LLC DALLAS, TEXAS

Schnabel ENGINEERING SCHNABEL ENGINEERING LICENSE NUMBER: C-2599	DESIGNED BY:	DRAWN BY: CAS	CHECKED BY: RTI
		LEFT RADIAL GATE SECTION	16000 Christensen Rd., Ste. 101 / Seattle, WA / 98188 T/ 206-573-5190 F/206-573-5195 / schnabel-eng.com

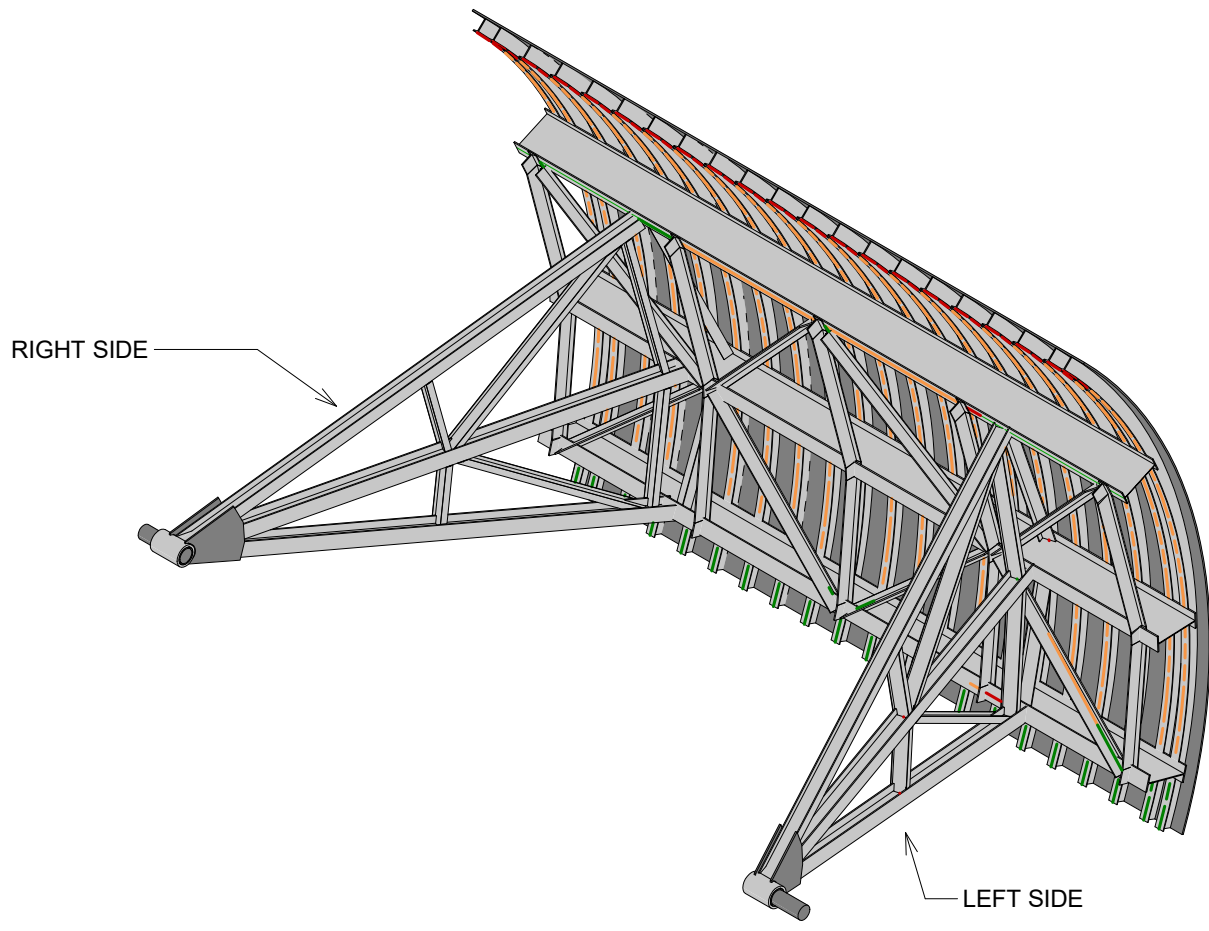
① Typical Isometric View

SCHNABEL ENGINEERING LICENSE NUMBER: C-2599	DESIGNED BY:	DRAWN BY: CAS	CHECKED BY: RTI
			SOUTH ELEVATION		16000 Christensen Rd., Ste. 101 / Seattle, WA / 98188 T/ 206-573-5190 F/206-573-5195 / schnabel-eng.com
