VISUAL INSPECTION AND EVALUATION REPORT

Rockwall-Forney Dam
Dallas Water Utilities
Dallas/Kaufman Counties, Texas

Schnabel Reference #20C22001.00
July 30, 2021

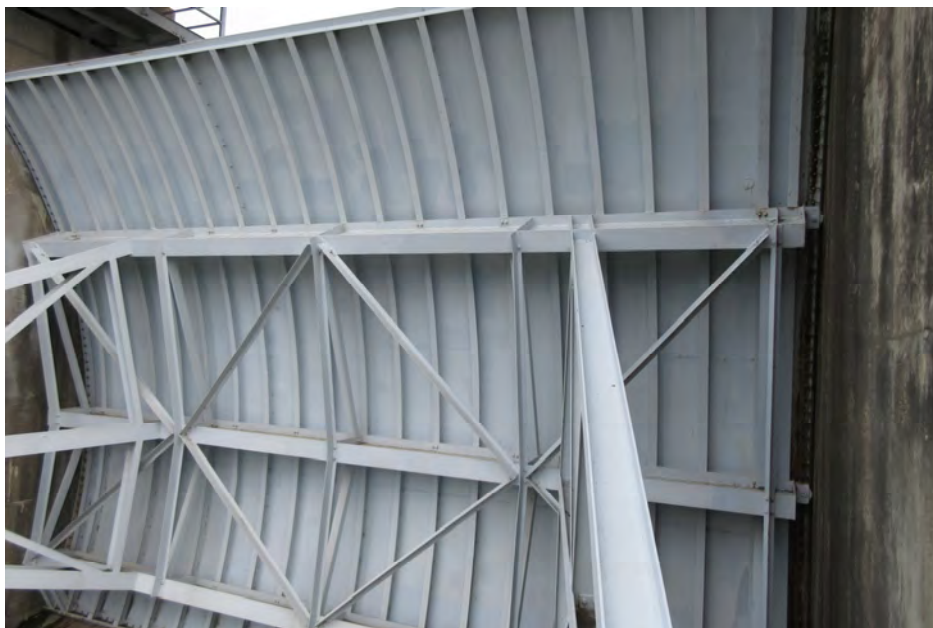
PHOTOGRAPH No.: 2
GATE: Gate 1
Photo Taken: 3/30/2020
File: MC-2.jpg

LOCATION:
Downstream face of gate.

COMMENTS:
Gate seals are effective with little seepage noted.

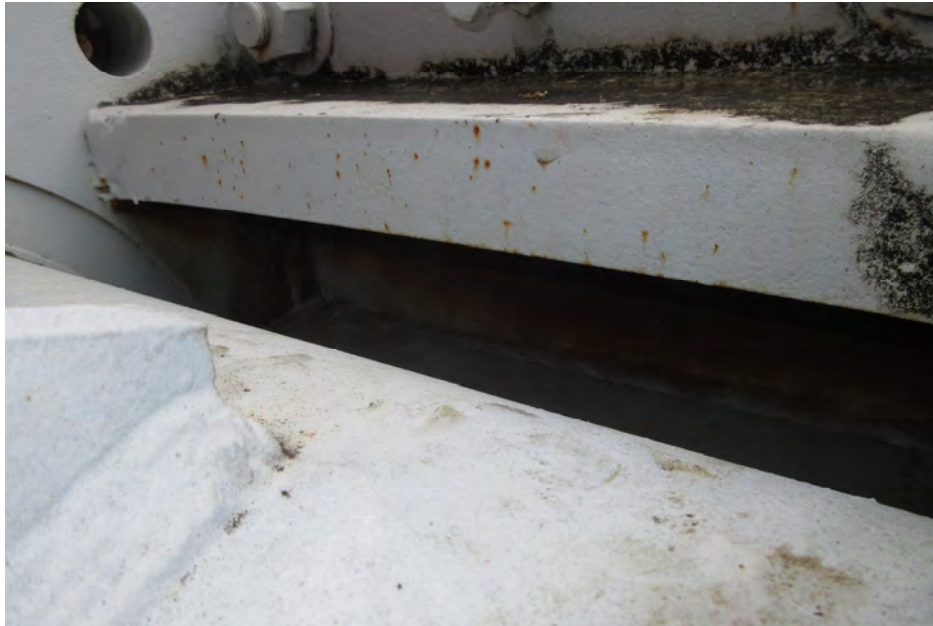
PHOTOGRAPH No.: 3
GATE: Gate 1
Photo Taken: 3/30/2020
File: MC-4.jpg

LOCATION:
Left trunnion casting.

COMMENTS:
Light surface rust and thin paint coating. No section loss noted.
CS-2

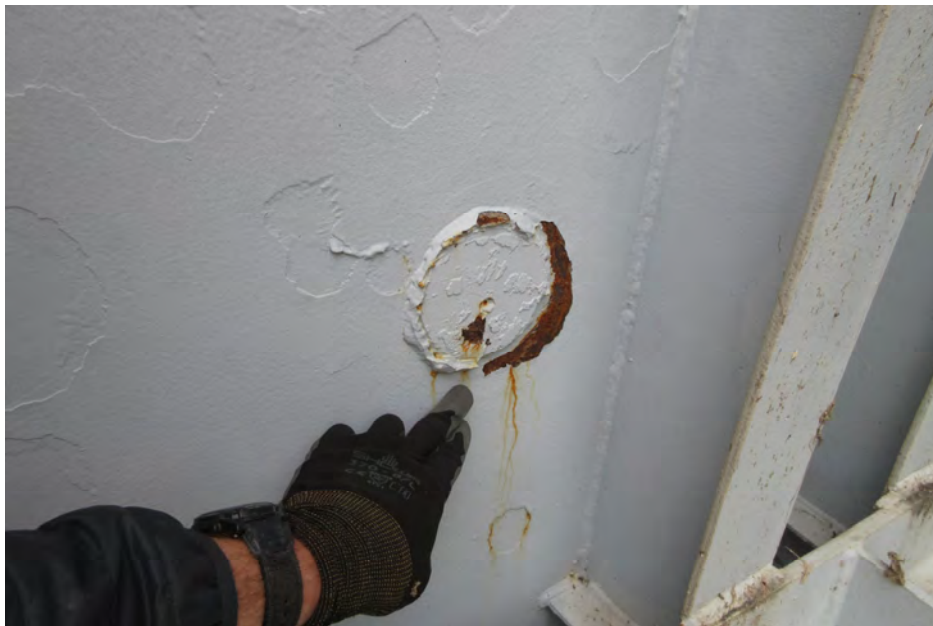
PHOTOGRAPH No.: 4
GATE: Gate 1
Photo Taken: 3/30/2020
File: MC-5.jpg

LOCATION:
Downstream face of skin between V-19 & V-20 and 1-1/2' above G-1.

COMMENTS:
4-1/2" diameter plate welded to skin with failing paint and moderate surface rust. CS-2.

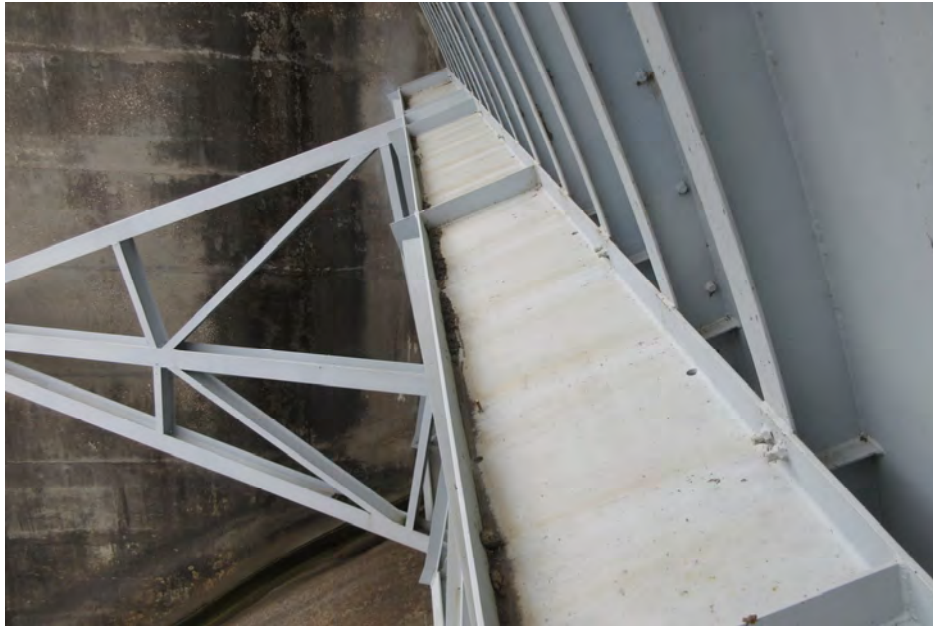
PHOTOGRAPH No.: 5
GATE: Gate 1
Photo Taken: 3/30/2020
File: MC-6.jpg

LOCATION:
G-1 looking right.

COMMENTS:
Minor debris buildup partially blocking drains. Typical for G-2 & G-3.

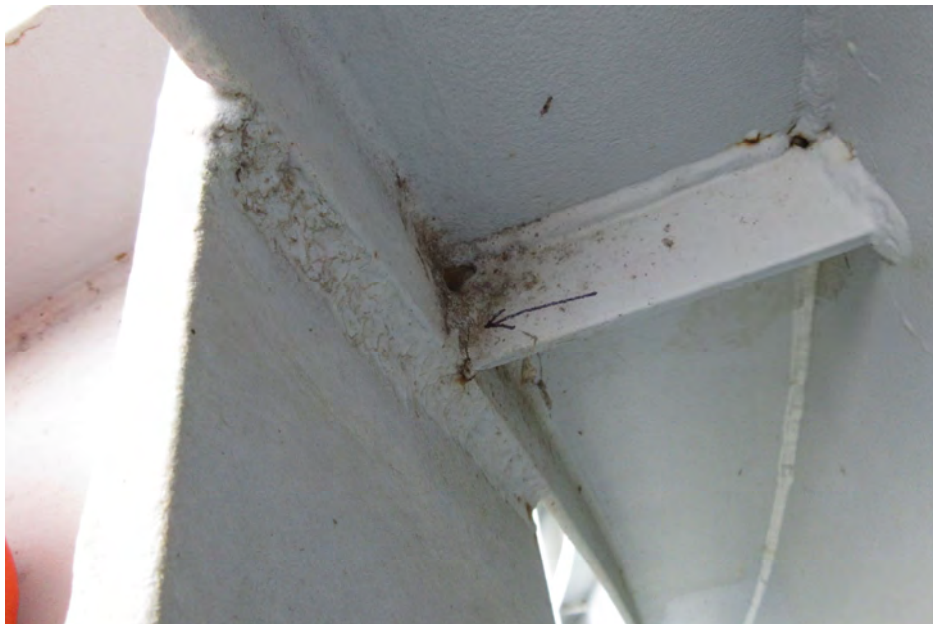
PHOTOGRAPH No.: 6
GATE: Gate 1
Photo Taken: 3/30/2020
File: MC-7.jpg

LOCATION:
V-17, left web stiffener at G-1.

COMMENTS:
Cracked weld. 100% cracked though. CS-2.

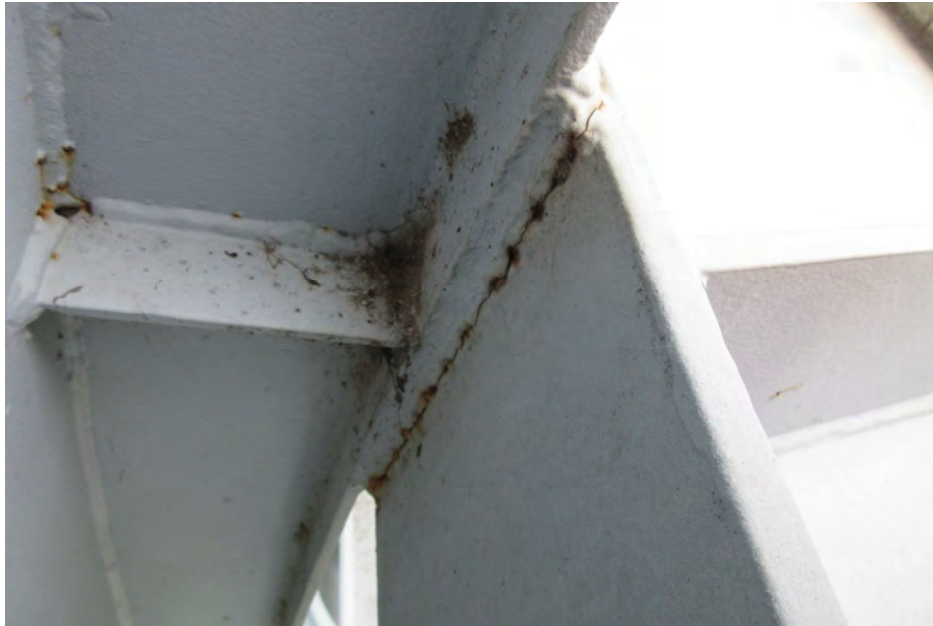
PHOTOGRAPH No.: 7
GATE: Gate 1
Photo Taken: 3/30/2020
File: MC-8.jpg

LOCATION:
V-17 at G-1.

COMMENTS:
Cracked weld along G-1 flange.
Potential for propagation. CS-3.

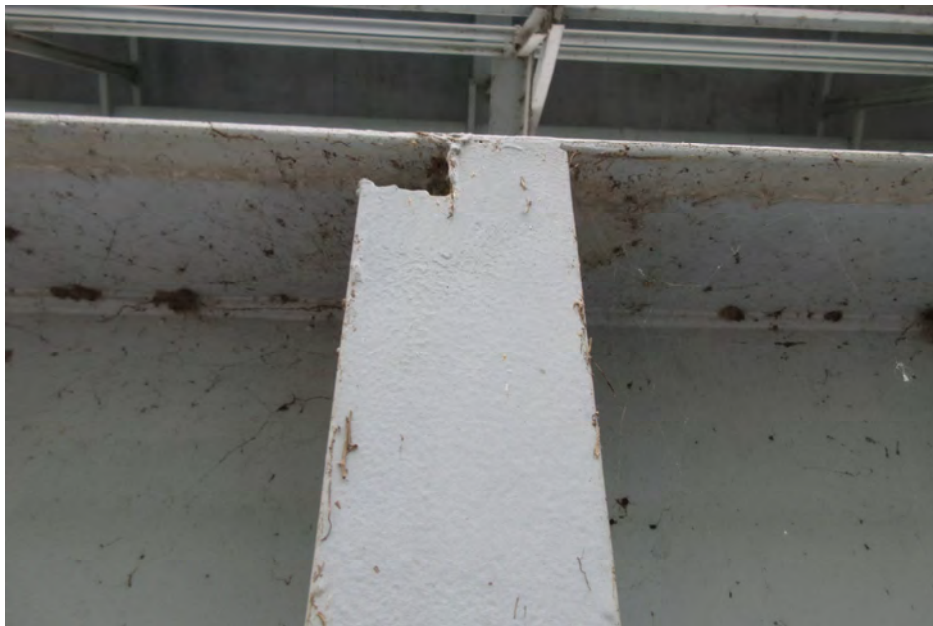
PHOTOGRAPH No.: 8
GATE: Gate 1
Photo Taken: 3/30/2020
File: MC-9.jpg

LOCATION:
V-14 at top of gate.

COMMENTS:
1-1/2" x 2" cutout of flange.
Similar at V-8.

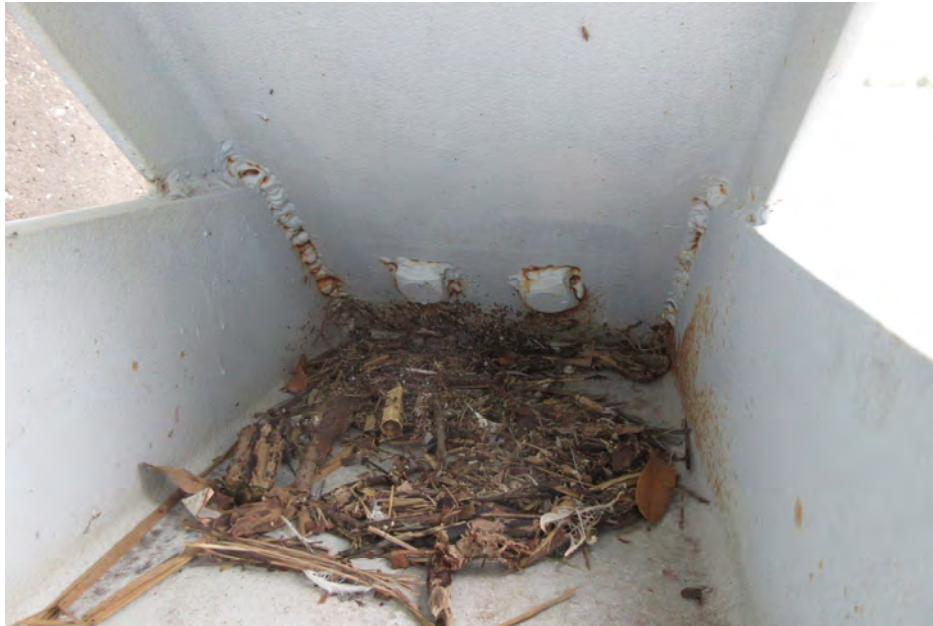
PHOTOGRAPH No.: 9
GATE: Gate 1
Photo Taken: 3/30/2020
File: MC-10.jpg

LOCATION:
LS-2 at LB-2.

COMMENTS:
Light surface rust along welds and assembly bolts. CS-2.

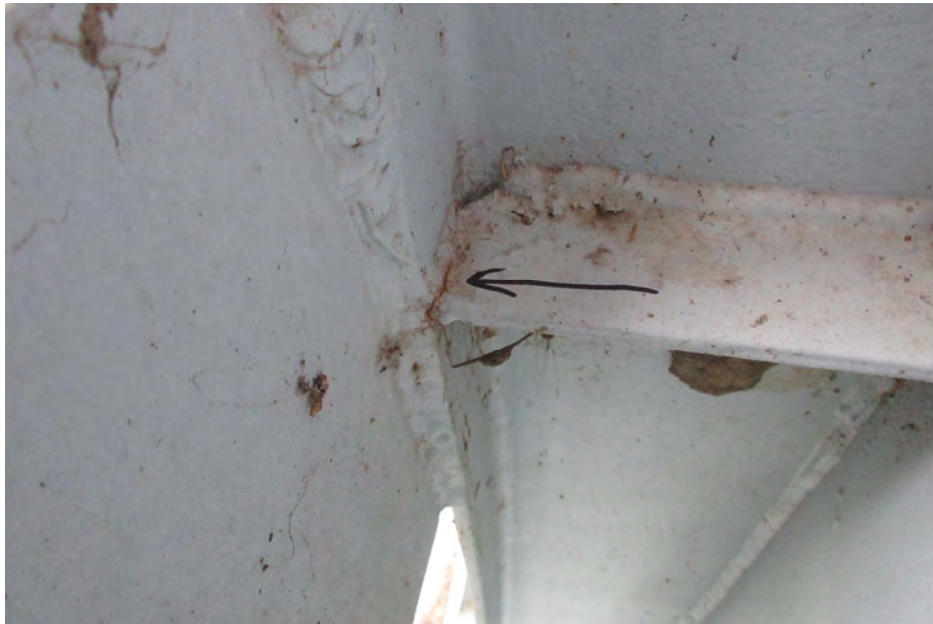
PHOTOGRAPH No.: 10
GATE: Gate 1
Photo Taken: 3/30/2020
File: MC-11.jpg

LOCATION:
V-16 left web stiffener at G-2.

COMMENTS:
Cracked weld. Potential for propagation. CS-3. Similar condition at V-17 and V-18.

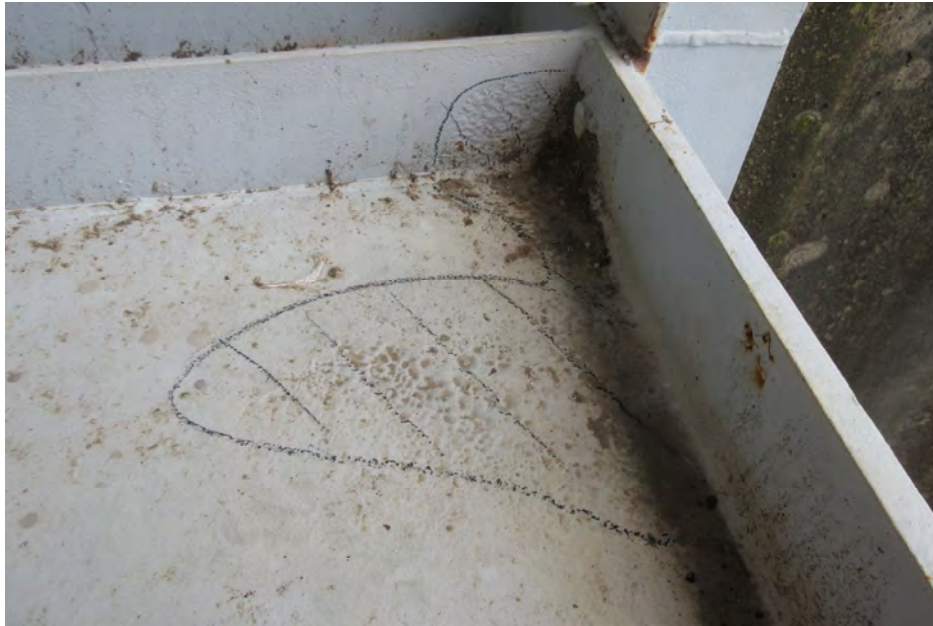
PHOTOGRAPH No.: 11

LOCATION:
G-2, left side.

COMMENTS:
Arrested pitting on web and stiffener up to 1/16" deep. CS-3.

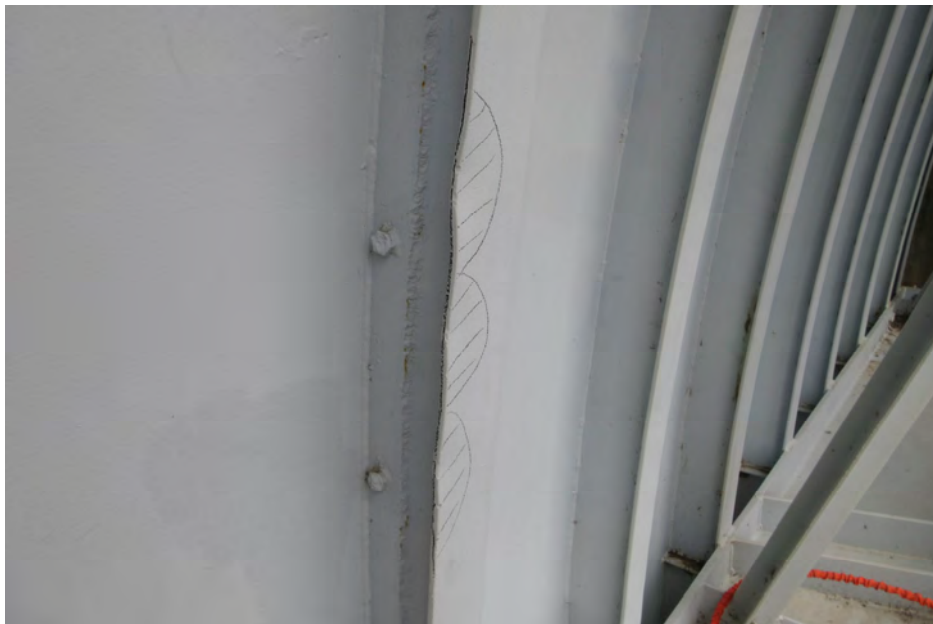
PHOTOGRAPH No.: 12

LOCATION:
V-14, 3' to 4' above G-2.

COMMENTS:
Out-of-plane bending in flange up to 1/4" over 5" long. Three locations. CS-2.

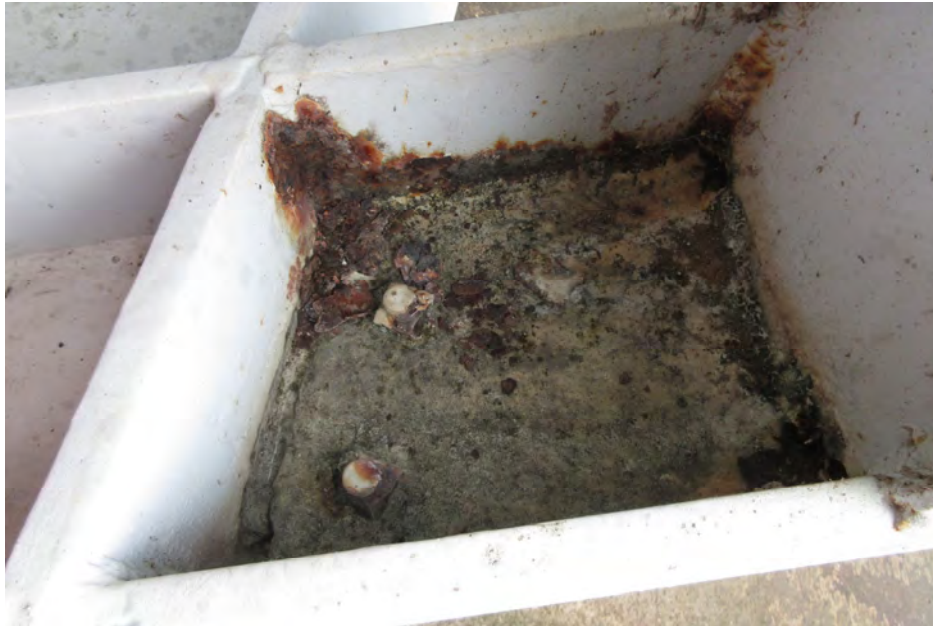
PHOTOGRAPH No.: 13

LOCATION:
LS-3 at LB-6.

COMMENTS:
Failed paint and moderate surface rust. Rust along welds. Minor section loss. CS-3. Drains partly blocked.

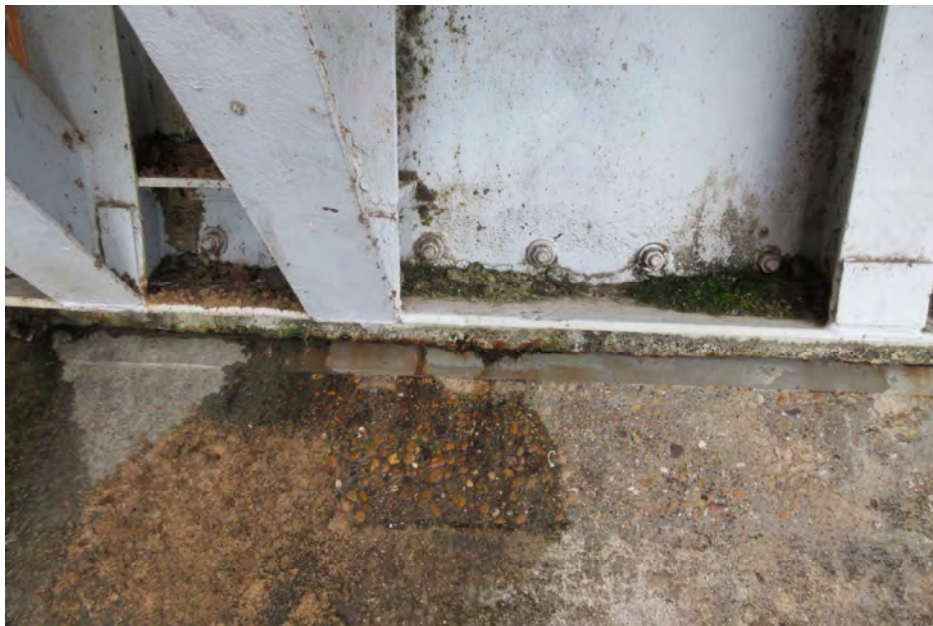
PHOTOGRAPH No.: 14

LOCATION:
Gate skin and verticals V-1 & V-2. below G-3.

COMMENTS:
Sand buildup on stiffener up to 2" deep.

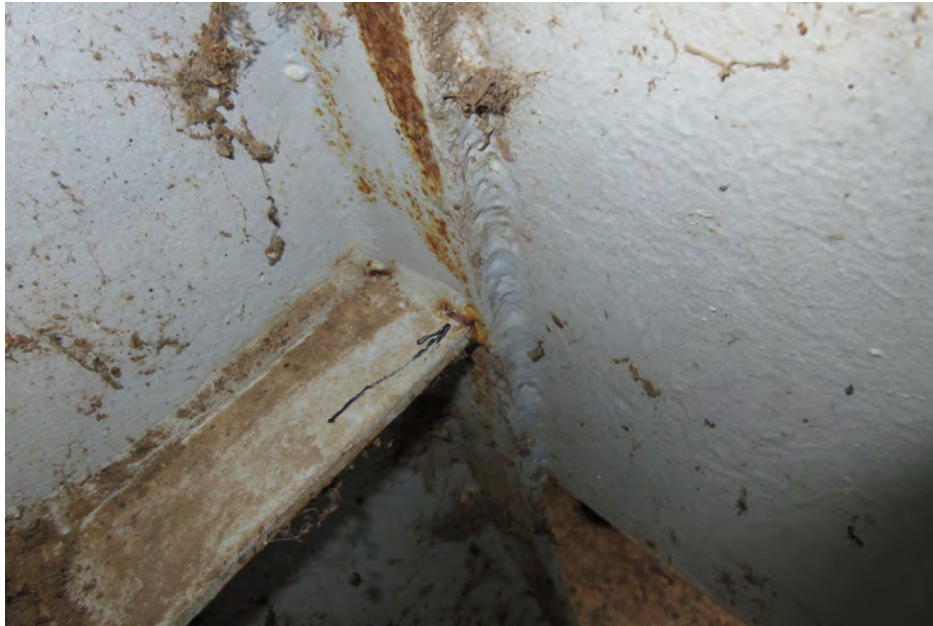
PHOTOGRAPH No.: 15

Cracked web. Potential for propagation. CS-3.

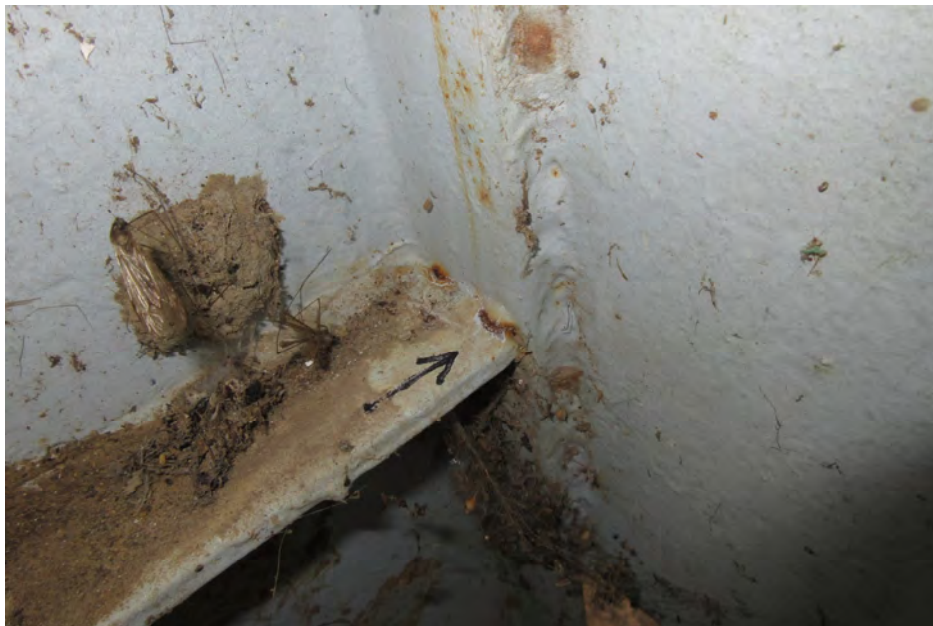
PHOTOGRAPH No.: 16

Cracked web. Potential for propagation. CS-3.

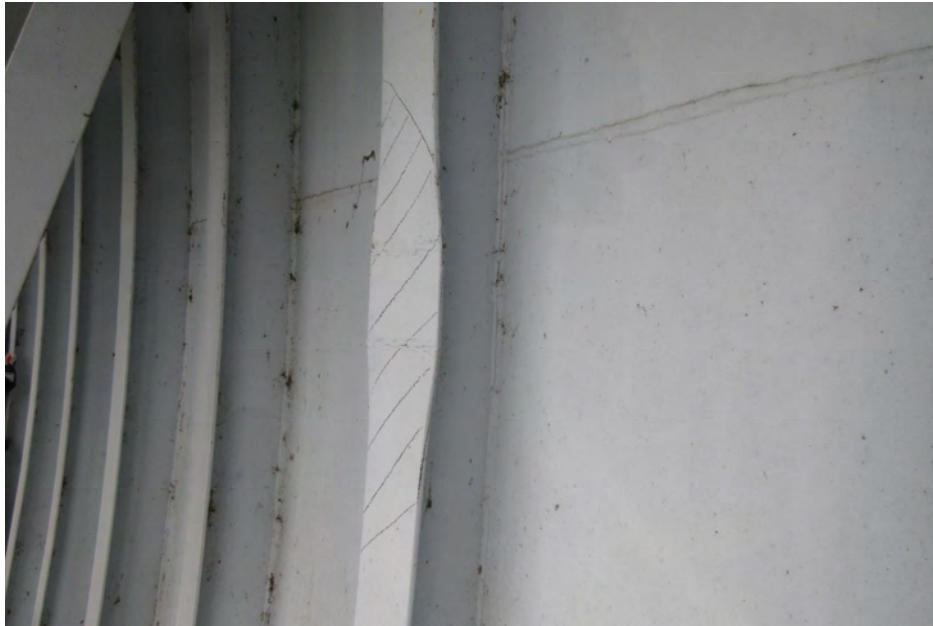
PHOTOGRAPH No.: 17

Out-of-plane bending in flange up to 2" over 20" long. CS-2. Also two torch cut gorges in flange up to 1/16" deep.

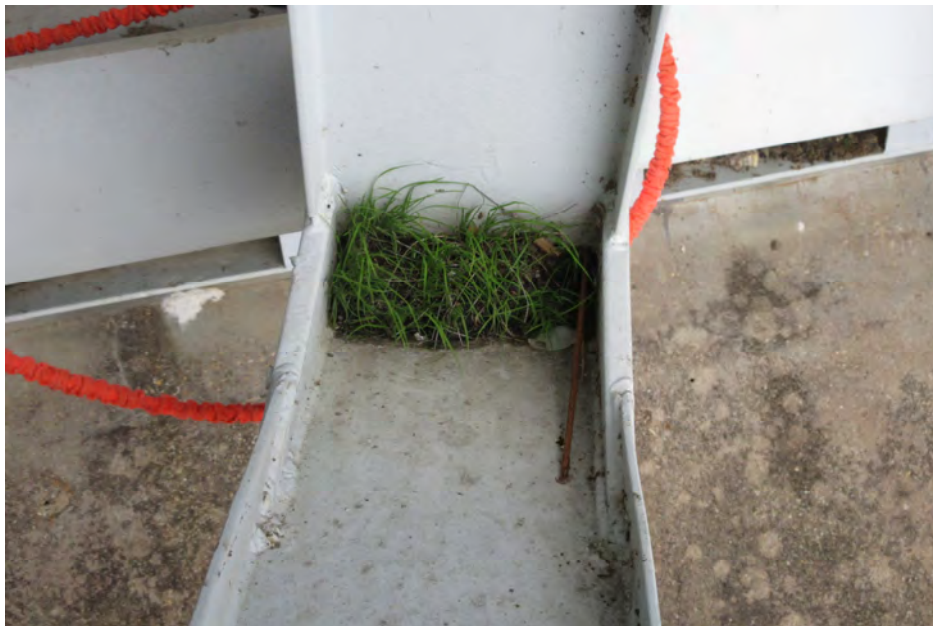
PHOTOGRAPH No.: 18

Debris & vegetation buildup to 3". Drain holes blocked.

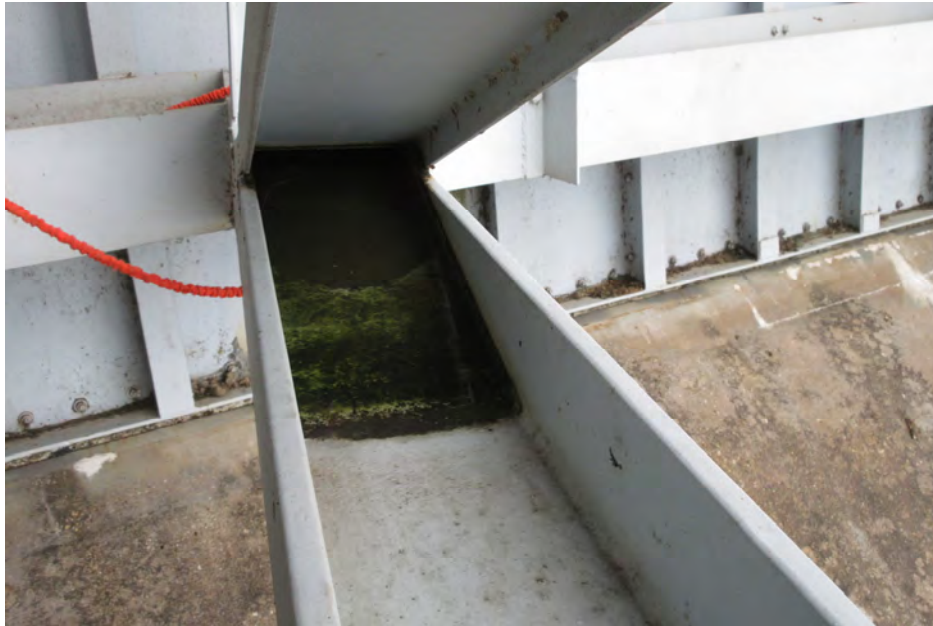
PHOTOGRAPH No.: 19

LOCATION:
RS-3 at RB-5.

COMMENTS:
Ponding water with sand
buildup.

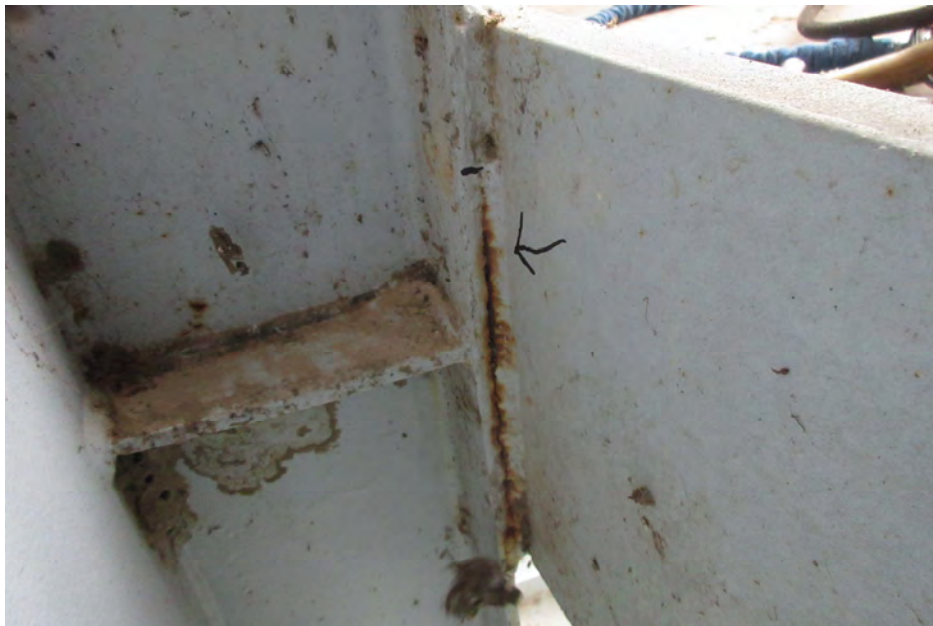
PHOTOGRAPH No.: 20

LOCATION:
V-3 at G-2.

COMMENTS:
Cracked weld along G-2 flange.
Potential for propagation as 2"
of weld has not cracked, CS-3.

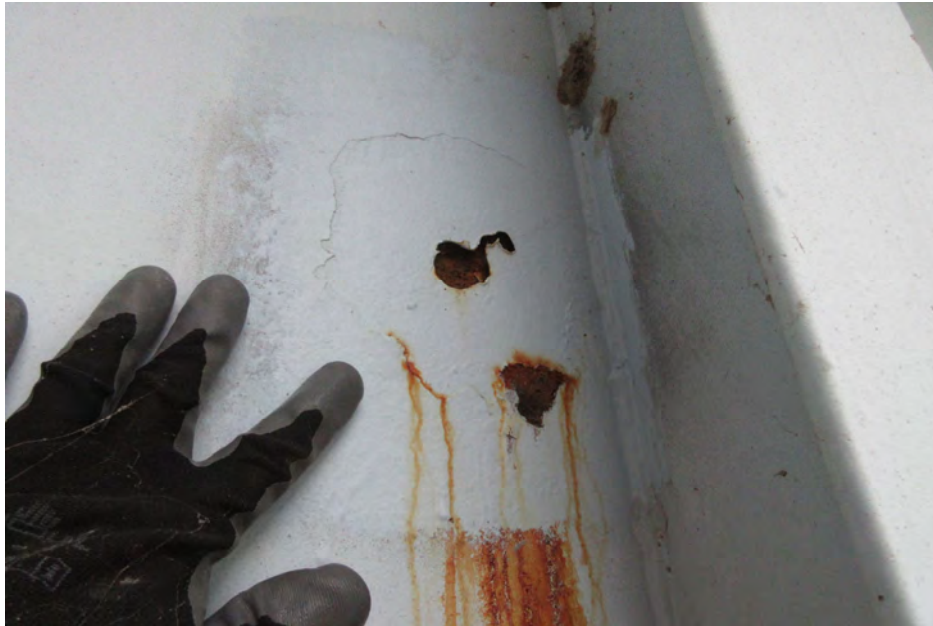
PHOTOGRAPH No.: 21

Hole through skin plate.
Patched from upstream side of
skin. No propagation potential.
CS-2.

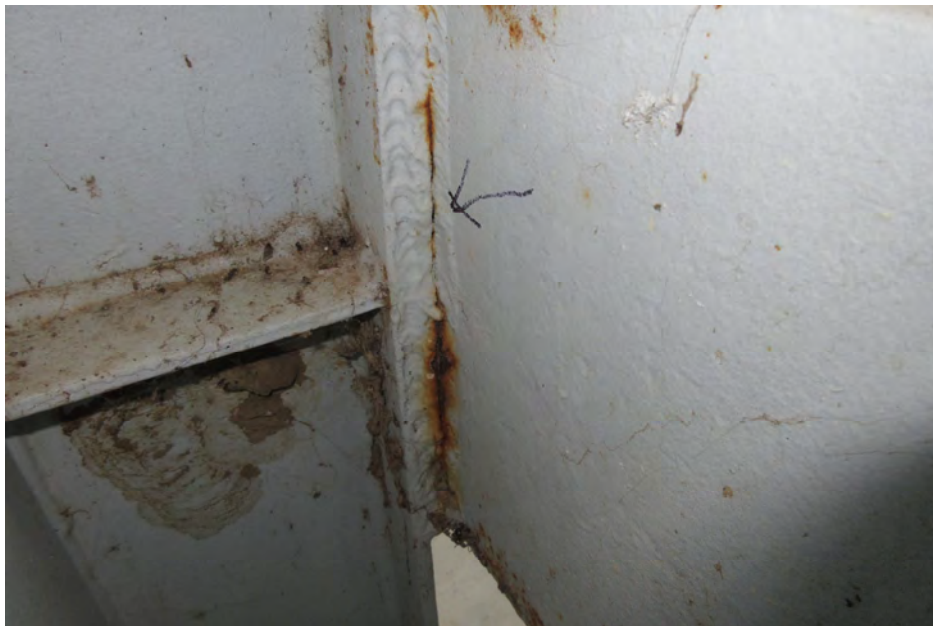
PHOTOGRAPH No.: 22

Cracked weld along G-2 flange.
Weld cracked 100%. No propa-
gation potential CS-2.

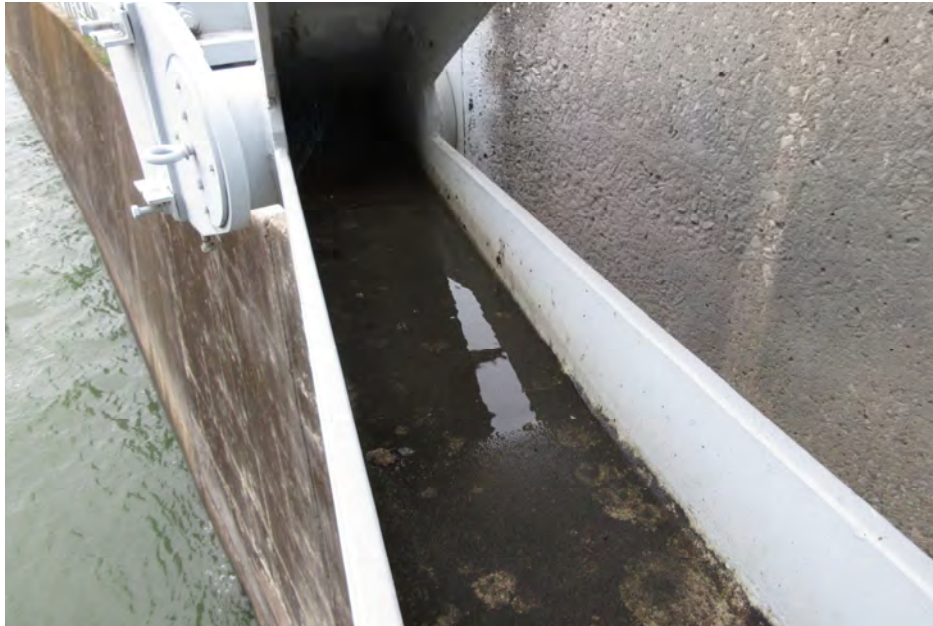
PHOTOGRAPH No.: 23

Ponding water and blocked drain.

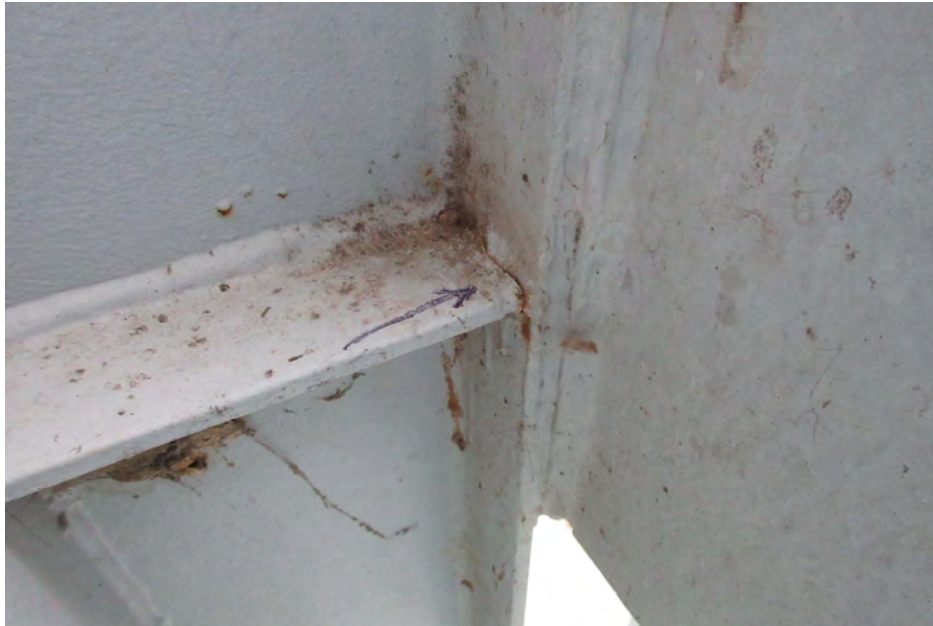
PHOTOGRAPH No.: 25

Cracked weld. 100% cracked through CS-2.

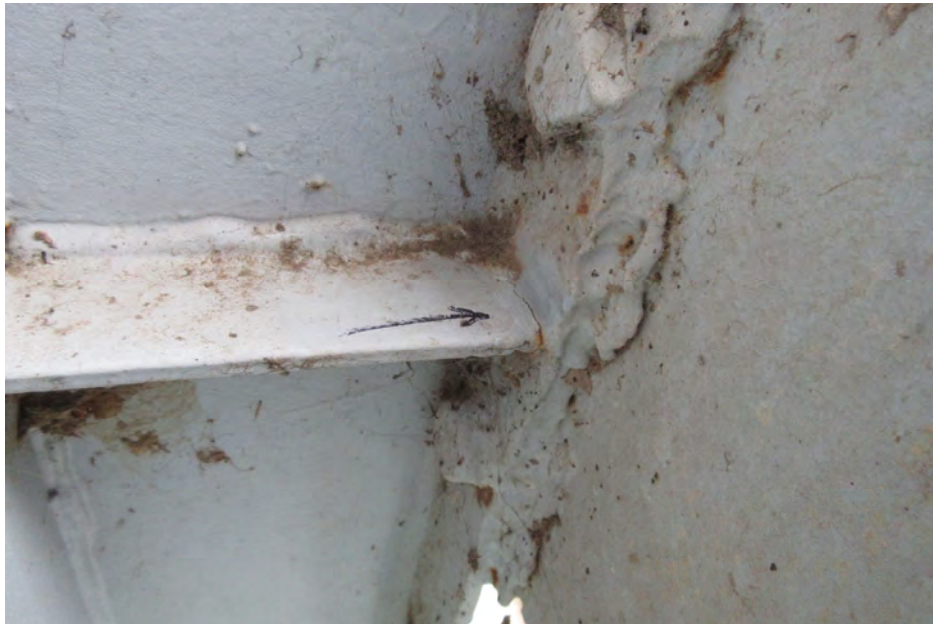
PHOTOGRAPH No.: 26

Cracked weld. 100% cracked through CS-2.

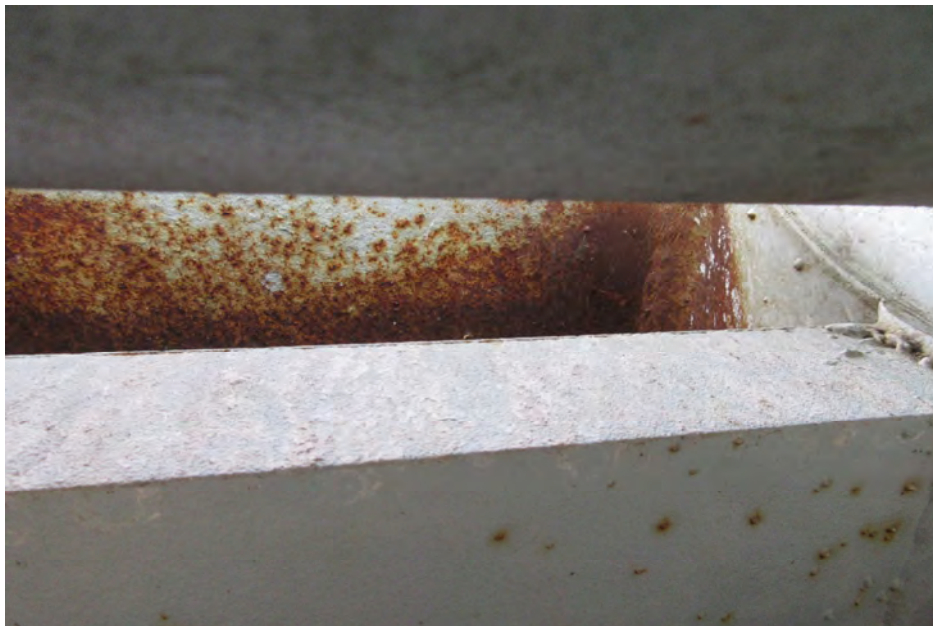
PHOTOGRAPH No.: 2
GATE: Gate 2
Photo Taken: 3/30/2020
File: CL-2.jpg

LOCATION:
Gate 2, right trunnion.

COMMENTS:
CS2 - rust on the inside of the coating. Common throughout.

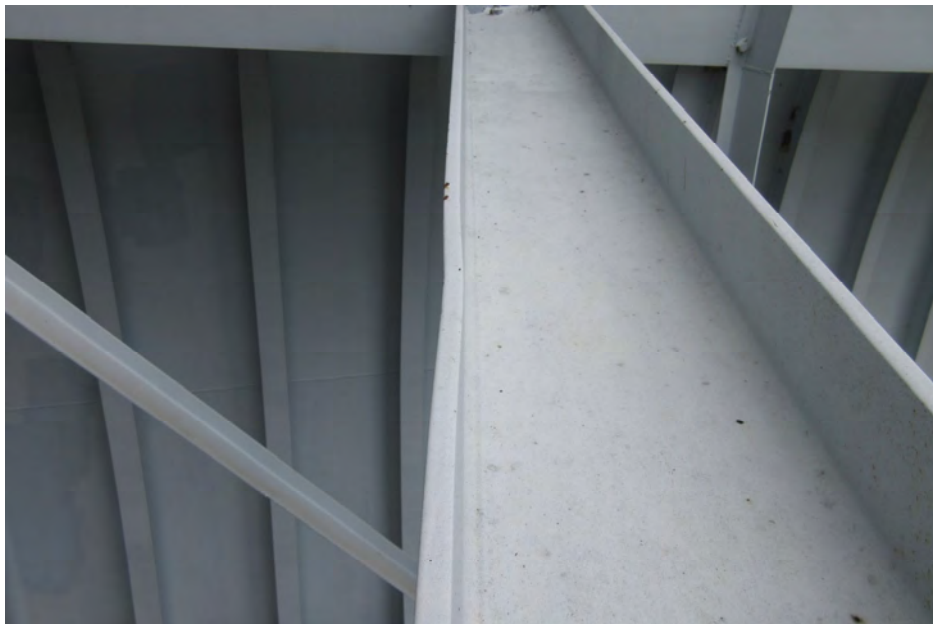
PHOTOGRAPH No.: 4
GATE: Gate 2
Photo Taken: 3/30/2020
File: CL-4.jpg

LOCATION:
Gate 2, RS-1, 5' from G-1.

COMMENTS:
Out-of-plane bending, 1/4" over
5" on flange of RS-1.

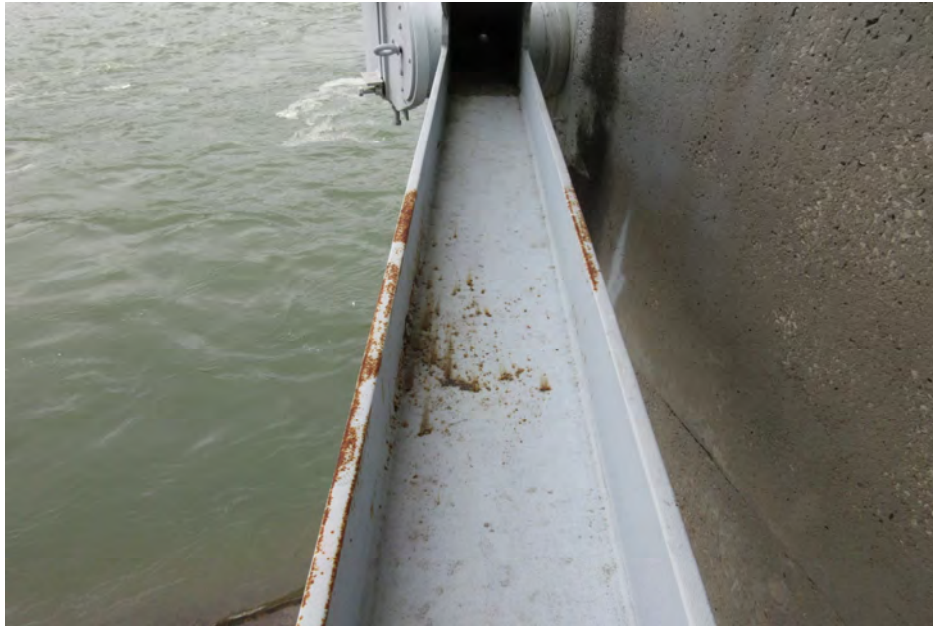
PHOTOGRAPH No.: 5

CS2 on edge of flanges for 4'.
Plus paint failure on web for 1'.
CS2 also.

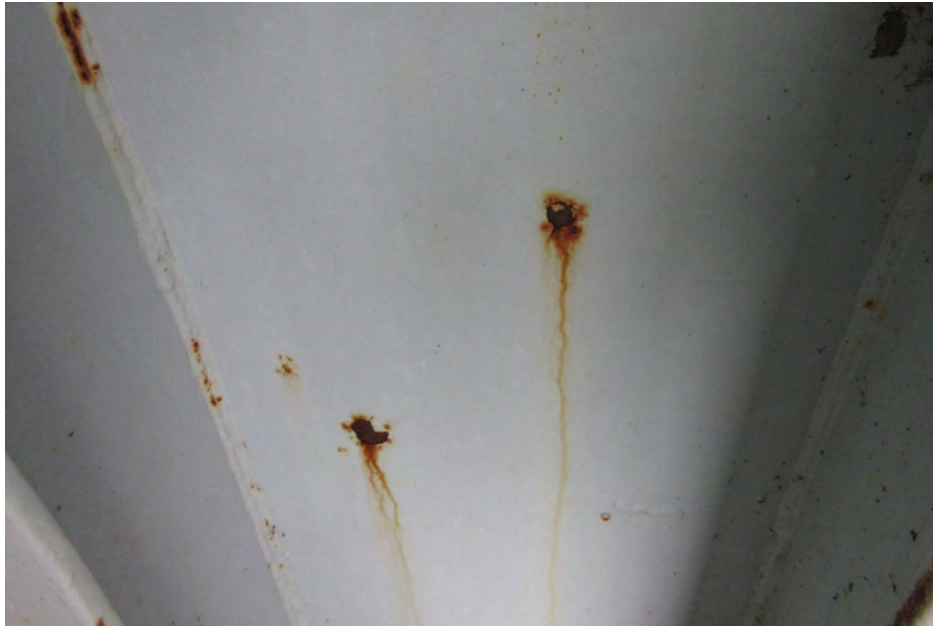
PHOTOGRAPH No.: 7
GATE: Gate 2
Photo Taken: 3/30/2020
File: CL-7.jpg

LOCATION:
Gate 2, skin between V-01 and V-02, 1' above G-2.

COMMENTS:
Two dimples from impact damage on upstream side paint failure with CS2 on both.

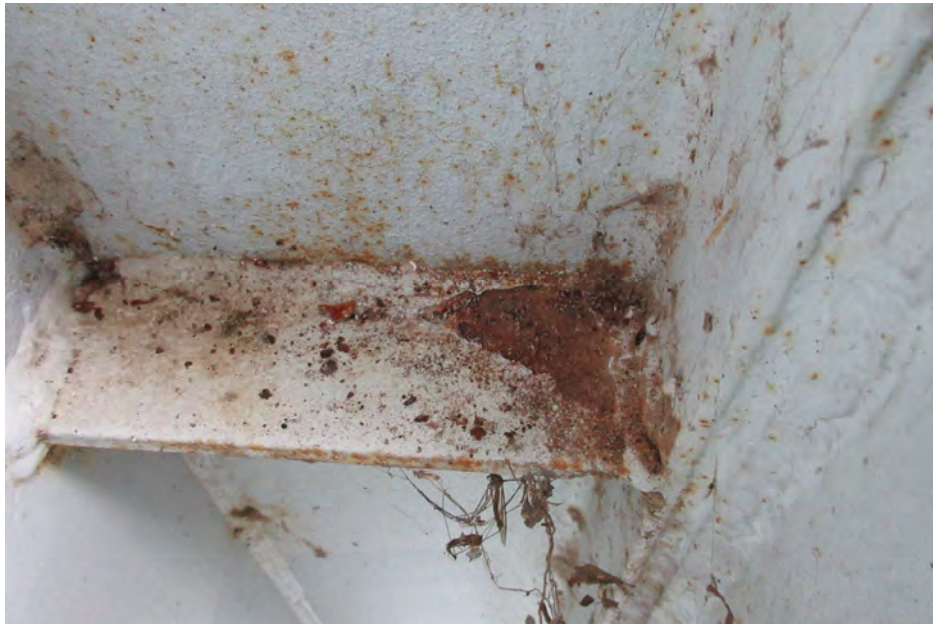
PHOTOGRAPH No.: 8
GATE: Gate 2
Photo Taken: 3/30/2020
File: CL-8.jpg

LOCATION:
Gate 2, V-04 at G-2 web stiffener.

COMMENTS:
Sand from paint job was not cleaned off and was painted over. CS2 was present after cleaning paint and sand.

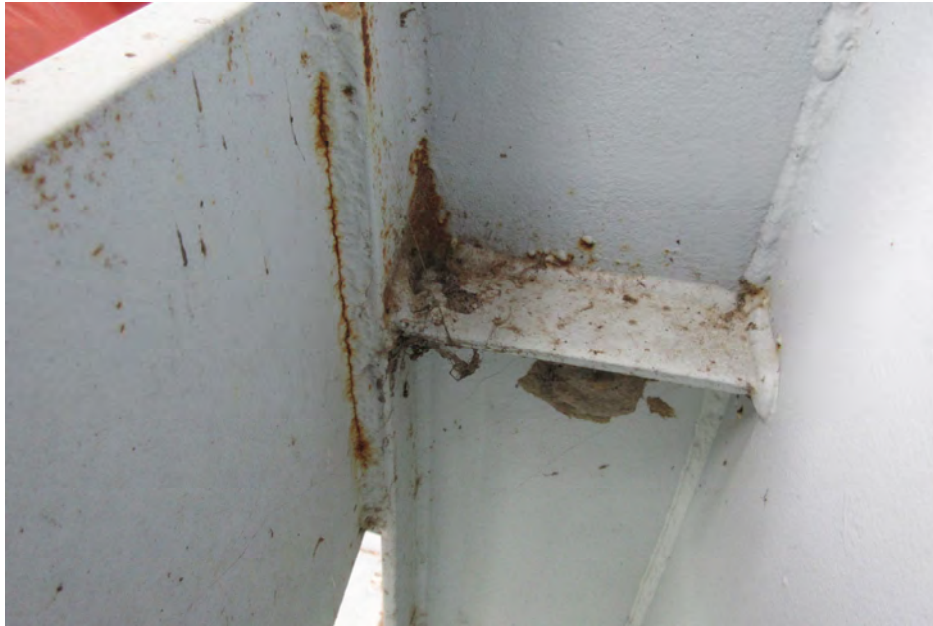
PHOTOGRAPH No.: 9
GATE: Gate 2
Photo Taken: 3/30/2020
File: CL-9.jpg

LOCATION:
Gate 2, V-04 at G-2 vertical
weld between girder and verti-
cal.

COMMENTS:
7" long crack in weld CS3.

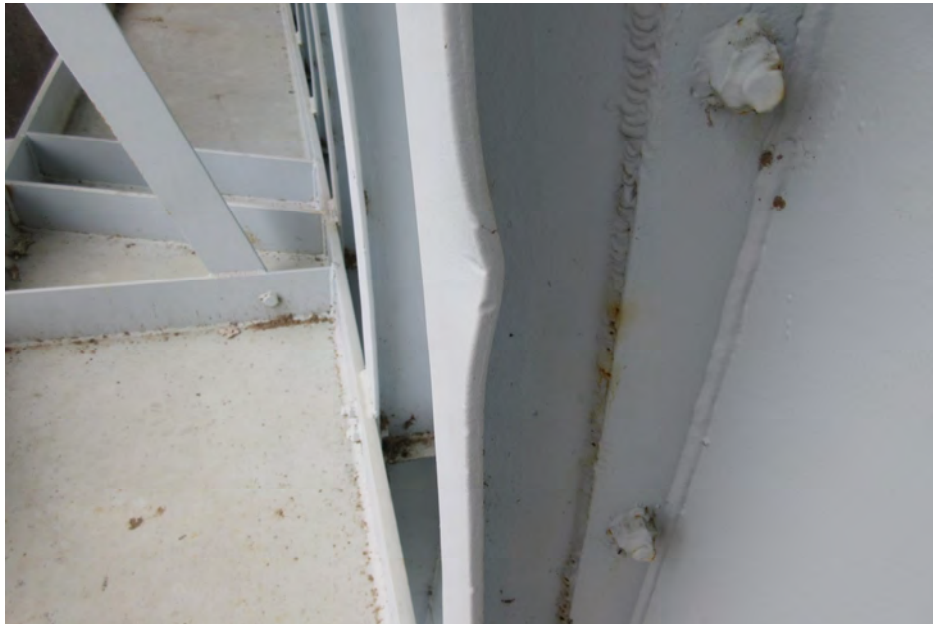
PHOTOGRAPH No.: 10
GATE: Gate 2
Photo Taken: 3/30/2020
File: CL-10.jpg

LOCATION:
Gate 2, V-08, 3' above G-2.

COMMENTS:
Out-of-plane bending in flange
over 2".

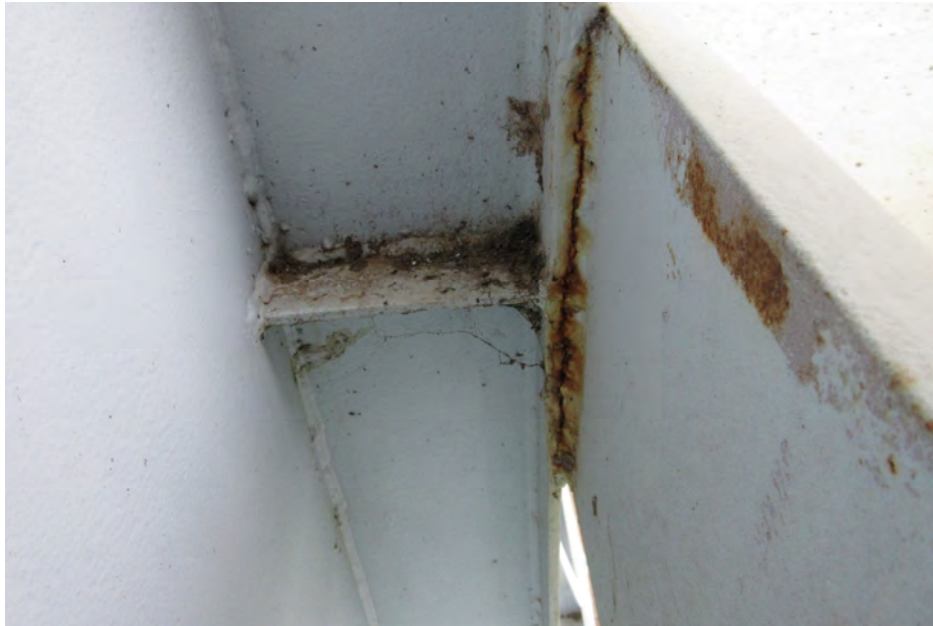
PHOTOGRAPH No.: 11

Full height crack in weld on both sides of flange.

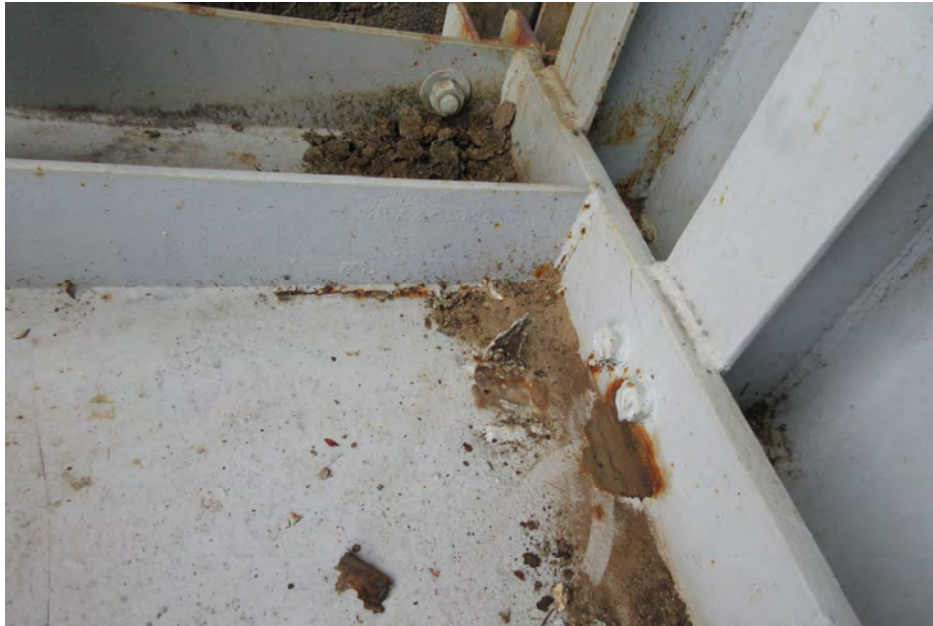
PHOTOGRAPH No.: 13

1-1/2" dimple from impact on upstream side causing paint failure at CS2.

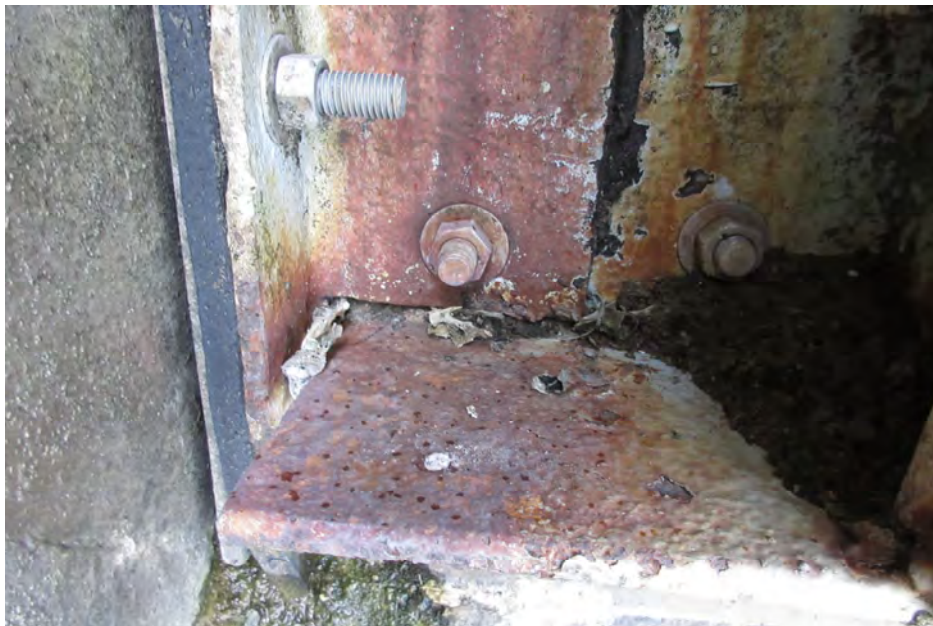
PHOTOGRAPH No.: 16

4" x 3" area of rust at CS3.

Note debris buildup between web stiffener.

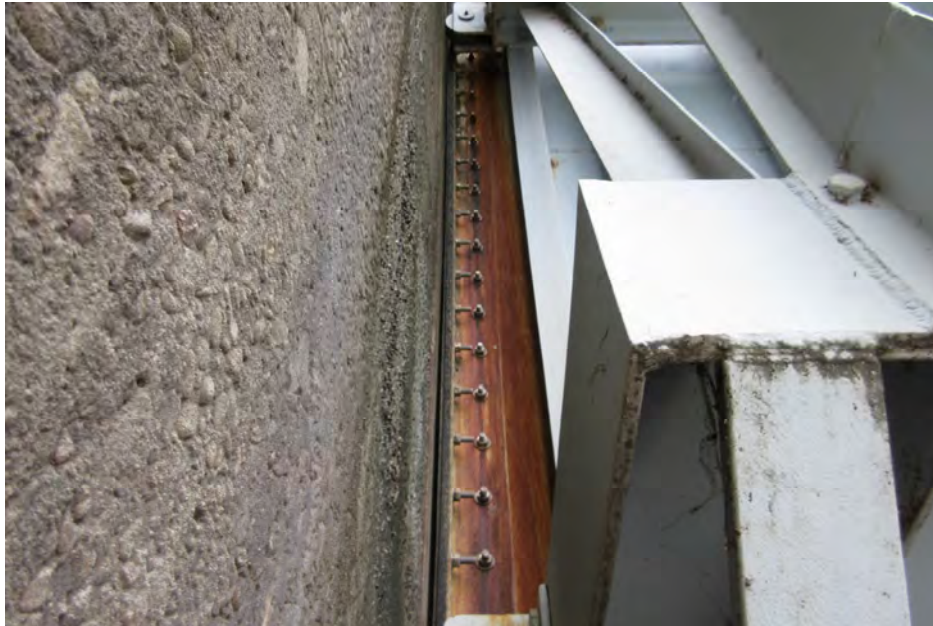
PHOTOGRAPH No.: 17

Heavy pitting up to 1/8" at CS3.

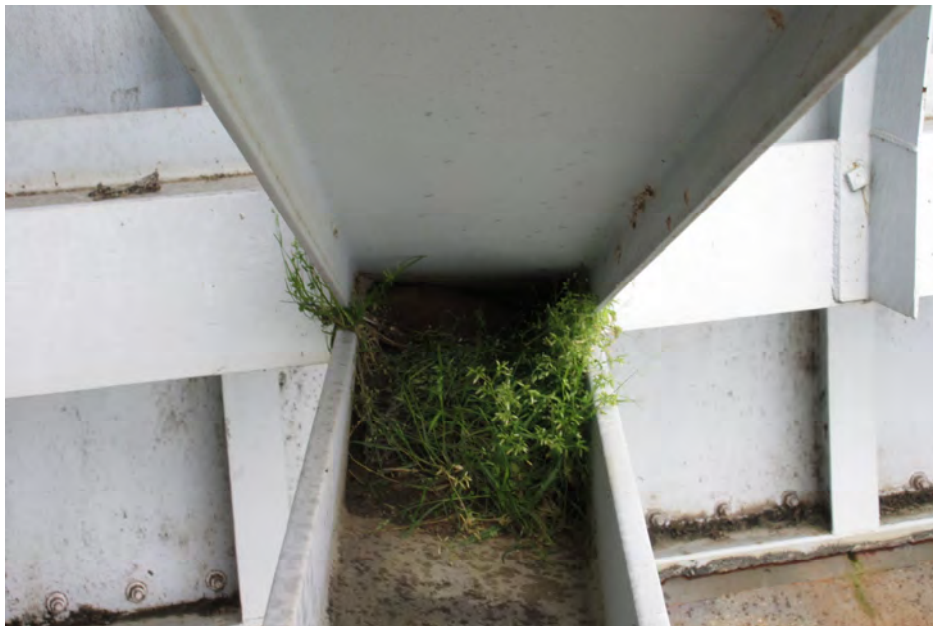
PHOTOGRAPH No.: 18

Heavy rust staining from pack rust about half way up. Note: seal is tight with no leakage.

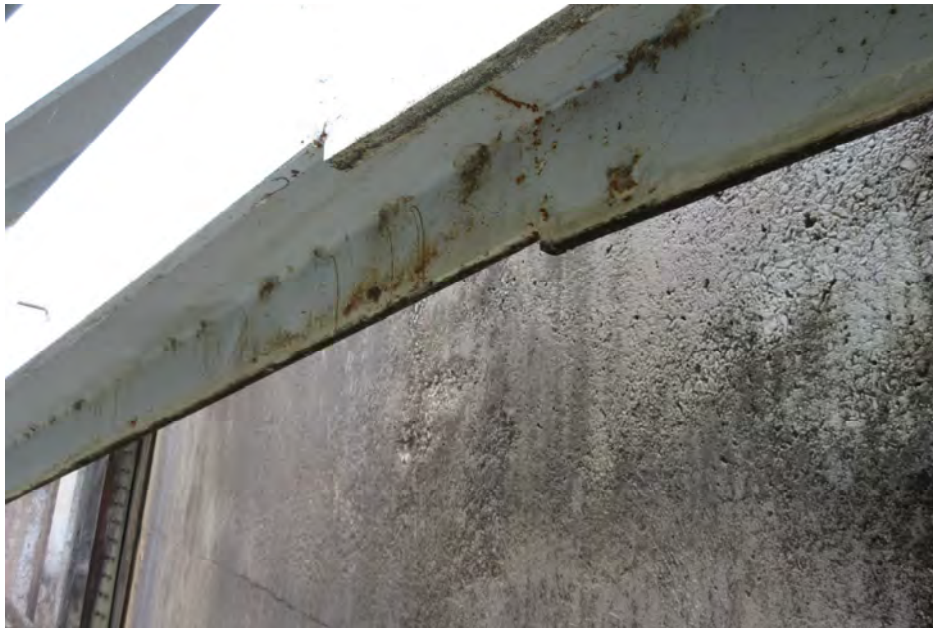
PHOTOGRAPH No.: 19

Heavy debris build up in web of RS-3. Up to 4" deep. No drain hole present.
