VISUAL INSPECTION AND EVALUATION REPORT

Rockwall-Forney Dam
Dallas Water Utilities
Dallas/Kaufman Counties, Texas

Schnabel Reference #20C22001.00
July 30, 2021

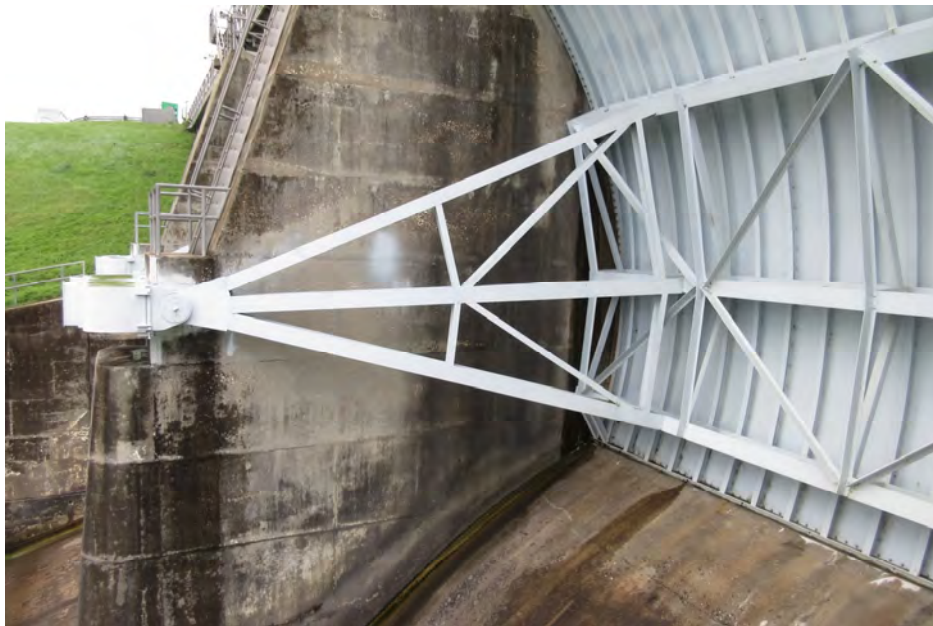
PHOTOGRAPH No.: 20

Multiple shallow gouges in flange with paint failure at CS2.

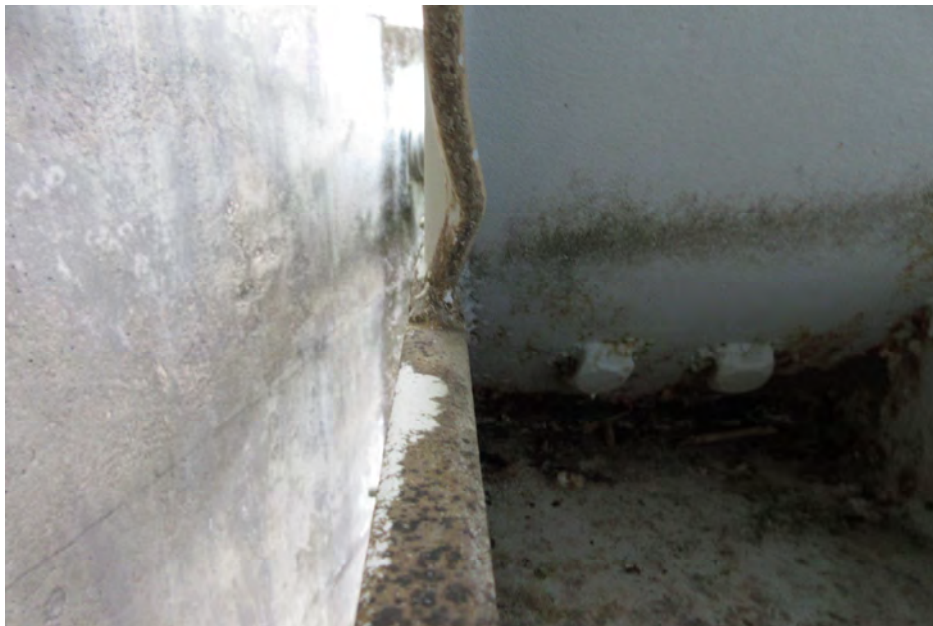
PHOTOGRAPH No.: 22

Full thickness hole that has a 4' x 4" repair patch.

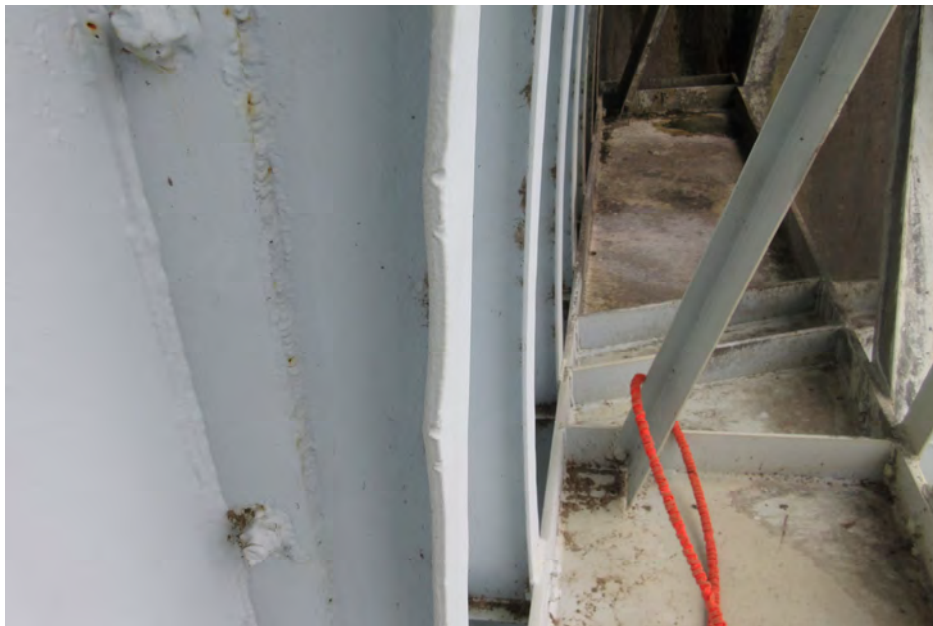
PHOTOGRAPH No.: 24

Plugged hole in skin. Wood and moss currently block hole. Evidence of moss and staining suggest a lot of water flowed at one time.

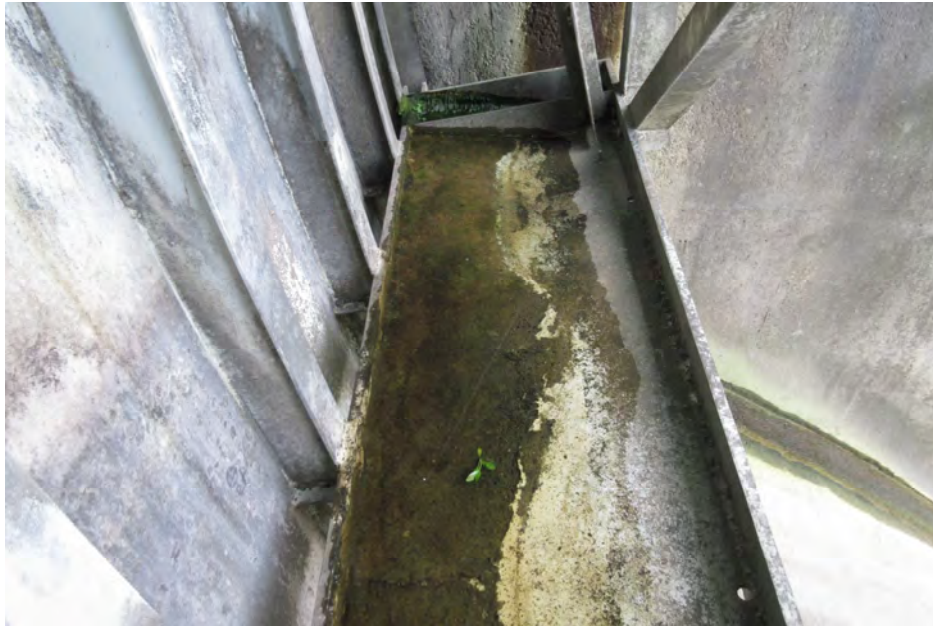
PHOTOGRAPH No.: 25

Out-of-plane bending in 3 spots on flange 1/4" over 1".

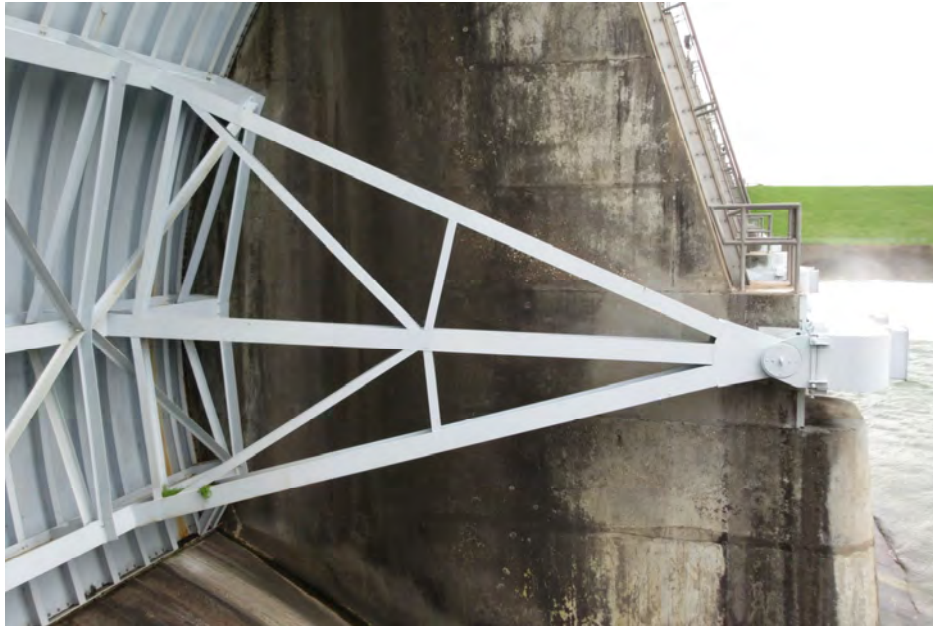
PHOTOGRAPH No.: 3
GATE: Gate 3
Photo Taken: 3/30/2020
File: DK-3.jpg

LOCATION:
Gate 3, right arms RS-3, under-
side flanges at RB-4.

COMMENTS:
Out-of-plane bending 3/16"
over 8" section CS2.

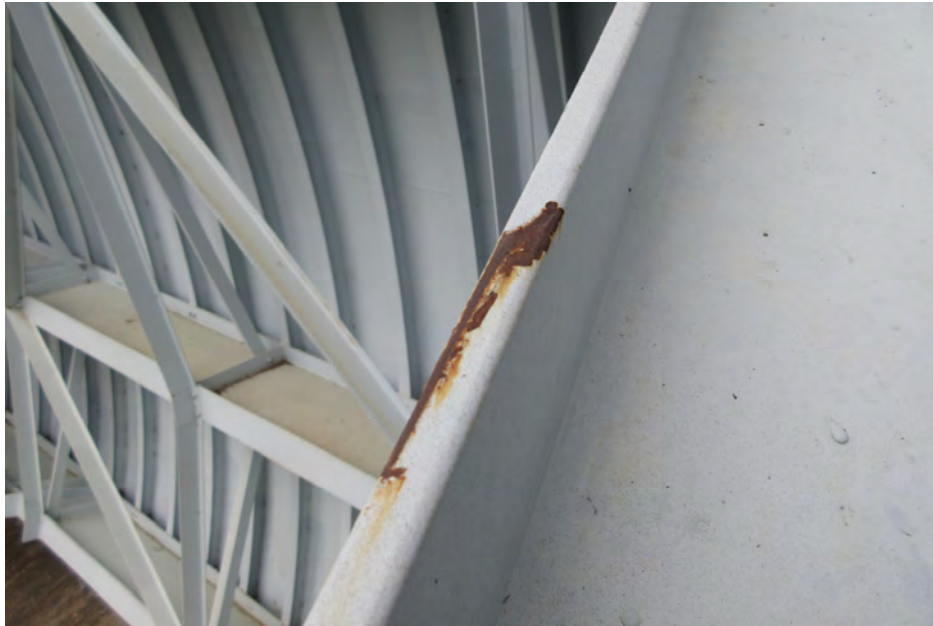
PHOTOGRAPH No.: 5
GATE: Gate 3
Photo Taken: 3/30/2020
File: DK-5.jpg

LOCATION:
Gate 3, Downstream side of
skin plate between V16 & V17,
1' above G-1.

COMMENTS:
A typical circular cover plate,
tack welds in good condition,
paint is cracked with rust bleed-
ing, CS2.

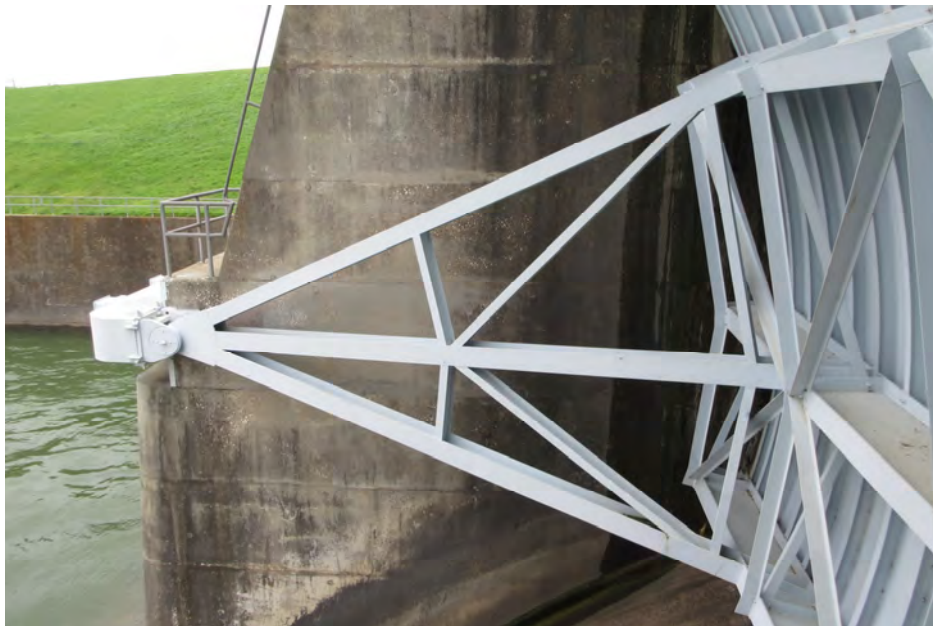
PHOTOGRAPH No.: 6
GATE: Gate 3
Photo Taken: 3/30/2020
File: DK-6.jpg

LOCATION:
Gate 3, left arm LS-1 topside
inboard flange 6' from G-1.

COMMENTS:
4" scrape along flange edge
with surface rust, CS2, 1/16"
deep.

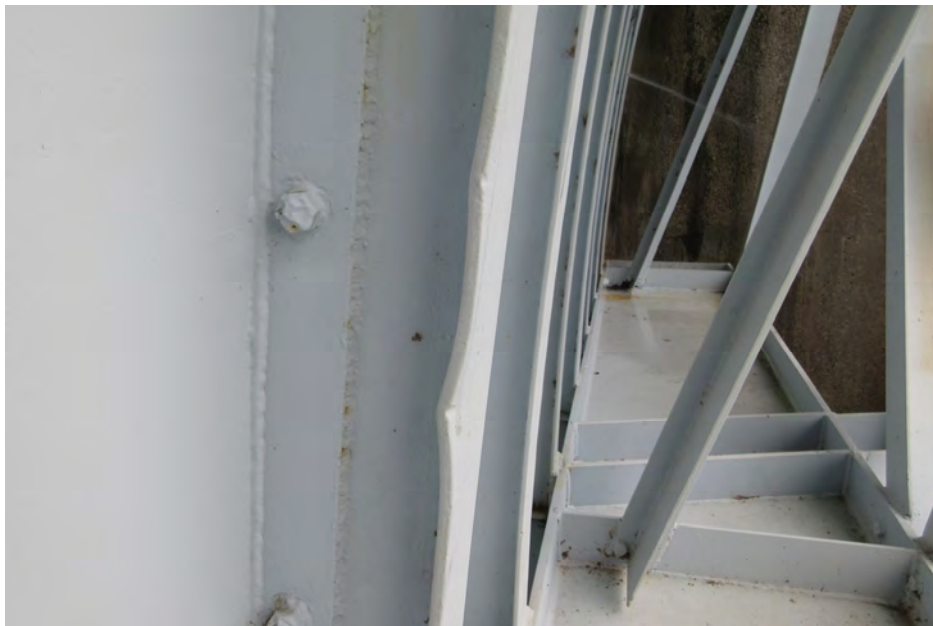
PHOTOGRAPH No.: 8
GATE: Gate 3
Photo Taken: 3/30/2020
File: DK-8.jpg

LOCATION:
Gate 3, Downstream side of skin, between V-19 & V-20, 4' above G-2.

COMMENTS:
1/2" drill hole through skin steel, leaking 2 gpm.

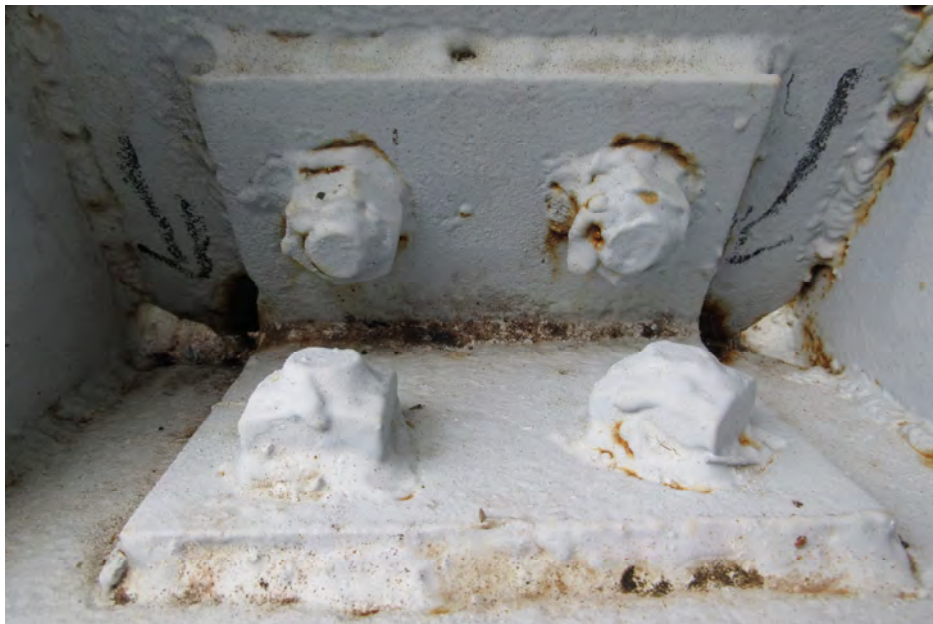
PHOTOGRAPH No.: 10

Areas of failed paint with light surface rust due to paint application over sand, CS2.

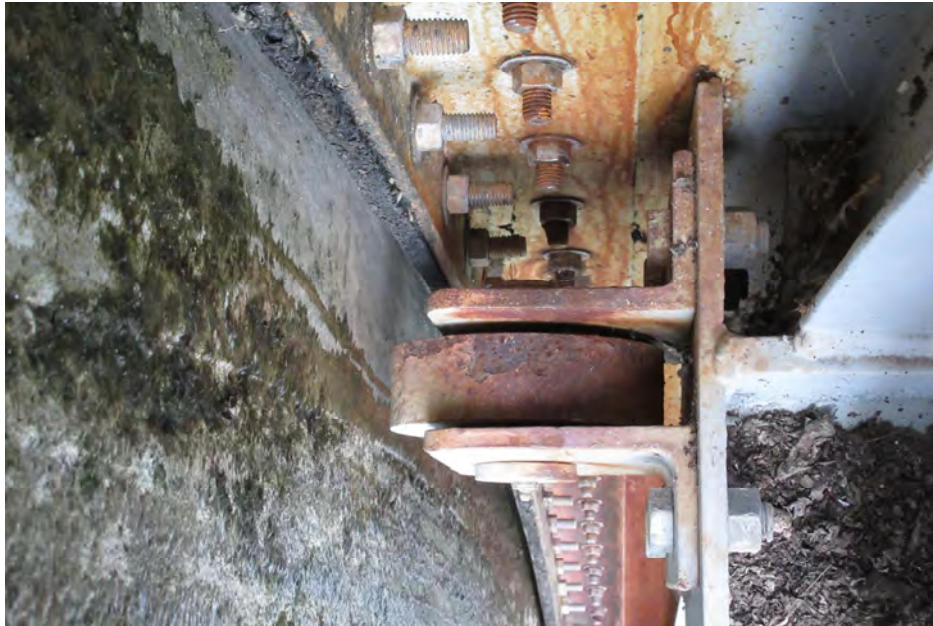
PHOTOGRAPH No.: 11

Corrosion at bottom of web, pitting to 1/8" & pack rust to 1/4", CS3.

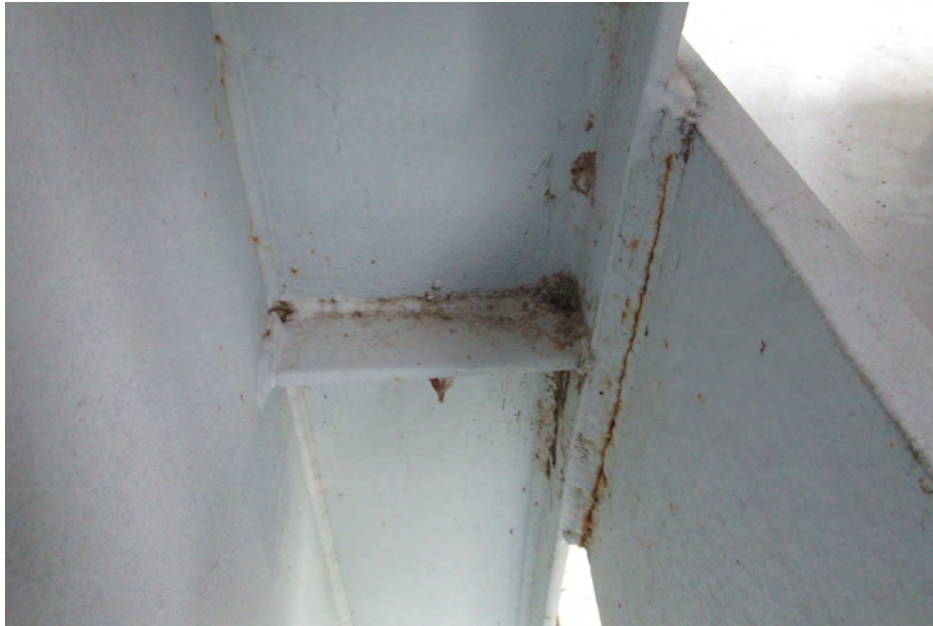
PHOTOGRAPH No.: 13

V-12 has field weld across flange with one end only 25% thick as normal flange thickness, CS2.

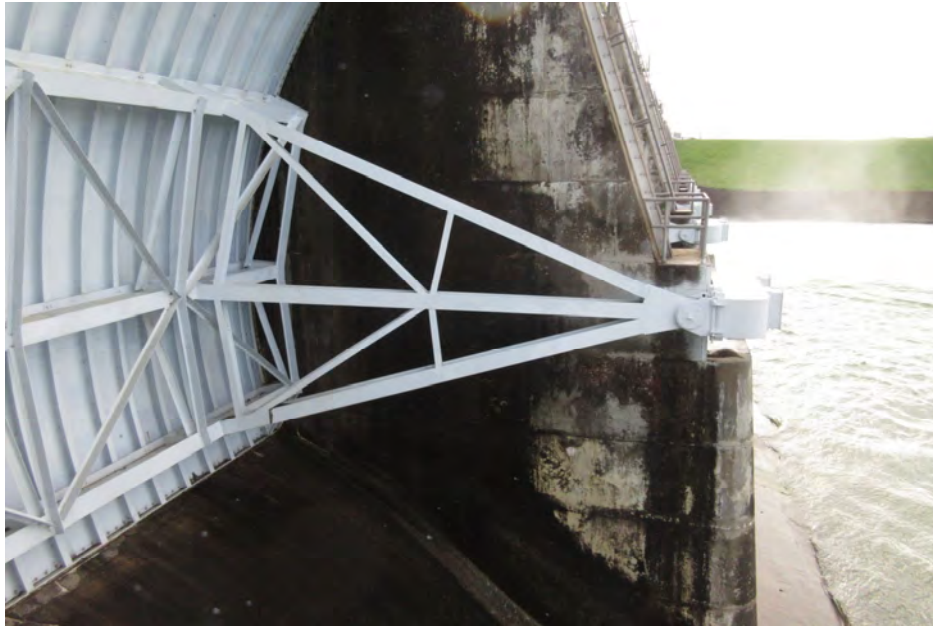
PHOTOGRAPH No.: 1
GATE: Gate 4
Photo Taken: 3/31/2020
File: CL-1.jpg

Corrosion & pack rust & pitting to 3/16" along 50% of gate, CS3.

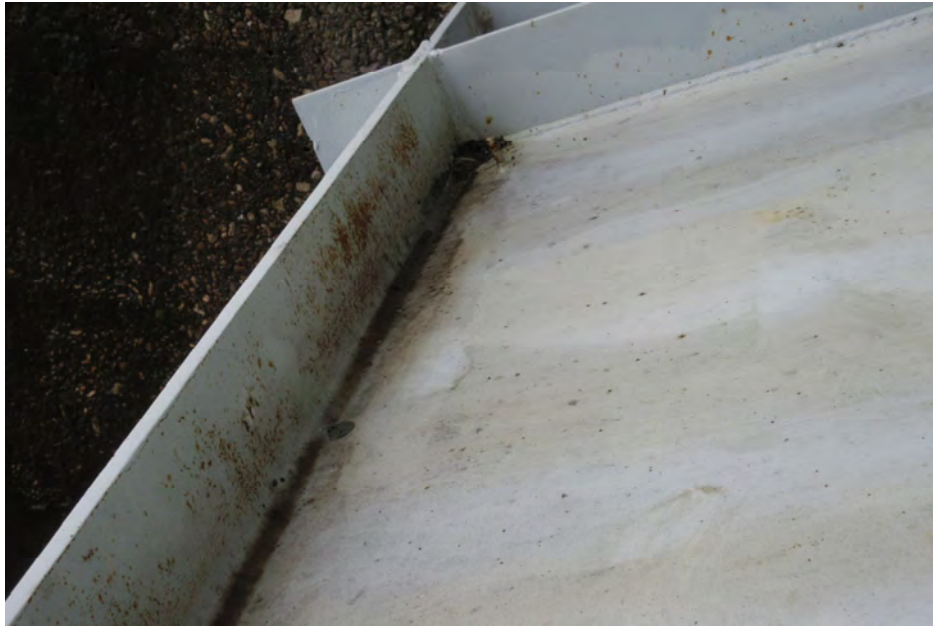
PHOTOGRAPH No.: 3
GATE: Gate 4
Photo Taken: 3/31/2020
File: CL-3.jpg

LOCATION:
Gate 4, right trunnion.

COMMENTS:
Paint failure on inside of trunnion CS-2. Same on left trunnion.

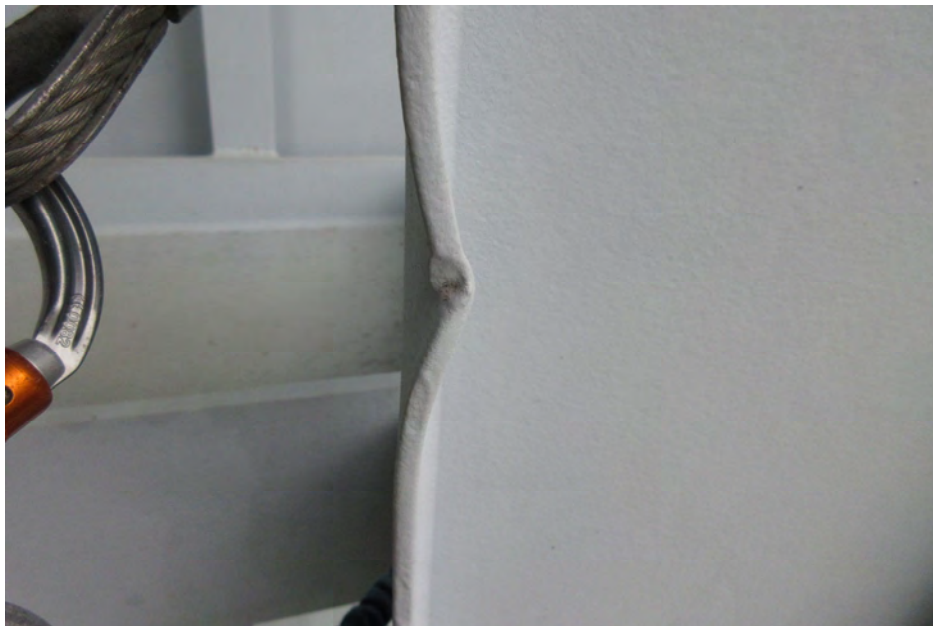
PHOTOGRAPH No.: 4
GATE: Gate 4
Photo Taken: 3/31/2020
File: CL-4.jpg

LOCATION:
Gate 4, G-1 top right side.

COMMENTS:
Freckle rust bleeding through on bottom flange. CS2 and typical for all.

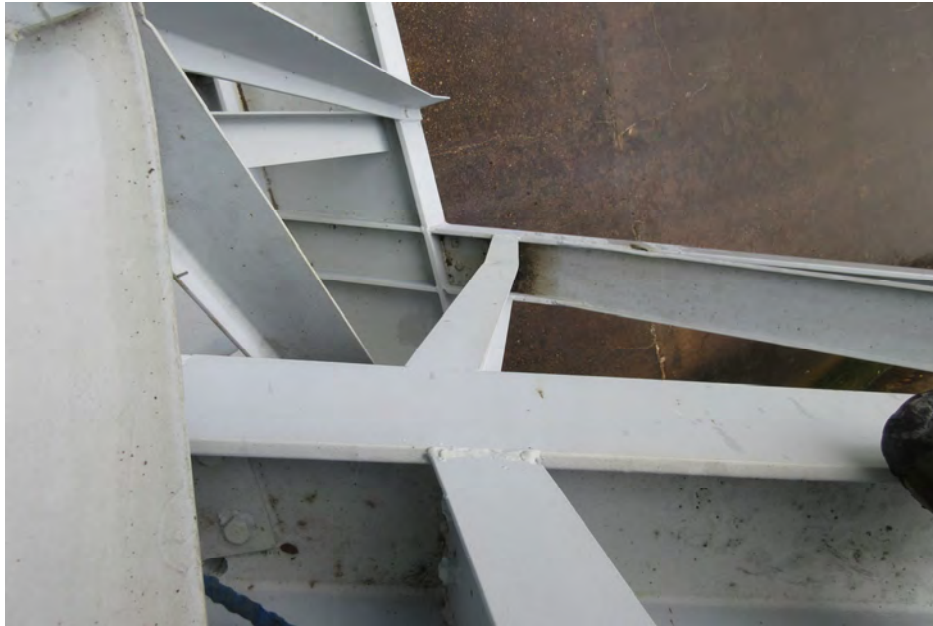
PHOTOGRAPH No.: 5
GATE: Gate 4
Photo Taken: 3/31/2020
File: CL-5.jpg

LOCATION:
Gate 4, RB-3 1' above RS-2.

COMMENTS:
Out-of-plane bending, 1" over 2" on flange .

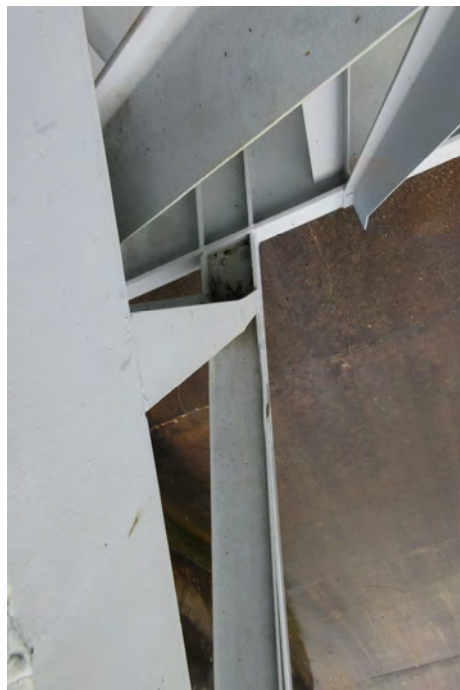
PHOTOGRAPH No.: 6
GATE: Gate 4
Photo Taken: 3/31/2020
File: CL-6.jpg

LOCATION:
Gate 4, RB-6.

COMMENTS:
Out-of-plane bending on the whole member 1" over 6'. Due to impact, not to the member buckling.

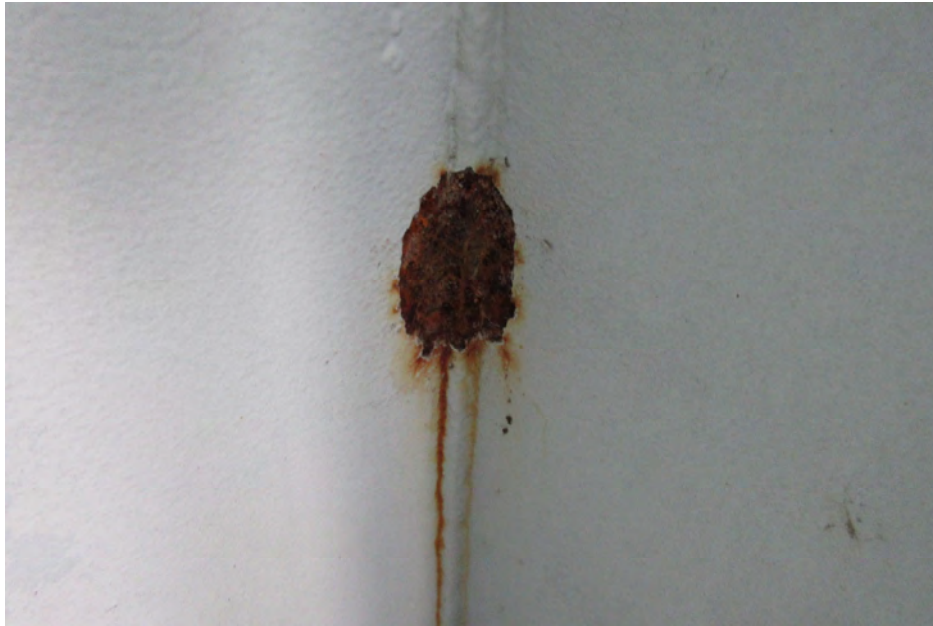
PHOTOGRAPH No.: 7
GATE: Gate 4
Photo Taken: 3/31/2020
File: CL-7.jpg

LOCATION:
Gate 4, skin plate 1' above G-2
by V-05.

COMMENTS:
2" x 2" paint failure with pitting
to 1/16", CS3.

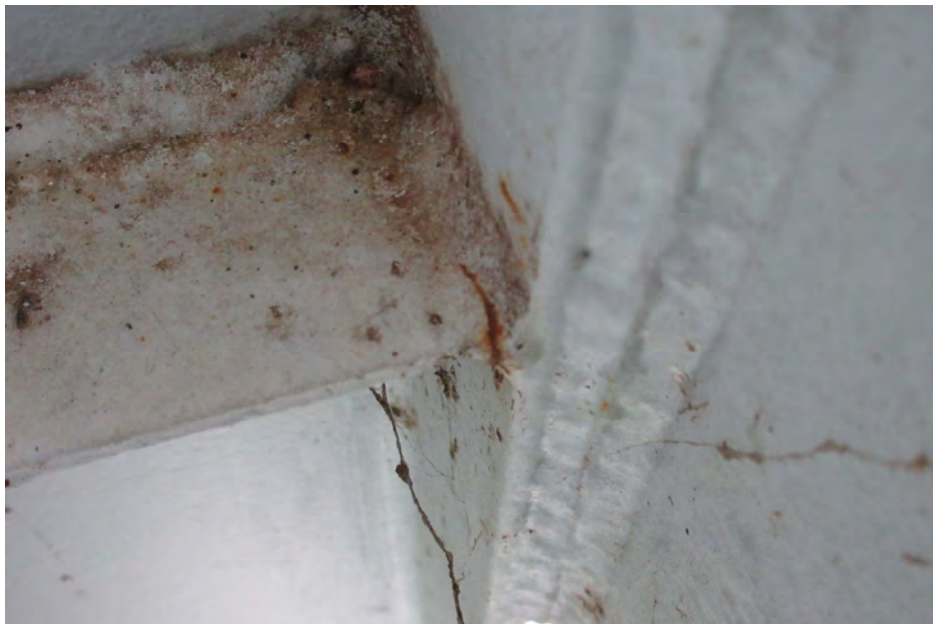
PHOTOGRAPH No.: 8
GATE: Gate 4
Photo Taken: 3/31/2020
File: CL-8.jpg

LOCATION:
Gate 4, web stiffener on V-06
by G-2.

COMMENTS:
1/2" long crack in weld on stiff-
ener CS3.

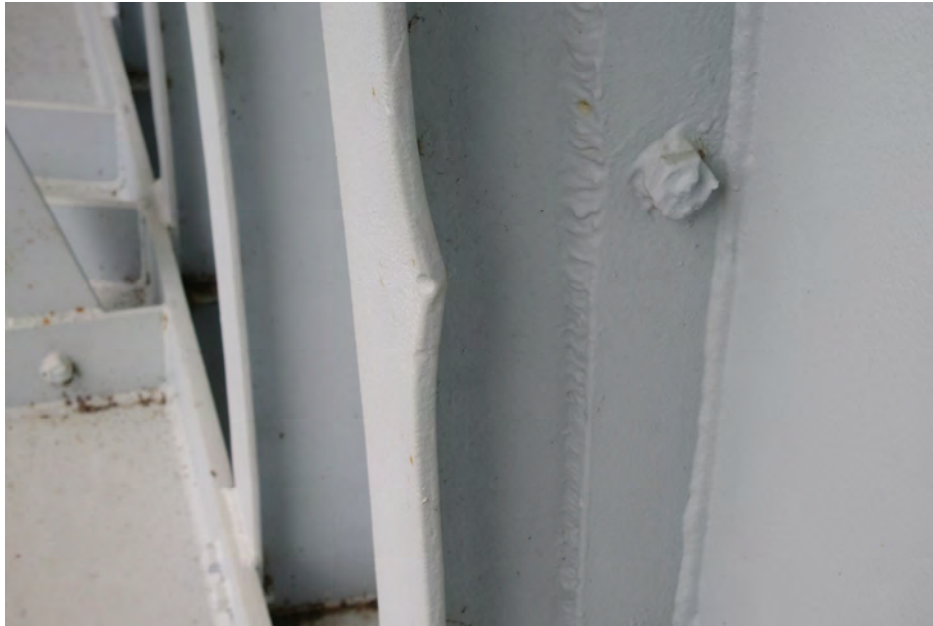
PHOTOGRAPH No.: 9
GATE: Gate 4
Photo Taken: 3/31/2020
File: CL-9.jpg

LOCATION:
Gate 4, V-08, 3' above G-2.

COMMENTS:
Out-of-plane bending 1" over 2"
in flange.

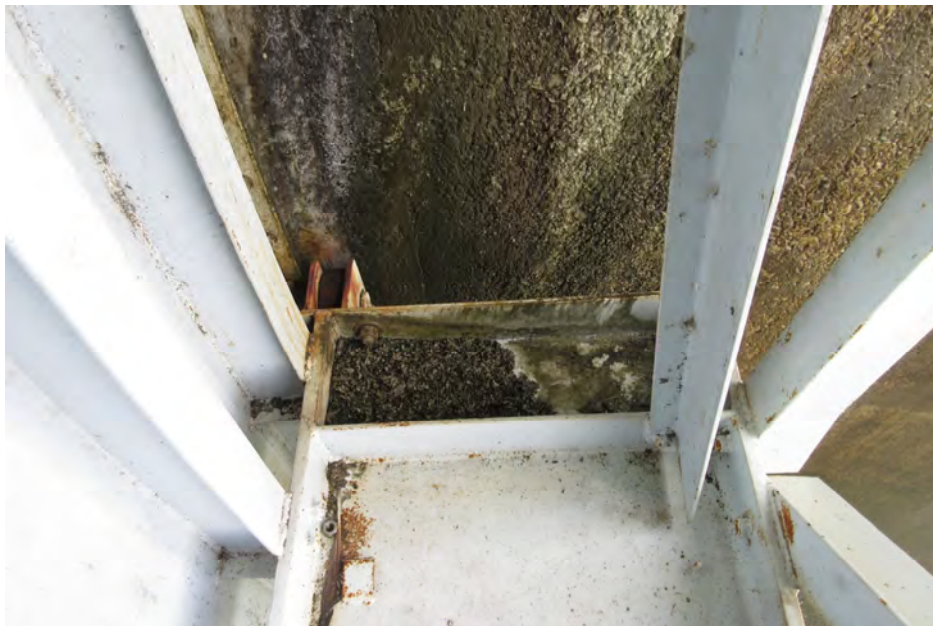
PHOTOGRAPH No.: 10
GATE: Gate 4
Photo Taken: 3/31/2020
File: CL-10.jpg

LOCATION:
Gate 4, G-3 left side.

COMMENTS:
No drain hole. Water and de-
bris collects same on right
side .

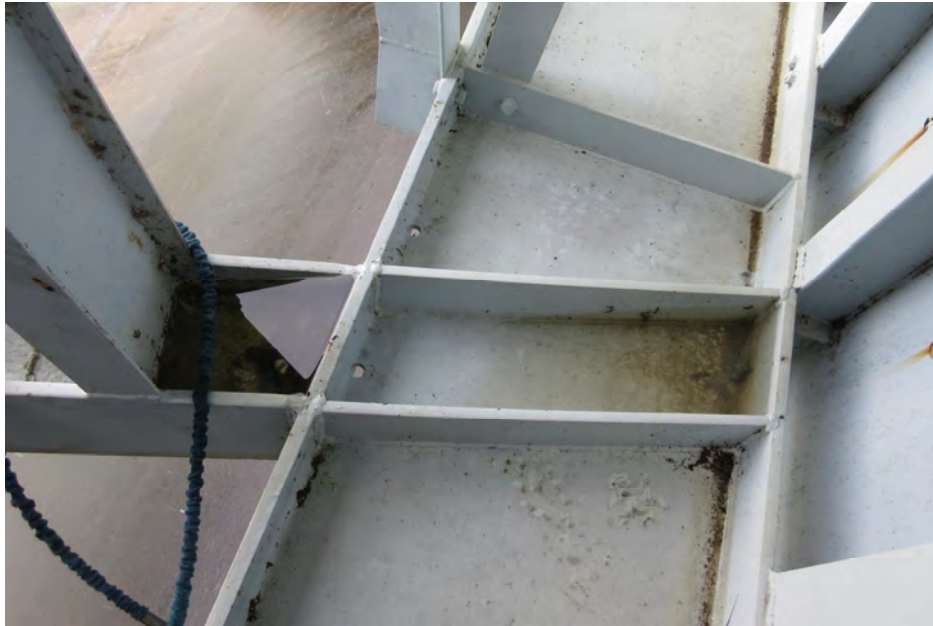
PHOTOGRAPH No.: 11

Drain hole plugged, 5" of standing water in bays.

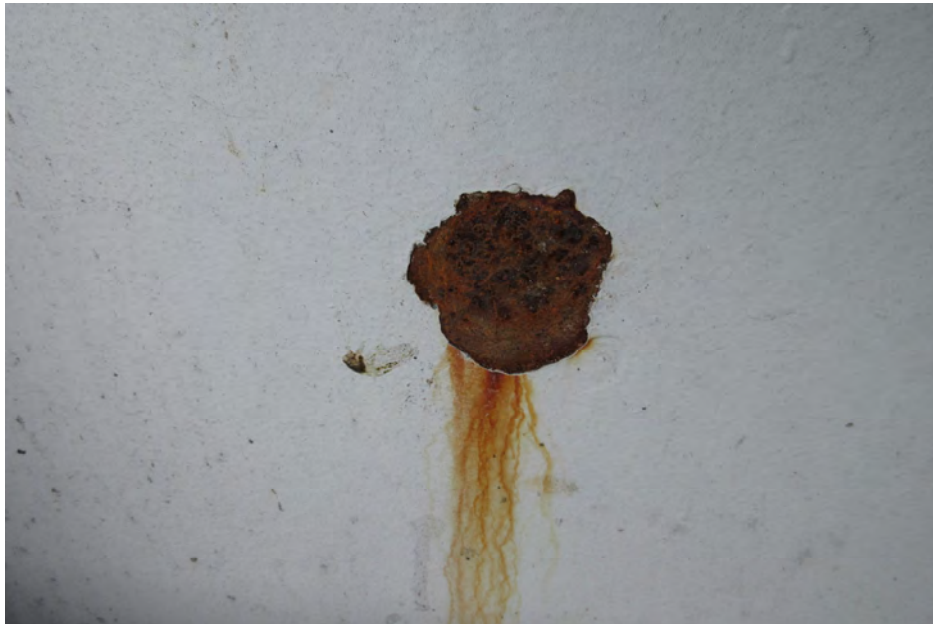
PHOTOGRAPH No.: 12

3" round paint failure with heavy surface rust. Similar spot between V-17 and V-16, CS2 for both.

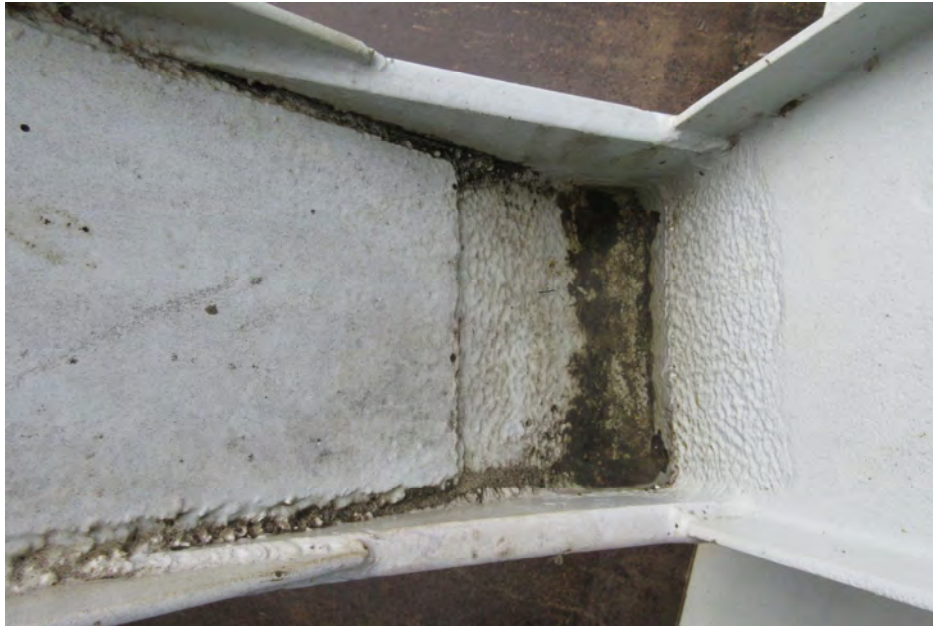
PHOTOGRAPH No.: 13

Heavy arrested pitting throughout web of both members.

Note: built up repair in web of LB-5 web.

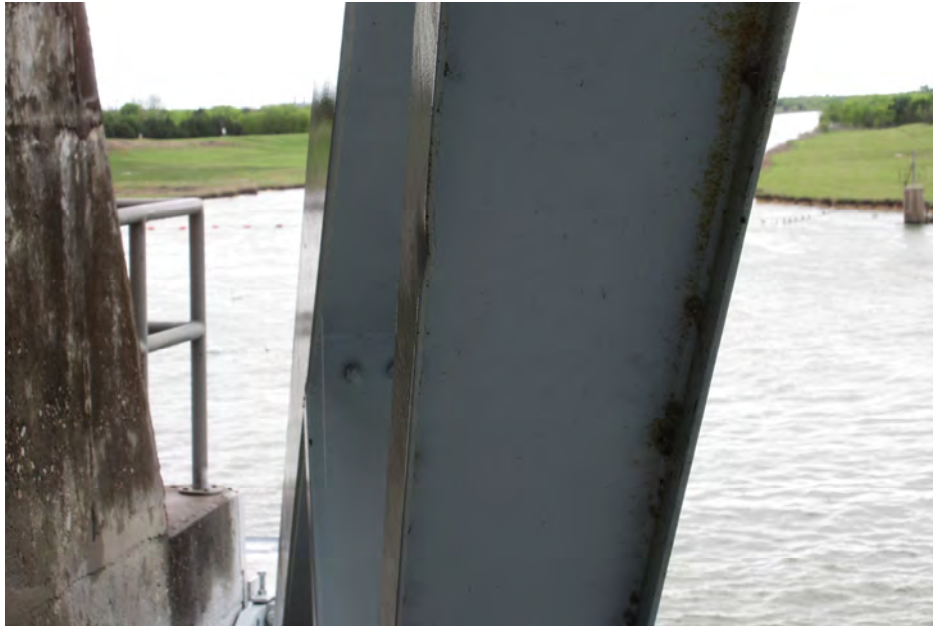
PHOTOGRAPH No.: 15

Out-of-plane bending, 1/2" over 2" on flange.

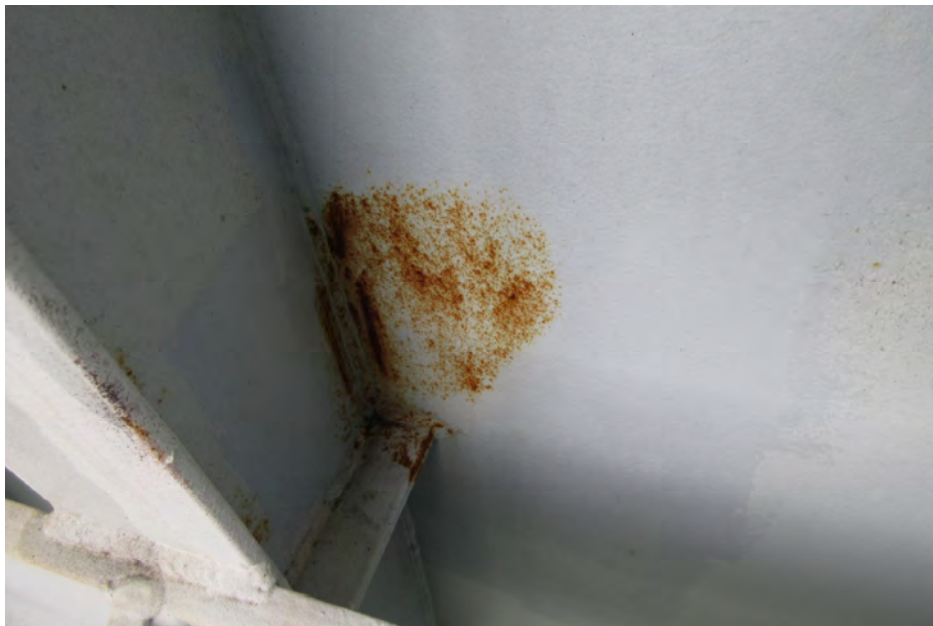
PHOTOGRAPH No.: 16

6" x 10" area of paint failure with heavy rust bleed CS2. Similar spot between V-17 and V-18 at G-2.

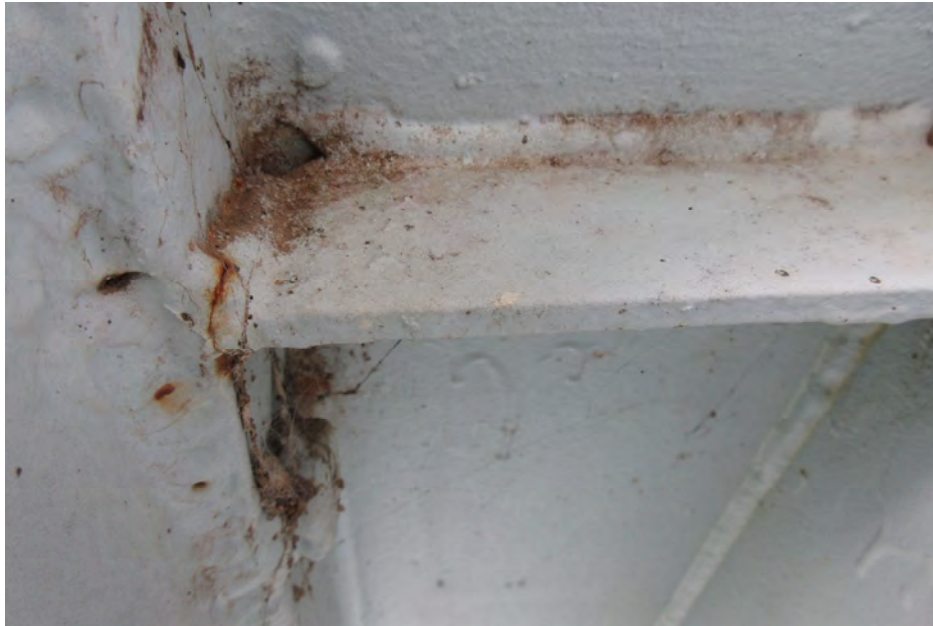
PHOTOGRAPH No.: 17

1/2" crack in weld of web stiffener, CS3.

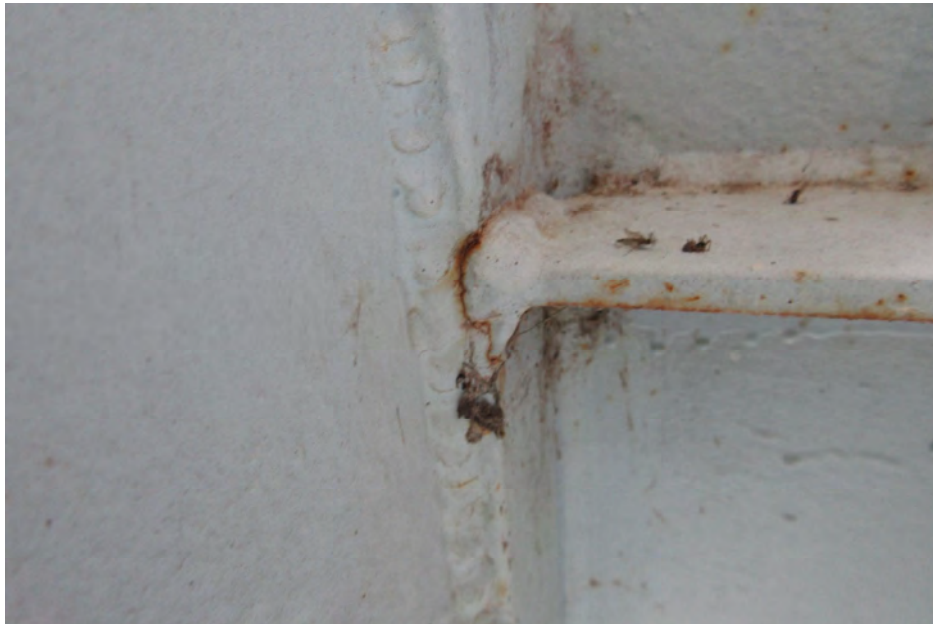
PHOTOGRAPH No.: 18

1/2" crack in weld of web stiffener, CS3.

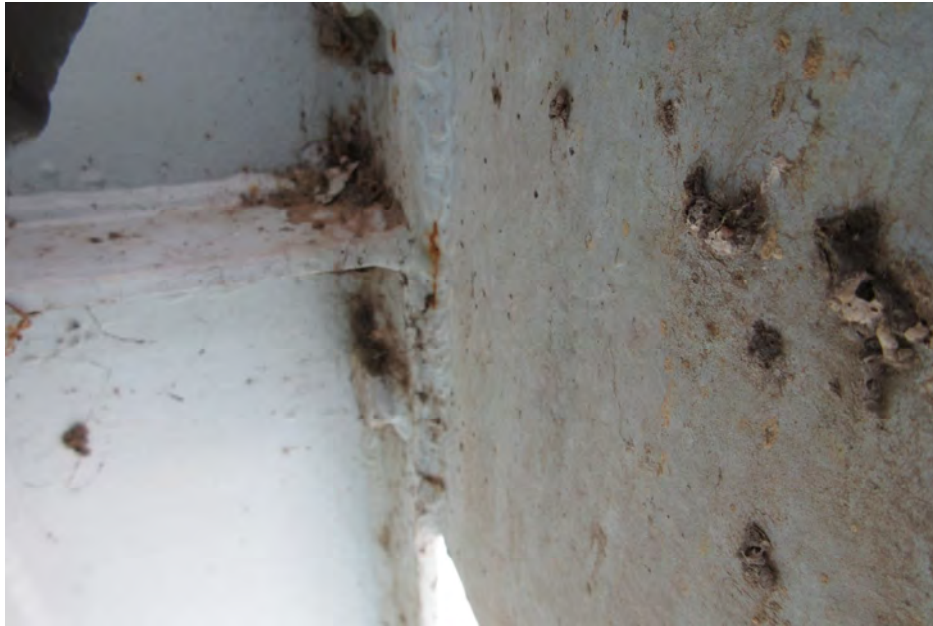
PHOTOGRAPH No.: 19

1" long crack in vertical weld between vertical and girder, CS3.

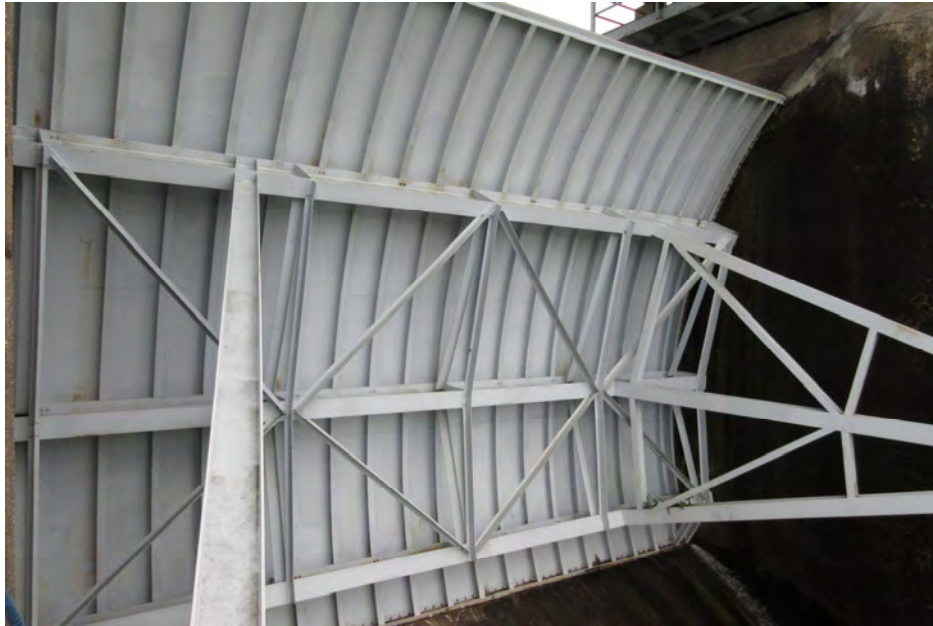
PHOTOGRAPH No.: 1
GATE: Gate 5
Photo Taken: 3/31/2020
File: DK-25.jpg

LOCATION:
Gate 5, overview.

COMMENTS:
Overview - isolated areas of
freckle rust on girders & skin.

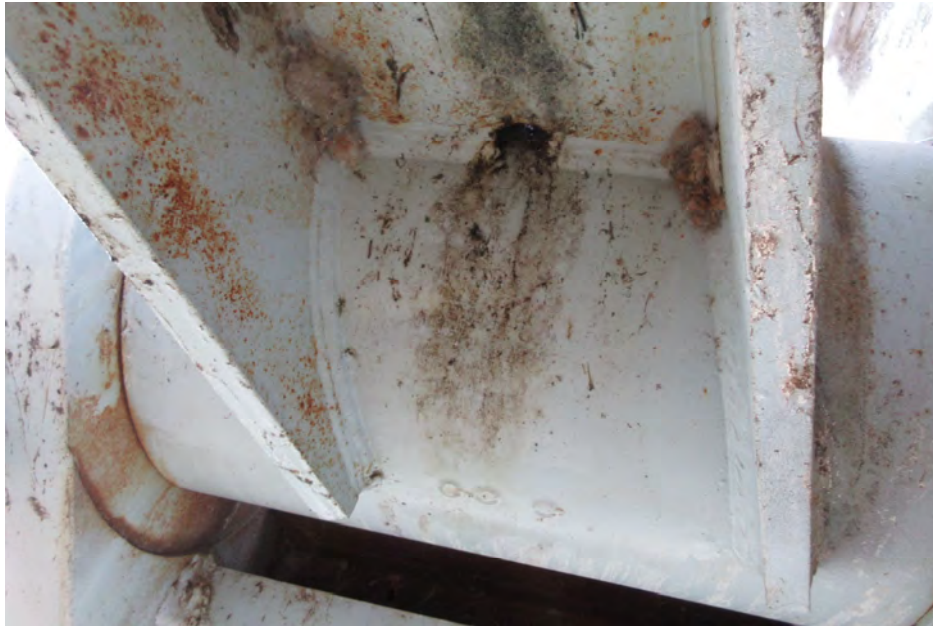
PHOTOGRAPH No.: 3
GATE: Gate 5
Photo Taken: 3/31/2020
File: DK-27.jpg

LOCATION:
Gate 5, right arm trunnion, underside connection of RS-3, gusset plate & trunnion.

COMMENTS:
Areas of freckle rust, CS-2.

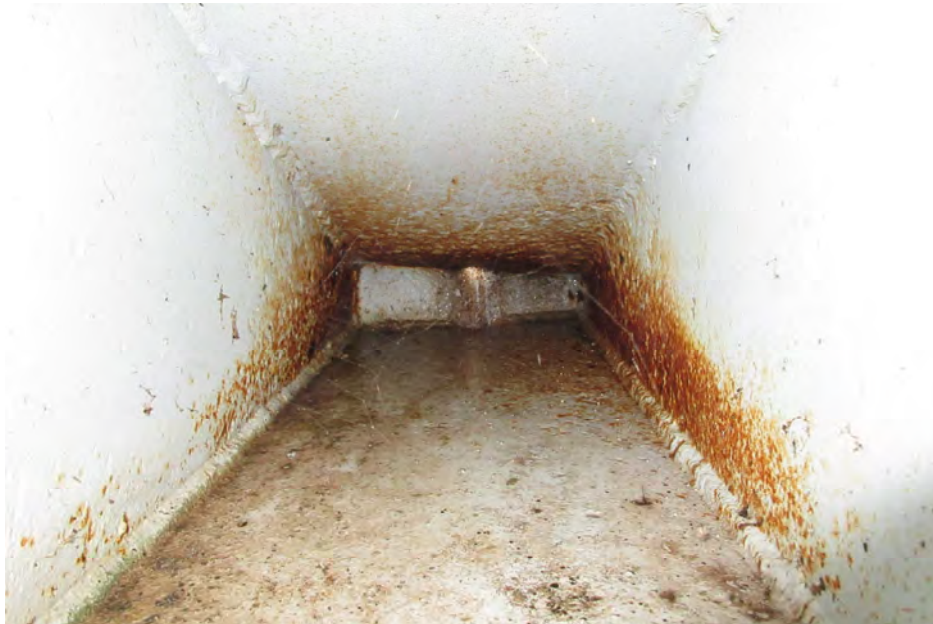
PHOTOGRAPH No.: 4
GATE: Gate 5
Photo Taken: 3/31/2020
File: DK-28.jpg

LOCATION:
Gate 5, interior of gusset plate between RS-1 & RS-2

COMMENTS:
Heavy freckle rust, pitting to 1/8", unarrested, CS-3.

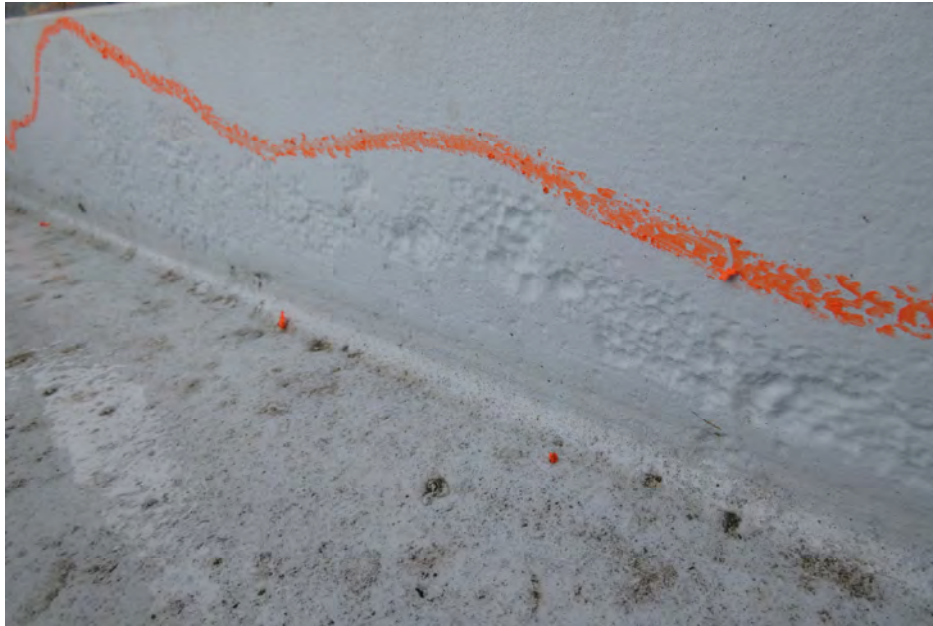
PHOTOGRAPH No.: 5
GATE: Gate 5
Photo Taken: 3/31/2020
File: DK-29.jpg

LOCATION:
Gate 5, RS-2, topside/outboard flange, 6 ft from trunnion.

COMMENTS:
Arrested pitting to 1/8" over 3' section, CS-3.

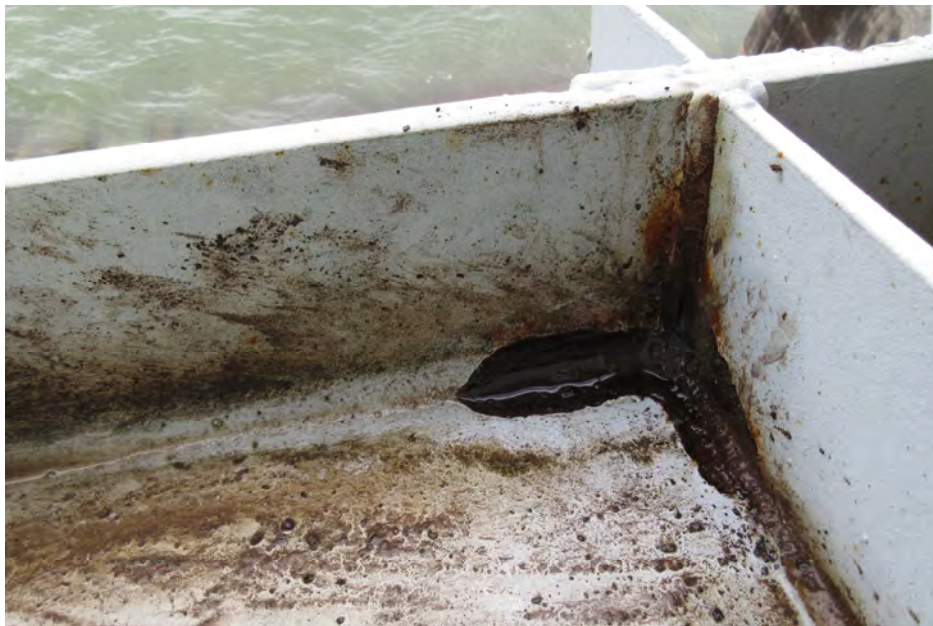
PHOTOGRAPH No.: 6
GATE: Gate 5
Photo Taken: 3/31/2020
File: DK-30.jpg

LOCATION:
Gate 5, G-1 at stiffener at V-11 (midspan).

COMMENTS:
Topside of G-1 web and stiffener welds have paint failure with unarrested pitting to 1/8" (about 4" x 6" area) (due to dirt accumulation holding moisture), CS-3.

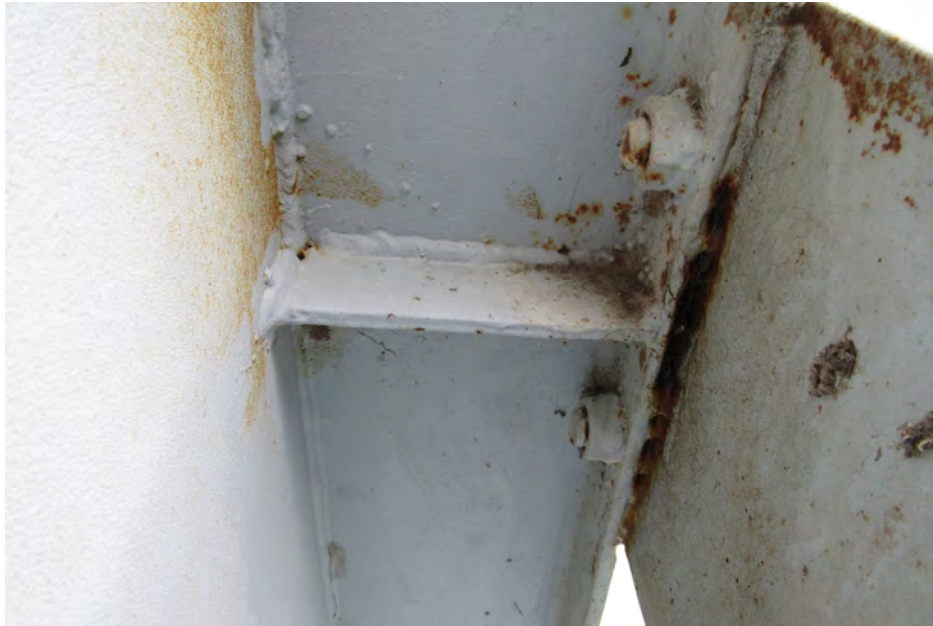
PHOTOGRAPH No.: 7
GATE: Gate 5
Photo Taken: 3/31/2020
File: DK-31.jpg

LOCATION:
Gate 5, V-7 at G-1.

COMMENTS:
Pack rust to 1/4" between rib & girder flanges, CS-3.

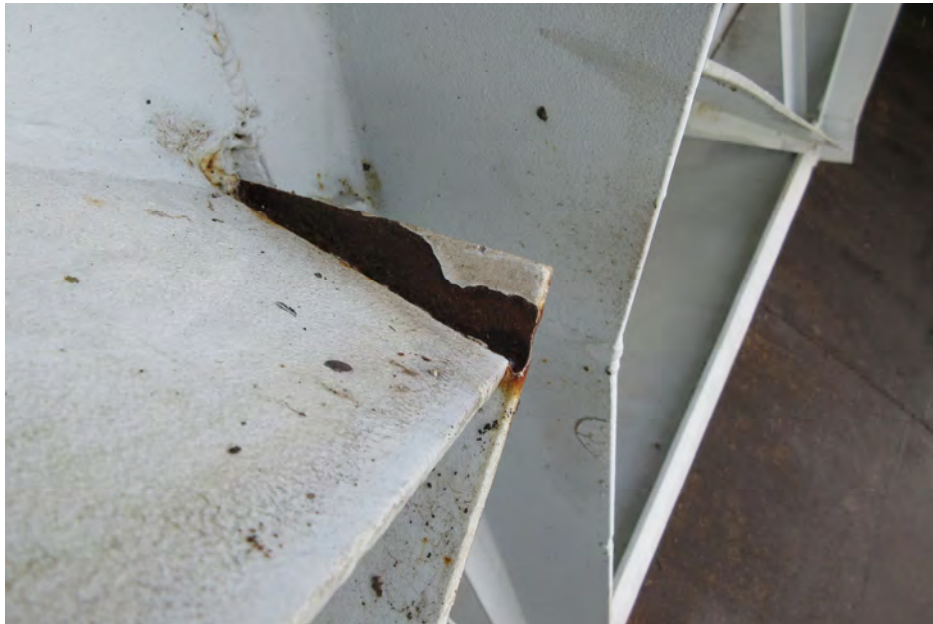
PHOTOGRAPH No.: 8
GATE: Gate 5
Photo Taken: 3/31/2020
File: DK-32.jpg

LOCATION:
Gate 5, B-22 at G-2 connection.

COMMENTS:
5" x 1" area of paint failure, surface rust with light pitting, CS-3.

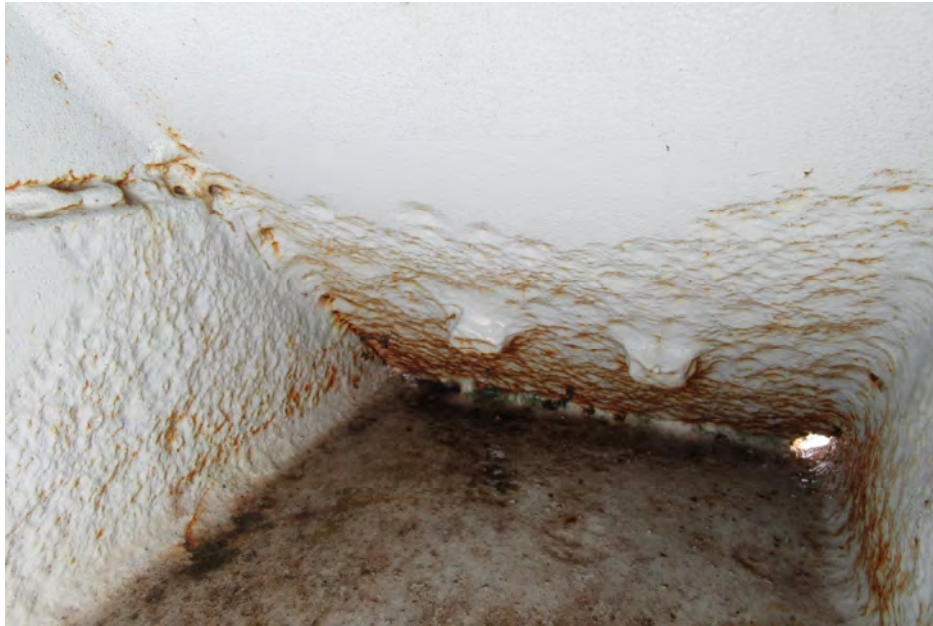
PHOTOGRAPH No.: 9
GATE: Gate 5
Photo Taken: 3/31/2020
File: DK-33.jpg

LOCATION:
Gate 5, RB-2 & RS-2 connection.

COMMENTS:
2' x 1' area of pitting on both members to 1/8". 75% arrested, CS-3.

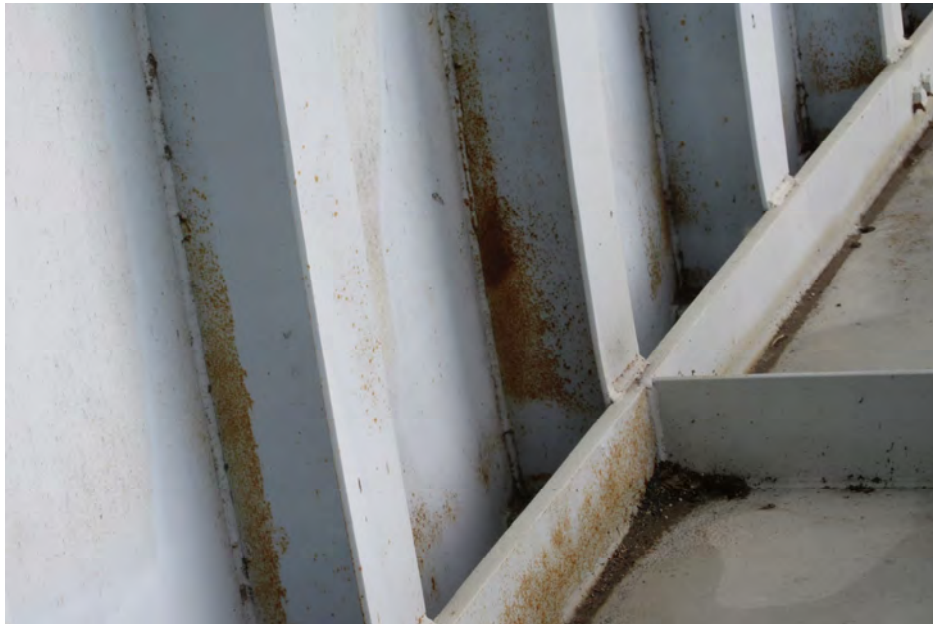
PHOTOGRAPH No.: 10
GATE: Gate 5
Photo Taken: 3/31/2020
File: DK-34.jpg

LOCATION:
Gate 5, V-9 - V-11 & G-3.

COMMENTS:
Areas of freckle rust (typical throughout), CS-2.
