VISUAL INSPECTION AND EVALUATION REPORT

Rockwall-Forney Dam
Dallas Water Utilities
Dallas/Kaufman Counties, Texas

Schnabel Reference #20C22001.00
July 30, 2021

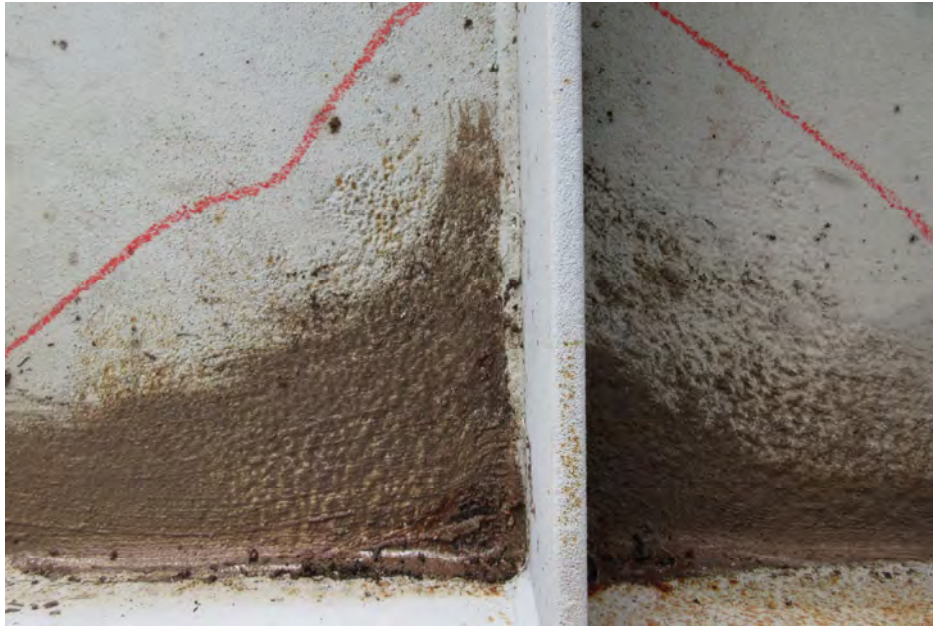
PHOTOGRAPH No.: 11

Topside web has 2' x 1' area of arrested pitting to 1/16", CS-3.

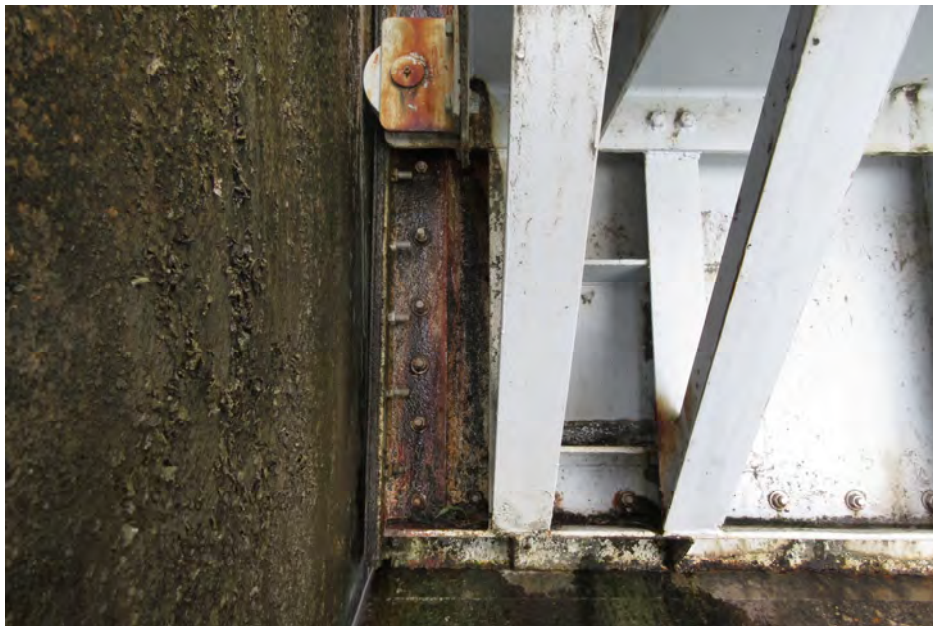
PHOTOGRAPH No.: 12

Minor leak (about 1 gpm) typical rust staining down edges onto rollers, V1 & V2 flange edges have corrosion & section loss at bottom plate, CS-3.

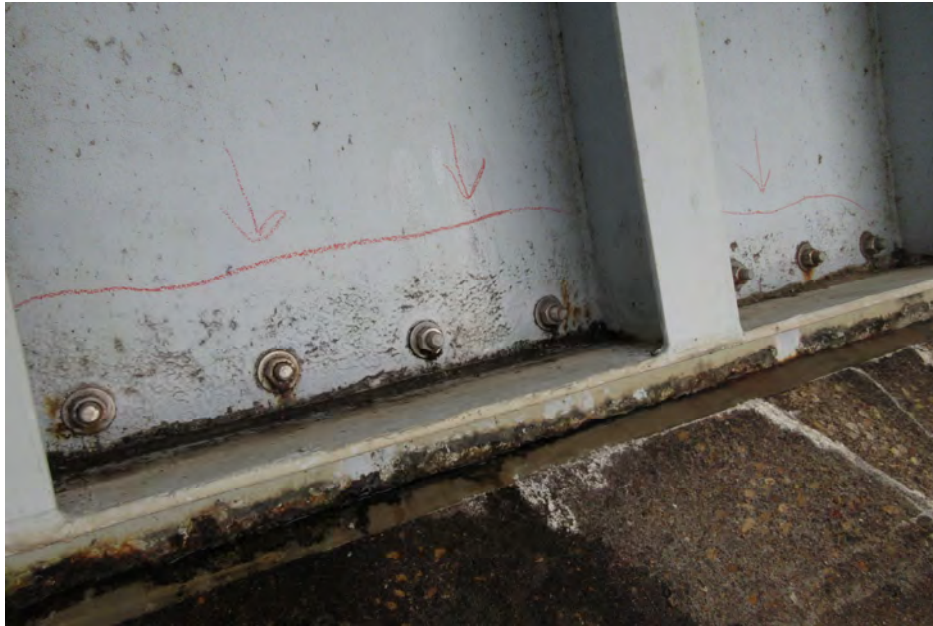
PHOTOGRAPH No.: 13

This area has pitting to 1/8" arrested along full width of gate, bottom edge is also corroded full width with section loss, CS-3.

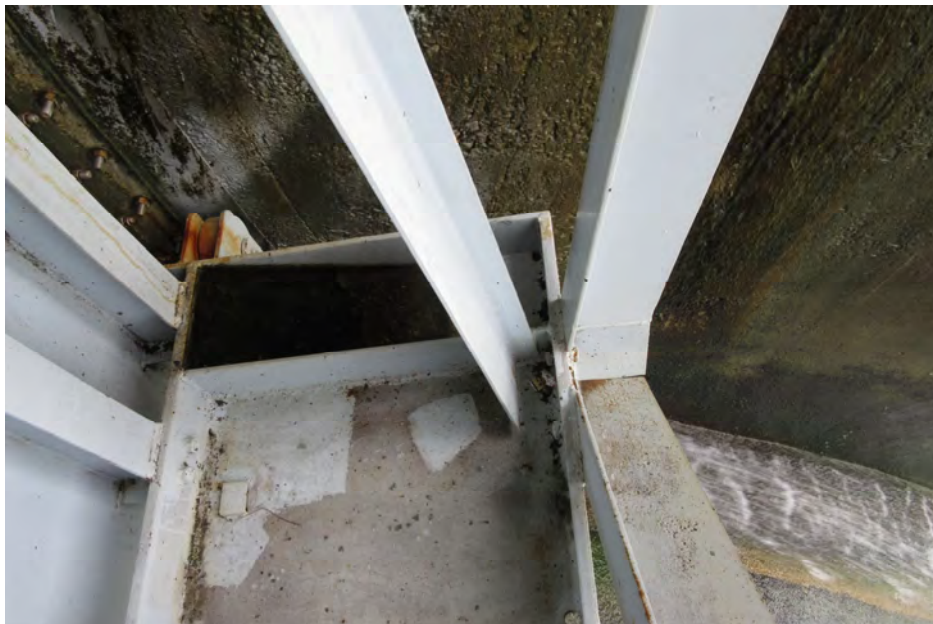
PHOTOGRAPH No.: 14

Dirt/debris is holding water between stiffeners & more significant leak in seal at the bottom left corner, about 3 gpm.

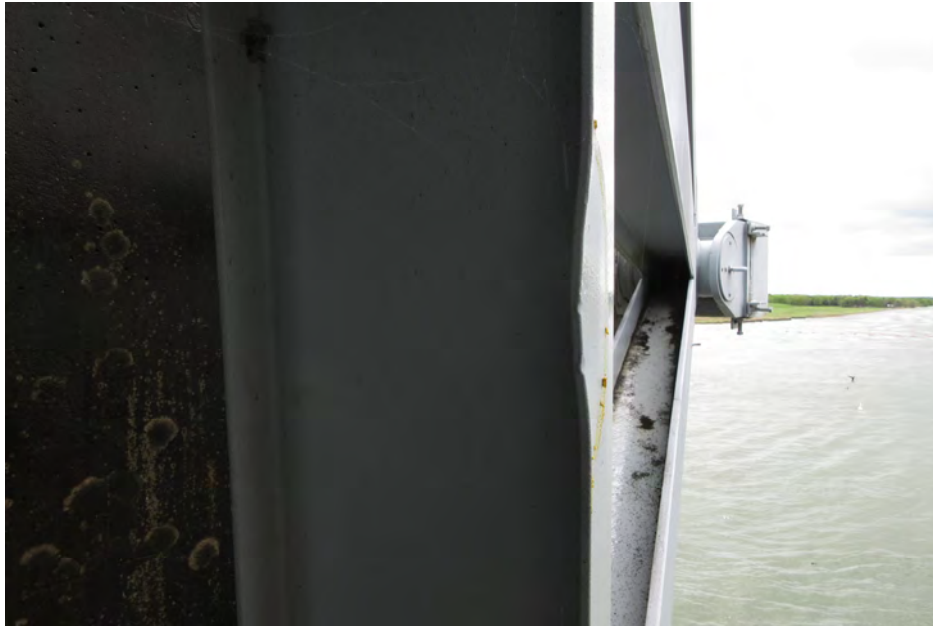
PHOTOGRAPH No.: 15

Out-of-plane bending of in-board U/S flange, 1/2" over 6" section, CS-2.

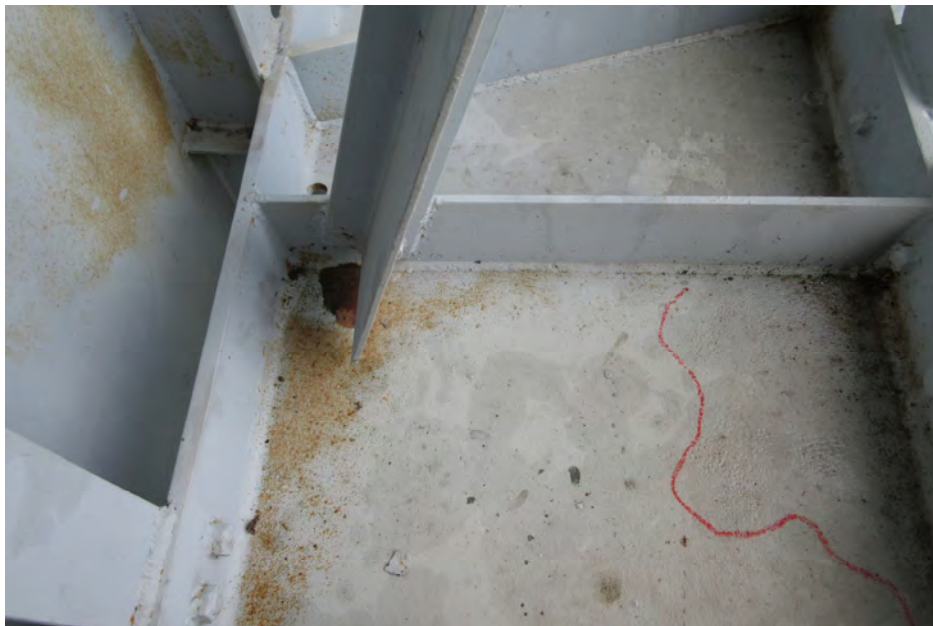
PHOTOGRAPH No.: 16

4" x 3" area paint failure with surface rust & light pitting, also 1' x 2' area of arrested pitting to 1/16" on topside web and typical freckle rust on girder & skin CS-3.

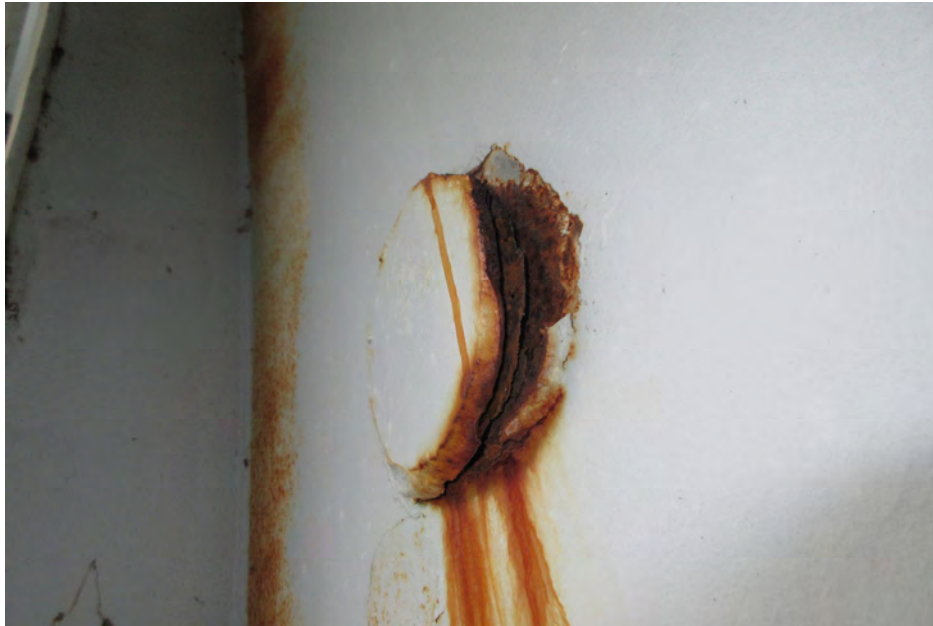
PHOTOGRAPH No.: 17

Tack welds have failed along left side and 1" of pack rust exists between cover plate & skin plate. Skin plate is pitted to 1/16" inch behind pack rust.

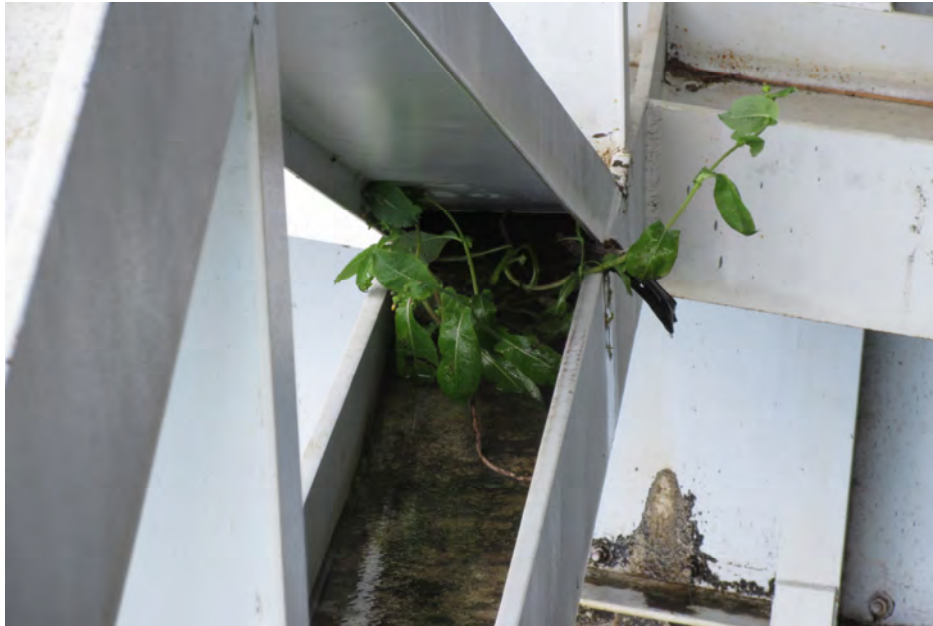
PHOTOGRAPH No.: 19

Dirt & debris collected between members holding water & vegetation.

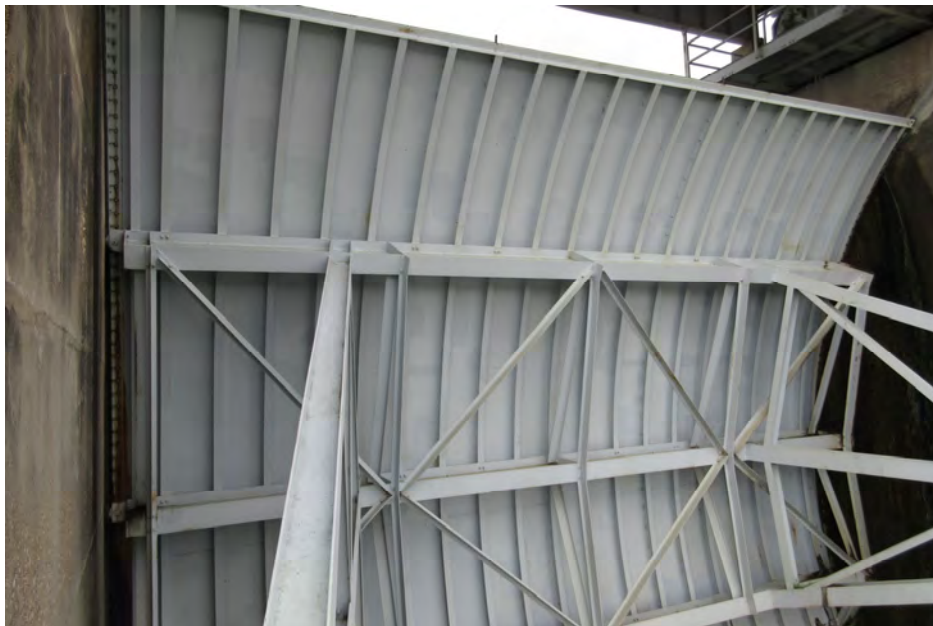
PHOTOGRAPH No.: 2
GATE: Gate 6
Photo Taken: 3/31/2020
File: MC-02.jpg

LOCATION:
Gate 6, Downstream face of gate.

COMMENTS:
Right roller guides at G-1 & G-2 spin free w/ 1/4" gap. Right roller guide at G-3 is touching buttress wall.

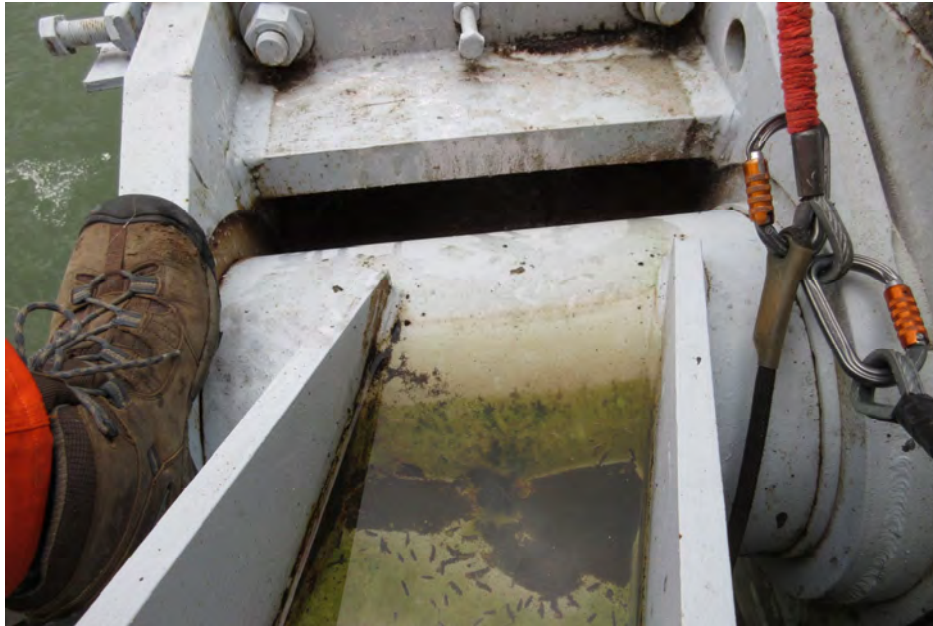
PHOTOGRAPH No.: 3
GATE: Gate 6
Photo Taken: 3/31/2020
File: MC-03.jpg

LOCATION:
Gate 6, right trunnion.

COMMENTS:
Blocked drain and ponding water at RS-1 & RS-2. Light surface rust on trunnion and trunnion casting CS-2.

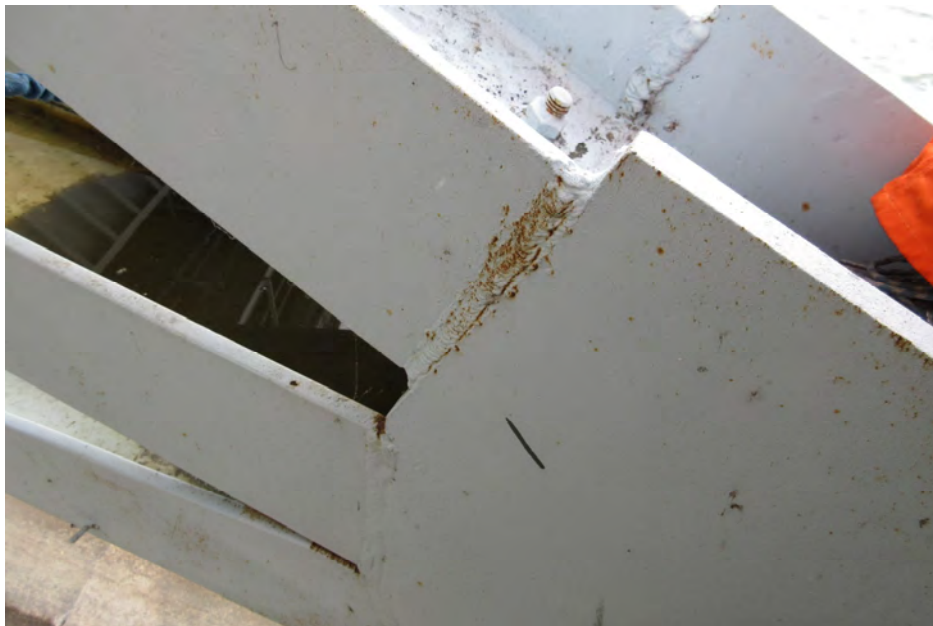
PHOTOGRAPH No.: 4
GATE: Gate 6
Photo Taken: 3/31/2020
File: MC-04.jpg

LOCATION:
Gate 6, RS-1 at gusset plate.
Outboard vertical field weld.

COMMENTS:
Rust bleed along weld. Weld appears to have poor penetration along the downstream edge. CS-2.

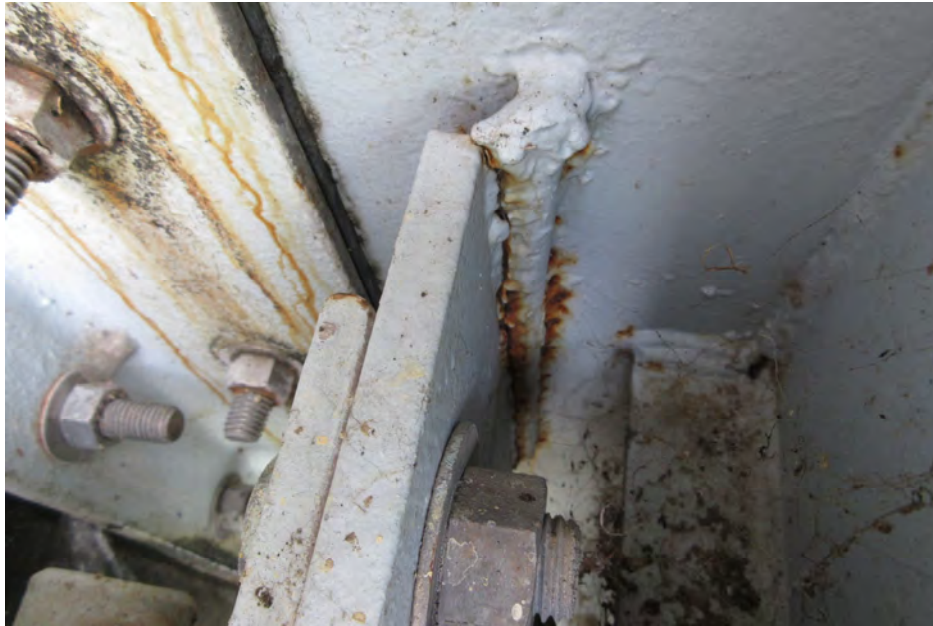
PHOTOGRAPH No.: 5

Vertical crack. 1/2" rebar or round rod was welded in place between skin and end of G-1. Crack is 100% through. No chance of propagation. CS-2.

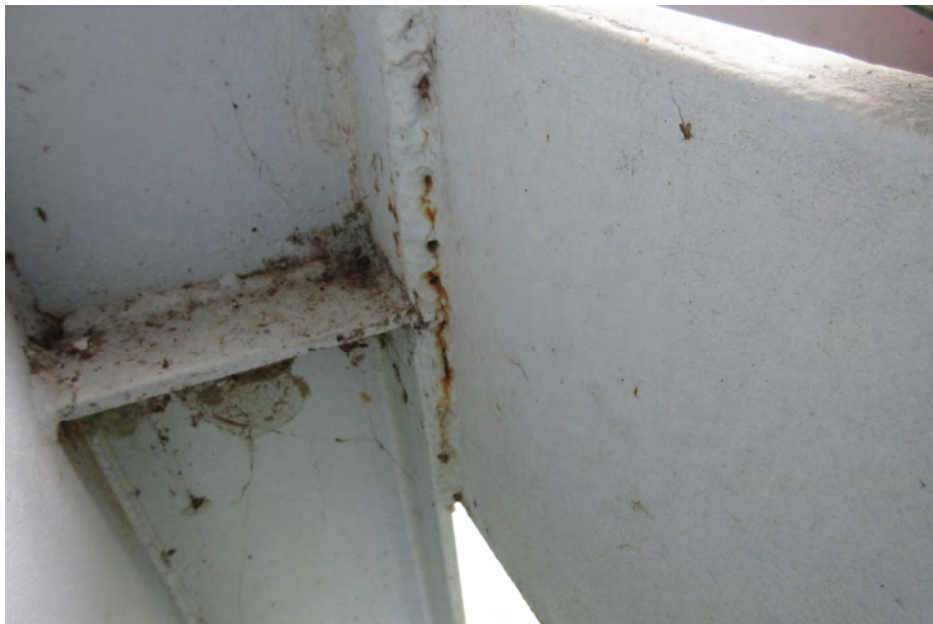
PHOTOGRAPH No.: 6

Cracked weld. Potential for propagation. CS-3.

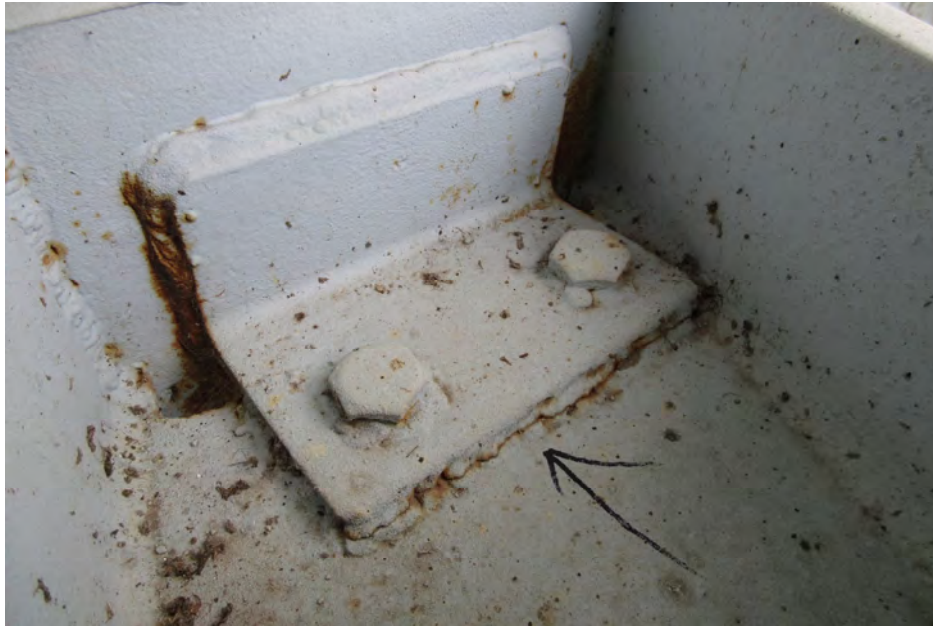
PHOTOGRAPH No.: 7
GATE: Gate 6
Photo Taken: 3/31/2020
File: MC-07.jpg

LOCATION:
Gate 6, RS-2 at G-2.

COMMENTS:
Cracked weld. Potential for propagation. CS-3.

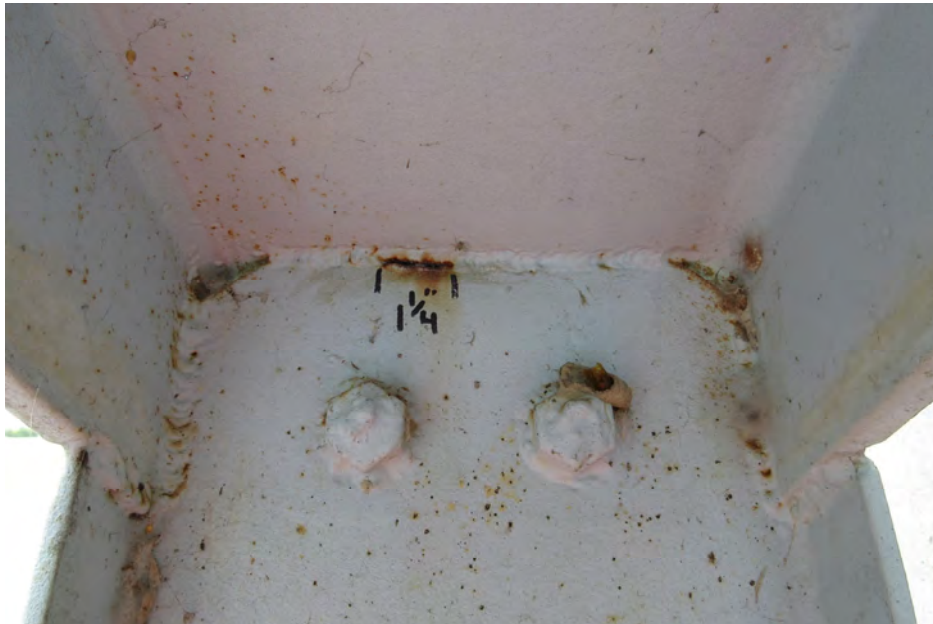
PHOTOGRAPH No.: 8
GATE: Gate 6
Photo Taken: 3/31/2020
File: MC-08.jpg

LOCATION:
Gate 6, RB-1 at RS-1.

COMMENTS:
Void in weld 1-1/4" long w/light surface rust. CS-2.

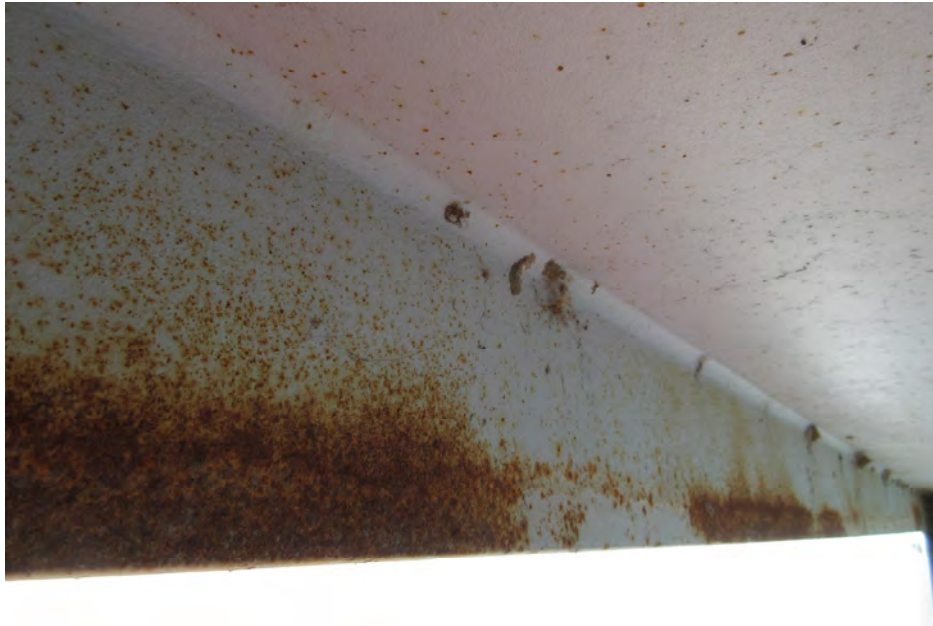
PHOTOGRAPH No.: 9
GATE: Gate 6
Photo Taken: 3/31/2020
File: MC-09.jpg

LOCATION:
Gate 6, underside of RS-2 between RB-1 & RB-3.

COMMENTS:
Light surface rust along flanges. CS-2.

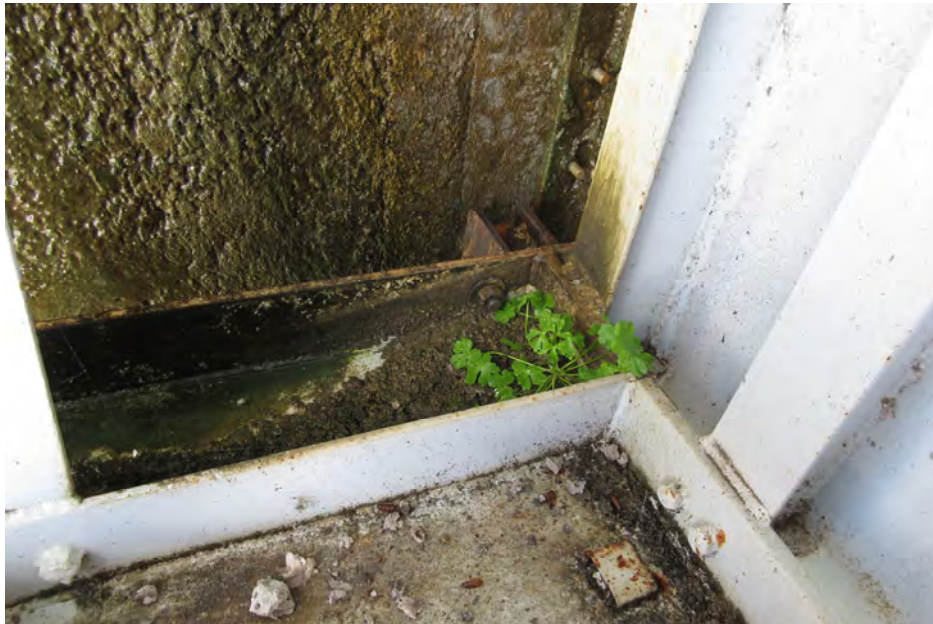
PHOTOGRAPH No.: 10
GATE: Gate 6
Photo Taken: 3/31/2020
File: MC-10.jpg

LOCATION:
Gate 6, G-3 right side.

COMMENTS:
Debris build-up to 2-1/2" w/ vegetation. Similar at left side of G-3.

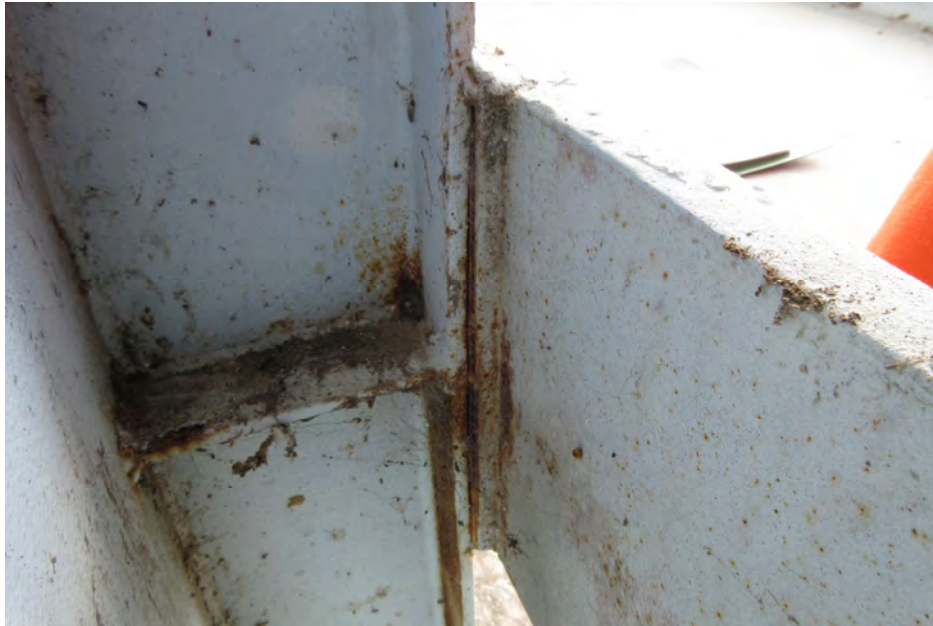
PHOTOGRAPH No.: 11

Lack of vertical weld to G-3 flange, skin plate material visible. CS-3.

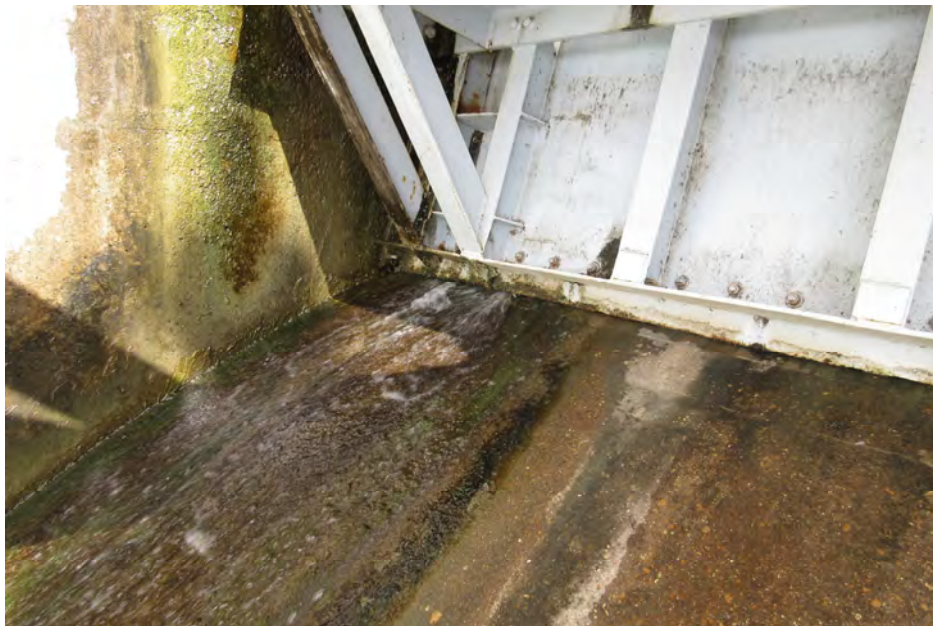
PHOTOGRAPH No.: 12

Approximately 20 gpm flow. No visible obstruction.

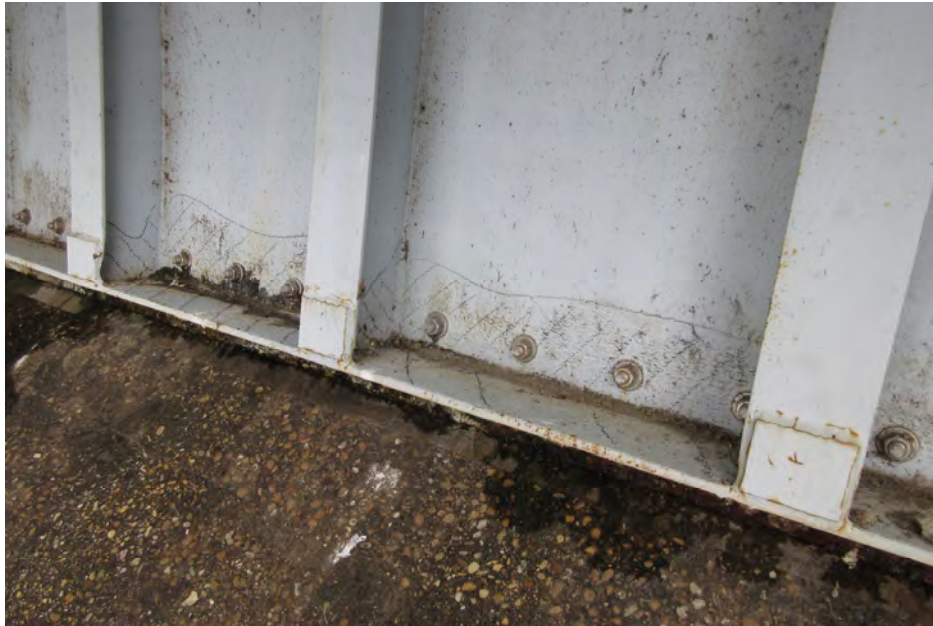
PHOTOGRAPH No.: 13

Mostly arrested pitting up to 3/16" in bottom horizontal 7/16" plate and up to 1/16" in skin plate. Typical throughout gate bottom 8". CS-3.

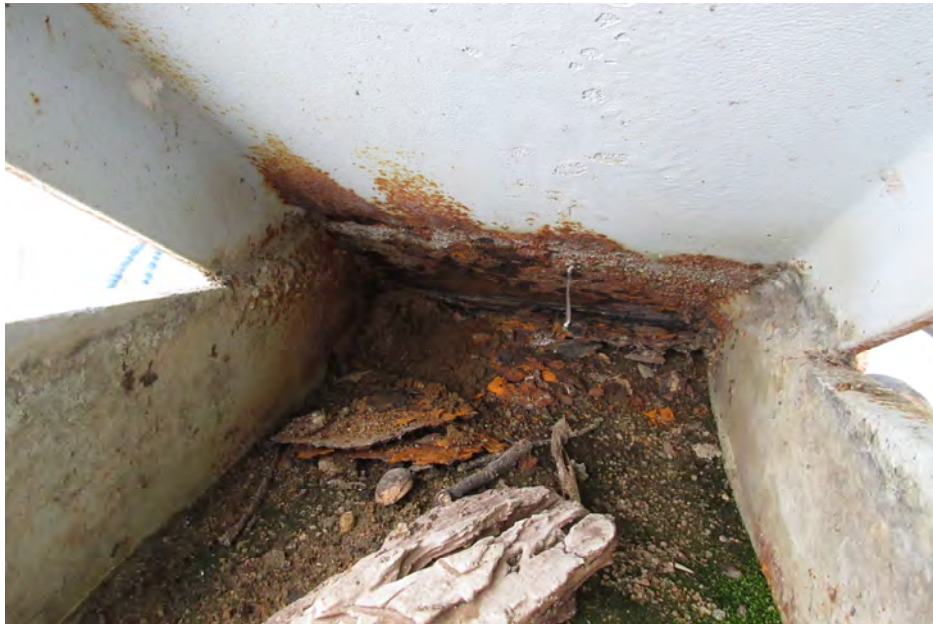
PHOTOGRAPH No.: 14

Laminar rust w/minor section loss. Approx. 10% CS-3. Debris build-up and blocked drain.

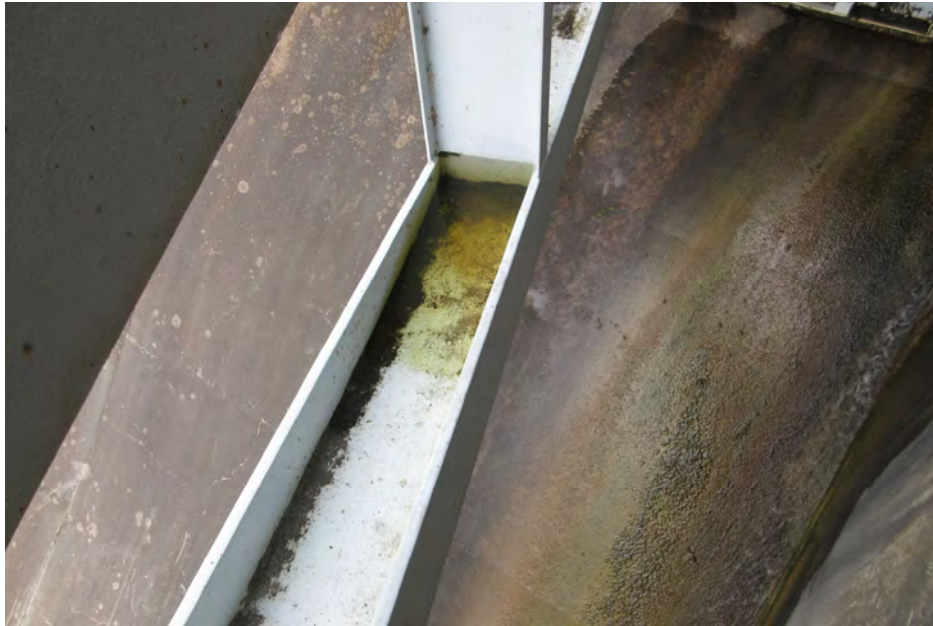
PHOTOGRAPH No.: 15

Ponding water and blocked drain.

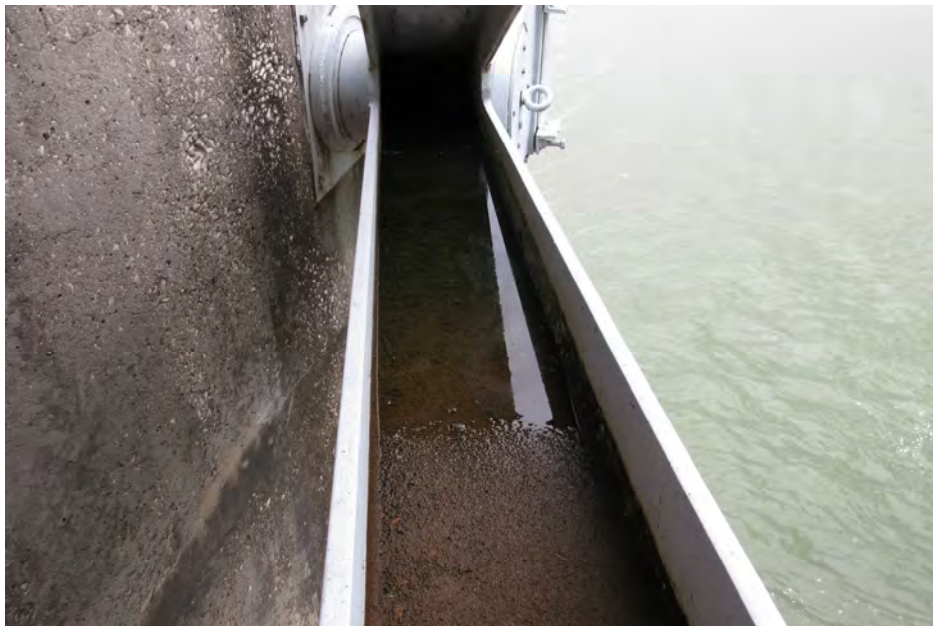
PHOTOGRAPH No.: 16

Ponding water and blocked drain.

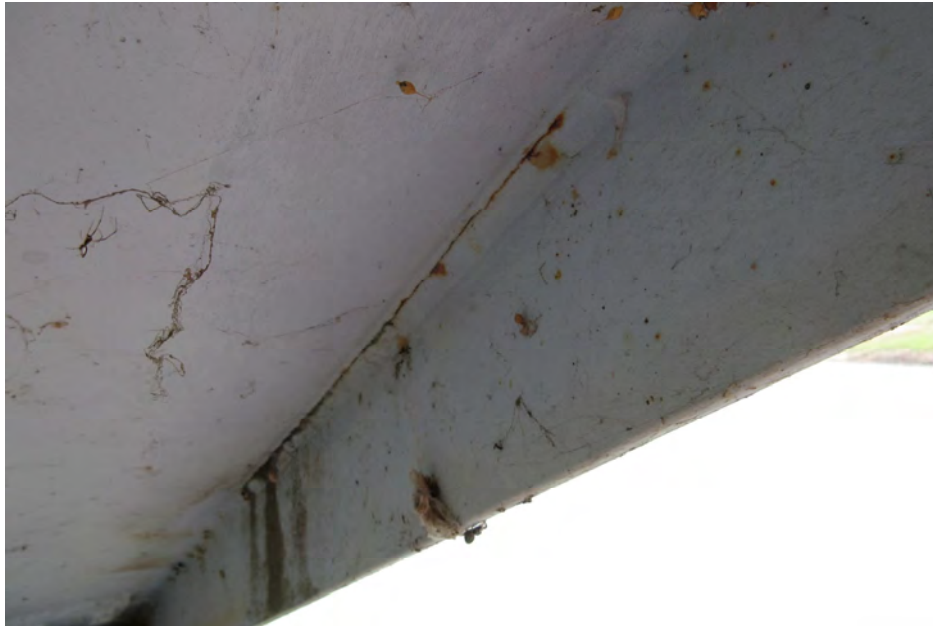
PHOTOGRAPH No.: 17

Cracked weld. Flange to web weld crack 18" long. Potential for propagation. CS-4.

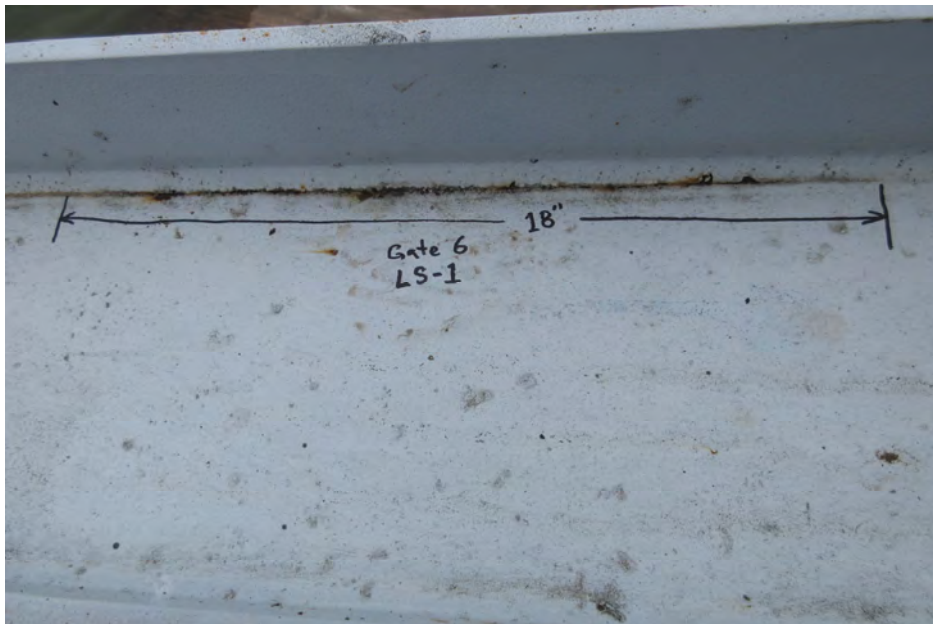
PHOTOGRAPH No.: 18

Cracked weld. Flange to web weld crack 18" long. Potential for propagation. CS-4.

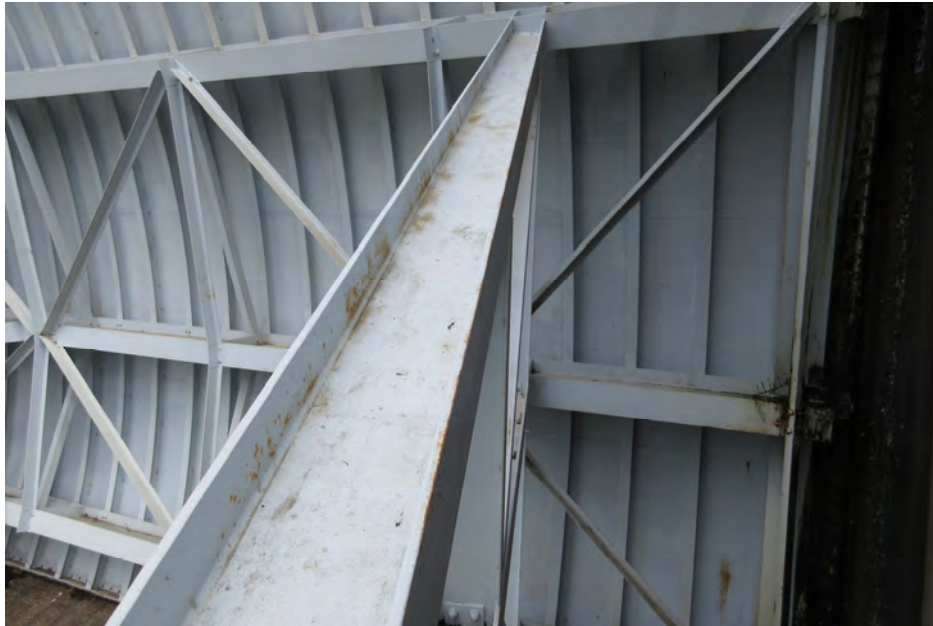
PHOTOGRAPH No.: 19

LOCATION:
Gate 6, LS-1.

COMMENTS:
Failing paint with light rust bleed through. CS-2.

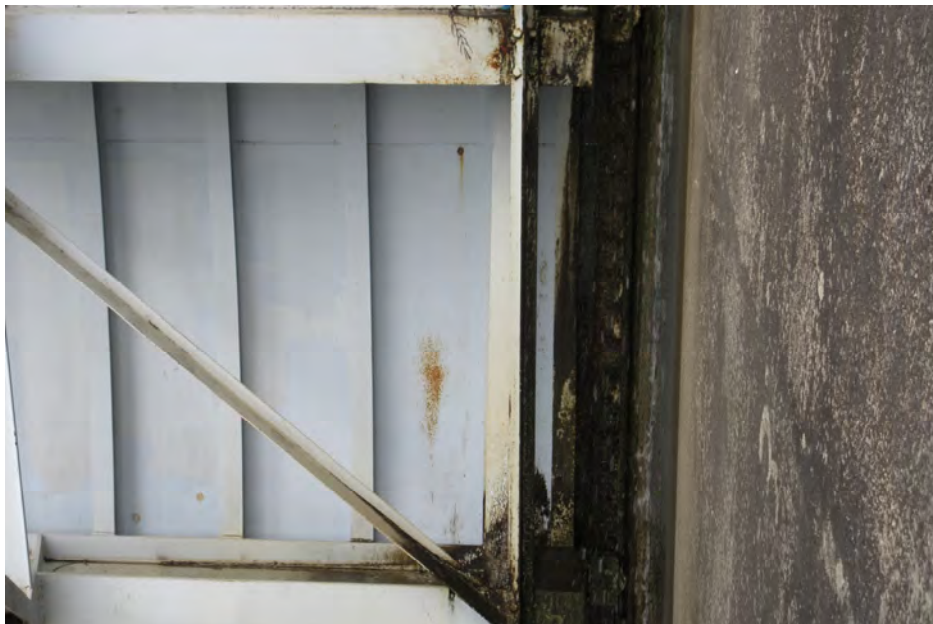
PHOTOGRAPH No.: 20

COMMENTS:
Minor paint chip w/moderate surface rust and rust bleed through. Typical of isolated spots throughout skin. CS-2.

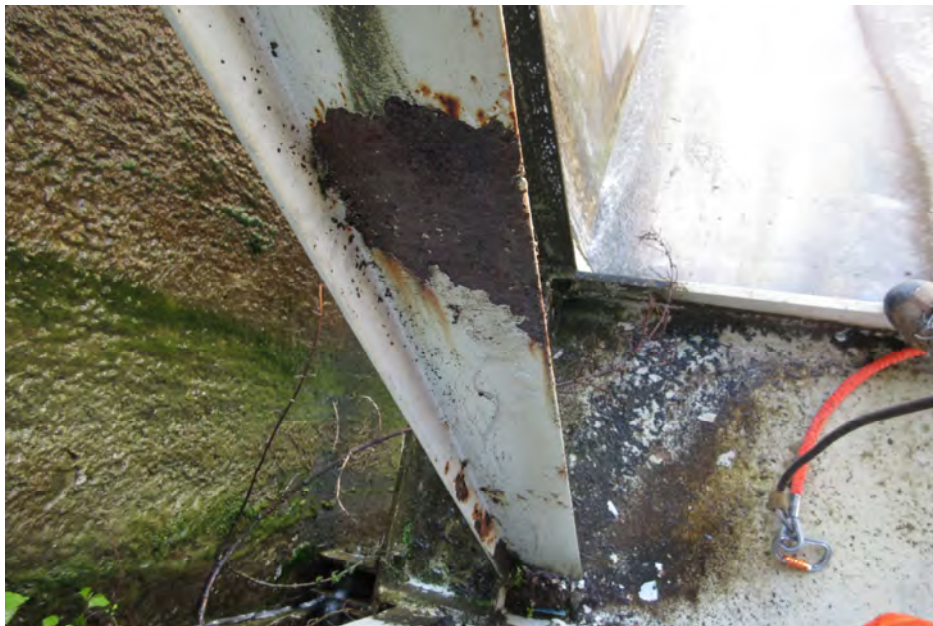
PHOTOGRAPH No.: 22

Failed paint with heavy corrosion and section loss to 1/16". CS-3.

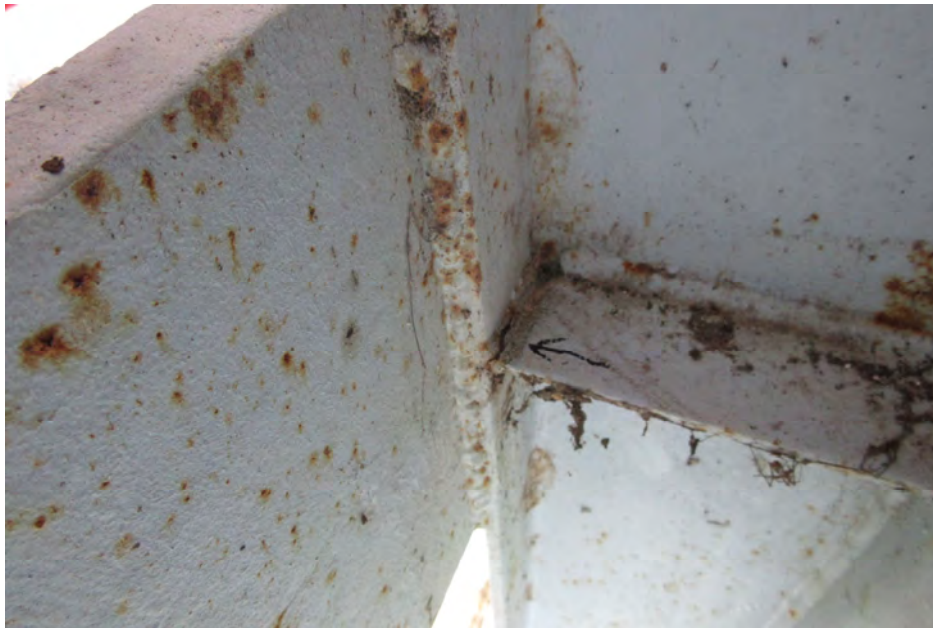
PHOTOGRAPH No.: 23

Cracked weld. Partially cracked weld. Potential for propagation. CS-3.

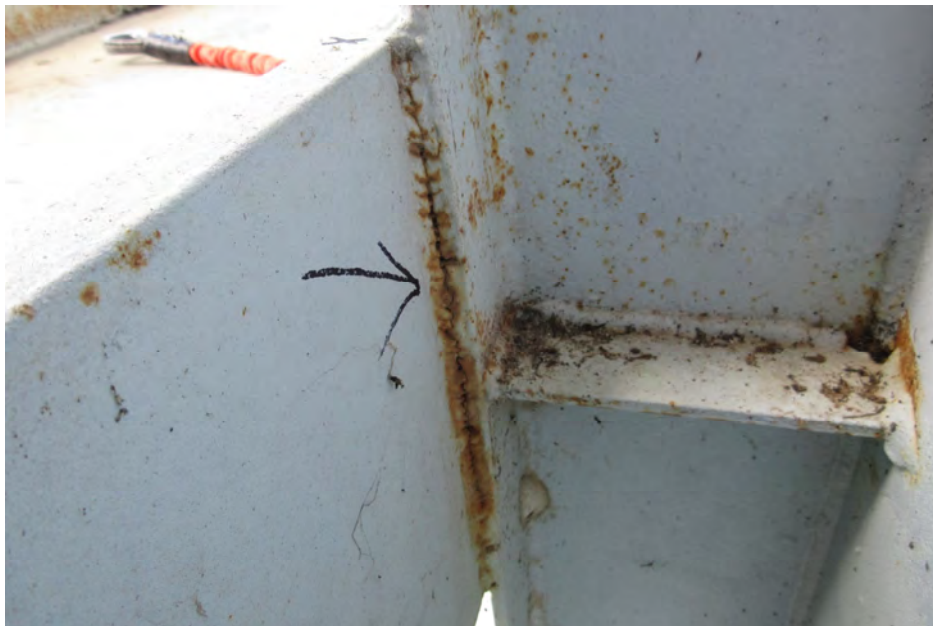
PHOTOGRAPH No.: 24

Cracked weld. 100% cracked through. No potential for propagation. CS-2.

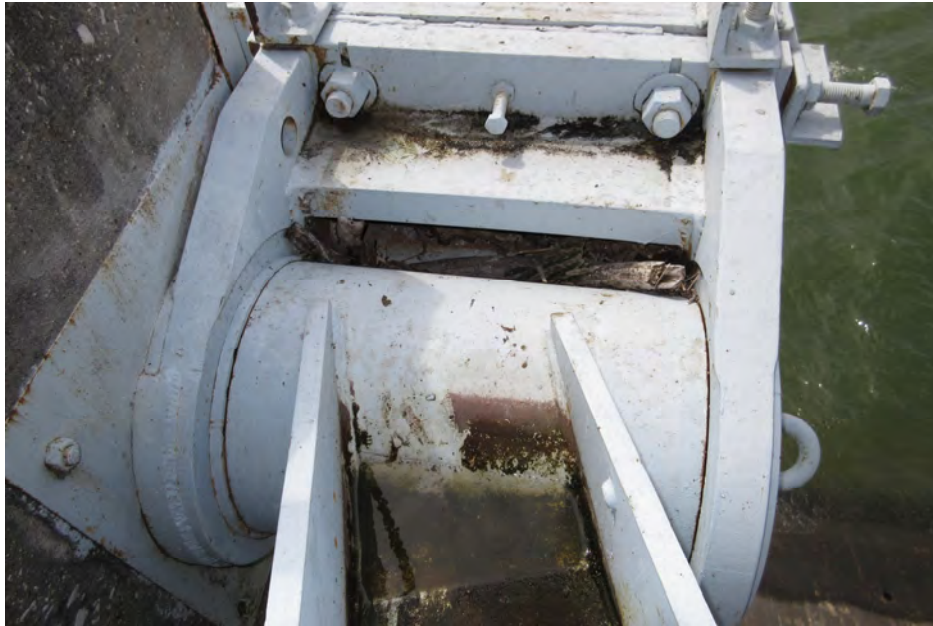
PHOTOGRAPH No.: 25

Sticks and debris build-up inside casting.

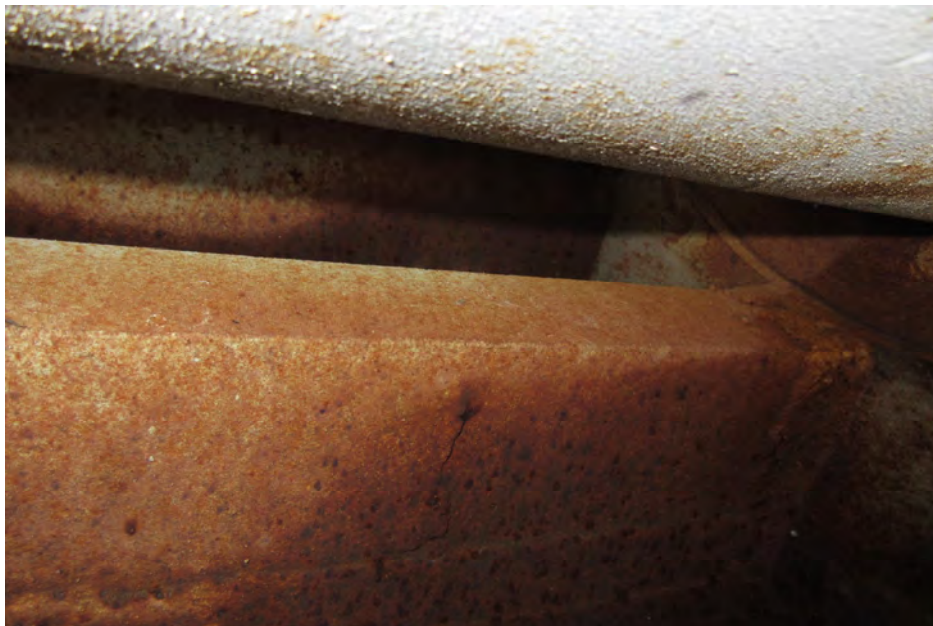
PHOTOGRAPH No.: 2
GATE: Gate 7
Photo Taken: 3/31/2020
File: CL-25.jpg

LOCATION:
Gate 7, right trunnion

COMMENTS:
Inside of casting has paint failure with heavy rust bleed throughout, CS2.

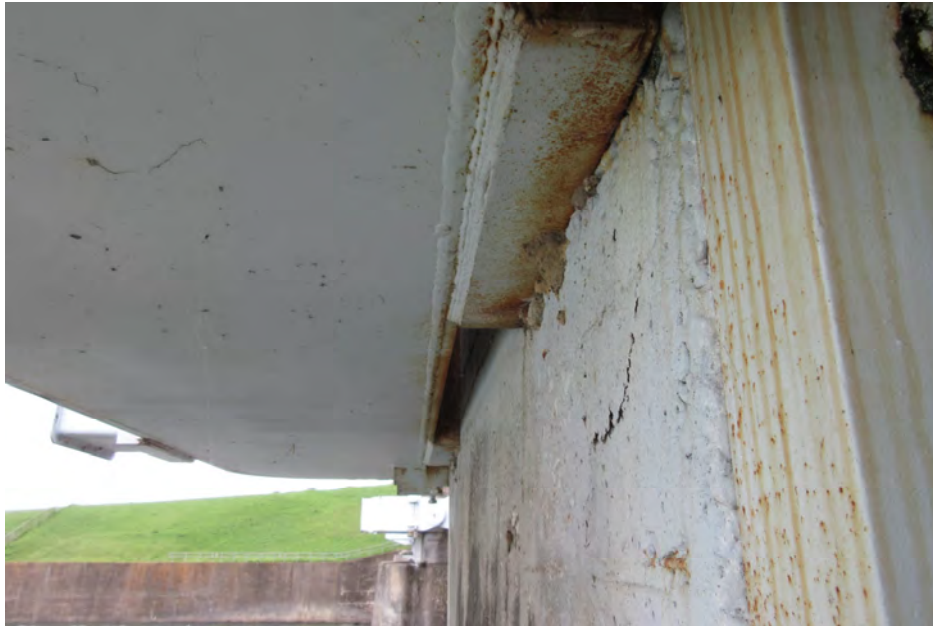
PHOTOGRAPH No.: 3
GATE: Gate 7
Photo Taken: 3/31/2020
File: CL-26.jpg

LOCATION:
Gate 7, trunnion girder between Gates 7 & 6.

COMMENTS:
Paint failure on backside of block, CS2.

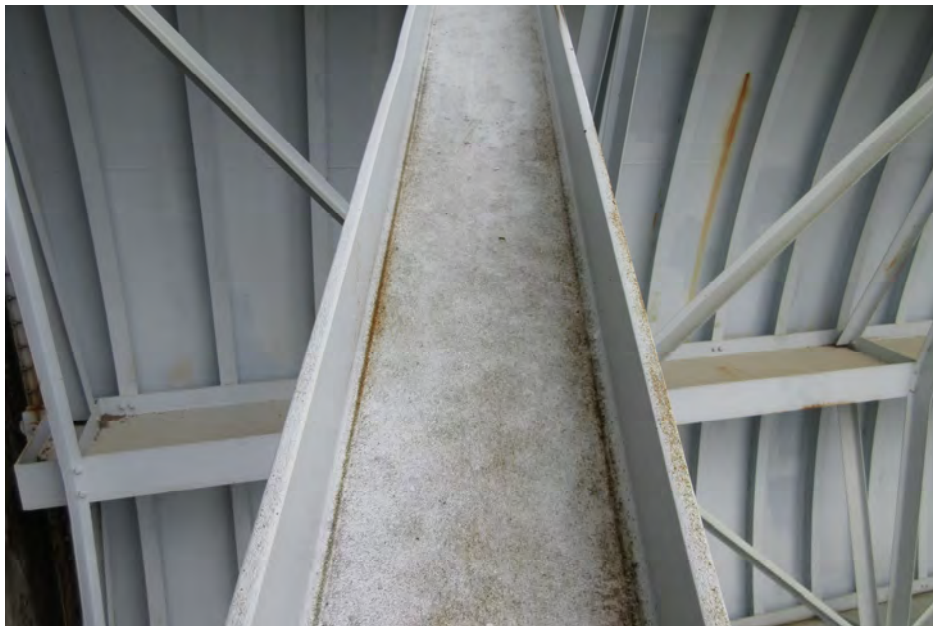
PHOTOGRAPH No.: 4
GATE: Gate 7
Photo Taken: 3/31/2020
File: CL-27.jpg

LOCATION:
Gate 7, RS-1 at RB-1.

COMMENTS:
Rust bleed throughout. Plus out-of-plane bending in flange 1/4" over 5", CS2.

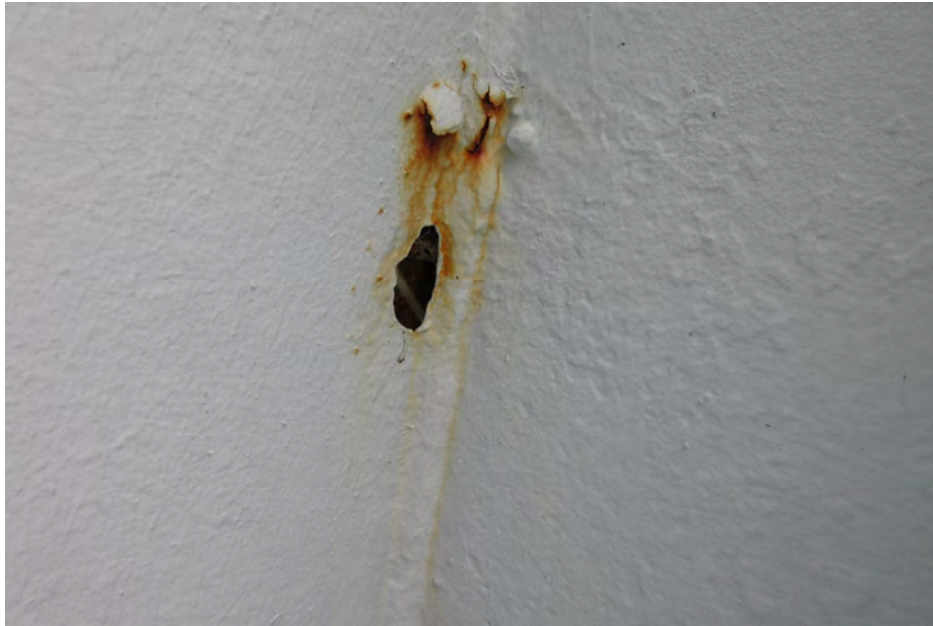
PHOTOGRAPH No.: 5
GATE: Gate 7
Photo Taken: 3/31/2020
File: CL-28.jpg

LOCATION:
Gate 7, skin plate 2' above G-16 at V-06.

COMMENTS:
3/4" hole in skin plate that has been patched.

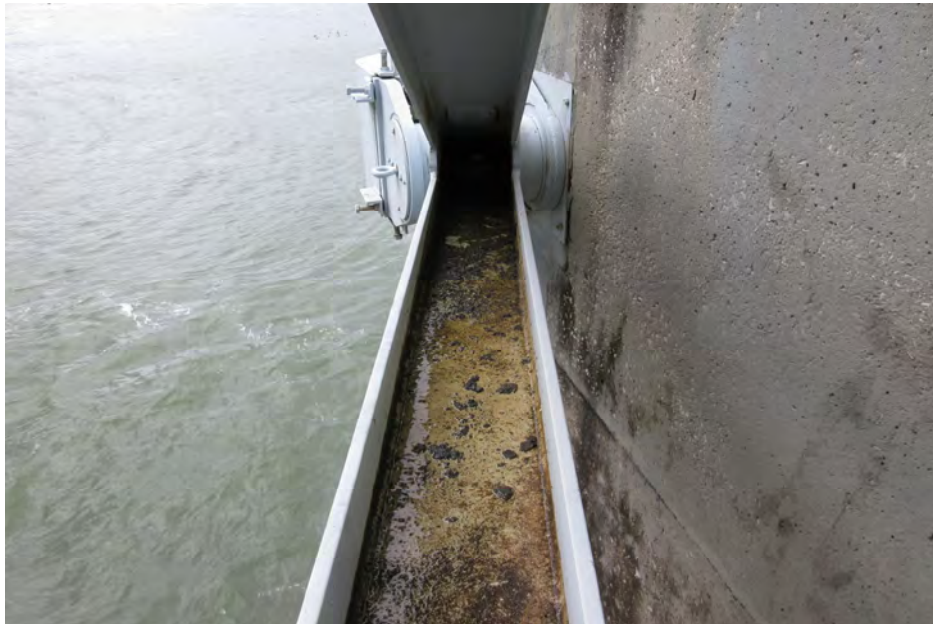
PHOTOGRAPH No.: 6
GATE: Gate 7
Photo Taken: 3/31/2020
File: CL-29.jpg

LOCATION:
Gate 7, RS-2 at trunnion.

COMMENTS:
Drain hole plugged holding debris and water.

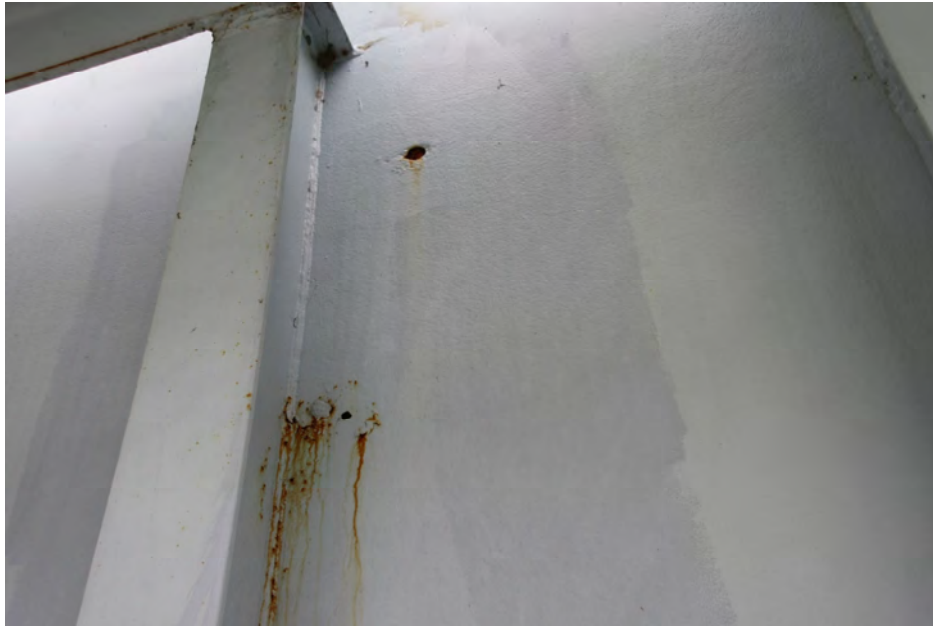
PHOTOGRAPH No.: 7
GATE: Gate 7
Photo Taken: 3/31/2020
File: CL-31.jpg

LOCATION:
Gate 7, skin plate between V-04 and V-05, 9' above G-2.

COMMENTS:
Two full depth holes in skin plate that have been patched.
