VISUAL INSPECTION AND EVALUATION REPORT

Rockwall-Forney Dam
Dallas Water Utilities
Dallas/Kaufman Counties, Texas

Schnabel Reference #20C22001.00
July 30, 2021

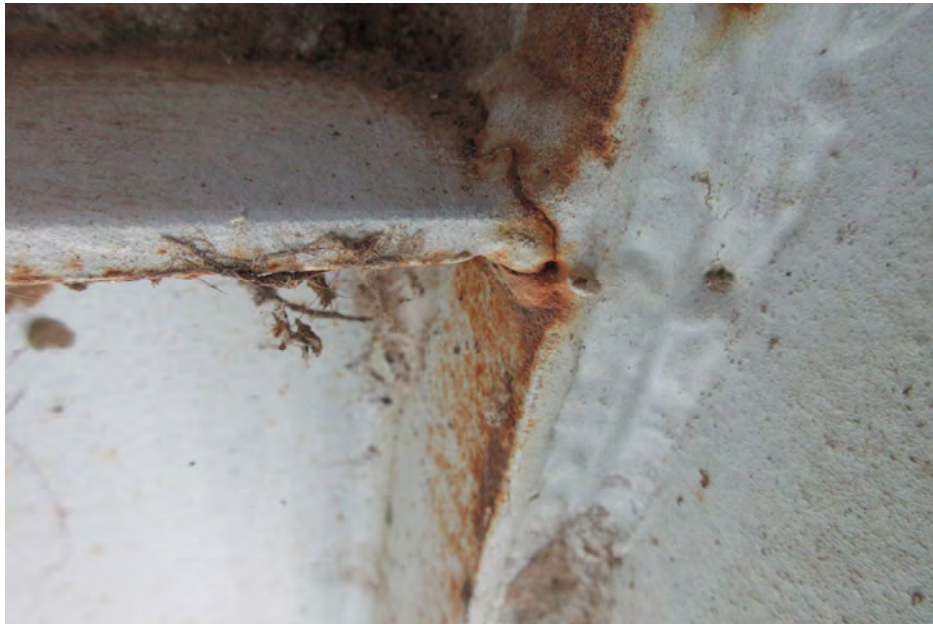
PHOTOGRAPH No.: 8
GATE: Gate 7
Photo Taken: 3/31/2020
File: CL-32.jpg

LOCATION:
Gate 7, V-04 at G-2 web stiffener.

COMMENTS:
3/4" long crack in weld, CS3.

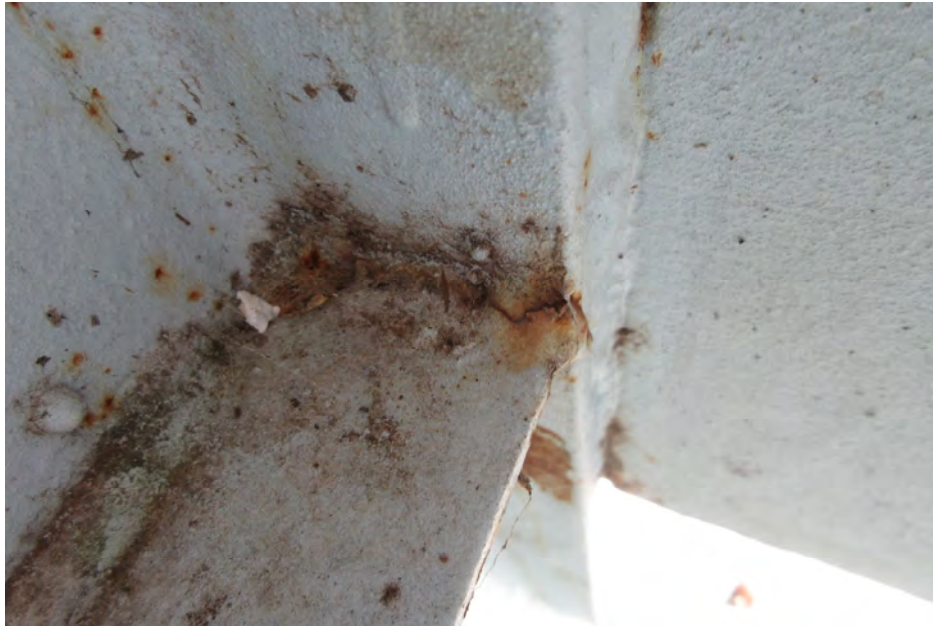
PHOTOGRAPH No.: 9
GATE: Gate 7
Photo Taken: 3/31/2020
File: CL-34.jpg

LOCATION:
Gate 7, V-06 at G-2 web stiffener.

COMMENTS:
3/4" long crack in weld, CS3.

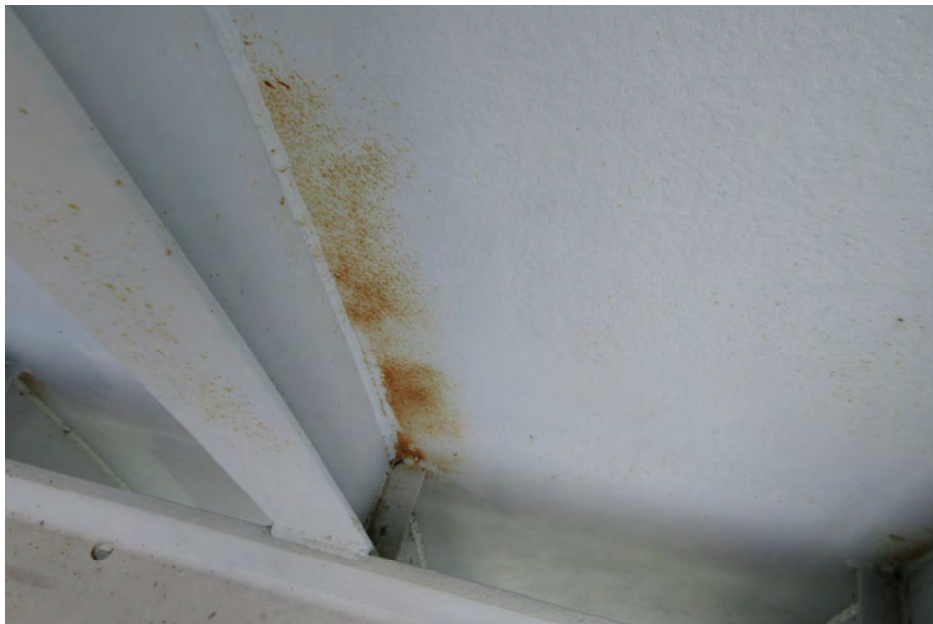
PHOTOGRAPH No.: 10
GATE: Gate 7
Photo Taken: 3/31/2020
File: CL-35.jpg

LOCATION:
Gate 7, skin plate between V-05 and V-06 at G-2.

COMMENTS:
Rust bleed through paint CS2.
Common on 10% of this gate.

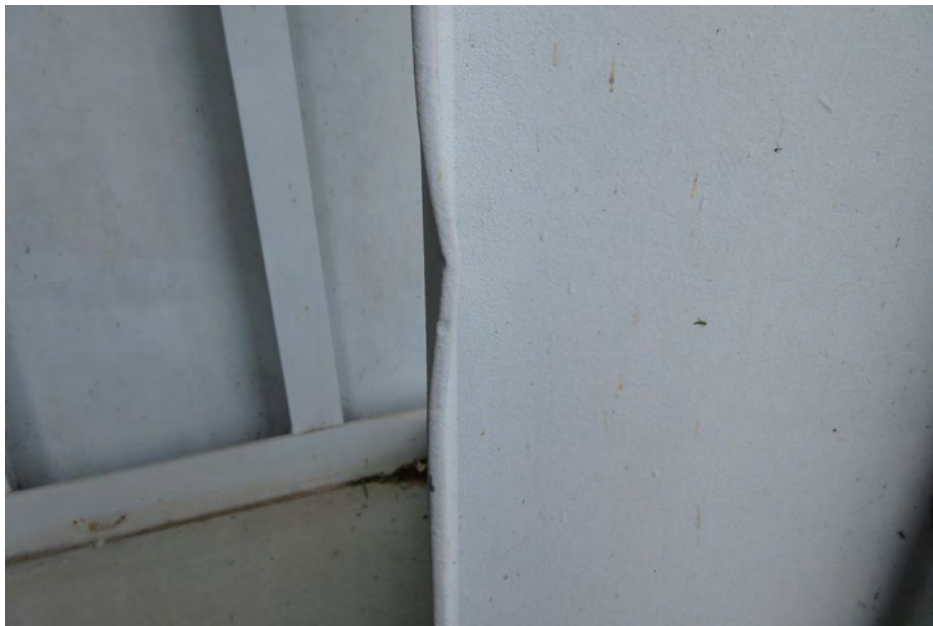
PHOTOGRAPH No.: 12

Out-of-plane bending 1/2" over 2" on flange.

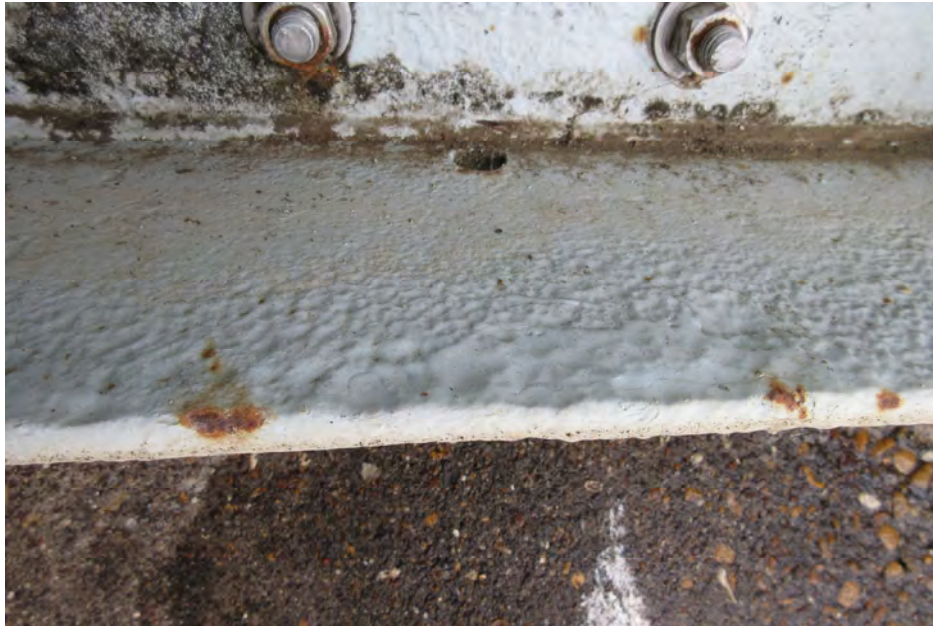
PHOTOGRAPH No.: 13

Heavy pitting up to 1/8". Common for the whole plate.

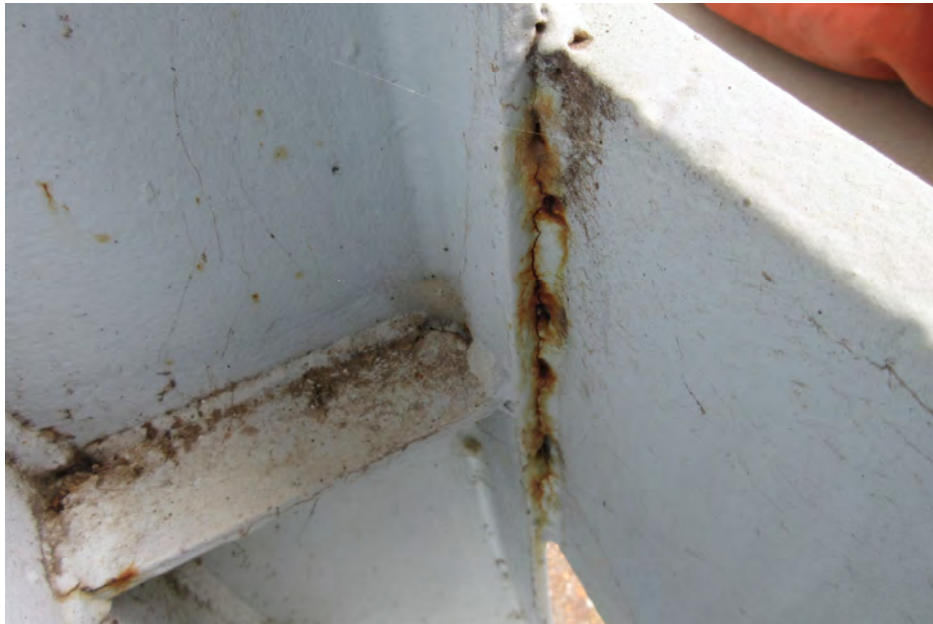
PHOTOGRAPH No.: 14

Both welds on either side of the vertical are cracked, CS3.

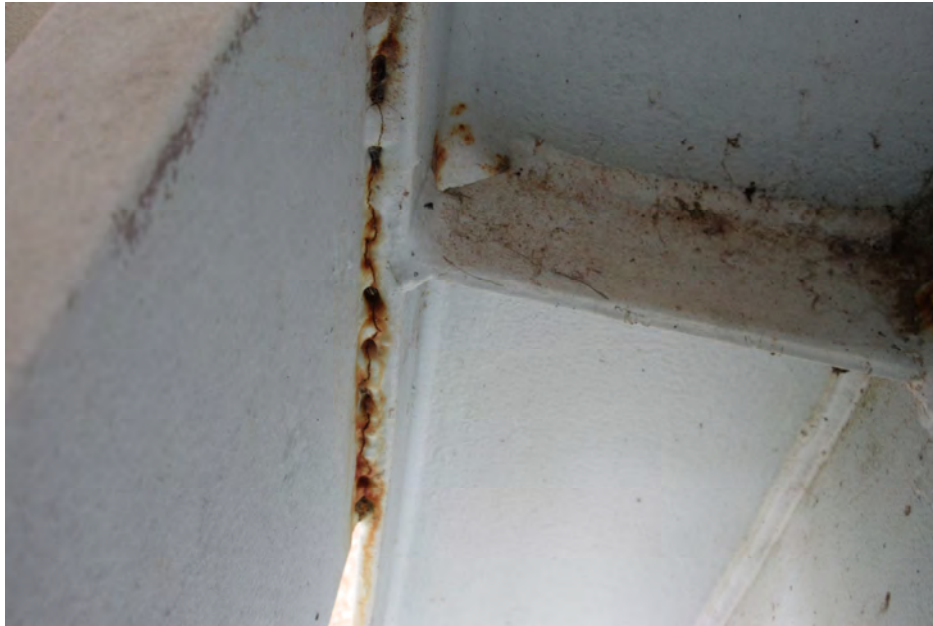
PHOTOGRAPH No.: 15

Both welds on either side of the vertical are cracked, CS3.

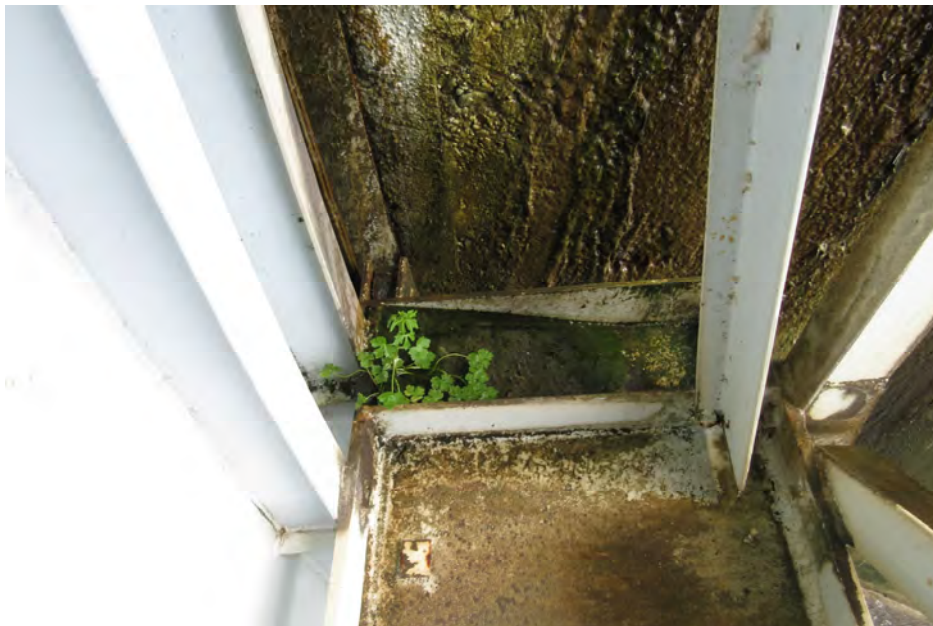
PHOTOGRAPH No.: 16

No drain hole in left section allows for standing water and debris in web.

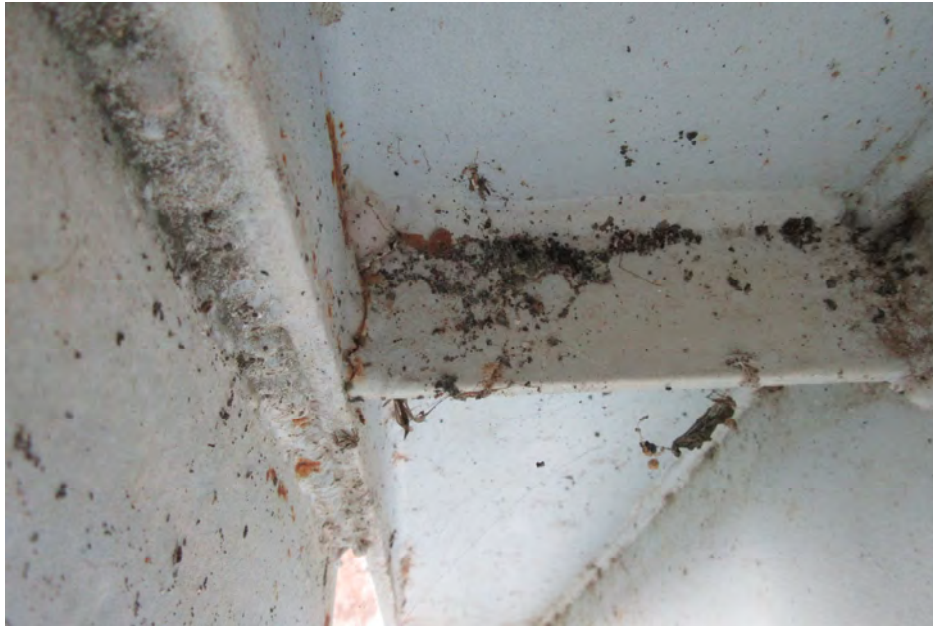
PHOTOGRAPH No.: 17

Weld in web stiffener is cracked clean through, CS2.

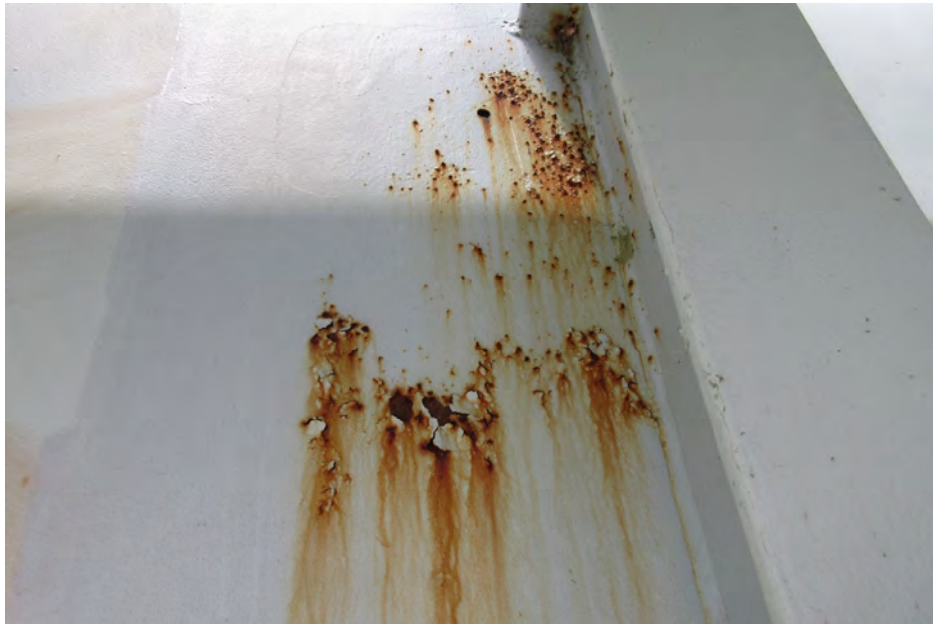
PHOTOGRAPH No.: 18

Hole in skin plate 1/2" round has been repaired 10" x 20" area of paint failure with heavy surface rust, CS2.

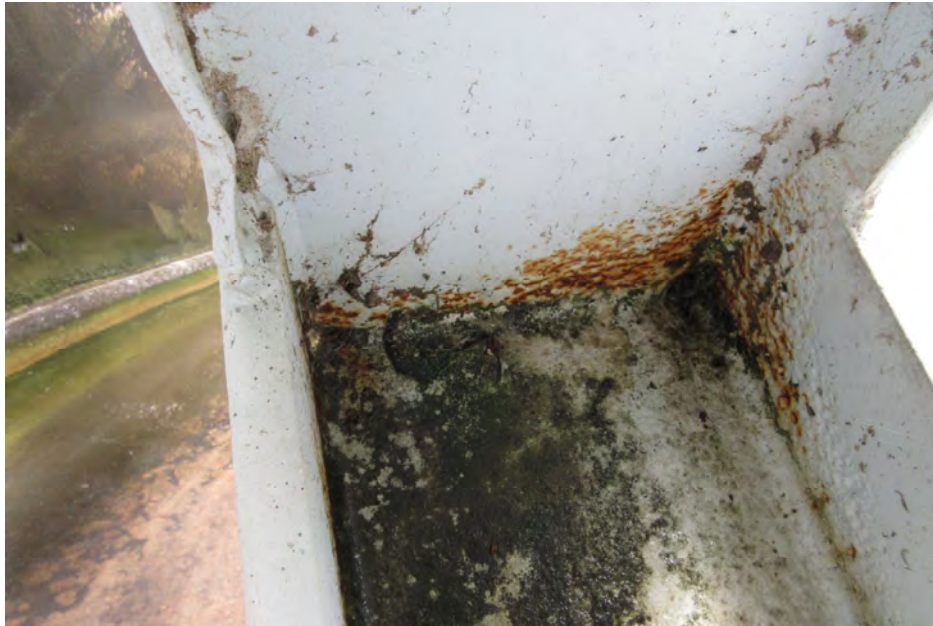
PHOTOGRAPH No.: 19

Heavy pitting in LB-6 web rust bleed through most recent paint job. Note: Out-of-plane bending in flange 1/2" over 2".

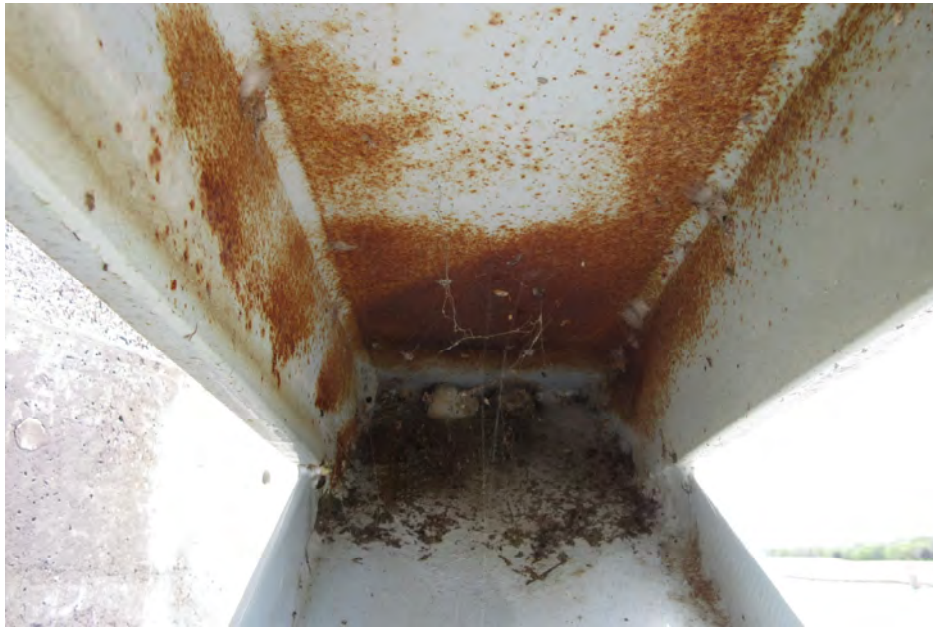
PHOTOGRAPH No.: 20

Paint failure with moderate rust bleed 1' x 1', CS2.

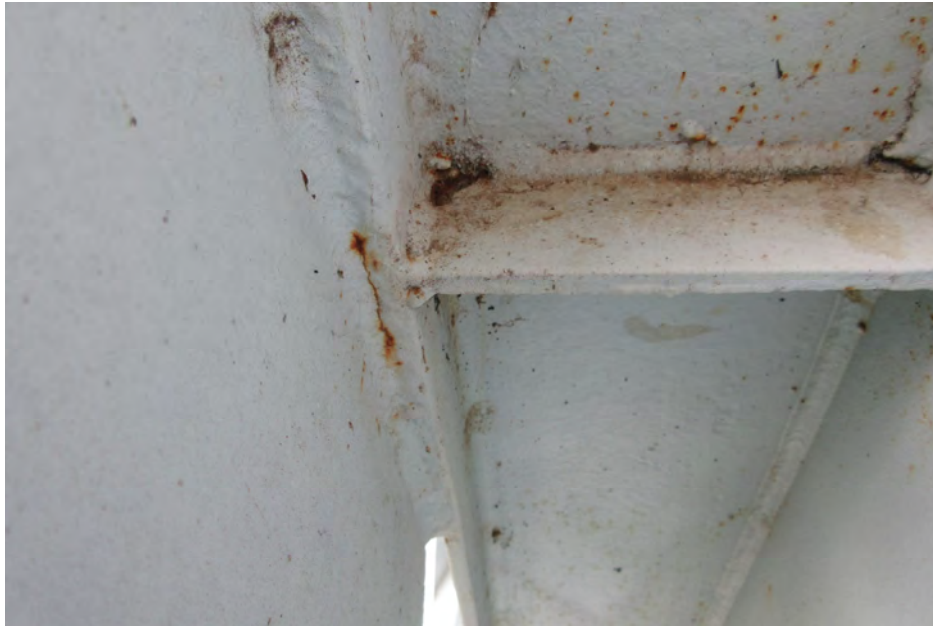
PHOTOGRAPH No.: 21

1 1/2" crack in vertical weld,
CS3.

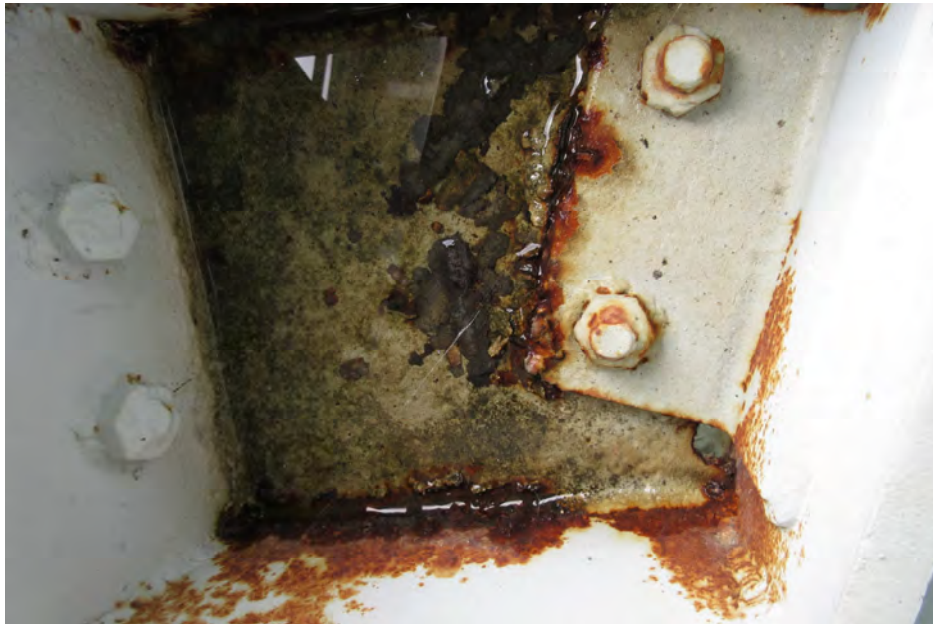
PHOTOGRAPH No.: 22

Angle bracket and flange have
heavy surface rust and some
minor section loss, CS3.

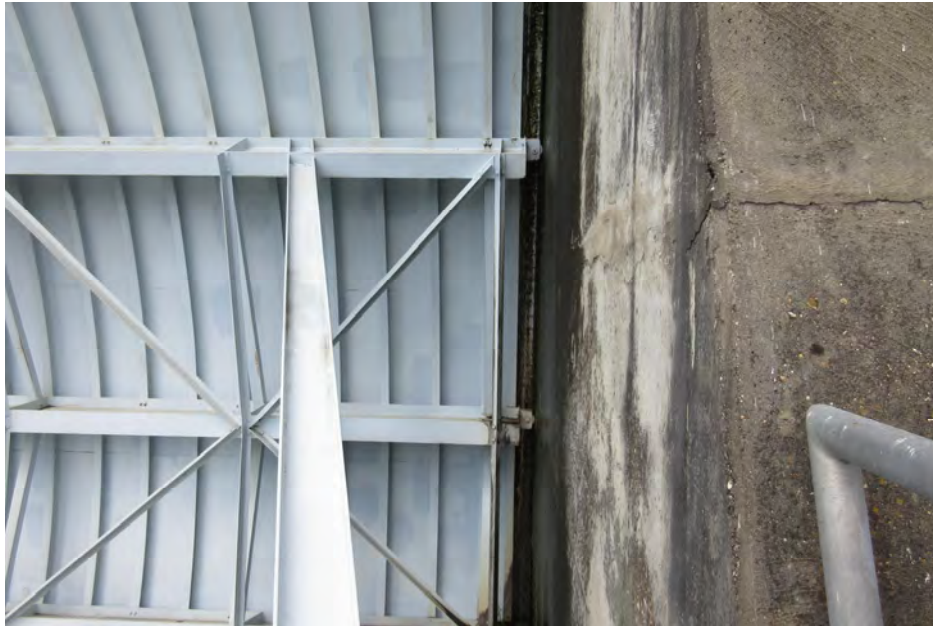
PHOTOGRAPH No.: 23

Minor leaks are causing mold and constant moisture.

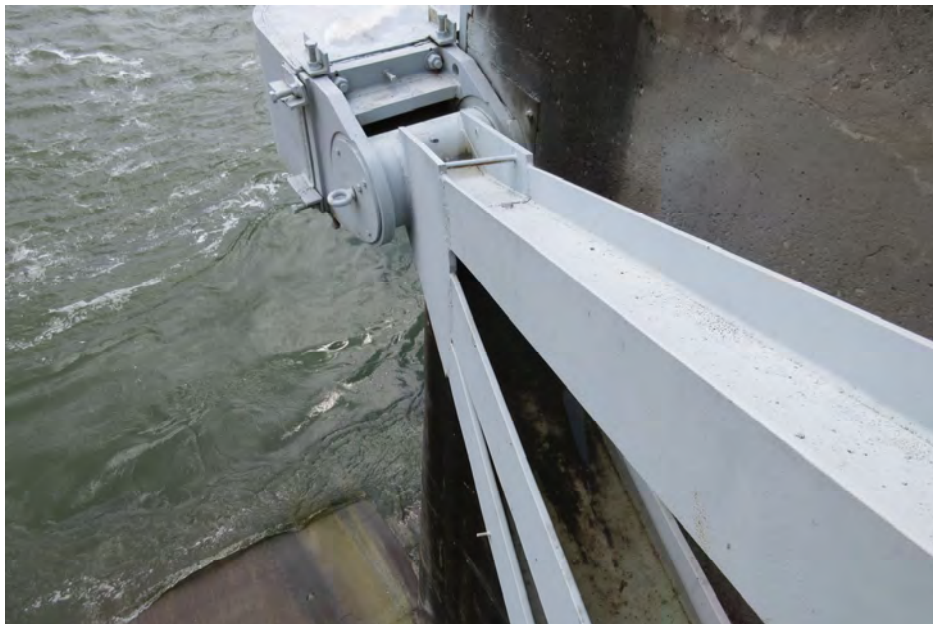
PHOTOGRAPH No.: 2
GATE: Gate 8
Photo Taken: 3/31/2020
File: MC-28.jpg

LOCATION:
Gate 8, RS-1 & RS-2 at gusset plate.

COMMENTS:
Ponding water and blocked drains.

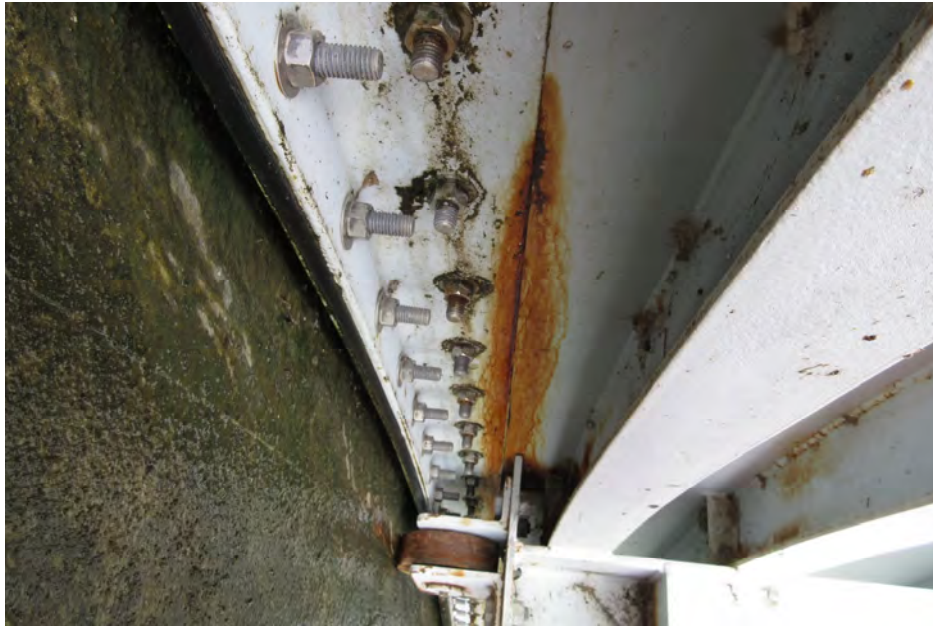
PHOTOGRAPH No.: 3
GATE: Gate 8
Photo Taken: 3/31/2020
File: MC-29.jpg

LOCATION:
Gate 8, right seal above G-1.

COMMENTS:
Rust staining from seal plate.
Roller guide is in contact with
buttress, CS-2.

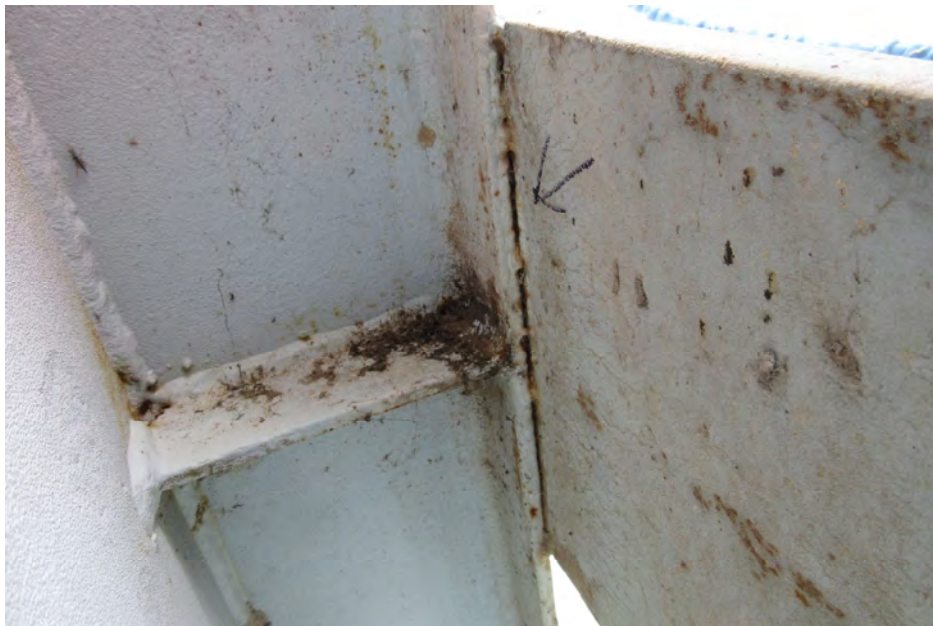
PHOTOGRAPH No.: 4
GATE: Gate 8
Photo Taken: 3/31/2020
File: MC-30.jpg

LOCATION:
Gate 8, V-3 at G-1, right side.

COMMENTS:
Lack of vertical weld to G-1
flange, CS-3.

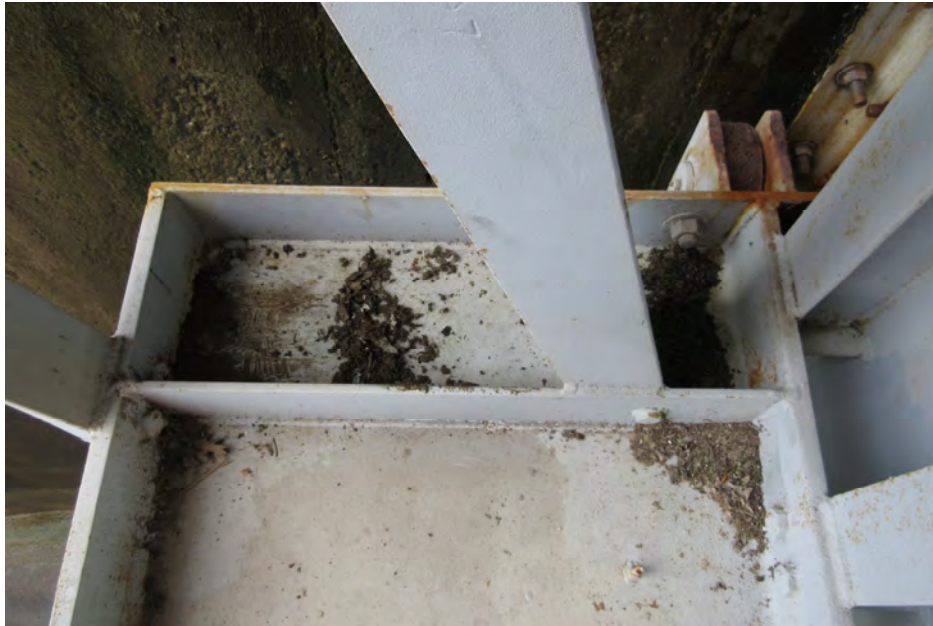
PHOTOGRAPH No.: 5
GATE: Gate 8
Photo Taken: 3/31/2020
File: MC-31.jpg

LOCATION:
Gate 8, G-2 right side.

COMMENTS:
Light debris build-up on girder.
Drain holes are clear. 4" x 6"
area of flaking paint and moderate surface rust. CS-2. Roller guide spins freely and is 1/4" from buttress.

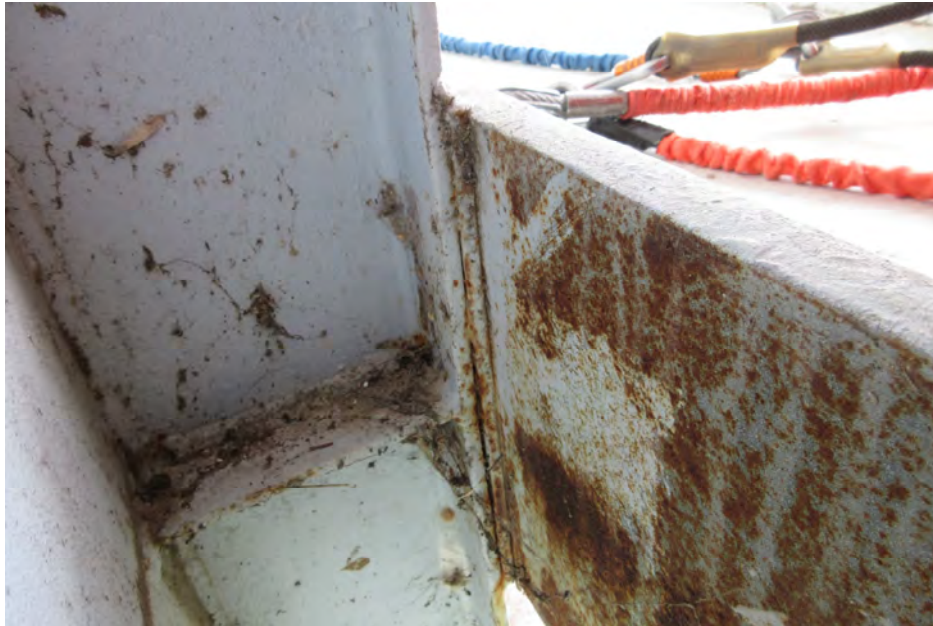
PHOTOGRAPH No.: 7
GATE: Gate 8
Photo Taken: 3/31/2020
File: MC-33.jpg

LOCATION:
Gate 8, V-3 at G-3, right side.

COMMENTS:
Lack of vertical weld to G-3 flange. 1/4" shim visible. Light pack rust. CS-3. Similar at V-4.

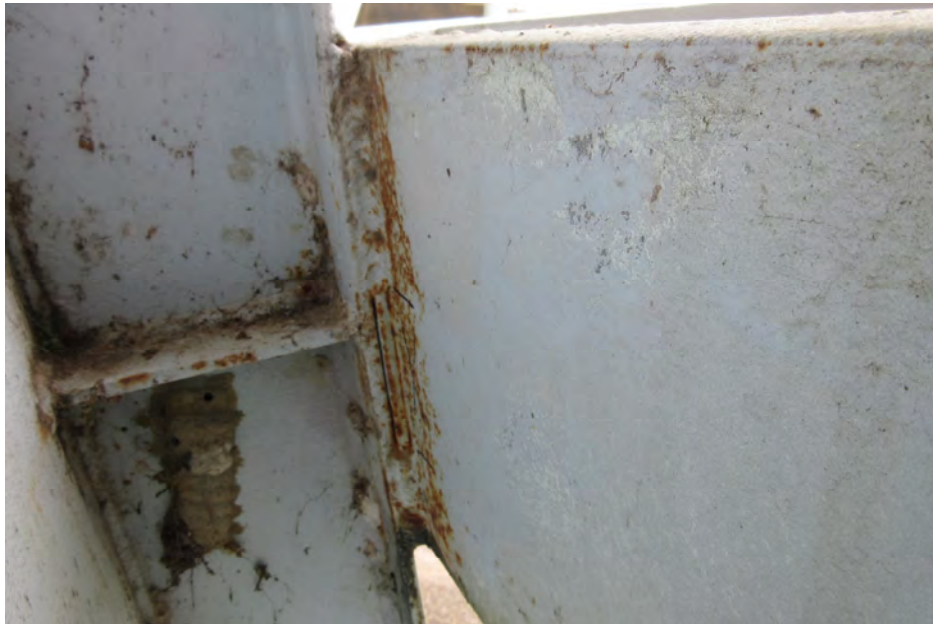
PHOTOGRAPH No.: 8
GATE: Gate 8
Photo Taken: 3/31/2020
File: MC-34.jpg

LOCATION:
Gate 8, V-6 at G-3, right side.

COMMENTS:
4" long area without vertical weld to G-1 flange. 1/4" shim visible. No significant deficiency. CS-2.

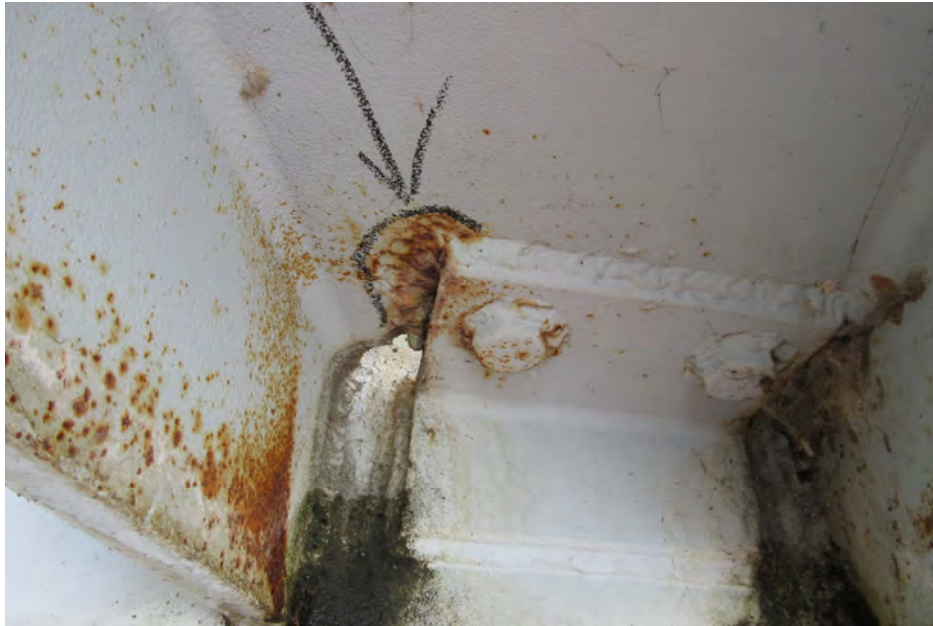
PHOTOGRAPH No.: 9
GATE: Gate 8
Photo Taken: 3/31/2020
File: MC-35.jpg

LOCATION:
Gate 8, RS-3 at G-3.

COMMENTS:
Pitting area on underside of web. 1 1/4" x 2 1/2" x 3/16" deep. Light surface rust. CS-3.

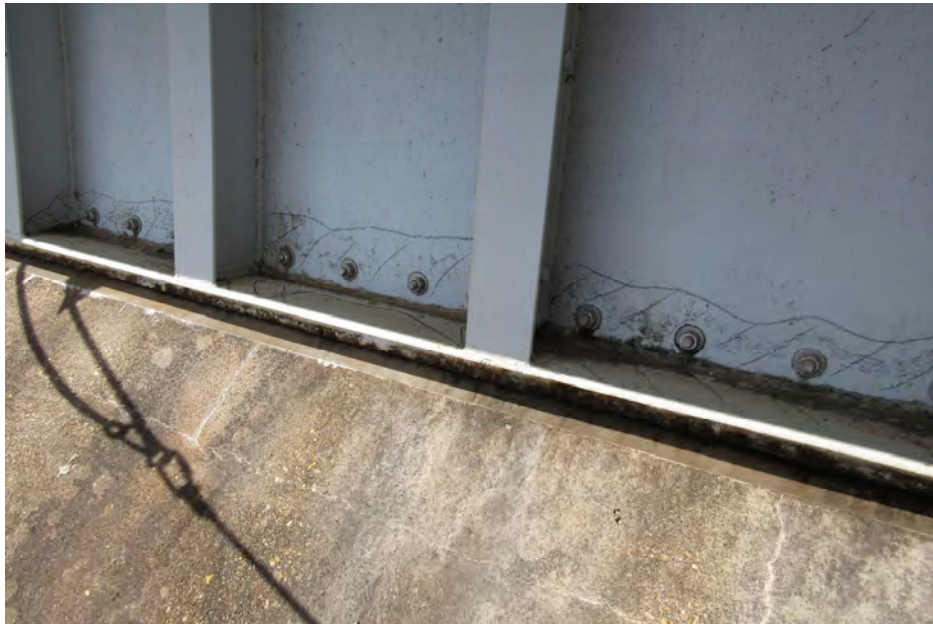
PHOTOGRAPH No.: 10
GATE: Gate 8
Photo Taken: 3/31/2020
File: MC-36.jpg

LOCATION:
Gate 8, bottom of gate at V-12 to V-15 and 7/16" thick bottom plate.

COMMENTS:
Mostly arrested pitting up to 1/8" deep along the bottom 6" of skin and bottom plate. Typical throughout.

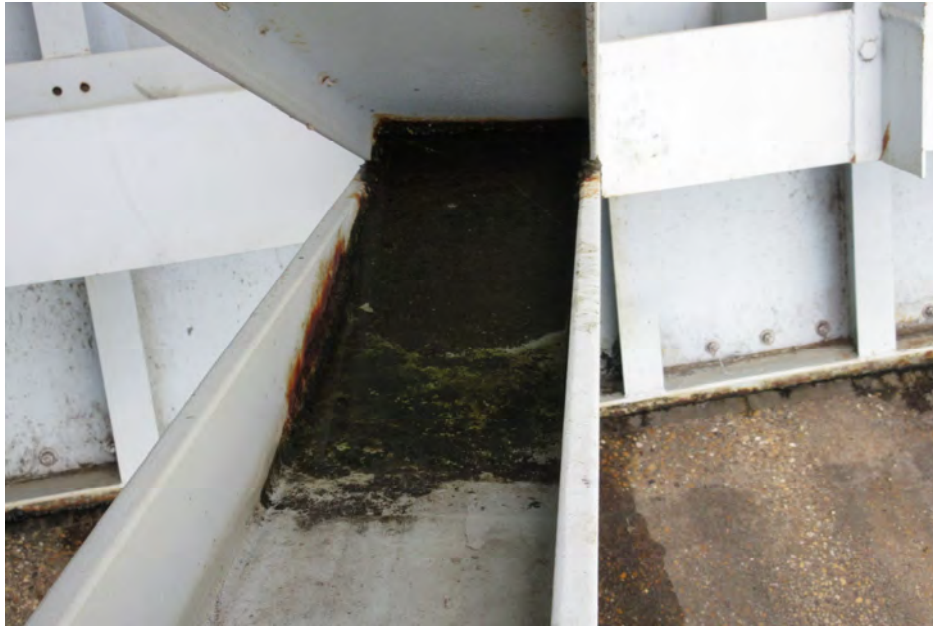
PHOTOGRAPH No.: 11

Ponding water and debris w/
blocked drains.

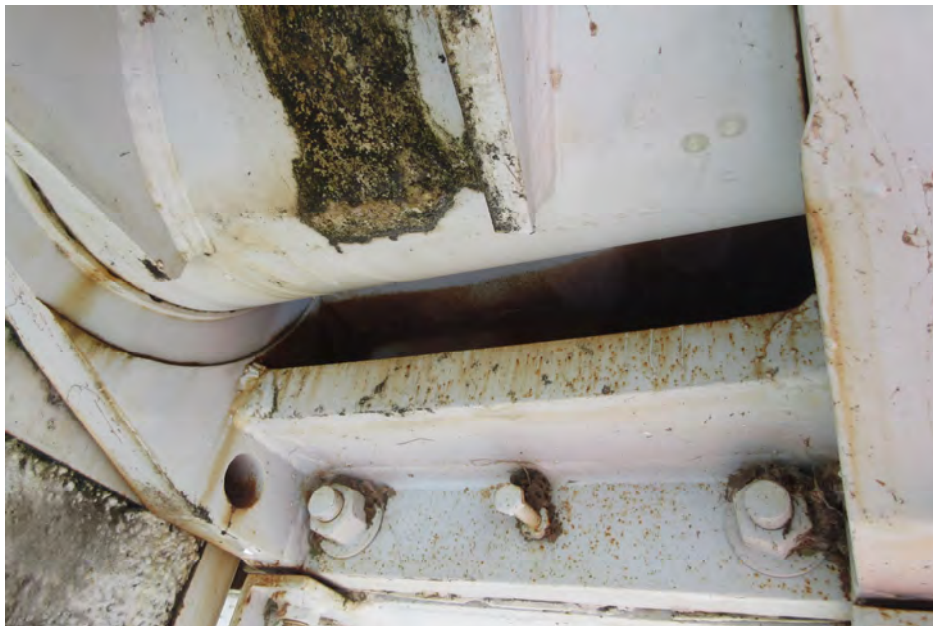
PHOTOGRAPH No.: 14

Heavy freckle rust inside trunnion casting, this trunnion has its pick-point eyebolt torched off. CS-2.

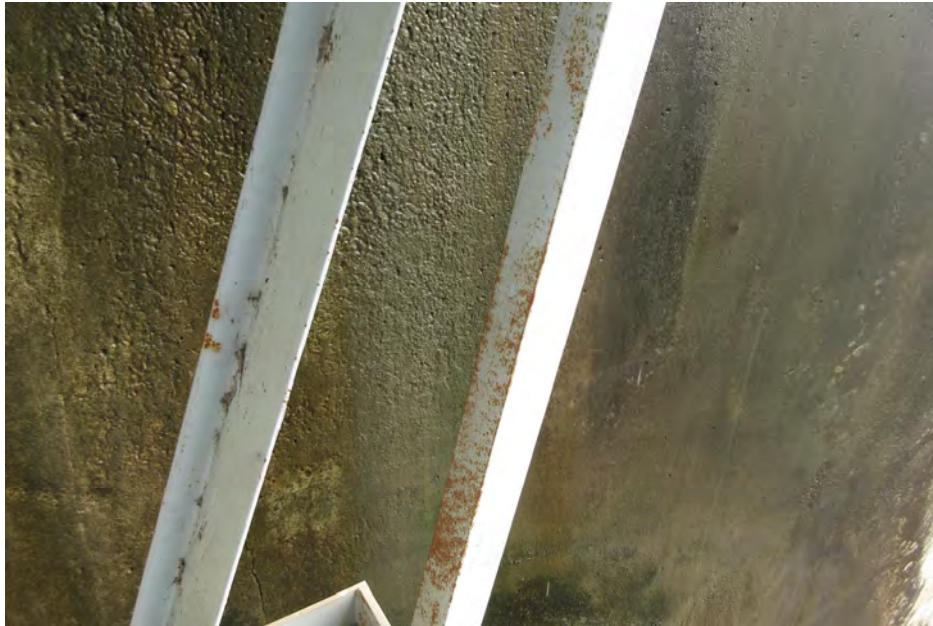
PHOTOGRAPH No.: 15

Typical area of freckle rusting, CS-2.

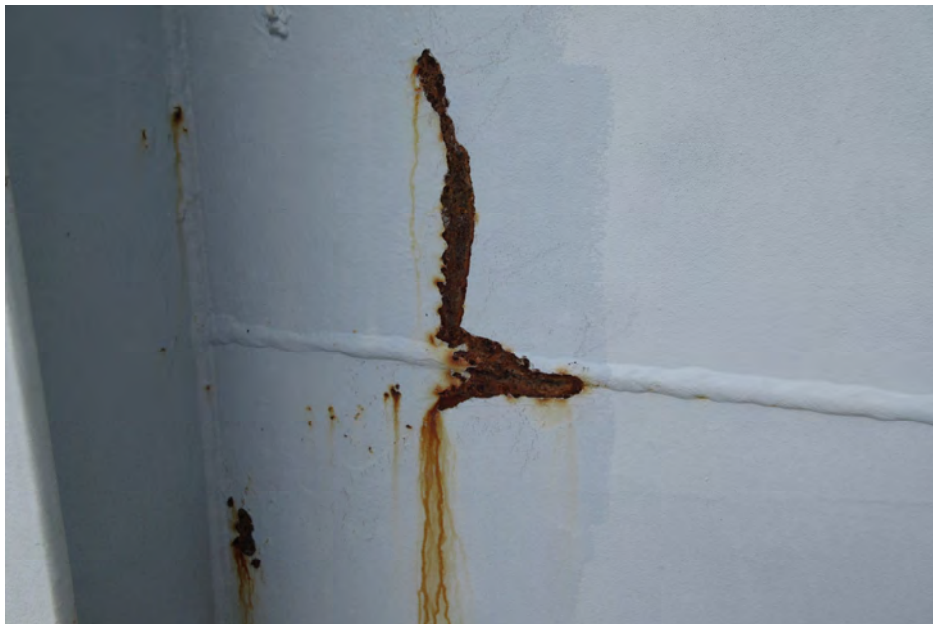
PHOTOGRAPH No.: 16

8'x4" and 2"x1" areas of paint failure with surface rust and light pitting, CS-3.

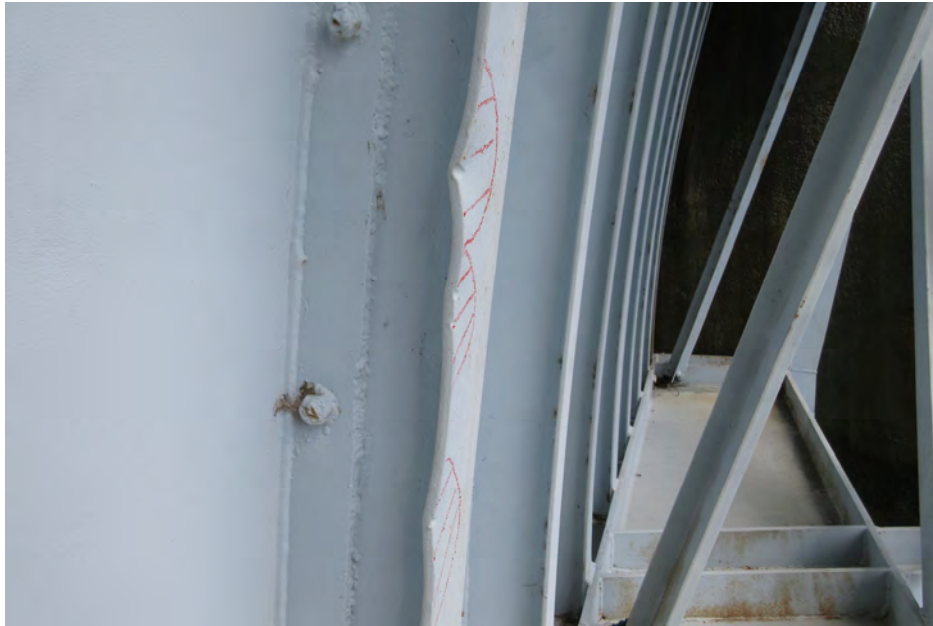
PHOTOGRAPH No.: 17

Three points of out of plane bending up to 1/2" over an 18" section, CS-2.

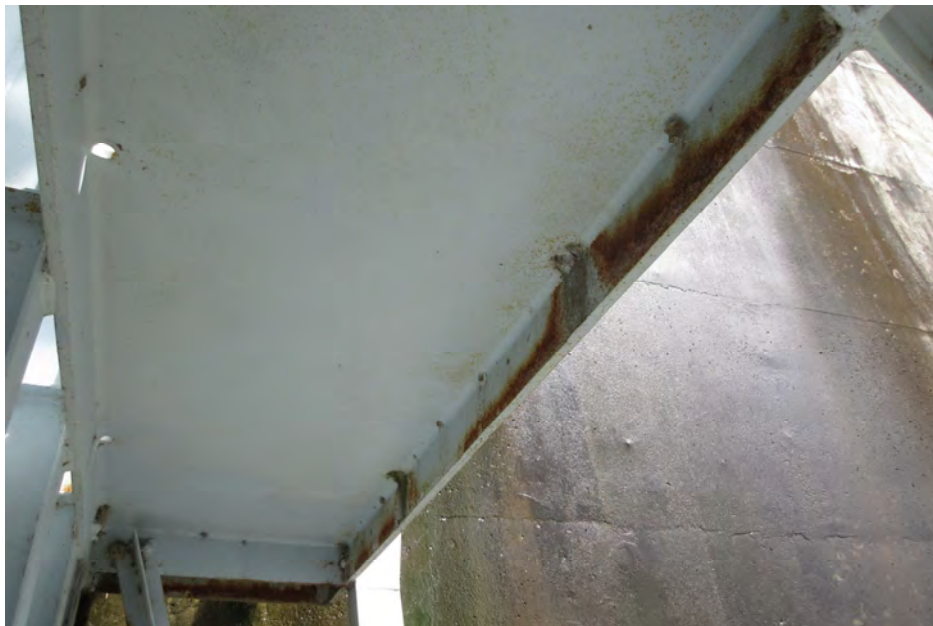
PHOTOGRAPH No.: 18

Areas of moderate freckle rust, CS-2.

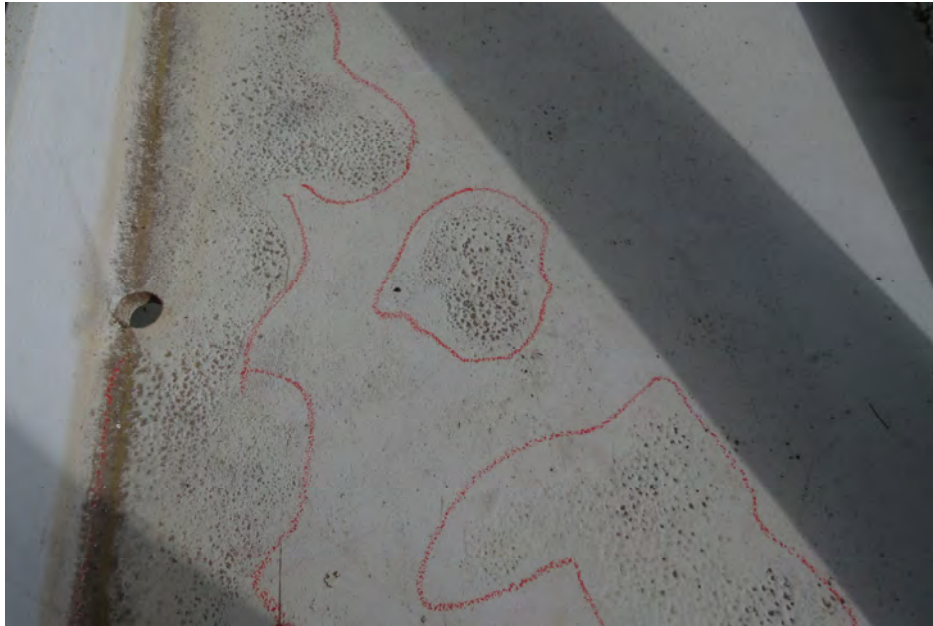
PHOTOGRAPH No.: 19

Arrested pitting to 1/8" throughout, CS-3.

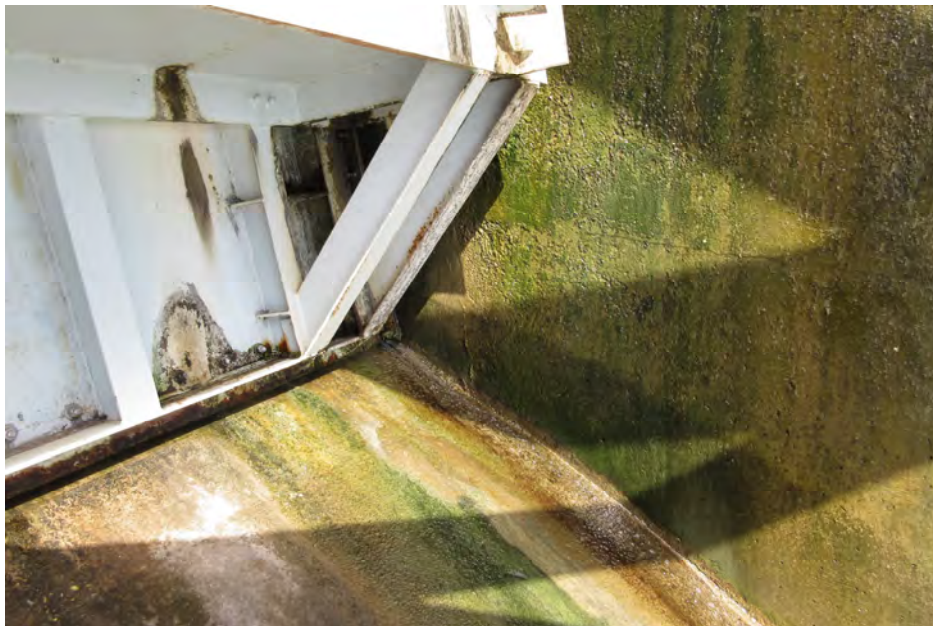
PHOTOGRAPH No.: 20

Left seal has minor leaks throughout resulting in a buildup of organic matter on G-3 left end.

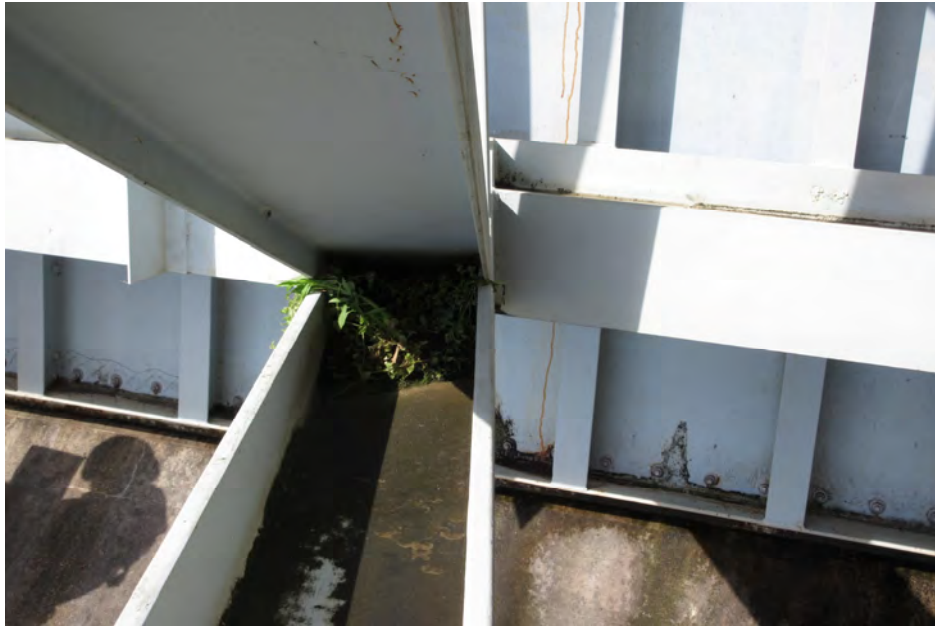
PHOTOGRAPH No.: 21

Build up of dirt/debris between members holding water and vegetation.

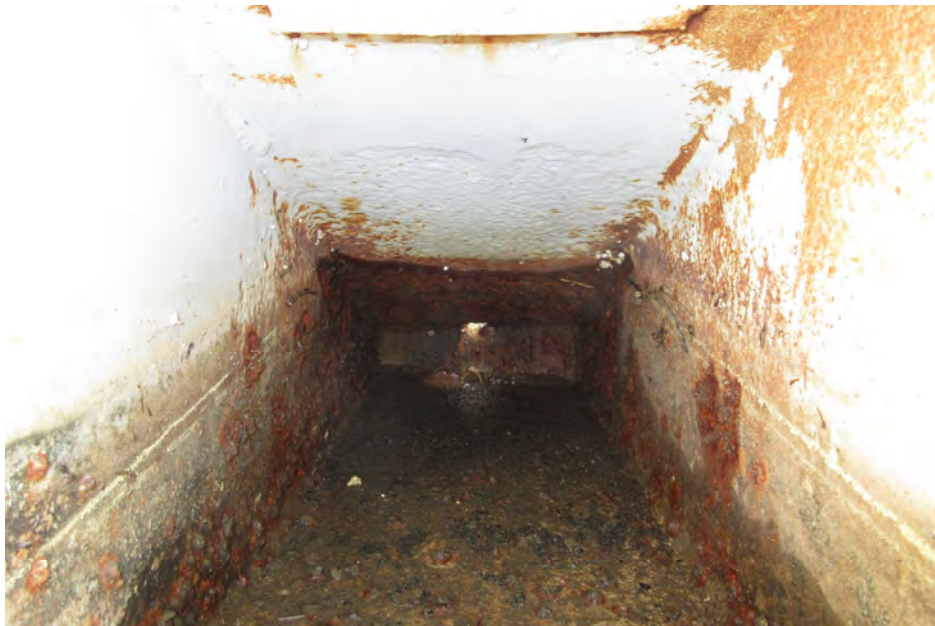
PHOTOGRAPH No.: 22

Paint failure with pitting to 1/8". 50% of pitting is arrested, CS-3.

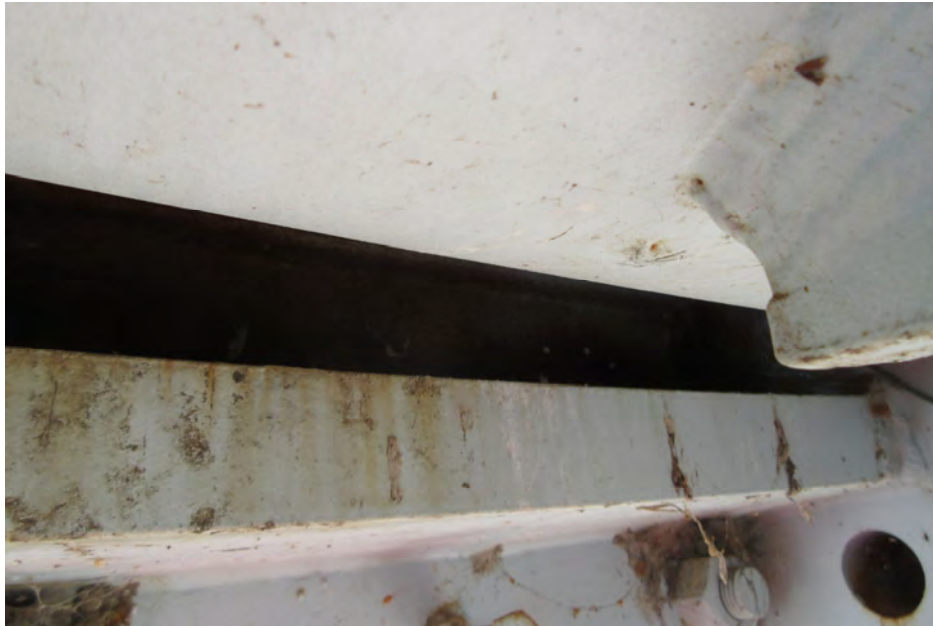
PHOTOGRAPH No.: 3

Light surface rust. CS-2.

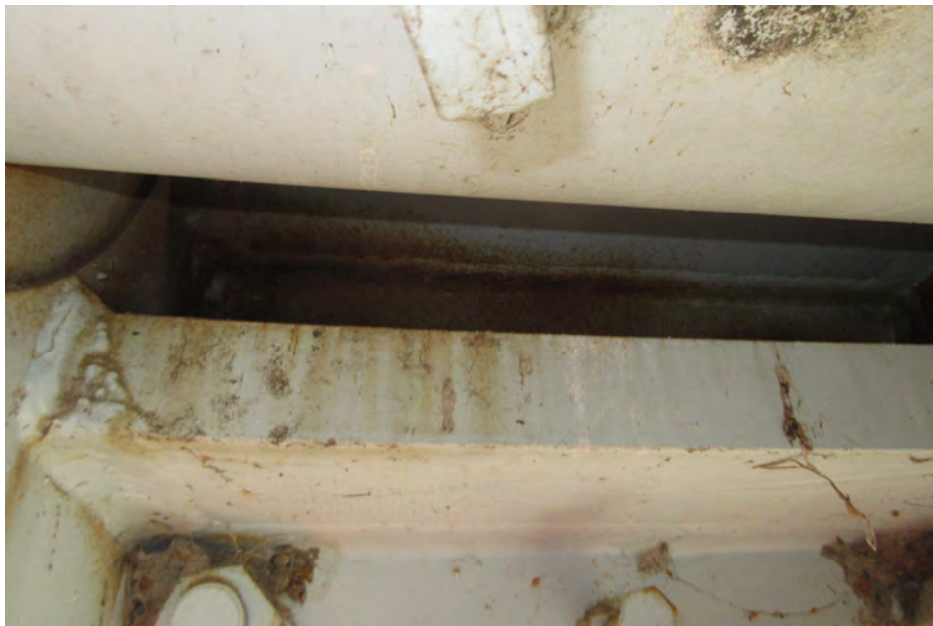
PHOTOGRAPH No.: 4

Light surface rust. CS-2.

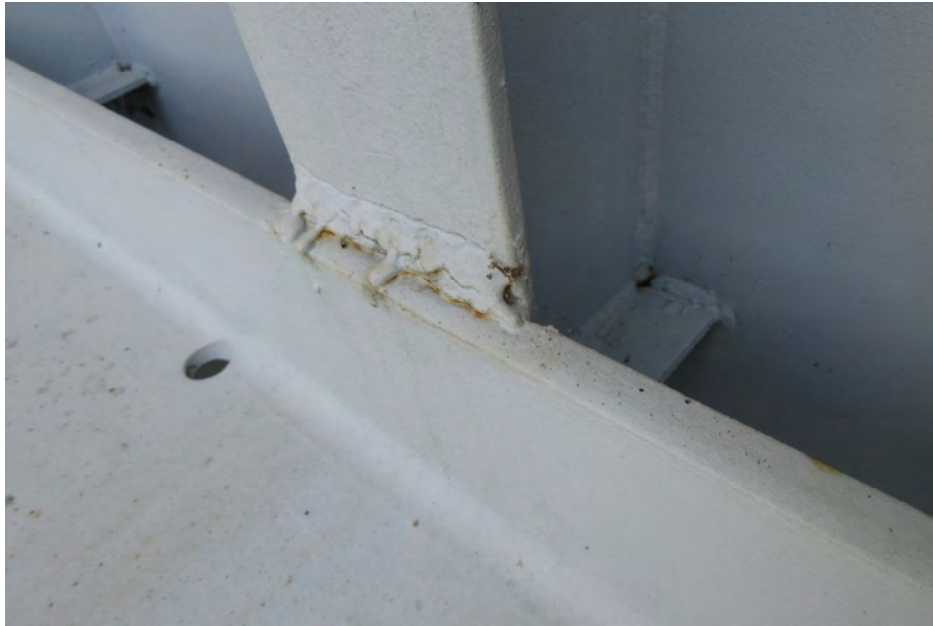
PHOTOGRAPH No.: 5

Low quality, built up field weld.

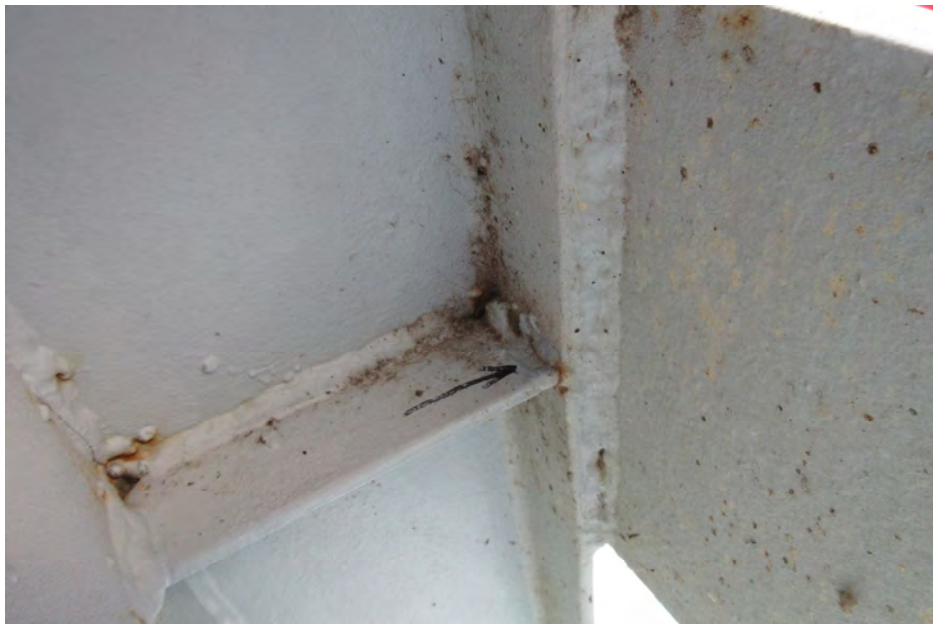
PHOTOGRAPH No.: 6

Cracked weld. Not fully cracked. Potential for propagation. CS-3.
