VISUAL INSPECTION AND EVALUATION REPORT

Rockwall-Forney Dam
Dallas Water Utilities
Dallas/Kaufman Counties, Texas

Schnabel Reference #20C22001.00
July 30, 2021

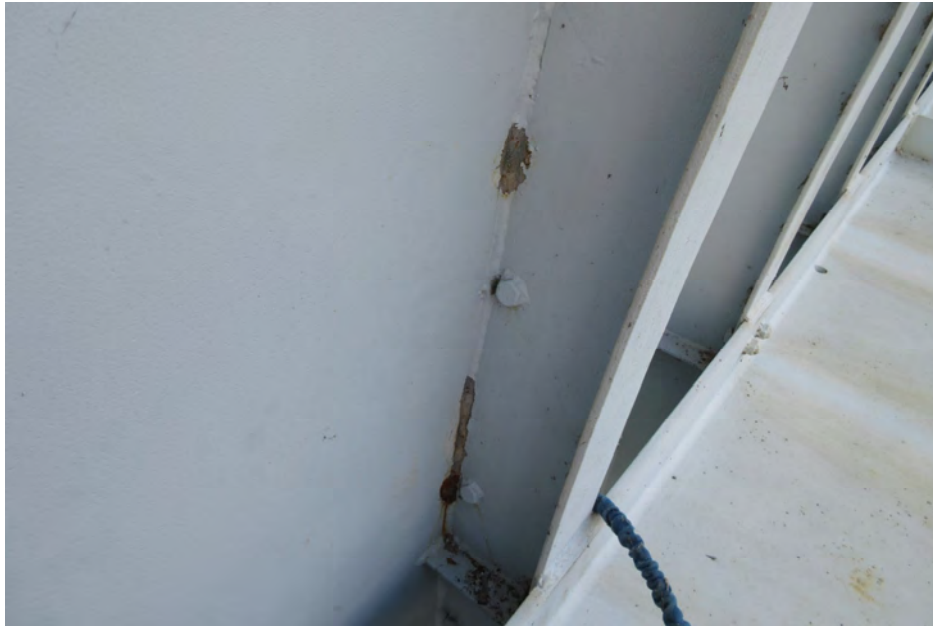
PHOTOGRAPH No.: 7

12" of flaking paint with light surface rust. CS-2.

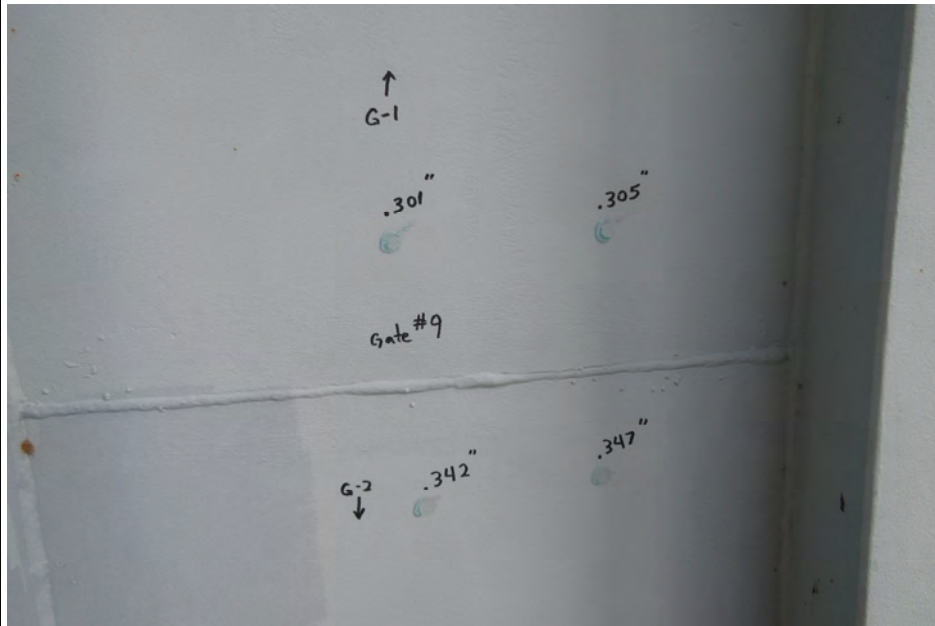
PHOTOGRAPH No.: 9

Above weld measurements: .301" & .305"

Below weld measurements: .342 & .347"

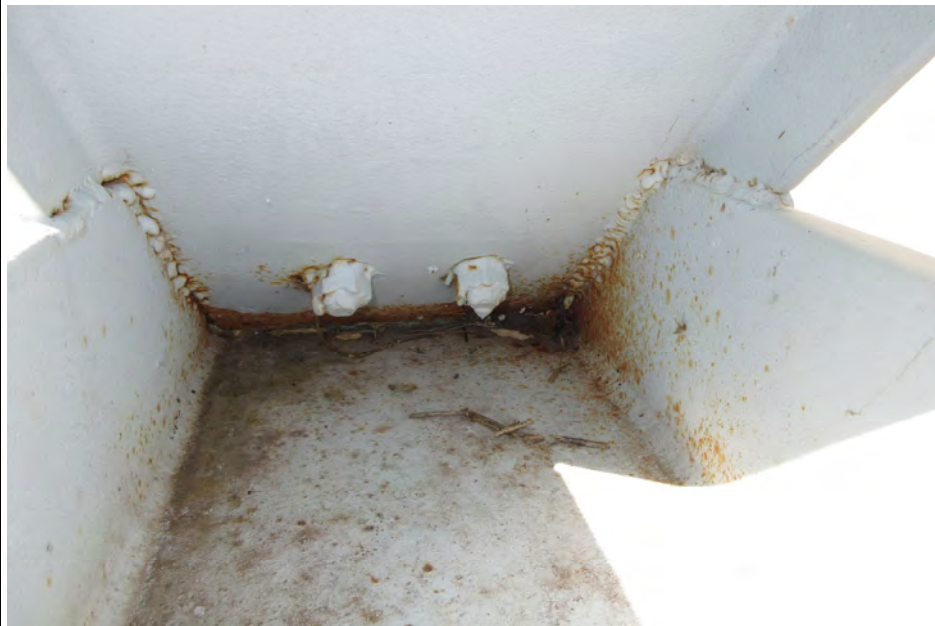
PHOTOGRAPH No.: 10

Moderate surface rust and low quality field welds. CS-2

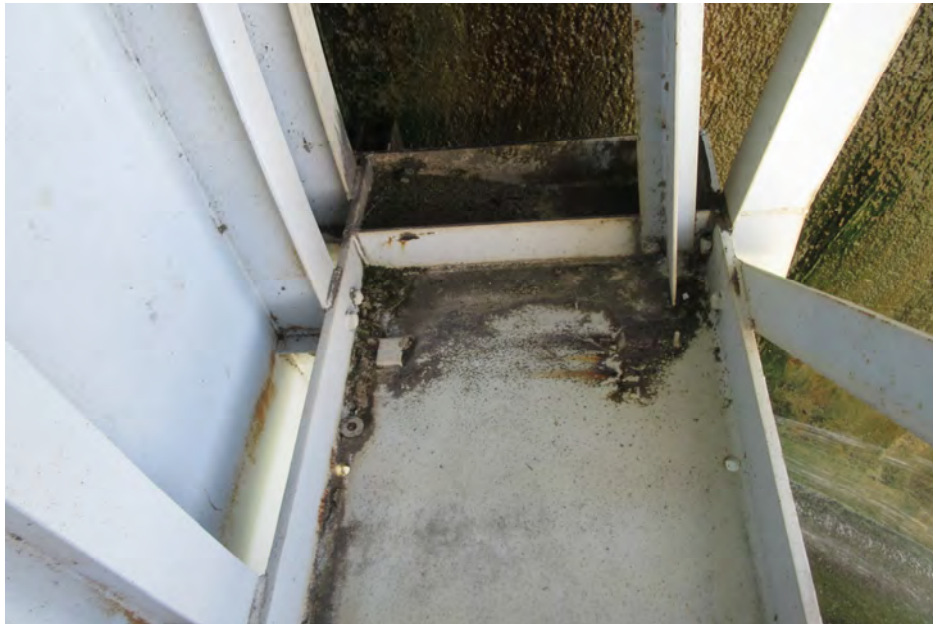
PHOTOGRAPH No.: 12

Debris & vegetation buildup.
Drains are blocked.

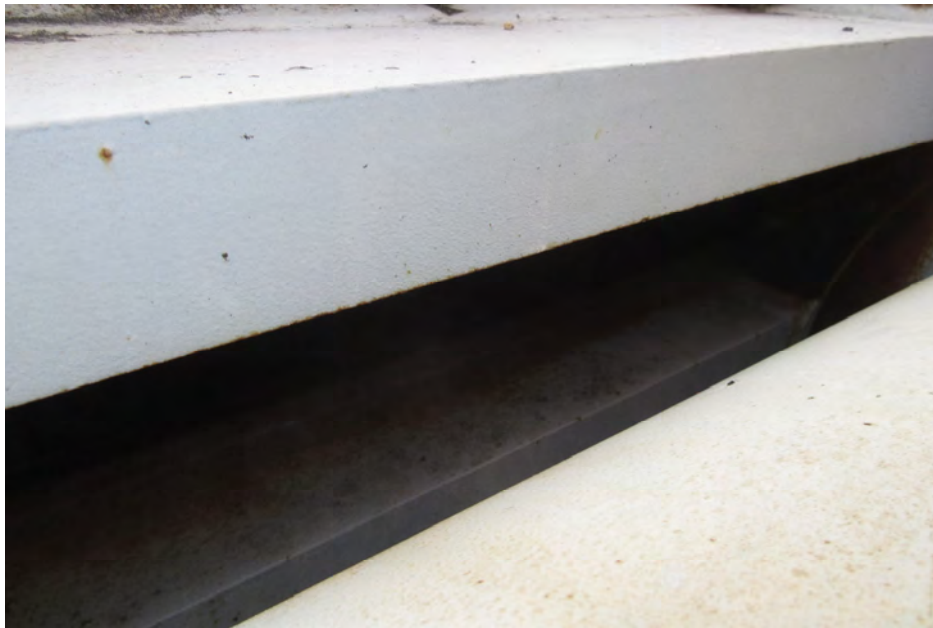
PHOTOGRAPH No.: 17

Moderate surface rust. CS-2.

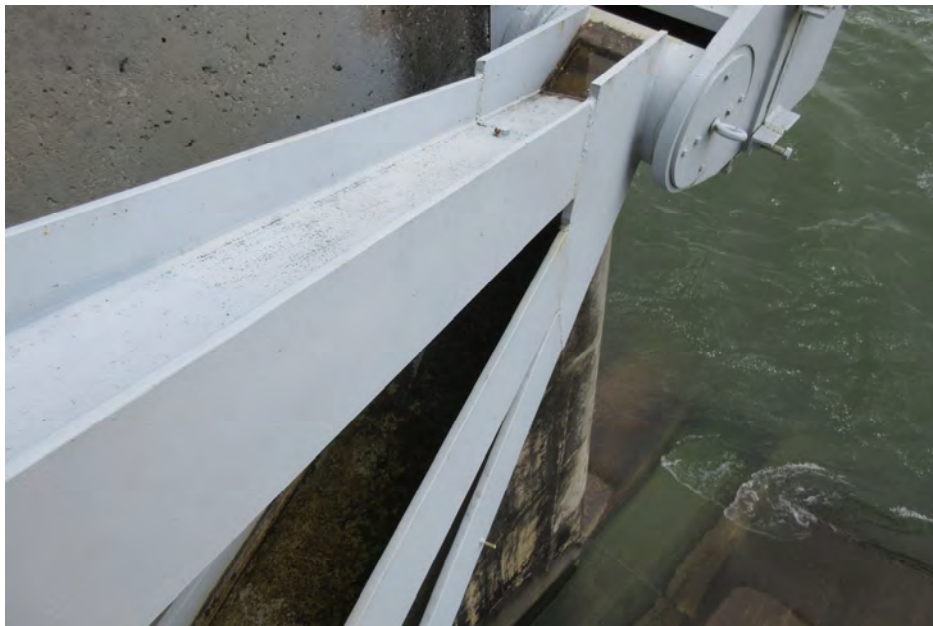
PHOTOGRAPH No.: 18

Ponding water and debris with blocked drains.

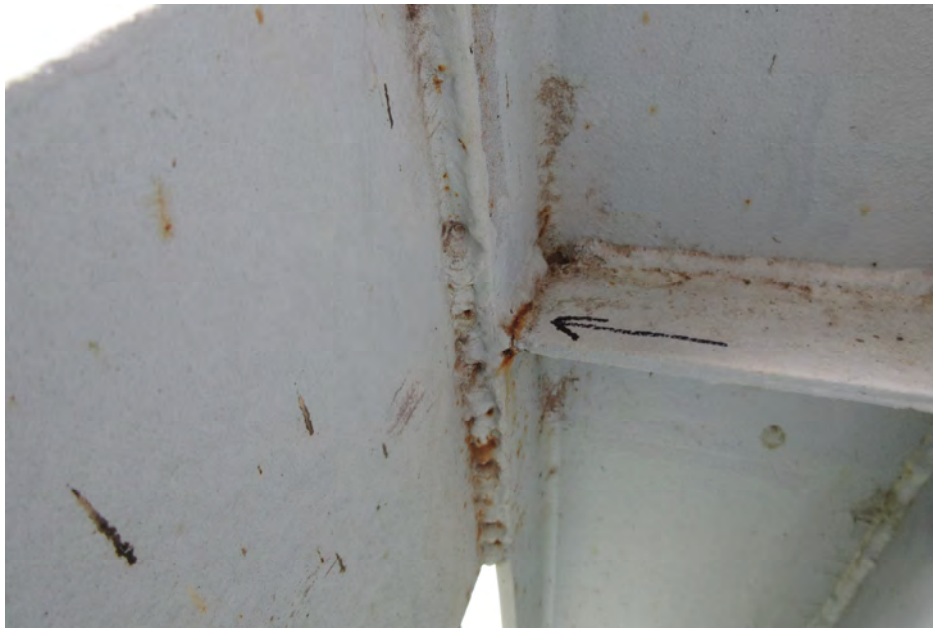
PHOTOGRAPH No.: 19

Cracked weld in left stiffener.
Potential for propagation. CS-3.

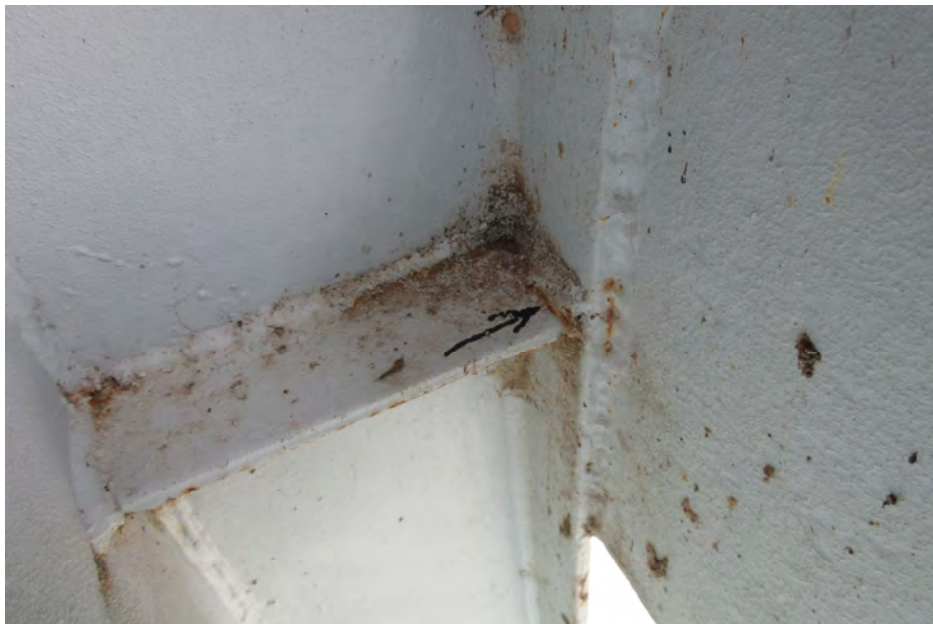
PHOTOGRAPH No.: 20

Cracked weld in right stiffener.
No potential for propagation.
Cracked 100% through. CS-2

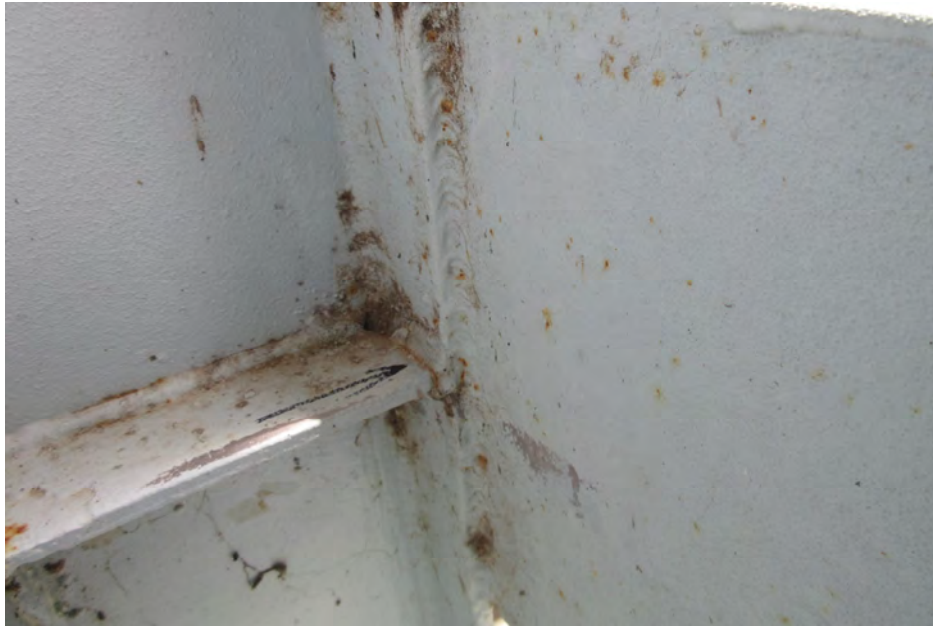
PHOTOGRAPH No.: 21

Cracked weld in stiffener. No chance for propagation. Weld cracked clear through. CS-2.

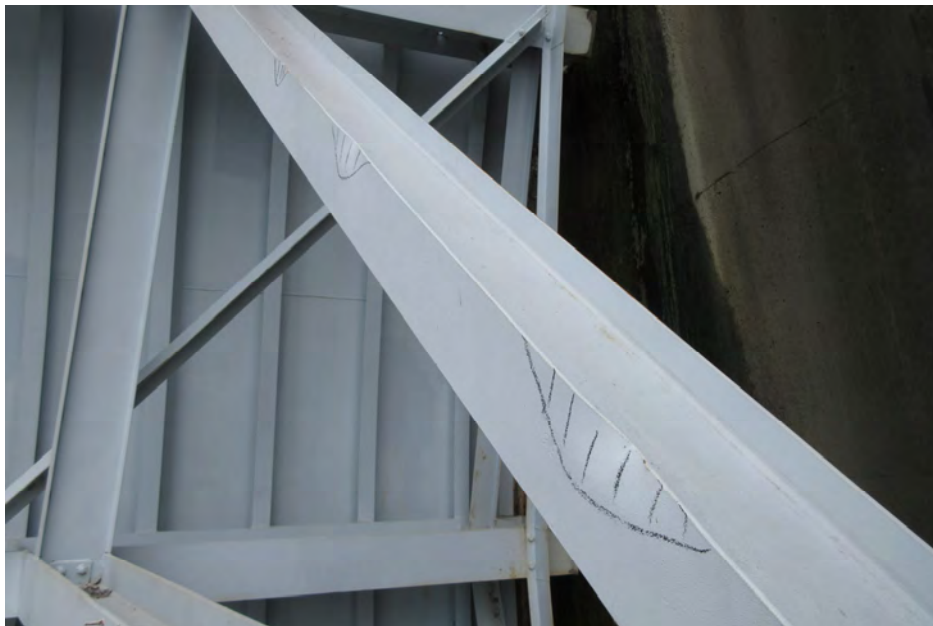
PHOTOGRAPH No.: 22

Three areas of out of plane bending up to 9" x 1". CS-2.

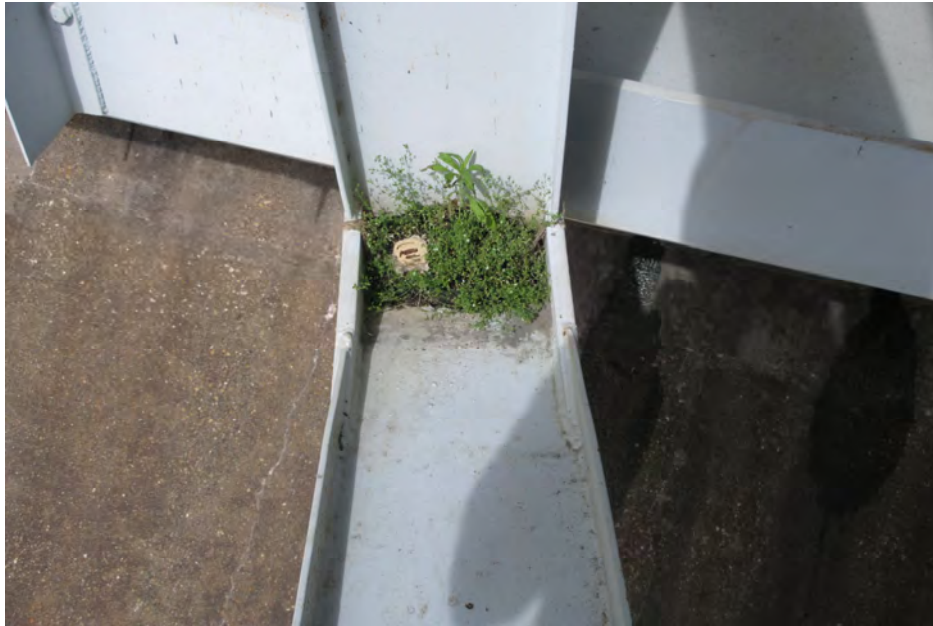
PHOTOGRAPH No.: 23

Debris build-up w/vegetation.
Drains blocked.

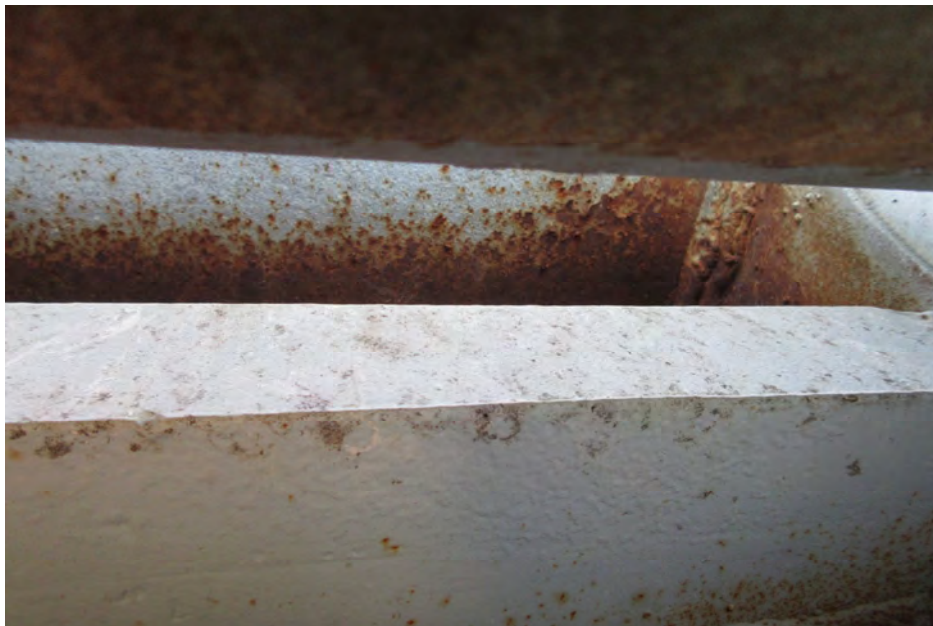
PHOTOGRAPH No.: 2
GATE: Gate 10
Photo Taken: 4/1/2020
File: CL-2.jpg

LOCATION:
Gate 10, right trunnion.

COMMENTS:
Inside of trunnion cast has moderate surface rust.

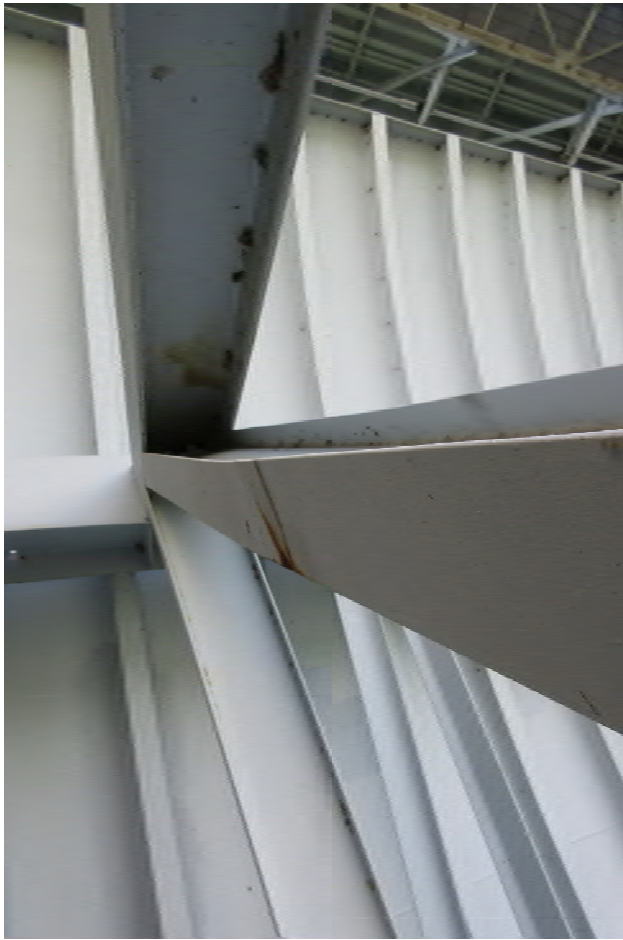
PHOTOGRAPH No.: 3
GATE: Gate 10
Photo Taken: 4/1/2020
File: CL-3.jpg

LOCATION:
Gate 10, RB-2.

COMMENTS:
Out-of-plane bending, 1" over
5' in the beam itself.

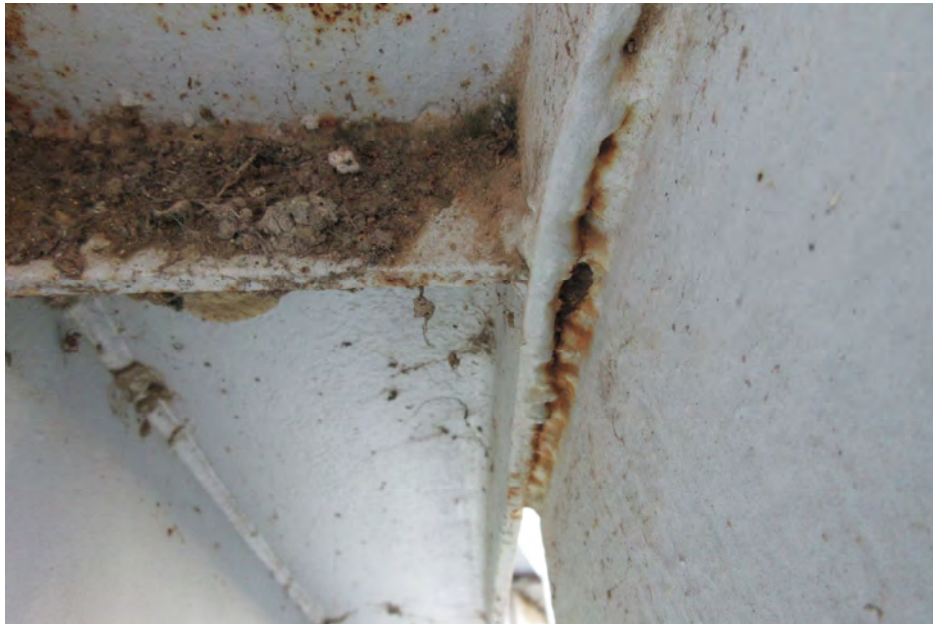
PHOTOGRAPH No.: 4
GATE: Gate 10
Photo Taken: 4/1/2020
File: CL-4.jpg

LOCATION:
Gate 10, V-03 at G-2.

COMMENTS:
6" long crack in vertical weld,
CS3.

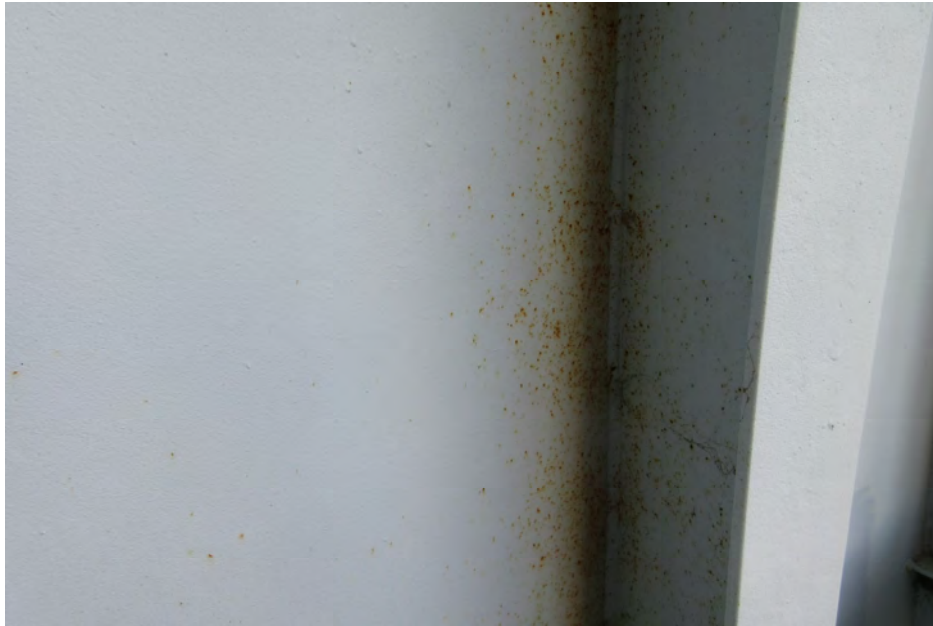
PHOTOGRAPH No.: 5

Light rust bleed 8" x 30", CS2.

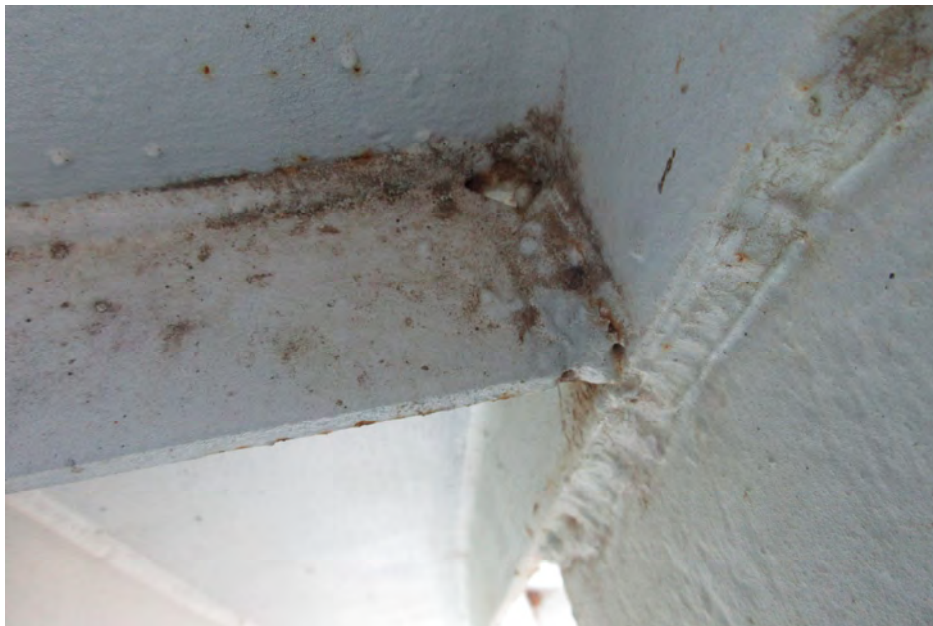
PHOTOGRAPH No.: 6

1" long crack in weld of web stiffener, CS3.

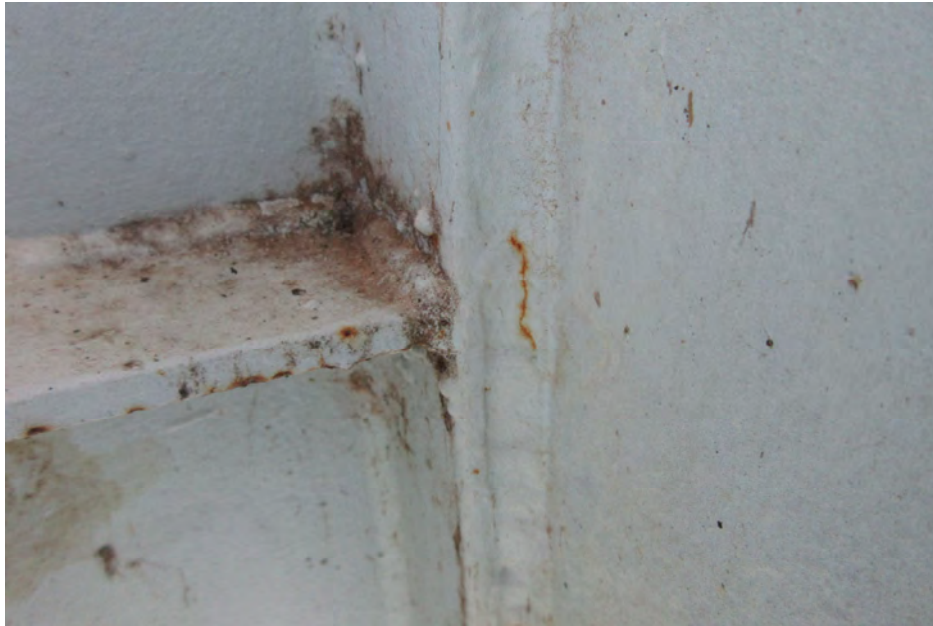
PHOTOGRAPH No.: 7

1-1/2" long crack in vertical weld, CS3.

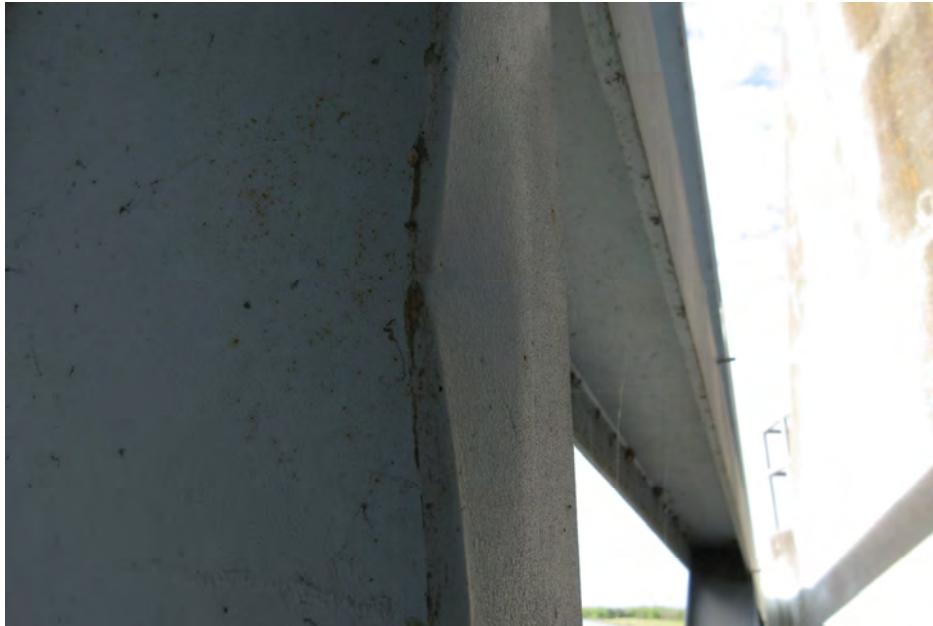
PHOTOGRAPH No.: 9

Out-of-plane bending 1" over 3"
in flange.

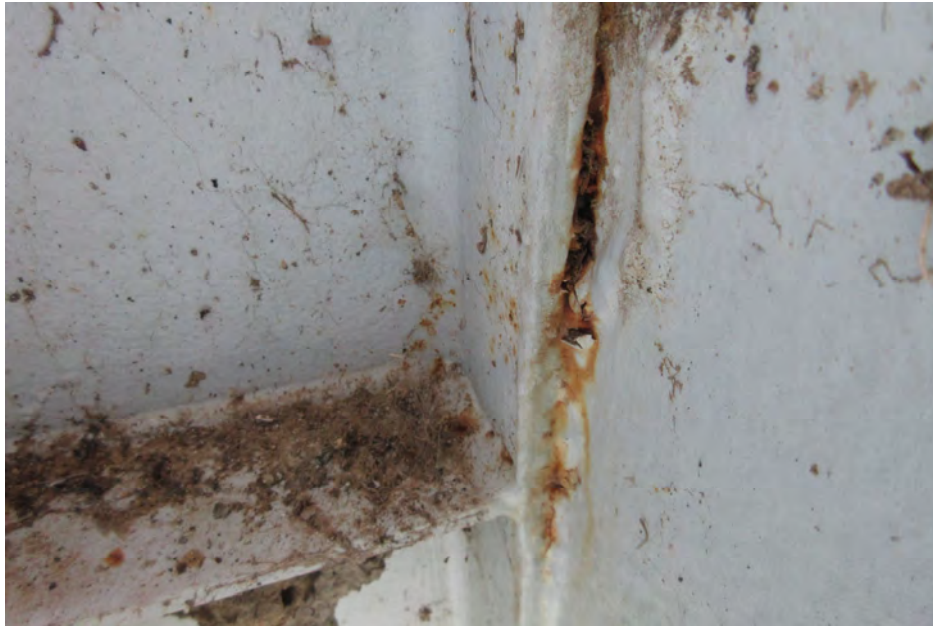
PHOTOGRAPH No.: 11

3" long crack in vertical weld.
Note: 1/8" pack rust starting in
between vertical rib and G-1
flange.

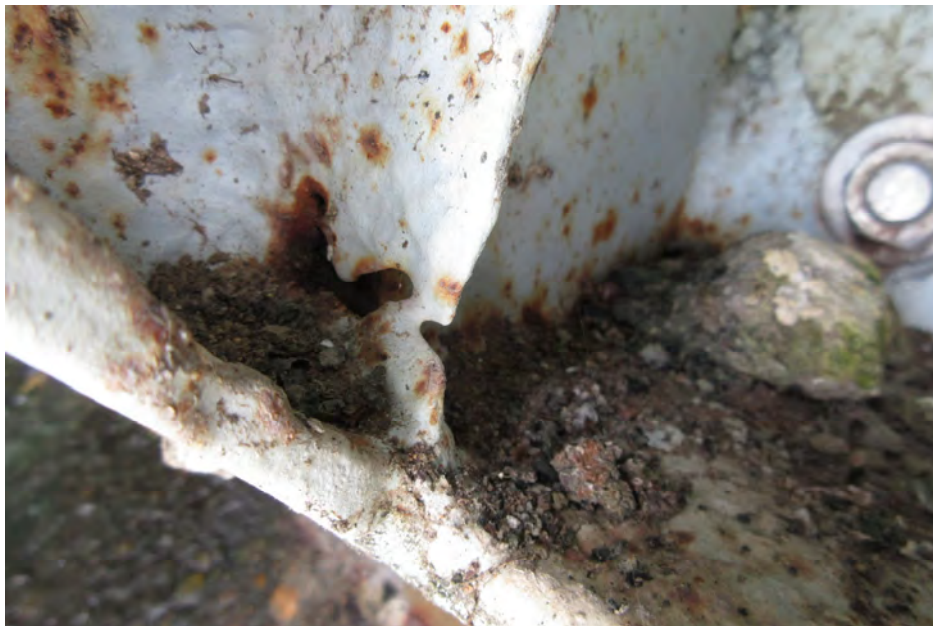
PHOTOGRAPH No.: 12

Up to 100% section loss on
flange of rib coming to a knife
edge. Similar condition on V-
02.

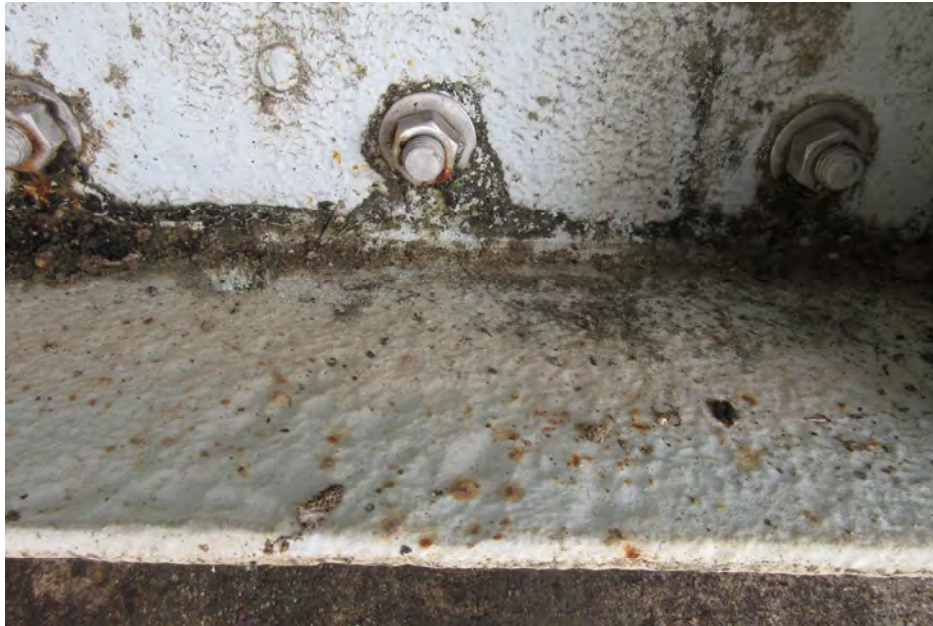
PHOTOGRAPH No.: 13

Heavy arrested pitting through-out plate up to 1/8" deep. Similar condition across whole gate.

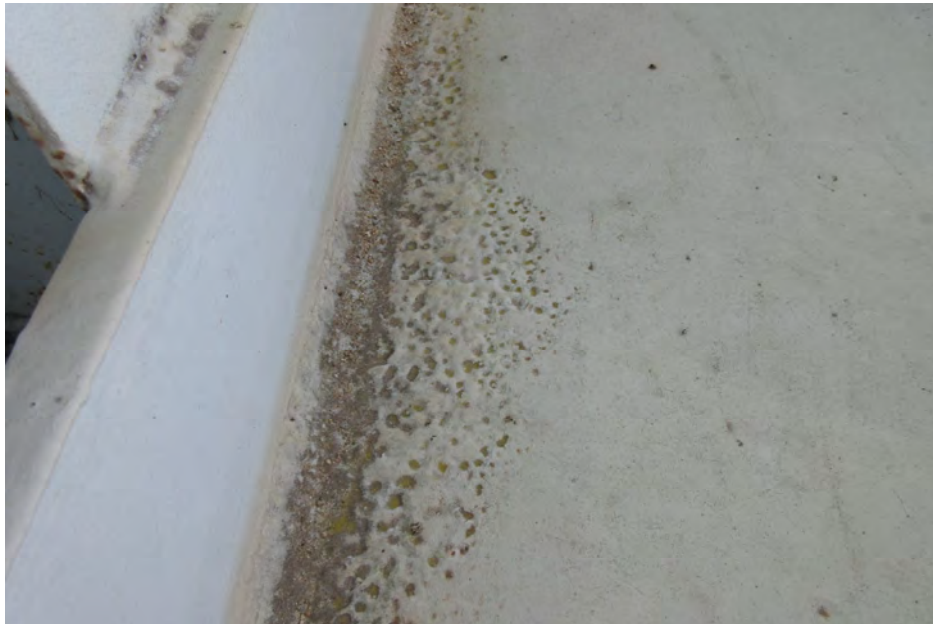
PHOTOGRAPH No.: 14

Heavy arrested pitting the whole length of girder up to 6" wide and 1/8" deep.

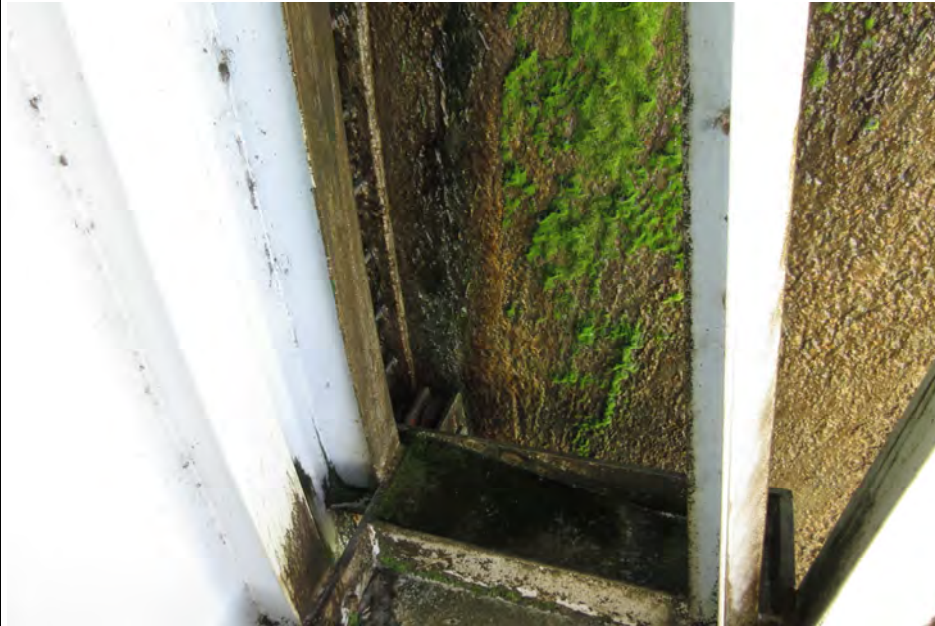
PHOTOGRAPH No.: 15

Leak in seal is keeping buttress wall and end of girder constantly wet. Heavy debris and growth along with standing water are present. CS2.

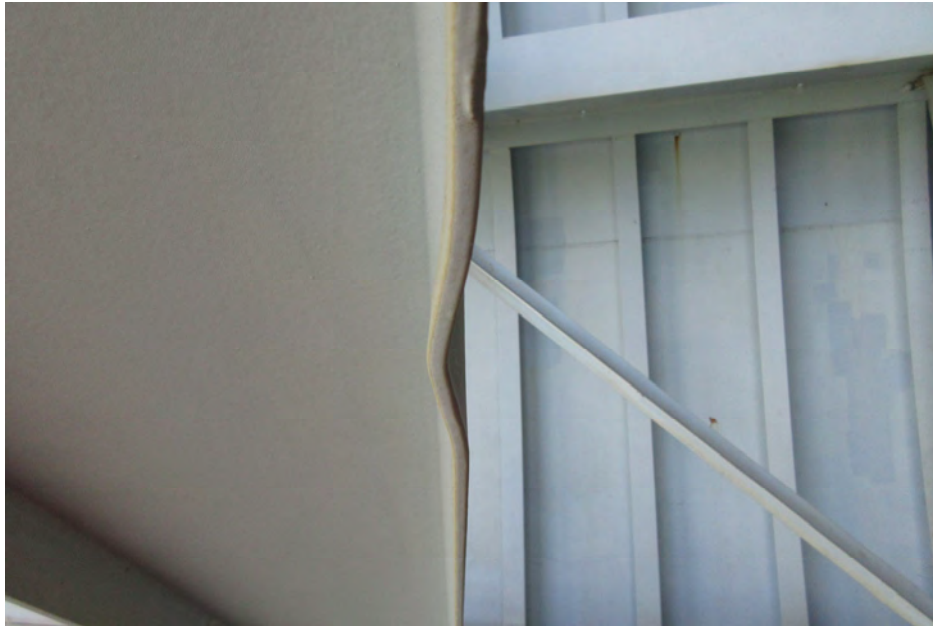
PHOTOGRAPH No.: 17

Out-of-plane bending 3/4" over 3" on flange.

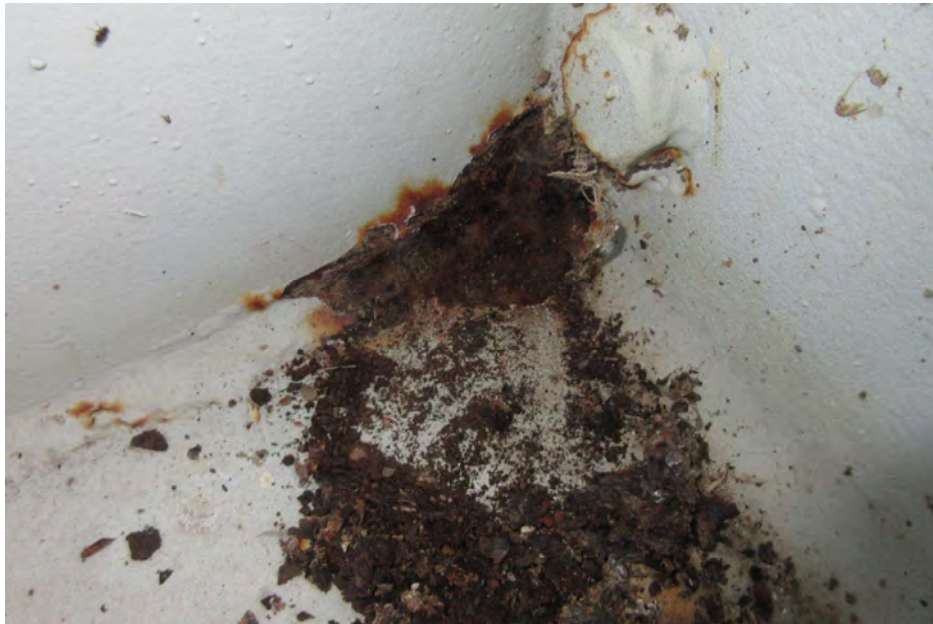
PHOTOGRAPH No.: 18

3" x 2" area of paint failure with section loss and pitting to 1/8".

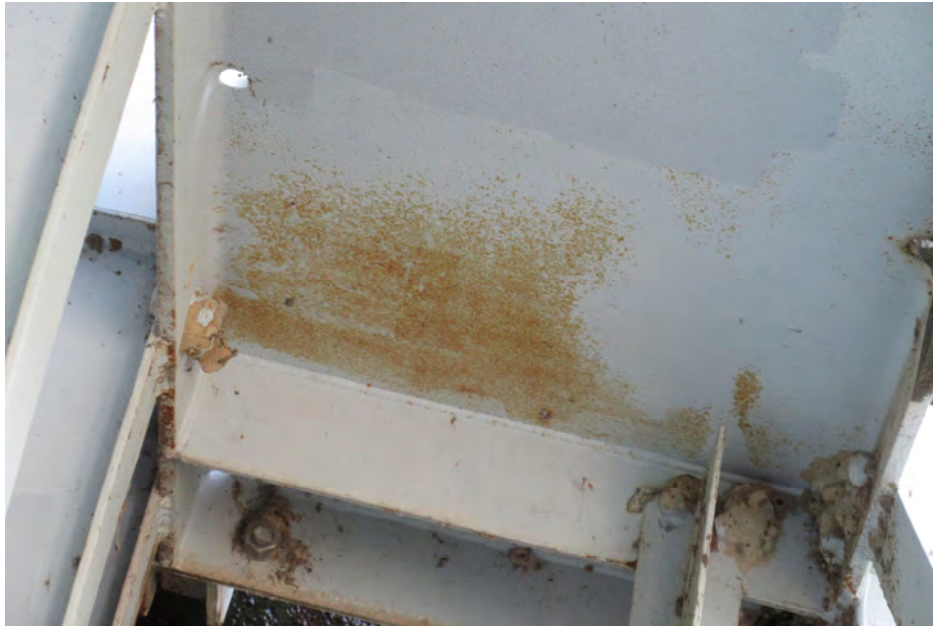
PHOTOGRAPH No.: 19

2' x 2' area of paint failure moderate rust bleed, CS2.

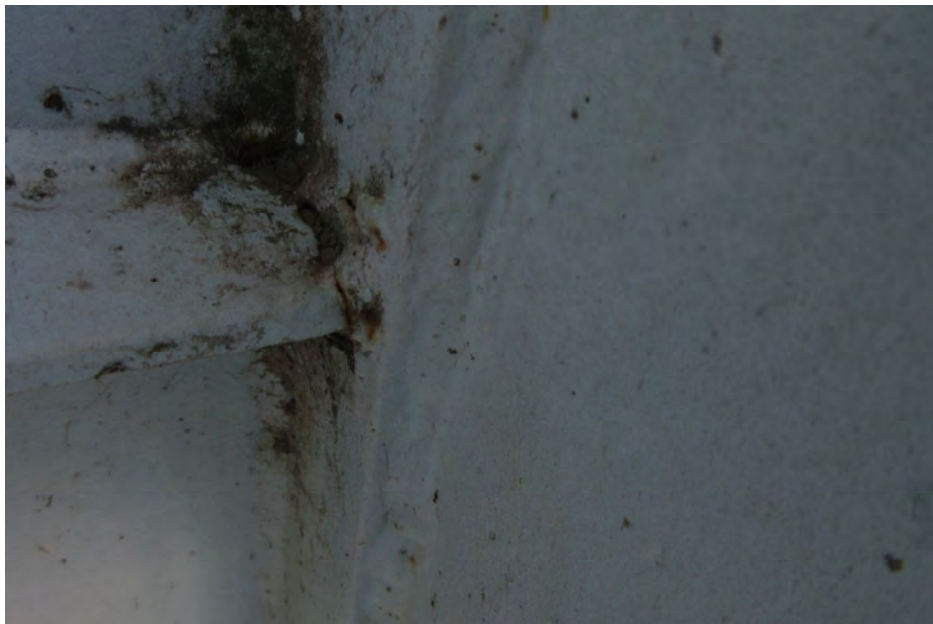
PHOTOGRAPH No.: 20

Web stiffener has 3/8" crack in
weld, CS3.

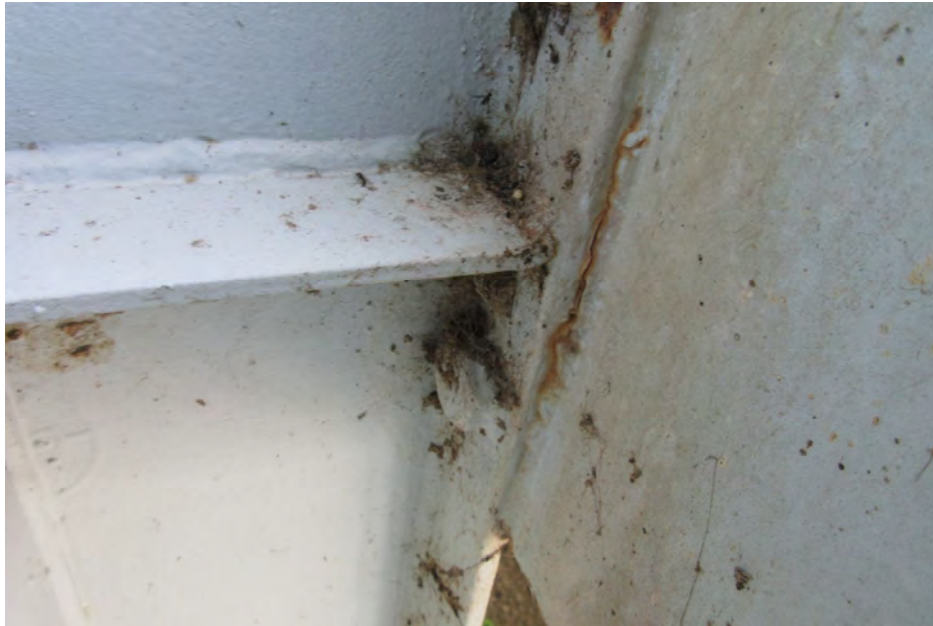
PHOTOGRAPH No.: 21

3" long crack in vertical weld,
CS3.

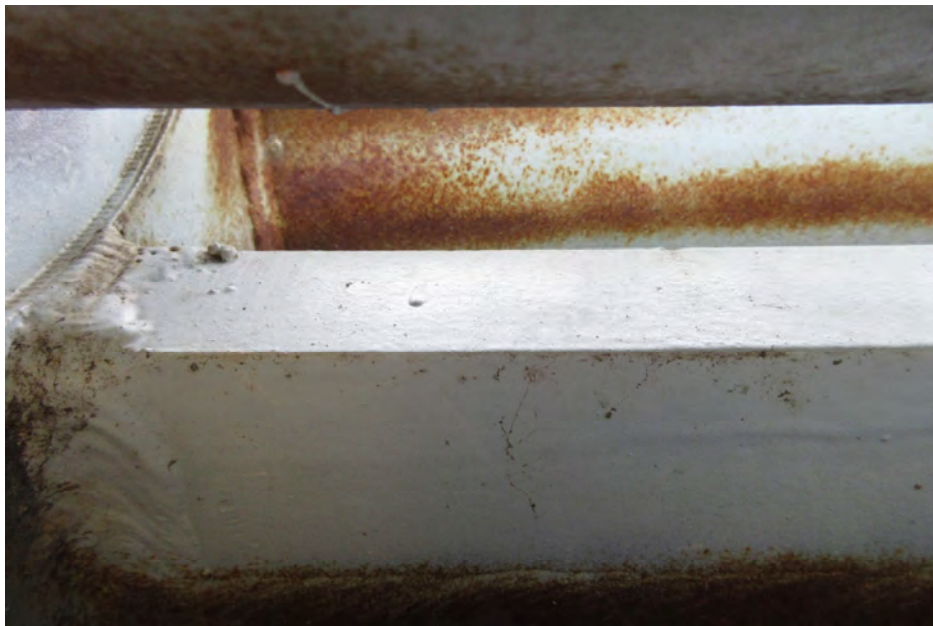
PHOTOGRAPH No.: 26

Paint failure moderate rust bleed on inside of trunnion.

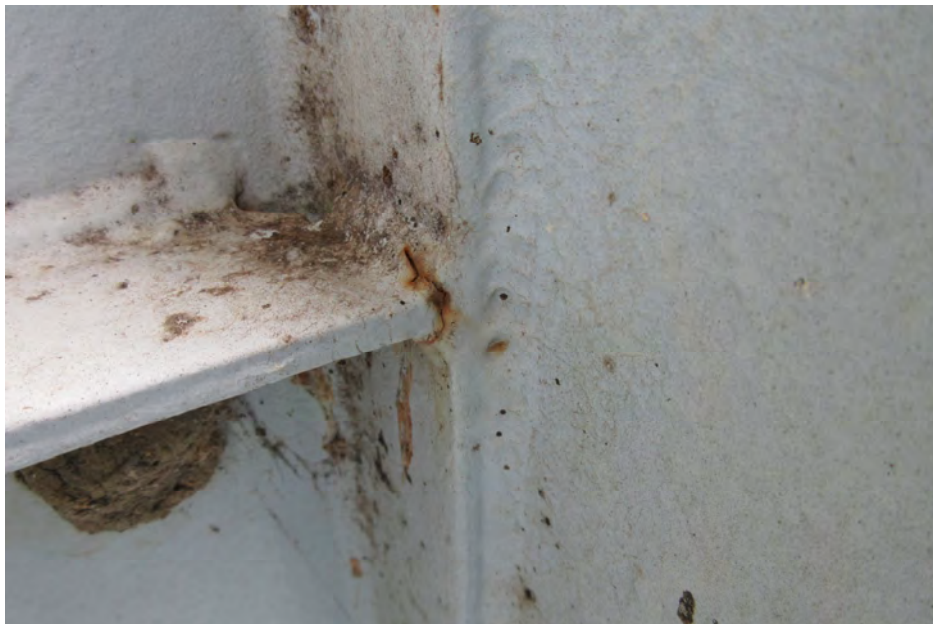
PHOTOGRAPH No.: 28

1" long crack in vertical weld,
CS3.

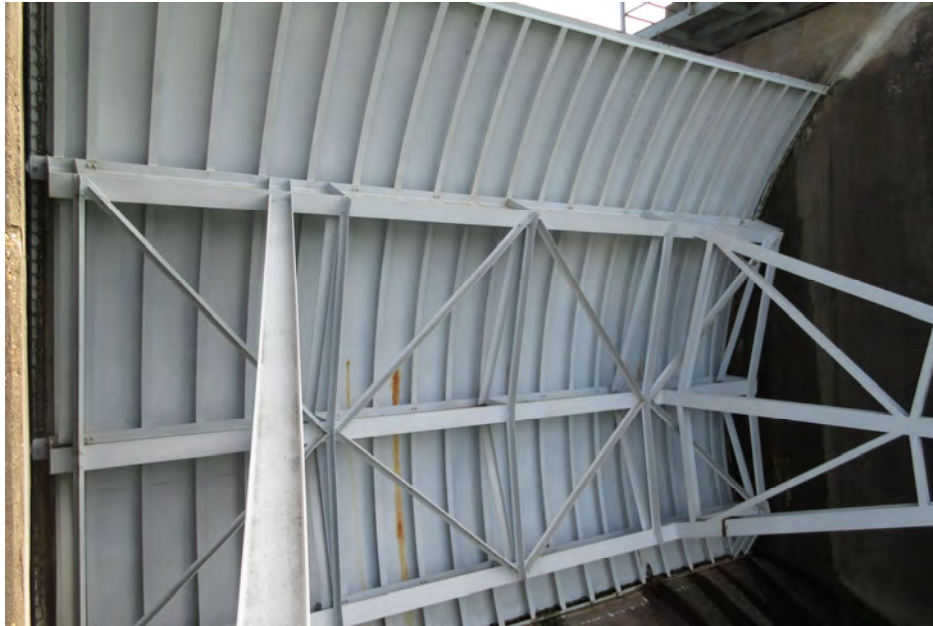
PHOTOGRAPH No.: 1
GATE: Gate 11
Photo Taken: 4/1/2020
File: DK-01.jpg

LOCATION:
Gate 11, overview.

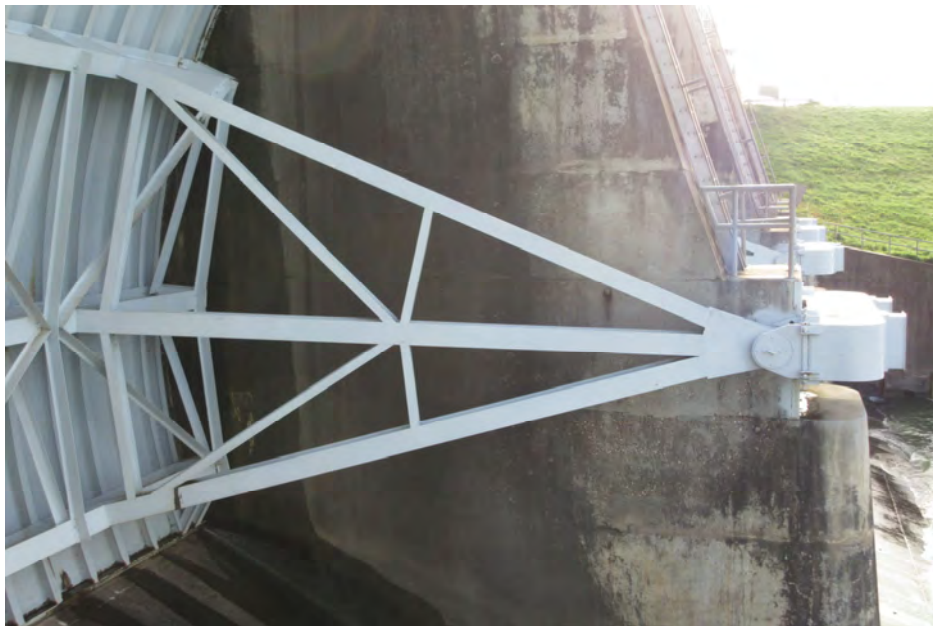
PHOTOGRAPH No.: 2
GATE: Gate 11
Photo Taken: 4/1/2020
File: DK-02.jpg

LOCATION:
Gate 11, left arm overview.

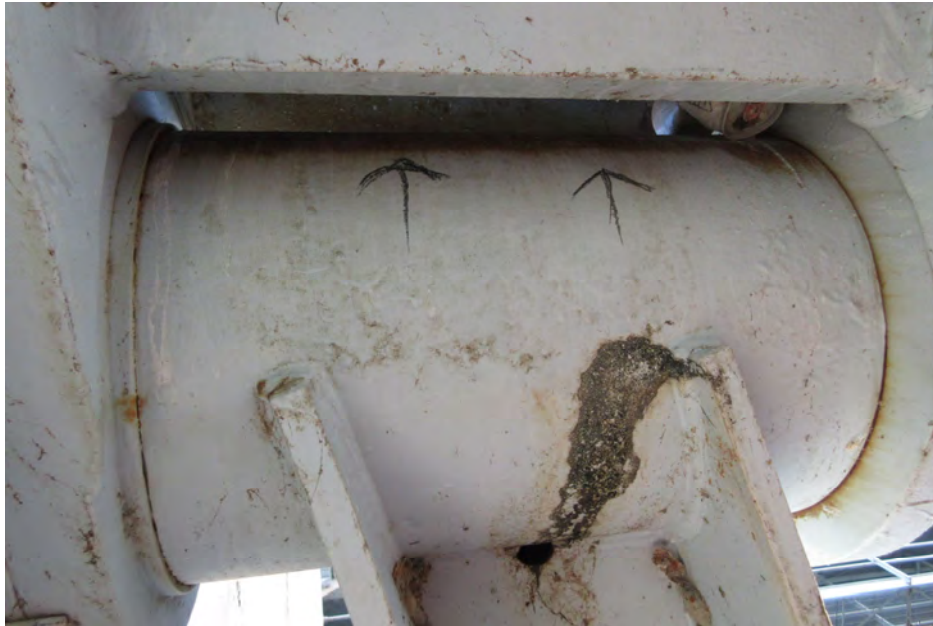
PHOTOGRAPH No.: 3

Downstream side of right arm trunnion has moderate surface rust due to lack of paint coating. No pitting present. CS-2.

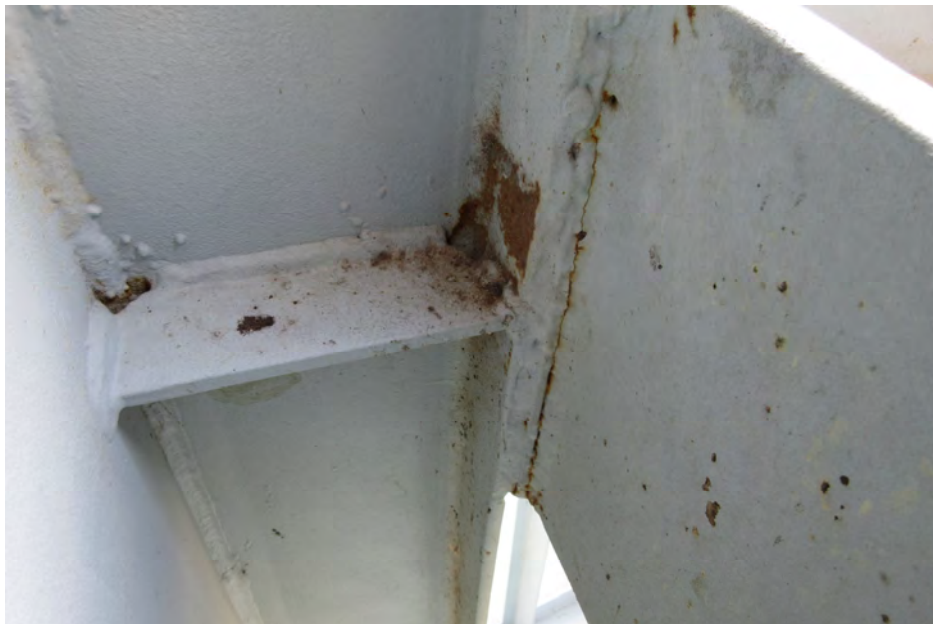
PHOTOGRAPH No.: 4

Vertical weld between members is cracked 80% of weld length, CS-2.

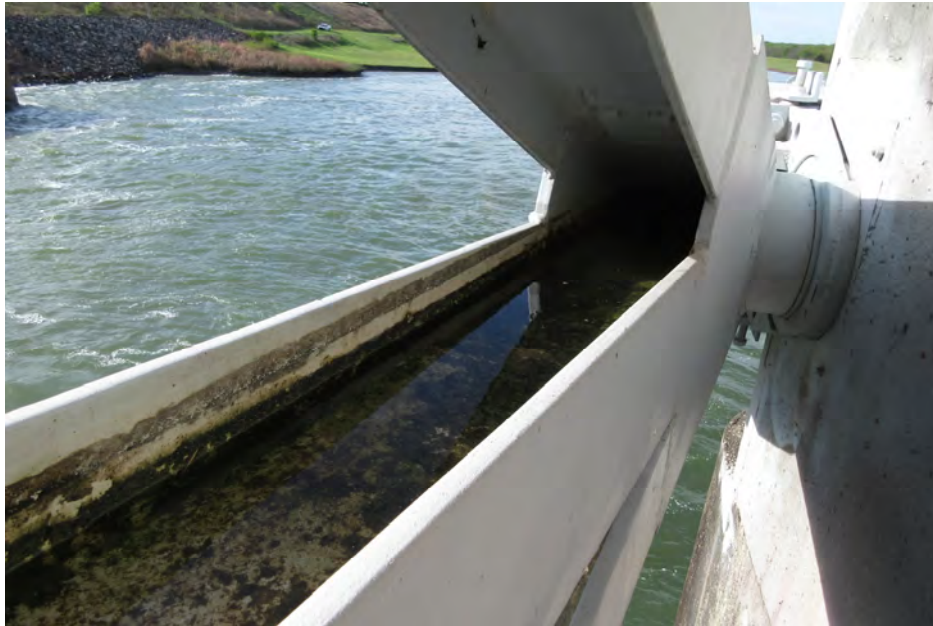
PHOTOGRAPH No.: 5

Member is holding water at the trunnion due to clogged drain hole.

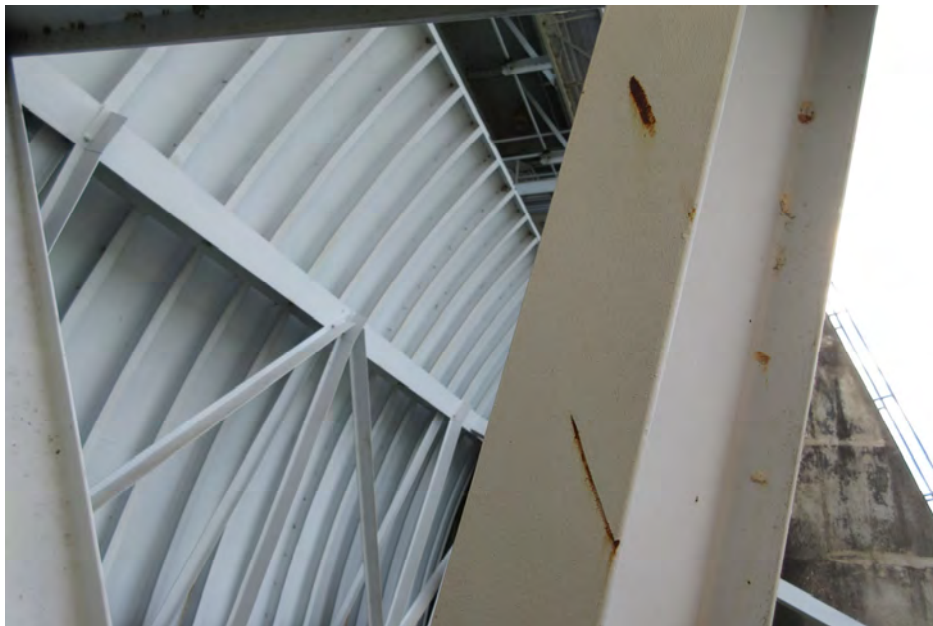
PHOTOGRAPH No.: 6

Outboard flange has two small areas of impact damage resulting in paint failure with surface rust, CS-2.

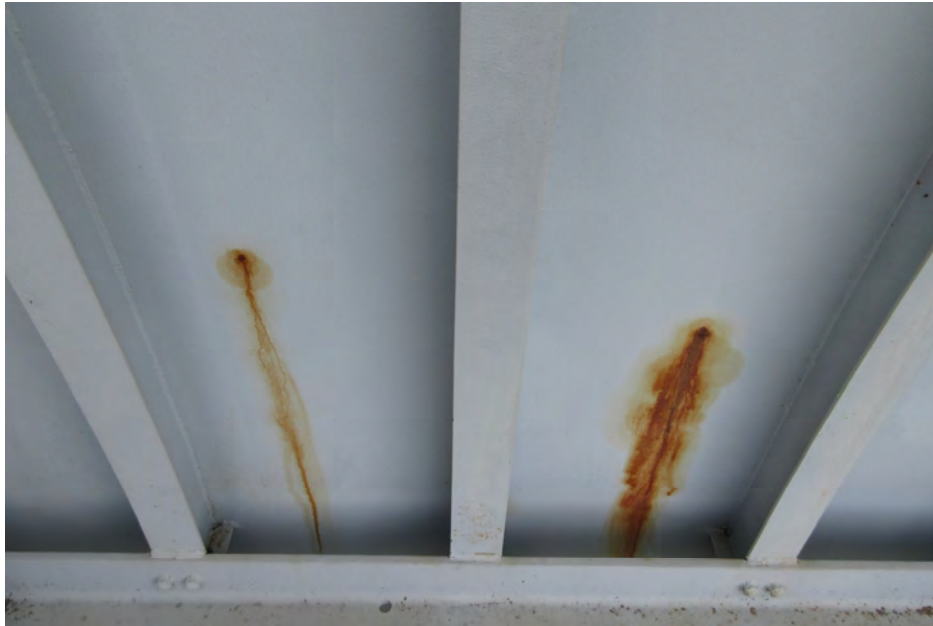
PHOTOGRAPH No.: 7

(2) Dents in skin plates (impact from upstream) resulting in paint failure downstream and rust bleeding down gate, downstream bulges measure 3/16" out of plane from skin plate, CS -2.

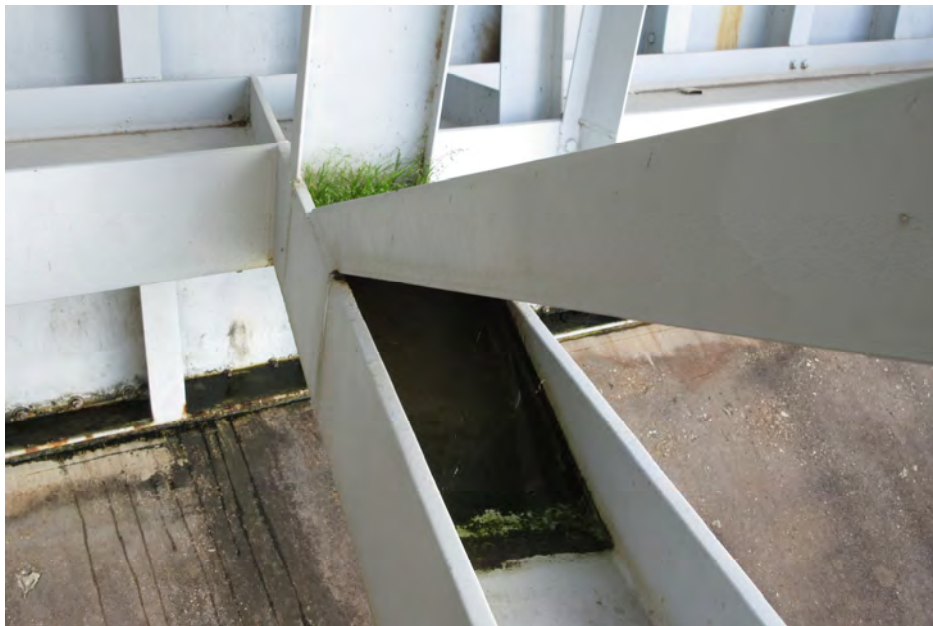
PHOTOGRAPH No.: 8

Build-up of dirt & debris at the connection of these members holding water & vegetation.
