VISUAL INSPECTION AND EVALUATION REPORT

Rockwall-Forney Dam
Dallas Water Utilities
Dallas/Kaufman Counties, Texas

Schnabel Reference #20C22001.00
July 30, 2021

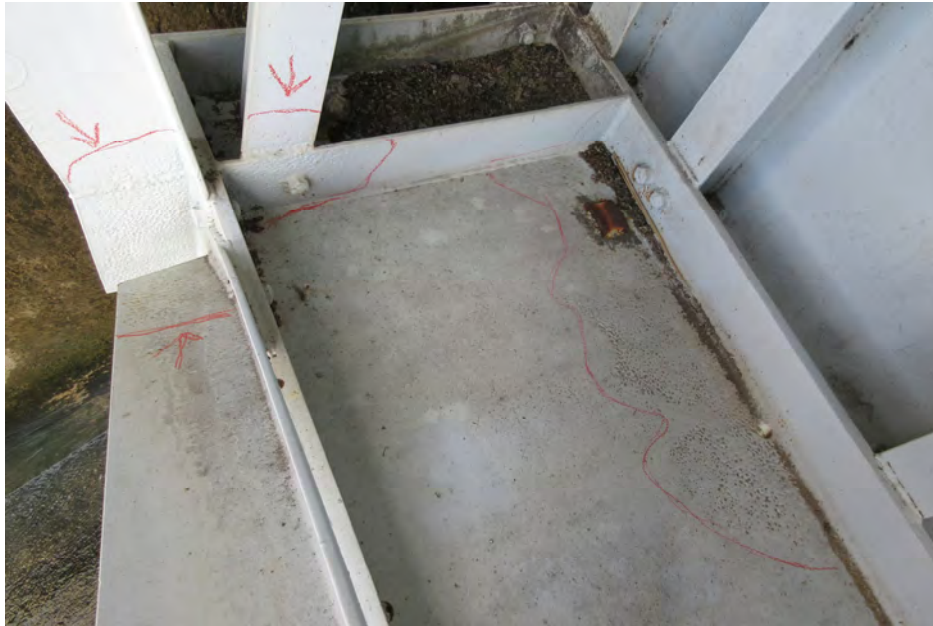
PHOTOGRAPH No.: 9

These (3) members have isolated areas of arrested pitting to 1/8", CS-3.

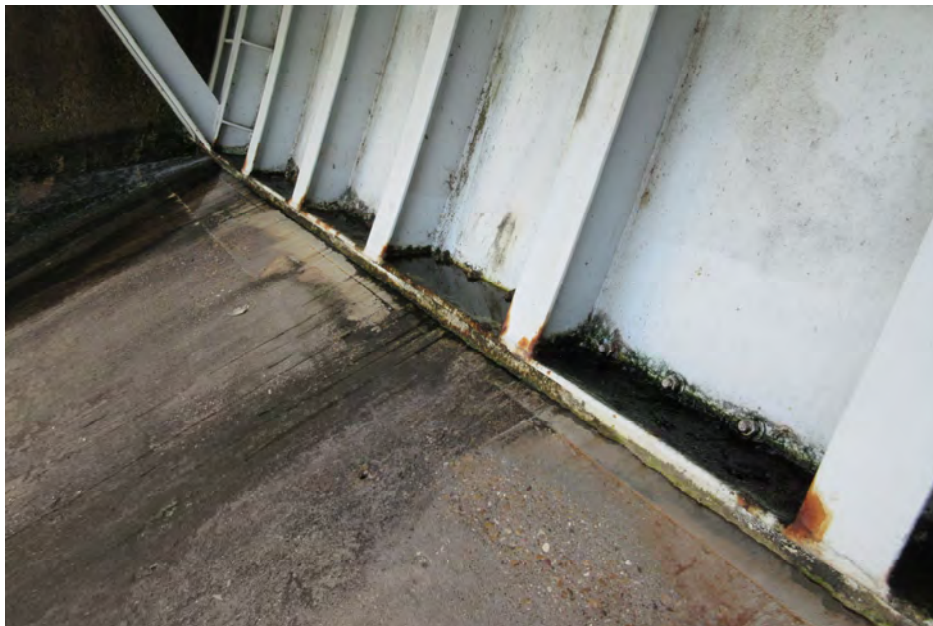
PHOTOGRAPH No.: 10

Bottom plate is holding water and organic matter between every vertical across gate, vertical flanges are corroding at bottom as a result, also noted bottom right seal has minor leak 2 gpm, left corner is similar.

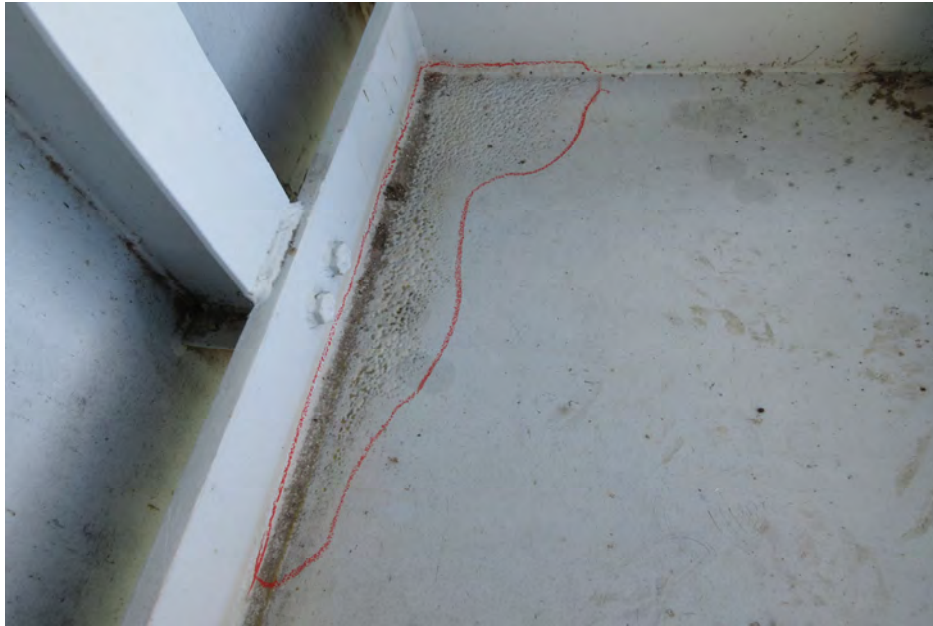
PHOTOGRAPH No.: 11

Several areas of arrested pitting to 1/8" exist along G-3's topside of web, CS-3.

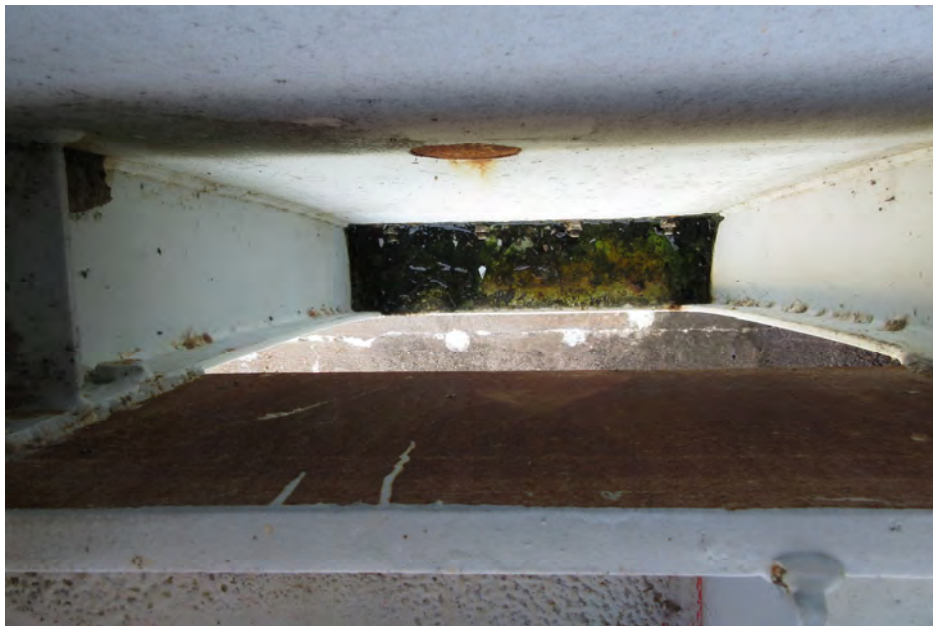
PHOTOGRAPH No.: 12

Upstream flange has moderate surface rust from failed application of paint, skin plate facing that area has a 4" circle of paint failure with surface rust, CS-2.

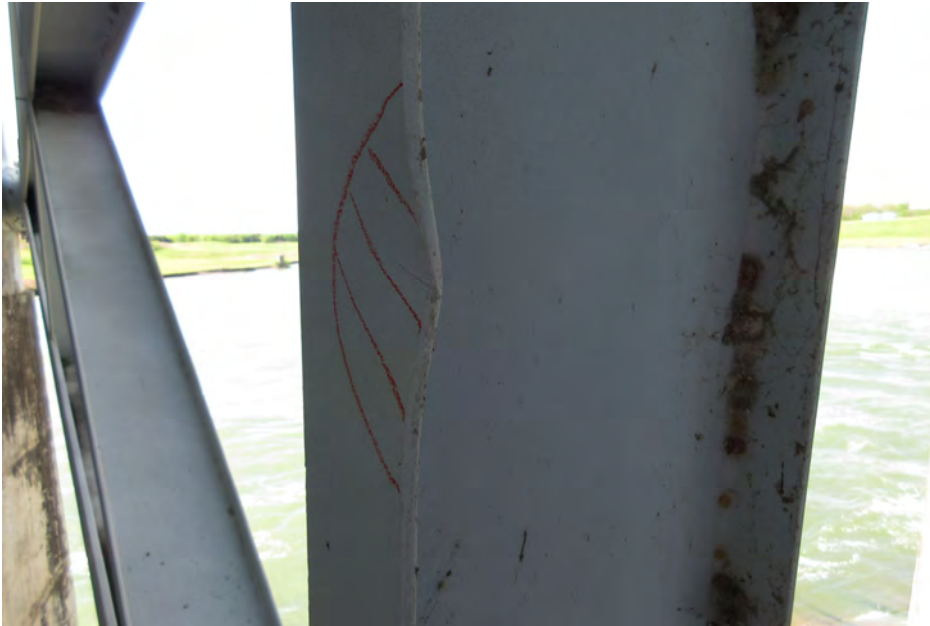
PHOTOGRAPH No.: 13

Out-of-plane bending 1/2" over 6" section, CS-2.

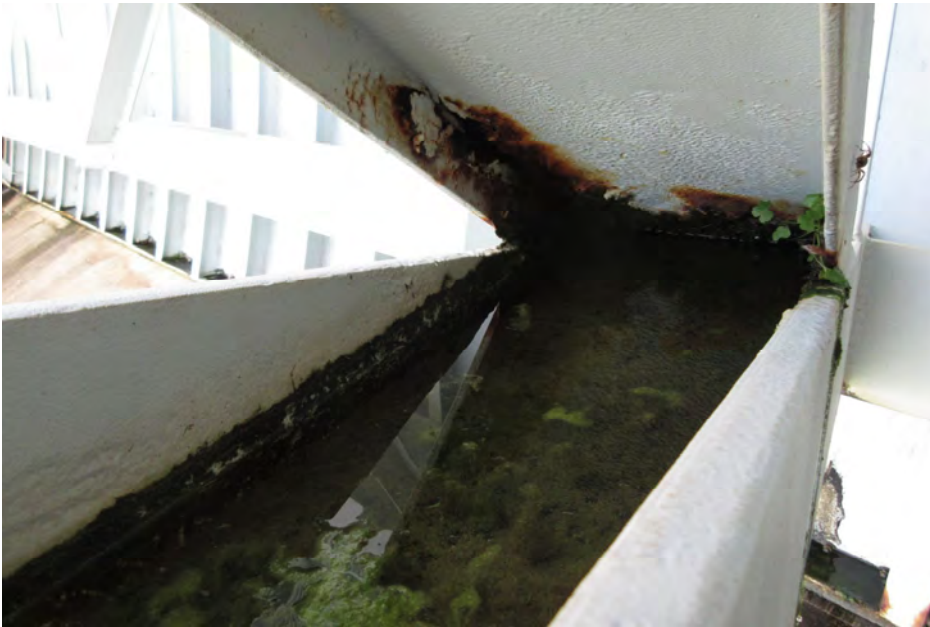
PHOTOGRAPH No.: 14

Ponding water at this connection, LB-5 has paint failure with heavy rust and pitting to 1/8", CS-3.

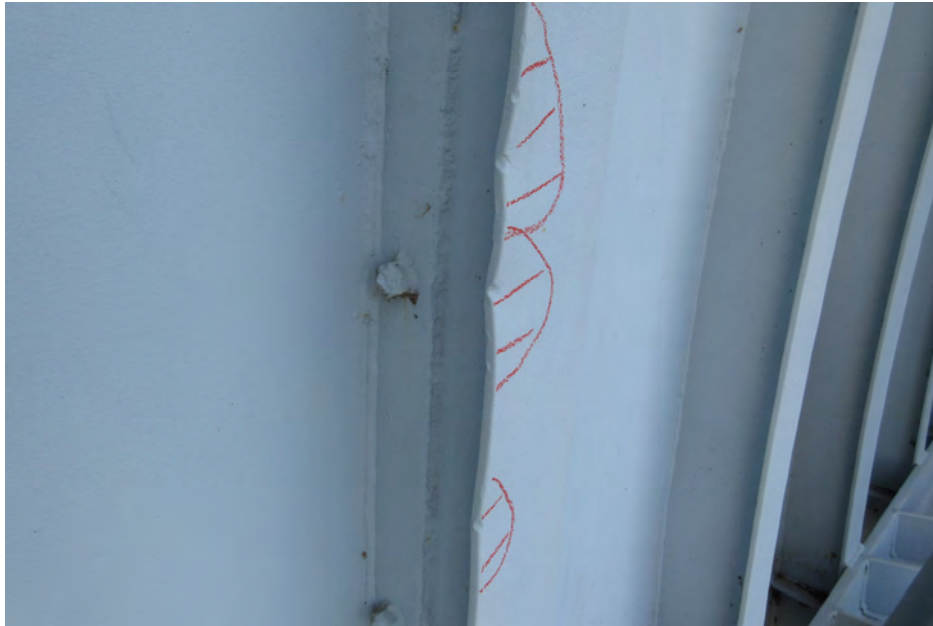
PHOTOGRAPH No.: 15

(3) points of out-of-plane bending up to 5/16" over 18" section, CS-2.

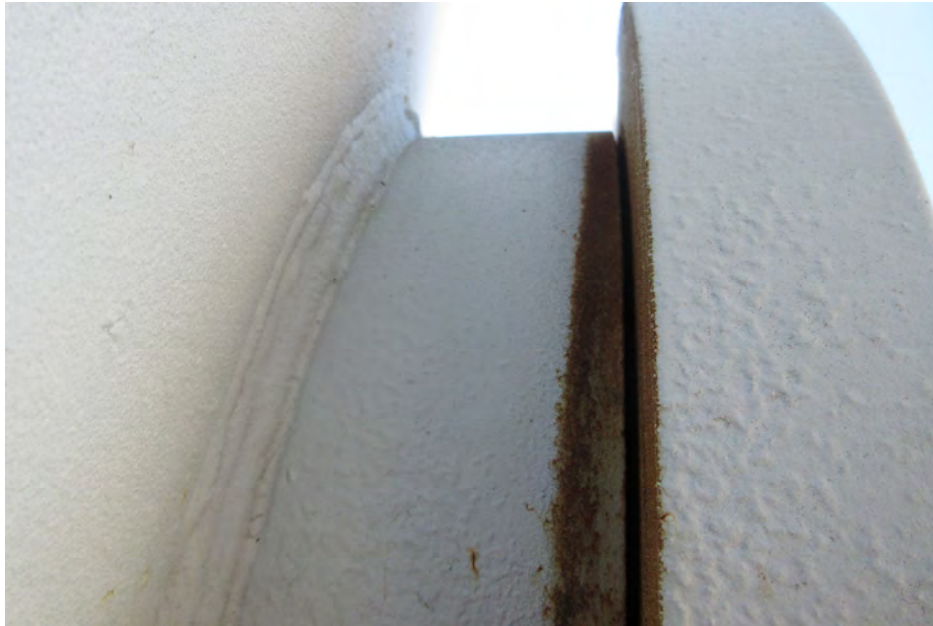
PHOTOGRAPH No.: 17

Areas of moderate surface rust where paint application failed, CS2.

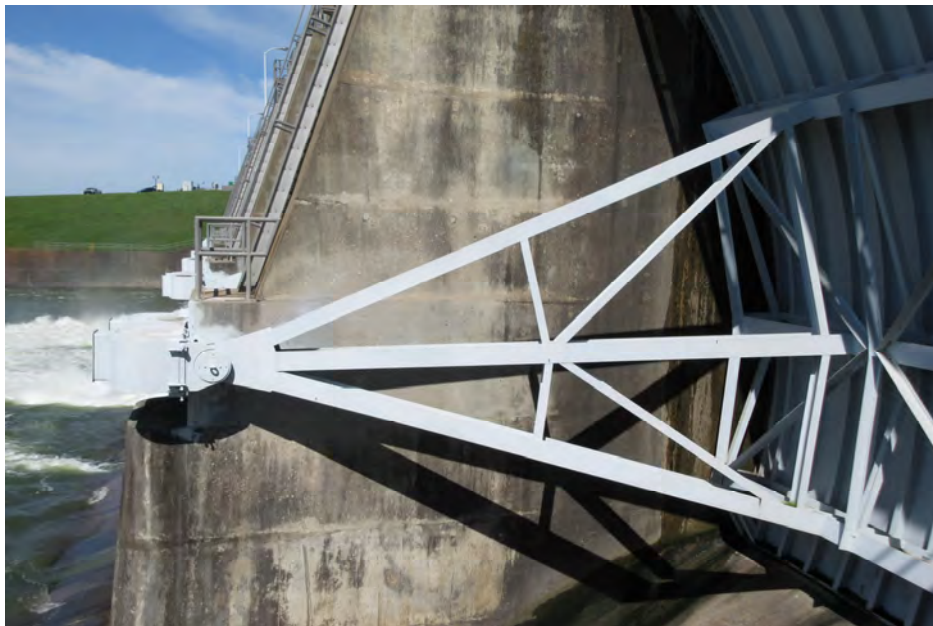
PHOTOGRAPH No.: 18

Gate 11, right arm overview.

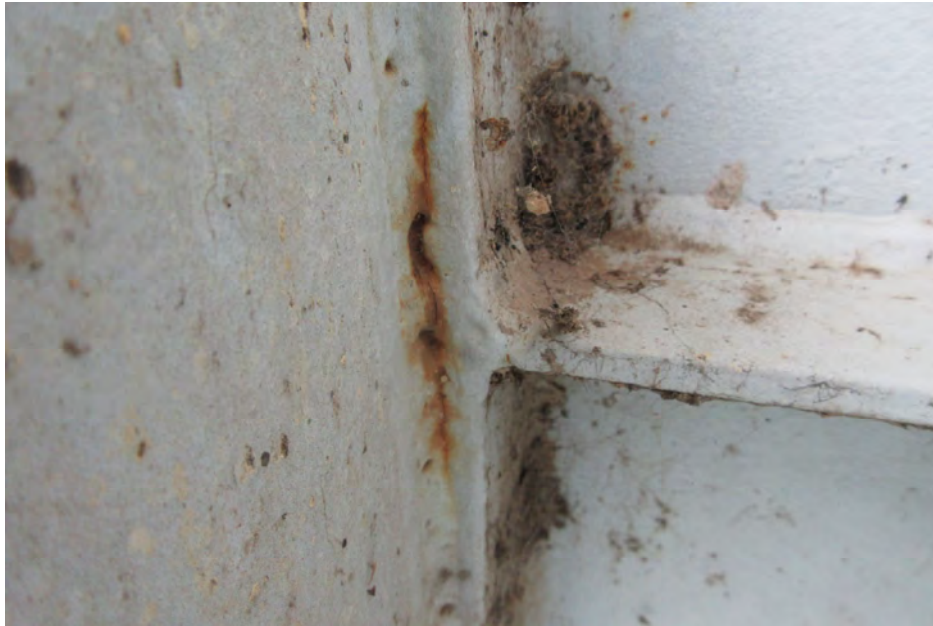
PHOTOGRAPH No.: 1

2" long vertical crack in weld,
CS3.

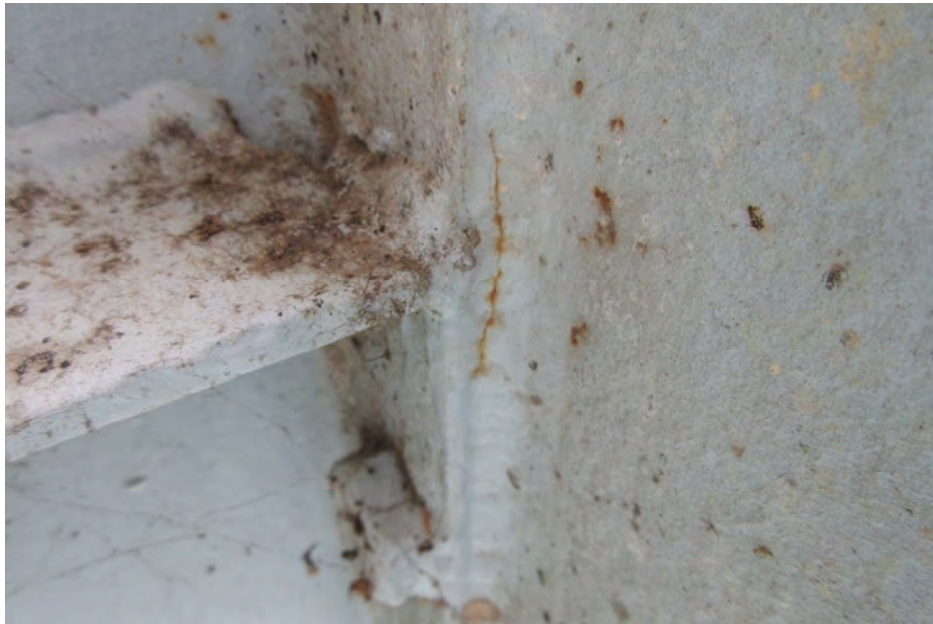
PHOTOGRAPH No.: 2

1-1/2" long vertical crack in
weld, CS3.

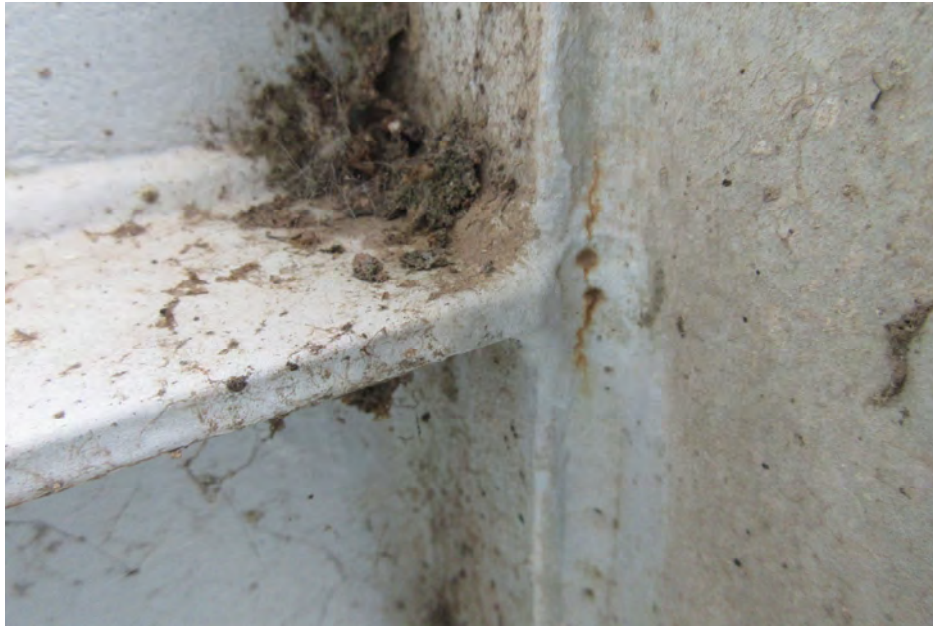
PHOTOGRAPH No.: 3

1" long vertical crack in weld,
CS3.

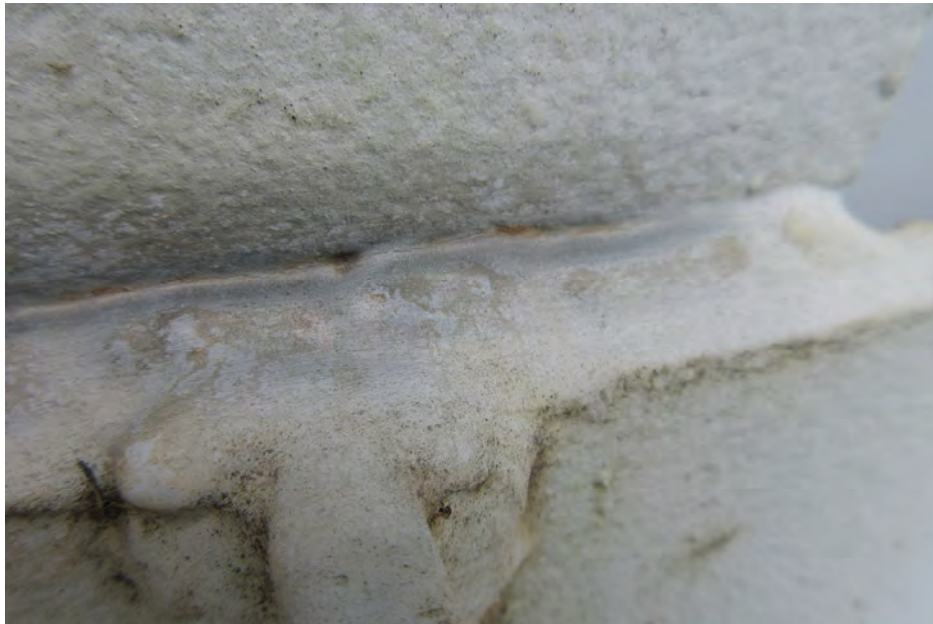
PHOTOGRAPH No.: 4

2-1/2" long crack in weld be-
tween the flange of the rib and
the edge of the flange on the
girder.

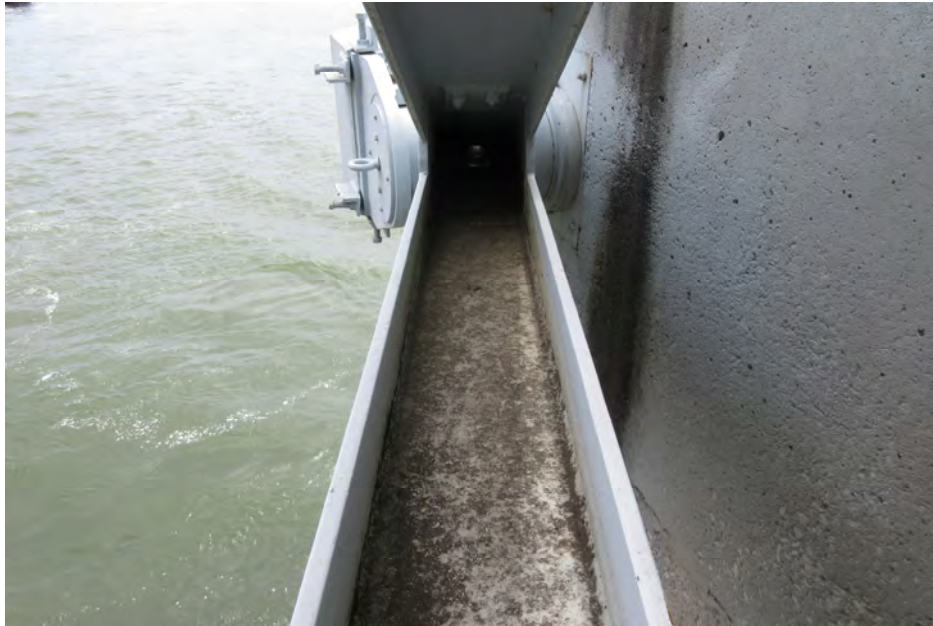
PHOTOGRAPH No.: 5

Evidence of the water and debris recently being present, paint intact.

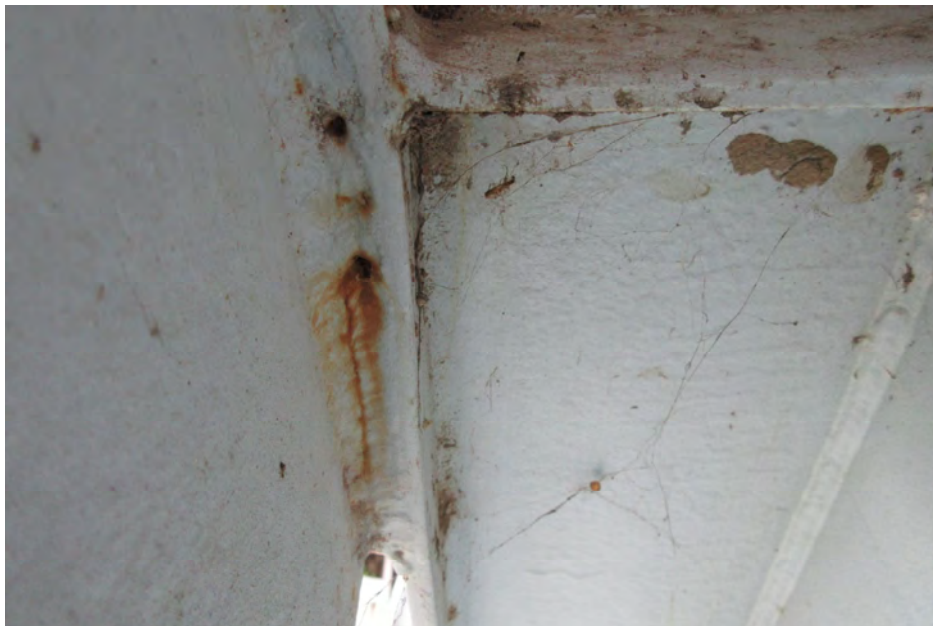
PHOTOGRAPH No.: 6

Cracks on either side of vertical on the vertical welds, CS3.

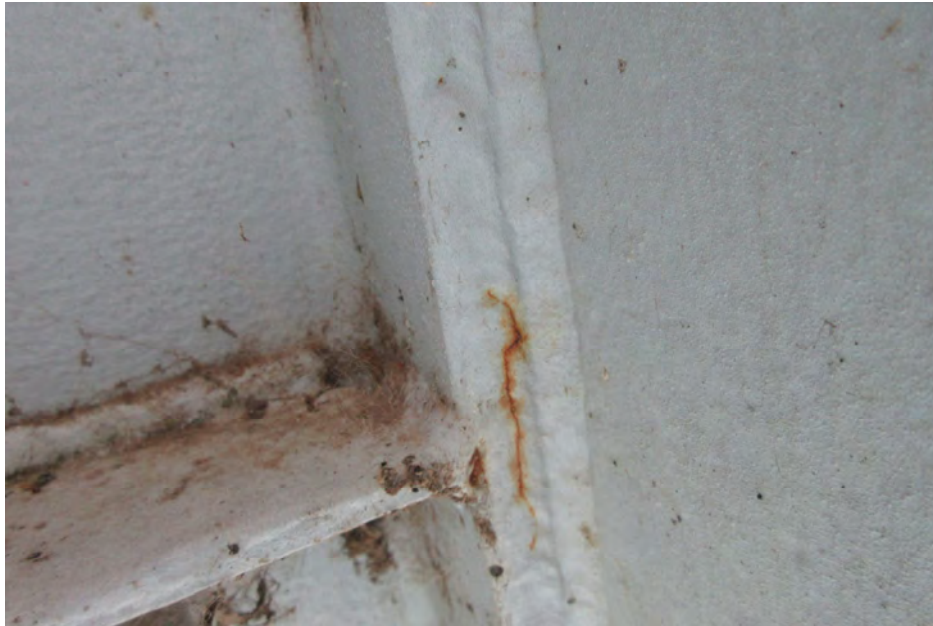
PHOTOGRAPH No.: 7

Cracks on either side of vertical on the vertical, CS3.

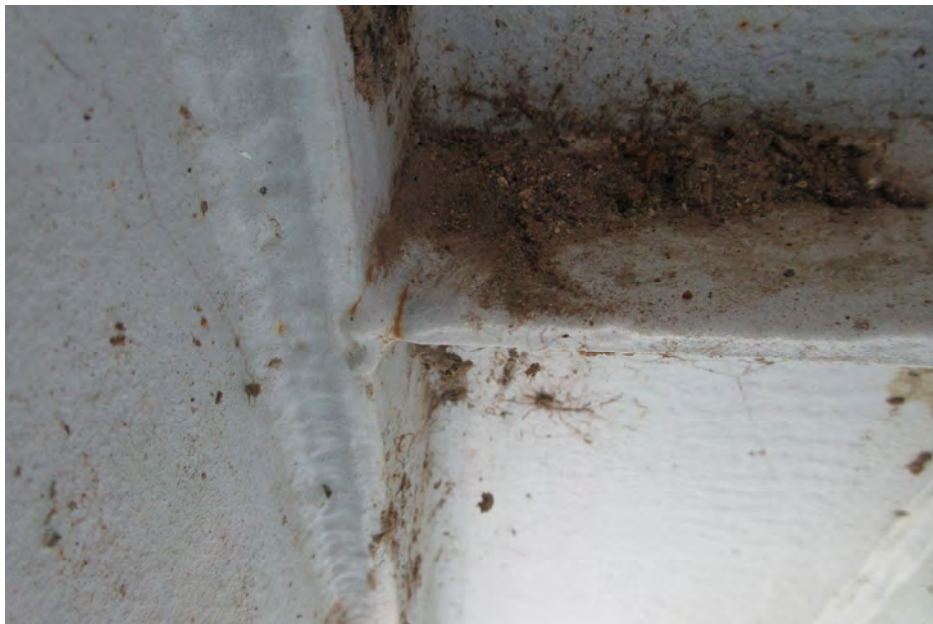
PHOTOGRAPH No.: 8

1/2" crack in web stiffener, CS3.

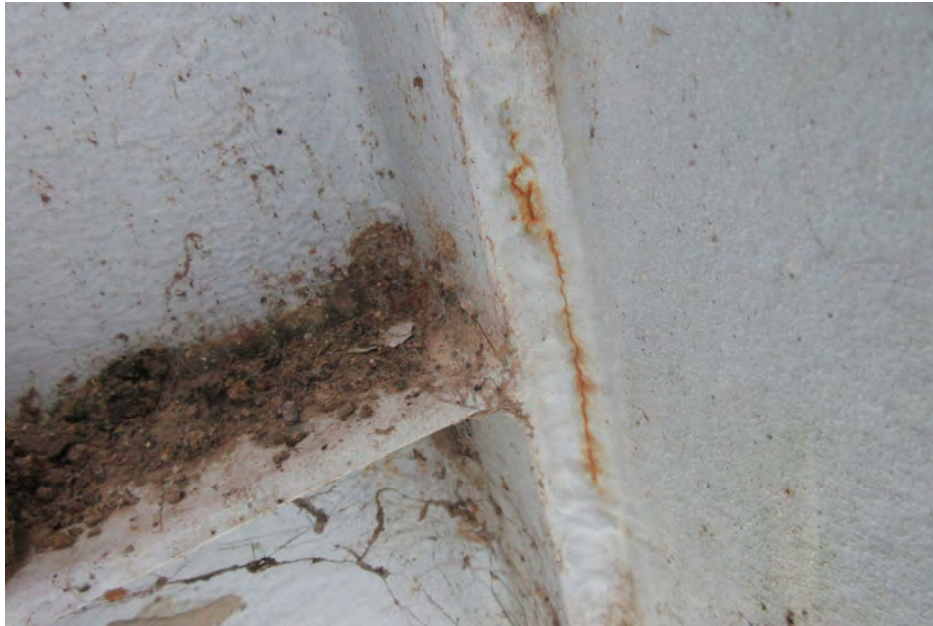
PHOTOGRAPH No.: 9

3" long in vertical weld, CS3.

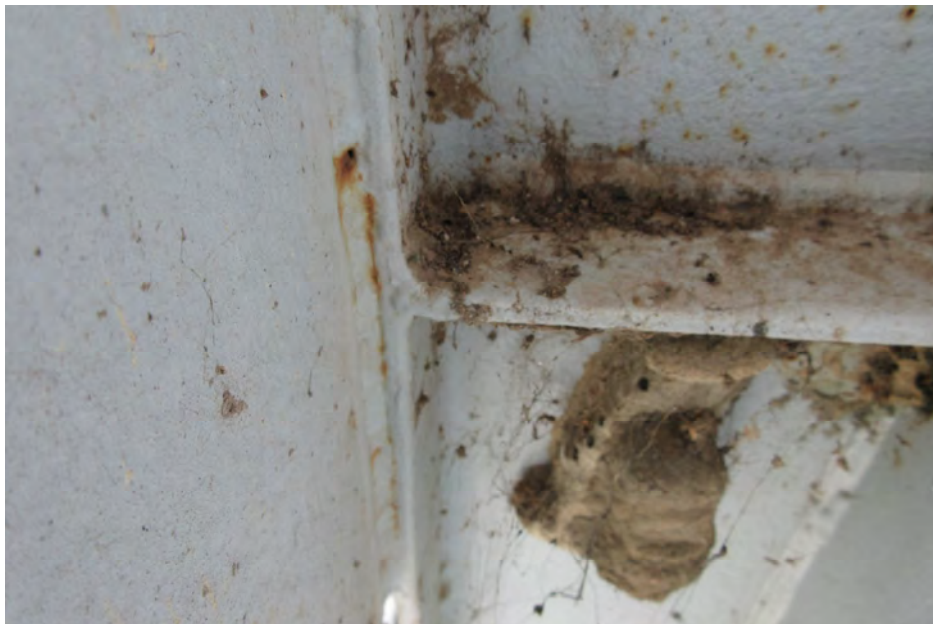
PHOTOGRAPH No.: 10

5" long crack in vertical weld,
CS3.

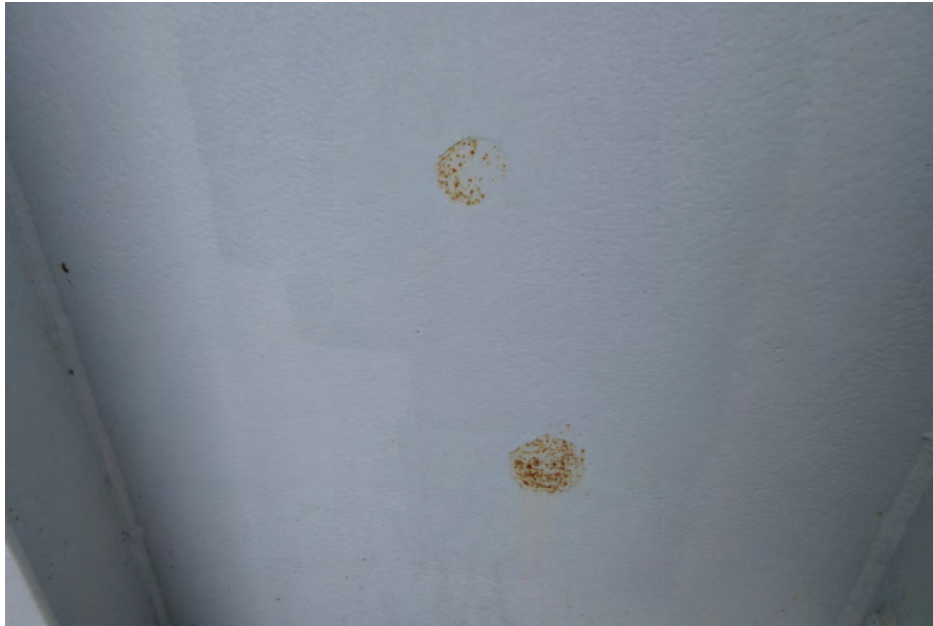
PHOTOGRAPH No.: 11

2" round paint failure with moderate surface rust, CS2. Spots are common through out gate.

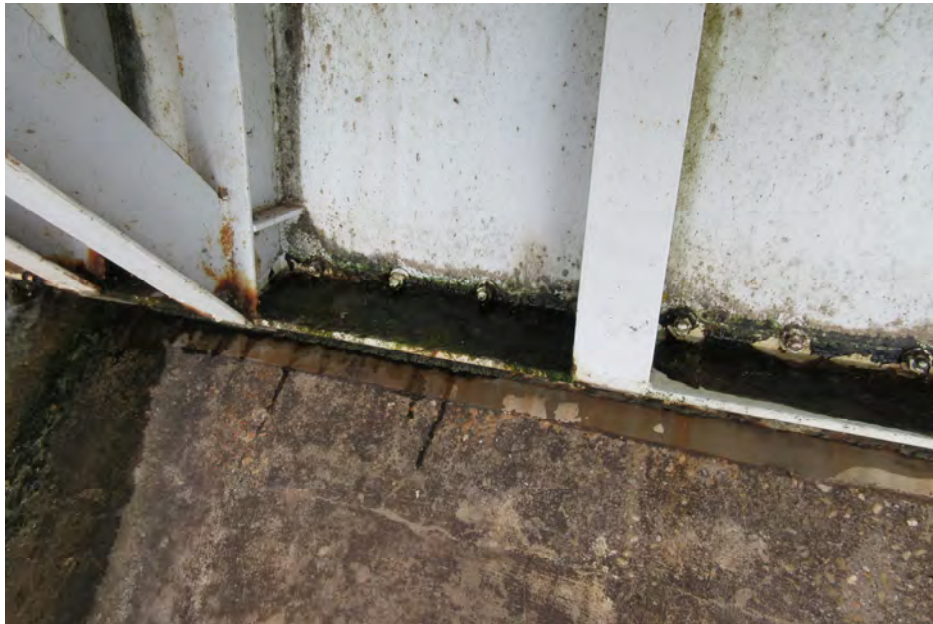
PHOTOGRAPH No.: 12

Standing water and plant growth in plate. Area of paint failure with moderate to heavy surface rust. Common for bottom plate of gate.

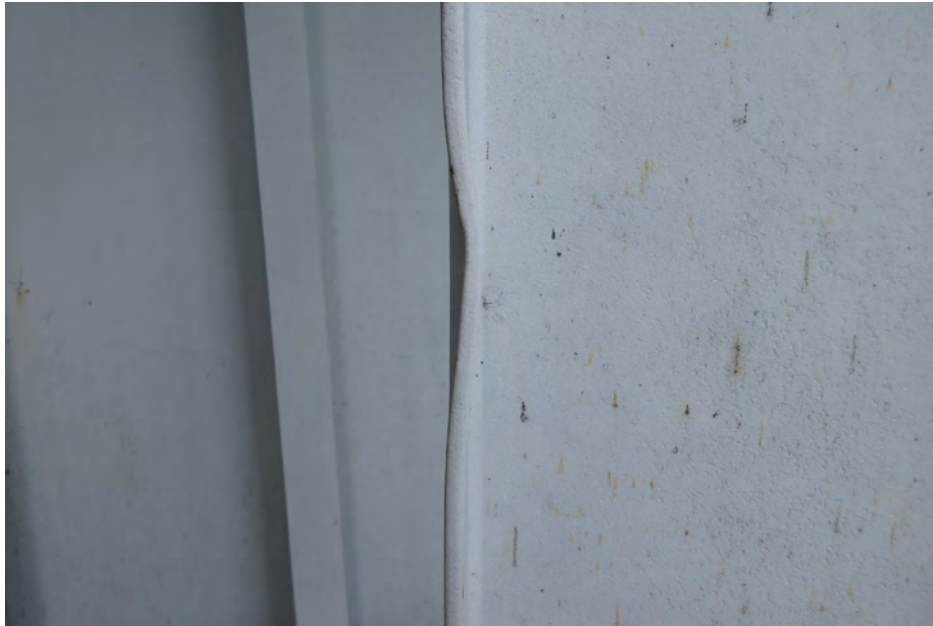
PHOTOGRAPH No.: 13

Out-of-plane bending, 1" over 3" in flange.

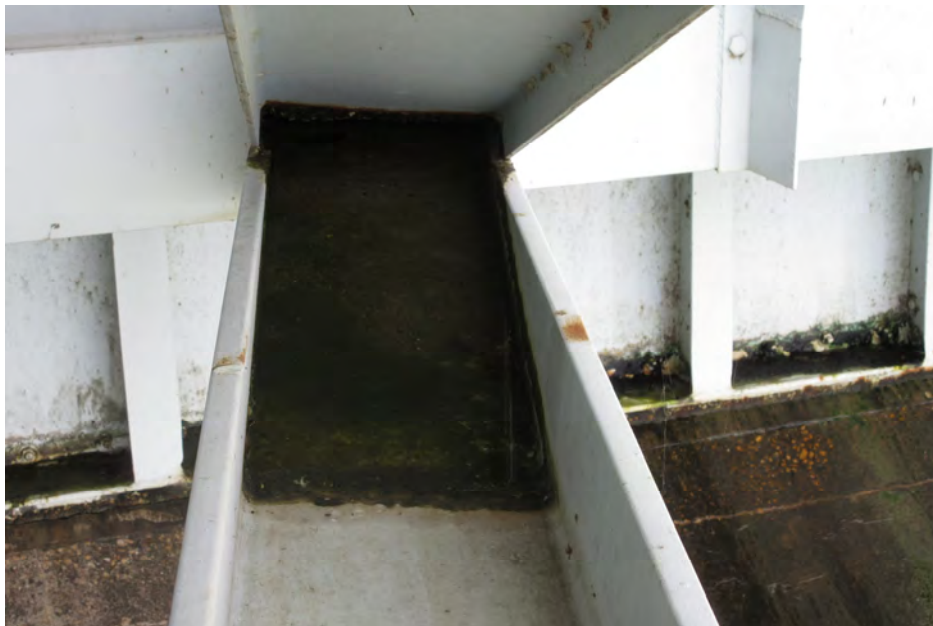
PHOTOGRAPH No.: 14

Drain hole is plugged and 5" of water and sand are present.

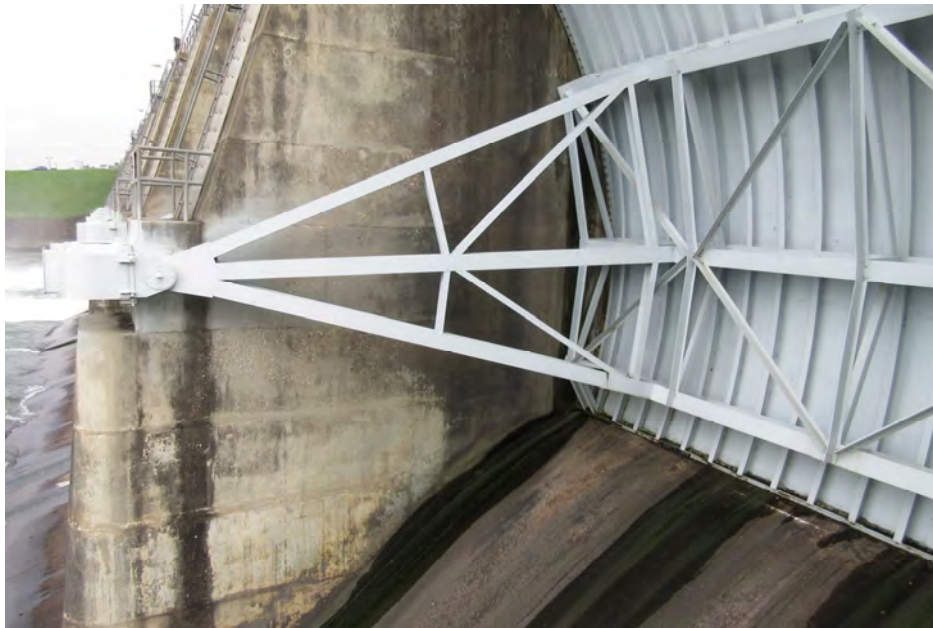
PHOTOGRAPH No.: 15

Gate 12, right arm.

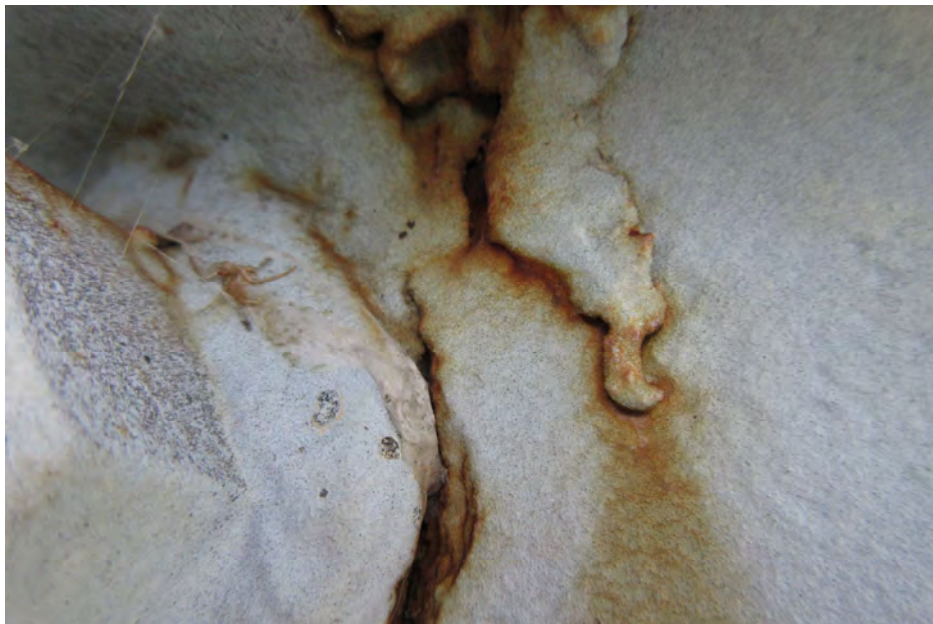
PHOTOGRAPH No.: 16

1/2" crack in alignment bolt plate. CS-3.

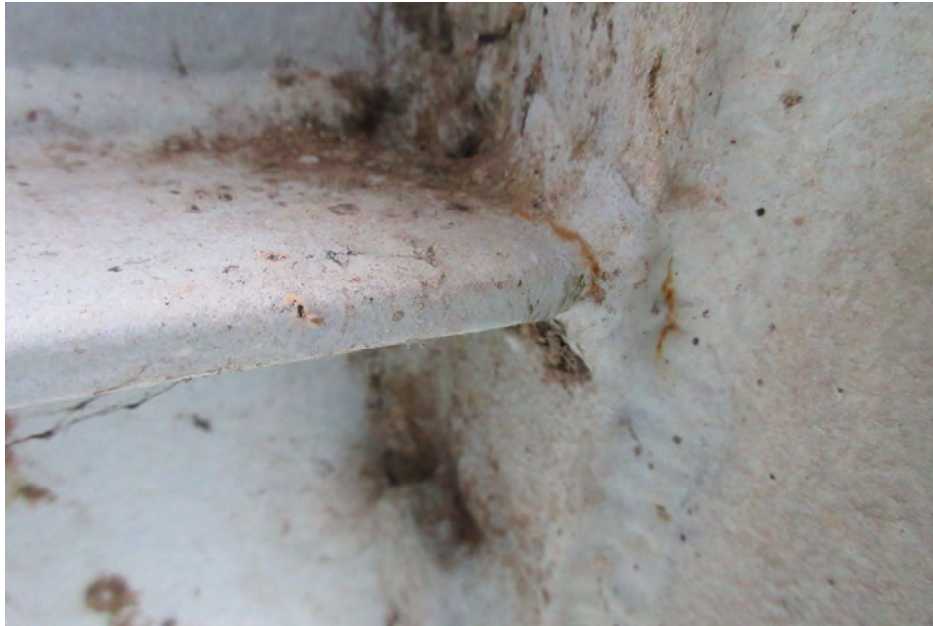
PHOTOGRAPH No.: 17

1/2" crack in weld of web stiffener.

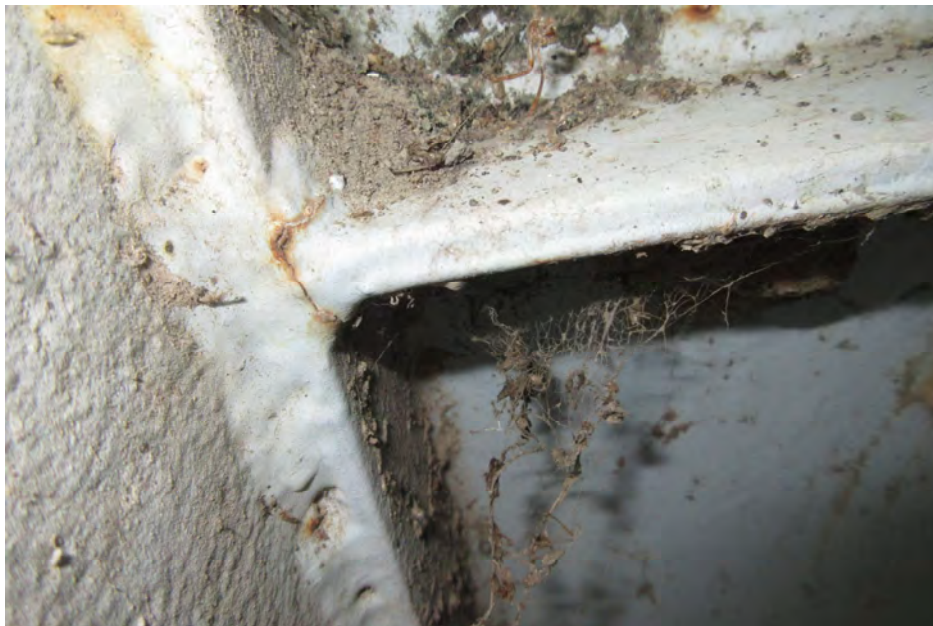
PHOTOGRAPH No.: 18

1/2" crack in weld of web stiffener.

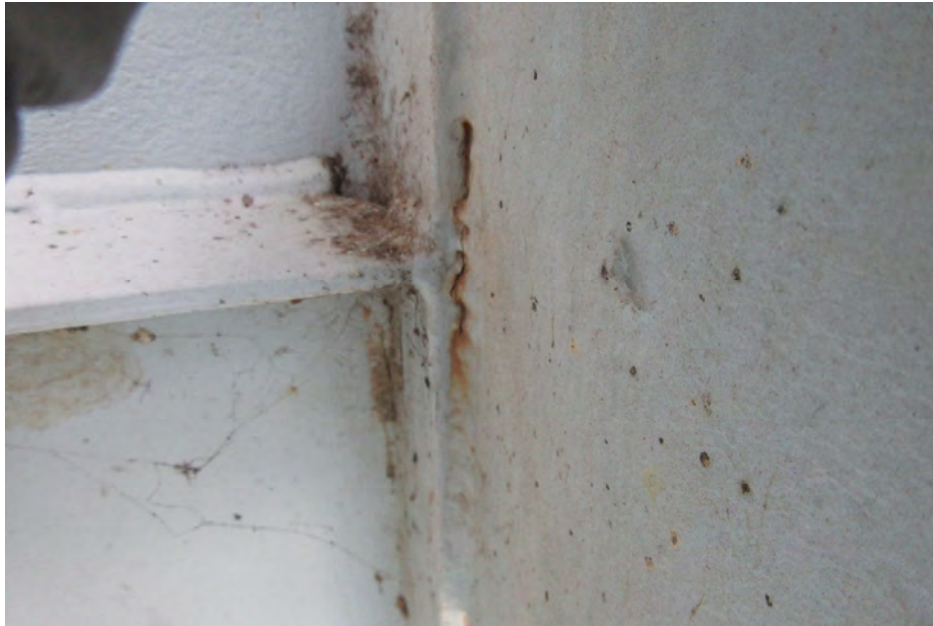
PHOTOGRAPH No.: 19

2" long crack in vertical weld,
CS3.

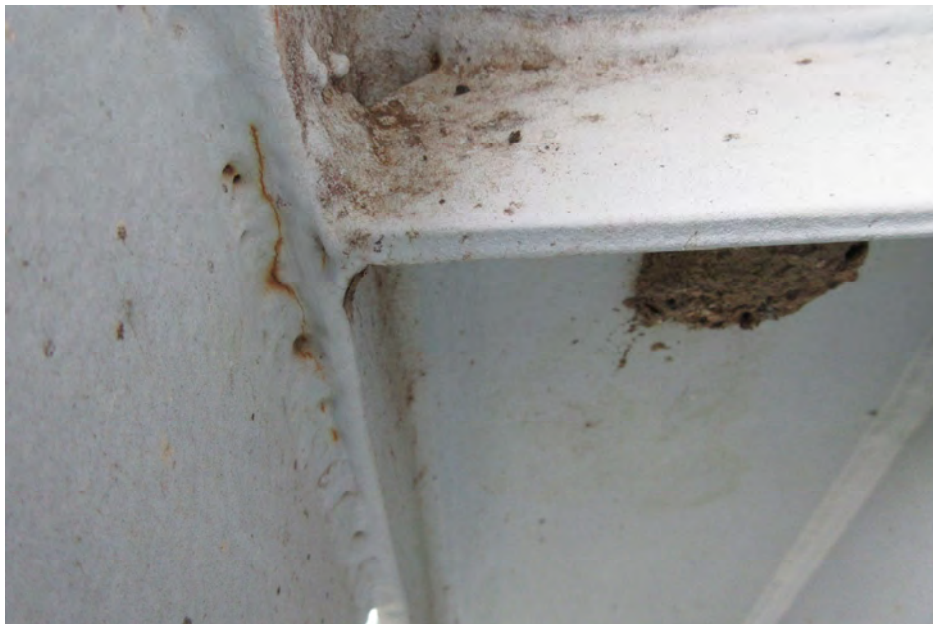
PHOTOGRAPH No.: 20

2-1/2" long crack in vertical
weld.

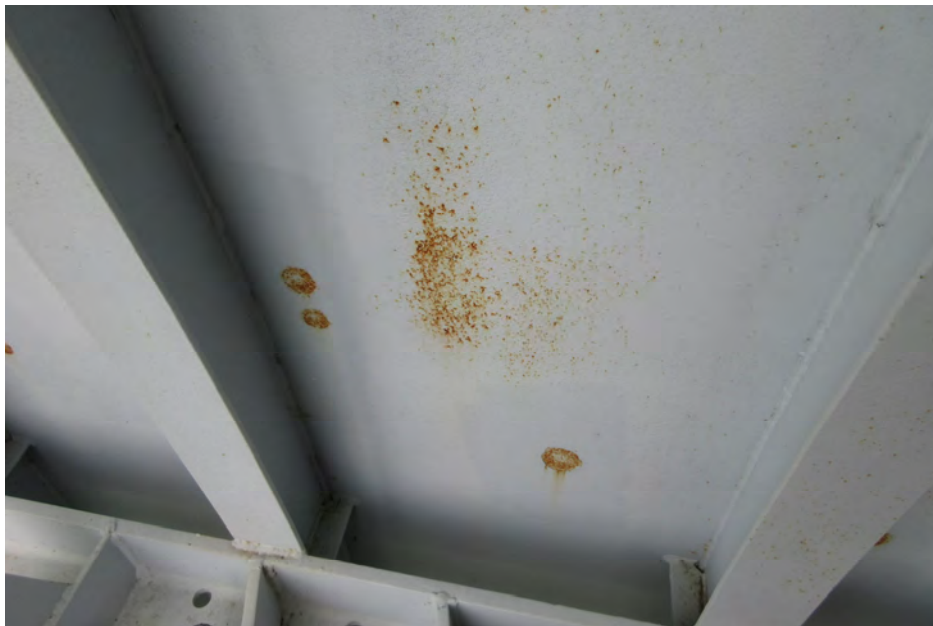
PHOTOGRAPH No.: 22

Evidence of water and debris recently being present due to drain hole being plugged.

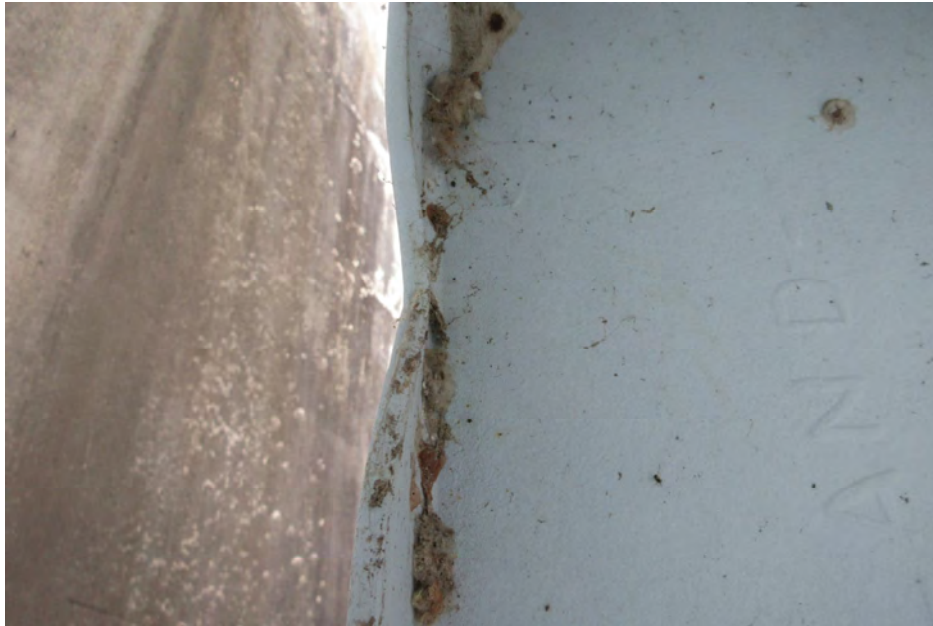
PHOTOGRAPH No.: 23

16" x 4' area of paint failure. Moderate surface rust, CS2.

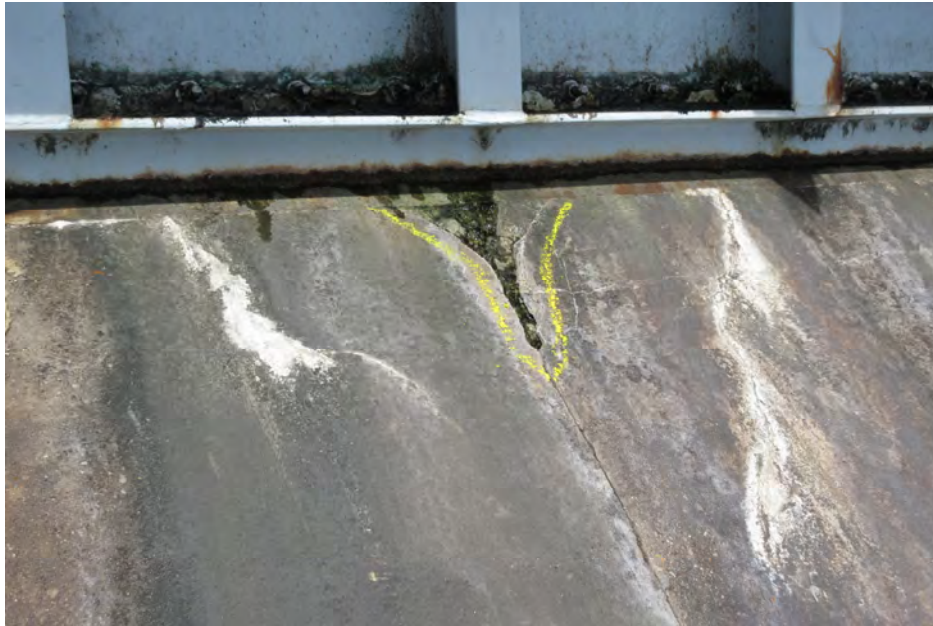
PHOTOGRAPH No.: 9

Spall about 7' x 3' x 4" deep, no exposed rebar.

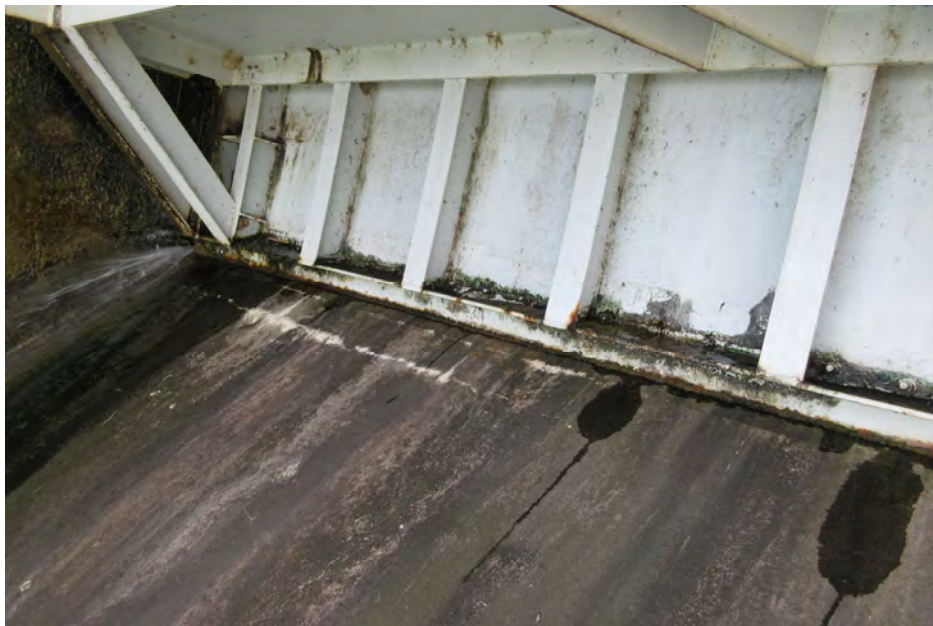
PHOTOGRAPH No.: 10

Spall just below gate (12" long x 3/4" deep) surrounded by diagonal cracks with efflorescence.

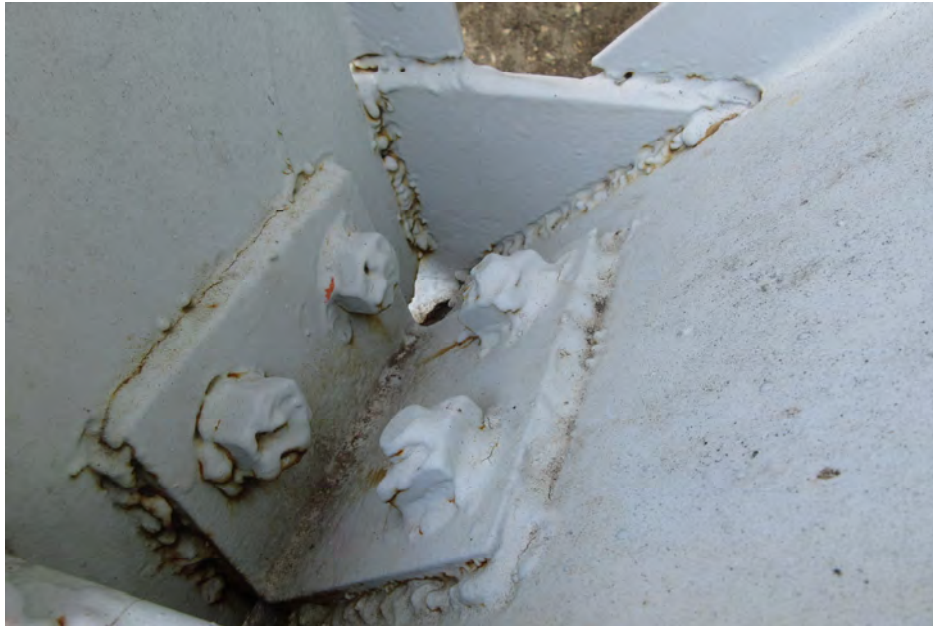
PHOTOGRAPH No.: 11

Bottom plate is holding water and organic matter corroding vertical flange edges, CS-3. Bottom right corner also has minor leak about 3 gpm.

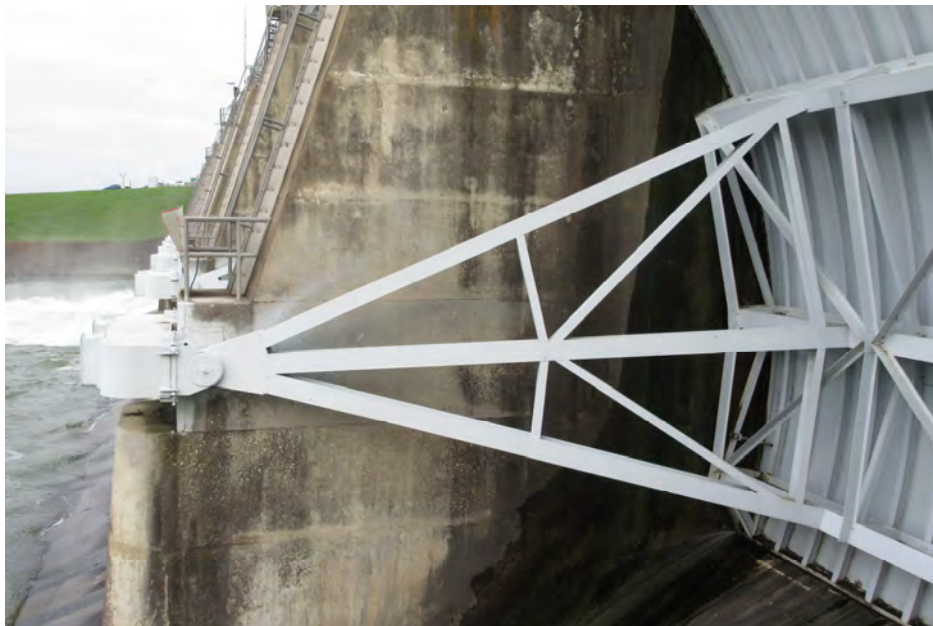
PHOTOGRAPH No.: 12

Non-uniform field welds at connection (typical at most arm braces).

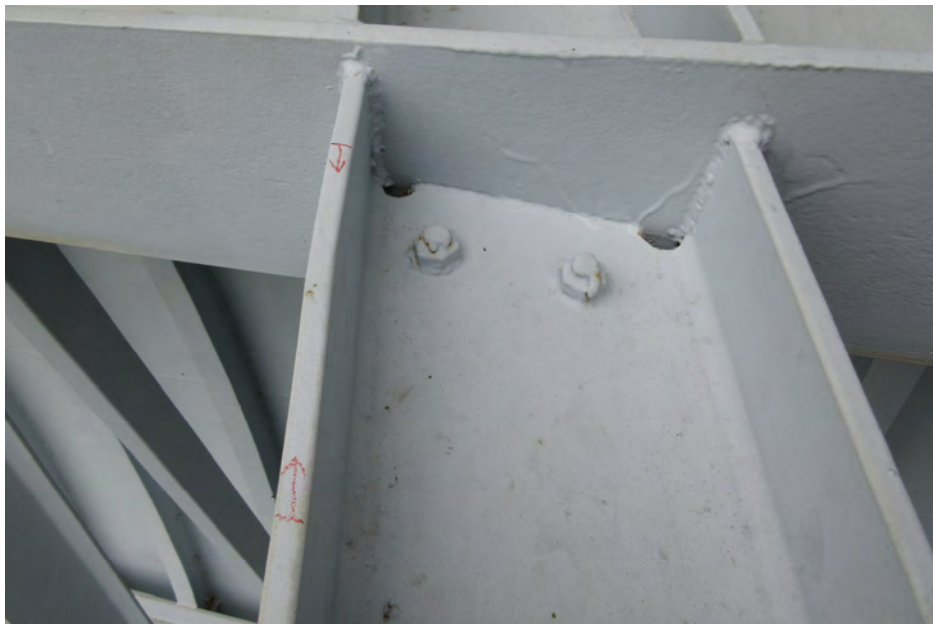
PHOTOGRAPH No.: 16

Minor leak high on left seal is pooling water on G2 & G3 left ends.

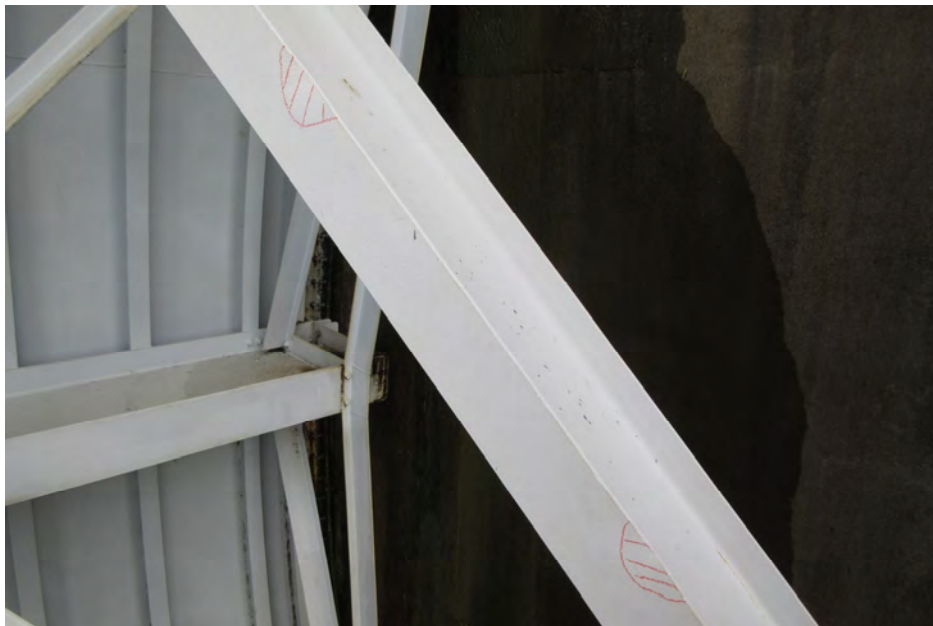
PHOTOGRAPH No.: 18

(2) areas of out-of-plane bending on outboard/ downstream flange, both measures 3/16" over 5".

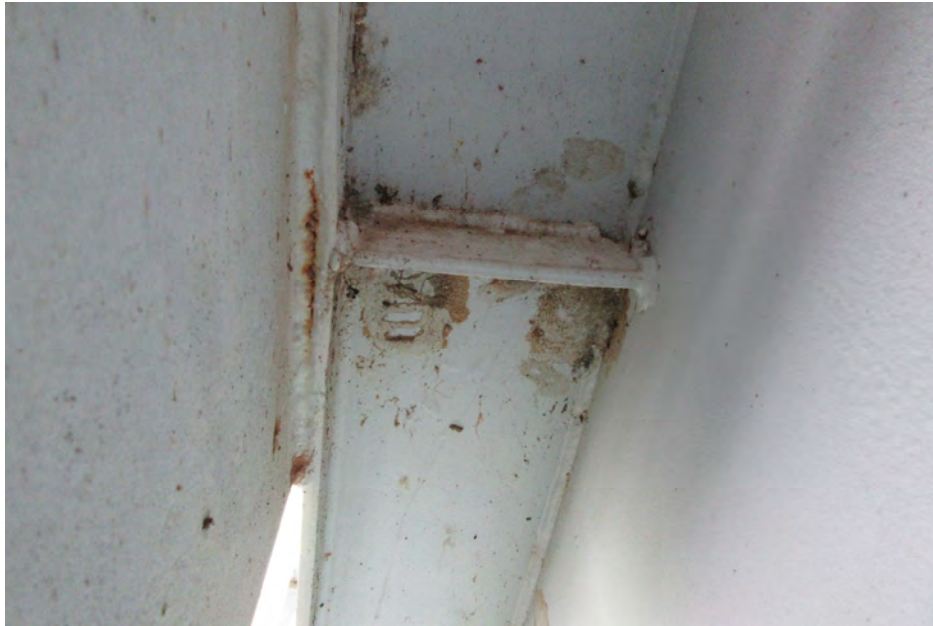
PHOTOGRAPH No.: 19

(2) areas of out-of-plane bending on inboard/upper flange, both measure 3/16" over 4".
