VISUAL INSPECTION AND EVALUATION REPORT

Rockwall-Forney Dam
Dallas Water Utilities
Dallas/Kaufman Counties, Texas

Schnabel Reference #20C22001.00
July 30, 2021

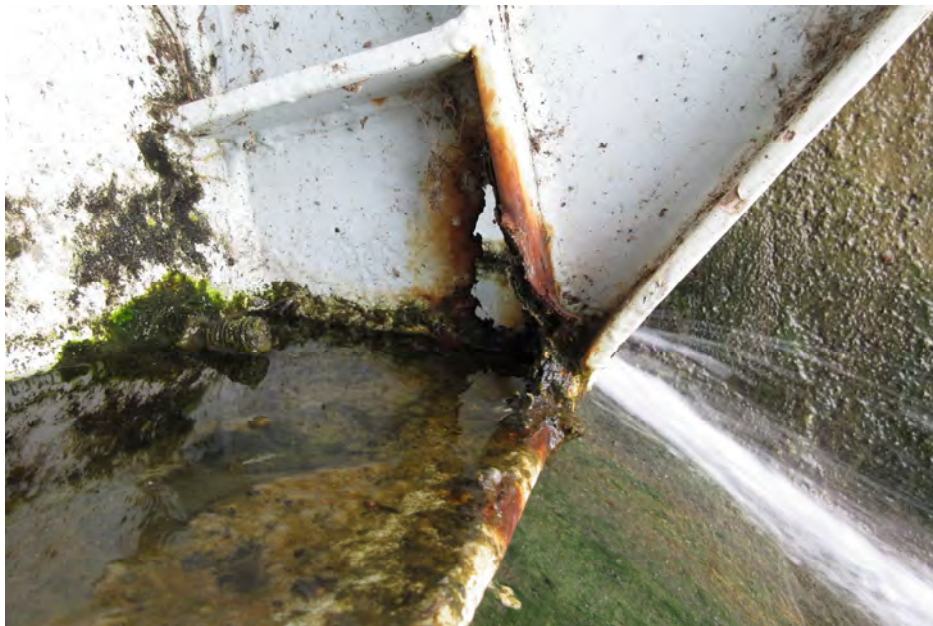
PHOTOGRAPH No.: 20

Middle 1/3 of weld is cracked, CS-2.

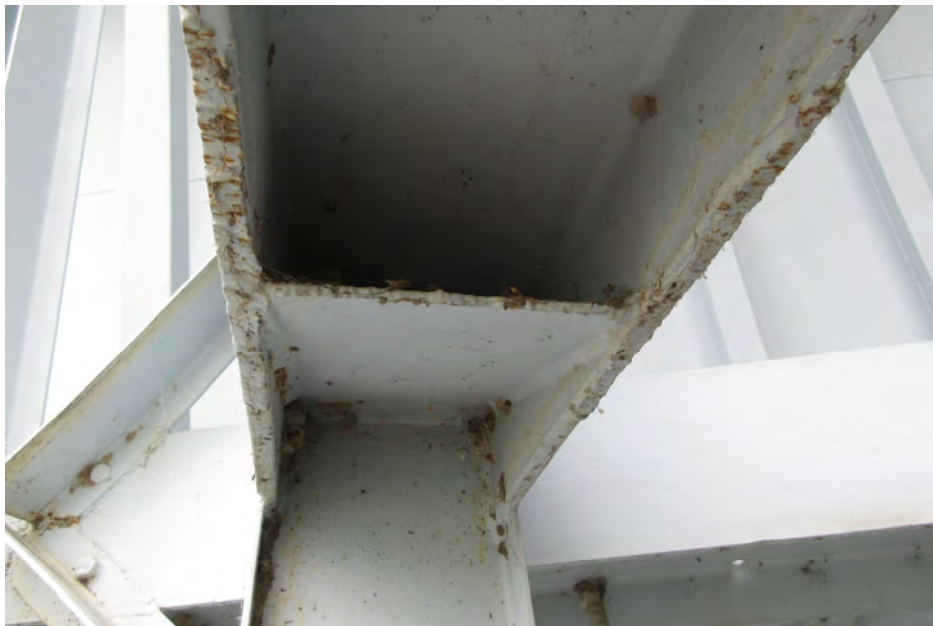
PHOTOGRAPH No.: 22

LB-5 appears to have installed incorrectly, cut, and installed correctly requiring this splice plate, a splice plate exists on the underside of web also.

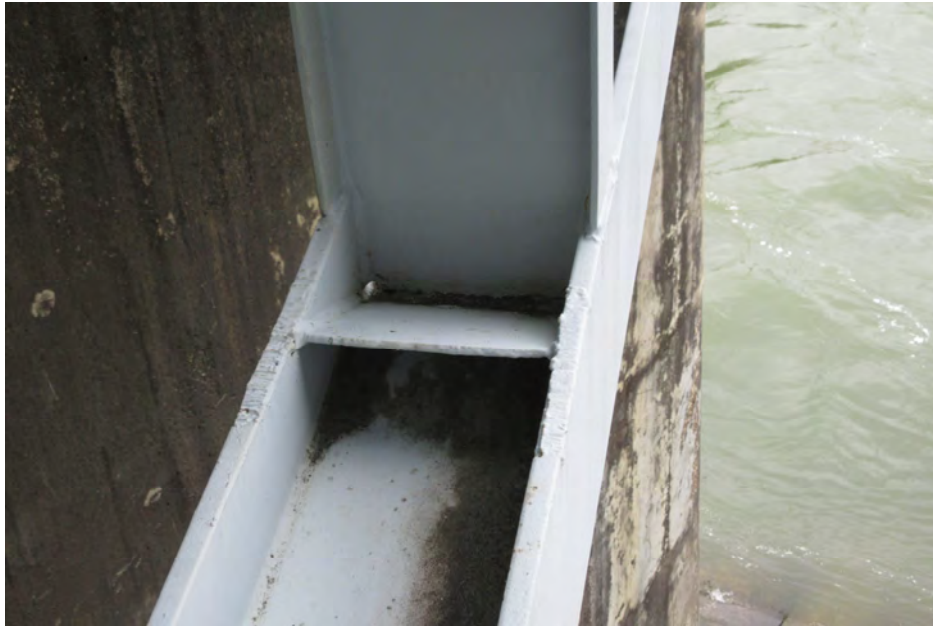
PHOTOGRAPH No.: 23

Remnants of LB-5 incorrect installation and being cut out.

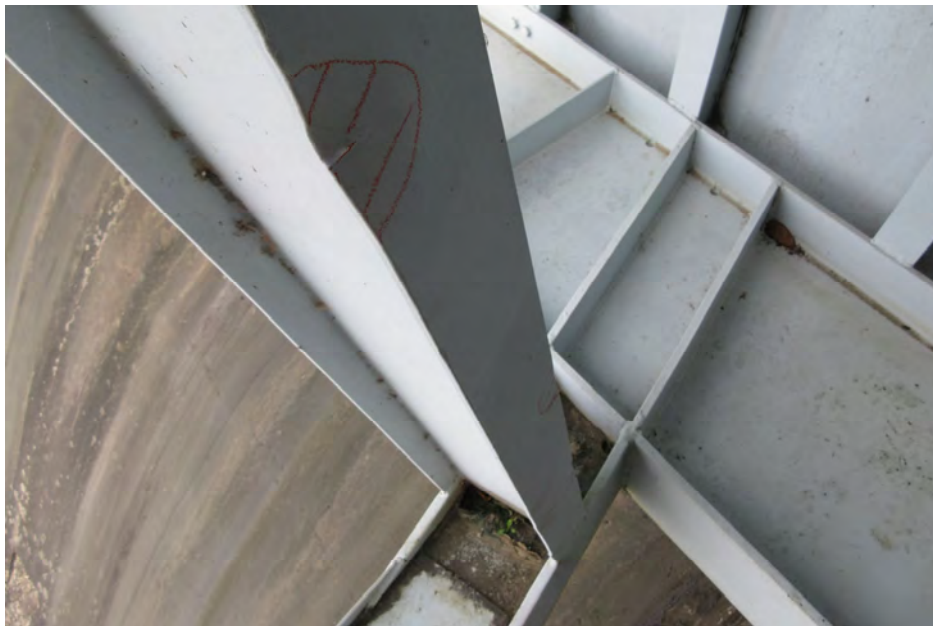
PHOTOGRAPH No.: 24

Remnants of LB-5 incorrect installation and being cut out.

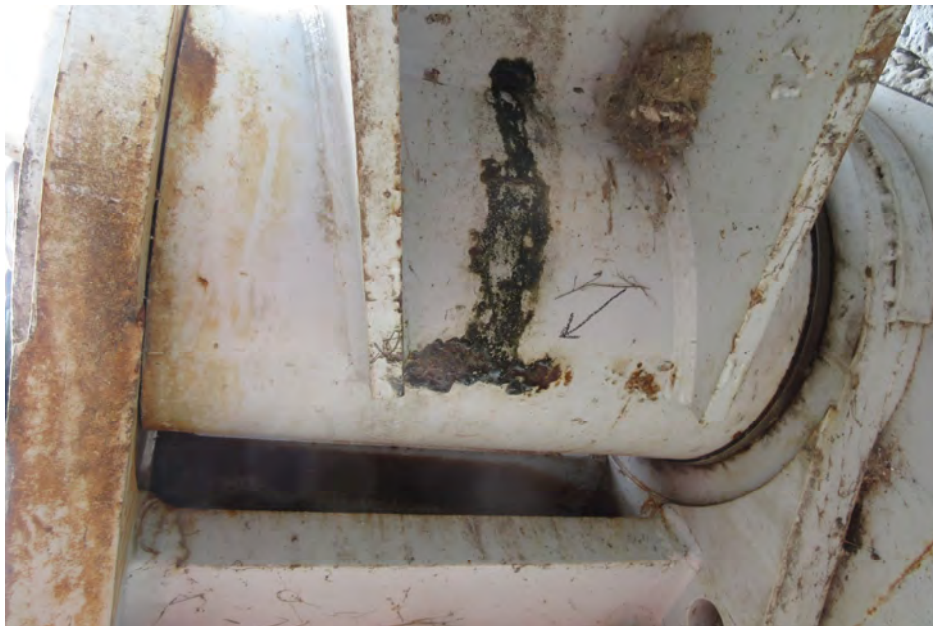
PHOTOGRAPH No.: 4

Moderate surface rust. CS-2.

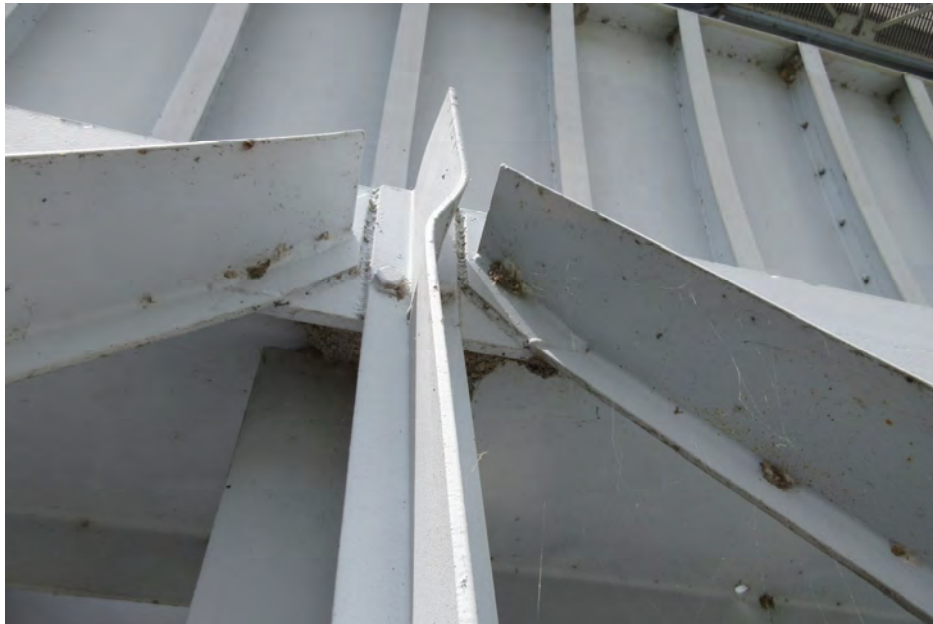
PHOTOGRAPH No.: 12

Partially cracked vertical weld. Potential for propagation. Low quality field weld. CS-3.

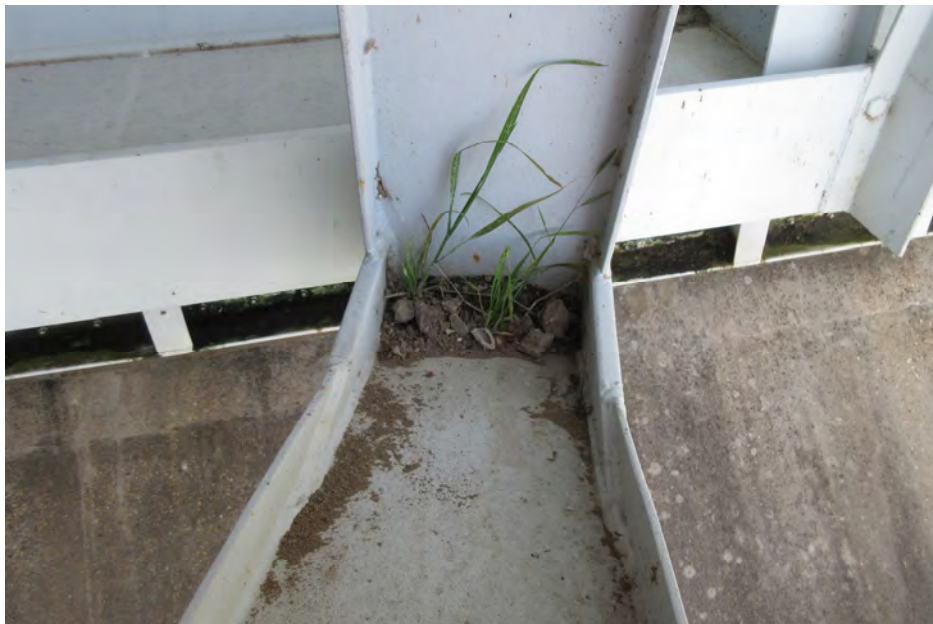
PHOTOGRAPH No.: 14

Out of plane bending, 1" over 7" long. CS-2.

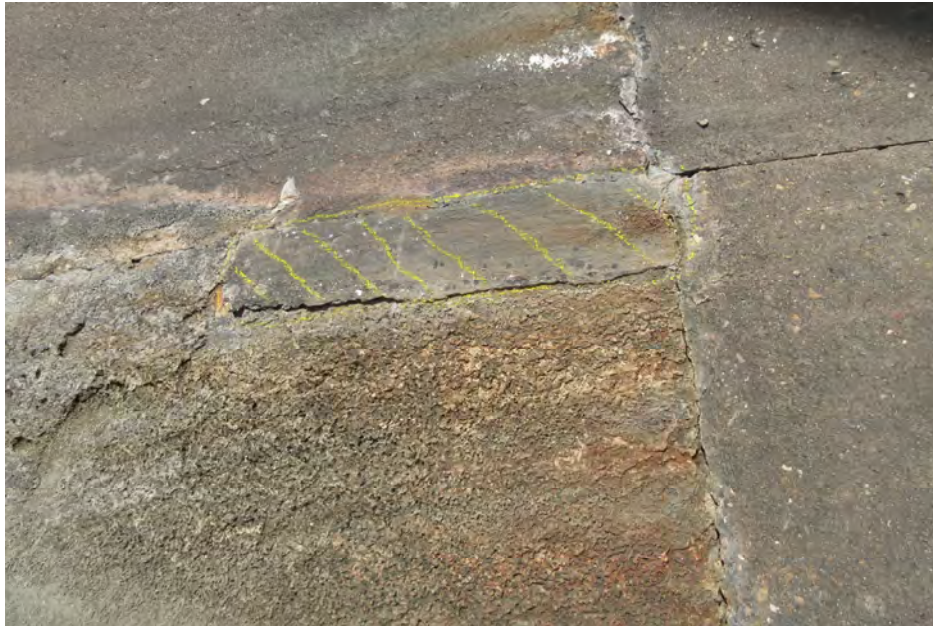
PHOTOGRAPH No.: 15

Delaminated grout patch 26" x 6".

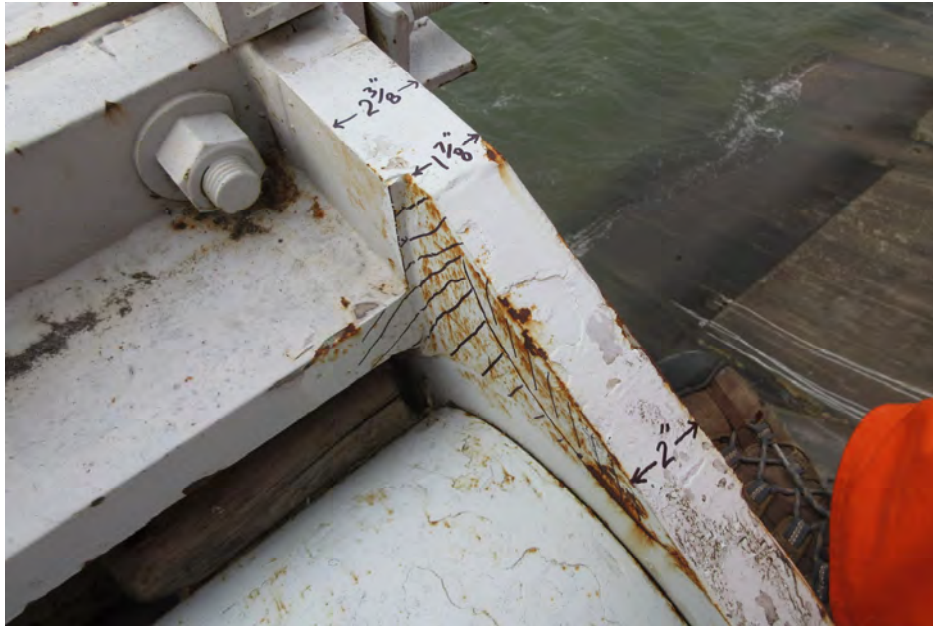
PHOTOGRAPH No.: 17

Area with grinding marks. Approximately 1/2" of material has been ground away. Light surface rust. CS-4 due to section loss.

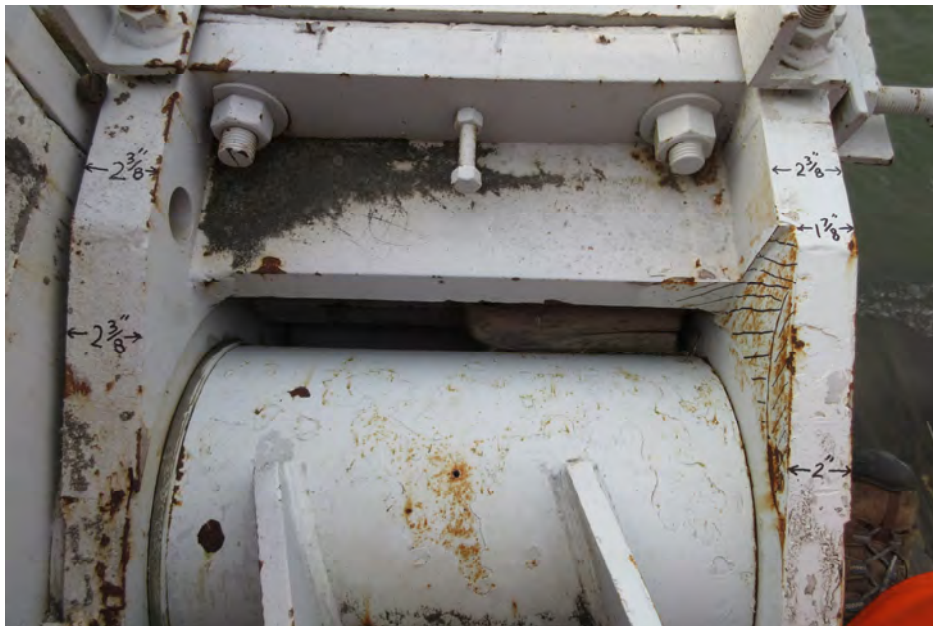
PHOTOGRAPH No.: 18

Area with grinding marks. Approximately 1/2" of material has been ground away. Light surface rust. CS-4 due to section loss.

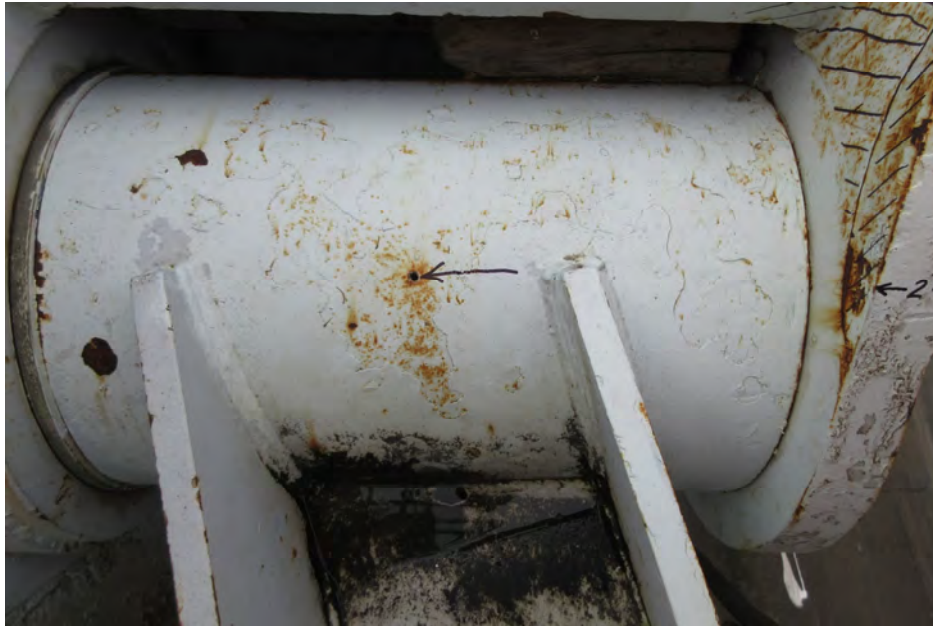
PHOTOGRAPH No.: 19

5/16" hole drilled in top of trunnion. Light surface rust. CS-2.

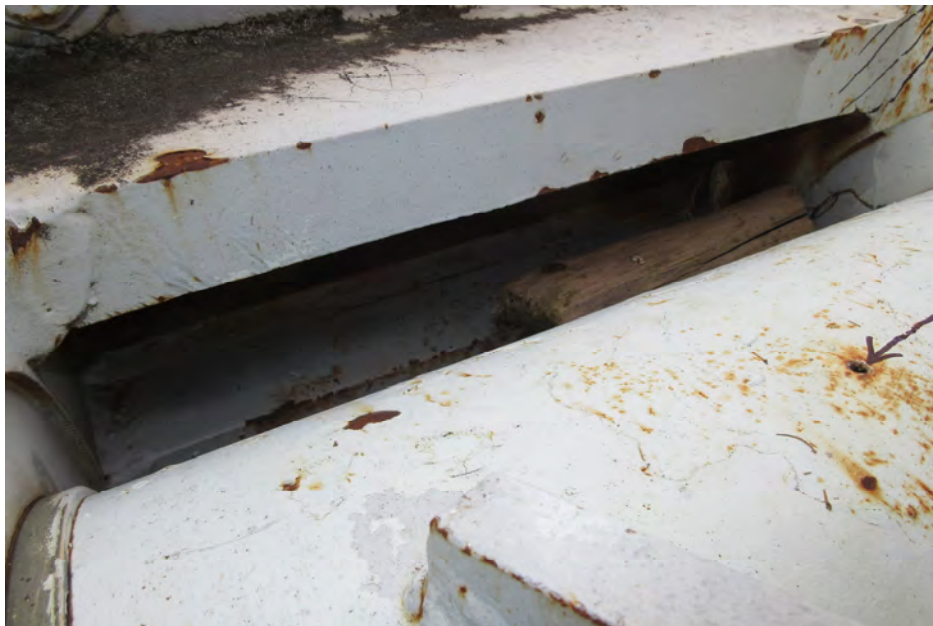
PHOTOGRAPH No.: 20

Wood debris inside casting. Light surface rust. CS-2.

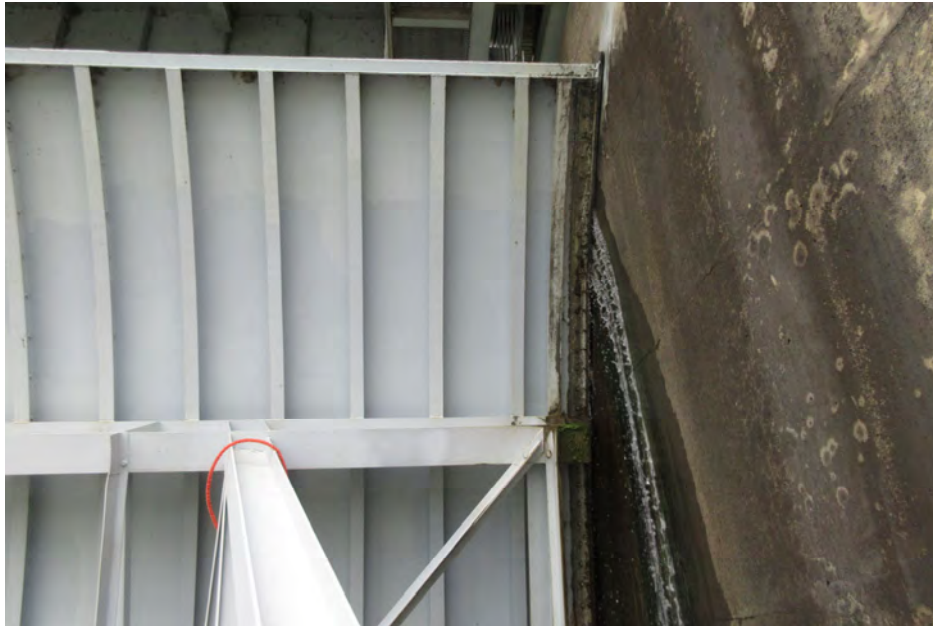
PHOTOGRAPH No.: 21

Leak, approximately 20 gpm.

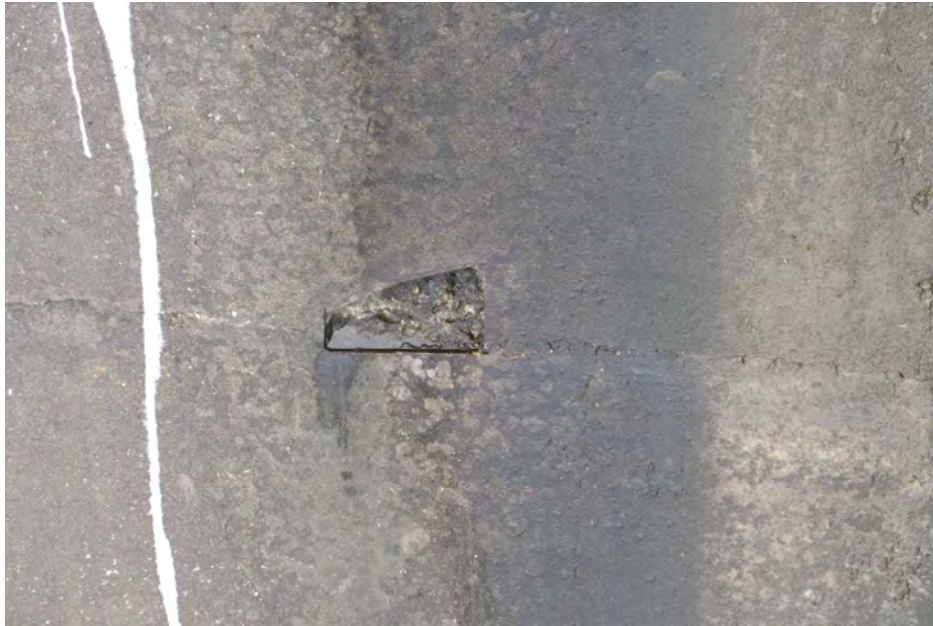
PHOTOGRAPH No.: 23

Spall 14" x 22" x 2 1/2" deep.

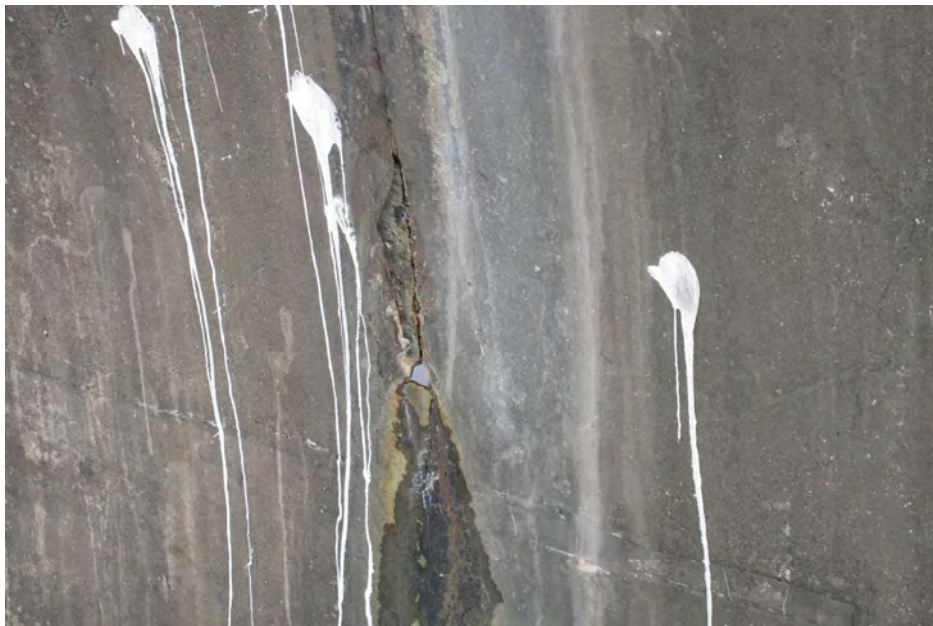
PHOTOGRAPH No.: 24

Spall 38" x 7" x 2 1/2" deep.

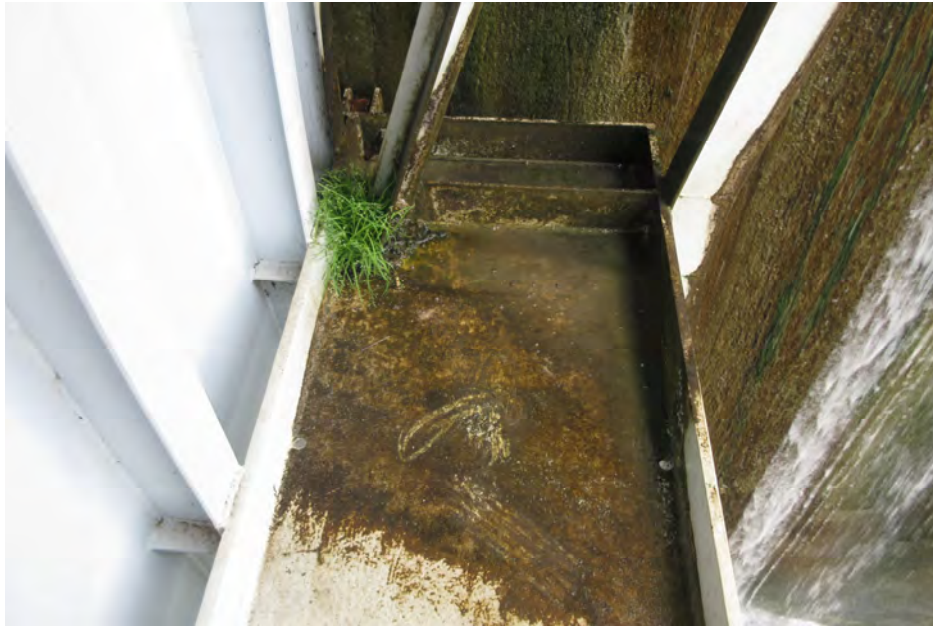
PHOTOGRAPH No.: 25

Minor debris buildup with vegetation. Drains are clear.

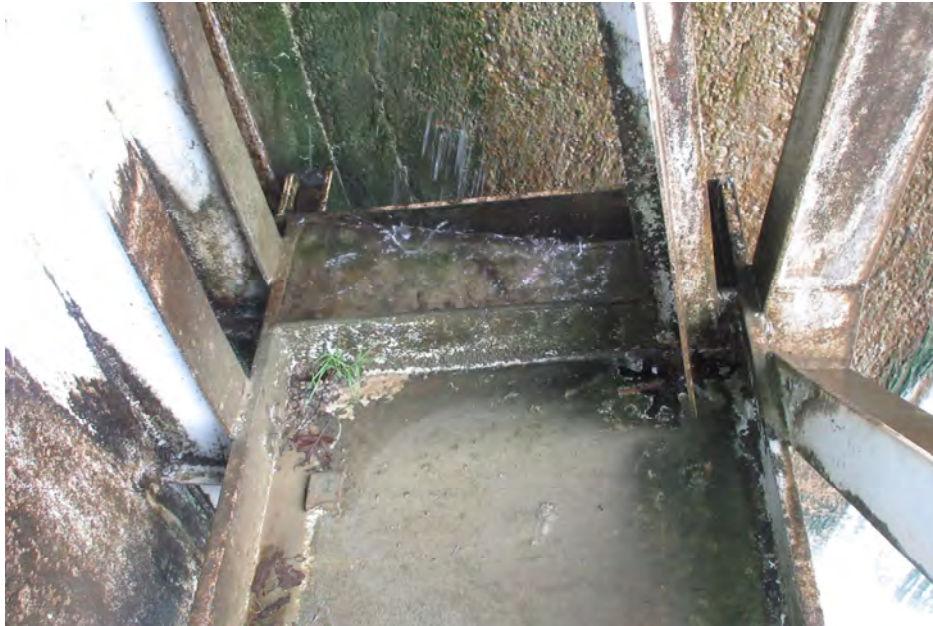
PHOTOGRAPH No.: 27

Ponding water and debris buildup. Drains blocked.

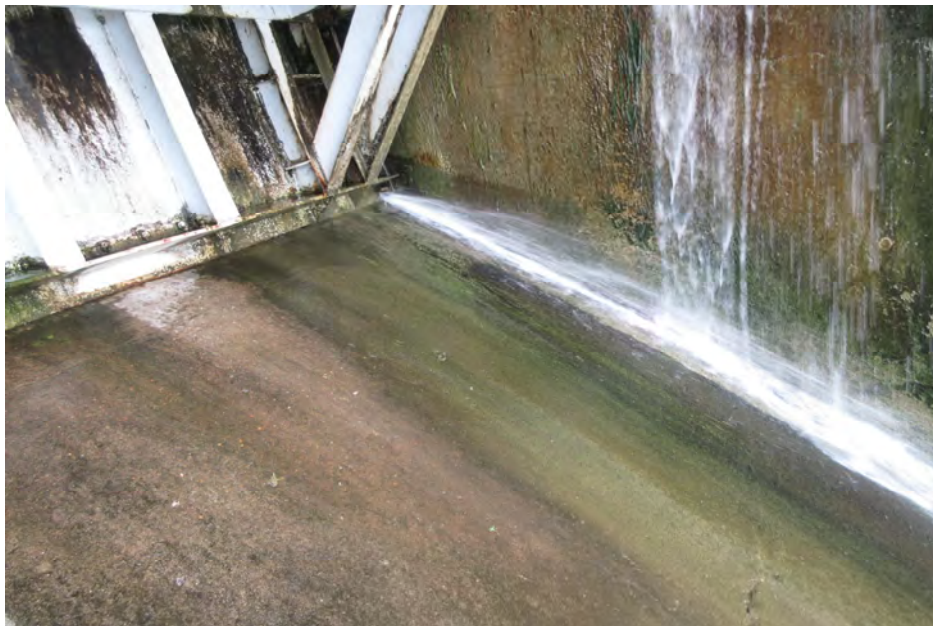
PHOTOGRAPH No.: 28

Leak, approximately 10 gpm.

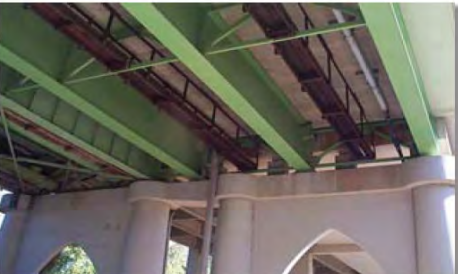
Condition State	Description	Example
Condition State 1 (CS-1)	There is no evidence of corrosion and any paint systems are sound and functioning as intended to protect the metal surface.

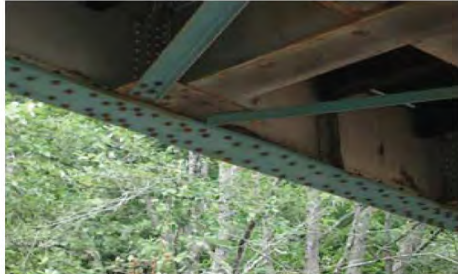
Condition State 2 (CS-3)	Surface or freckled rust is moderate to heavy. There may be exposed metal, but there is no measurable loss of section.

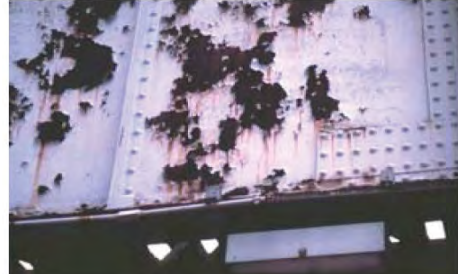
Condition State 3 (CS-4)	The paint system has failed. Corrosion may be present but any section loss due to active corrosion does not yet warrant a structural analysis of the element.

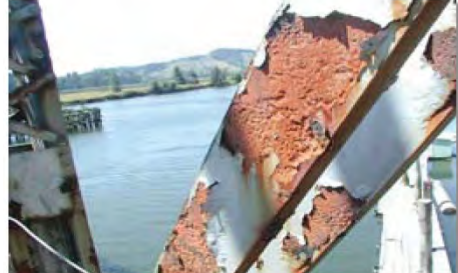
Condition State 4 (CS-5)	Corrosion has caused section loss and is sufficient to warrant structural analysis to ascertain the impact on the ultimate strength and/or serviceability of either the element.

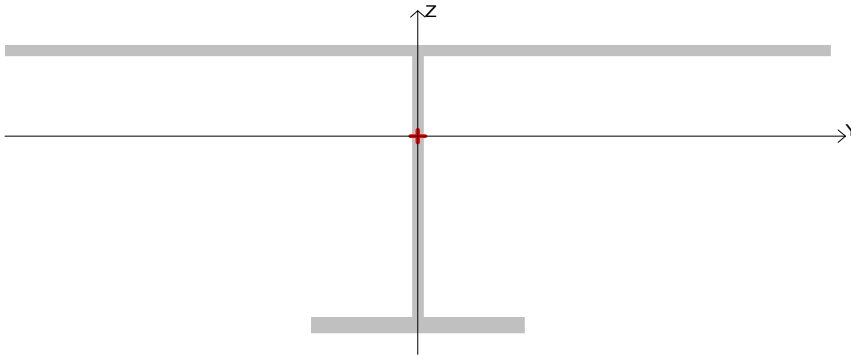
Section Properties of Skin-Rib Composite
Composed of ST6B9.5 and 15.5-inch wide and 0.25-inch thick Skin Plate
Using STAAD Section Wizard

Section element	Rotation angle	Mirror	Material	E (kip/inch ²)
Sheet 4.01 x 0.349			Steel	29732.747
Sheet 5.731 x 0.24	90.0		Steel	29732.747
Sheet 15.5 x 0.25			Steel	29732.747

The overall dimensions of the section are 15 x 6 inch

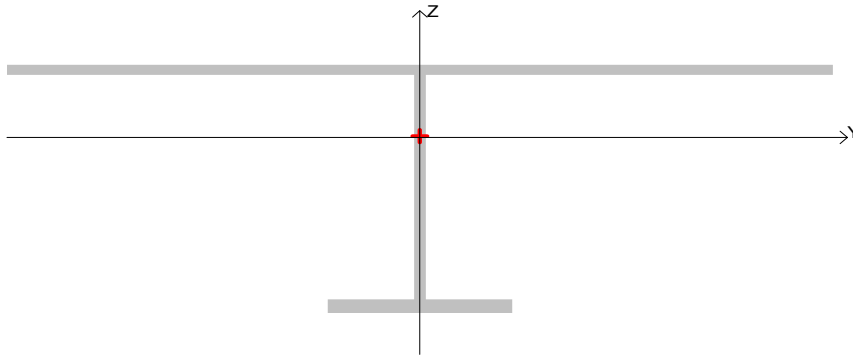
Section Properties of Skin-Rib Composite
Composed of ST6B9.5 and 18-inch wide and 0.25-inch thick Skin Plate
Using STAAD Section Wizard

Section element	Rotation angle	Mirror	Material	E (kip/inch ²)
Sheet 4.01 x 0.349			Steel	29732.747
Sheet 5.731 x 0.24	90.0		Steel	29732.747
Sheet 18 x 0.25			Steel	29732.747

The overall dimensions of the section are 18 x 6 inch

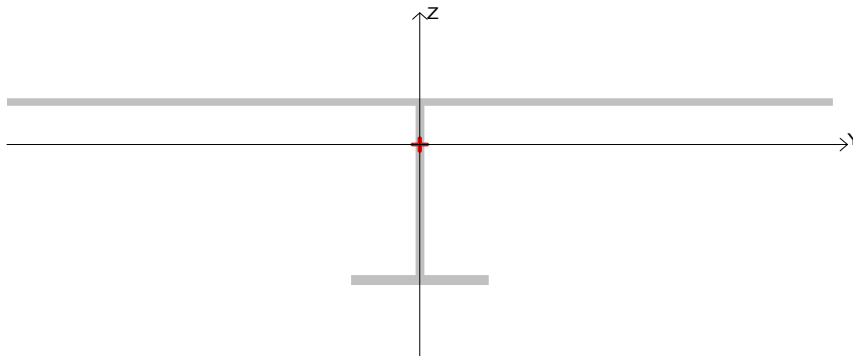
Section Properties of Skin-Rib Composite
Composed of ST6B9.5 and 24-inch wide and 0.25-inch thick Skin Plate
Using STAAD Section Wizard

Section element	Rotation angle	Mirror	Material	E (kip/inch ²)
Sheet 4.01 x 0.349			Steel	29732.747
Sheet 5.731 x 0.24	90.0		Steel	29732.747
Sheet 24 x 0.25			Steel	29732.747

The overall dimensions of the section are 24 x 6 inch

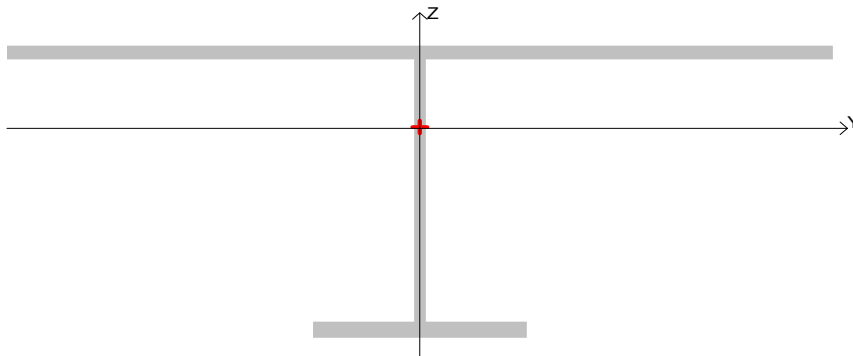
Section Properties of Skin-Rib Composite
Composed of ST6B9.5 and 15.5-inch wide and 0.3125-inch thick Skin Plate
Using STAAD Section Wizard

Section element	Rotation angle	Mirror	Material	E (kip/inch ²)
Sheet 4.01 x 0.349			Steel	29732.747
Sheet 5.731 x 0.24	90.0		Steel	29732.747
Sheet 15.5 x 0.3125			Steel	29732.747

The overall dimensions of the section are 15 x 6 inch

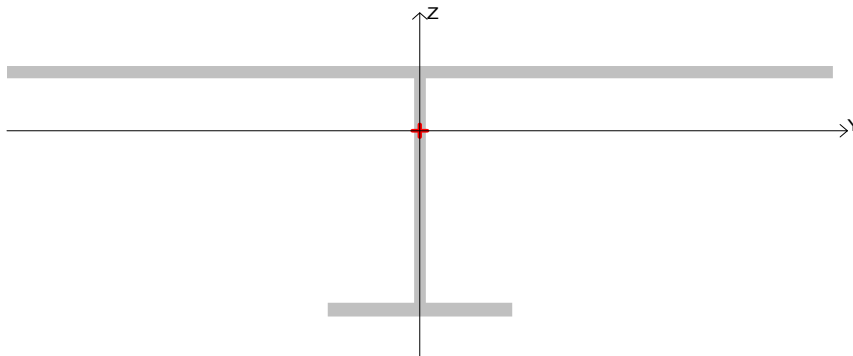
Section Properties of Skin-Rib Composite
Composed of ST6B9.5 and 18-inch wide and 0.3125-inch thick Skin Plate
Using STAAD Section Wizard

Section element	Rotation angle	Mirror	Material	E (kip/inch ²)
Sheet 4.01 x 0.349			Steel	29732.747
Sheet 5.731 x 0.24	90.0		Steel	29732.747
Sheet 18 x 0.3125			Steel	29732.747

The overall dimensions of the section are 18 x 6 inch

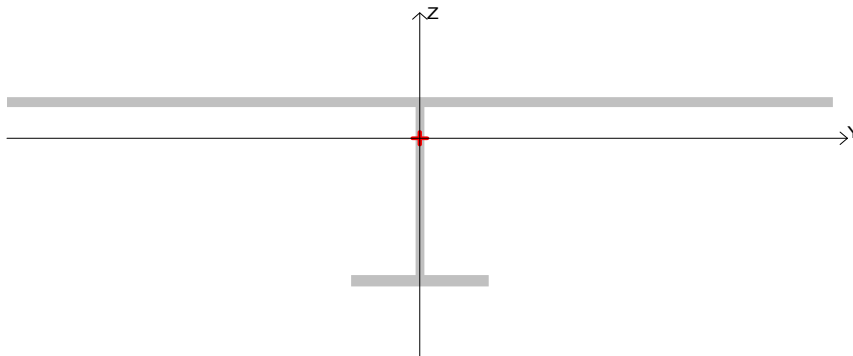
Section Properties of Skin-Rib Composite
Composed of ST6B9.5 and 24-inch wide and 0.3125-inch thick Skin Plate
Using STAAD Section Wizard

Section element	Rotation angle	Mirror	Material	E (kip/inch ²)
Sheet 4.01 x 0.349			Steel	29732.747
Sheet 5.731 x 0.24	90.0		Steel	29732.747
Sheet 24 x 0.3125			Steel	29732.747

The overall dimensions of the section are 24 x 6 inch

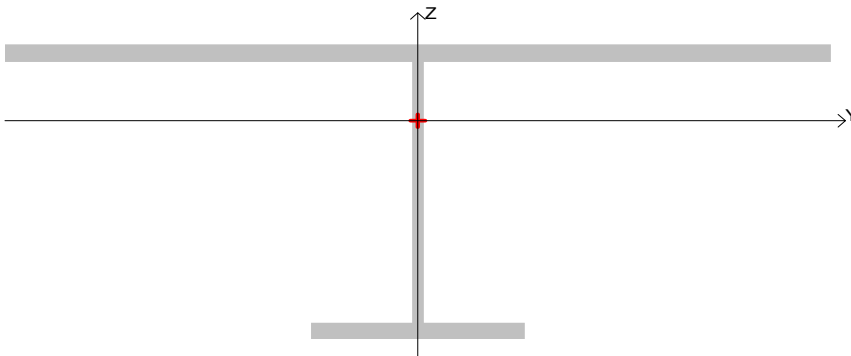
Section Properties of Skin-Rib Composite
Composed of ST6B9.5 and 15.5-inch wide and 0.375-inch thick Skin Plate
Using STAAD Section Wizard

Section element	Rotation angle	Mirror	Material	E (kip/inch ²)
Sheet 4.01 x 0.349			Steel	29732.747
Sheet 5.731 x 0.24	90.0		Steel	29732.747
Sheet 15.5 x 0.375			Steel	29732.747

The overall dimensions of the section are 15 x 6 inch

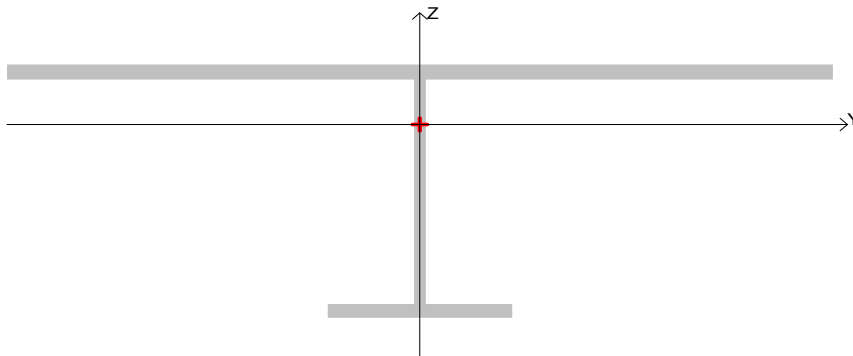
Section Properties of Skin-Rib Composite
Composed of ST6B9.5 and 18-inch wide and 0.375-inch thick Skin Plate
Using STAAD Section Wizard

Section element	Rotation angle	Mirror	Material	E (kip/inch ²)
Sheet 4.01 x 0.349			Steel	29732.747
Sheet 5.731 x 0.24	90.0		Steel	29732.747
Sheet 18 x 0.375			Steel	29732.747

The overall dimensions of the section are 18 x 6 inch

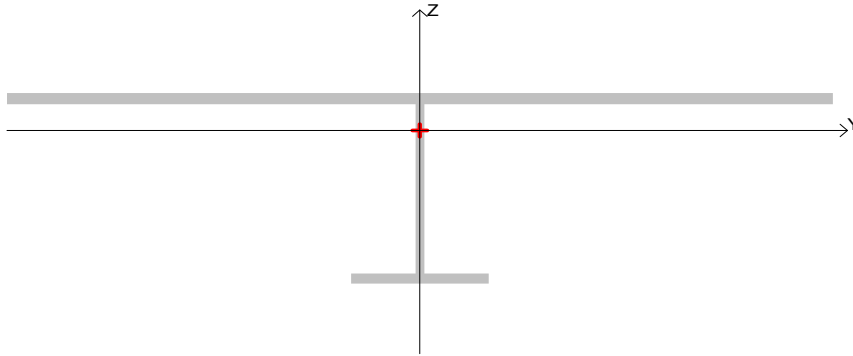
Section Properties of Skin-Rib Composite
Composed of ST6B9.5 and 24-inch wide and 0.375-inch thick Skin Plate
Using STAAD Section Wizard

Section element	Rotation angle	Mirror	Material	E (kip/inch ²)
Sheet 4.01 x 0.349			Steel	29732.747
Sheet 5.731 x 0.24	90.0		Steel	29732.747
Sheet 24 x 0.375			Steel	29732.747

The overall dimensions of the section are 24 x 6 inch

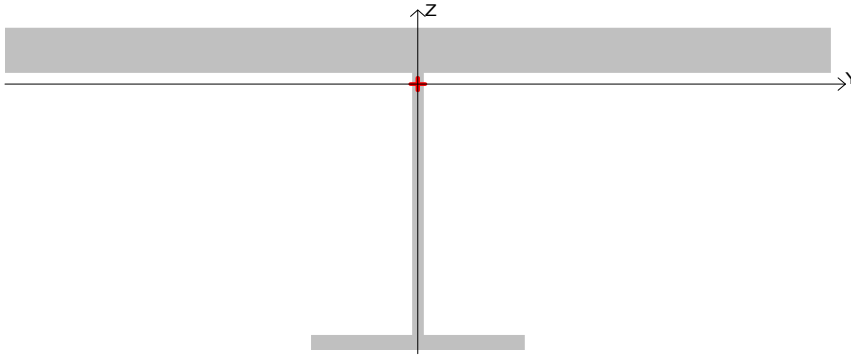
Section Properties of Skin-Rib Composite
Composed of ST6B9.5 and 15.5-inch wide and 1.0-inch thick Plate at cable hitch
Using STAAD Section Wizard

Section element	Rotation angle	Mirror	Material	E (kip/inch ²)
Sheet 4.01 x 0.349			Steel	29732.747
Sheet 5.731 x 0.24	90.0		Steel	29732.747
Sheet 15.5 x 1			Steel	29732.747

The overall dimensions of the section are 15 x 7 inch

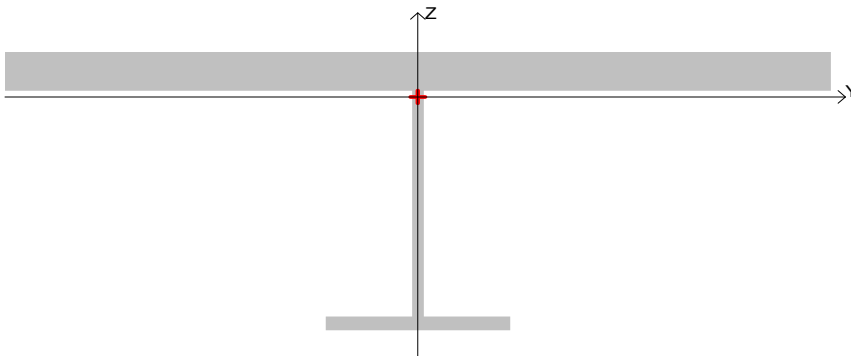
Section Properties of Skin-Rib Composite
Composed of ST6B9.5 and 18-inch wide and 1.0-inch thick Plate at cable hitch
Using STAAD Section Wizard

Section element	Rotation angle	Mirror	Material	E (kip/inch ²)
Sheet 4.01 x 0.349			Steel	29732.747
Sheet 5.731 x 0.24	90.0		Steel	29732.747
Sheet 18 x 1			Steel	29732.747

The overall dimensions of the section are 18 x 7 inch

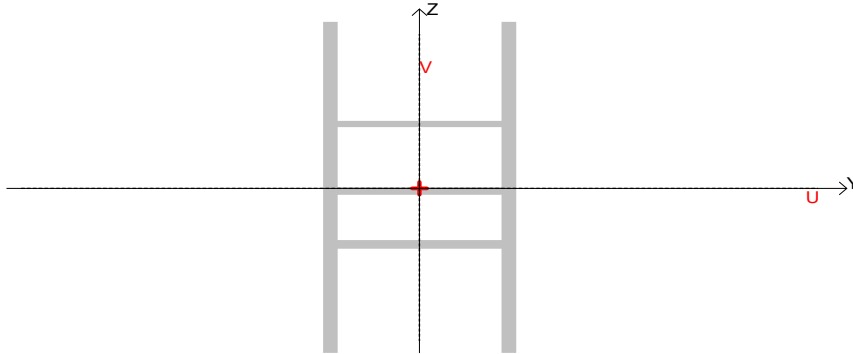
**Approximate Built-up Hub Section Properties at 0.94ft from Trunnion Centerline
Using STAAD Section Wizard**

Section element	Rotation angle	Mirror	Material	E (kip/inch ²)
Sheet 21.132 x 0.8125	90.0		Steel	29732.747
Sheet 21.132 x 0.8125	90.0		Steel	29732.747
Sheet 9 x 0.375			Steel	29732.747
Sheet 9 x 0.5			Steel	29732.747
Sheet 9 x 0.5			Steel	29732.747

The overall dimensions of the section are 11 x 21 inch

Note: STAAD Section Wizard calculated Torsional moment of inertia is based on summation of the torsional moment of inertia of individual plate elements. Although conservative, this approach can dramatically underestimate the torsional properties of closed hollow sections. For this reason, torsional moment of inertia is approximated by a rectangular hollow tube instead.

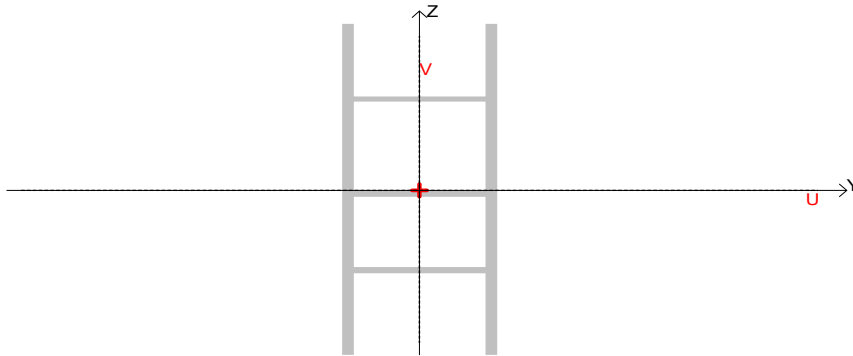
**Approximate Built-up Hub Section Properties at 1.67ft from Trunnion Centerline
Using STAAD Section Wizard**

Section element	Rotation angle	Mirror	Material	E (kip/inch ²)
Sheet 26.228 x 0.8125	90.0		Steel	29732.747
Sheet 26.228 x 0.8125	90.0		Steel	29732.747
Sheet 9 x 0.375			Steel	29732.747
Sheet 9 x 0.5			Steel	29732.747
Sheet 9 x 0.5			Steel	29732.747

The overall dimensions of the section are 11 x 26 inch

Note: STAAD Section Wizard calculated Torsional moment of inertia is based on summation of the torsional moment of inertia of individual plate elements. Although conservative, this approach can dramatically underestimate the torsional properties of closed hollow sections. For this reason, torsional moment of inertia is approximated by a rectangular hollow tube instead.

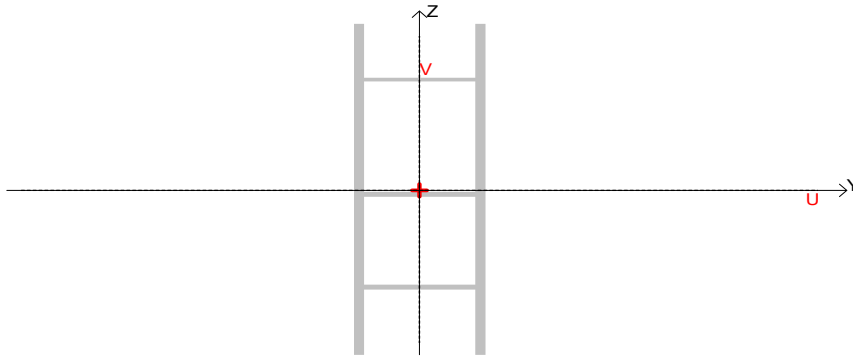
**Approximate Built-up Hub Section Properties at 2.39ft from Trunnion Centerline
Using STAAD Section Wizard**

Section element	Rotation angle	Mirror	Material	E (kip/inch ²)
Sheet 31.324 x 0.8125	90.0		Steel	29732.747
Sheet 31.324 x 0.8125	90.0		Steel	29732.747
Sheet 9 x 0.375			Steel	29732.747
Sheet 9 x 0.5			Steel	29732.747
Sheet 9 x 0.5			Steel	29732.747

The overall dimensions of the section are 11 x 31 inch

Torsion moment of inertia is replaced by torsion property of an approximate hollow rectangular section

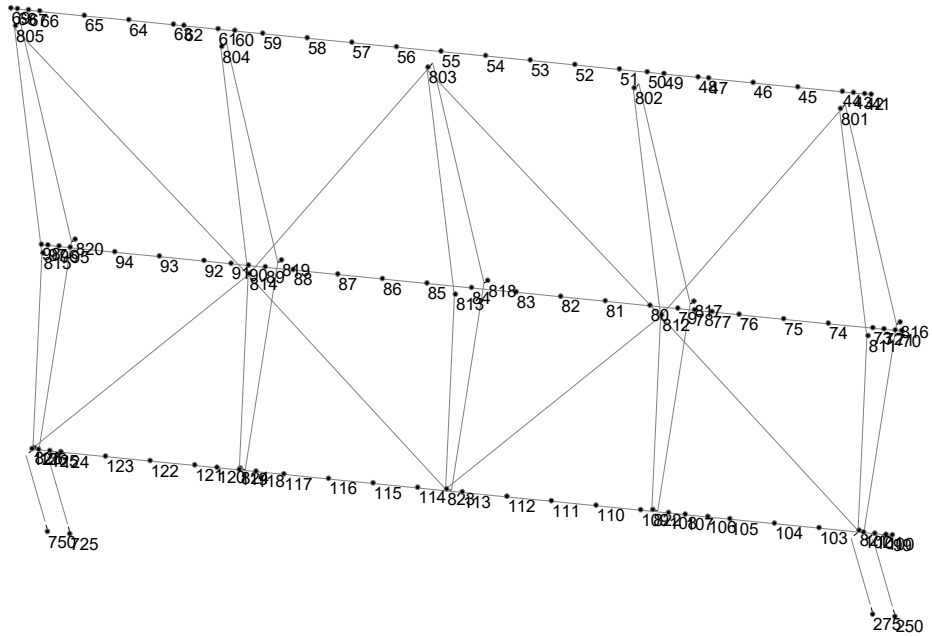
Girder and Girder Brace Node Numbers

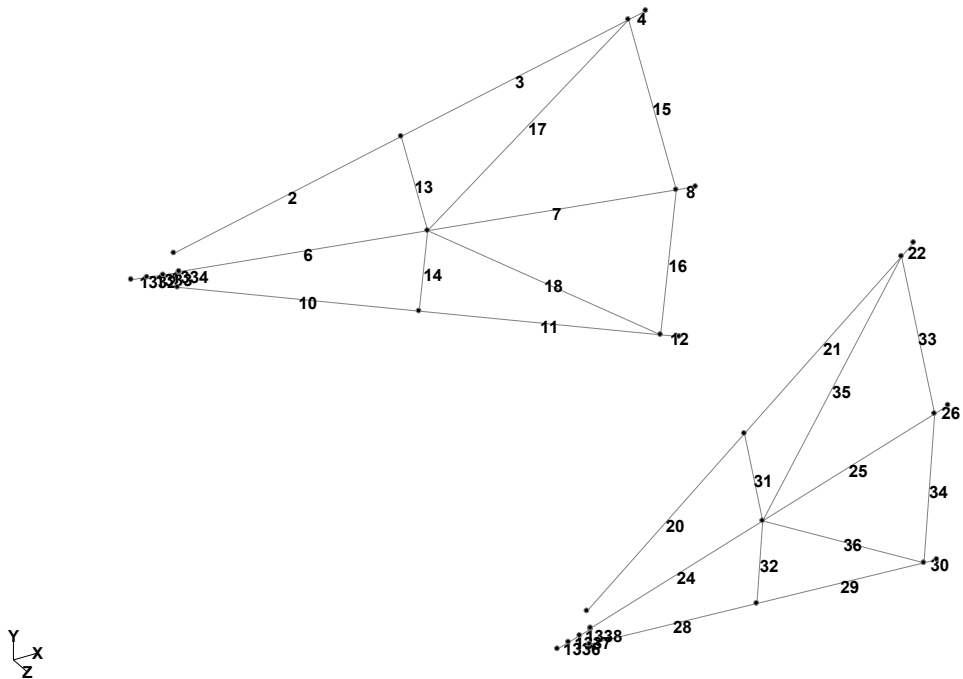
Built-up Hub, Strut, and Strut Bracing Member Numbers

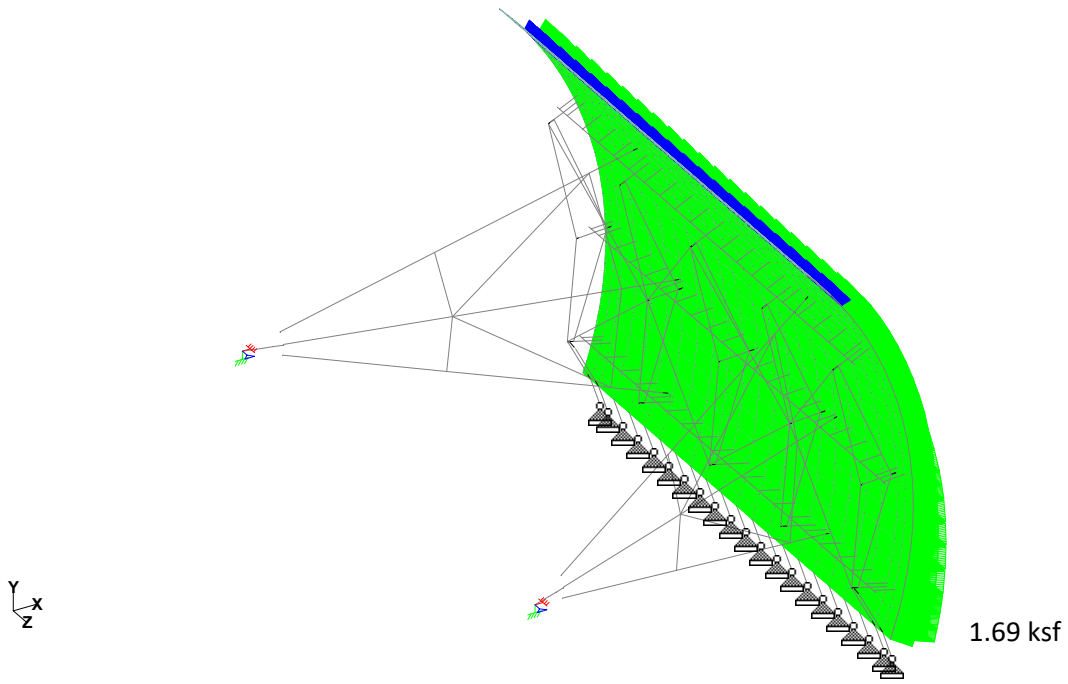
Hydrostatic Load H₁, Reservoir Elevation 435.5 ft

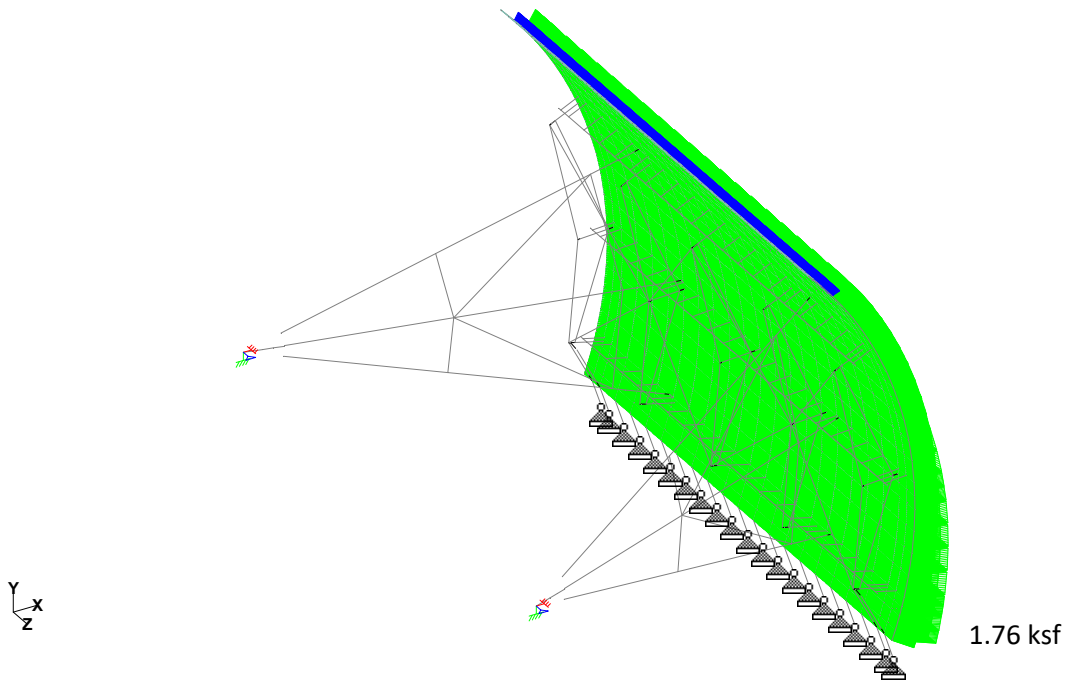
Hydrostatic Load H₂, Reservoir Elevation 436.5 ft

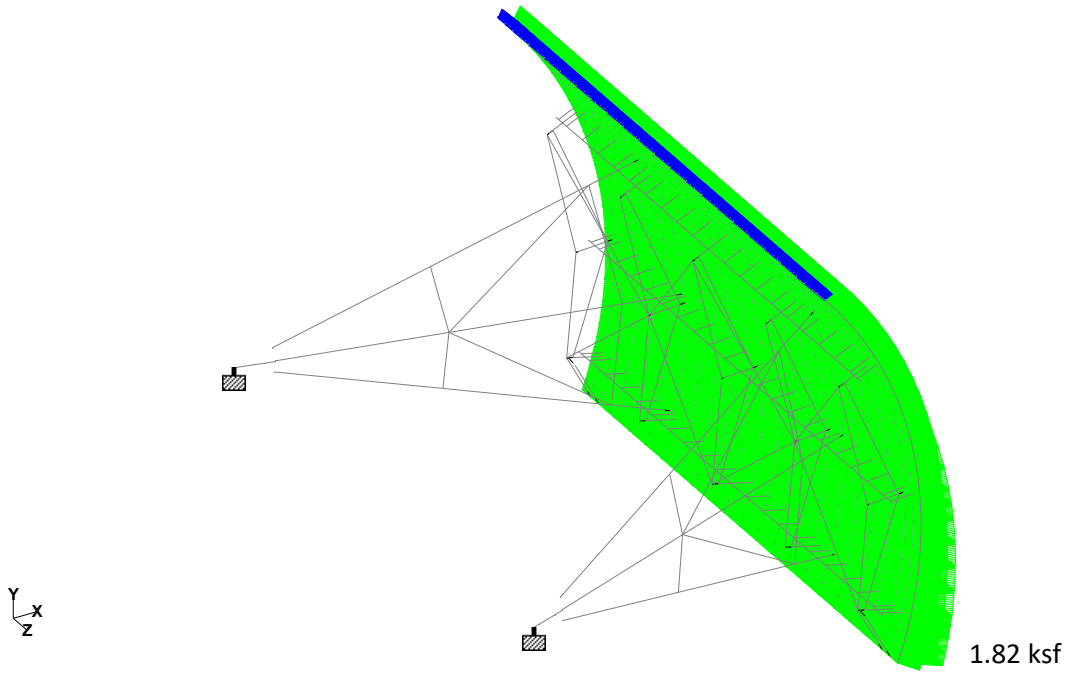
Hydrostatic Load H_3 , Reservoir Elevation 437.5 ft

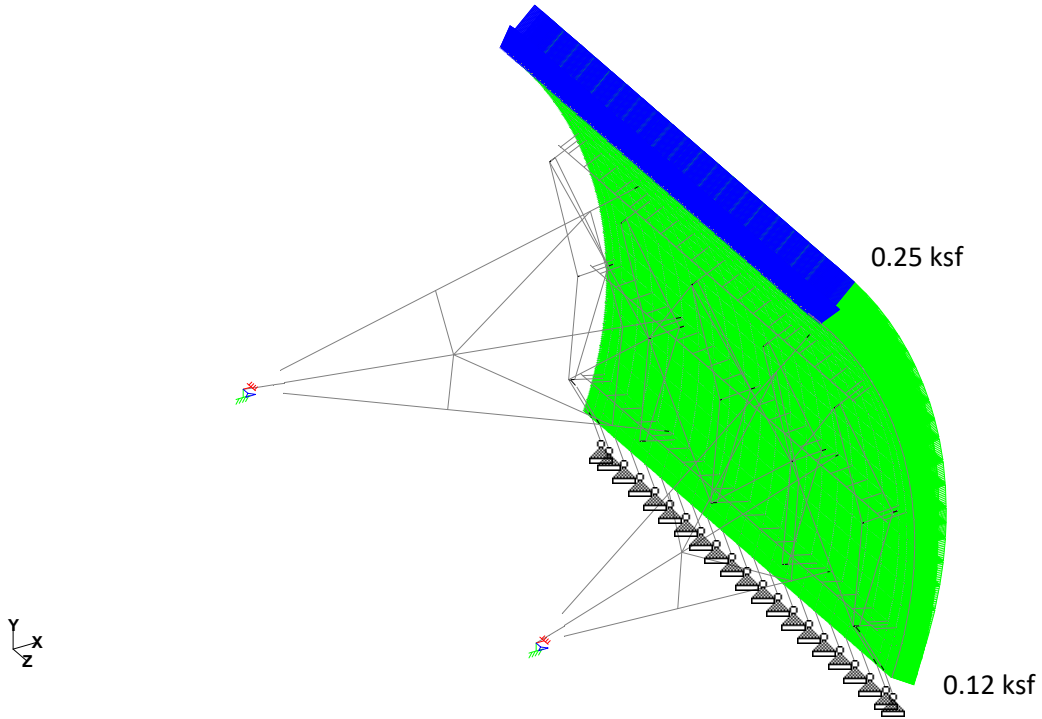
Hydrostatic Equivalent Wave Load W_A

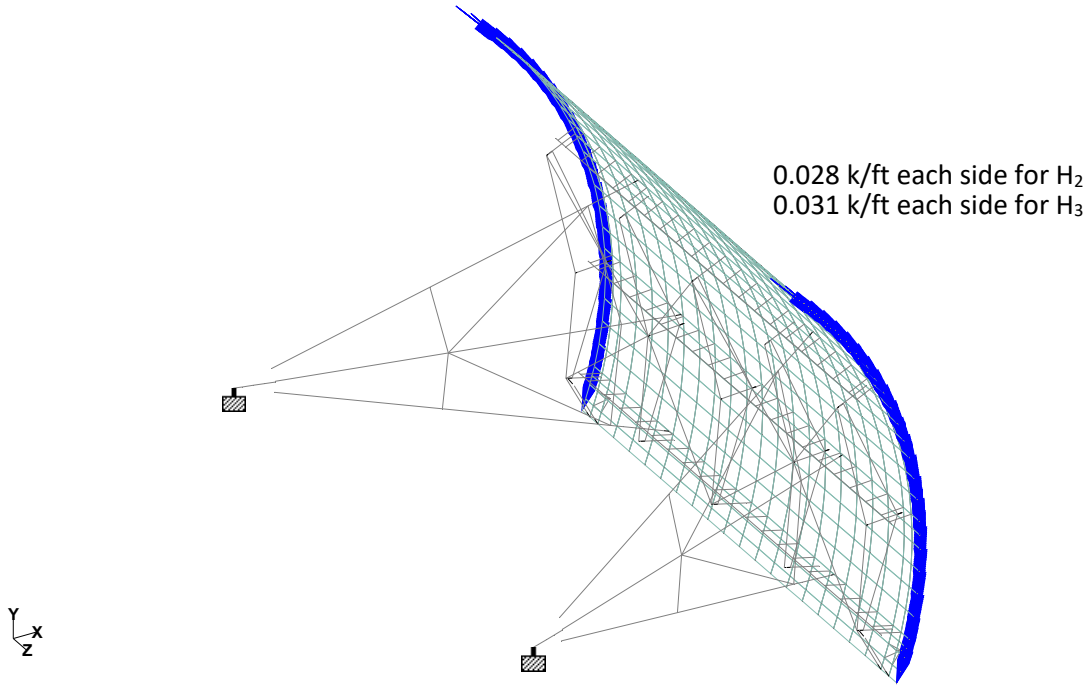
Side Seal Friction Load F_s
