VISUAL INSPECTION AND EVALUATION REPORT

Rockwall-Forney Dam
Dallas Water Utilities
Dallas/Kaufman Counties, Texas

Schnabel Reference #20C22001.00
July 30, 2021

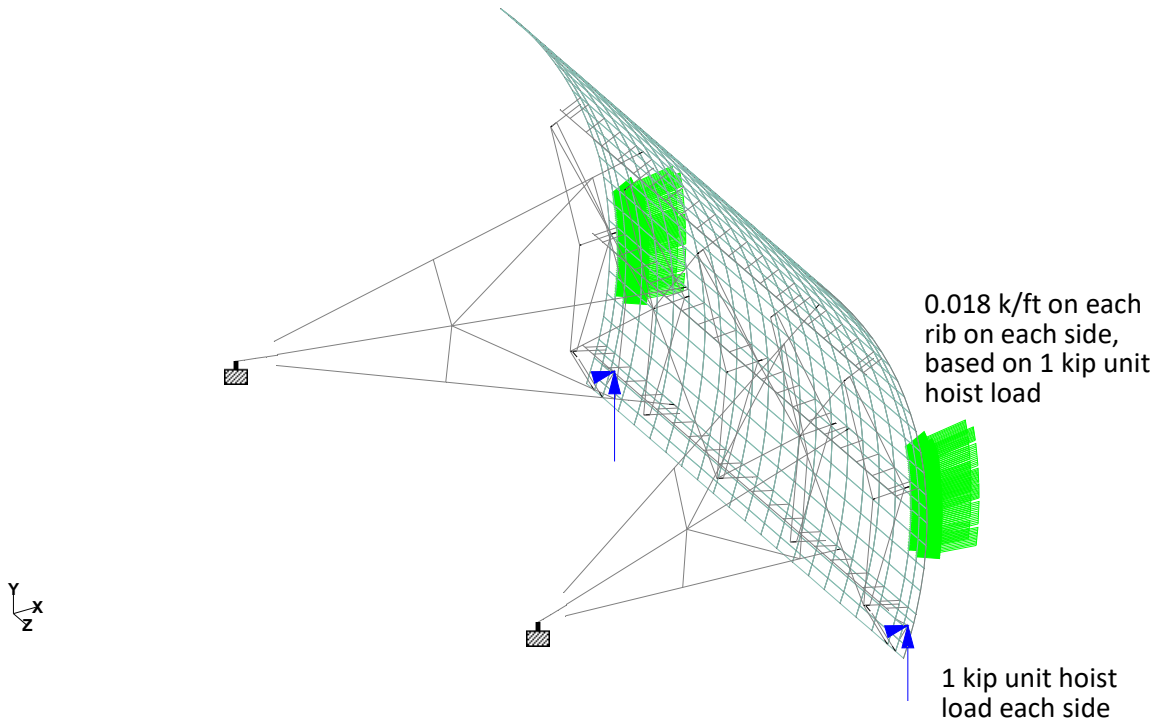
Unit Cable Hoist Lifting Load

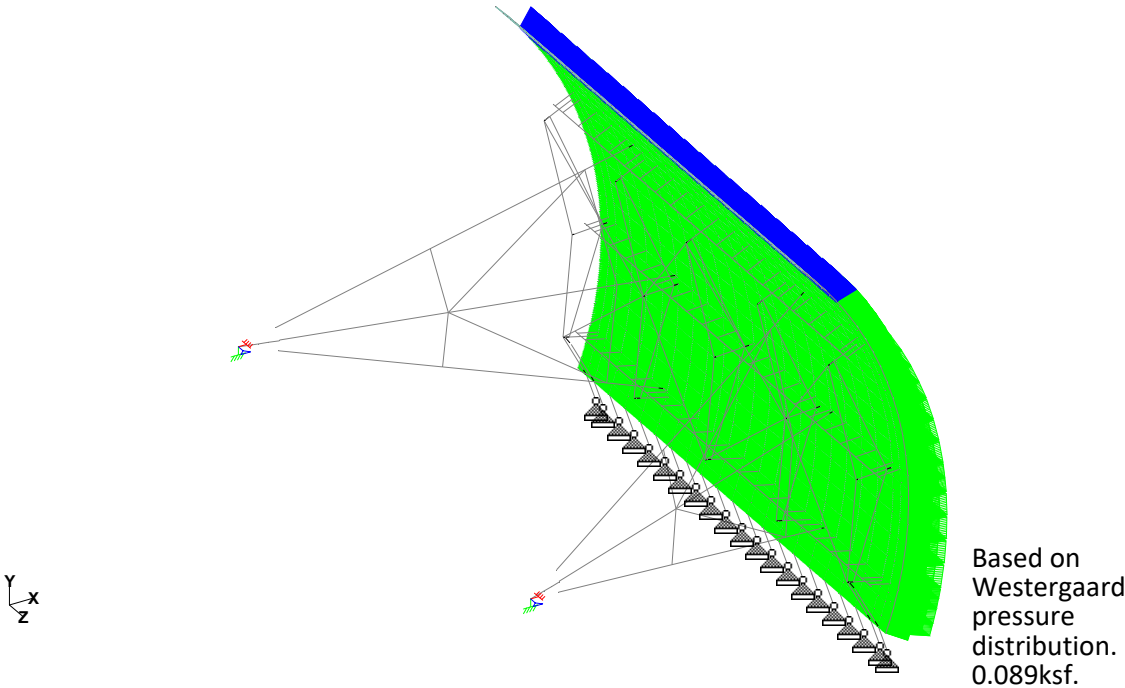
Seismic Hydrodynamic Load H_{EQ} , Reservoir Elevation 435.5 ft

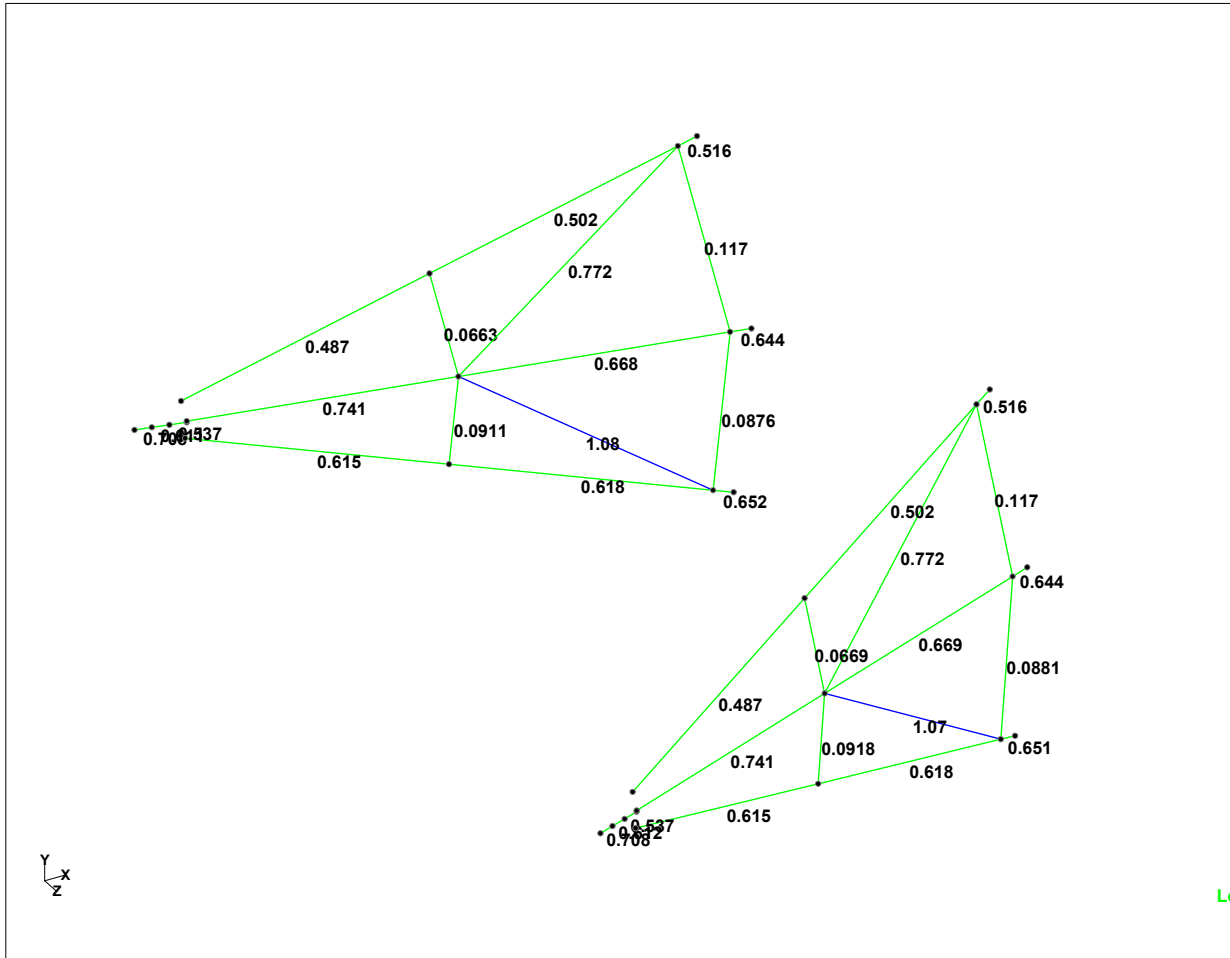
Arm Struts and Trunnion Hubs Member Utilization Ratios

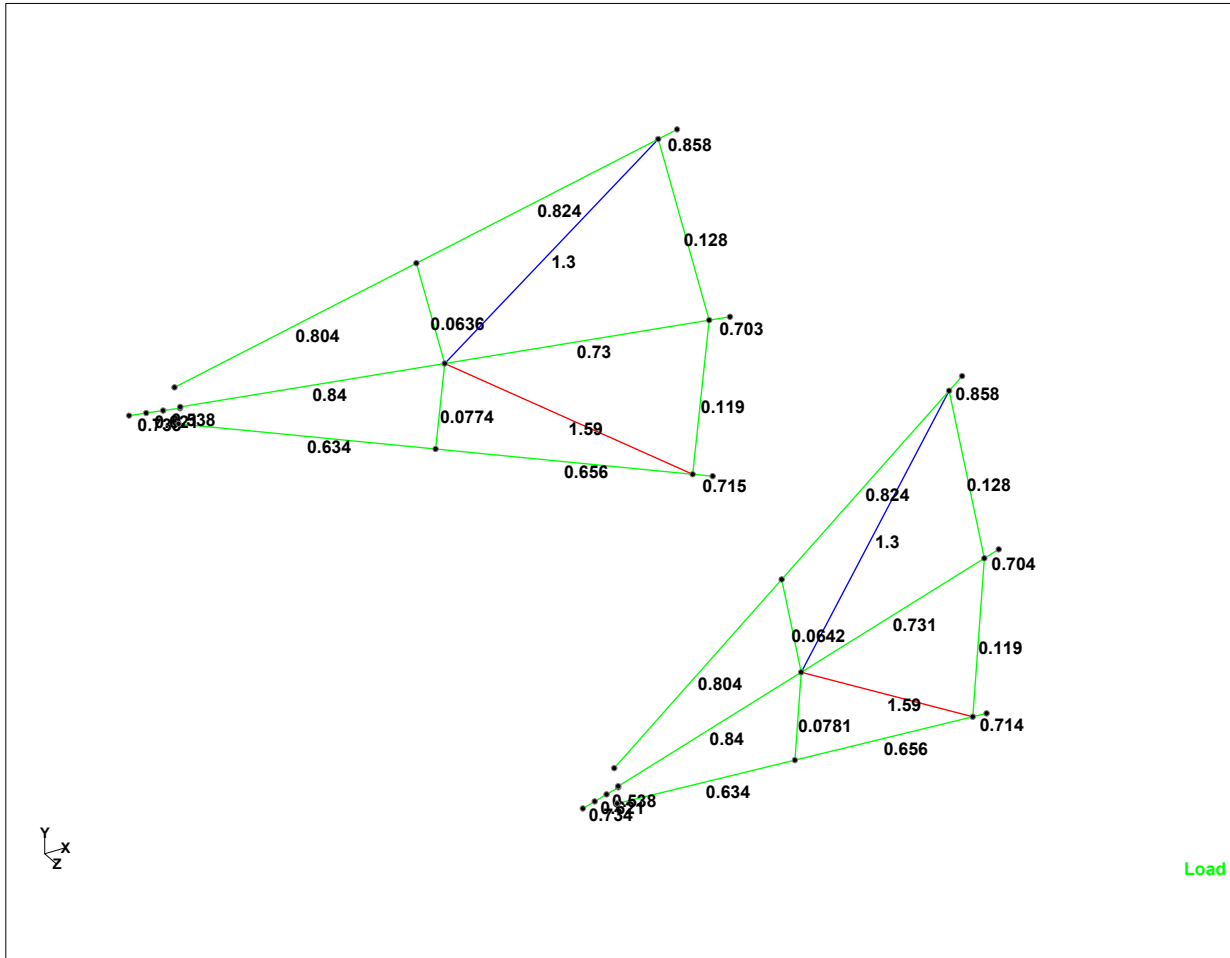
Arm Struts and Trunnion Hubs Member Utilization Ratios

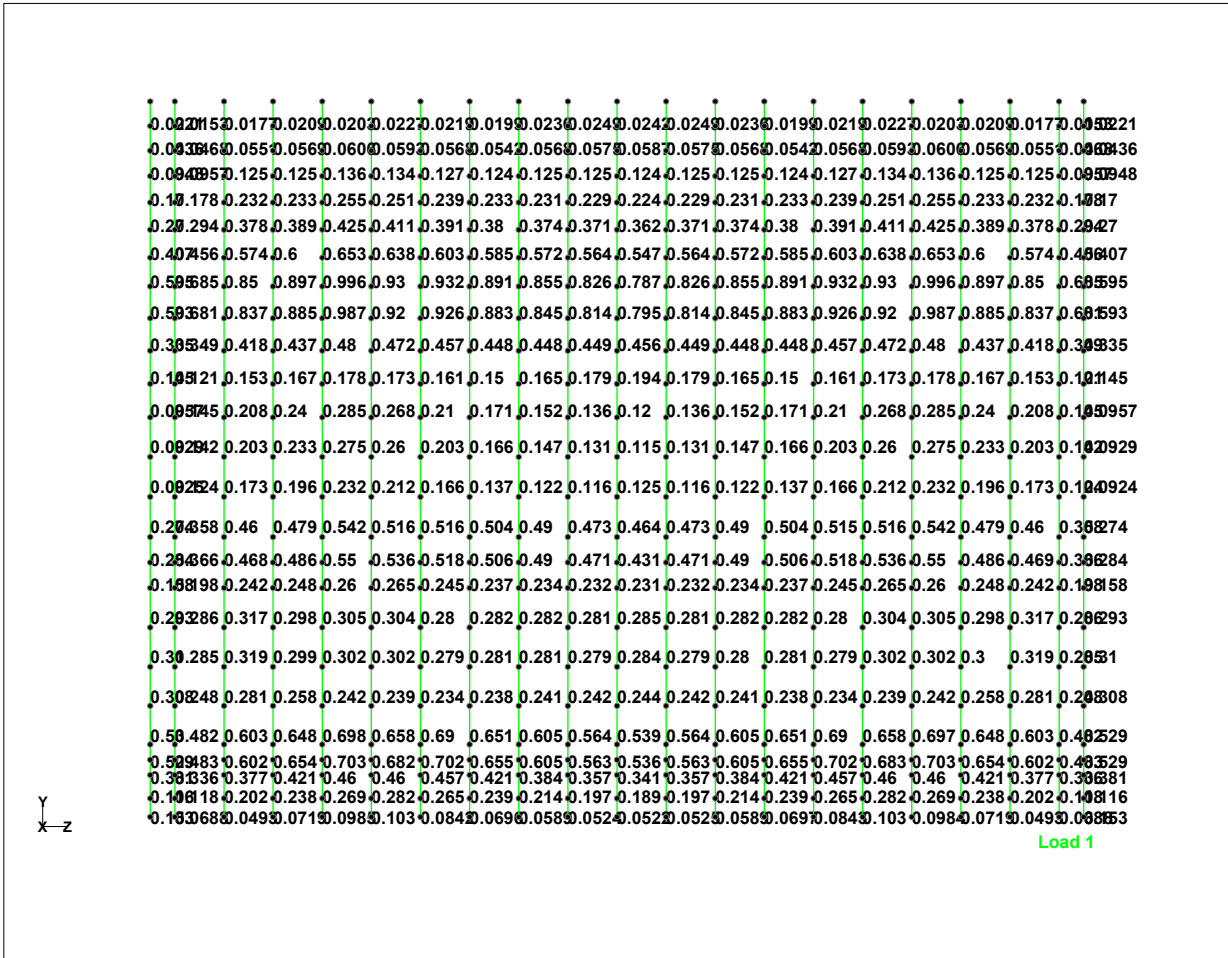
Skin-Rib Composite Member Utilization Ratios

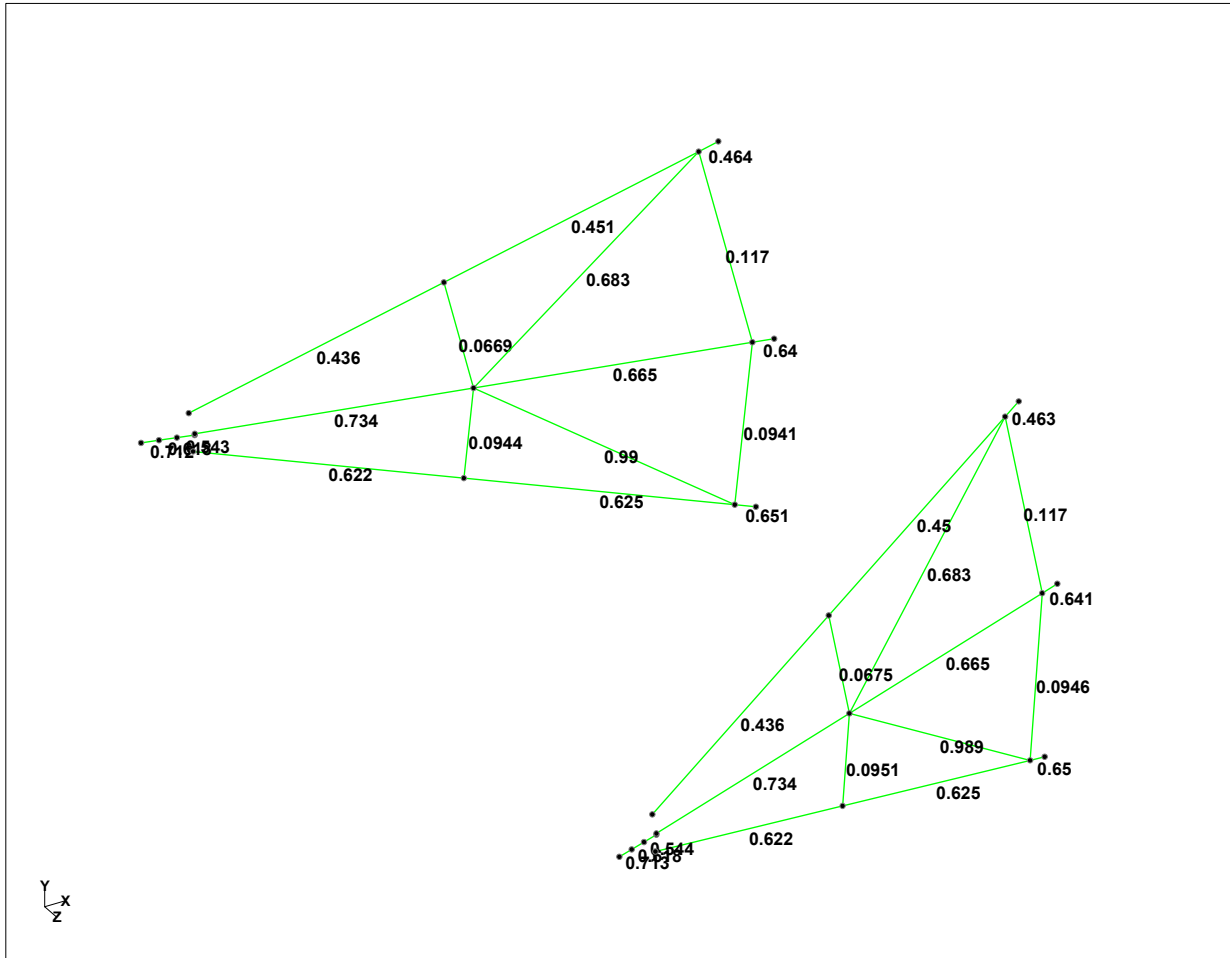
Arm Struts and Trunnion Hubs Member Utilization Ratios

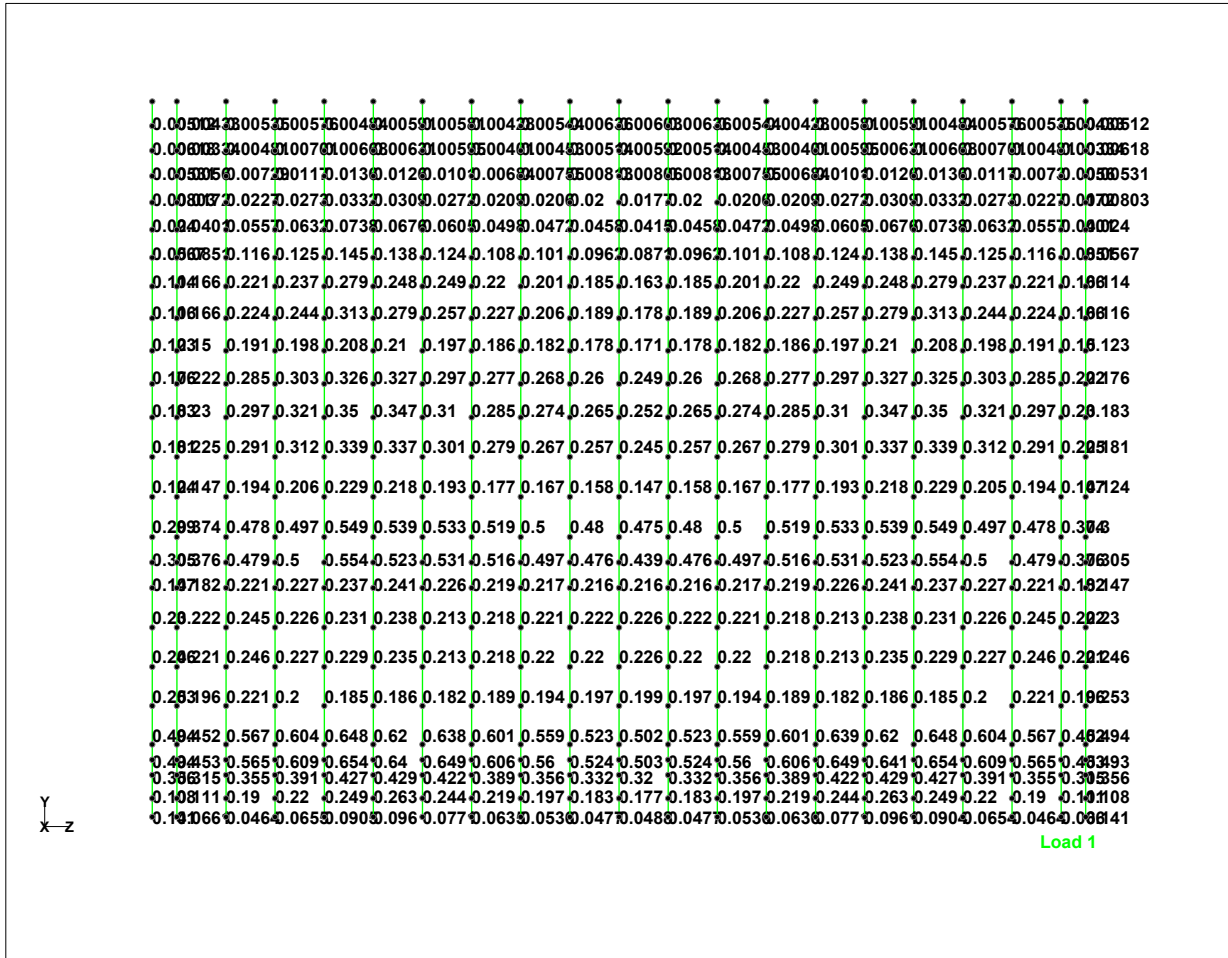
Skin-Rib Composite Member Utilization Ratios

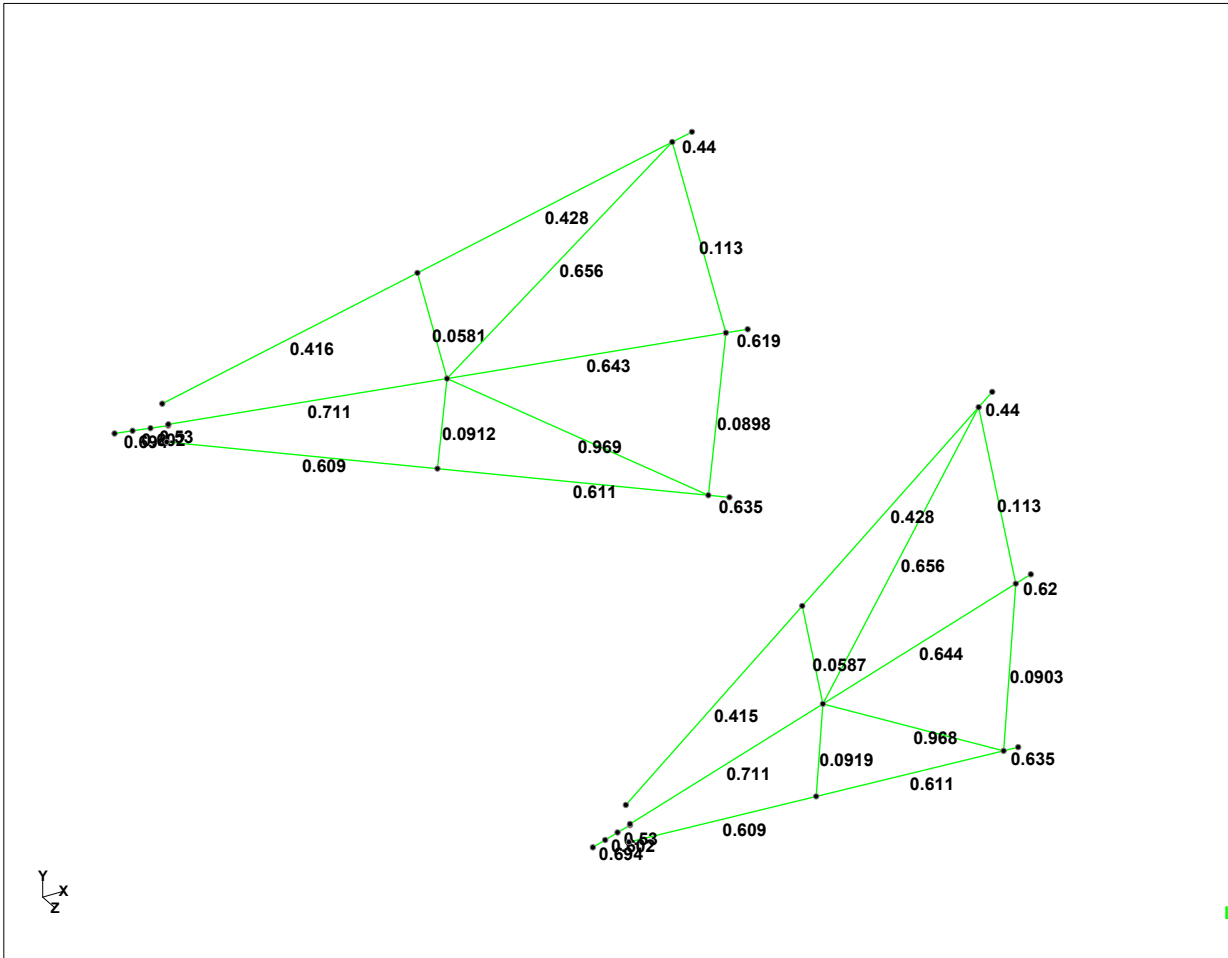
Arm Struts and Trunnion Hubs Member Utilization Ratios

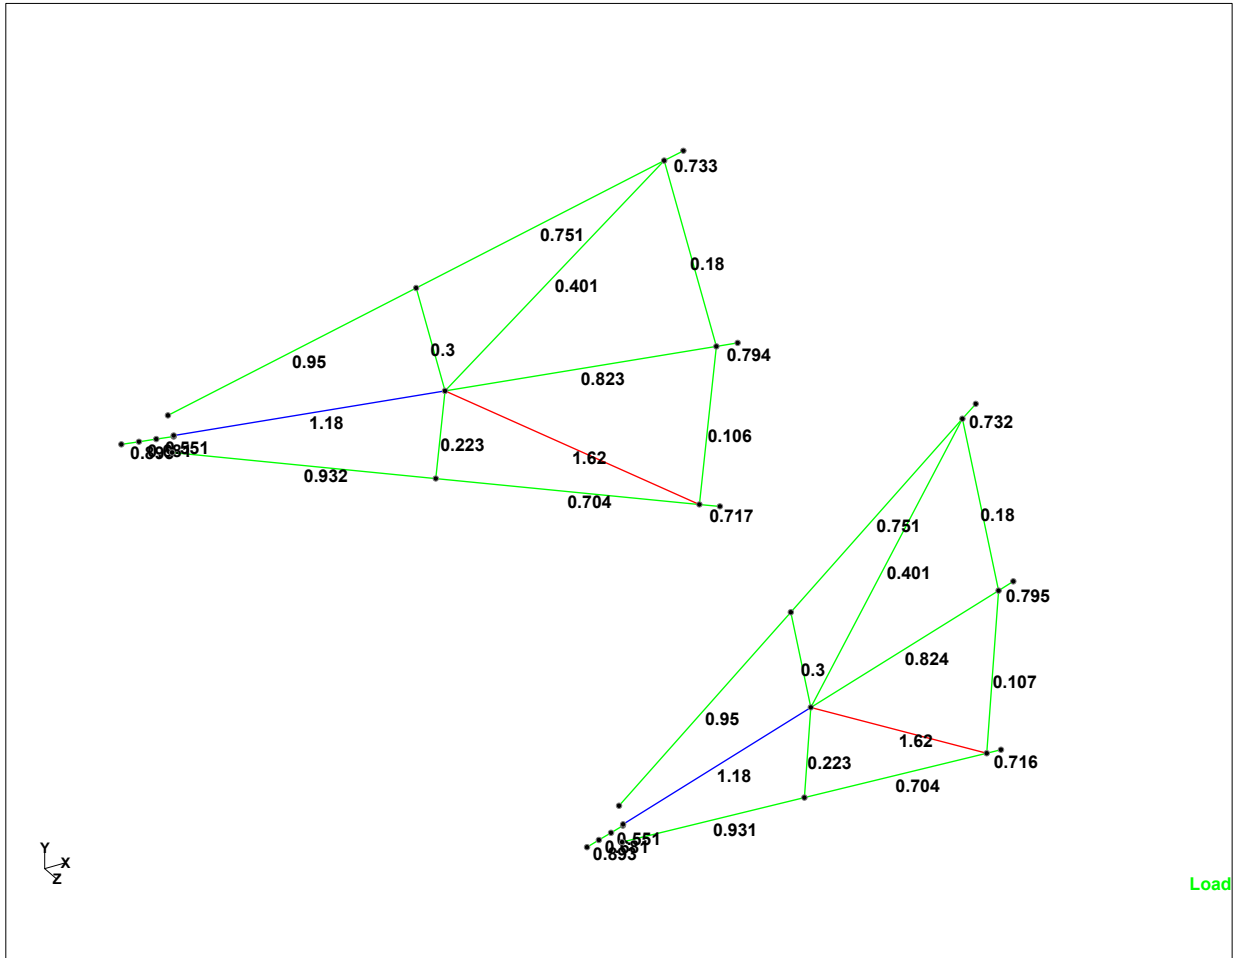
Arm Struts and Trunnion Hubs Member Utilization Ratios

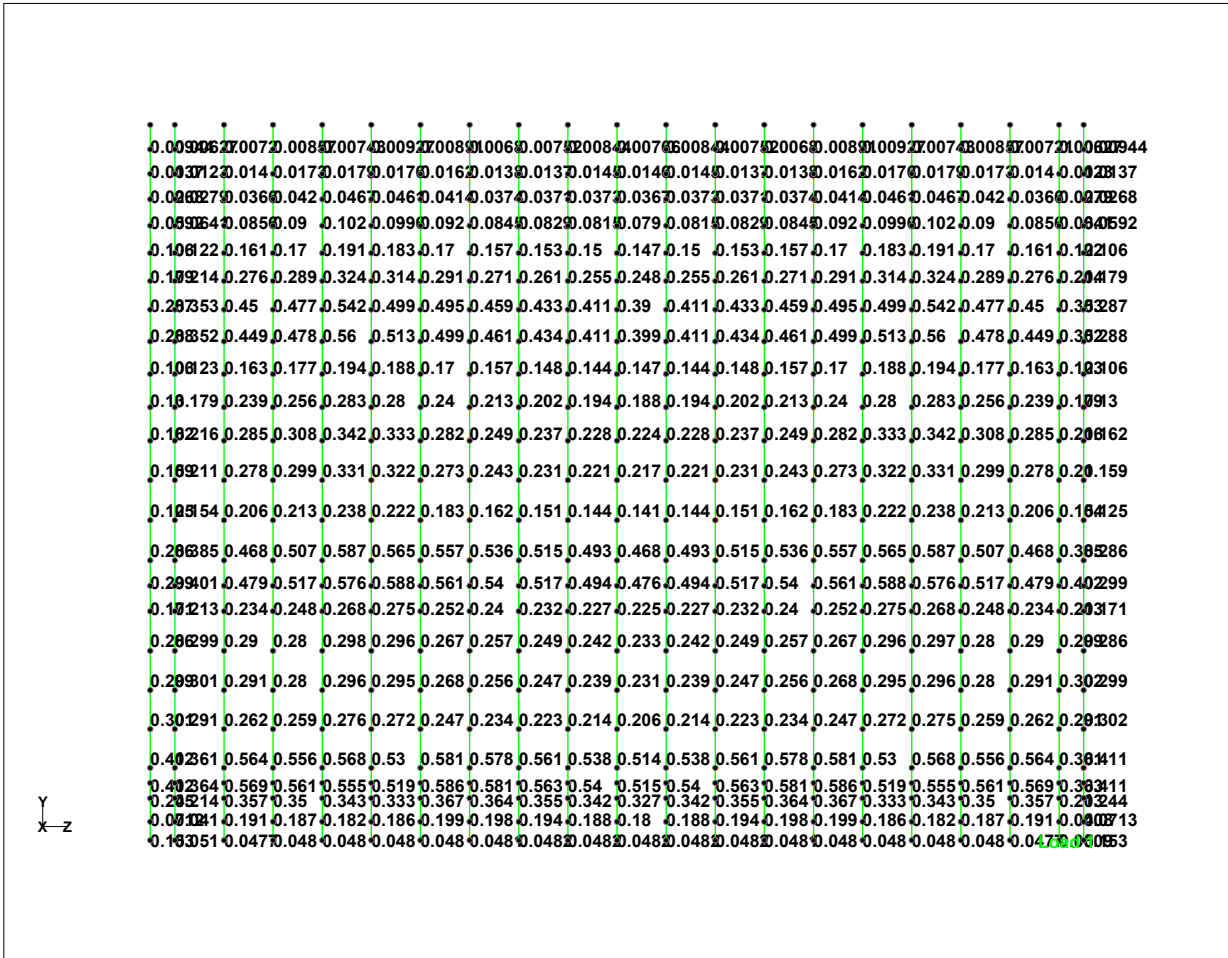
Skin-Rib Composite Member Utilization Ratios

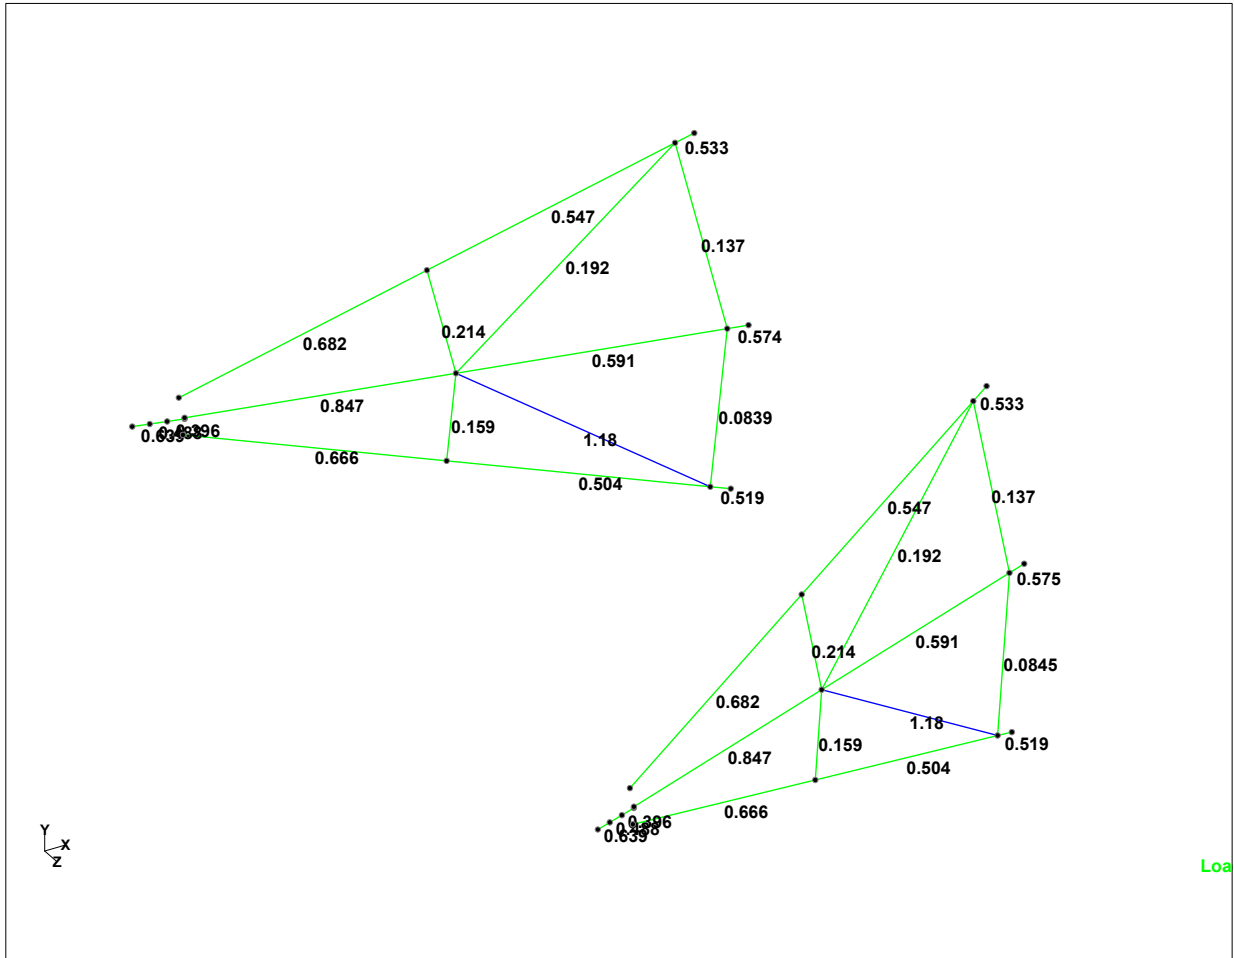
Arm Struts and Trunnion Hubs Member Utilization Ratios

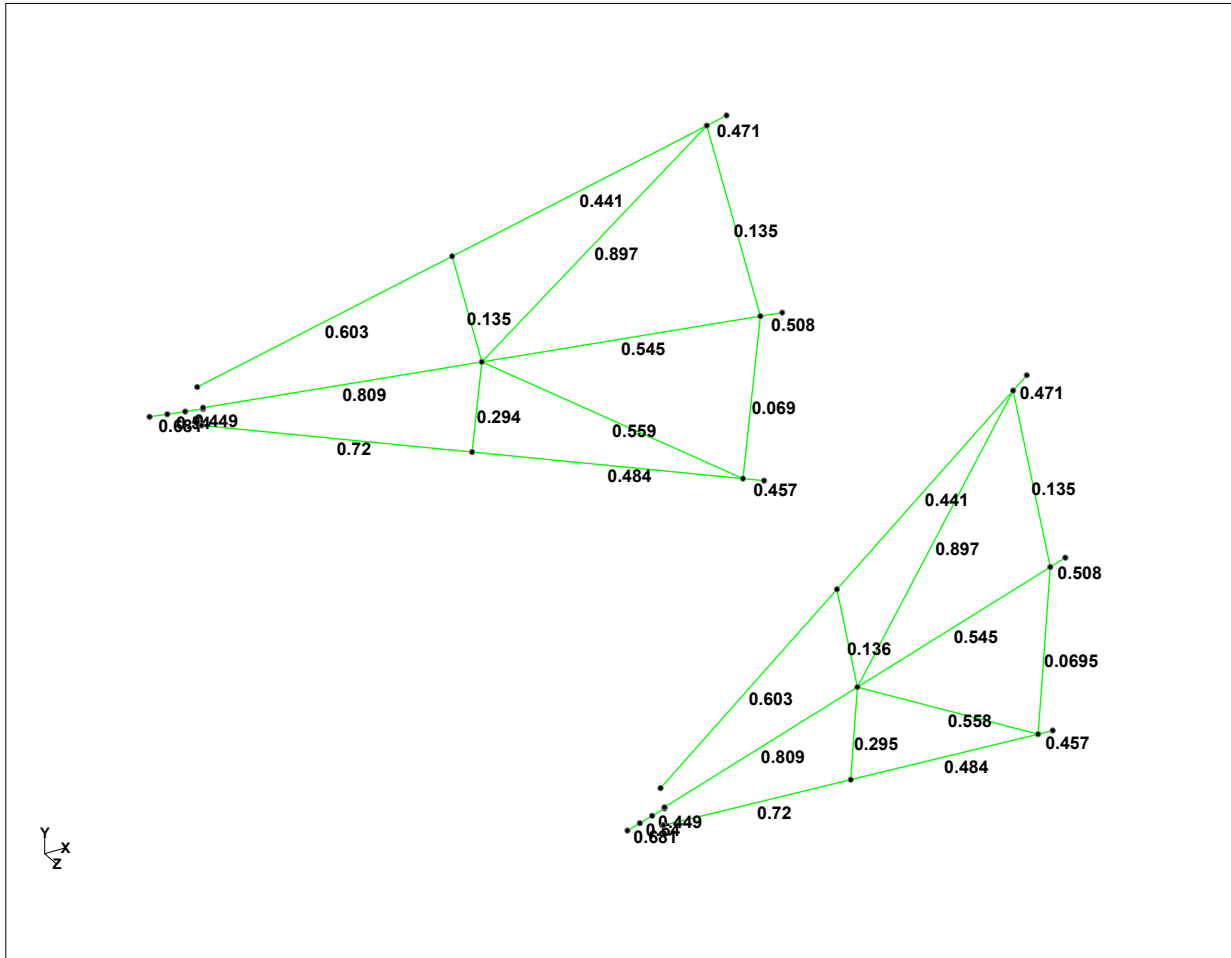
Arm Struts and Trunnion Hubs Member Utilization Ratios

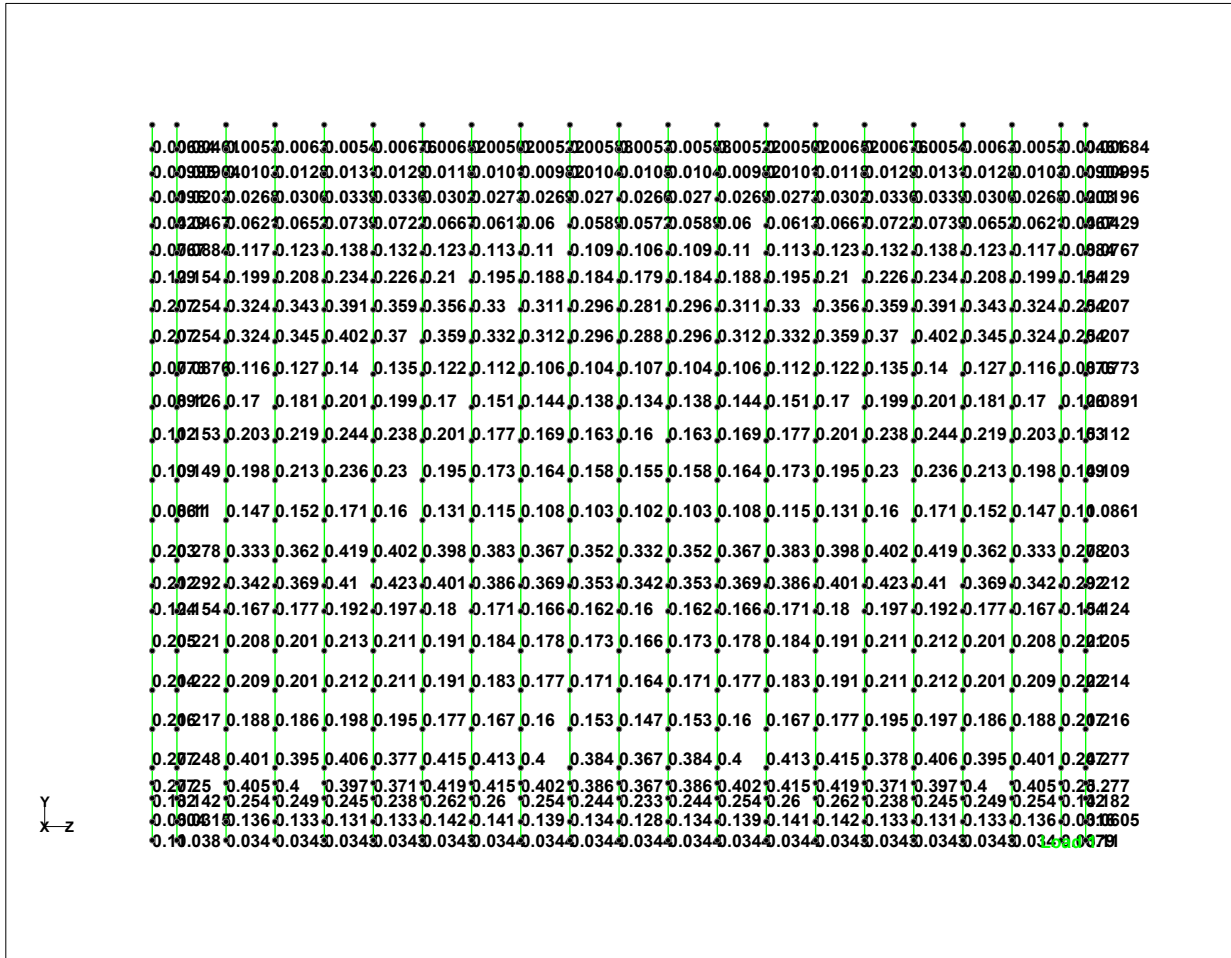
Skin-Rib Composite Member Utilization Ratios

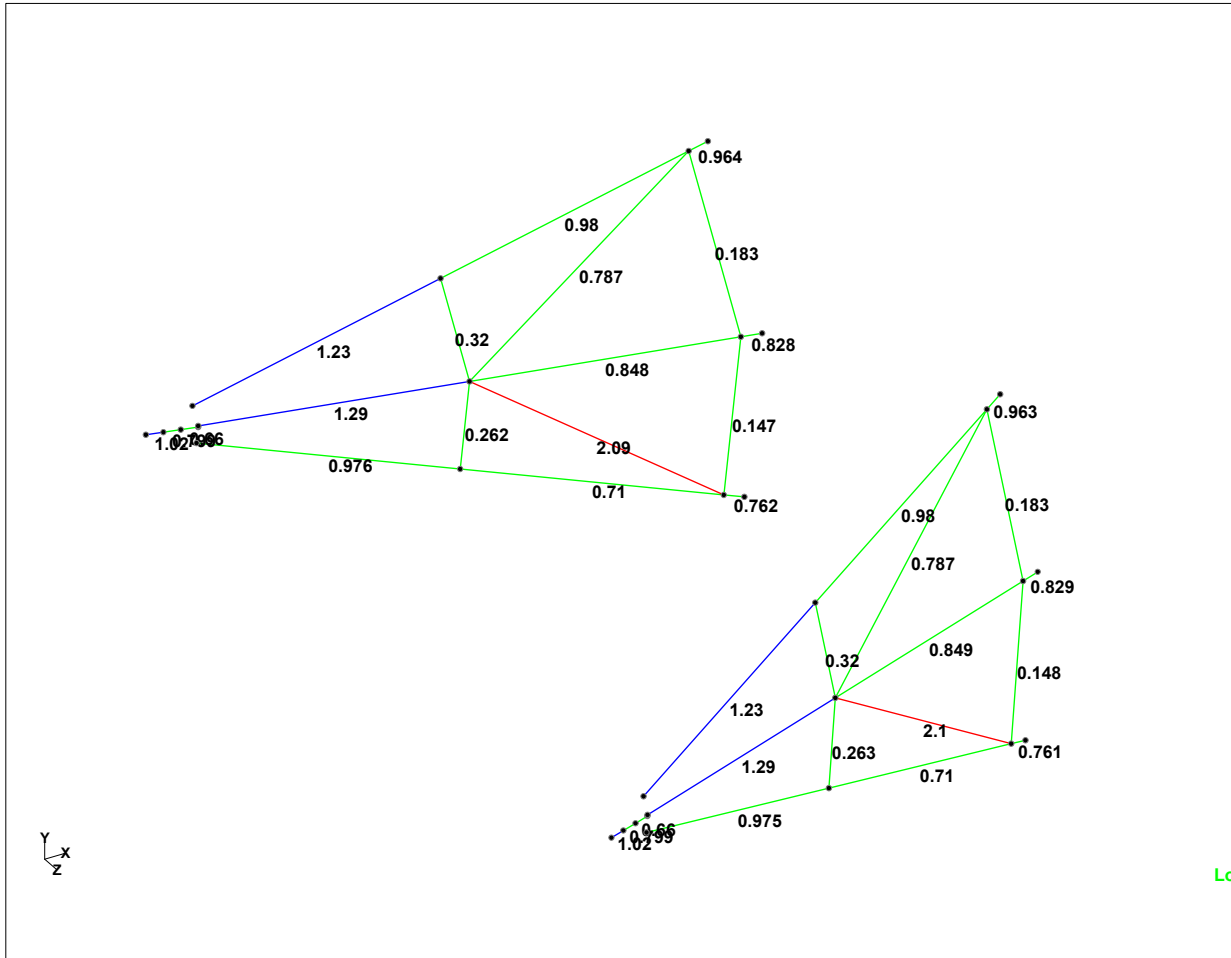
Arm Struts and Trunnion Hubs Member Utilization Ratios

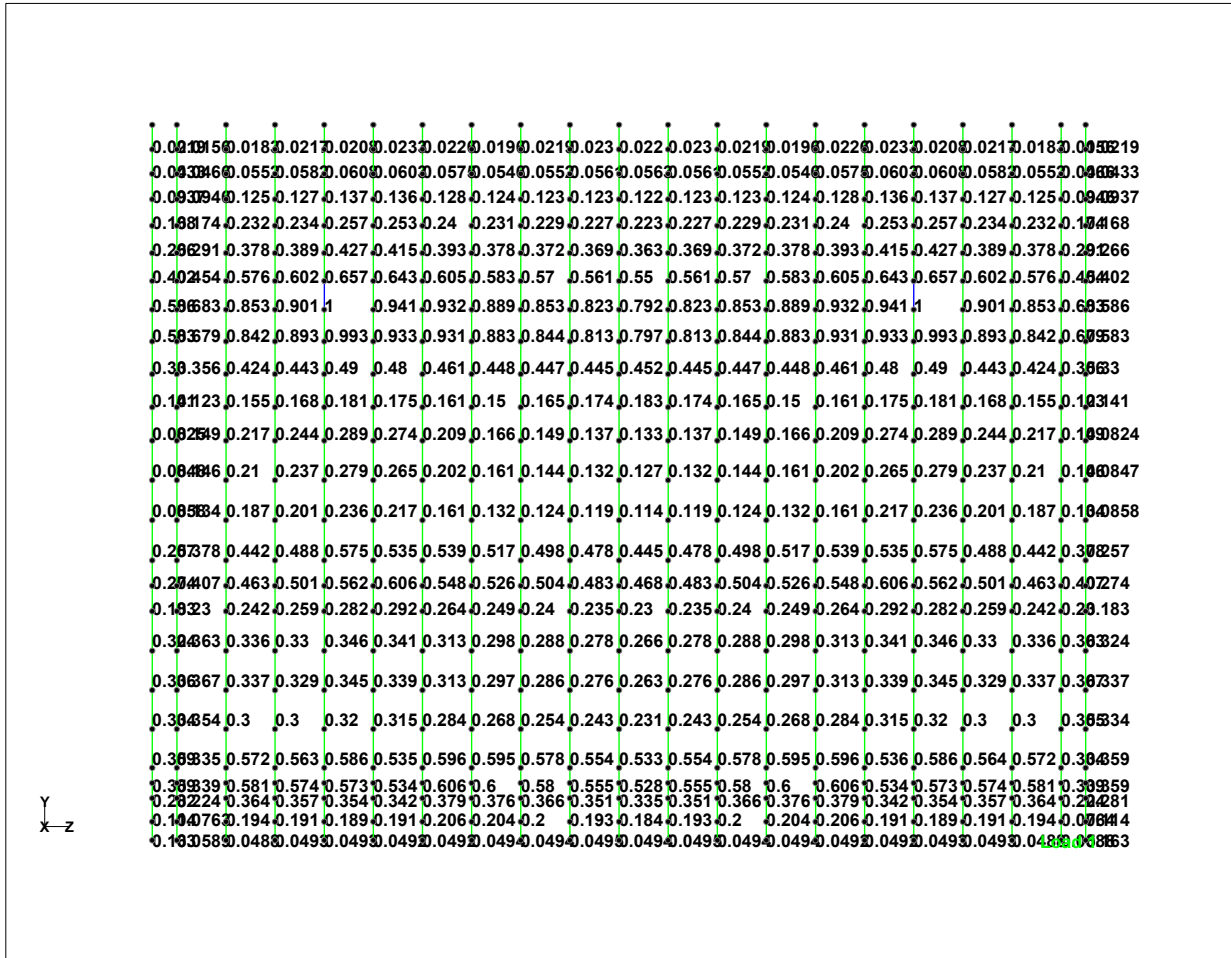
Skin-Rib Composite Member Utilization Ratios

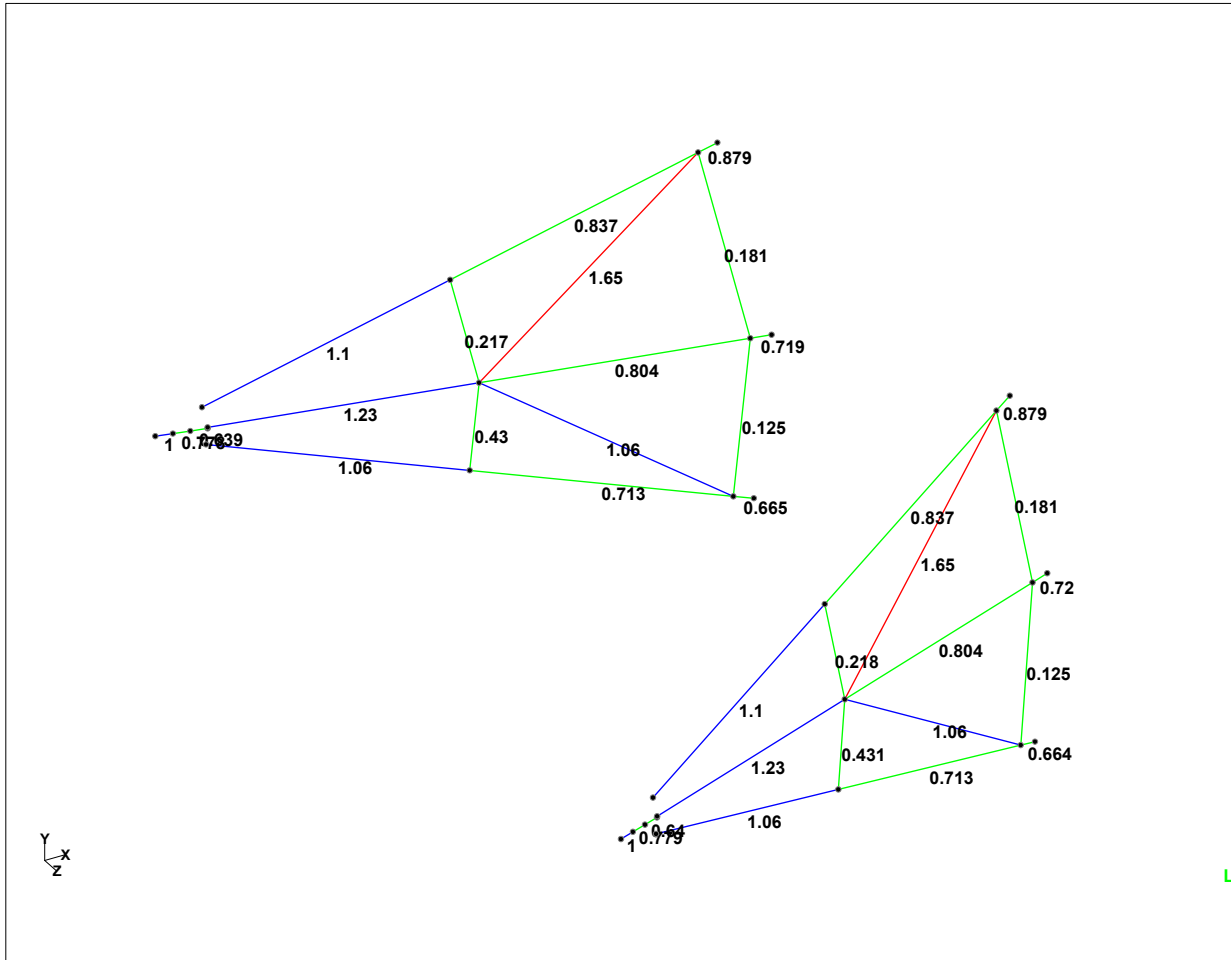
Arm Struts and Trunnion Hubs Member Utilization Ratios

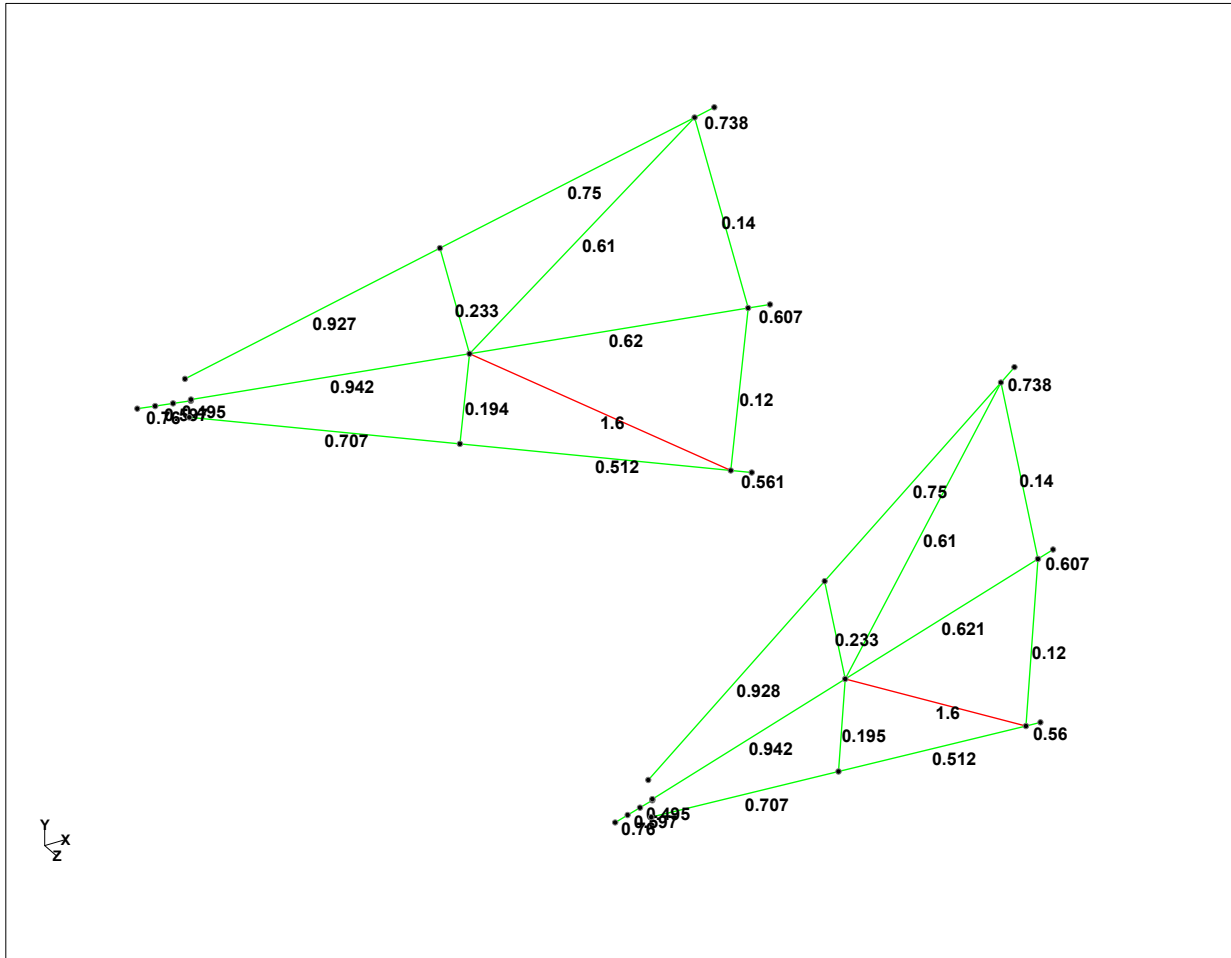
Arm Struts and Trunnion Hubs Member Utilization Ratios

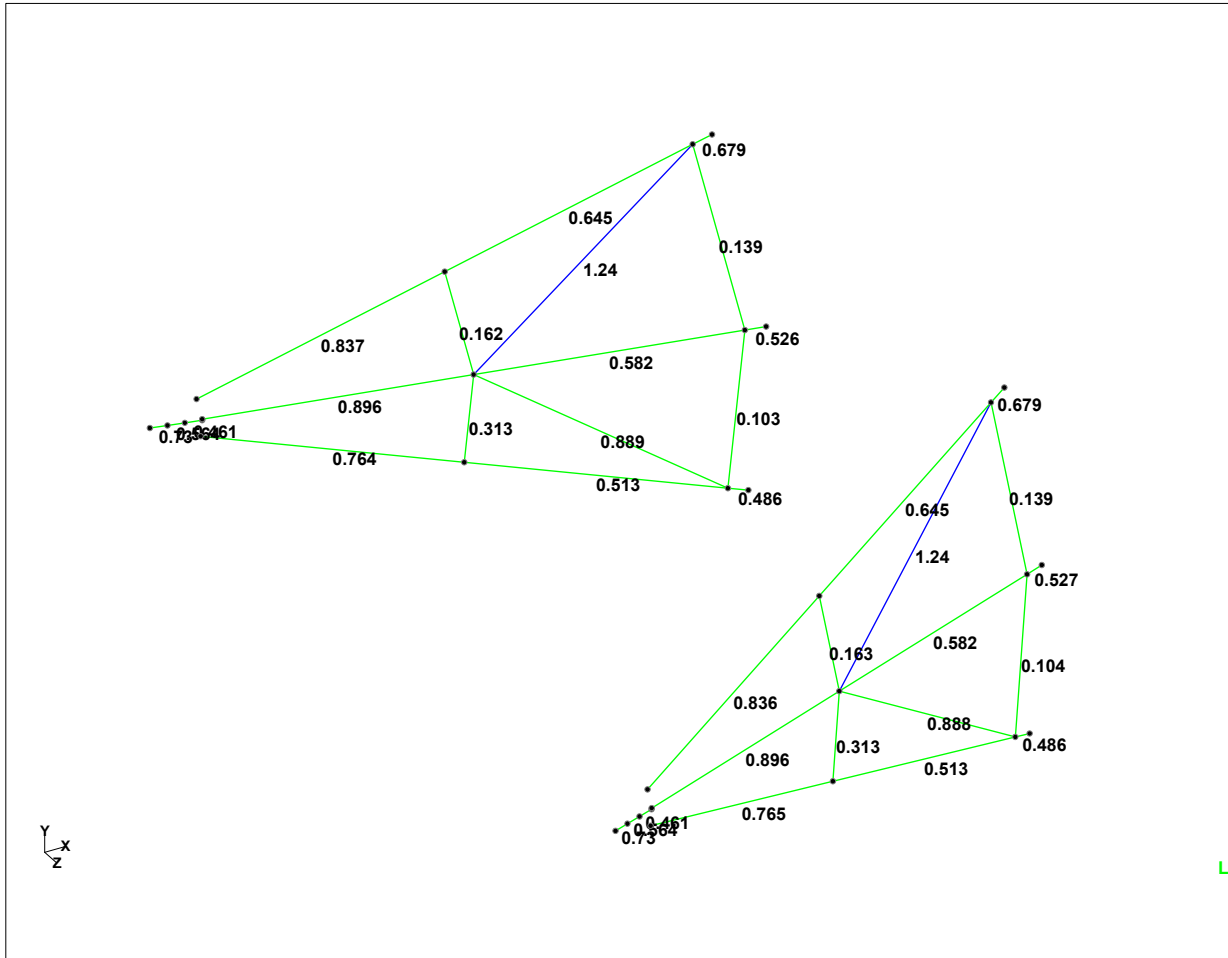
Arm Struts and Trunnion Hubs Member Utilization Ratios

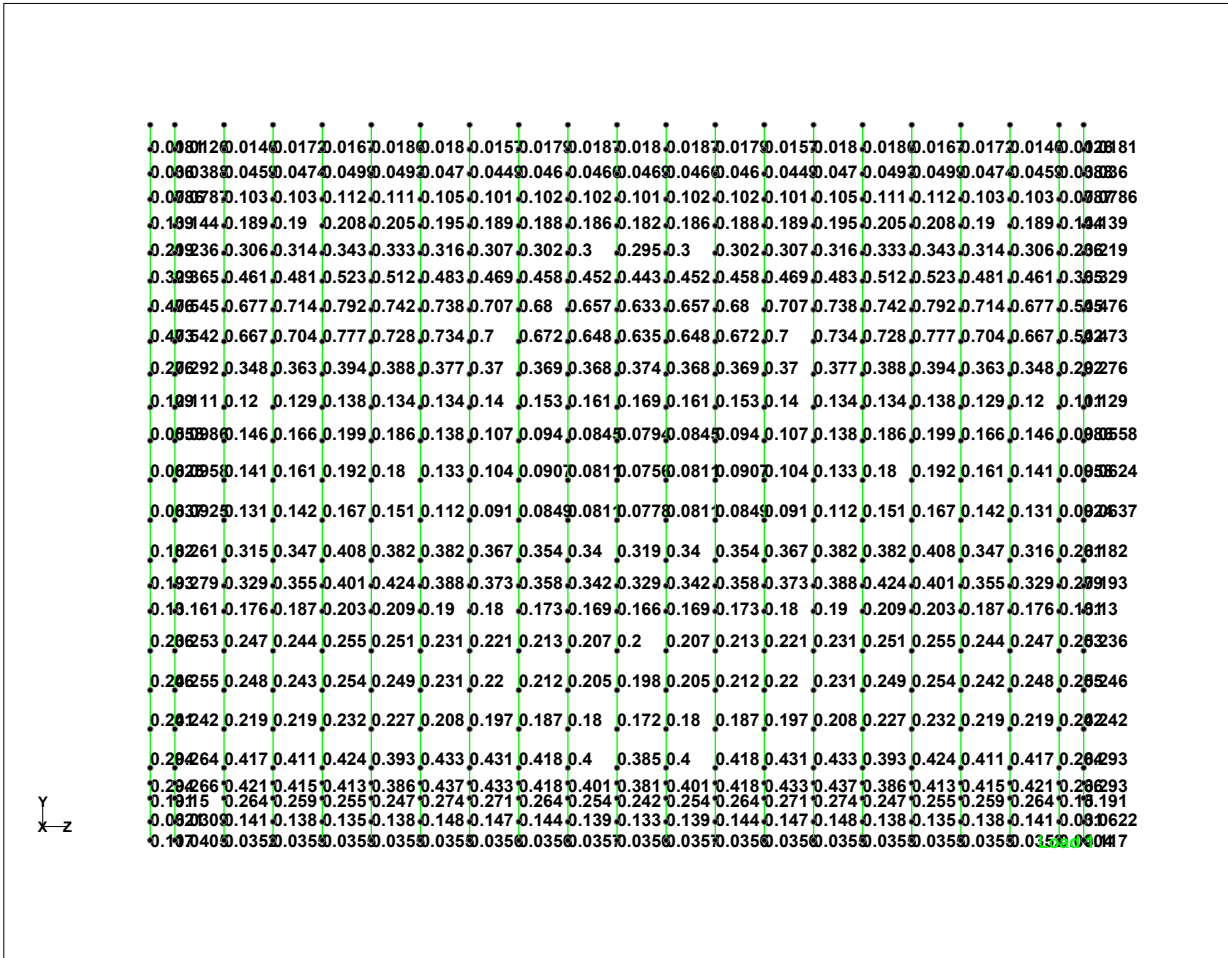
Skin-Rib Composite Member Utilization Ratios

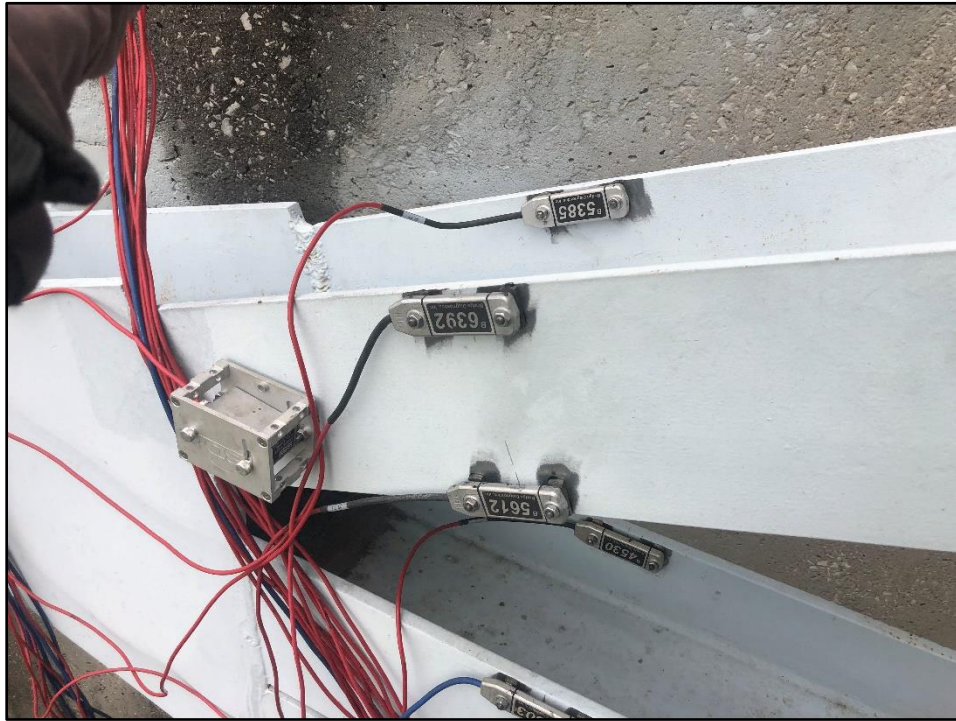
Figure 1 – BDI tiltmeter rotation sensor and reusable strain transducers installed near trunnion hub (Typical)

A typical installation has been shown in Figure 1 through Figure 4. Access to all the sensor locations was provided by BDI's own SPRAT certified rope access technicians and engineers as shown in Figure 5.
