VISUAL INSPECTION AND EVALUATION REPORT

Rockwall-Forney Dam
Dallas Water Utilities
Dallas/Kaufman Counties, Texas

Schnabel Reference #20C22001.00
July 30, 2021

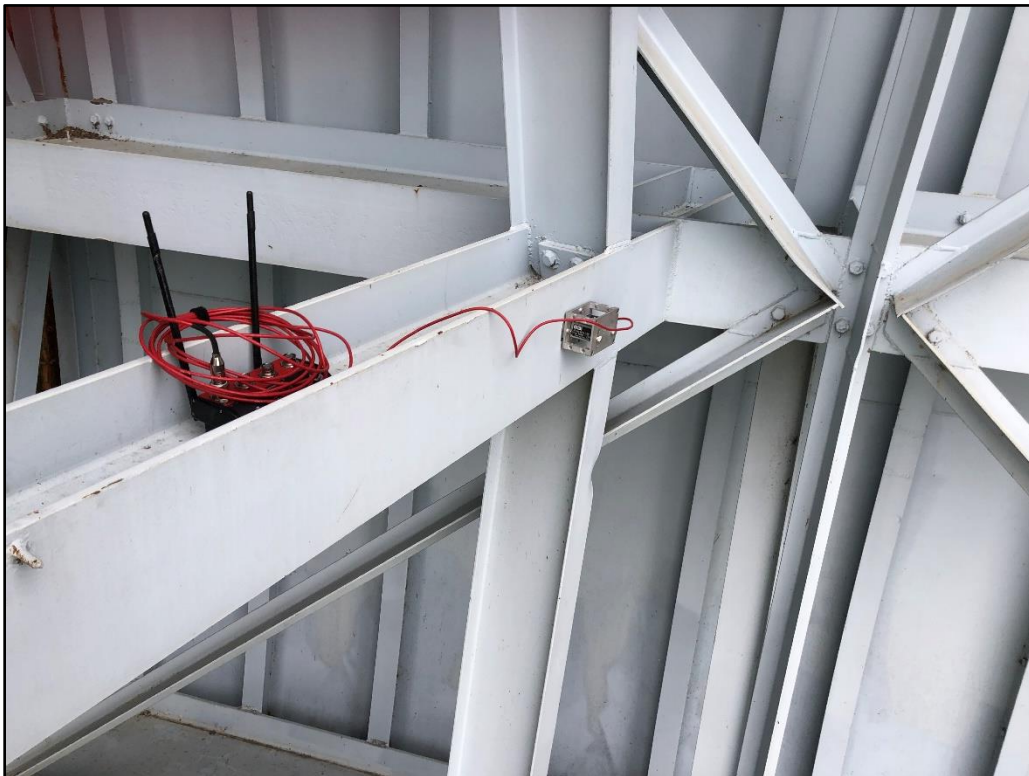
Figure 2 – BDI tiltmeter rotation sensor installed near skin plate (Typical)

A typical installation has been shown in Figure 1 through Figure 4. Access to all the sensor locations was provided by BDI's own SPRAT certified rope access technicians and engineers as shown in Figure 5.

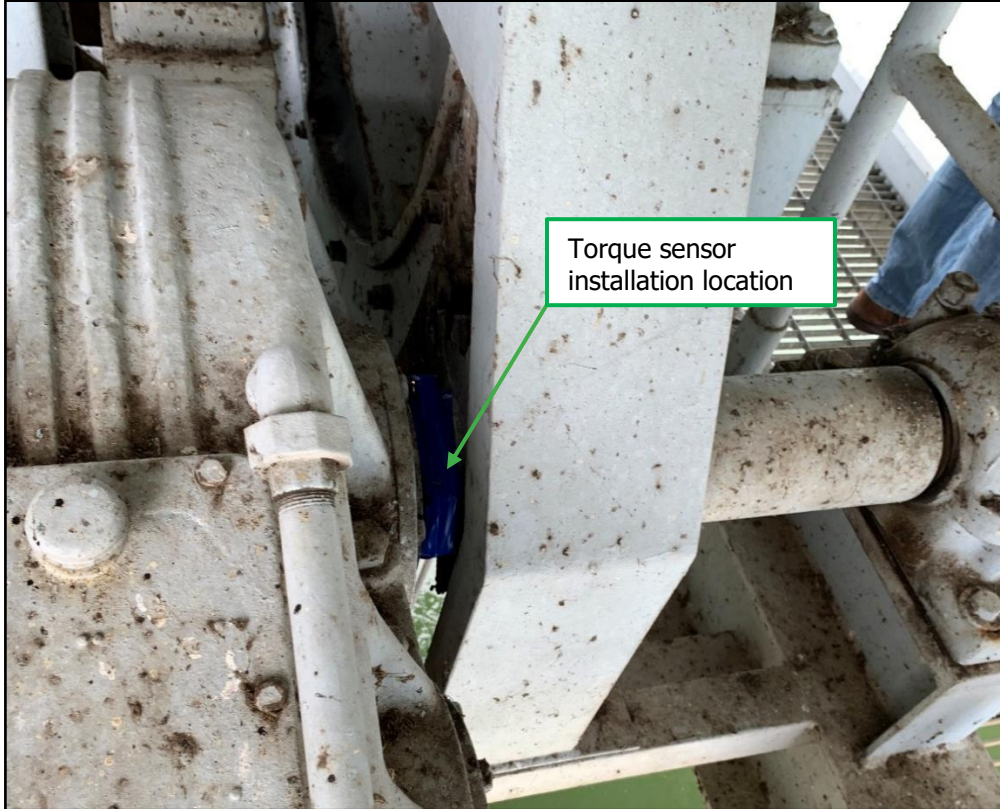
Figure 3 – Torque sensor installation on hoist pinion shaft (Typical)

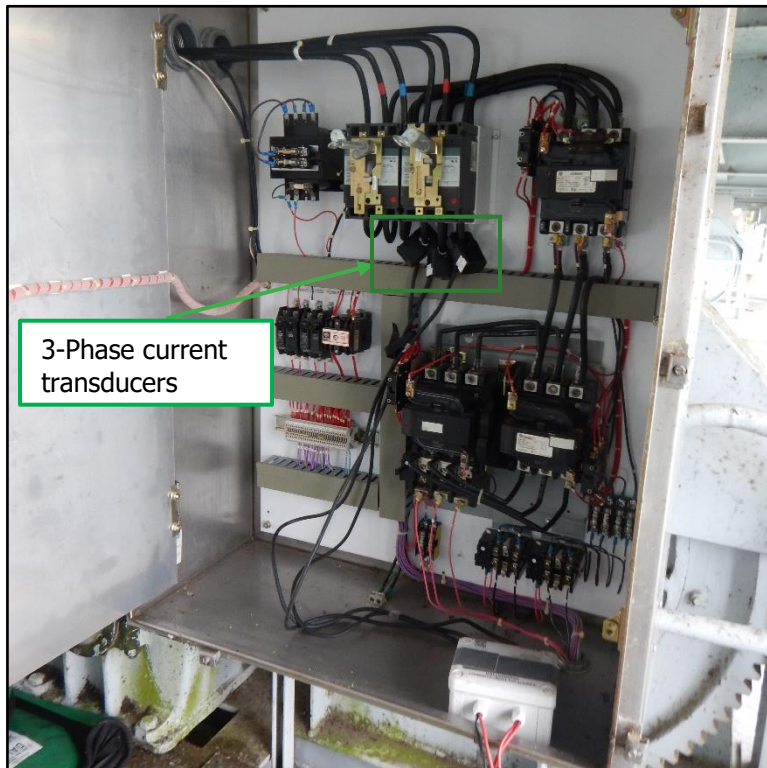
Figure 4 – Current transducers installed on hoist motor controls (Typical)

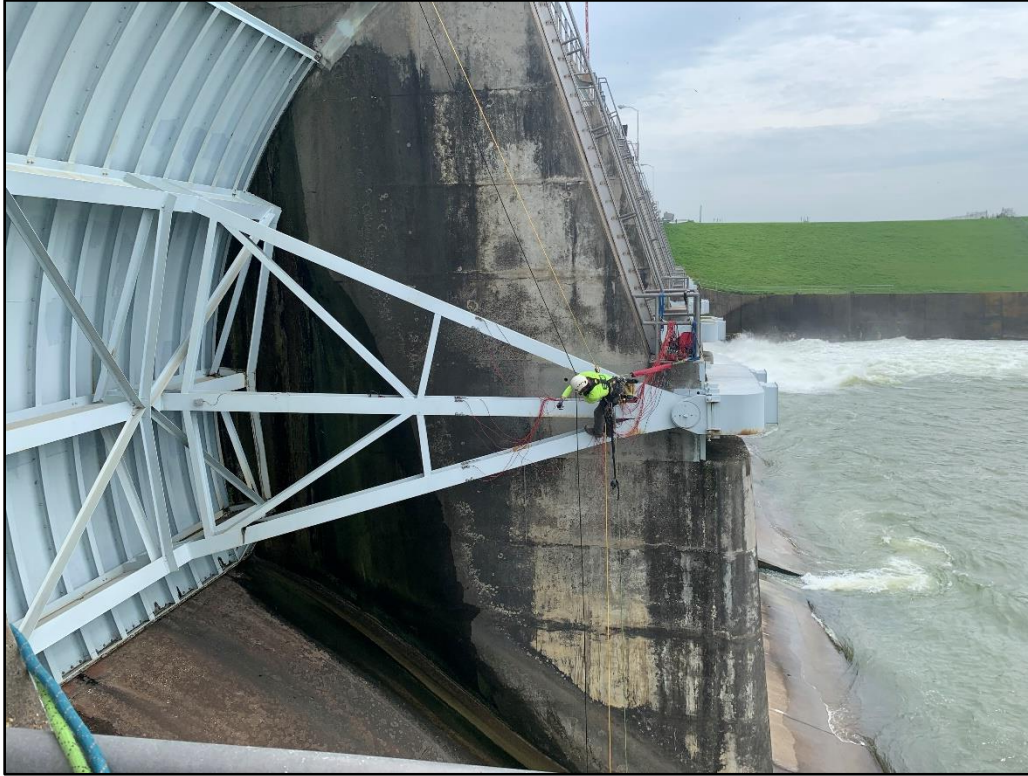
Figure 5 – BDI personnel installing instrumentation on the gate arm

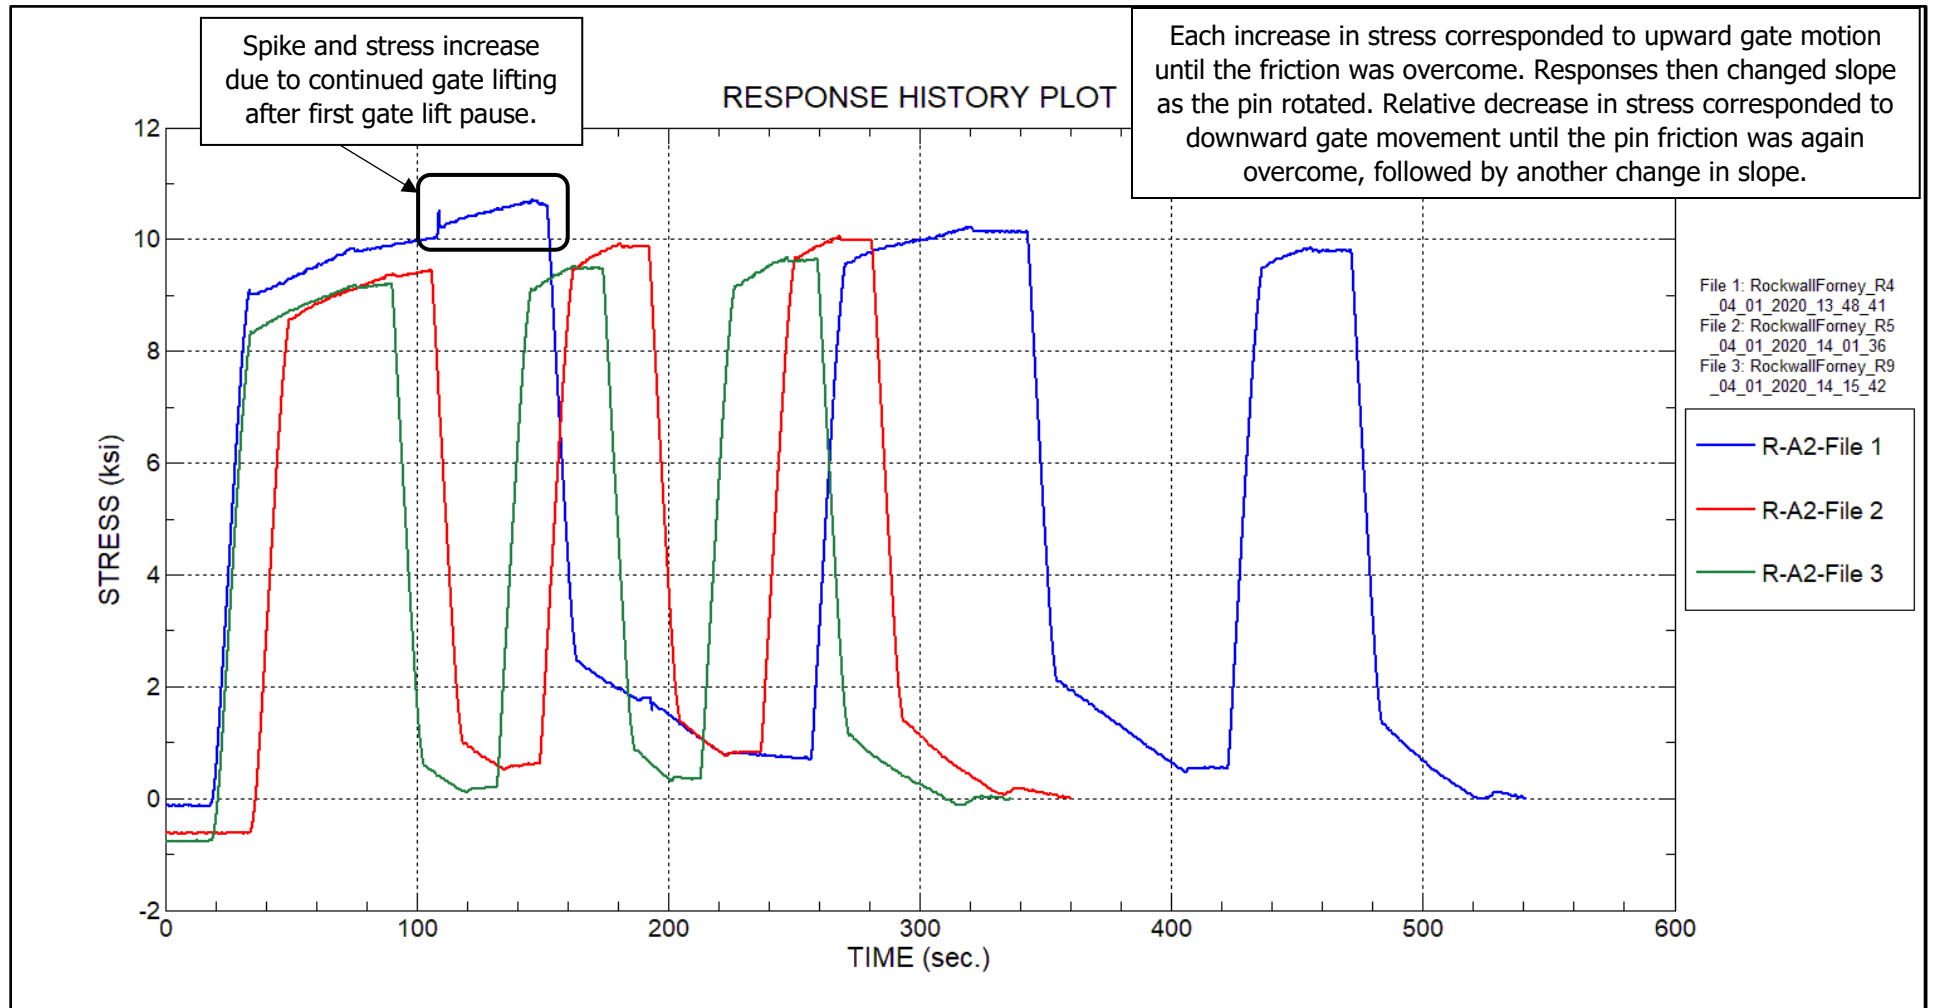
Figure 6 – Stress response history – Right arm – Gage A2 – Time based
File 1 = Test Run 1, File 2 = Test Run 2, File 3 = Test Run 3
(Section A along top strut near pin – Sensor location 2 along bottom of inner flange)

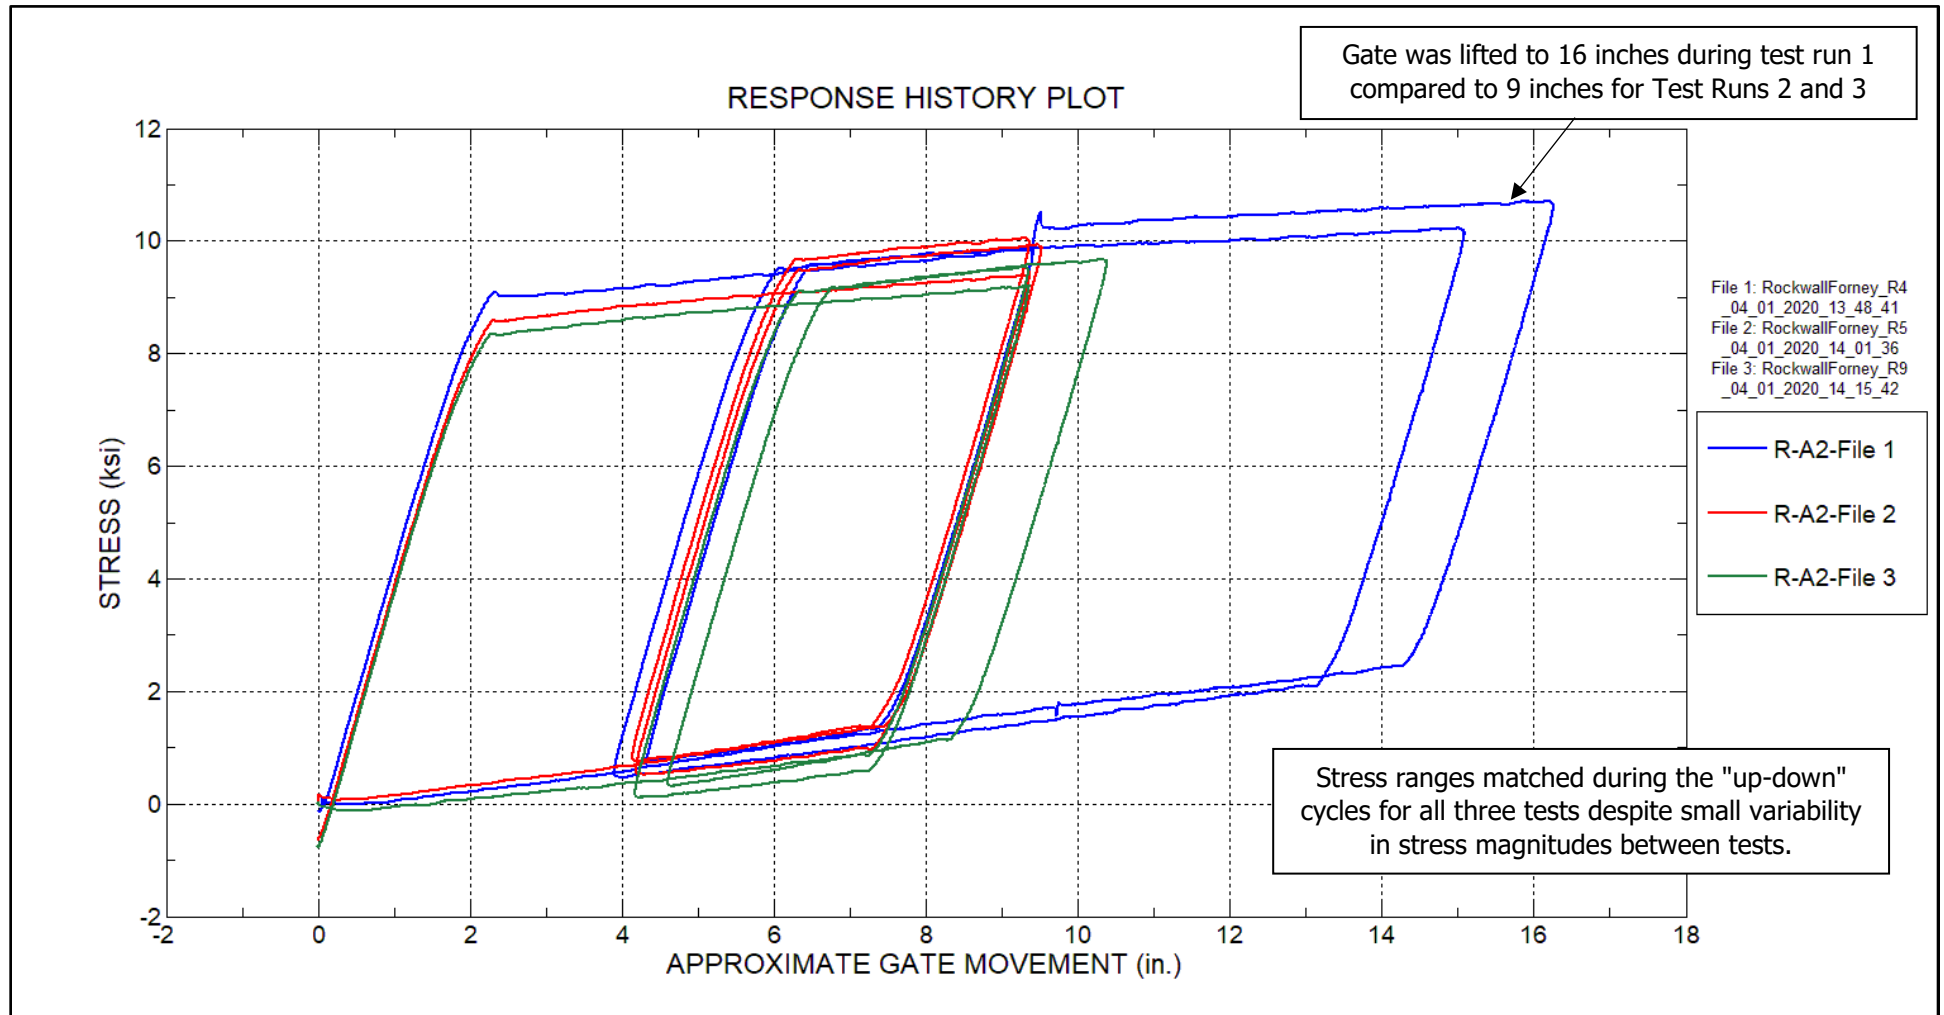
Figure 7 – Stress response history – Right arm – Gage A2 – Function of gate movement
File 1 = Test Run 1, File 2 = Test Run 2, File 3 = Test Run 3
(Section A along top strut near pin – Sensor location 2 along bottom of inner flange)

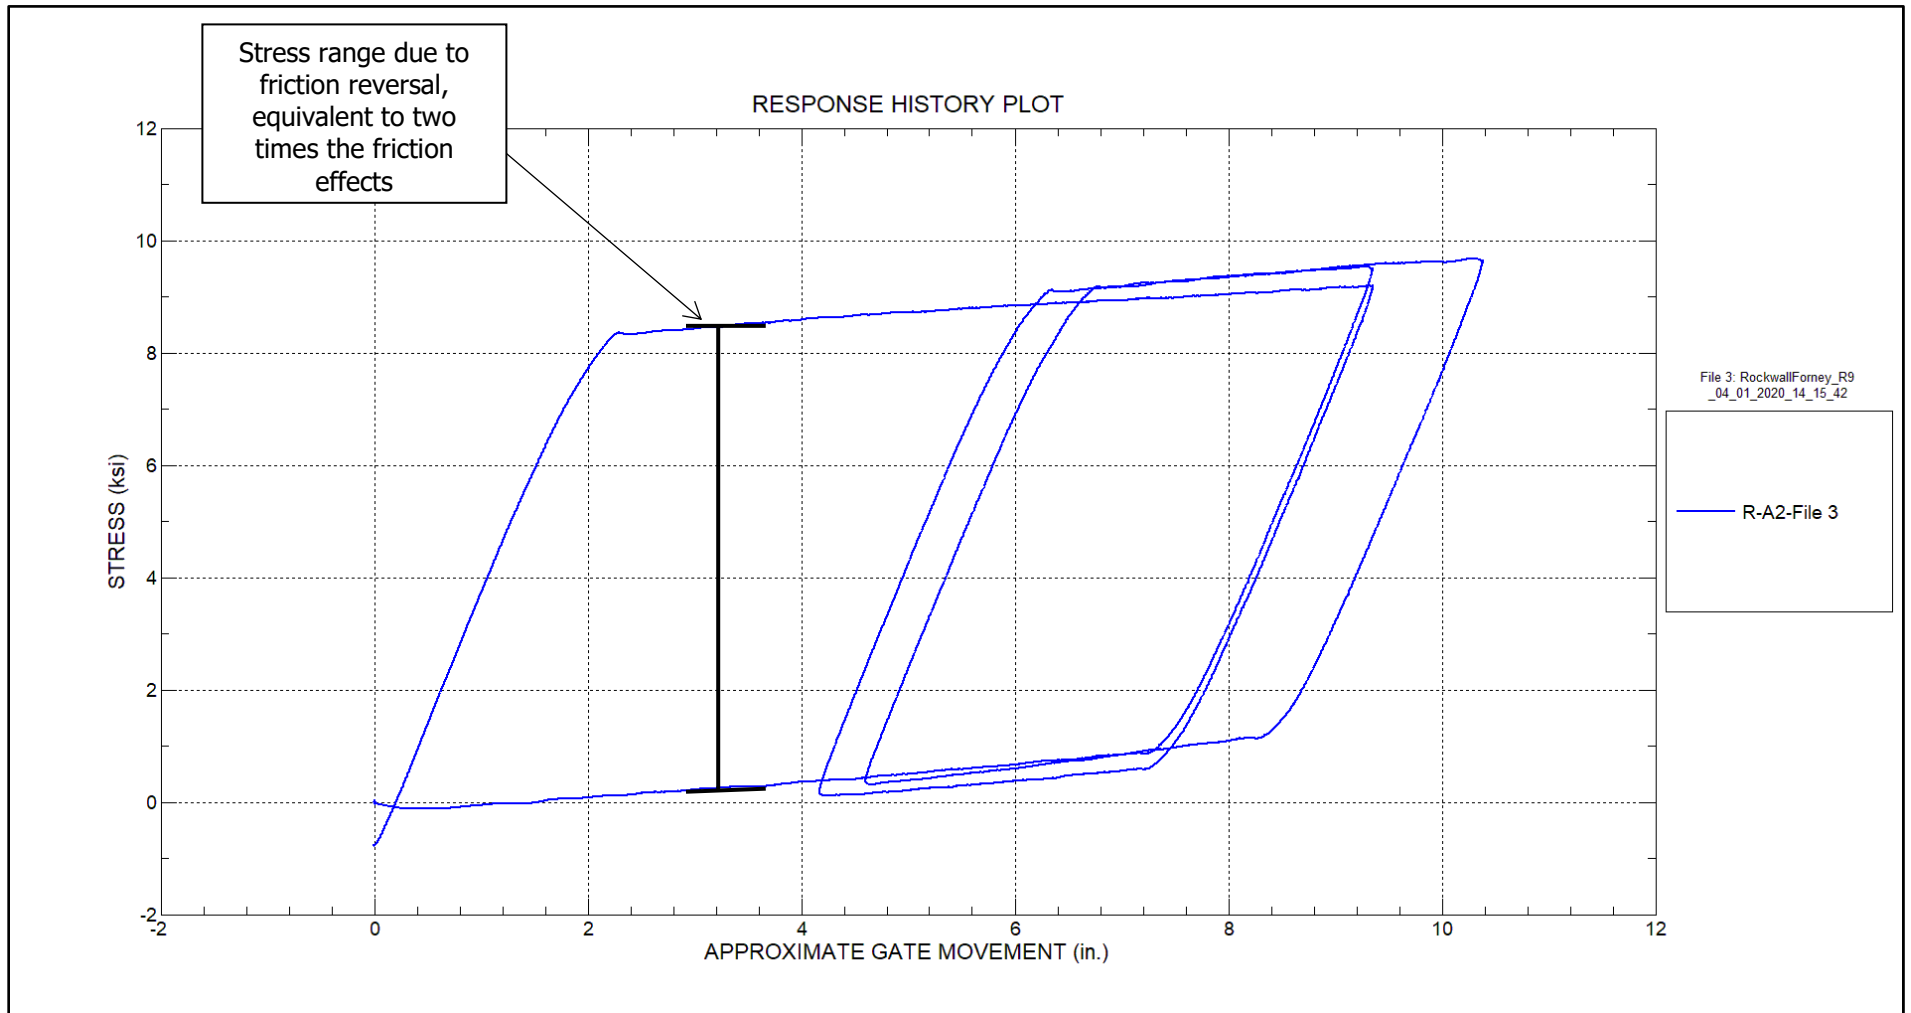
Figure 8 – Stress response history – Right arm – Gage A2 – Friction effect in stress responses
(Section A along top strut near pin – Sensor location 2 along bottom of inner flange)

- + **DIRECTION/FRICTION REVERSAL IN RESPONSES:** The difference in stress during gate opening and closing for a given position is shown in Figure 8. The stress variation at any given gate position was a result of direction reversal and in turn due to trunnion friction reversal. This statement is true since all other loads such as dead-load and hydrostatic pressure were essentially constant barring small changes in hydrostatic pressure due to slight changes in head. This direction/friction reversal is depicted in Figure 9, with deflected shape renderings from a gate arm finite element model under lifting and lowering loads. Note that this figure shows an arm configuration that does not match this gate, but the concept of the direction/friction reversal still applies.

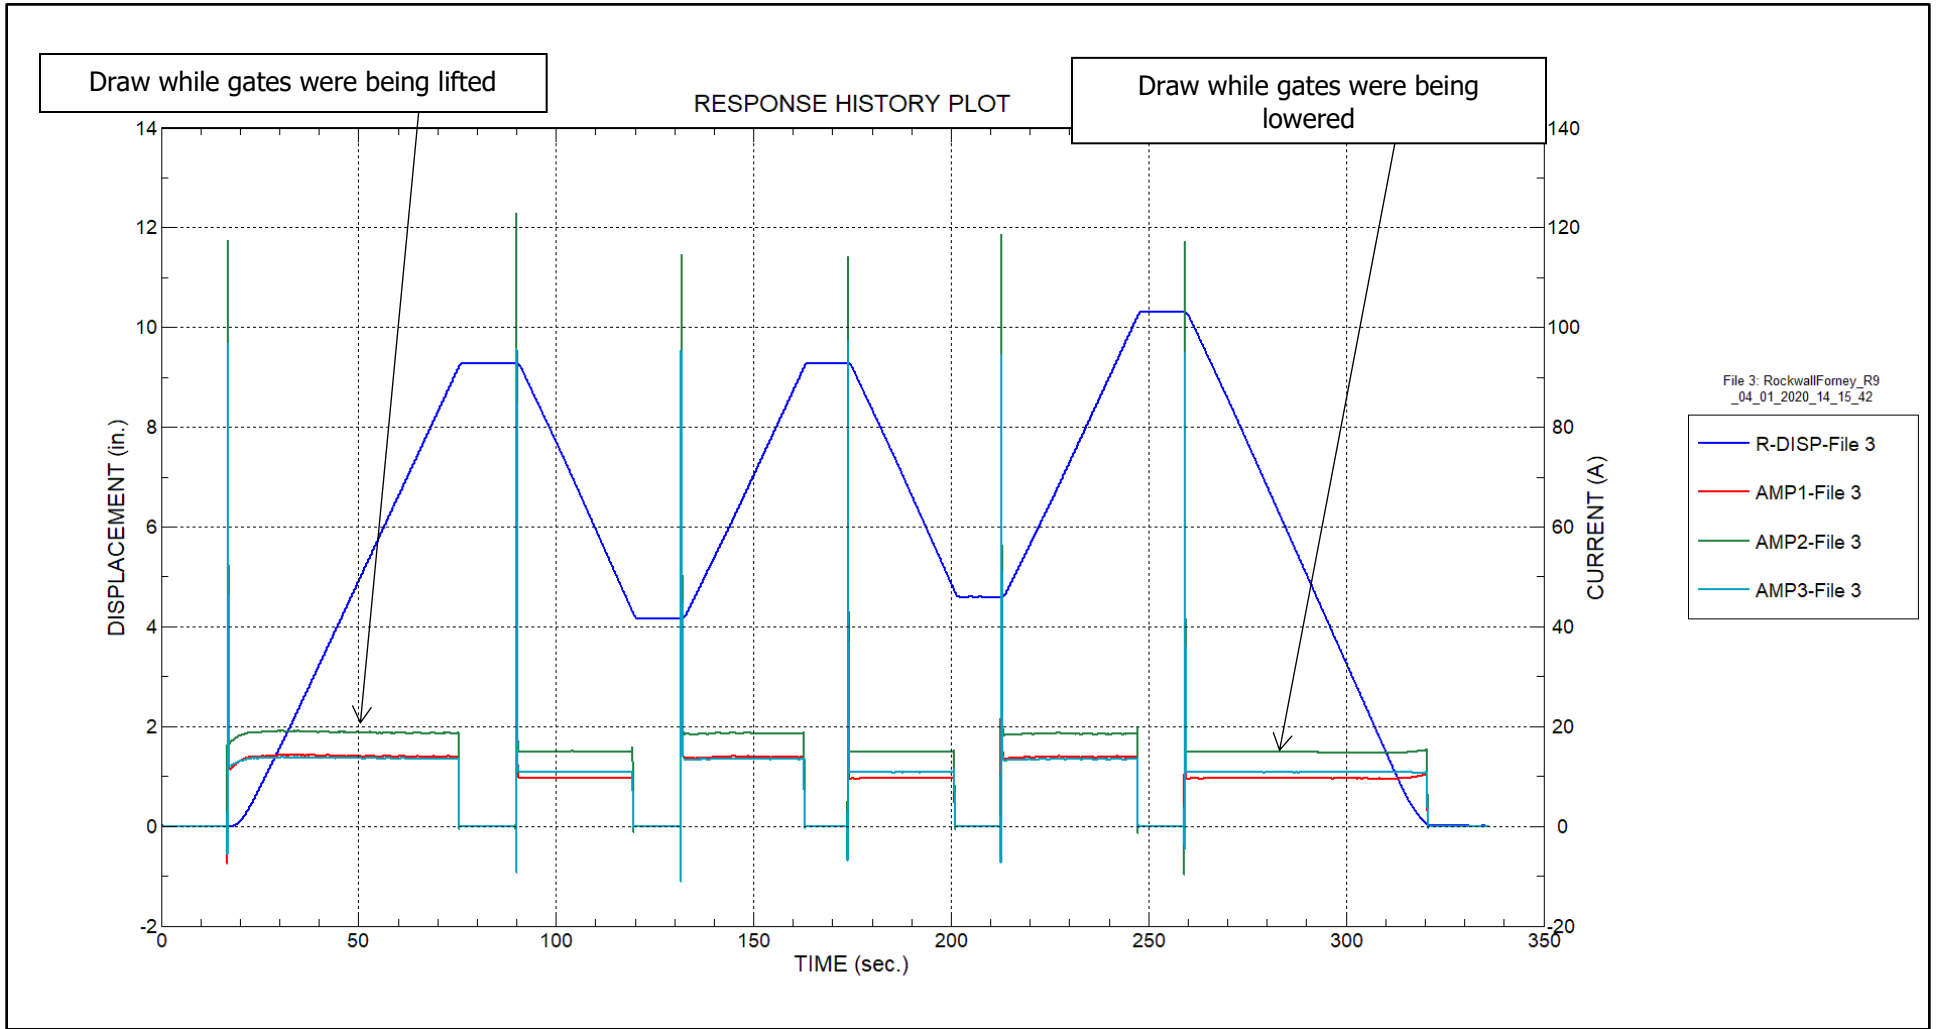
Figure 10 – Motor current & gate movement response history – Lift motor – Highlighting motor draw during lift and lower cycles

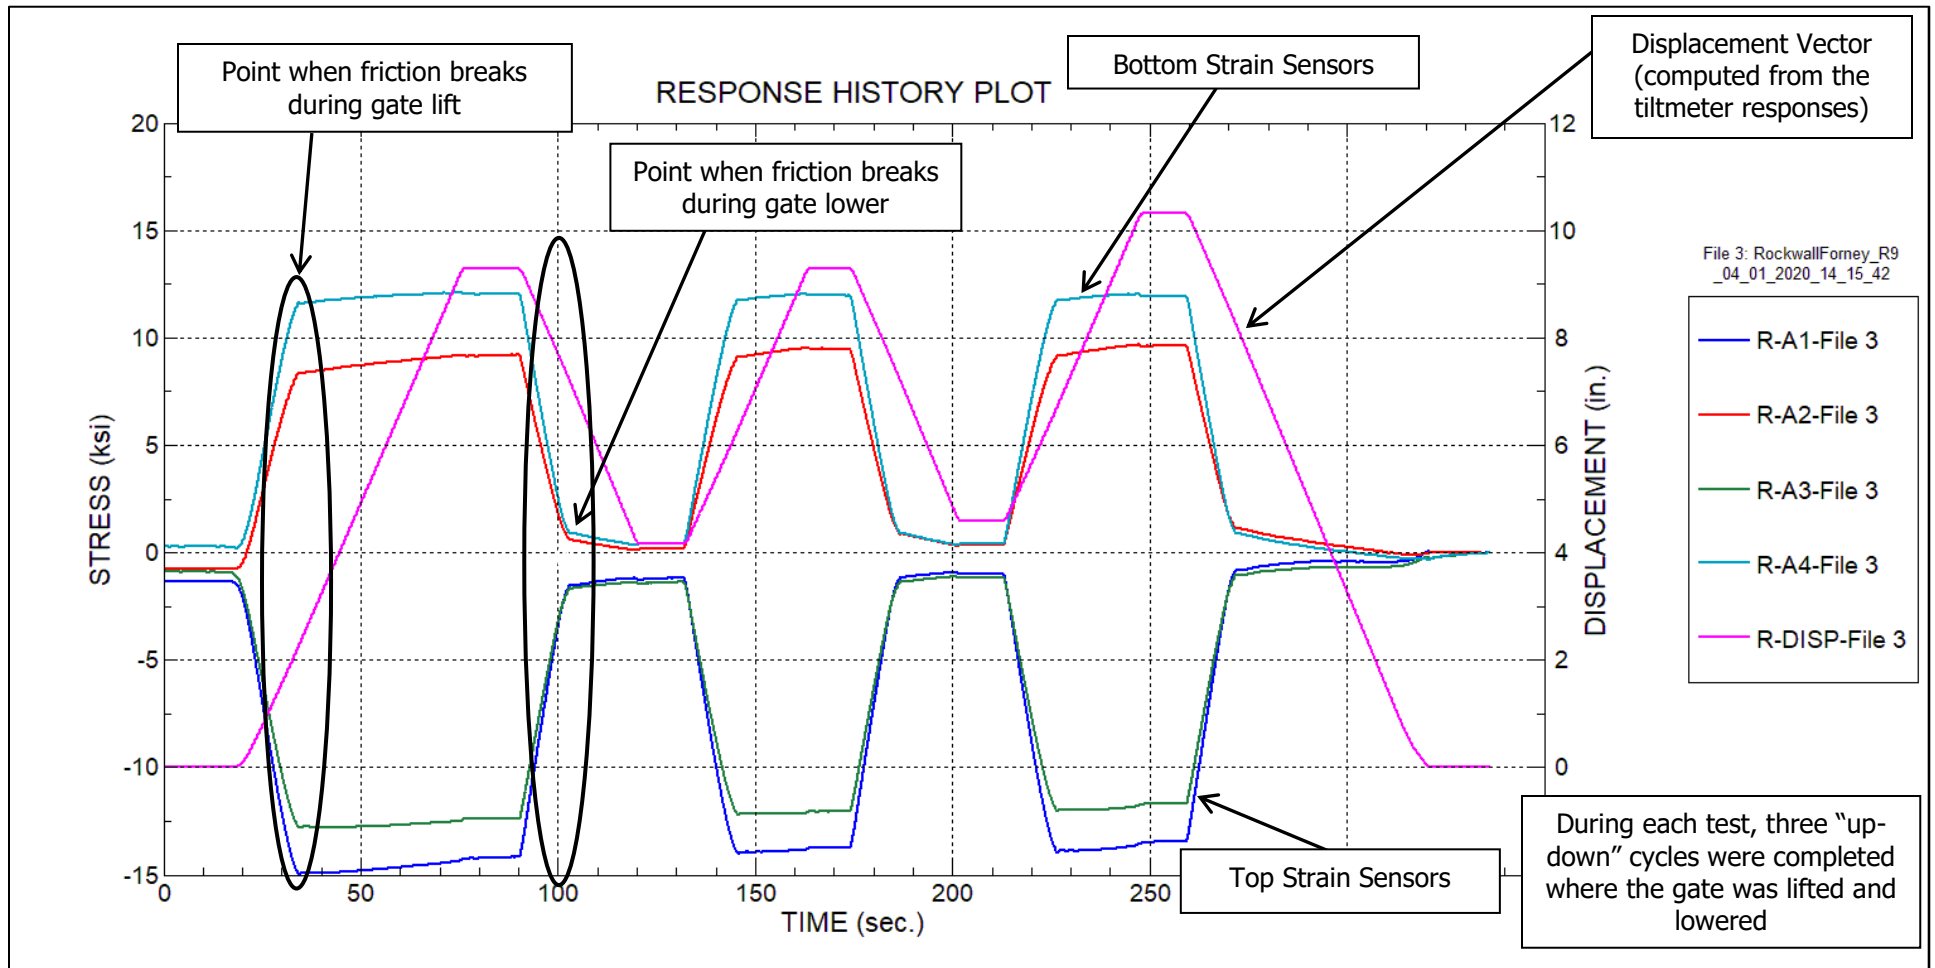
Figure 11 – Stress response & gate movement history – Right arm – Section A - Highlighting friction behavior (Section A along top strut near pin)

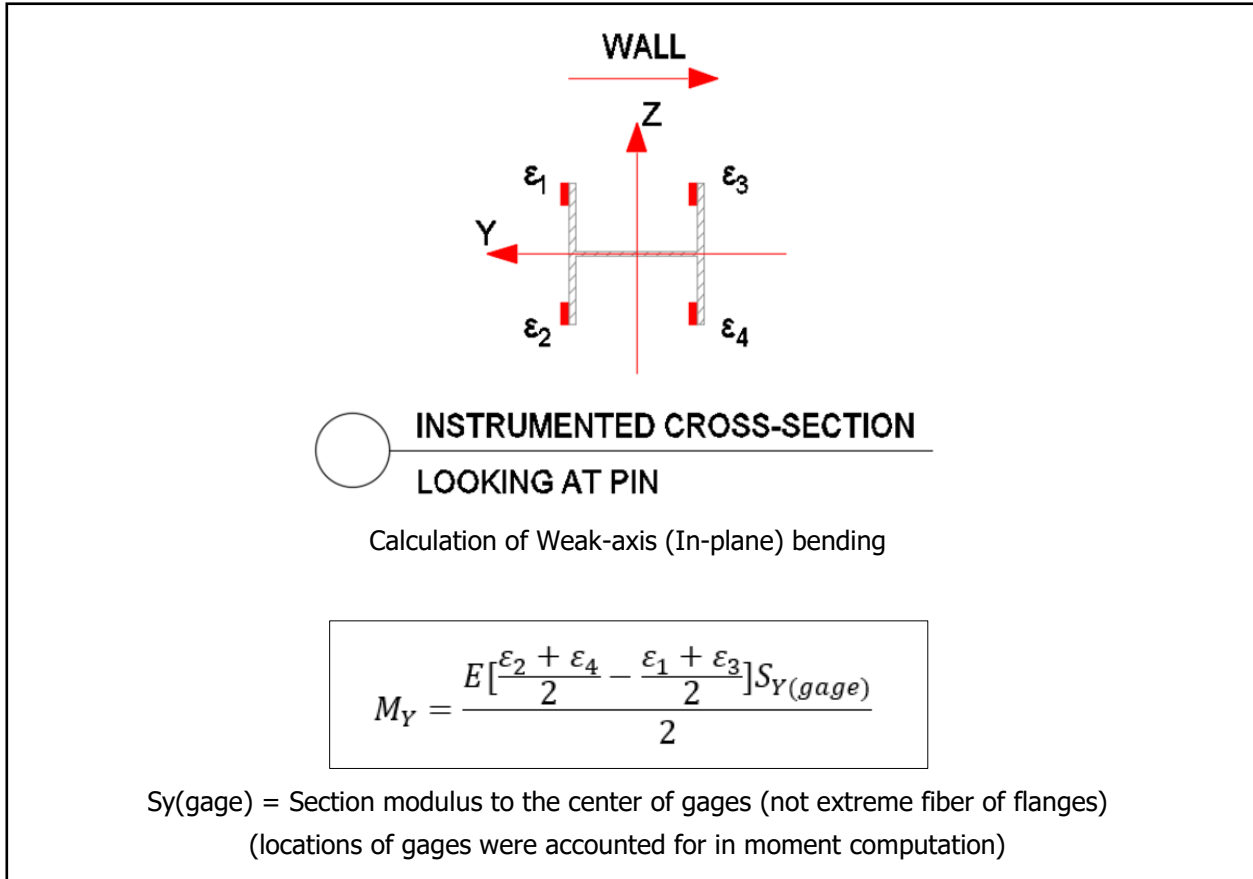
Figure 12 – Basic mechanic equation used to calculate moment

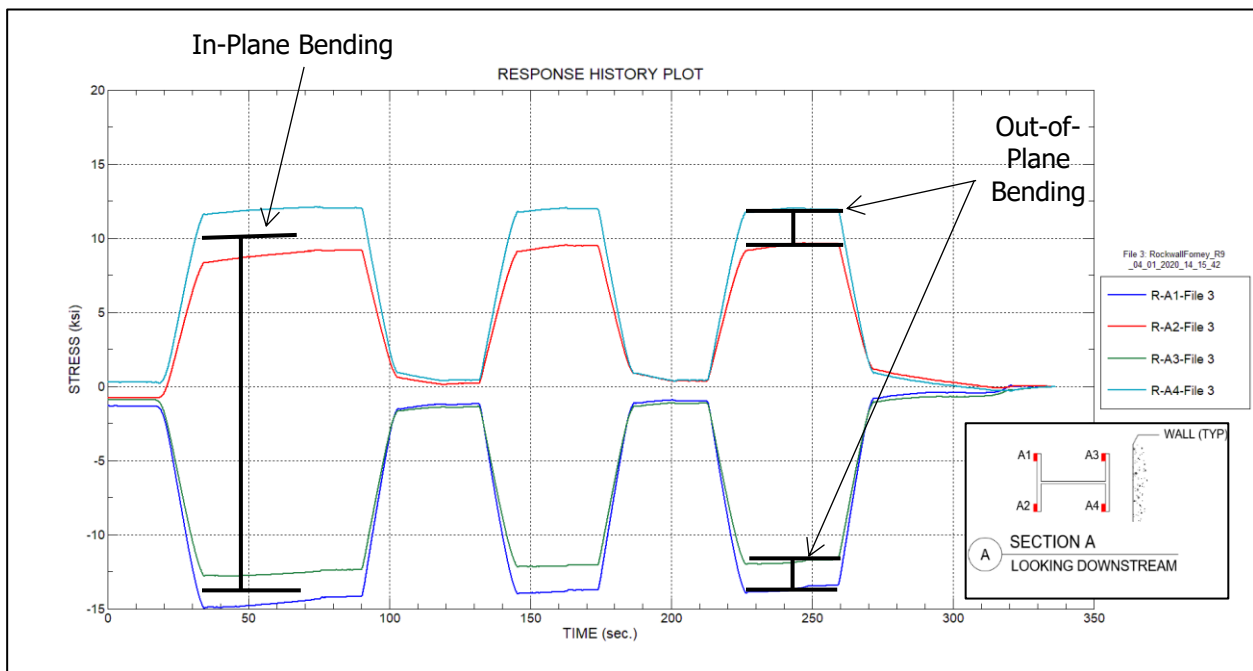
Figure 13 – Stress response history – Right arm – Section A – Bending components (Section A along top strut near pin)

In-plane or weak-axis flexure refers to bending about a given strut's web. This designation is consistent with typical nomenclature. In-plane bending can be observed visually from the strain response histories as a difference between the top and bottom stresses, whereas out-of-plane or strong-axis bending is visualized as the difference in stress from side to side. Figure 13 provides a visual reference for both types of strut flexure.

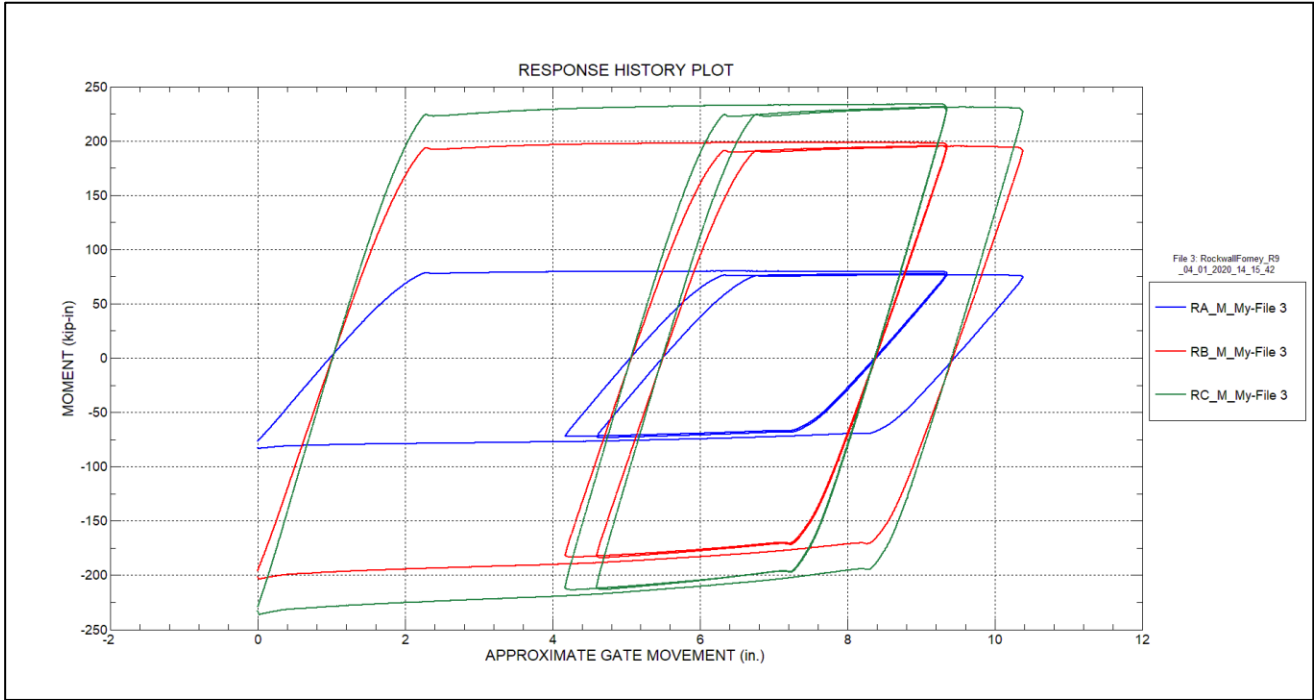
Figure 14 – In-plane moment response history – Right arm – Sections near pin
(RA = Right Arm Top Strut, RB = Right Arm Middle Strut, RC = Right Arm Bottom Strut)

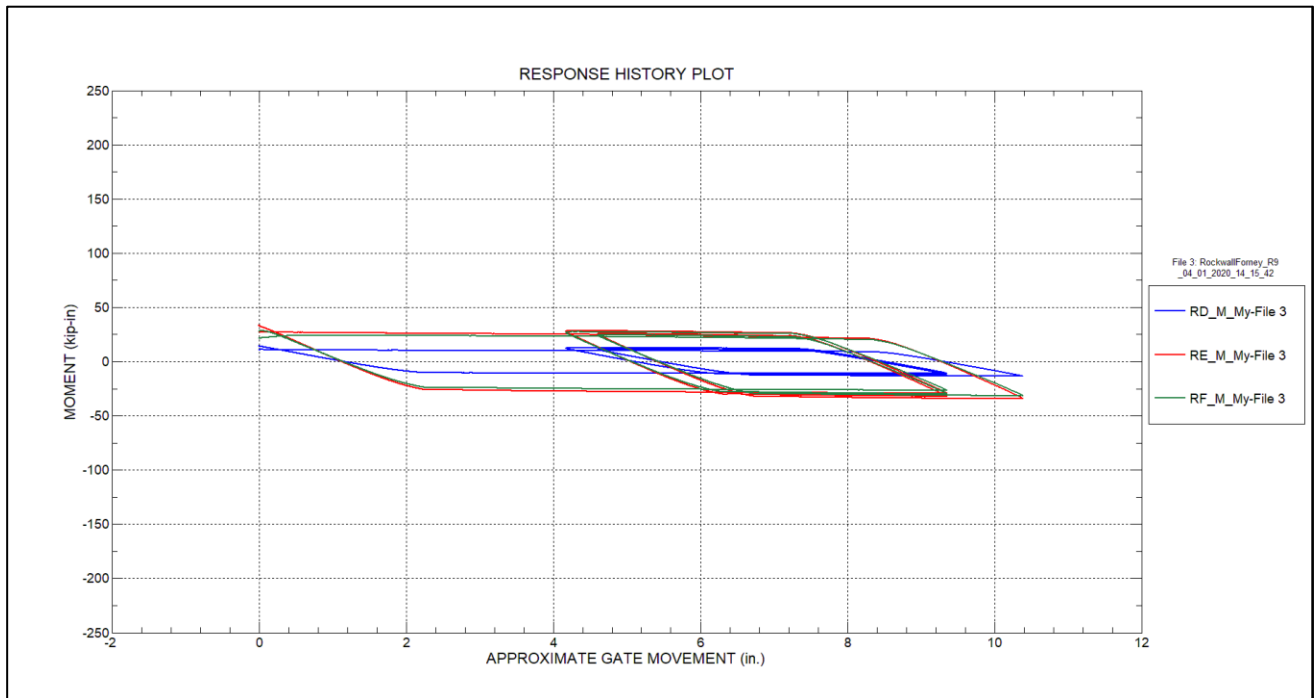
Figure 15 – In-plane moment response history – Right arm – Sections away from pin
(RD = Right Arm Top Strut, RE = Right Arm Middle Strut, RF = Right Arm Bottom Strut)

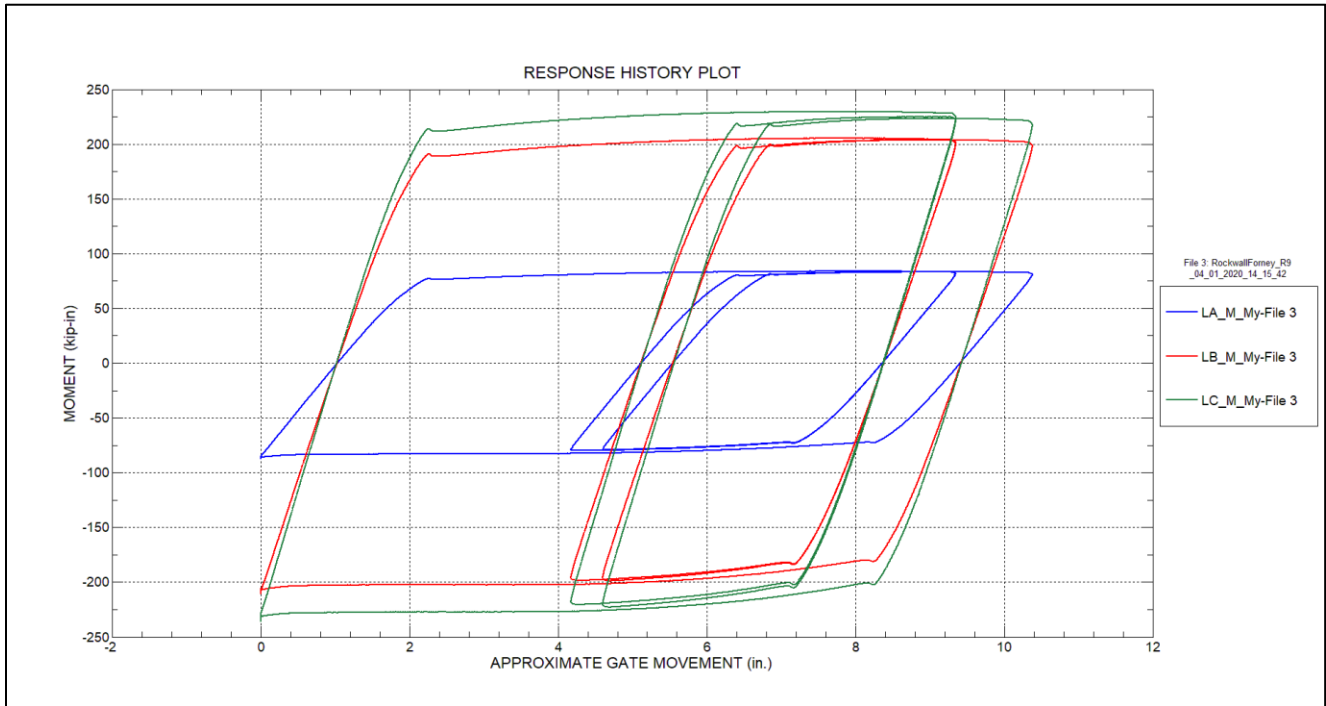
Figure 16 – In-plane moment response history – Left arm – Sections near pin
(LA = Left Arm Top Strut, LB = Left Arm Middle Strut, LC = Left Arm Bottom Strut)

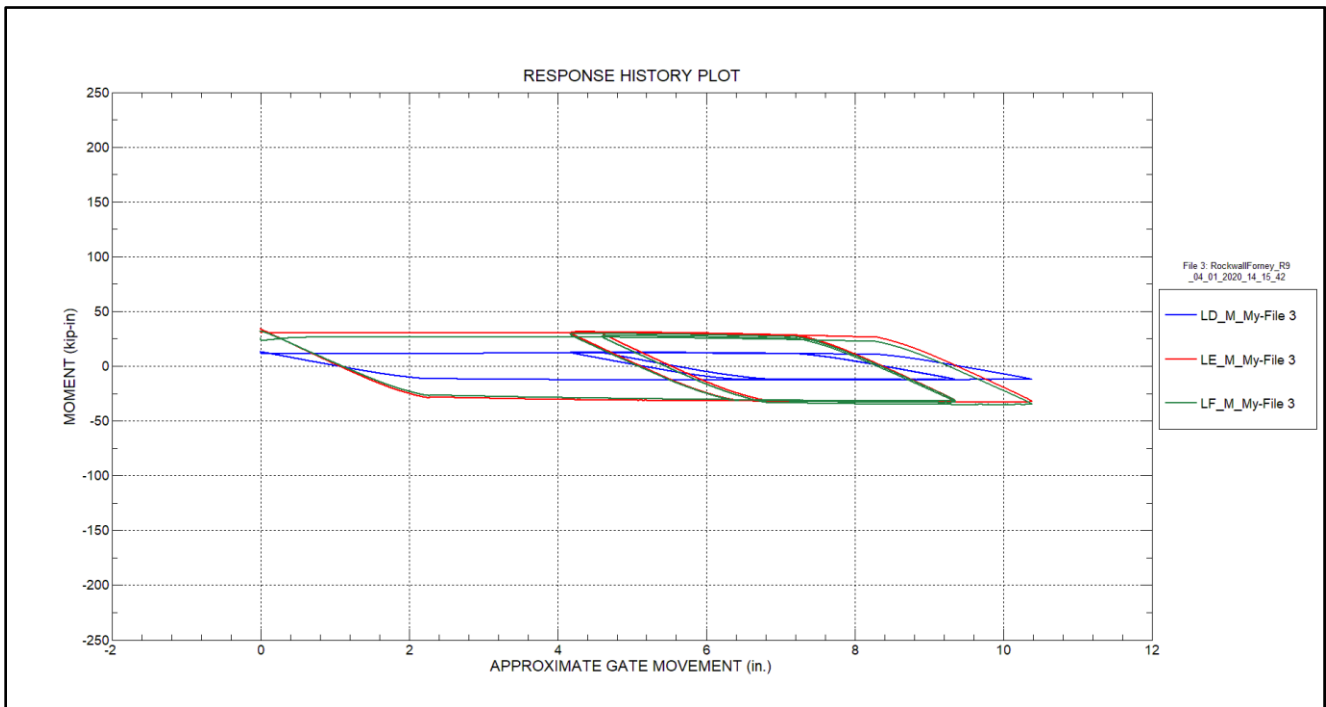
Figure 17 - In-plane moment response history – Left arm – Sections away from pin
(LD = Left Arm Top Strut, LE = Left Arm Middle Strut, LF = Left Arm Bottom Strut)

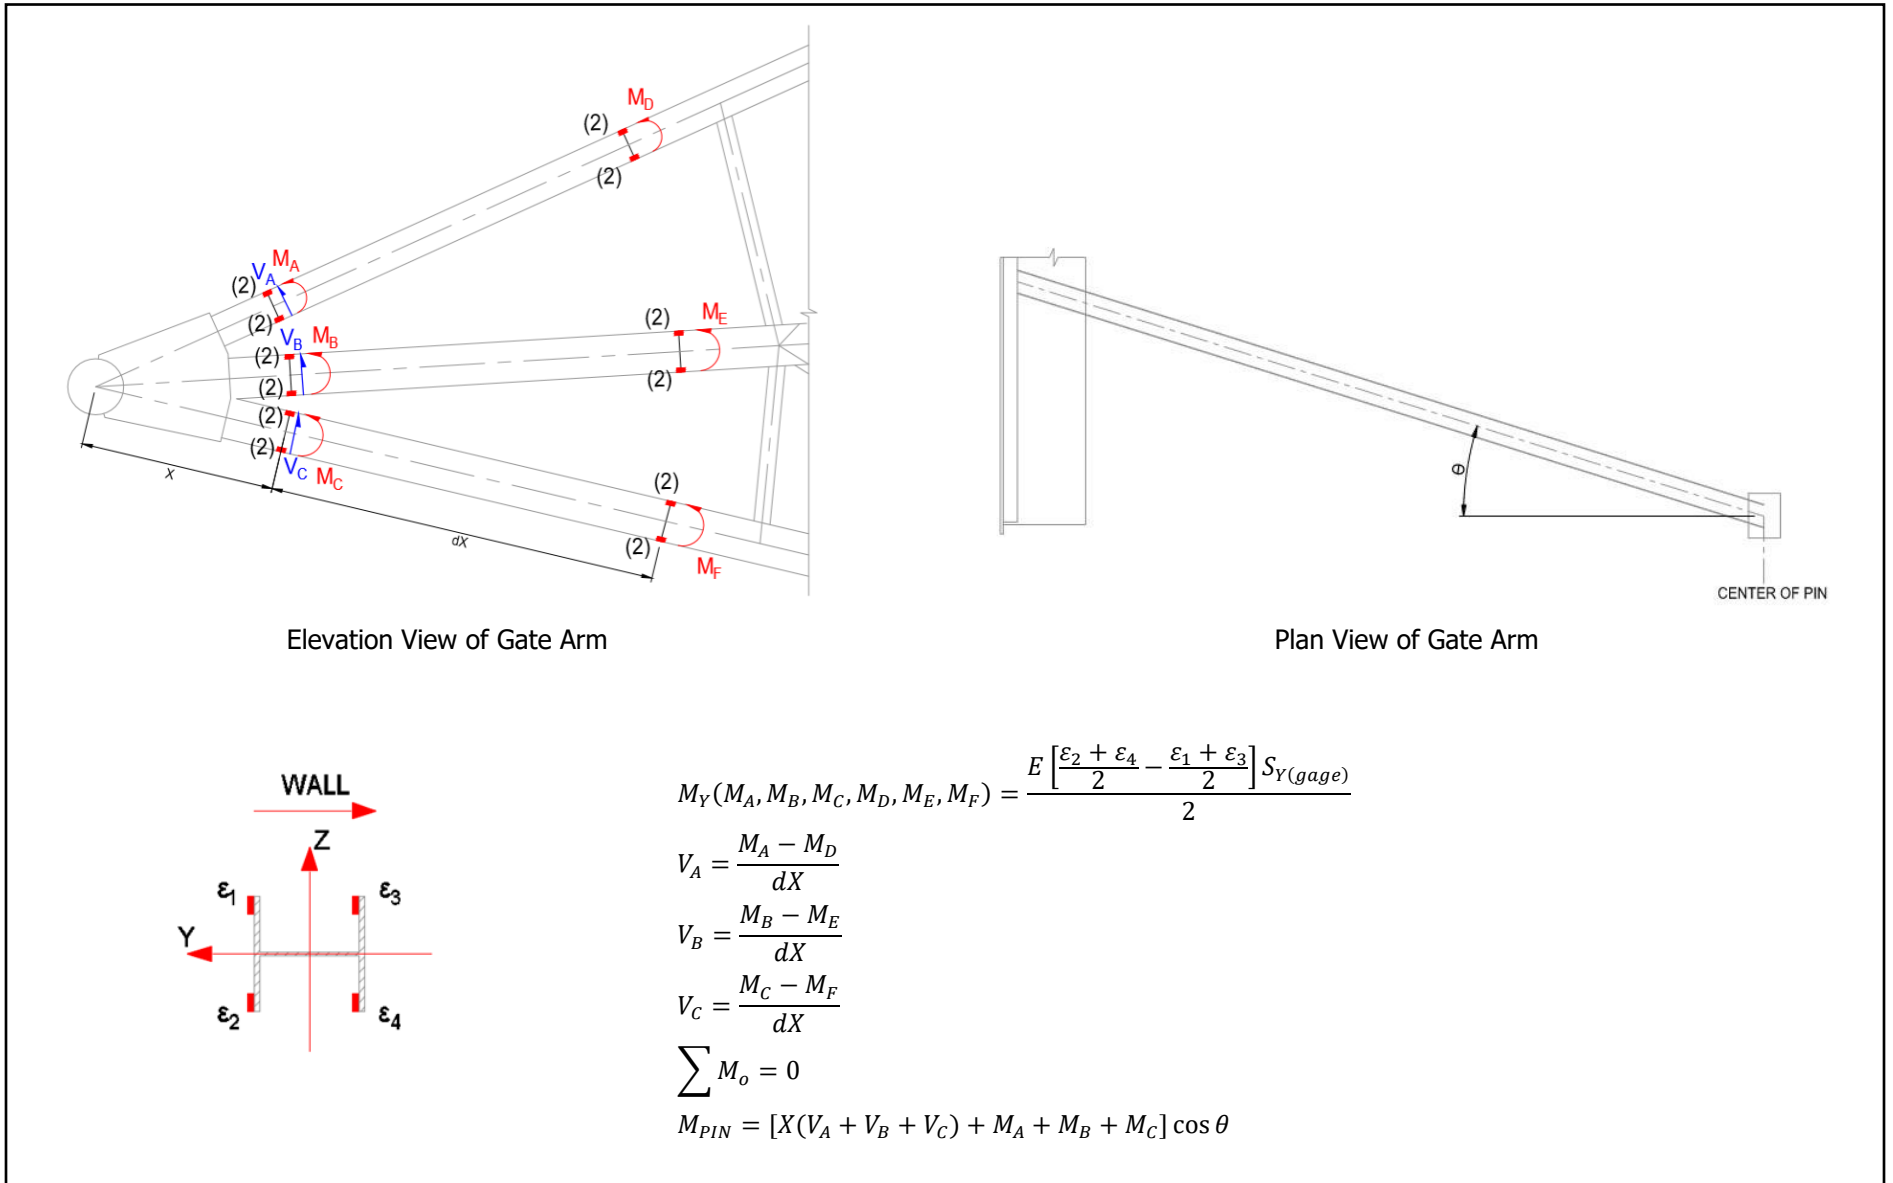
Figure 18 – Direct calculation of pin moment from strain measurements

- + **TRUNNION FREE-BODY-DIAGRAM & PIN MOMENT CALCULATION:** Figure 18 shows the instrumented member cross-sections and shows how the measured cross-sectional flexural responses were used to compute pin moment. The in-plane moment values used in these calculations were determined directly from the strain measurements at each cross-section using the provided mechanics equations. It should be noted that the out-of-plane moments were not considered in the calculation of pin moment since they were orthogonal to the axis of the pin rotation. Total pin moment was then determined by summing all the moment components about the pin, which included the in-plane moment and the shear components at the strut cross-sections nearest the pin.

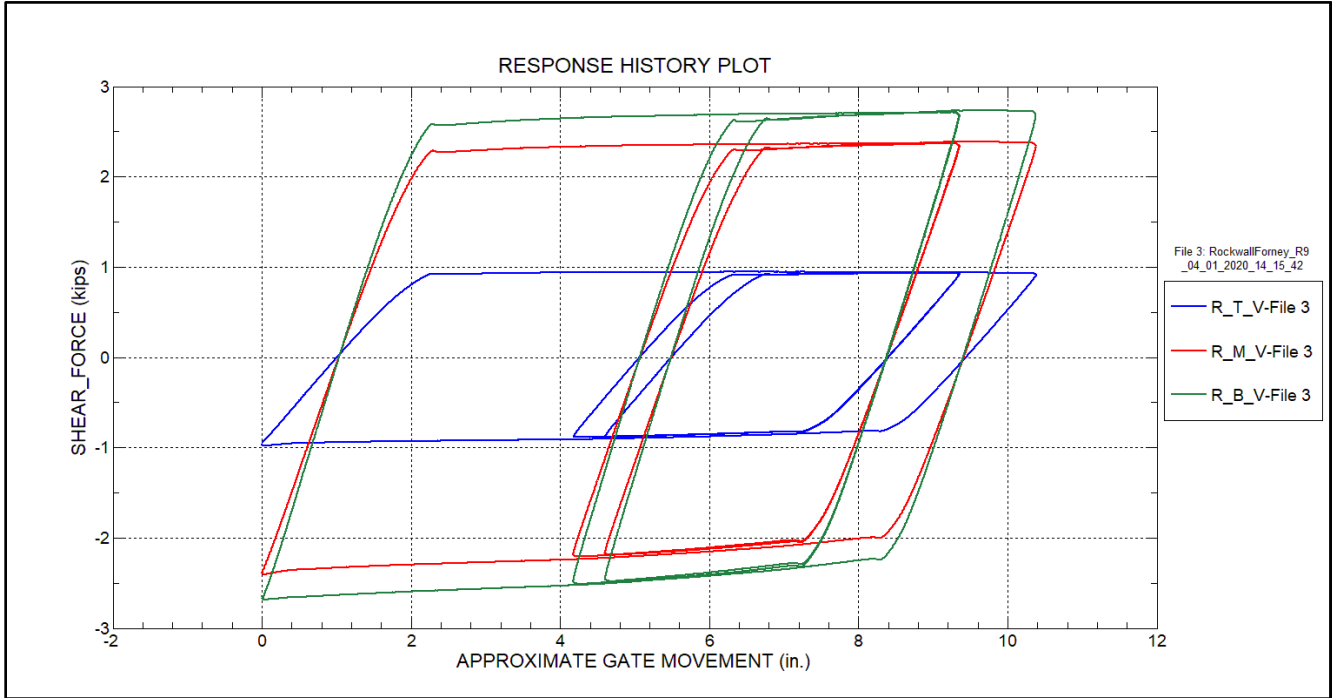
Figure 19 – Strut shear response history – Right arm

(R_T = Right Arm Top Strut, R_M = Right Arm Middle Strut, R_B = Right Arm Bottom Strut)
