VISUAL INSPECTION AND EVALUATION REPORT

Rockwall-Forney Dam
Dallas Water Utilities
Dallas/Kaufman Counties, Texas

Schnabel Reference #20C22001.00
July 30, 2021

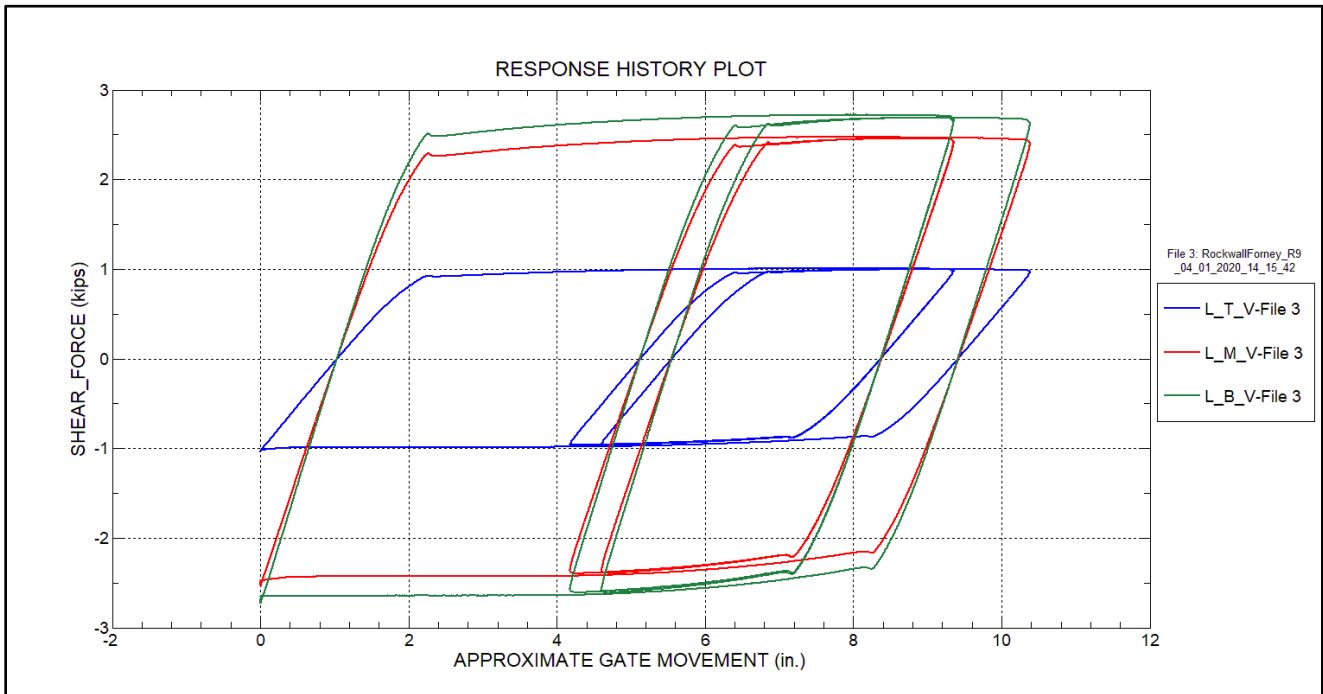
Figure 20 – Strut shear response history – Left arm

(L_T = Left Arm Top Strut, L_M = Left Arm Middle Strut, L_B = Left Arm Bottom Strut)

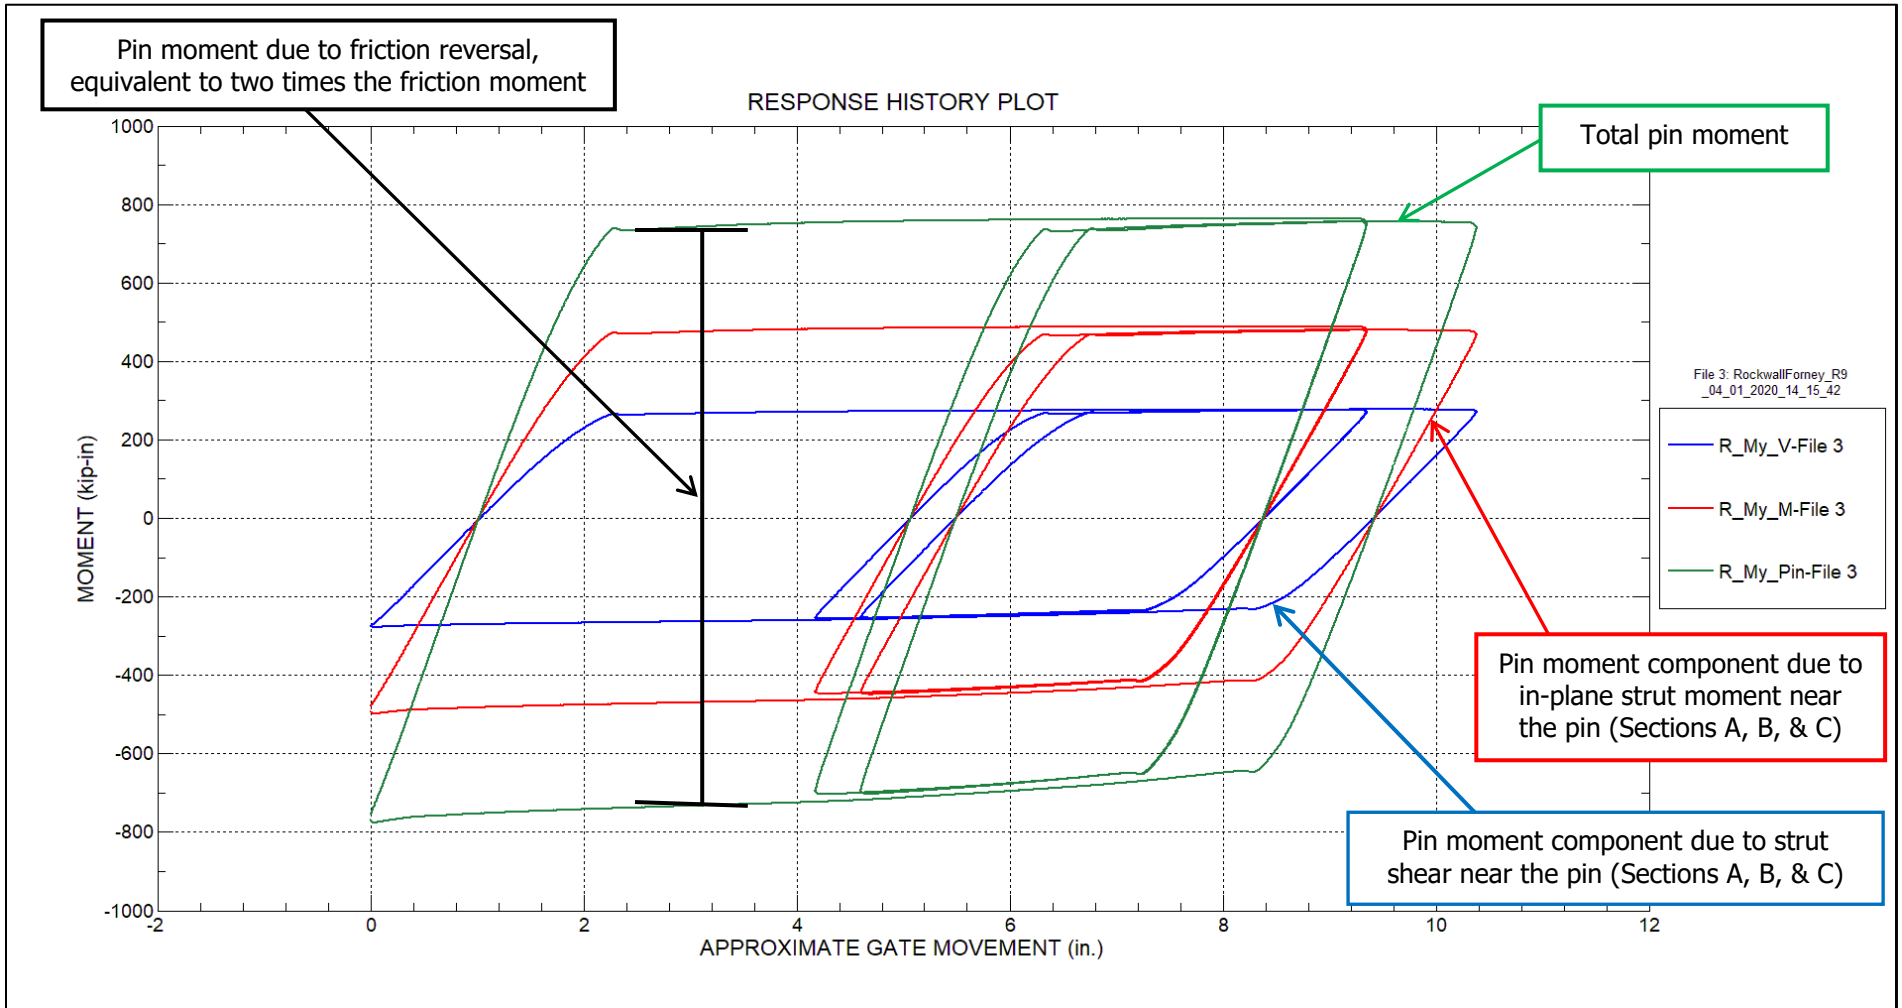
Figure 21 – Pin moment response history – Right arm

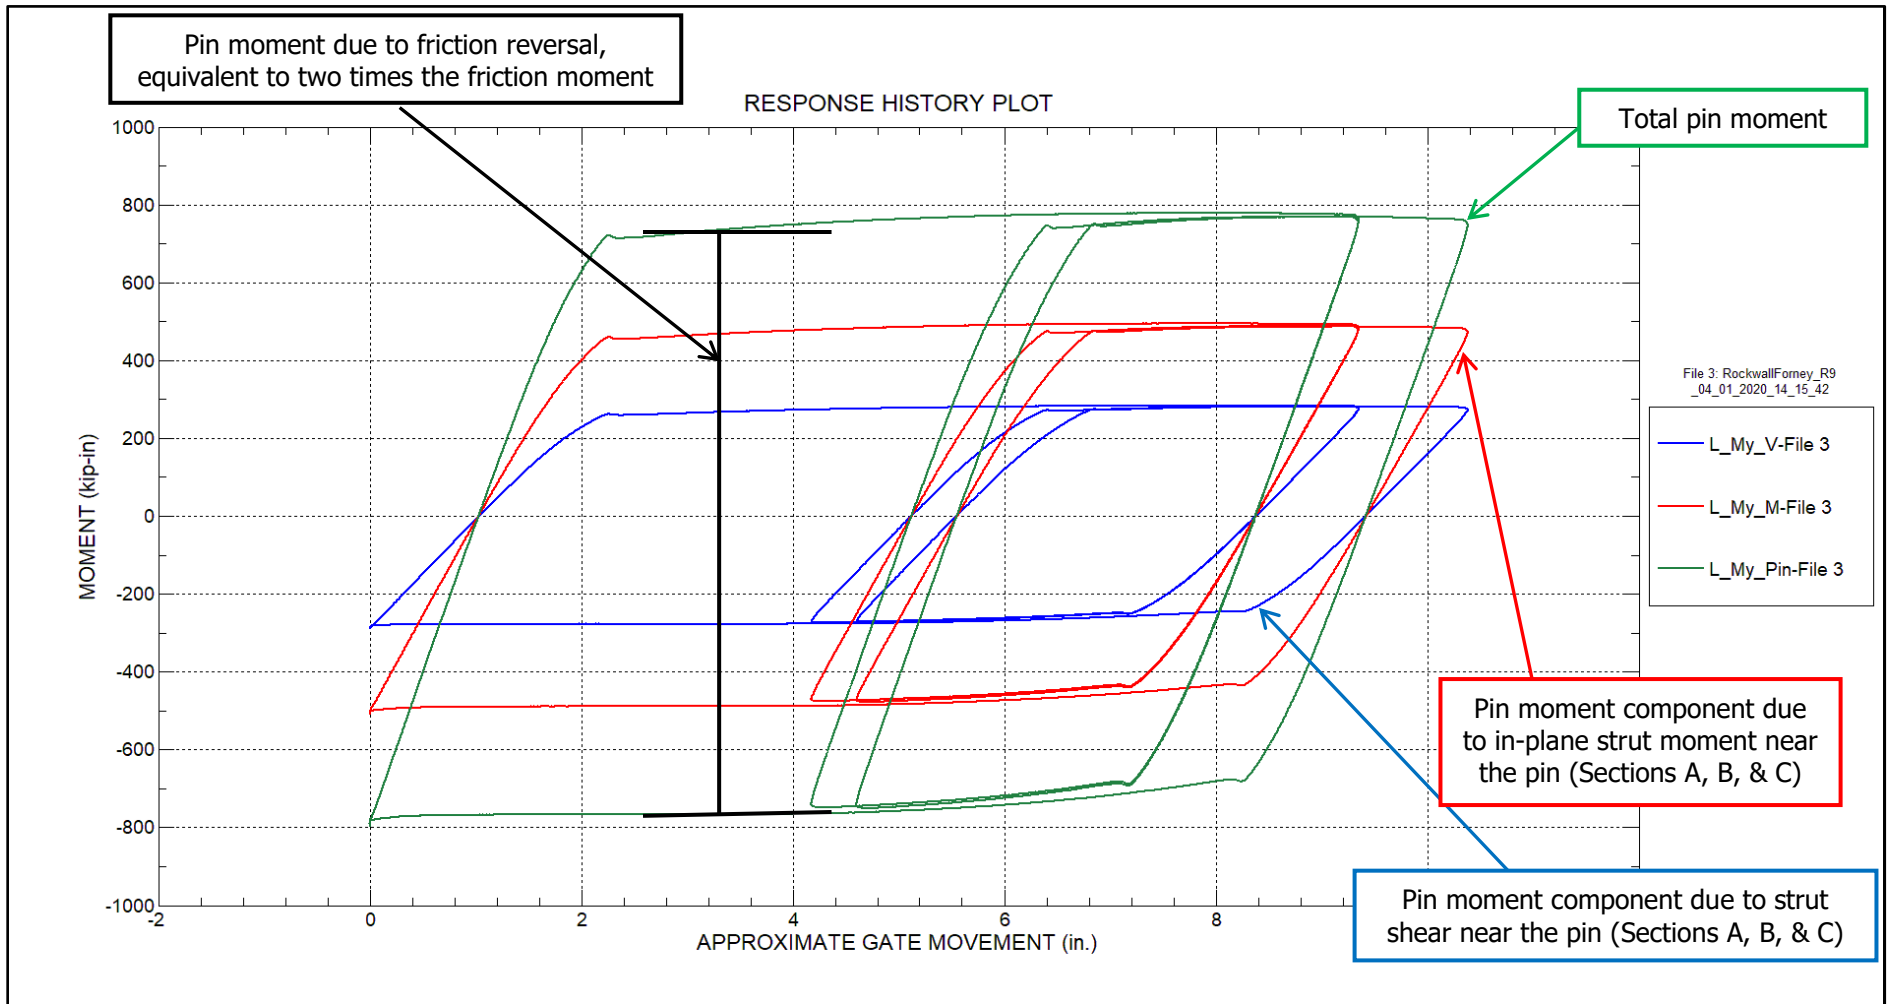
Figure 22 – Pin moment response history – Left arm

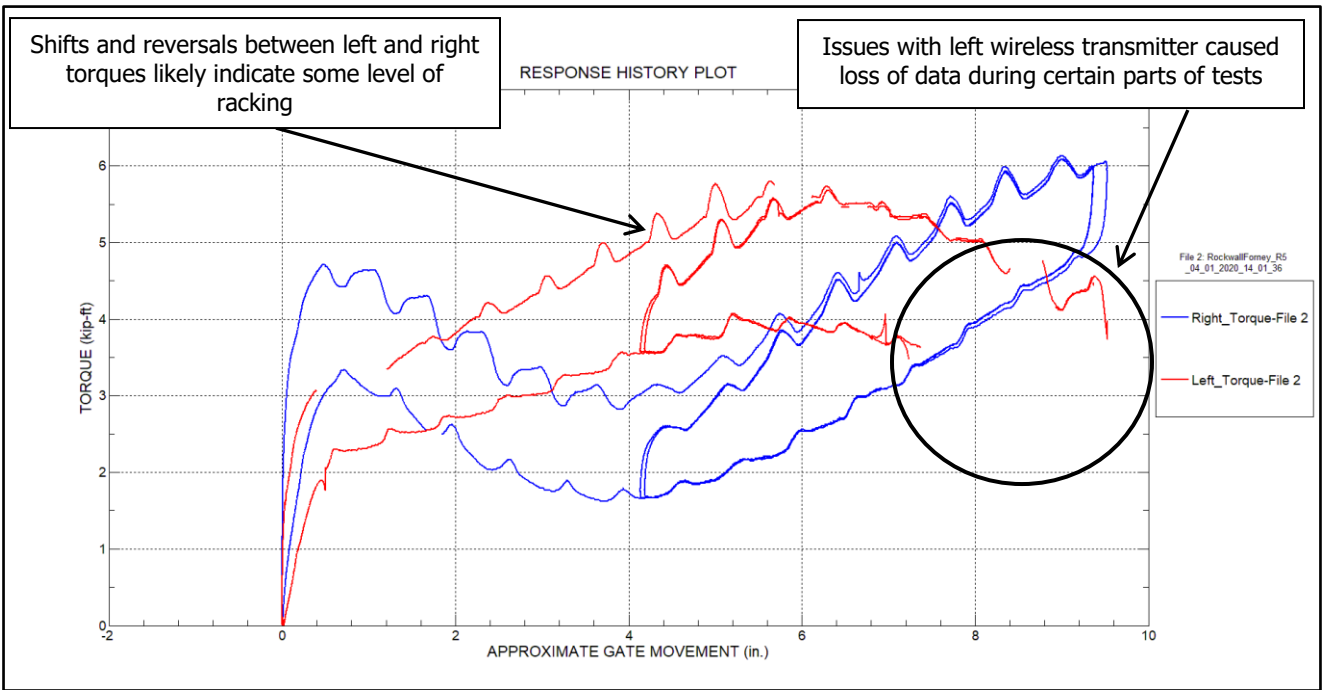
Figure 23 – Hoist torque response history – Gate 1 – Test 2

Note: missing left hoist data due to wireless connectivity issues as the sensor rotated with the pinion shaft

Figure 23 shows example torque measurements, recorded on the Gate 1 torque shafts. Best practices for torque measurements is to measure torque on opposite sides of the shaft so that any bending in the shaft can be removed by averaging the two responses. Due to access limitations, only one gage at each location could be installed. Therefore, any bending in the shaft may be reflected in the torque measurements and may be related to the peaks and valleys observed in the torque responses.

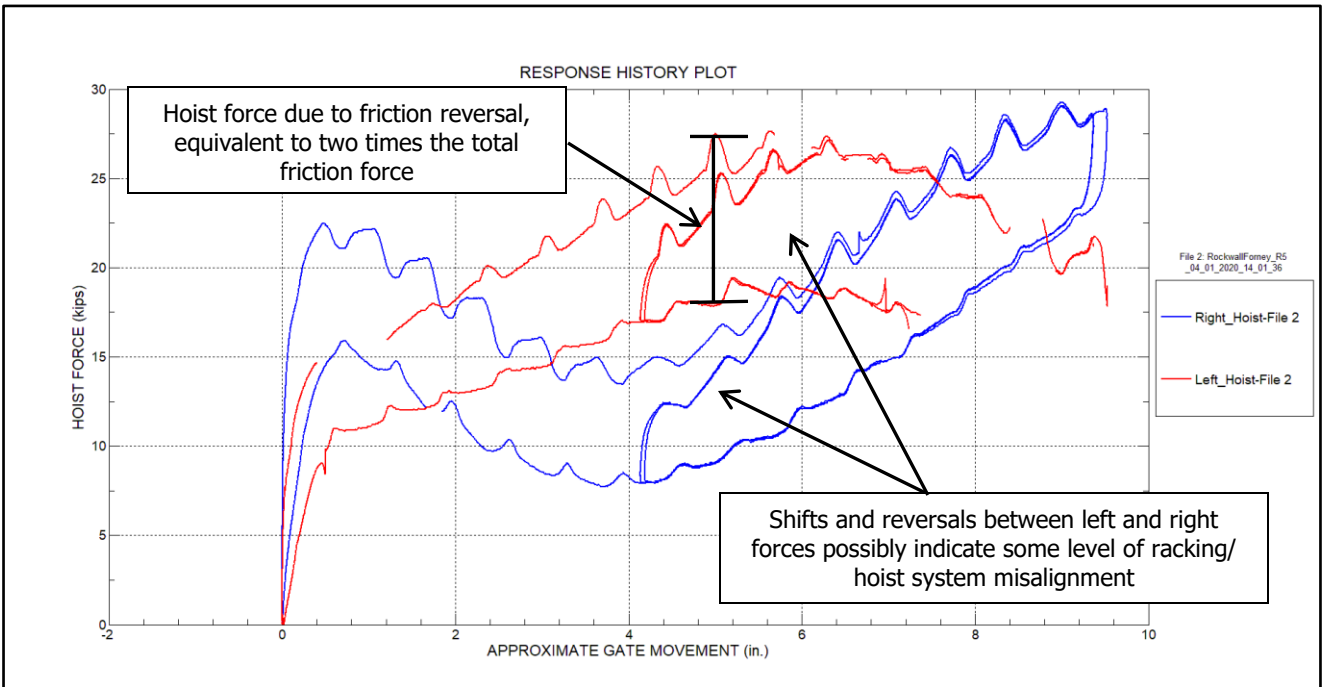
Figure 24 – Hoist force response history – Gate 1 – Test 2

Note: missing left hoist data due to wireless connectivity issues as the sensor rotated with the pinion shaft

- + **TORQUE AND HOIST FORCE:** Due to restrictions caused by the hoist limit switches, the hoist cables could not always be fully slacked at the beginning and end of the performed tests. Throughout testing of the Rockwell Forney gates, it was found that this limit switch restriction varied gate to gate and arm to arm. Therefore, it is not recommended to use the collected torque and hoist force data to quantify overall hoist forces. Rather, this data was utilized to evaluate total friction behavior, which is observed as half the difference between the lifting and lowering torque/force (friction reversal). Torque measurements taken at the hoist pinion shafts, and the derived hoist forces, had a certain degree of shifting and reversals between arms as shown in Figure 23 and Figure 24. This observed behavior indicated some level of racking/hoist system alignment issues in the gate as

Torque values were converted to force in the hoist cables per gate arm using the gear ratio and drum radius, as shown in Figure 24. The gear ratio and drum radius were 5.182 and 1.086 feet respectively, as defined in the provided as-built shop drawings. It should be noted that the hoist force calculated may be smaller than the actual hoist force applied. This difference is due to the limit switch engaging the brake before the hoist cable was fully slacked, resulting in an initial force in the cable. A hoist force due to total gate friction was then calculated. This friction hoist force was equal to half the differential in force measured during the lifting and lowering of the gate (similar to the pin friction calculations). As shown in Table 3, the change in cable force due to friction was generally consistent between tests. Note that the total hoist force was due to the total friction effects, including side seal, hoist bearings, trunnion friction effects, etc. It is difficult to determine the exact proportion and composition of the total friction sources. Additional torque and hoist force plots for all collected data files are provided in Appendix A – Gate 1 Torque and Hoist Force Plots.

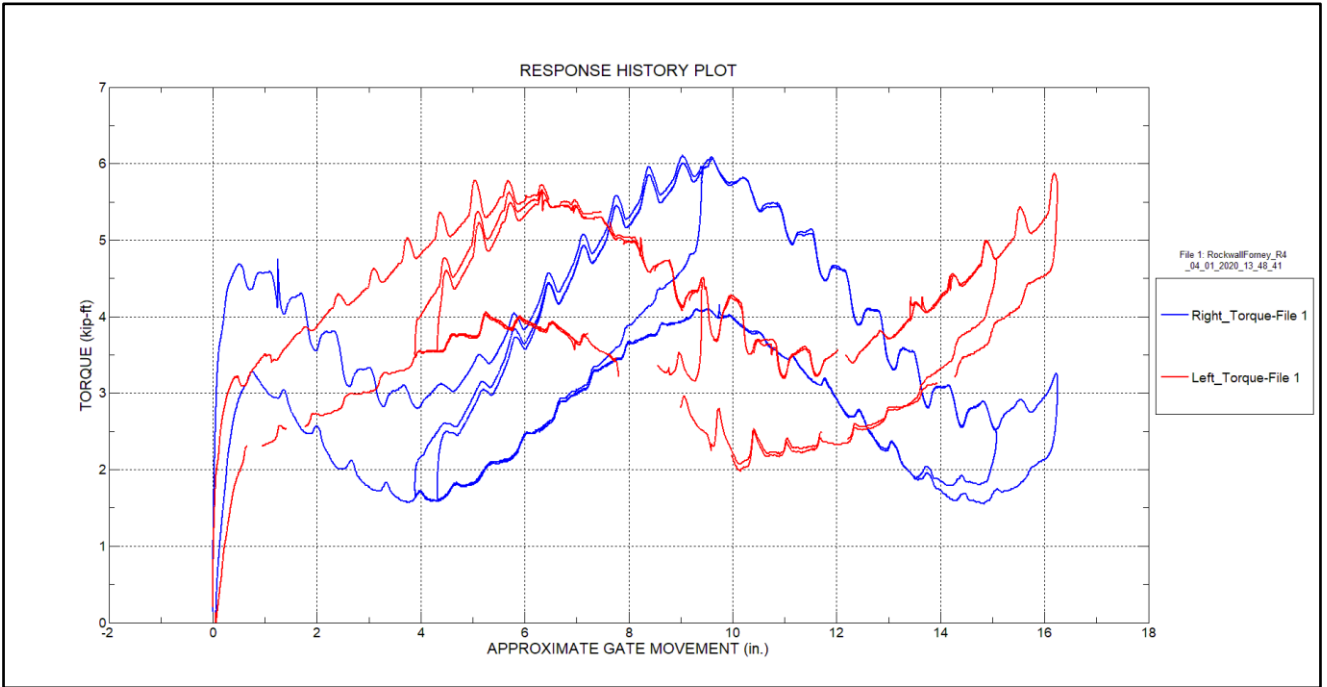
Figure 25 – Hoist torque response history – Gate 1 – Test 1

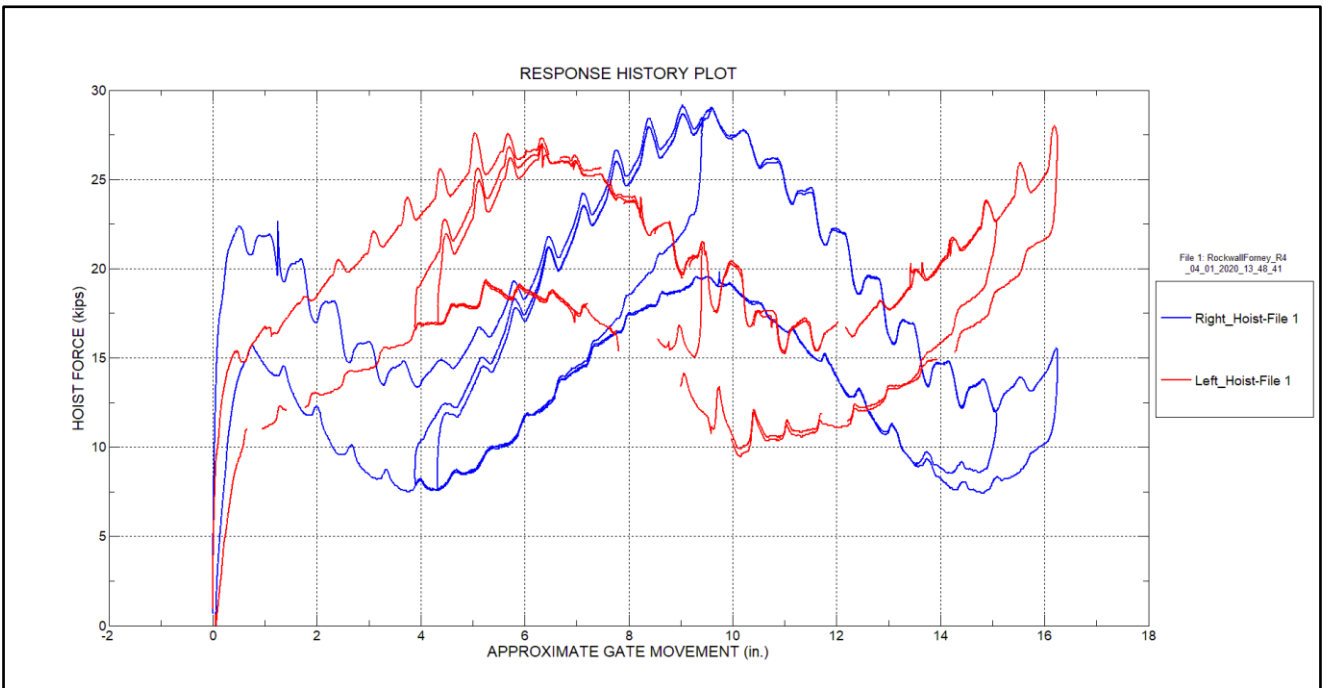
Figure 26 – Hoist force response history – Gate 1 – Test 1

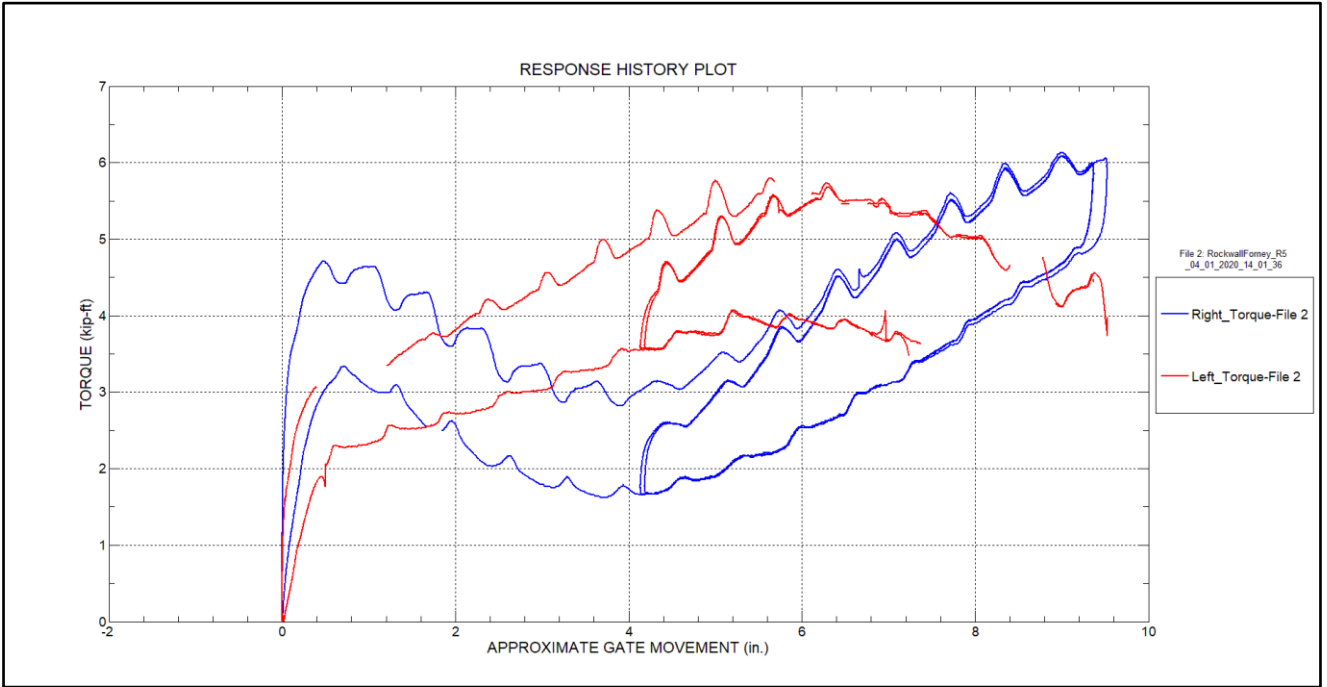
Figure 27 – Hoist torque response history – Gate 1 – Test 2

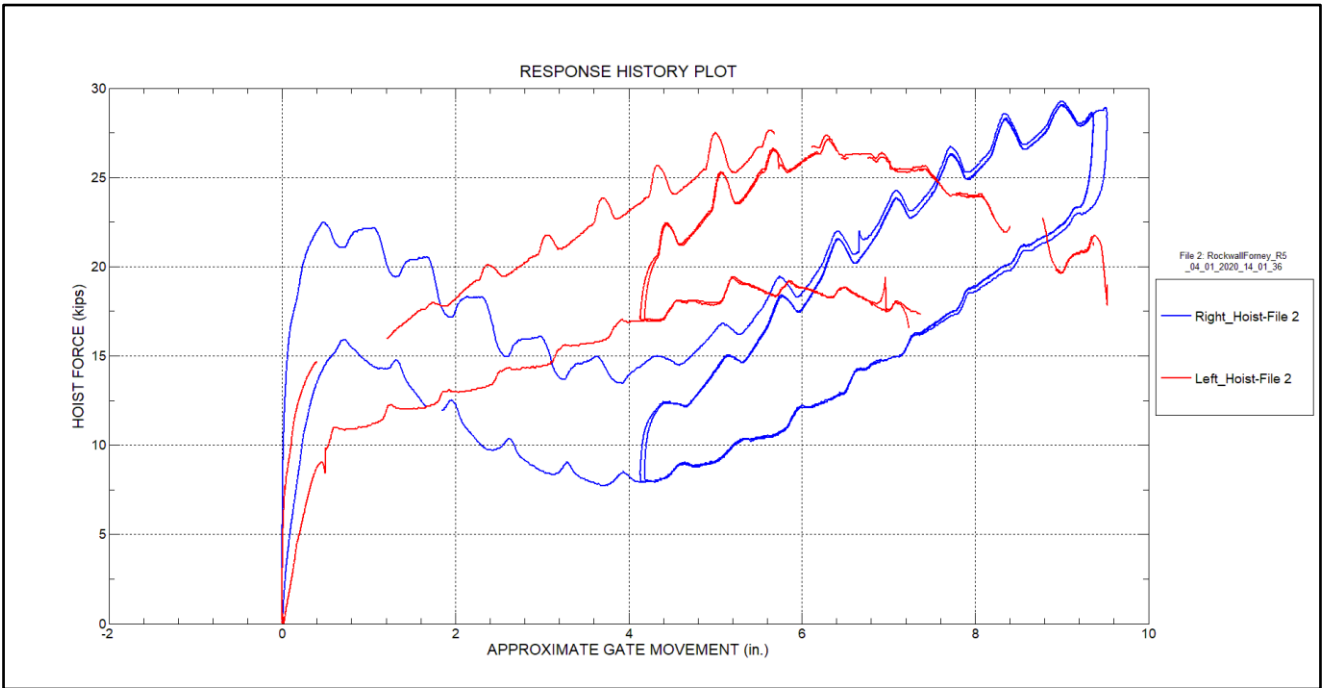
Figure 28 – Hoist force response history – Gate 1 – Test 2

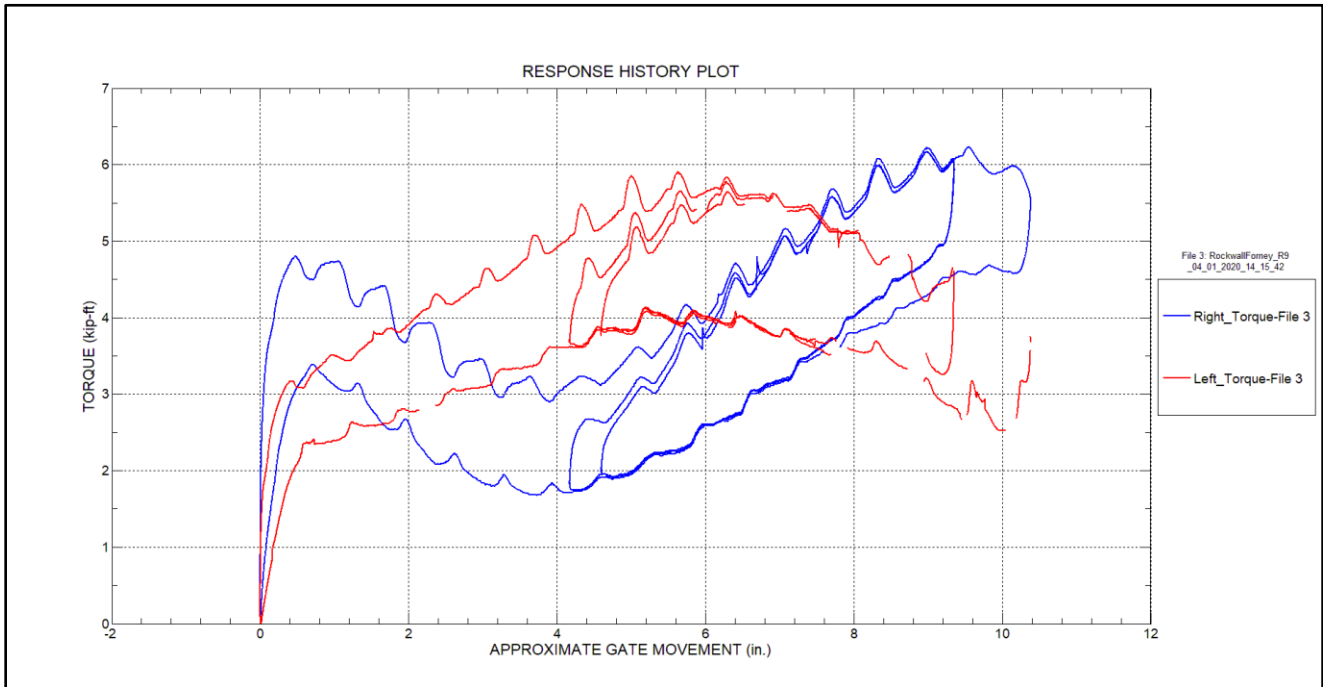
Figure 29 – Hoist torque response history – Gate 1 – Test 3

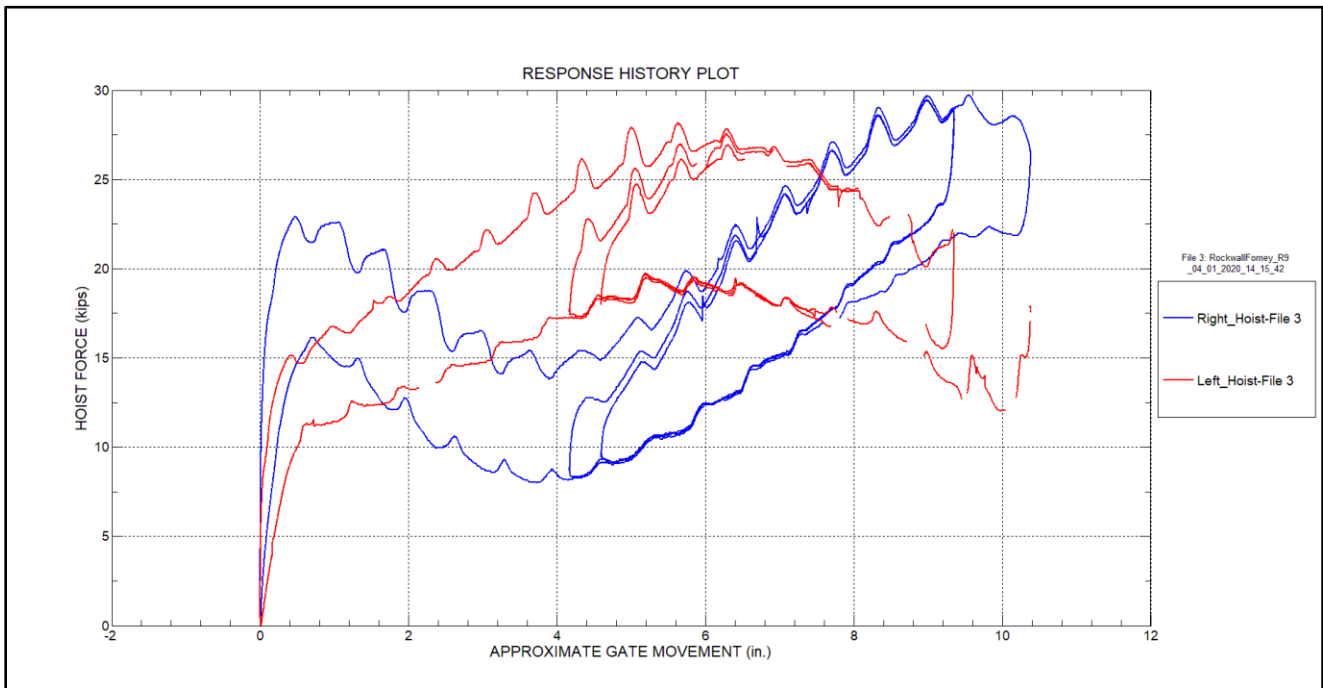
Figure 30 – Hoist force response history – Gate 1 – Test 3

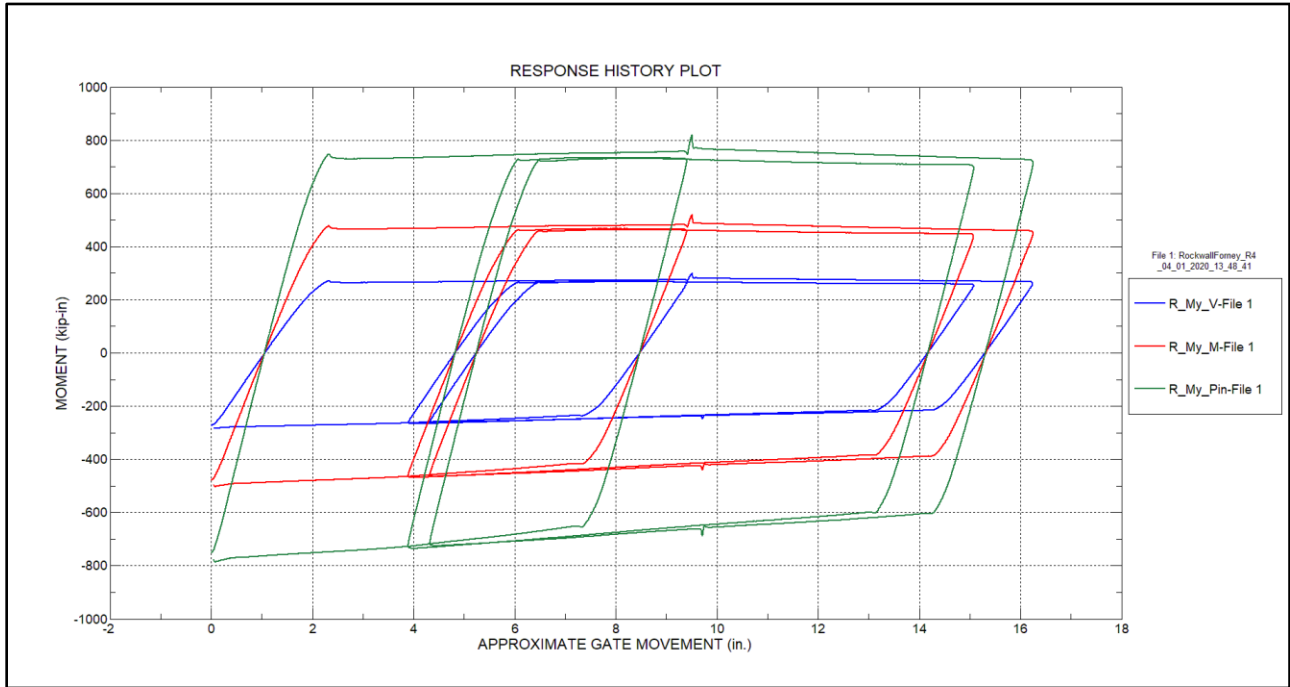
Figure 31 – Pin moment response history – Right arm – Test run 1

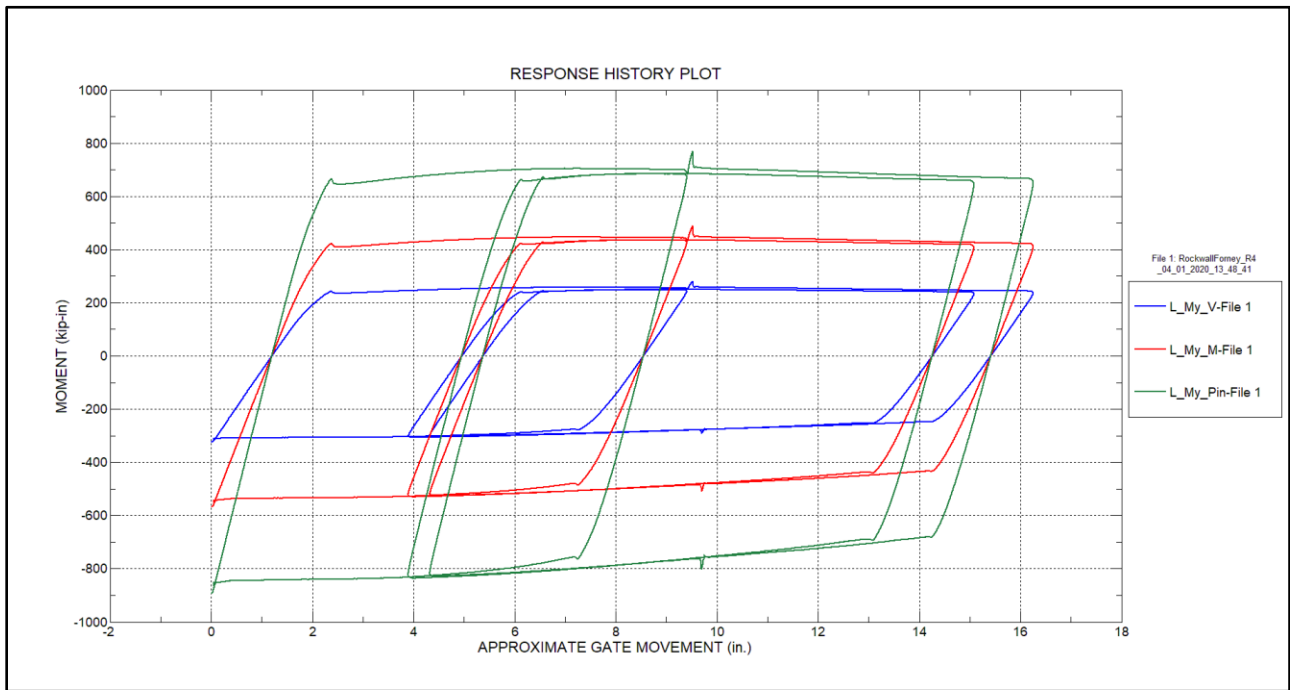
Figure 32 – Pin moment response history – Left arm – Test run 1

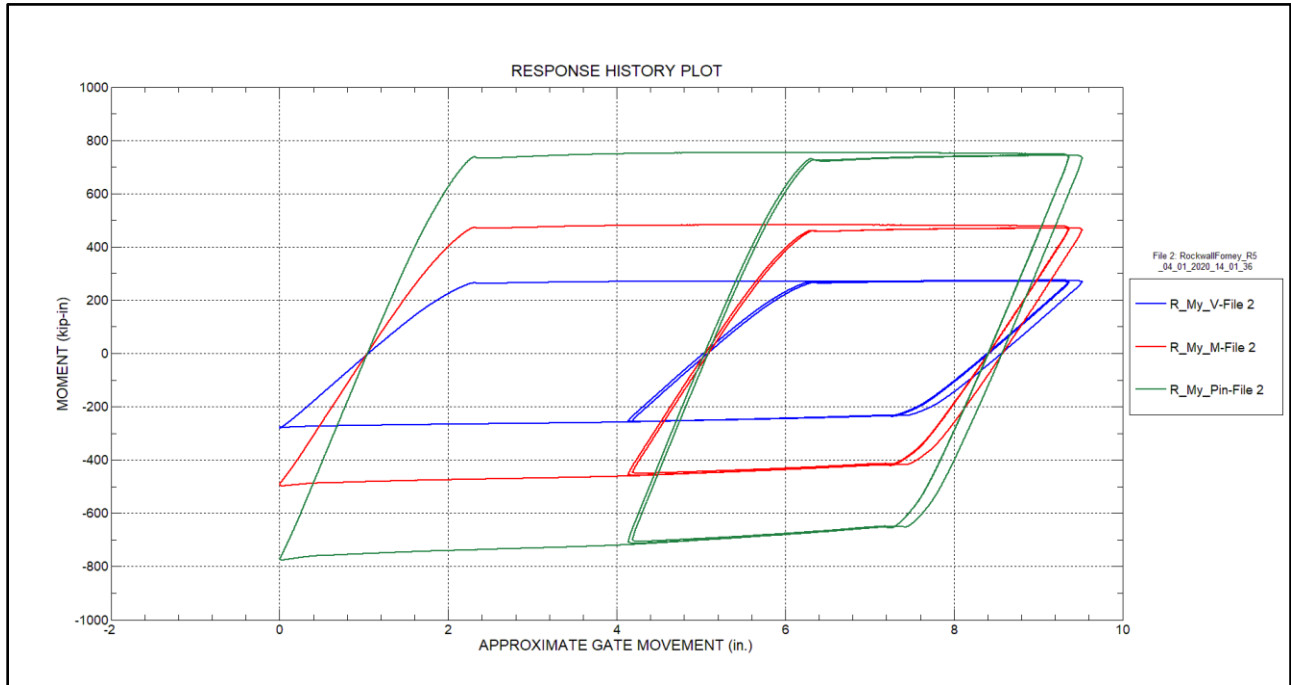
Figure 33 – Pin moment response history – Right arm – Test run 2

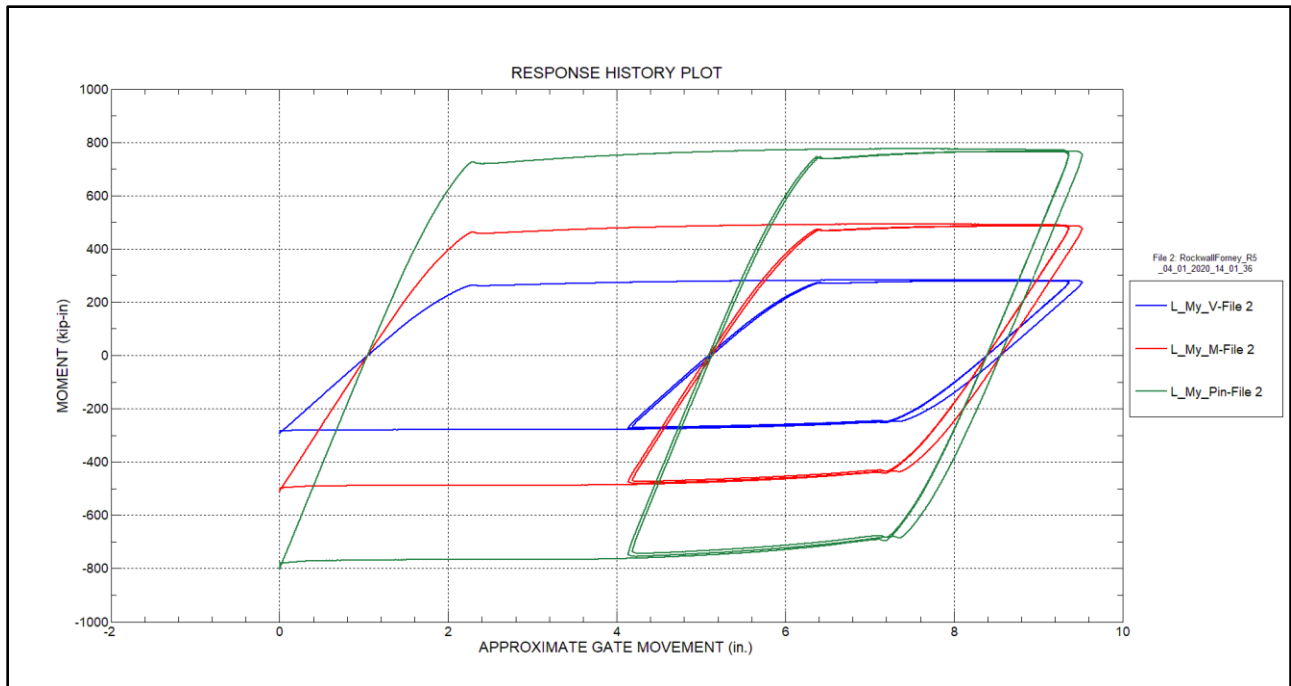
Figure 34 – Pin moment response history – Left arm – Test run 2

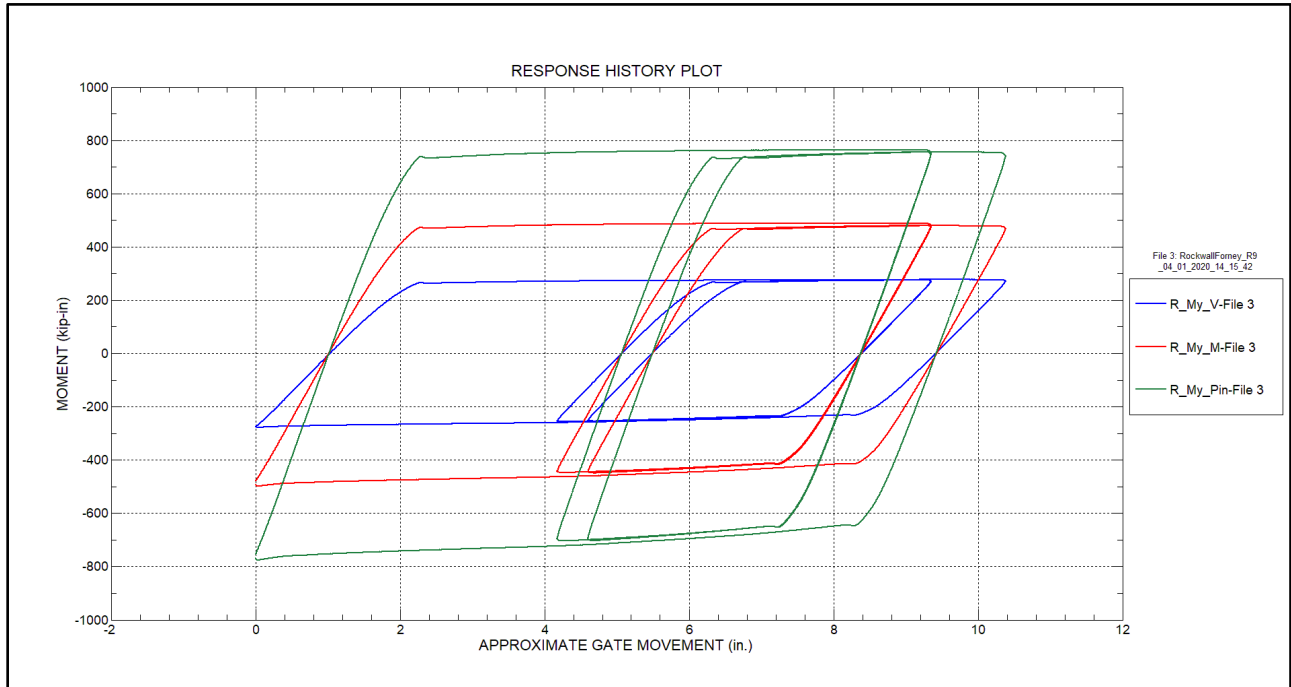
Figure 35 – Pin moment response history – Right arm – Test run 3

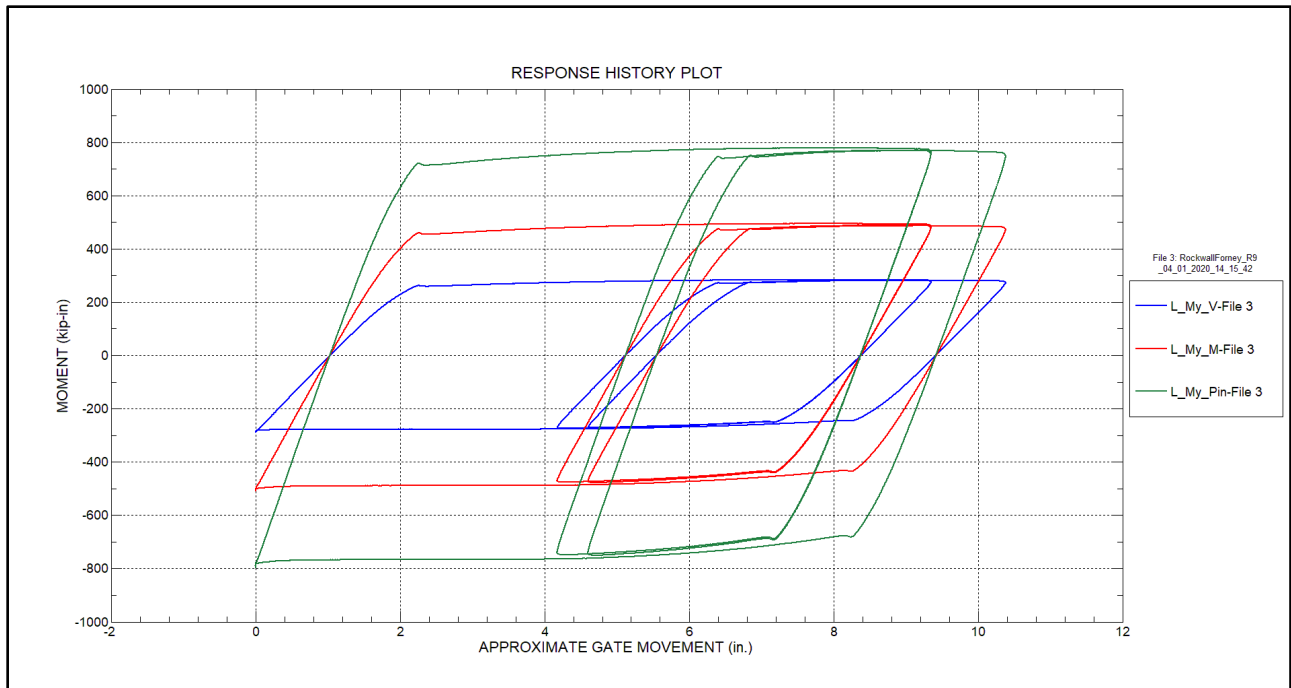
Figure 36 – Pin moment response history – Left arm – Test run 3

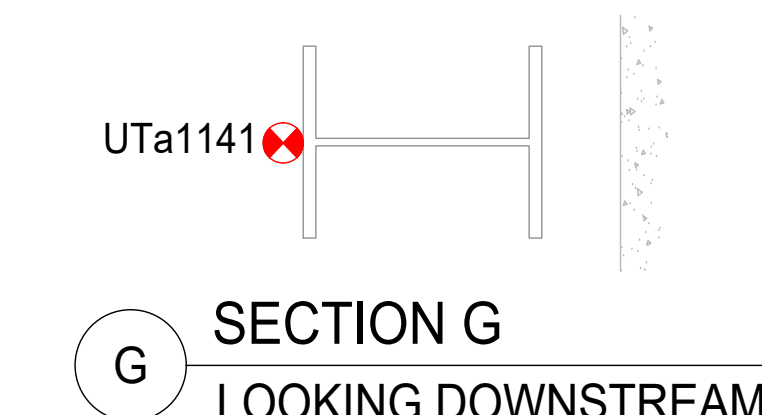
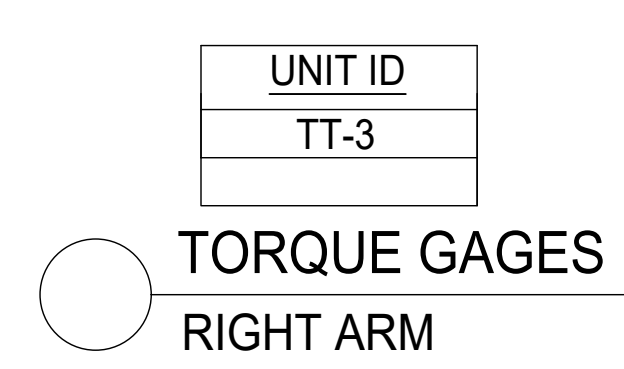
1. SECTIONS A, B, & C SHALL BE INSTALLED 15 INCHES AWAY FROM TRUNNION PLATE.
2. TILTMETERS SHALL BE INSTALLED CENTERED ON THE MIDDLE STRUT FLANGE.
3. SECTION G'S TILTMETER SHALL BE INSTALLED AS CLOSE TO THE SKINPLATE AS POSSIBLE.

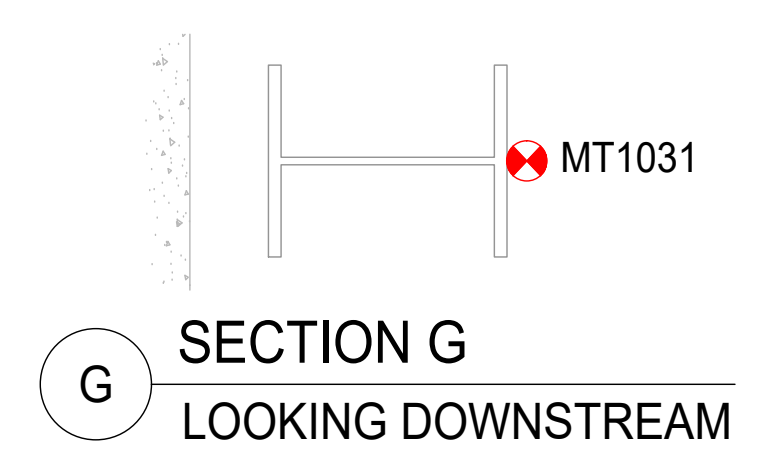
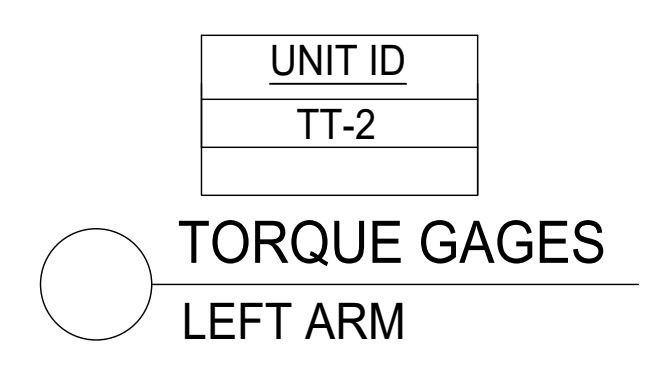
- NOTES:**
1. SECTIONS A, B, & C SHALL BE INSTALLED 15 INCHES AWAY FROM TRUNNION PLATE.
 2. TILTMETERS SHALL BE INSTALLED CENTERED ON THE MIDDLE STRUT FLANGE.
 3. SECTION G'S TILTMETER SHALL BE INSTALLED AS CLOSE TO THE SKINPLATE AS POSSIBLE.

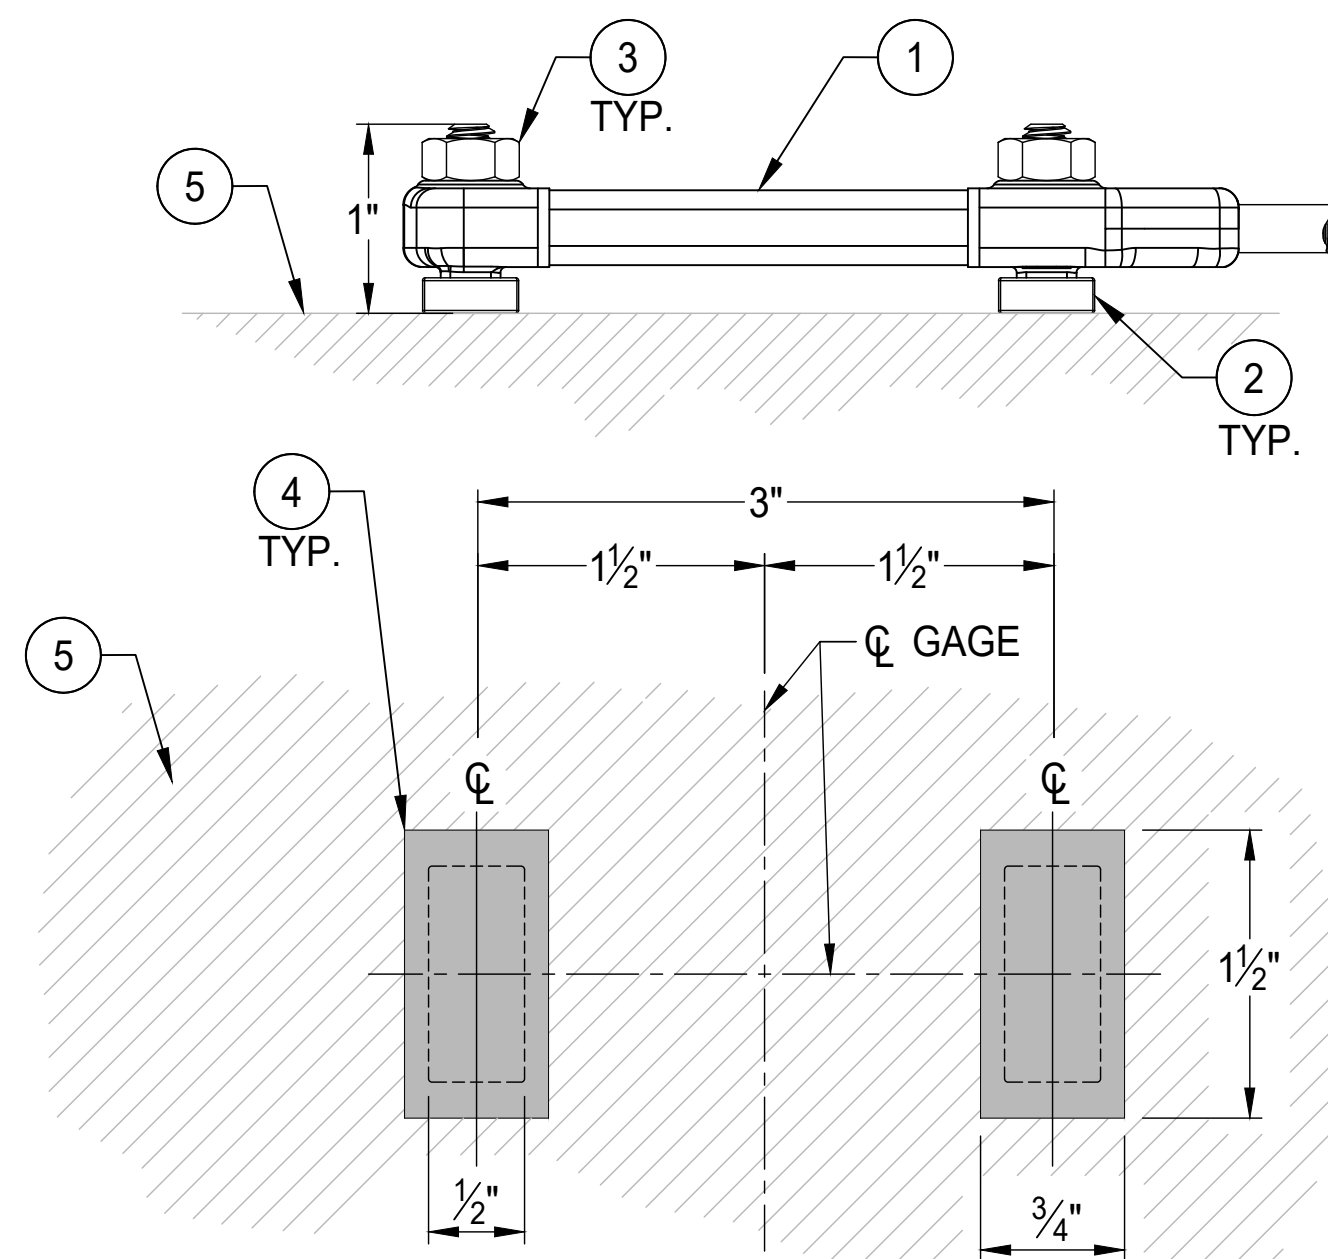
1 TYPICAL ST350 STRAIN GAGE INSTALLATION

1. ST350 STRAIN GAGE
2. 1/4"-20 THREADED MOUNTING TAB
3. 1/4"-20 STAINLESS STEEL NUT
4. TYPICAL SURFACE PREP REQUIRED TO MOUNT STRAIN GAGES
5. TYPICAL MOUNTING SURFACE

1. STRAIN GAGES SHALL BE MOUNTED WITH LOCTITE 410 INSTANT ADHESIVE AND LOCTITE 7452 ACCELERANT
2. DURING SURFACE PREP ALL PAINT AND SURFACE DEFORMATIONS MUST BE REMOVED.
3. SURFACE PREP IS REQUIRED JUST PRIOR TO GAGE INSTALLATION AS TO NOT ALLOW SURFACE CONTAMINANTS TO ACCUMULATE.

1. ST350 STRAIN GAGE
2. 1/4"-20 THREADED MOUNTING TAB
3. 1/4"-20 STAINLESS STEEL NUT
4. TYPICAL SURFACE PREP REQUIRED TO MOUNT STRAIN GAGES
5. TYPICAL MOUNTING SURFACE

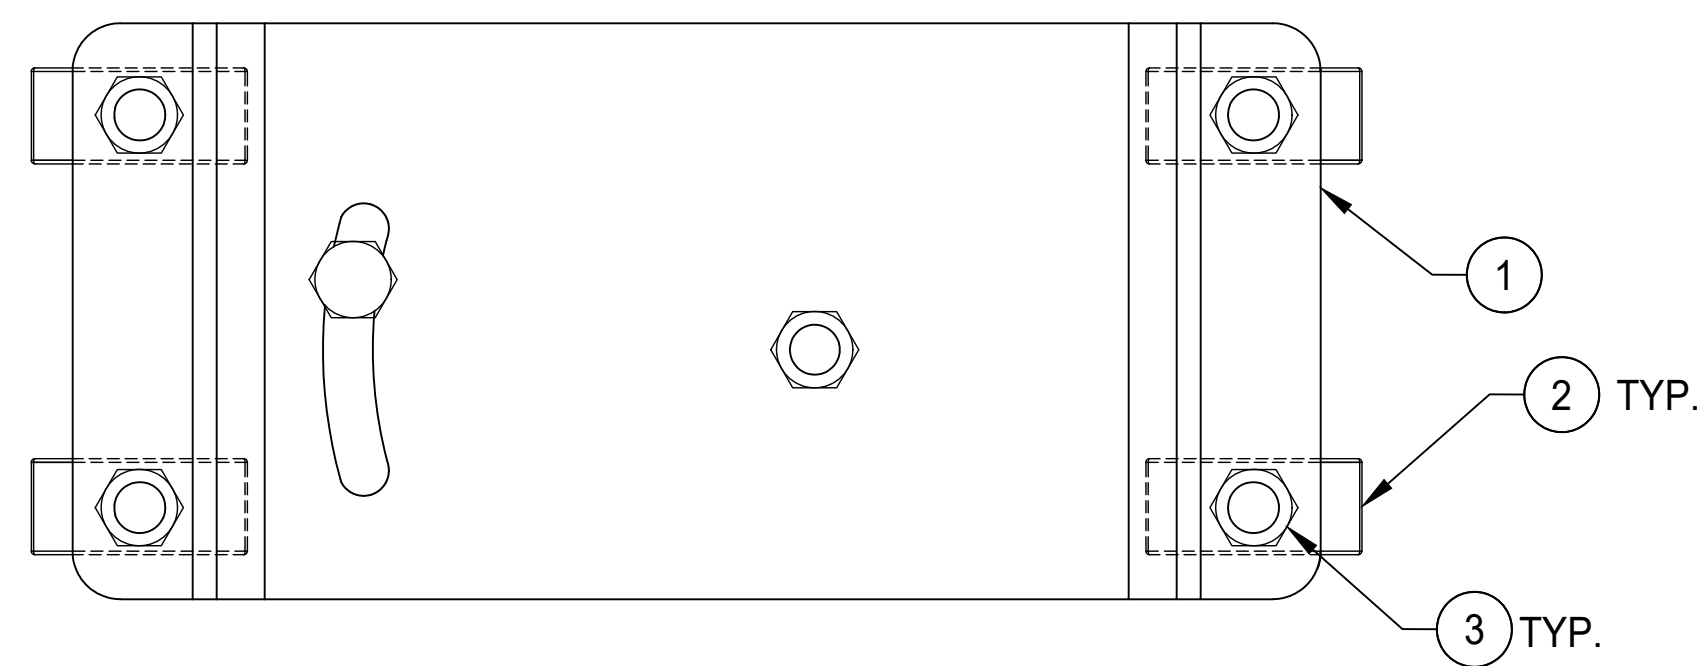
2 TYPICAL BDI TILTMETER INSTALLATION

1. BDI +/- 15 DEGREE TILTMETER WITH COVER AND ADJUSTMENT BOLTS
2. 1/4"-20 THREADED MOUNTING TAB
3. 1/4"-20 STAINLESS STEEL NUT
4. TYPICAL SURFACE PREP REQUIRED TO MOUNT TILTMETERS
5. TYPICAL MOUNTING SURFACE

1. TILTMETERS SHALL BE MOUNTED WITH LOCTITE 410 INSTANT ADHESIVE AND LOCTITE 7452 ACCELERANT
2. DURING SURFACE PREP ALL PAINT AND SURFACE DEFORMATIONS MUST BE REMOVED.
3. SURFACE PREP IS REQUIRED JUST PRIOR TO GAGE INSTALLATION AS TO NOT ALLOW SURFACE CONTAMINANTS TO ACCUMULATE.

1. BDI +/- 15 DEGREE TILTMETER WITH COVER AND ADJUSTMENT BOLTS
2. 1/4"-20 THREADED MOUNTING TAB
3. 1/4"-20 STAINLESS STEEL NUT
4. TYPICAL SURFACE PREP REQUIRED TO MOUNT TILTMETERS
5. TYPICAL MOUNTING SURFACE
